METROPOLITAN COAL

2021 ANNUAL REVIEW

Project No. MET-22-29
Document No. 01127847

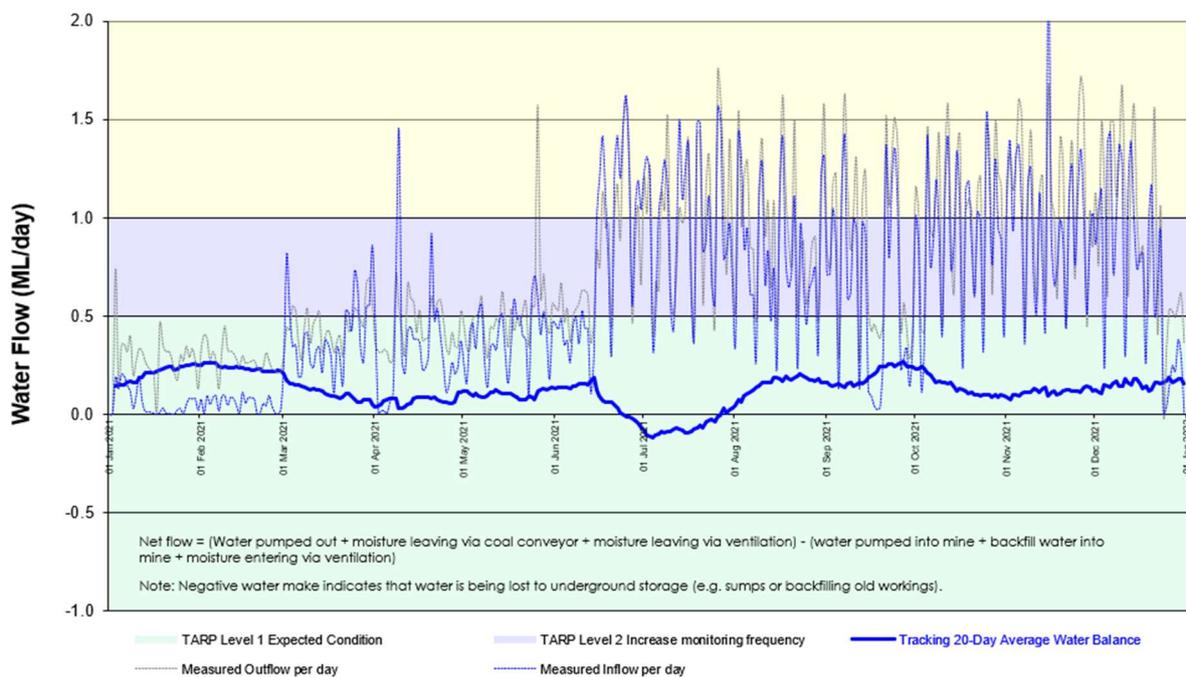
The 20 day average daily mine water make was approximately 0.13 ML/day during the reporting period (i.e. well below the 0.5 ML/day Level 2 TARP trigger) (Chart 69).

Chart 69 Estimated Daily Mine Water Make

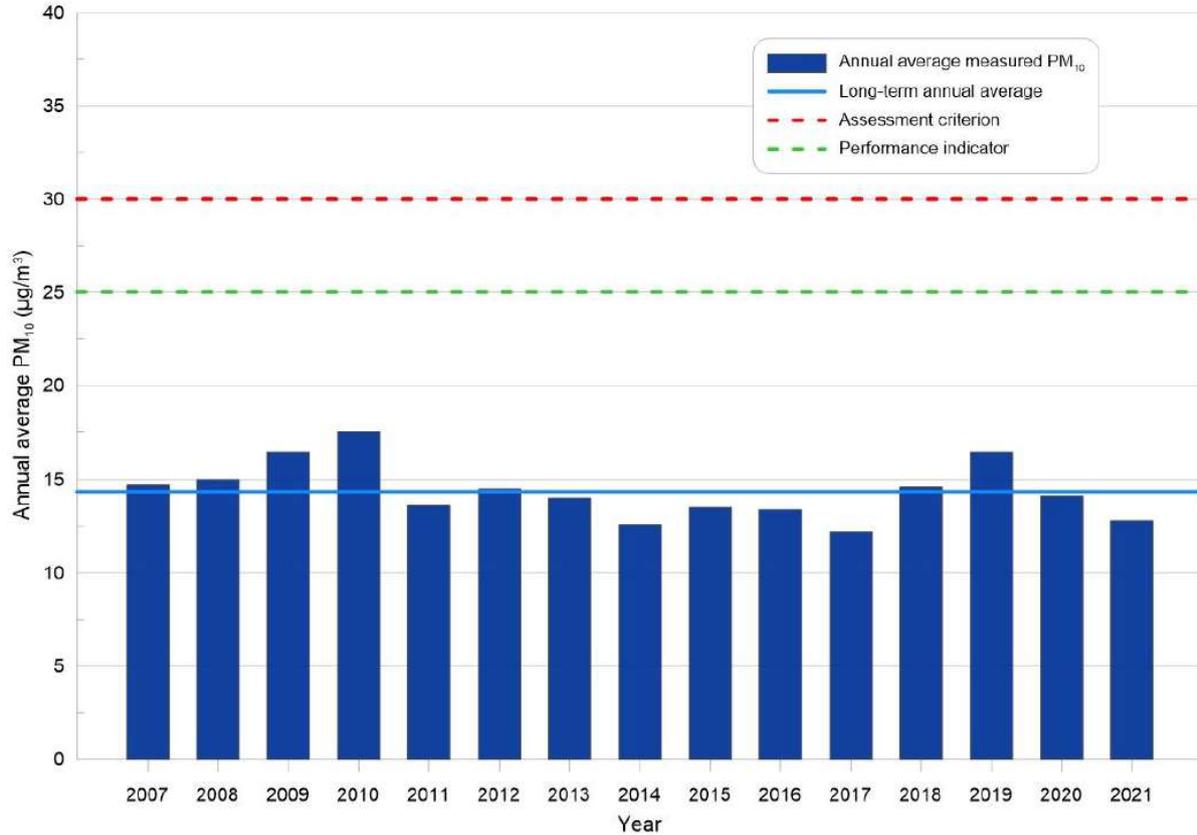
The annual average PM₁₀ concentrations (measured by the HVAS) from 2007 to 2021 are shown on Chart 74. The annual average PM₁₀ concentration measured at the HVAS for the review period was 12.8 micrograms per cubic metre (µg/m³), which is lower than the annual average PM₁₀ performance indicator of 25 µg/m³ and well below the annual average PM₁₀ air quality impact assessment criterion of 30 µg/m³ (Chart 74).

Chart 74 Annual Average PM₁₀ Concentrations from 2007 to 2021 (measured by the HVAS)

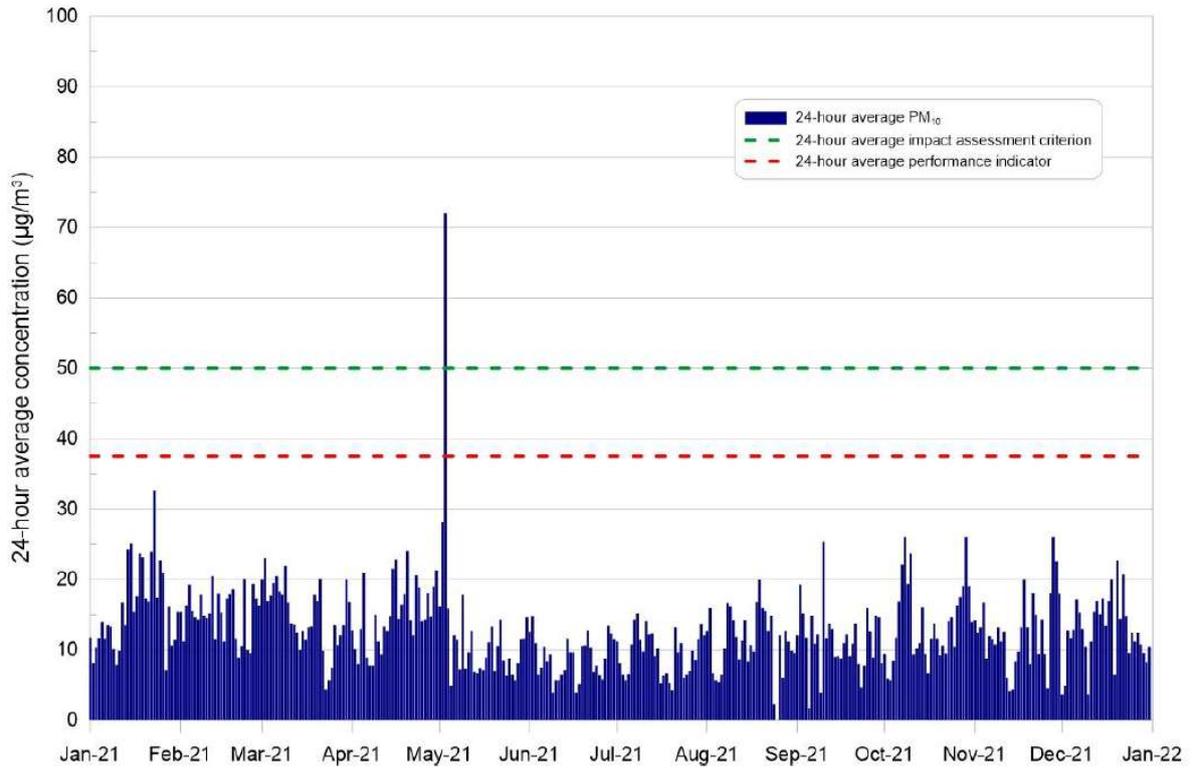
There was one exceedance of the PM₁₀ 24-hour average performance indicator concentration (37.5 µg/m³) recorded by the TEOM during 2021 (Chart 75). An additional exceedance was measured using the HVAS (Chart 76). Exceedances are documented as being related to severe hazard reduction burn events that were conducted during early May 2021. As such, these exceedances are considered to be unrelated to mine activities.

Chart 75 24-hour Average PM₁₀ Concentrations (measured by the TEOM)

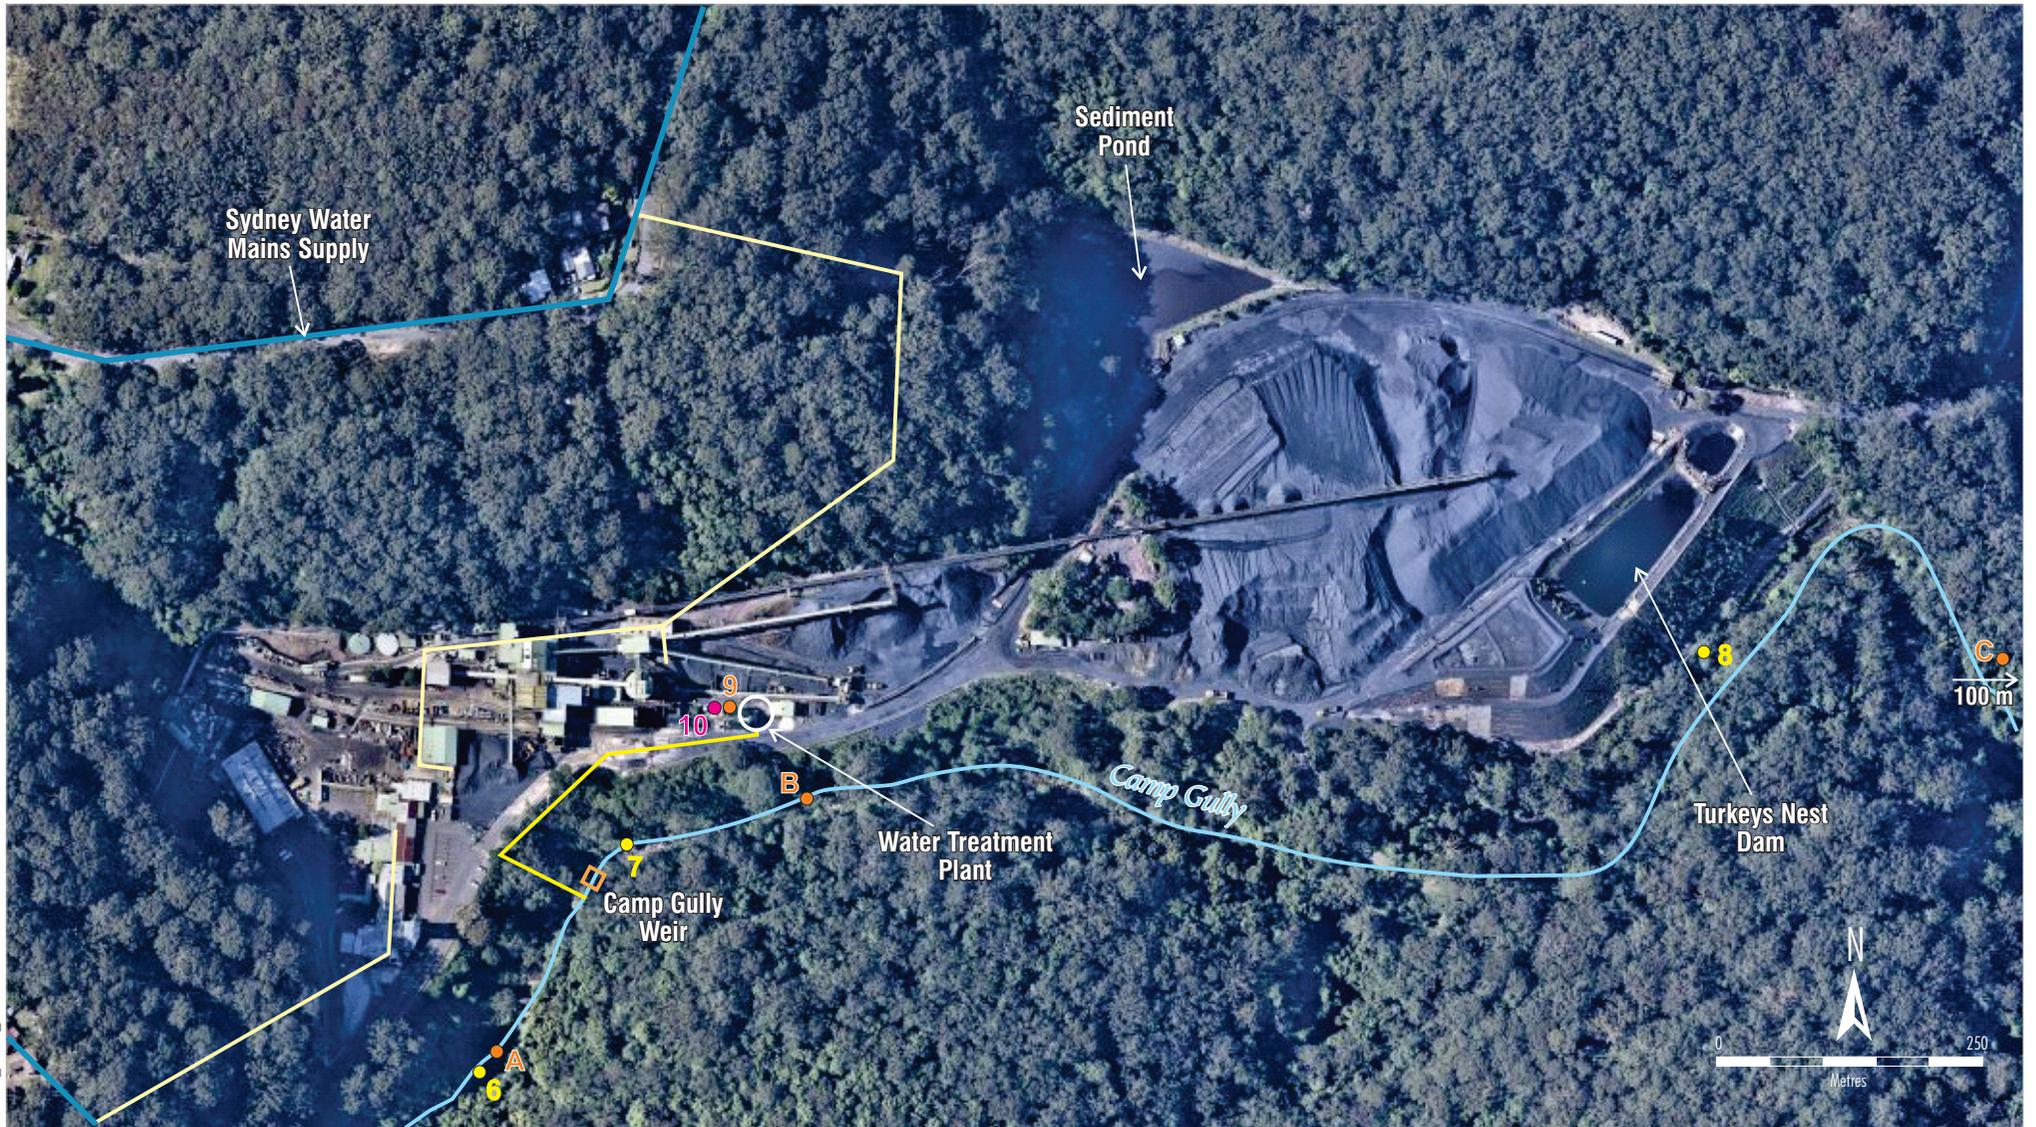
Figure 22

Peabody
 METROPOLITAN COAL
 Surface Facilities Area
 Water Monitoring Sites

Camp Gully runs adjacent to the southern edge of Metropolitan Coal's surface facilities area (Figure 22). Metropolitan Coal's extraction of water from Camp Gully is specifically regulated by the Camp Creek Weir Surface Water Certificate of Title and more generally by the *Water Act, 1912* and the *Water Management Act, 2000*.

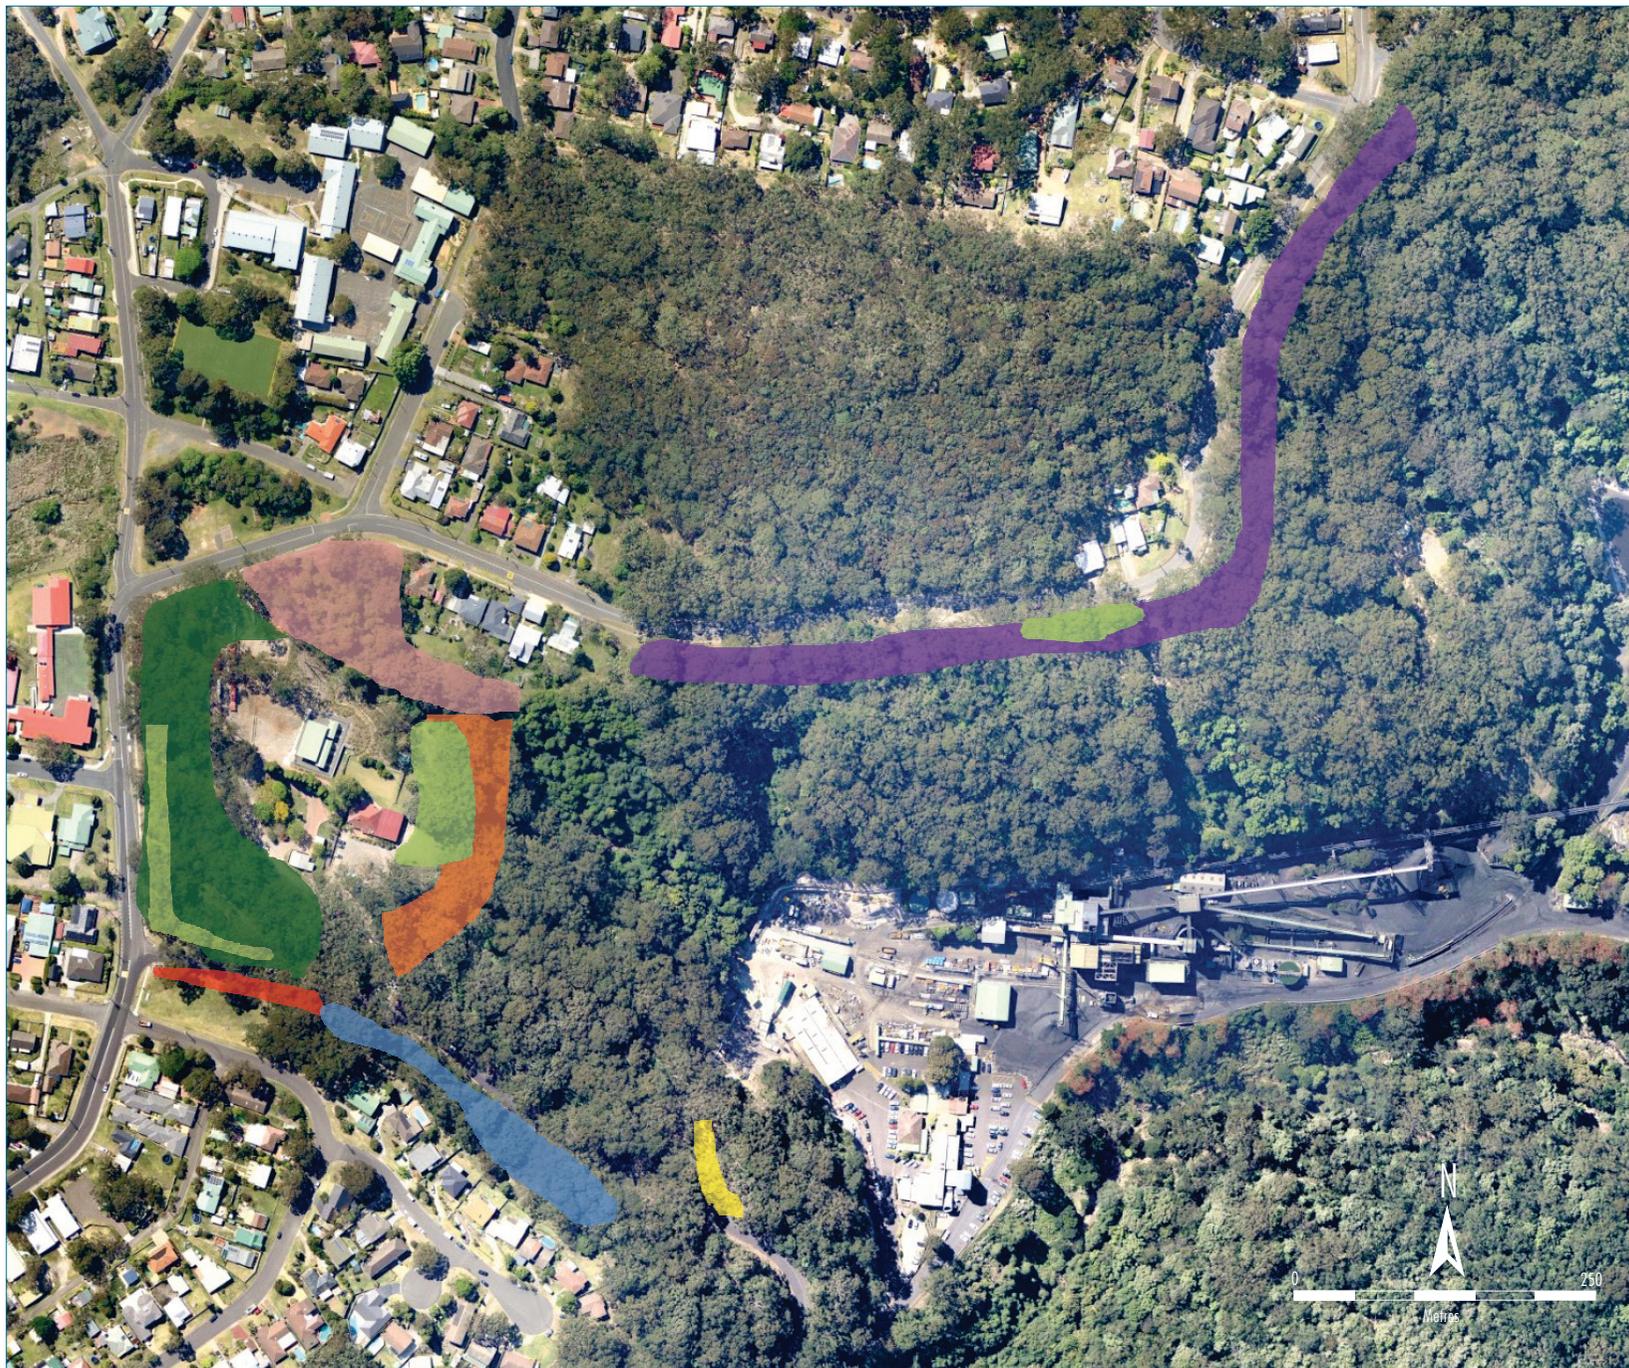
Peabody
 METROPOLITAN COAL
 Rehabilitation Zones Currently Available at the Surface Facilities Area
