# **DETAILED SITE HISTORY FOR "AREA E" TERRANORA PREPARED FOR GILBERT & SUTHERLAND MAY 2003**

**Soil Contamination  
Assessment for  
'Area E' Properties  
Terranora**

**Volume 2 -  
Laboratory Results**

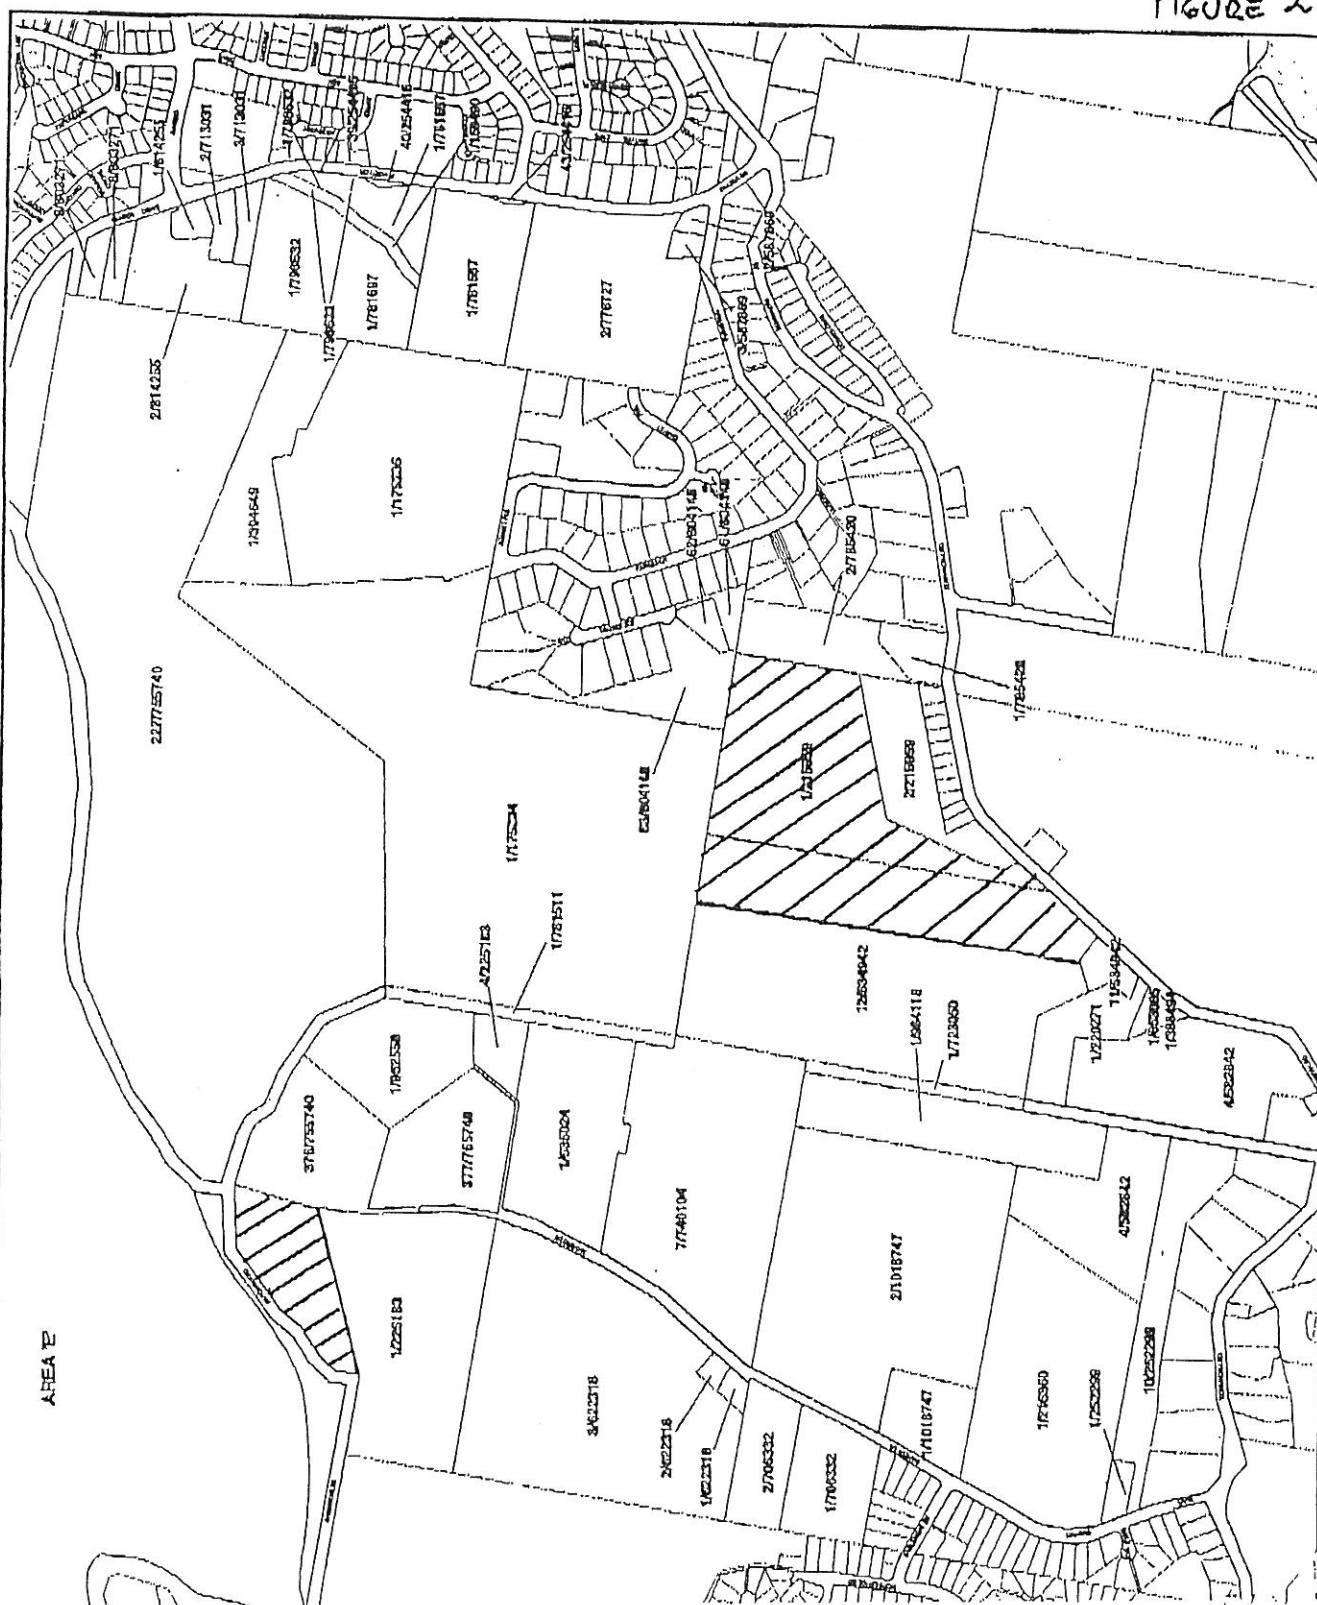
FIGURE 2

Due to the predominant use of the subject land for crop usage it is recommended that appropriate sampling occur on the land to determine if any possible contamination is evident. This is particularly recommended for those areas of the land that have been used for banana plantation purposes. These areas are indicated on the attached plan (see Figure 2).

### POSSIBLE BANANA PLANTATION USE
