FIGURE C18  
PEAK FLOOD LEVEL IMPACT  
POST-SWRL  
1% AEP CLIMATE CHANGE  
CROSSING 7a

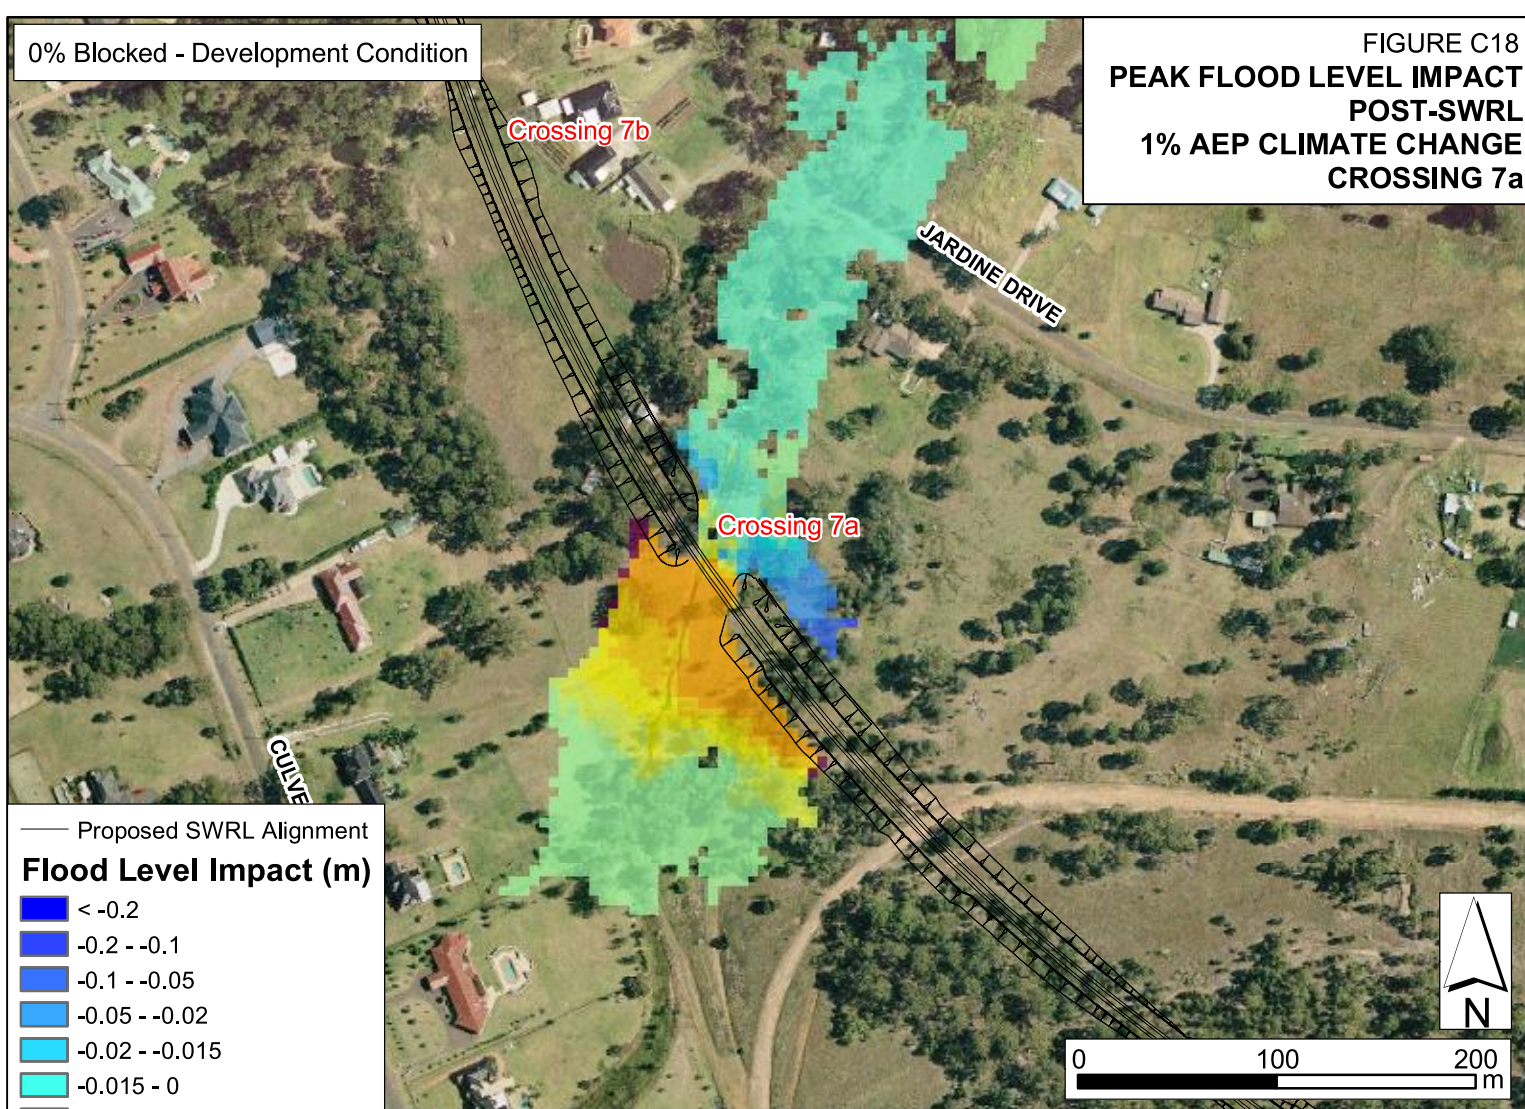
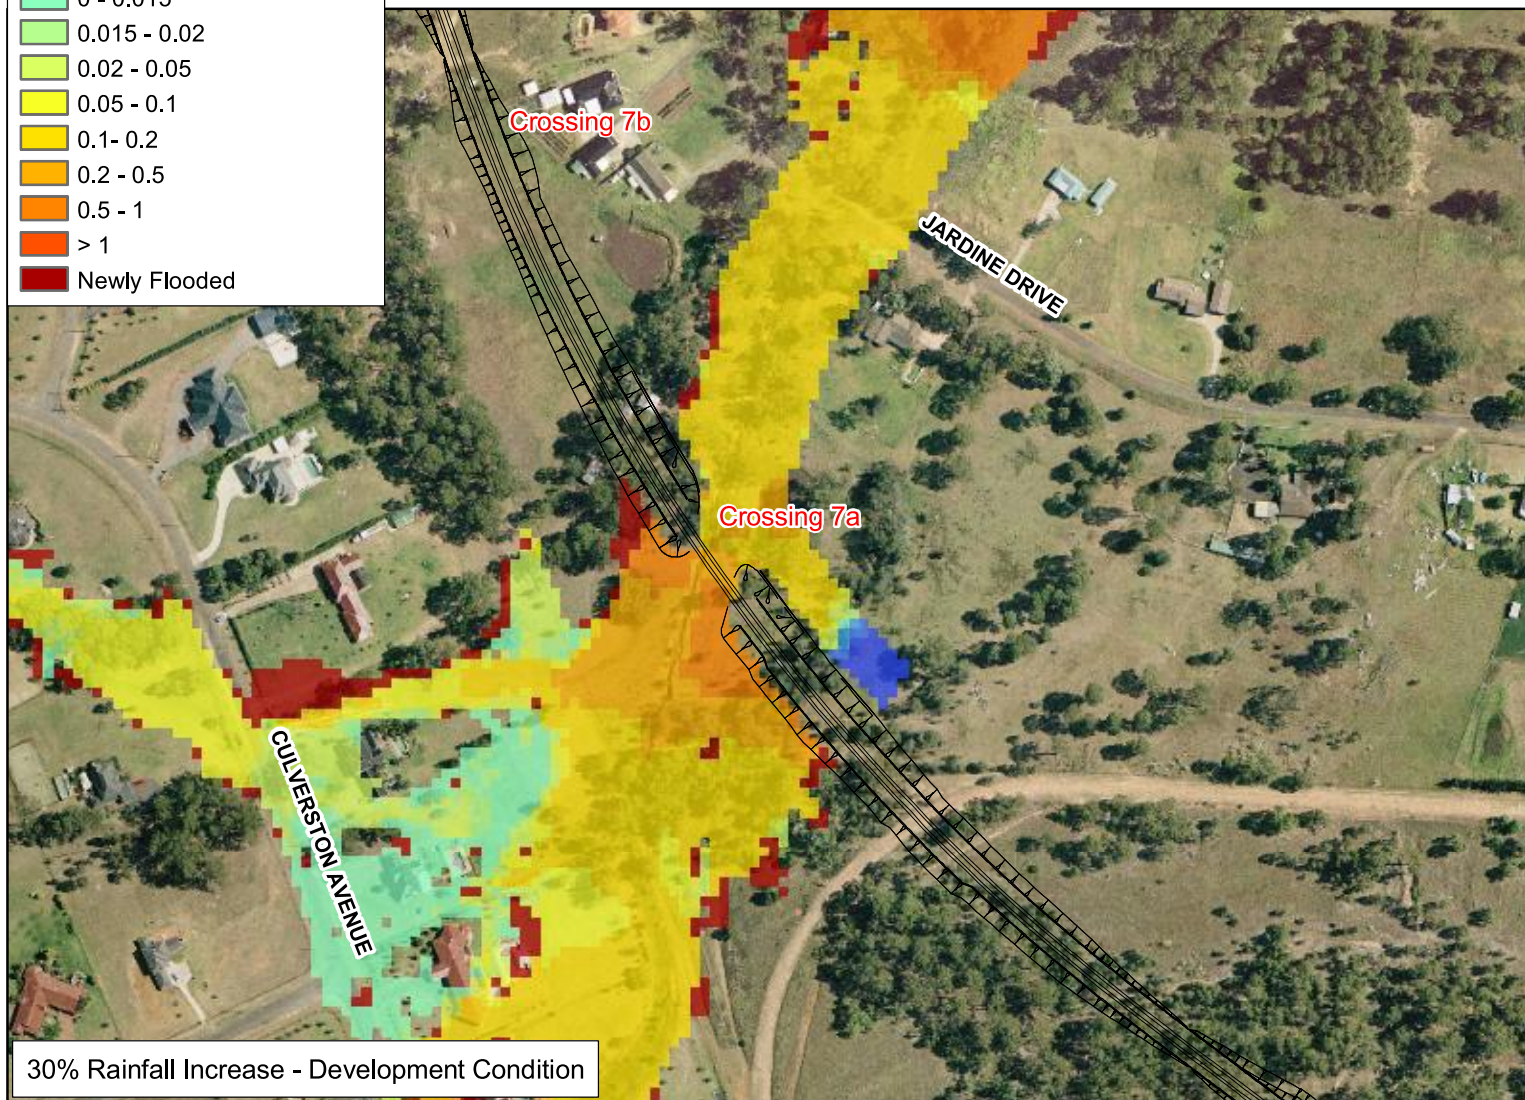
0% Blocked - Development Condition

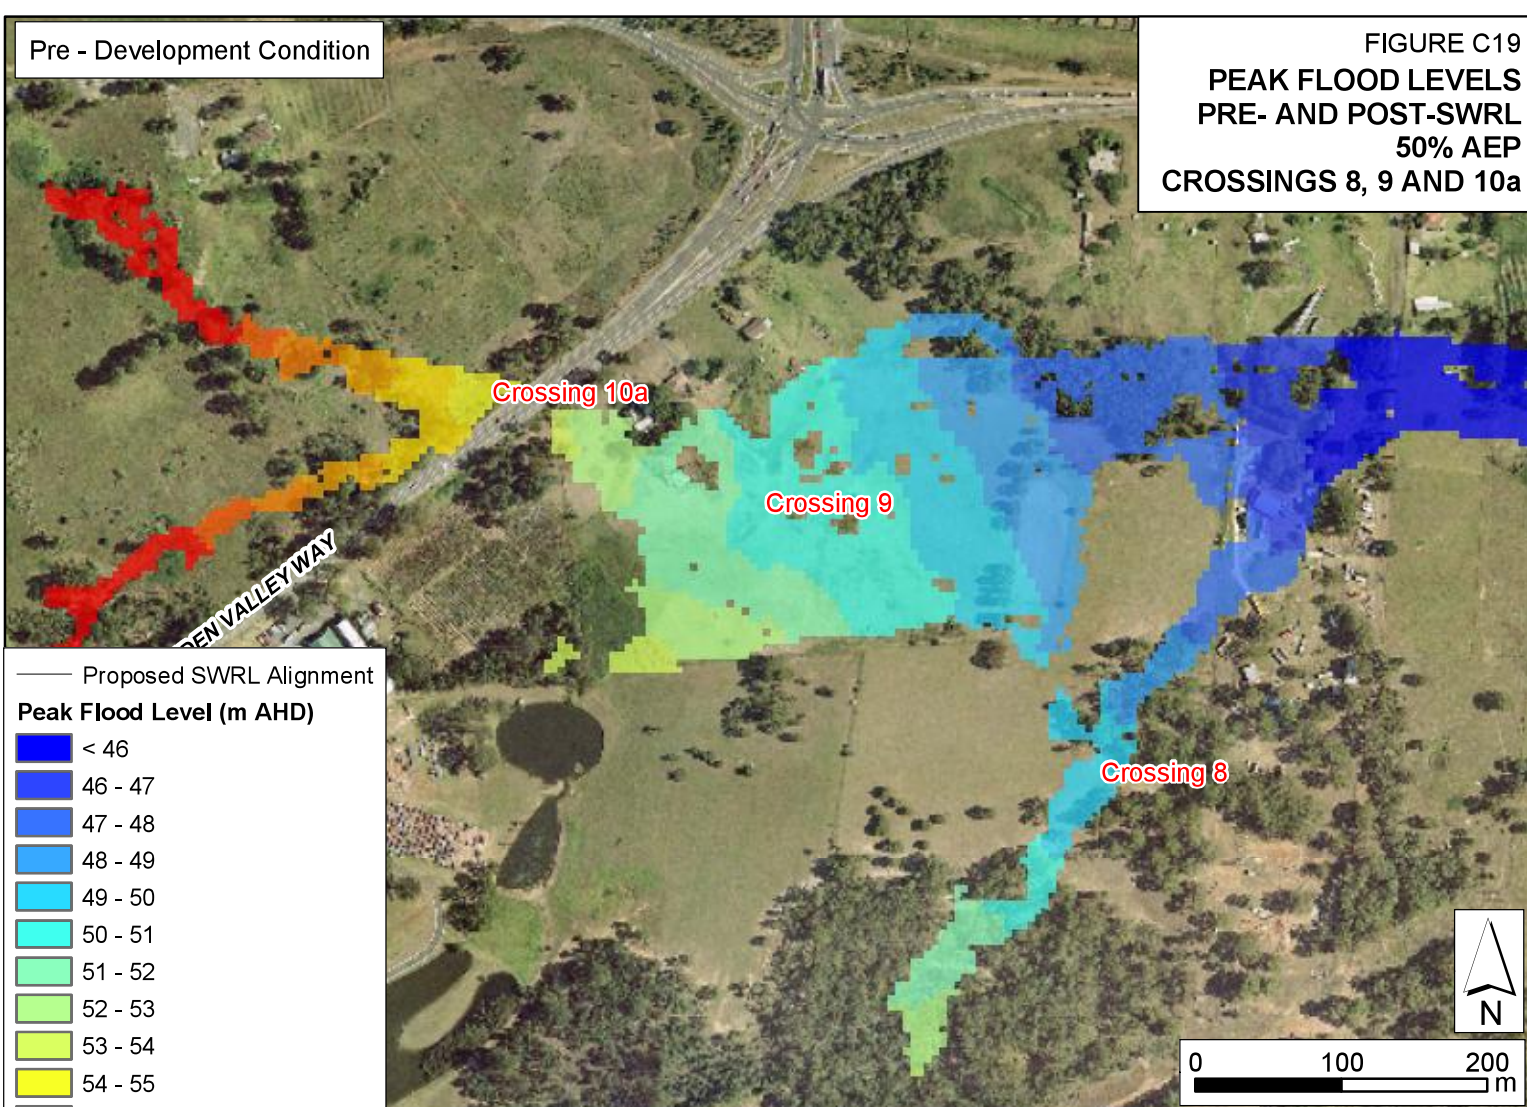
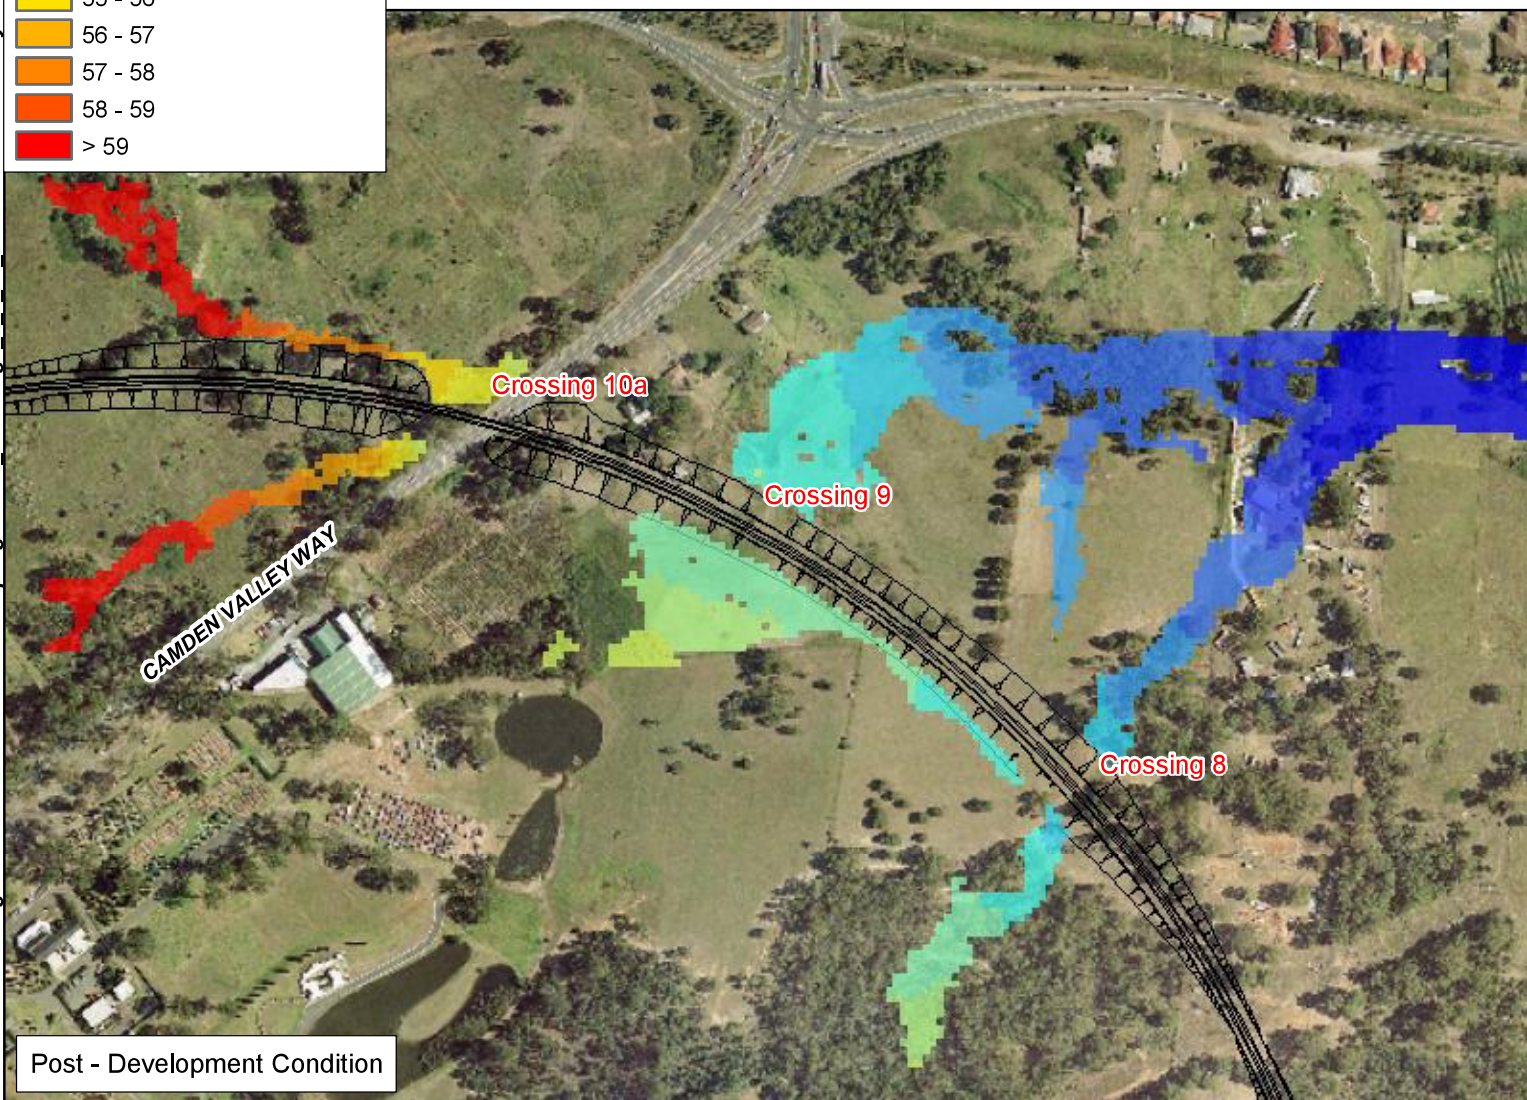
Pre - Development Condition

FIGURE C19  
PEAK FLOOD LEVELS  
PRE- AND POST-SWRL  
50% AEP  
CROSSINGS 8, 9 AND 10a

Post - Development Condition

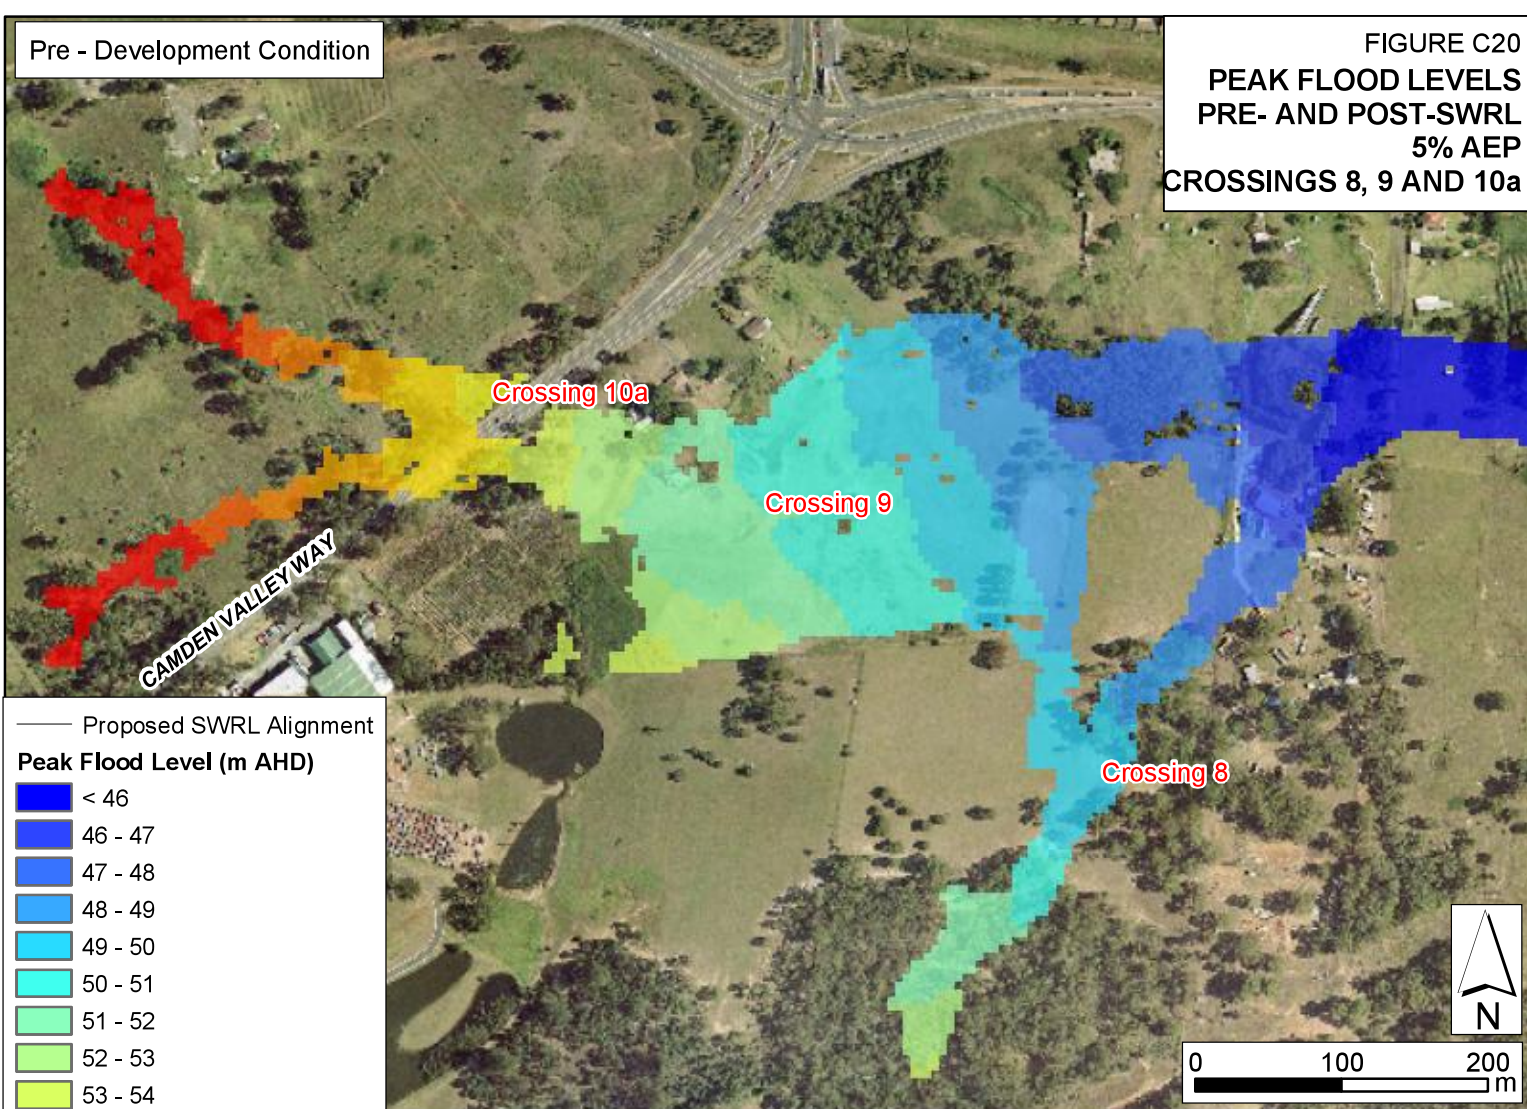
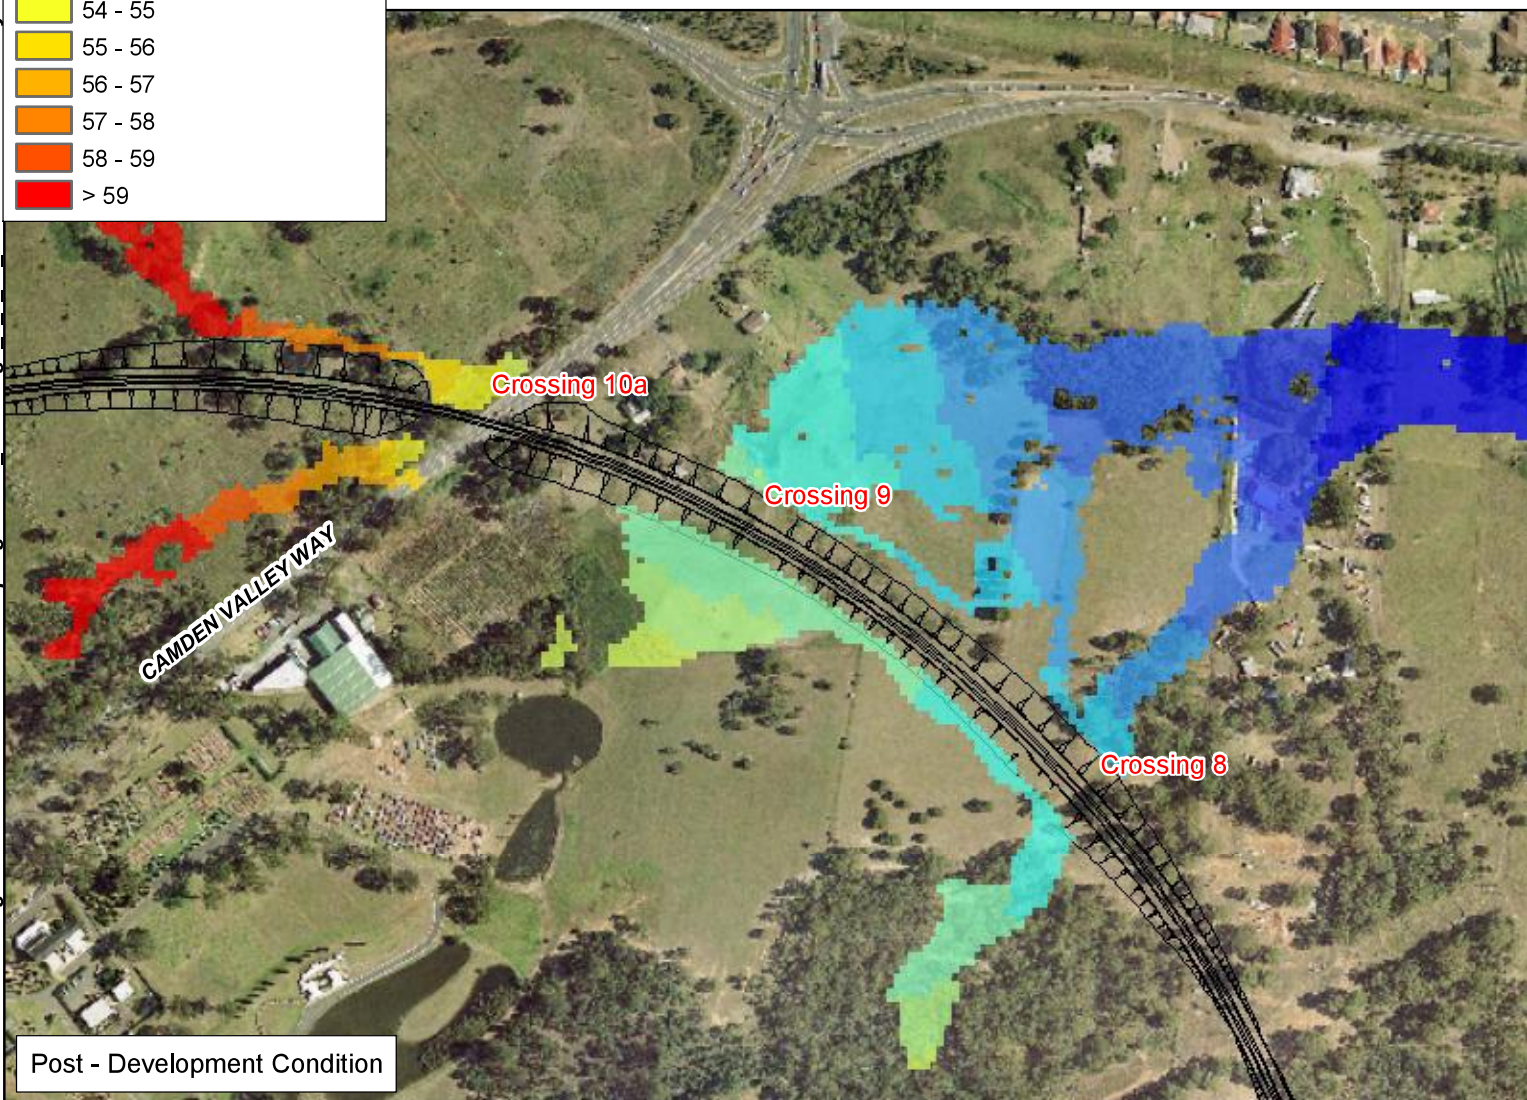
Pre - Development Condition

FIGURE C20  
PEAK FLOOD LEVELS  
PRE- AND POST-SWRL  
5% AEP  
CROSSINGS 8, 9 AND 10a

Post - Development Condition

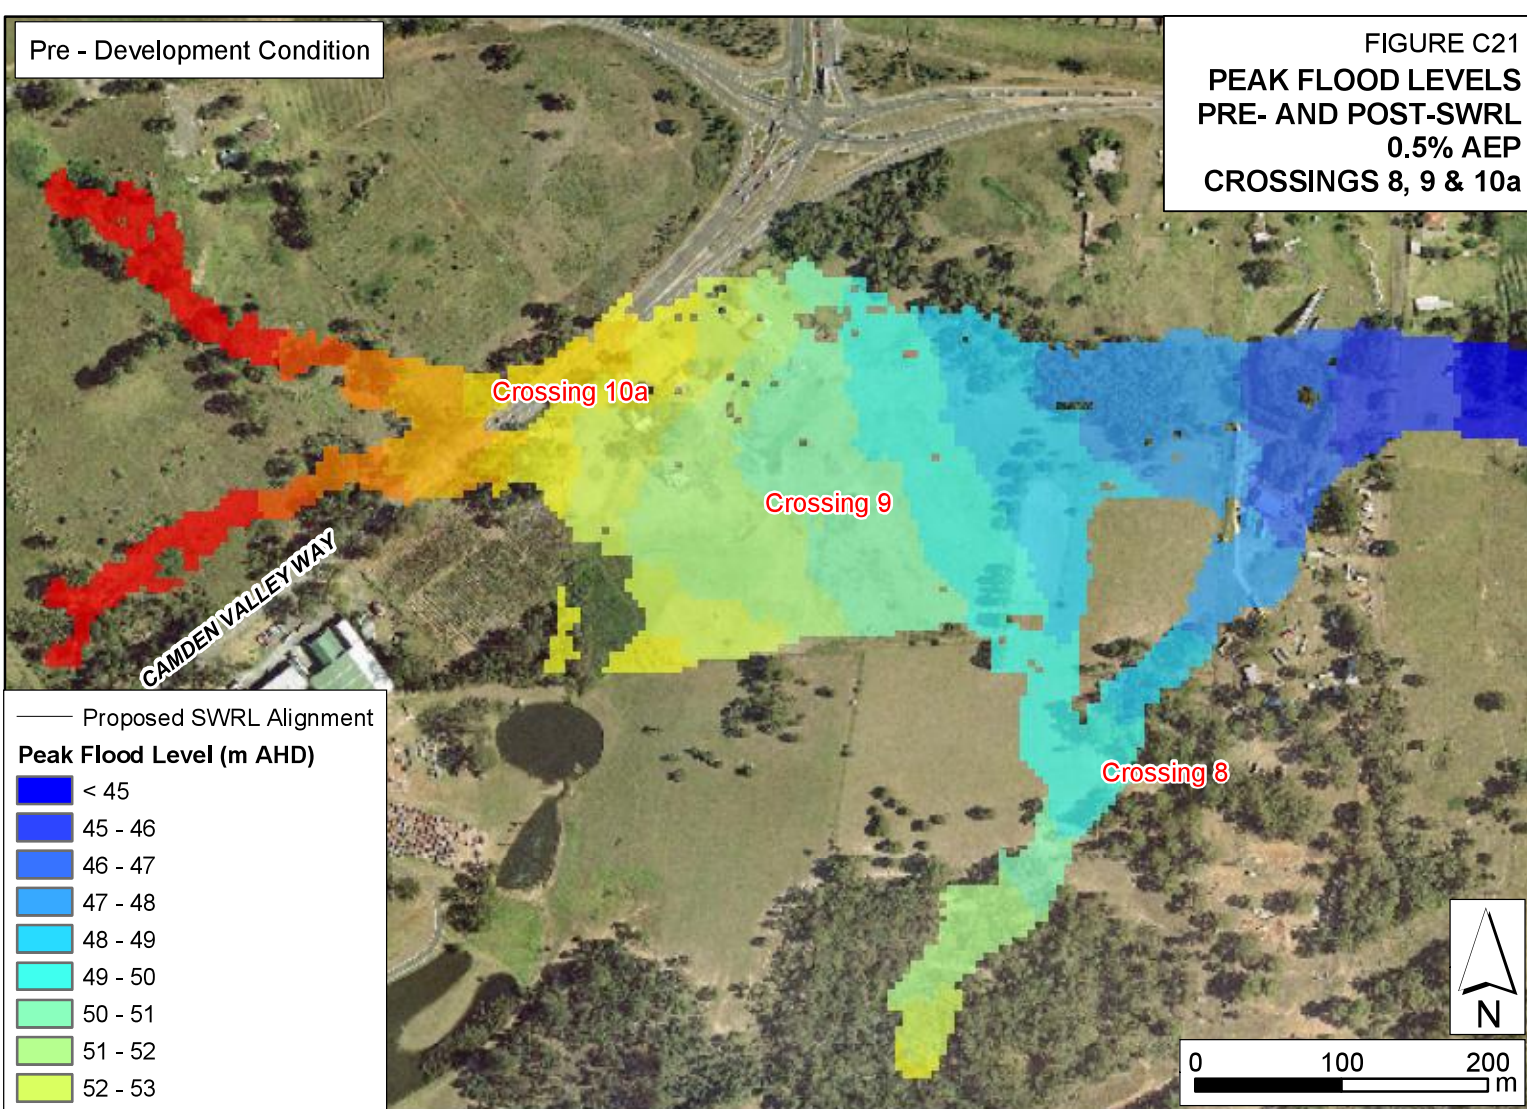
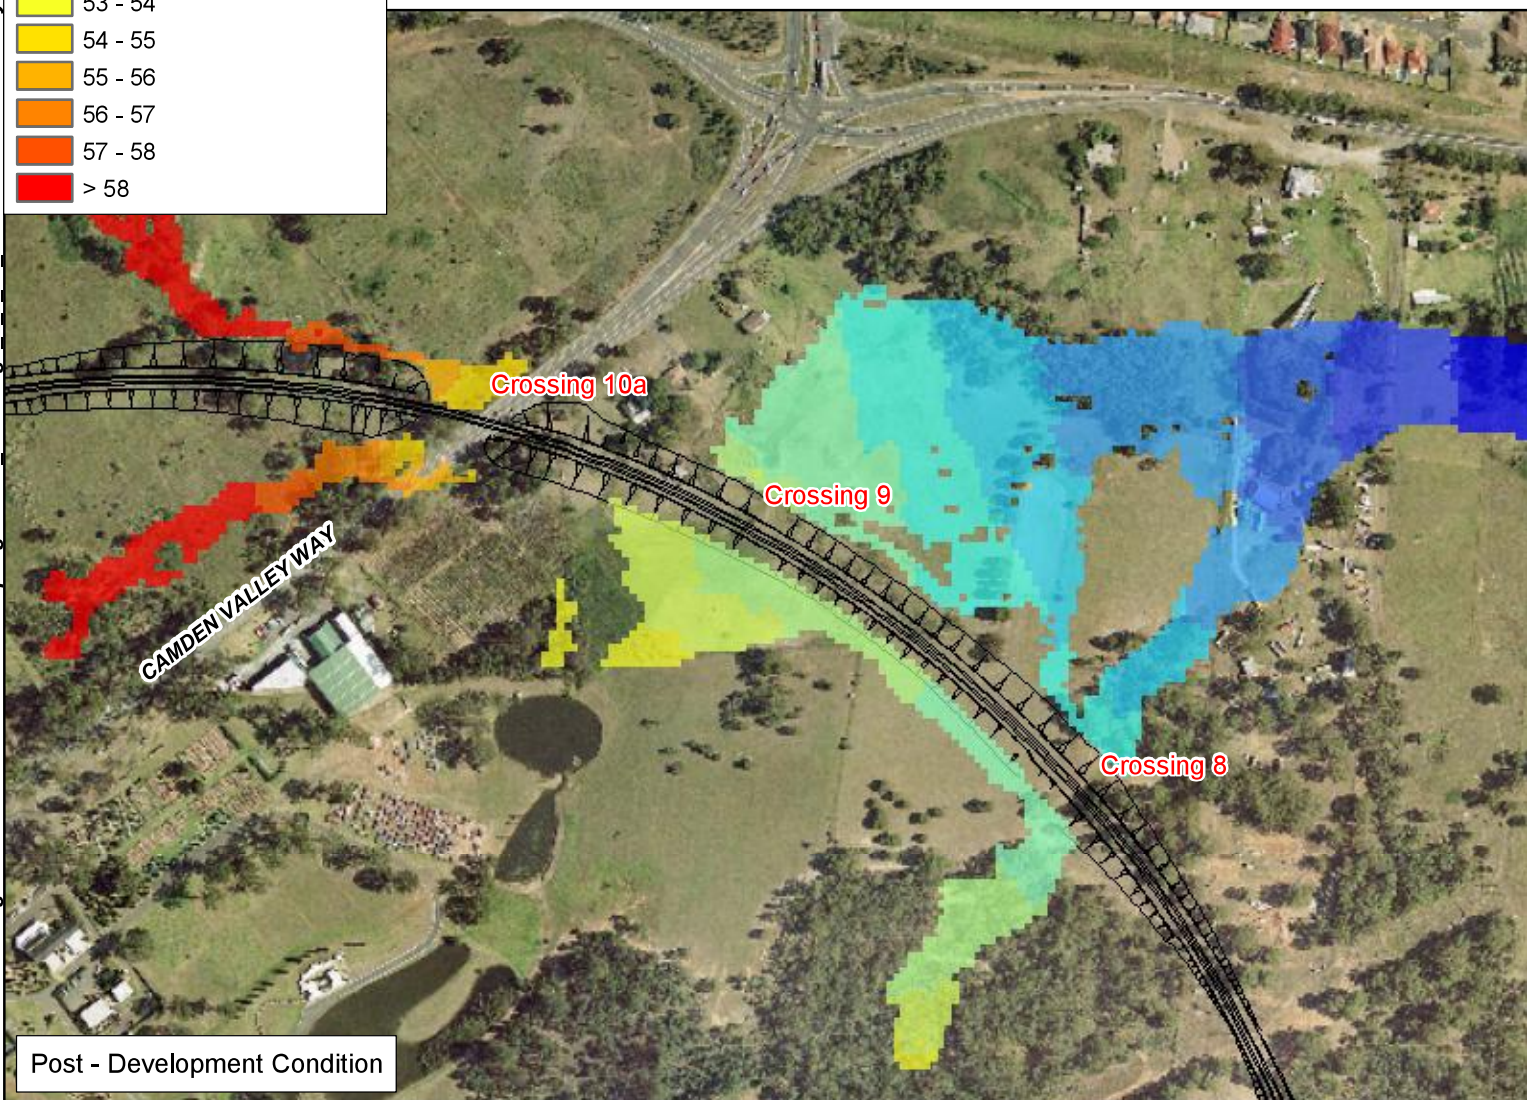
Pre - Development Condition

FIGURE C21  
PEAK FLOOD LEVELS  
PRE- AND POST-SWRL  
0.5% AEP  
CROSSINGS 8, 9 & 10a

Post - Development Condition

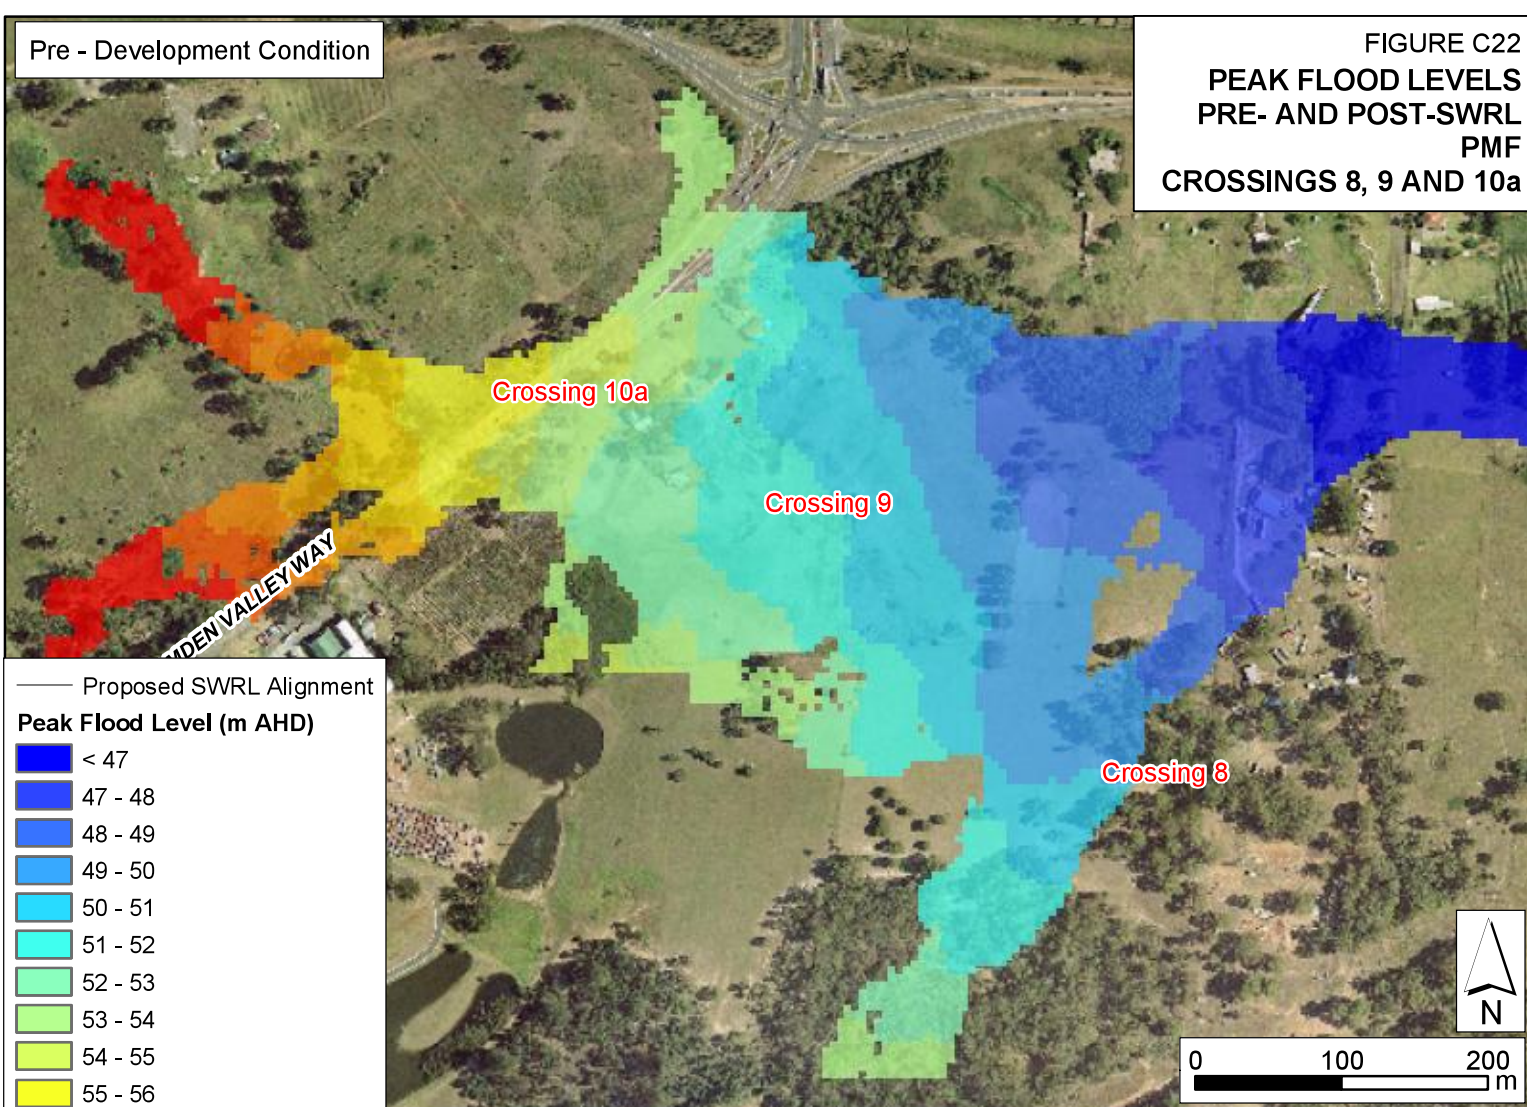
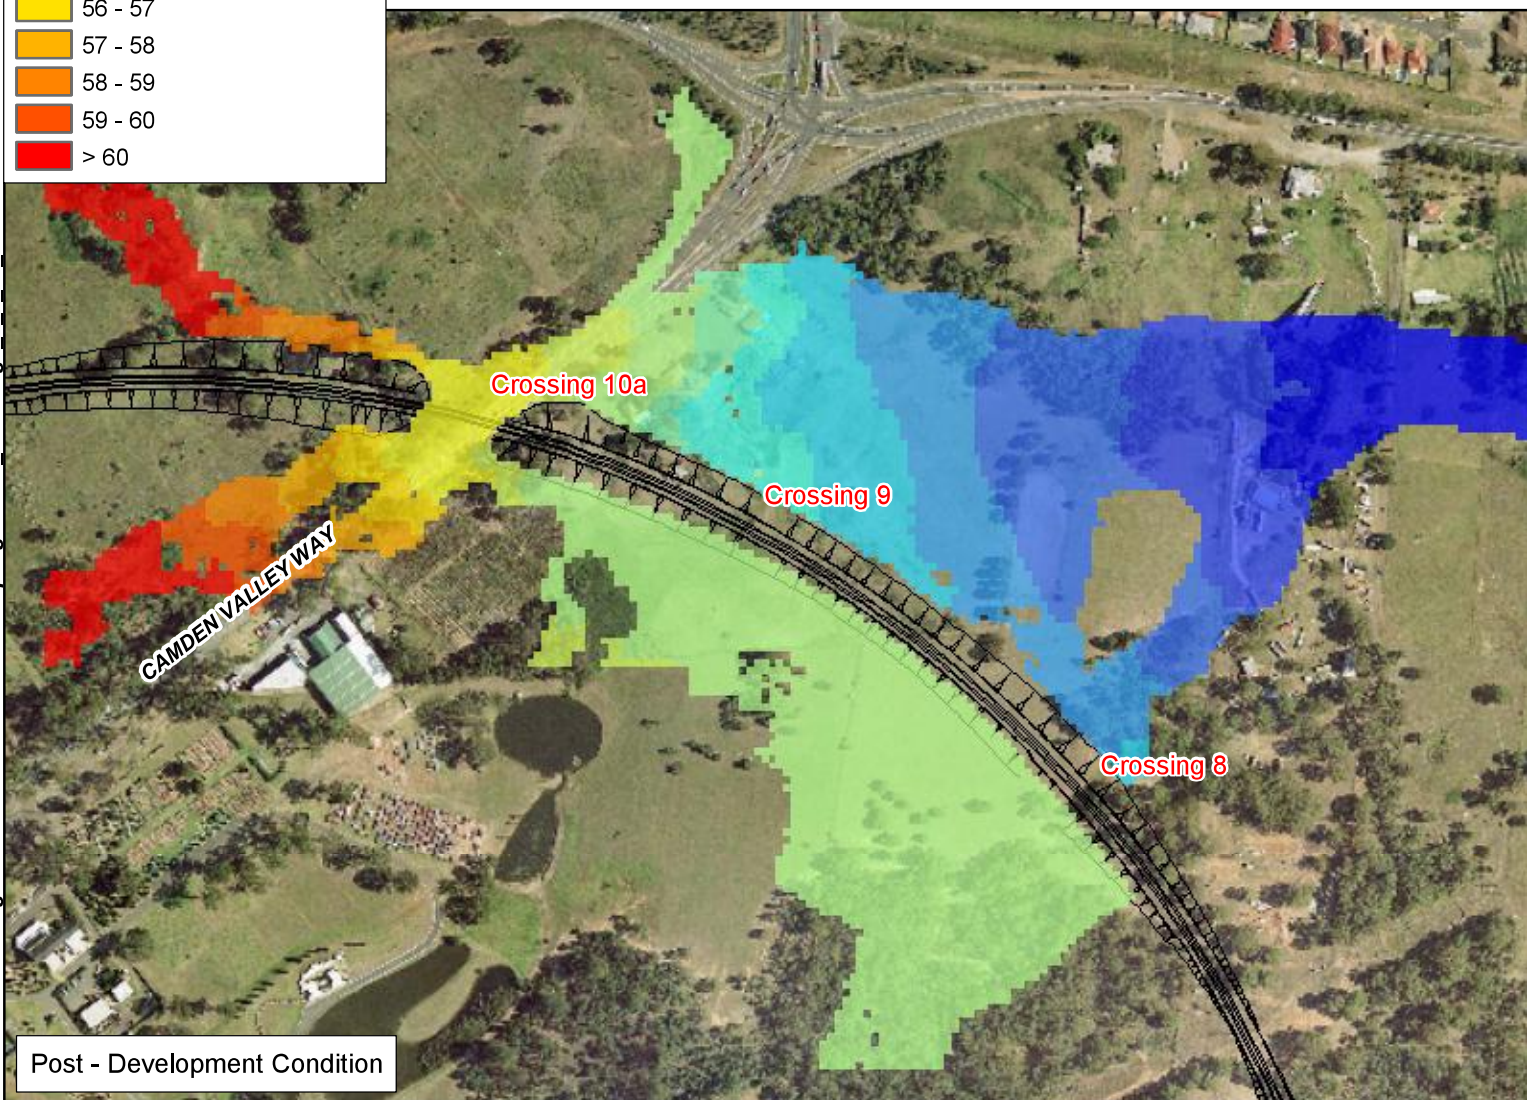
Pre - Development Condition

FIGURE C22  
PEAK FLOOD LEVELS  
PRE- AND POST-SWRL  
PMF  
CROSSINGS 8, 9 AND 10a

Post - Development Condition

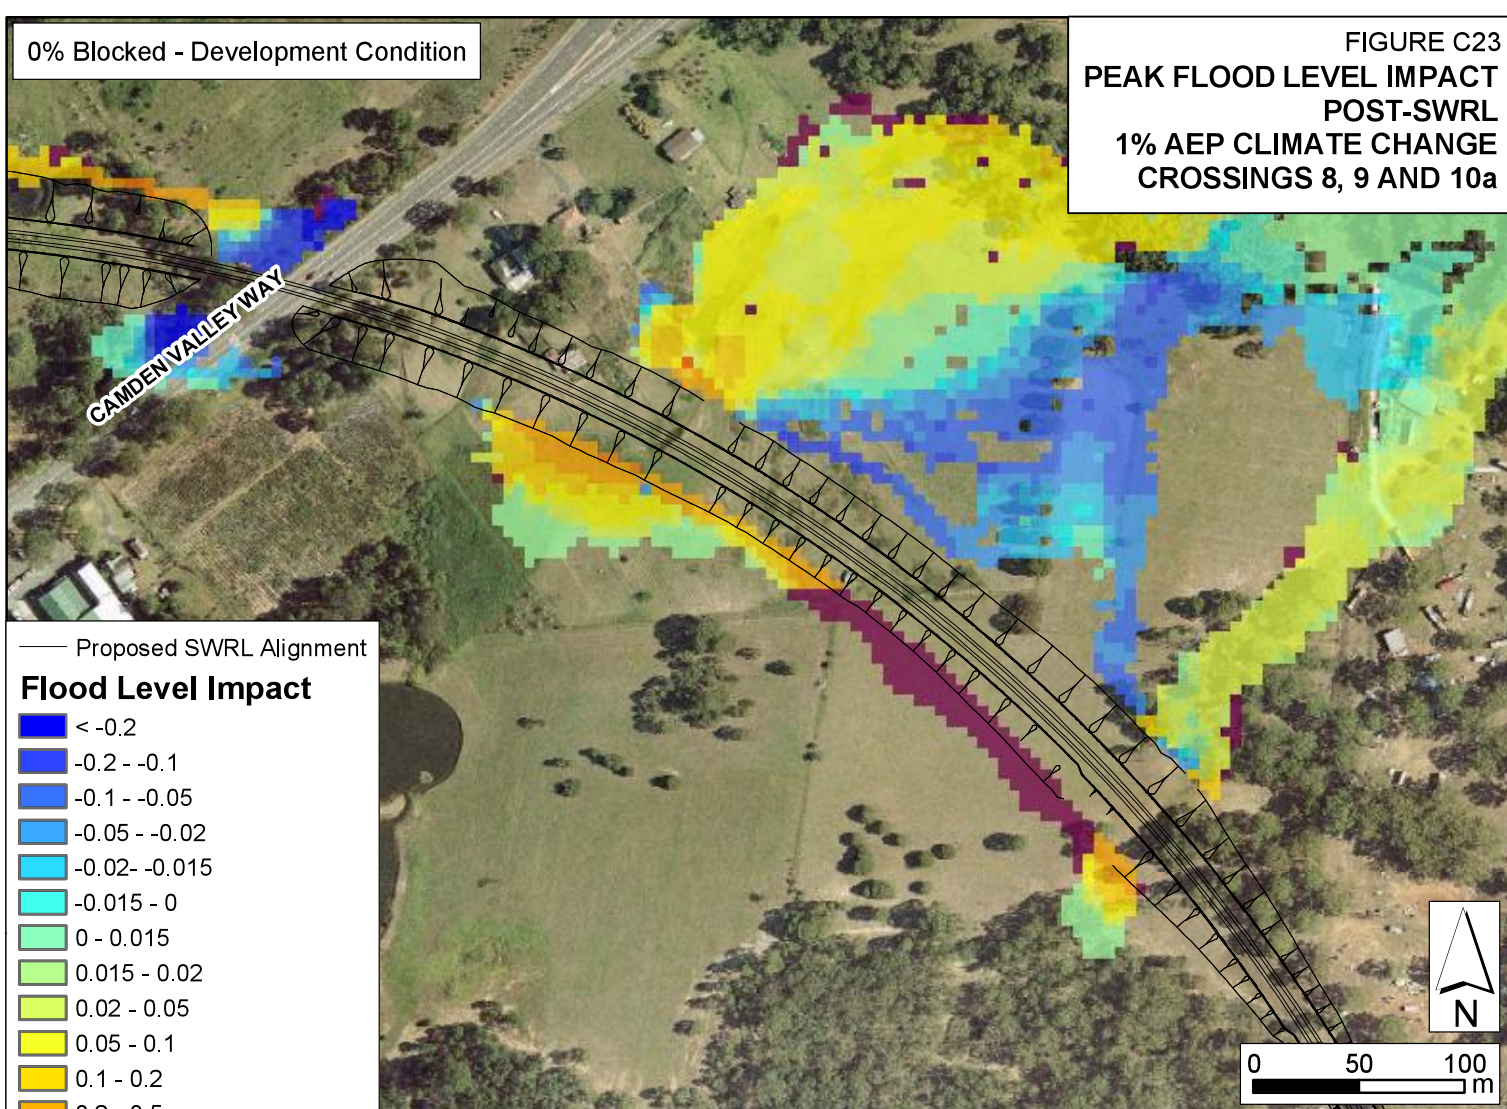
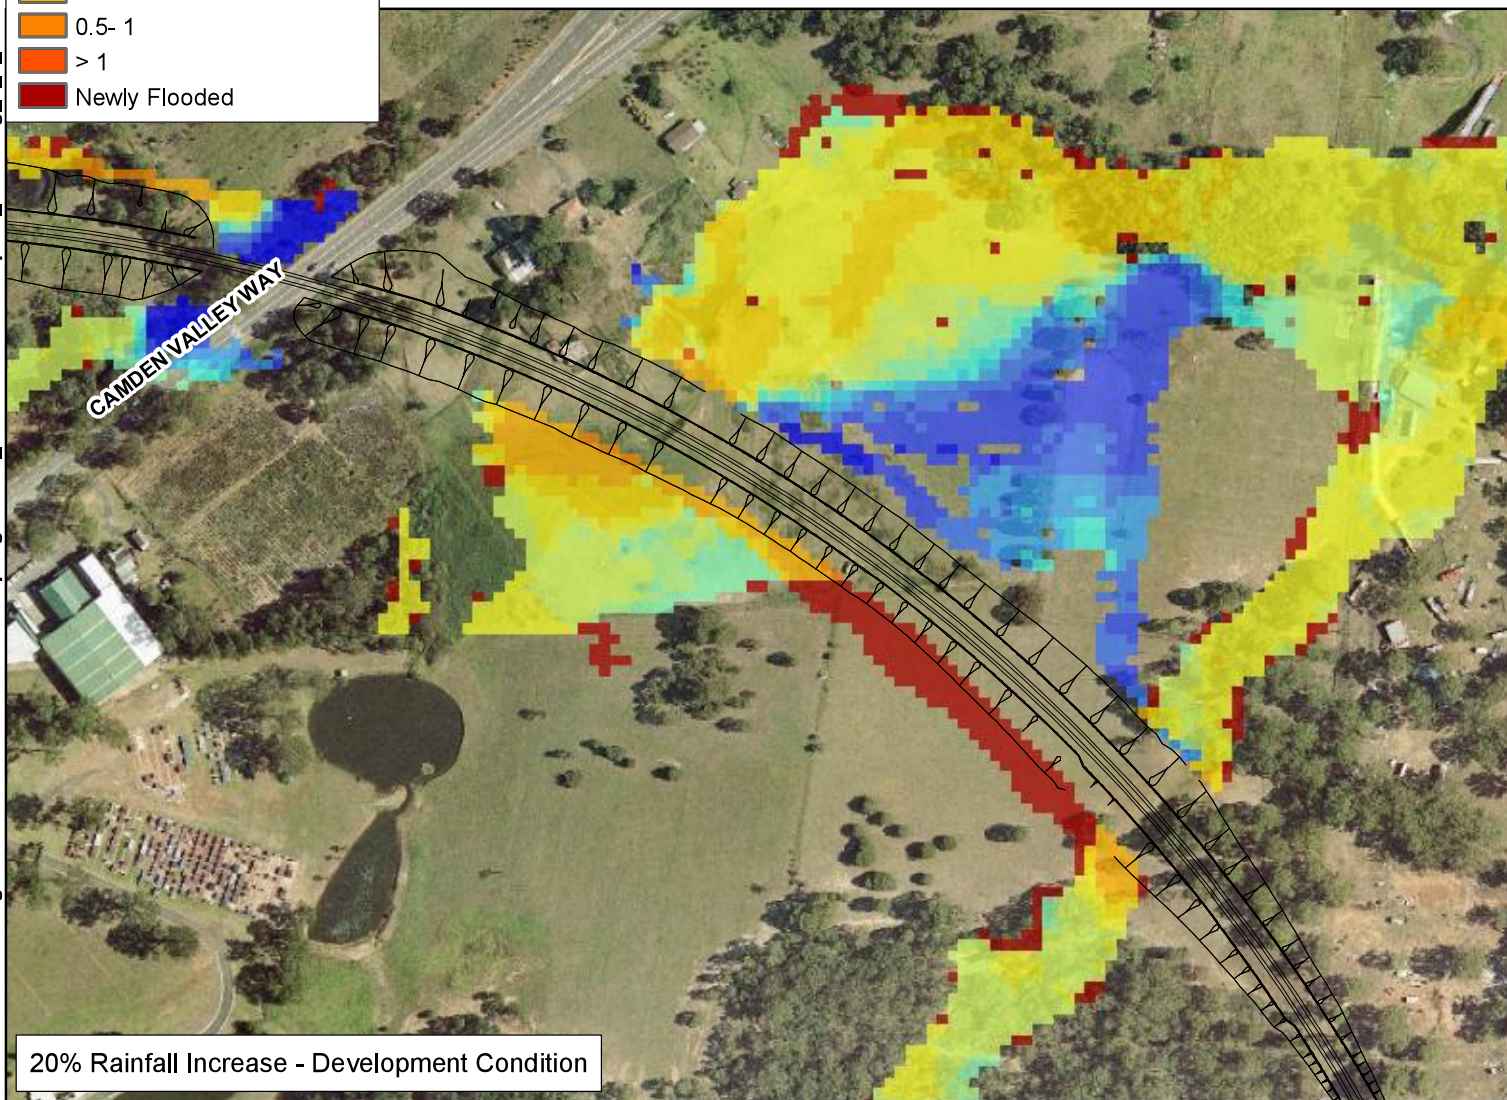
0% Blocked - Development Condition

FIGURE C23  
PEAK FLOOD LEVEL IMPACT  
POST-SWRL  
1% AEP CLIMATE CHANGE  
CROSSINGS 8, 9 AND 10a

20% Rainfall Increase - Development Condition
