FIGURE C18  
PEAK FLOOD LEVEL IMPACT  
POST-SWRL  
1% AEP CLIMATE CHANGE  
CROSSING 7a

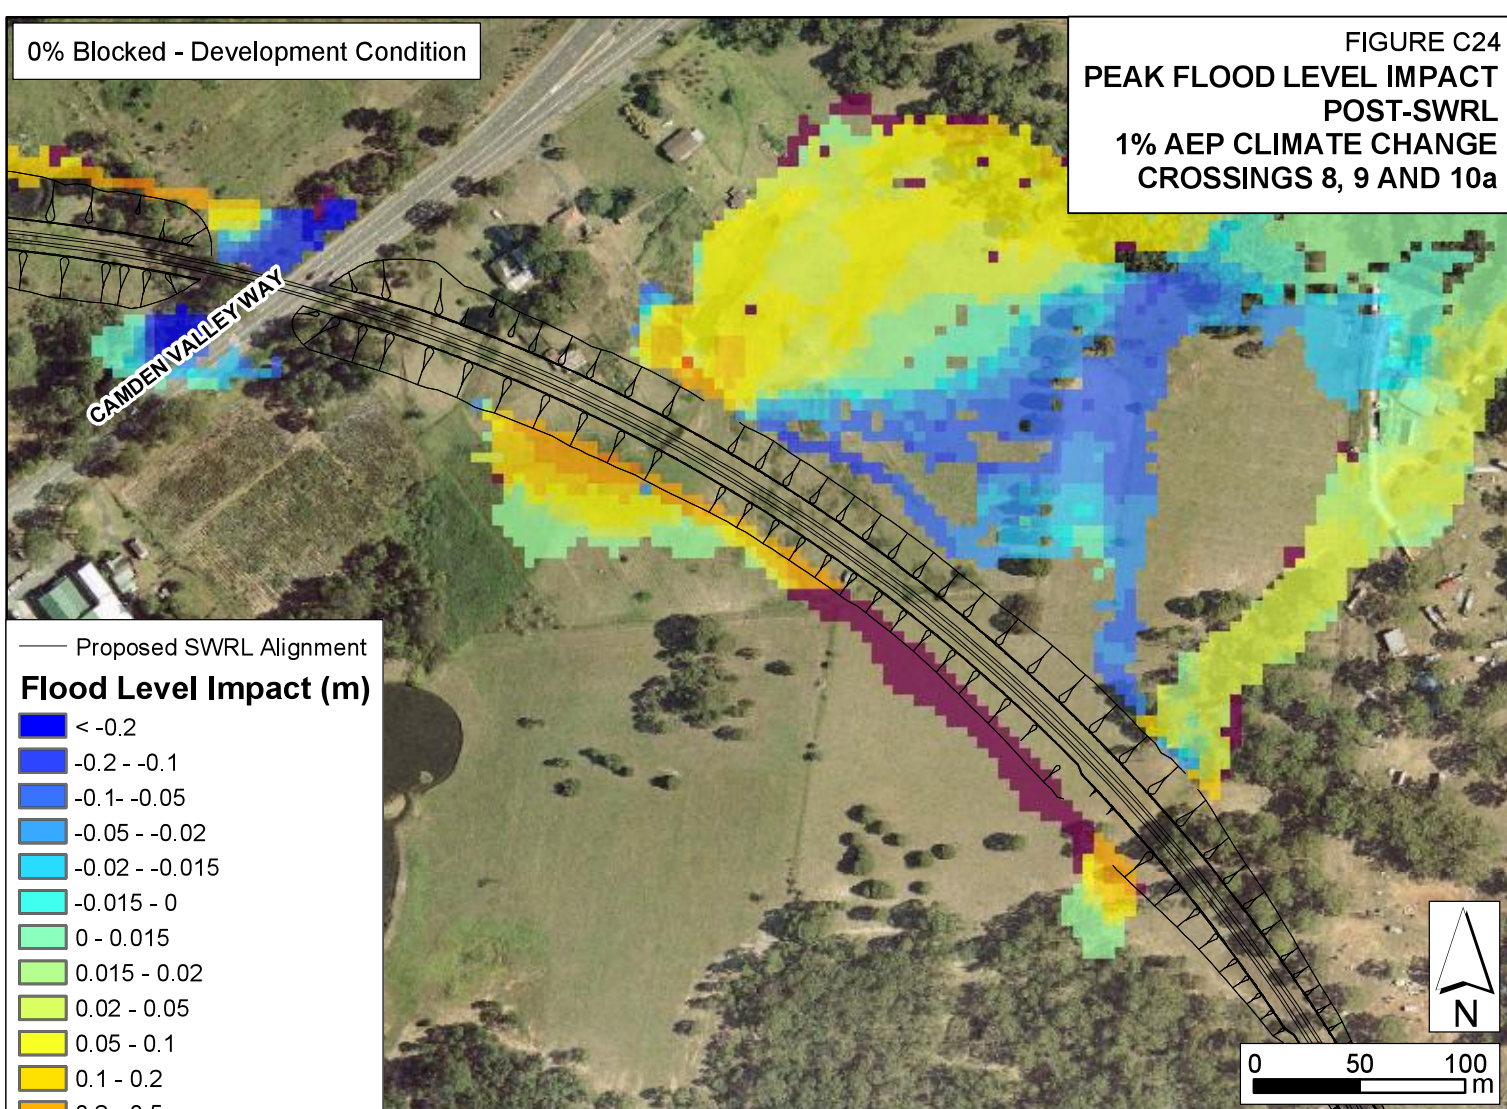
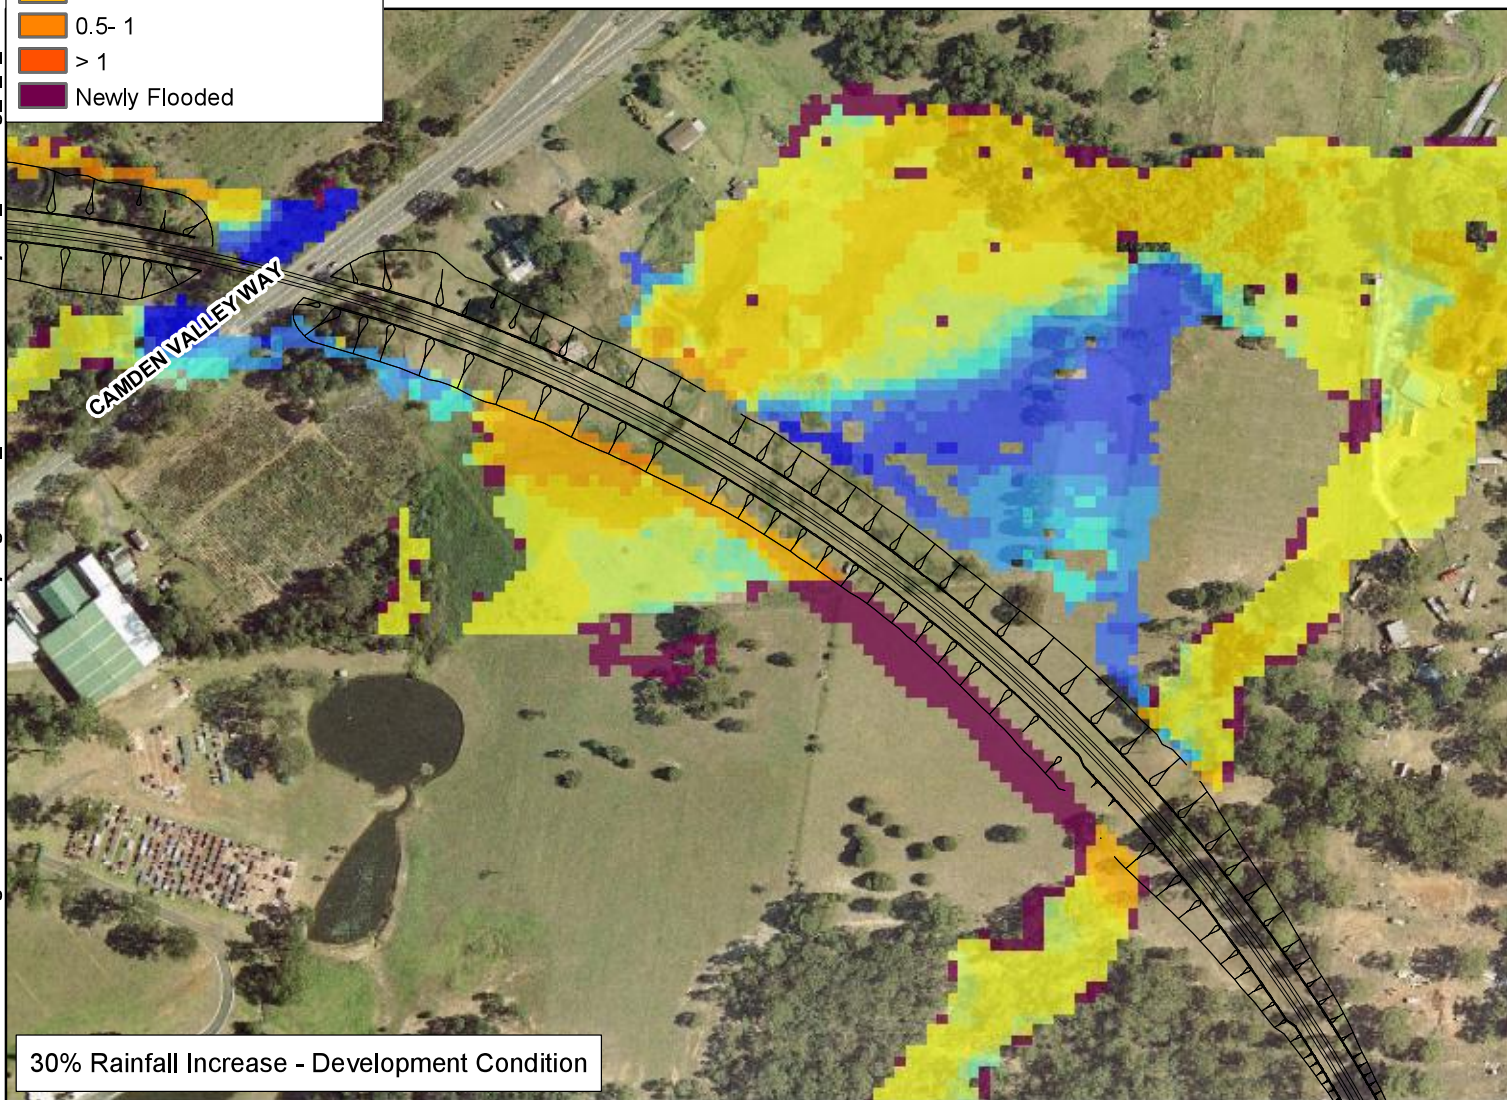
0% Blocked - Development Condition

FIGURE C24  
PEAK FLOOD LEVEL IMPACT  
POST-SWRL  
1% AEP CLIMATE CHANGE  
CROSSINGS 8, 9 AND 10a

30% Rainfall Increase - Development Condition
