## **Detailed Site Investigation (Phase 2)**

## **First Fleet Park The Rocks NSW**

**Sydney Harbour Foreshore Authority  
February 2010**

**(Report: C4024.Q2011.B12748FA)**

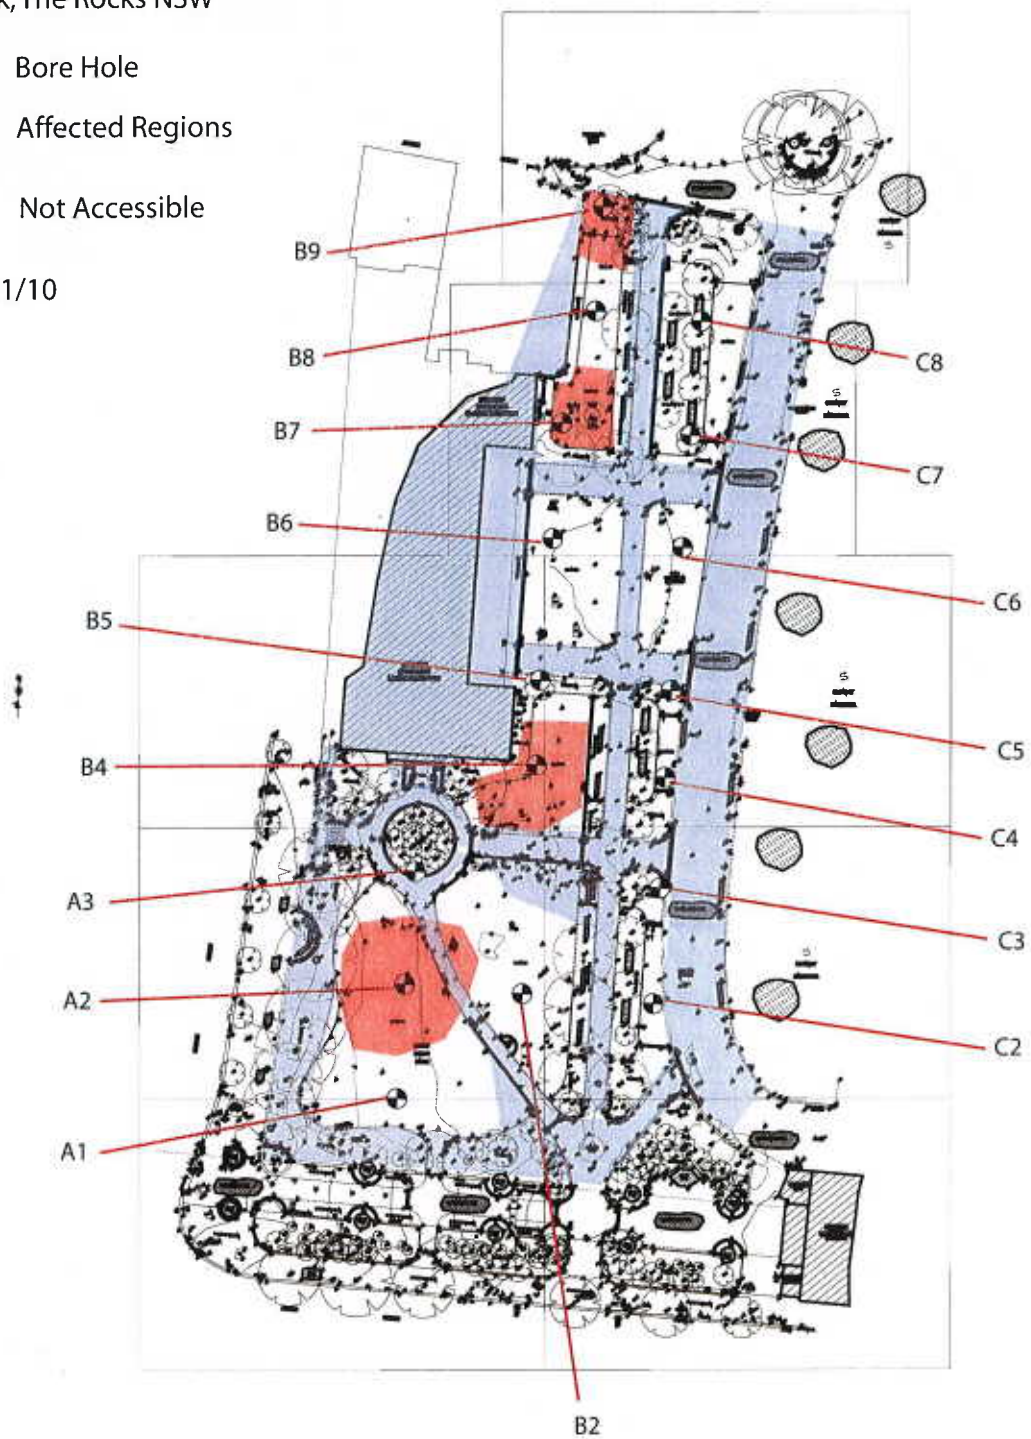
### Map 2 - Regions of Elevated Results

- A2/0.5m exceeds the HILs for BaP (6.3 mg/kg) and PAH (73.4 mg/kg); and
- B4/0.35m exceeds the HILs for BaP (8.4 mg/kg) and PAH (73.1 mg/kg).

- B7/0.1m exceeds the EILs for Mercury (1.2 mg/kg); and
- B9/0.1m exceeds the EILs for Zinc (290 mg/kg).

The results indicate that the surface topsoil materials at locations B7 and B9 and the subsurface soil materials at A2 and B4 contain elevated contaminants. See Appendix B for full results compared to the adopted Guidelines.

It is the recommendation of SESL that these isolated areas may be removed from site under the guidance of a site-specific Remedial Action Plan (RAP) or maintained on site under the guidance of a site specific Environmental Management Plan (EMP). Based on this Phase 2 DSI, SESL consider the site suitable for the current open space landuse, subject to the implementation of a Remedial Action Plan (RAP) or Environmental Management Plan (EMP). A Site Validation Report (SVR) shall be carried out to ensure success of the RAP if adopted.
