RE: INTERIM AUDIT ADVICE LETTER NO. 3 - REMEDIATION ACTION PLAN, 11-13 PERCY STREET, AUBURN NSW

- 'Remediation Action Plan, 11-13 Percy Street, Auburn, NSW 2144' dated 4 February 2021, Geo-Logix Pty Ltd (Geo-Logix) (*the RAP*)

Attachments: 1 Site Boundaries
 2 Proposed Development Plan
 3 Extent of Proposed Remediation

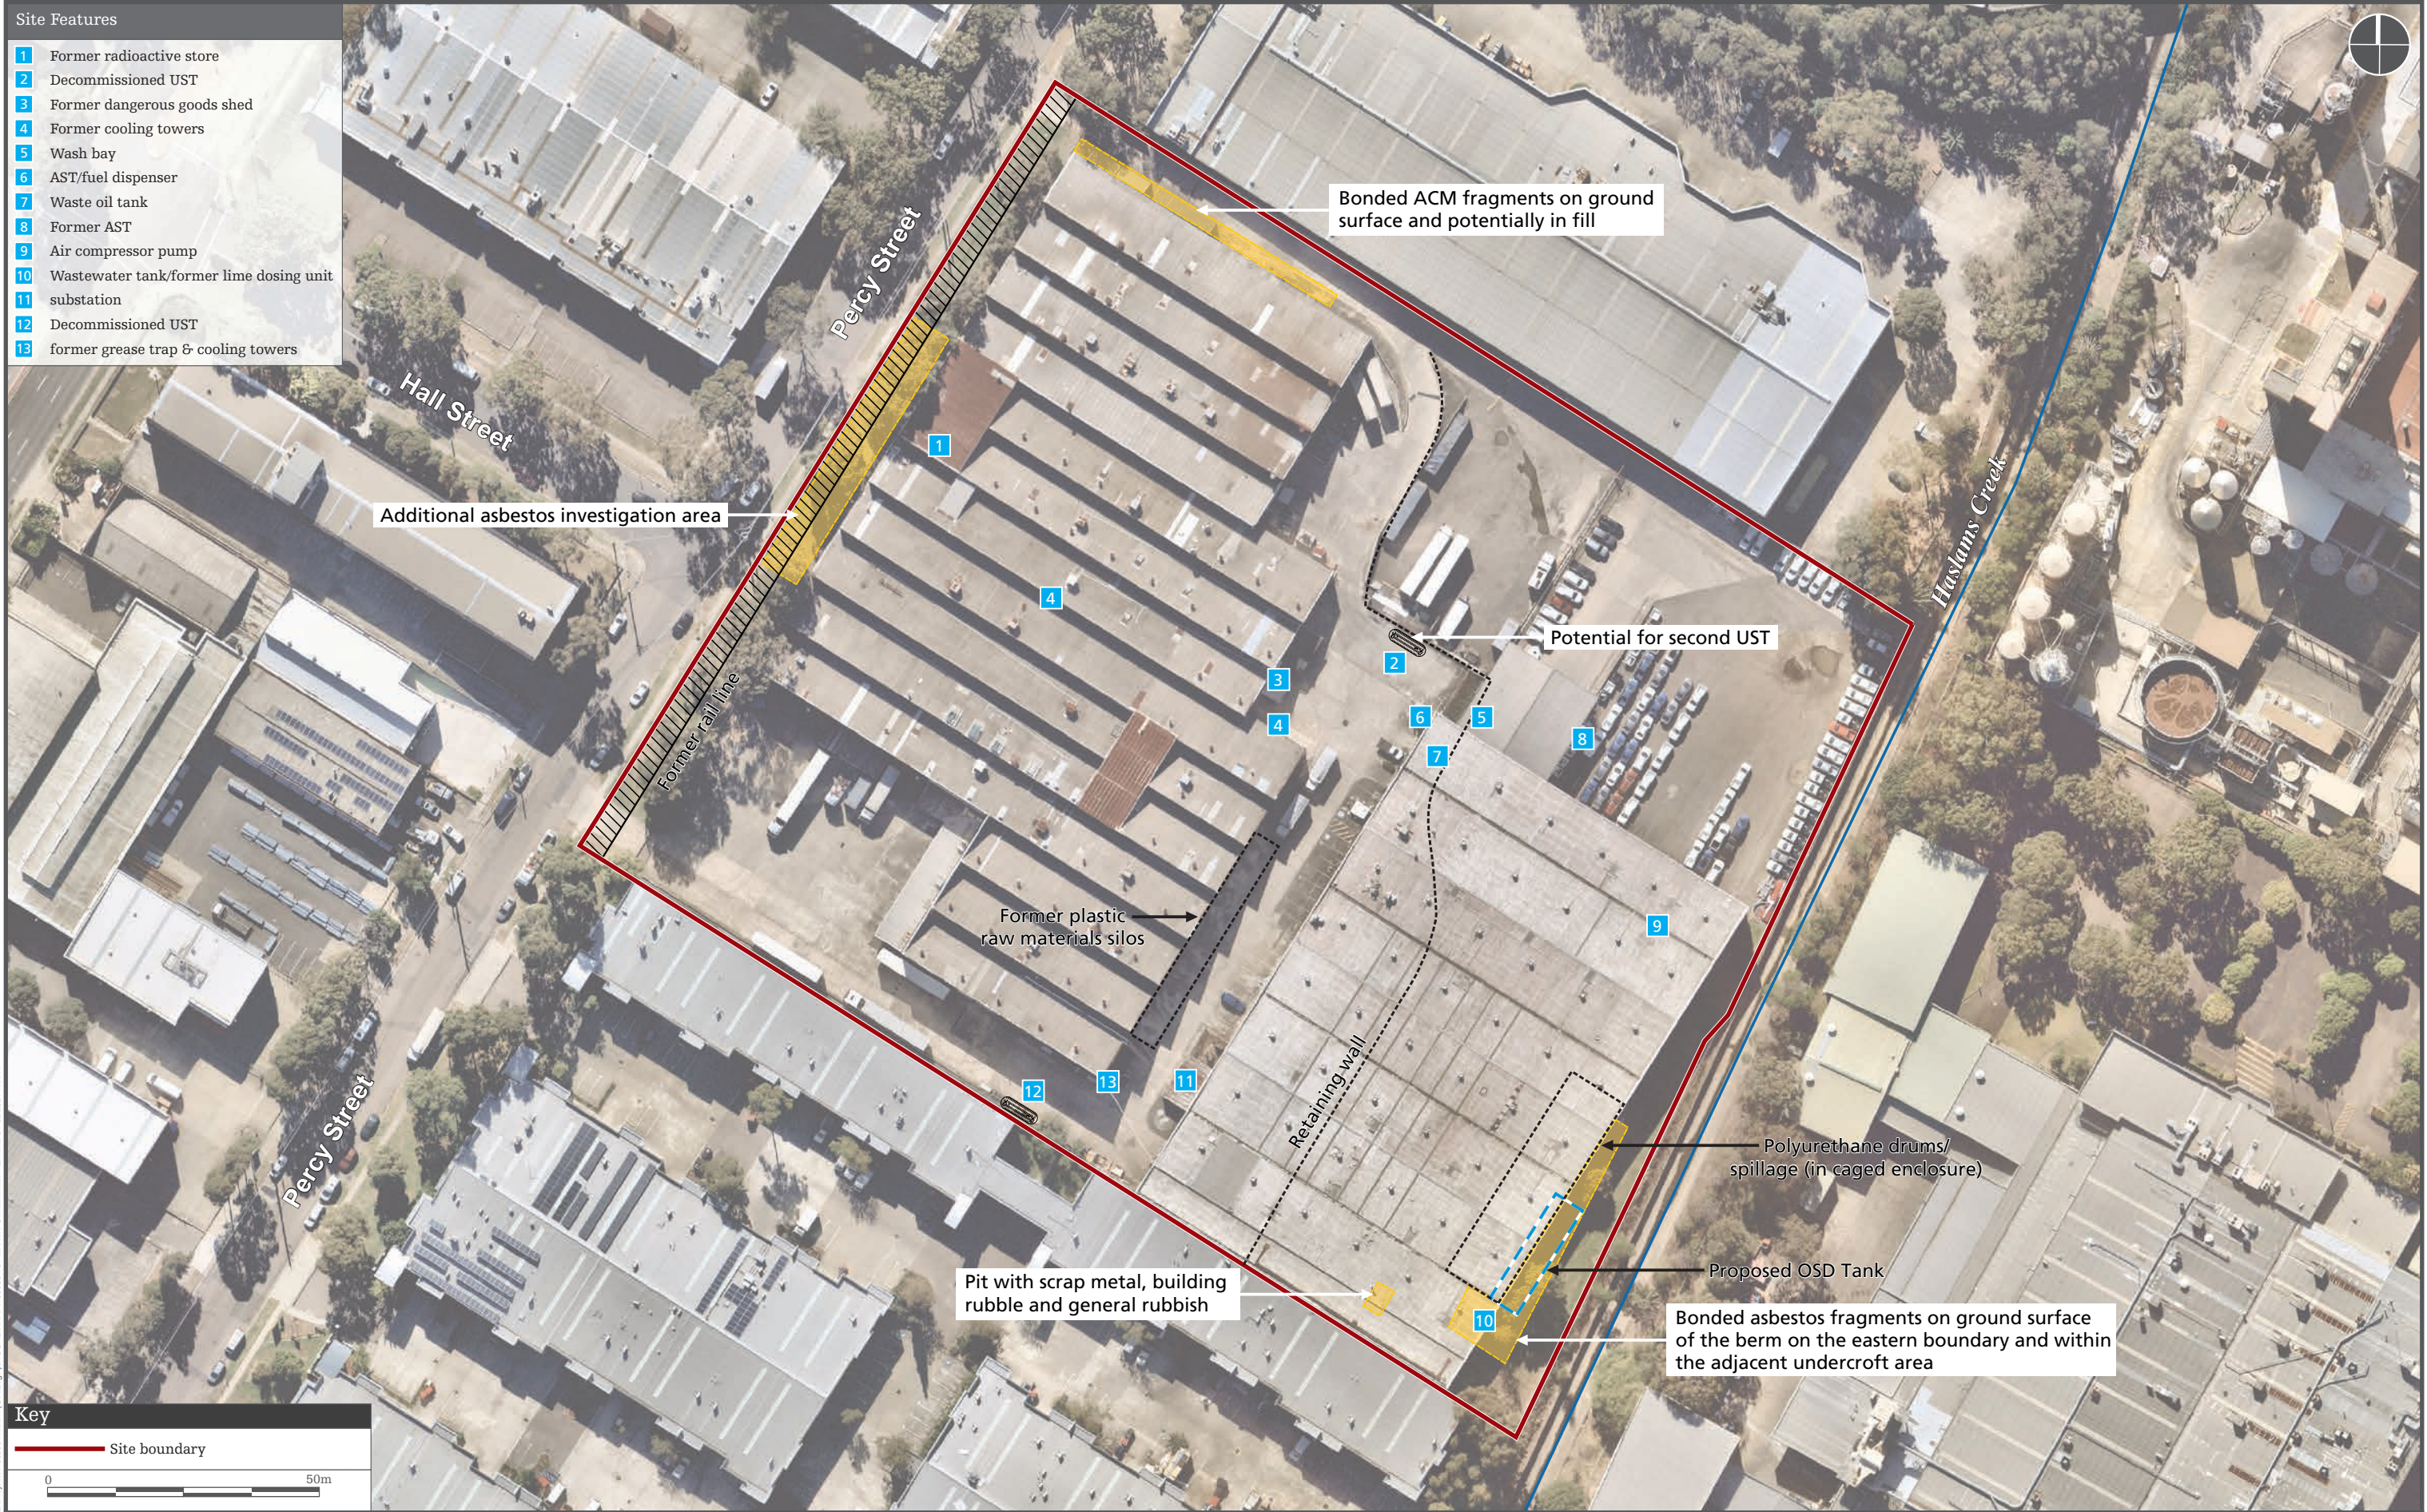
Drawing Title
SITE PLAN - OPTION 7

Project Name
CFC Percy St. Auburn

The site is to be redeveloped by Fabcot as a distribution centre for online sales. The development is to comprise a single-story warehouse across most of the site footprint (occupying approximately 16,200 m²) with truck and car parking to the east, south and west of the warehouse.

The eastern portion of the building extends across the lower area of the site currently occupied by the building undercroft, car parking area and wash bay. Due to this portion of the site being a flood zone, the building across this area is proposed to be constructed on a suspended slab. The area below the suspended slab is to an open and unoccupied area. The design plan is provided in Attachment 2.
