PUBLIC DOMAIN & LANDSCAPE REPORT

Qantas Airways Ltd (Qantas)

Qantas Group Flight Training Centre

Project Number: 20180199

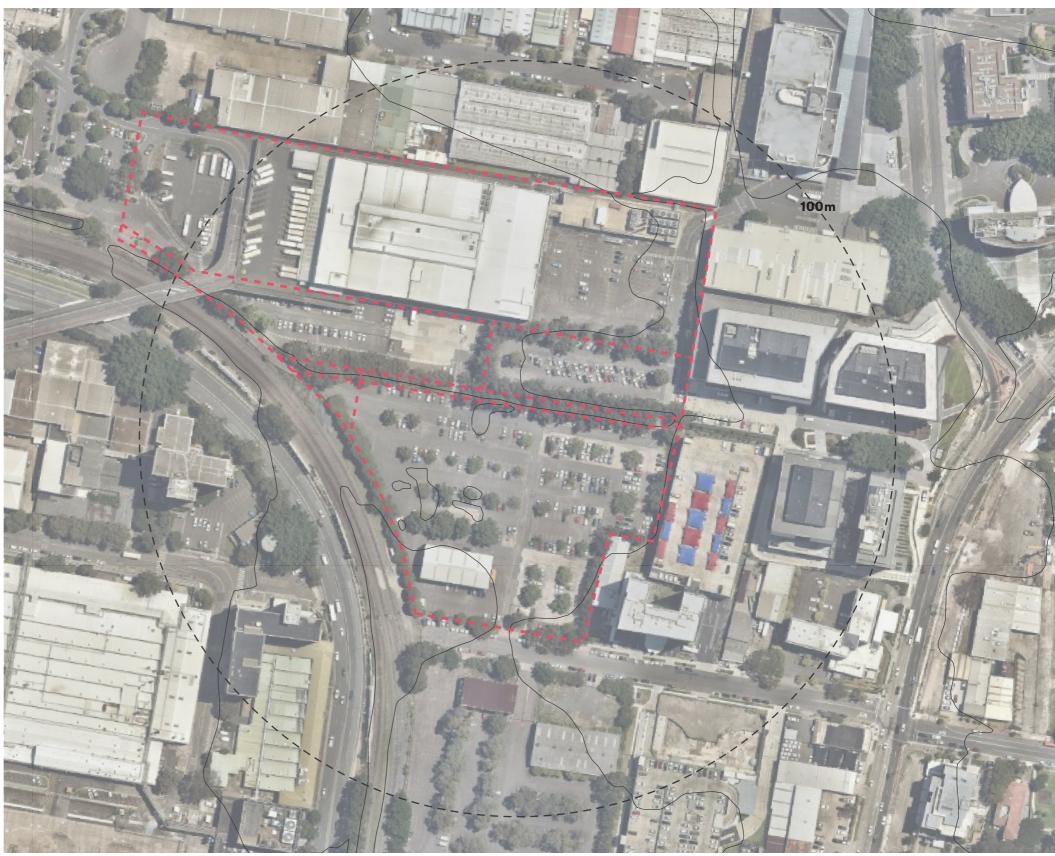
Figure 2 Existing Site Plan

- + The site is approximately 5.417ha and is an irregular shape. It is approximately 240m in length and maintains a variable width of between approximately 321m in the northern portion of the site and approximately 93m along the King Street frontage (refer to Figure 2).

- + The site possesses a relatively level slope across the site. An open Sydney Water drainage channel bisects the northern portion of the site in an eastwest direction. There are some isolated changes in level immediately adjacent to this channel. A Site Survey Plan accompanies the application which details the topographic characteristics of the site.

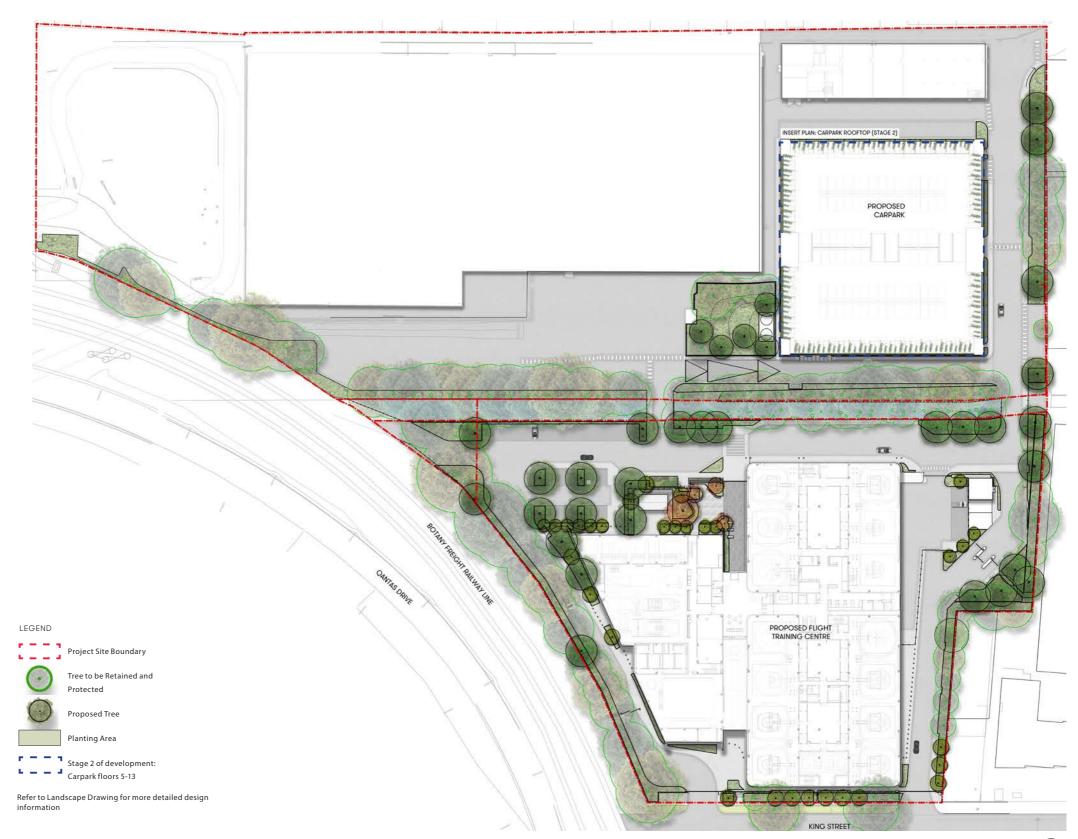
Figure 8 Landscape Site Plan

Figure 8 Illustrates the proposed Landscape Site Plan. Following is a description of each of the key landscape areas and treatments.

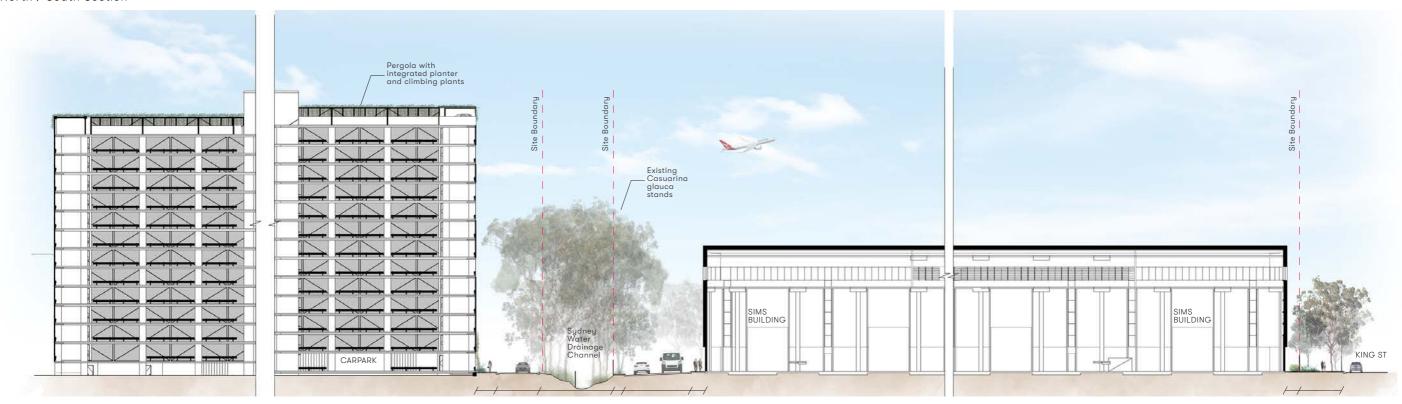
North / South Section

Figure 9 Landscape Site Sections

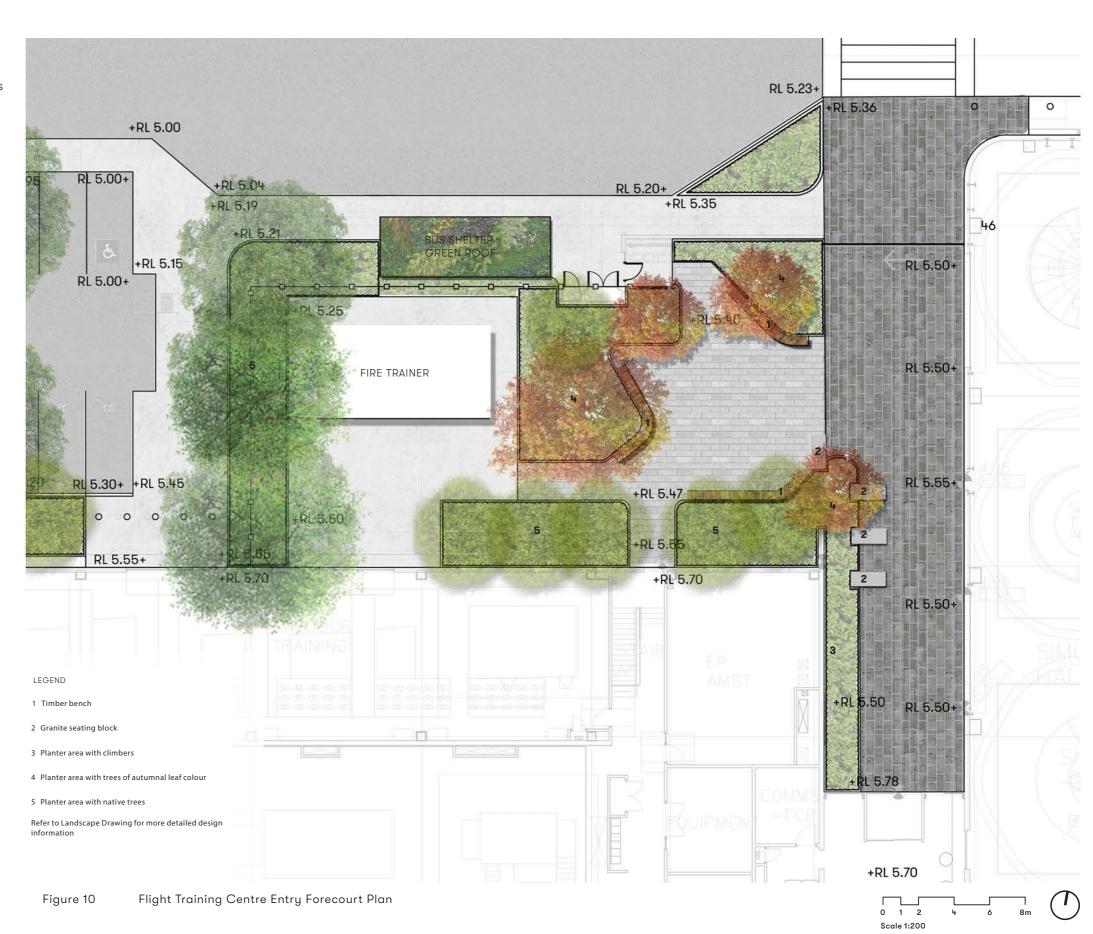
The space adjacent the entry of the Flight Training Centre needs to accomodate a number of functions as follows:

- + 2400m fenced forecourt to allow after hours security and the inclusion of an after hours pedestrian gate
- + Paved main entry zone with signage and main gate (to remain open during the day). A largely open area providing clear visual connection from the internal street to the entry. In keeping with the Qantas Corporate Headquarters forecourt in Bourke Road a series of stone seats will provide amenity to the entry area. This space must also accommodate access for the removal of the simulators during replacement

- + Staff breakout area with fixed benches and shade structure supported against the security fence and the potential for additional movable furniture.

- + Landscape provides shade, visual amenity and soft screening from the internal street and of the fence.
- + Fire Trainer (Container)
- + Access to the cabin training facilities including for replacement of training equipment.

- + Internal bus stops (2 directions) with bus shelter structure on the southern side stop supported against the security fence.
- + Car parking related directly to the Flight Training Centre.

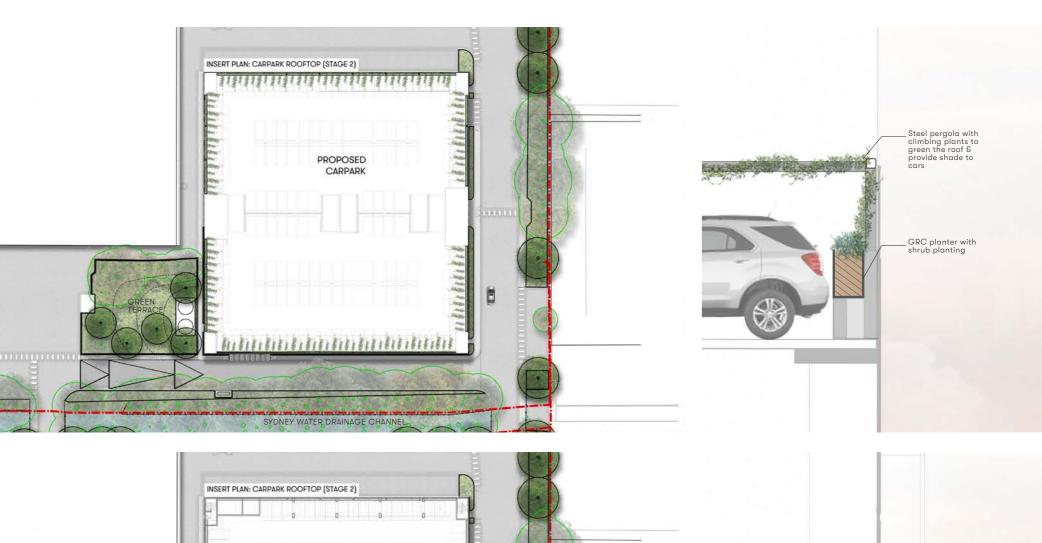
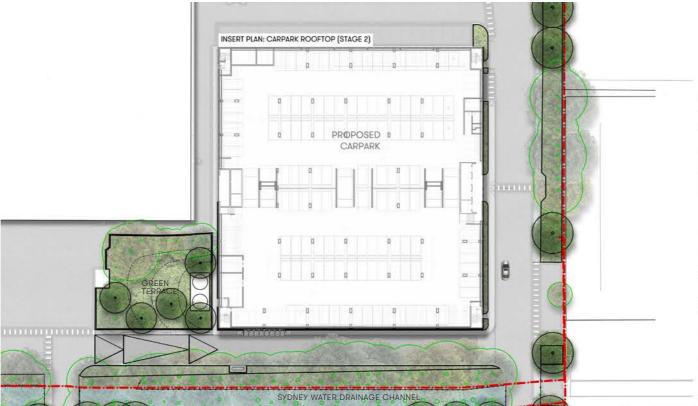
Figure 11 Proposed Multi Level Carpark Ground & Roof Plans

The multi level carpark will incorporate a number of landscape elements to improve its visual quality and add to the landscape character of the site for the amenity of users. These elements are as follows:

- + To the west retain the existing trees and augment with additional landscaping outside the building footprint.
- + To the south along the Sydney Water Chanel, retain and protect the existing growth of Casuarina trees.
- + Along the facade to the east and south of the carpark building, a planter is incorporated outside the building line planted with climbers to grow up the mesh facade for the height of the ground floor.
- + On the rooftop level of parking (level 13), a raised planter and pergola structure will accommodate both trailing and climbing plants. This landscaped treatment will perform the duel function of providing shade to the parked cars and visual mitigation for taller surrounding buildings and the public domain where the structure will be visible.
