**REPORT TO**  
**KINCOPPAL - ROSE BAY SCHOOL**

**ON**  
**GEOTECHNICAL AND HYDROGEOLOGICAL**  
**INVESTIGATION**

**FOR**  
**PROPOSED ELEVATED WALKWAY AND ROAD**

**AT**  
**CNR NEW SOUTH ROAD AND VAUCLUSE ROAD,**  
**VAUCLUSE, NSW**

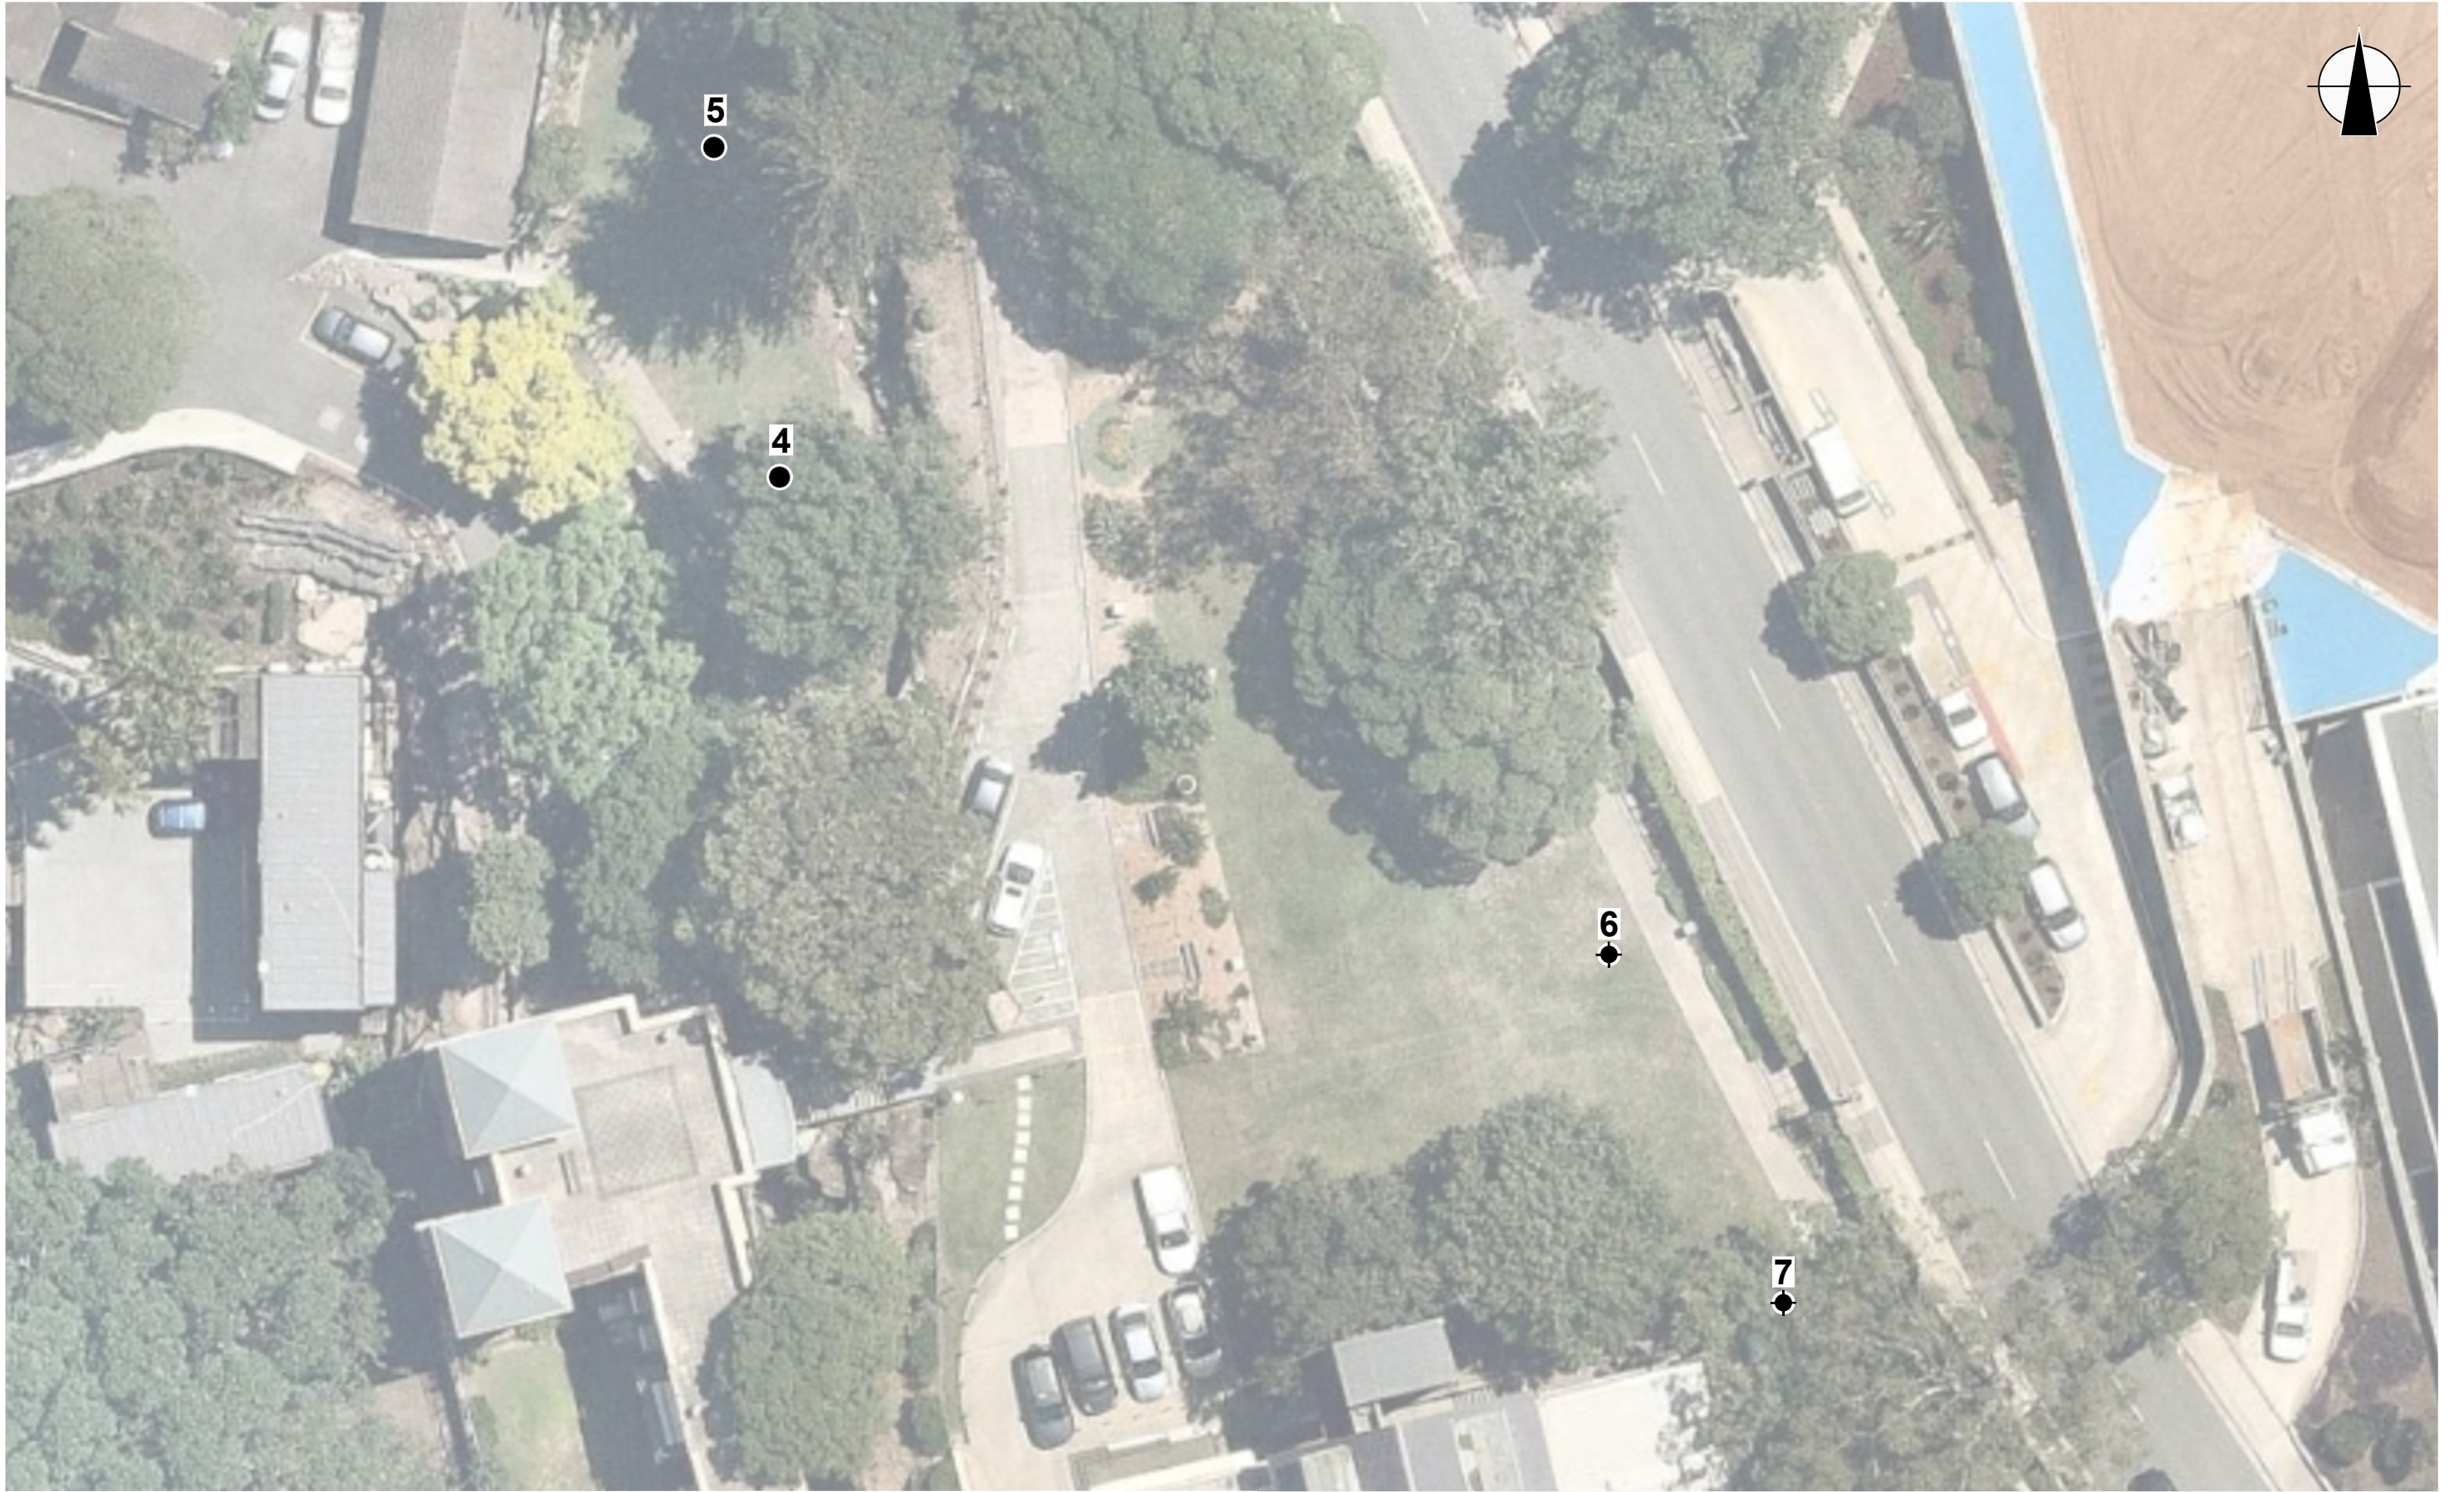
Figure 2: Borehole Location Plan

The borehole locations, which were set out in consultation with Mr Mahady prior to the commencement of drilling, are shown on the attached Figure 2 and were recorded using a tape measure off existing surface

features. The surface RLs of BH6 and BH7 were obtained using a Topcon GRS-1 differential GPS unit; due to the presence of trees, it was not possible for the GPS to obtain surface RLs for BH4 and BH5. The surface RL to the Australian Height Datum [AHD] of BH6 and BH7 are shown on the respective borehole logs. At the time the GPS coordinates were recorded, the accuracy was about 100mm in all directions. Figure 2 is based on a recent Nearmap image of the site.

- BOREHOLE
- ◆ BOREHOLE AND DCP TEST
