Remediation Action Plan

Proposed Mixed Use Development  
42 Honeysuckle Drive, Newcastle

Prepared for  
Doma Holdings (Honeysuckle) Pty Ltd

Project 91181.00  
December 2017

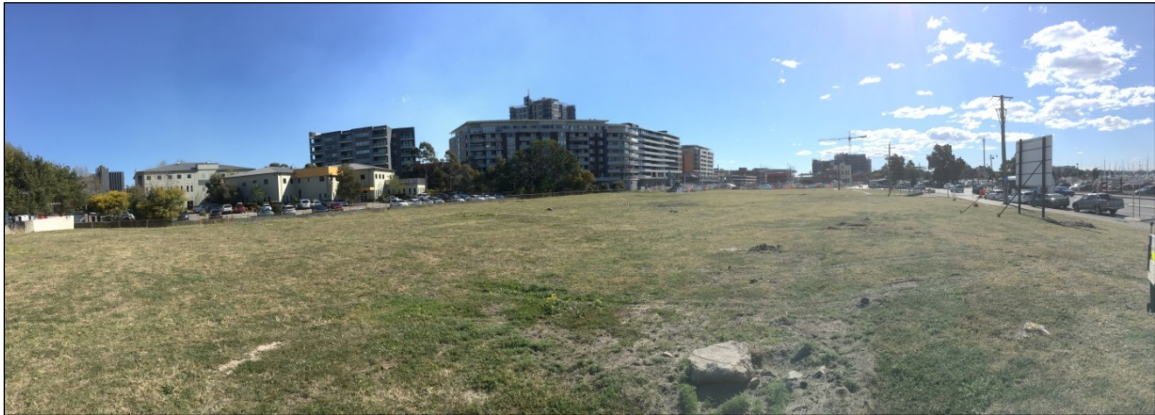
**Figure 1: Looking west from north east portion site. Likely former test pit location in foreground (disturbed surface).**

Several localised surface disturbances (likely to be former test pit locations) were evident across the site. Where present, building materials (i.e. concrete, timber and bricks), slag and asphalt were observed at the surface. A fibro sheet fragment (later confirmed as ACM – refer to Section 4) was observed at the disturbed surface of a former test pit within the south west corner of the site (refer to Figure 3).

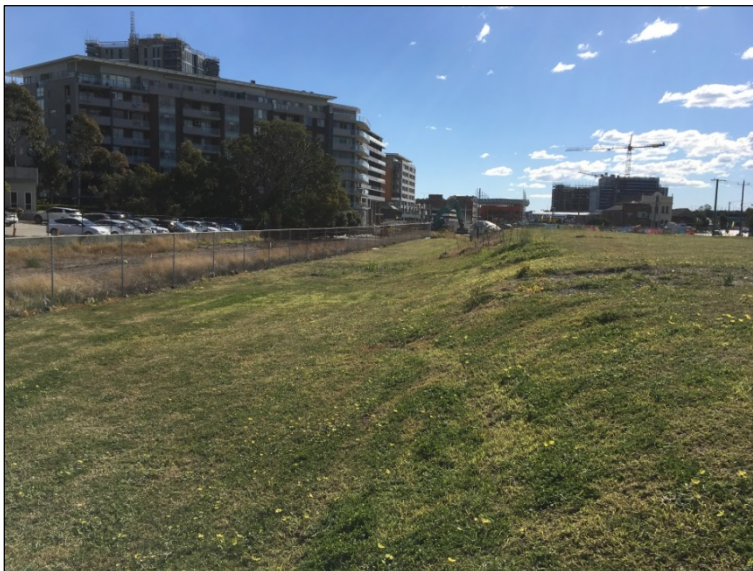
**Figure 2: Looking north from southern portion of site. Fill batter in centre, former railway line south of fence.**

The site was vacant, predominantly grassed and contained mounded fill in September 2017. The mounded fill covers the majority of the site footprint, which has raised site levels 1.5 m to 2 m above the street level. The fill mound extends into the adjacent allotment to the west (Lot 23) and batters down to Cottage Creek;

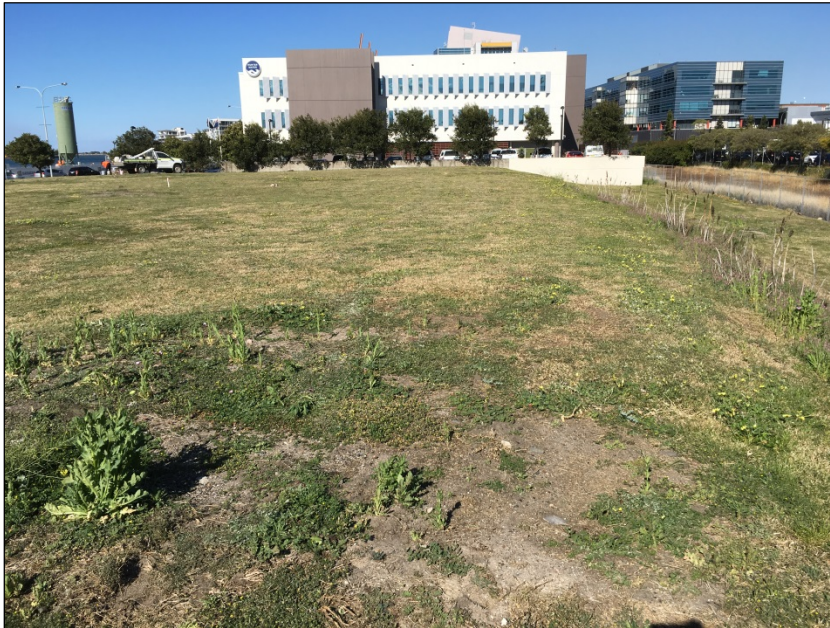
**Figure 3: Looking east at the southern portion of site. Fibro fragment in foreground amongst disturbed ground from likely former test pit.**

Asbestos has been detected by observation and confirmed by laboratory analysis within filling at the surface of the site (likely to be associated with deeper fill materials brought to the surface through previous test pitting by others). Building demolition materials, such as concrete and brick were also identified in filling and these are considered as indicative of the possible presence of hazardous building materials (HBM), including asbestos.

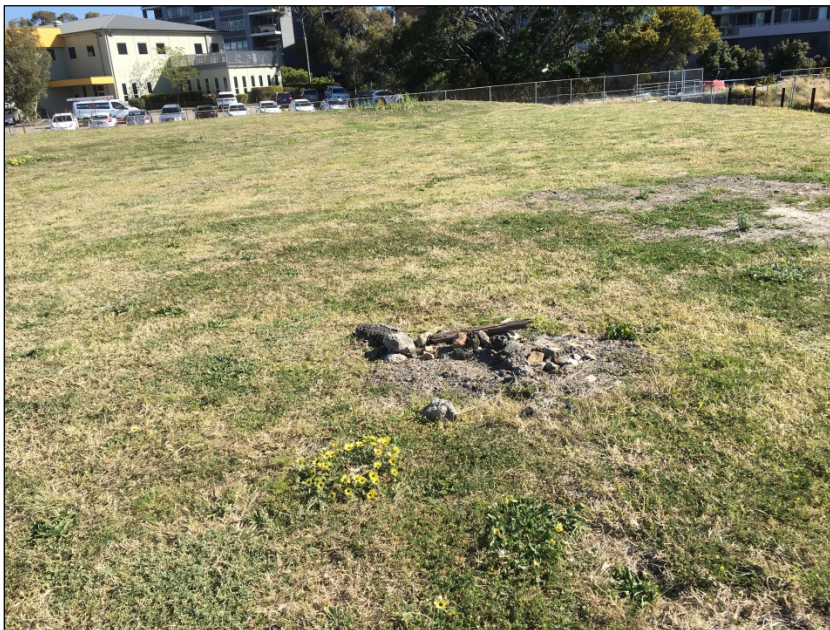
**Figure 4: Looking south west at disturbed ground from likely former test pit.**

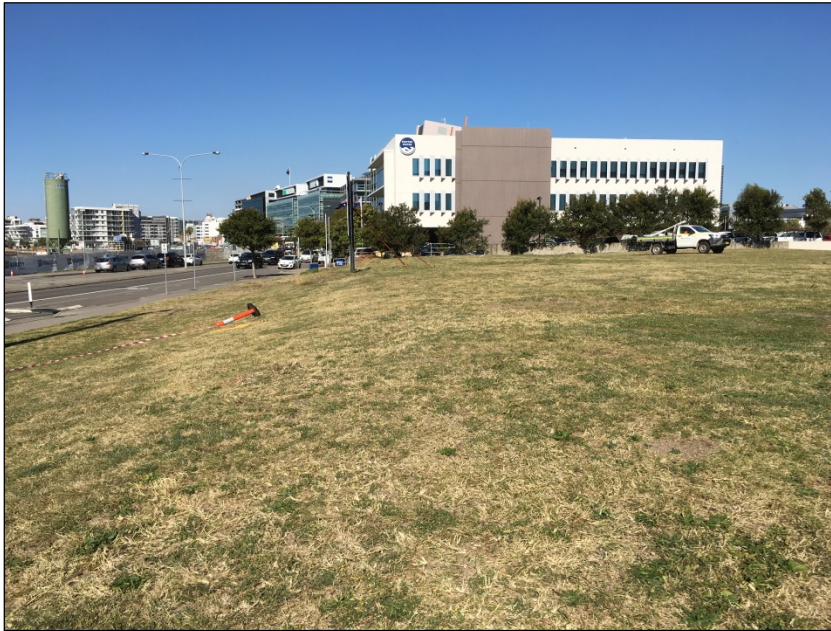
**Figure 5: Looking east at northern portion site and fill batter.**
