# GROUNDWATER MANAGEMENT PLAN – REV C

Aspect Industrial Estate, Mamre Road, Kemps Creek, NSW

Prepared for Mirvac Office and Industrial Pty Ltd

09 OCTOBER 2020

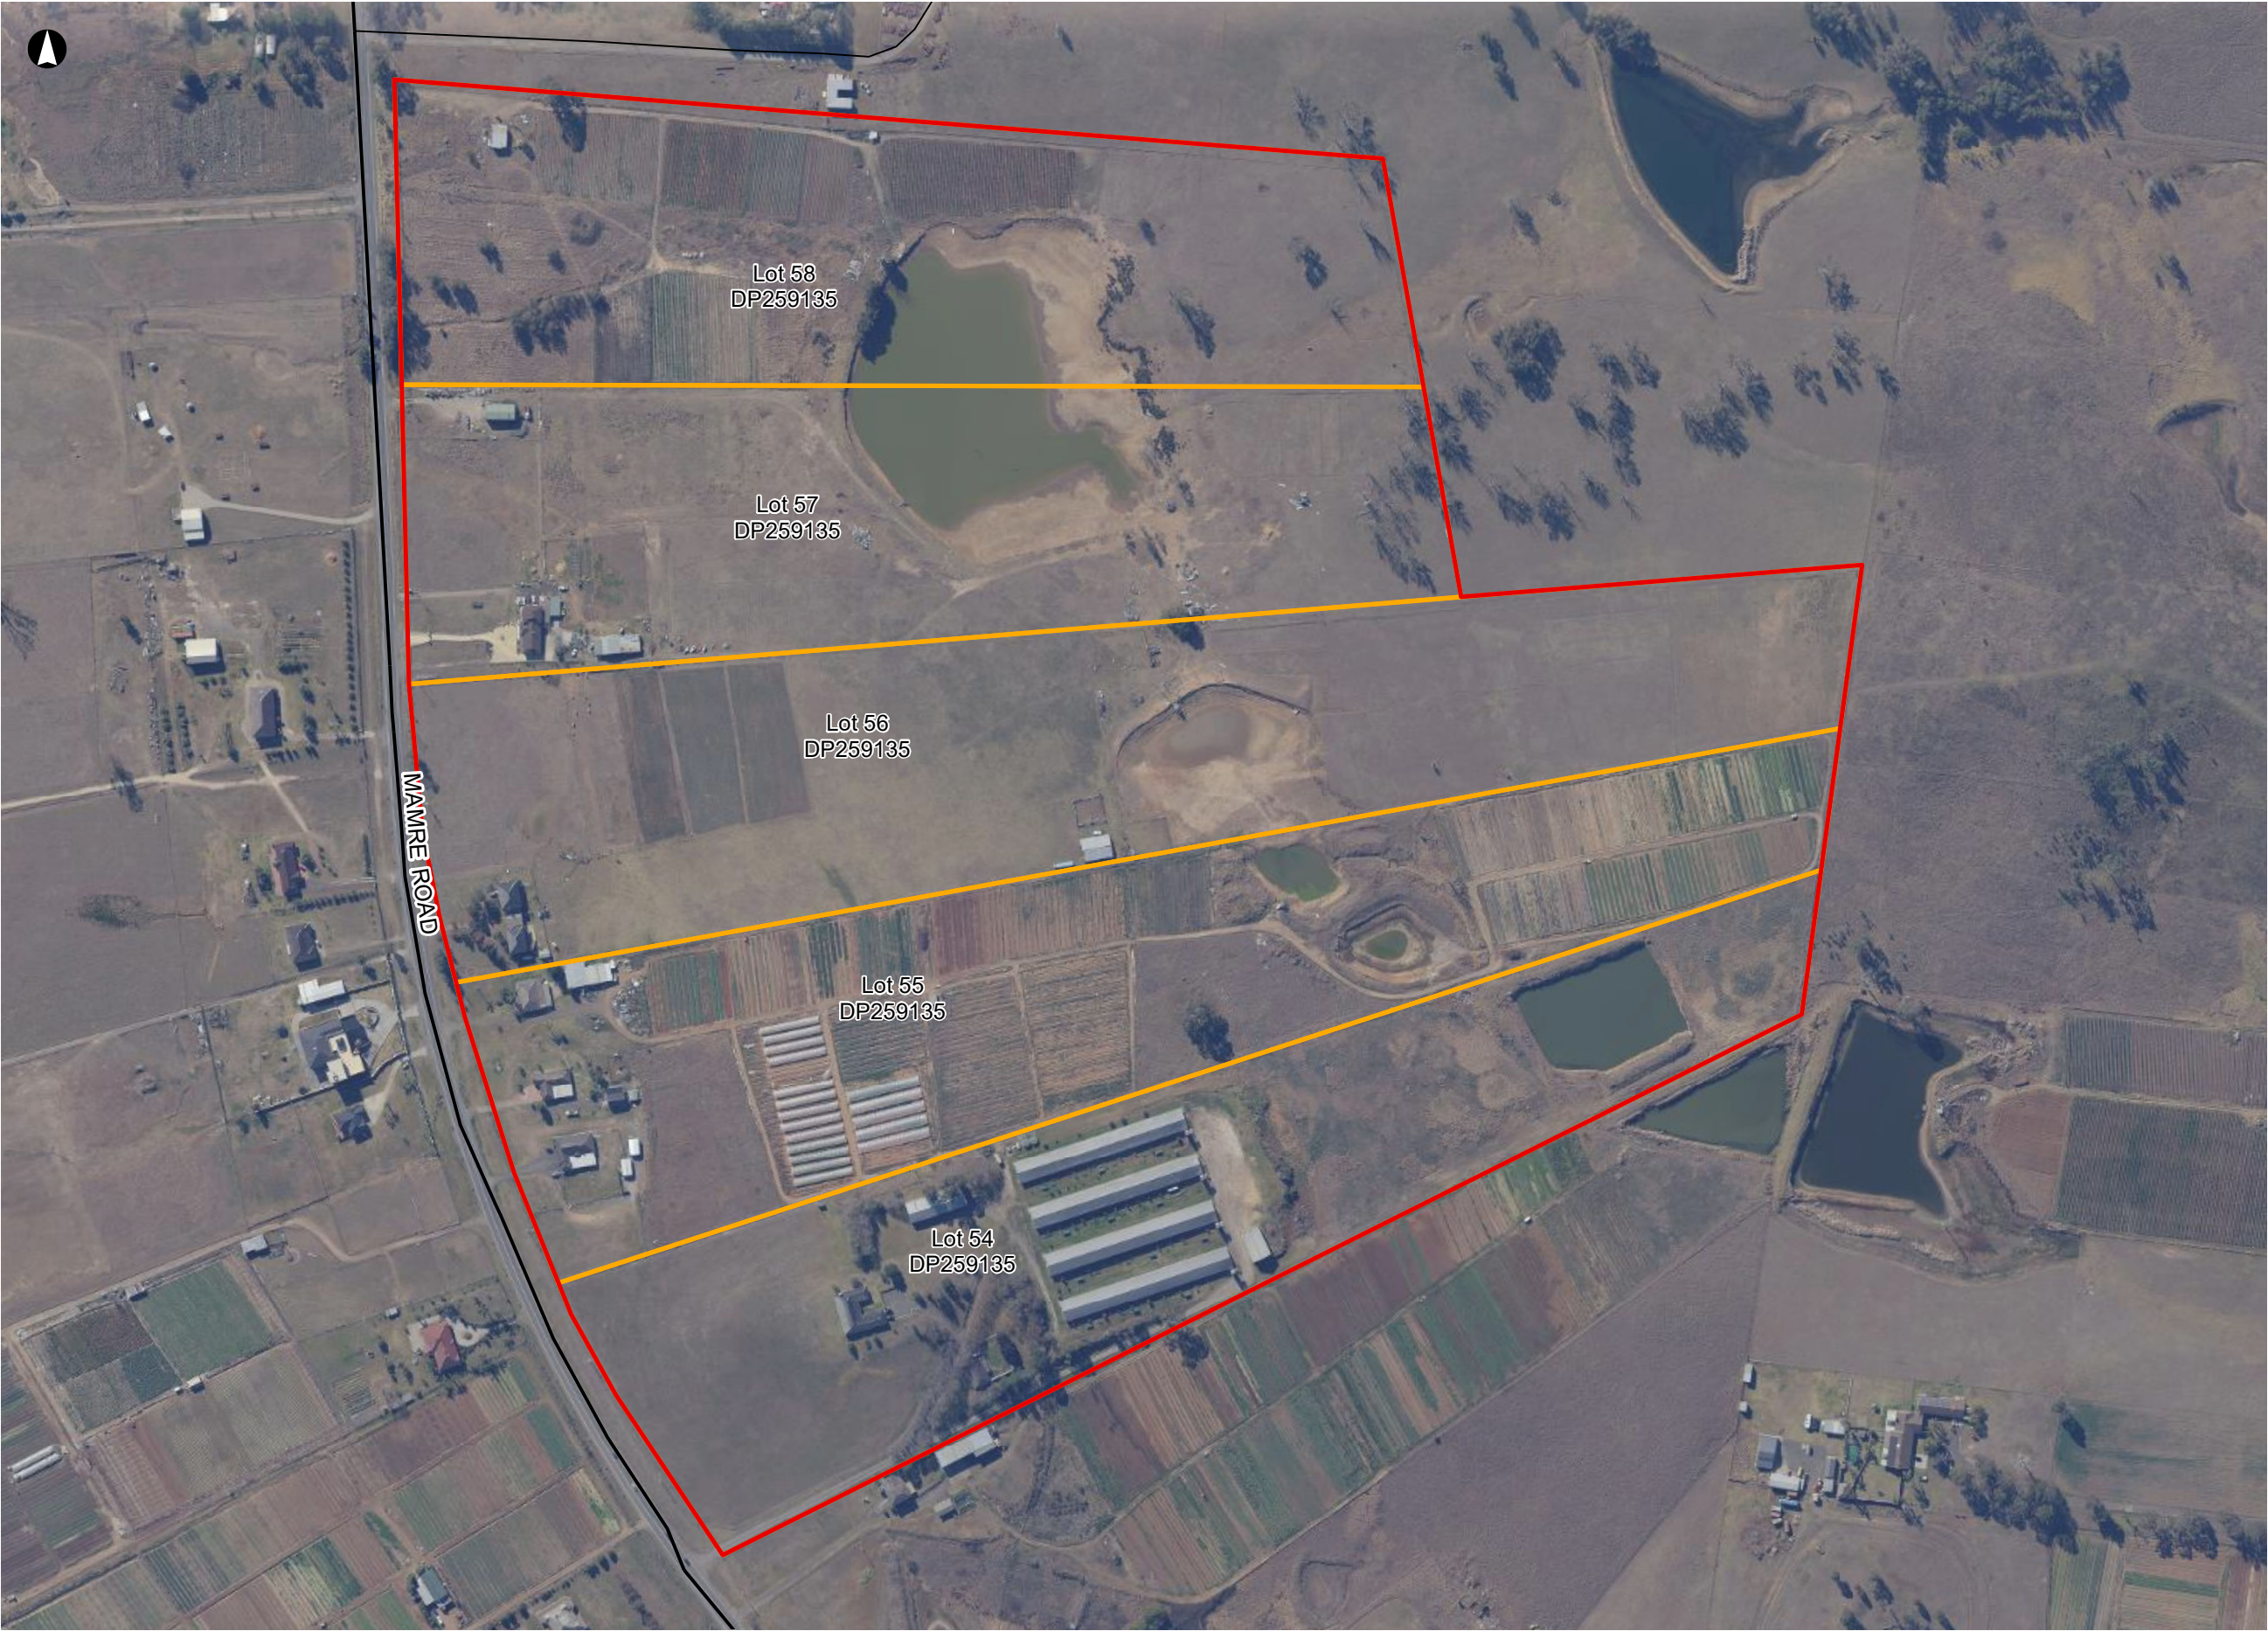
The location and layout of the site are shown in Figures 1 and 2, **Appendix A**. The site details are provided in Table 2-1 below and described in detail in the following sections.

Arcadis Australia Pacific (Arcadis) was engaged by Mirvac Office and Industrial (Mircvac) to prepare a Groundwater Management Plan (GMP) to support the proposed Aspect Industrial Estate development located at Lots 54-58 DP259135 Mamre Road, Kemps Creek, NSW 2178 (the site). The location of the site is illustrated in Figure 1, **Appendix A**.
