# Moorebank Intermodal Terminal Project Environmental Impact Statement

# Technical Paper 5 Environmental Site Assessment (Phase 2) – Appendix C - F

## **Phase 1 Environmental Site Assessment, Moorebank Intermodal Terminal**

### **Northern Rail Access Option**

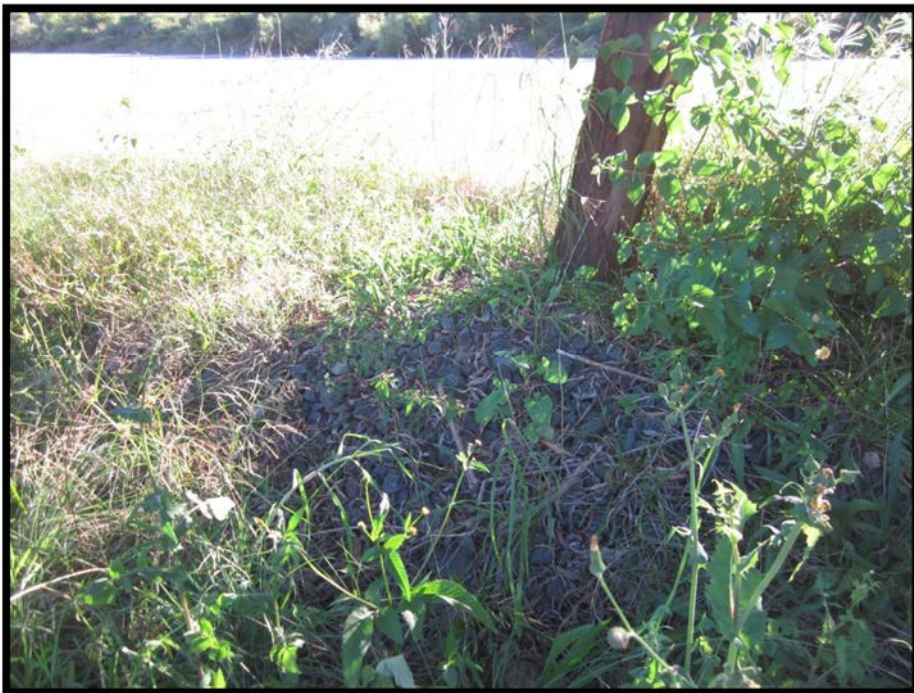
- The northern area of the site was low lying with signage indicating that this area was prone to flooding in periods of heavy rain.
- Some mounds and depressions did exist at the site. These were generally covered with vegetation suggesting they were well established. No obvious evidence of dumping/fly tipping of wastes was observed.

Photograph 5: Ballast mound near central footpath.

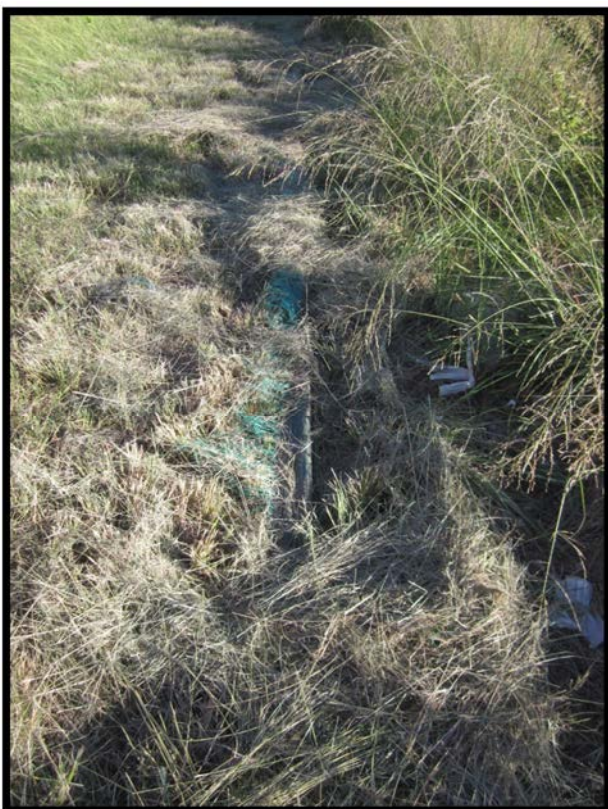
- The site appears to have been recently graded from the newly constructed Powerhouse Road gently sloping downwards towards the Georges River. Grass cover in this area was sparse with fill material scattered over the surface including concrete, ballast like stones, road base material within a sandy clay matrix. Fragments of brick, geotextile (silt fence) and plastic fragments were also observed across the site surface.

Photograph 6: Geotextile/silt fence identified along the central footpath in the central area of the site.

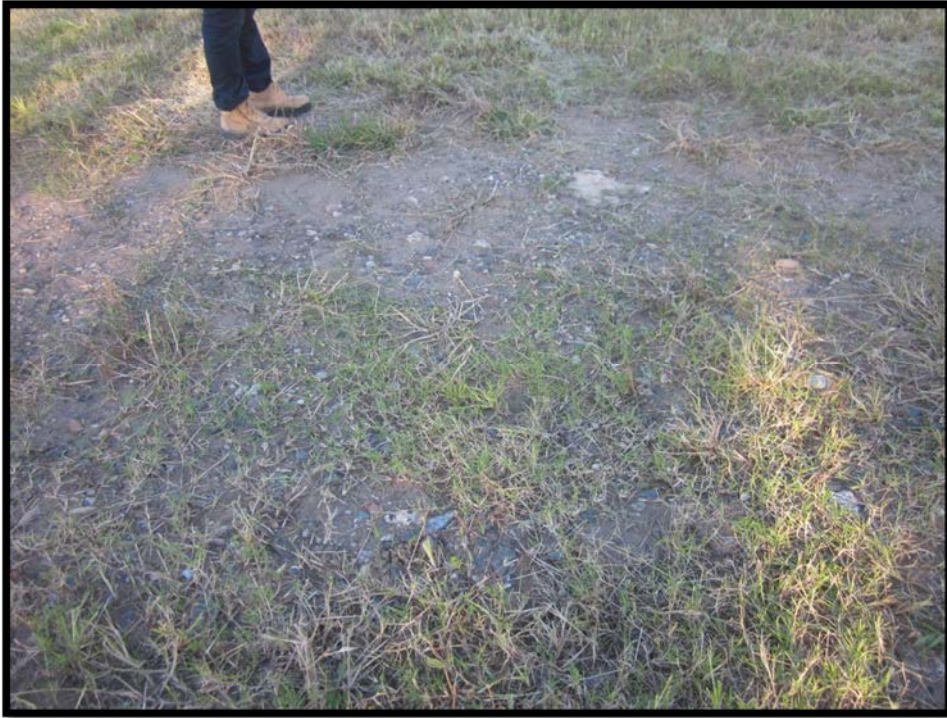
Photograph 7: Recently graded surface adjacent to Powerhouse Road (grass has not yet become established).

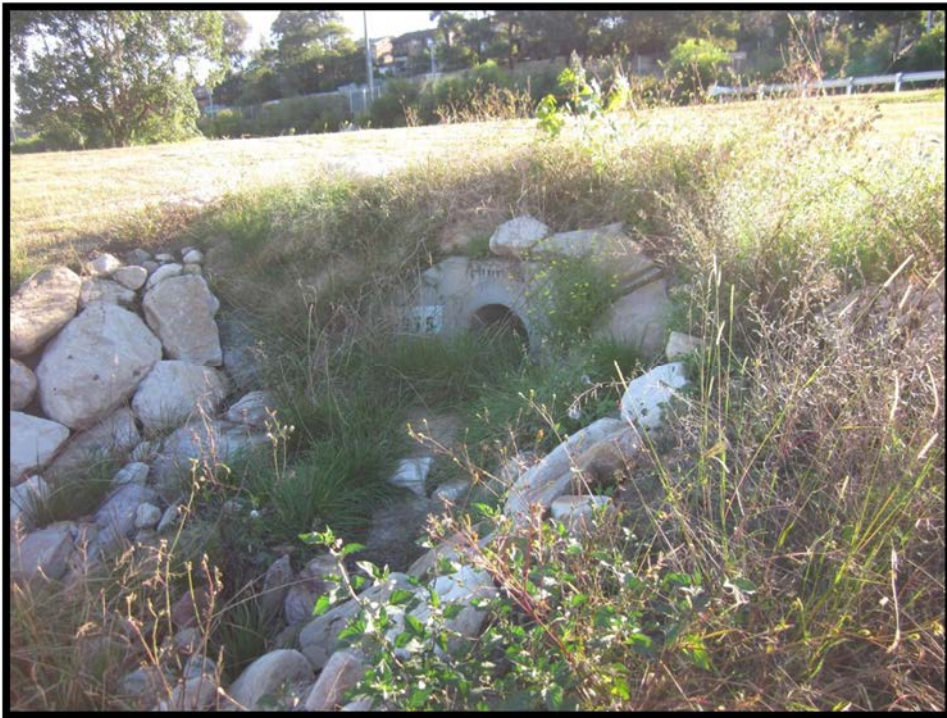
Photograph 8: Stormwater drain adjacent to Powerhouse Road.

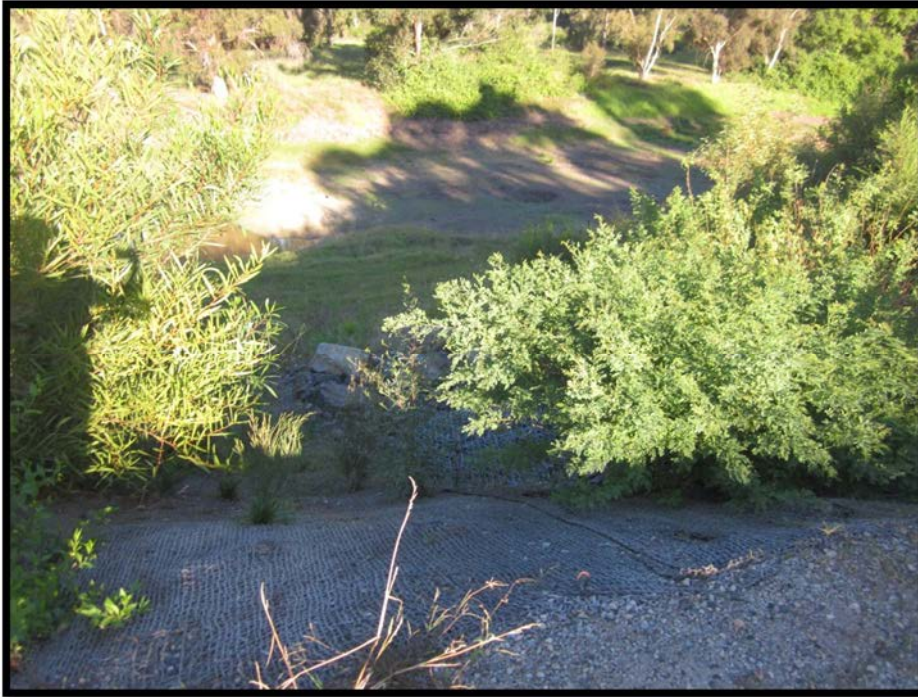
- No monitoring or abstraction wells were observed to be present at the site.
- Stormwater retention ponds were present in the southern portion of the site although these are situated outside of the proposed northern rail access option footprint.

Photograph 9: View east from Powerhouse Road at the southern end of site, steep embankment leading to retention ponds.

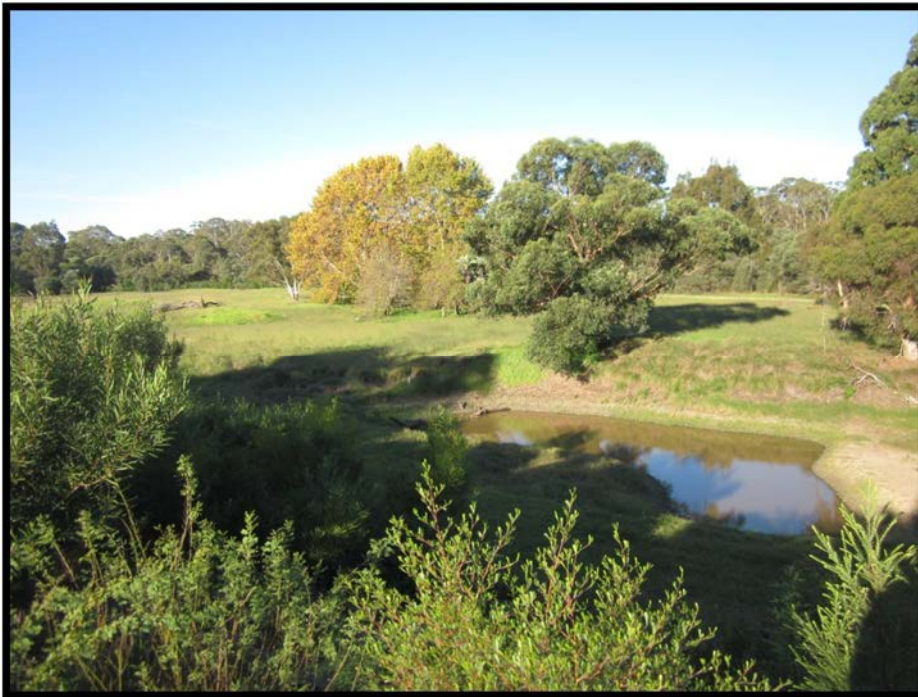
Photograph 10: View north east from Powerhouse Road at the southern end of site, steep embankment and water retention ponds.

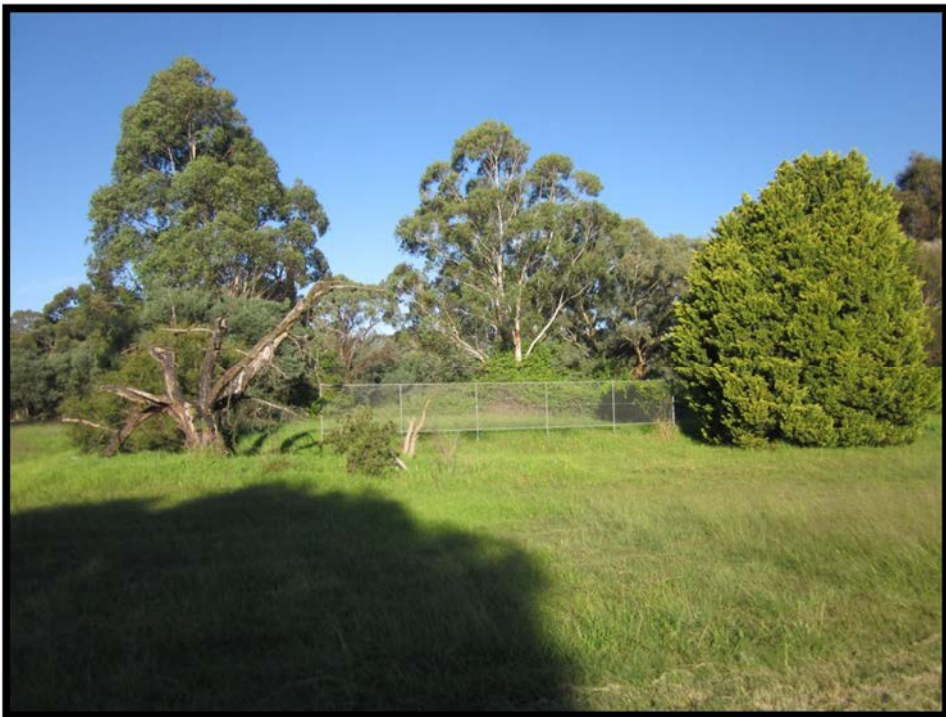
- The site is unfenced with access along the western boundary from Powerhouse Road. A chain wire panel fence (considered likely to be associated with the former golf course) was present in the central area of the site. This fence was in good condition.

Photograph 11: Existing fence in the central area of the site.

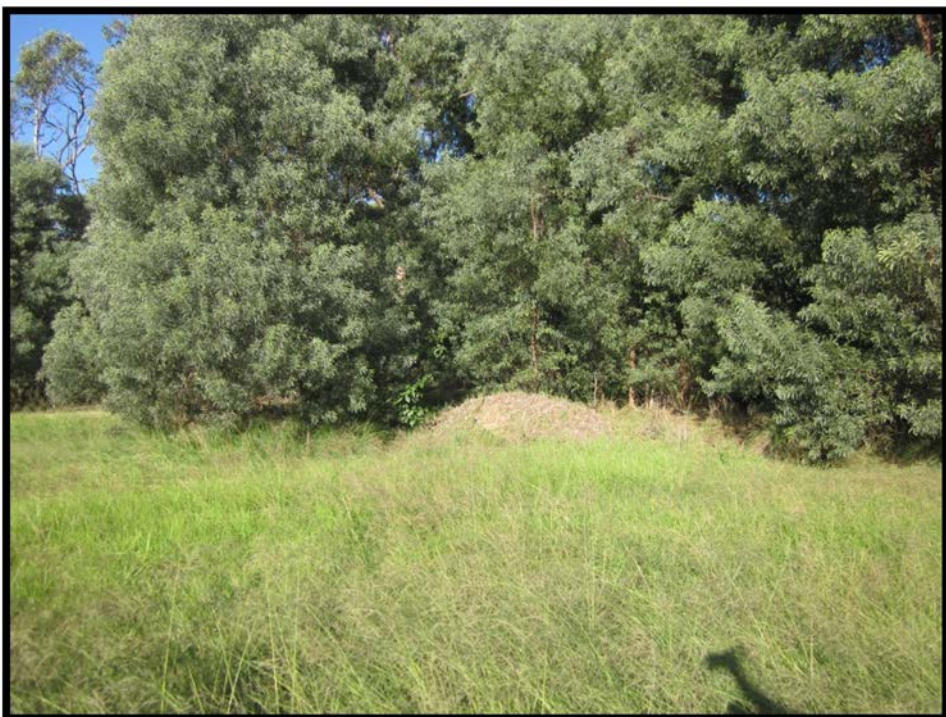
Photograph 12: Fill mound in the central area of the site adjacent to the cycle way.

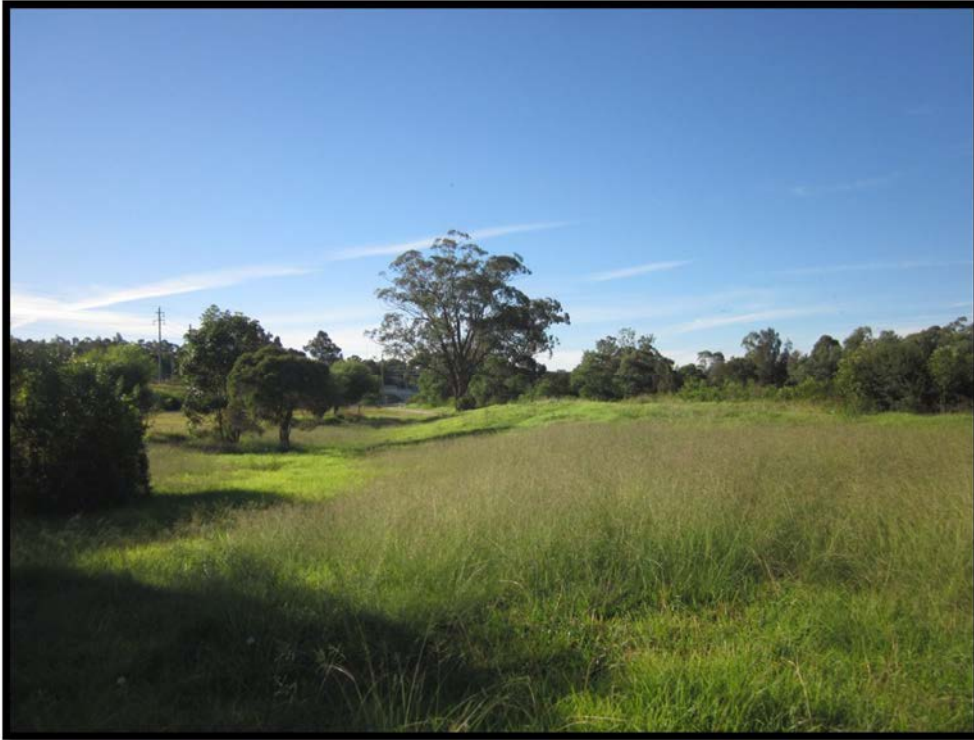
Photograph 13 View north from the central area showing undulating topography (mounds and depressions).

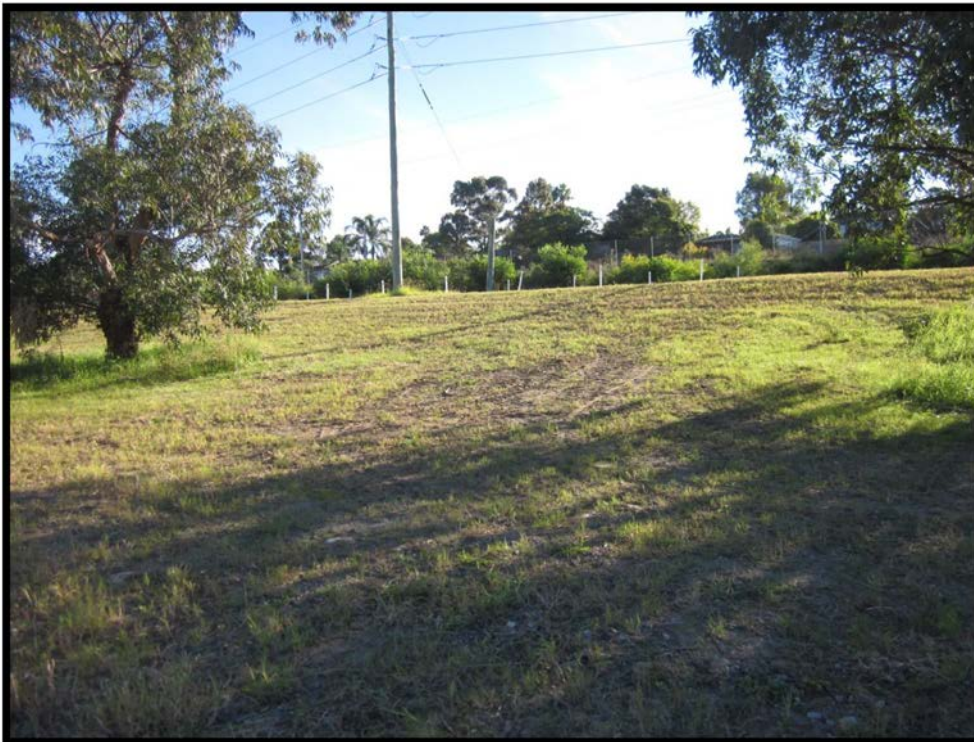
Photograph 14 View west from the central area showing recently graded soils and Powerhouse Road beyond.
