| 50 WYLLIE ROAD, KEMBLA GRANGE – ADDENDUM REPORT | | | | |

## APPENDIX 4

### Flood Inundation Maps Velocity

### Flood Inundation Maps Velocity x Depth

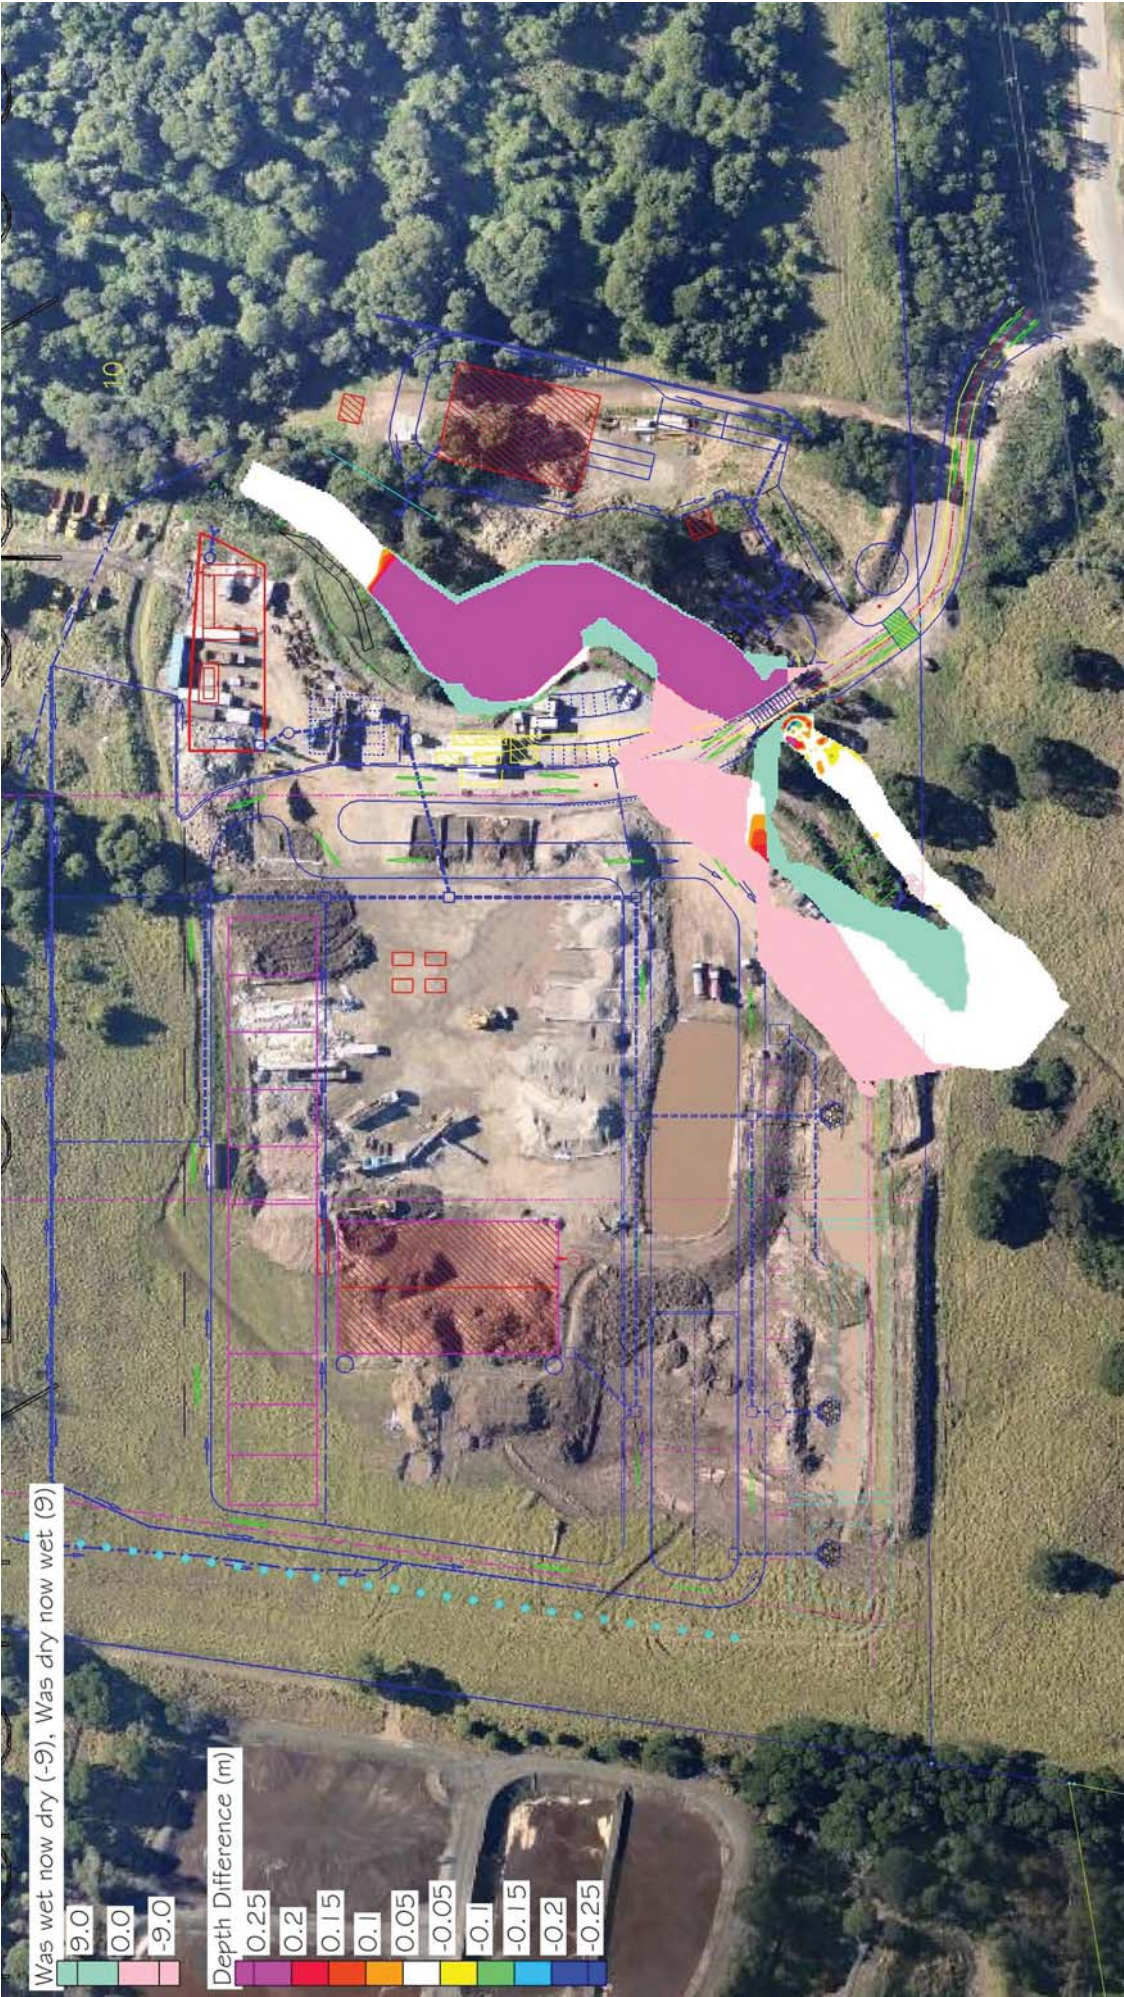
| 50 WYLLIE ROAD, KEMBLA GRANGE – ADDENDUM REPORT | | | | |
|---|---|---|---|---|
| Post(Blocked) - Pre | 100yr | Difference | A | KF110816 |

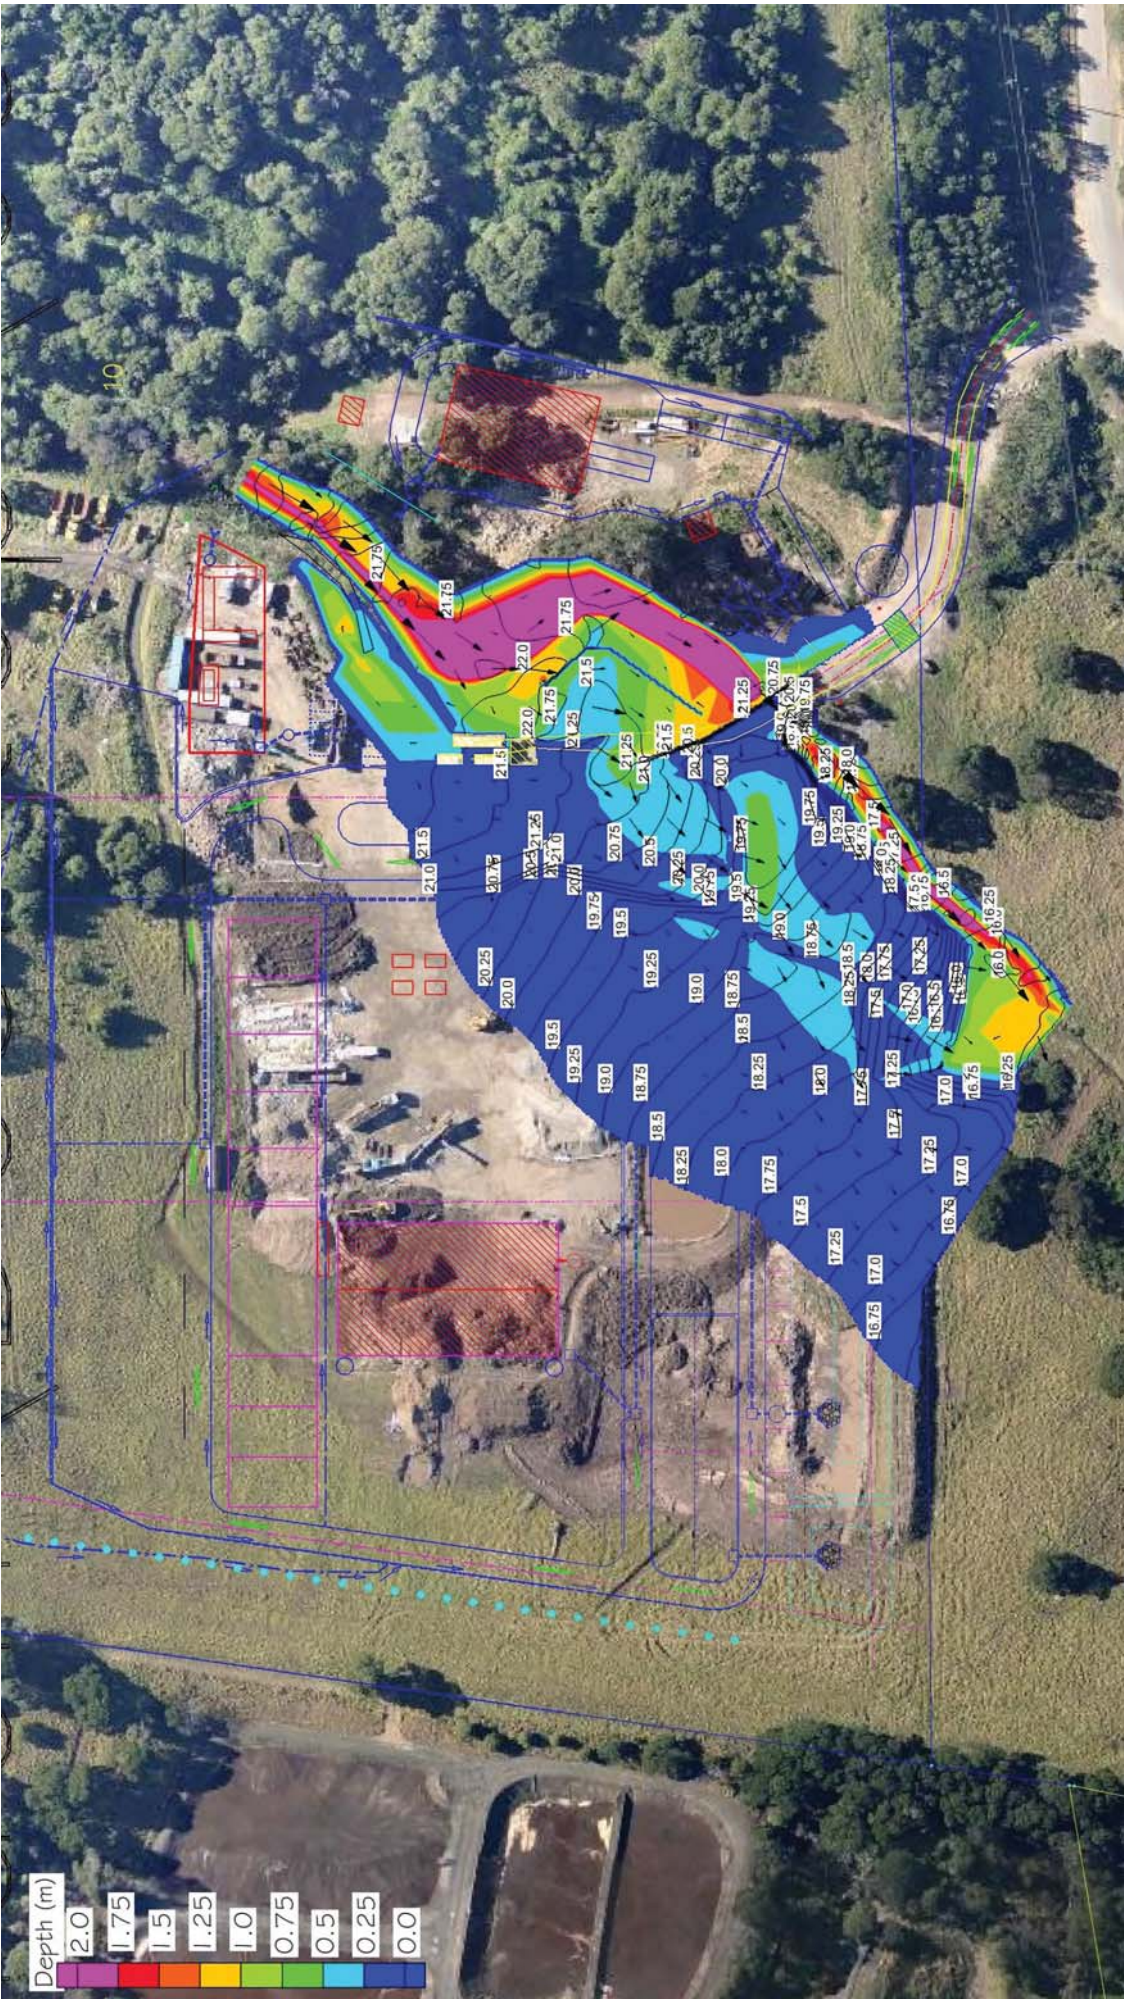
| 50 WYLLIE ROAD, KEMBLA GRANGE – ADDENDUM REPORT | | | | |
|---|---|---|---|---|
| Pre-Developed | PMF | Flood Depth | A | KF110816 |

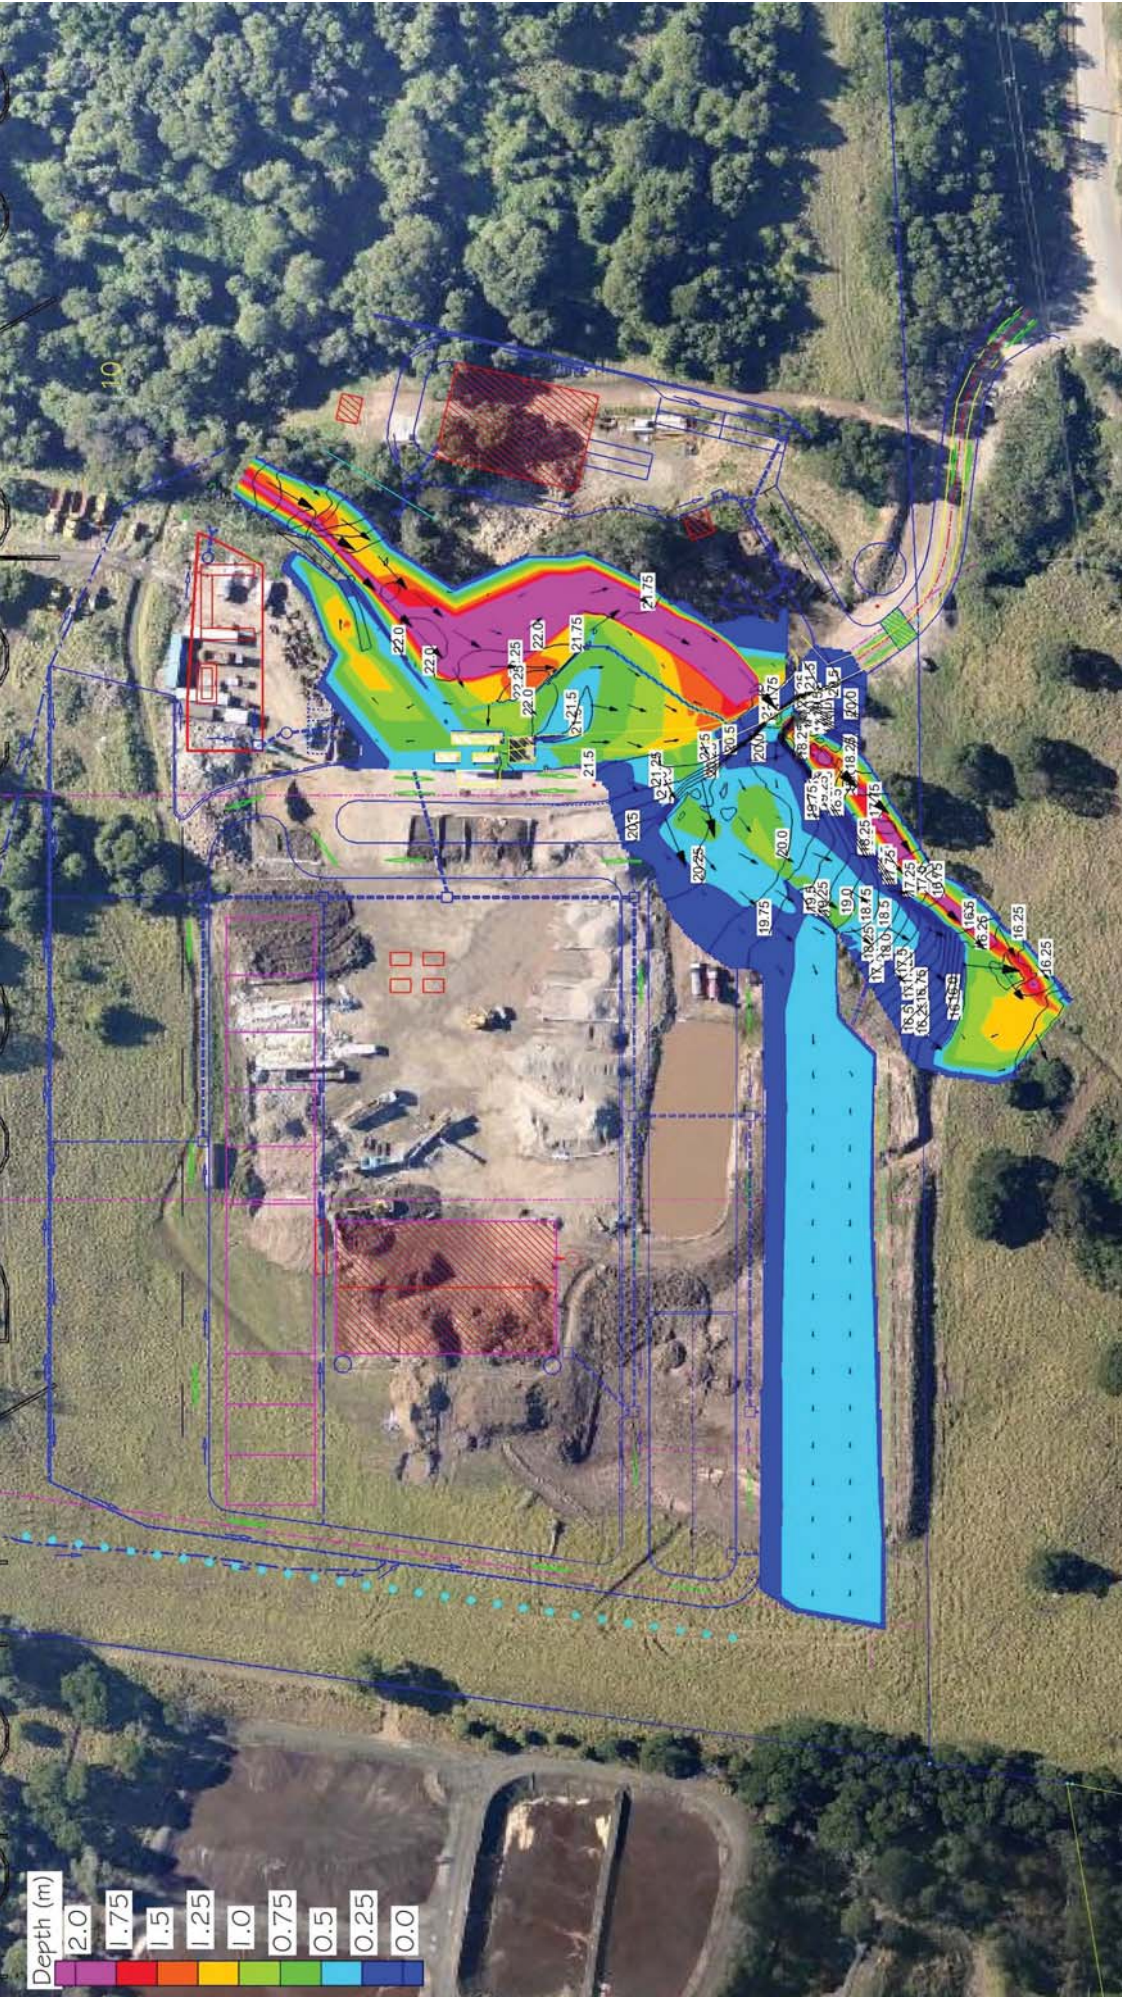
| 50 WYLLIE ROAD, KEMBLA GRANGE – ADDENDUM REPORT | | | | |
|---|---|---|---|---|
| Post-Developed<br>Unblocked | PMF | Flood Depth | A | KF110816 |

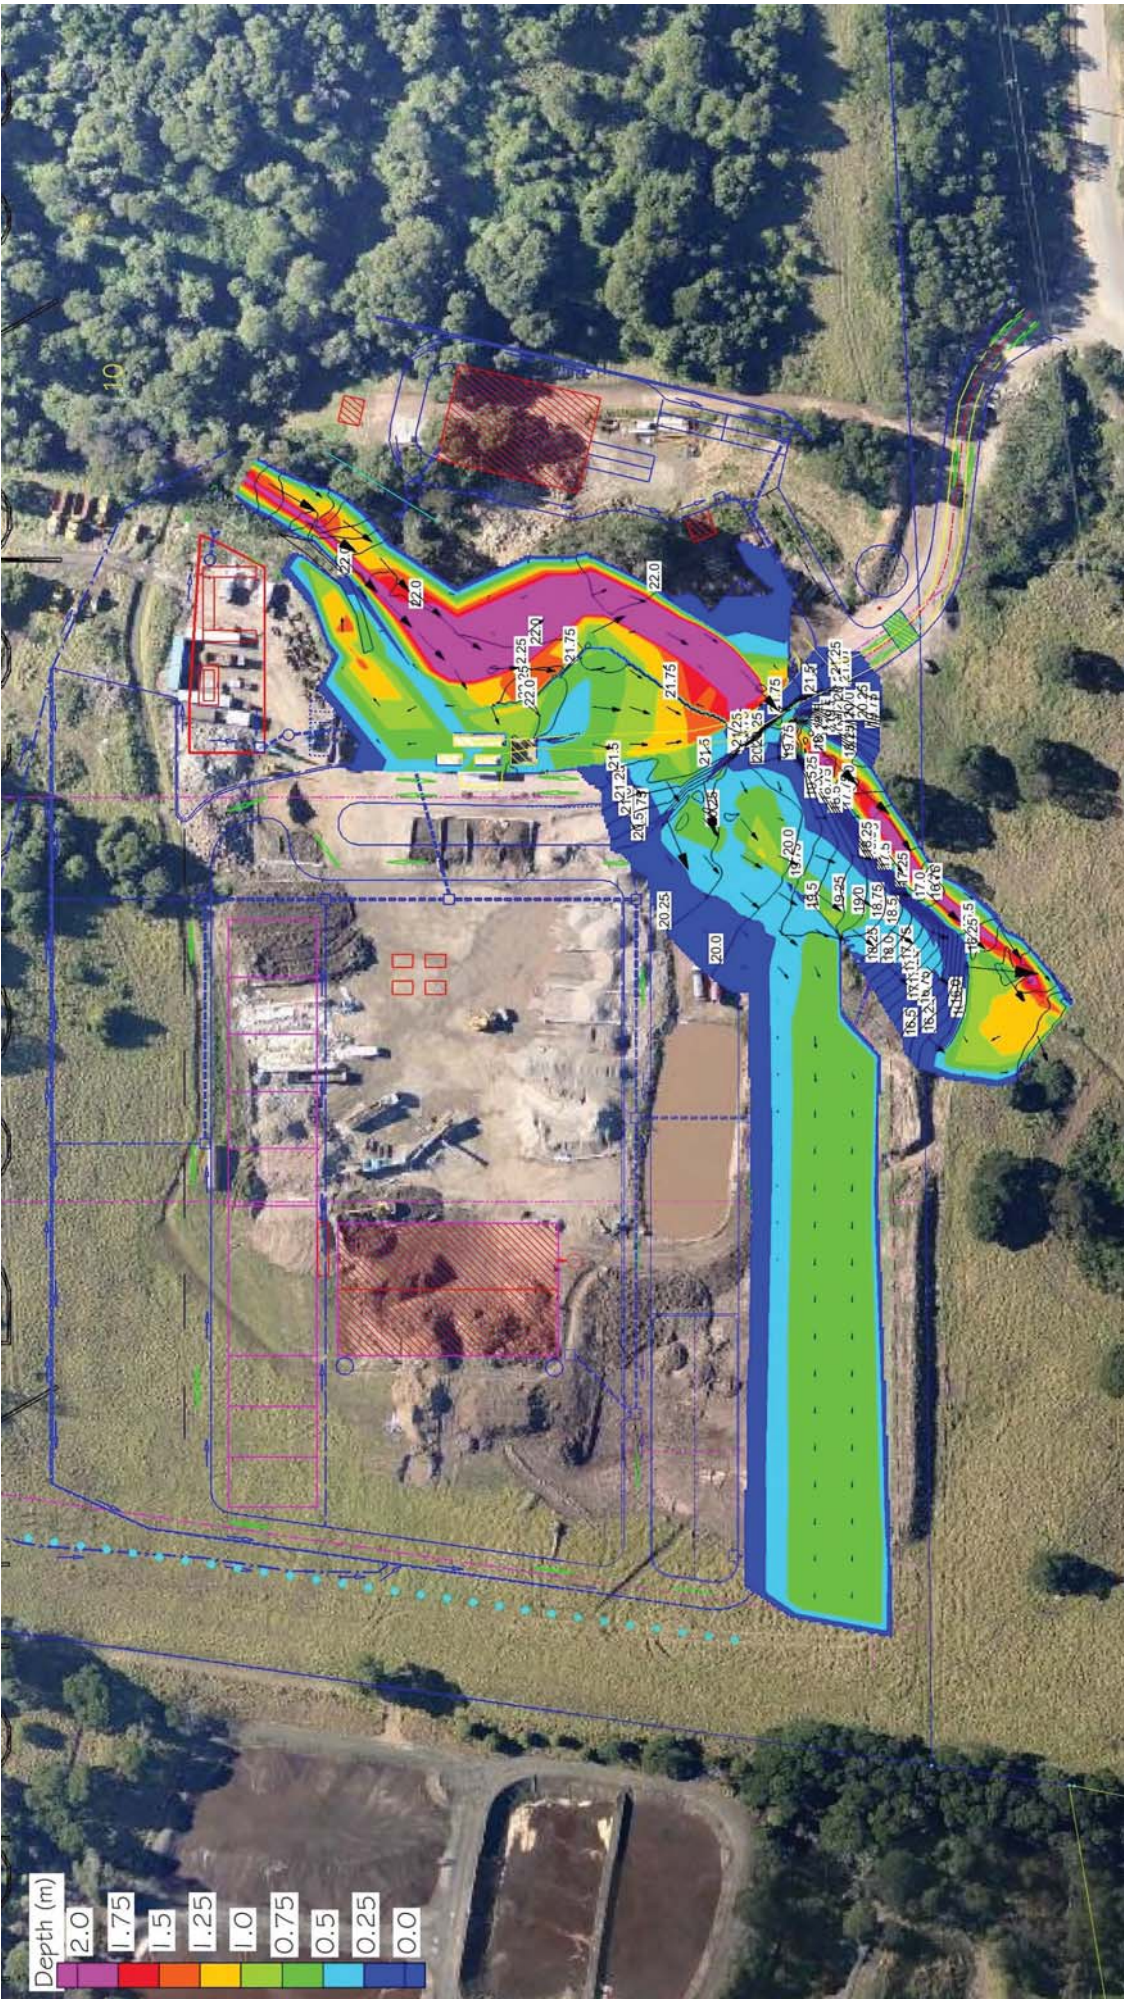
| 50 WYLLIE ROAD, KEMBLA GRANGE – ADDENDUM REPORT | | | | |
|---|---|---|---|---|
| Post-Developed Blocked | PMF | Flood Depth | A | KF110816 |

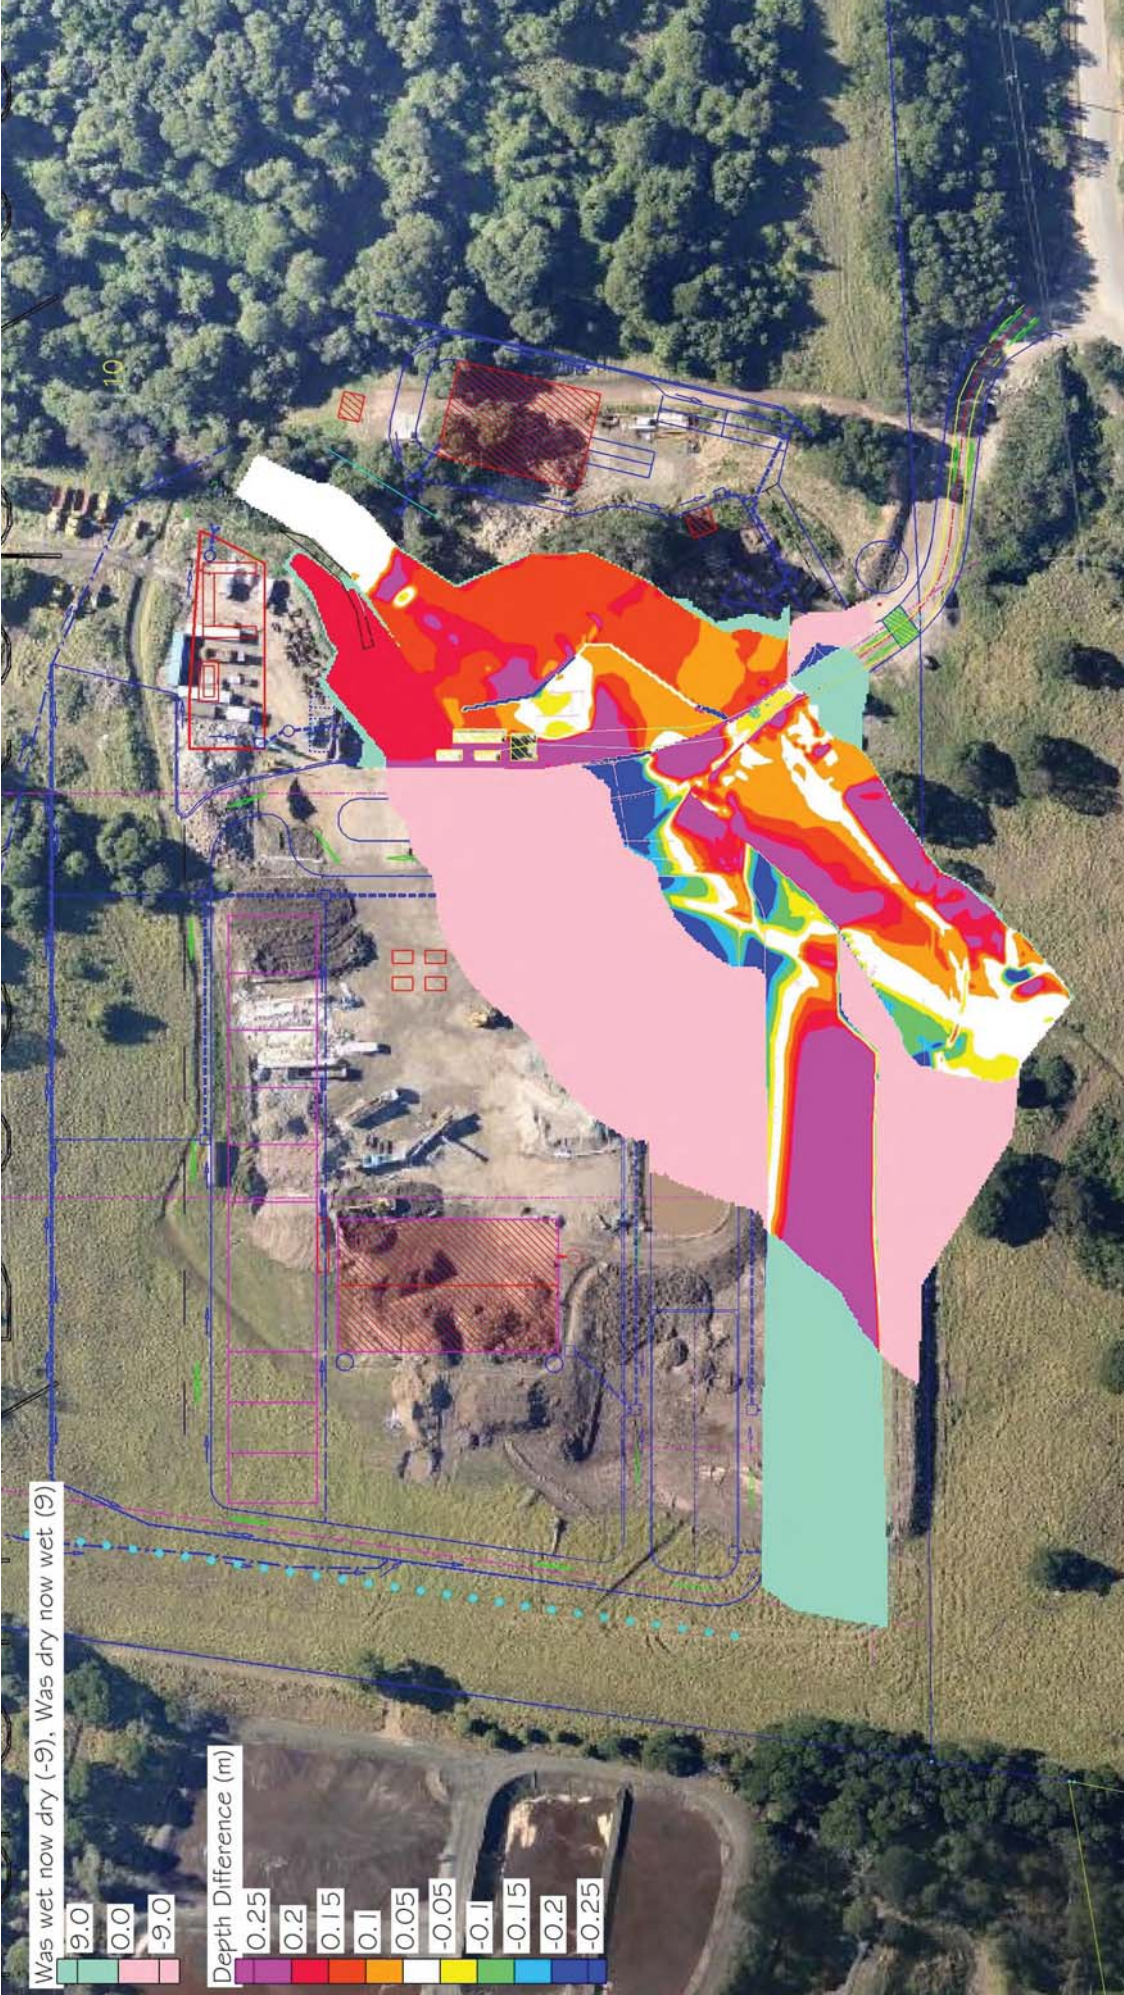
| 50 WYLLIE ROAD, KEMBLA GRANGE – ADDENDUM REPORT | | | | |
|---|---|---|---|---|
| Post(Unblocked) - Pre | PMF | Difference | A | KF110816 |

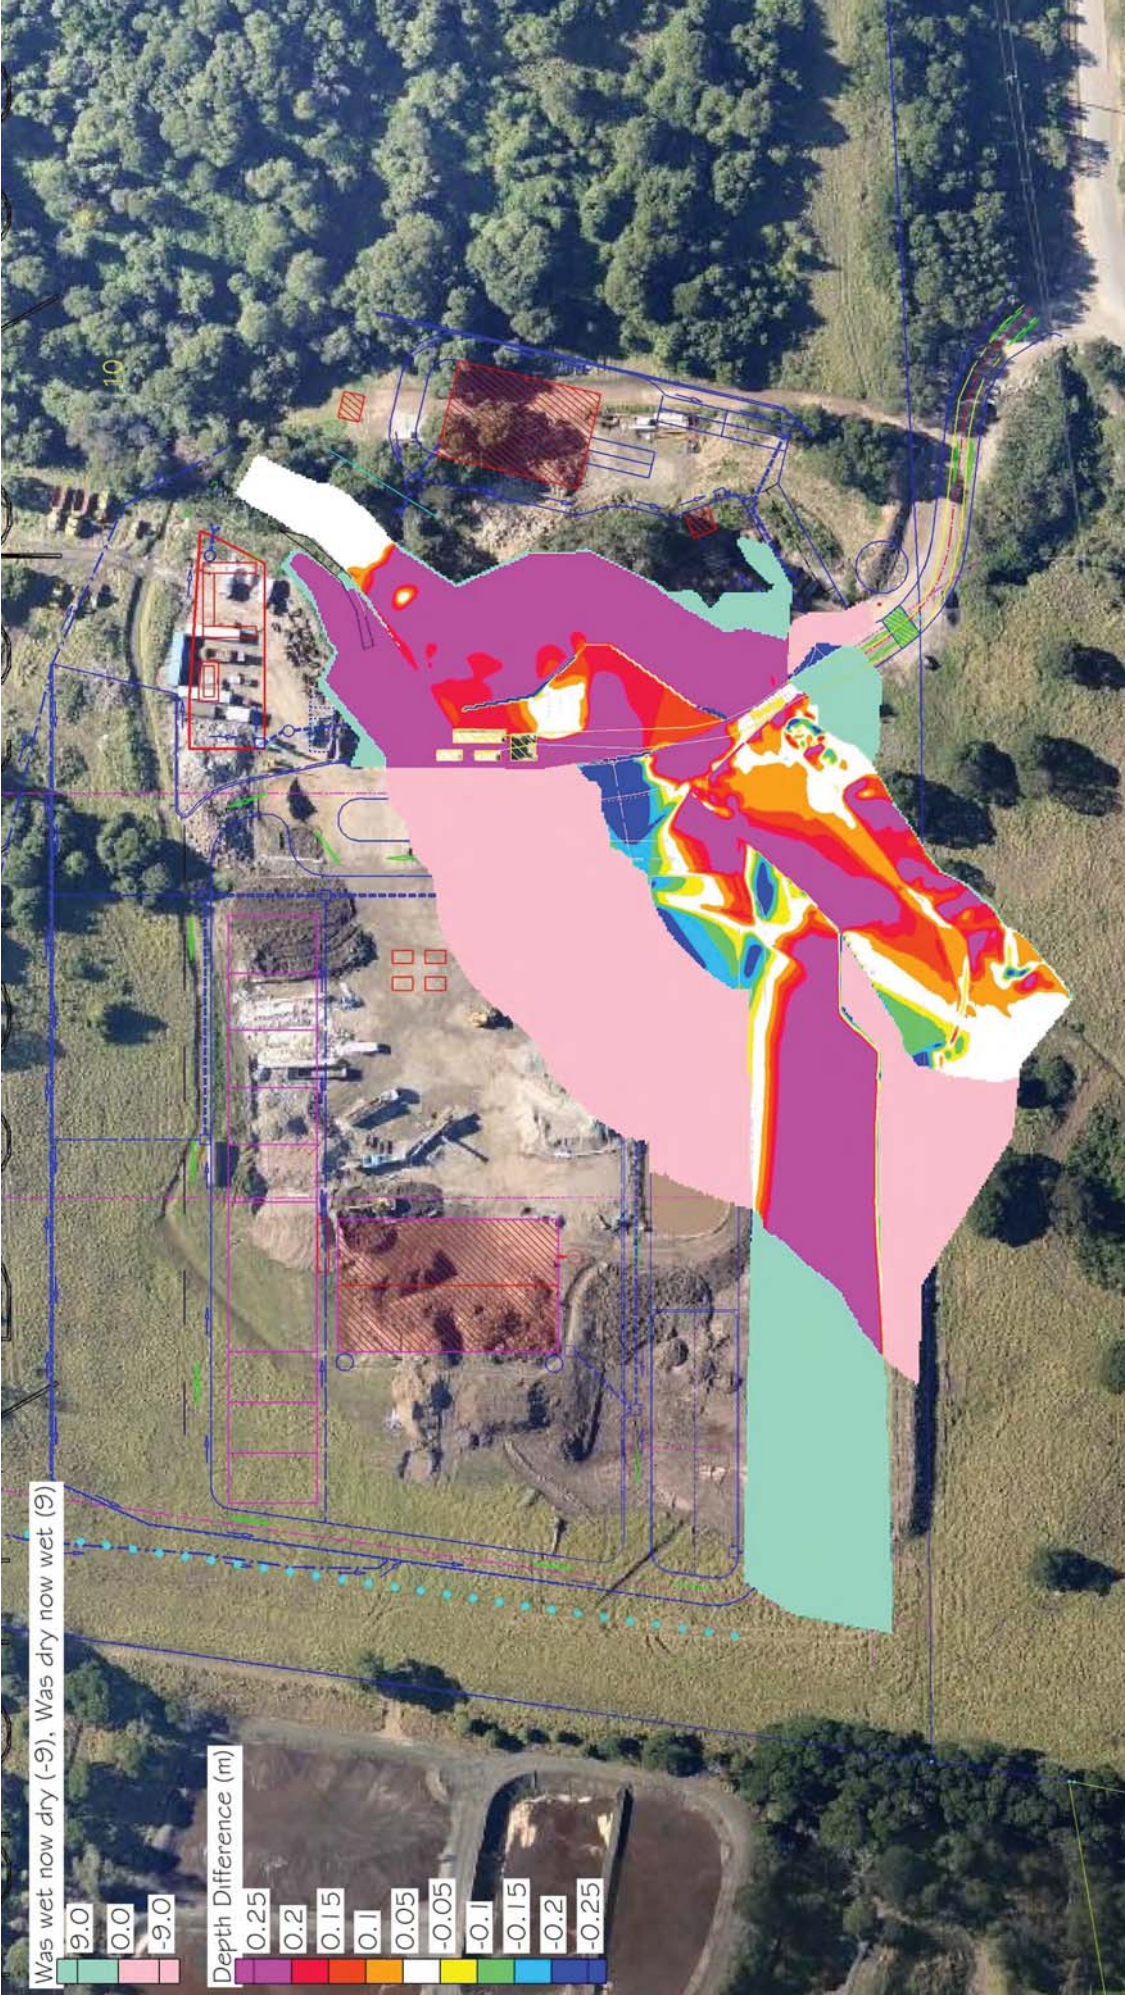
| 50 WYLLIE ROAD, KEMBLA GRANGE – ADDENDUM REPORT | | | | |
|---|---|---|---|---|
| Post(Blocked) - Pre | PMF | Difference | A | KF110816 |

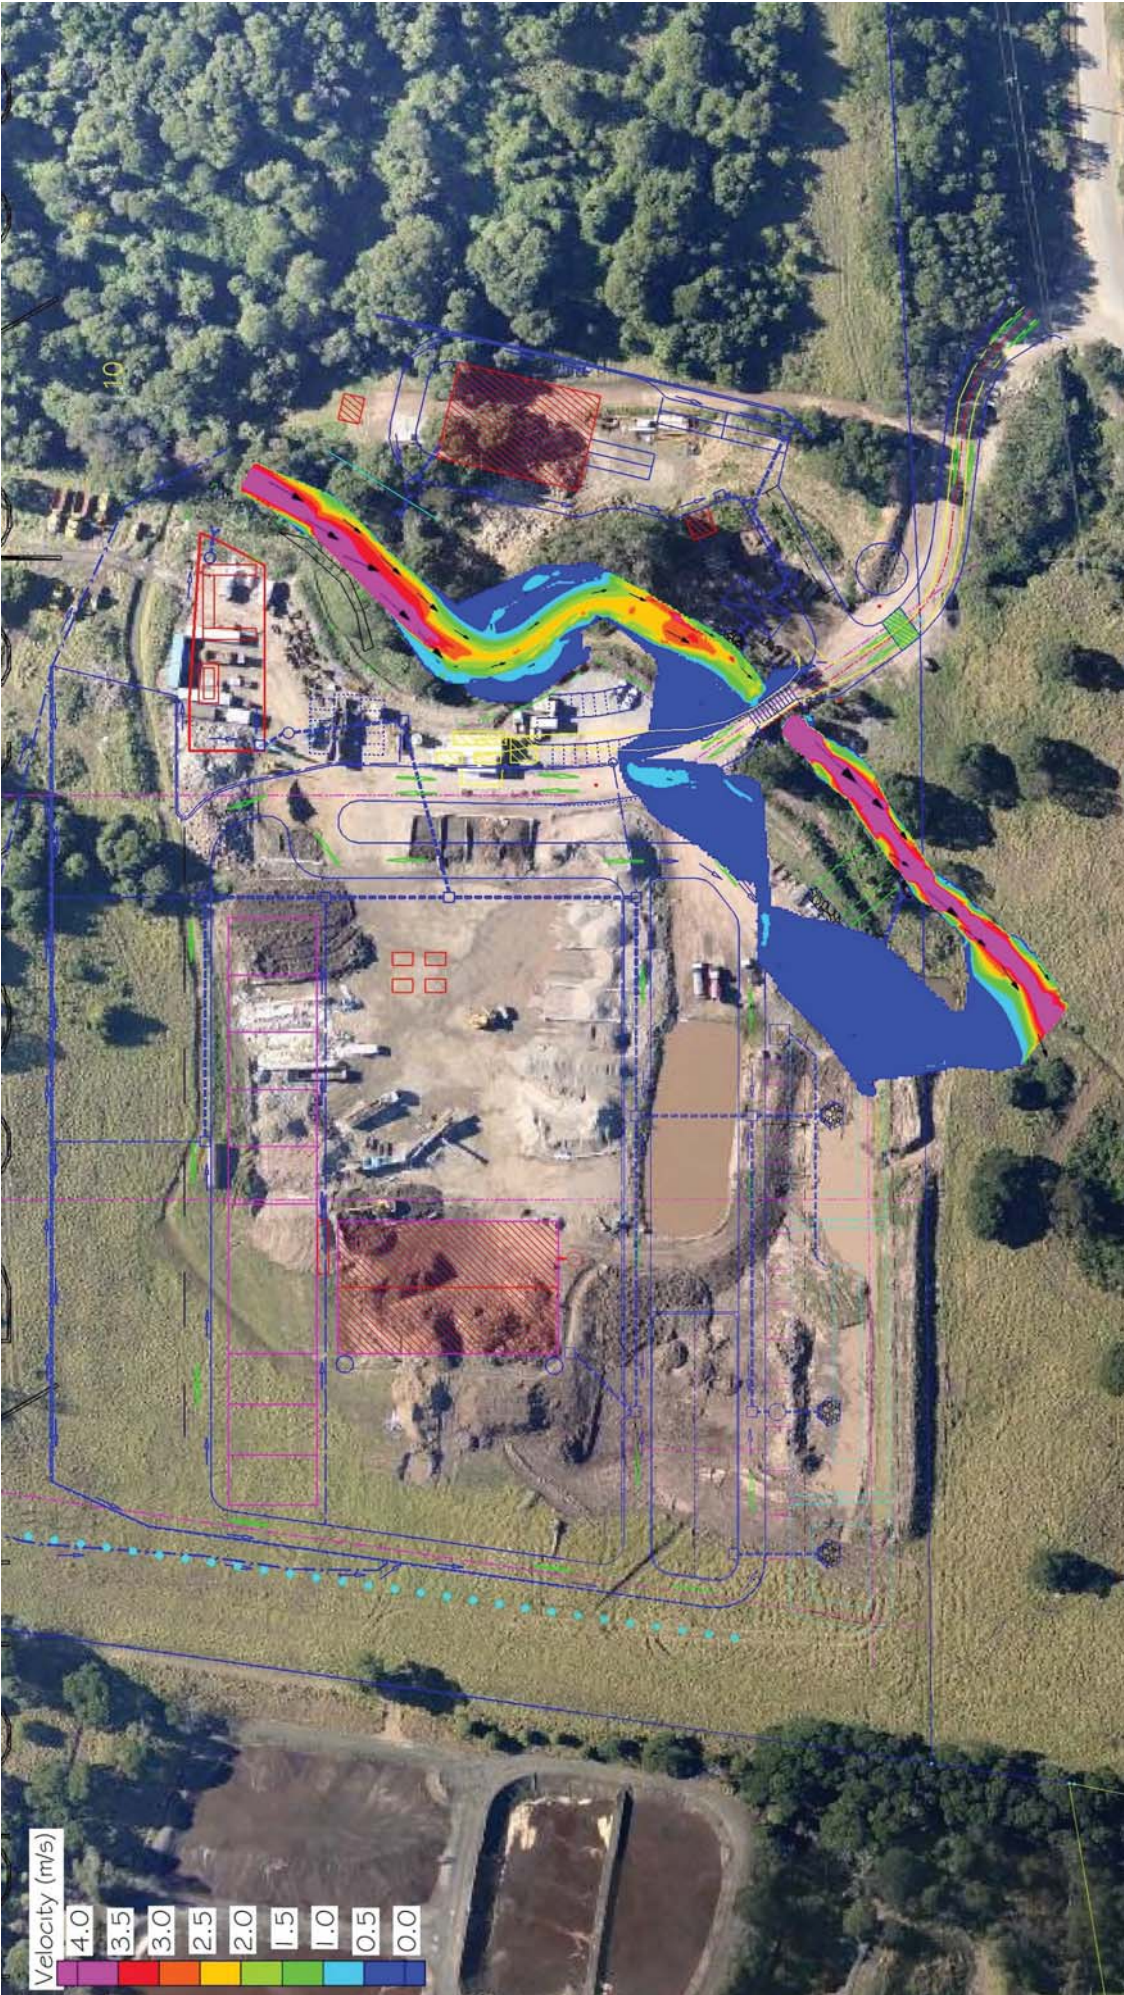
| 50 WYLLIE ROAD, KEMBLA GRANGE – ADDENDUM REPORT | | | | |
|---|---|---|---|---|
| Pre-Developed | 100yr | Velocity | A | KF110816 |

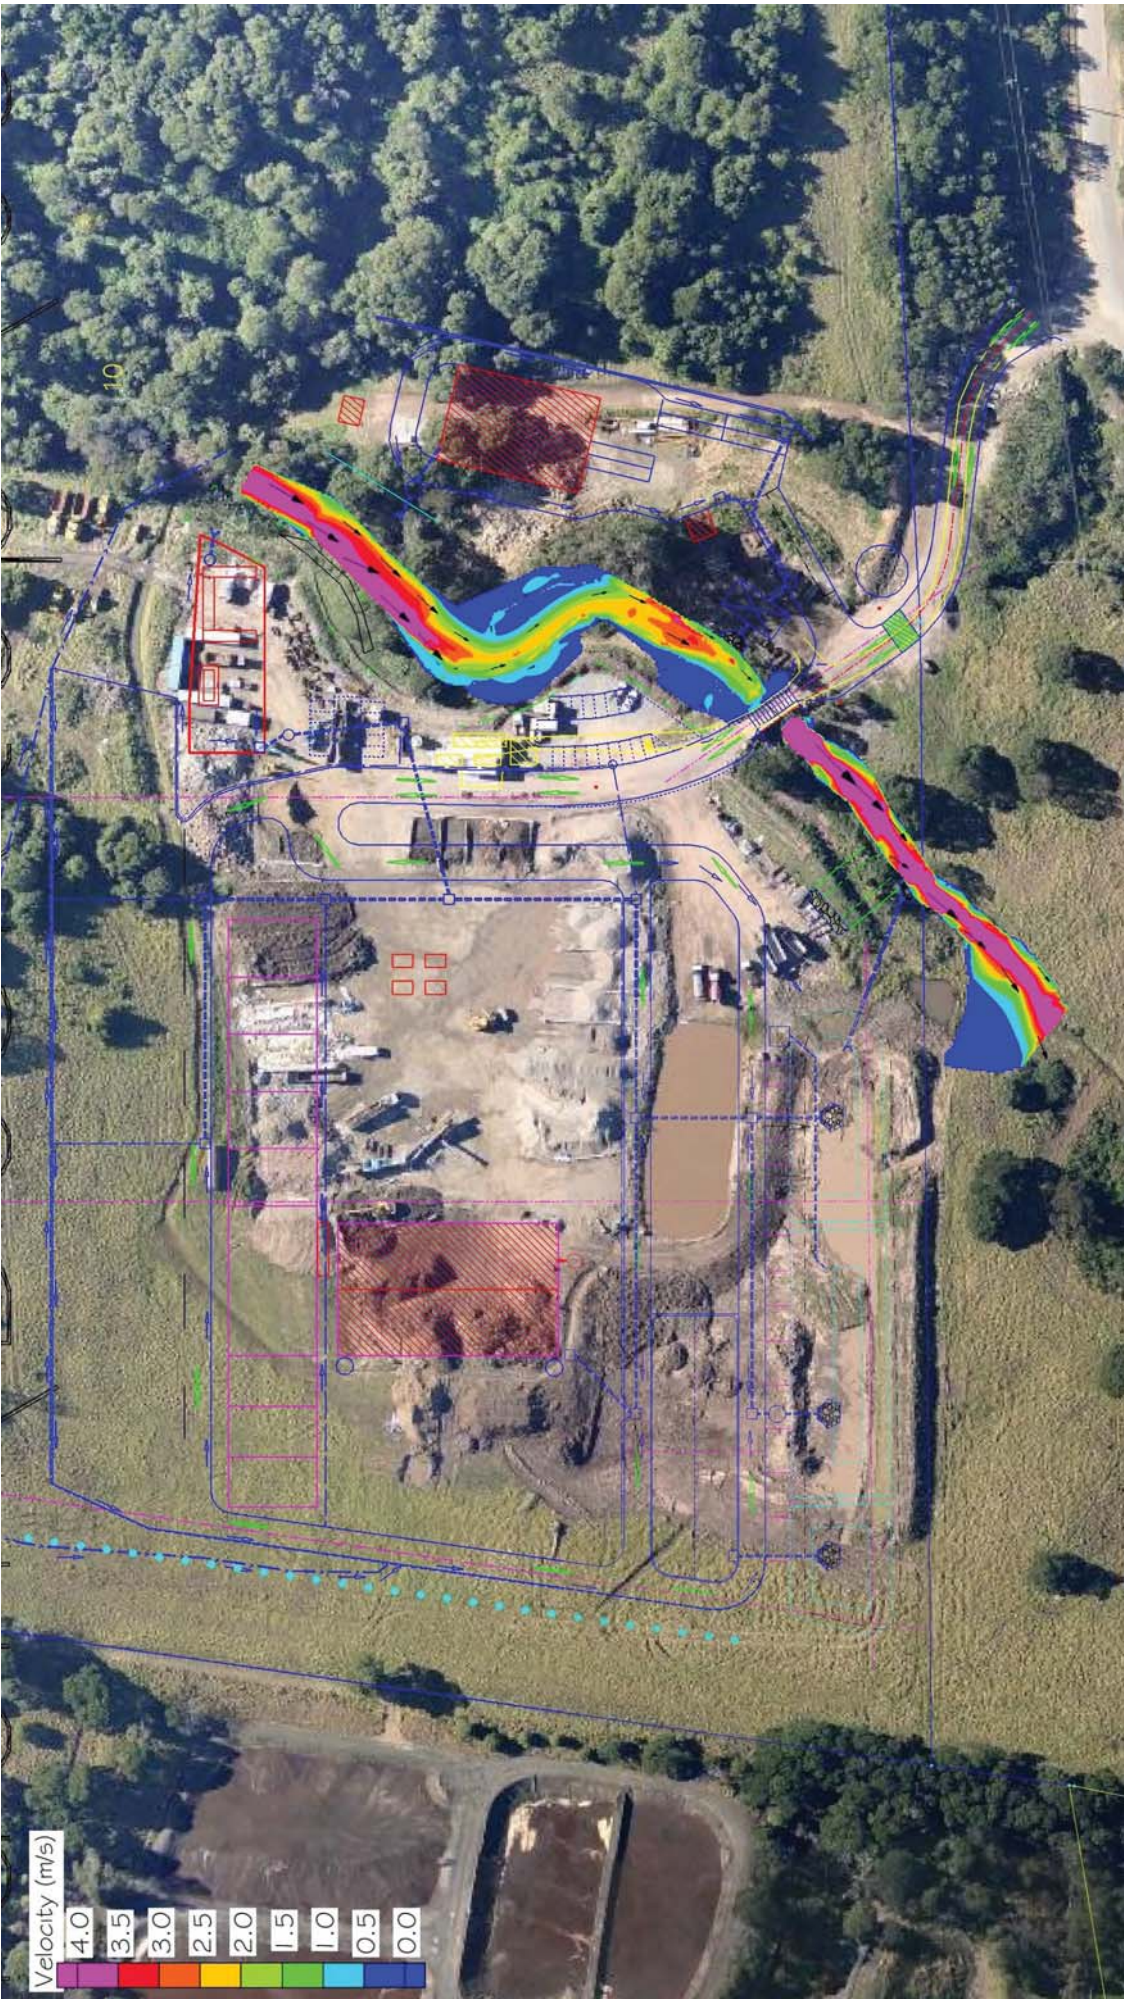
| 50 WYLLIE ROAD, KEMBLA GRANGE – ADDENDUM REPORT | | | | |
|---|---|---|---|---|
| Post-Developed<br>Unblocked | 100yr | Velocity | A | KF110816 |

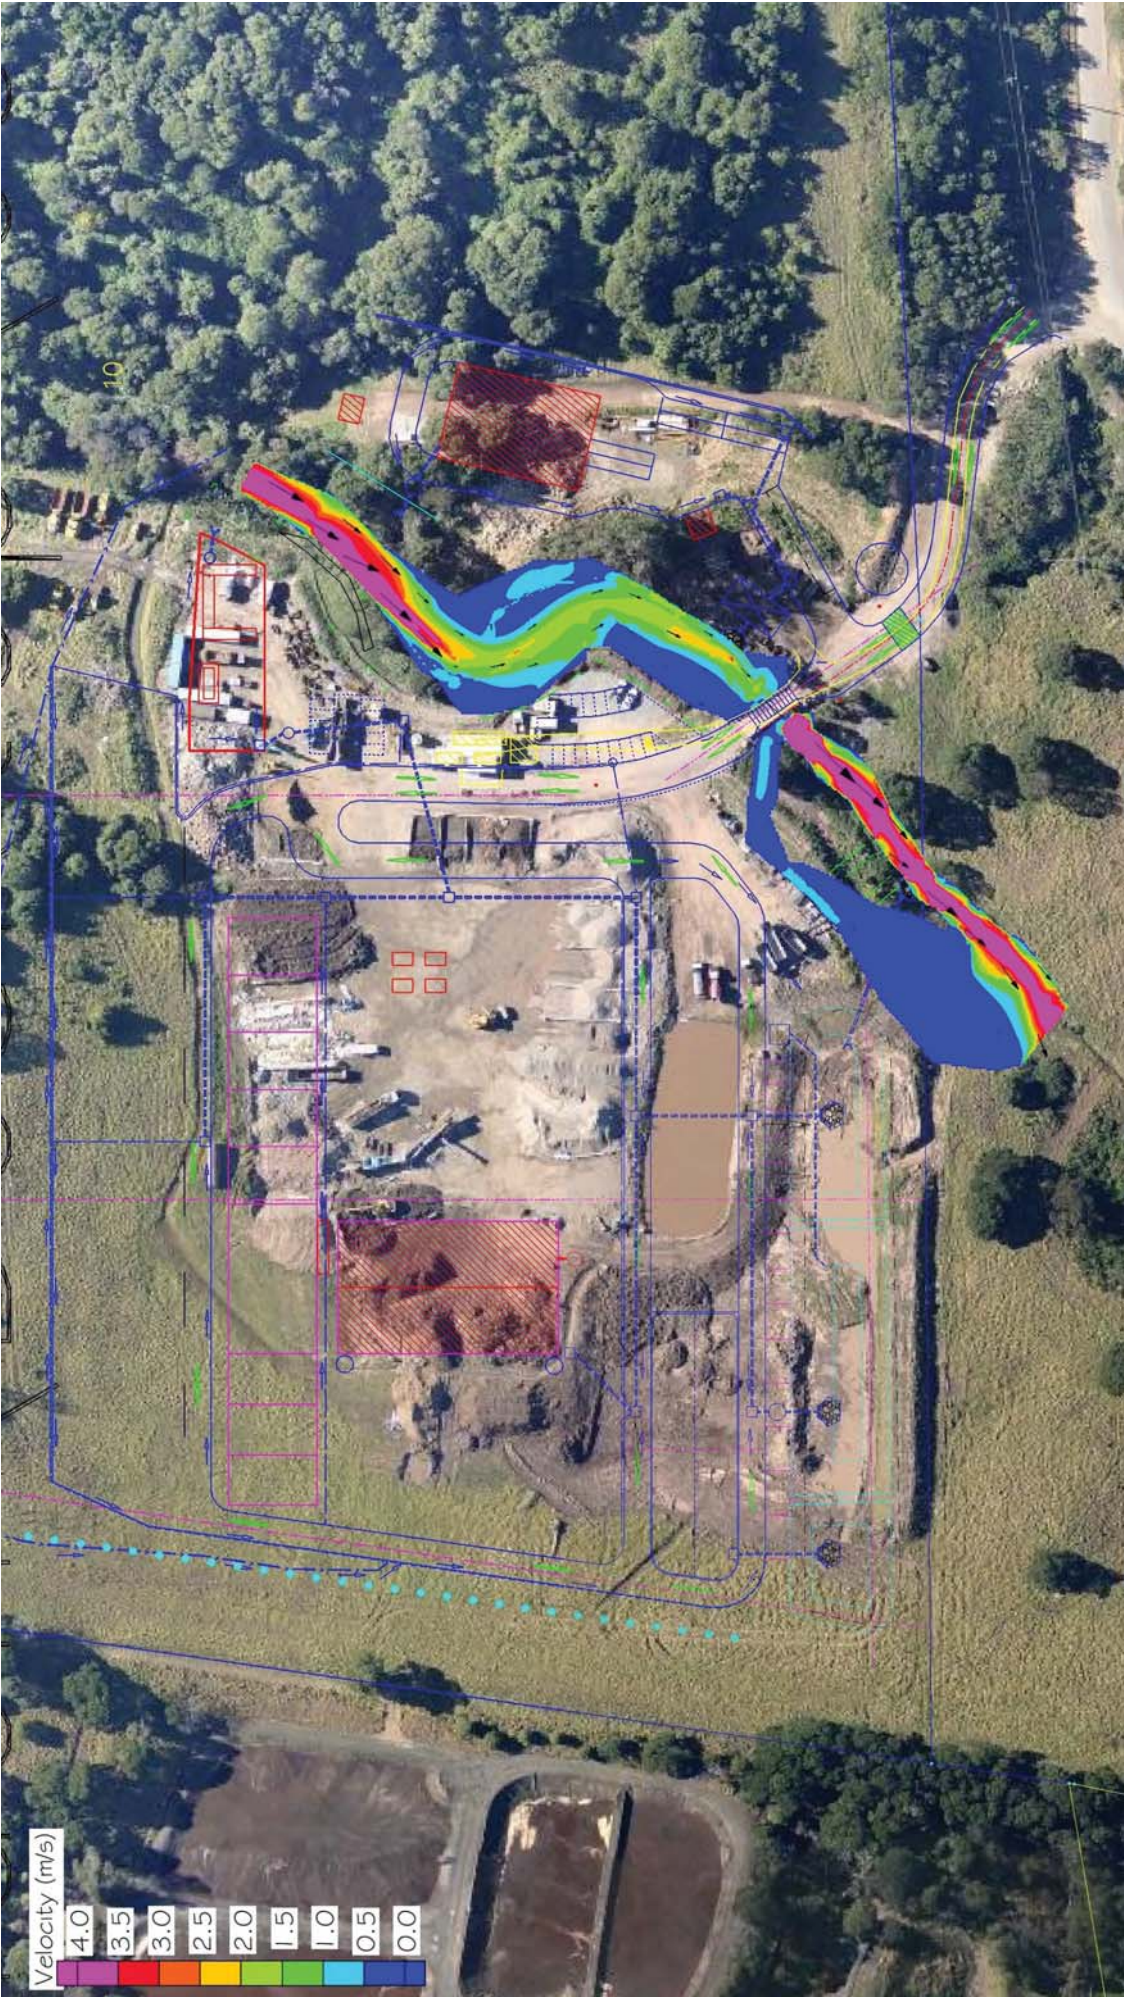
| 50 WYLLIE ROAD, KEMBLA GRANGE – ADDENDUM REPORT | | | | |
|---|---|---|---|---|
| Post-Developed Blocked | 100yr | Velocity | A | KF110816 |

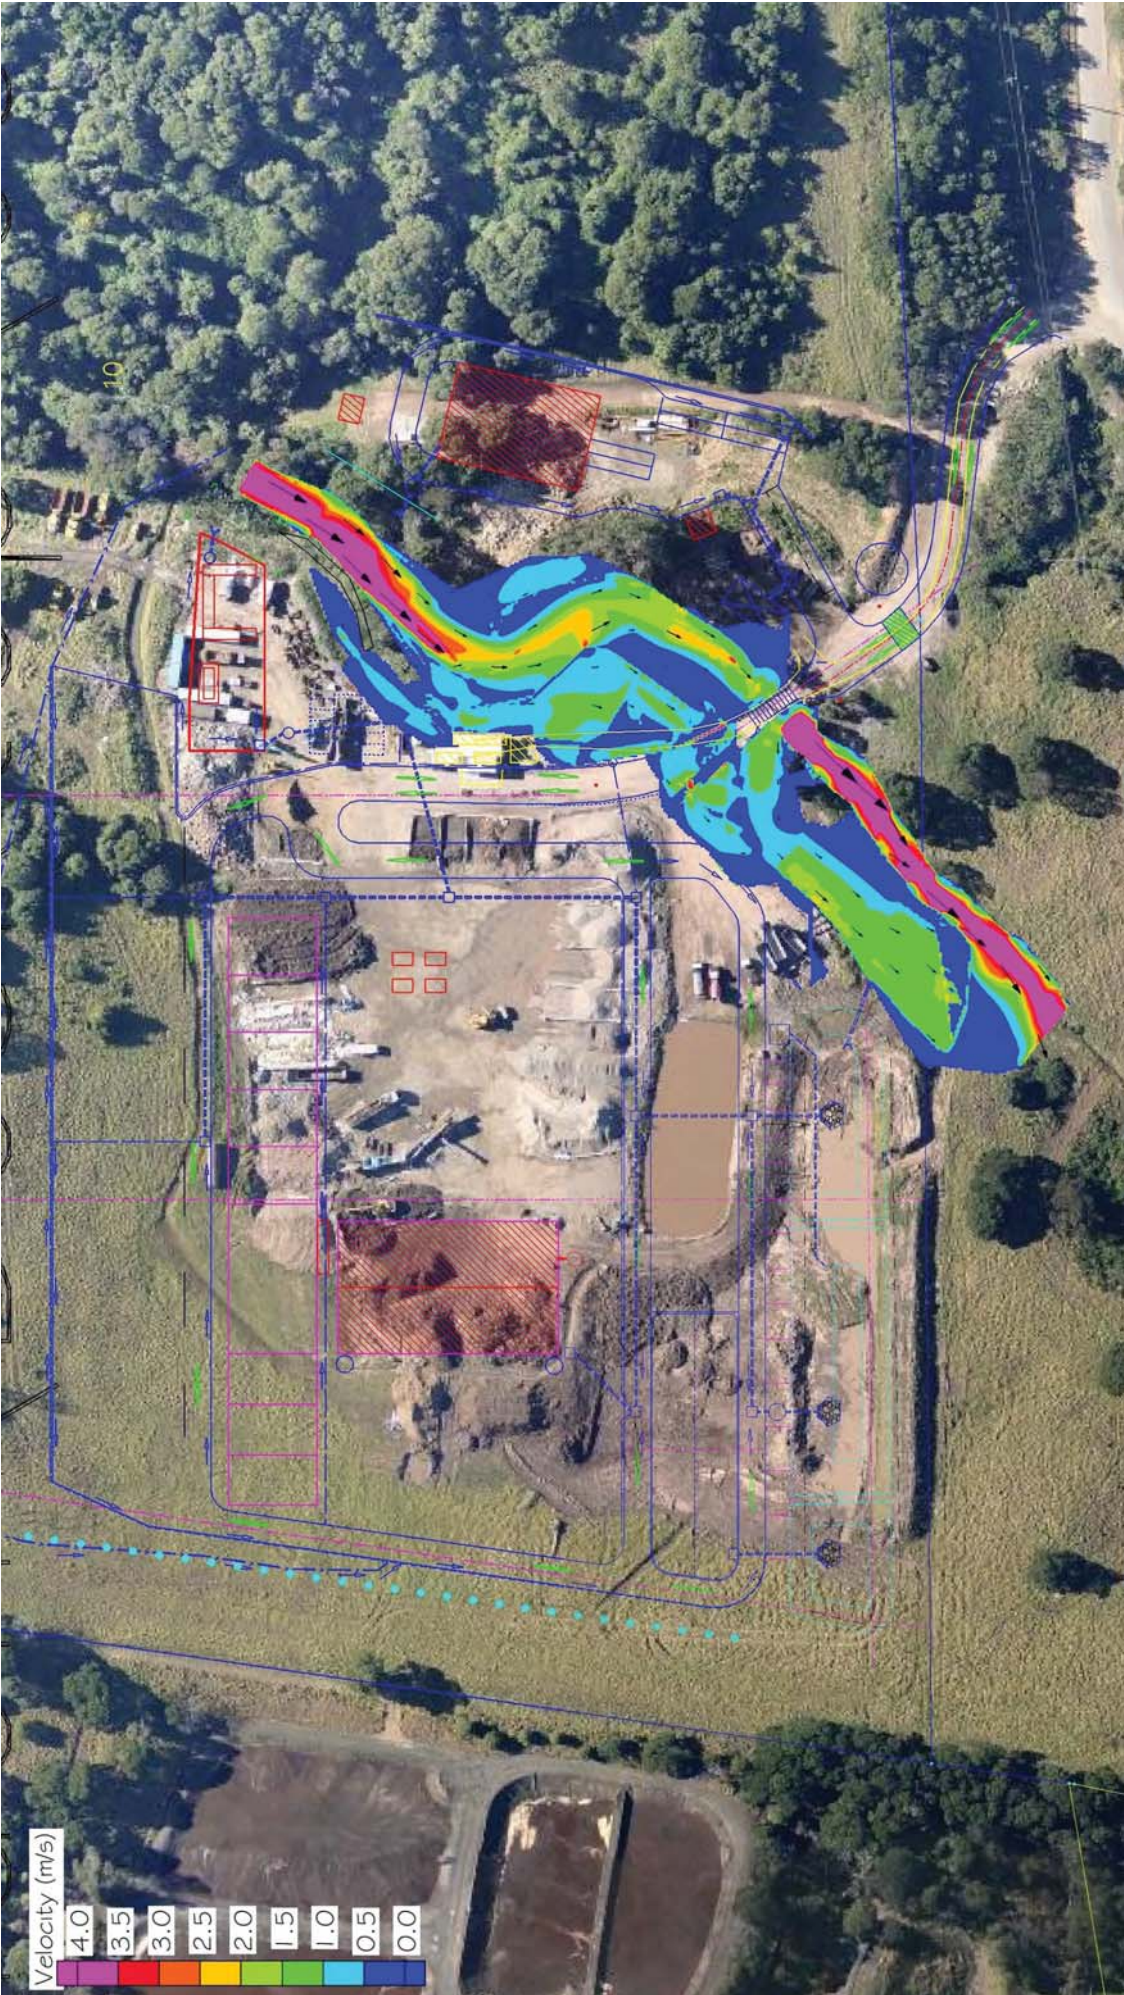
| 50 WYLLIE ROAD, KEMBLA GRANGE – ADDENDUM REPORT | | | | |
|---|---|---|---|---|
| Post-Developed<br>Blocked with 30%<br>Climate Change | 100yr | Velocity | A | KF110816 |
