| 50 WYLLIE ROAD, KEMBLA GRANGE – ADDENDUM REPORT | | | | |

## APPENDIX 4

### Flood Inundation Maps Velocity

### Flood Inundation Maps Velocity x Depth

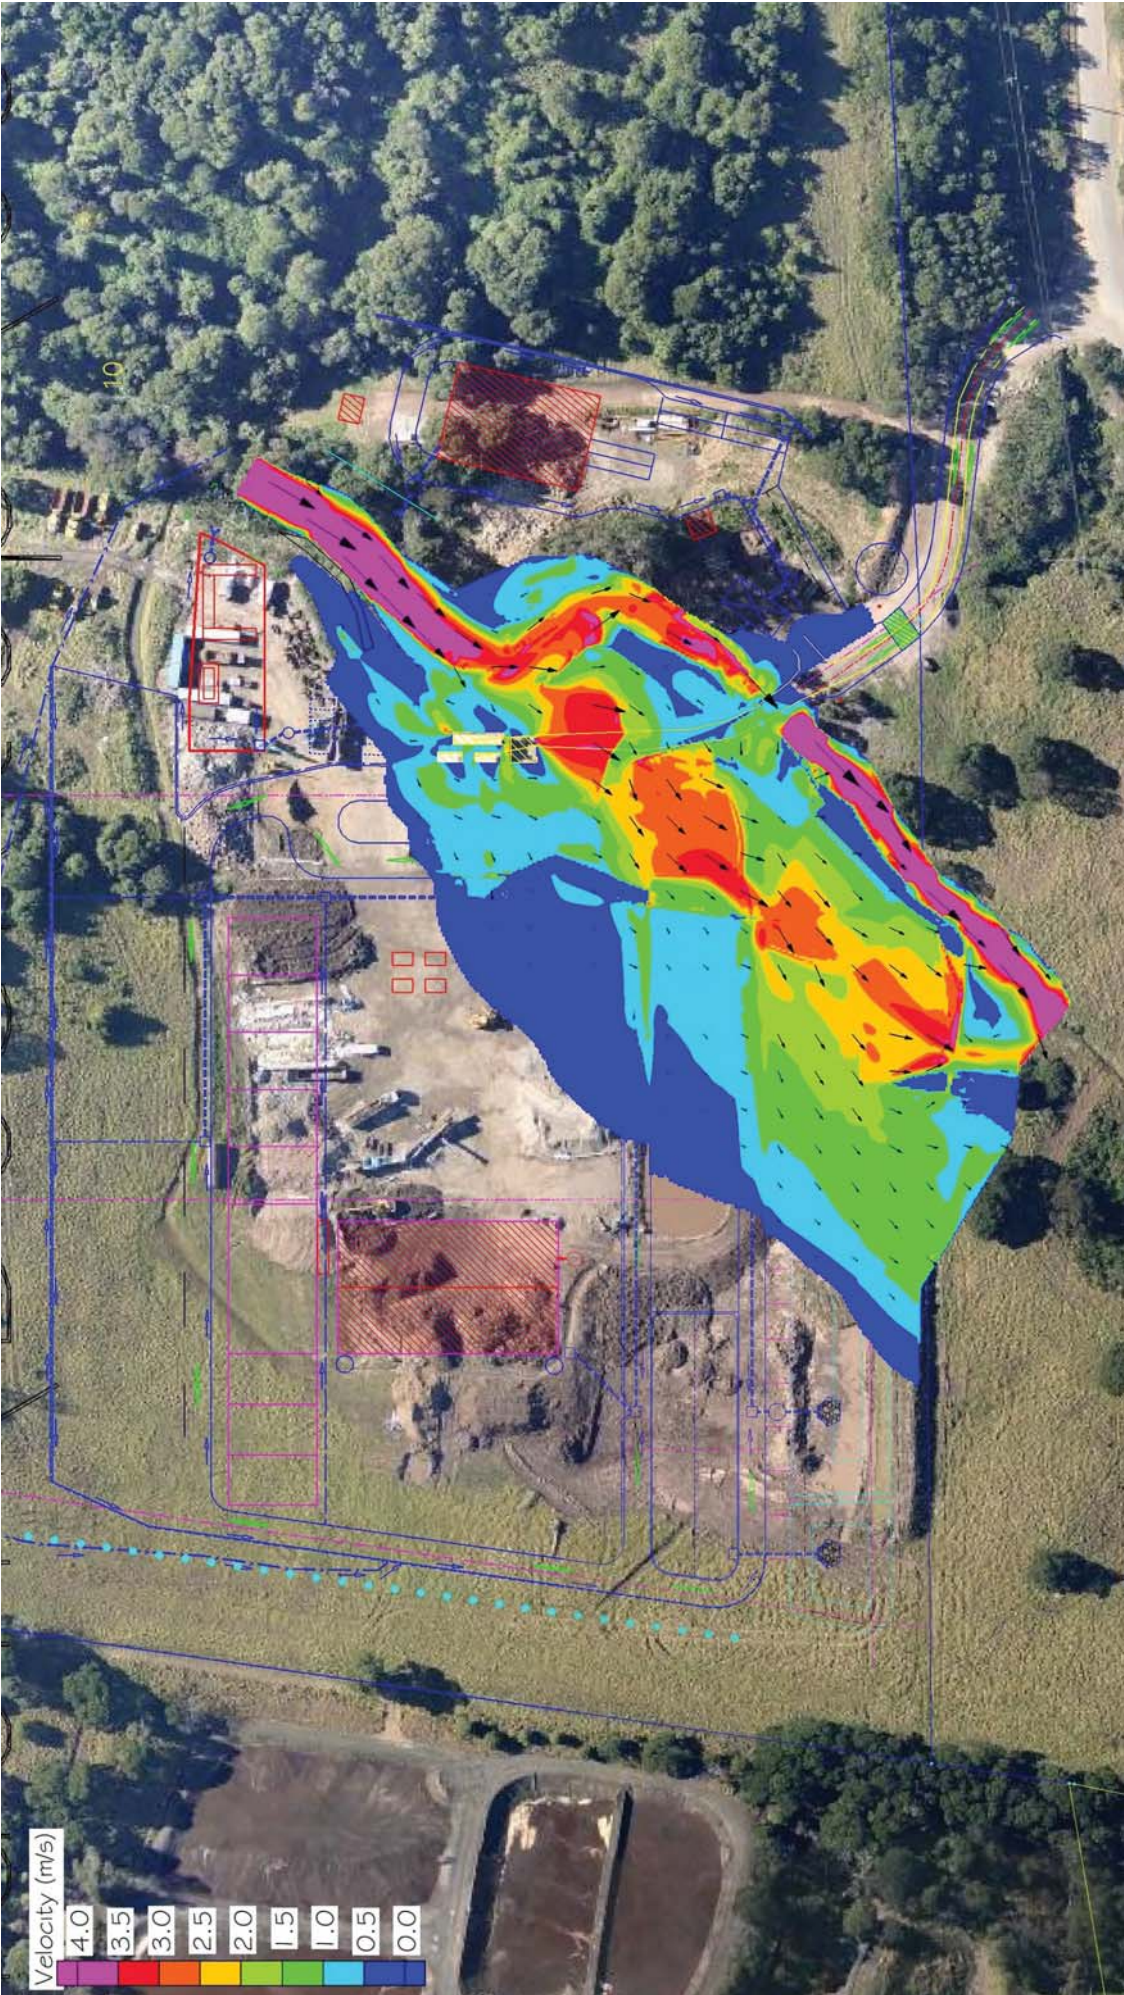
| 50 WYLLIE ROAD, KEMBLA GRANGE – ADDENDUM REPORT | | | | |
|---|---|---|---|---|
| Pre-Developed | PMF | Velocity | A | KF110816 |

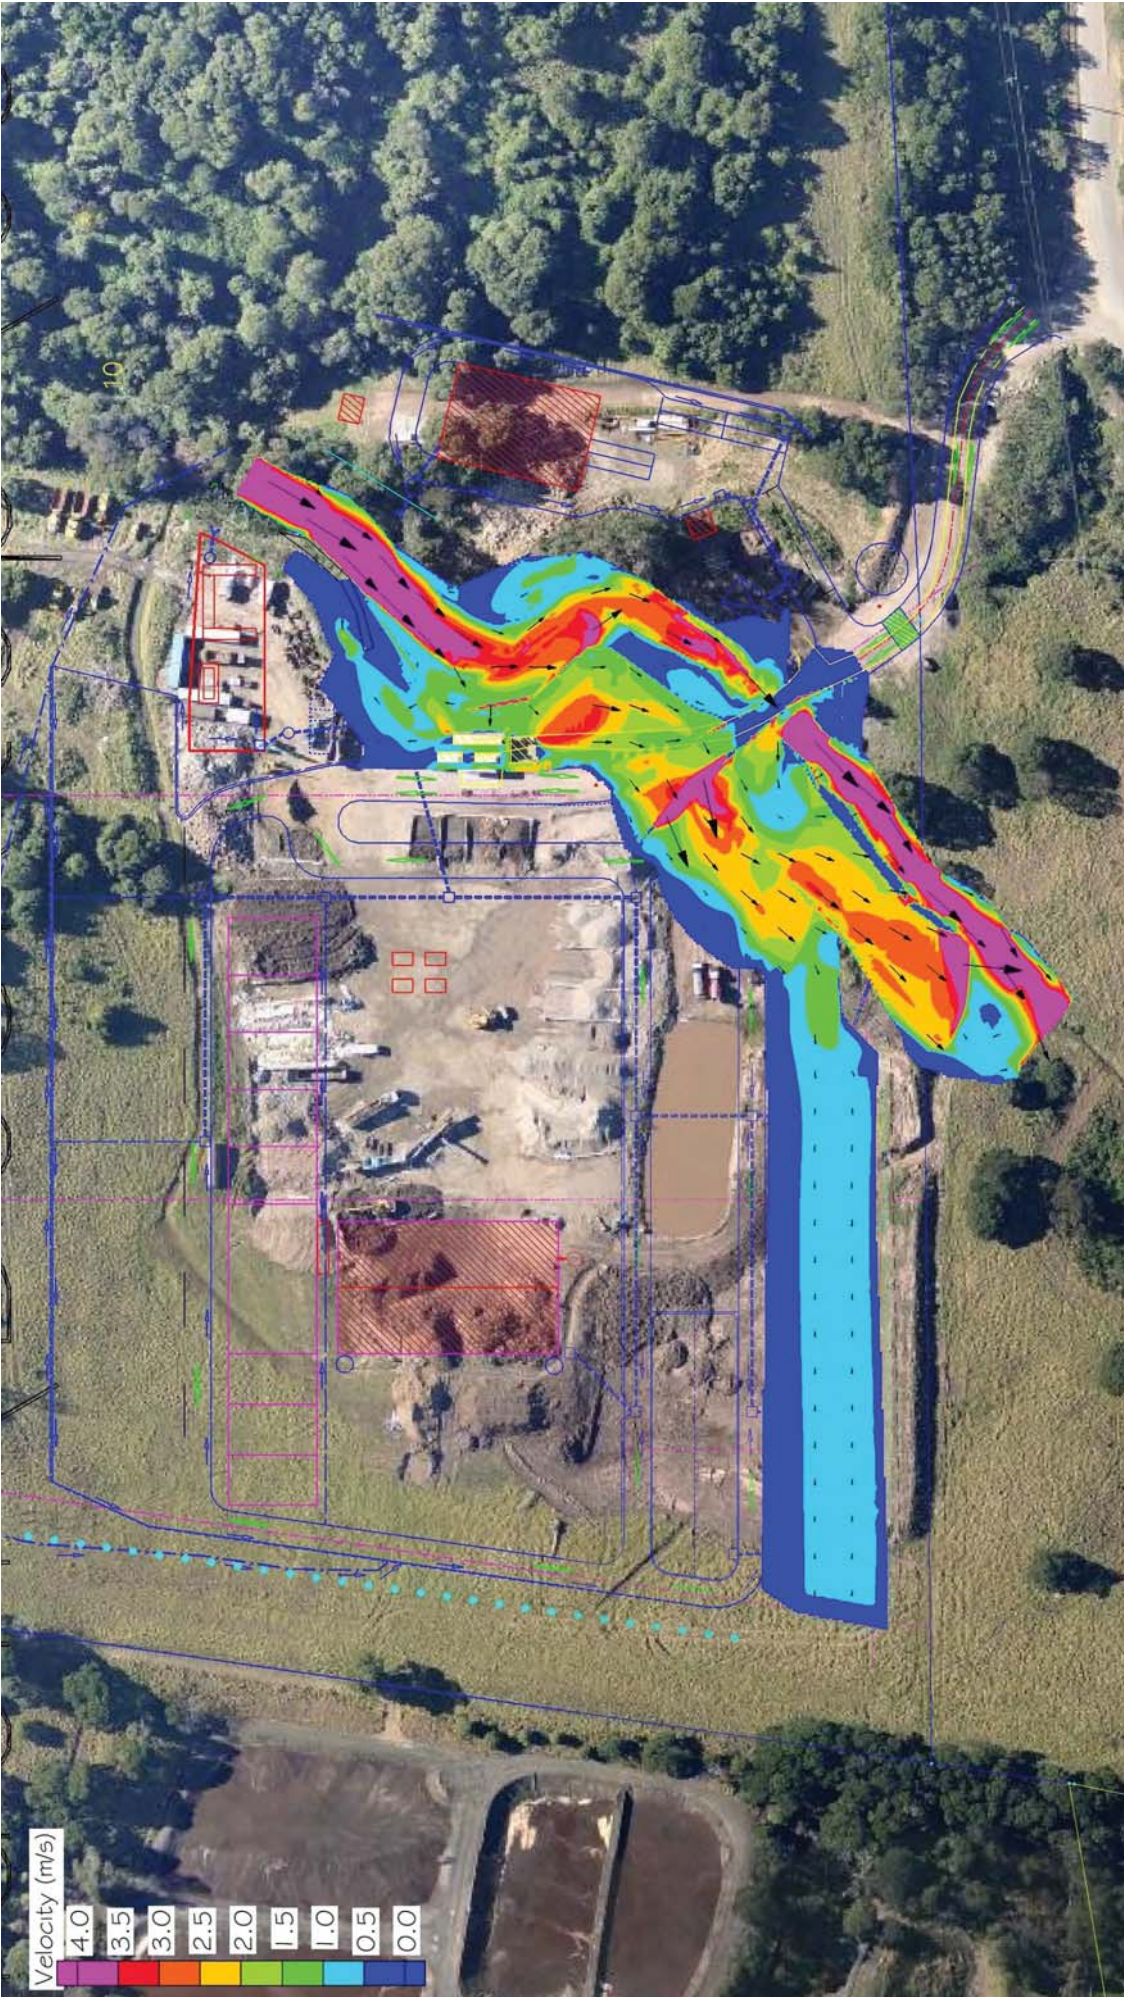
| 50 WYLLIE ROAD, KEMBLA GRANGE – ADDENDUM REPORT | | | | |
|---|---|---|---|---|
| Post-Developed<br>Unblocked | PMF | Velocity | A | KF110816 |

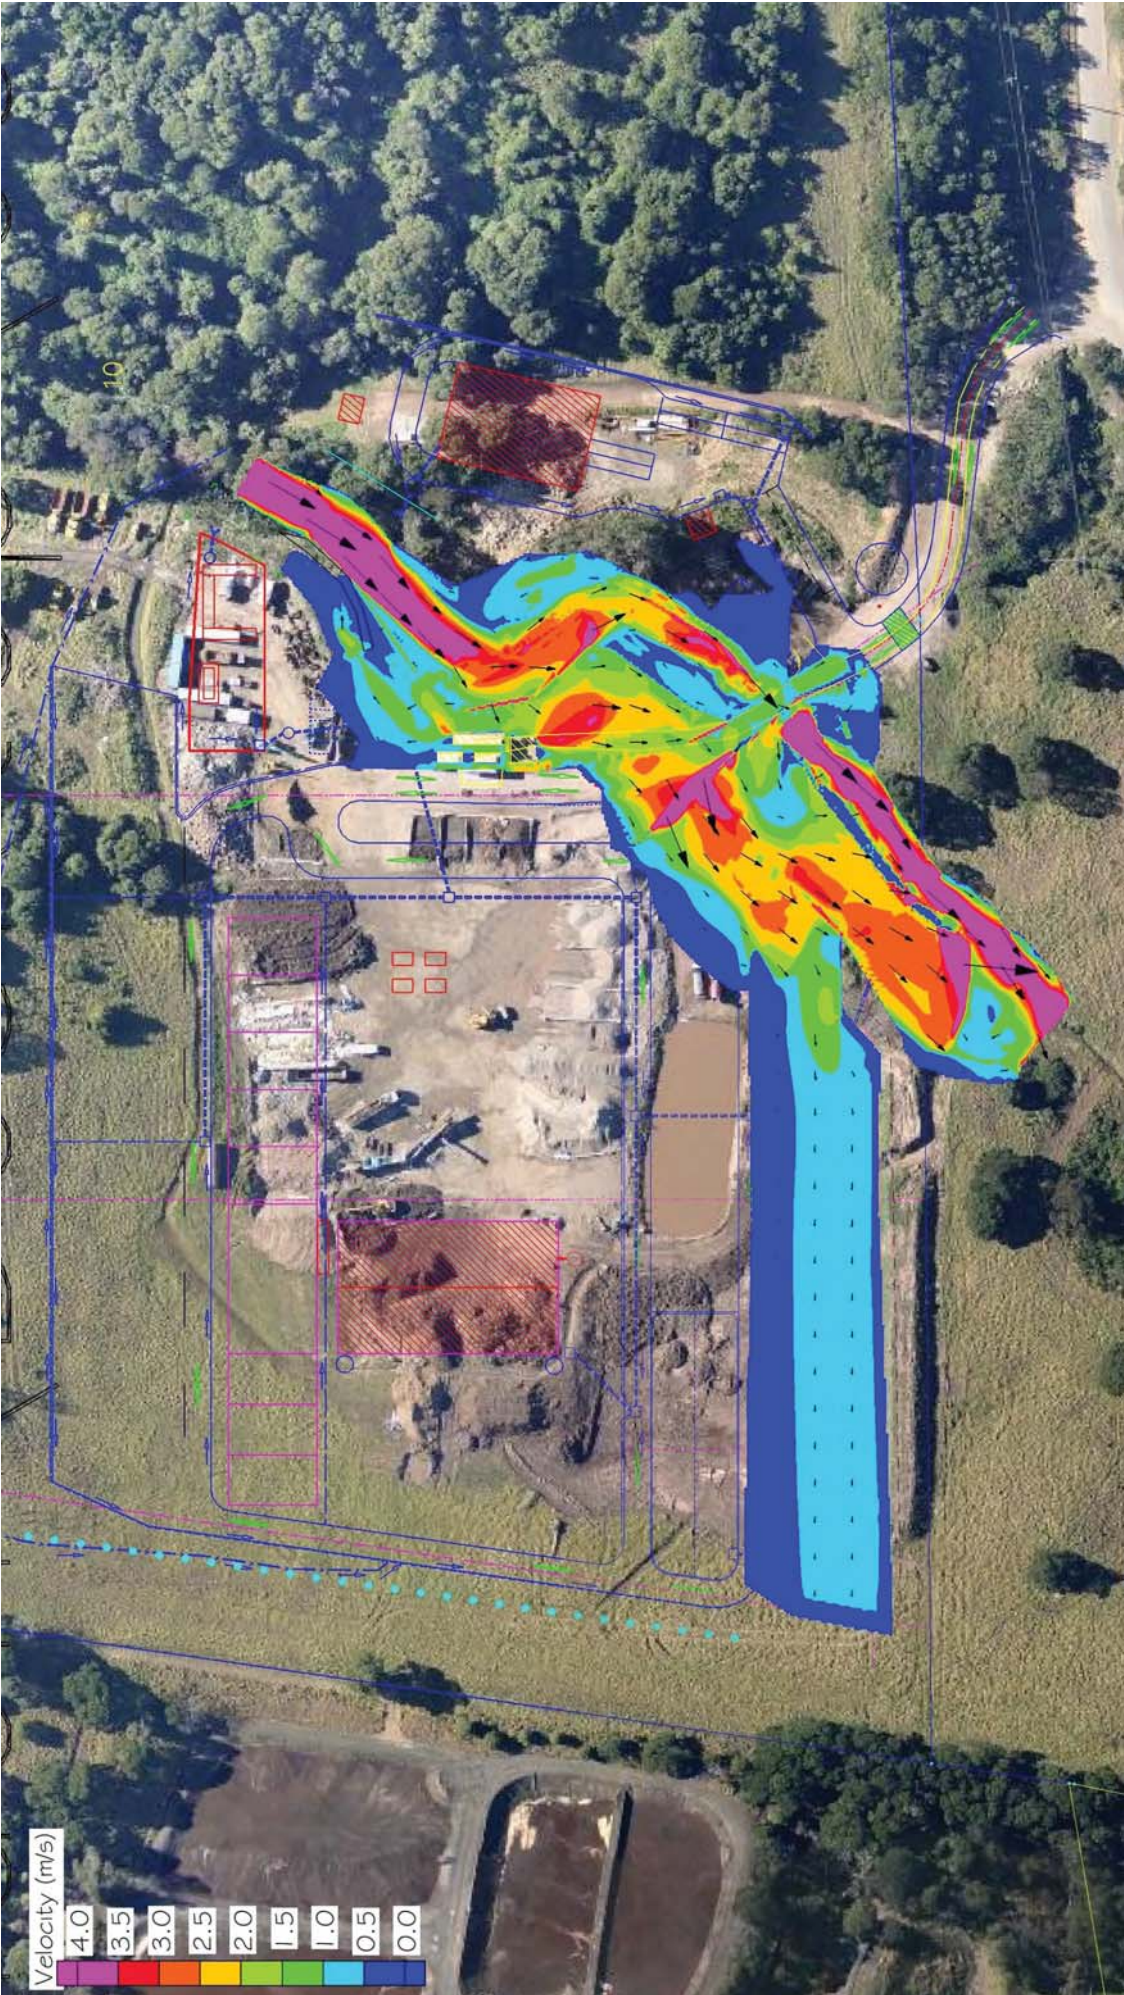
| 50 WYLLIE ROAD, KEMBLA GRANGE – ADDENDUM REPORT | | | | |
|---|---|---|---|---|
| Post-Developed Blocked | PMF | Velocity | A | KF110816 |

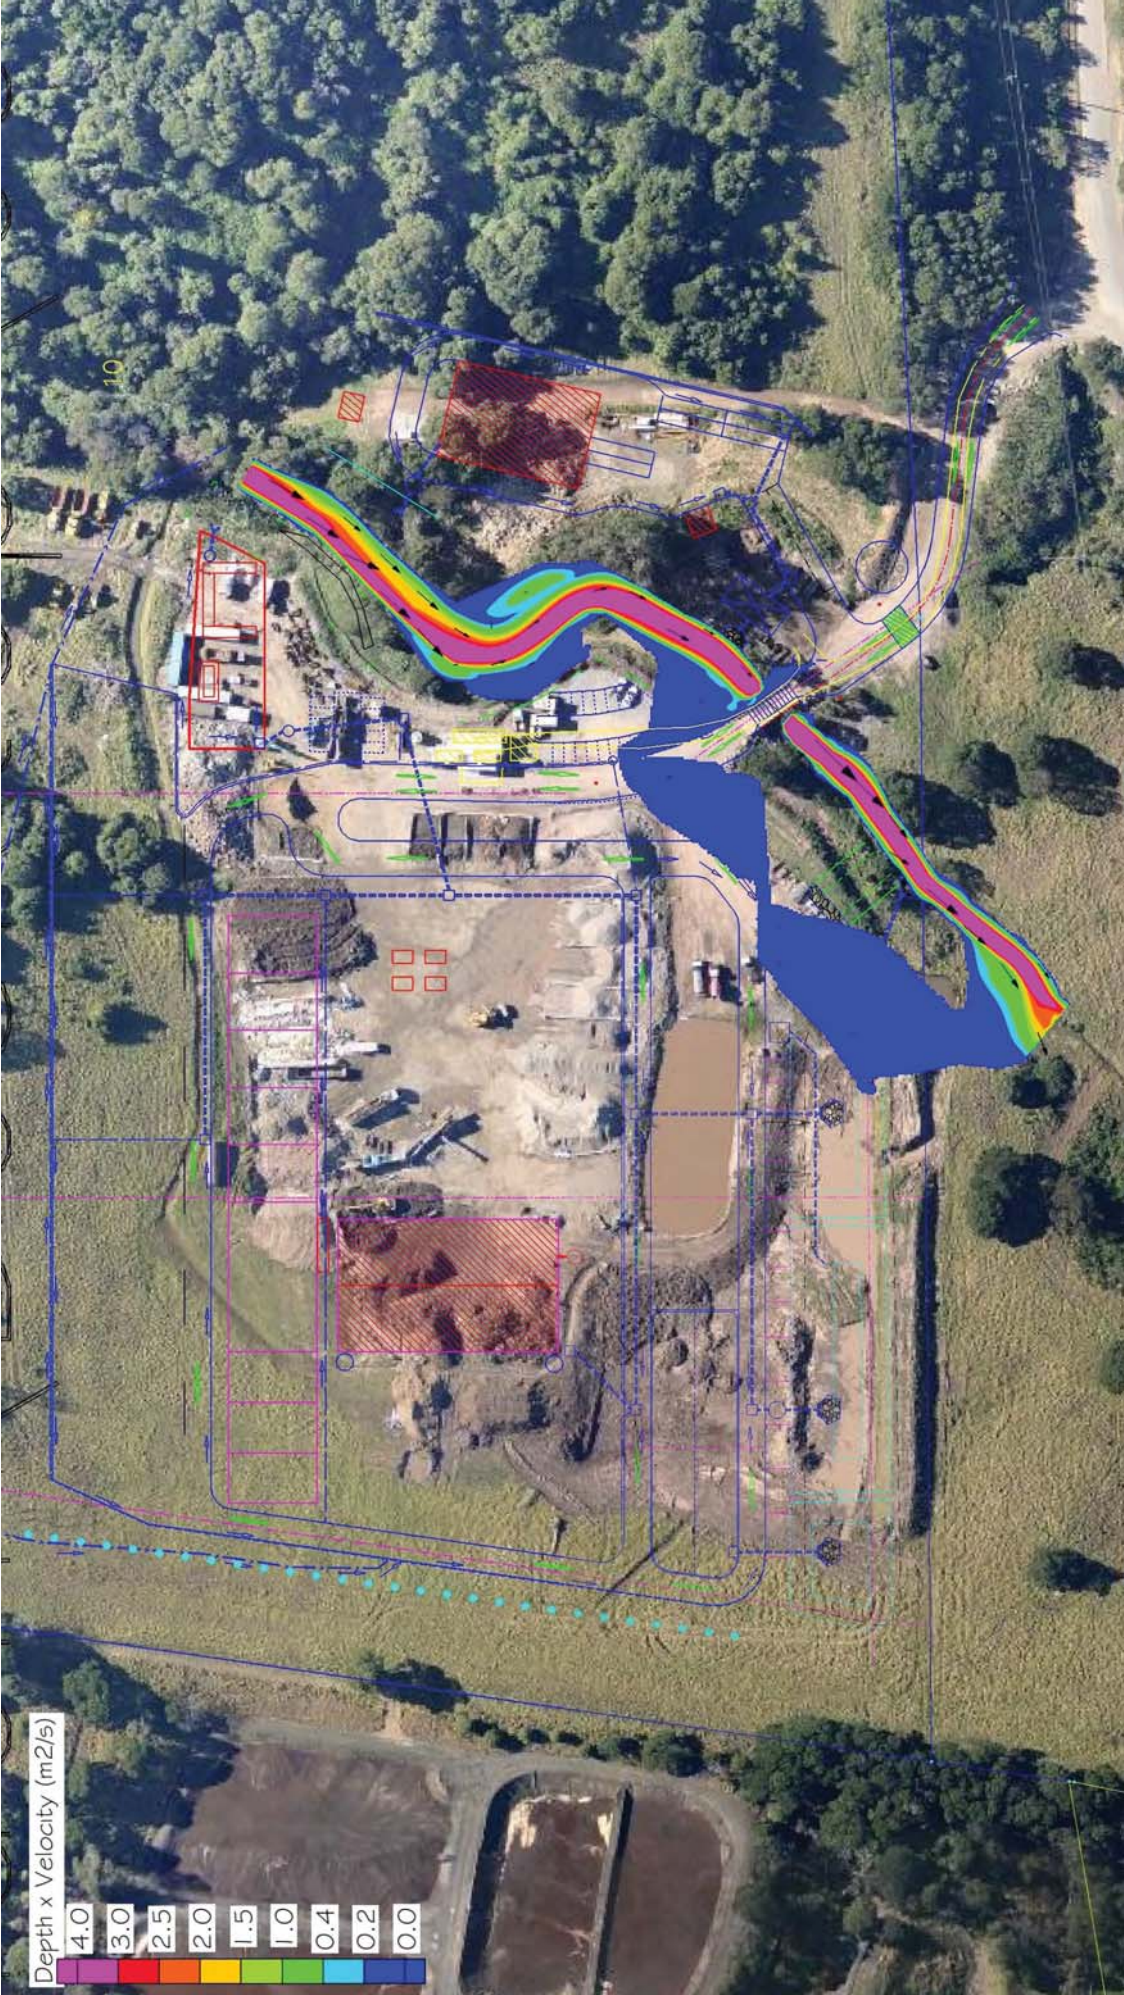
| 50 WYLLIE ROAD, KEMBLA GRANGE – ADDENDUM REPORT | | | | |
|---|---|---|---|---|
| Pre-Developed | 100yr | Velocity x Depth | A | KF110816 |

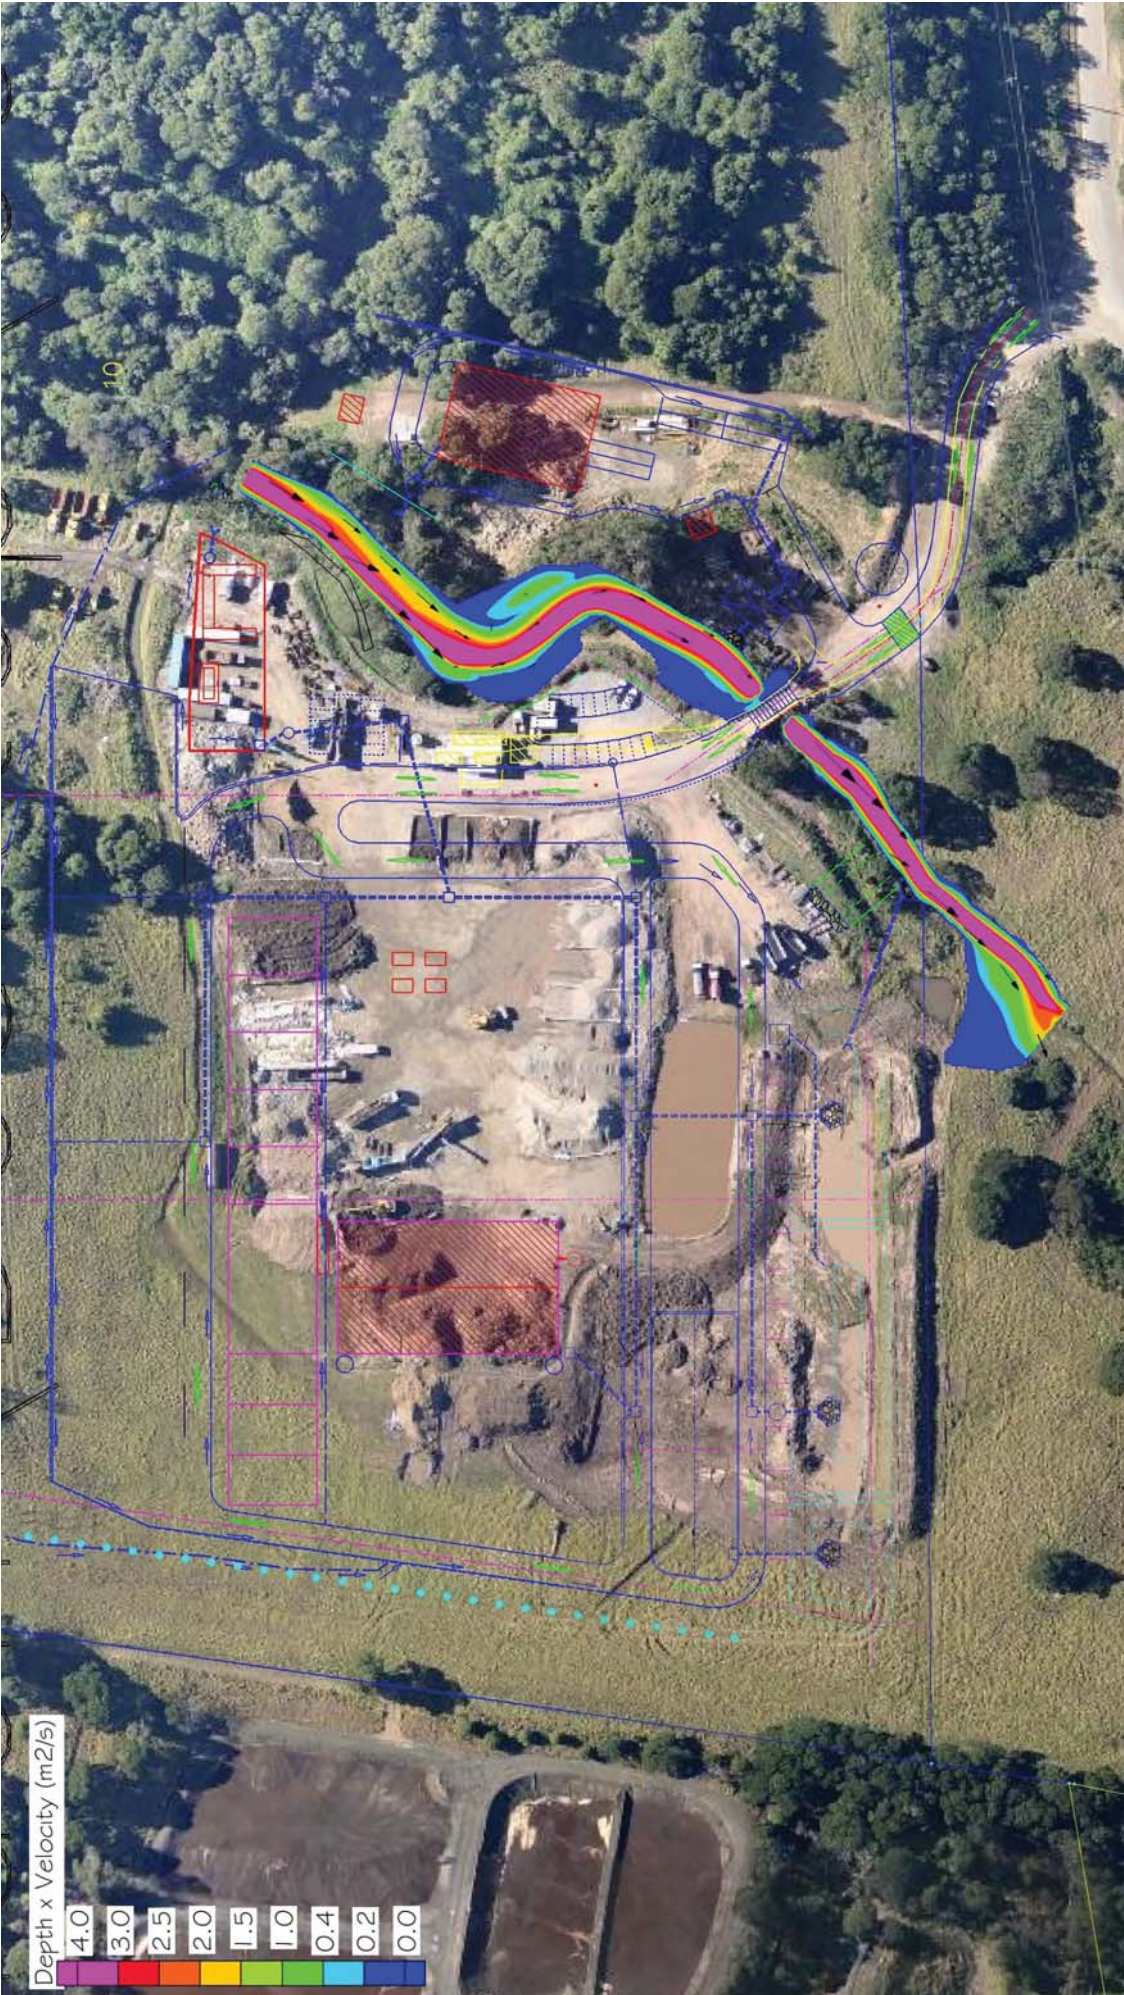
| 50 WYLLIE ROAD, KEMBLA GRANGE – ADDENDUM REPORT | | | | |
|---|---|---|---|---|
| Post-Developed<br>Unblocked | 100yr | Velocity x Depth | A | KF110816 |

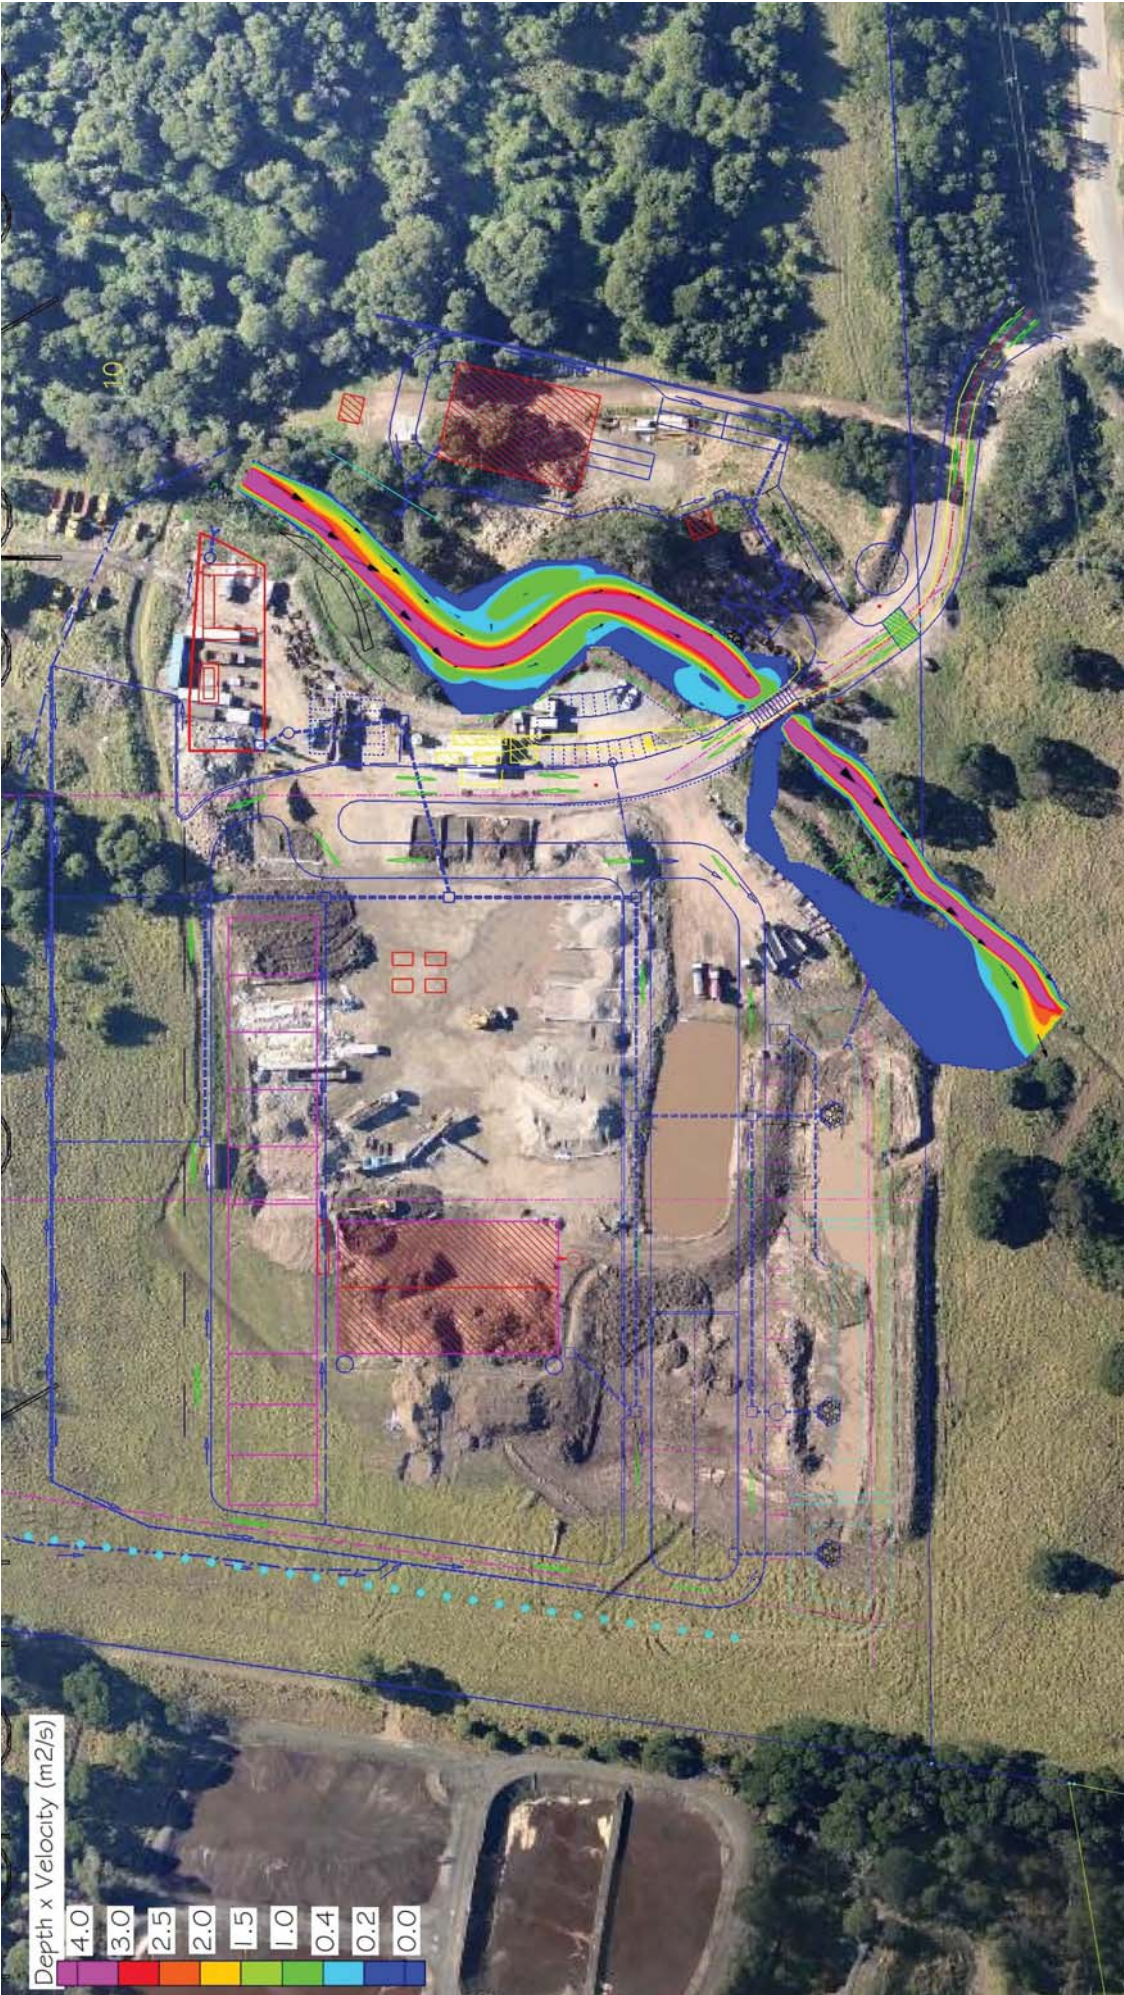
| 50 WYLLIE ROAD, KEMBLA GRANGE – ADDENDUM REPORT | | | | |
|---|---|---|---|---|
| Post-Developed Blocked | 100yr | Velocity x Depth | A | KF110816 |

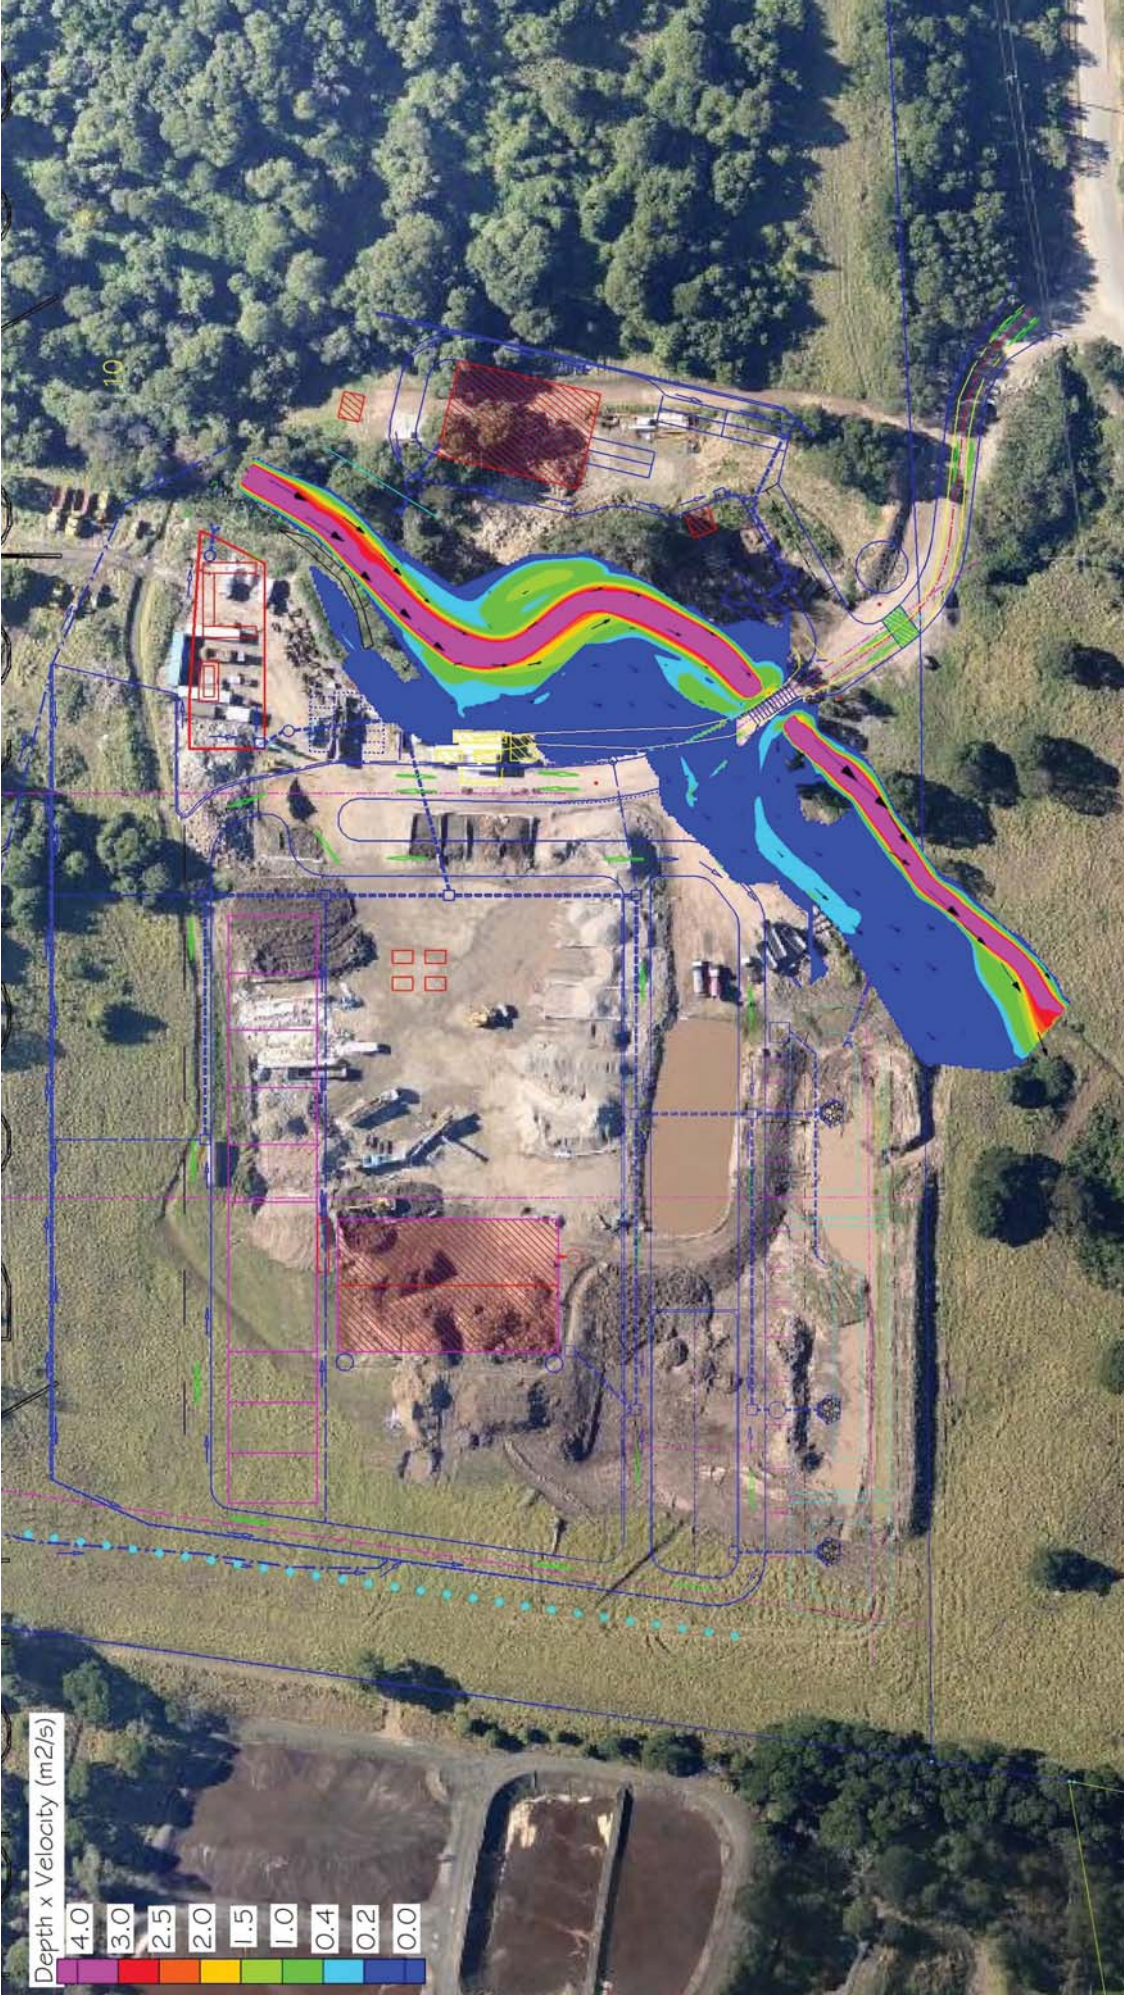
| 50 WYLLIE ROAD, KEMBLA GRANGE – ADDENDUM REPORT | | | | |
|---|---|---|---|---|
| Blocked with 30% Climate Change | 100yr | Velocity x Depth | A | KF110816 |

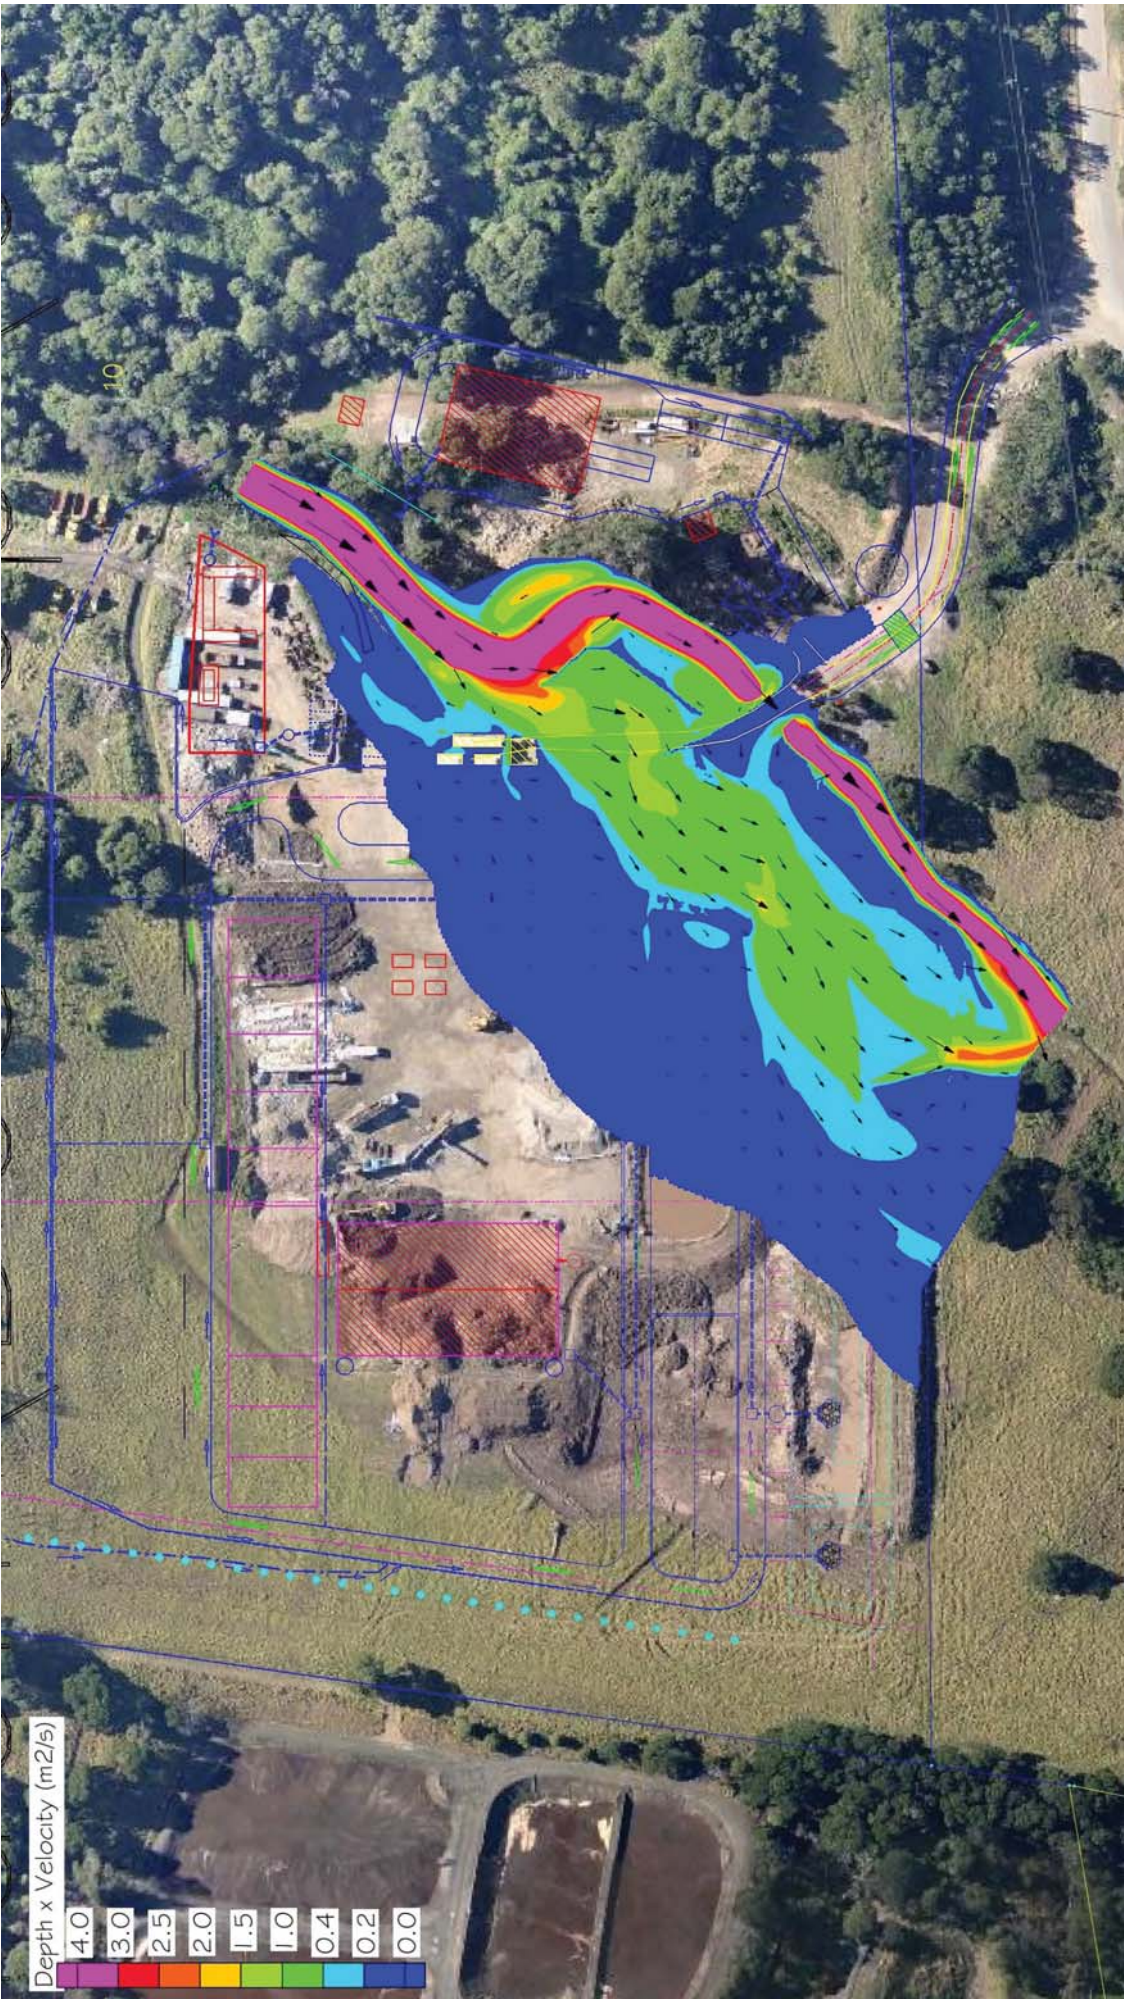
| 50 WYLLIE ROAD, KEMBLA GRANGE – ADDENDUM REPORT | | | | |
|---|---|---|---|---|
| Pre-Developed | PMF | Velocity x Depth | A | KF110816 |

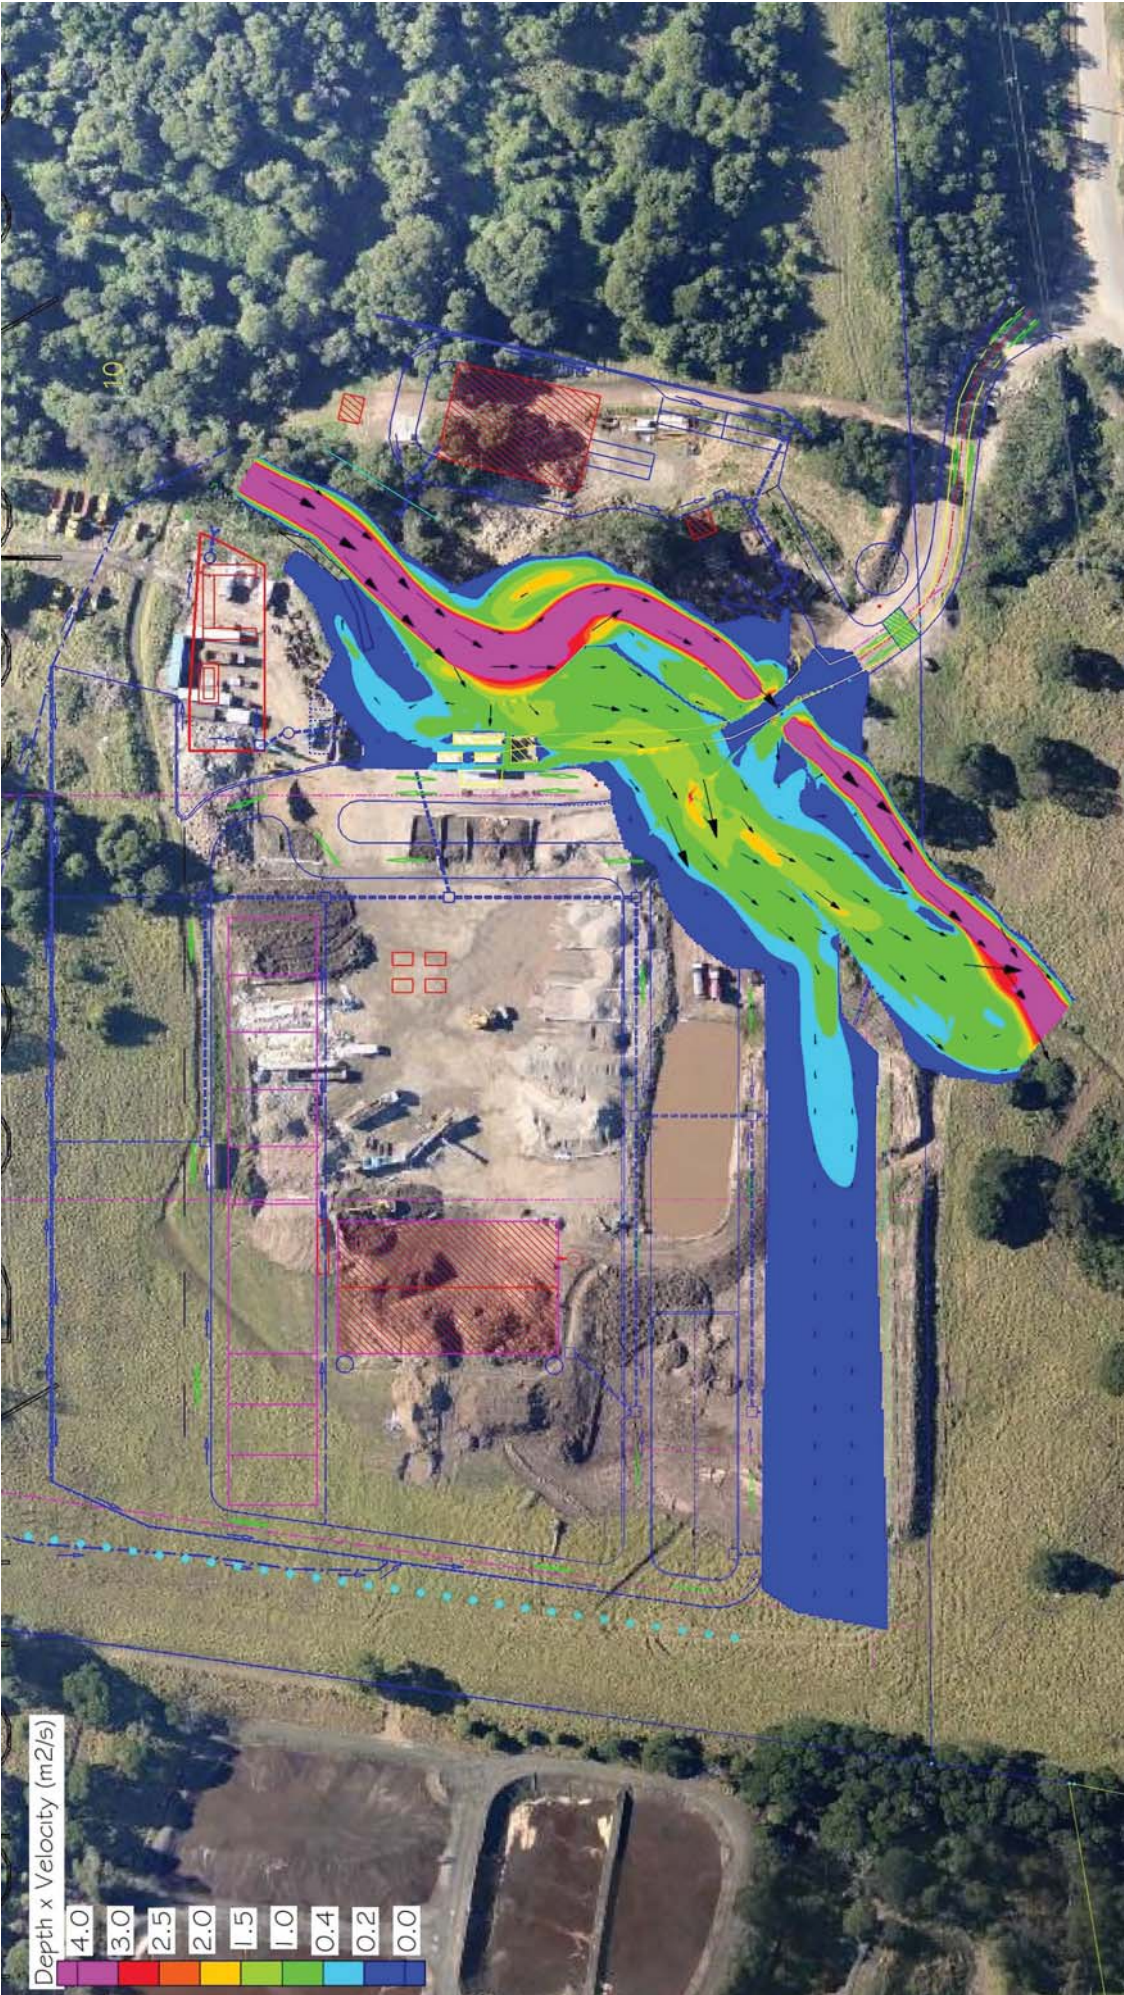
| 50 WYLLIE ROAD, KEMBLA GRANGE – ADDENDUM REPORT | | | | |
|---|---|---|---|---|
| Post-Developed<br>Unblocked | PMF | Velocity x Depth | A | KF110816 |

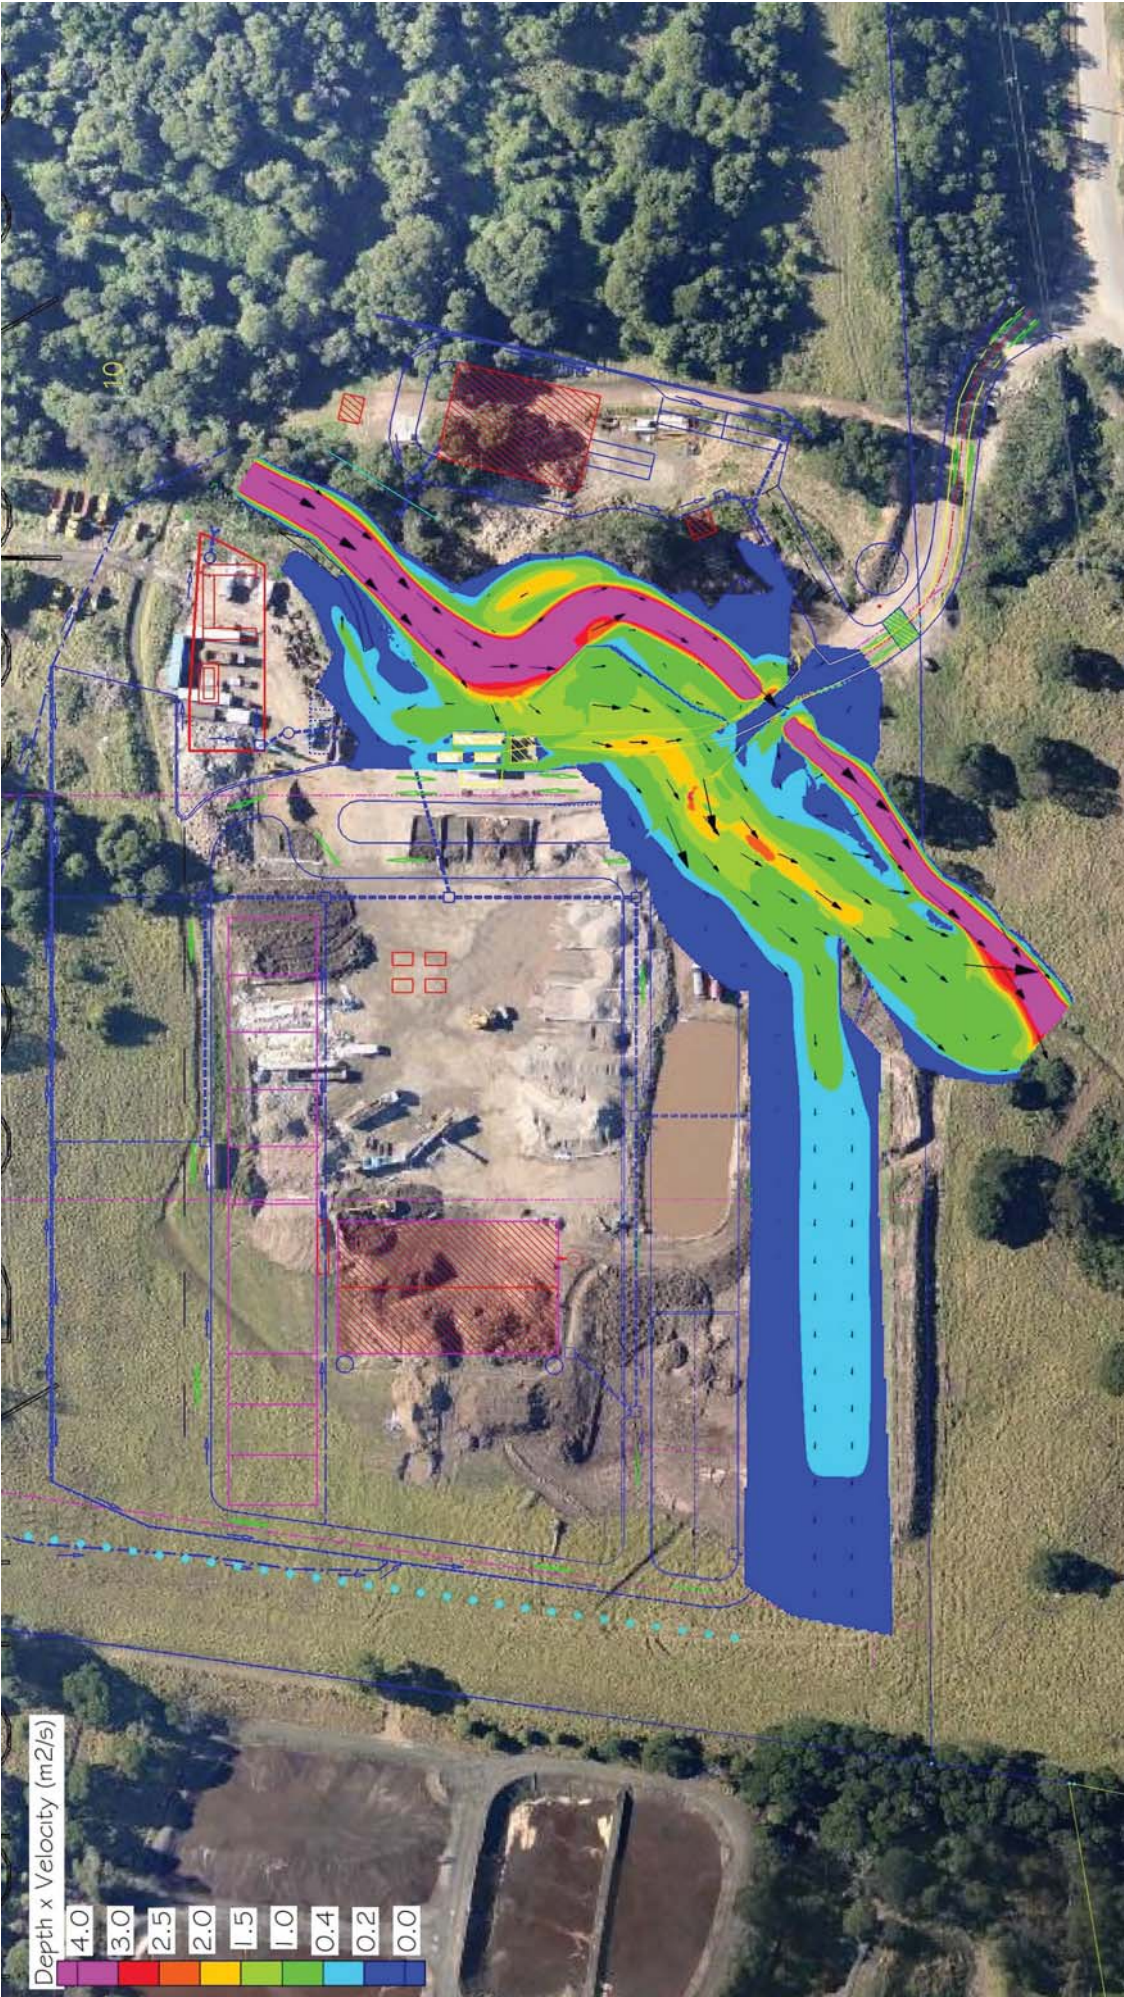
| 50 WYLLIE ROAD, KEMBLA GRANGE – ADDENDUM REPORT | | | | |
|---|---|---|---|---|
| Post-Developed Blocked | PMF | Velocity x Depth | A | KF110816 |
