Sydney International Convention, Exhibition and Entertainment Precinct (SICEEP) Concept Plan, The Haymarket - SSDA2

Non-Indigenous Archaeological Assessment and Impact Statement

Report to
Lend Lease Development Pty Ltd
March 2013

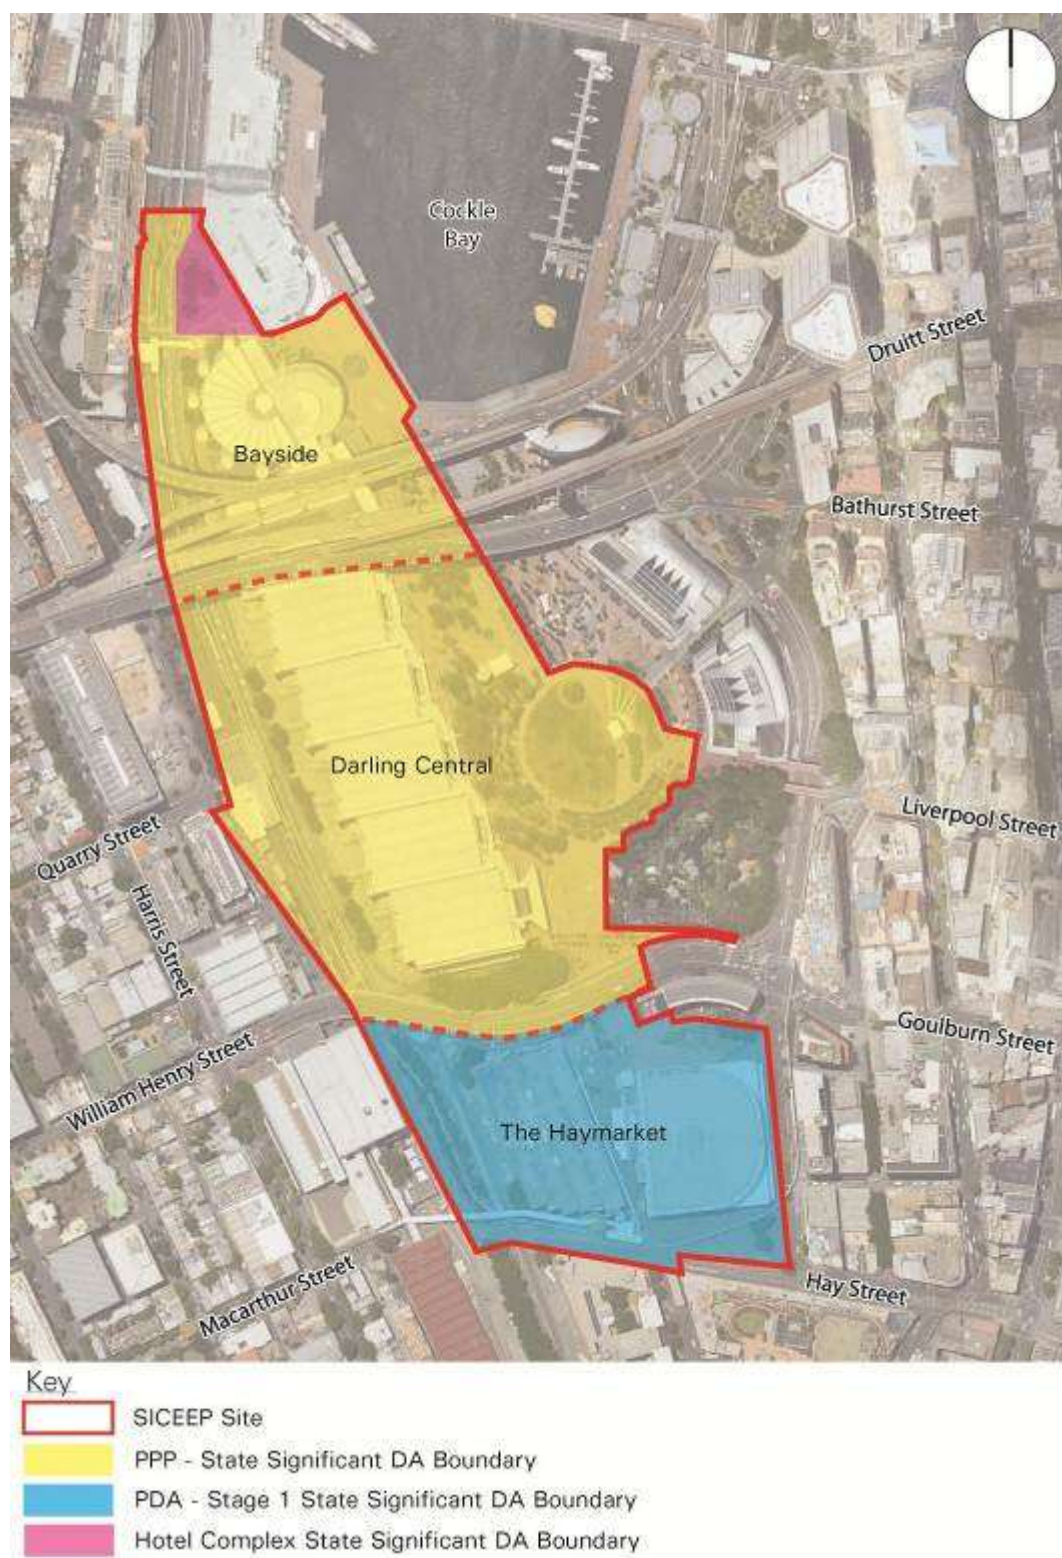
Figure 1.1: The Haymarket study area is highlighted in blue.

The SICEEP Site has been divided into three distinct redevelopment areas (from north to south) – Bayside, Darling Central and The Haymarket. The PPP Application Site area is located within Bayside and Darling Central as shown in Figure 1.1.

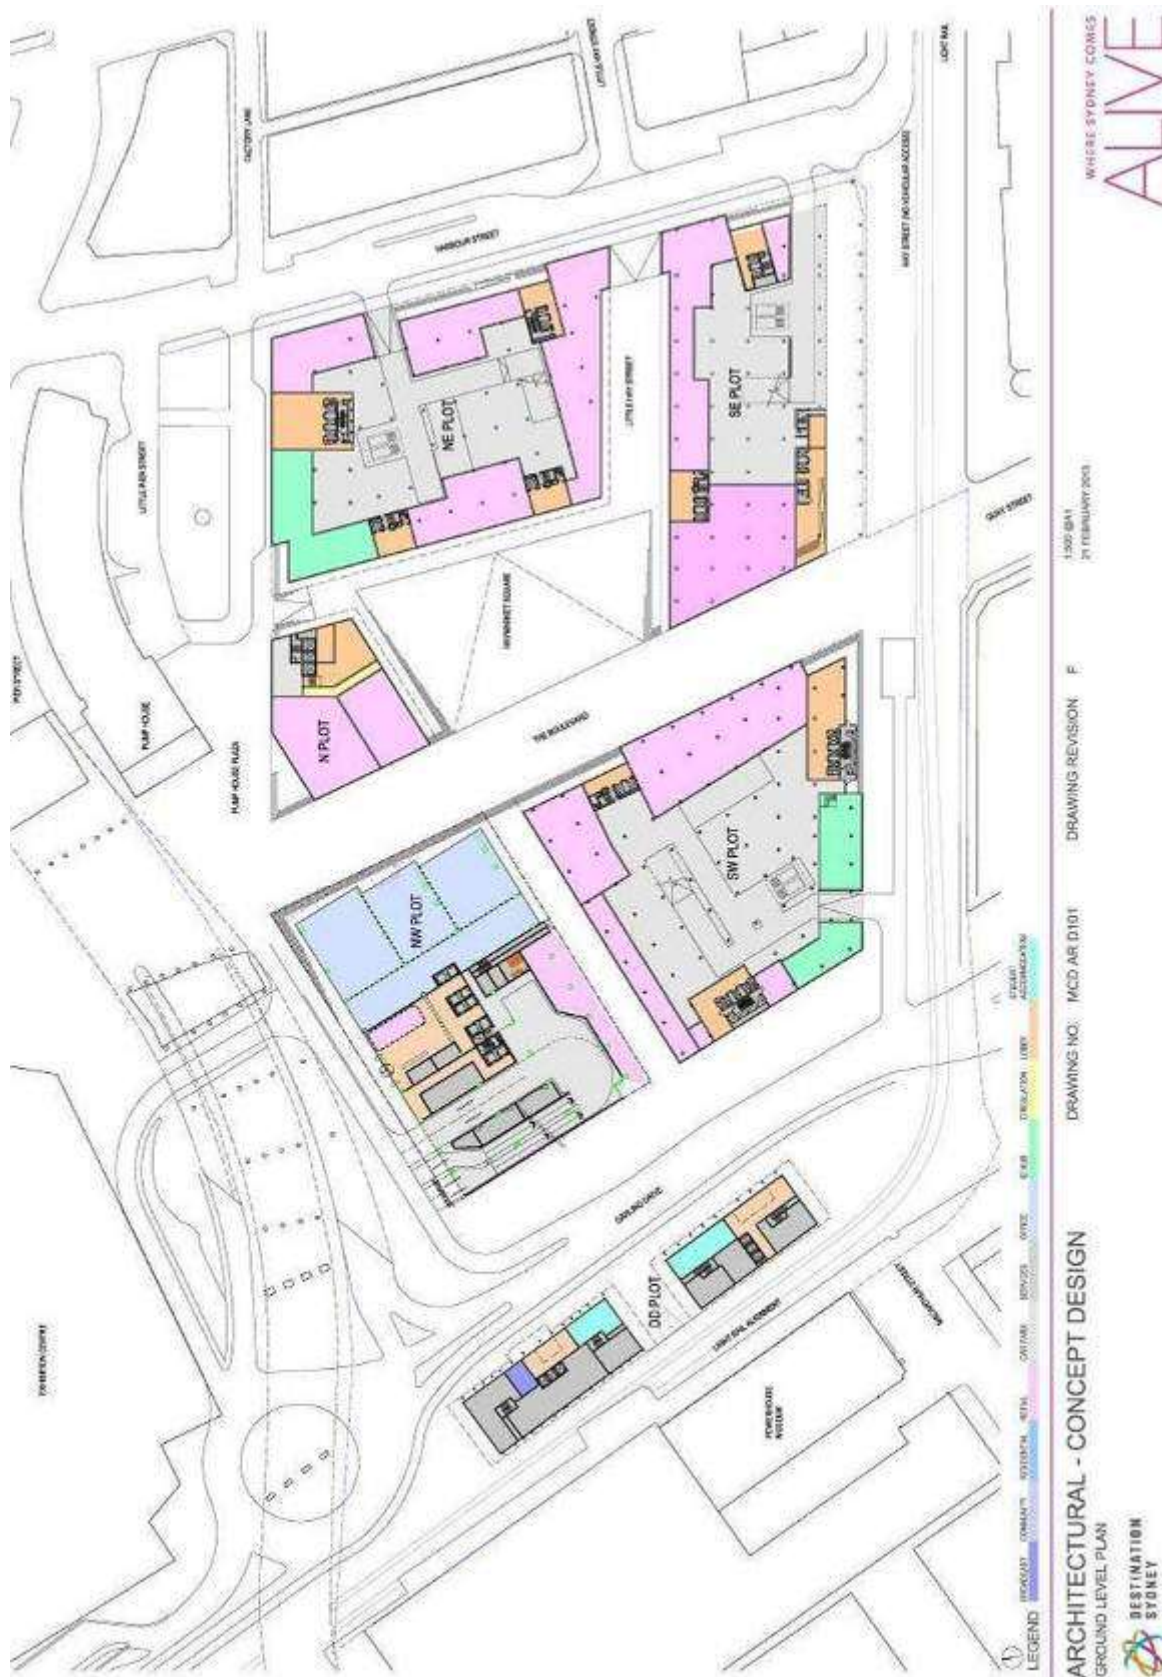
Figure 1.3: Buildings proposed as part of the Concept Plan. Lend Lease Development Pty Ltd

The Haymarket will include student housing, public car parking, a commercial office building, and four mixed use development blocks (retail/commercial/residential podium with residential towers above) centred around a new public square to be named Haymarket Square (Figure 1.2, Figure 1.3).

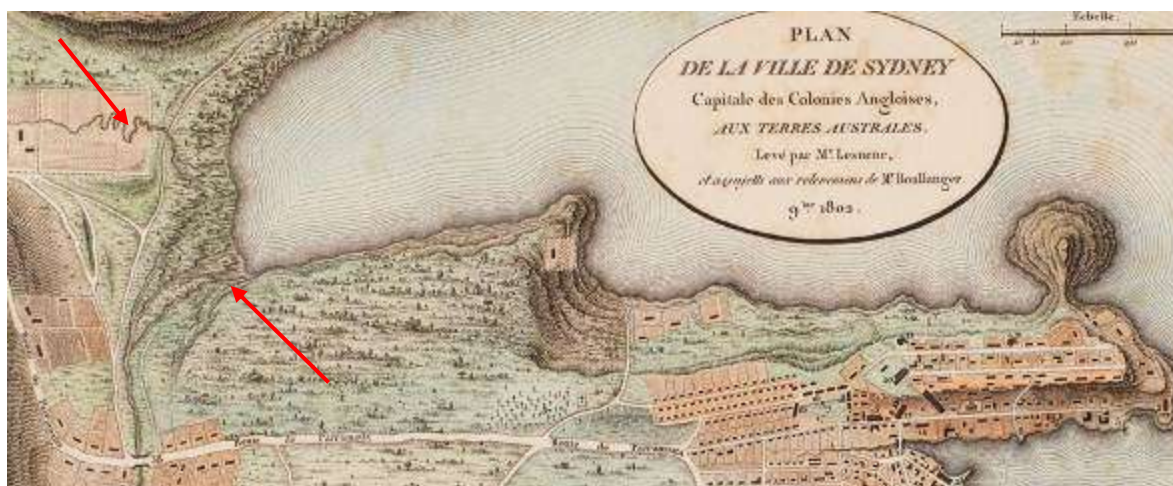
Figure 2.1: Part of the *Plan de la Ville de Sydney* by Charles Leseur (1802) showing creeks and other watercourses feeding into the wetlands at the head of Darling Harbour (top left). Leseur 1802, ML SLNSW.

Darling Harbour is named 'Long Cove' in colonial government records as early as 1788.⁴ This inlet to the west of Sydney Cove, the focus of the colonial settlement, was commonly known as Cockle Bay until officially named Darling Harbour in 1826. The rocky shores of Cockle Bay were covered in scrub and the wetlands at the head of the tidal inlet were fed by a number of small streams. An 1802 plan by Charles Leseur illustrates some of the characteristics of the landscape (Figure 2.1).

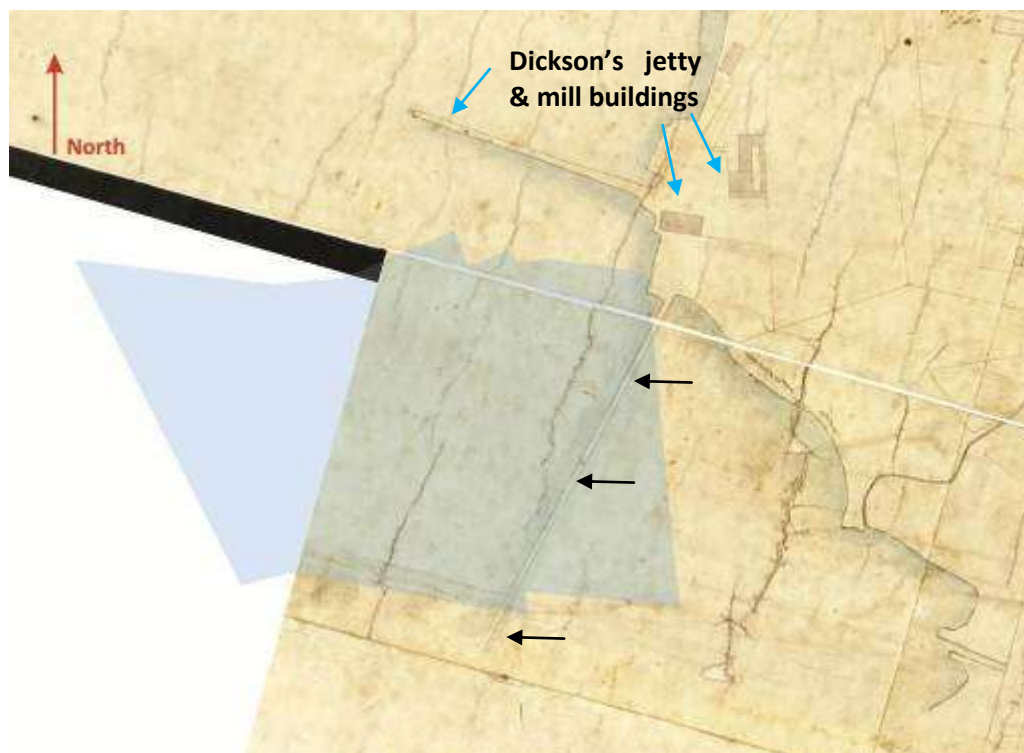
Figure 2.4: Plan showing Dickson's 1815 dam wall (black arrows), jetty and mill buildings (blue arrows) erected by 1822. Only the dam wall from the original mill is within the Haymarket study area. Harper 1822 plan, SRNSW AO Map SZ435, SZ436.

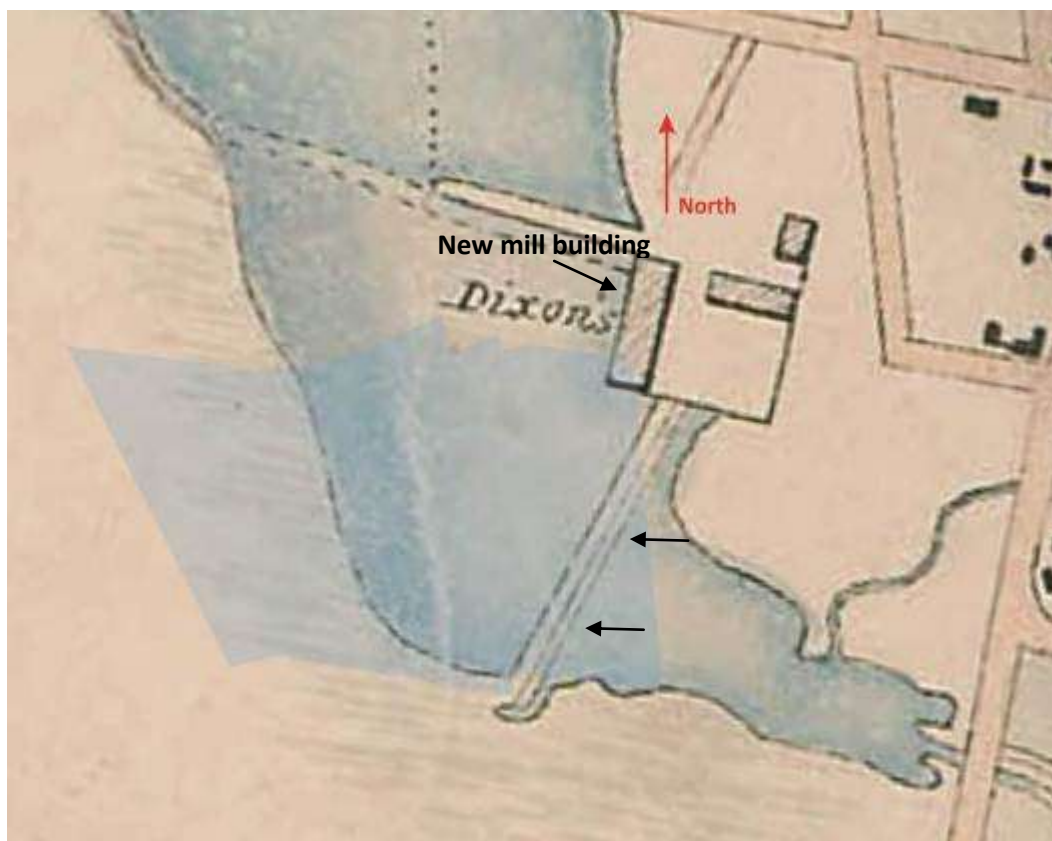
Figure 2.5: A plan showing the development of Dixon's [sic] mill by 1828. Features of the study area include the millpond dam wall (black arrows), and buildings to the south of the jetty which appear to be those shown on the 1831 field book (Figure 2.6) are just within the study area. A later mill building was built on reclaimed land. Surveyor Thompson, SR Item No: SZ467 SRNSW, accessed at acliarts.usyd.edu.au.

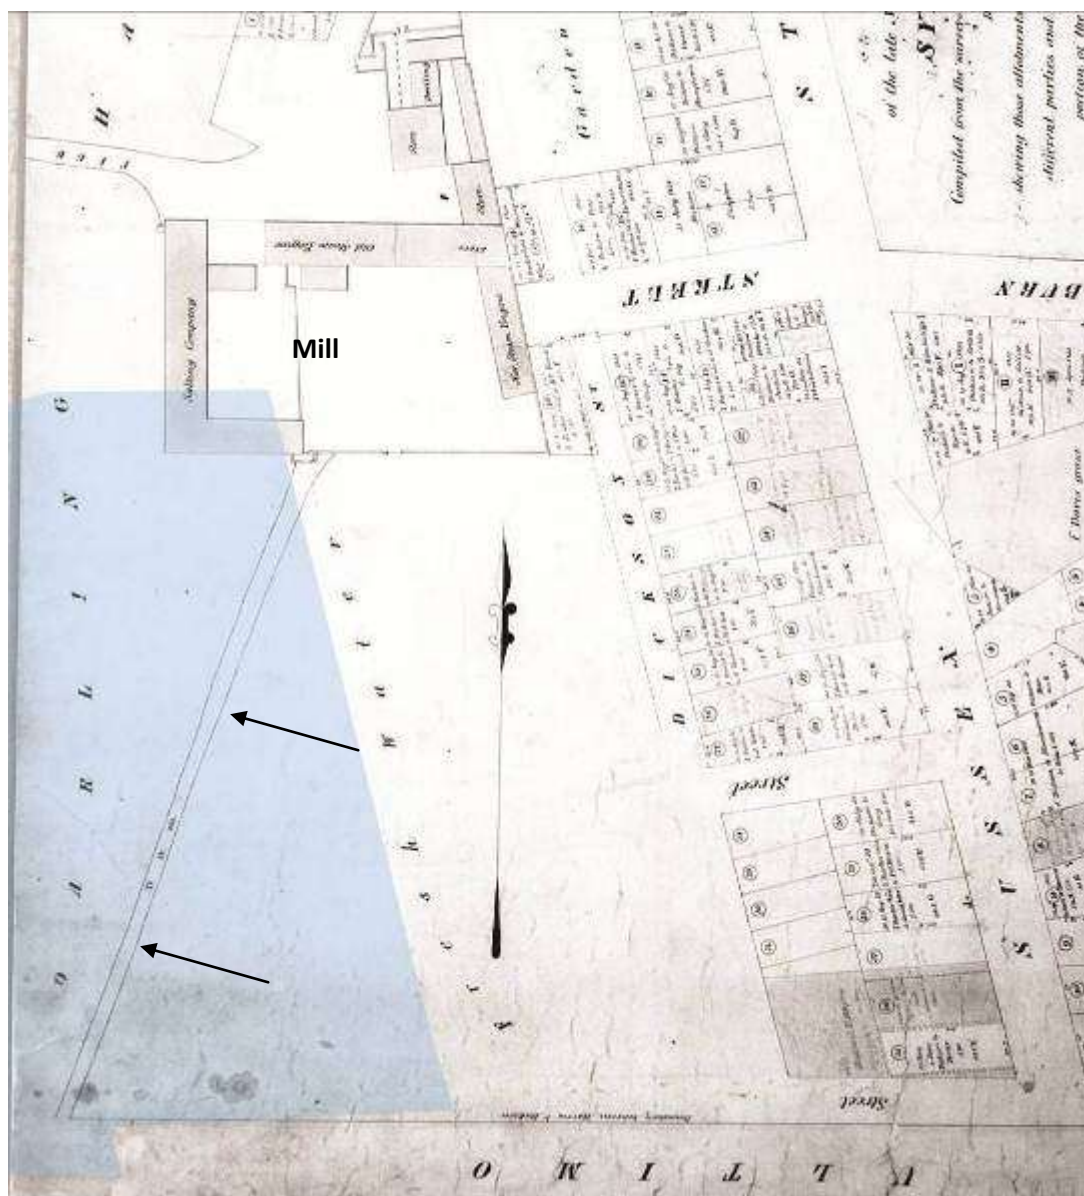
Figure 2.9: Part of the plan of the late John Dickson's grant showing the enclosed mill precinct, dam embankment (arrowed), and the fresh water millpond. Part of the millpond, the dam wall and southern portion of the 'Salting Company' building are within the study area. Knapp 27 Jul 1844, ML SLNSW.

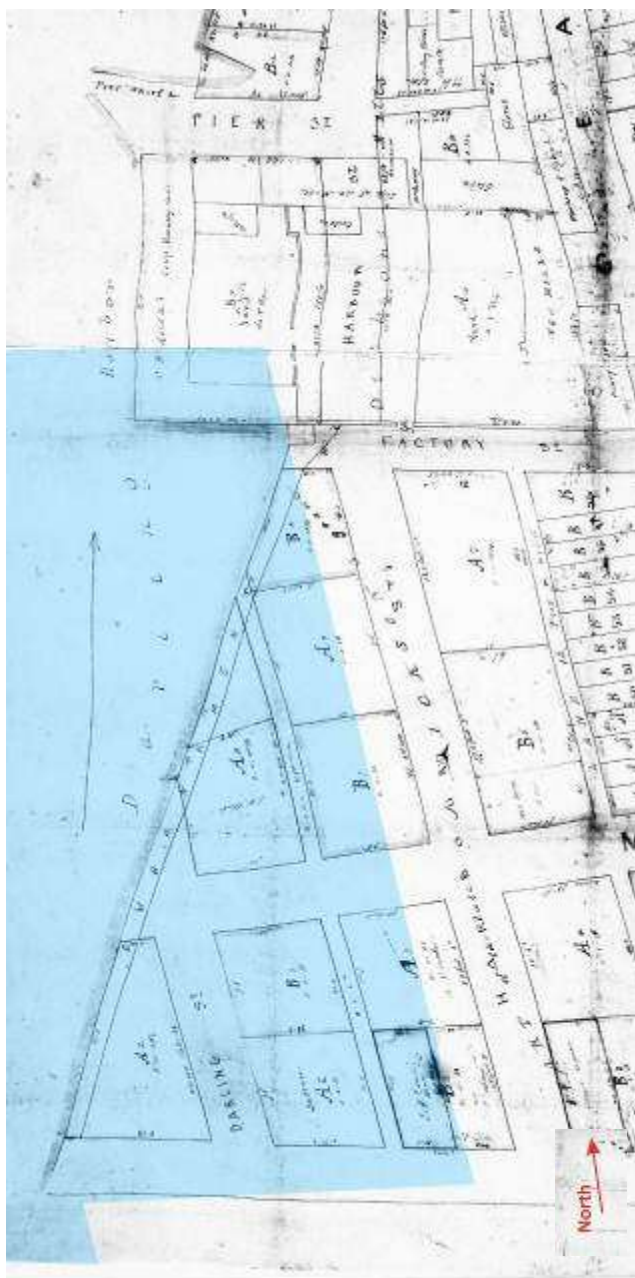
Figure 2.10: Portion of a plan of Dickson's Estate dated 1859 showing Block B9 leased by WB Allen from at least 1855. It shows the reclamation and subdivision of the land within the former millpond to the east of the dam wall. Knapp 1859, ML SLNSW.

In April 1844 the Sydney Salting Company took out a lease on the 'L-shaped' building between the dam embankment and Dickson's Pier.³⁴ The building is located in Block B9 of the of Dickson's Mill subdivision in 1859, the southern part of which is in the study area (Figure 2.10).

A second plan for the partition of the Dickson's Mill Estate in 1859 shows W B Allen's Soap Factory as occupying the former Salting Company L-shaped building adjacent to Darling Harbour (Figure 2.10).³⁷ Allen moved to the site in early March 1852 and commenced candle and soap production, attracting the attention of the City Council as the melting of tallow contravened one part of the *Slaughtering Act* (1849). Records of the court case describe the manufacturing process used by Allen. He was fined and is likely to have carried out tallow melting elsewhere for soap manufacture. Had Allen's business been melting tallow on the site before 1849 he would have been granted permission to continue there until 1860.³⁸

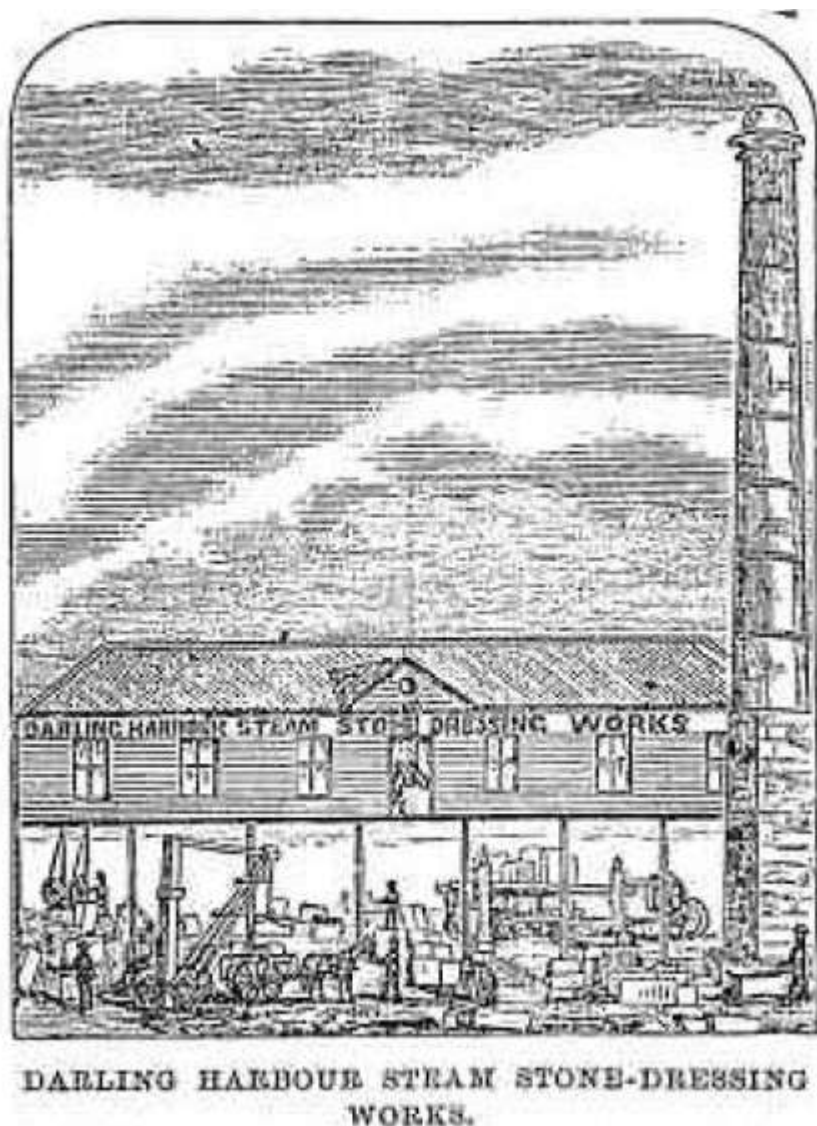
Figure 2.20: Wadsworth's stone dressing works at Darling Harbour was powered by a steam engine. A masonry chimneystack was a feature of this site and no doubt other Darling Harbour factory sites of the era. *AT&CJ* 19 Oct 1872:13.

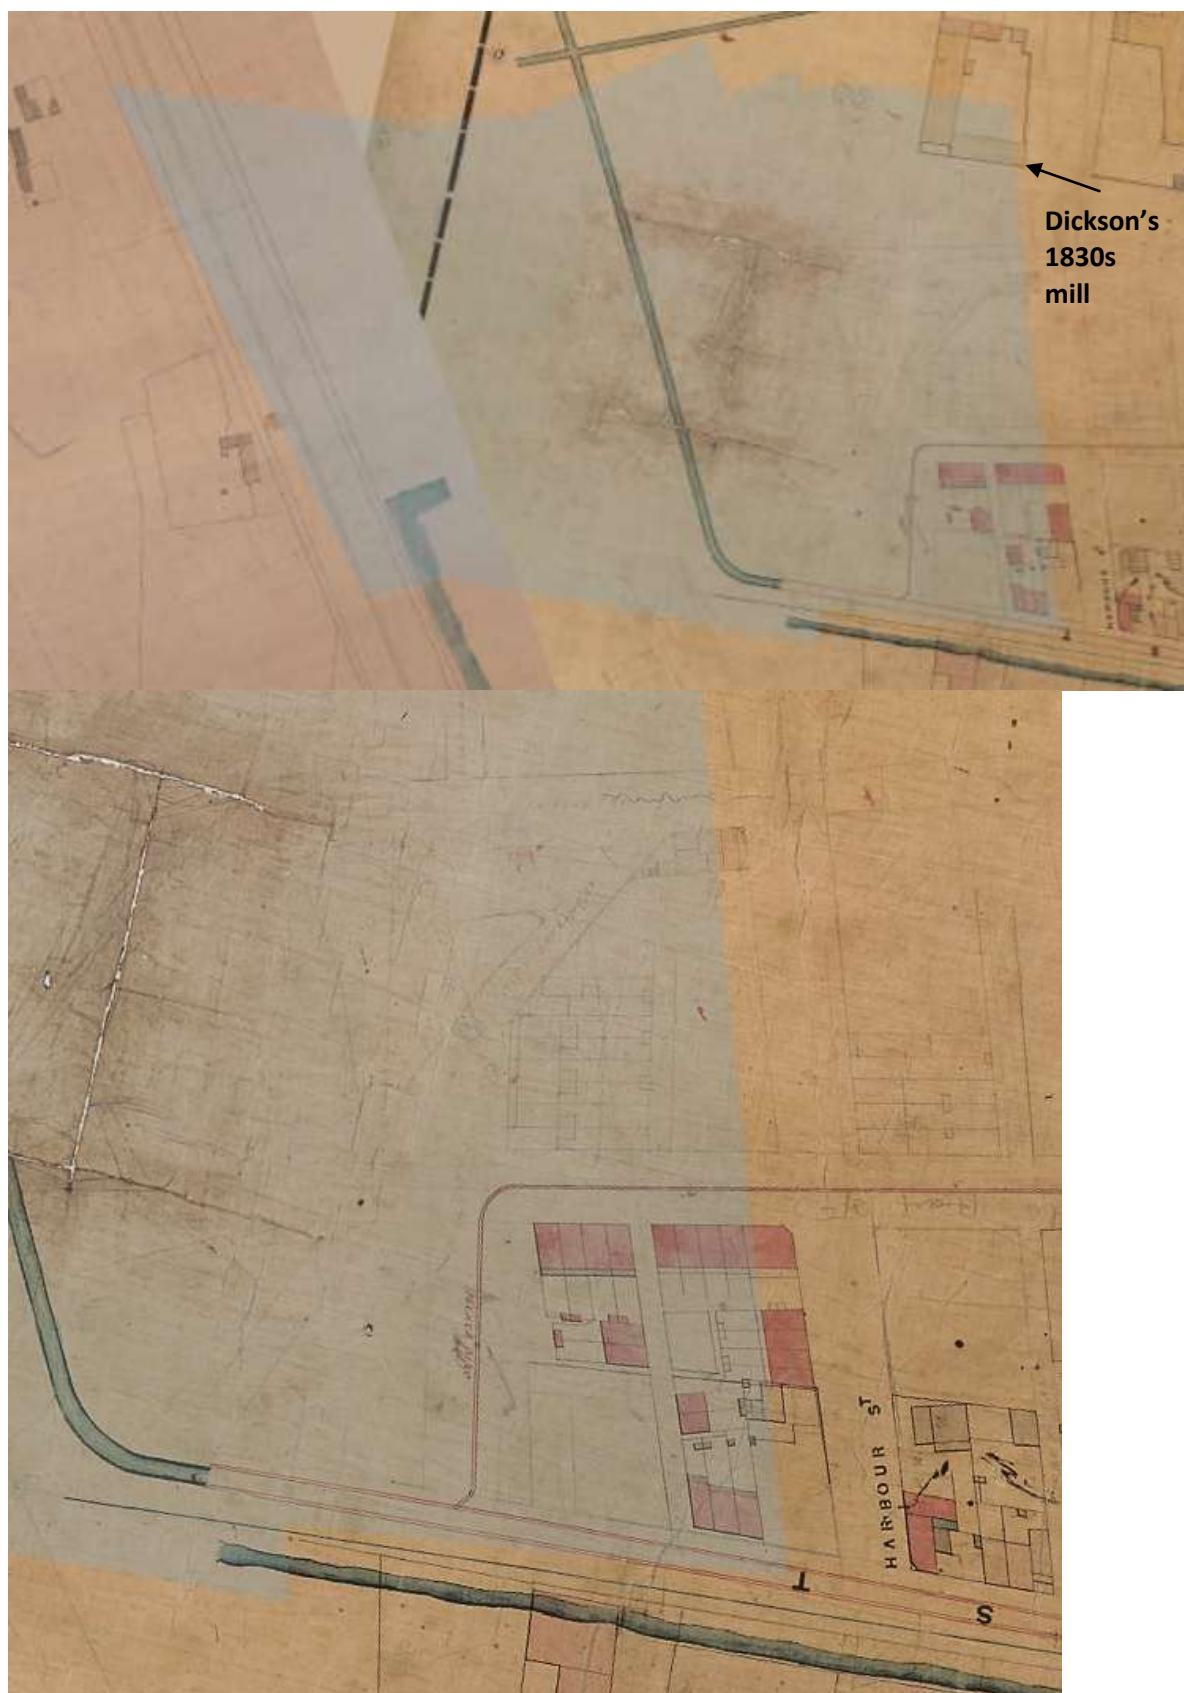
Figure 2.24: Only a small section of The Haymarket land was built on by 1865 (study area in blue). This was on blocks B1, A3 and B2; compare Figure 2.17. The lower section is a detail from the top plan. The pencil annotations to the north indicate later development. Dickson's 1830s mill buildings are just within the northeast corner of the study area. North at the top. Trigonometrical Survey, 1865, Historical Atlas of Sydney, City of Sydney Archives.

Frederick George Candish purchased the western part of Block B2 of Dickson's Mill Subdivision on 11 April 1865 (Figure 2.17, Figure 2.24). The site located on the southwest corner of Hay Street and Little Harbour Lane adjoined Block A3 on the north. By 1867 Candish had built a two-storey, brick house in Hay Street. By 1871 two more houses with shingled rooves were built with the address of the group shown in records as 44, 46 and 48 Hay Street. Candish lived in No 46 and the other two were unoccupied at the time of the 1871 rates assessment.

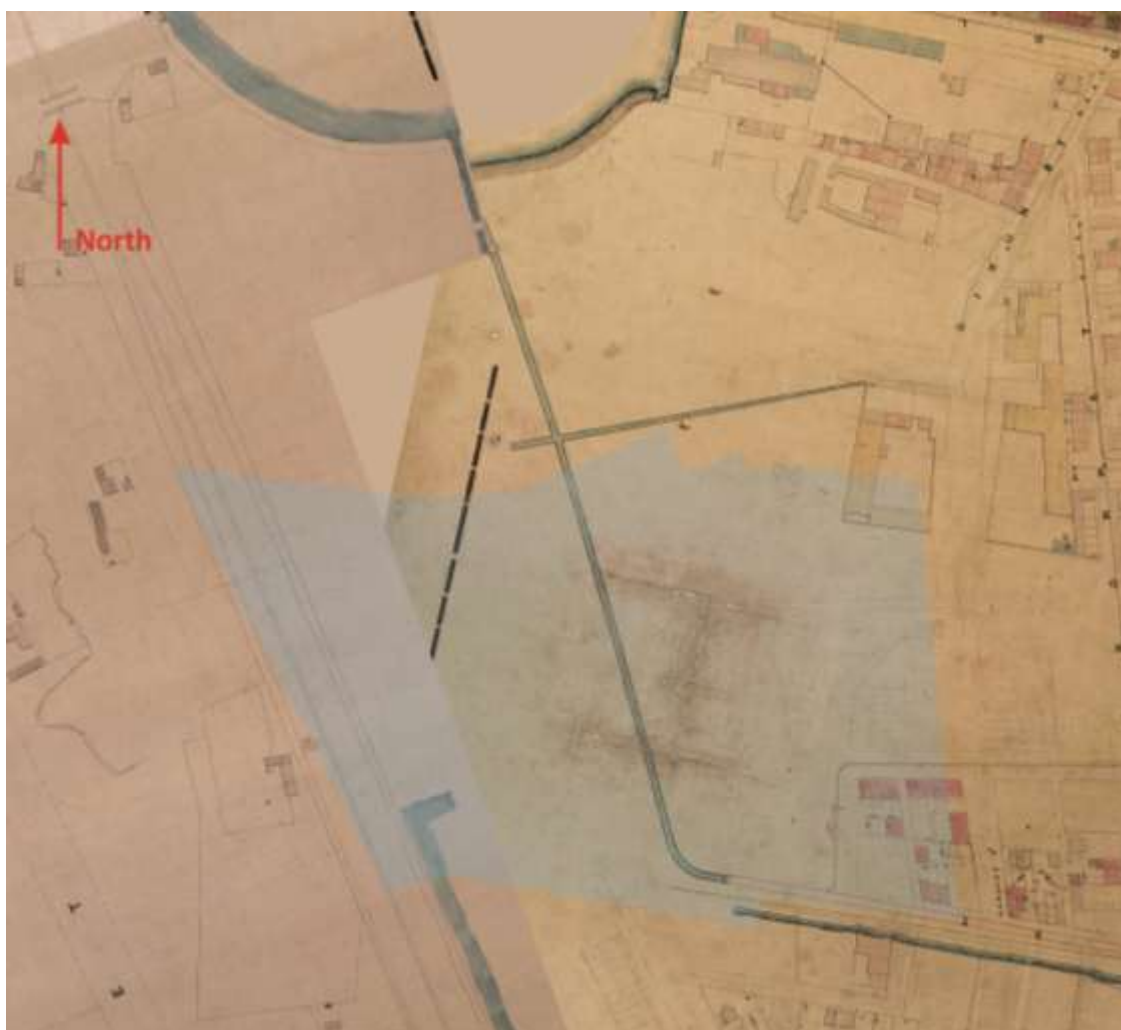
Figure 2.30: Part of the 1865 survey showing the reclamation of land at the head of Darling Harbour and the line of sewerage and stormwater channels draining into the harbour. The Hay Street sewer extension is the channel running approximately north-south and left open for a period of time. Note the pencil markings indicating the Council annotations of later buildings and streets. The former creekline and proposed drain along Hay Street to the south is visible. Trig Survey: Section T, 1865, Historical Atlas of Sydney, City of Sydney Archives.

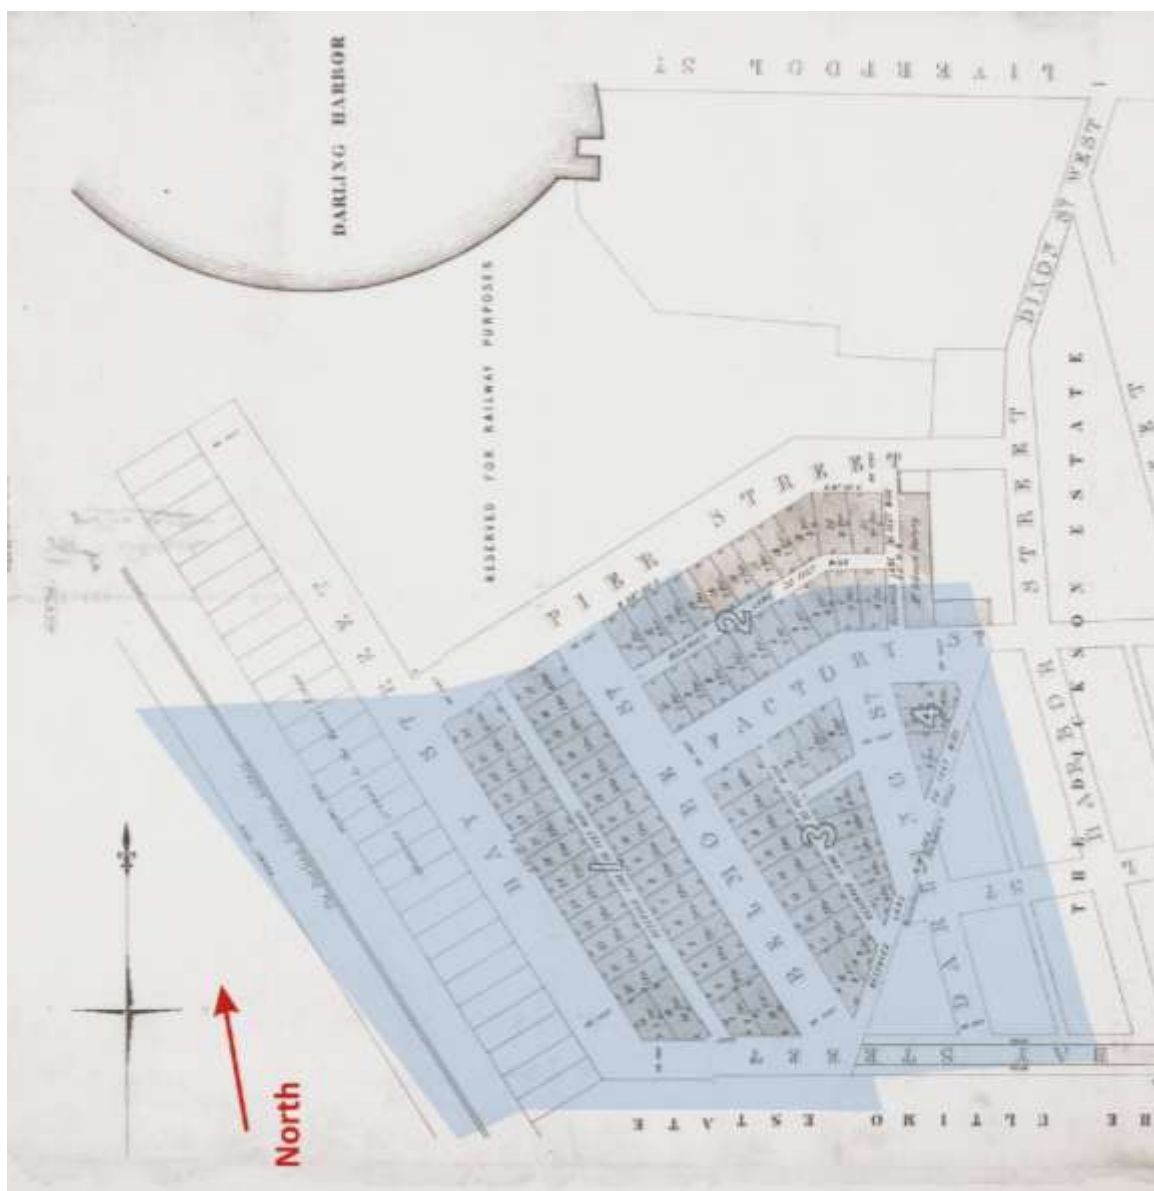
Figure 2.33: Plan dated 1870 showing the government subdivision on reclaimed land at the head of Darling Harbour adjacent to Dickson's Mill Subdivision. M2 811.1733/1870/1 ML SLNSW.

A portion of reclaimed land was reserved for railway purposes while an area bounded by extensions of Pier Street and Hay Street, and Little Darling Street (Fraser Street), Factory Street, and Little Harbour Street was released for public auction (Figure 2.33).

A brief history of the development of the government subdivision is provided through examination of some of the businesses established. Due to the size of the subdivision and the number of land titles transactions it is not possible to discuss each site individually. The following sections in the report should be read in conjunction with schedules in Appendix 5: Land Titles - Government Subdivision, 1870, Appendix 7: City of Sydney Council's Rates and Assessments, and Appendix 8: *Sands Directory*. The plan in Figure 2.33 should be referred to for the location of allotments.⁸⁷

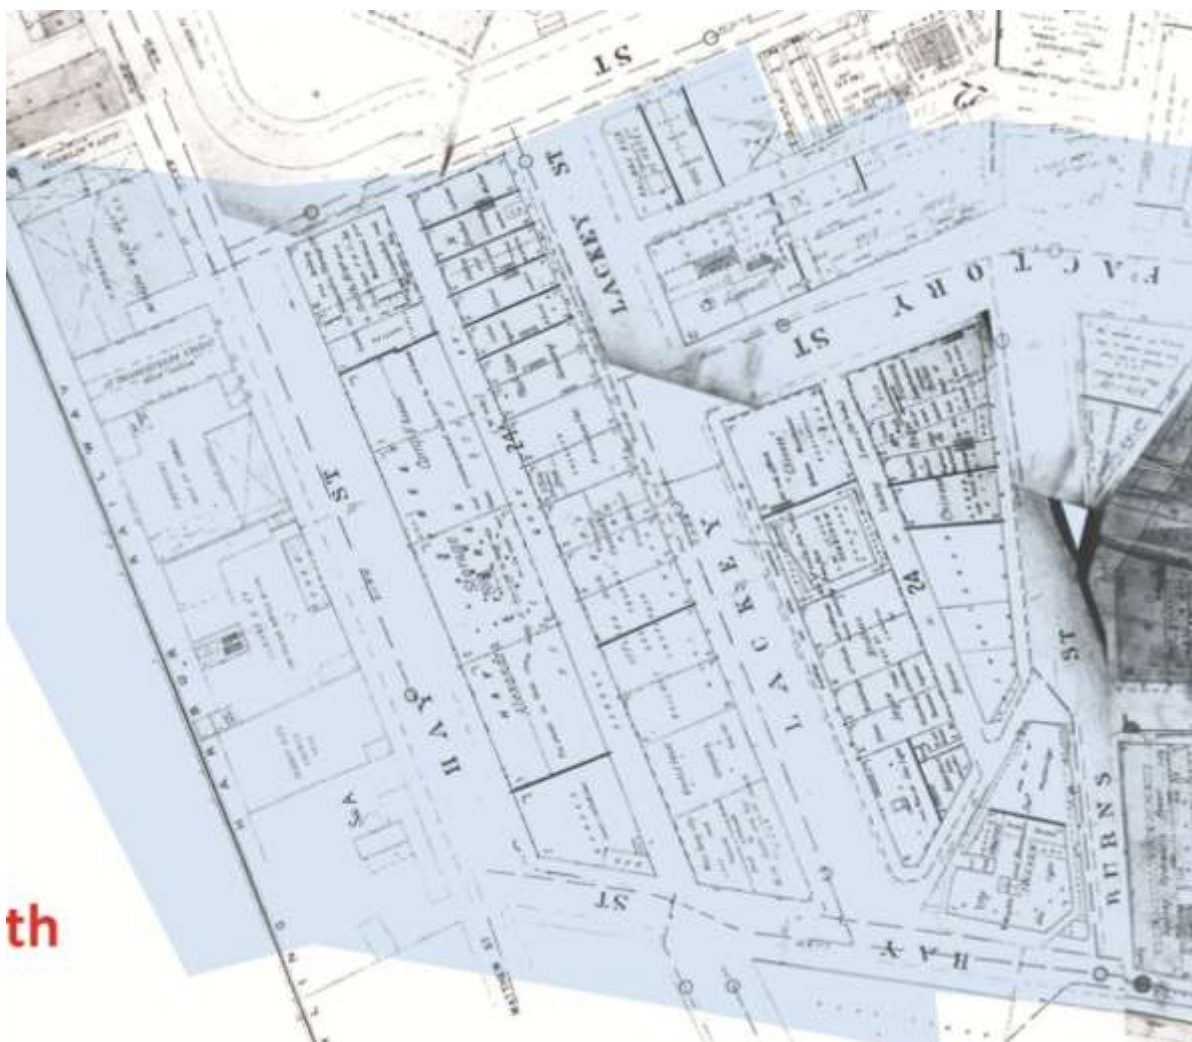
Figure 2.35: By the early 20th century most of the western half of the study area was developed. North at top. *Structural plans of the City of Sydney* (cartographic material), *Ignis et Aqua* series, vol.1 / by F. Oliver Jones, Civil Engineer & Surveyor. ML, SLNSW.

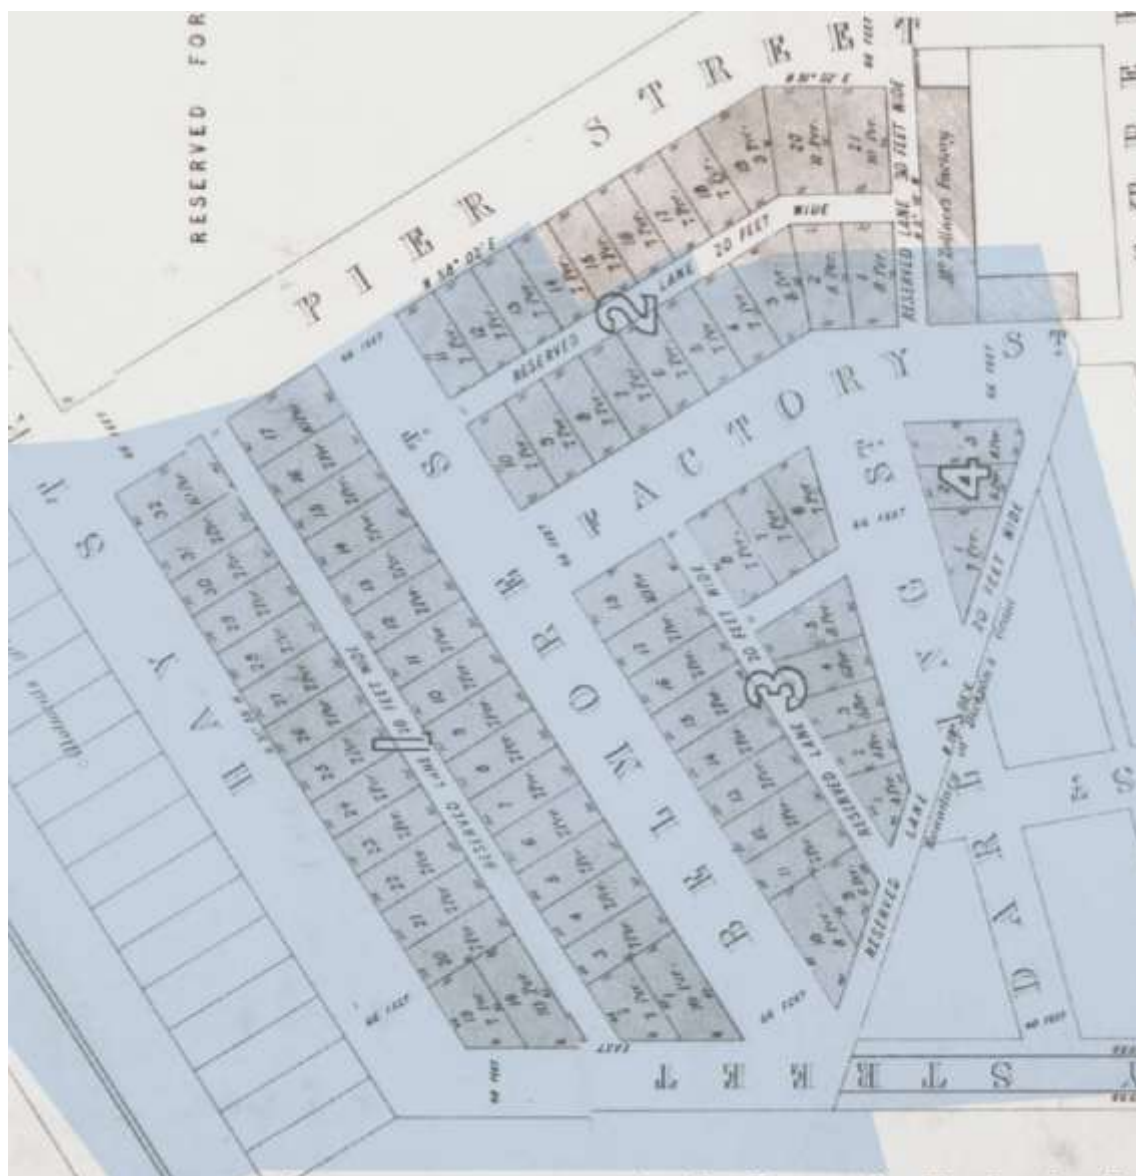
Figure 2.36: Detail of 1870 plan showing the government subdivision on reclaimed land at the head of Darling Harbour adjacent to Dickson's Mill Subdivision. M2 811.1733/1870/1 ML SLNSW.

Alexander William Cormack of Bullanaming Street, Redfern purchased Lot 3 Section 3 (5 p in Darling Street, later Burns Street) at the government auction in December 1870 (Figure 2.36). It was one of a number of pieces of land that he acquired or leased in the subdivision over the next two decades. The majority of Cormack's landholdings were in Section 3 with frontages to Burns Street, Factory Street and Belmore Street, with others in Section 1 facing Belmore Street and Hay Street (Figure 2.38).

William Goodin, a Camperdown tollkeeper, purchased Lots 1 and 2 Section 2 in 1870 (Figure 2.36, Figure 2.38). The land on the corner of Factory Street and Little Harbour Street was to the west of Zollner's Galvanizing Factory. Goodin established a wood and coal yard at 28 Factory Street and by 1880 had built a single-storey, timber and iron building. Dove's 1880 plan of the area shows the Parramatta Wood Co yard which Goodin is thought to have operated (Figure 2.38). By 1882 the property was leased to George Taylor. Other tenants associated with the site include Cowell & Co fuel and produce merchants (c1887-1891). Mary W Paterson purchased Lots 1 and 2 in 1901 and the title was transferred to Sydney Wholesale Druggists and a large building was erected to cover the property (Figure 2.41).

Mort & Co gradually acquired Lots 9 to 17 Section 1 west of Lackey Street from 1884 (Figure 2.36).¹⁰² This land is the northern half of the property on the western side of Lackey Street (Figure 2.40). Rates and assessment records for 1882 show Mort & Co had established stores on the site (1, 3 & 5 Lackey Street at this time). The two-storey iron buildings with iron roofs were valued at the

William Oswald Gilchrist (d1920) and John Brown Watt, merchants of Market Street, purchased Lots 13-19 Section 2 at the government auction at Darling Harbour in 1870 (Figure 2.36). The Pier Street site extended from Little Harbour Street to Lackey Street. Gilchrist and Watt also acquired other land in Harbour Street to the east. Lots 13 to 16 and part of 17 are thought to be associated with the study area. Purchased for its investment potential or later use, the land remained vacant until c1880-1881 when 41 Pier Street, a small part of Gilchrist and Watt's land, was leased to William Nelson for a turner's shop that was demolished by 1882. The rest of the vacant land was fenced.

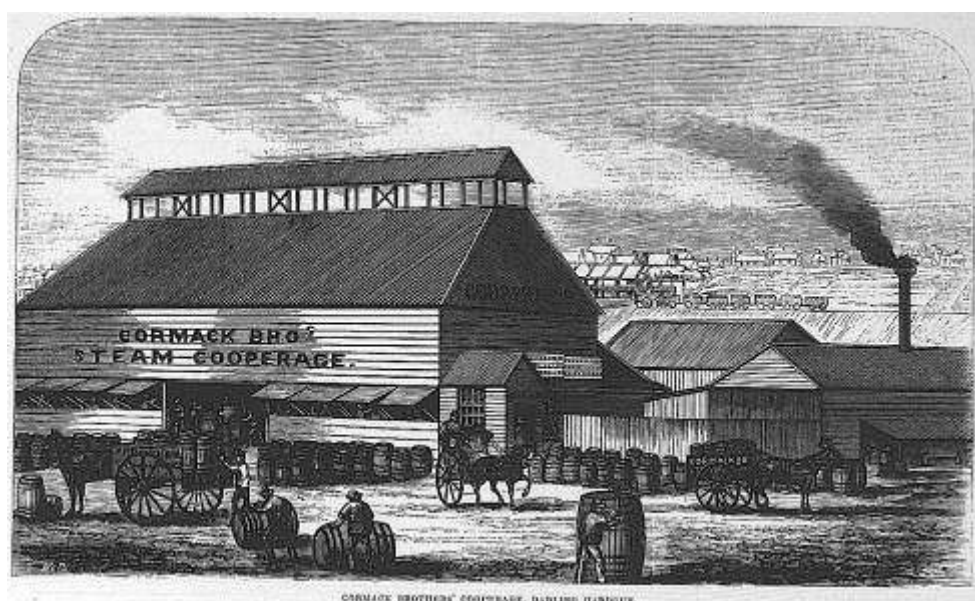
Figure 2.37:
Cormack
Brothers
Cooperage with
the Darling
Harbour Branch
line in the
background.
AT&CJ 26 Sep
1874: 501.

Purchasing land from another successful bidder at the government auction, Cormack added Lots 24 and 25 Section 1 to his landholdings in 1871. Cormack's cooperage began operations at Darling Harbour in 1872 and in 1873 he purchased Lots 4 to 8 in Section 3 to the east. The extent of Messrs Cormack Brothers cooperage in 1874 is illustrated in Figure 2.37.⁸⁹

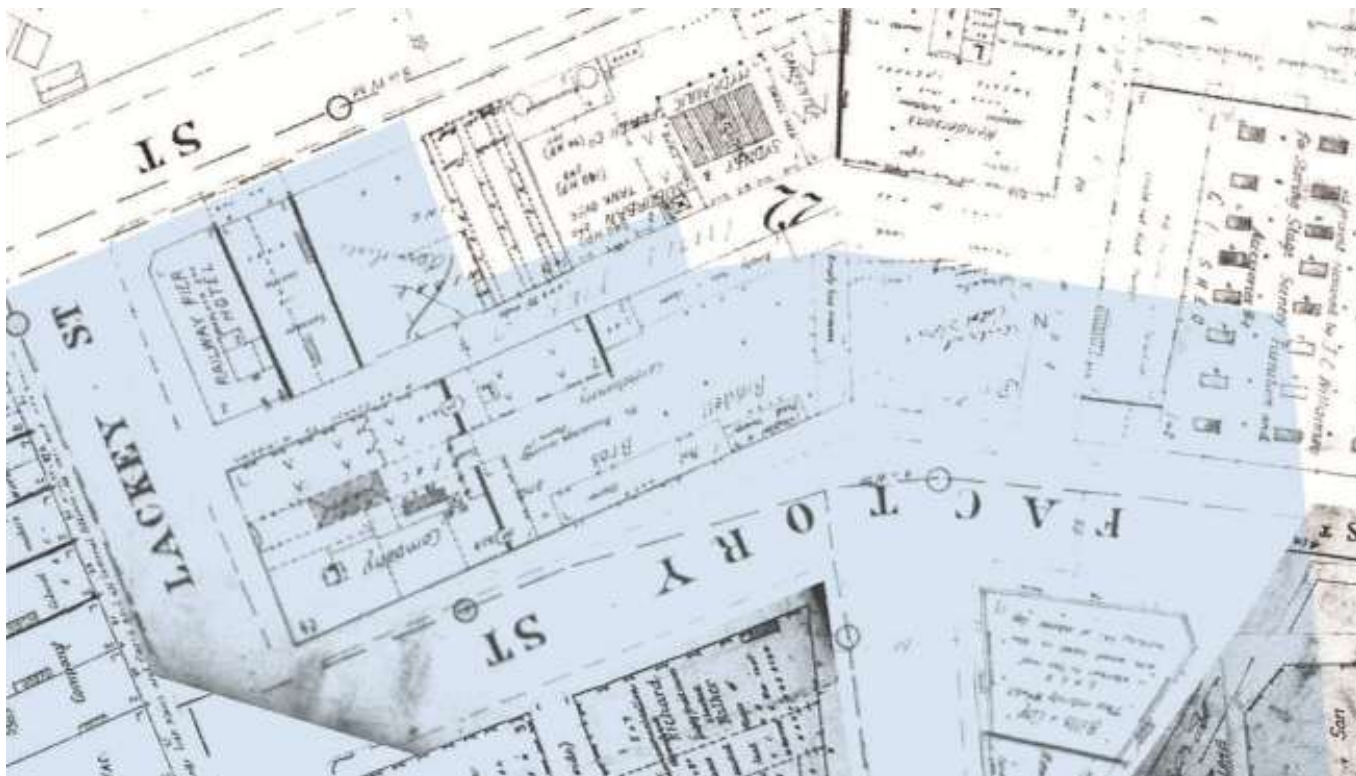
Figure 2.41: Section 2 of the government subdivision of the western section of the study area. This shows the extent of the Biddell Bros confectionery factory and the location of the Railway Hotel on the corner of Pier and Lackey Streets. North at top. *Structural plans of the City of Sydney* (cartographic material), *Ignis et Aqua* series, vol.1 / by F. Oliver Jones, Civil Engineer & Surveyor. ML, SLNSW.

Part or all of buildings thought to be located in the study area include workshops at 17 Pier Street built in the 1920s (Figure 2.41, Figure 2.44, Figure 2.45). A view of Pier Street looking west is reproduced in Figure 2.48, showing the westernmost part of the site in November 1932 (Figure 2.48). The building was demolished c1962 and replaced by a tyre business (Figure 2.49).¹⁰⁴

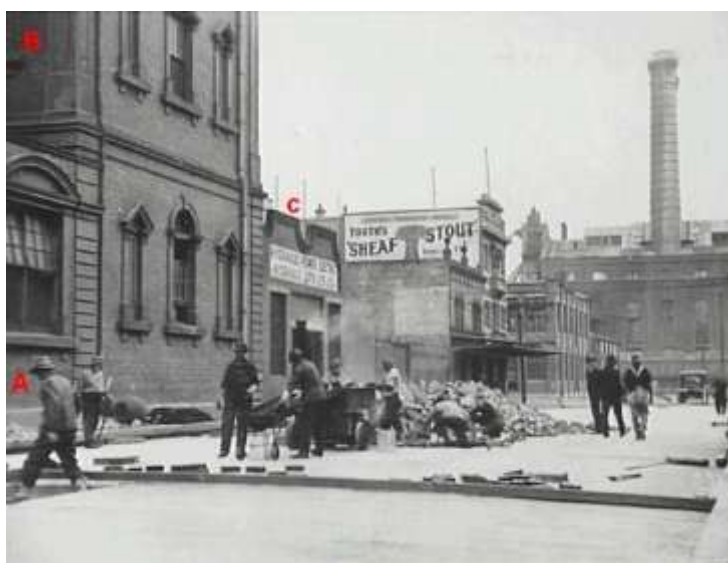
Figure 2.48: Photograph of road works in Pier Street in November 1932 with the parapeted, single-storey pumping station workshop (C), adjacent to the study area, to the right of the main pumping station building (B). CCSA 036372.

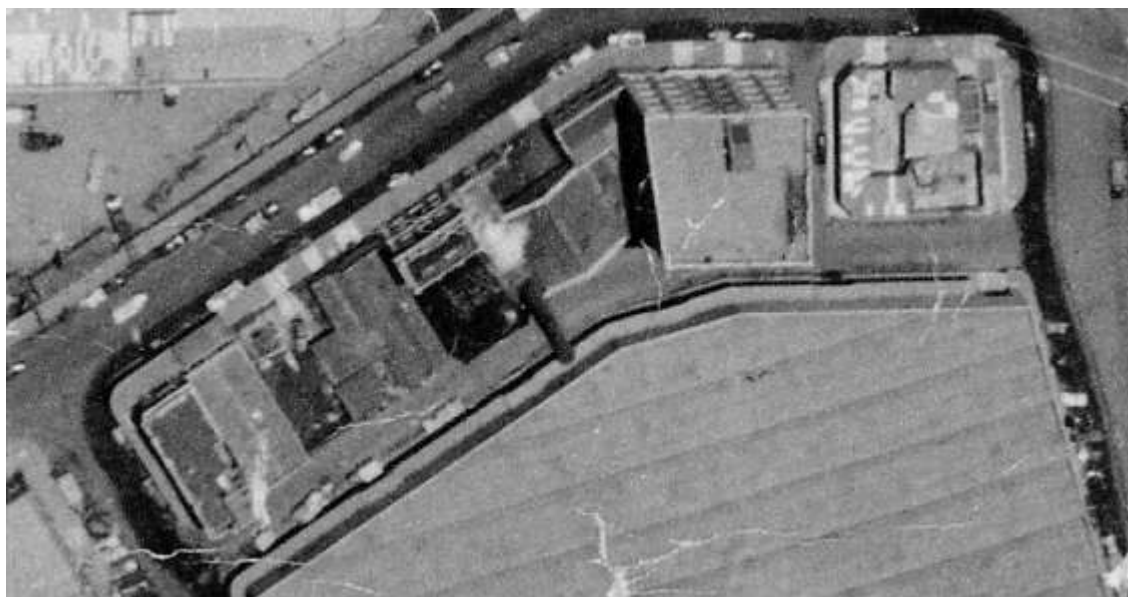
Figure 2.50: Aerial view of Pier Street in 1949 and the Sydney & Suburban Hydraulic Power Co's buildings at this time. Aerial Survey AO037, 15 Dec 1949, Historical Atlas of Sydney, City of Sydney Archives.

An aerial photograph of the site in 1949 illustrates the footprint of the buildings on the site at this time (Figure 2.50).
