Sydney International Convention, Exhibition and Entertainment Precinct (SICEEP) Concept Plan, The Haymarket - SSDA2

Non-Indigenous Archaeological Assessment and Impact Statement

Report to
Lend Lease Development Pty Ltd
March 2013

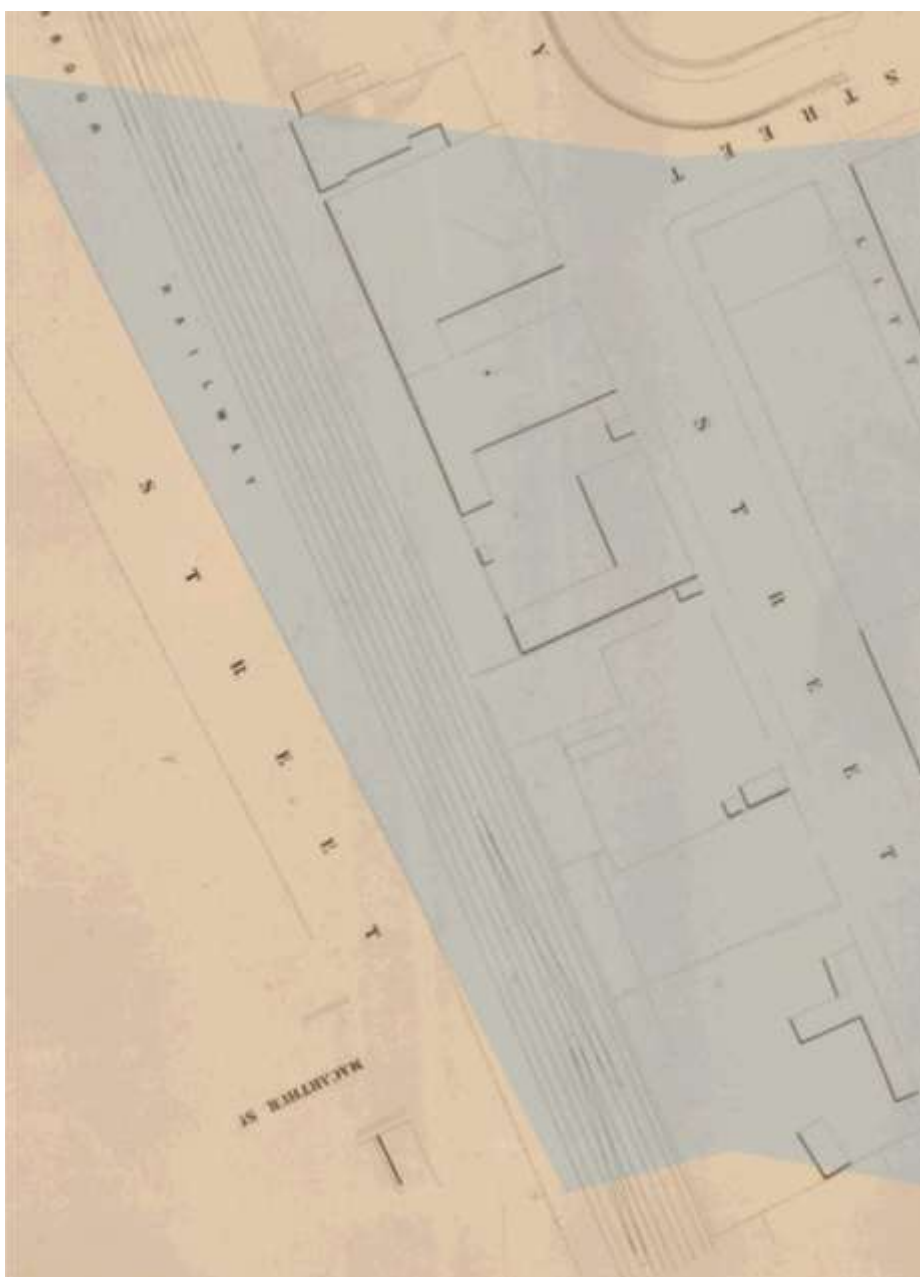
Figure 2.52: Detail from 1890s Metropolitan Detail Series plan showing a range of large buildings immediately to the west of Hay Street and the railway line. ML, SLNSW

Davy died in April 1874 and in September 1882 the land (2 r 13 ¾ p) was conveyed to Thomas Robert Allt 'upon trusts of Abraham Davy'. The land was bounded on the west by the Darling Harbour Branch Line, on the north by William Henry Street and on the east by Hay Street (Figure 2.52). Thomas A Field and the Riverstone Meat Company leased the property at the time of its resumption by the Railway Commissioners in 1907 (Figure 2.53).¹⁰⁹

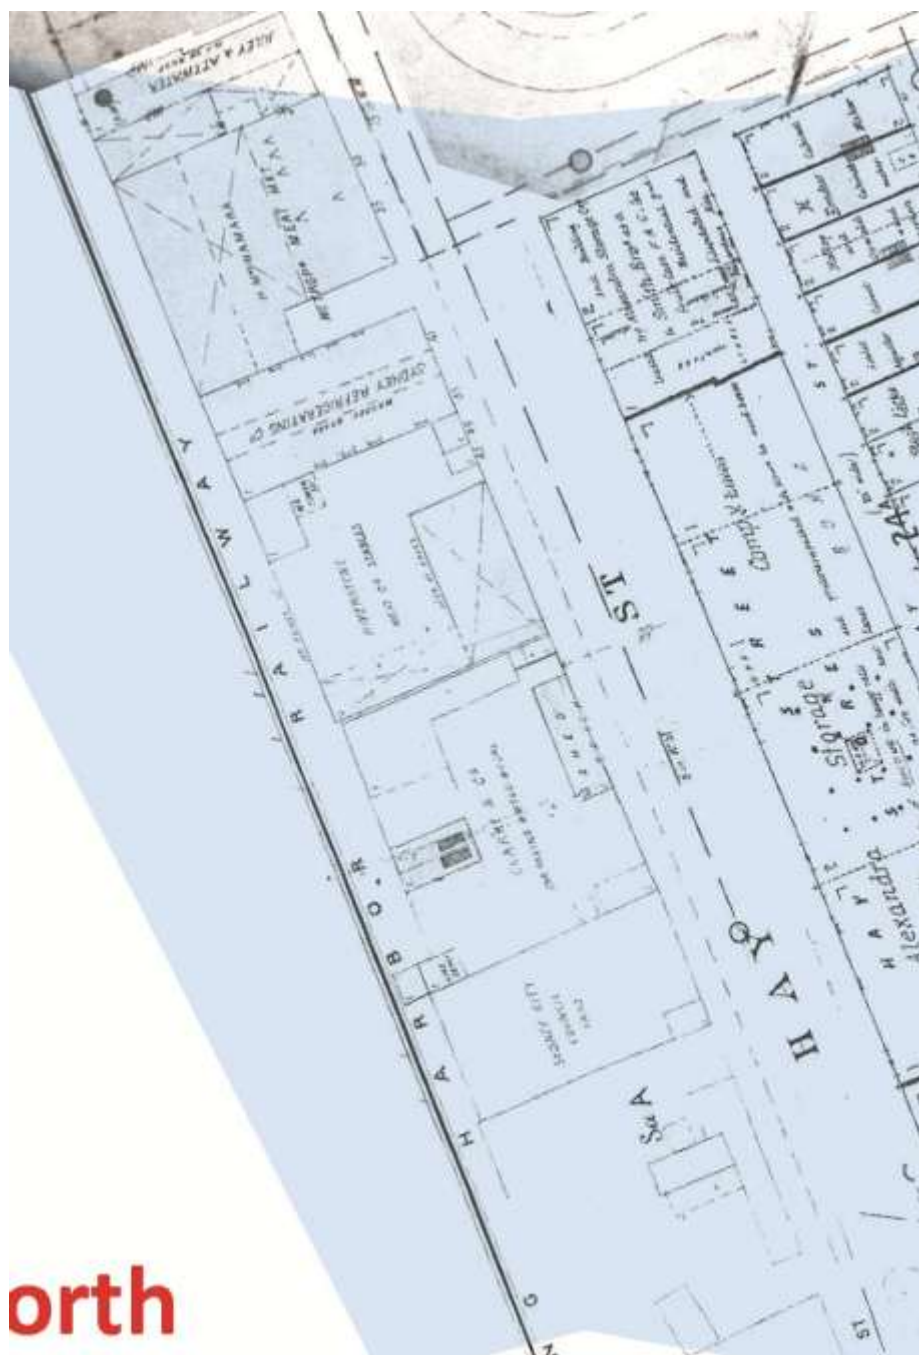
Figure 2.53: Western edge of the Haymarket study area after 1901 with the Darling Harbour Goods Line to the west and Hay Street to the east. *Structural plans of the City of Sydney* (cartographic material), *Ignis et Aqua* series, vol.1 / by F. Oliver Jones, Civil Engineer & Surveyor. ML, SLNSW

The Sydney Council occupied about 25 perches of land to the south of Fairfax's property. Aligned with Macarthur Street, Ultimo, it is thought to have been a road reserve for the possible extension of the street. It was being used as a council road metal yard (Figure 2.53). Both the City Council and Bell & White, on the adjacent site, maintained road metal shoots adjacent to the railway line.¹¹⁰

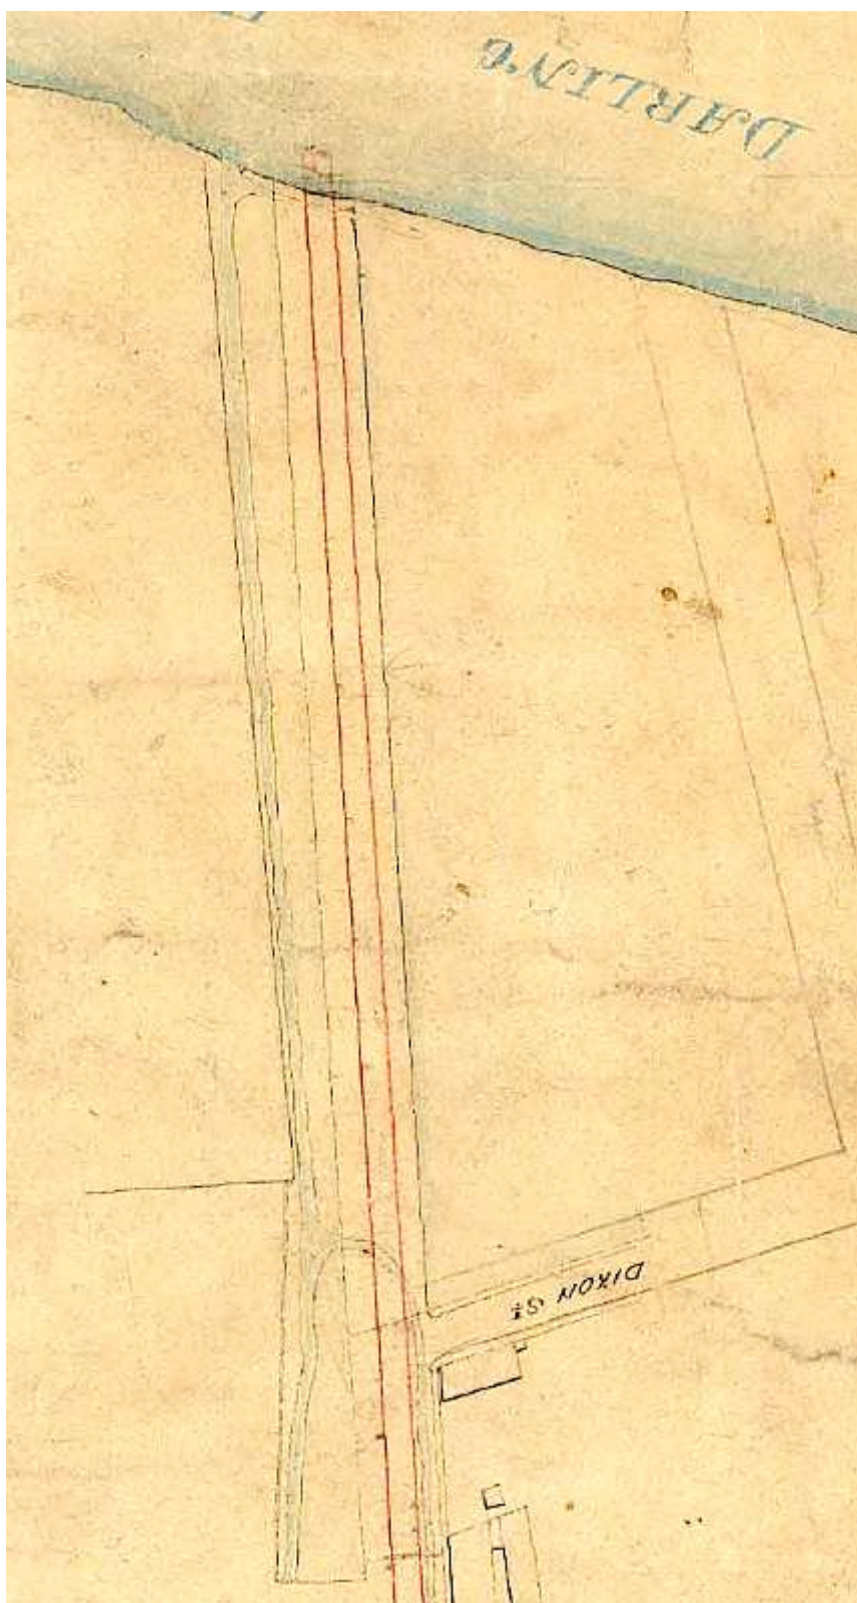
Figure 2.59: Plan of the Hay Street Sewer prepared in 1862 by Edward Bell, the City Council Engineer. The sewer ran south of Dickson's subdivision and parallel to the creek, both discharging into Darling Harbour. OCP 67, Plan No 0088890, Sydney Water.

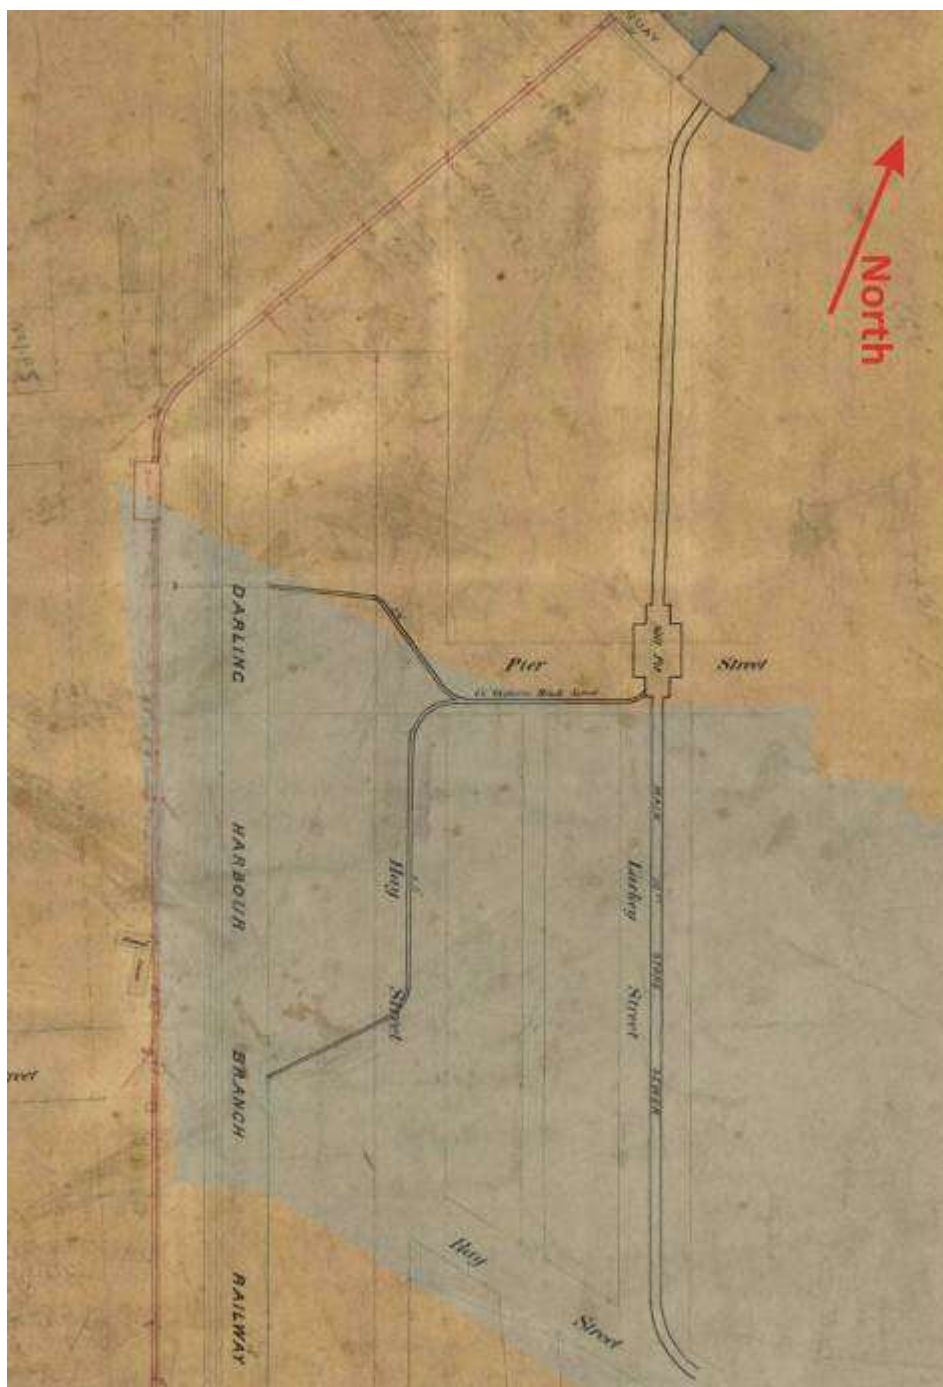
Figure 2.63: Plan of the Lackey Street branch of the Hay Street stone sewer in 1880. The channel outlet is located under a pier of the Iron Wharf. OCP 276, 23 Sep 1880, Sydney Water.

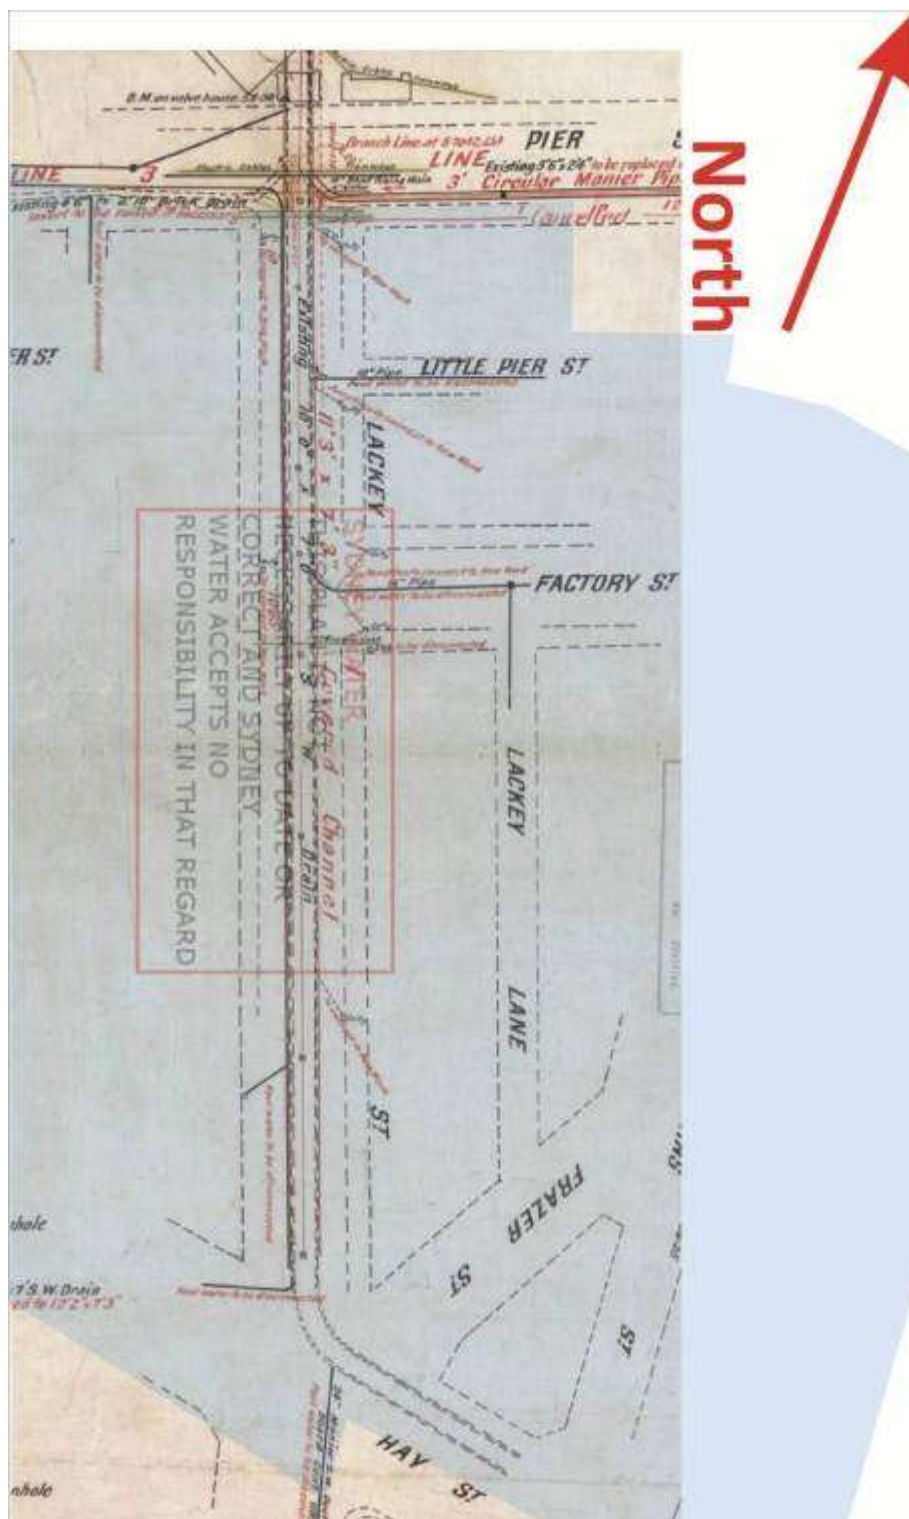
Figure 2.66: A plan of the proposed enlargement of the Lackey Street section of the Hay Street channel. DL 2614 Sheet 1, 13 Jun 1927, Sydney Water.

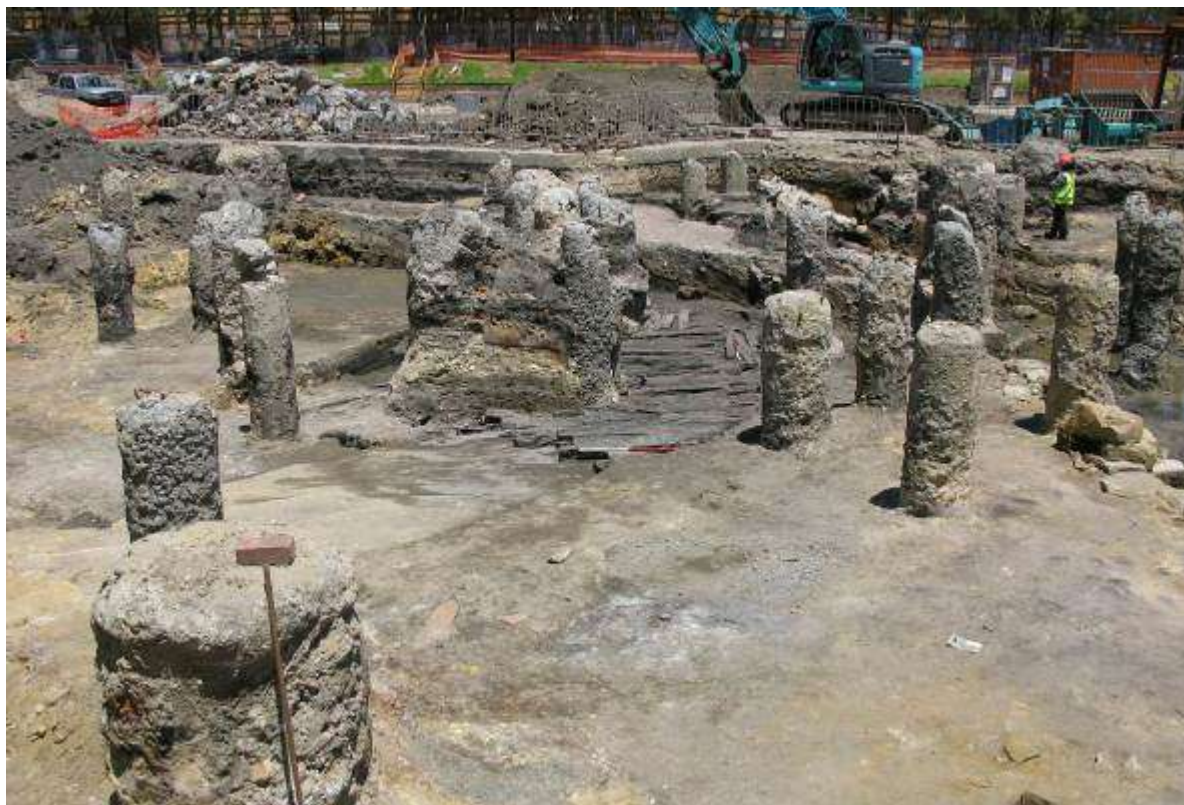
Figure 3.1: Piles in the area of Barker's Jetty (c1826) and the early timber slip (1810s), Darling Walk. This area was a focus of many piles. If there had been many more then the archaeology in this area would have been seriously compromised or destroyed. Looking west. Casey & Lowe 2009.

Our understanding of the Entertainment Centre (EC) and the EC carpark is that they are built on concrete slabs at approximately RL 2.5m with piles into bedrock. Archaeological excavation at Darling Quarter (Walk) identified that two sets of piles can have impacts but still leave a considerable amount of archaeology surviving within an area (Figure 3.1, Figure 3.2). A concentration of piles in any single area can make recovery of archaeological information in the future very difficult. It is considered likely that a third set of piles would mean that the archaeology would be too impacted and that prior open area excavation would be required. Currently there is only one set of piles from a modern building although there will be some pile bases associated with the Market Building.

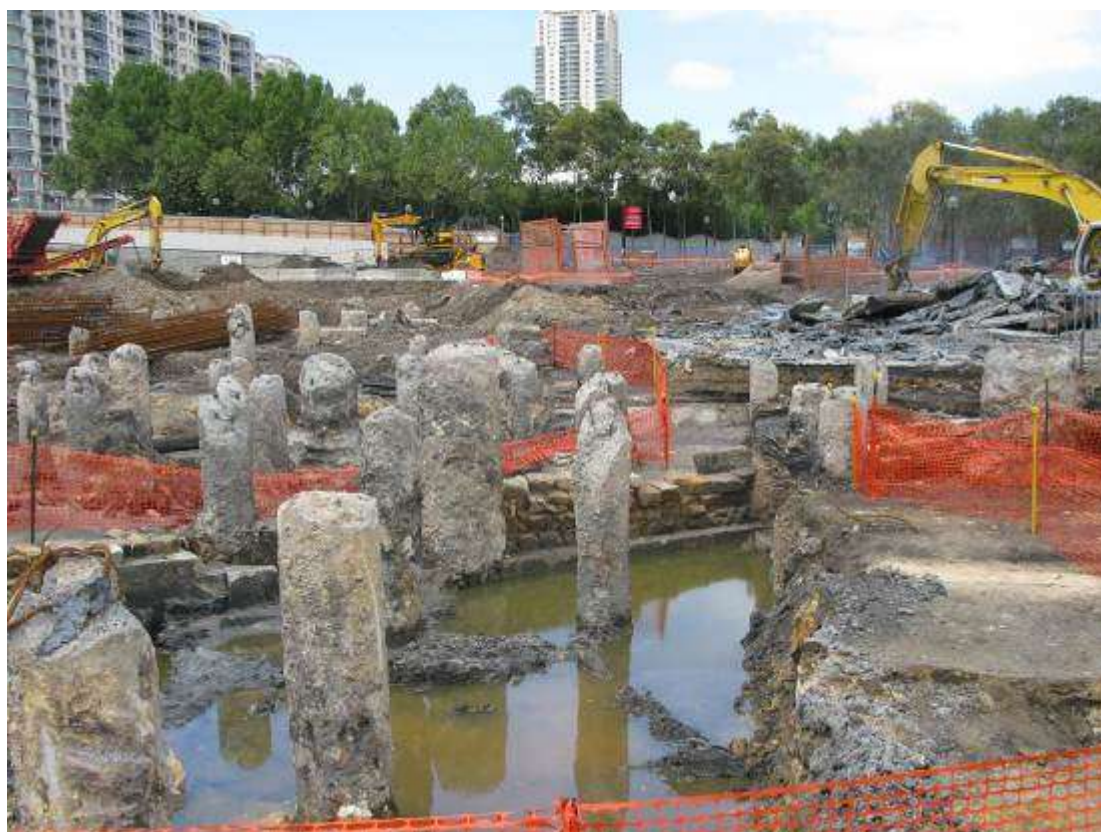
Figure 3.2: View to south with the stone walling of Barker's Jetty (c1826) in the middle ground, Darling Walk. There were many piles in this area from the two sets of building, making access to the archaeology quite difficult. Casey & Lowe 2009

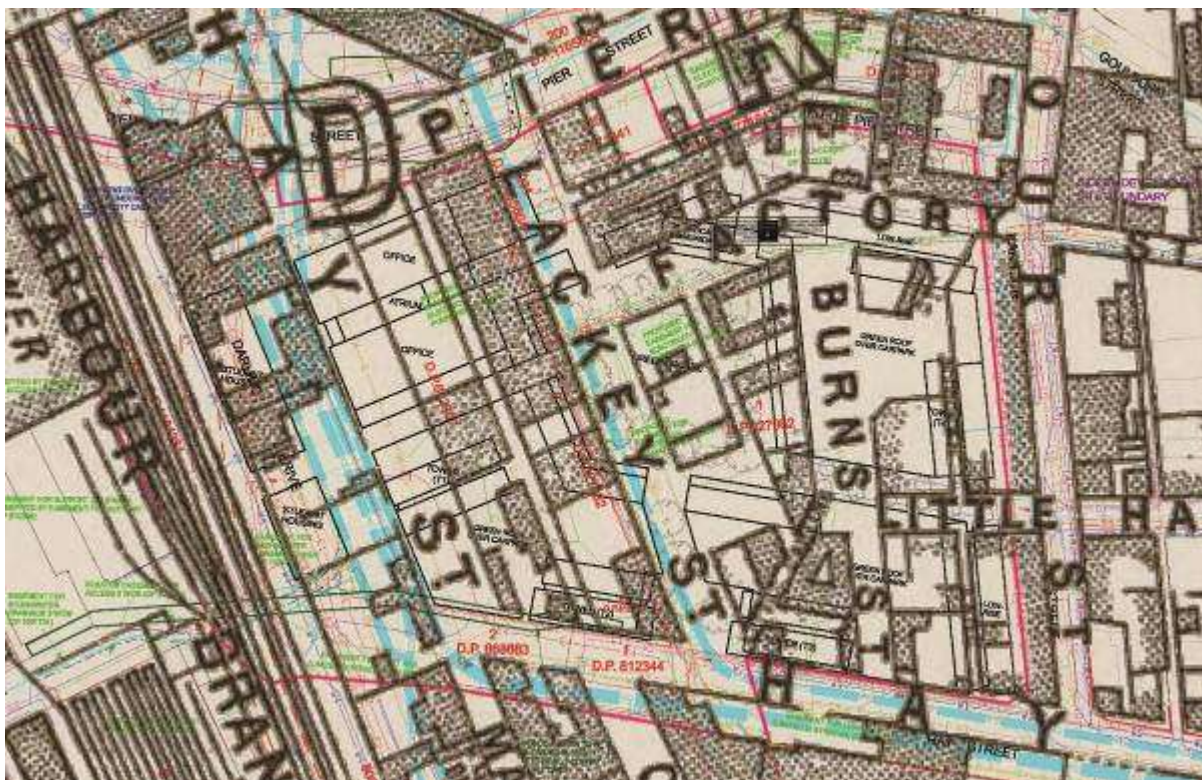
Figure 3.4: The north-south culverts running along the western boundary have had considerable impact on the early 20th-century buildings. Rygate's overlay onto 1903 plan.

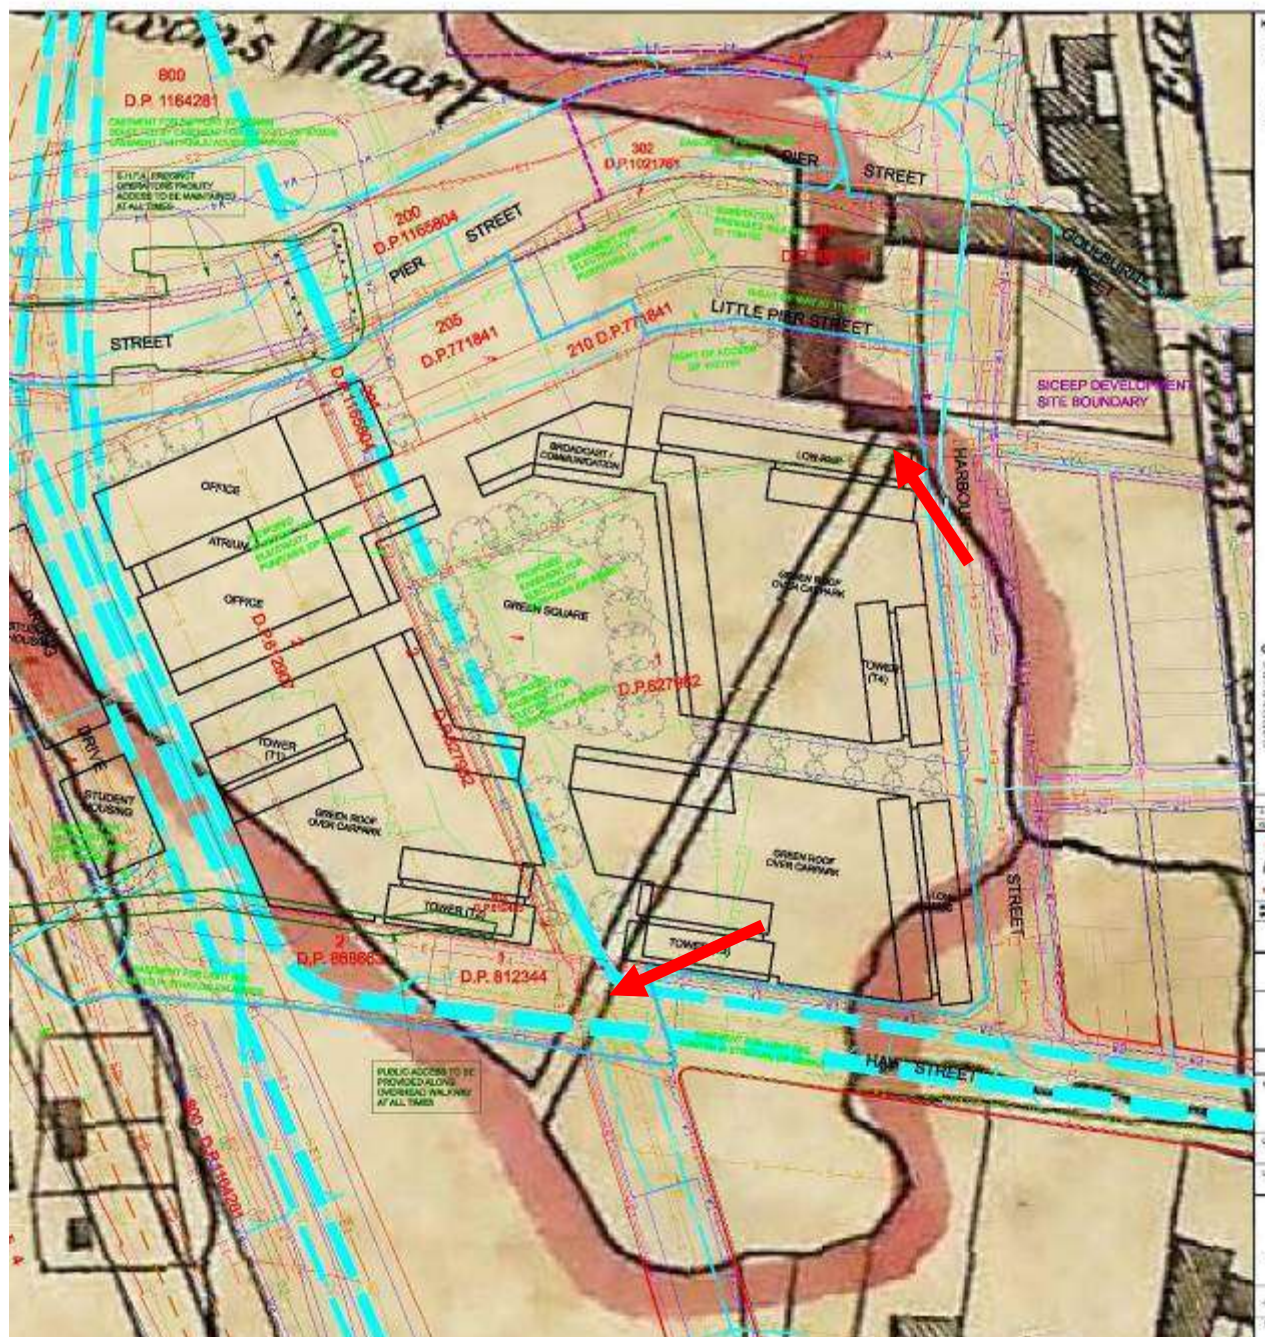
Figure 3.5: Overlay of services onto the 1854 plan showing dam wall (red arrows) to Dickson's millpond. Two large culverts cross through it along Hay Street. It is also likely that the high voltage cable near the northern red arrow has also cut through it. Rygate's overlay onto Woolcott & Clark's 1854 plan.

Modern services in Hay Street will have impacted on the southern section of the dam wall, and therefore only isolated elements may survive within Hay Street (Figure 3.5). Likely impacts in Hay Street include the c1865 Hay Street stormwater and a 1980s stormwater culvert. The extent of known impacts in the northern area, near former Factory Street and south of Little Pier Street, are limited to modern services, such as the high voltage cable which will need to be relocated. Based

on current understanding of impacts it is likely that the dam wall survives substantially intact to the north of Hay Street, except where it was cut by deeper services. The nature of impacts on a substantial structure such as the dam wall may have disturbed the upper 2 to 3m only and deeper intact sections of the wall may survive below these services. Clearly where deep services like the modern concrete culverts have been excavated these impacts may have caused major damage to the dam wall.

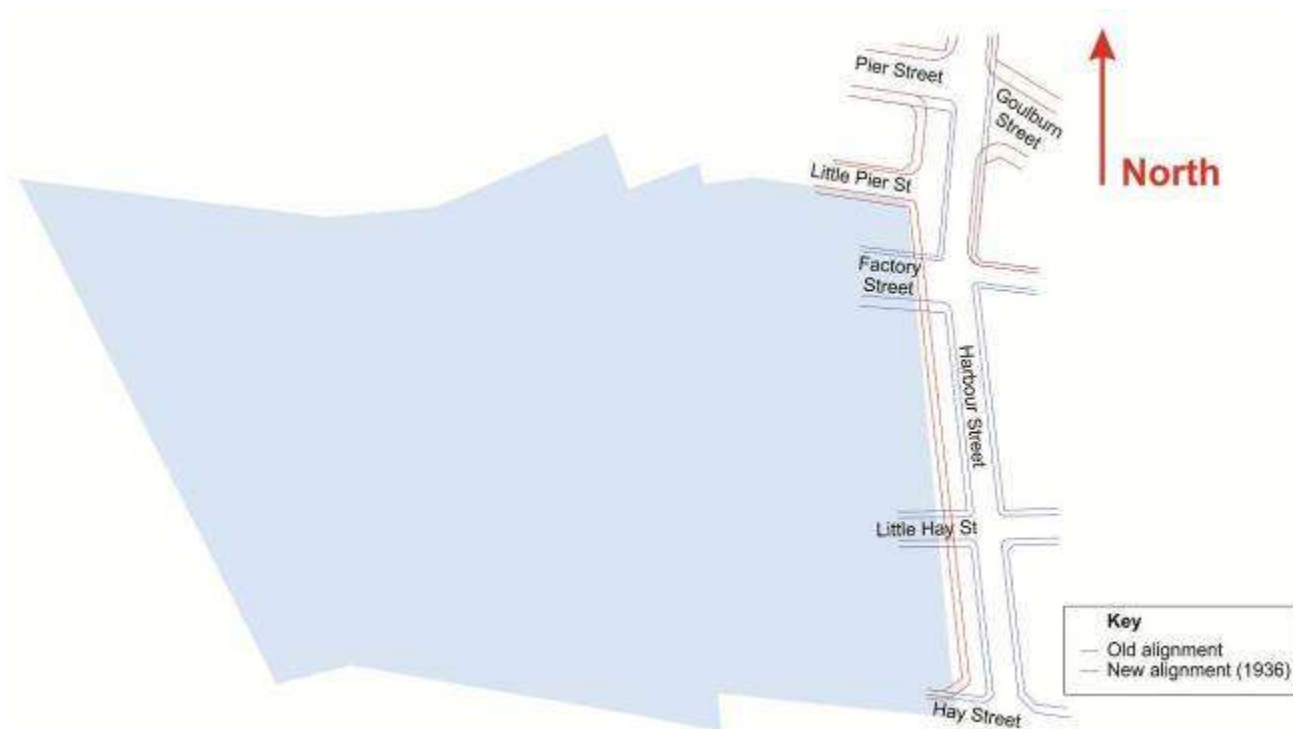
Figure 3.7: Tracing of council plan showing the widening of Harbour Street in 1936. Road reconstruction plan: Widening and reconstruction Harbour Street from Hay Street to Pier Street, 21 Feb 1936, Item E1-452/4, Series 473, City of Sydney Council Archives.

As Figure 3.6 illustrates, the 1880s Harbour Street housing is mostly to the east of the study area. This is because Harbour Street was widened in the 1930s and these houses are beneath Harbour Street and footpath. It is noted that we have not been able to find the detailed plans for the widening but there are clear indications from a range of sources that this happened in association with the establishment of the market building. Therefore, in relation to the 25 houses, the Trades Union hotel, William's grocery shop, Australian Inn, and the Castlemaine hotel, the footings of these structures are outside the current study area. Within the study area are the backyards of these houses, which will include sheds, additions, yard surfaces and cesspits. Cesspits have frequently been found to contain quantities of artefacts but this depends upon the date at which the cesspits were sewered. If they were sewered in the 20th century then they probably have a sterile clean backfill. If they were backfilled prior to 1900 it is quite likely each cesspit may contain 100s of artefacts. Many of the Harbour Street houses were still standing in the 1890s (Figure 3.9).

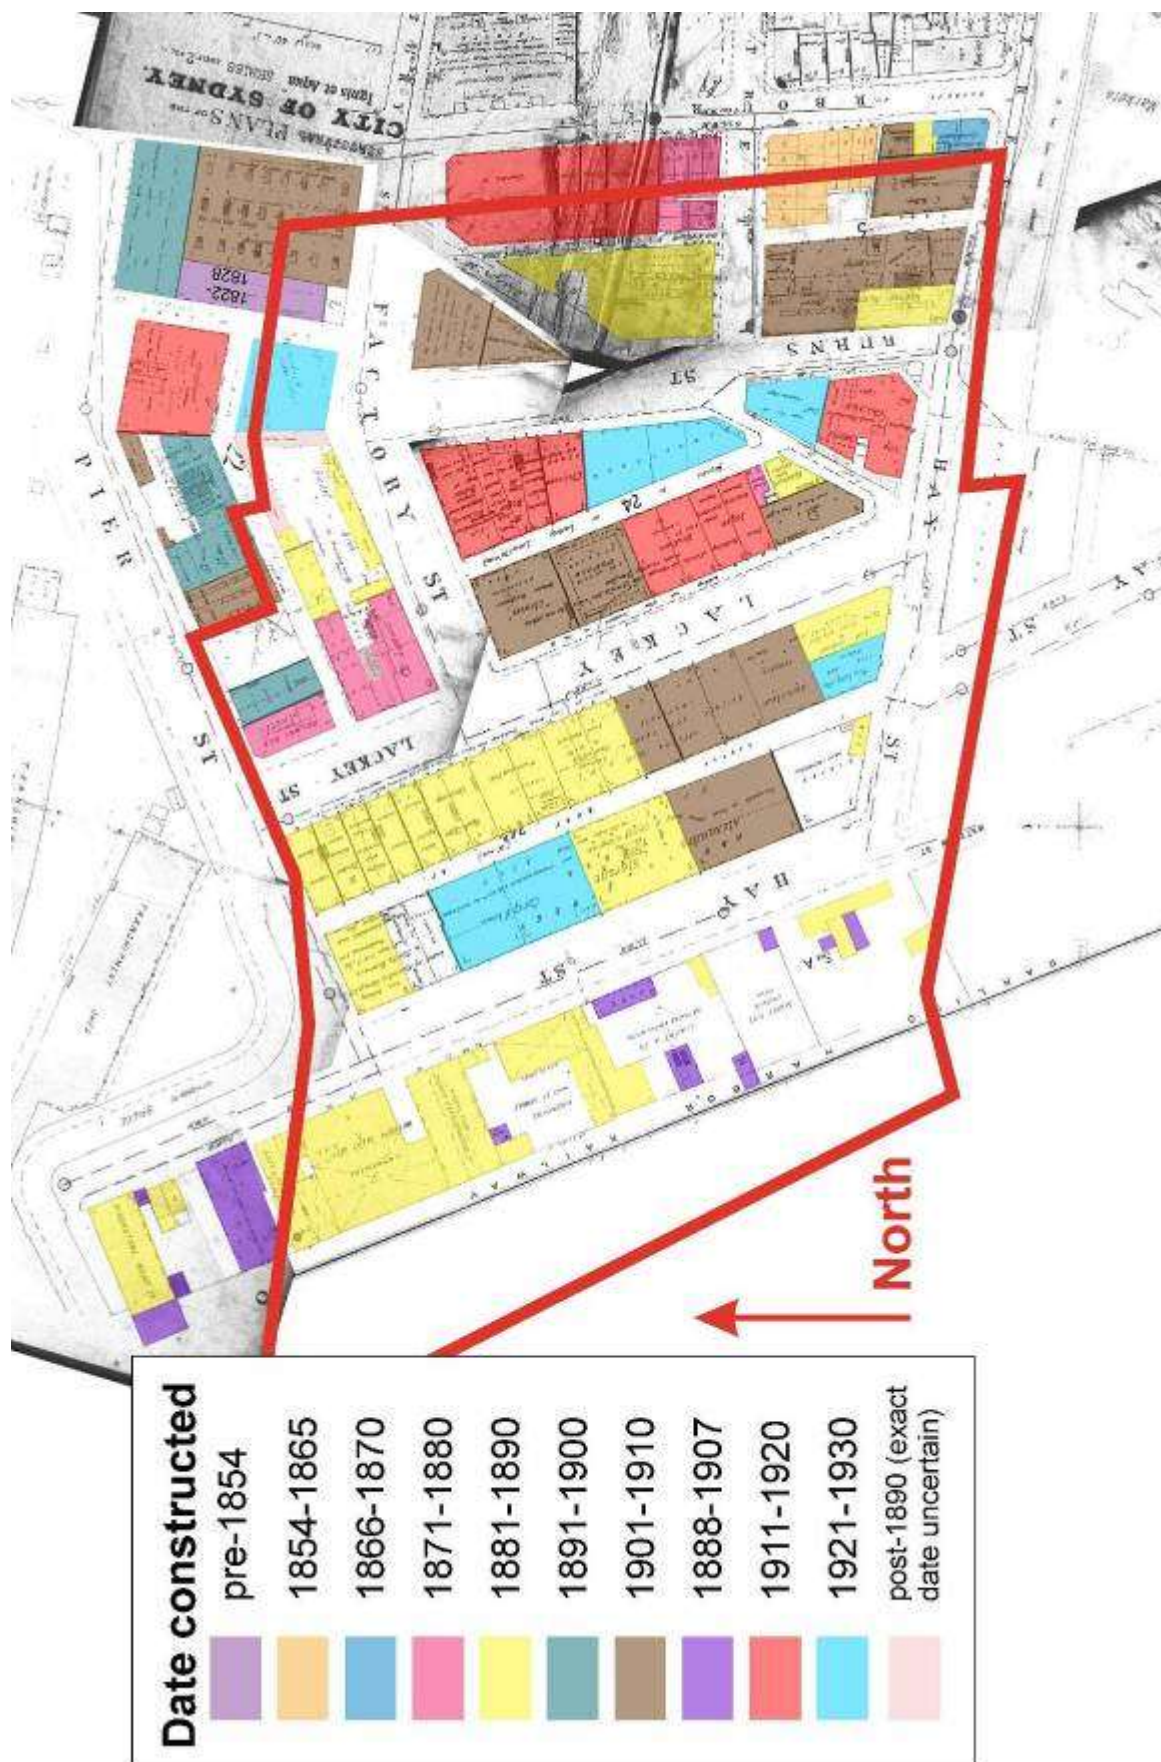
Figure 3.13: Early 20th-century plan, *Ignis & Aqua* plan of the study area providing details of buildings erected during the 1890s. Structural plans of the City of Sydney (cartographic material), *Ignis et Aqua* series, vol.1 / by F. Oliver Jones, Civil Engineer & Surveyor. ML, SLNSW.

- **Cormack cooperage**, established 1872-73, used a number of properties. The main cooperage occupied a couple of lots with a cooperage workshop and yard between the northern end of Hay Street and Little Quay Street (Figure 3.6). By the late 1880s the cooperage, by then the Centennial Cooperage, was occupying four separate properties (Figure 3.8). Another cooperage building on the western side of Burns Street survived into the 20th century (Figure 3.6, Figure 3.13). This was a steam cooperage. It continued to
