Annex S - Stage 1 Sand Deposit Investigation

BOBS FARM SAND DEPOSIT STAGE 1 INVESTIGATION FOR PATRA HOLDING PTY. LTD.

Report Title	Bobs Farm Sand Deposit Stage 1 Investigation	Report Number	2013-05-21-F
Client	Patra Holdings	Prepared by	MP, MvK
Date	2/7/2013	Checked by	MvK

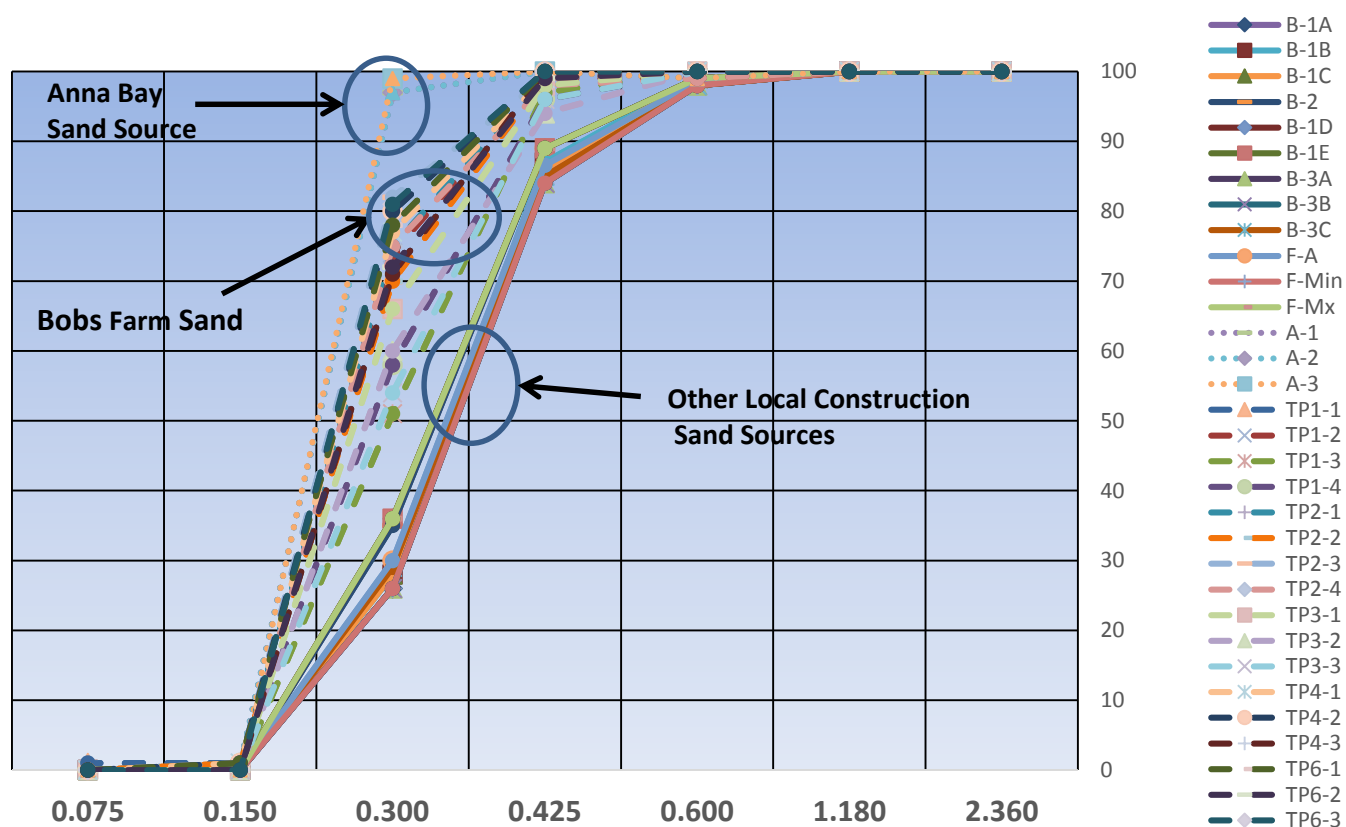
• Figure 12 Bobs Farm Sand vs. existing local sand sources

The sand tested from the Bobs Farm site when compared to the local construction sands appear very fine in comparison and suggest limited construction sand applications. However it should be noted that sand samples TP1-3, TP1-4 and TP3-3 contain coarser sand which may be suitable for use in concrete etc. with further testing and their presence suggests that coarser lenses of sand may also continue with depth toward the water table. This could not be confirmed due to pit wall collapse during digging of the test pits but may mean that potentially across the site the dunal deposited sand is in general coarser and deeper while the wind- blown sand is finer and closer to the existing ground surface.

Bobs Farm Sand compared to other Local Sand Sources

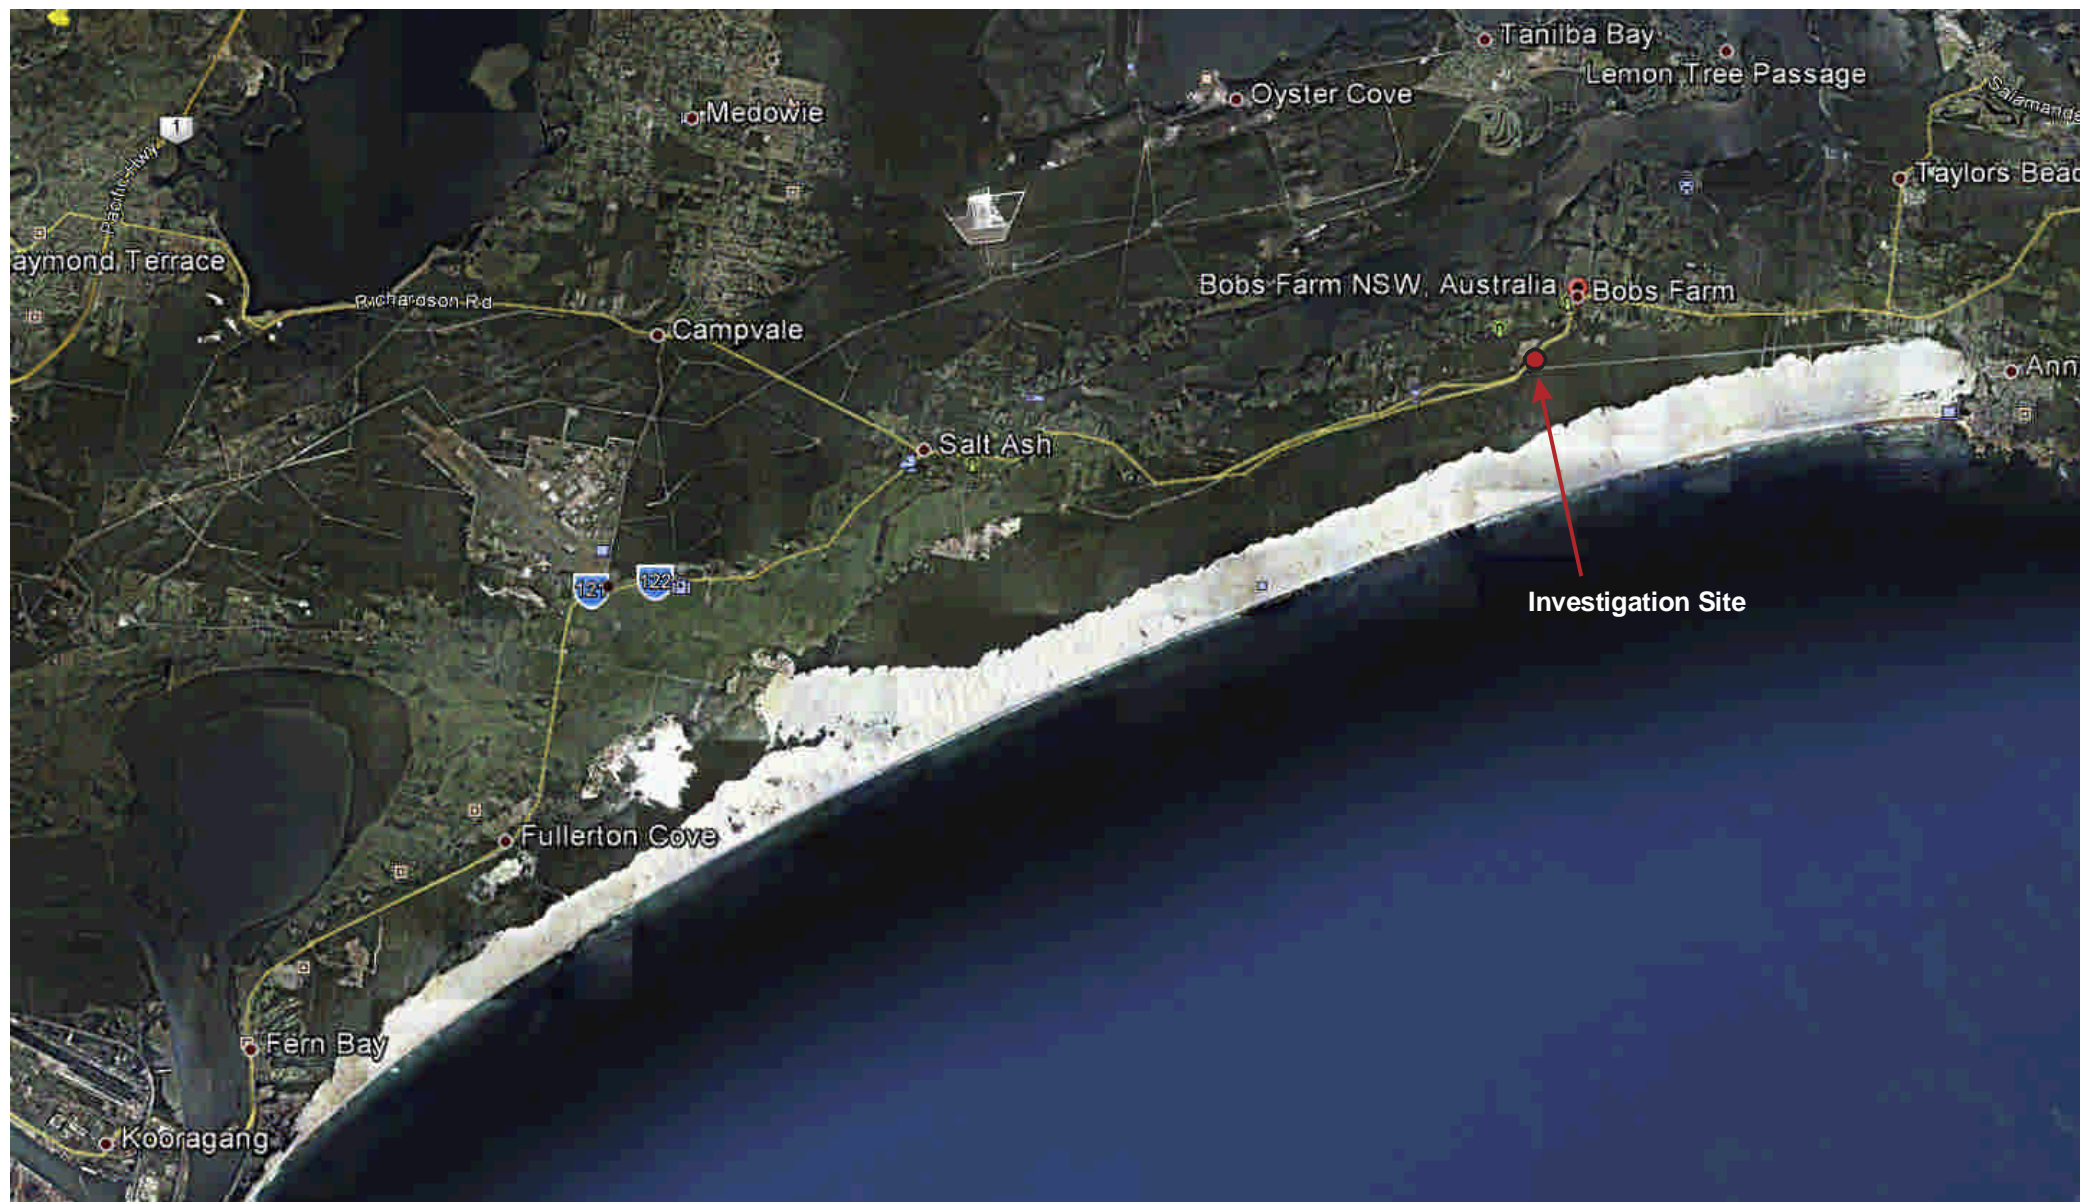
- Qhb, Sand, present beach and active dunes
- Qhd, Sand, older beach and low level windblown dunes
- Qhs, Sand, stable dunes
- Qe, Silt, clay and estuarine sediments

Background of the Resource: VGT reviewed the location of the site, see *Figure One*, and utilising the Newcastle and Port Stephens 1:100,000 geological sheets determined that the site is underlain by sand dunes ranging between 7,000 and 9,000 years old as found in the Holocene Epoch. *Figure Two* shows the geological units which have been interpolated to the other sand deposits in the local area, which show that the units are similar to four other key local sand producers, being 3, 4, 5 and 6 on *Figure Two*.

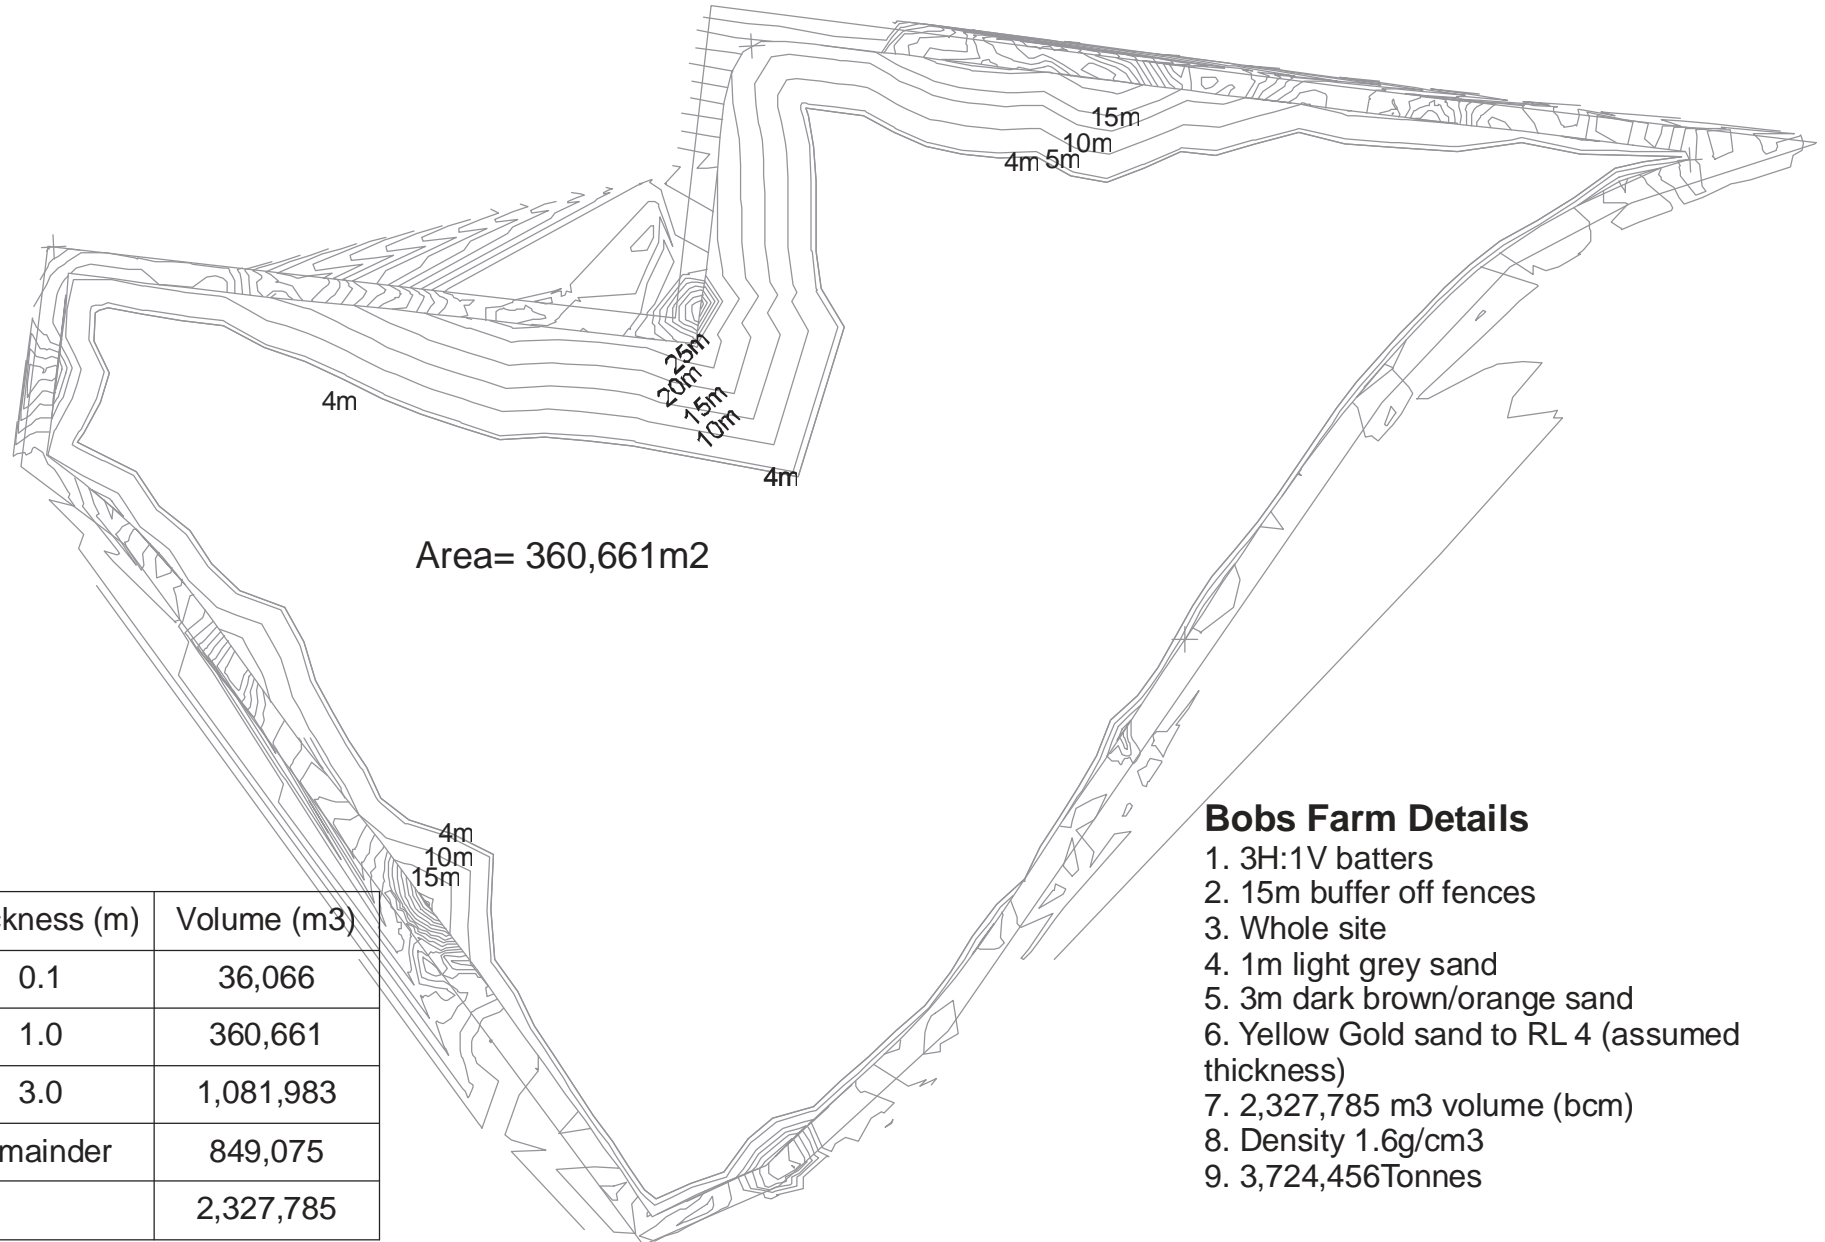
Sand	Thickness (m)	Volume (m ³)
Topsoi	0.1	36,066
Light Grey	1.0	360,661
Dark Brown	3.0	1,081,983
Yellow Gold	remainder	849,075
Total		2,327,785

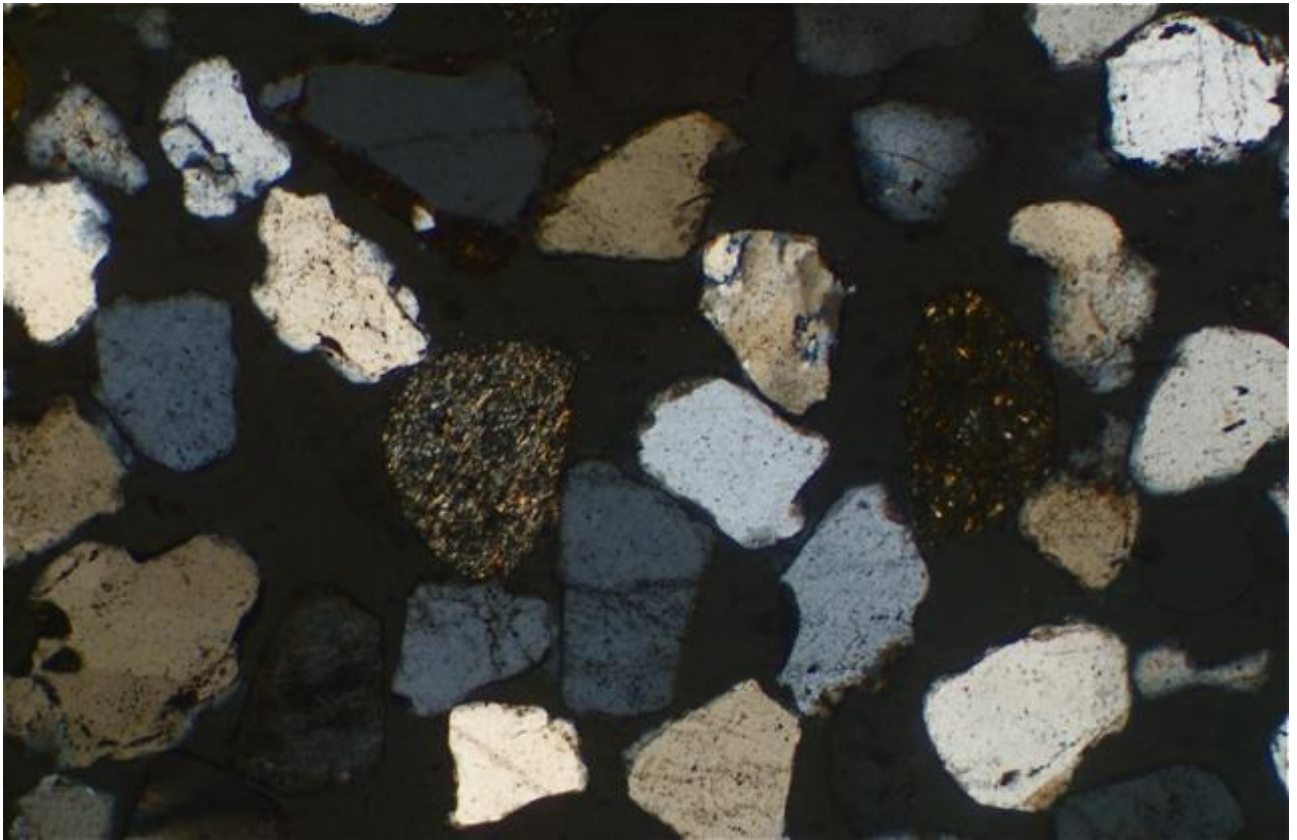
BL/HM-P a – typical view of sand in polarized light showing the grain shape variation and compositional variation. Note the good sorting here. To the left of centre is a sericitized felsic volcanic rock fragment and right of centre is a strongly modified (weathered) silicified volcanic ash rock. Dark grey crystal at lower left is alkali feldspar. Note also three grains with quartz overgrowths. Scale: side of photograph is 1.6mm

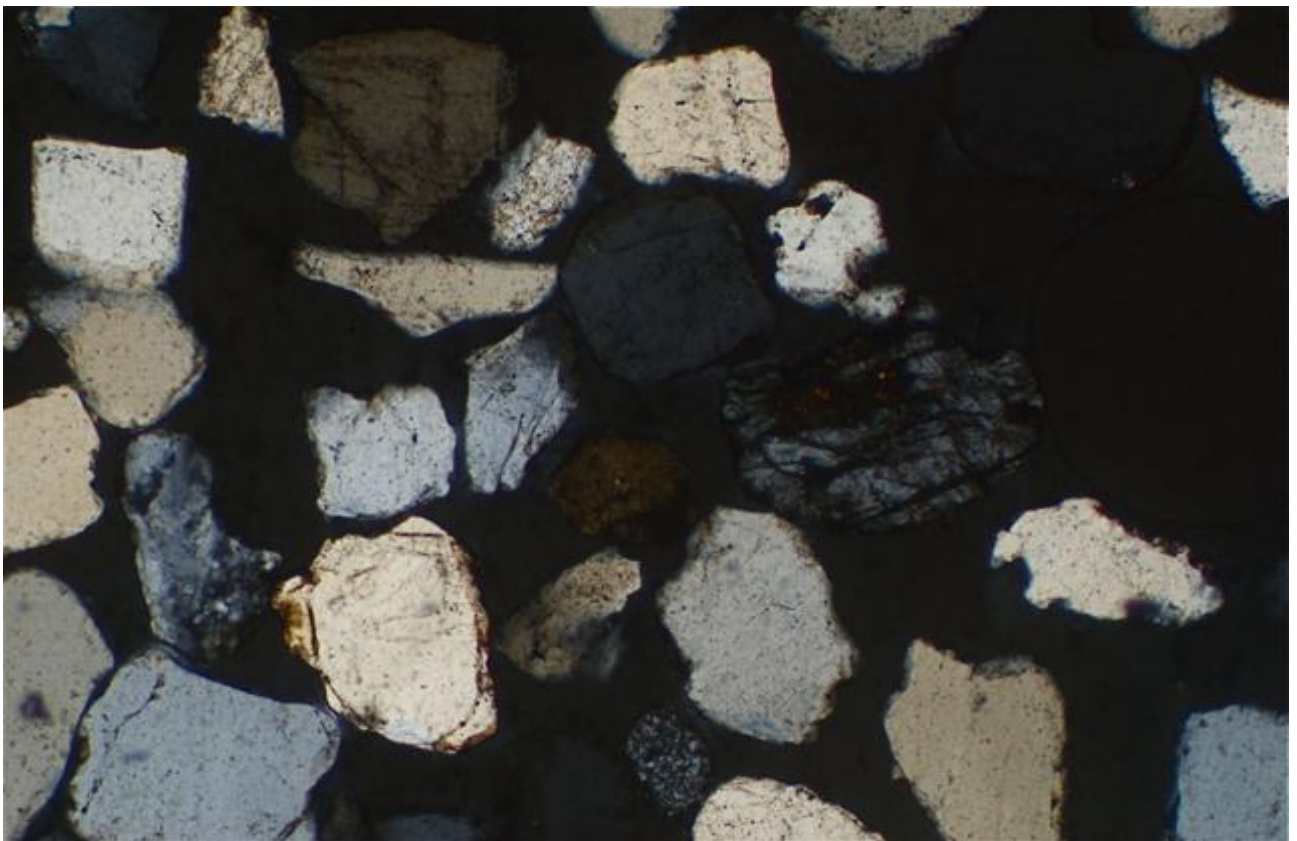
BL/HM-P b – another view with several feldspar crystals and two rock fragments. Again note the prominent quartz overgrowths indicating a sedimentary (recycled) provenance. Scale: side of photograph is 1.6mm

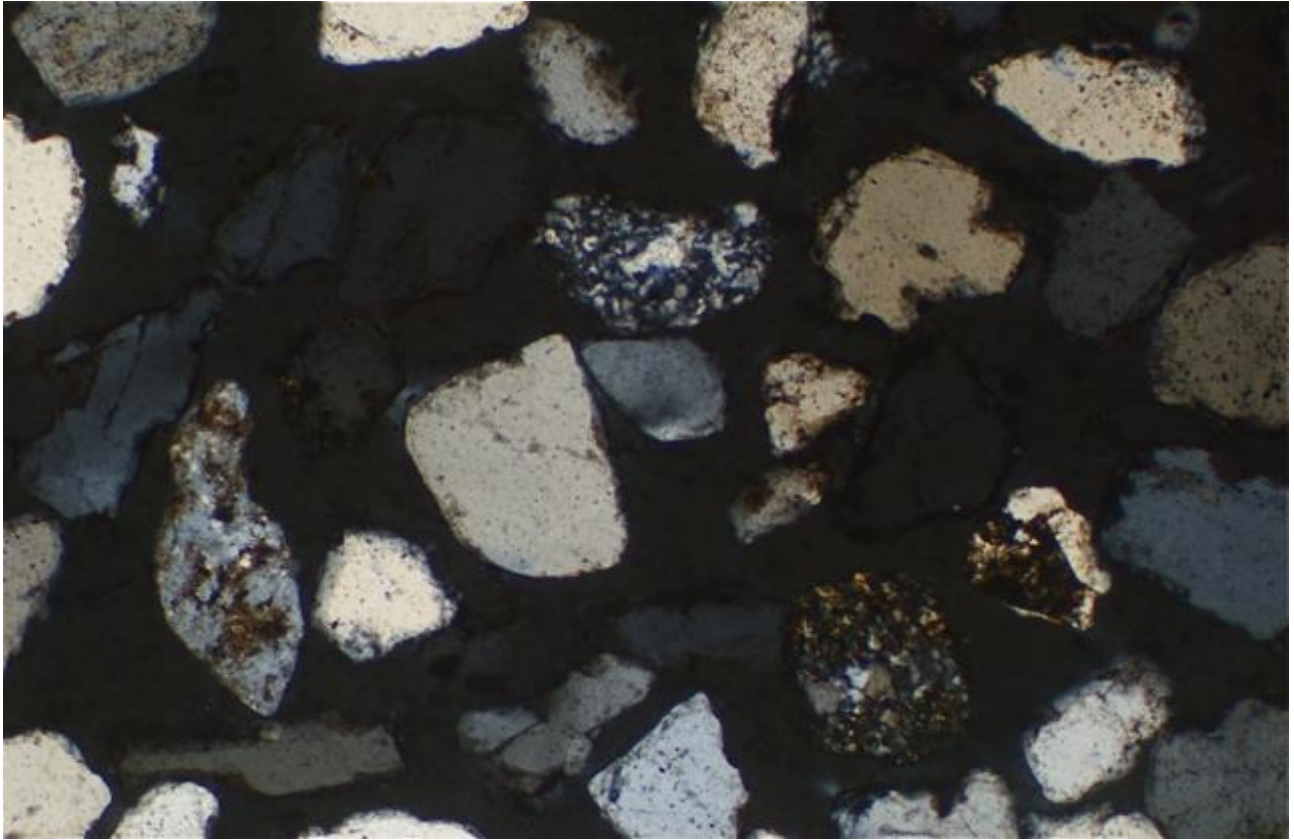
BL/HM-P c – selected view showing a number of very fine-grained speckled felsic volcanic rock fragments. Brownish weathered grain at centre left is a mildly perthitic alkali feldspar. Light grey quartz crystal just left of centre is derived from felsic volcanic rocks. Note the typical angularity of the majority of grains. Scale: side of photograph is 1.6mm

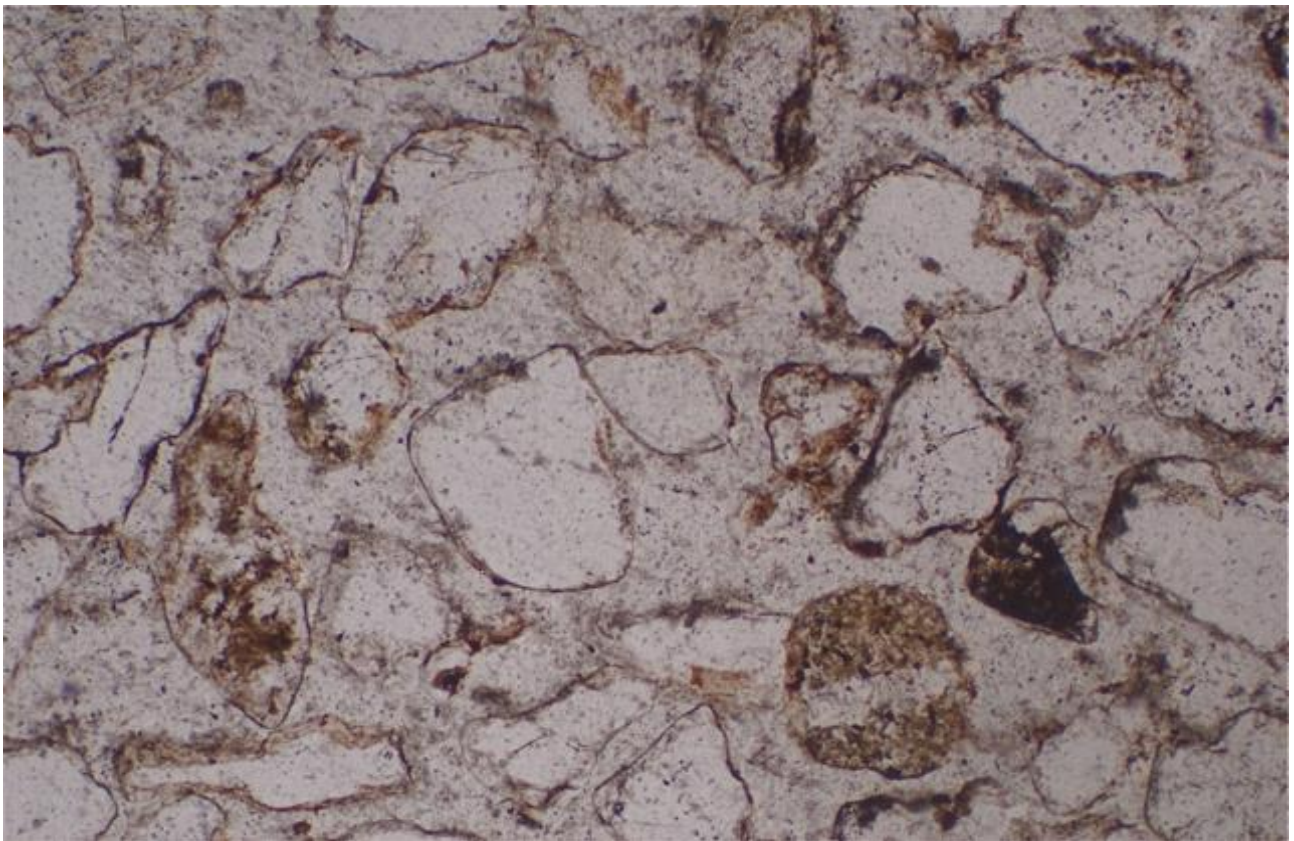
BL/HM-P d – same view as previous photograph in ordinary transmitted light highlighting the messy appearance due to the abundance of hydrated iron oxide around the grains and in the lithic fragments. Scale: side of photograph is 1.6mm

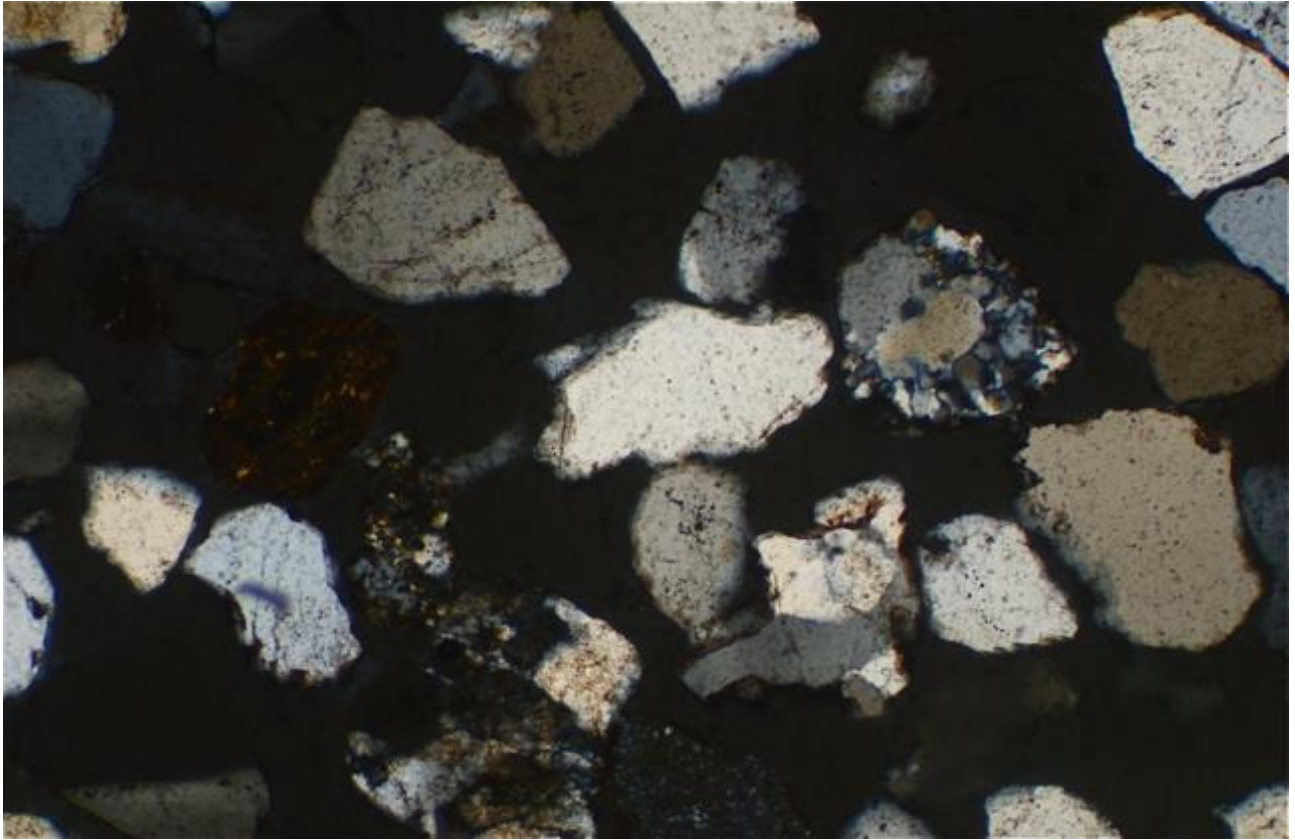
BL/HM-P e – another view in polarized light showing composite lithic fragments (right of centre and below centre) and a highly weathered (ferruginized) fragment (left of centre). Scale: side of photograph is 1.6mm

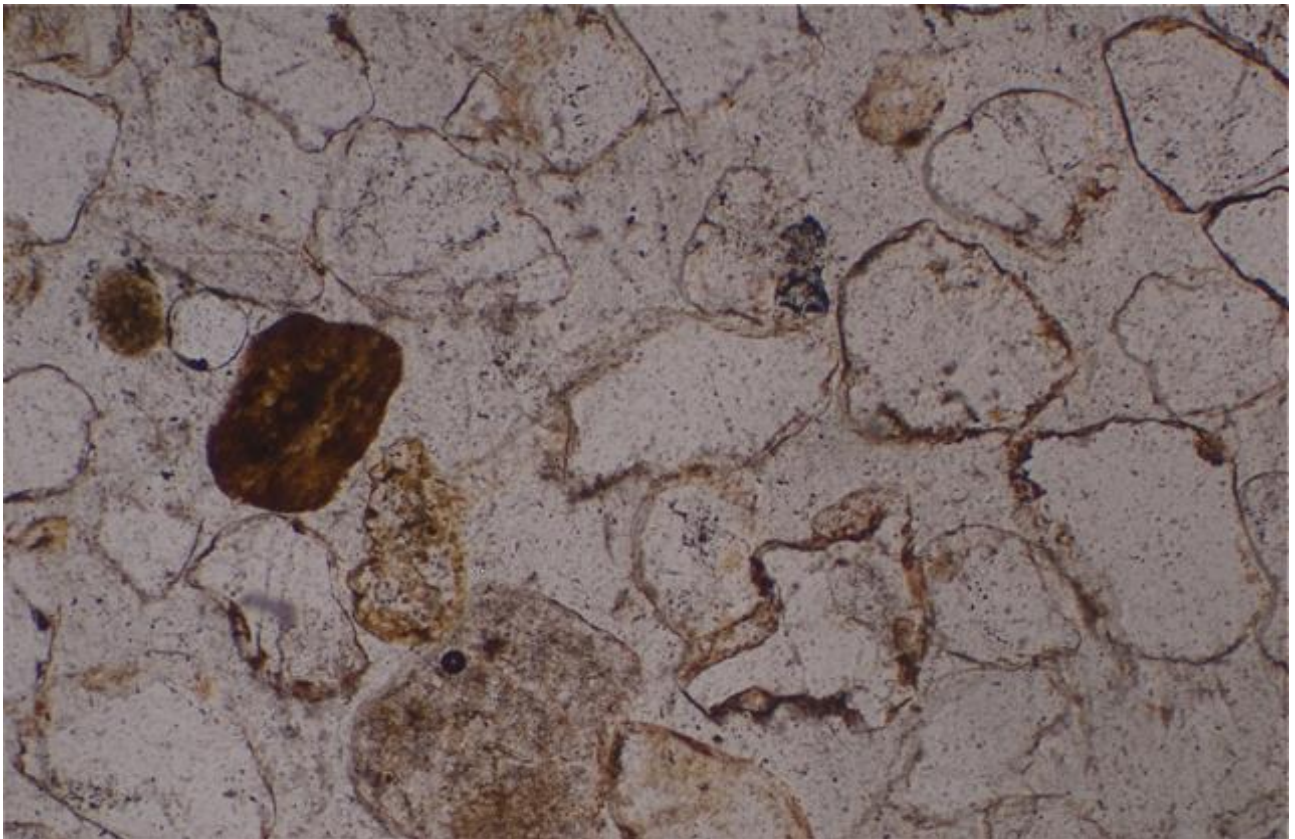
BL/HM-P f – same view as previous photograph in ordinary transmitted light again highlighting the adhesion to the grains of hydrated iron oxide. Scale: side of photograph is 1.6mm

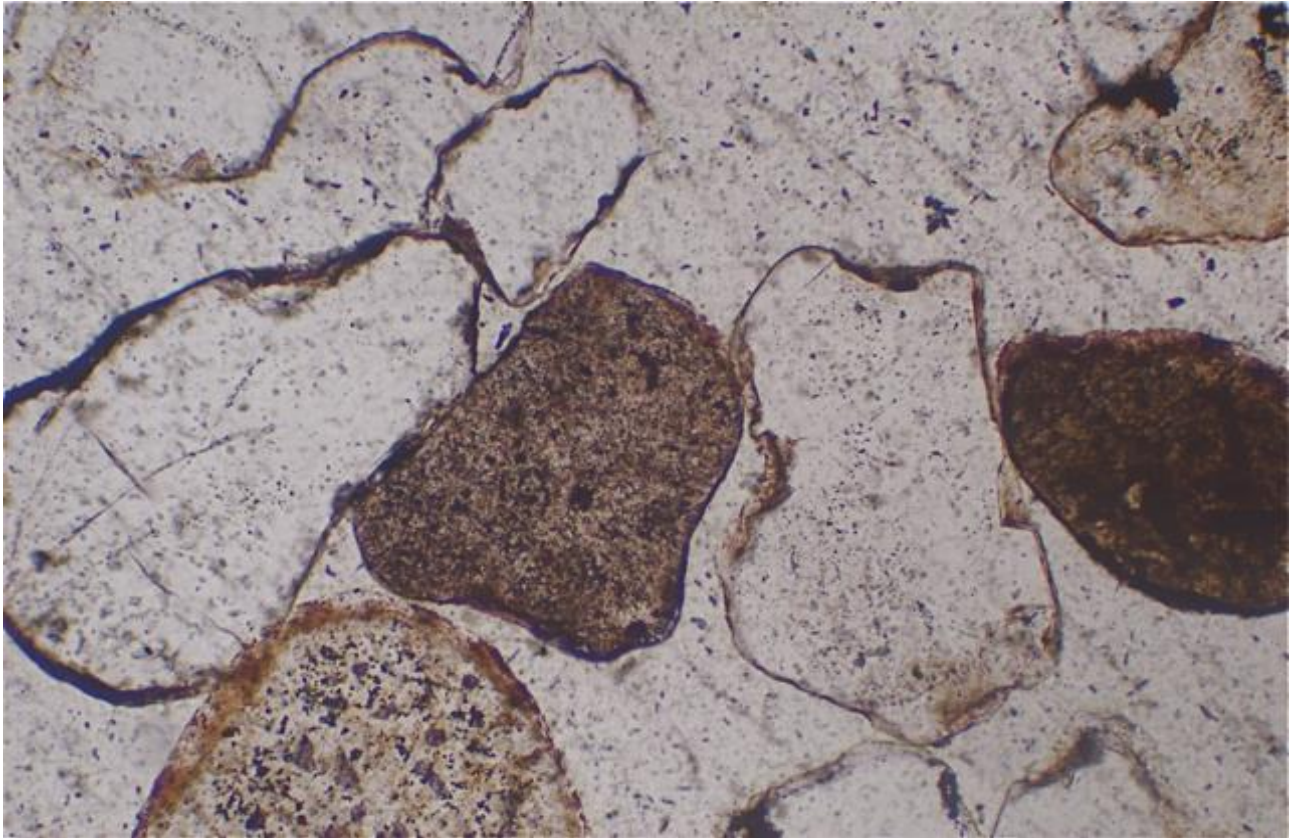
BL/HM-P g – slightly magnified view in ordinary transmitted light to show the textural variation of the brown lithic fragments but also the hydrated iron oxide margins. Scale: side of photograph is 0.8mm

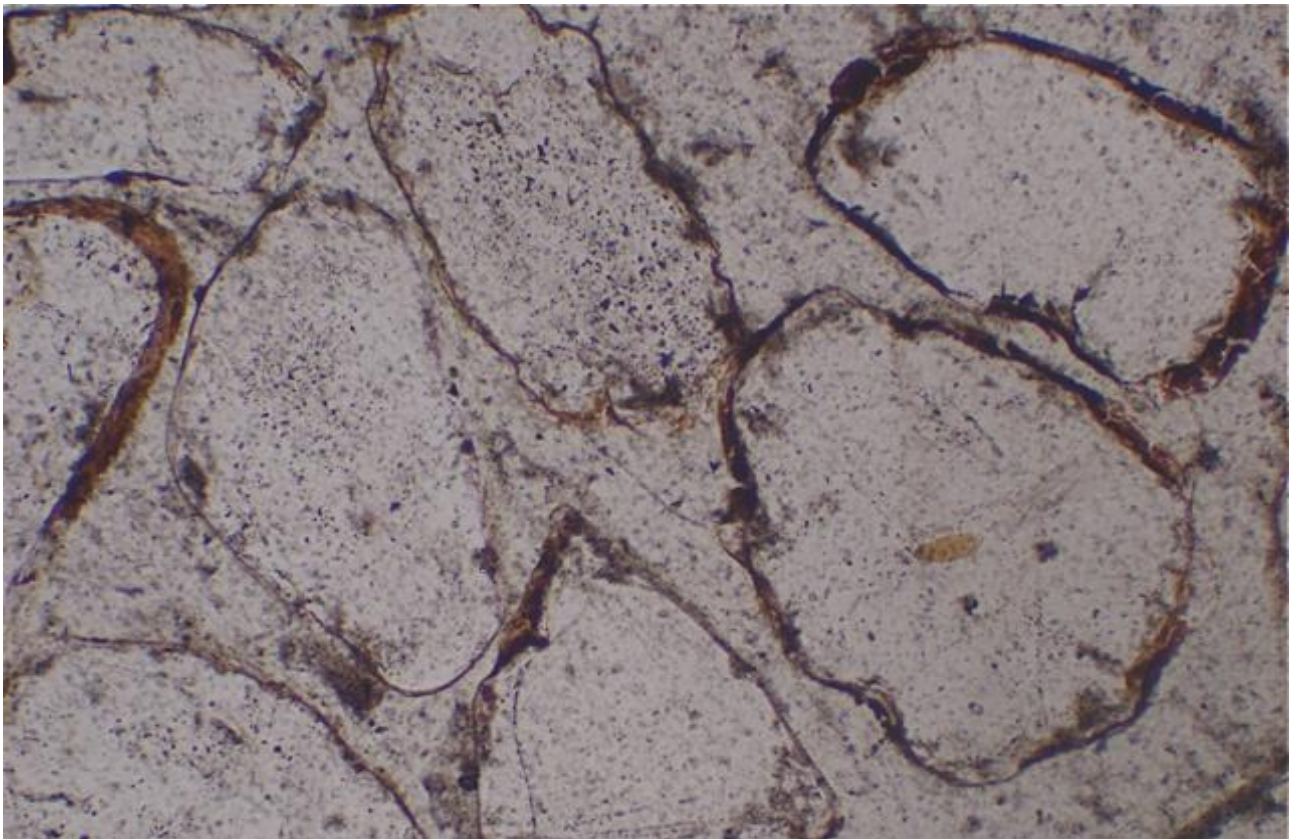
BL/HM-P h – slightly magnified view in ordinary transmitted light to show the variations in the coating thickness. The thick coatings on some grains, such as at top right, display cracks which could signify the presence of small amounts of admixed clay in the hydrated iron oxide coating. Scale: side of photograph is 0.8mm

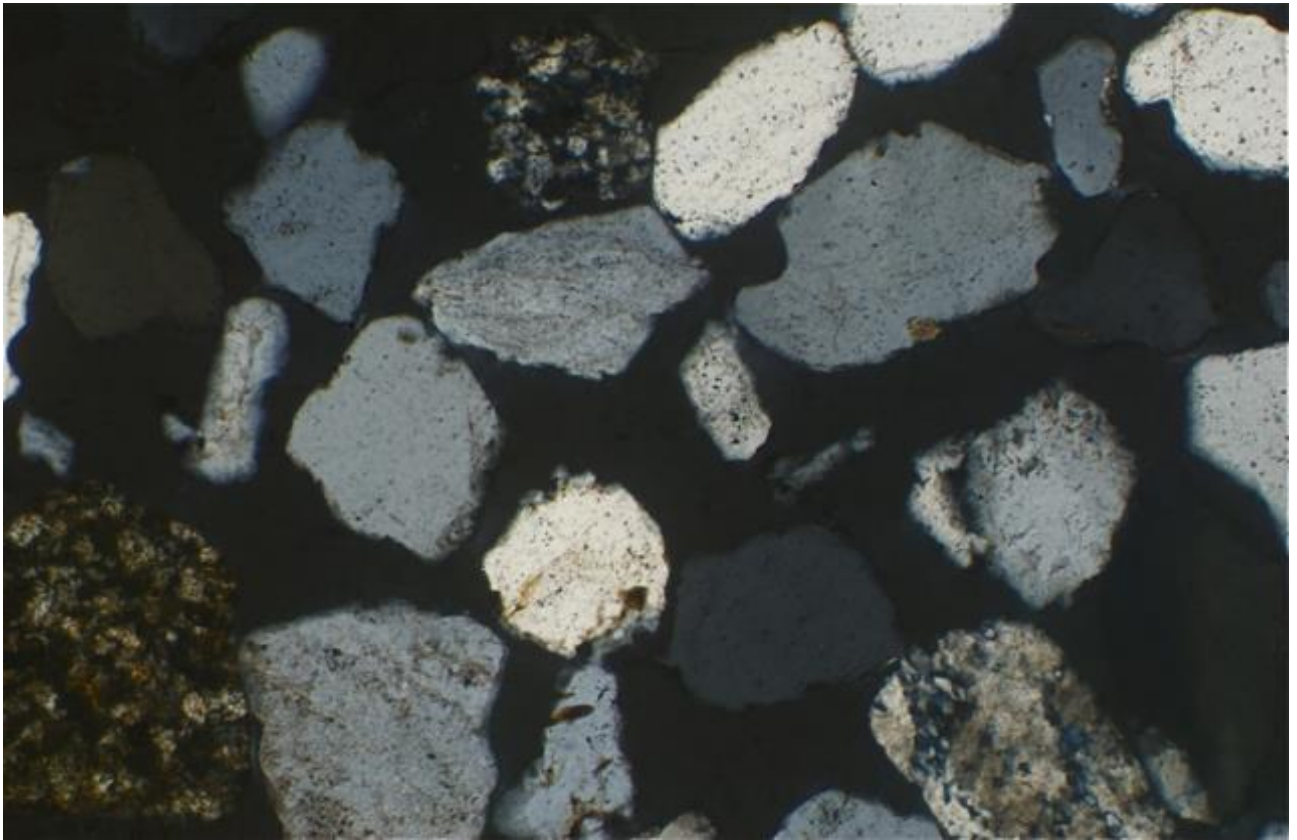
BL/C a – typical view showing some of the features of this sand including good sorting, a range of different crystal shapes, and compositional variation. The two speckled grains are from felsic volcanic rocks and the one at bottom right is a strongly deformed quartzitic rock. Scale: side of photograph is 1.6mm

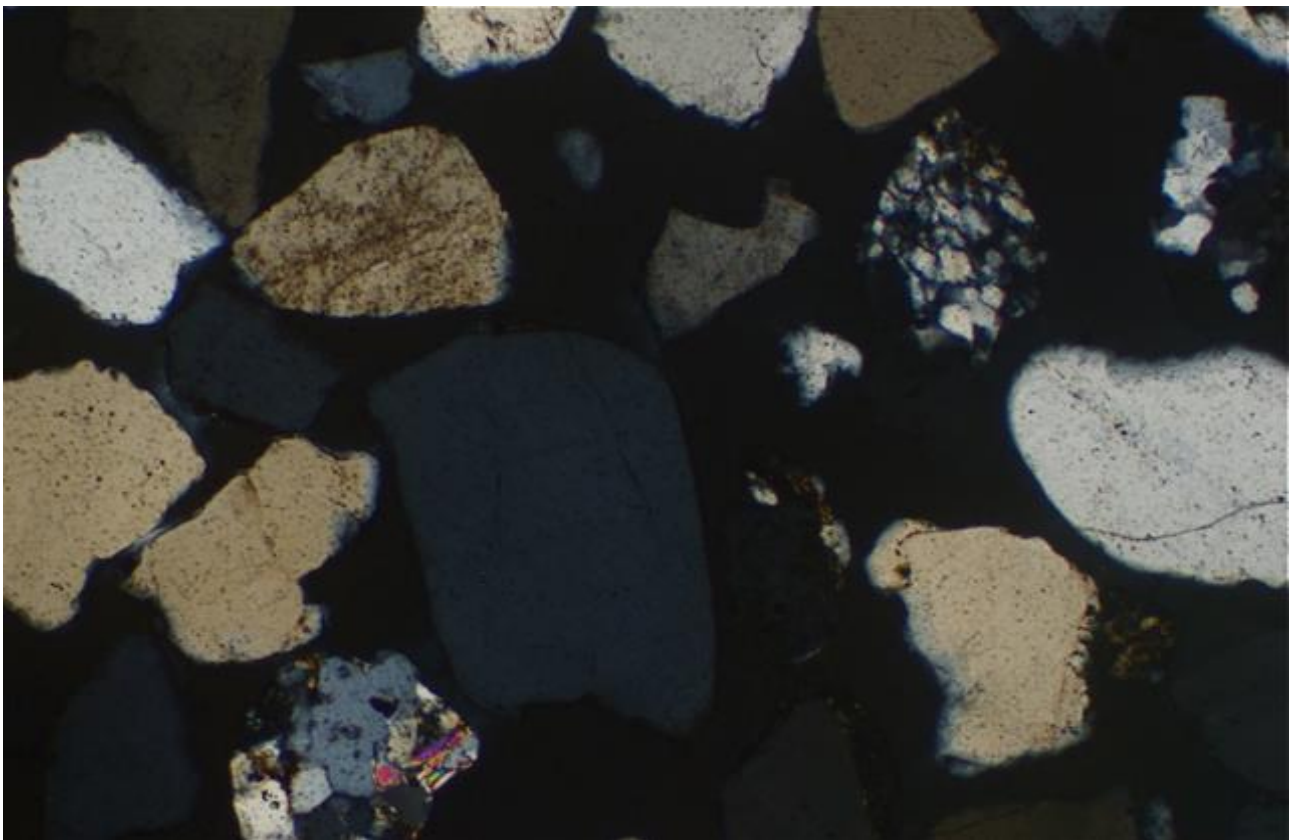
BL/C b – another general view showing two lithic fragments and a range of grain sizes. Note also the small quartz overgrowths left and right below centre. The coloured flakes in the micro-granitic lithic fragment at bottom left are muscovite (white mica). Scale: side of photograph is 1.6mm

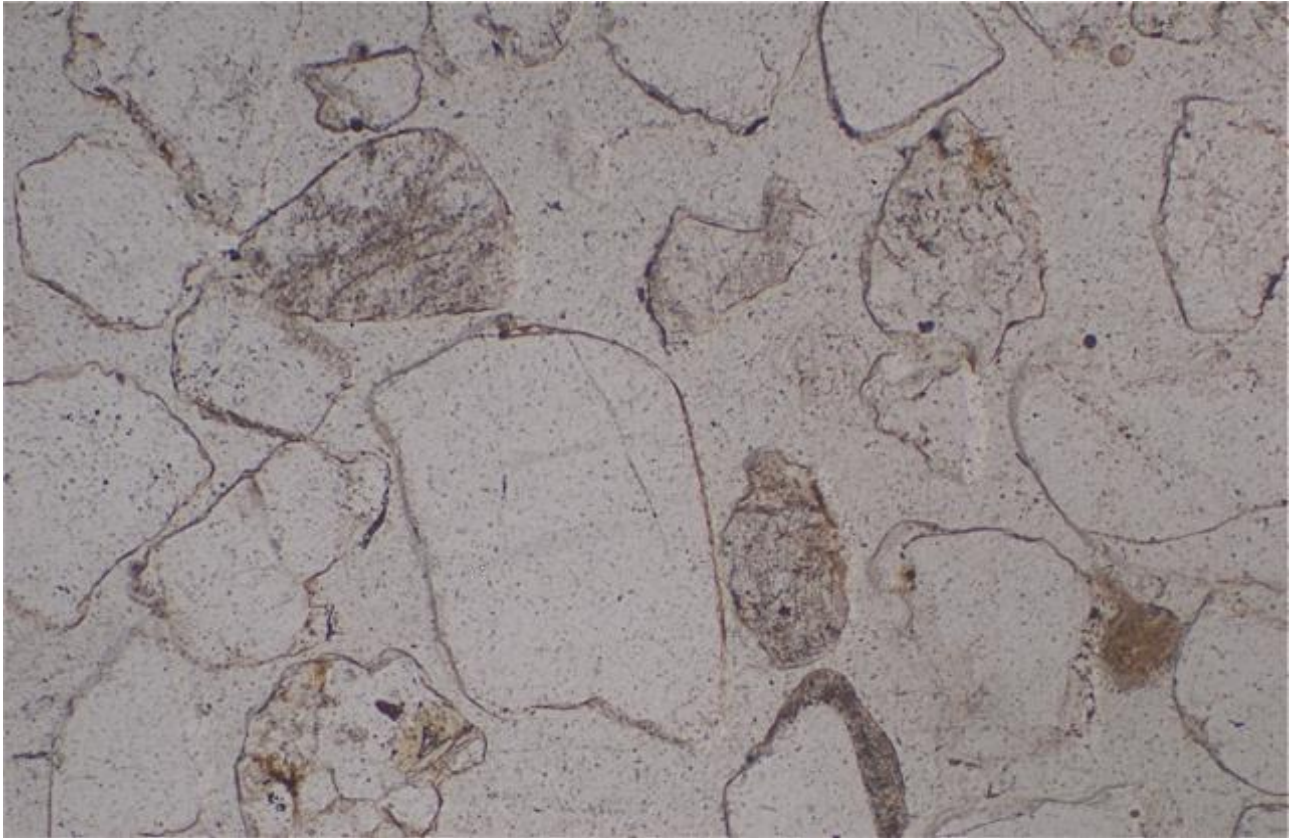
BL/C c – same view as previous photo in ordinary transmitted light to show the generally clean grain boundaries. Scale: side of photograph is 1.6mm

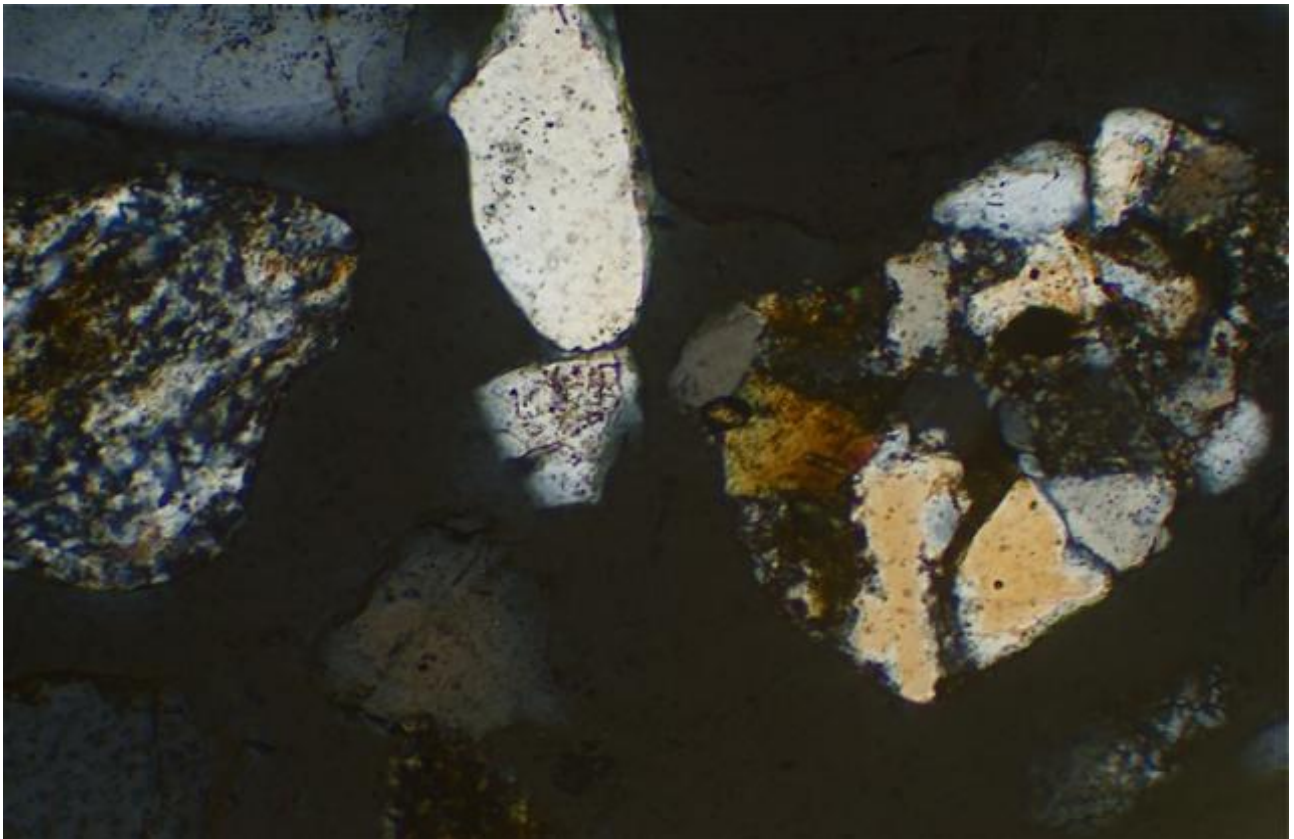
BL/C d – slightly magnified selected view of two lithic fragments. The one on the left is a somewhat foliated felsic volcanic rock fragment whereas the one on the right appears to be psammitic – held together by an extremely fine-grained cement. The greenish-brown crystal is an amphibole containing a small elongate inclusion of apatite. Associated with the amphibole are several small rounded grains of zircon (coloured). Scale: side of photograph is 0.8mm

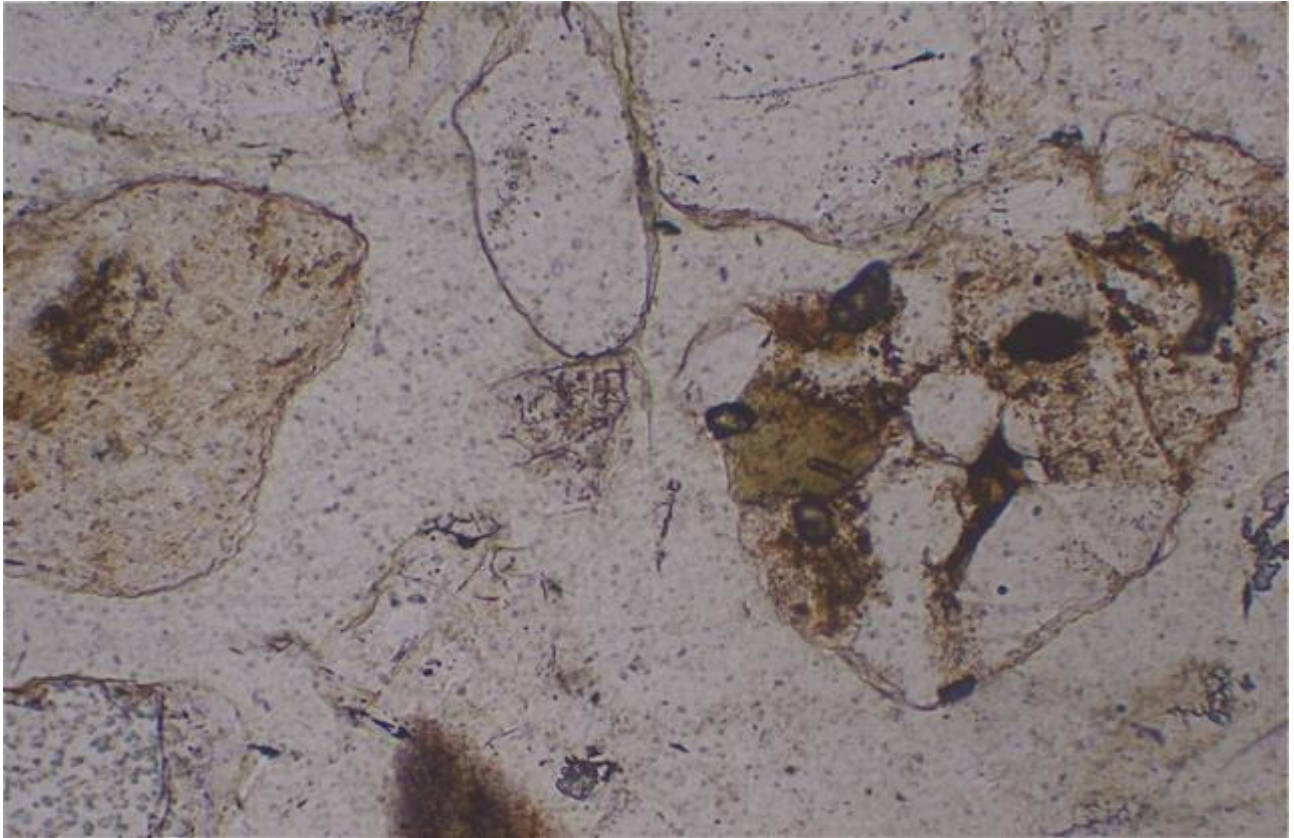
BL/C e – same view as previous photo in ordinary transmitted light to highlight the style of weathering/alteration in the lithic fragments. Scale: side of photograph is 0.8mm

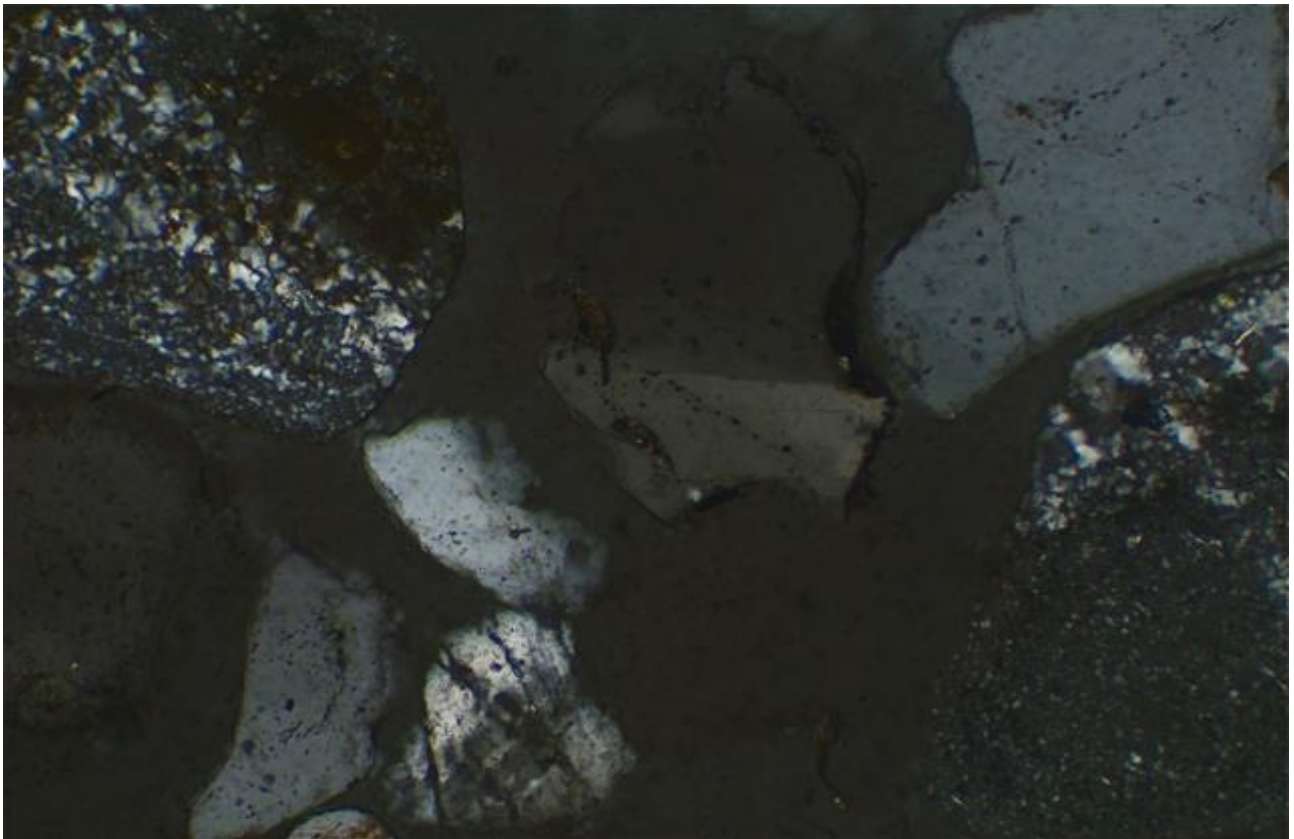
BL/C f – another slightly magnified view showing two very siliceous felsic volcanic rock fragments. The three quartz crystals down the centre are all mildly deformed. Scale: side of photograph is 0.8mm
