Annex S - Stage 1 Sand Deposit Investigation

BOBS FARM SAND DEPOSIT STAGE 1 INVESTIGATION FOR PATRA HOLDING PTY. LTD.

Report Title	Bobs Farm Sand Deposit Stage 1 Investigation	Report Number	2013-05-21-F
Client	Patra Holdings	Prepared by	MP, MvK
Date	2/7/2013	Checked by	MvK

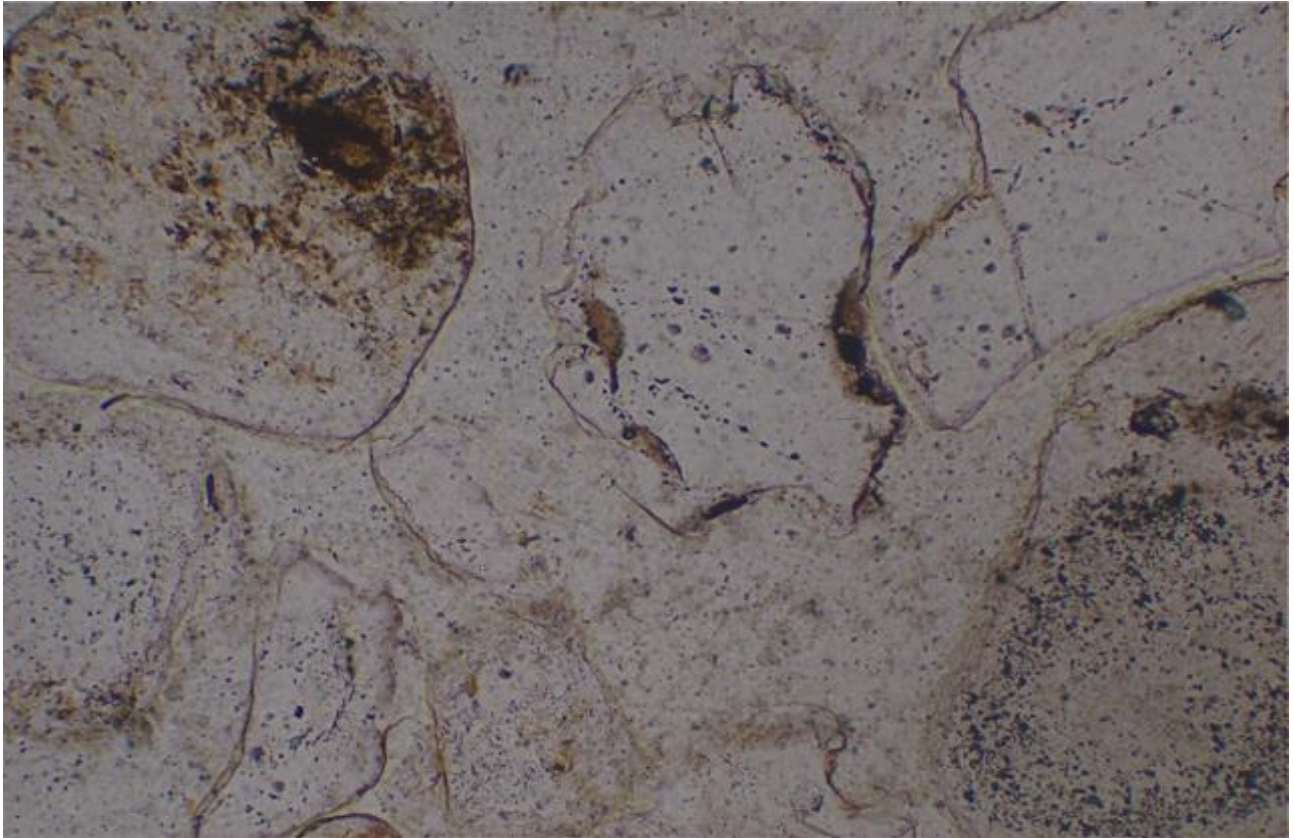
BL/C g – same view as previous photograph in ordinary transmitted light to show the small amount of adhering hydrated iron oxide and the extent of alteration of the lithic fragments. Scale: side of photograph is 0.8mm

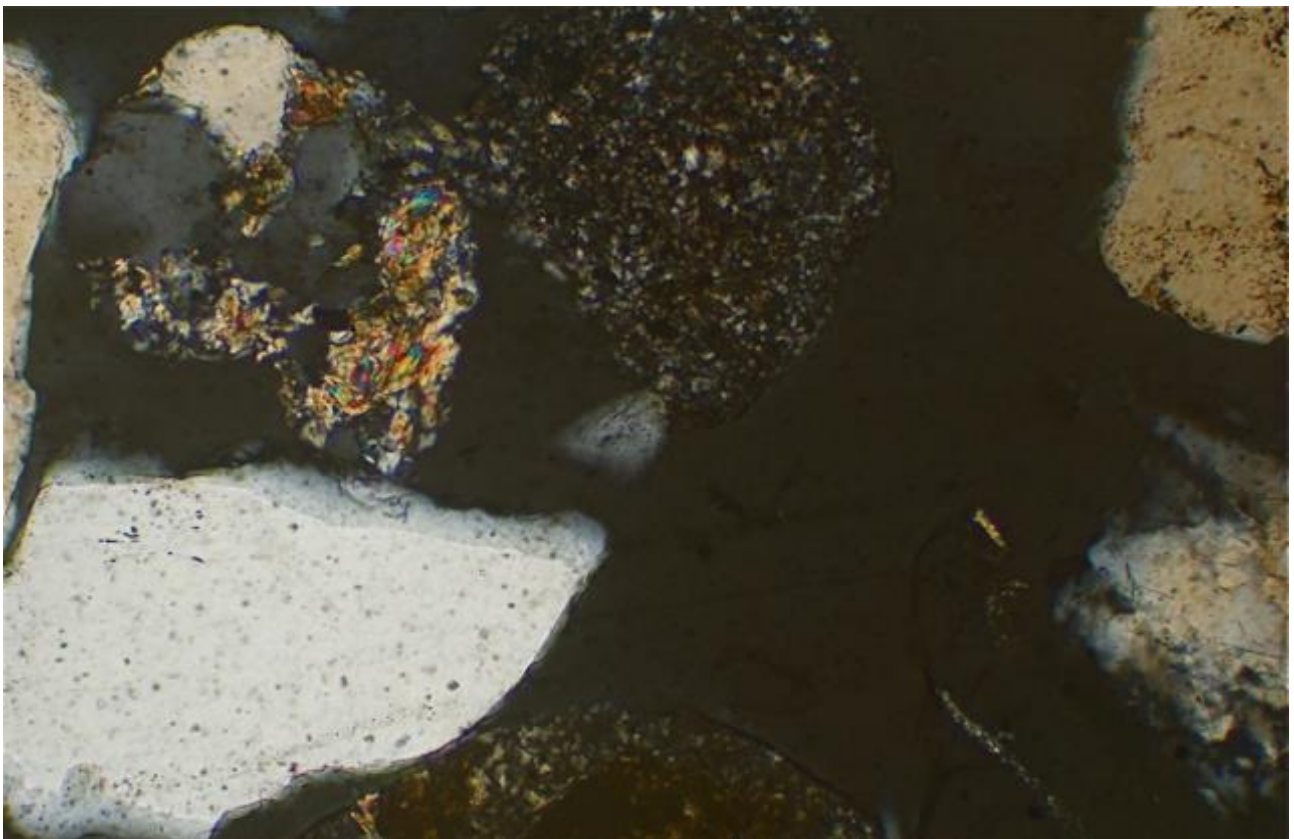
BL/C h – selected view showing several contrasting lithic fragments. The grain at top left is microgranitic or metamorphic and contains white mica (coloured). Scale: side of photograph is 0.8mm

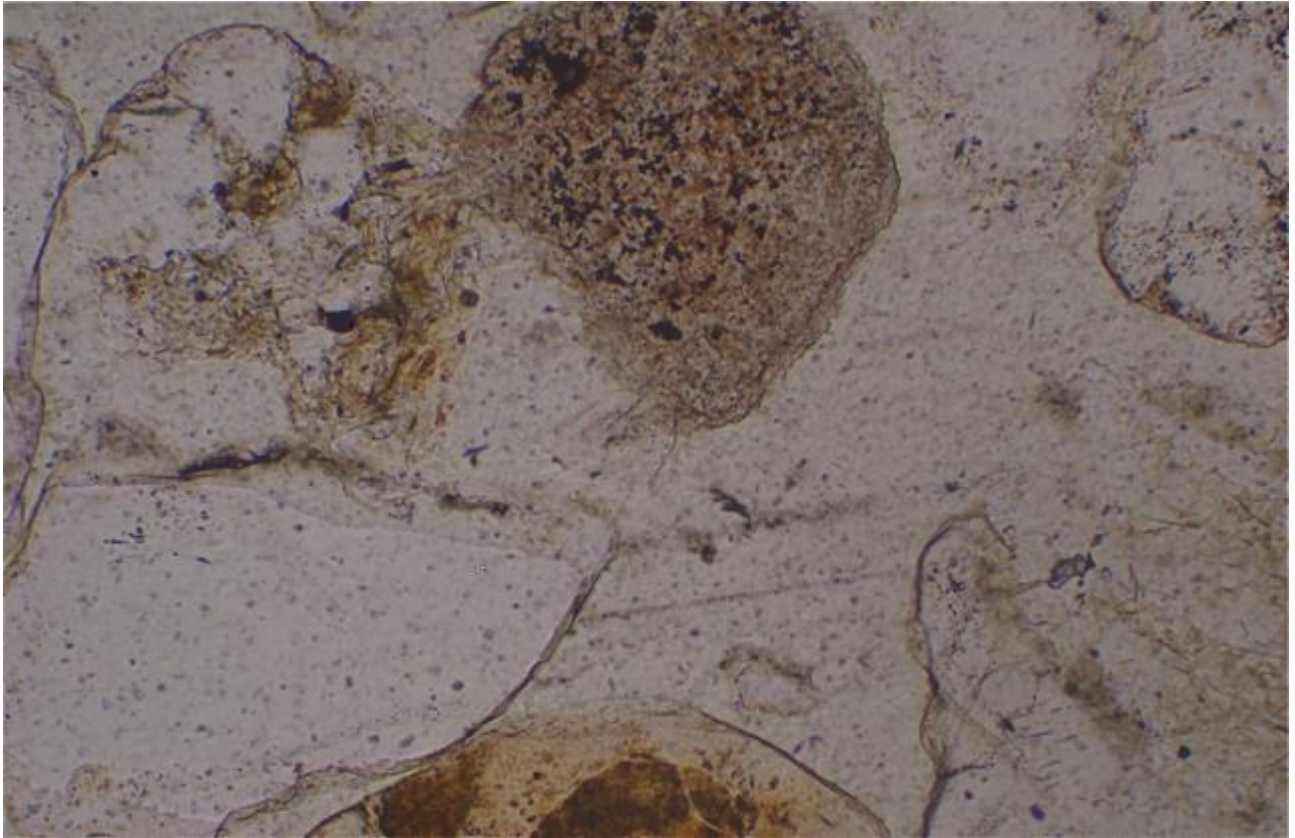
BL/C i – same view as previous photograph in ordinary transmitted light to show the small amount of adhering hydrated iron oxide and the extent of alteration of the lithic fragments. Scale: side of photograph is 0.8mm

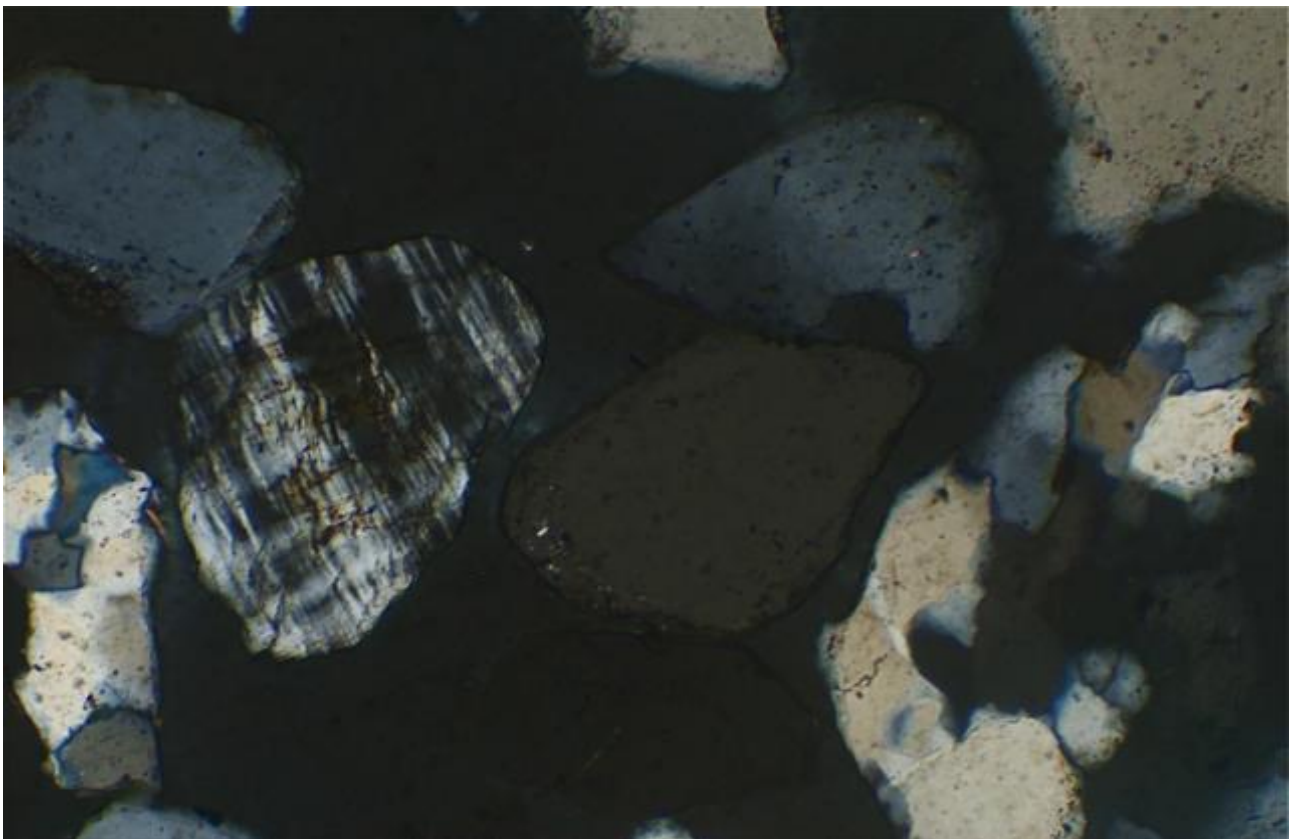
BL/C j – view of several composite grains of quartz and a reasonably fresh crystal of well-twinned microcline (alkali feldspar). Scale: side of photograph is 0.8mm

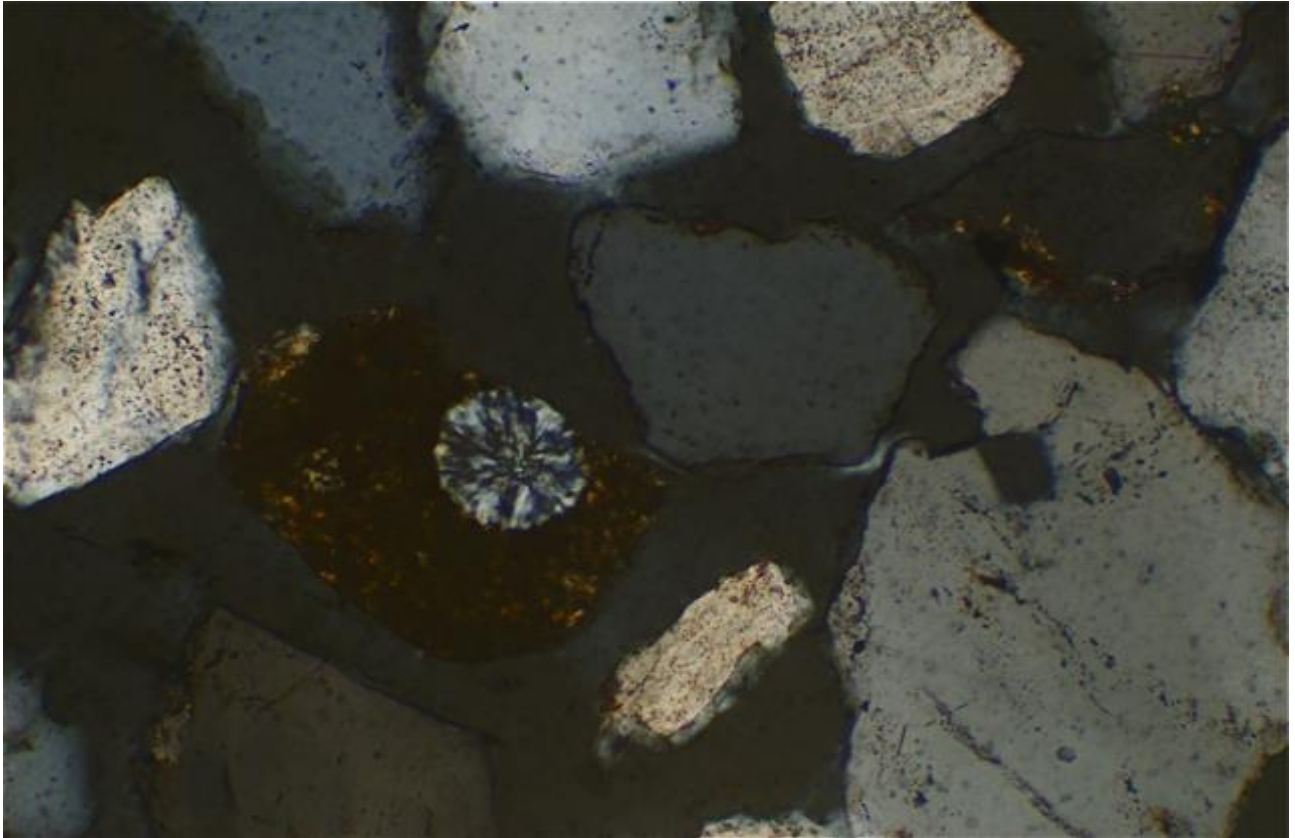
BL/C k – another selected view showing a strongly weathered volcanic lithic fragment containing a radiating spherulite of chalcedony. Scale: side of photograph is 0.8mm

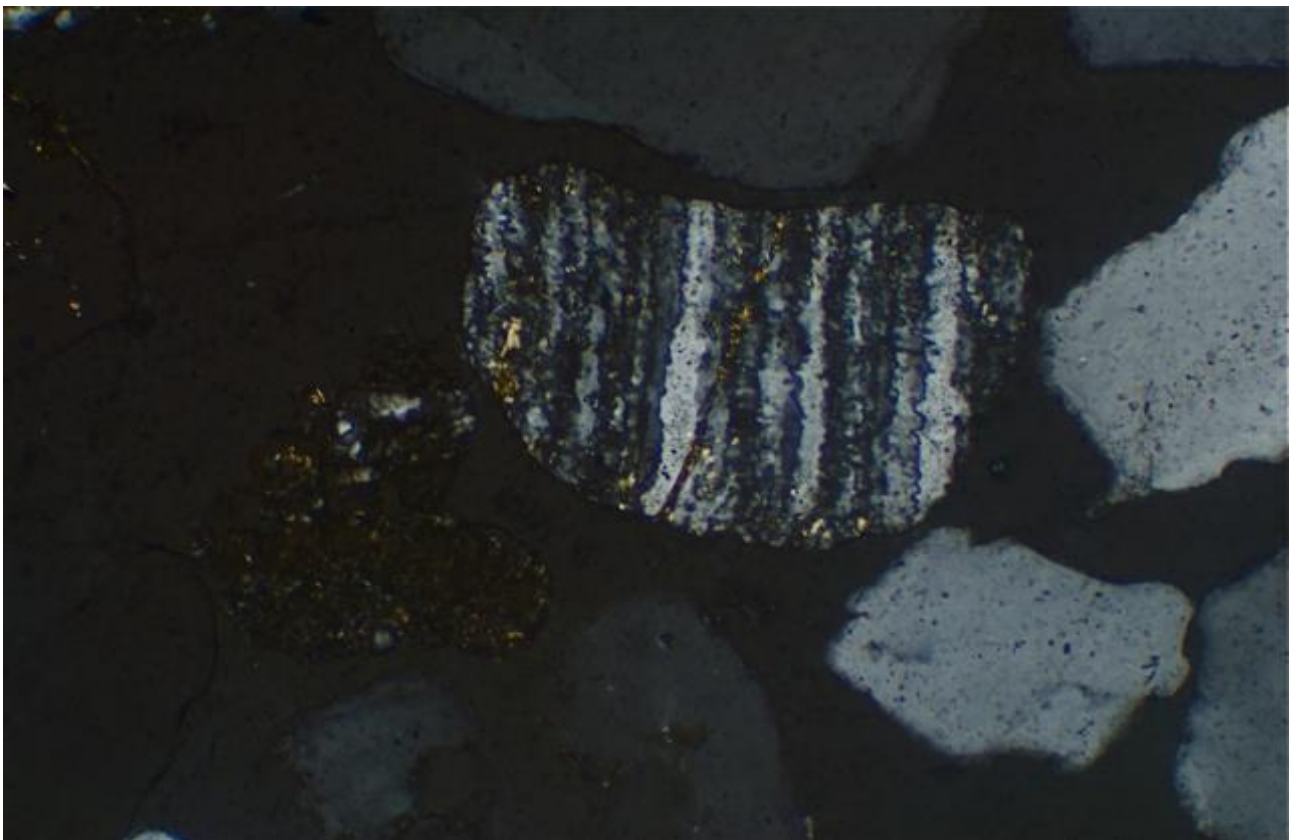
BL/C L – a conspicuous grain of highly deformed, mildly altered ribbon quartz. Scale: side of photograph is 0.8mm

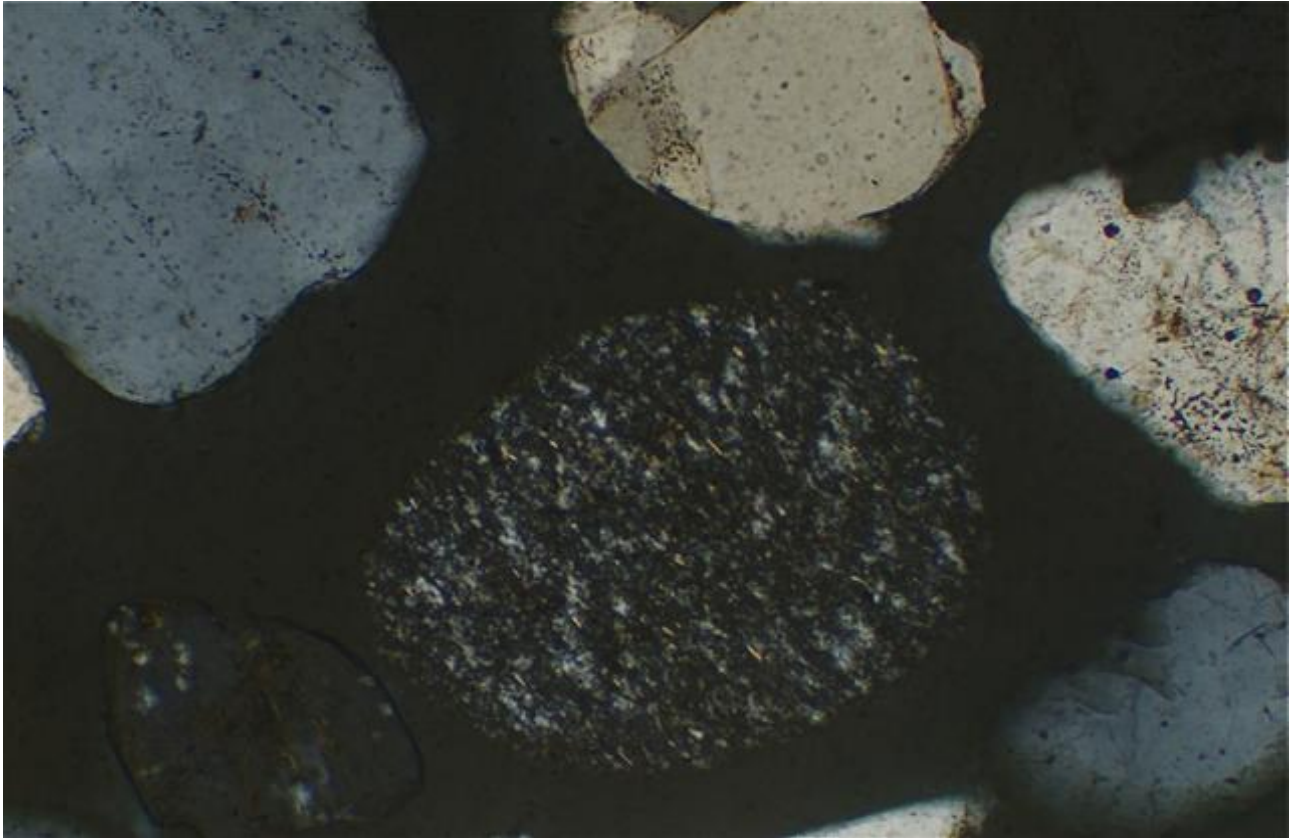
BL/C m – a reasonably fresh, mildly foliated or flow-banded felsic volcanic rock fragment. At lower left is a crystal of alkali feldspar showing mild exsolution of a sodic phase. Scale: side of photograph is 0.8mm

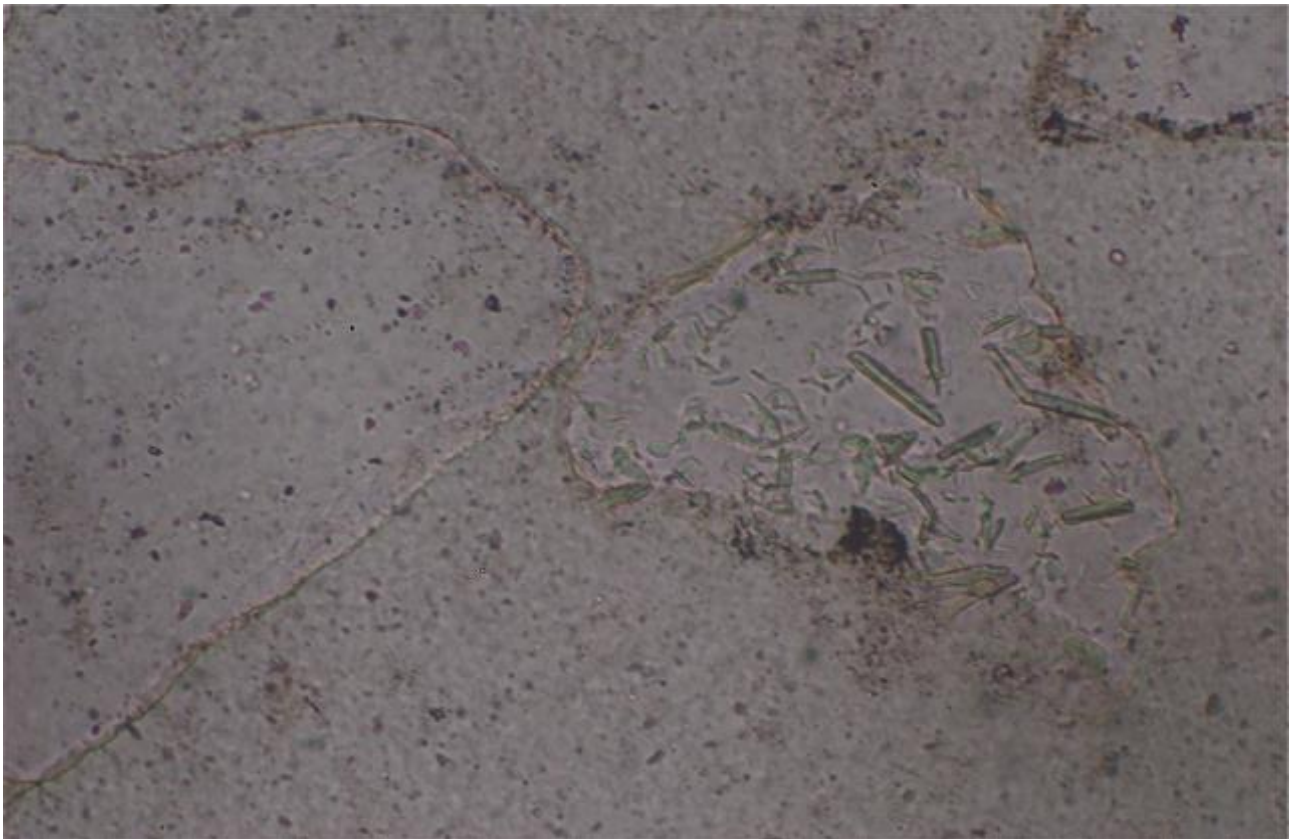
BL/C n – more magnified view in condenser-enhanced ordinary transmitted light of a metamorphic or pneumatolytic grain containing greenish prismatic crystals. Note again the virtual absence of hydrated iron oxide rims. Scale: side of photograph is 0.4mm

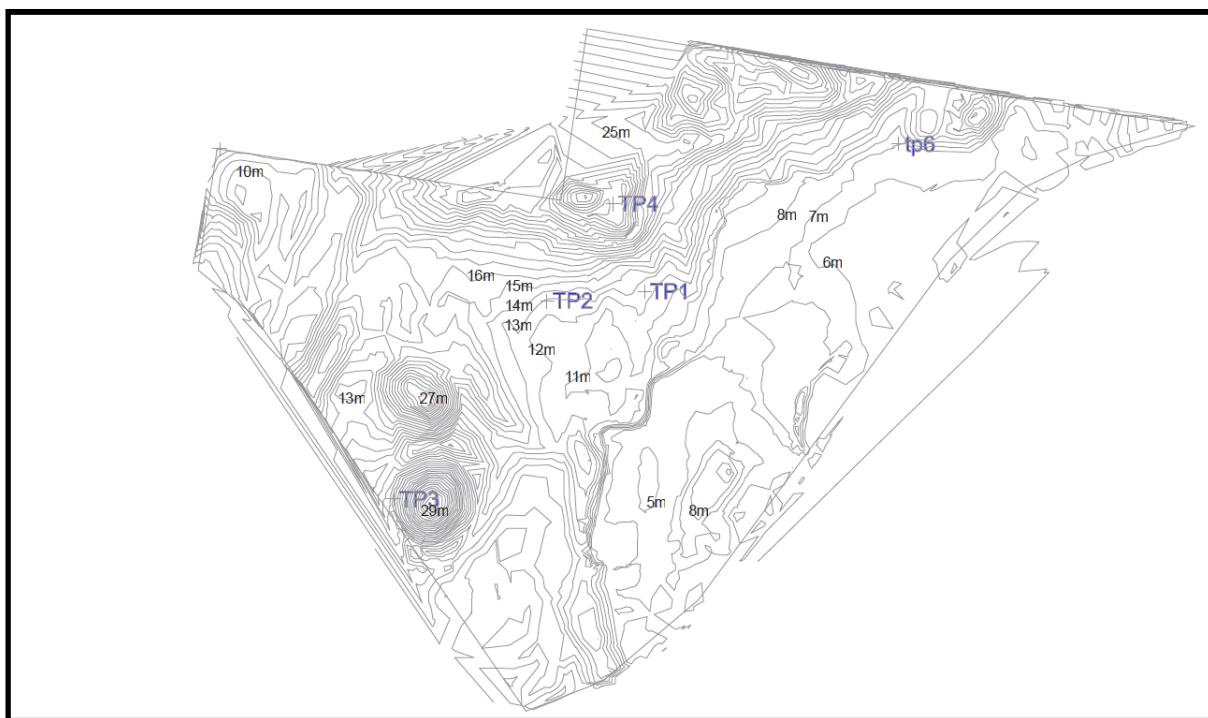
Figure 3. Contoured elevations of the Bob's Farm area.

The dunes have a steep northerly to westerly face and a gentler slope showing erosion channels to the seaward side.

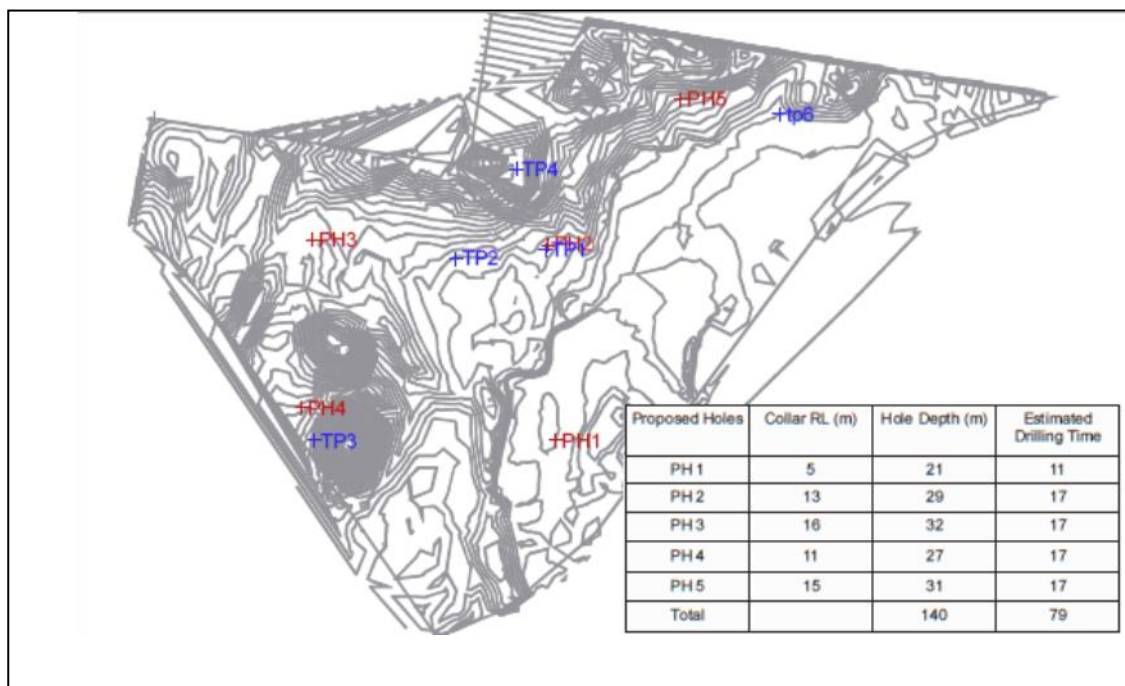
Figure 5. Location of test pits and boreholes.

QMS contracted VGT Pty Ltd to undertake a resource assessment on the Bob's Farm area in April, 2013. Their chosen exploration method in Stage 1 involved the digging of five test pits (PT1, PT2, PT3, PT4, PT6) using a long reach excavator (Figure 5 and Plate 3).

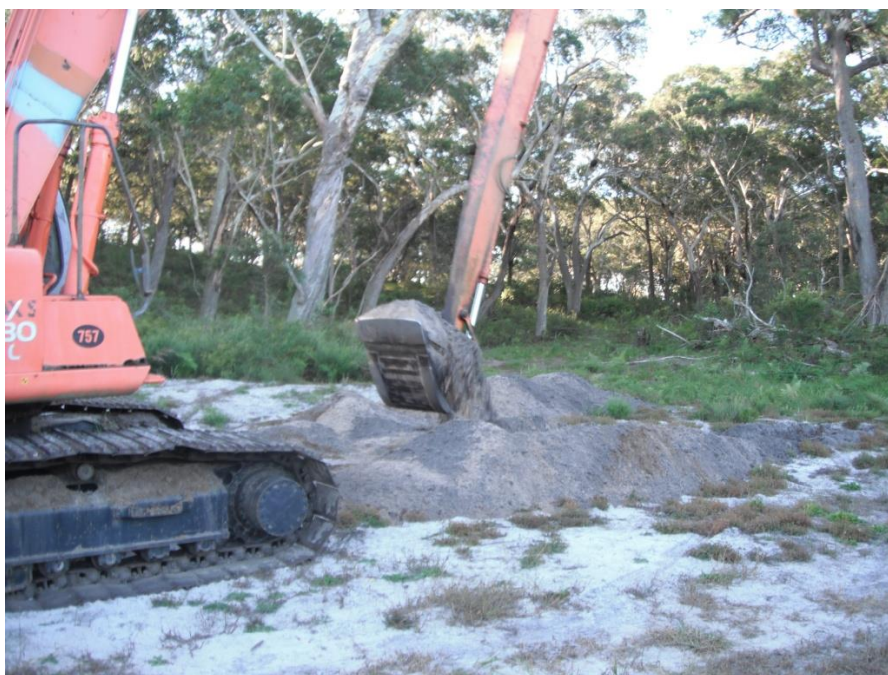
Plate3. Excavator digging a test pit at Bob’s Farm investigation site. Photograph provided by QMS.

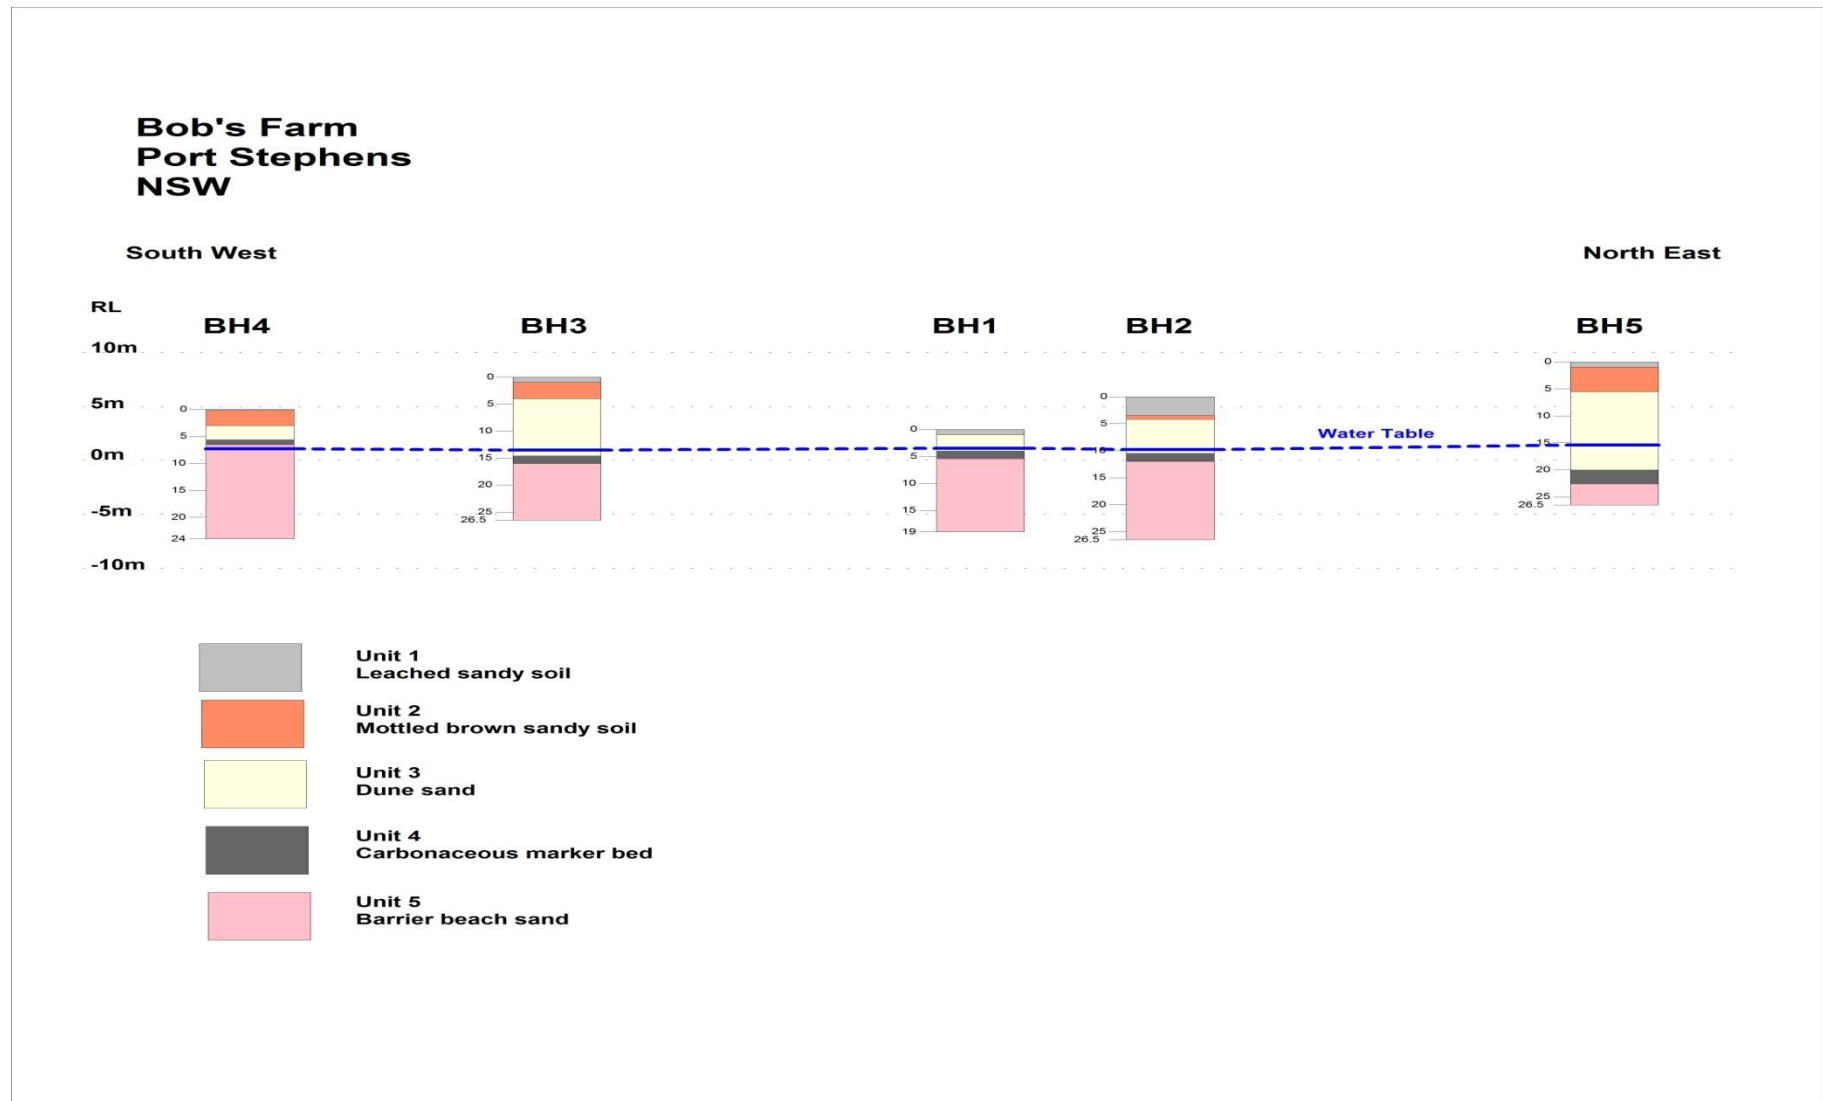
Figure 6. Stratigraphic cross section of the five boreholes showing Units 1 – 5 and water table level in Bob's Farm Area.

A stratigraphic cross section running south-west to north-east (BH4- BH3-BH1-BH2-BH5) is shown in Figure 6.

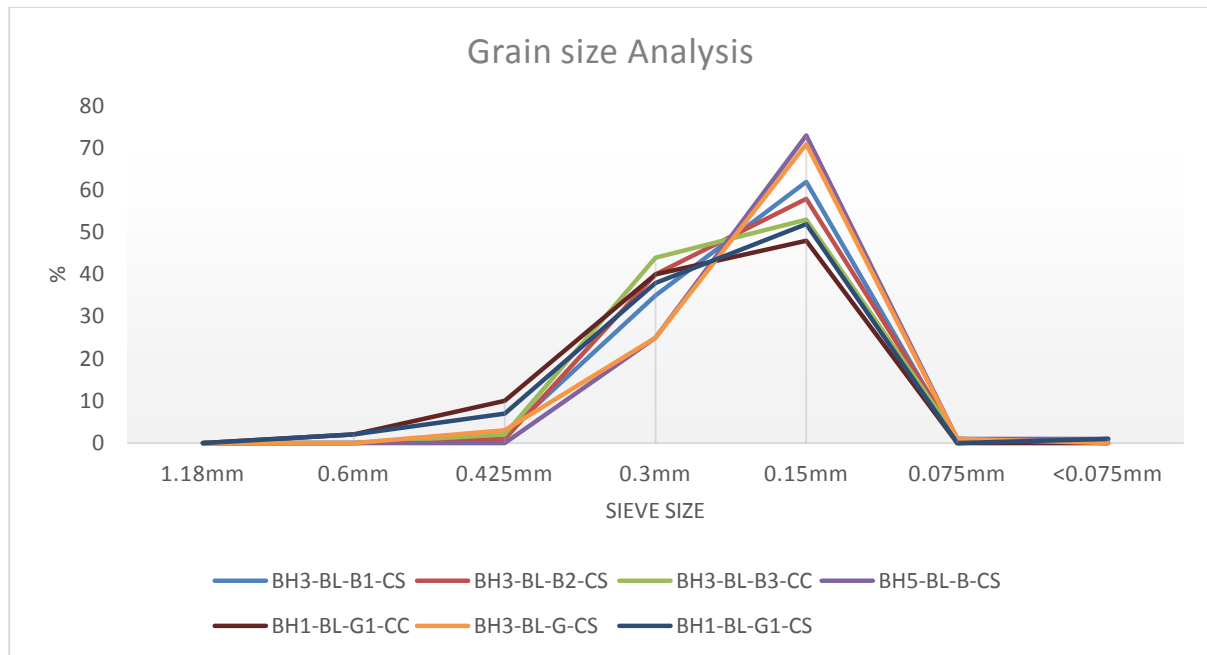
Graph 1. Plot of sieve sizes against wt% retain on each sieve which demonstrates the fairly narrow grainsize range.

The 7 selected borehole sand samples are fairly narrowly graded, fine to medium quartz sands. The grainsizes range mainly between -0.6 and +0.15 mm but are generally concentrated in the -.425 to -0.15 mm in particle sizes (see Graph 1 below).

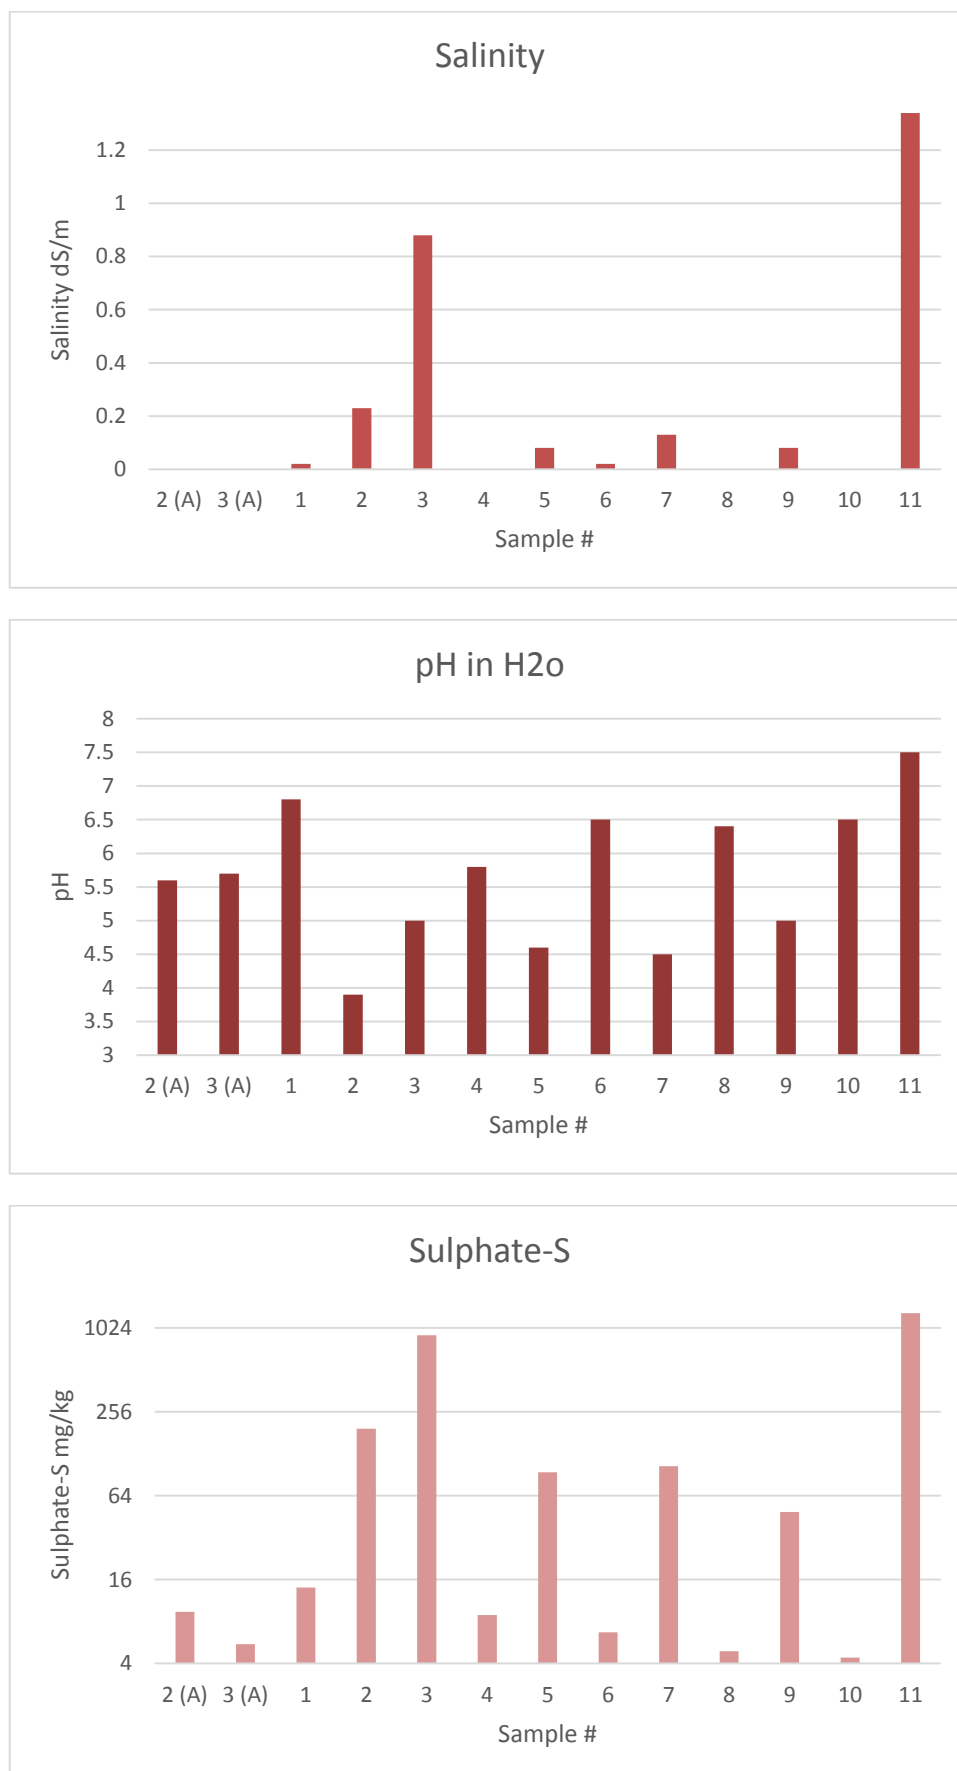
Graph 2, 3, 4 – Plot of salinity, Ph and sulphate levels against sample numbers.

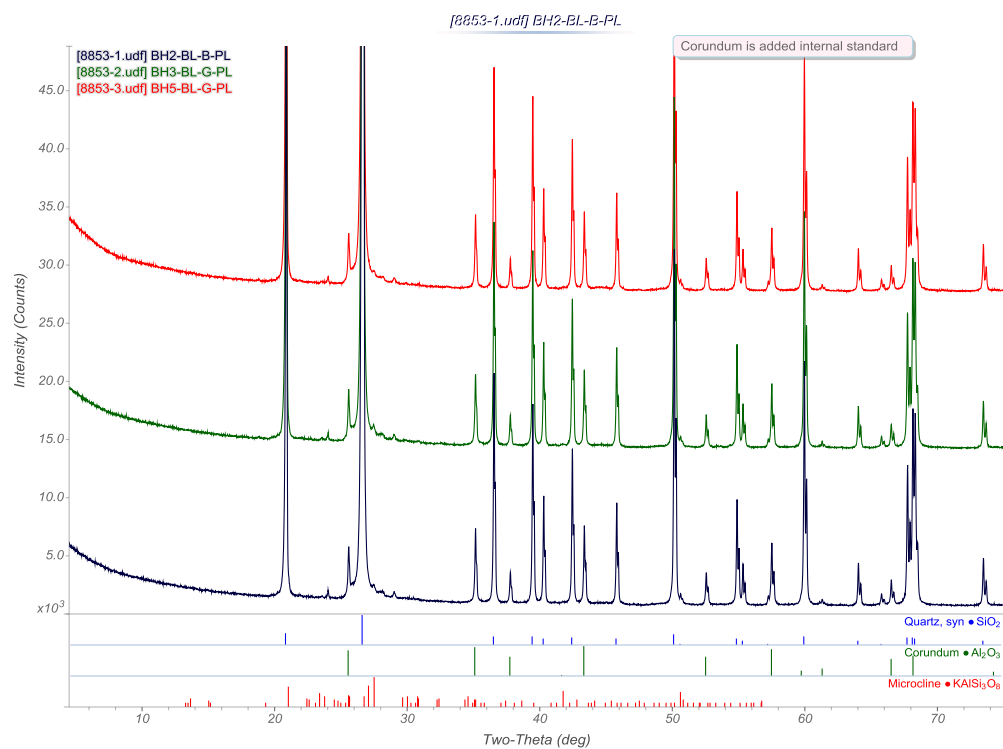
Figure 1. Powder XRD patterns of the three sand samples.

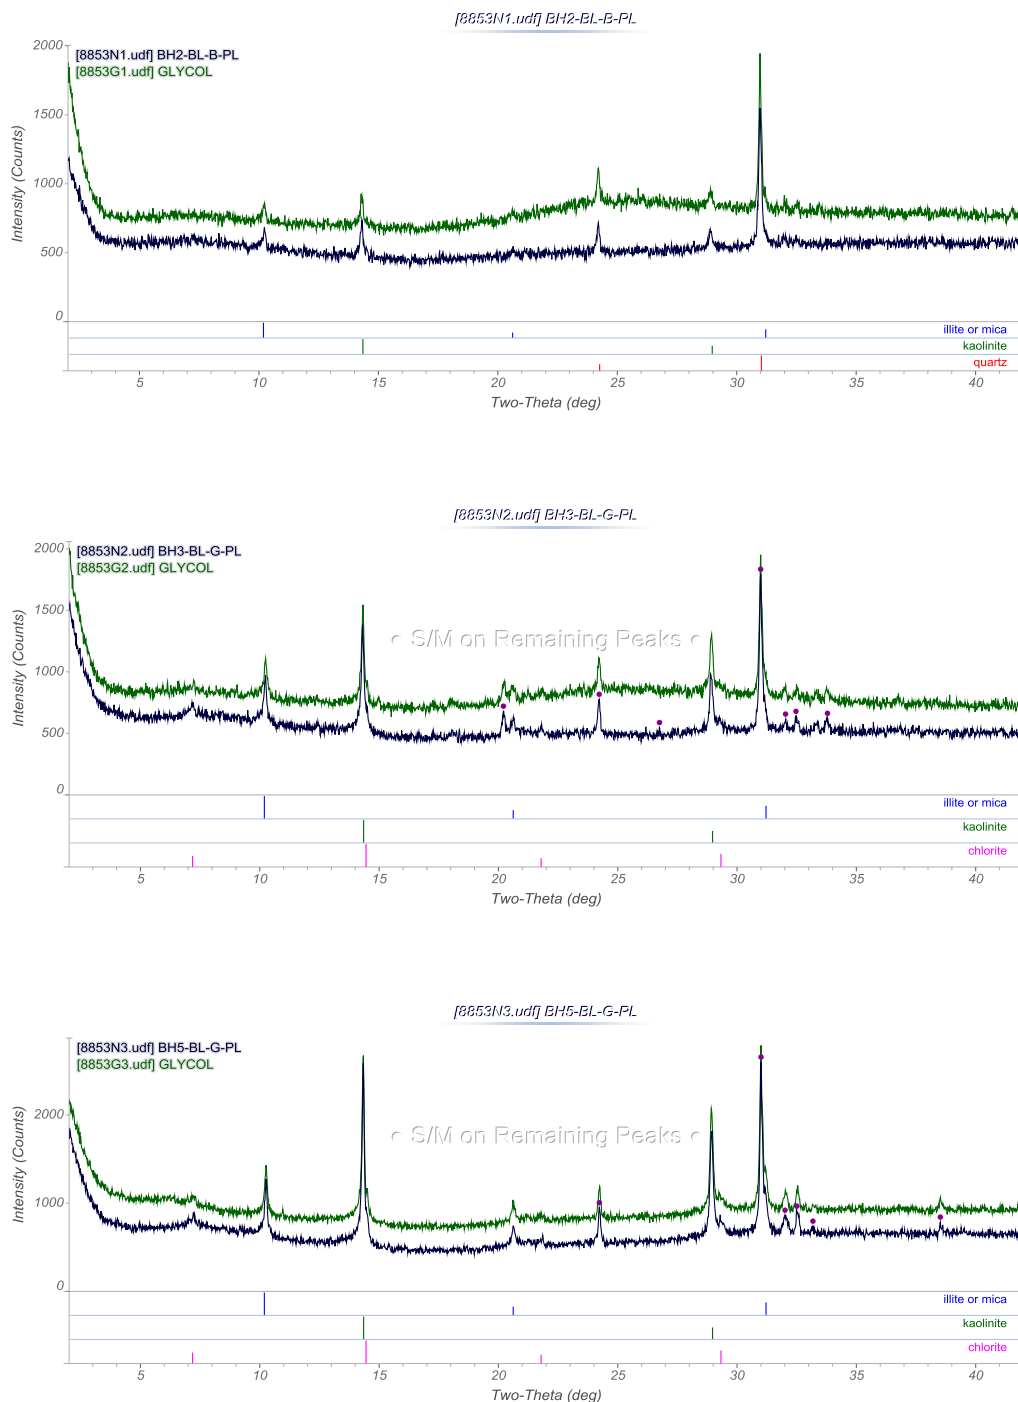
Figure 2. Clay XRD patterns of the three sand samples.

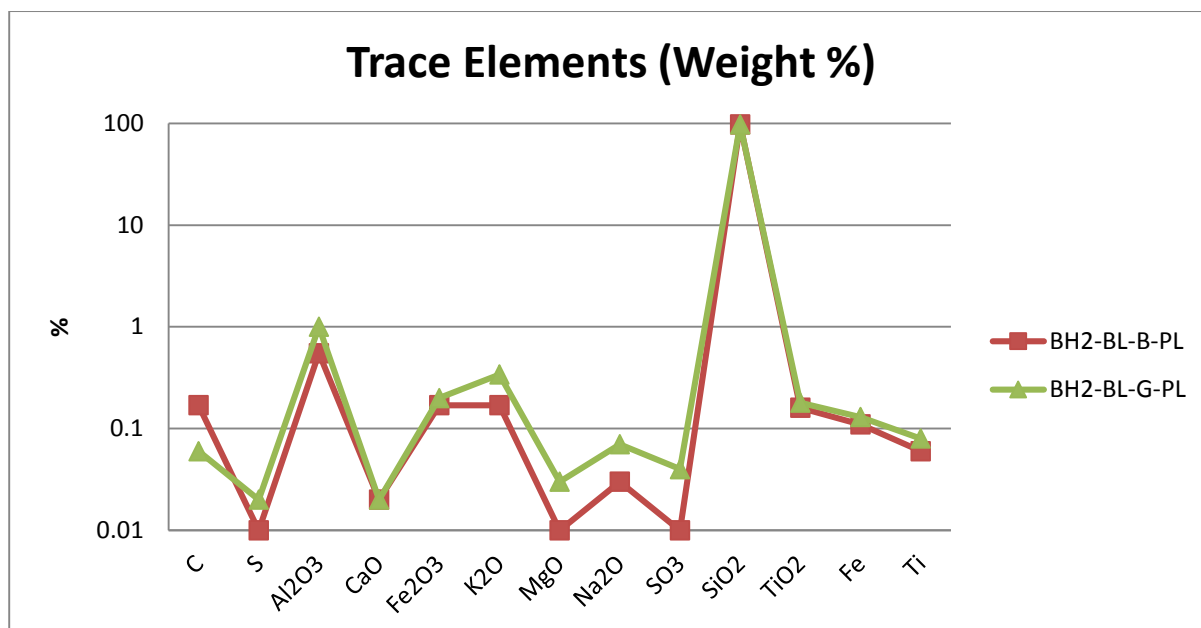
Figure 3. Note trend showing slight depletion of oxides and elements for the upper blonde sand in BH2. The exception is total carbon results which are higher in blonde sand than the lower grey beach sand (this excludes the contaminated grey sand sample in BH1). SiO₂ is regarded as insoluble so does not deplete from upper to lower sand units.

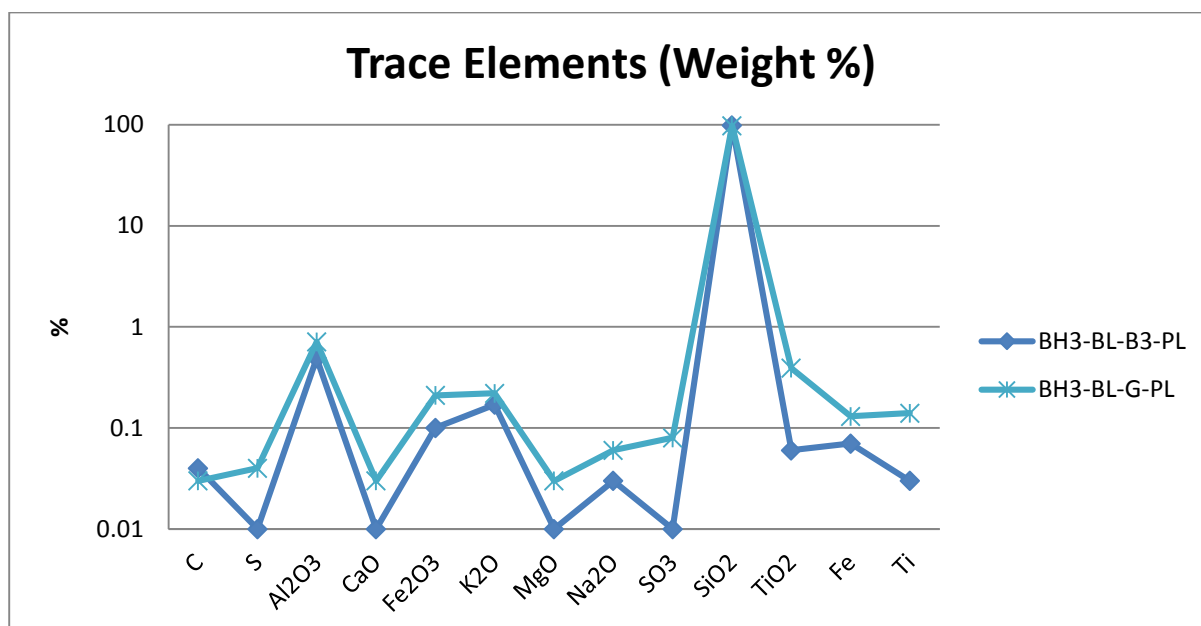
Figure 4. Note trend showing slight depletion of oxides and elements for the upper blonde sand in BH3. The exception is total carbon results which are higher in blonde sand than the lower grey beach sand (this excludes the contaminated grey sand sample in BH1). SiO₂ is regarded as insoluble so does not deplete from upper to lower sand units.

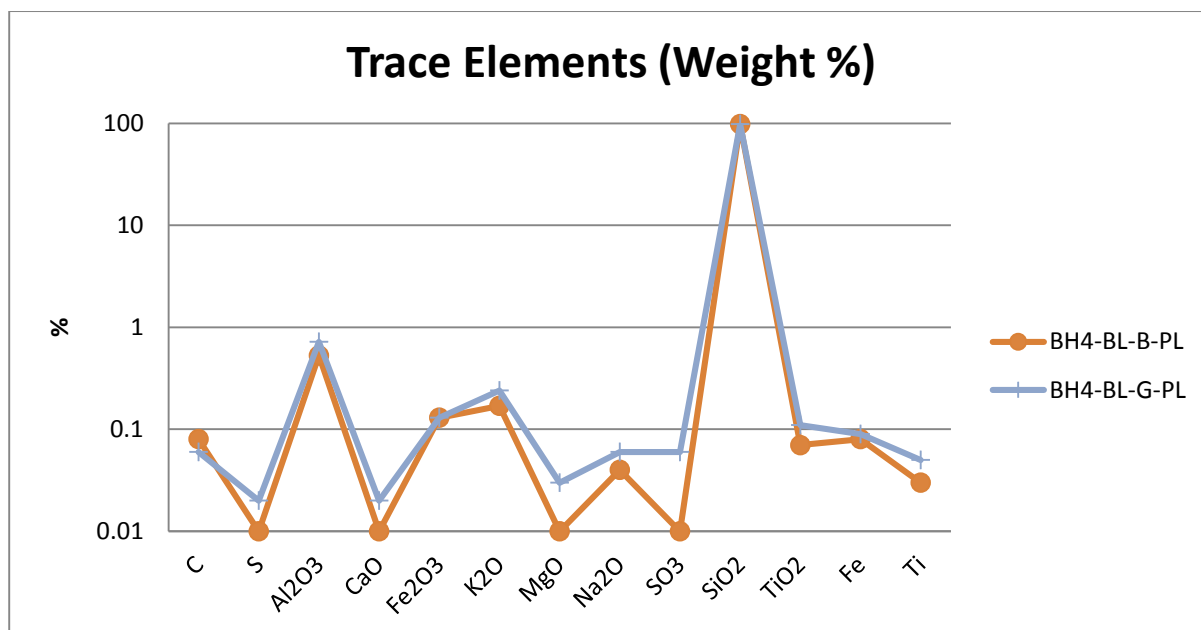
Figure 5. Note trend showing slight depletion of oxides and elements for the upper blonde sand in BH4. The exception is total carbon results which are higher in blonde sand than the lower grey beach sand (this excludes the contaminated grey sand sample in BH1). SiO₂ is regarded as insoluble so does not deplete from upper to lower sand units.

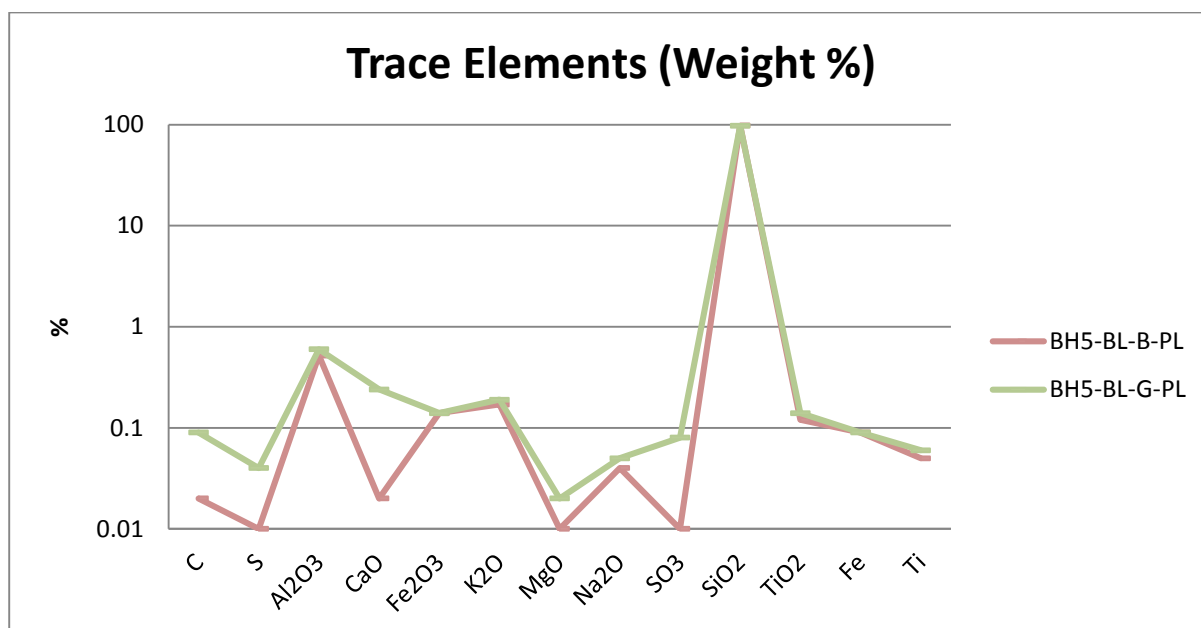
Figure 6. Note trend showing slight depletion of oxides and elements for the upper blonde sand in BH5. SiO₂ is regarded as insoluble so does not deplete from upper to lower sand units.

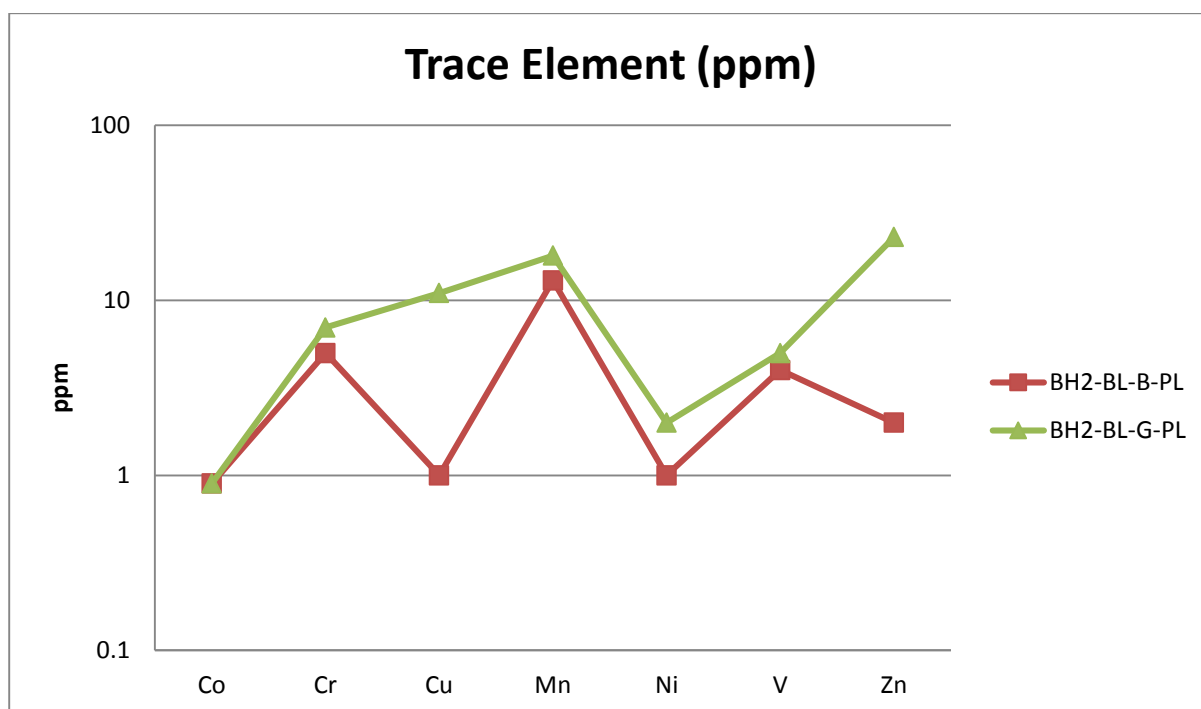
Figure 7. Note trend showing slight depletion of elements for the upper blonde sand in BH2. The Co and Ni results are quite low and relatively stable.
