Annex S - Stage 1 Sand Deposit Investigation

BOBS FARM SAND DEPOSIT STAGE 1 INVESTIGATION FOR PATRA HOLDING PTY. LTD.

Report Title	Bobs Farm Sand Deposit Stage 1 Investigation	Report Number	2013-05-21-F
Client	Patra Holdings	Prepared by	MP, MvK
Date	2/7/2013	Checked by	MvK

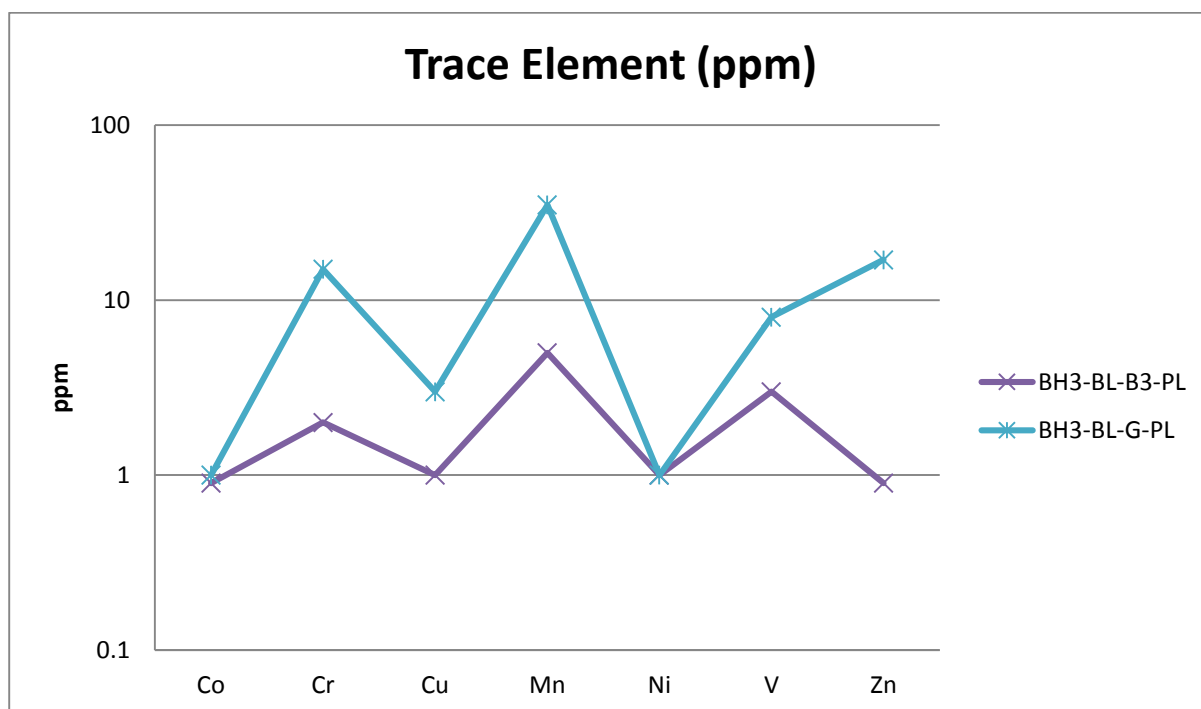
Figure 8. Note trend showing slight depletion of elements for the upper blonde sand in BH3. The Co and Ni results are quite low and relatively stable.

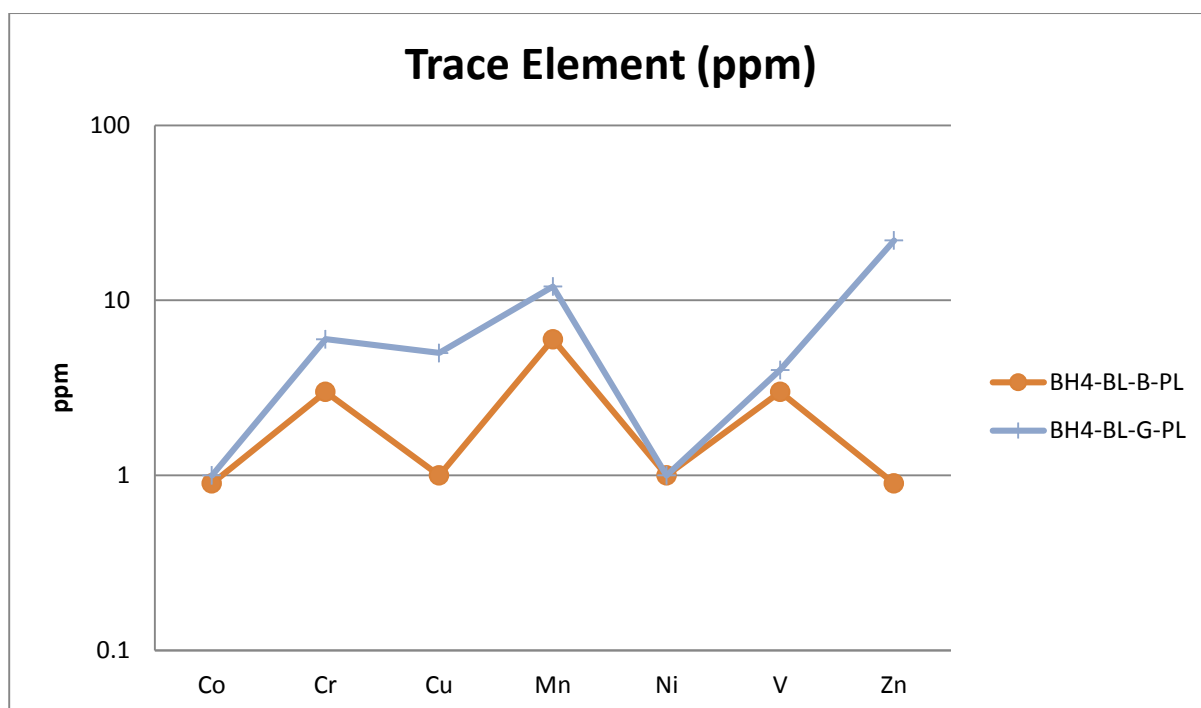
Figure 9. Note trend showing slight depletion of elements for the upper blonde sand in BH4. The Co and Ni results are quite low and relatively stable.

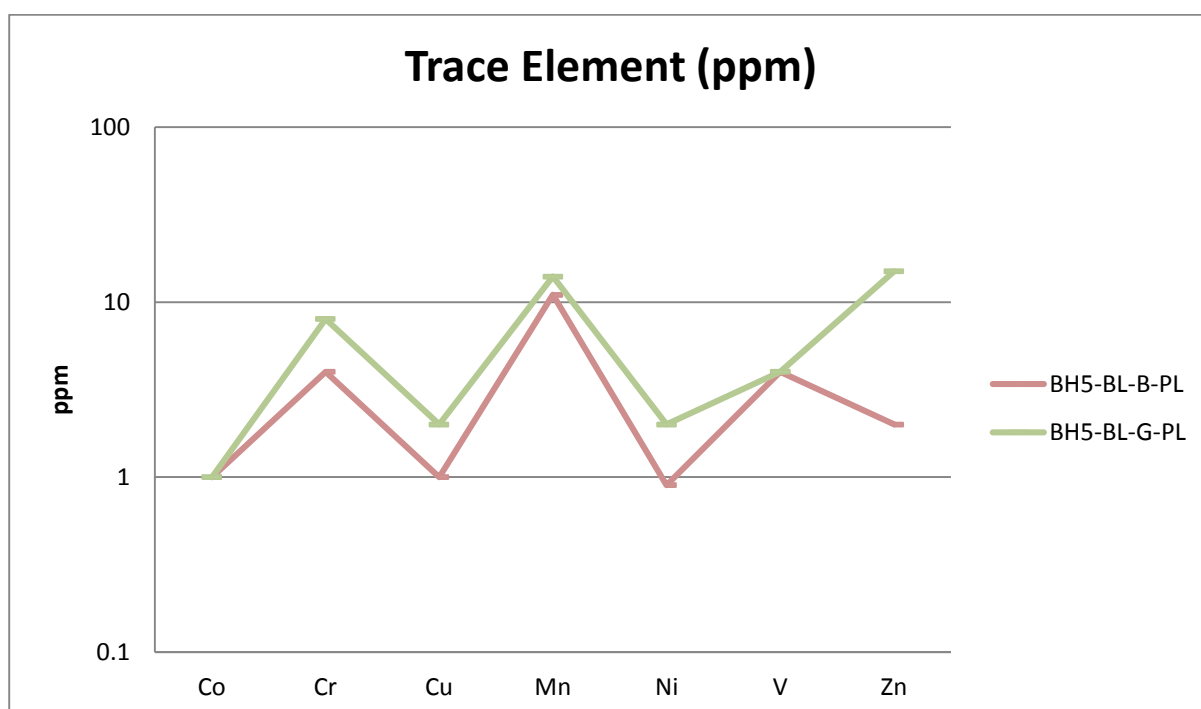
Figure 10. Note trend showing slight depletion of elements for the upper blonde sand in BH5. The Co and Ni results are quite low and relatively stable.

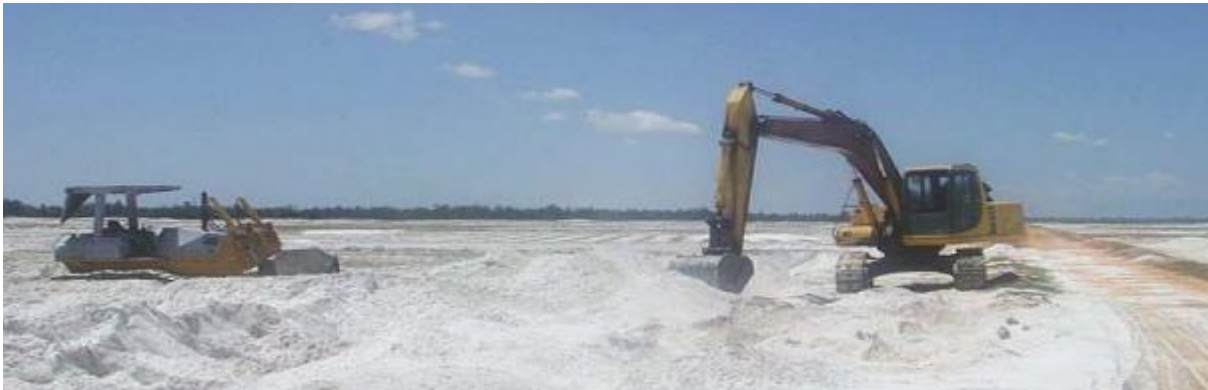
Figure 4 Typical silica sand mining 60 km south of Danang Vietnam. Bulldoze then load truck Sand depth ~ 2 metres.

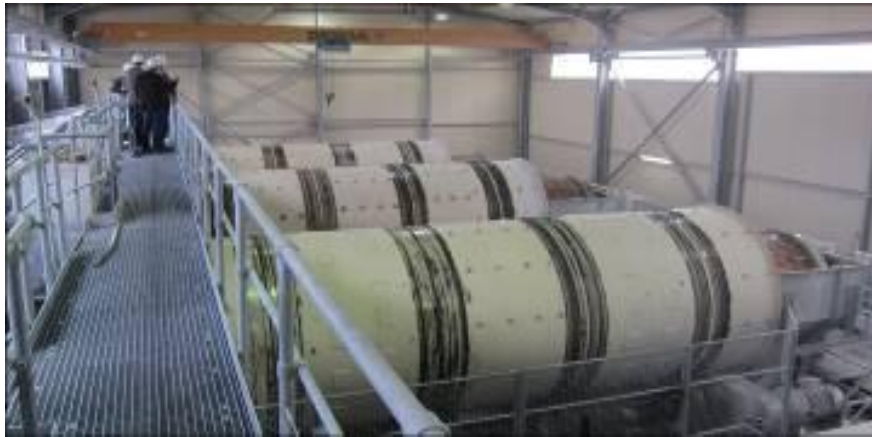
Figure 6: Washing kaolin from silica sand in trommel drums at Quarzwerke Hirschau plant

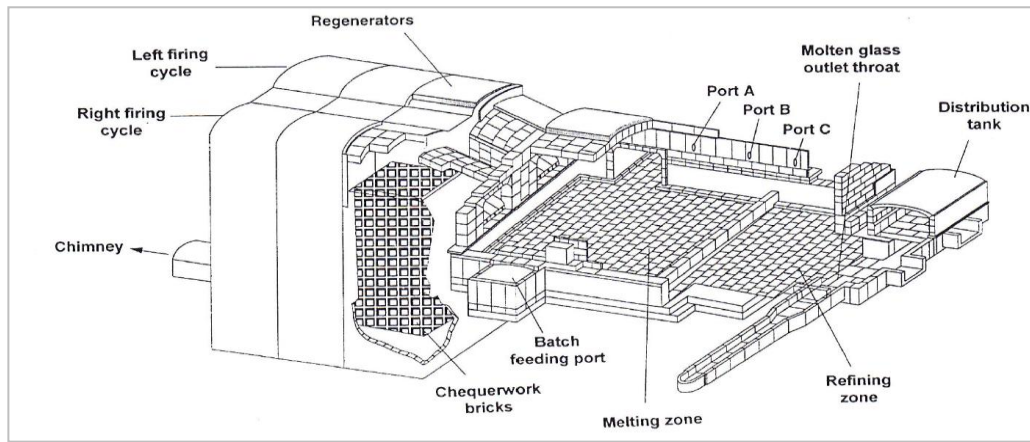
Figure 7: Schematic view of glass furnace

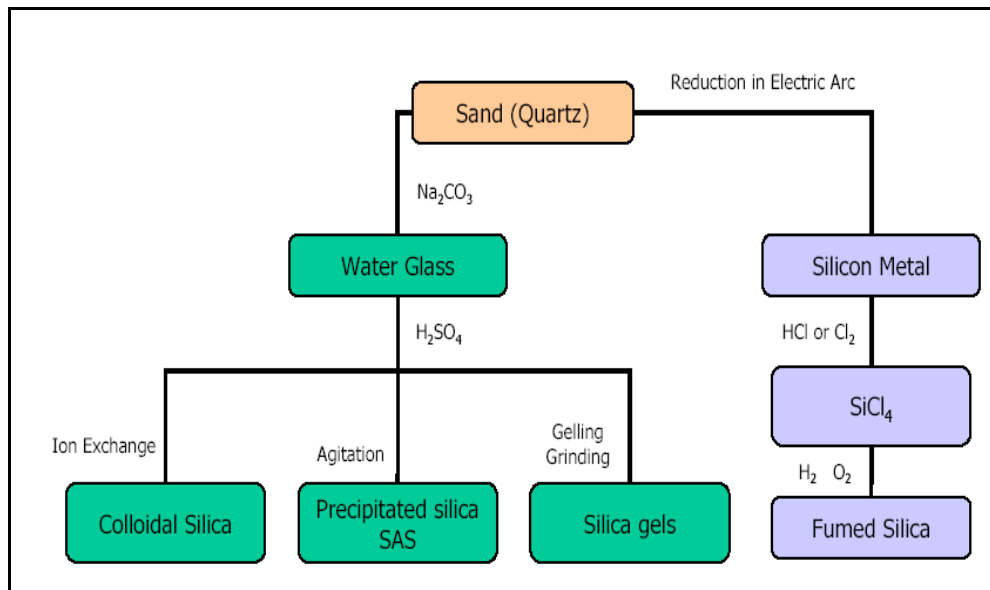
Figure 19: Simplified flowsheet of adding value to Silica and Quartz materials
