Twynam Property Group

Remedial Action Plan  
Lot 3 DP568613 & Lot 384 DP 755952  
Mundamia, NSW.

P0802193JR04V01  
April 2013

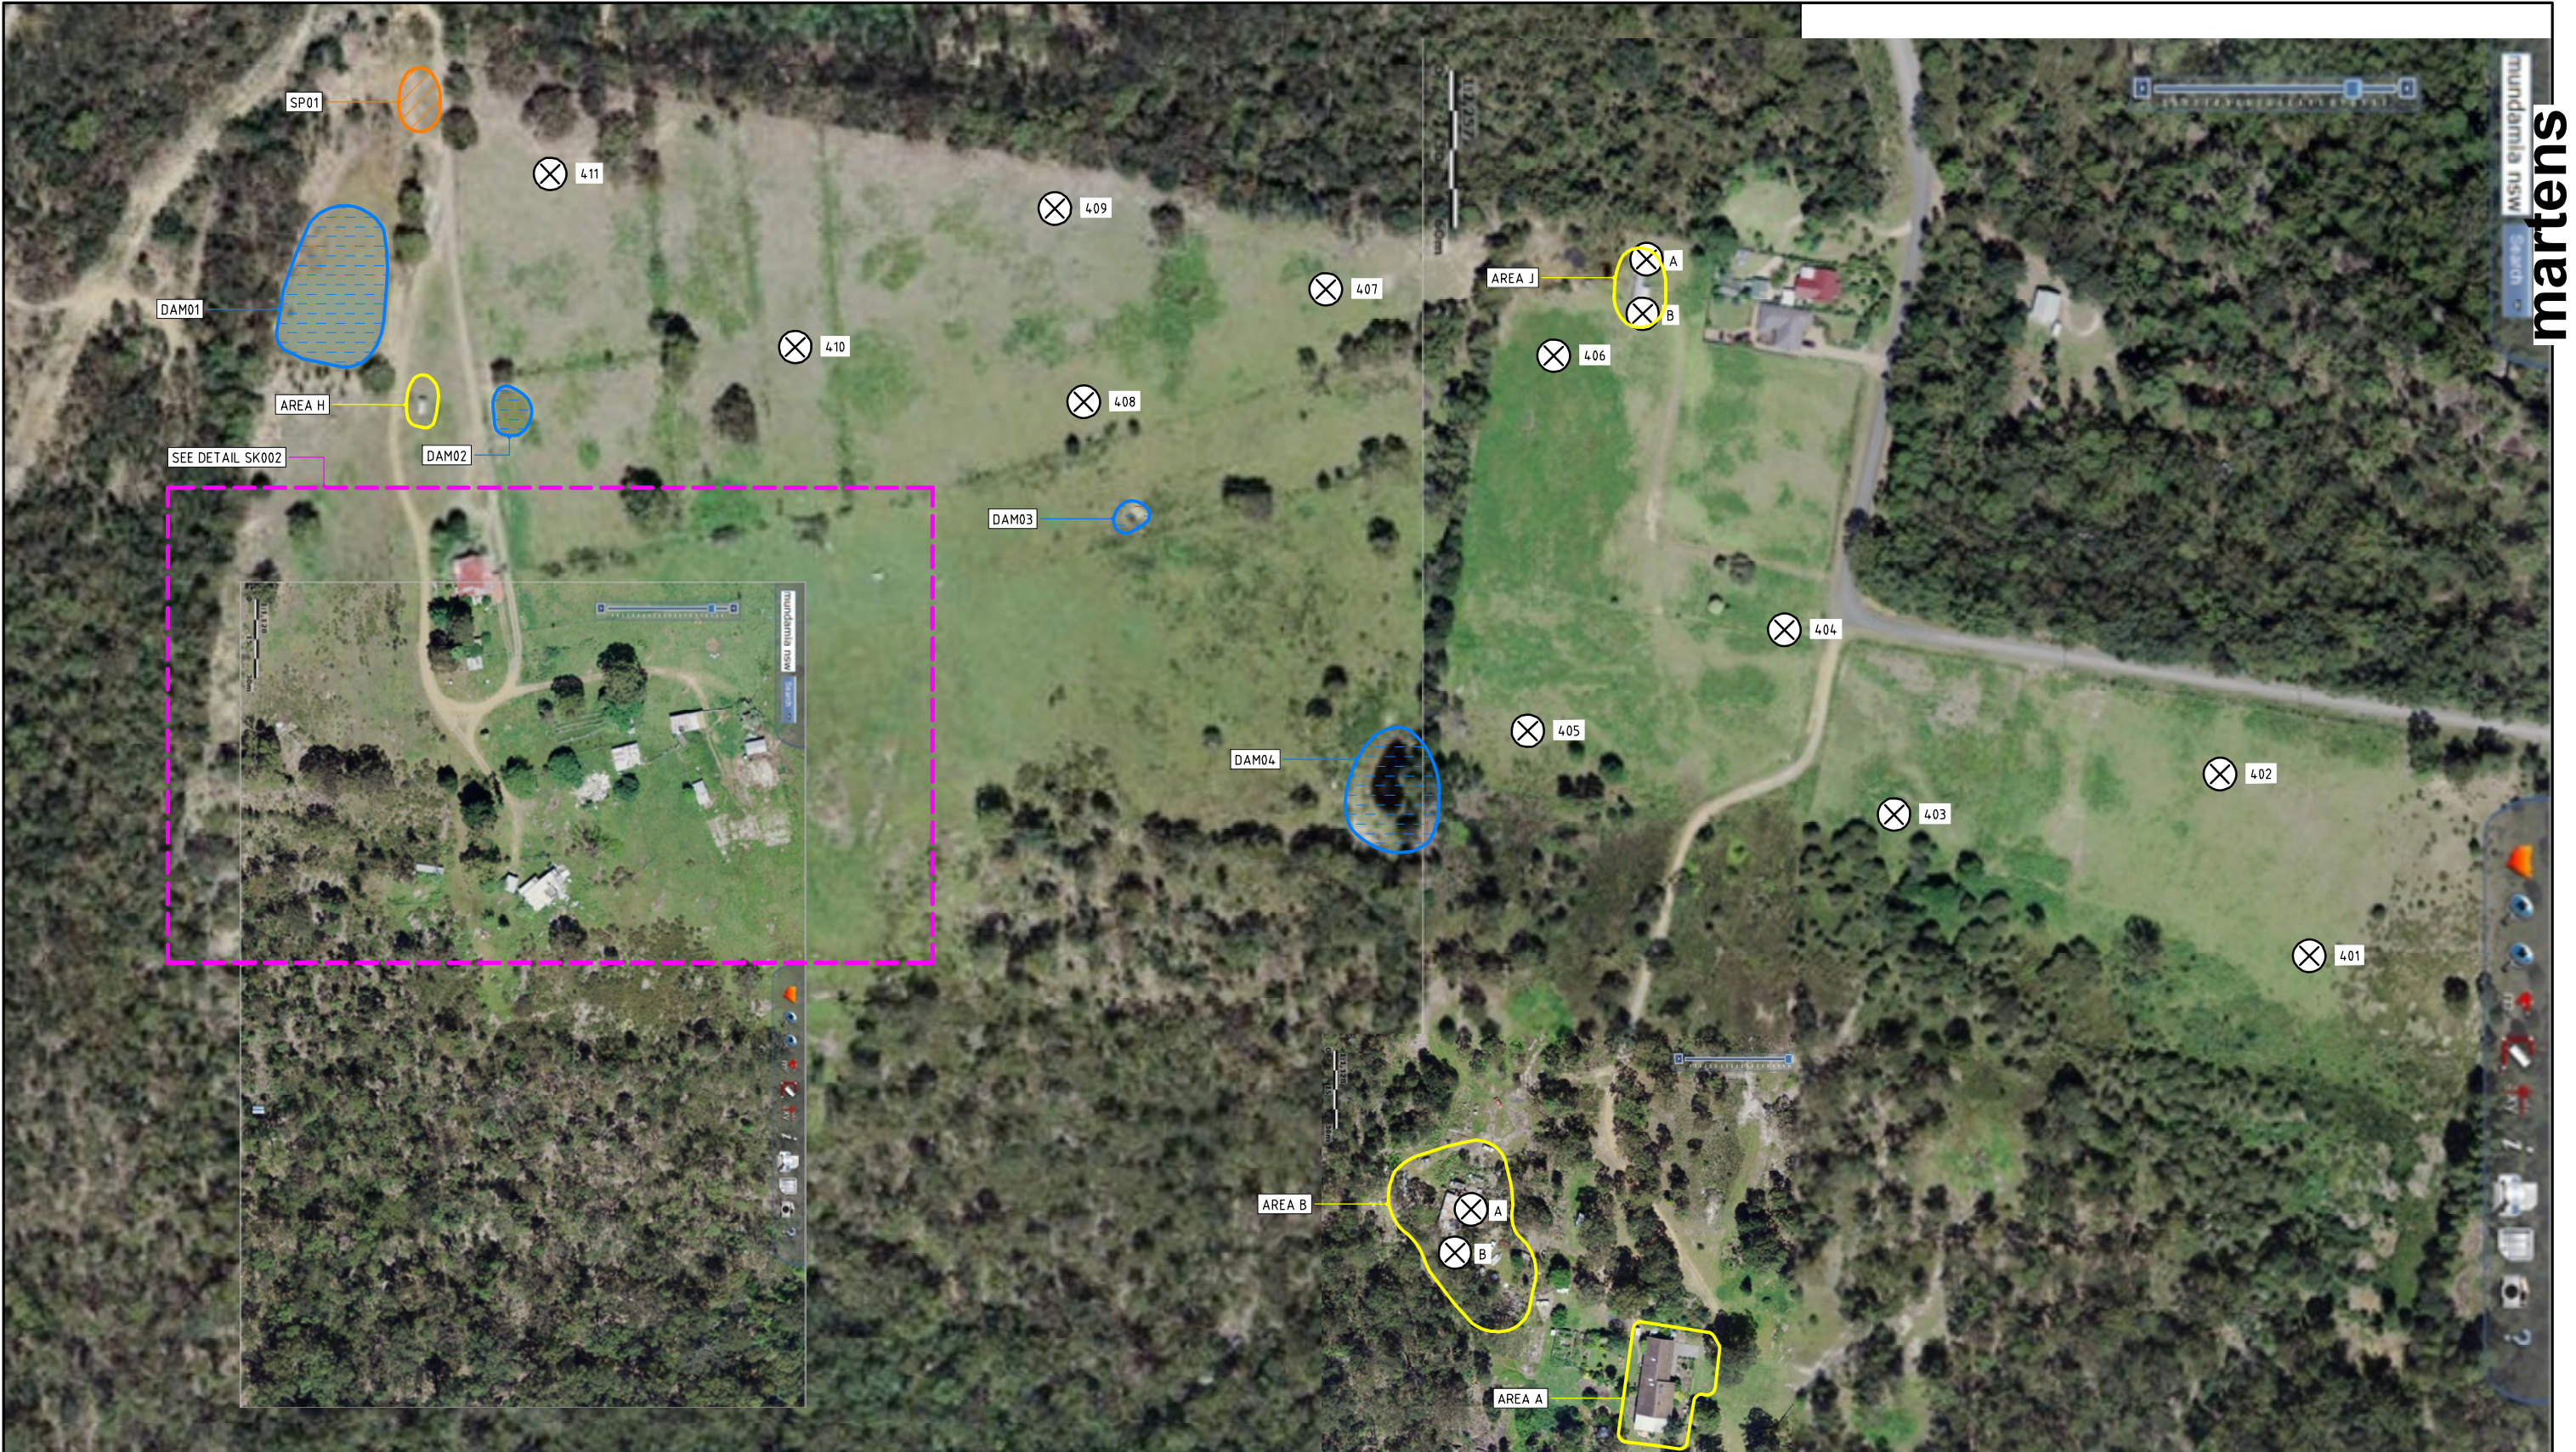
## 11 Attachment A – Site Plan

Previous reports have identified contamination in excess of adopted project SILs. Samples are summarised in Table 2 and locations are shown in Attachment A.

Remedial excavation will target and excavate the area identified in MA (2012) as “Area B” and, following asbestos survey, any areas found to contain ACM. Remediation procedure includes:
