6.6 BUILDING D

6.6.1 Proposed Works to Building D

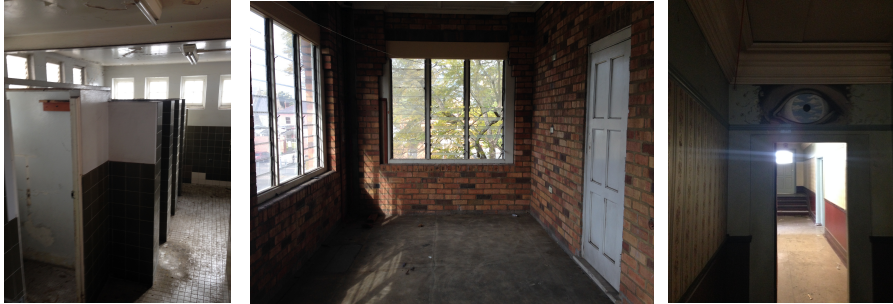
</div> <p>Figures 123, 124, 125: Amenities on the ground floor, the louvre windows to the level two verandahs, and the typical internal floors and walls at level two, all to be removed.</p> <p>Source: Tonkin Zulaikha Greer Architects, 2016.</p>

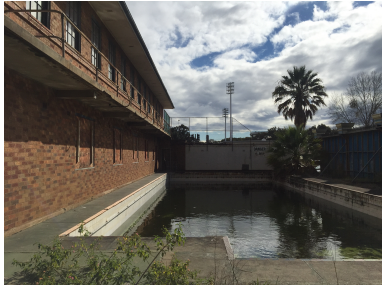
<p>Figure 127: View across the existing swimming pool, to be retained and adaptively re-used. The floor slab of Building F is to be removed. Note: Demolition of Building F (to ground slab level) was included in the Early Works Package. Source: Tonkin Zulaikha Greer Architects, 2016.</p>

Significance	Moderate
Use	Site for new School Hall
Demolition	<ul style="list-style-type: none"> • Demolition of Building F ground floor slab. • Retention of the swimming pool and retaining wall on northern side. • Removal and capping off of redundant services.
