A): ARBORICULTURAL IMPACT ASSESSMENT

B). TREE MANAGEMENT PLAN

Alexandria Park Community School  
7-11 Park Road,  
Alexandria NSW

Prepared 14 August 2017  
Revised 1 September 2017  
Ref: 2781

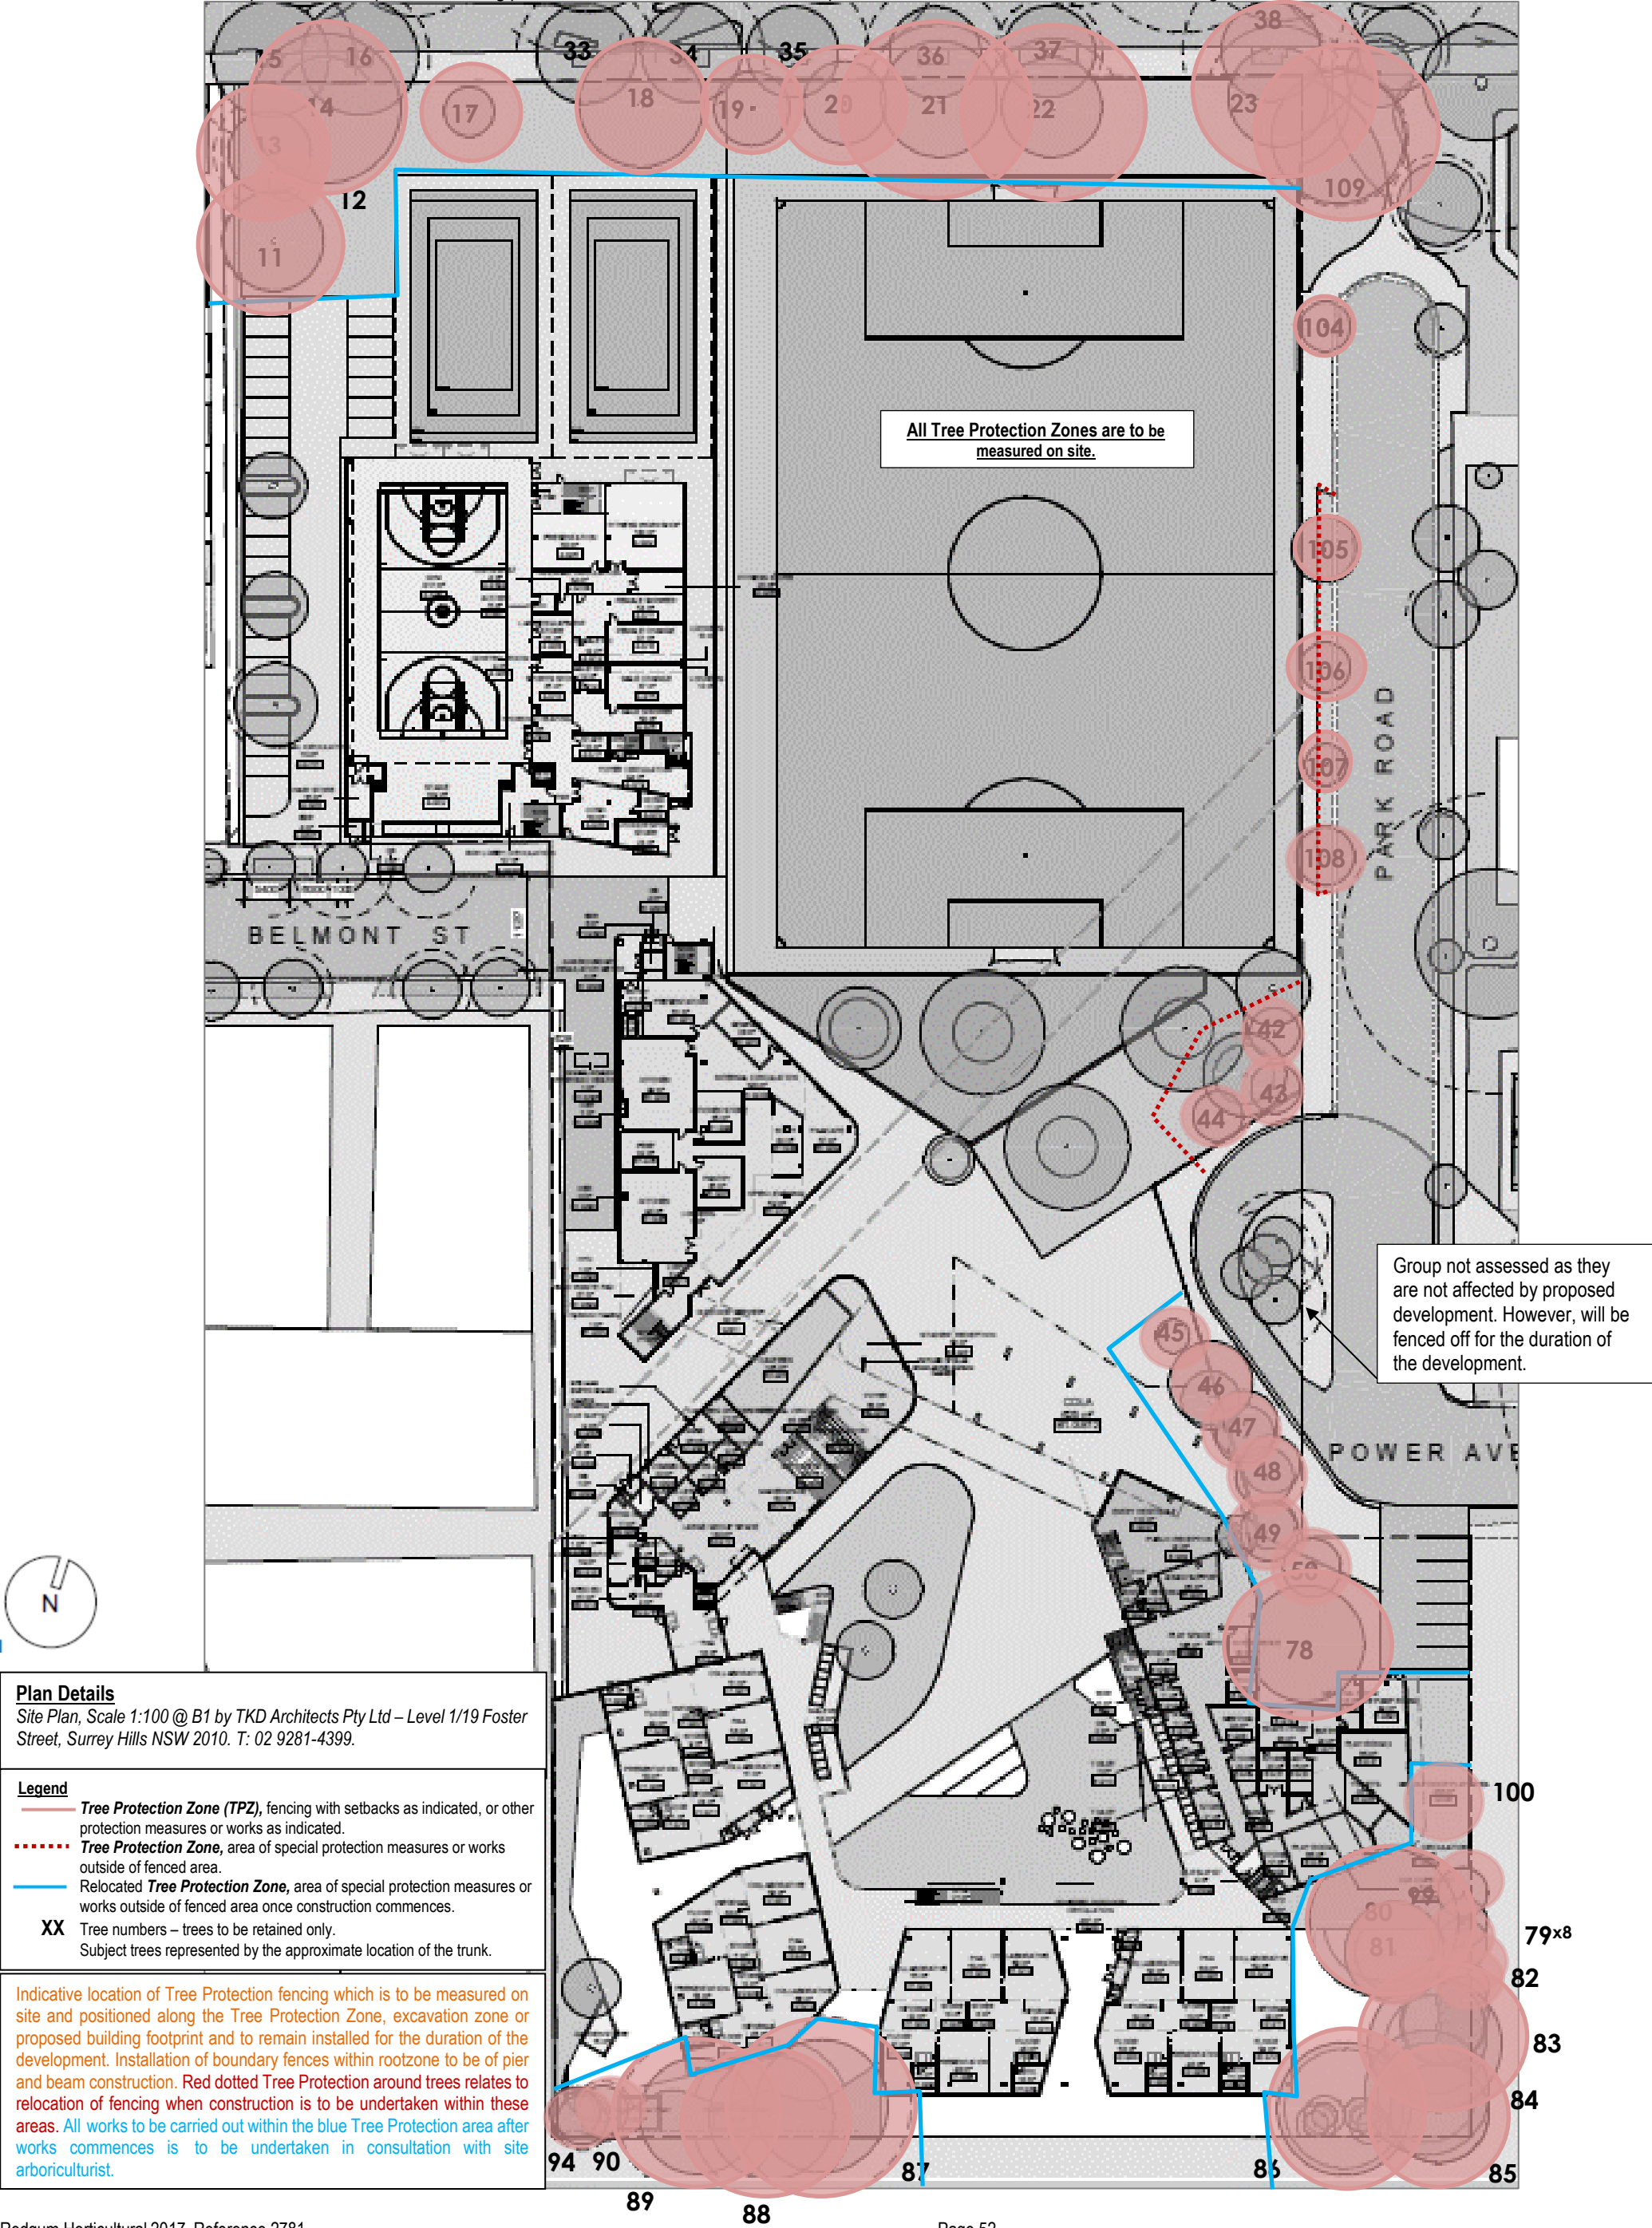
## Site Plan - Redgum Survey of Subject Trees to be Retained & Tree Protection Zones

This report has relied upon the following plan/s and documents which has been reproduced from electronic transmission and no longer to original scale.
