VISUAL IMPACT ASSESSMENT

KARIONG SAND AND SOIL SUPPLIES LOT 4 DP 227279 | 90 GINDURRA ROAD SOMERSBY, NSW

Prepared for: Jackson Environment & Planning on behalf of Mr & Mrs Ray and Sue Davies

Project No: 1569 Issue: FINAL (REVISION E) Date: 9 JANUARY 2019

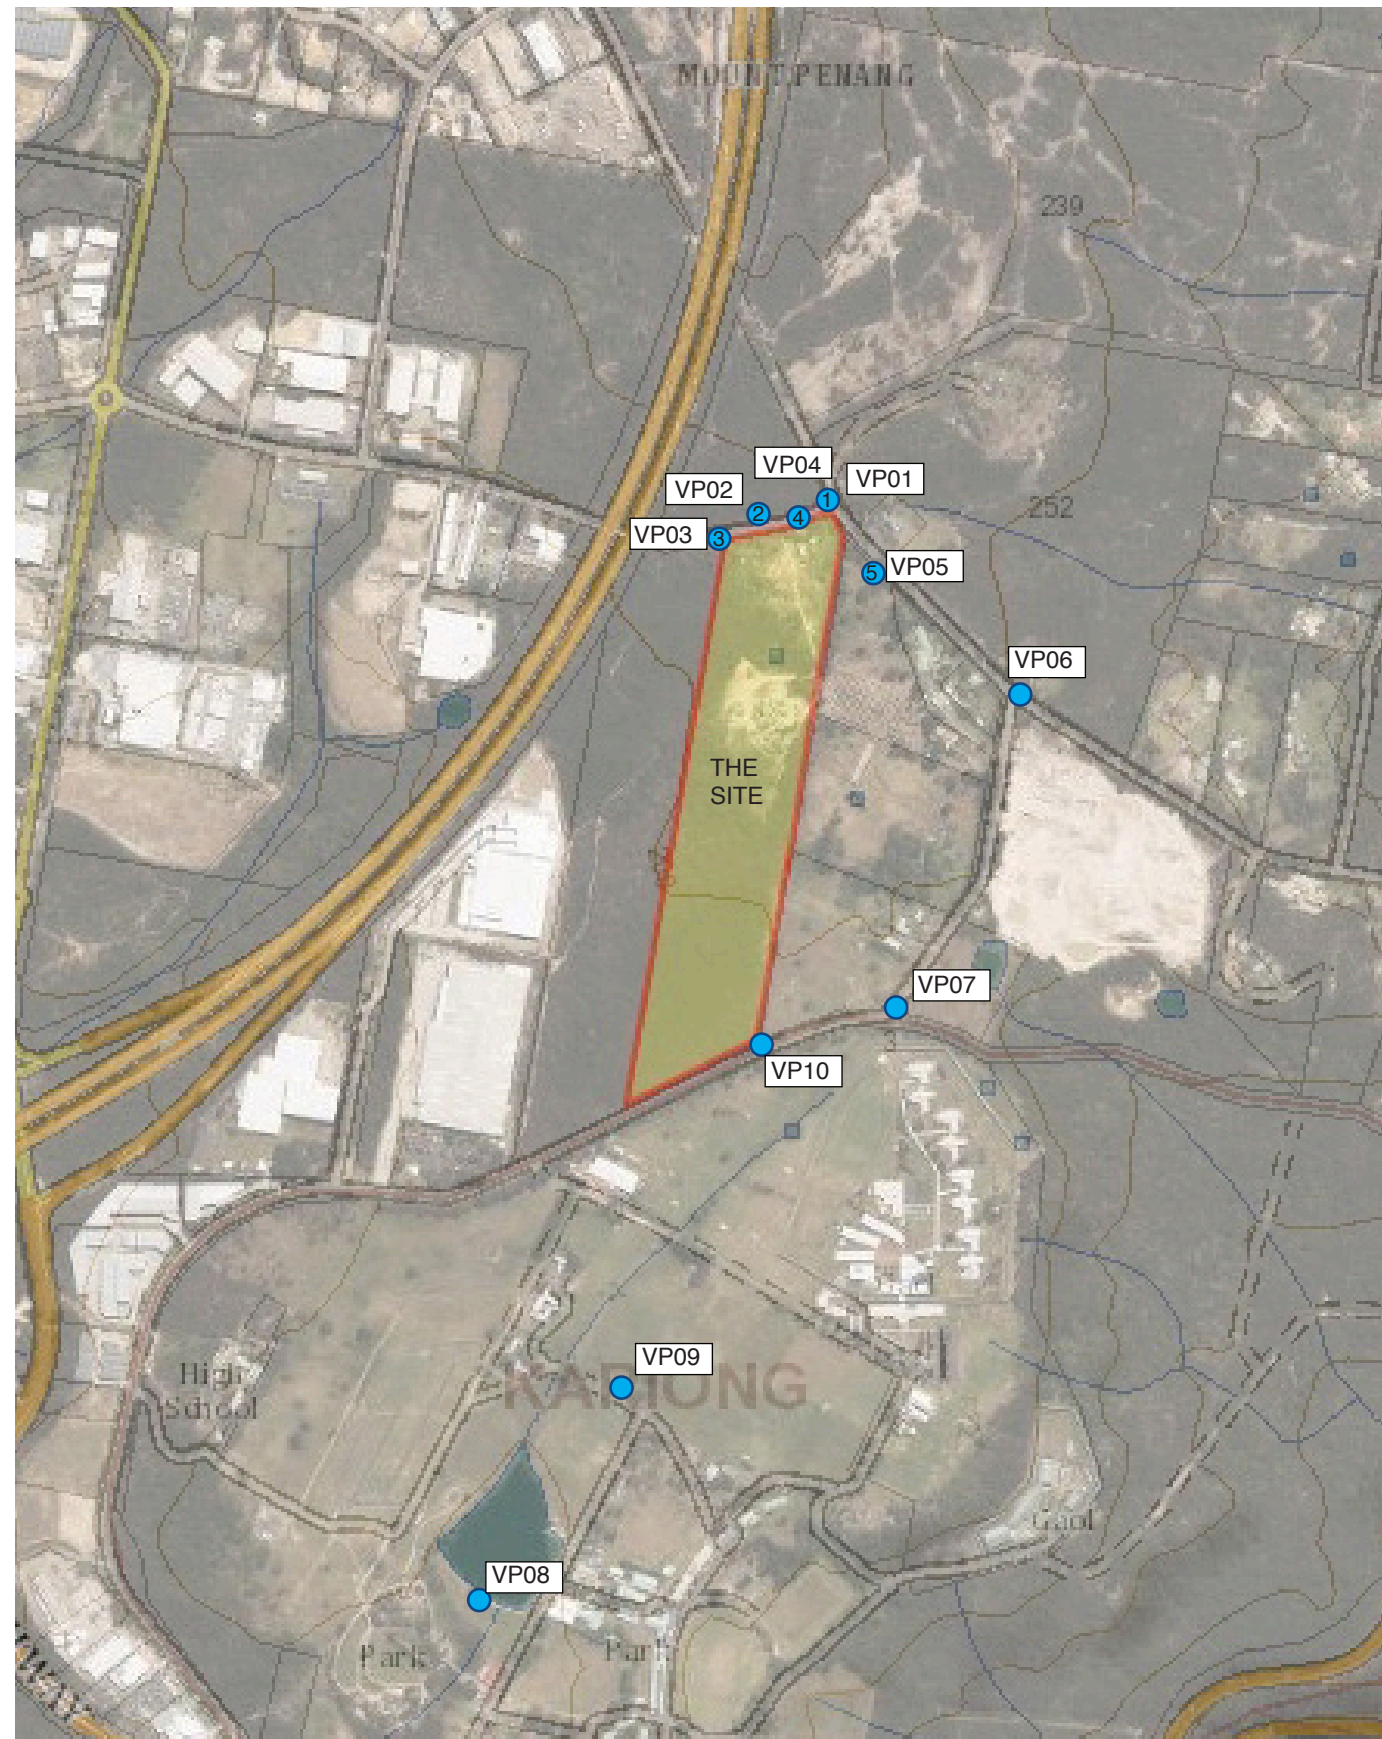
FIGURE 6: Viewpoint Assessment Locations

A total of **10 viewpoints** were recorded as part of the field work process. The majority of these viewpoints were taken from publicly accessible roads surrounding the site. The viewpoints which have been included represent the areas from where the development would appear most prominent, either based on the degree of exposure or the number of people likely to be affected.

The visual impact of the viewpoint was then assessed both on site and with the topographic and aerial information to ensure accuracy. Viewpoint photographs and analysis is included in the following pages. The findings of the viewpoint analysis have been quantified and are summarised in **Table 3**.

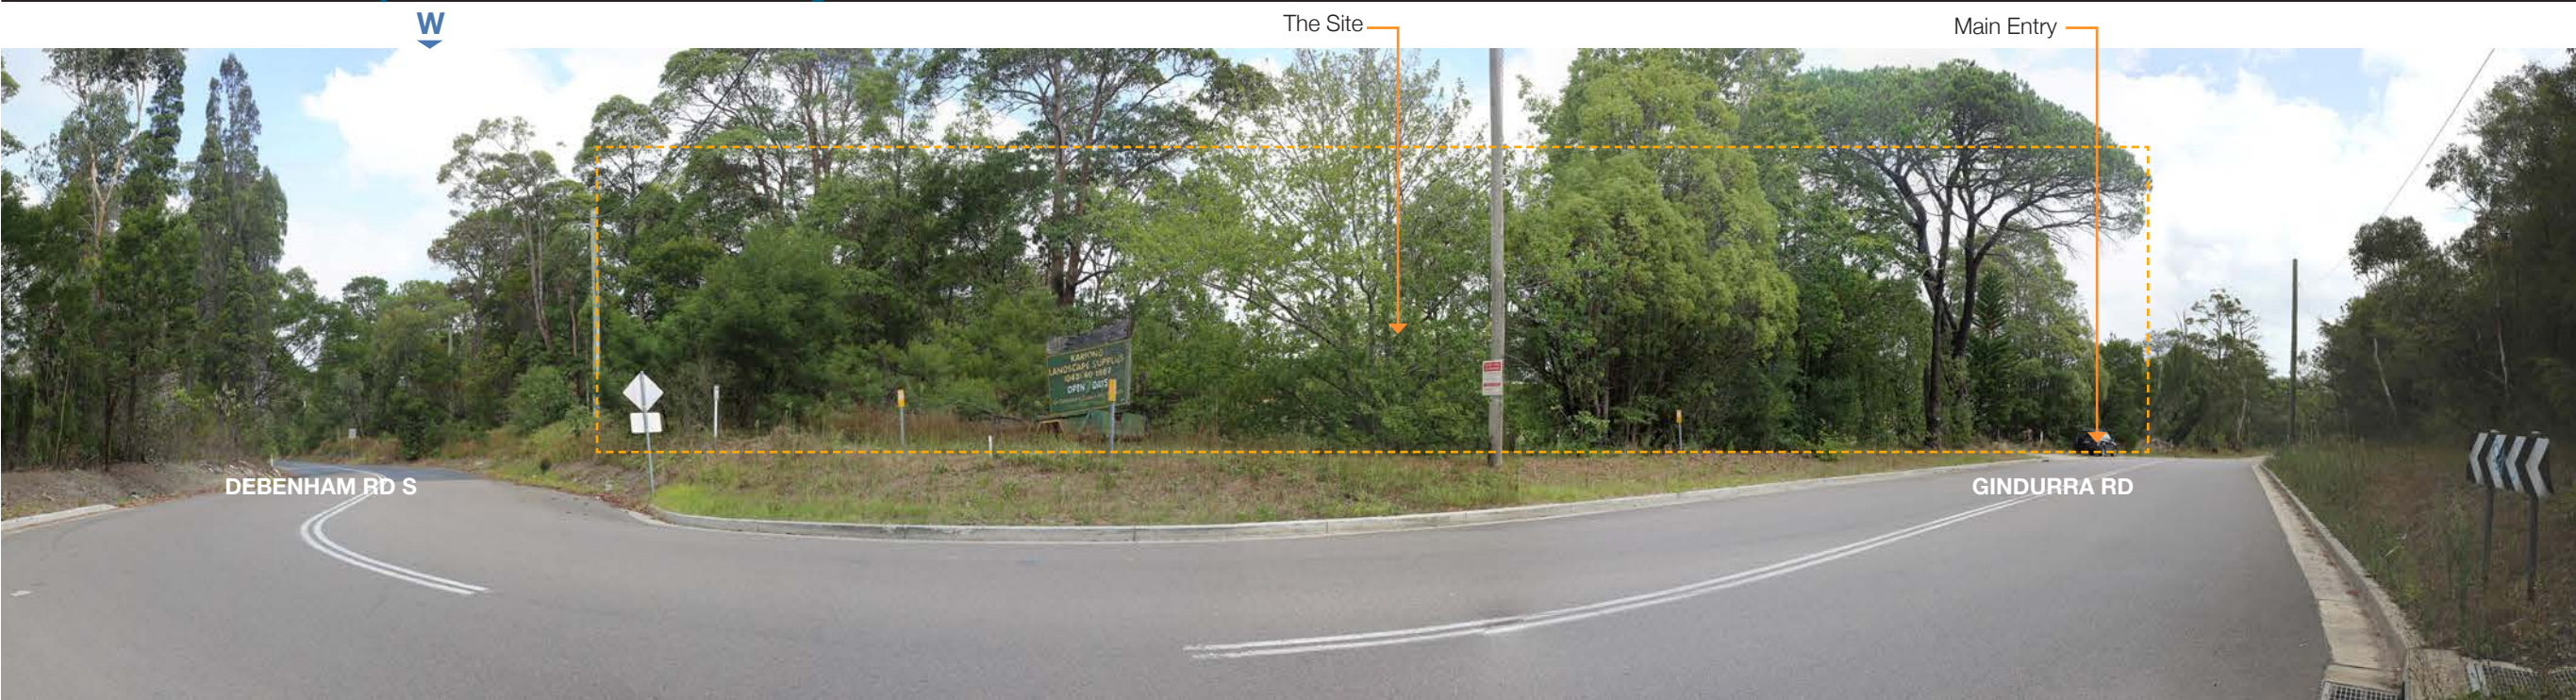
VIEWPOINT 01 View from corner of Gindurra Rd and Debenham Road S

VIEWPOINT 01			
SUMMARY OF VIEWPOINT		VIEWPOINT DESCRIPTION	POTENTIAL VISUAL IMPACT
LOCATION	Cnr Gindurra RD and Debenham Road S	This photograph was taken from the intersection of Gindurra Rd and Debenham Rd S with a view towards the site. The main entry to the site is visible as is signage for the previous operation of the site as a landscape supplies centre.	From this location views into the Site are fragmented by the vegetation along the northern boundary which fronts Gindurra Rd. The noise barrier will be visible from the road along the boundary.
COORDINATES	33° 21'54.94S 151° 18.0'39"E		
ELEVATION	217m	This section Gindurra Rd and Debenham Rd S is characterised by dense roadside vegetation that restricts views into properties. Vegetation is primarily mixed native plantings.	The visual effect has been assessed as <i>high</i> due to proximity of the noise wall to the road and removal of vegetation along the boundary. The resulting visual impact would be <i>high</i> from this viewpoint. Refer photomontage PM01.

VIEWING DIRECTION	South West		
DISTANCE TO SITE	Approx. 20m		
LAND USE	Industrial/Rural Residential	Sensitivity to the development is between industrial uses (generally low) and residential (generally High or Moderate). The visual sensitivity of this viewpoint has been rated as <i>moderate</i> .	
VISUAL EFFECT	High		
VISUAL IMPACT	High

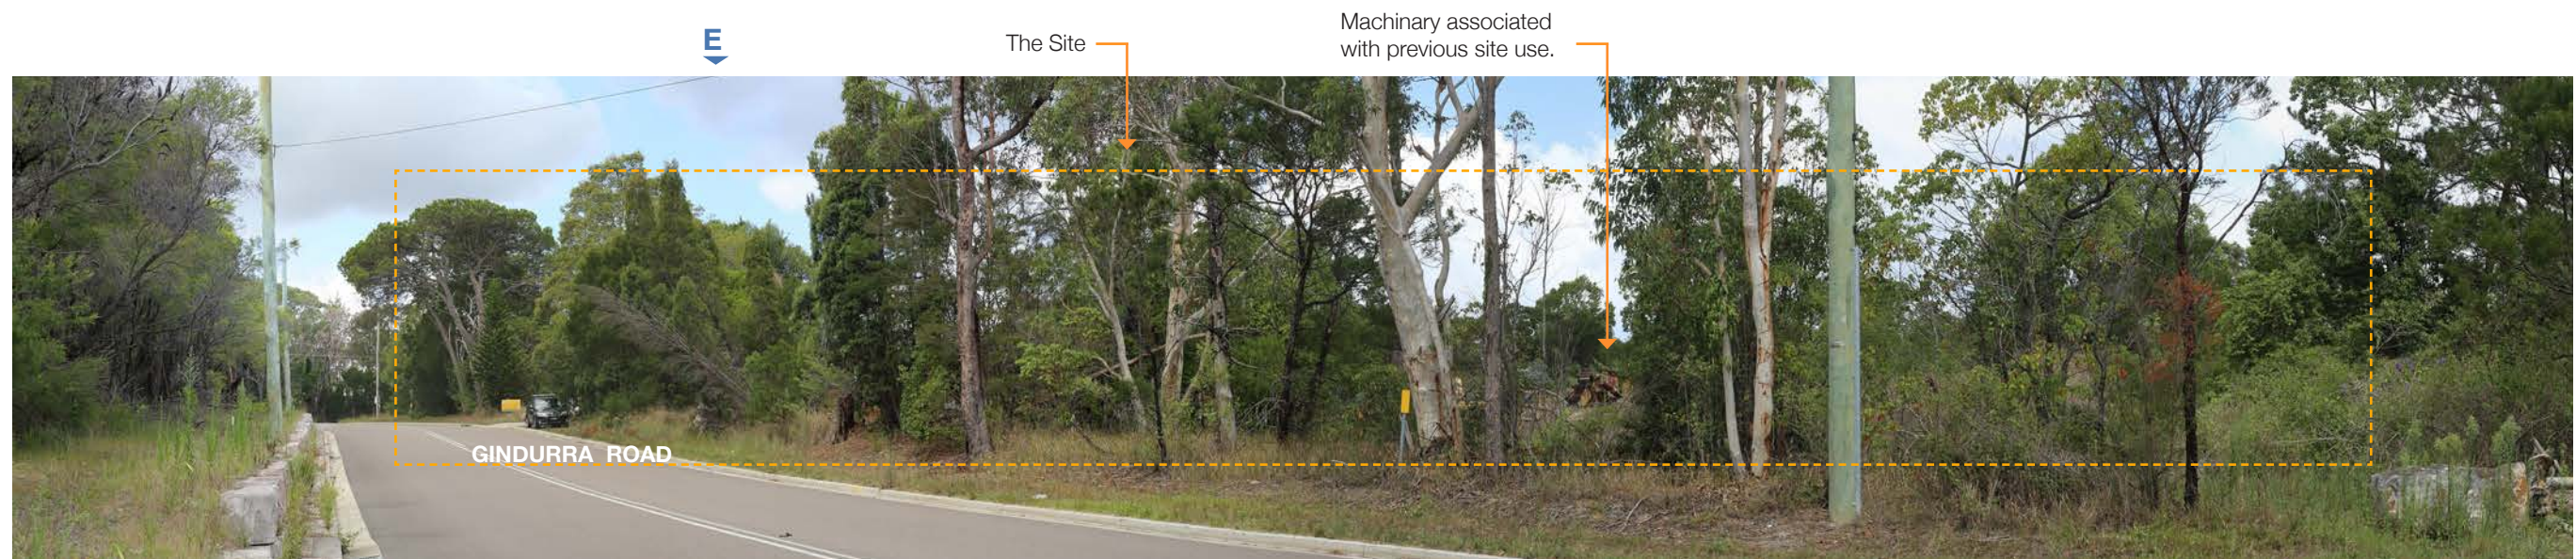
VIEWPOINT 02 View East on Gindurra Rd

VIEWPOINT 02			
SUMMARY OF VIEWPOINT		VIEWPOINT DESCRIPTION	POTENTIAL VISUAL IMPACT
LOCATION	Gindurra Road	This photograph was taken on Gindurra Road approximately in alignment with the north western boundary of the site.	From this location views into the Site are fragmented by the vegetation along the northern boundary which fronts Gindurra Rd. It is likely the proposed <i>office and maintenance building and noise barrier</i> would be partially visible through the vegetation.
COORDINATES	33° 24'53.53S 151° 17.54'12"E		
ELEVATION	212m	Machinery adjacent to the existing site sheds is visible in the middle of the photo. This demonstrates the extent of visual permeability of the roadside vegetation. Views into the site are largely fragmented and constrained by the vegetation.	
VIEWING DIRECTION	East		
DISTANCE TO SITE	Approx. 30m		
LAND USE	Industrial	The visual sensitivity from this viewpoint has been rated as <i>moderate</i> due to the proximity to the site, existing vegetation and current land use.	The visual effect has been assessed as <i>moderate</i> and the resulting visual impact would be <i>moderate</i> from this viewpoint.

VISUAL EFFECT	Moderate		
VISUAL IMPACT	Moderate

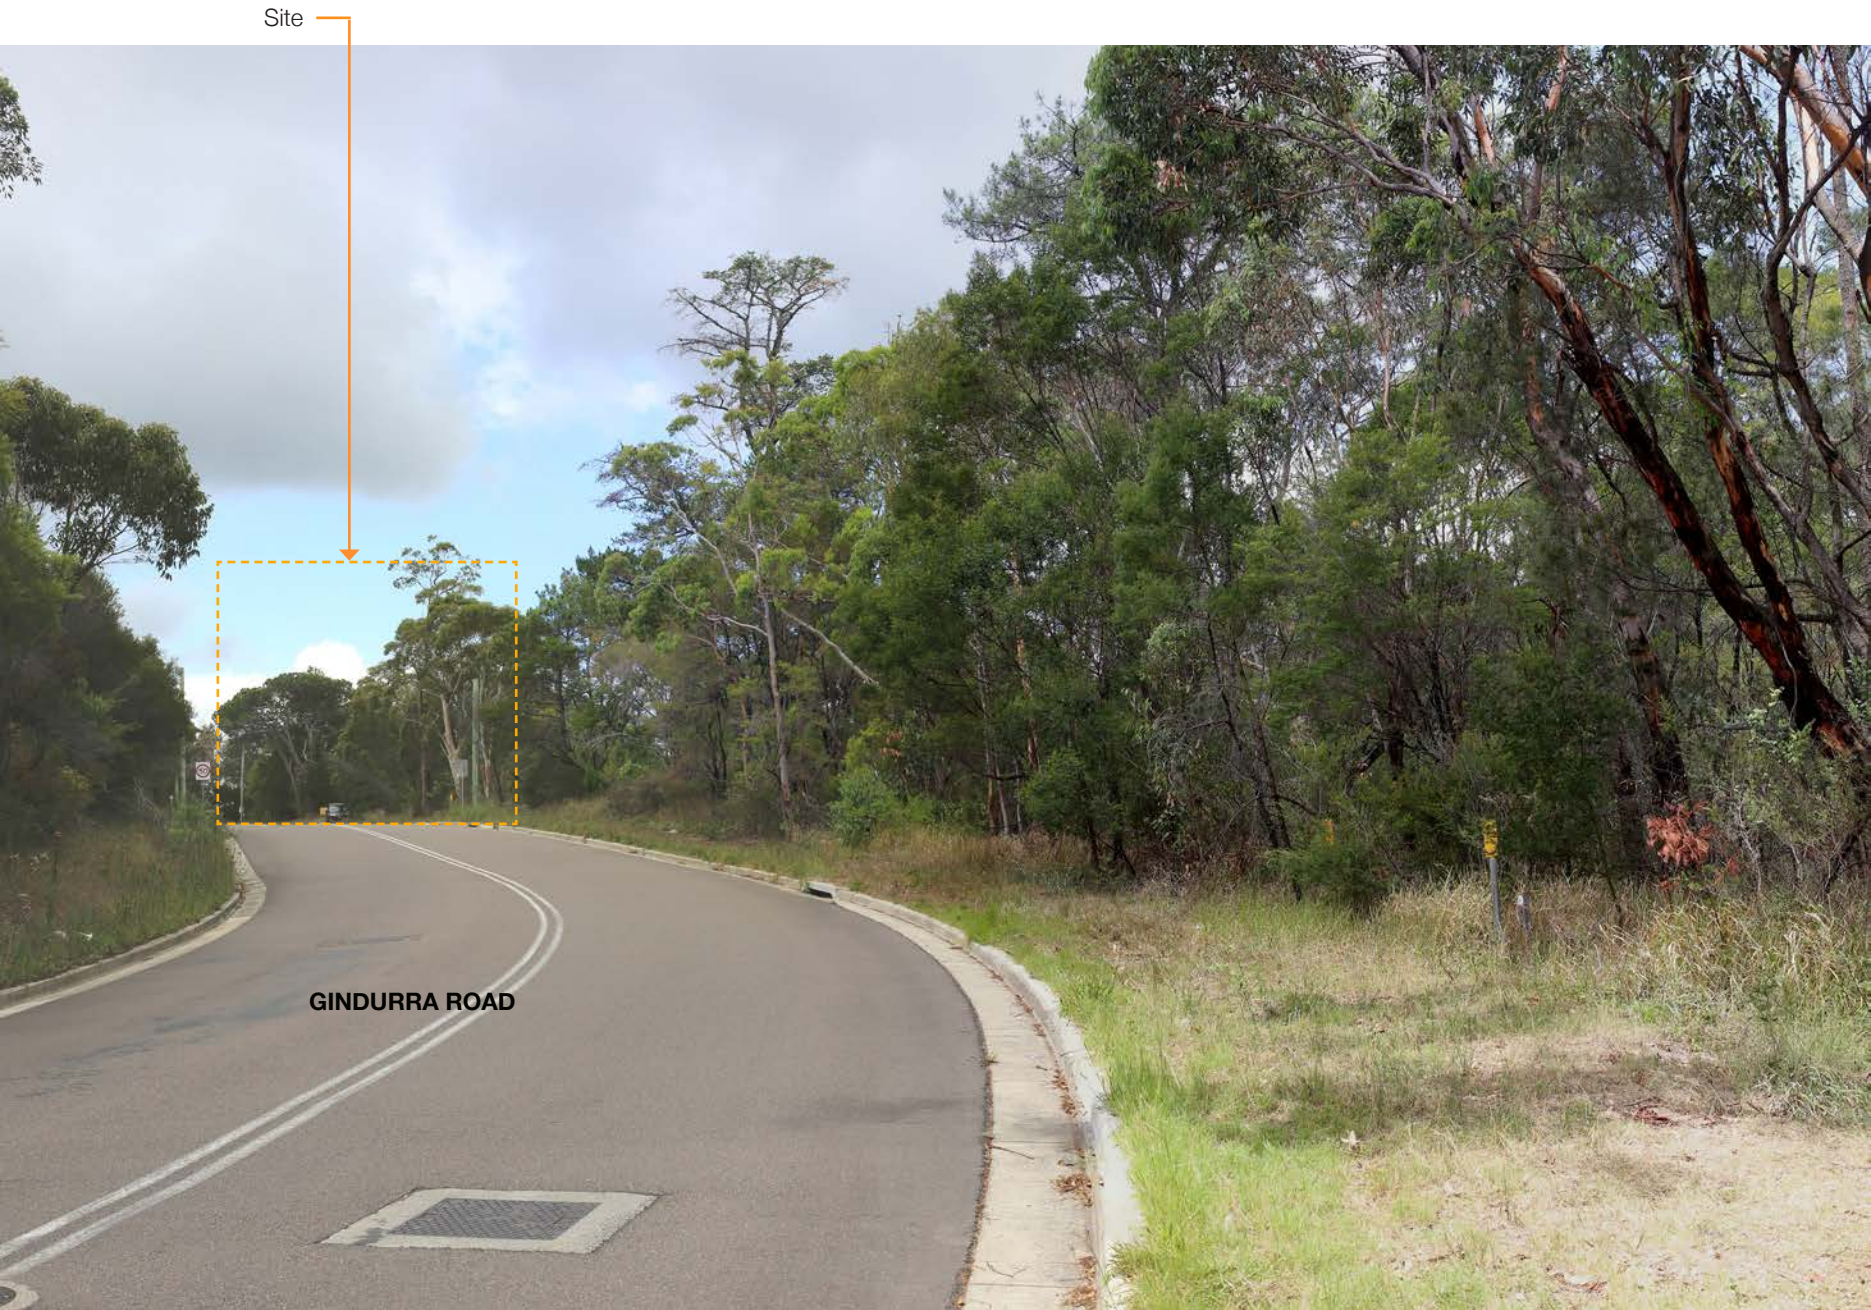
VIEWPOINT 03 View East along Gindurra Road..

VIEWPOINT 03			
SUMMARY OF VIEWPOINT		VIEWPOINT DESCRIPTION	POTENTIAL VISUAL IMPACT
LOCATION	Gindurra Road	This photograph was taken from the eastern edge of the Gindurra Road M1 tunnel. The signage associated with the site entry is visible on the road edge. Views toward the western boundary of the site are screened by roadside vegetation and by dense vegetation on the adjoining lot to the West.	From this viewpoint, the new development areas will be partially visible, generally associated with 2m high fencing along the perimeter. Existing vegetation provides substantial screening of the site. Proposed signage at the entry will likely be visible from this location and glimpses of the noise wall may be possible.
COORDINATES	33° 24'53.78S 151° 17.50'47"E		
ELEVATION	205m	The visual sensitivity of this viewpoint has been rated as moderate due to the significant roadside vegetation which dominates the character from this viewpoint, current land use and proximity.	The visual effect is likely to be moderate resulting in a moderate visual impact.

VIEWING DIRECTION	East		
DISTANCE TO SITE	Approx. 100m		
LAND USE	Industrial		
VISUAL EFFECT	Moderate		
VISUAL IMPACT	Moderate

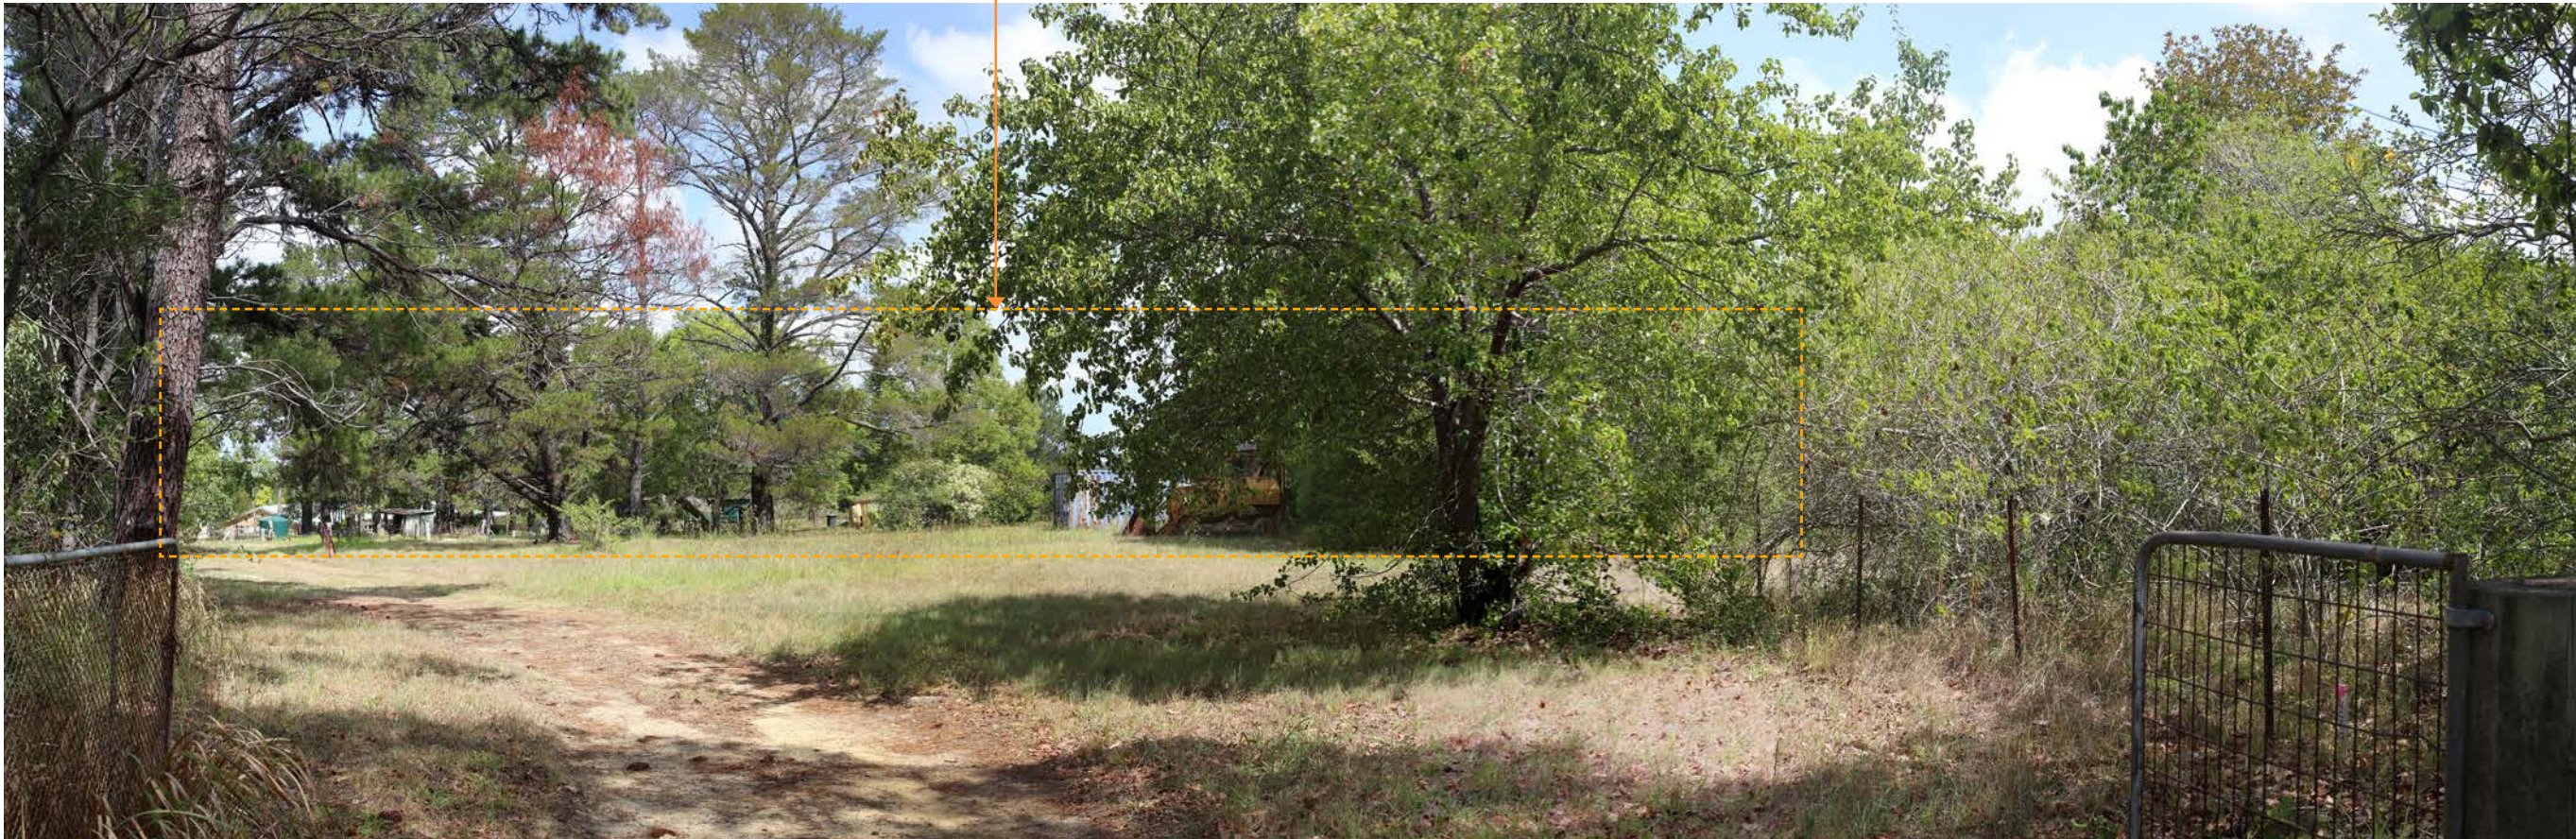
VIEWPOINT 05 View into neighbouring property towards site from access off Debenham Road S.

VIEWPOINT 05			
SUMMARY OF VIEWPOINT		VIEWPOINT DESCRIPTION	POTENTIAL VISUAL IMPACT
LOCATION	No.12 Debenham Road S	This photograph was taken from the entry to No.12 Debenham Road S. No 12 is the neighbouring property on eastern boundary of the site, The access has filtered views into the site through established trees that are situated across the boundary of both properties.	Views from the public domain are open due to construction of 5m noise wall and removal of mature boundary vegetation that would form a screen. The visual effect has been assessed as high due to proximity of the noise wall to public domain and removal of vegetation along the boundary. The resulting visual impact would be high from this viewpoint. Refer photomontage PM02
COORDINATES	33° 24'25.80"S 150° 17'58.17'E		
ELEVATION	213m	The visual sensitivity of this viewpoint has been rated as moderate due to the transition from industrial to rural residential land use.

VIEWING DIRECTION	South west		
DISTANCE TO SITE	Approx. 10m		
LAND USE	Rural		
VISUAL EFFECT	High		
VISUAL IMPACT	High

The residence associated with the access off Debenham Rd S (as identified in Viewpoint 05) is likely to experience a change in character of their view to the West, in particular as a result of the proposed 5m noise attenuation fencing that is to be positioned along the eastern boundary.

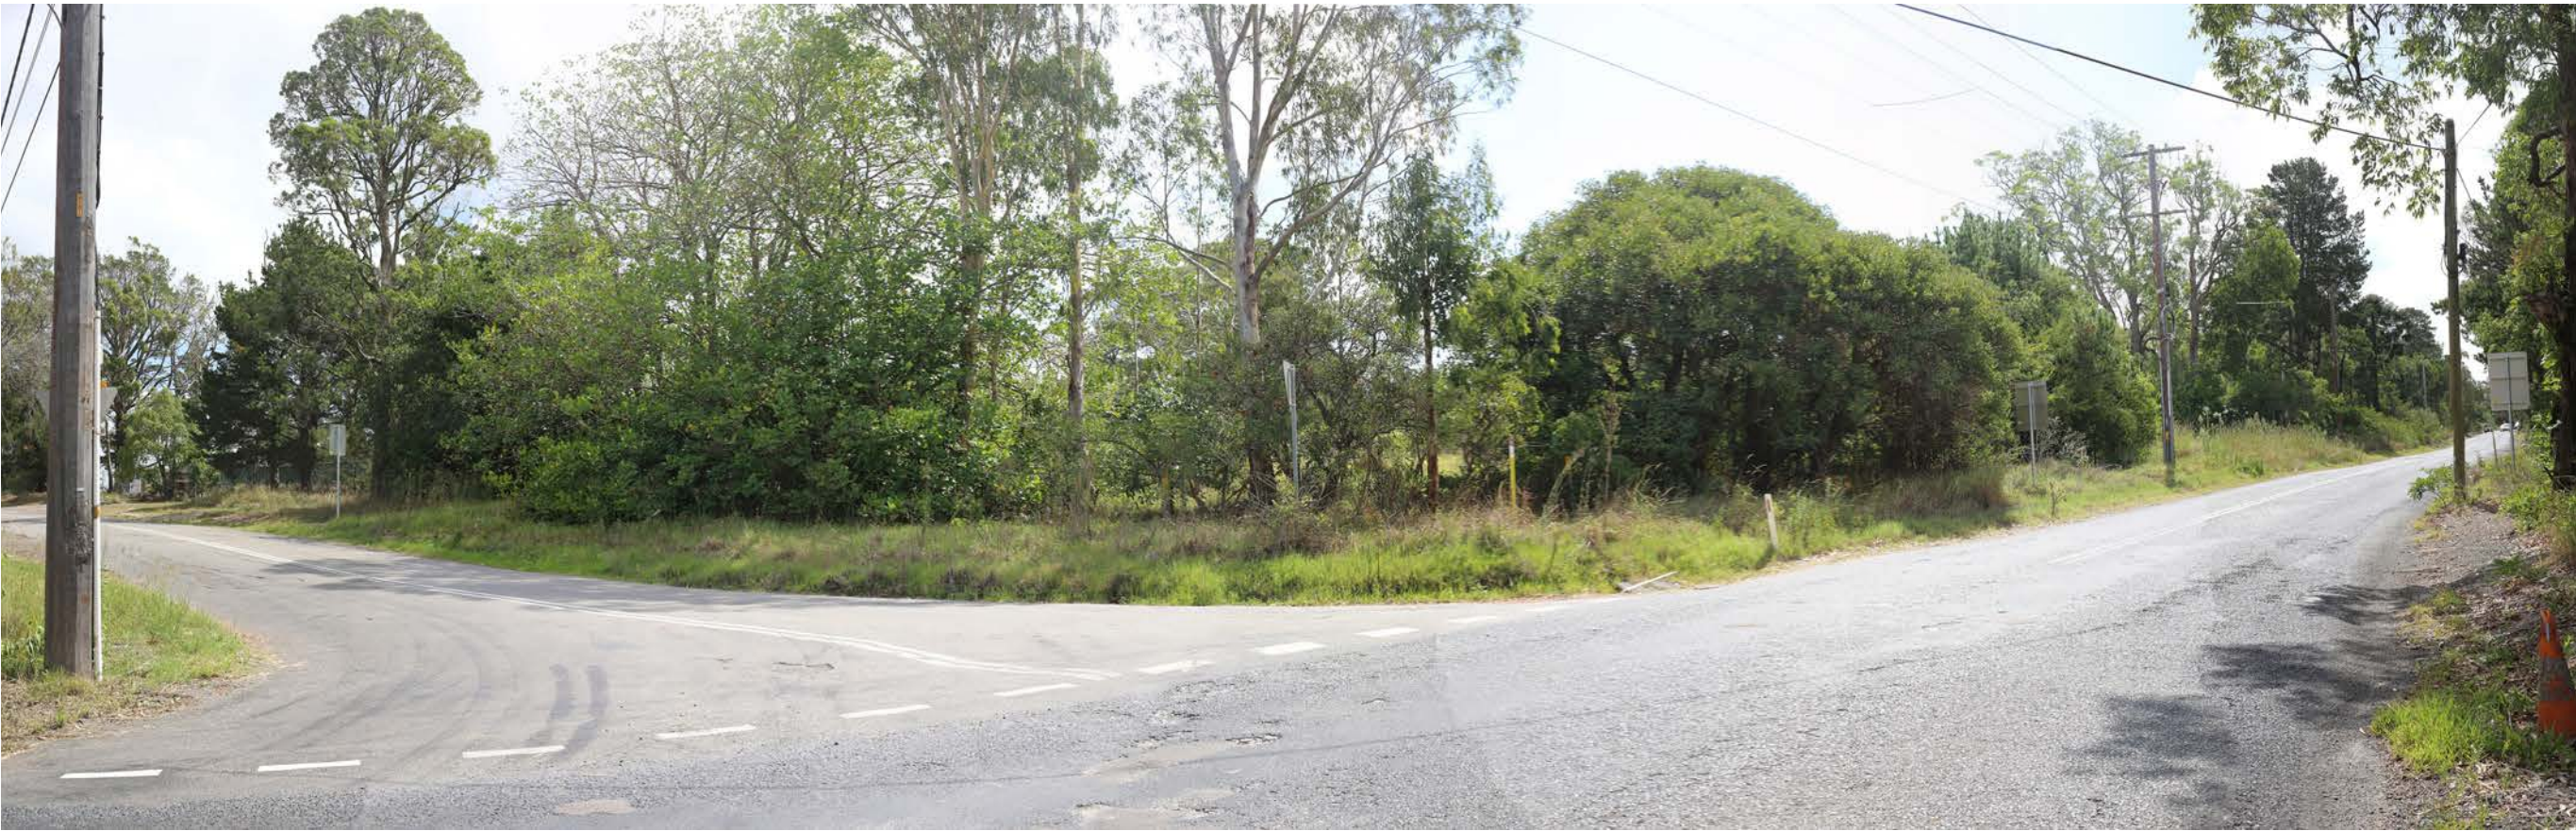
VIEWPOINT 06 View West from the corner of Debenham Rd S and Acacia Rd.

VIEWPOINT 06			
SUMMARY OF VIEWPOINT		VIEWPOINT DESCRIPTION	POTENTIAL VISUAL IMPACT
LOCATION	Corner Debenham Rd S and Acacia Rd	This photograph was taken from the corner of Debenham Road S and Acacia Rd. Although only 250m distance from the site extensive roadside vegetation provides significant screening.	From this location views into the site are largely screened by the existing vegetation along roadside and through the adjoining property.
COORDINATES	33° 25'0.35"S 151° 18'9.72"E		
ELEVATION	192m	Several layers of vegetation associated with the neighbouring residence between the viewpoint and the site form part of the character of the land use transition from industrial to rural residential.	Glimpses of the noise attenuation may be visible due to removal of vegetation and proximity to the site.
VIEWING DIRECTION	West		
DISTANCE TO SITE	Approx. 255m	The visual sensitivity of this viewpoint has been rated as moderate due to the rural character of the site.	Due to close proximity and partially visibility of the site the visual effect is moderate .

LAND USE	Rural Residential		
VISUAL EFFECT	Moderate		
VISUAL IMPACT	Moderate		Visual Impact from this location is moderate .

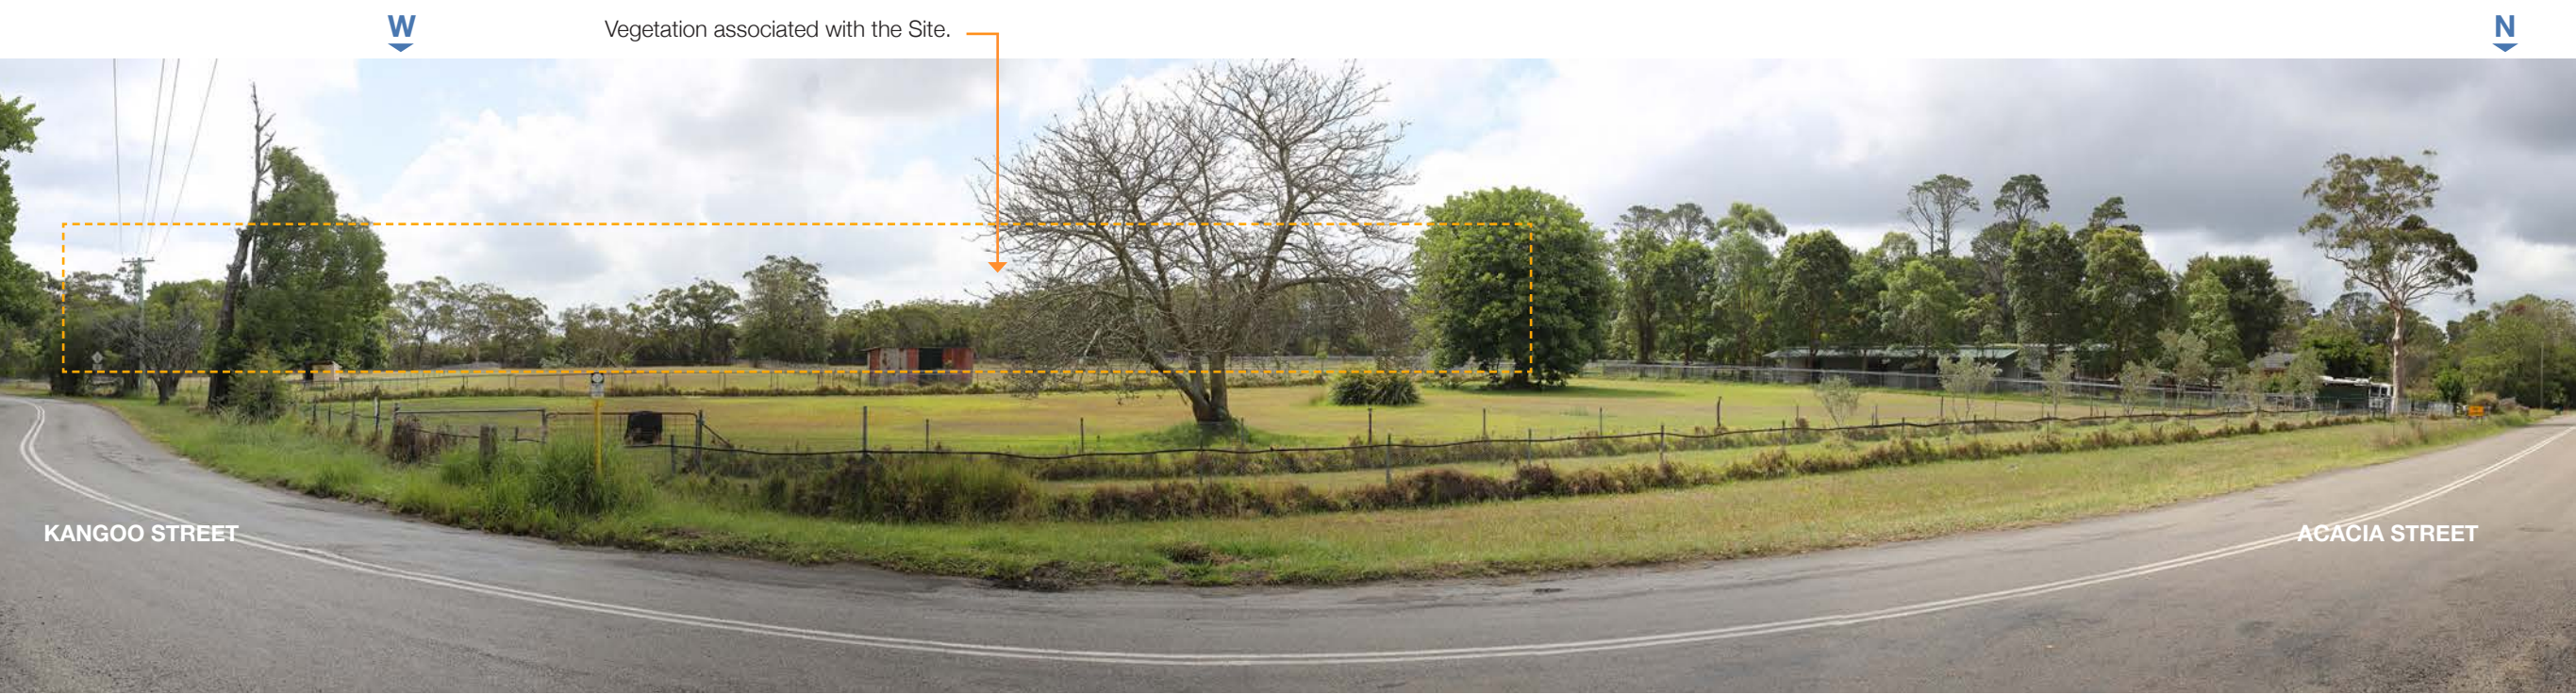
VIEWPOINT 07 View from North West across the neighbouring property from Kangoo and Acacia Roads.

VIEWPOINT 07			
SUMMARY OF VIEWPOINT		VIEWPOINT DESCRIPTION	POTENTIAL VISUAL IMPACT
LOCATION	Intersection of Kangoo Rd and Acacia Rd	This photograph was taken from the location where Kangoo Rd transitions into Acacia Road. The visual sensitivity of this location has been rated as <i>moderate</i> due to the rural residential land use.	From this location views towards the site are open and partial views to the southern end of the noise wall may be possible.
COORDINATES	33° 25' 13.69"S 151° 18' 02.85"E		Views to the proposed development area are screened by site vegetation at the southern end of the lot and mature vegetation on neighbouring lots.
ELEVATION	193m		
VIEWING DIRECTION	North West		As the site is partially visible the visual effect is assessed as <i>moderate</i> . Visual Impact from this location is <i>moderate</i> .
DISTANCE TO SITE	Approx. 193m		
LAND USE	Rural Residential		
VISUAL EFFECT	Moderate

VISUAL IMPACT	Moderate

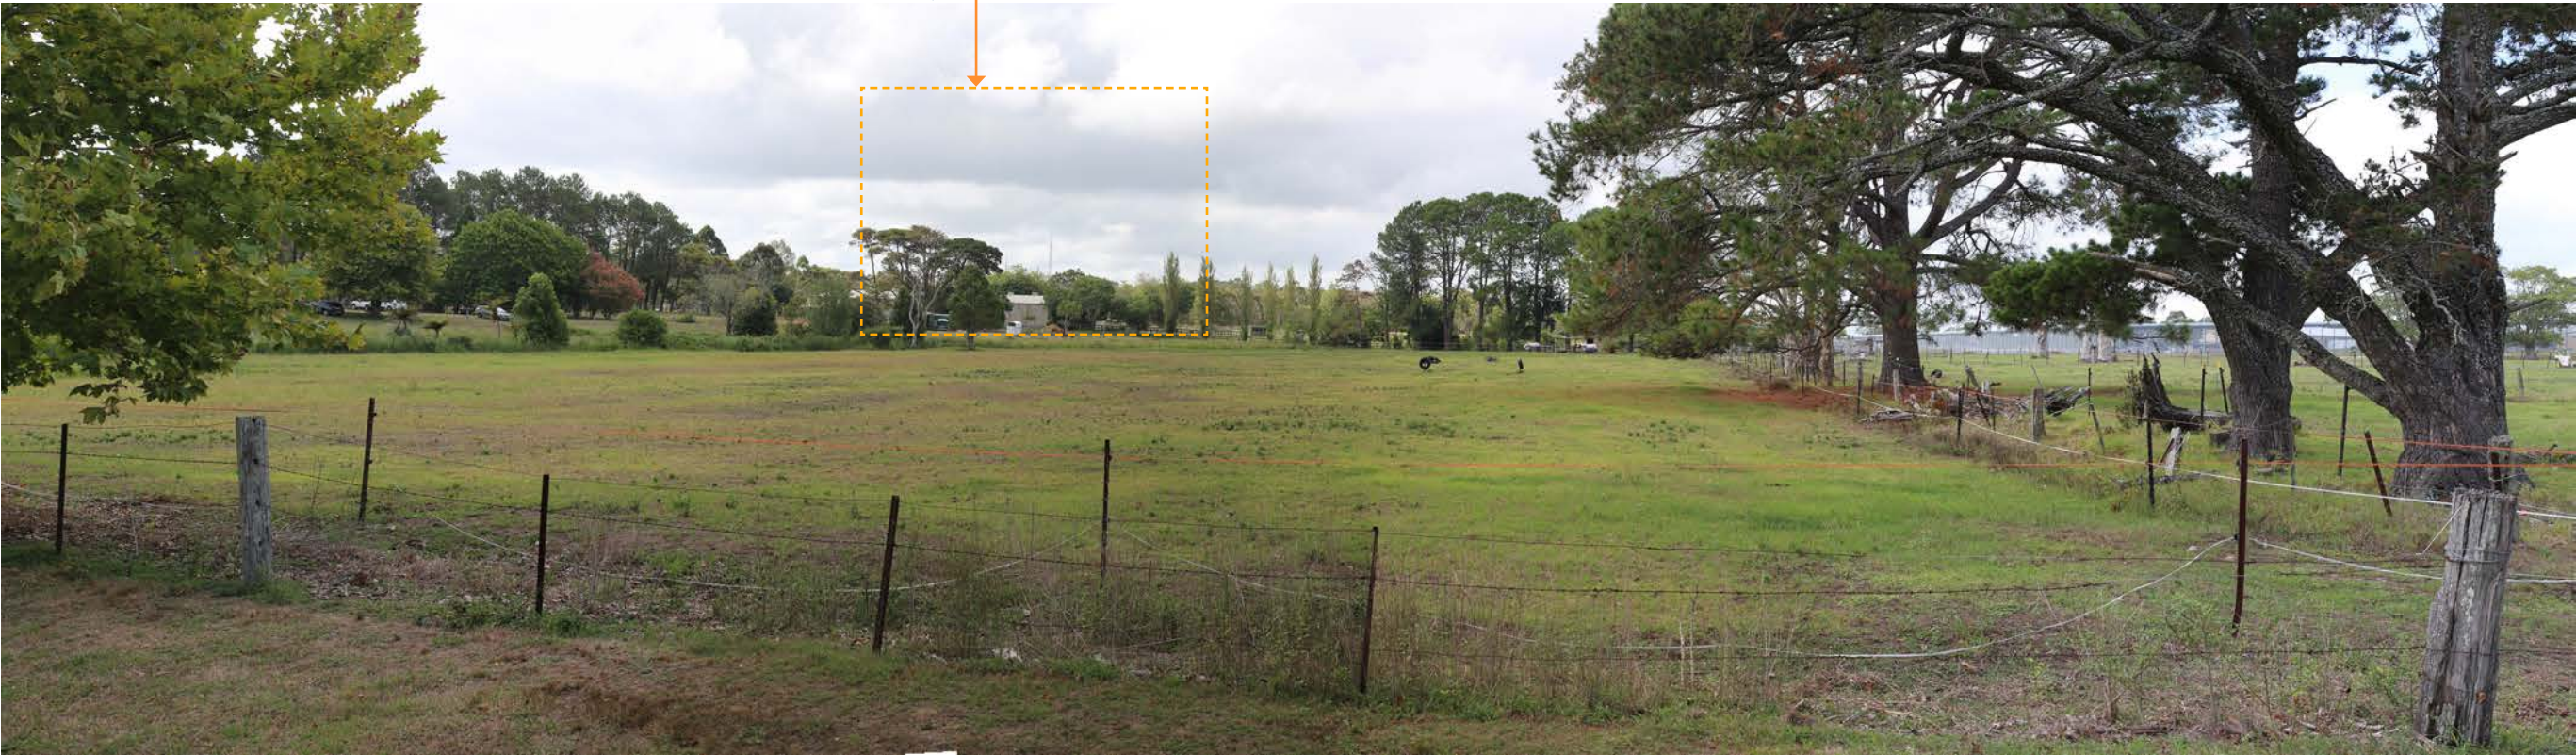
VIEWPOINT 09 View from McCabe Rd, Mt Penang Gardens

VIEWPOINT 09			
SUMMARY OF VIEWPOINT		VIEWPOINT DESCRIPTION	POTENTIAL VISUAL IMPACT
LOCATION	McCabe Drive, Mt Penang Gardens	This photograph was taken from McCabe Rd within Mt Penang Gardens. The Gaol is visible in the right of photo. The existing character retains the previous agricultural use of the site.	From this location views towards the site are screened by vegetation.
COORDINATES	33° 25’ 29.7”S 151’ 17’49.88”E		
ELEVATION	184m		
VIEWING DIRECTION	North	Extensive roadside vegetation associated with the parklands, Kangoo Rd and the southern portion of the screen any views to the development area of the site.	The proposal will <i>not</i> be visible from this location creating <i>nil</i> Visual effect and subsequently <i>nil</i> Visual Impact.
DISTANCE TO SITE	Approx. 800m (to development area)		
LAND USE	Recreation/Open Space		
VISUAL EFFECT	Nil	The visual sensitivity of this location has been rated as <i>high</i> due to the recreational land use.

VISUAL IMPACT	Nii

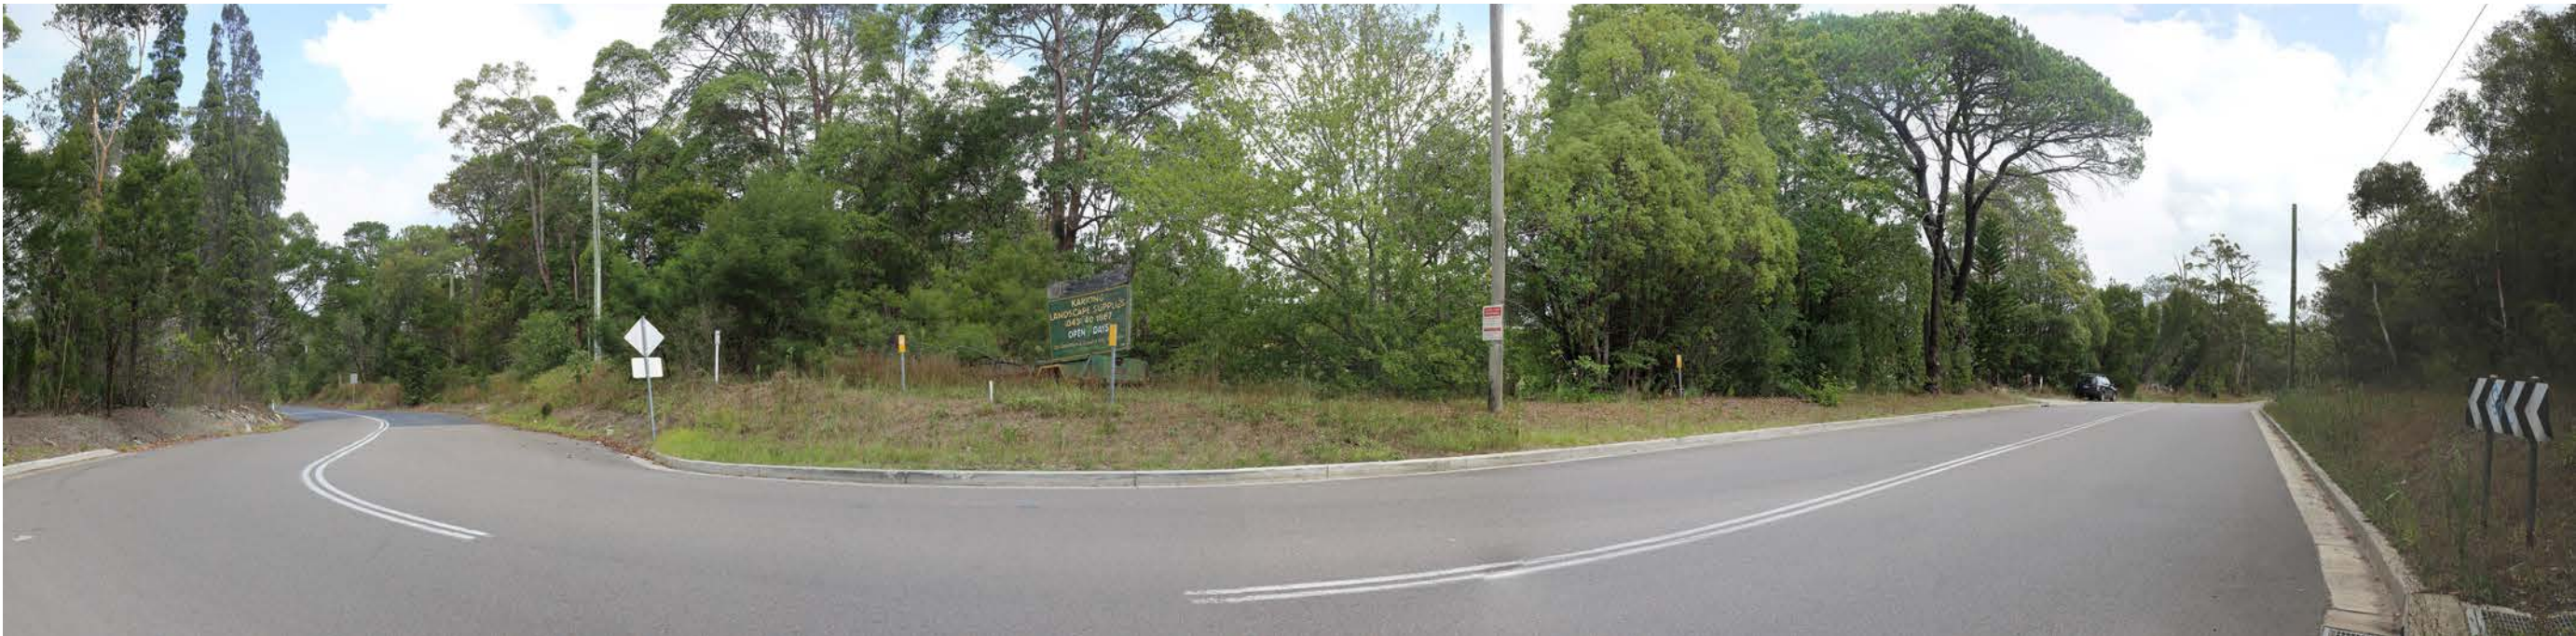
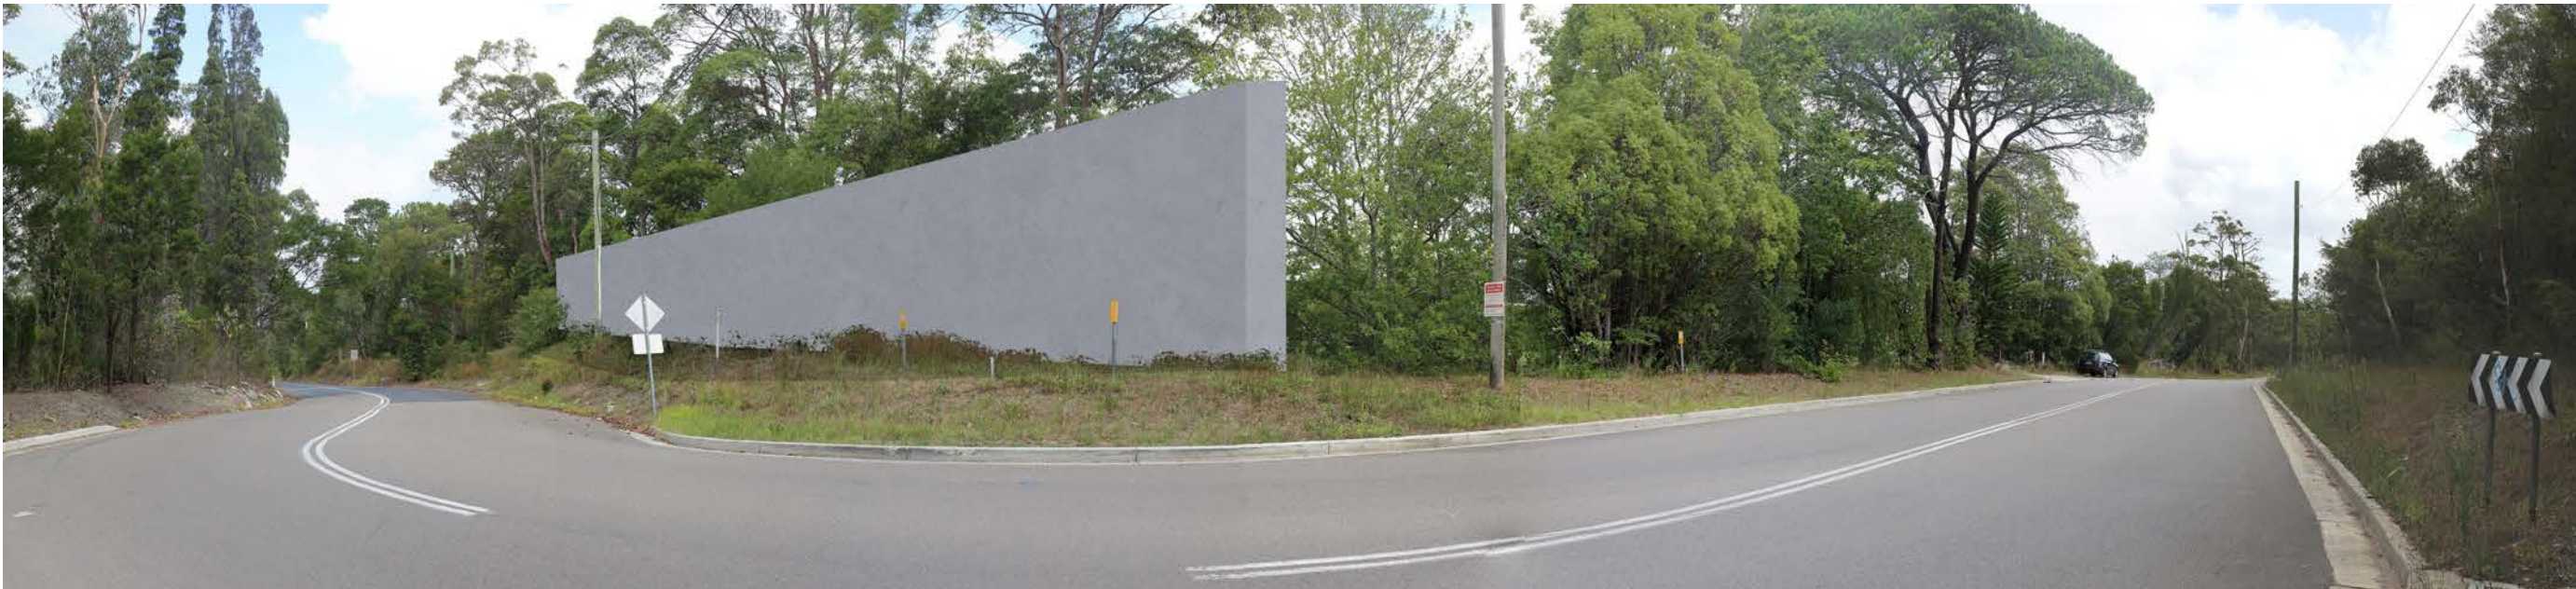
PHOTOMONTAGE PM01 View of proposal

A photomontage is a visualisation based on the superimposition of an image (ie building, road, landscape addition etc) onto a photograph for the purpose of creating a realistic representation of proposed or potential changes to a view. (Horner and Maclellan et al, 2006). Photomontages have been prepared for Viewpoint VP01 and VP05

Photomontages are representations of the development that are superimposed onto a photograph of The Site. The process for generating these images involves computer generation of a wire frame perspective view of The Site.

PANORAMA VP01 Existing View
