VISUAL IMPACT ASSESSMENT

KARIONG SAND AND SOIL SUPPLIES LOT 4 DP 227279 | 90 GINDURRA ROAD SOMERSBY, NSW

Prepared for: Jackson Environment & Planning on behalf of Mr & Mrs Ray and Sue Davies

Project No: 1569 Issue: FINAL (REVISION E) Date: 9 JANUARY 2019

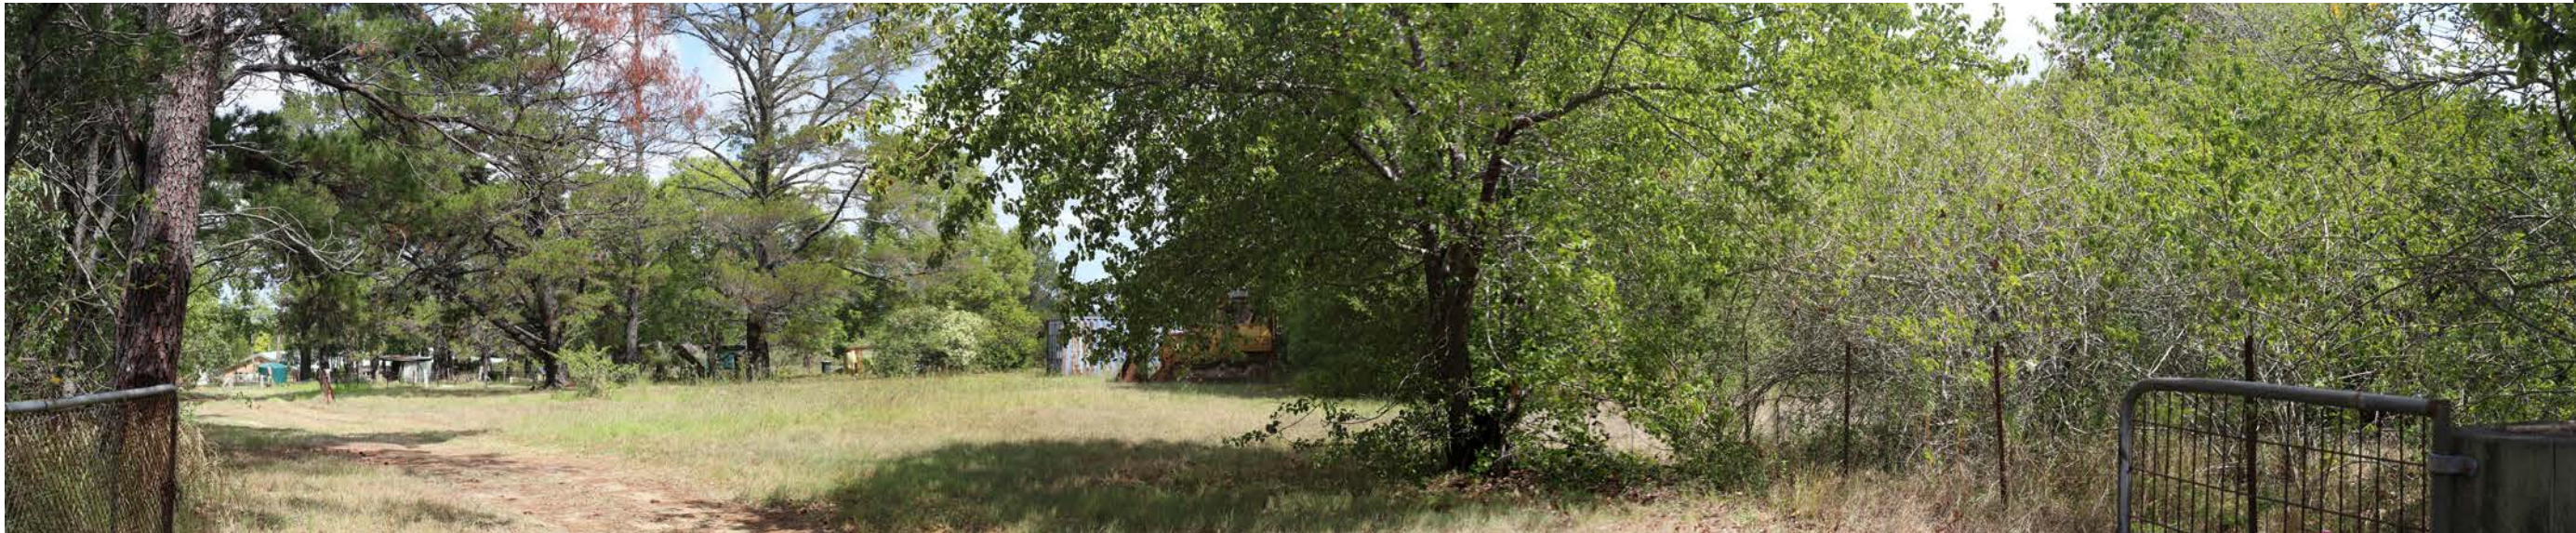
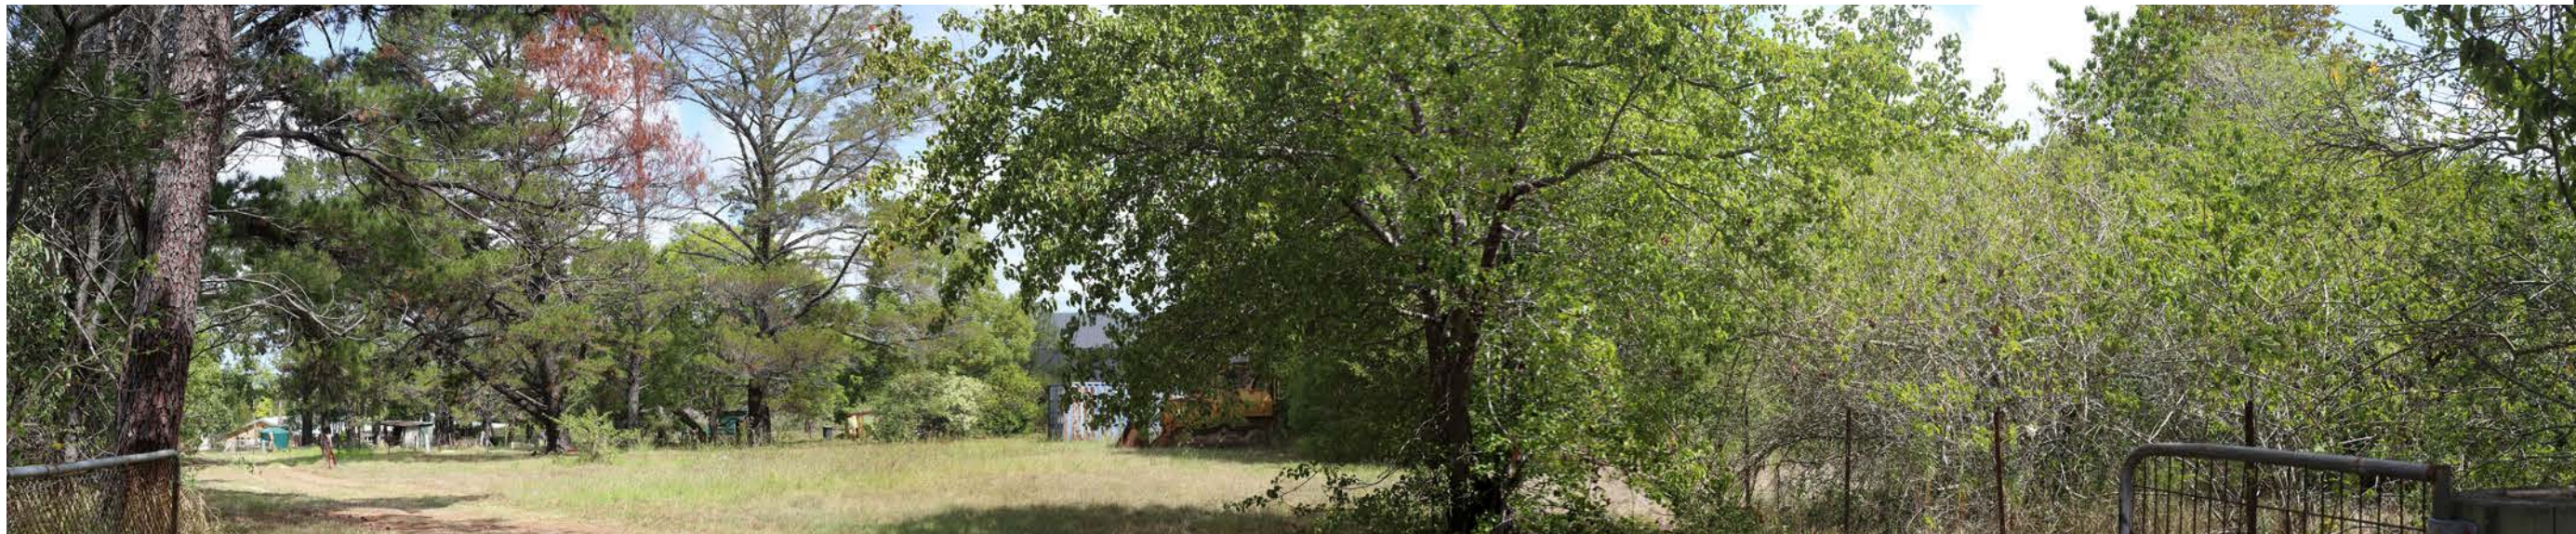
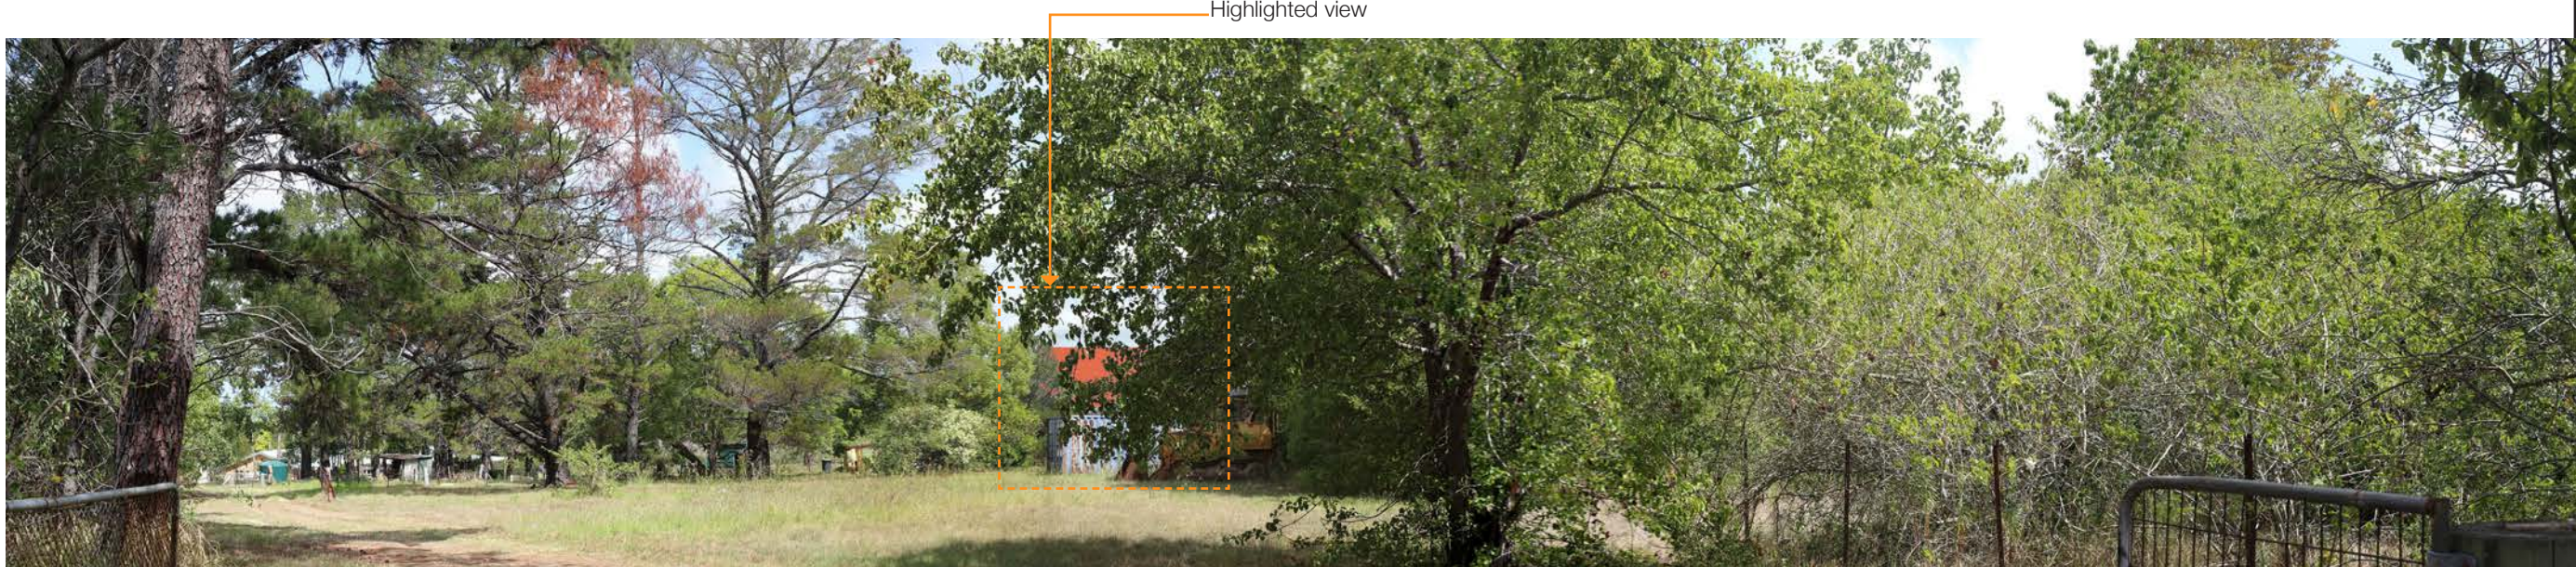
PHOTOMONTAGE PM02 View of the Proposal

A photomontage is a visualisation based on the superimposition of an image (ie building, road, landscape addition etc) onto a photograph for the purpose of creating a realistic representation of proposed or potential changes to a view. (Horner and Maclellan et al, 2006). Photomontages have been prepared for Viewpoint VP01 and VP05

VIEWPOINT VP05 Existing view

PHOTOMONTAGE PM02 Highlighted view of proposal
