# INDEPENDENT ENVIRONMENTAL AUDIT SEBASTOPOL SOLAR FARM (SSD 9098)

**April 2021**

**Auditee:** Beon Energy Solutions (contractor) on behalf of Sebastopol Solar Farm (proponent)

Site Inspection Photographs (25-26 March 2021)

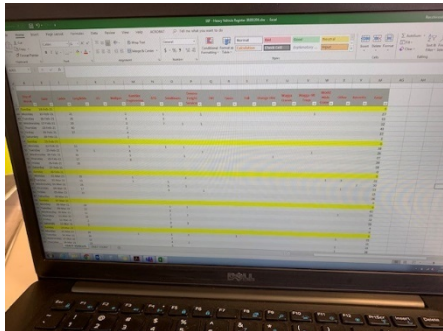
| Approval (ID) | Requirement | Evidence collected | Independent Audit Findings and Recommendations | Compliance Status |
|---|---|---|---|---|
| Schedule 3 Condition 2 | The Applicant must keep accurate records of the number of over-dimensional and heavy vehicles entering or leaving the site each day. | <ul style="list-style-type: none"><li>- Traffic Management Plan, Sebastopol Solar Farm, November 2020 (Rev. Final V1.0, 24/11/20) prepared by NGH Environmental</li><li>- DPIE approval letter of Traffic Management Plan (Rev. Final V1.0, 24/11/20) dated 14/12/20</li><li>- Environmental Inspection Checklists and heavy (HV) and over-dimensional (OD) vehicle tracking register viewed on site. Typical HV volumes were confirmed to range between 0 and 43 movements per day. No OD movements had occurred since the commencement of construction.</li></ul> | Heavy vehicle movements were appropriately tracked and consistent with Development Consent conditions. | Compliant |

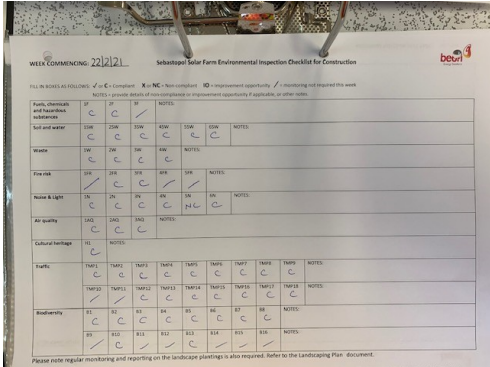
| Approval (ID) | Requirement | Evidence collected | Independent Audit Findings and Recommendations | Compliance Status |
|---|---|---|---|---|
| Schedule 3 Condition 3 | <p>All over-dimensional and heavy vehicles associated with the development must travel to and from the site via Goldfields Way and Eurolee Road and use the approved existing site access point on Eurolee Road, as identified in the figure in Appendix 3.</p> <p><i>Note: The Applicant is required to obtain relevant permits under the Heavy Vehicle National Law (NSW) for the use of over-dimensional vehicles on the road network.</i></p> | <p>Traffic Management Plan, Sebastopol Solar Farm, November 2020 (Rev. Final V1.0, 24/11/20) prepared by NGH Environmental</p> <ul style="list-style-type: none"><li>- DPIE approval letter of Traffic Management Plan (Rev. Final V1.0, 24/11/20) dated 14/12/20</li><li>- Environmental Inspection Checklists include relevant information</li></ul> | Vehicle movements were appropriately tracked and consistent with Development Consent conditions. | Compliant |

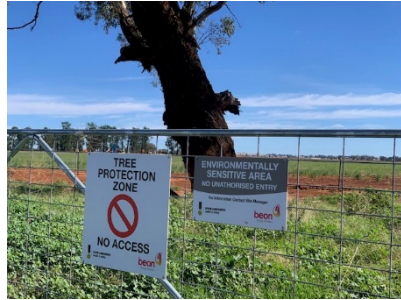
| Approval (ID) | Requirement | Evidence collected | Independent Audit Findings and Recommendations | Compliance Status |
|---|---|---|---|---|
| Schedule 3 Condition 18 | The Applicant must ensure the development does not cause any direct or indirect impacts on the Aboriginal heritage items identified in Table 2 of Appendix 4 or located outside the approved development footprint. | <ul style="list-style-type: none"> <li>- Cultural Heritage Management Plan (CHMP), Sebastopol Solar Farm, September 2020 (Rev. Final V1.6, 16/09/20) prepared by NGH Environmental</li> <li>- DPIE approval letter of Cultural Heritage Management Plan (Rev. Final V1.6, 16/09/20) dated 17/09/20</li> <li>- Exclusion zone fencing and signage</li> <li>- Boundary fencing</li> <li>- Site Induction (Rev 1.5, 12/03/21)</li> <li>- Inspection checklists</li> </ul> | <ul style="list-style-type: none"> <li>- Exclusion zone fencing and signage for heritage items within the construction footprint is in place</li> <li>- Boundary fencing installed to protect off-site items</li> <li>- In accordance with the CHMP the original development design was modified to exclude impacts to possible modified trees within the Project area.</li> <li>- Weekly environmental inspections are conducted to confirm heritage exclusion zones are in place</li> <li>- Heritage management issues are discussed in the site induction content and tool-boxing is conducted. The site HSE Advisor confirmed that severe disciplinary action and/or dismissal is a consequence of disturbing these areas.</li> </ul> | Compliant |

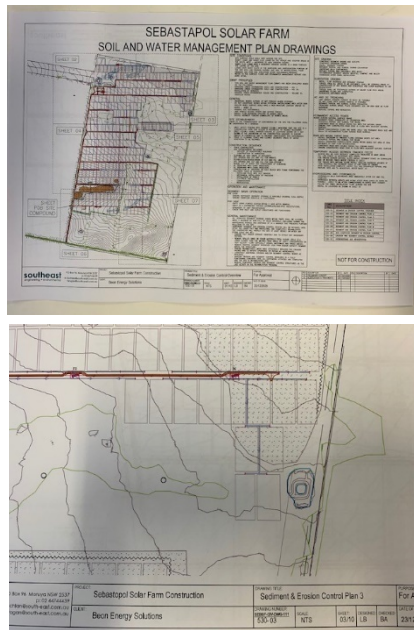
| Approval (ID) | Requirement | Evidence collected | Independent Audit Findings and Recommendations | Compliance Status |
|---|---|---|---|---|
| Schedule 3 Condition 21 | The Applicant must ensure that the development does not cause any water pollution, as defined under Section 120 of the POEO Act. | <ul style="list-style-type: none"> <li>- Sebastopol Solar Farm Work Health Safety And Environment Management Plan (WHSEMP) For Construction (Rev. 1.0, 19/02/21) prepared by beon.</li> <li>- Soil and Water Management Plan Drawings (Rev B, 13/01/21)</li> <li>- Environmental Inspection Checklists</li> <li>- On-site environmental controls were viewed during site visit</li> </ul> | <p>Erosion/sedimentation controls observed were consistent with Soil and Water Management Plan Drawings during site visit.</p> <p>No evidence of off-site flows of sediment-laden water and/or erosion and/or sedimentation were observed during the site visit despite a recent significant weather event that resulted in over 100mm of rainfall between 21-24/03/2021 as the closest Bureau of Meteorology monitoring station in Temora, NSW (<a href="http://www.bom.gov.au/climate/dwo/IDCJDW2130.latest.shtml">http://www.bom.gov.au/climate/dwo/IDCJDW2130.latest.shtml</a>)</p> | Compliant |

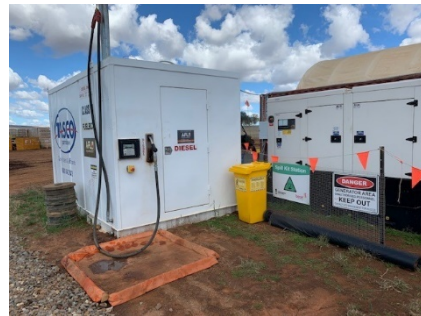
| Approval (ID) | Requirement | Evidence collected | Independent Audit Findings and Recommendations | Compliance Status |
|---|---|---|---|---|
| Schedule 3 Condition 24 | <p>The Applicant must store and handle all chemicals, fuels and oils used on-site in accordance with:</p> <p>(a) the requirements of all relevant Australian Standards; and</p> <p>(b) the NSW EPA's <i>Storing and Handling of Liquids: Environmental Protection – Participants Handbook</i> if the chemicals are liquids.</p> <p>In the event of an inconsistency between the requirements listed from (a) to (b) above, the most stringent requirement must prevail to the extent of the inconsistency.</p> | <p>- Environmental Management Strategy (EMS), Sebastopol Solar Farm, December 2020 (Rev. Final V1.1, 22/12/20) prepared by NGH Environmental</p> <p>- DPIE approval letter of Environmental Management Strategy (Rev. Final V1.1, 22/12/20) dated 23/12/20</p> <p>- Sebastopol Solar Farm Work Health Safety And Environment Management Plan (WHSEMP) for Construction (Rev. 1.0, 19/02/21) prepared by beon.</p> <p>- Environmental Inspection Checklists</p> <p>- Interviews and site visit</p> | <p>Review of spill prevention and clean-up measures documented in weekly Environmental Inspection Checklists.</p> <p>Well stocked spill kits present at key locations across Project site.</p> <p>Bunded storage containers present for flammable and combustible liquids.</p> <p>Safety Data Sheets held on-site.</p> <p>Portable bunds present at location where fuelling occurs.</p> | Compliant |

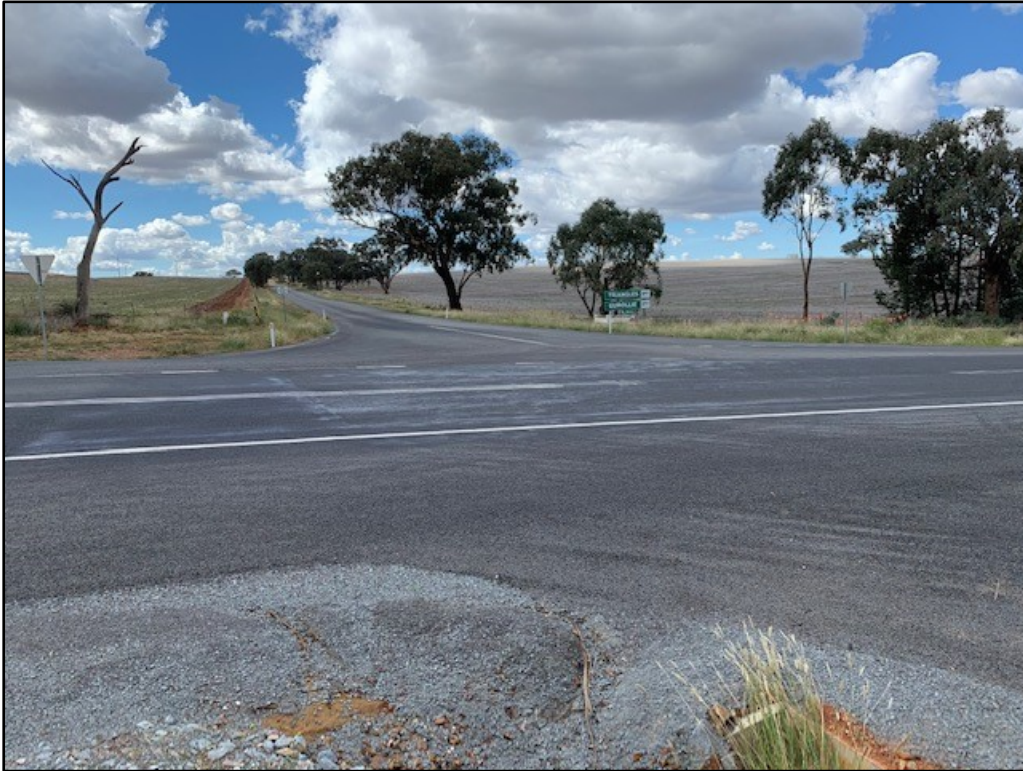
**Plate 1:** View of the upgraded Eurolee Road, looking east from the intersection of the Goldfields Way. The distance of new asphalt seal on Eurolee Road was measured during the audit to be approximately 400m from the intersection.

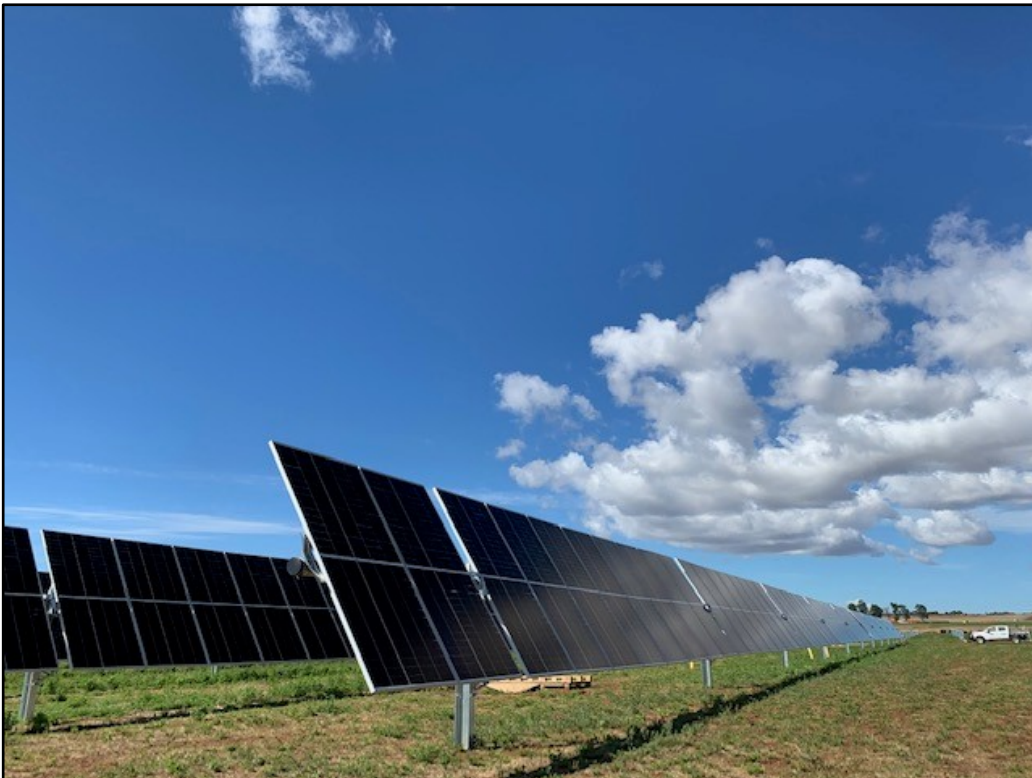
**Plate 2:** View of the recently installed solar panels associated with the northwest portion of the Project site. This area was the most advanced area of construction. Vegetative cover was generally good in this location and site layout was noted to be consistent with the Development Consent.

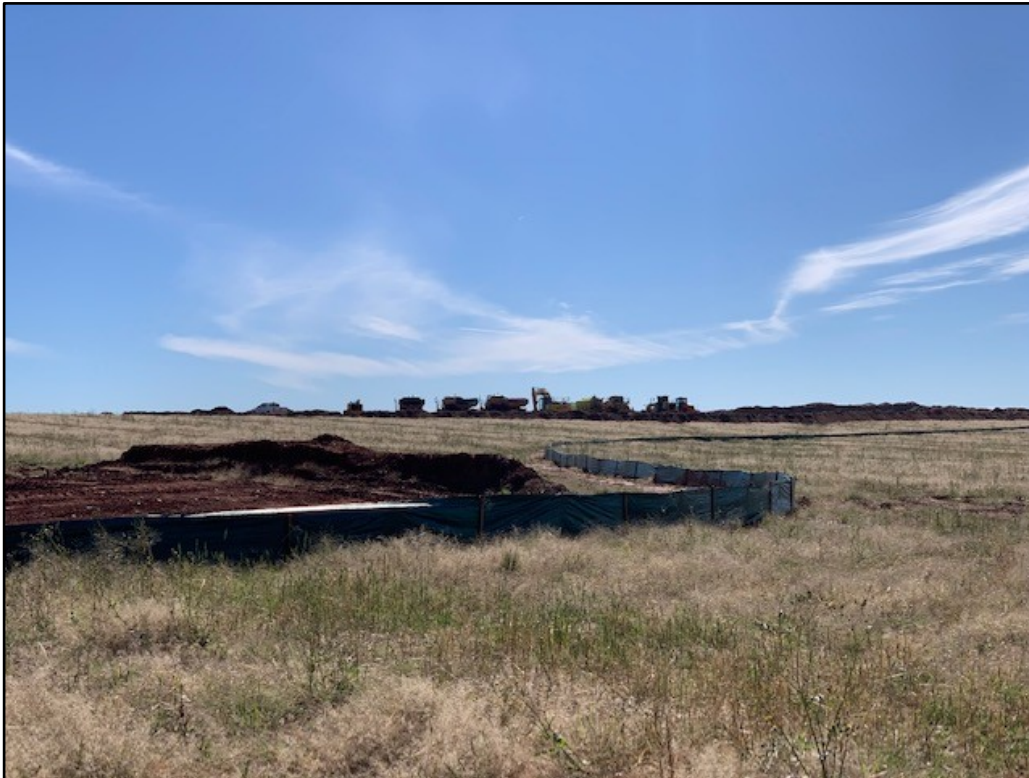
**Plate 3:** View of the sediment fencing and water quality basin installed on the southwest portion of the site as part of the Project erosion and sedimentation control measures documented within the Soil and Water Management Plan. No evidence of significant sedimentation and/or erosion was noted during the Auditor's site visit of 26/03/21.

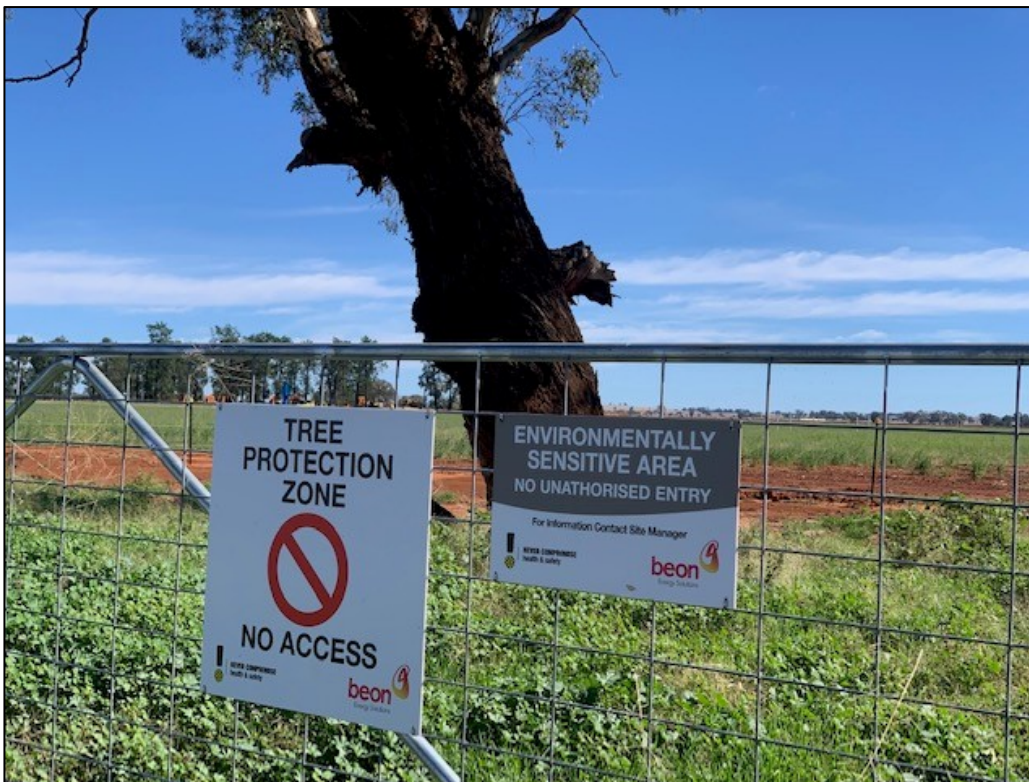
**Plate 4:** View of sensitive area protection signage and fencing installed in accordance with Development Consent Schedule 3, Condition 18.

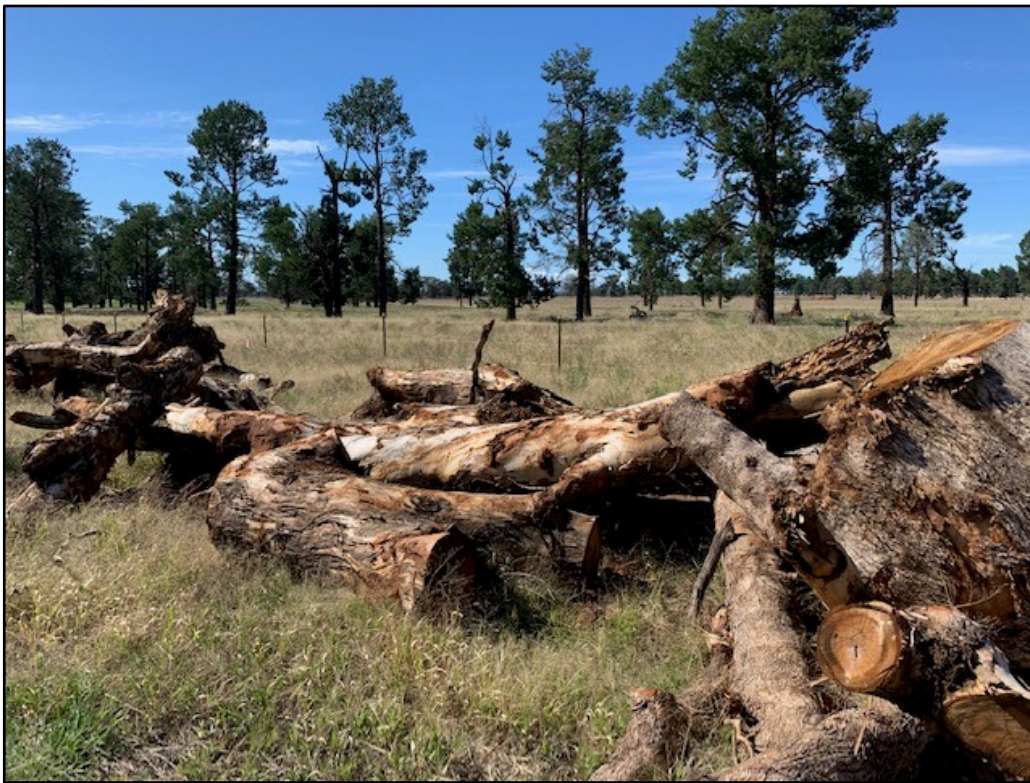
**Plate 5:** View of retained vegetation from site clearing activities for future re-use as habitat enhancement during site rehabilitation and landscaping as per Development Consent Schedule 3, Condition 11(a).

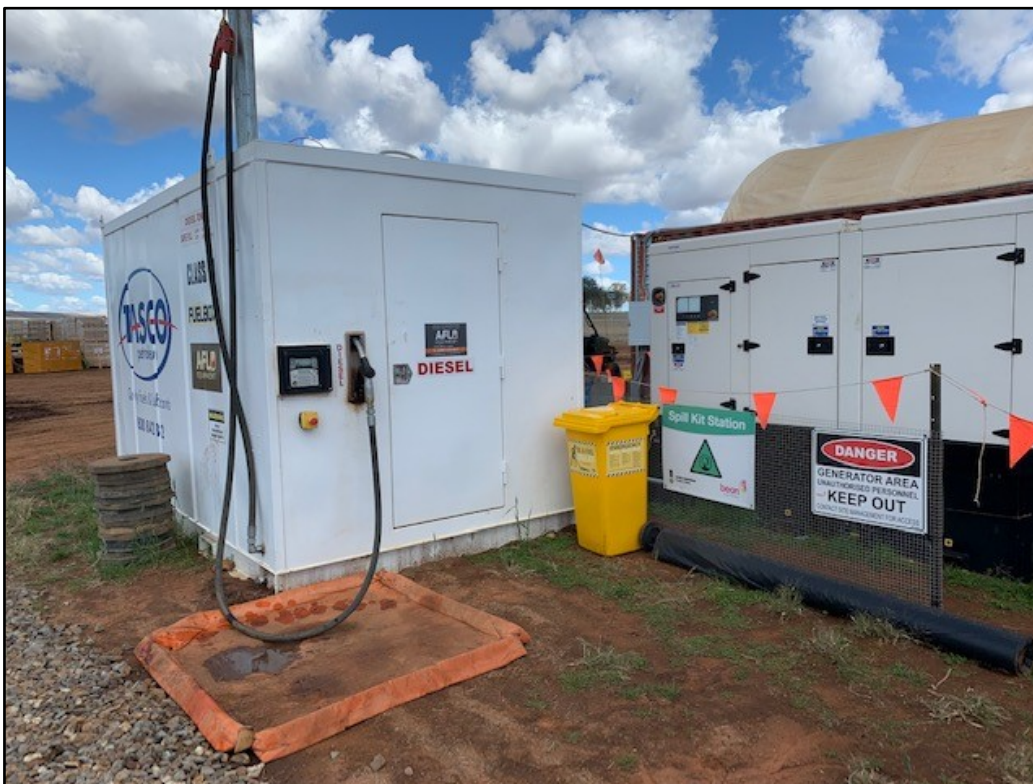
**Plate 6:** View of the site fuelling area at the time of the auditor's site visit on 26/03/21. An appropriately stocked spill kit was noted to be present along with signage, bunded storage and a portable spill containment bund.

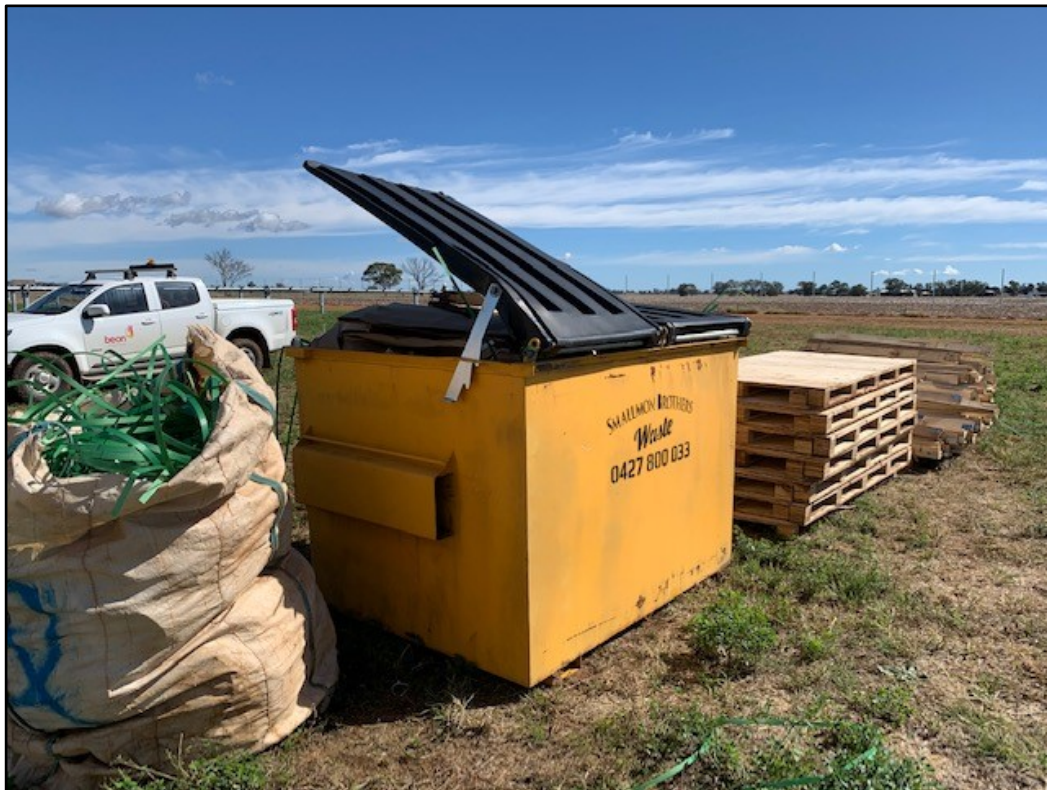
**Plate 7:** View of segregated construction waste and re-use materials prior to off-site transport for recycling or disposal. General housekeeping was noted to be of a very high standard across the project site.

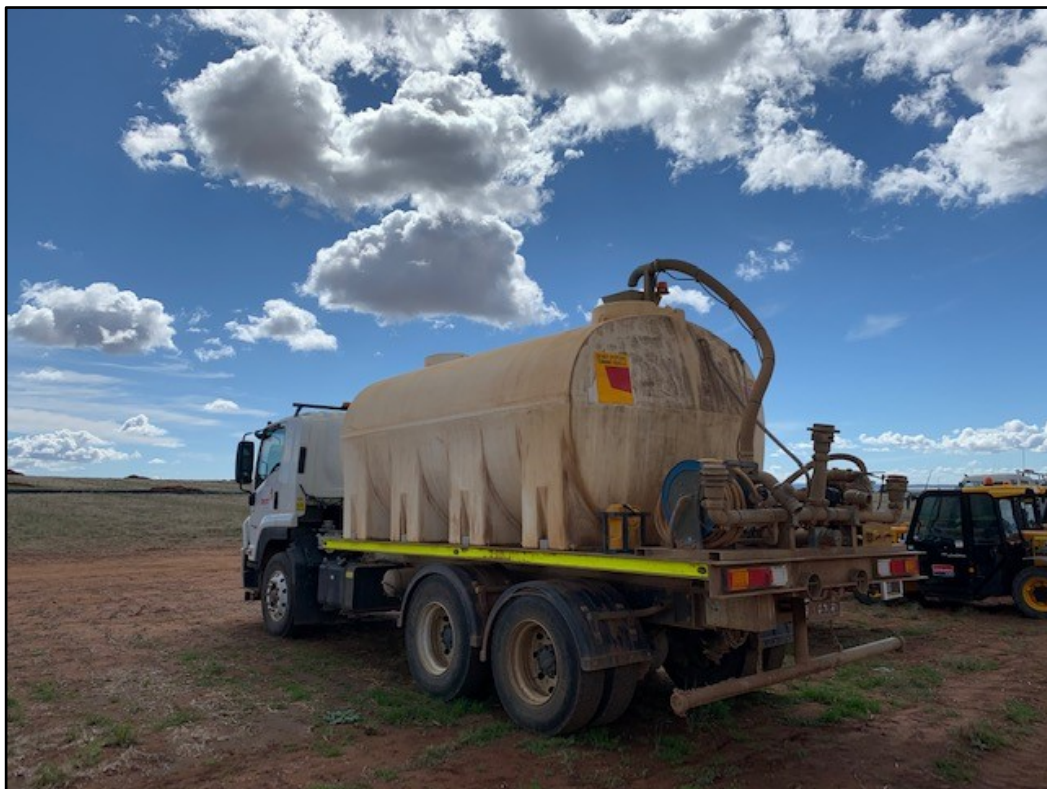
**Plate 8:** View of one (1) of five (5) site-based water carts used as part of the strategy to manage air quality during construction. No significant dust emissions were noted during site visit of 26/03/21.
