DECEMBER, 2018

JOB NO. GE18/144  
WOOD AND GRIEVE ENGINEERS PTY LTD  
ADDITIONAL GEOTECHNICAL INVESTIGATION  
PROPOSED TWEED VALLEY HOSPITAL  
LOT 102 ON DP870722  
CUDGEN ROAD  
KINGSCLIFF  
(TSA MANAGEMENT PTY LTD)

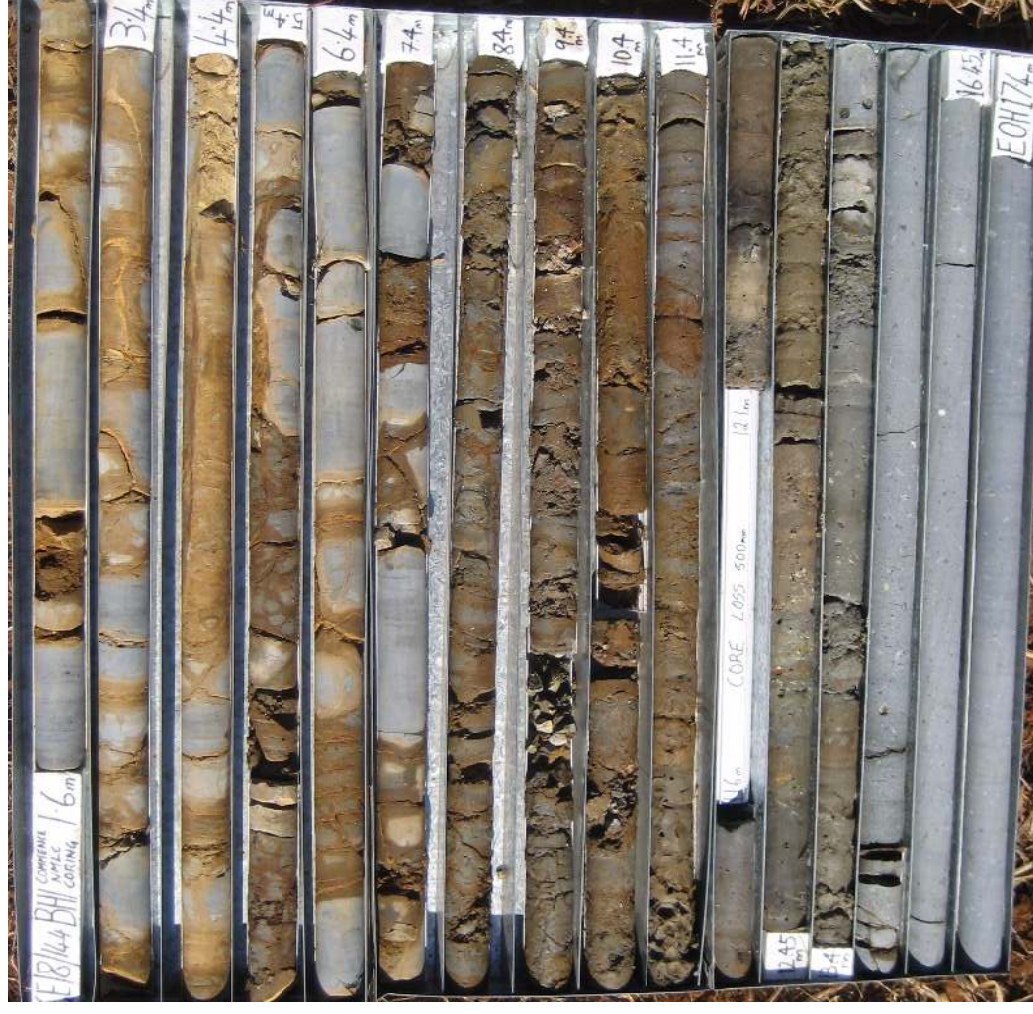
**CLIENT: WOOD AND GRIEVE ENGINEERS PTY LTD**  
**PROJECT: GEOTECHNICAL INVESTIGATION - TWEED VALLEY HOSPITAL**  
**LOCATION: CUDGEN ROAD, KINGSCLIFF**  
**JOB NUMBER: GE18/144**  
**BOREHOLE NUMBER: BH1**  
**BOREHOLE DEPTH: 1.6m TO 17.4m**

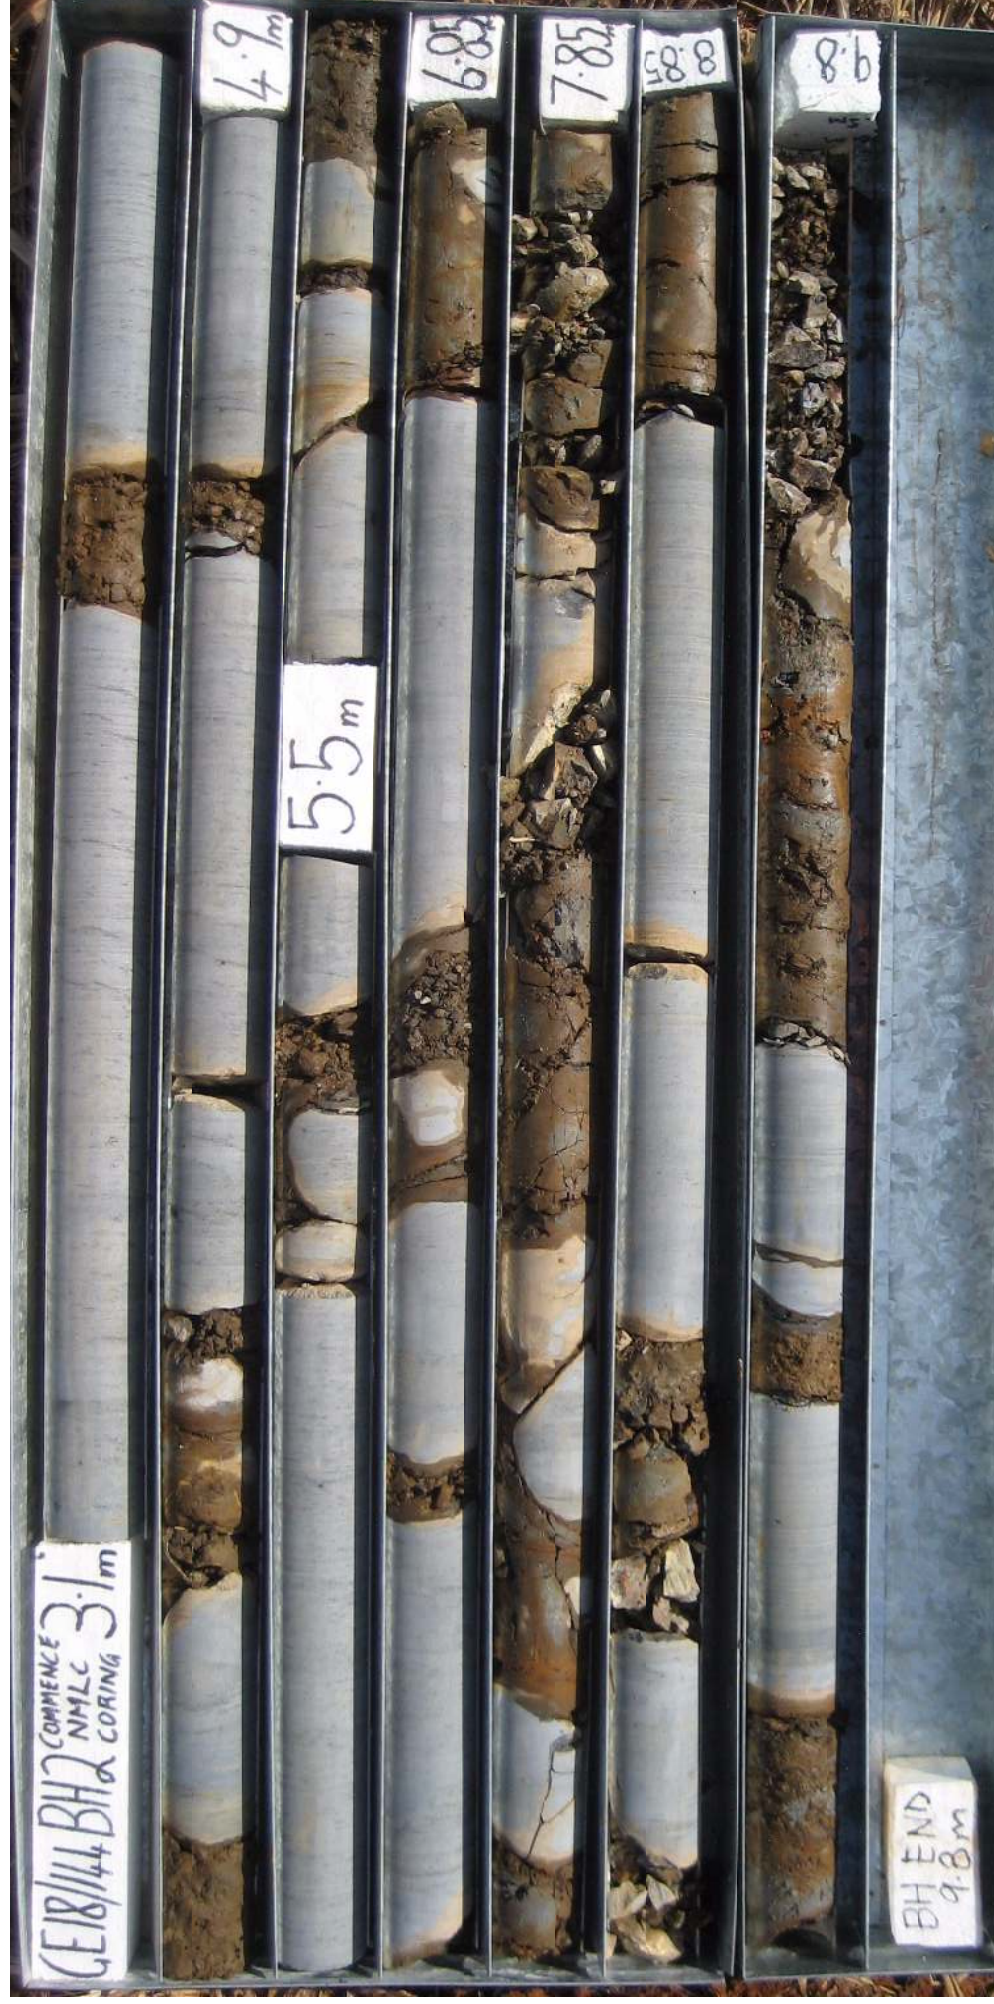
**CLIENT: WOOD AND GRIEVE ENGINEERS PTY LTD**  
**PROJECT: GEOTECHNICAL INVESTIGATION - TWEED VALLEY HOSPITAL**  
**LOCATION: CUDGEN ROAD, KINGSCLIFF**  
**JOB NUMBER: GE18/144**  
**BOREHOLE NUMBER: BH2**  
**BOREHOLE DEPTH: 3.1m TO 9.8m**

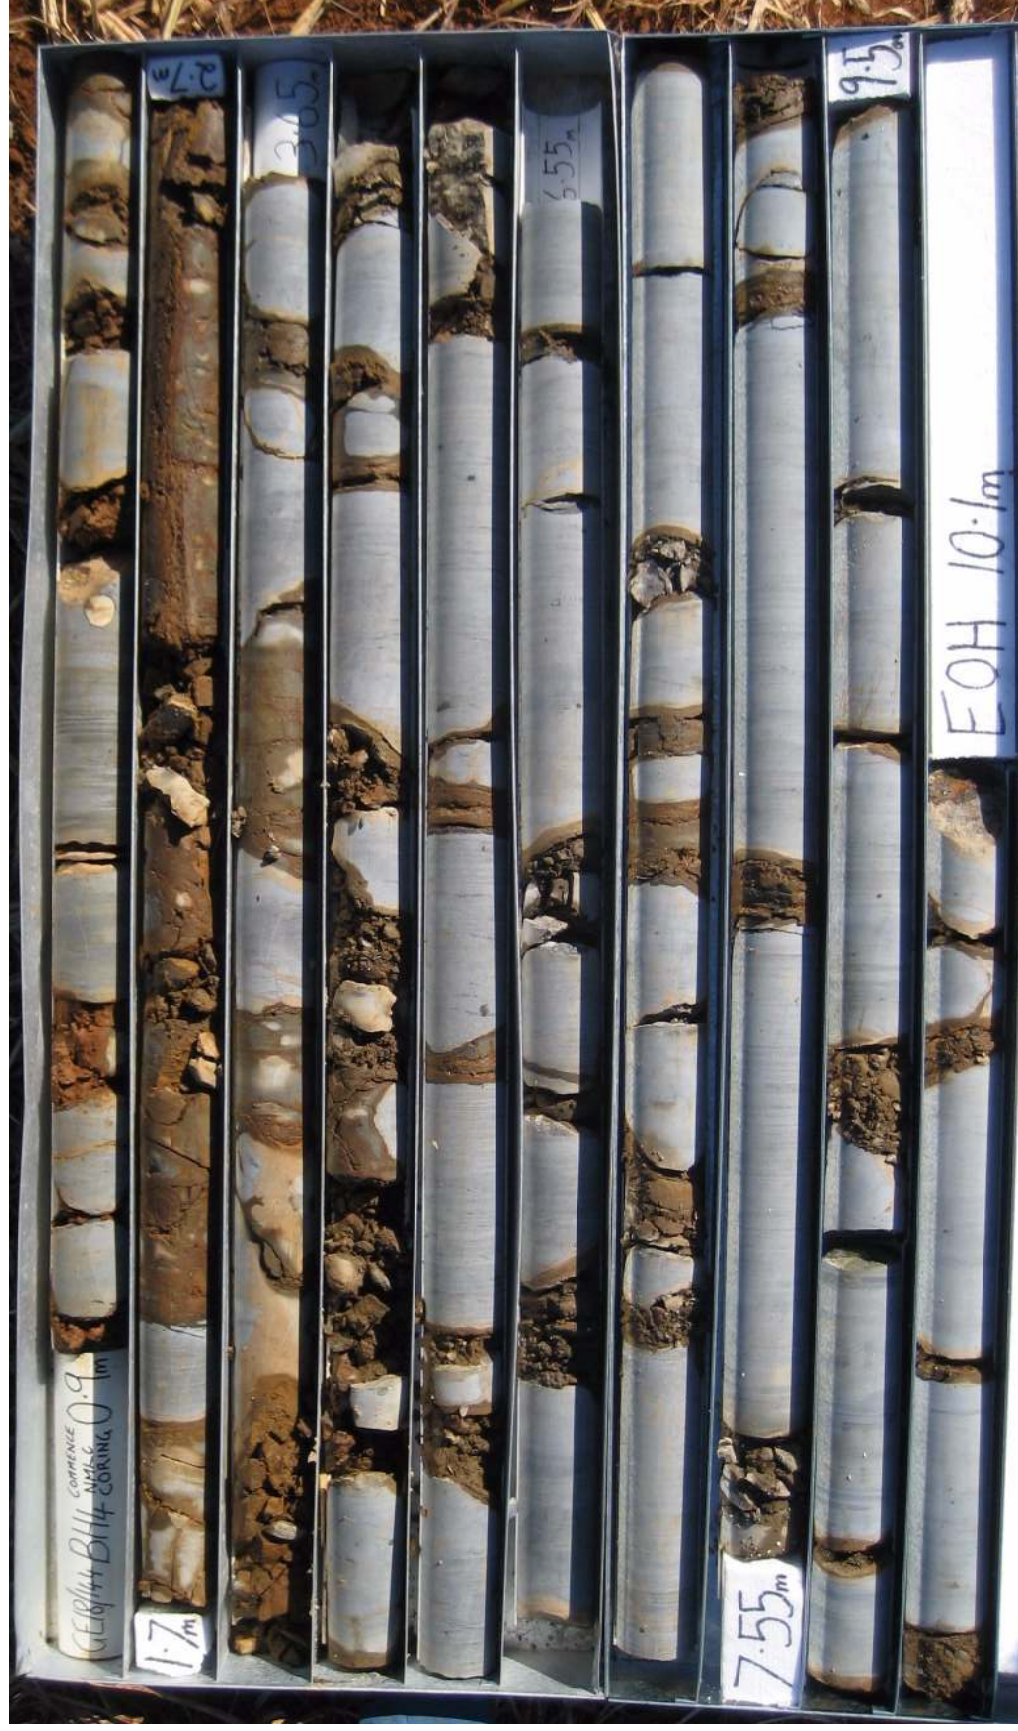
**CLIENT: WOOD AND GRIEVE ENGINEERS PTY LTD**  
**PROJECT: GEOTECHNICAL INVESTIGATION - TWEED VALLEY HOSPITAL**  
**LOCATION: CUDGEN ROAD, KINGSCLIFF**  
**JOB NUMBER: GE18/144**  
**BOREHOLE NUMBER: BH4**  
**BOREHOLE DEPTH: 3.1m TO 10.1m**

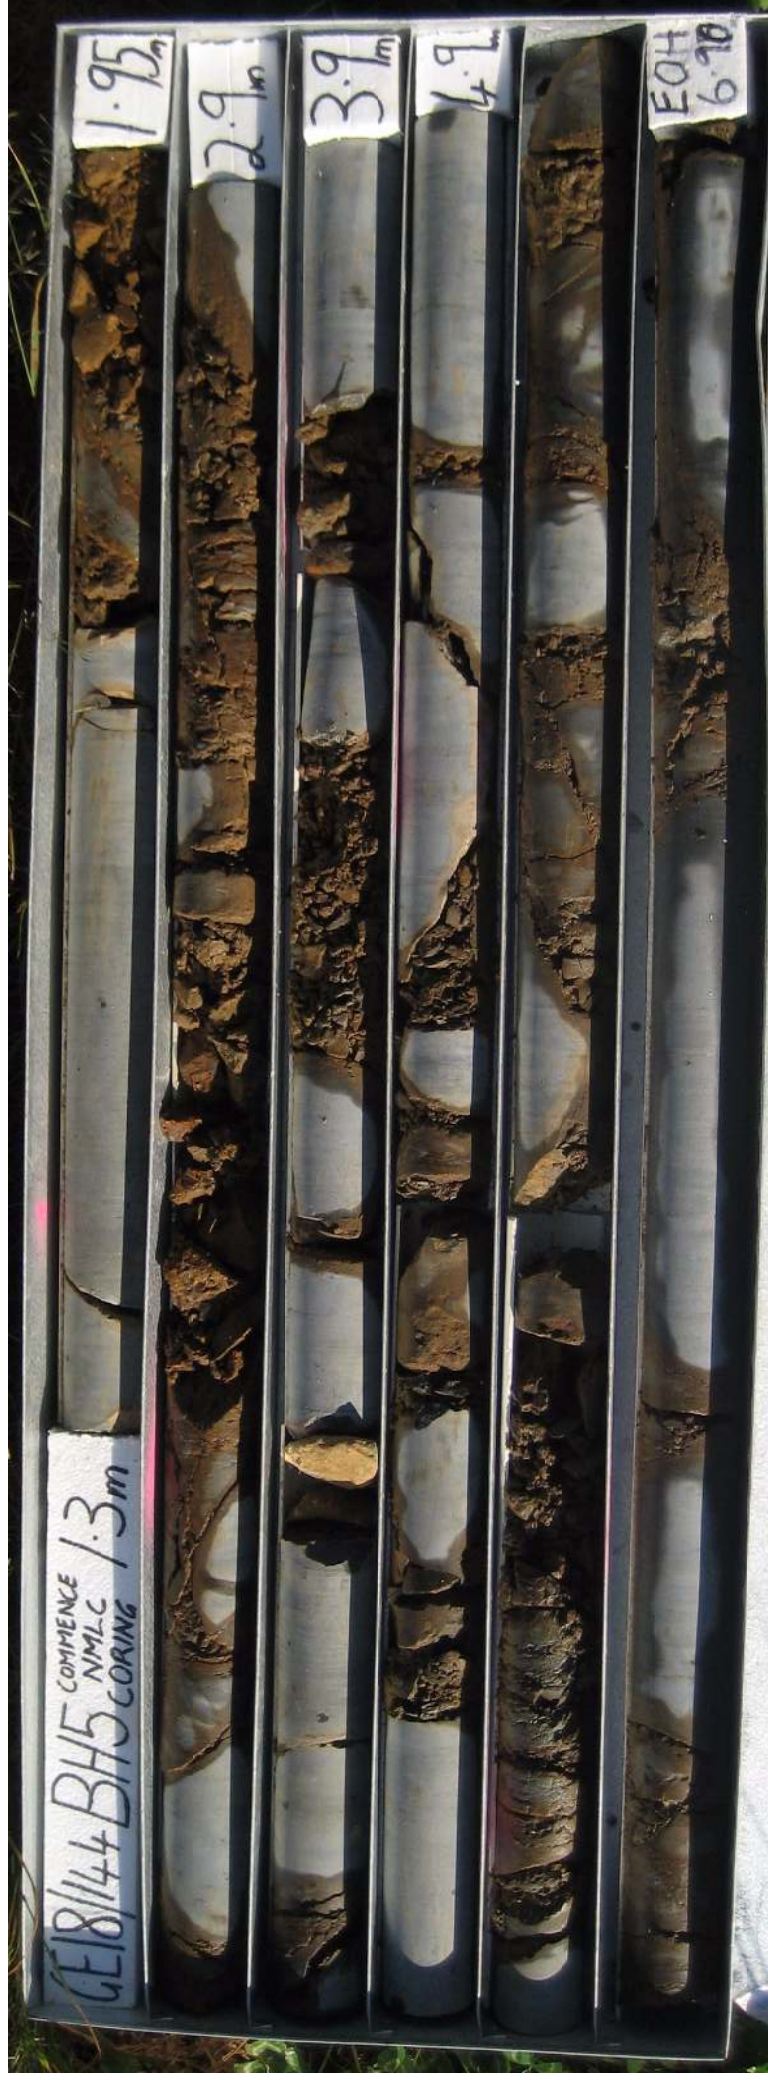
**CLIENT: WOOD AND GRIEVE ENGINEERS PTY LTD**  
**PROJECT: GEOTECHNICAL INVESTIGATION - TWEED VALLEY HOSPITAL**  
**LOCATION: CUDGEN ROAD, KINGSCLIFF**  
**JOB NUMBER: GE18/144**  
**BOREHOLE NUMBER: BH5**  
**BOREHOLE DEPTH: 1.3m TO 6.9m**

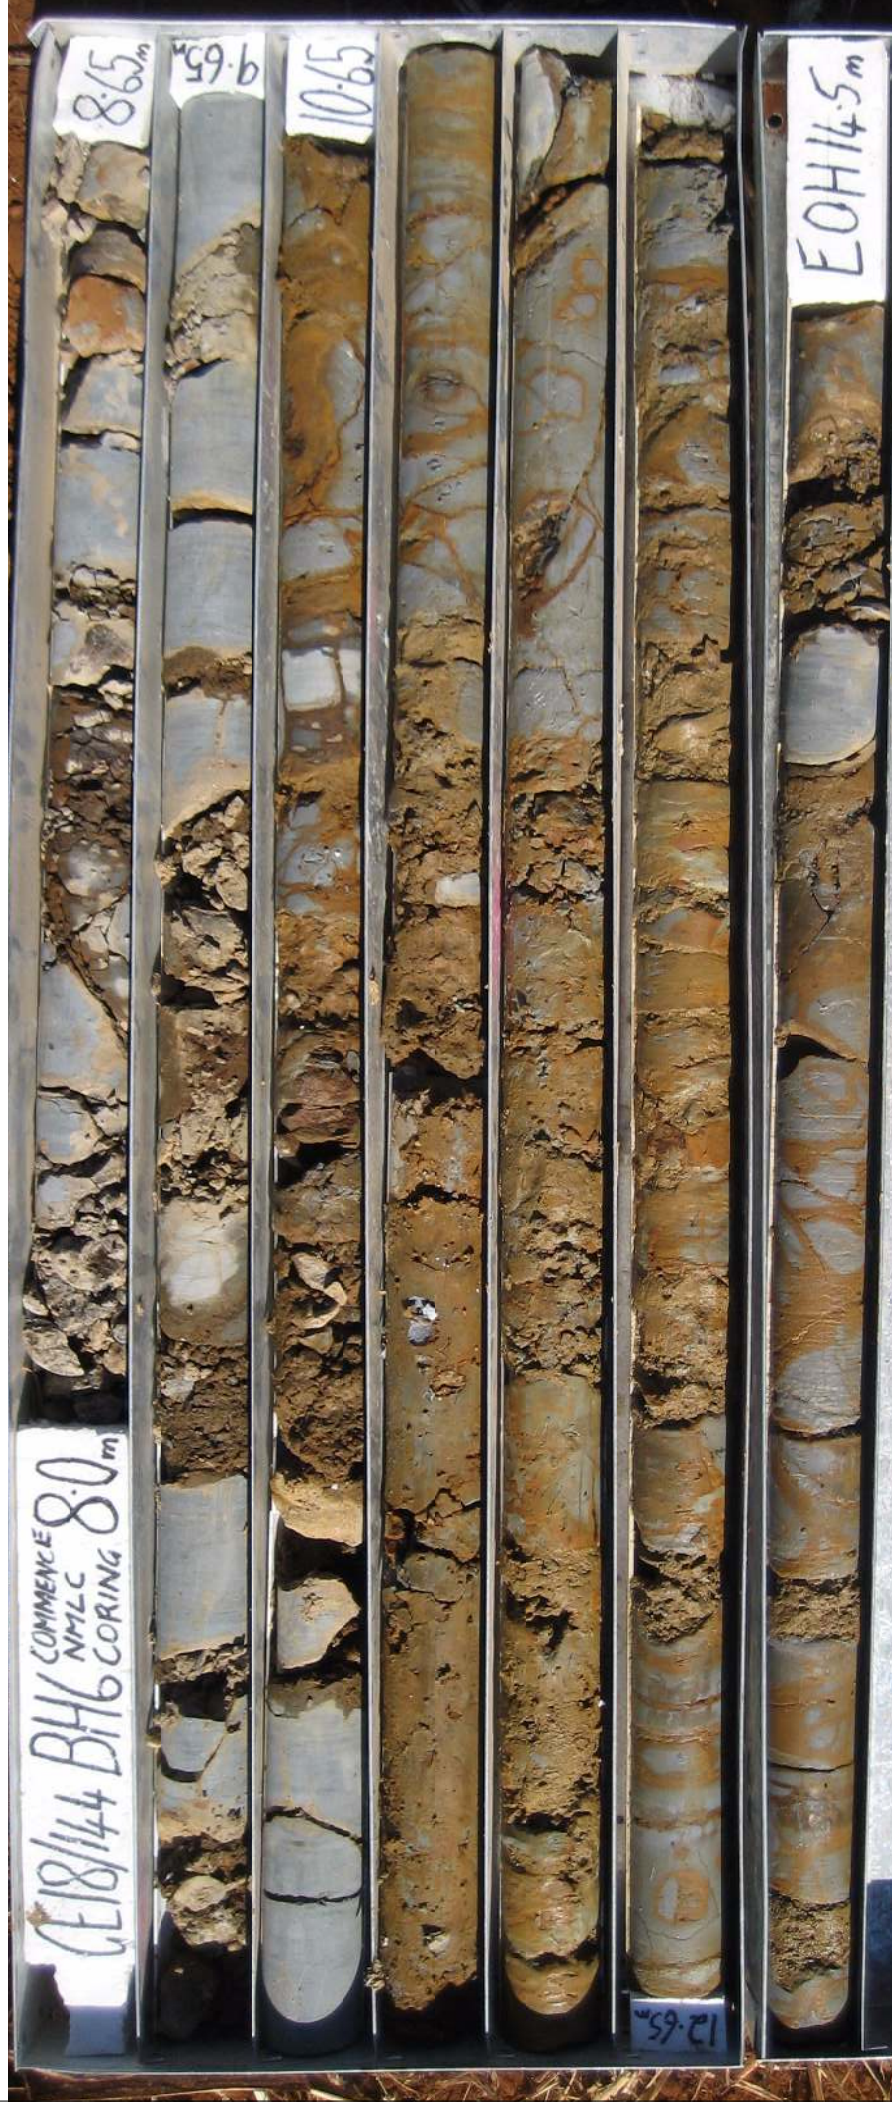
**CLIENT: WOOD AND GRIEVE ENGINEERS PTY LTD**  
**PROJECT: GEOTECHNICAL INVESTIGATION - TWEED VALLEY HOSPITAL**  
**LOCATION: CUDGEN ROAD, KINGSCLIFF**  
**JOB NUMBER: GE18/144**  
**BOREHOLE NUMBER: BH6**  
**BOREHOLE DEPTH: 8.0m TO 14.5m**

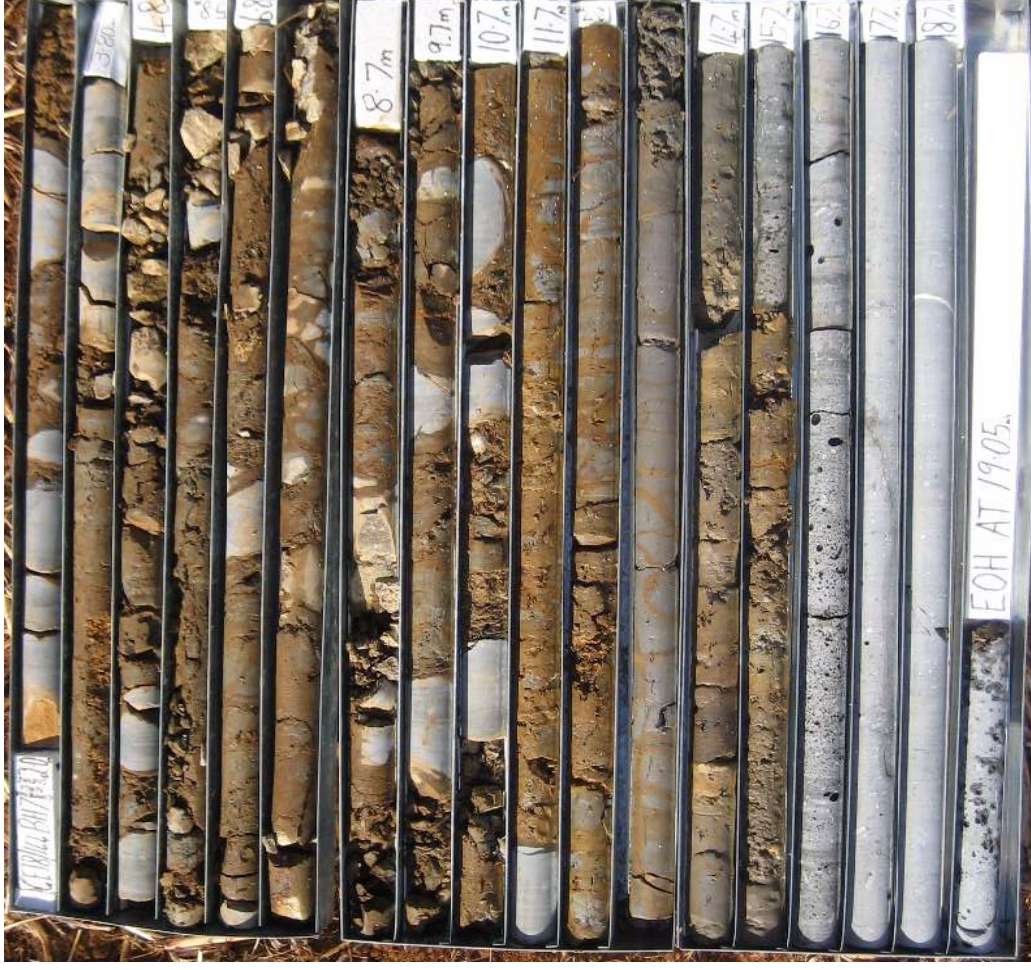
**CLIENT: WOOD AND GRIEVE ENGINEERS PTY LTD**  
**PROJECT: GEOTECHNICAL INVESTIGATION - TWEED VALLEY HOSPITAL**  
**LOCATION: CUDGEN ROAD, KINGSCLIFF**  
**JOB NUMBER: GE18/144**  
**BOREHOLE NUMBER: BH7**  
**BOREHOLE DEPTH: 2.0m TO 19.05m**
