RE: Marist Catholic College North Shore (SSD-10473). Response to Submissions and peer review. NSW Government, Department Planning, Industry and Environment (DPIE)

APPENDIX A: SUMMARY TABLE Marist Catholic College North Shore (SSD-10473). Response to Submissions.

This Schedule of Conservation Works is a list of work that is required to correct damage and deterioration to St. Mary's Presbytery, Marist Catholic College, 270 Miller Street, North Sydney NSW

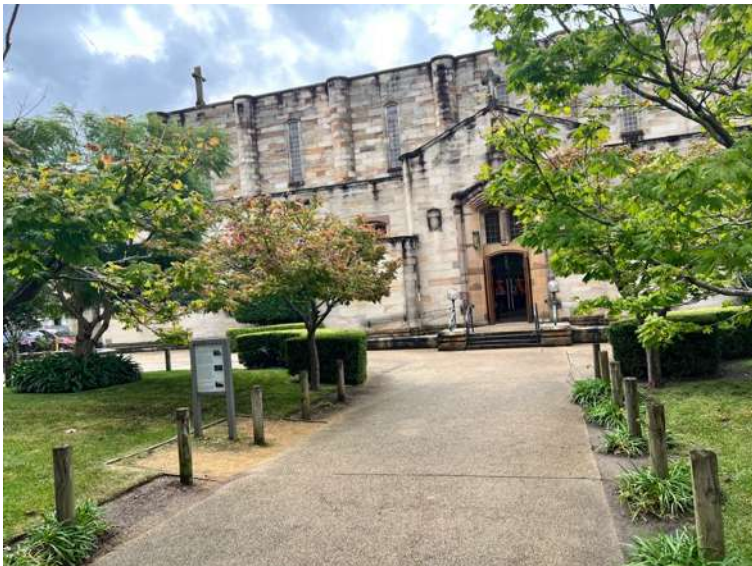
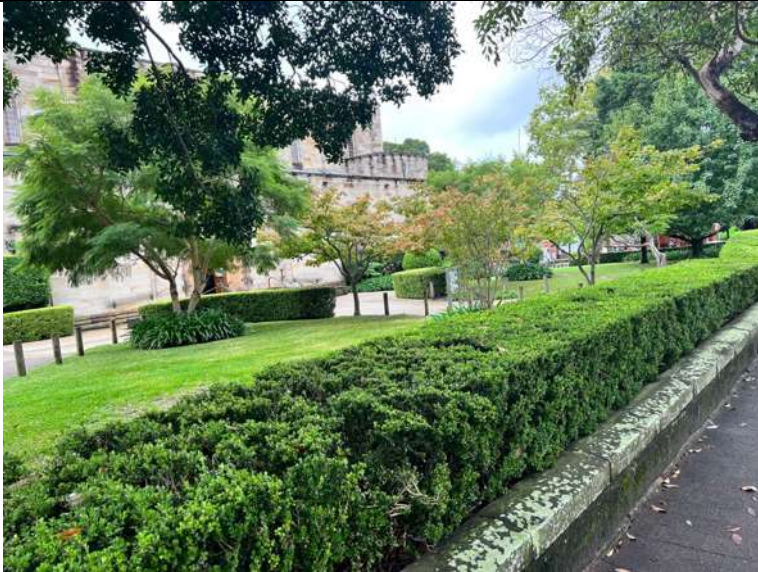
- The proposed landscape works to the southern Garden of the Church will retain and expand on the existing landscape planting. The proposal will replace the non original pebblecrete with granite paving, sympathetic to the tones of the sandstone, and will enable a greater usability of the garden for larger funeral and wedding gatherings.

St. Mary's Church southern Garden

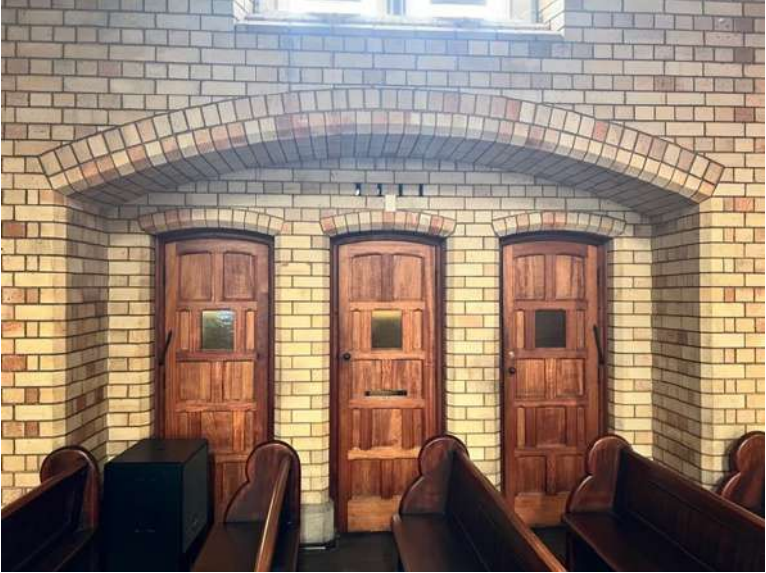
<p>Detail of confessional doors and surrounding brickwork to be removed.</p>

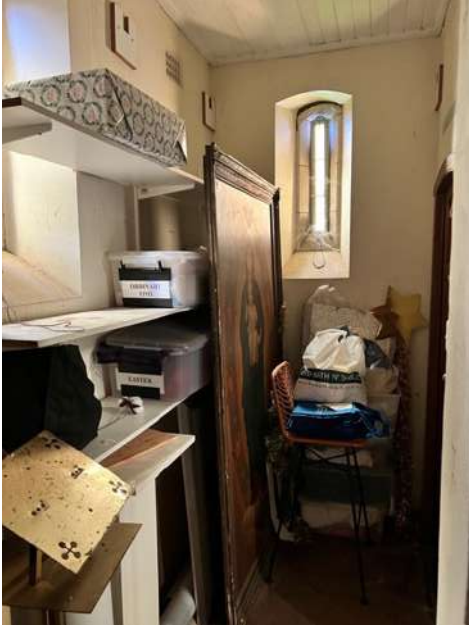
Interior of confessional to be adapted into entry portico to northern terrace.

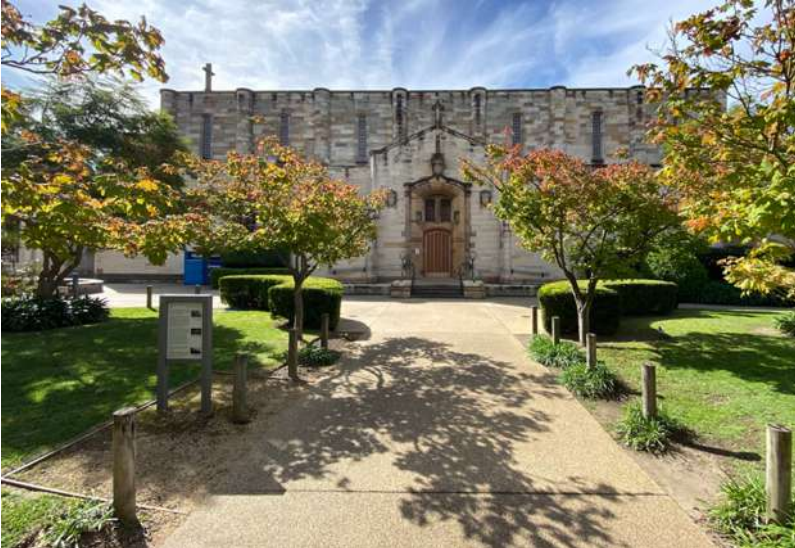
<p>St. Mary's Church - Condition/ Integrity The Church is highly intact and is well maintained. It presents as having high integrity although the following intrusive elements are noted:</p> <ul style="list-style-type: none">• Pebblecrete paths in the southern garden.• Some new and replacement external balustrades.• Frameless glass hinged entry door fitted to the principal eastern elevation.

South elevation and Garden to Church

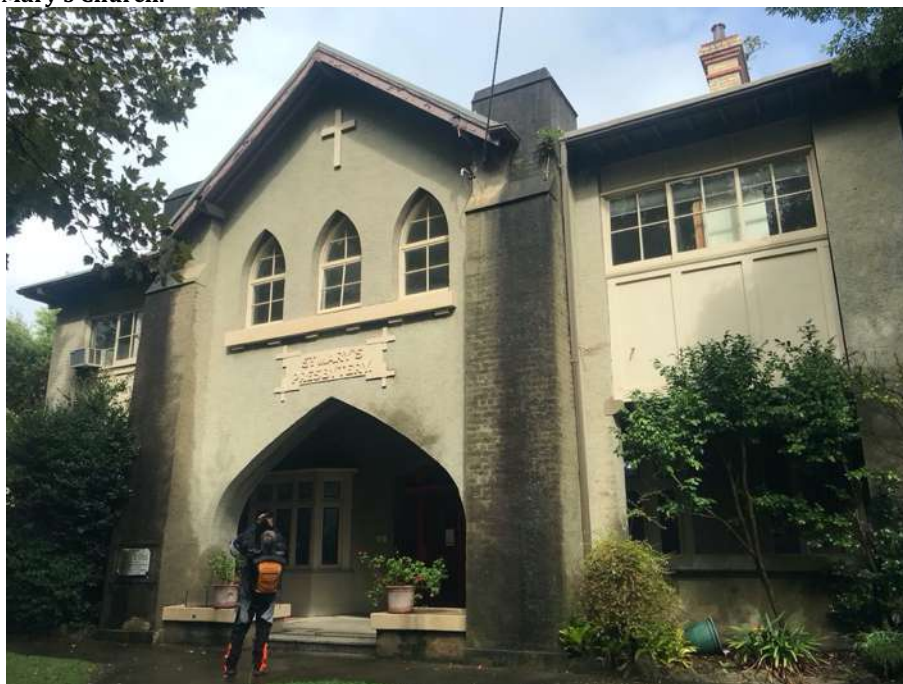
Image of the Presbytery building in 2022, encased with perimeter verandah and elevations.

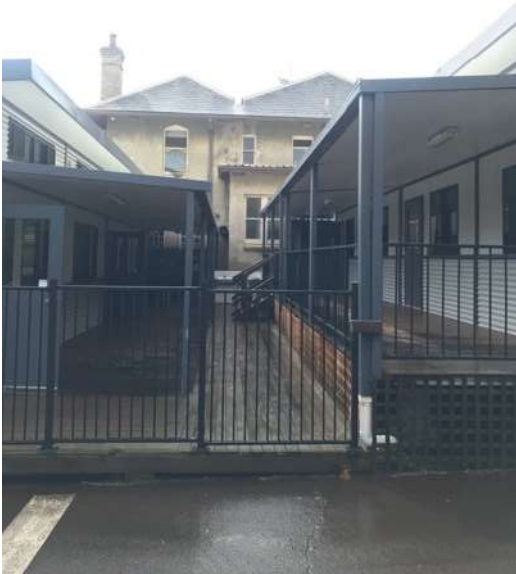
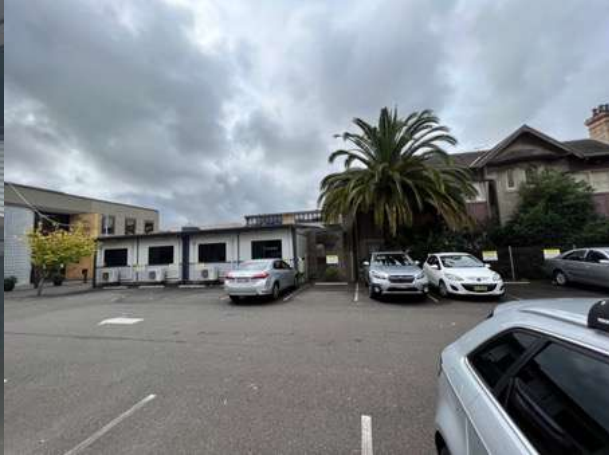
**Rear, western elevation of the St. Marys Presbytery with demountable classrooms.
Southern elevation of St. Marys Presbytery with demountable classrooms at the rear**

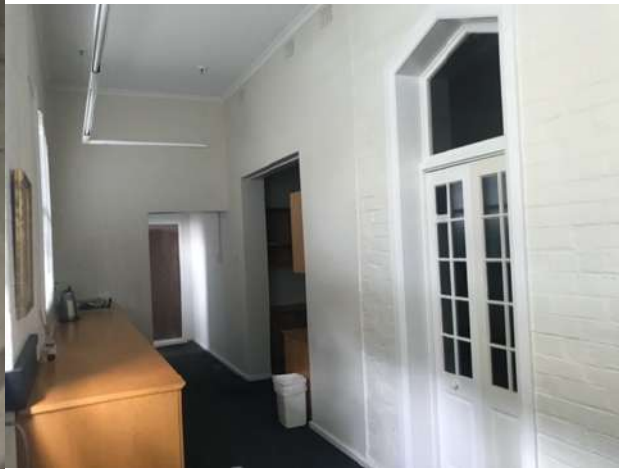
Enclosed section of southern ground floor verandah

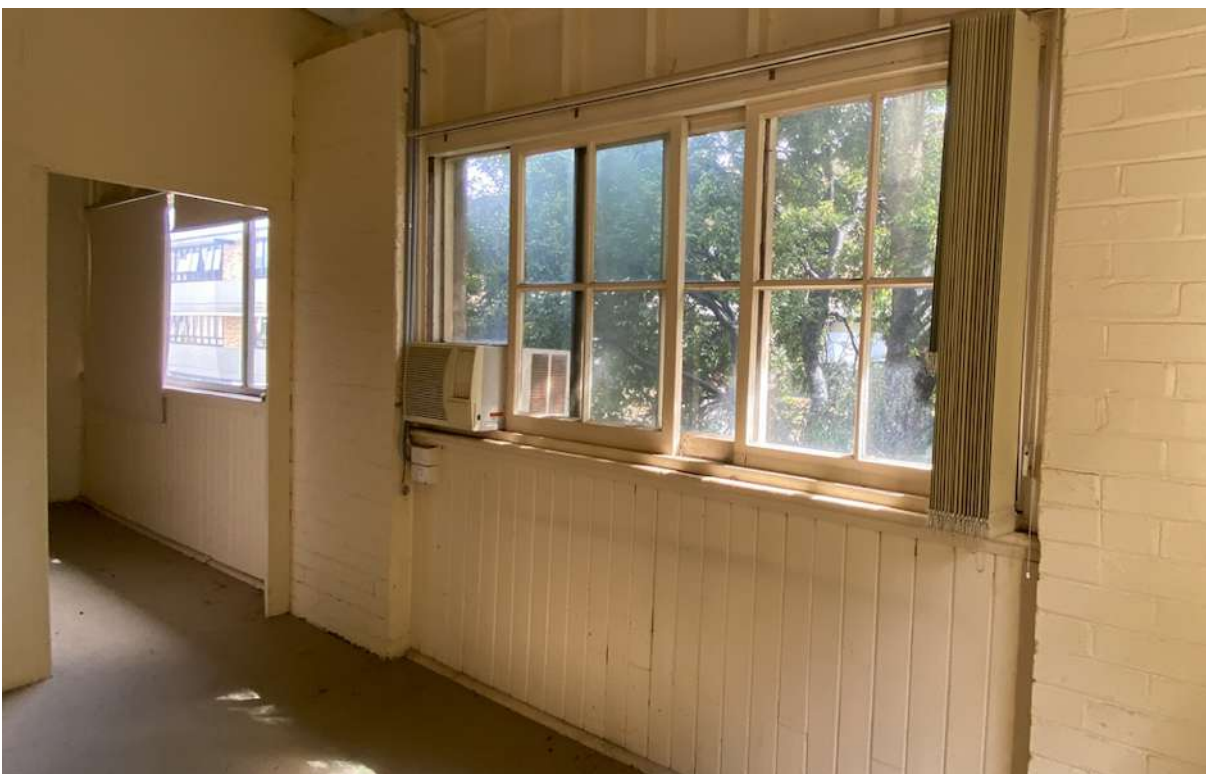
Photo. 16. Timber sliding windows removed to facilitate the reinstatement of the first floor verandahs are to be recycled or delivered to a heritage building centre.

- Timber sliding windows removed to facilitate the reinstatement of the first floor verandahs are to be recycled on site or delivered to a heritage building centre, (photo 16).

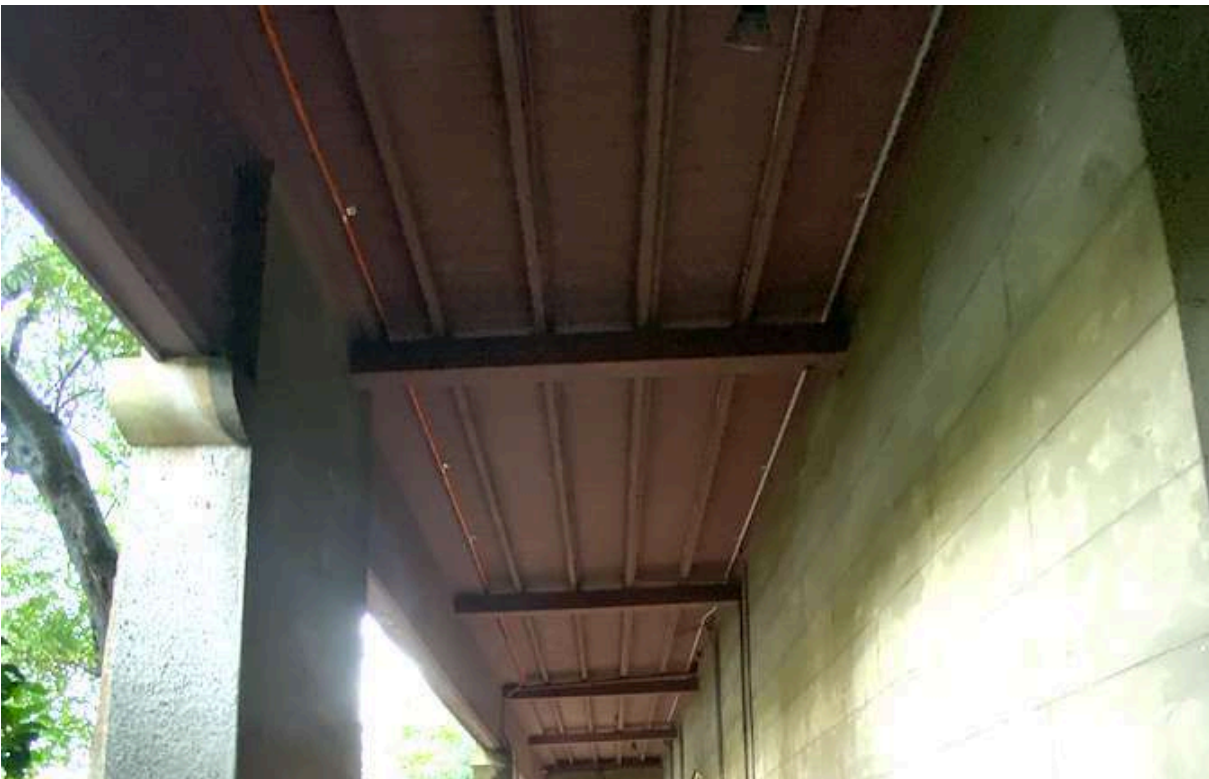
Photo. 18. The original heritage fabric of the first floor that will become open verandah floors are to be retained and protected from damage during building operation for approved alteration. Methods of weather proofing the proposed verandah floors are to be detailed and approve by the nominated heritage consultant.

- All aluminium windows and air-conditioning units are to be removed, (photo 17).
- The original heritage fabric of the first floor that will become open verandah floors are to be retained and protected from damage during building operation for approved alteration. Method of weather proofing the proposed verandah floors is to be detailed and approved by the nominated heritage consultant, (photo 18).

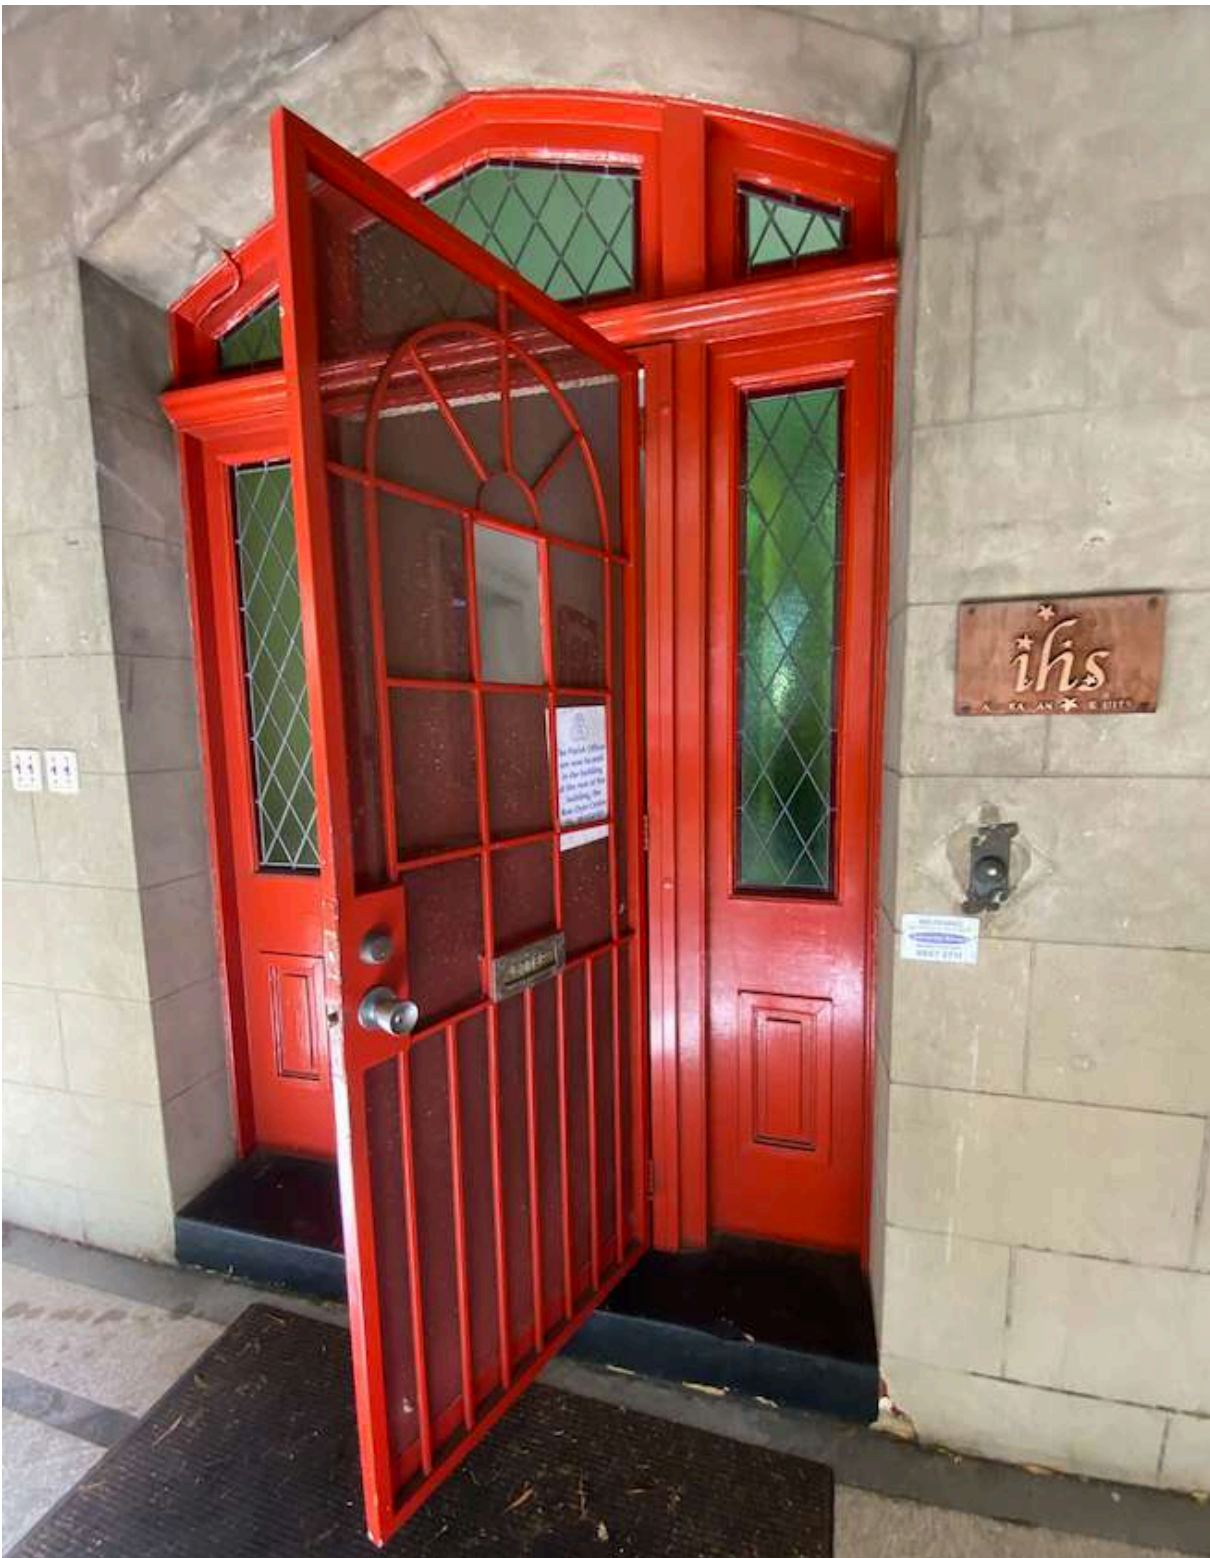
Photo. 19. The main entry door is to be retained and protected from damage during building operation for approved alteration.

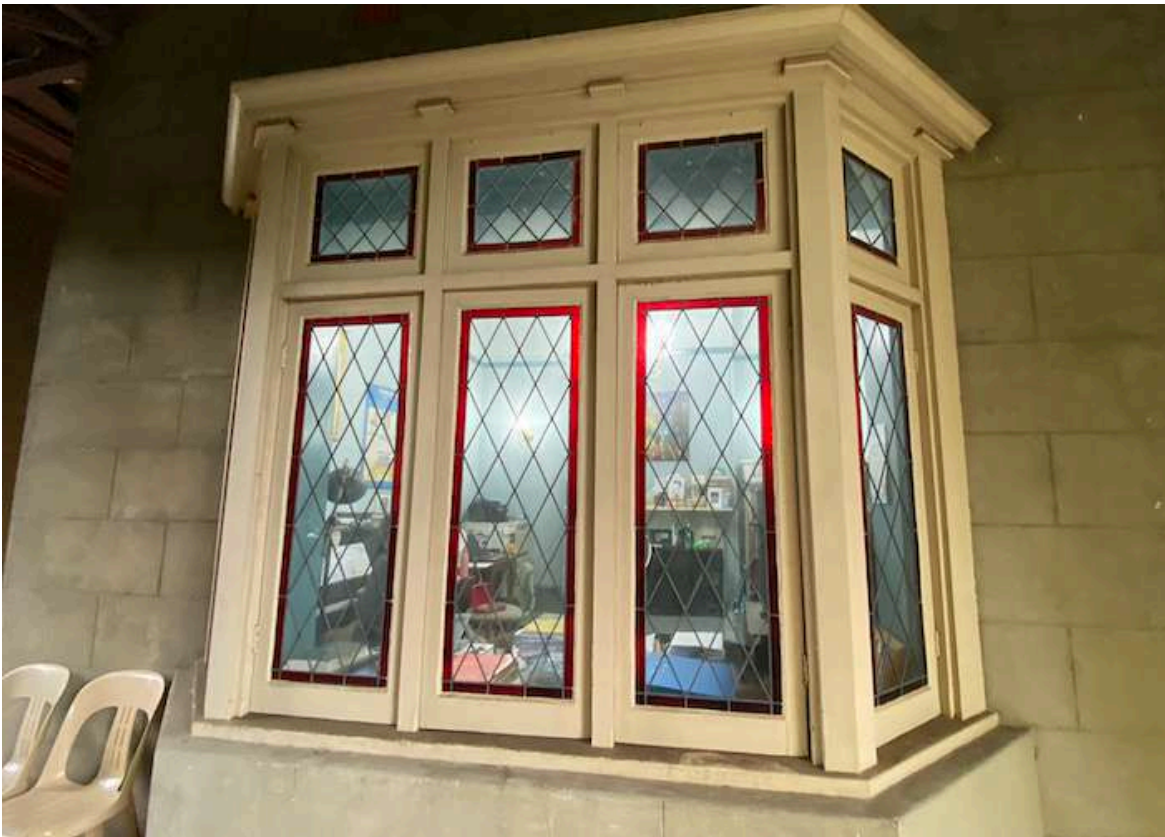
Photo. 20. The lead-light bay windows at the ground floor entry are to be retained and protected from damage during building operation for approved alteration.

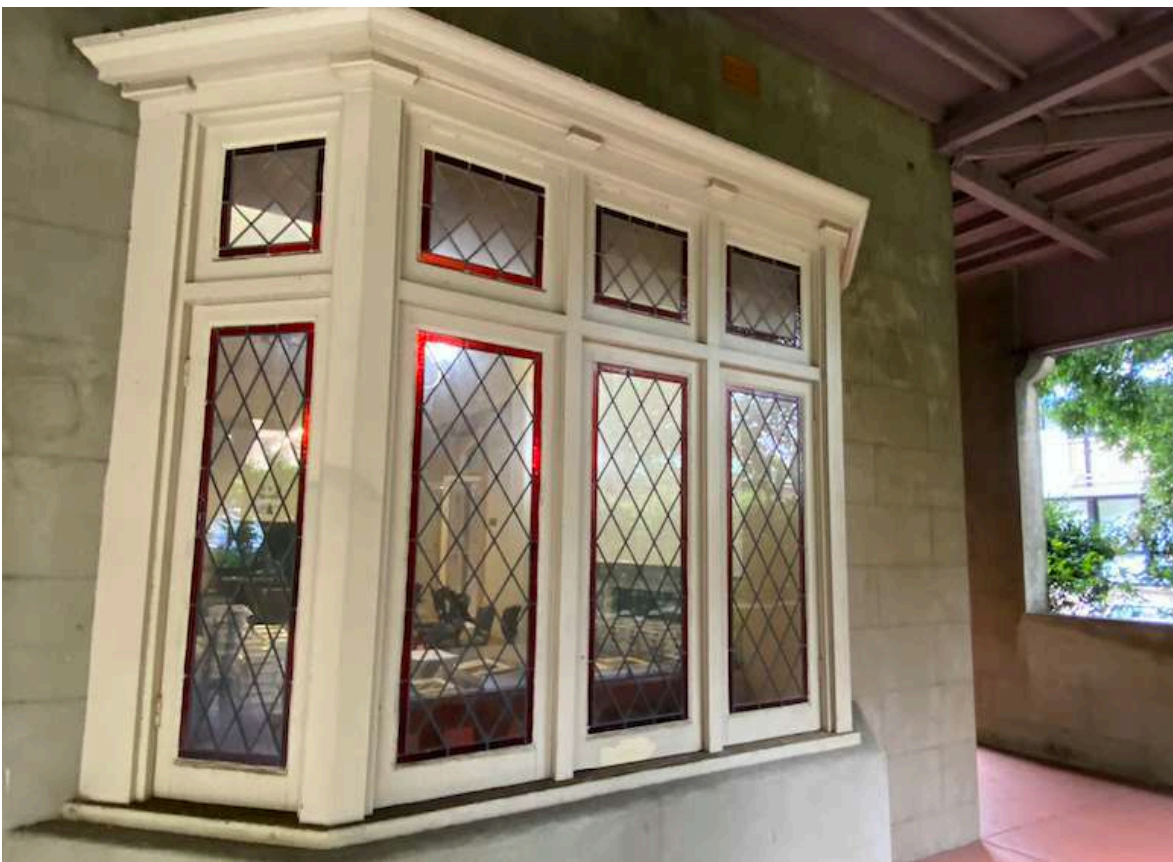
Photo. 21. The lead-light bay windows at the ground floor entry are to be retained and protected from damage during building operation for approved alteration.

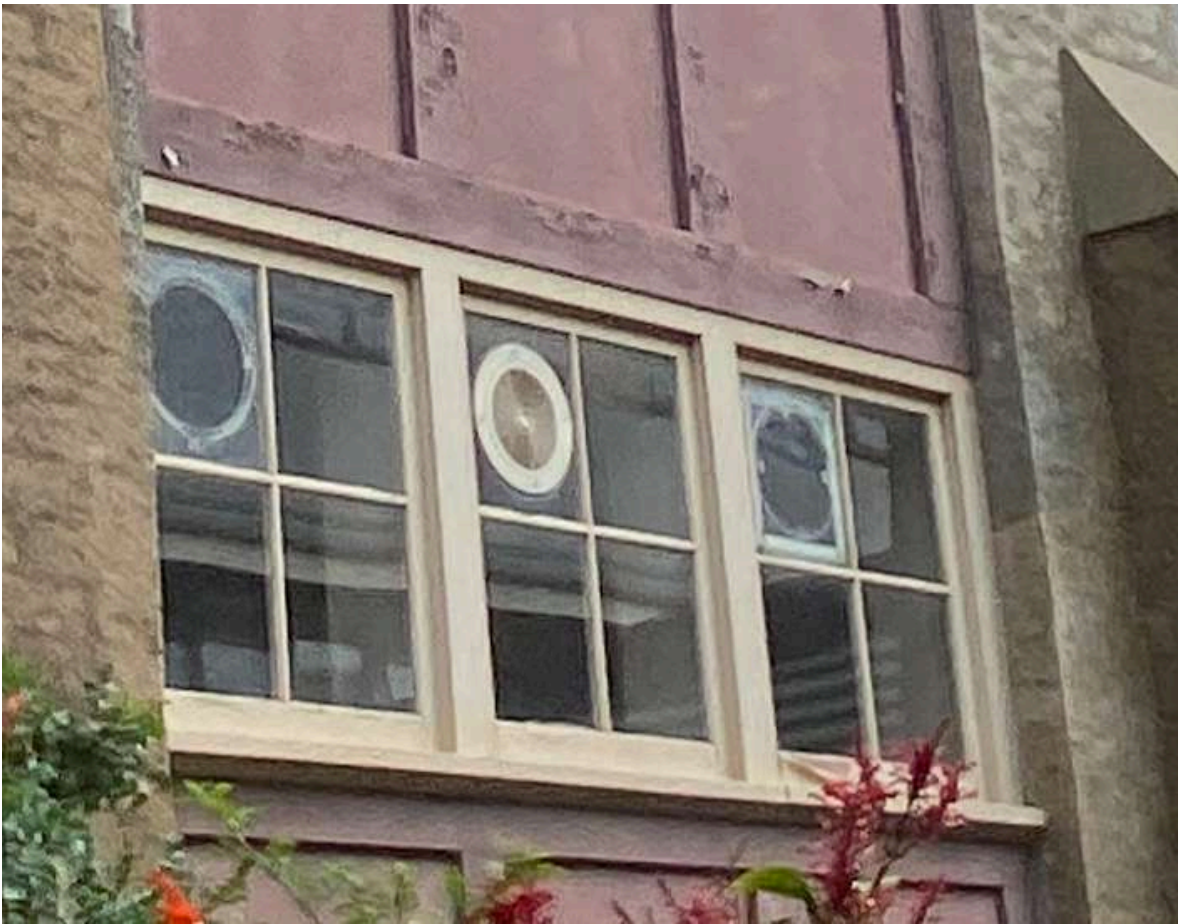
Photo. 22. The ground floor timber windows at the rear of the building on the northern elevation are to be retained or replaced with a sliding timber windows recycled from the first floor verandah.

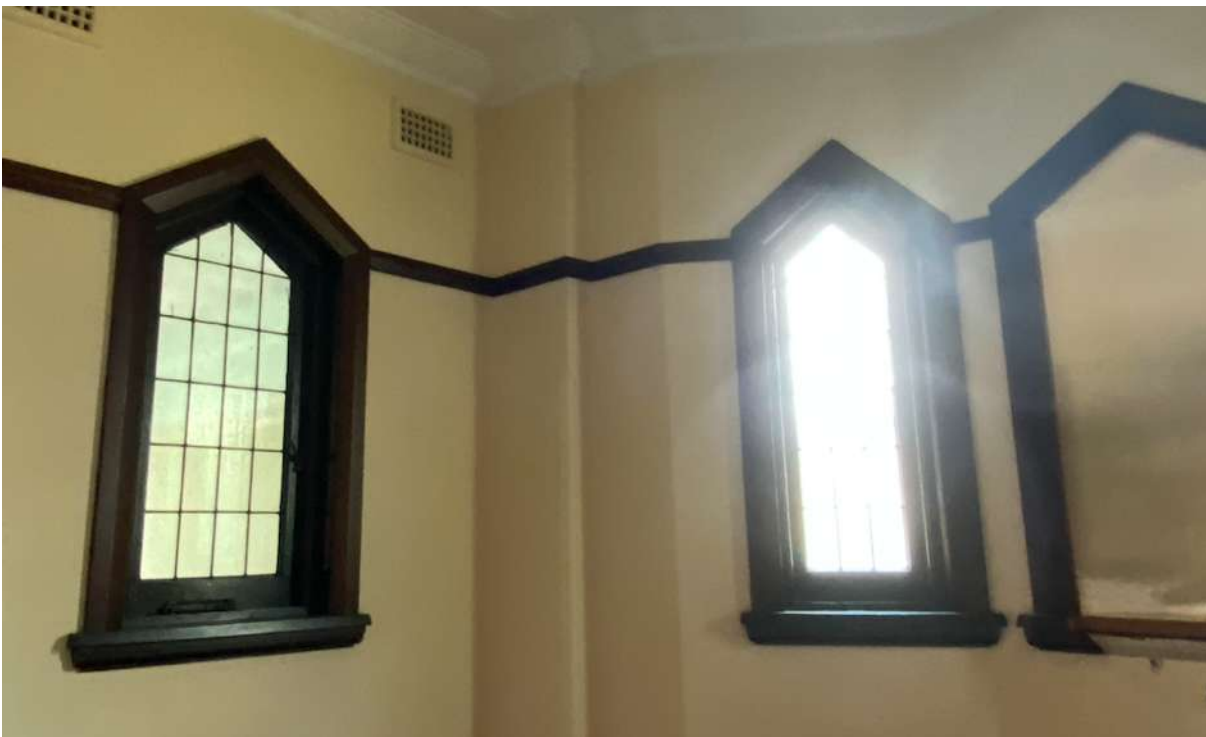
Photo. 23. The lead-light timber windows on the first floor are to be retained.

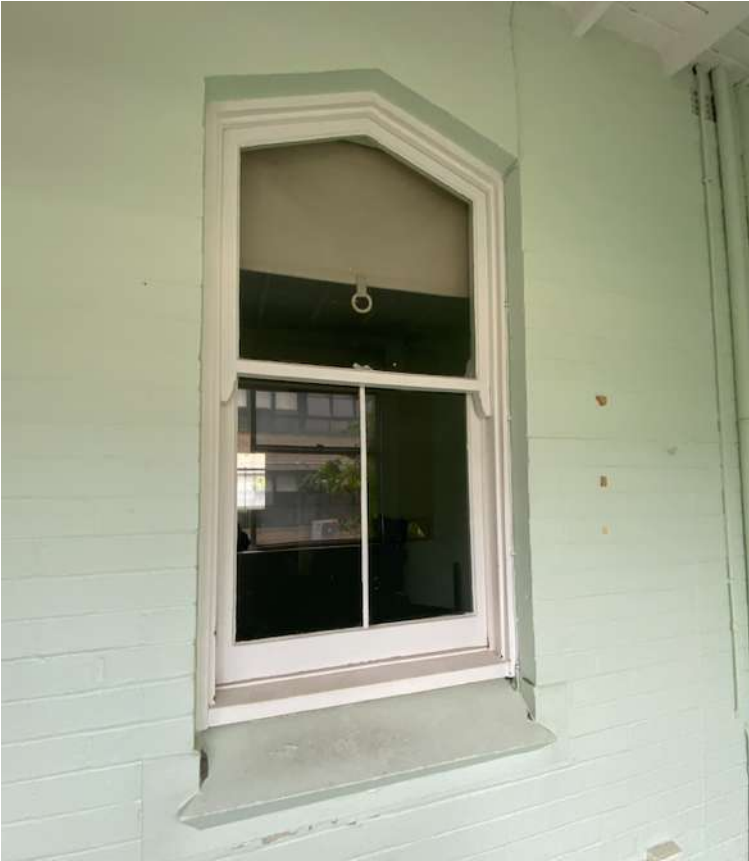
Photo. 24. All the double hung timber windows are to be retained.

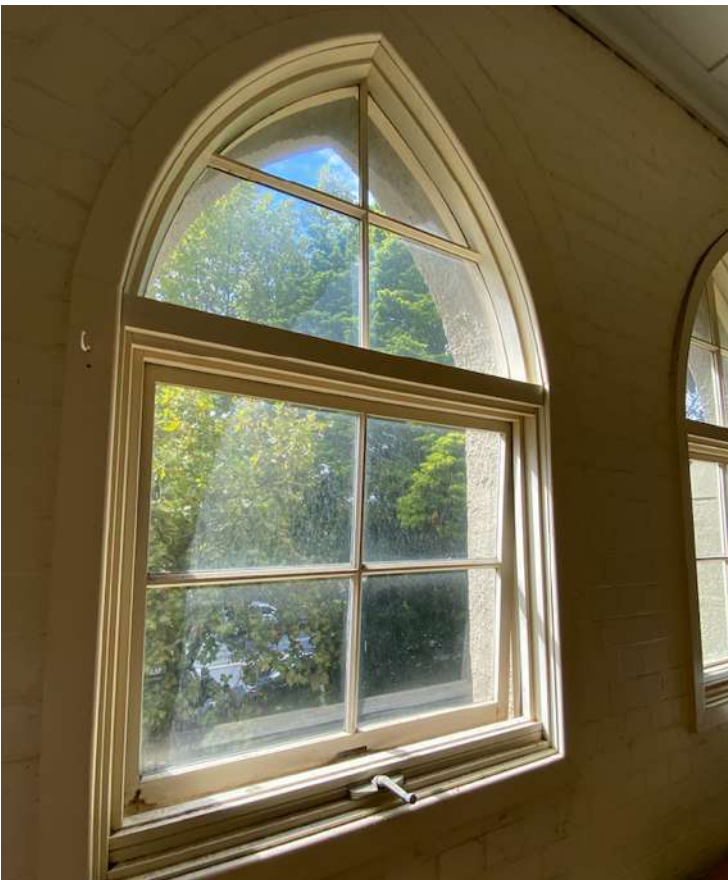
Photo. 25. The timber awning windows are to be retained.

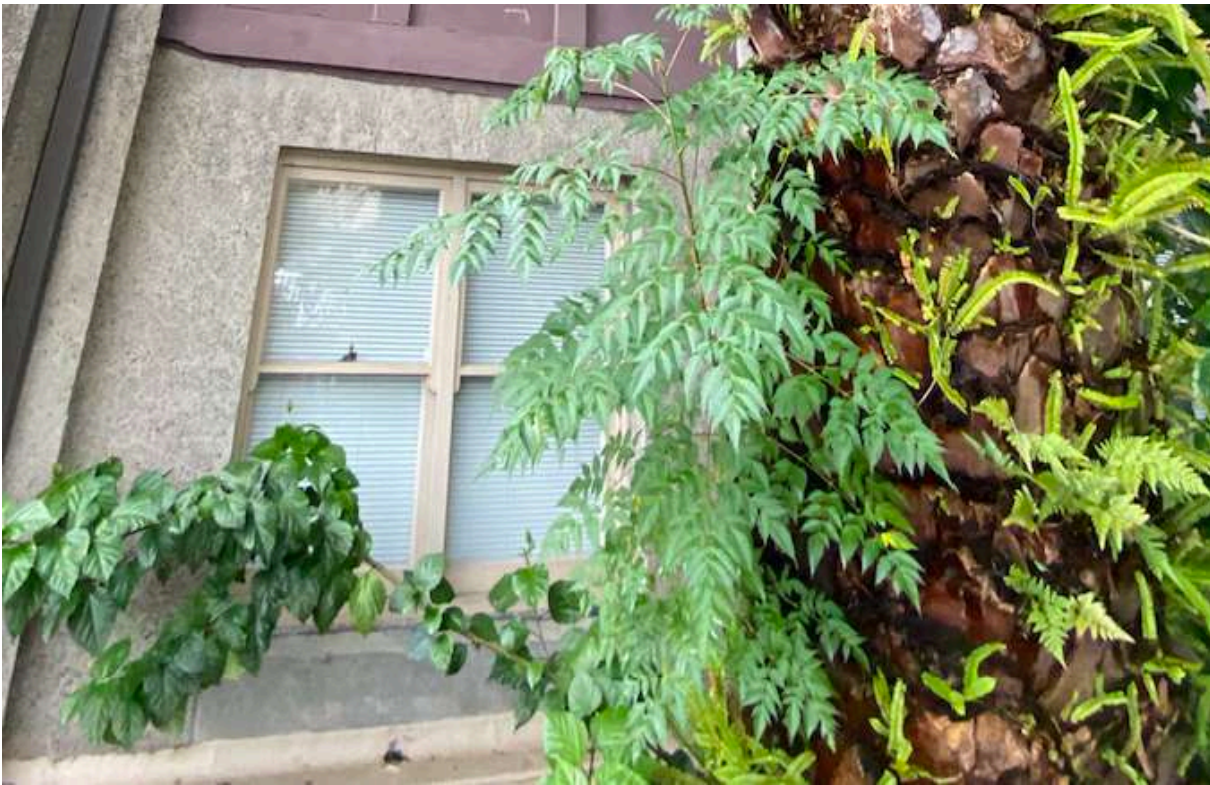
Photo. 26. All the double hung timber windows on the ground floor on the southern elevation at the rear of the Presbytery are to be retained.

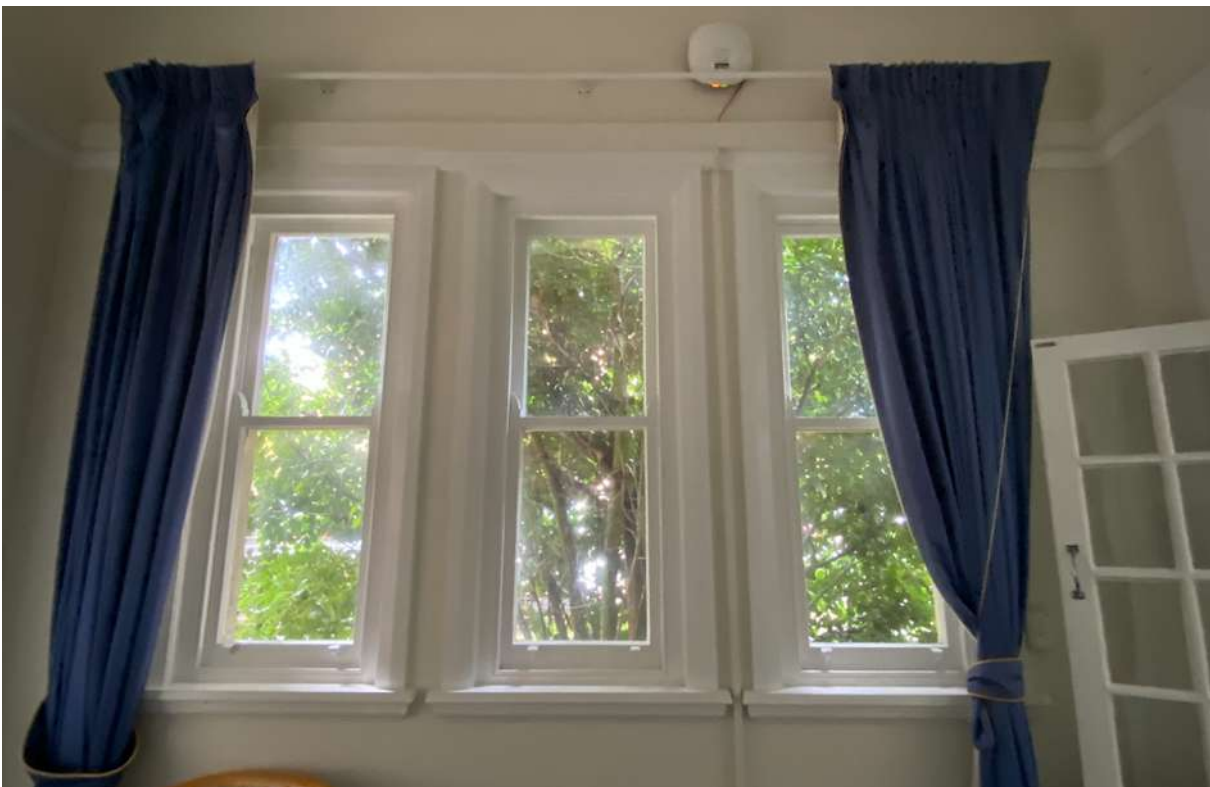
Photo. 27. All the double hung timber windows on the ground floor on the southern elevation at the rear of the Presbytery are to be retained.

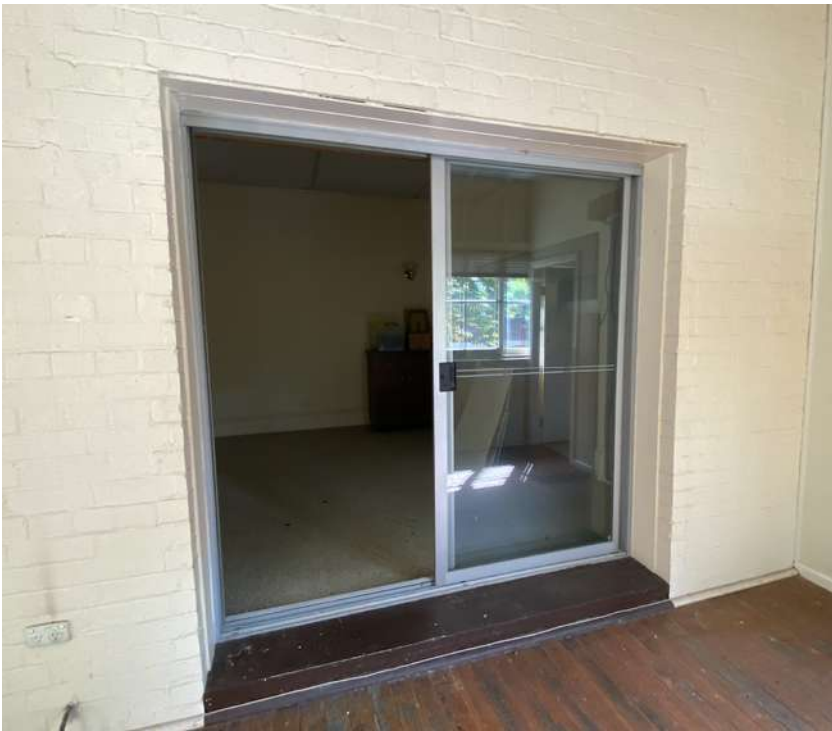
Photo. 28. The Aluminium sliding door at the north end of the eastern elevation on the first floor is to be removed. Details of the proposed new timber door or window are to be approved by the nominated heritage consultant.

- All the double hung timber windows on the ground floor on the southern elevation at the rear of the Presbytery are to be retained, (photo 26-27).
- The Aluminium sliding door at the north end of the eastern elevation on the first floor is to be removed. Details of the proposed new timber door or window are to be approved by the nominated heritage consultant, (photo 28).

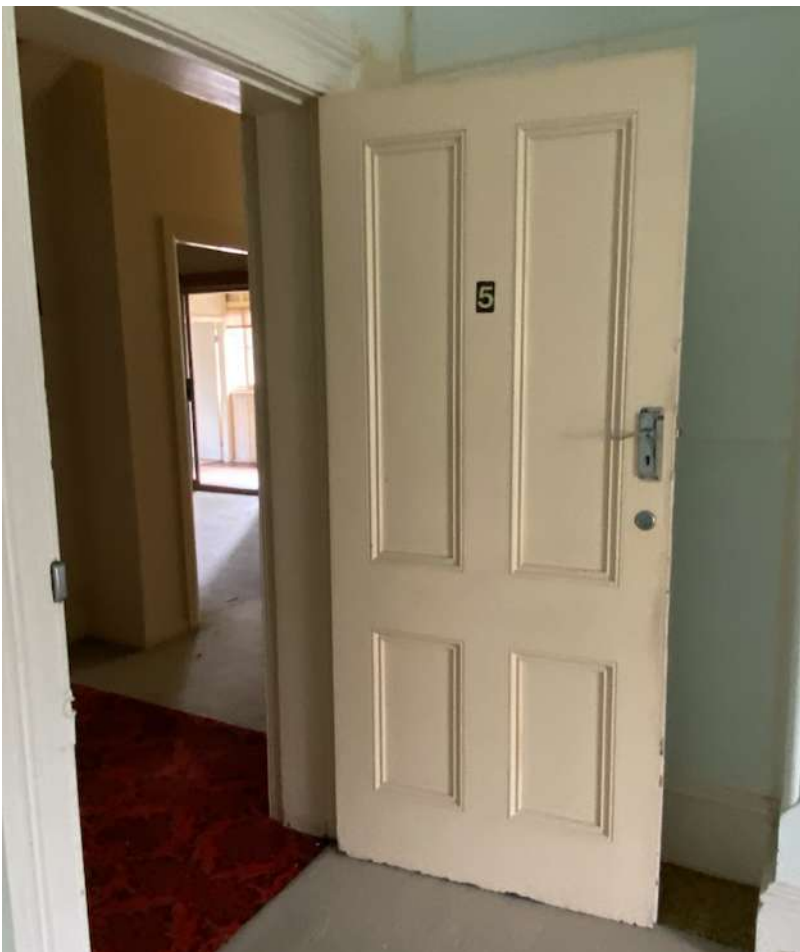
Photo. 29. The interior heritage doors are to be retained.

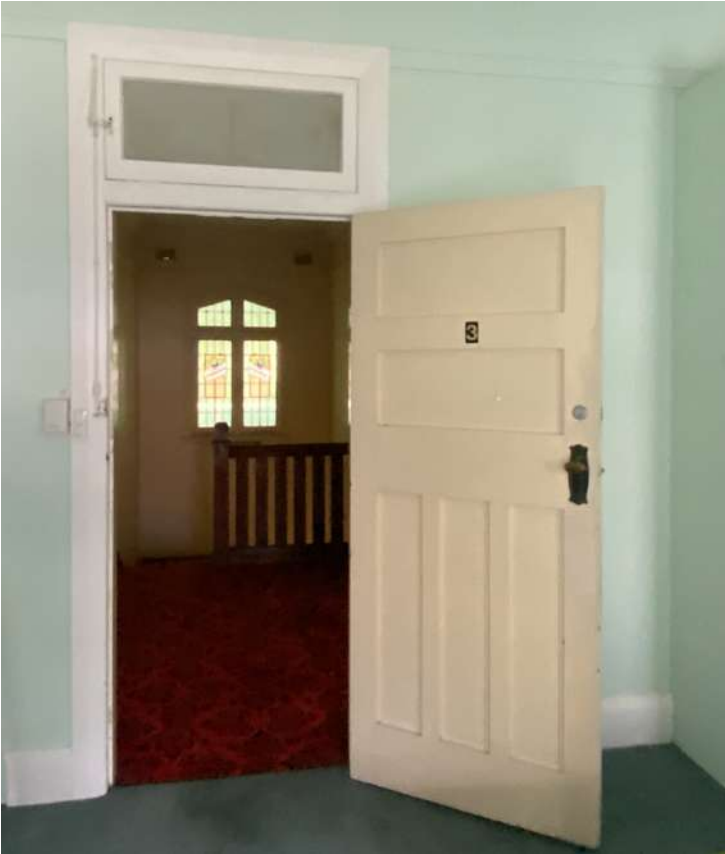
Photo. 30. The interior heritage doors, high-lights, door frames, architraves and skirtings are to be retained.

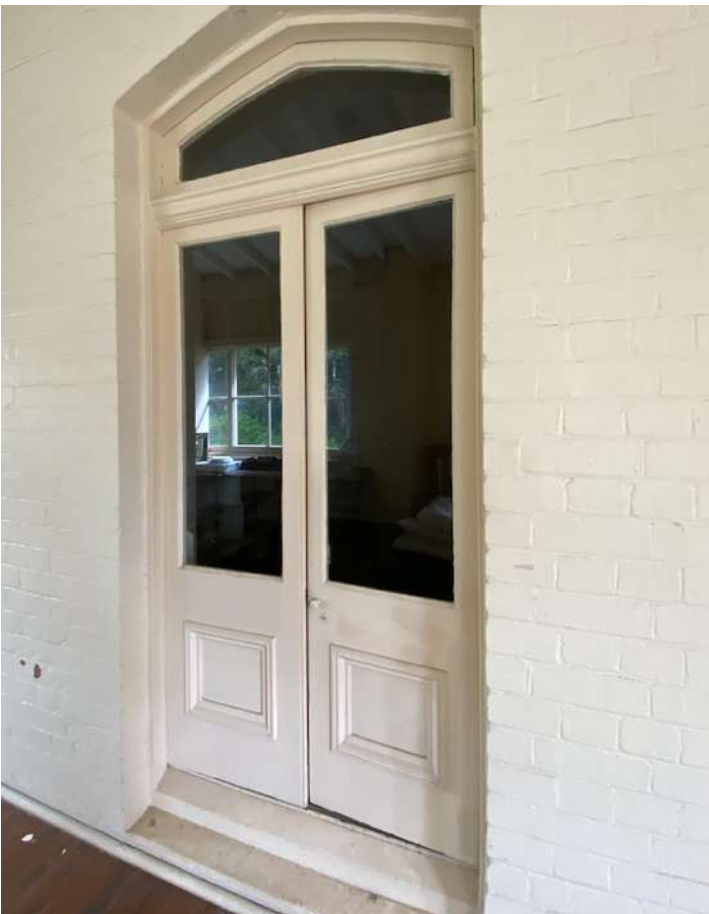
Photo. 31. The timber French doors, high-lights and door frames are to be retained.

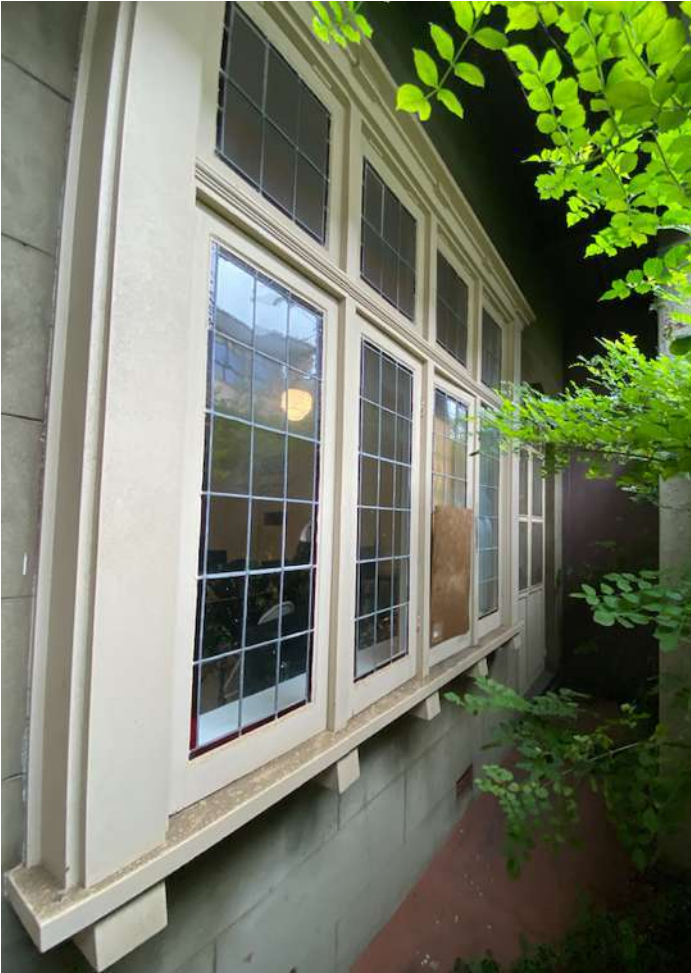
Photo. 32. The lead-light timber windows on the ground floor are to be retained.

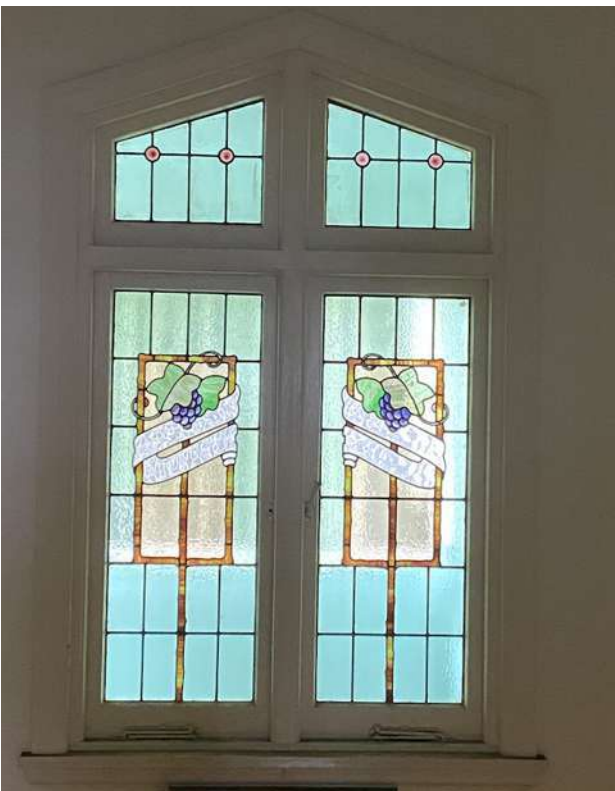
Photo. 33. All the lead-light timber windows are to be retained.

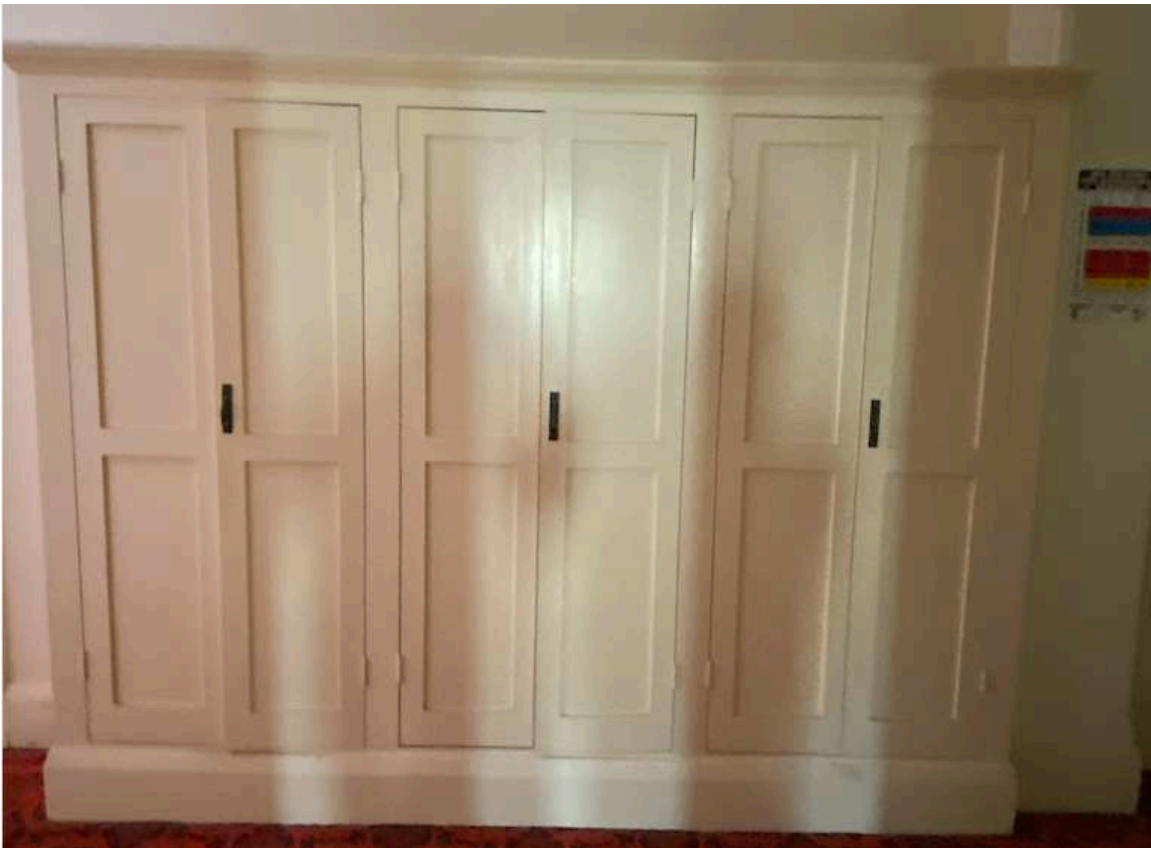
Photo. 36. The original cupboards in the central corridor on the first floor are to be retained.

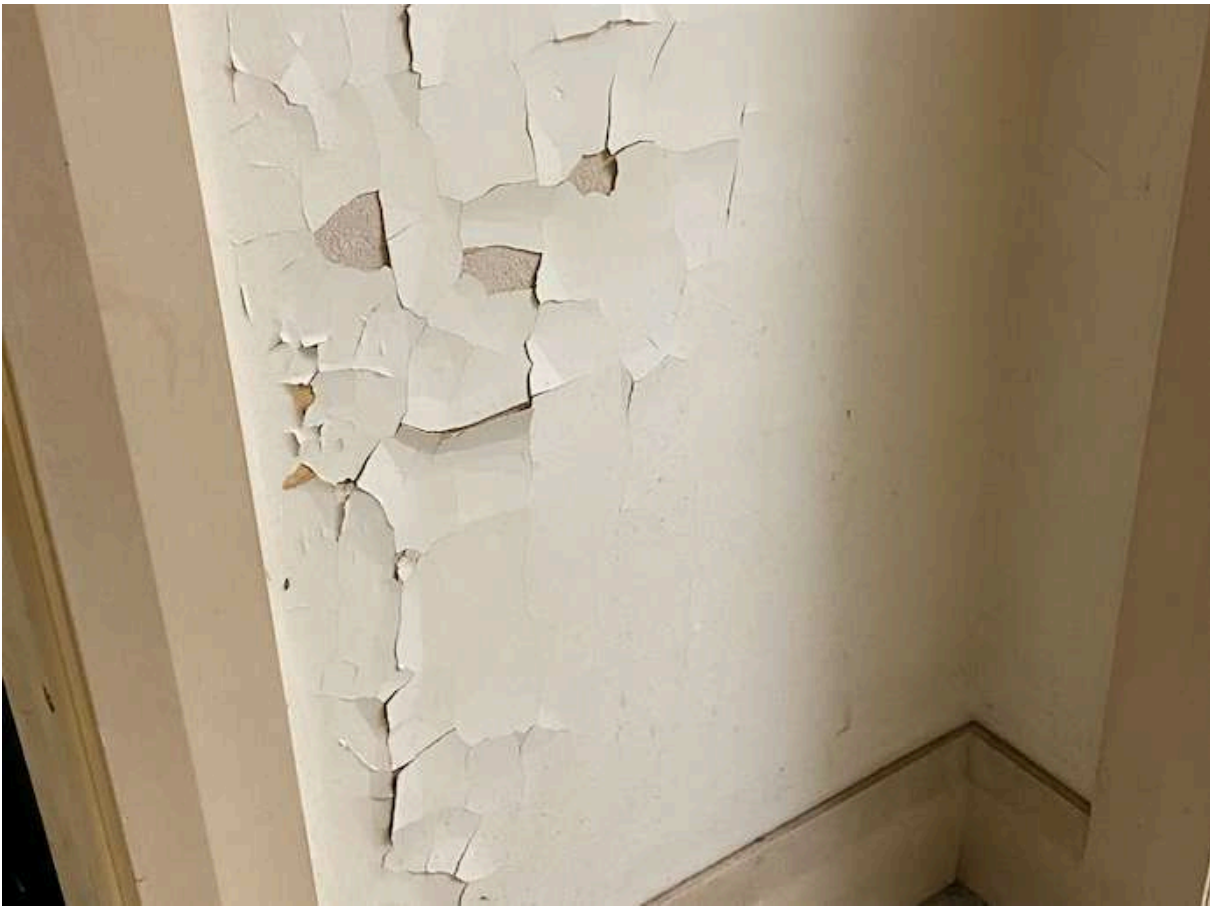
Photo. 40. The interior of the Presbytery is to be properly prepared and repainted.

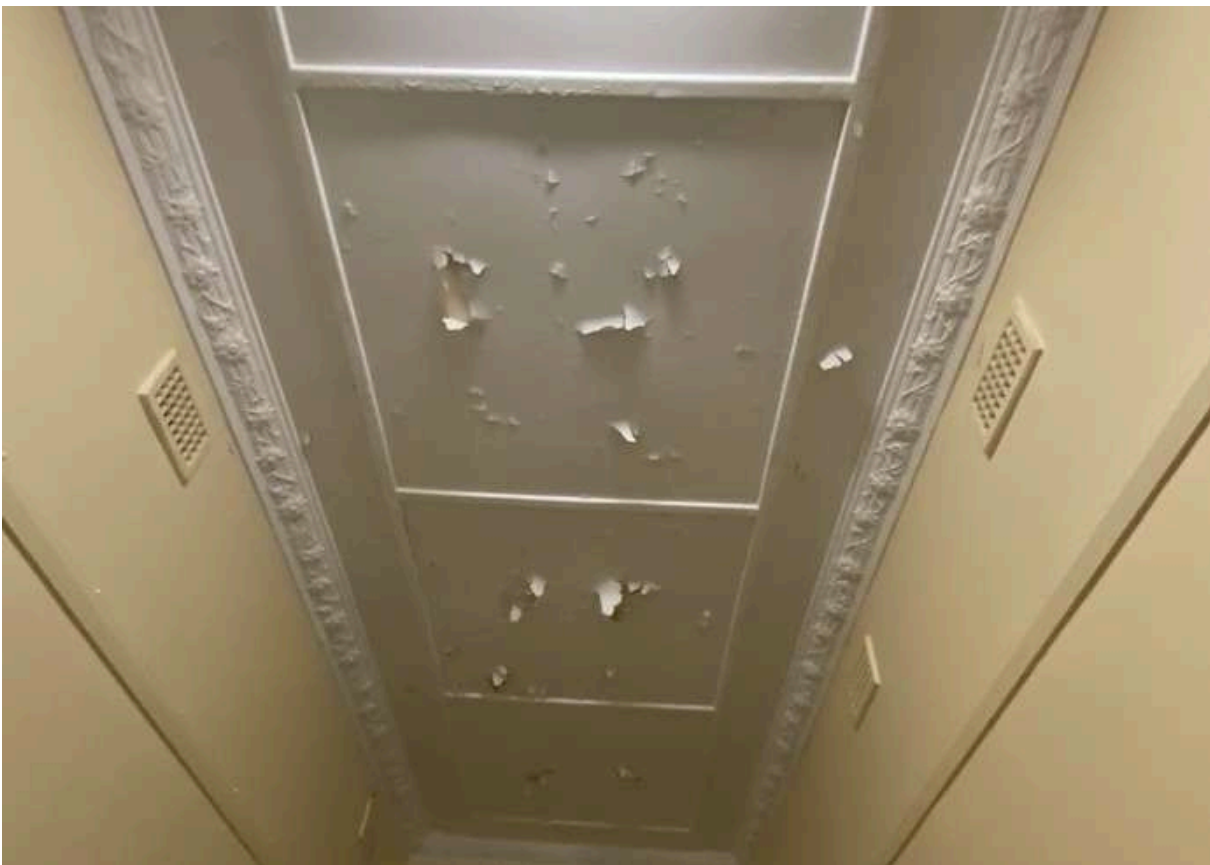
Photo. 41. The interior of the Presbytery is to be properly prepared and repainted.
