RE: Marist Catholic College North Shore (SSD-10473). Response to Submissions and peer review. NSW Government, Department Planning, Industry and Environment (DPIE)

APPENDIX A: SUMMARY TABLE Marist Catholic College North Shore (SSD-10473). Response to Submissions.

This Schedule of Conservation Works is a list of work that is required to correct damage and deterioration to St. Mary's Presbytery, Marist Catholic College, 270 Miller Street, North Sydney NSW

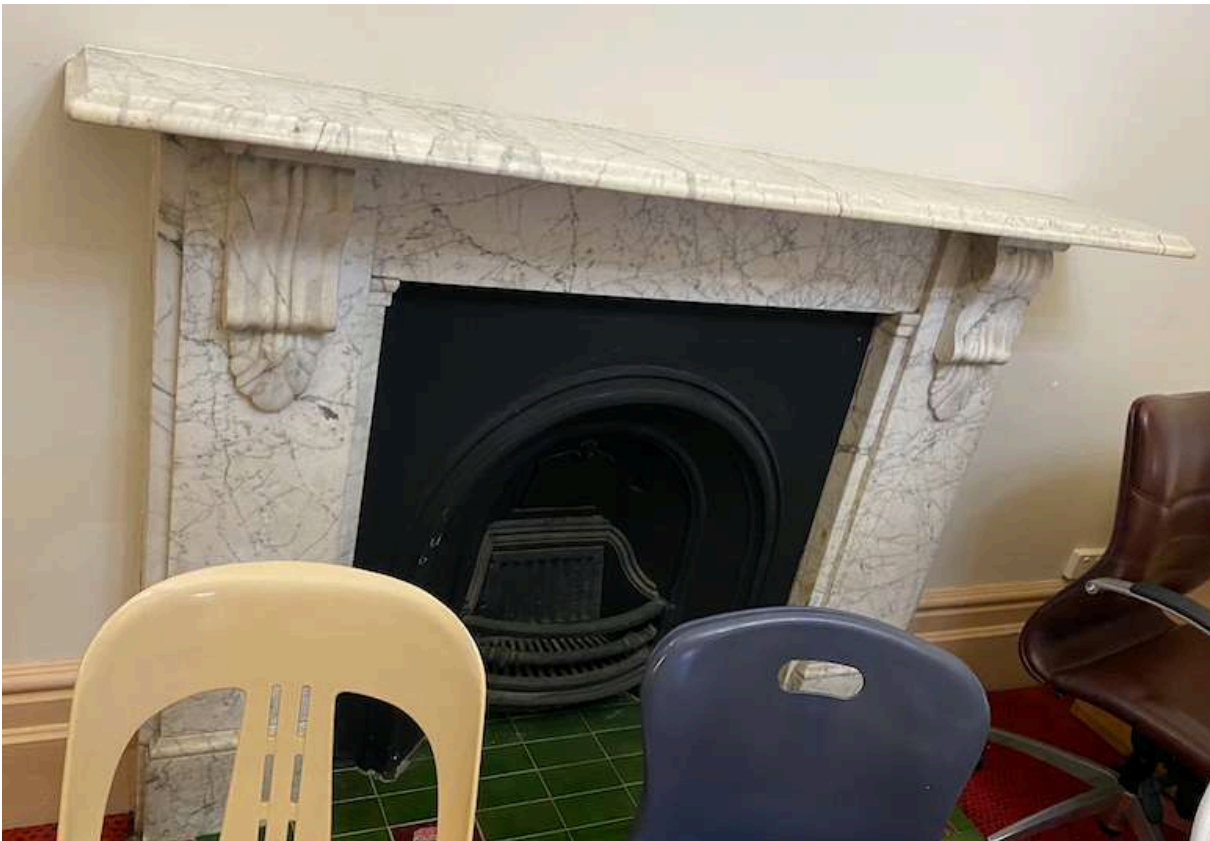
Photo. 42. The heritage fire places, surrounds, mantels and hearths are to be retained.

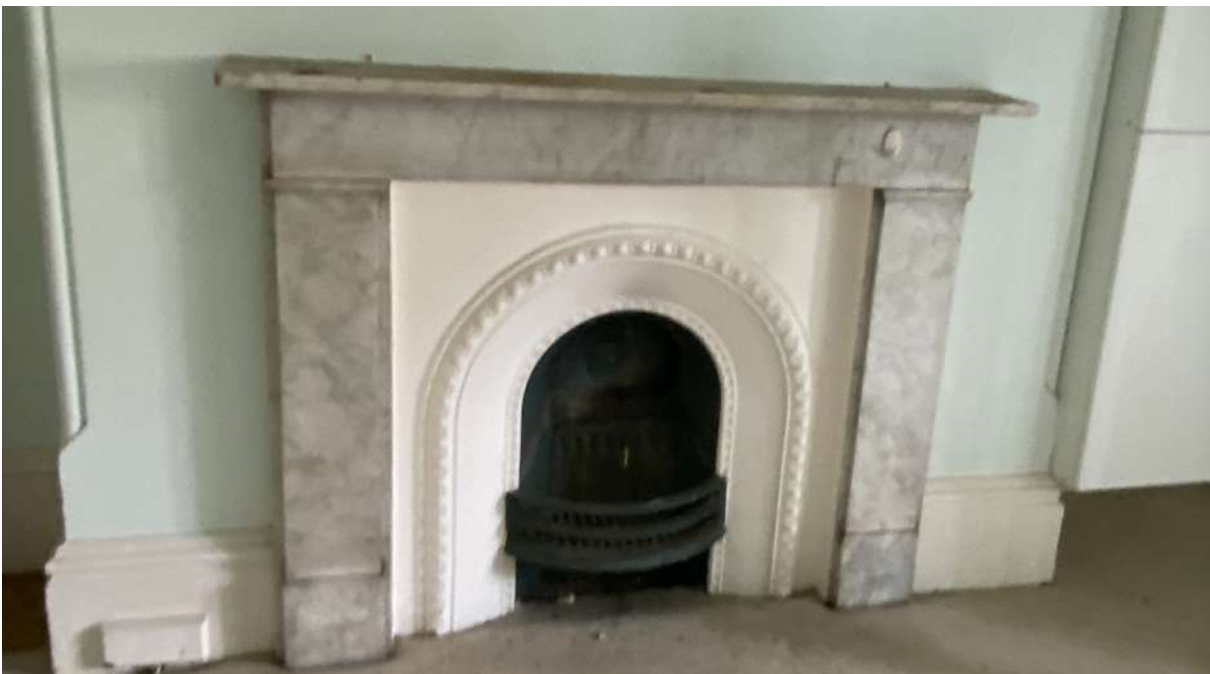
Photo. 43. The heritage fire places, surrounds, mantels and hearths are to be retained.

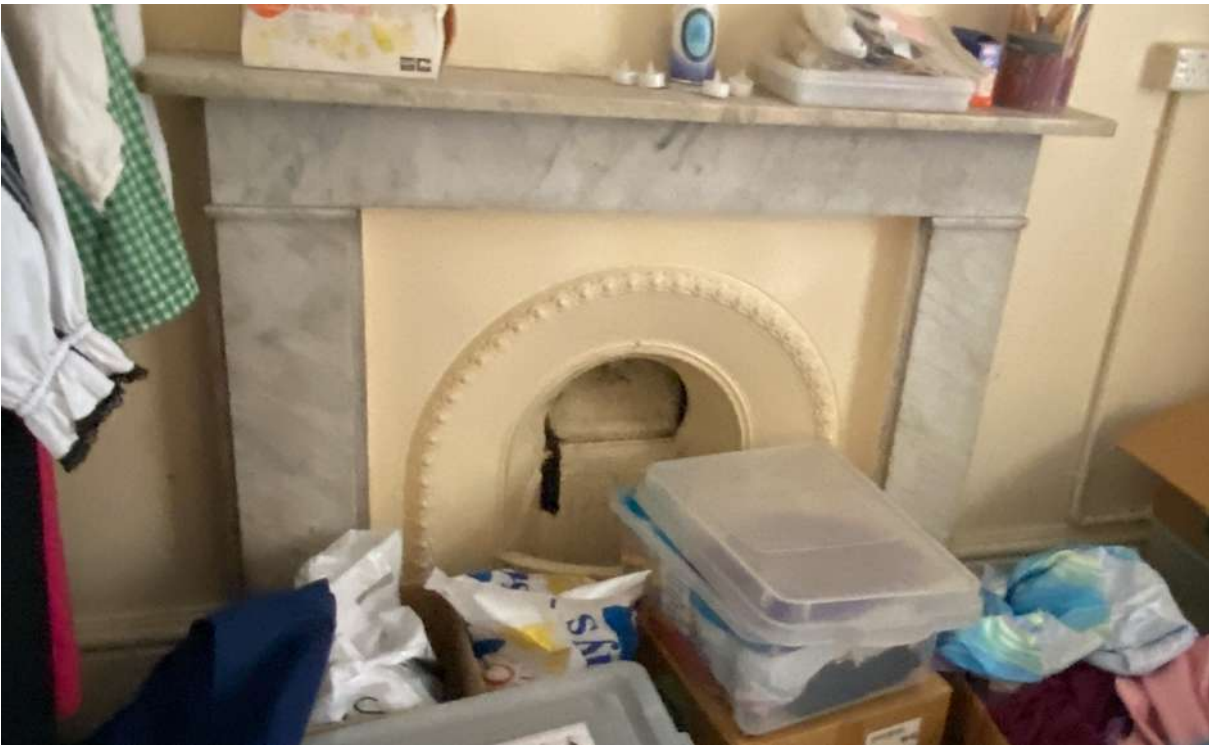
Photo. 44. The heritage fire places, surrounds, mantels and hearths are to be retained.

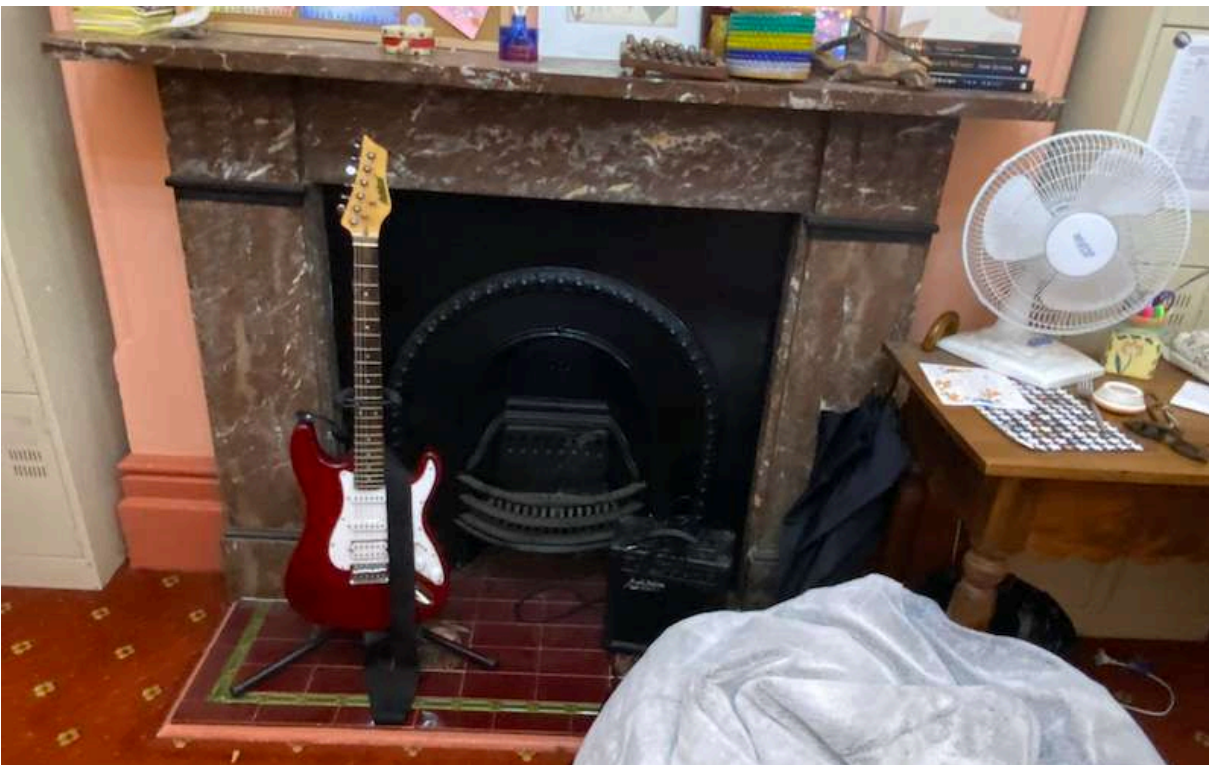
Photo. 45. The heritage fire places, surrounds, mantels and hearths are to be retained.

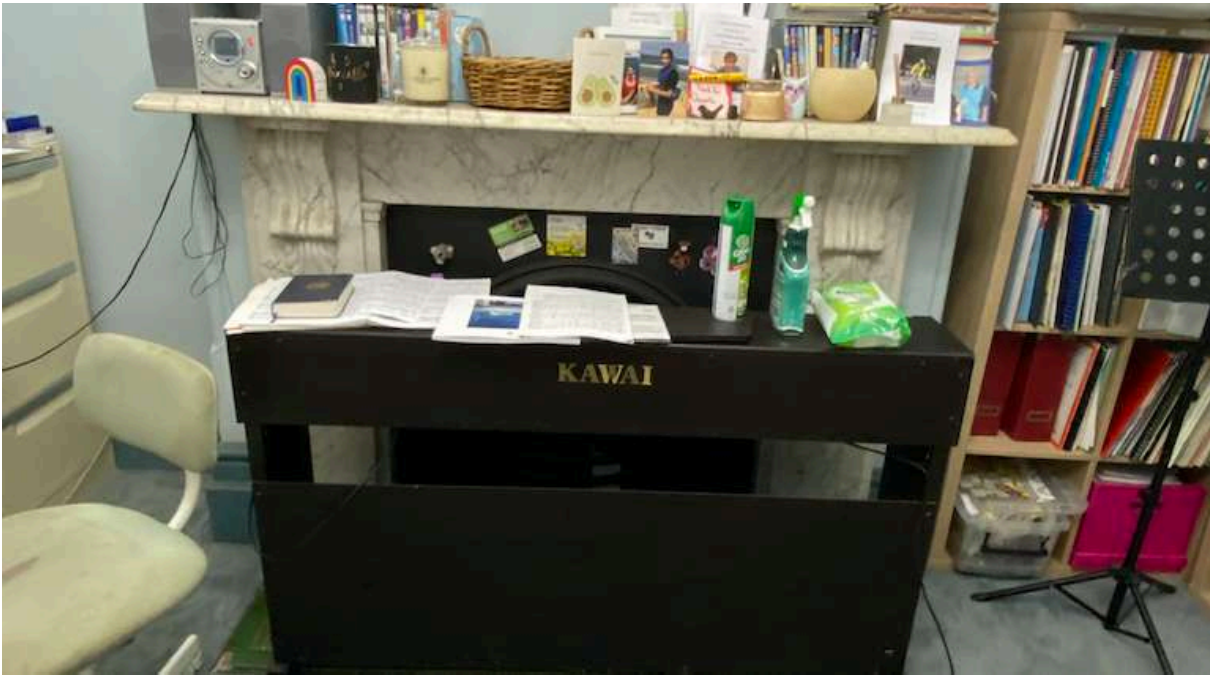
Photo. 46. The heritage fire places, surrounds, mantels and hearths are to be retained.

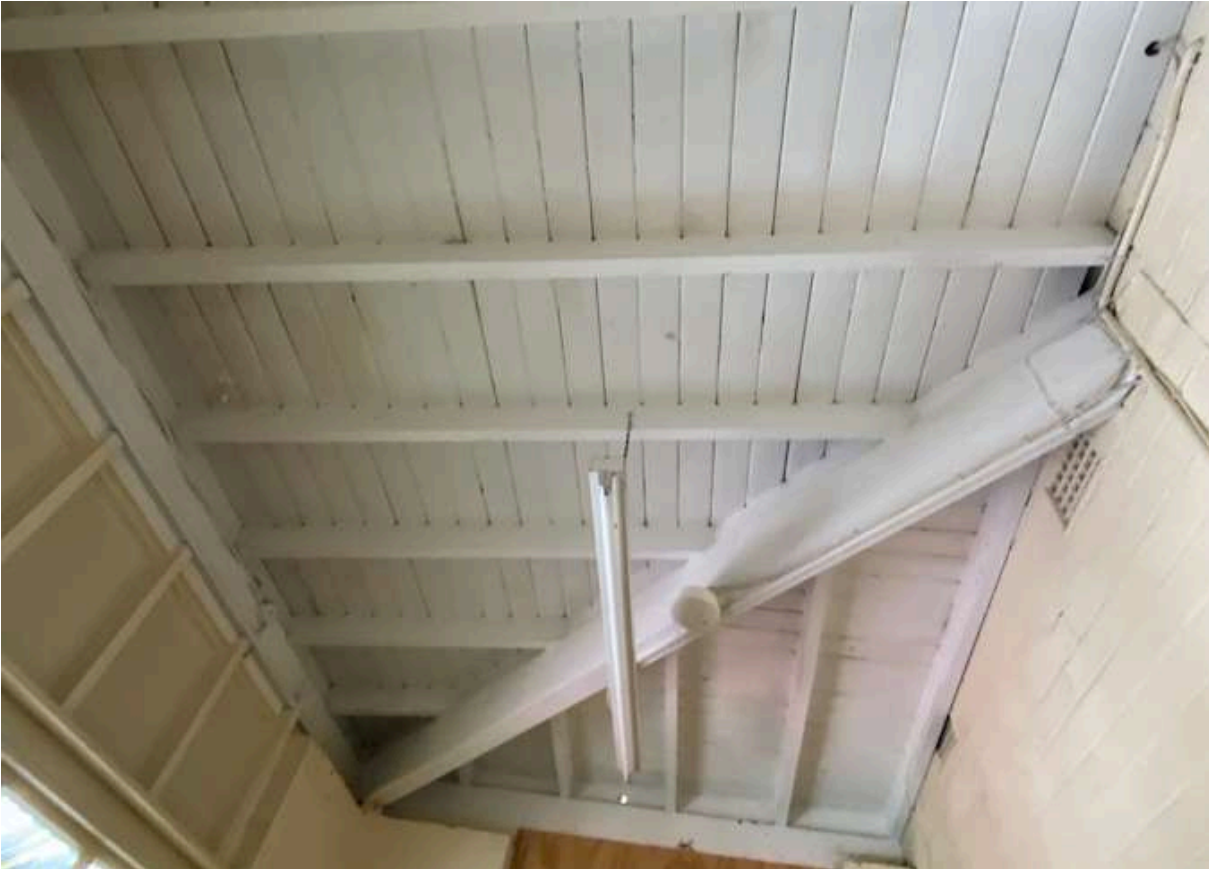
Photo. 48. The heritage timber panel verandah ceilings are to be retained and protected from damage during building operation for approved alteration.

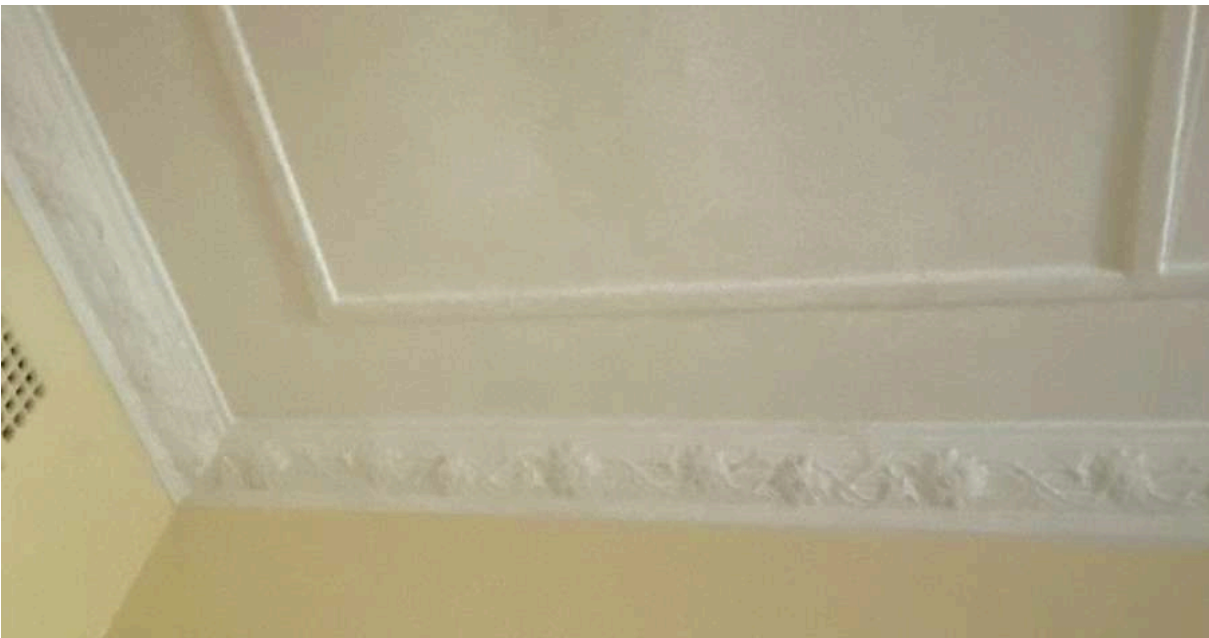
Photo. 49. All the heritage ceilings, cornices, ceiling roses and decorative elements are to be retained.

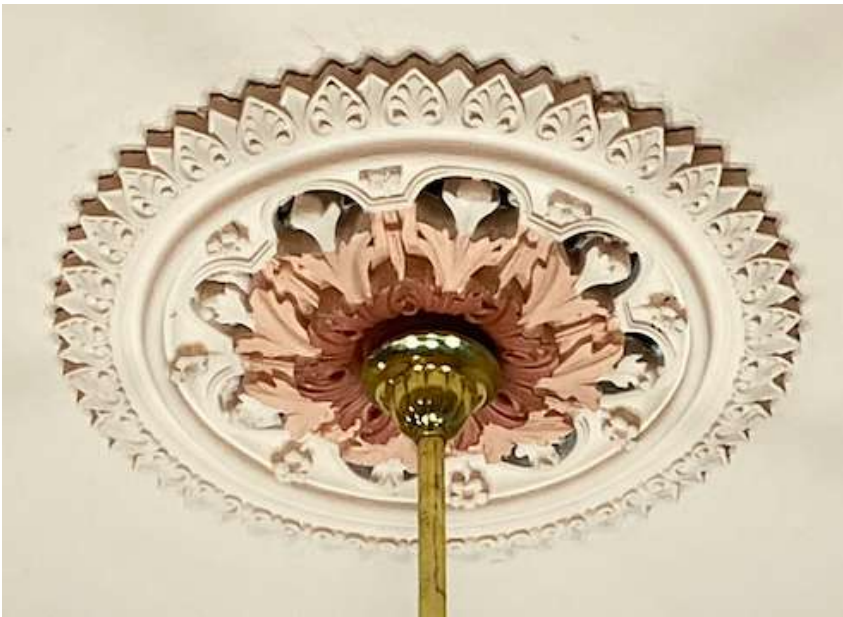
Photo. 50. All the heritage ceilings, cornices, ceiling roses and decorative elements are to be retained.

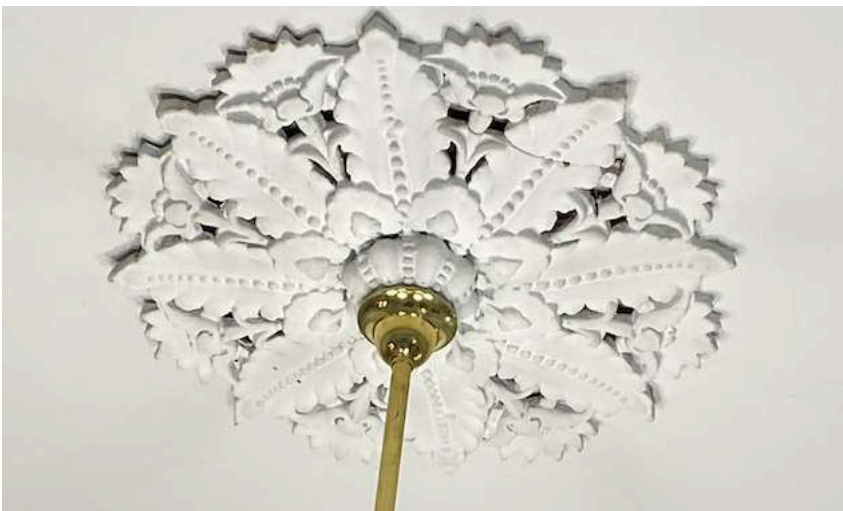
Photo. 51. All the heritage ceilings, cornices, ceiling roses and decorative elements are to be retained.

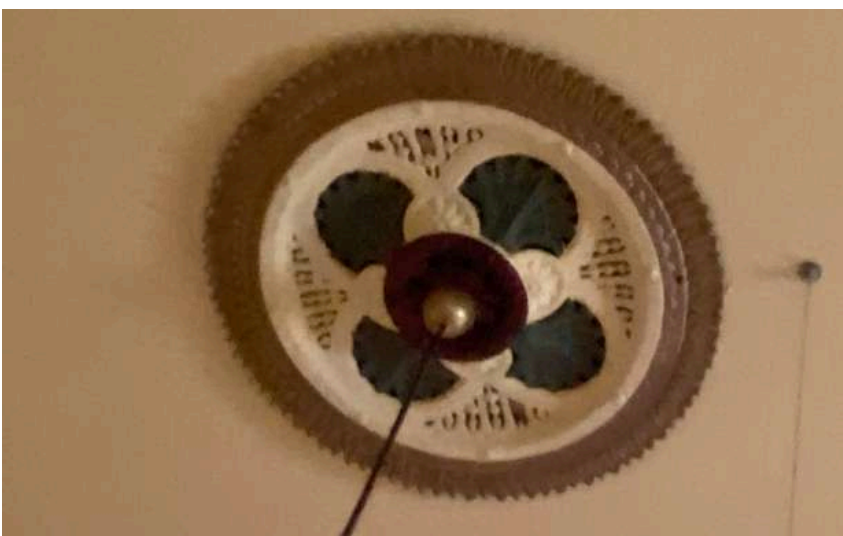
Photo. 52. All the heritage ceilings, cornices, ceiling roses and decorative elements are to be retained.

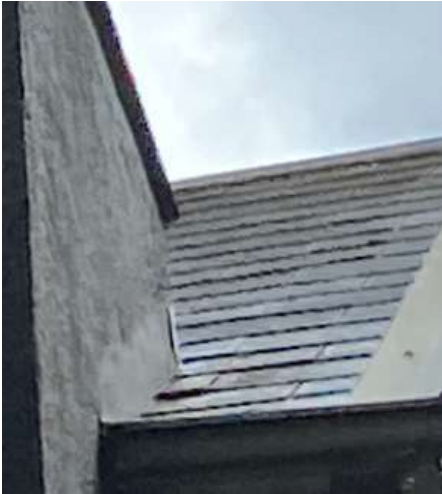
<p>LOCATION: Roofs</p> <p>WORK REQUIRED: The slate roof and all associated flashings are to be inspected by a heritage roof slate contractor with a proven record of satisfactory work to heritage slate roofs.</p> <p>Standards: AS 4597-1999 Installation of Roof Slate, AS 1562.1 2018, SA HB 3850.1-2015 Metal Roofing and AS/NZS 2179.1-1014 Metal Rainwater Goods.</p>

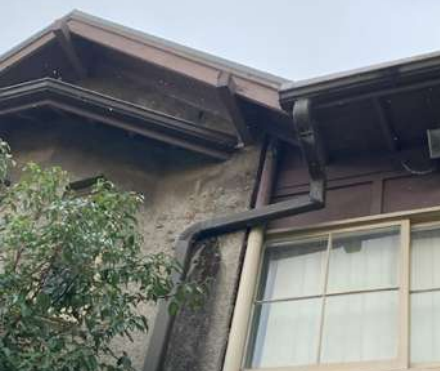
LOCATION: External Timbers WORK REQUIRED: All the exterior cladding and timber work is to be inspected by an experienced contractor with a proven record of satisfactory work on heritage buildings. Standard: AS 1684.2—2021 Timber framing

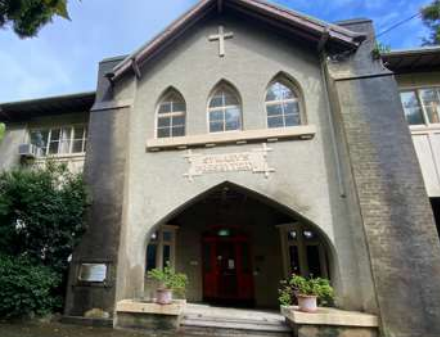
LOCATION: Entire Presbytery WORK REQUIRED: All of the external brickwork and masonry is to be professionally cleaned by an experienced masonry cleaning contractor with a proven record of satisfactory work on heritage buildings Standard: AS 3700-2018 Masonry Structures

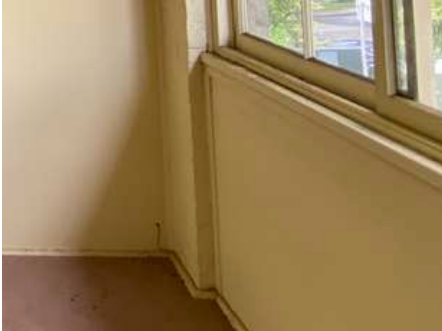
<p>LOCATION: Proposed Open Verandahs</p> <p>WORK REQUIRED: Prior to the removal of the existing windows to reinstate the first floor verandahs on the northern, east and southern elevations (demolition). Both internal and external cladding is to be examined by a licensed asbestos inspector to ensure the cladding material is not asbestos sheet.</p> <p>Standard: AS 4964-2004 Asbestos identification</p>		
Issue:	March 2022

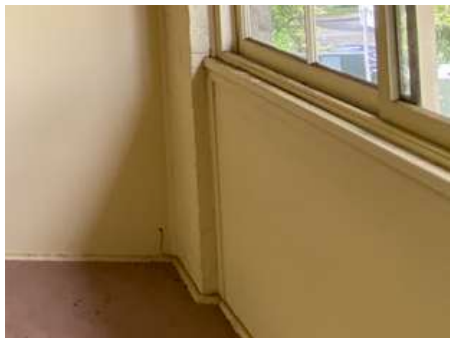
LOCATION: Proposed Open Verandahs WORK REQUIRED: Should the cladding contain asbestos the extent of reconstruction may be impacted. Reference photographs, material samples and detailed measurements of all the detailed timber trims, battens will be required to ensure faithful and accurate reproduction of any material that needs to be removed and cannot be reused.

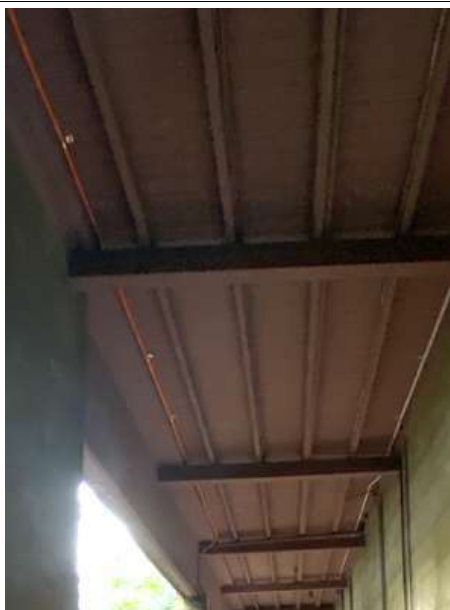
LOCATION: Proposed Open Verandahs WORK REQUIRED: The original heritage fabric of the first floor that will become open verandah floors are to be retained and protected from damage during building operation for approved alteration. Methods of weather proofing the proposed verandah floors are to be detailed and approve by the nominated heritage consultant. Standards: AS 1684.2—2021 Timber framing, AS 4654.2 -2012 Waterproofing membranes for external above-ground use and AS/NZS 4858:2004 Wet area membranes

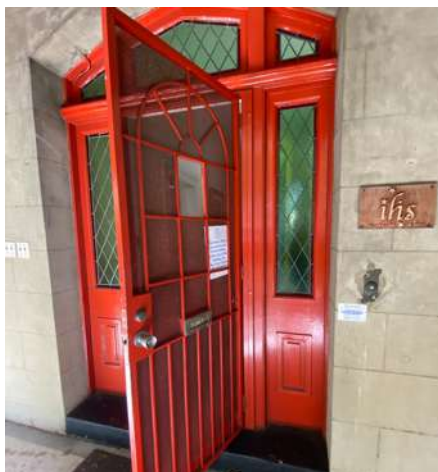
<p>LOCATION: Main Entry</p> <p>WORK REQUIRED: The main entry door is to be retained and protected from damage during building operation for approved alteration.</p>
