Harbourside

## Excavation Phase - Construction Noise and Vibration Management Plan

## 16.8 APPENDIX H – HAZARDOUS BUILDING MATERIAL SURVEY (JBS&G)

Mirvac Retail Sub SPV Pty Ltd  
Hazardous Building Materials Survey  
Harbourside Shopping Centre Redevelopment  
2-10 Darling Drive,  
Sydney, NSW

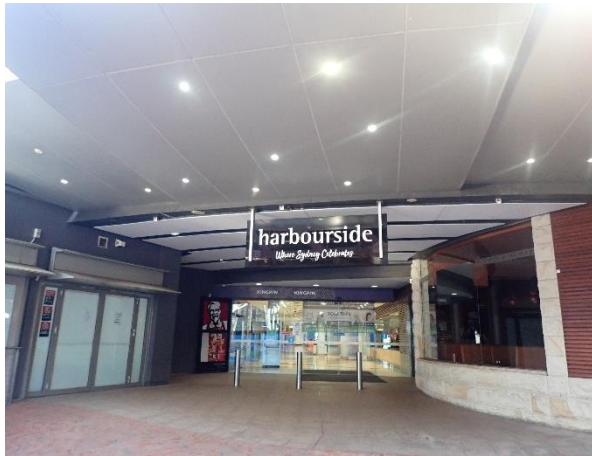
Photo 1: Overview of Harbourside Shopping Centre

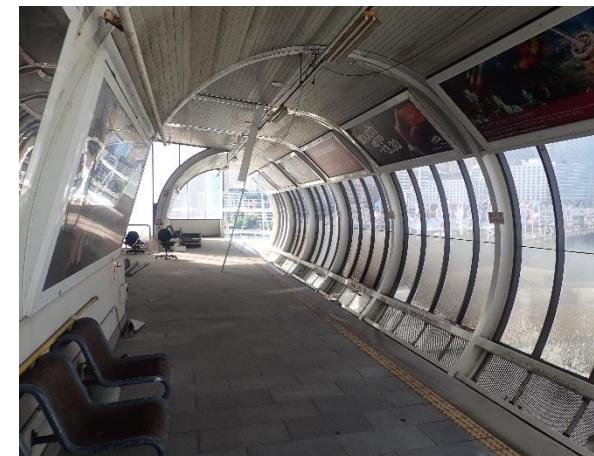
Photo 57: Overview of Former Monorail Station
