BANK STREET COMMERCIAL WHARF – DRY WORKS

POST-CONSTRUCTION DILAPIDATION REPORT

July 22nd 2020

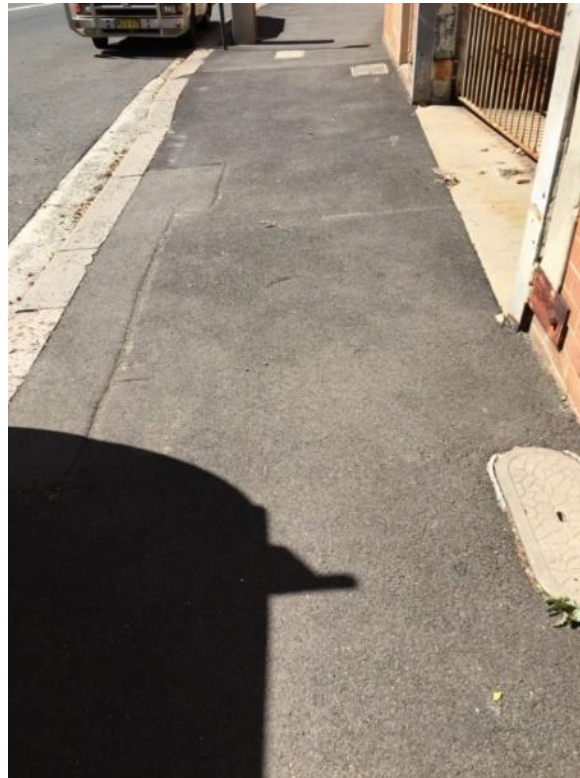
1

For reference

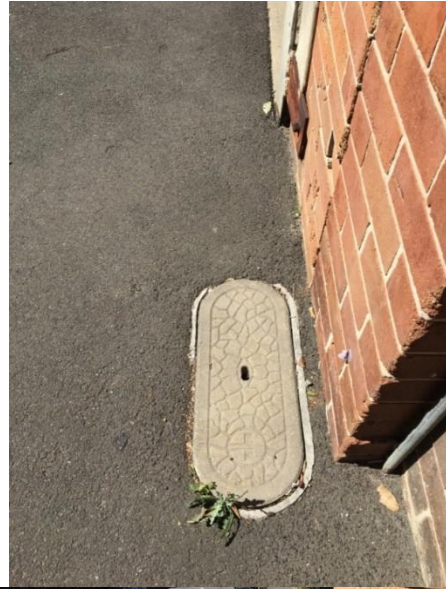
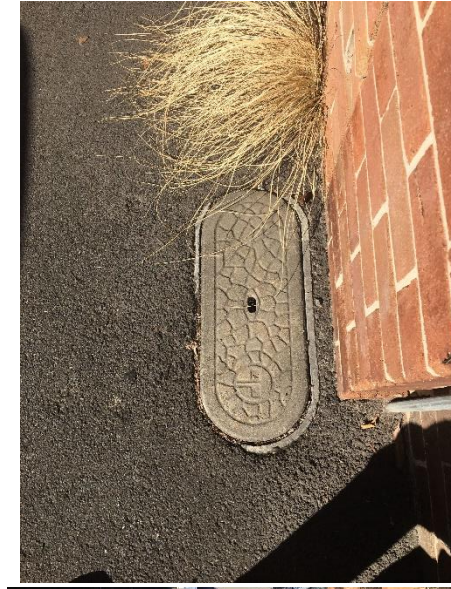
2

For reference

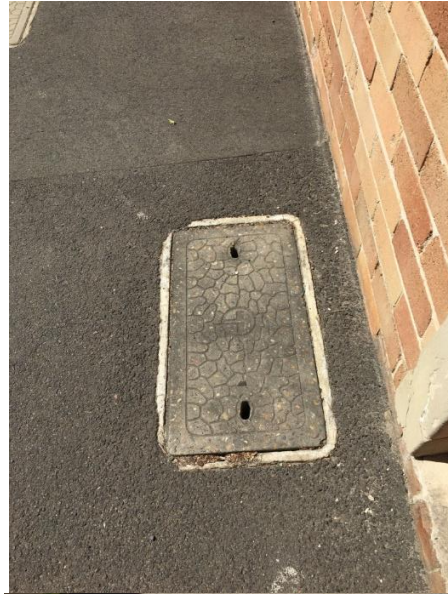
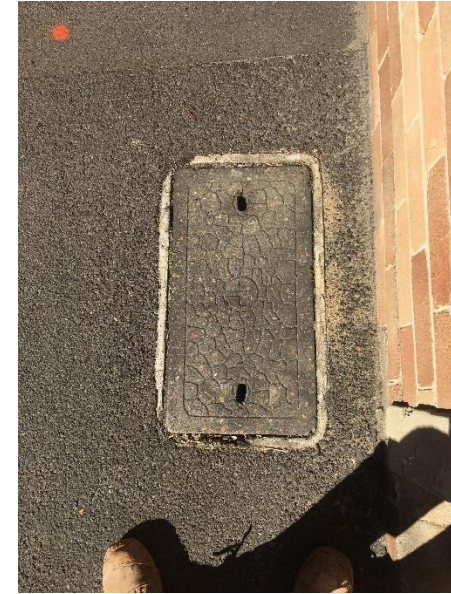
4

For reference

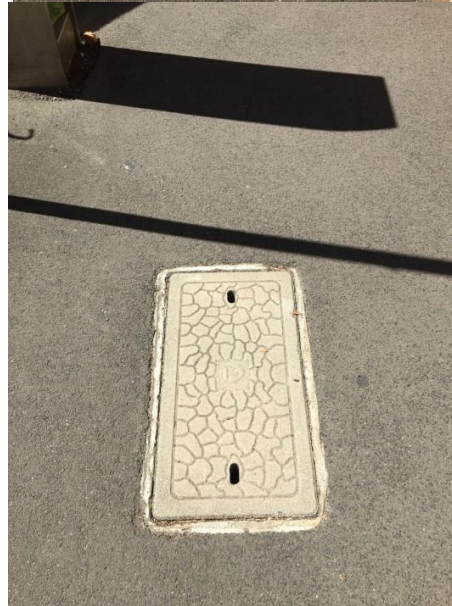
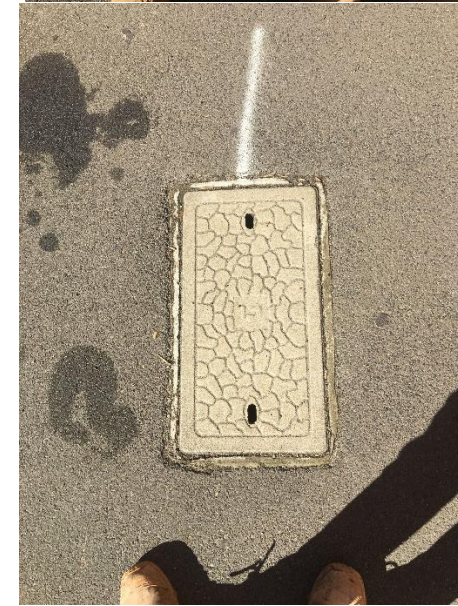
5

For reference

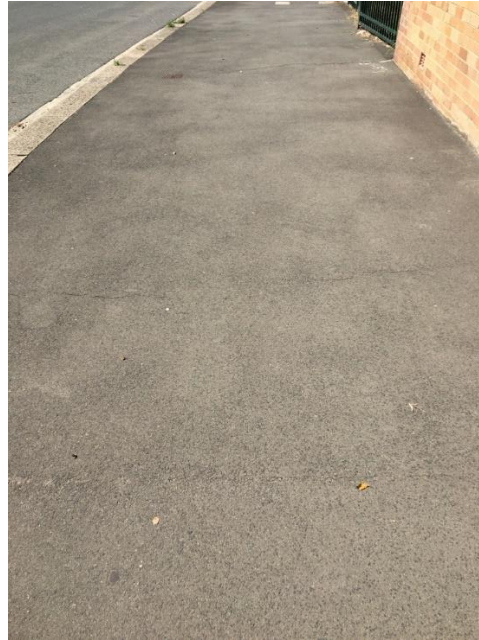
6

For reference

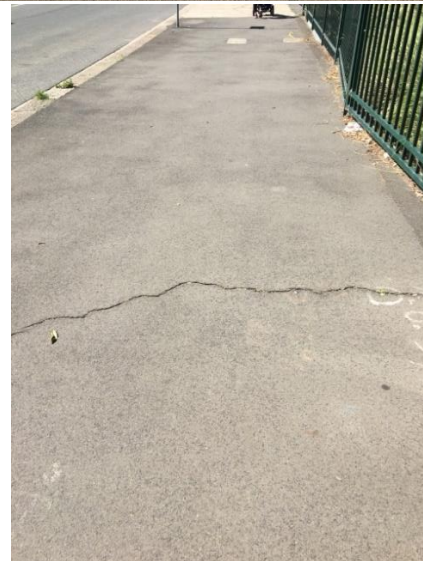
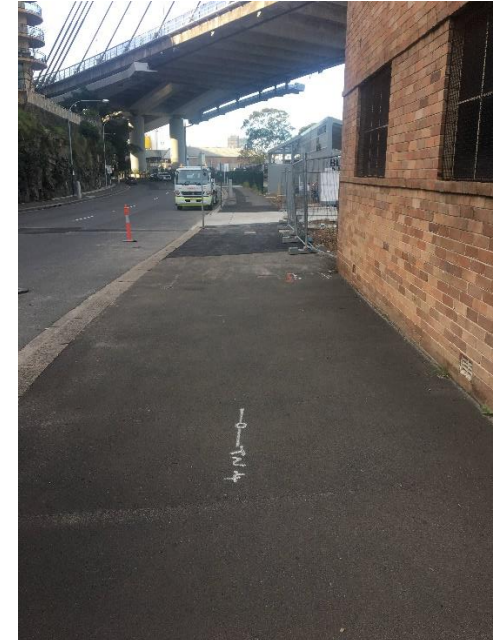
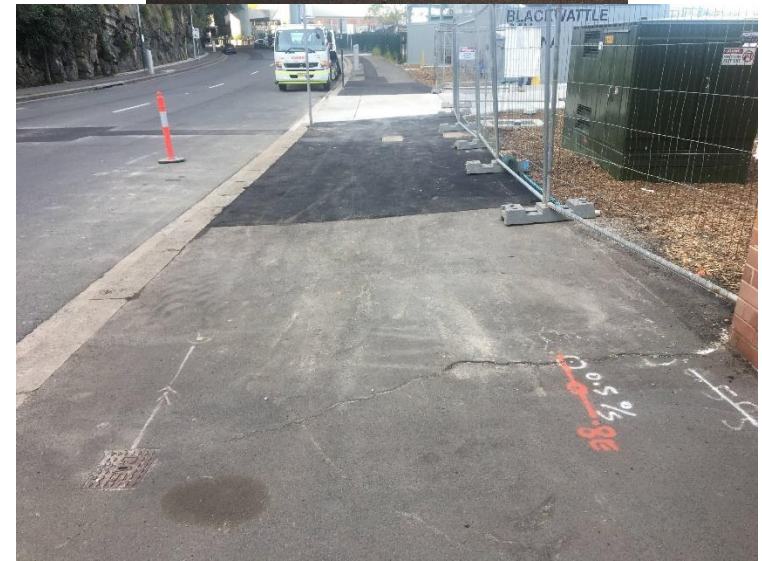
7

For reference

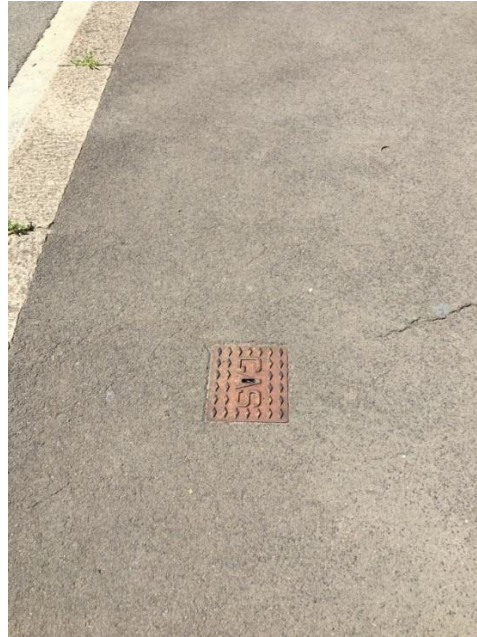
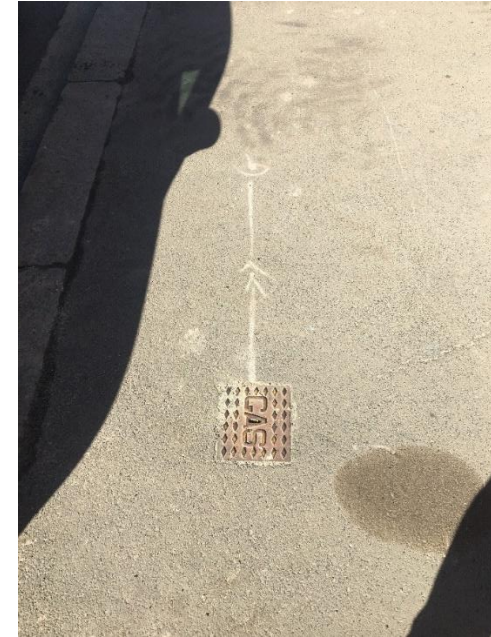
8

For reference

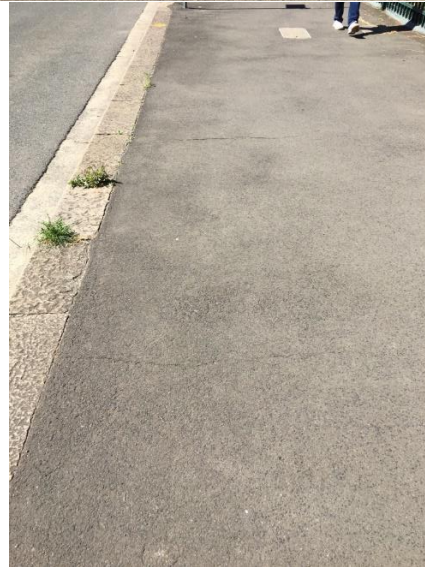
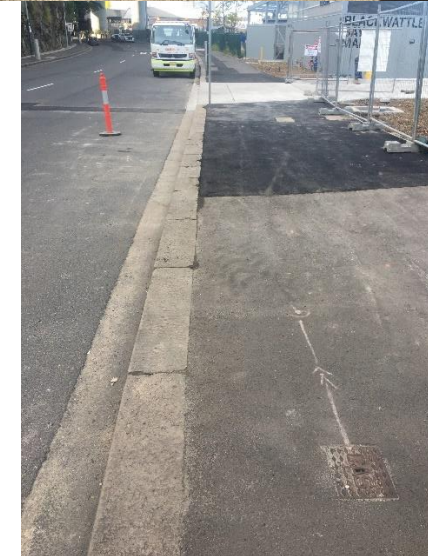
9

For reference

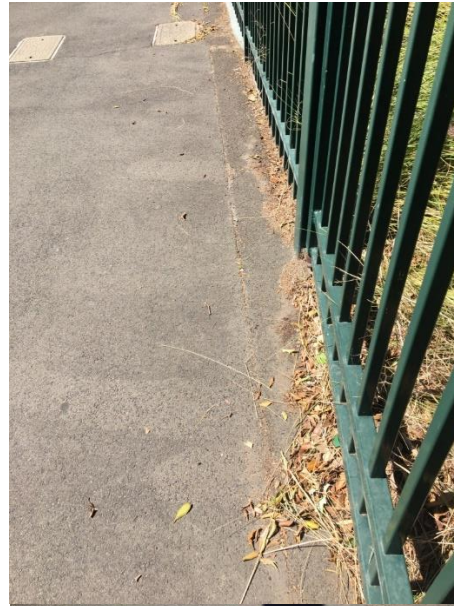
10

For reference

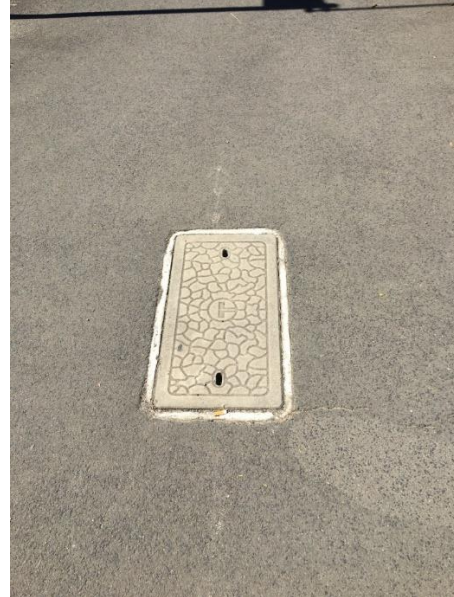
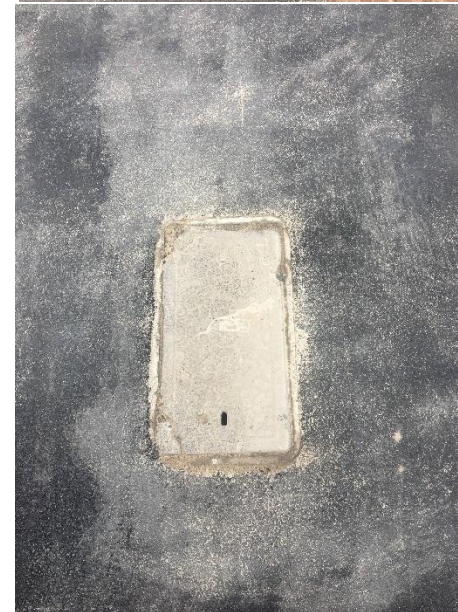
11

For reference,

permanent

restoration works

post-construction

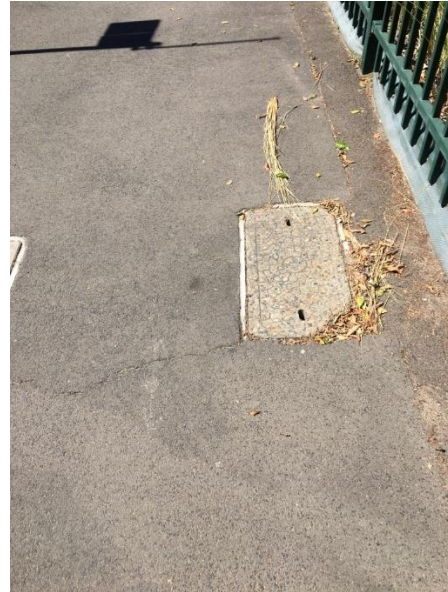
12

For reference,
permanent
restoration works
post-construction

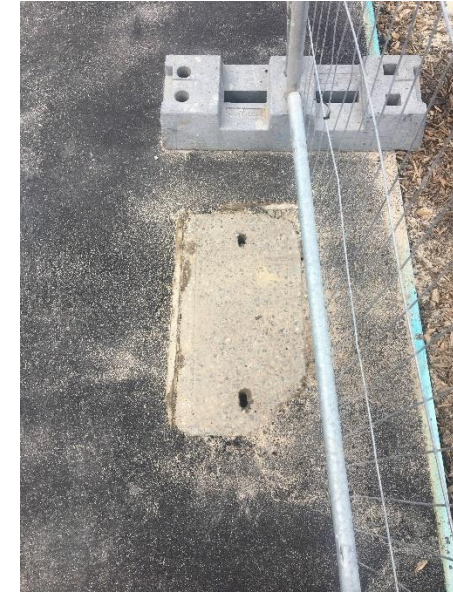
13

For reference,
permanent
restoration works
post-construction

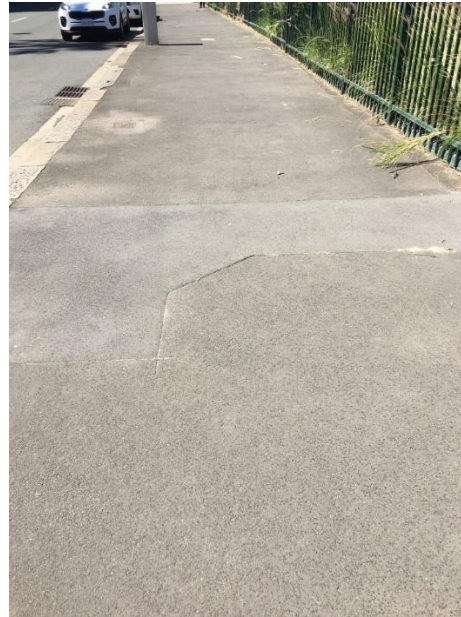
16

For reference,
permanent
restoration works
post-construction

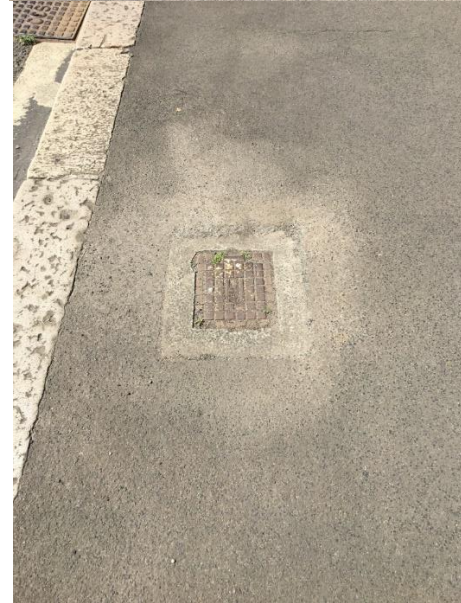
17

For reference,
permanent
restoration works
post-construction

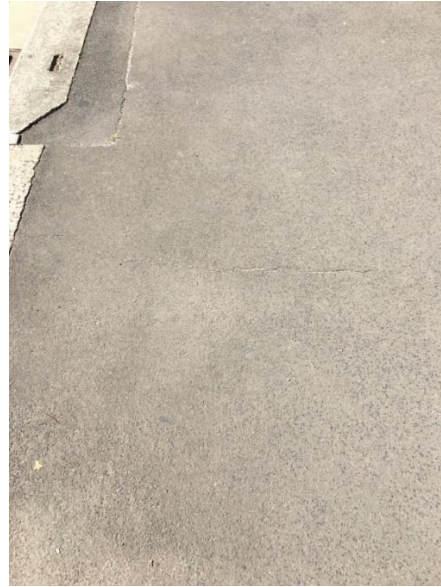
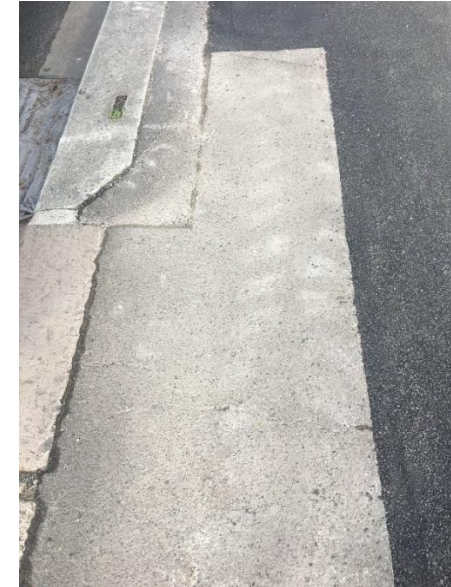
18

For reference,
permanent
restoration works
post-construction

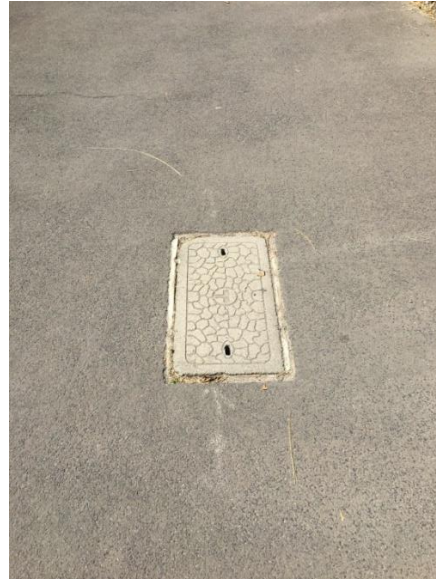
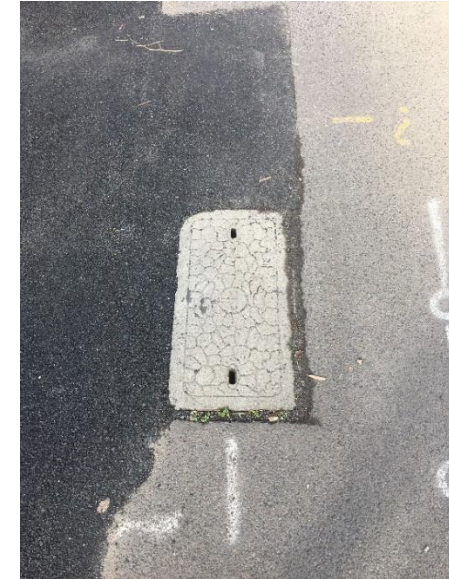
For reference,
permanent
restoration works
post-construction

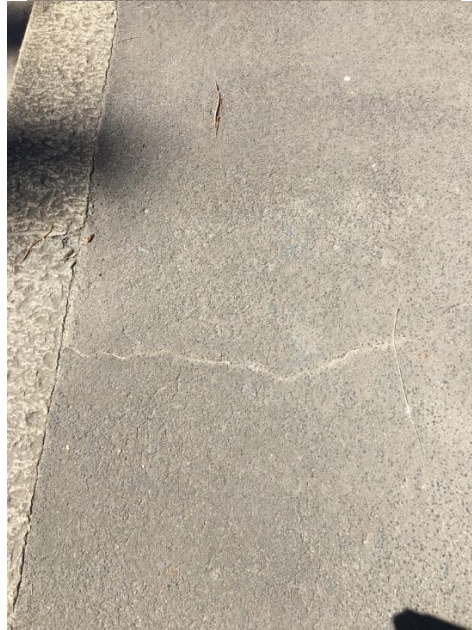
21

For reference

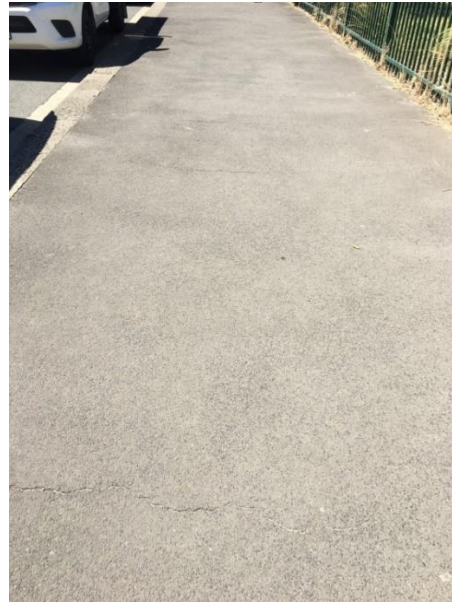
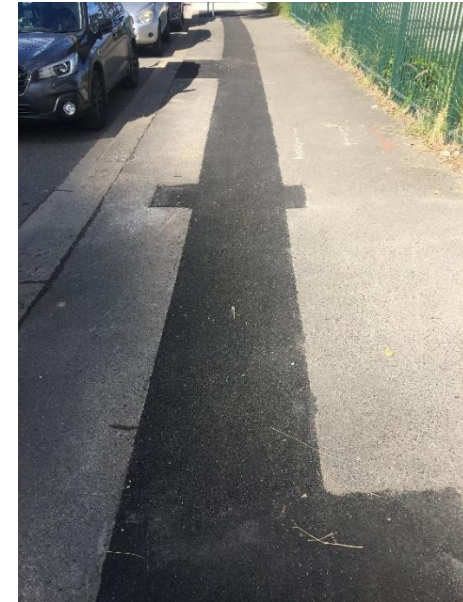
22

For reference,
permanent
restoration works
post-construction

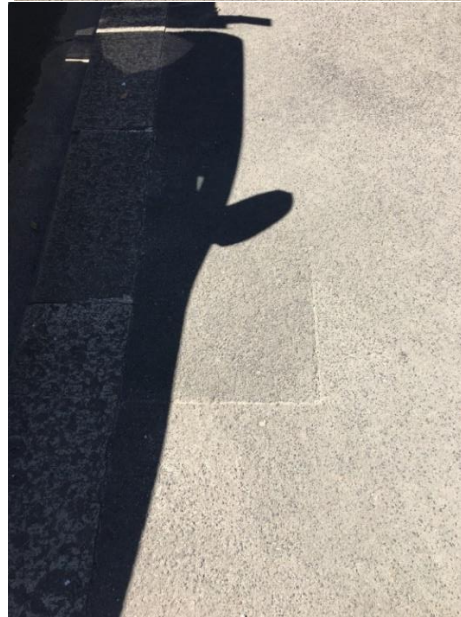
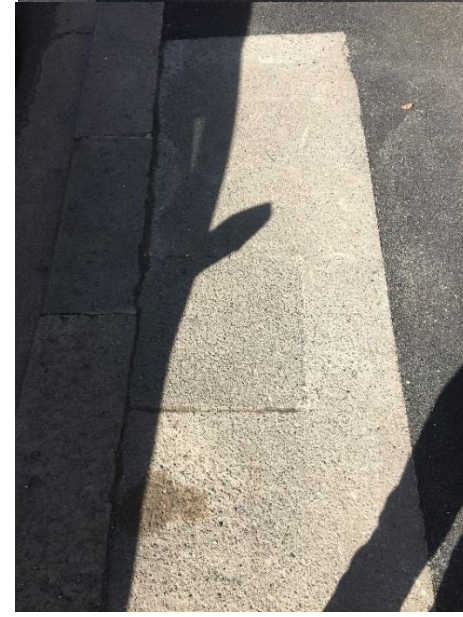
23

For reference

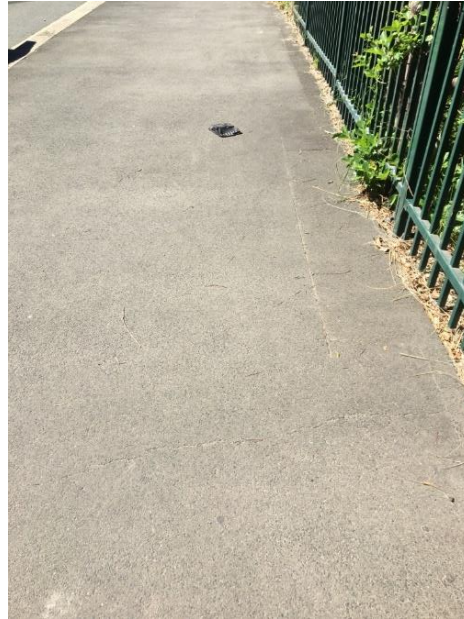
24

For reference

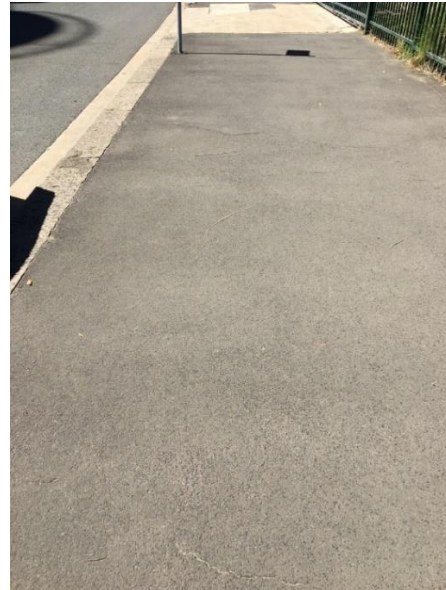
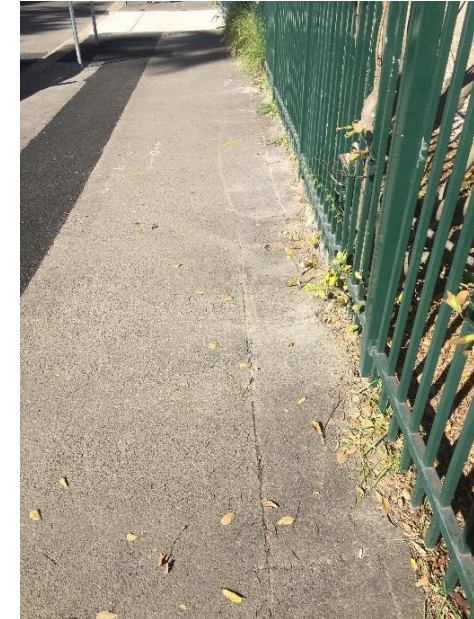
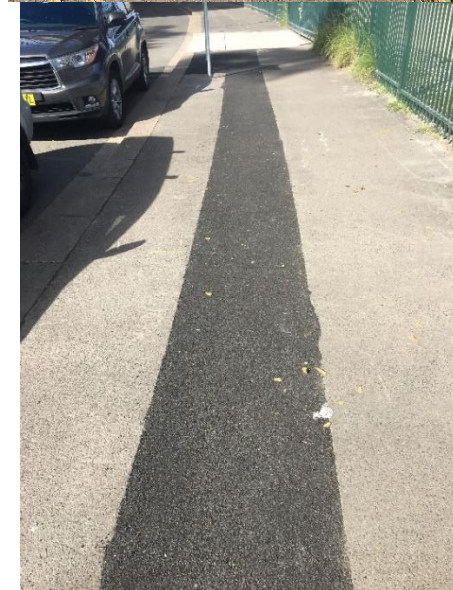
For reference,
permanent
restoration works
post-construction

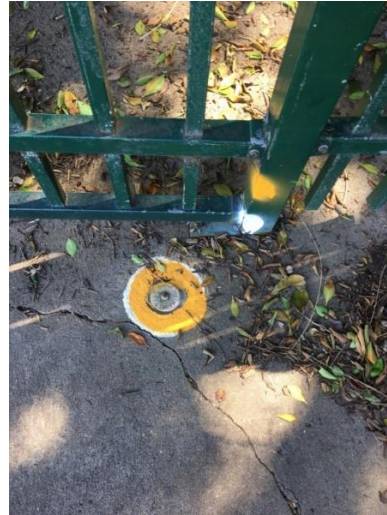
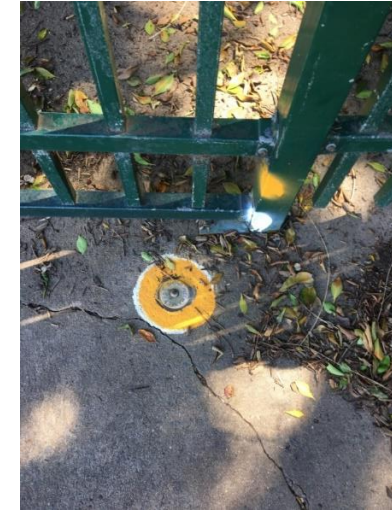
State Survey Mark
(SS32843F) (for
location see
Appendix)

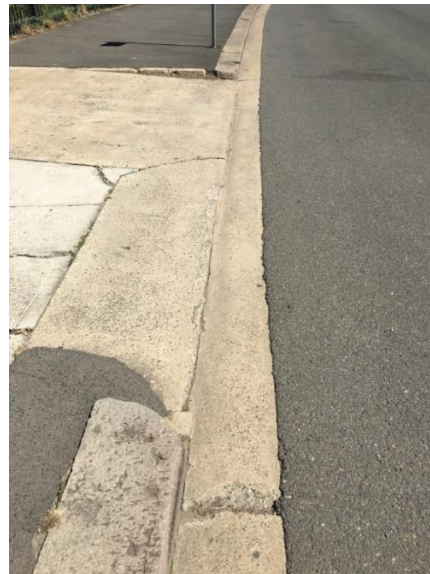
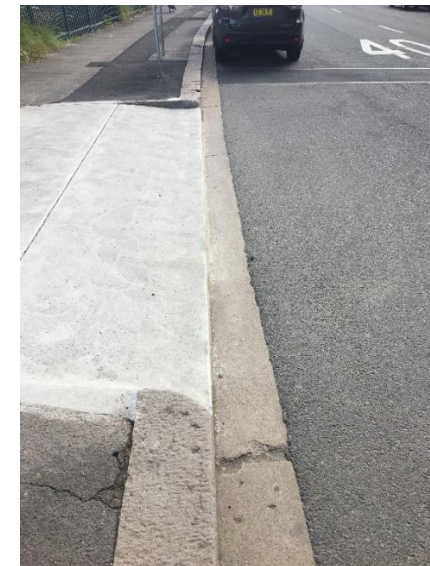
For reference,
permanent
restoration works
post-construction

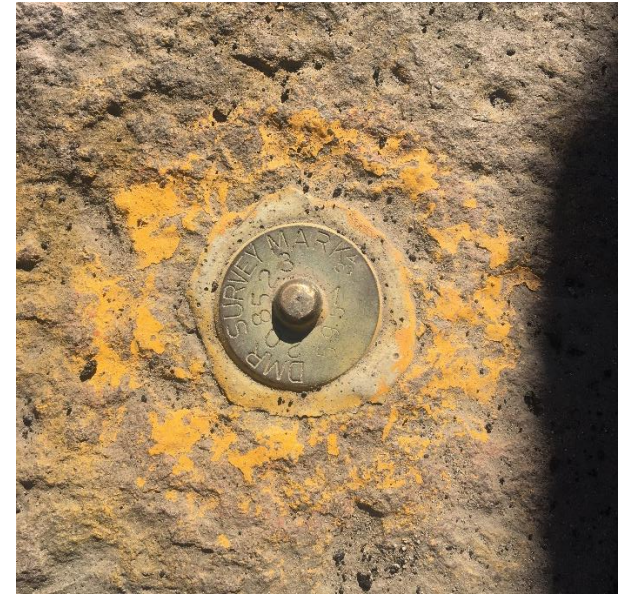
State Survey Mark
(SS208523) (for
location see
Appendix)

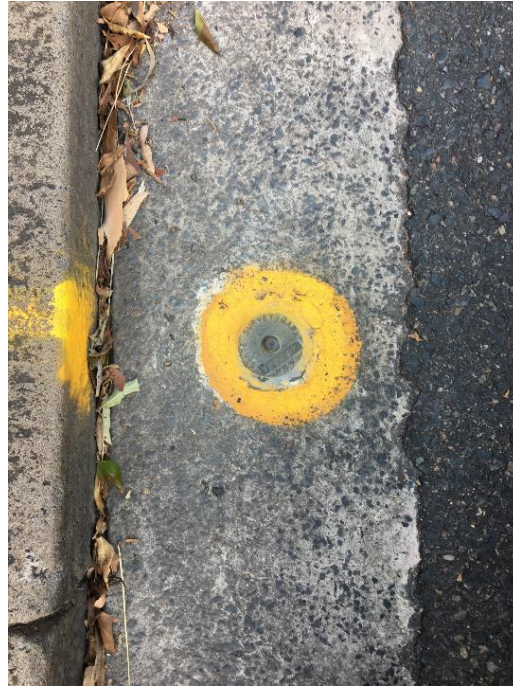
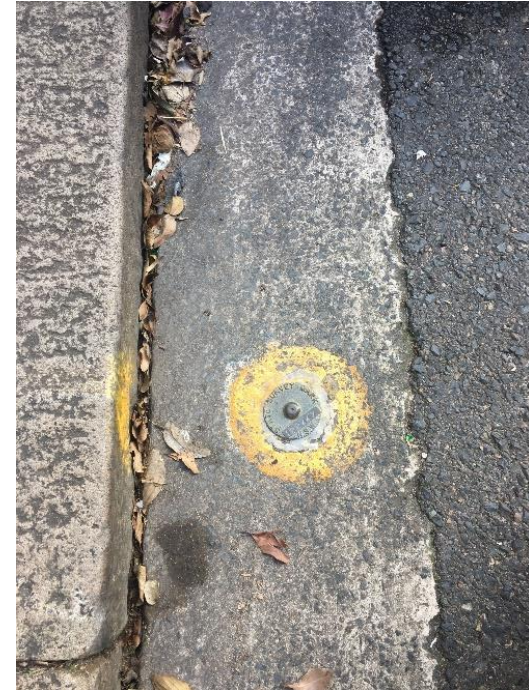
State Survey Mark
(SS122447) (for
location see
Appendix)

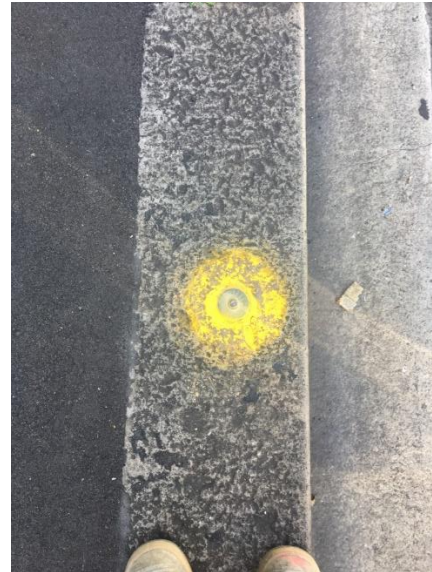
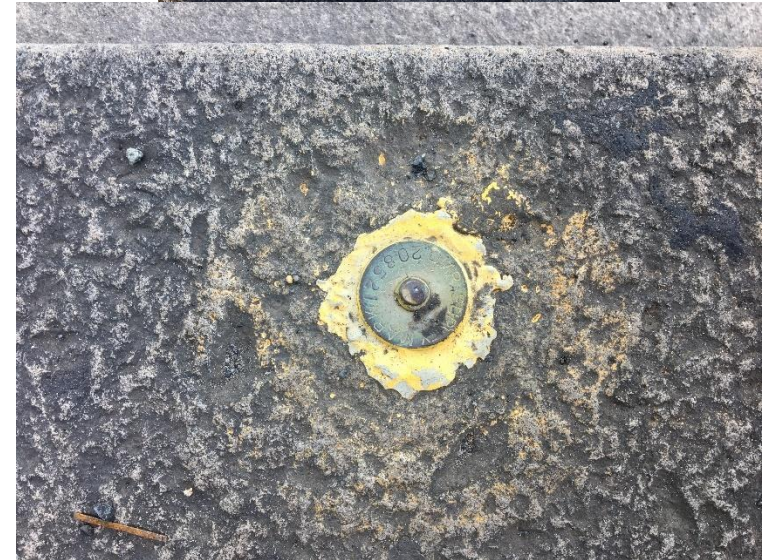
73

State Survey Mark

(SS208521) (for

location see

Appendix)

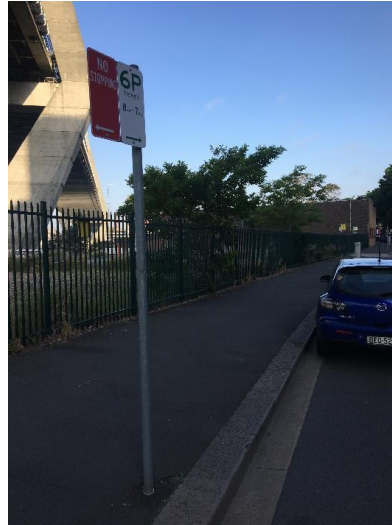
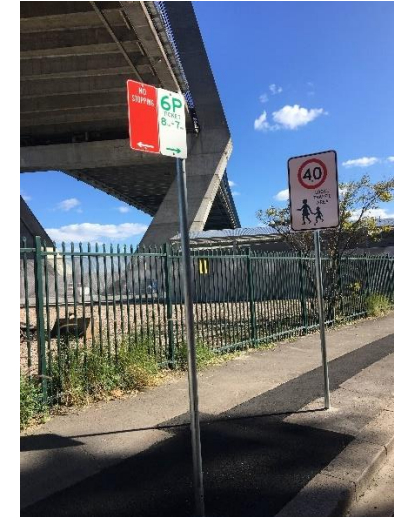
For reference

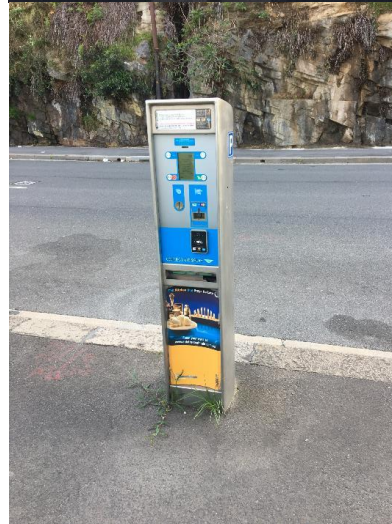
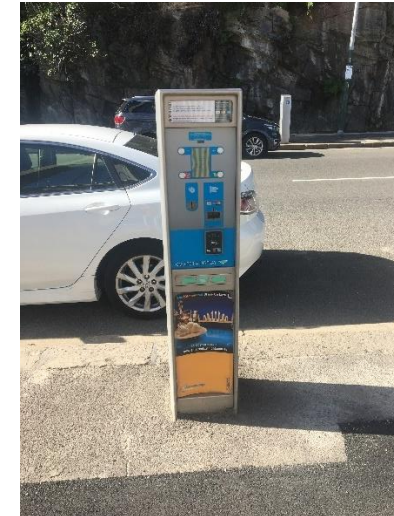
89

For reference

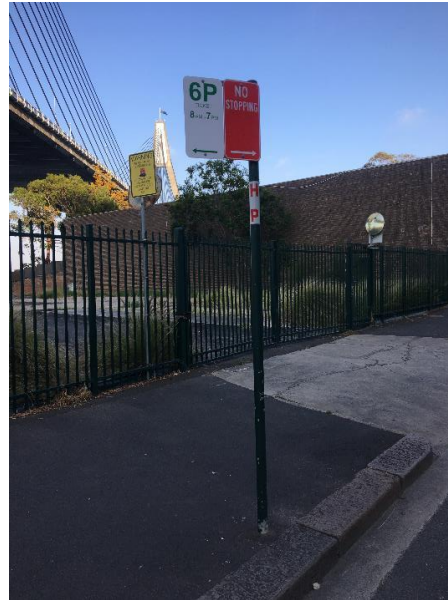
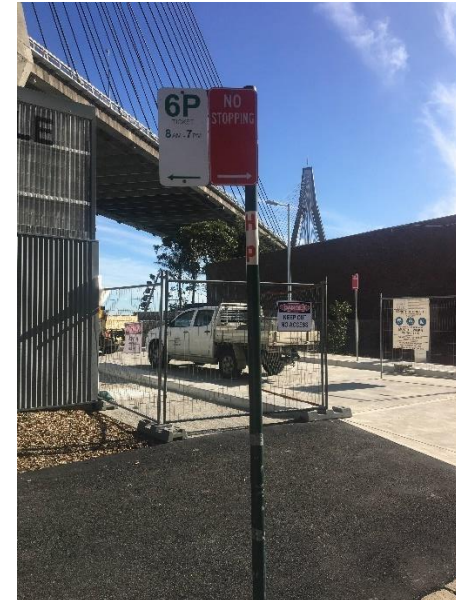
90

For reference

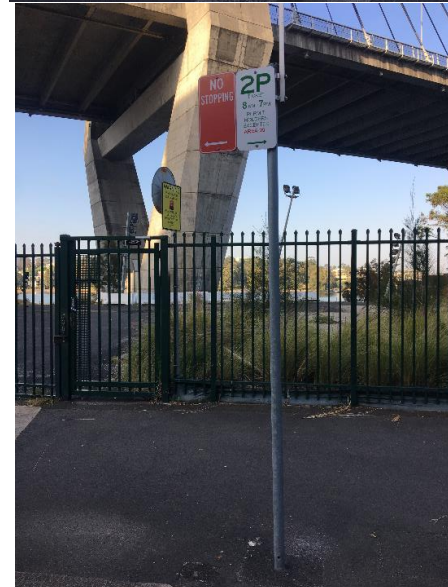
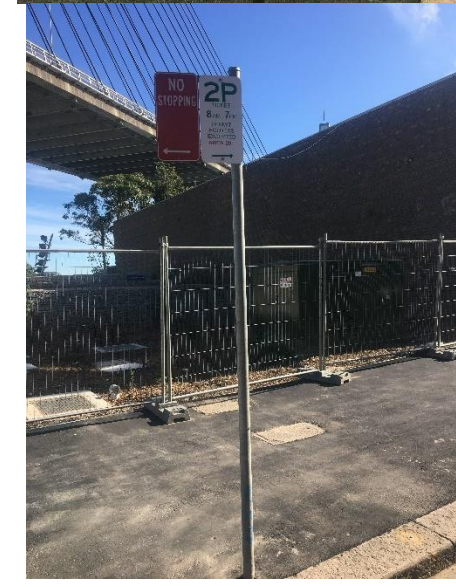
91

For reference
