# Arborist Assessment Report

Department of Education NSW

PROJECT: SSD-21854025 Wee Waa High School

Site Address: 105-107 Mitchel Wee Waa NSW

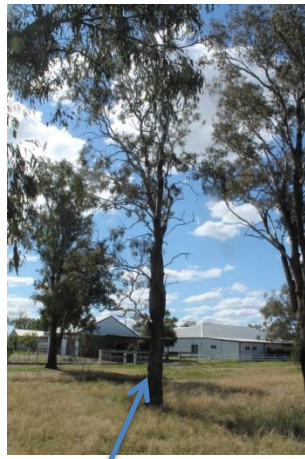
TREE 32A swelling at union
