**Manildra – Port Kembla Bulk Liquid Terminal**

# Remedial Action Plan

Reference No. 30013038-R02

Prepared for Manildra Group Pty Ltd

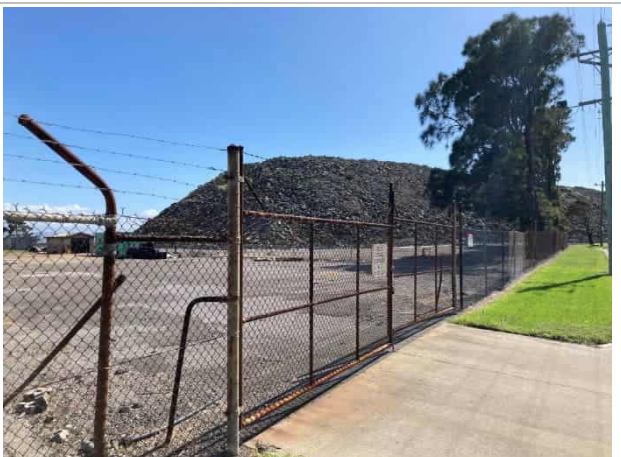
- A small steel structure bridge was in the eastern portion of the Site (towards the north) crossing the stormwater channel
- The Site perimeter was enclosed by a chain wire fence with an entrance gate to the south, leading to Foreshore Road (Photo 2-6)

Photo 2-6 Looking north east along southern perimeter fence (March 2021)

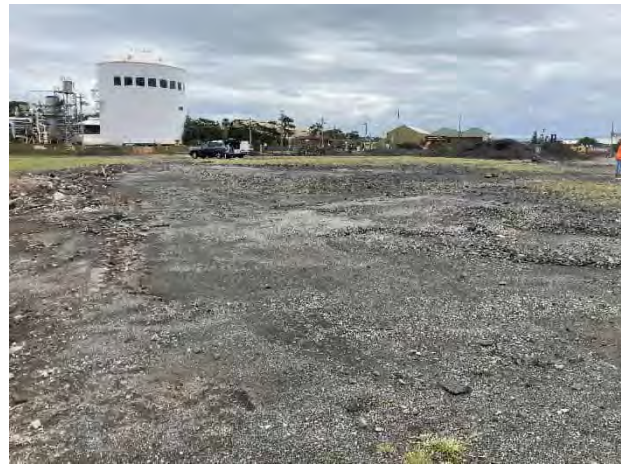
Photo 2-12 Areas west of the channel facing south-west towards Foreshore Road (October 2021)
