## PRE CONSTRUCTION CONDITION SURVEY

Fort Street Public School, Millers Point NSW

Upper Fort Street Public School  
MILLERS POINT NSW 2000

19 January 2021

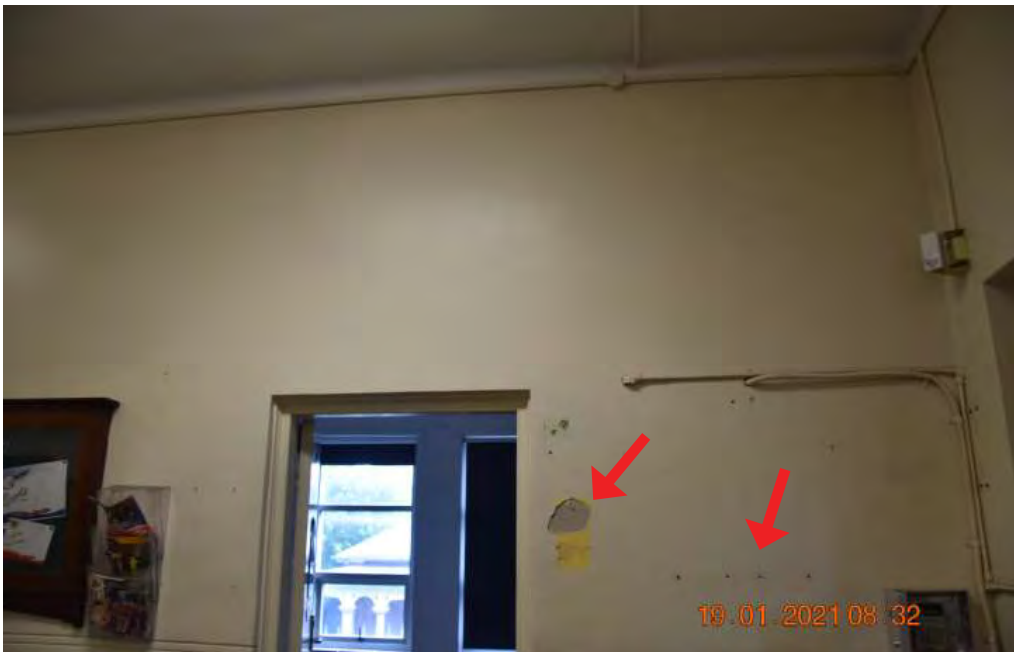
Figure: 0014

South wall in the entrance lobby. Showing nailing marks and damage.

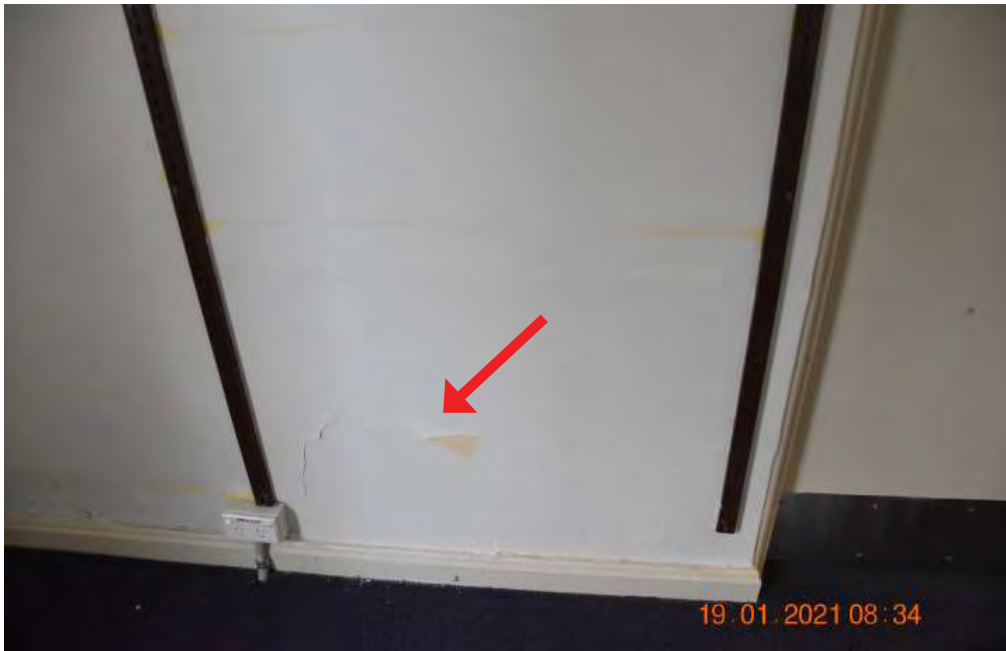
Figure: 0031

Peeling paint in the west wall in the rainbow room.

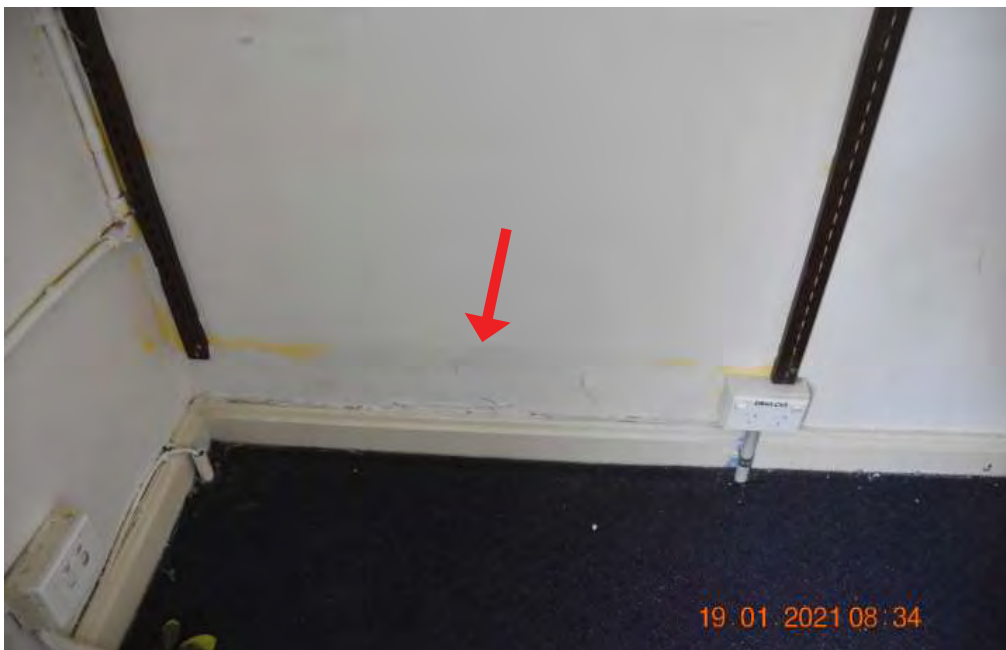
Figure: 0032

Peeling paint in the west wall in the rainbow room.

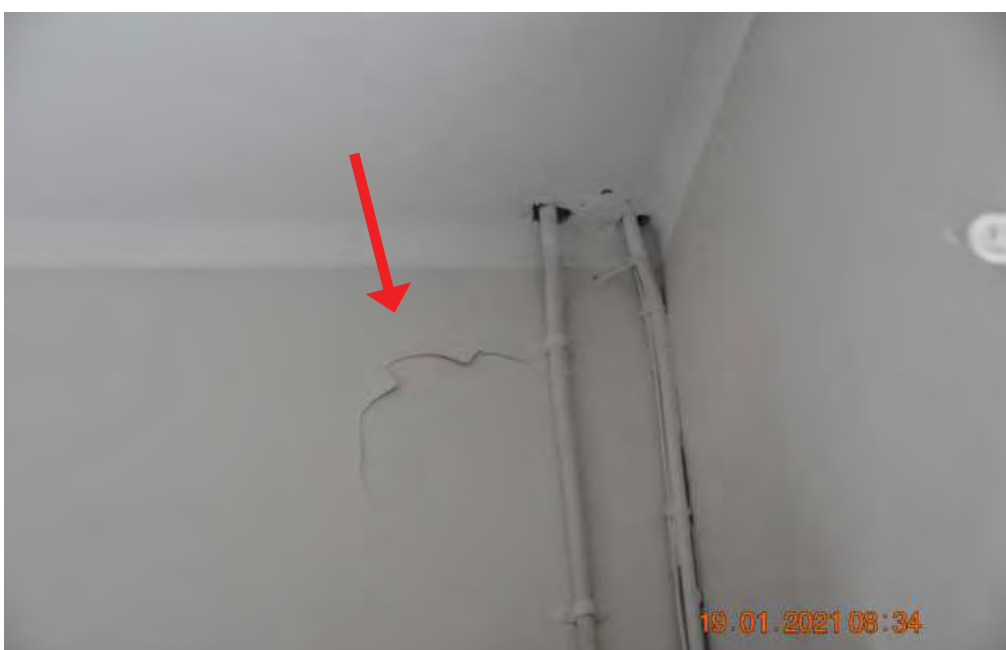
Figure: 0033

Peeling paint in the east wall in the rainbow room, south side.

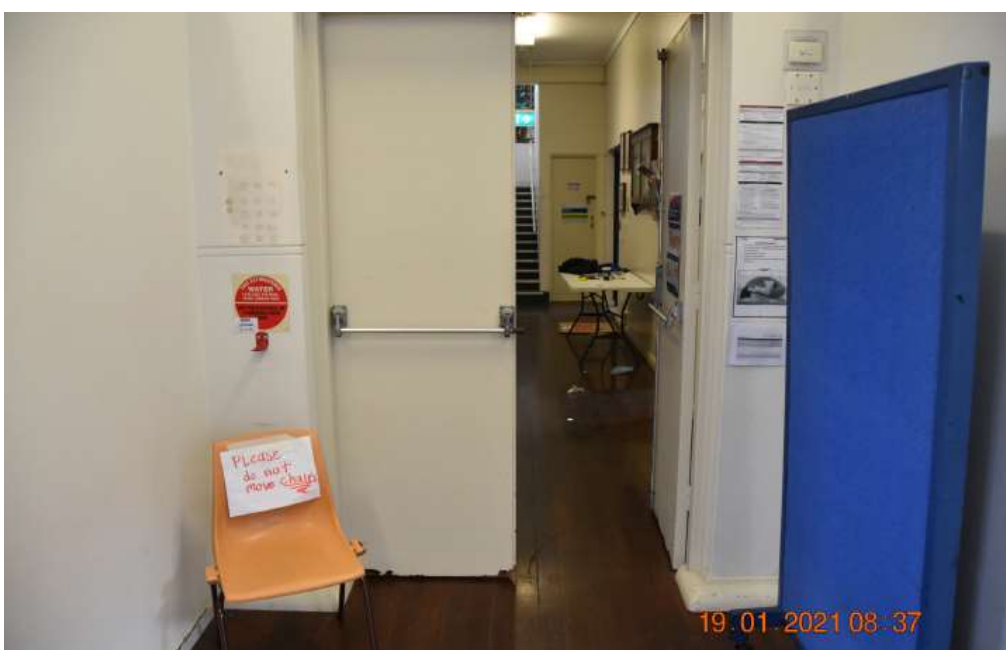
Figure: 0047

East wall in the auditorium. Showing peeling paint.

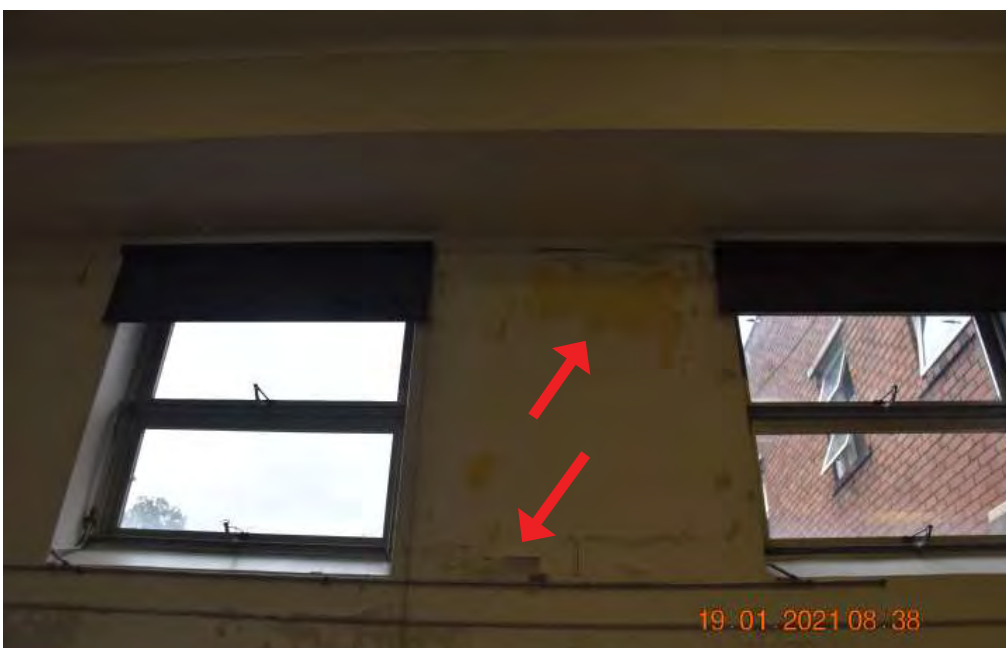
Figure: 0060

North wall in the auditorium. Showing peeling paint and water damage.

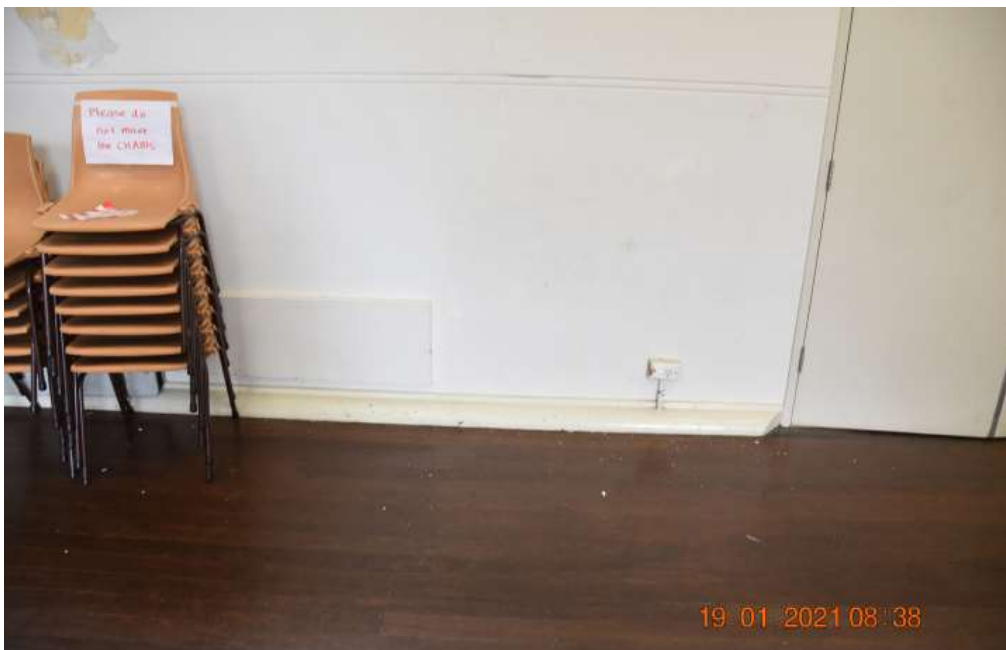
Figure: 0061

North wall in the auditorium. Showing peeling paint.

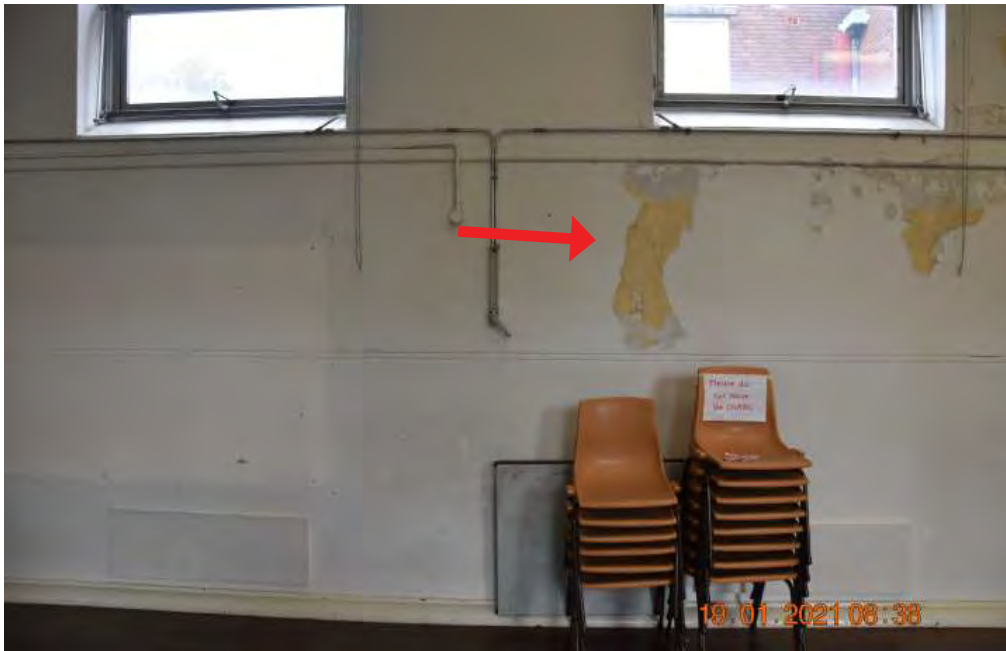
Figure: 0063

North wall in the auditorium. Showing peeling paint.

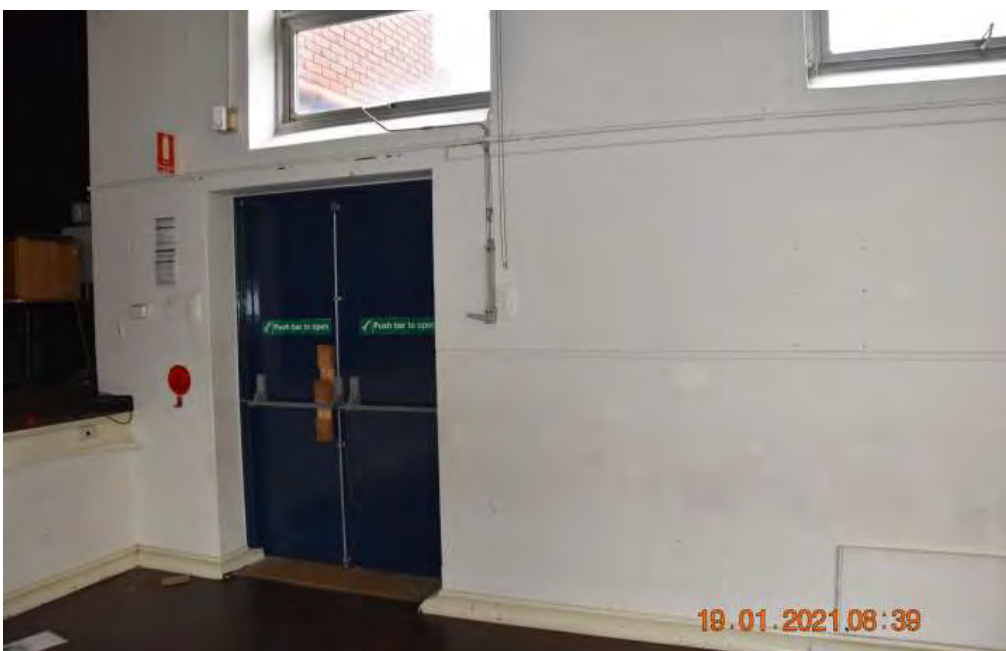
Figure: 0071

North wall in the auditorium. Showing peeling paint.

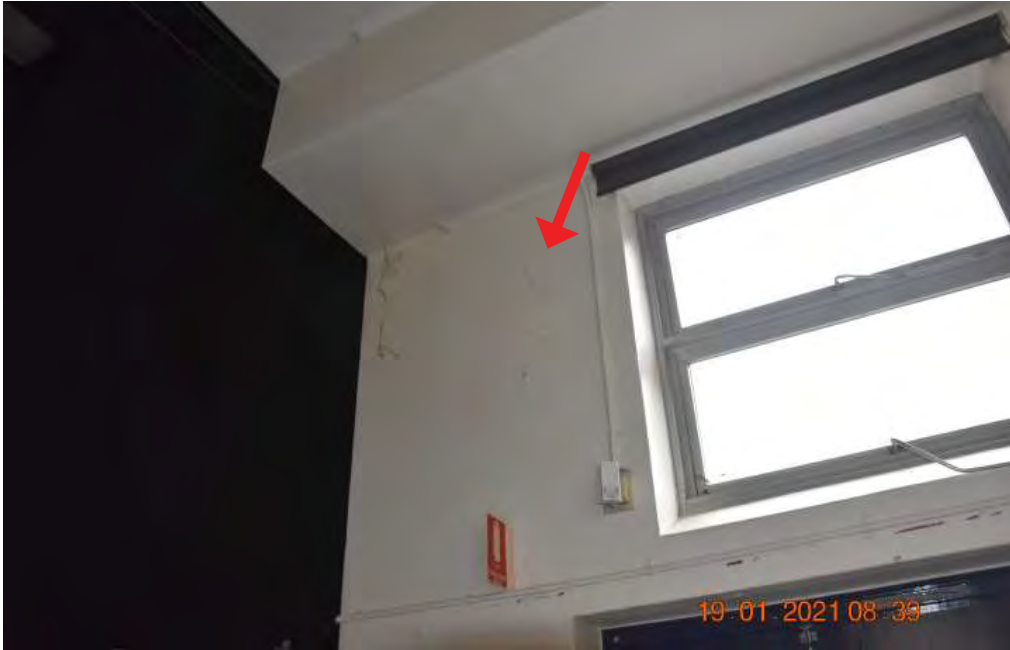
Figure: 0073

North wall in the auditorium. Showing peeling paint.

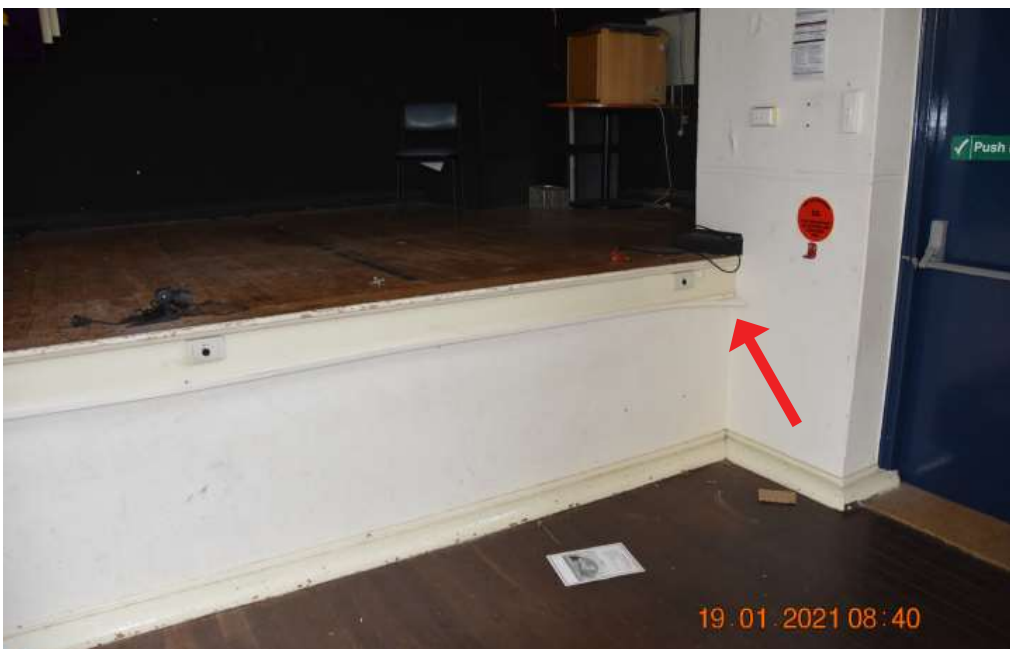
Figure: 0075

General view in the stage area in the auditorium. Showing detached conduit.

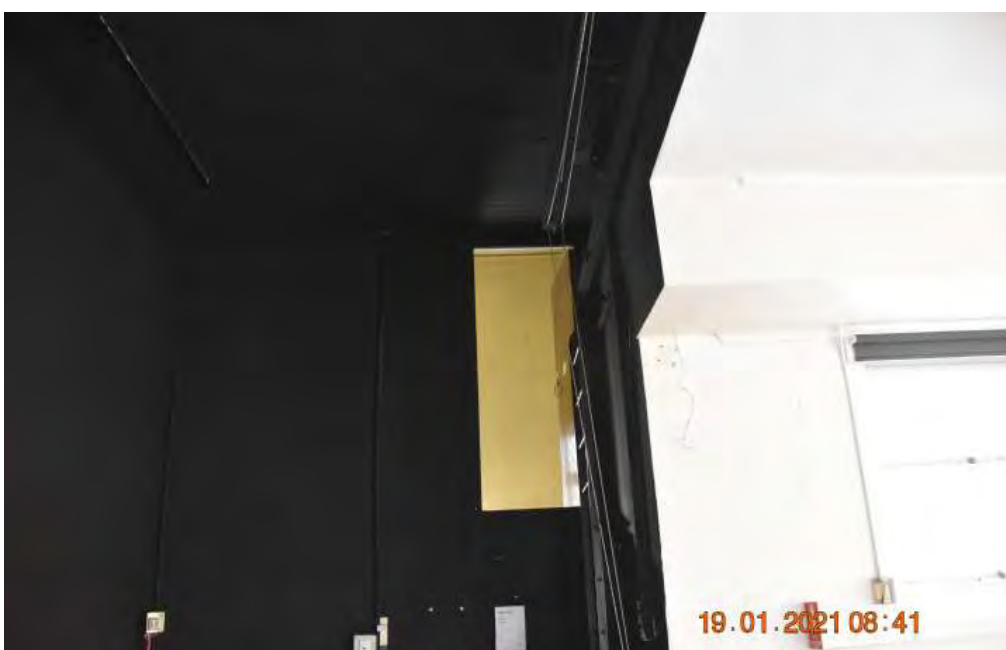
Figure: 0077

General view in the stage area in the auditorium. Showing scratching in the skirting.

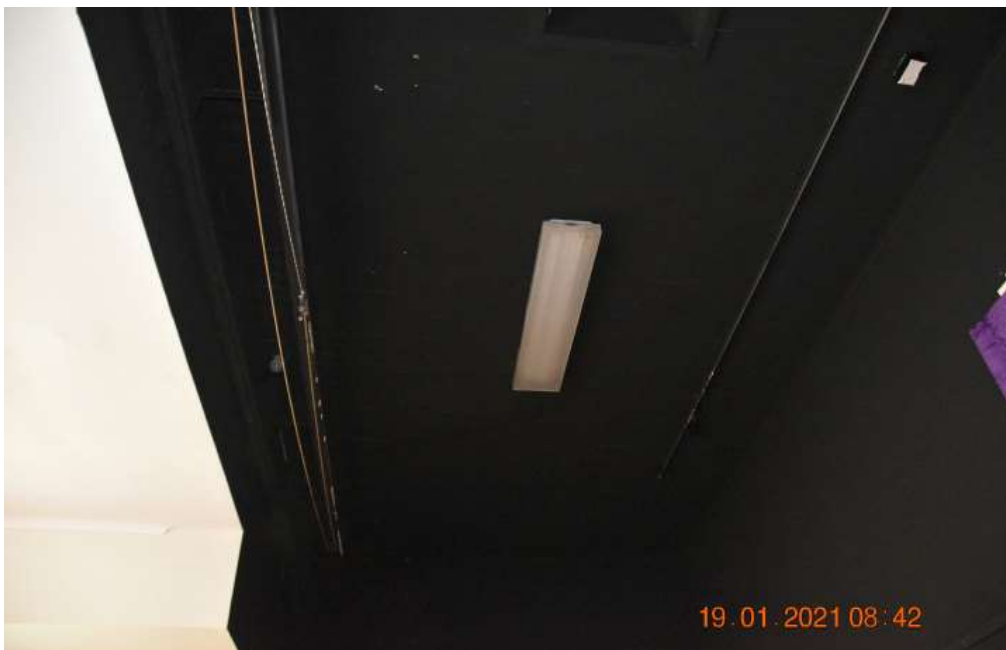
Figure: 0082

Ceiling in the stage area in the auditorium.

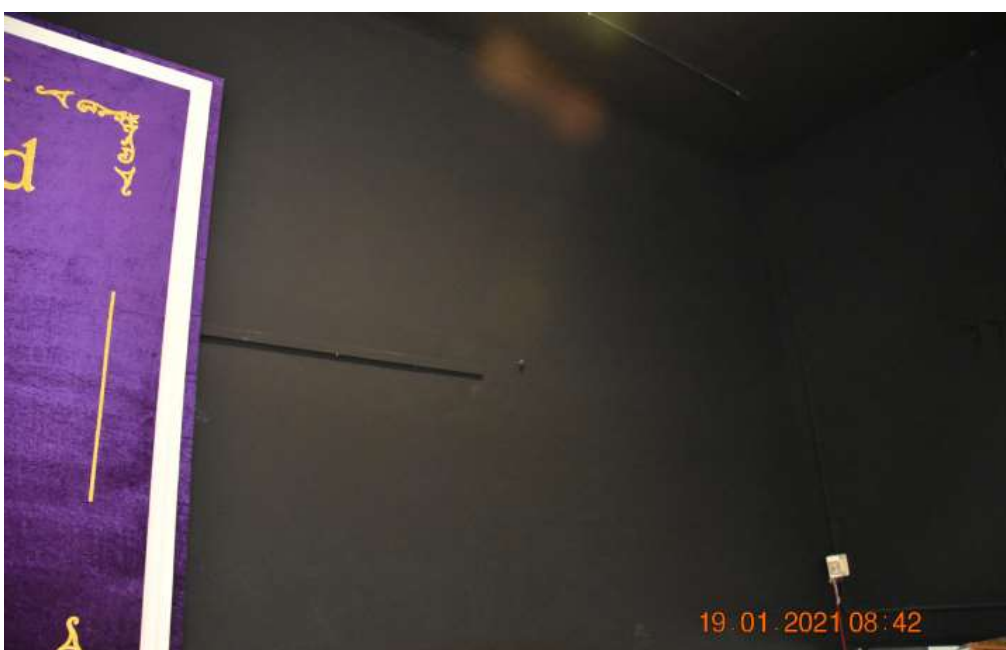
Figure: 0083

Ceiling in the stage area in the auditorium.

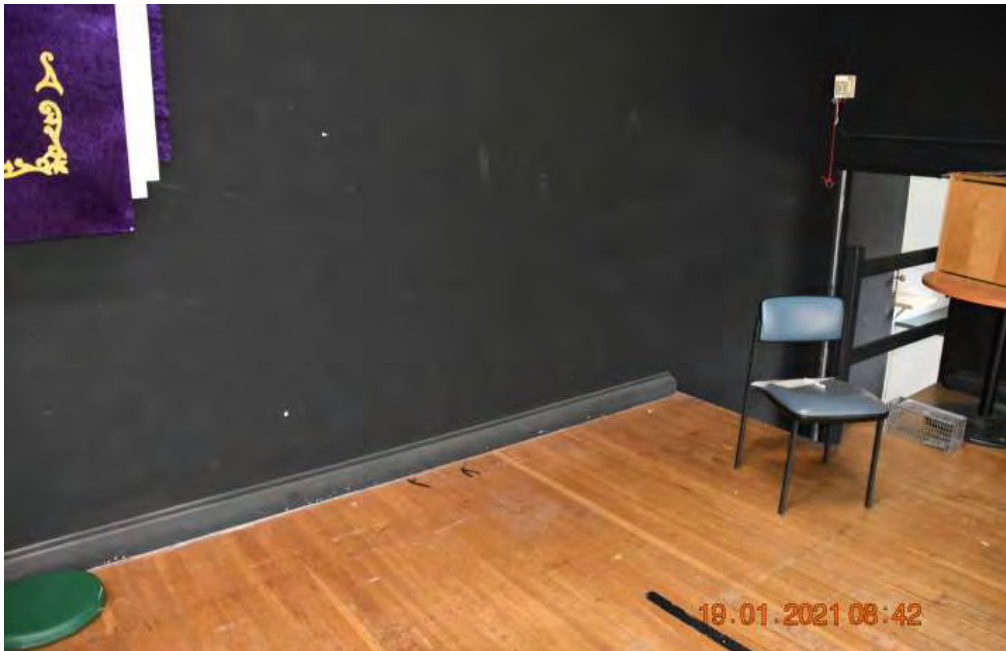
Figure: 0084

West wall in the stage area in the auditorium.

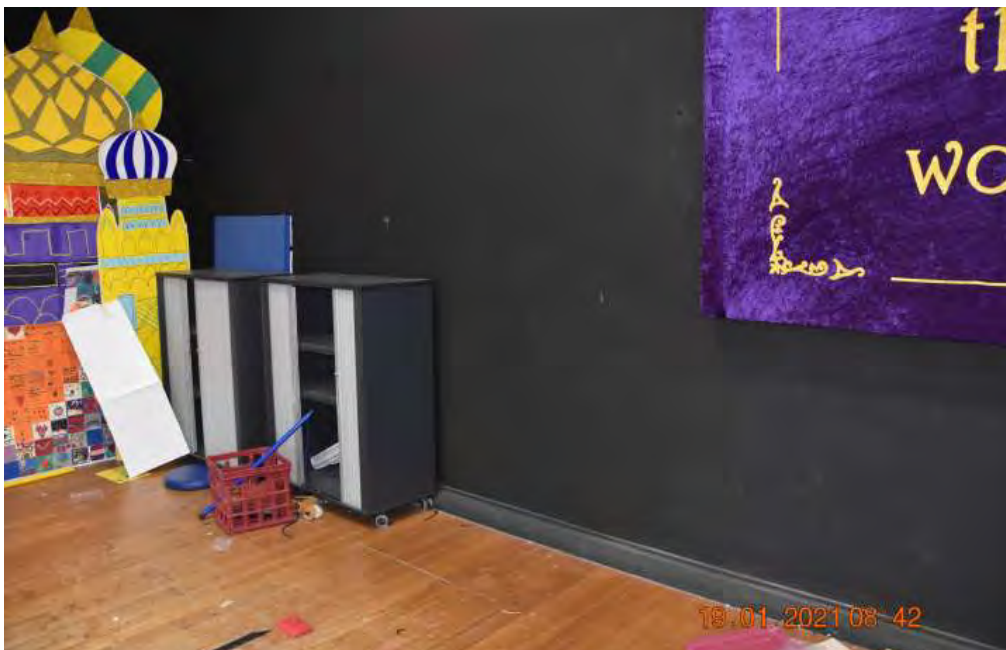
Figure: 0085

West wall in the stage area in the auditorium.

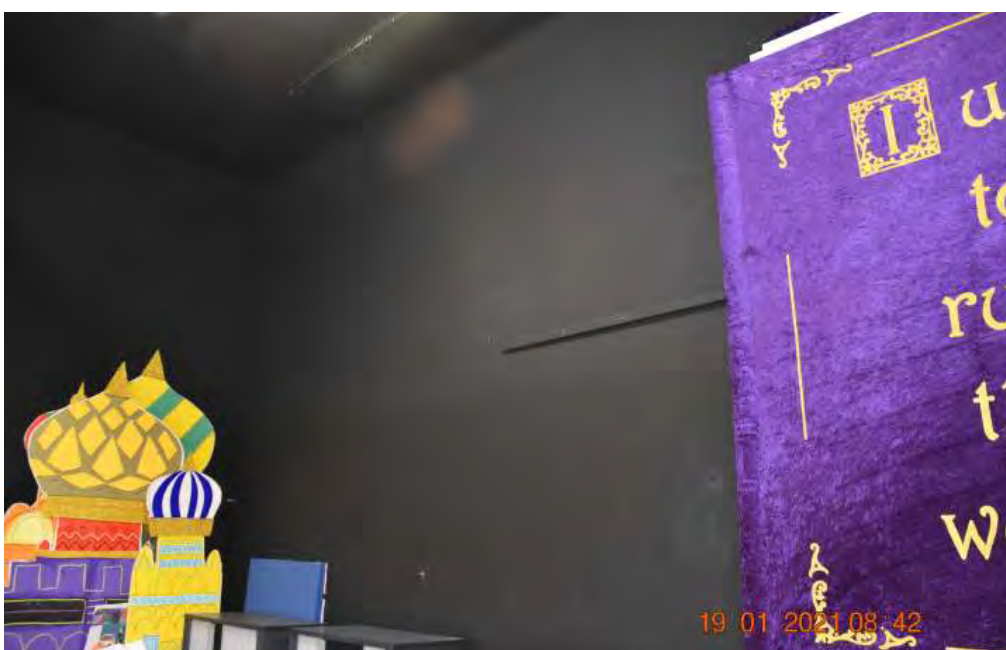
Figure: 0086

West wall in the stage area in the auditorium.

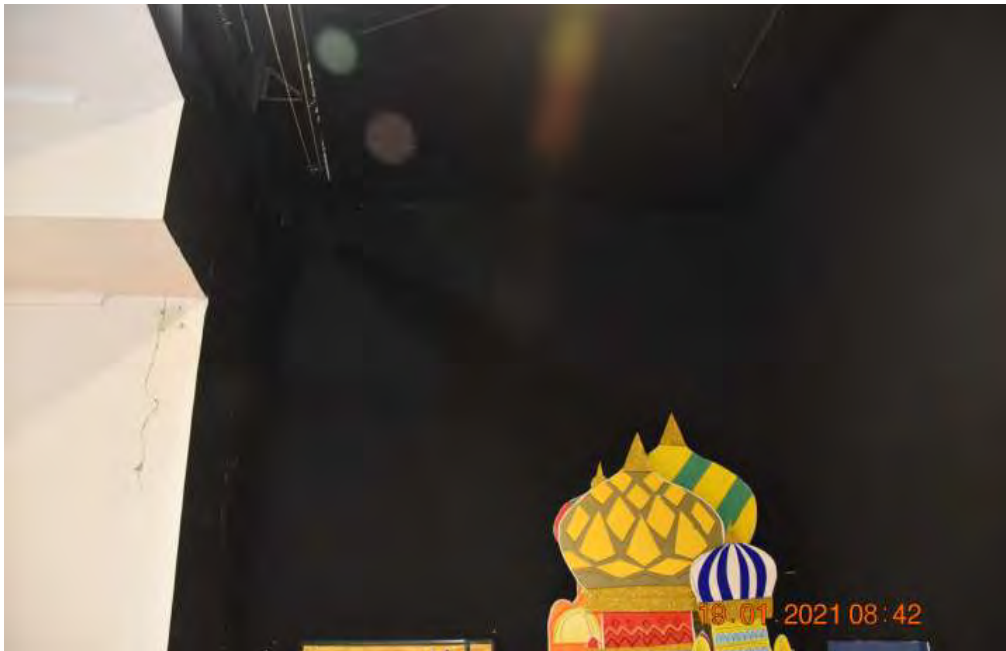
Figure: 0087

West wall in the stage area in the auditorium.

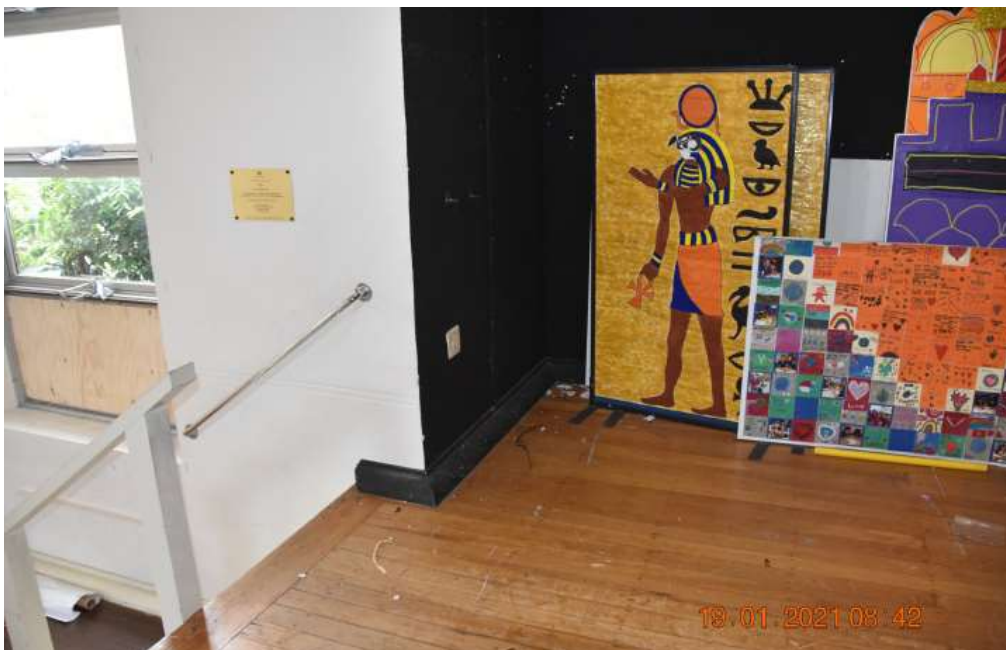
Figure: 0088

South wall in the stage area in the auditorium.

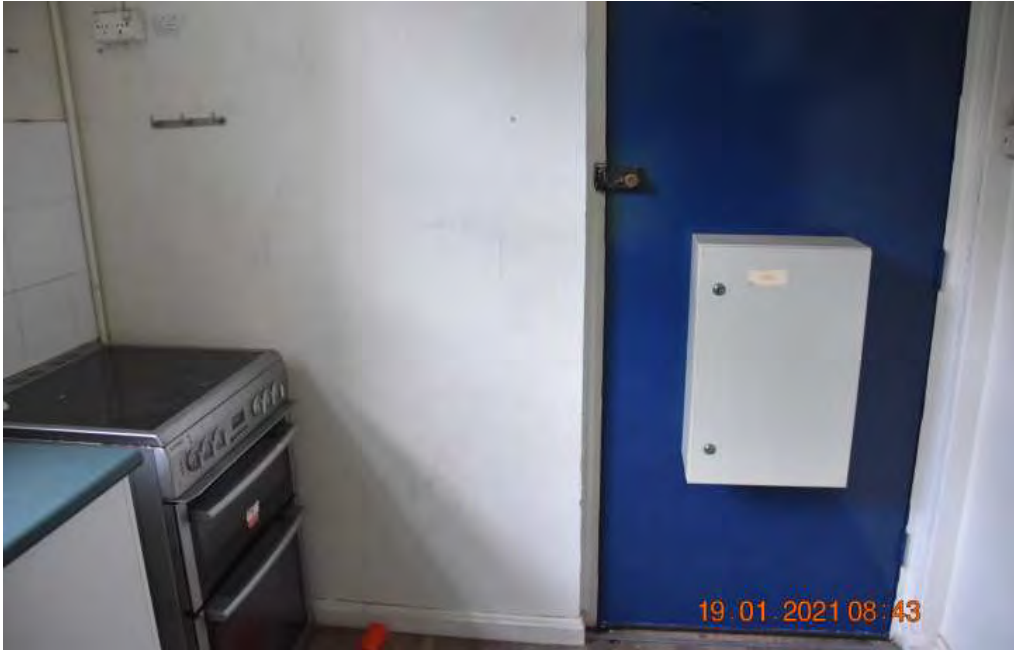
Figure: 0090

East wall in the auditorium kitchenette.

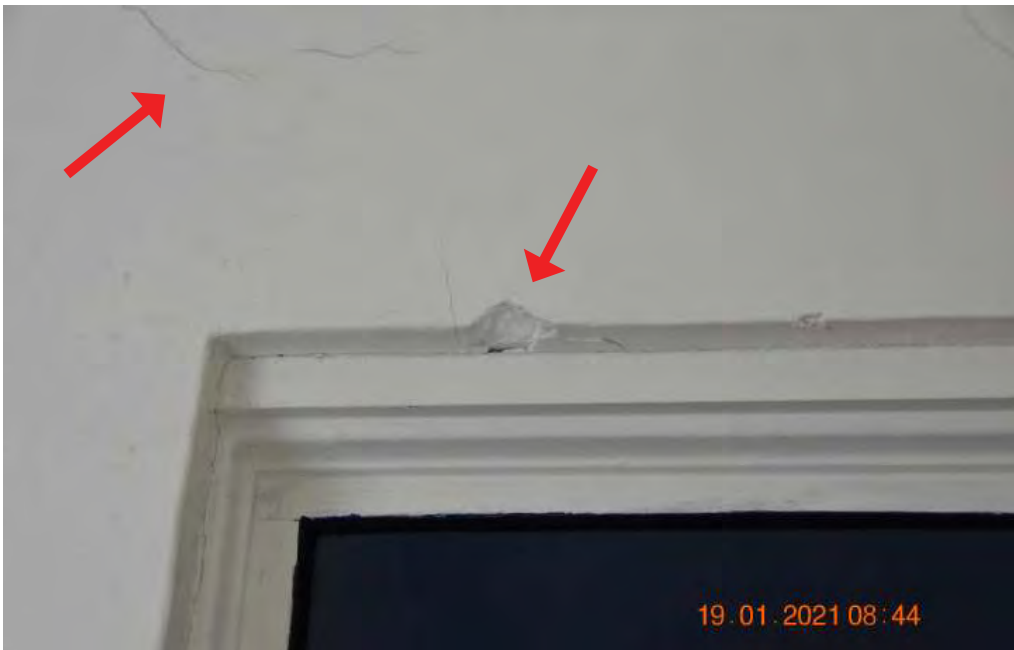
Figure: 0091

East wall in the auditorium kitchenette.

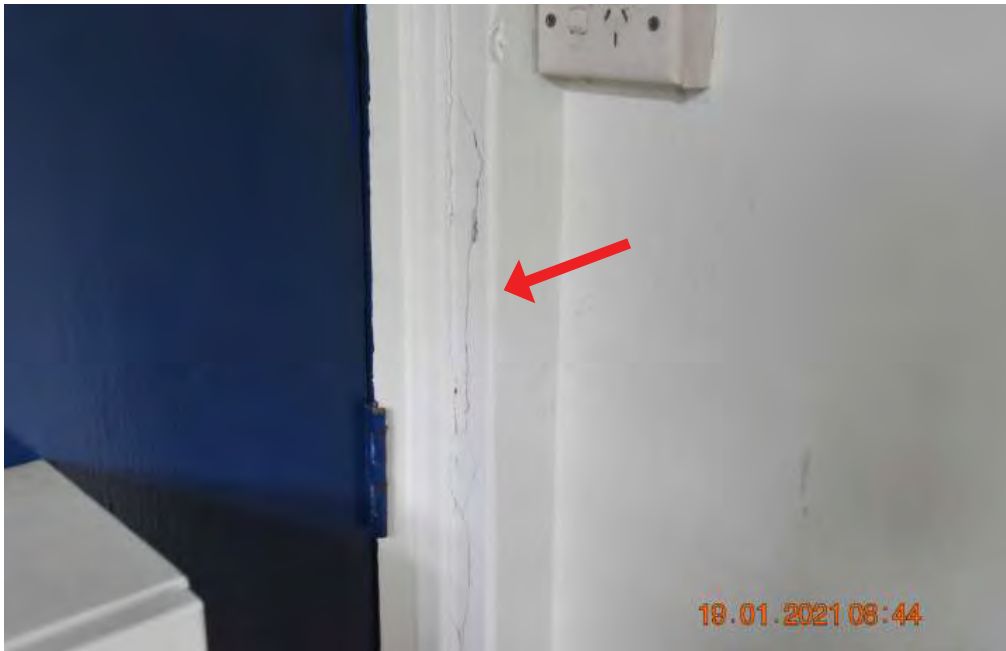
Figure: 0093

Separation cracking between the door frame and the east wall in the auditorium kitchenette.

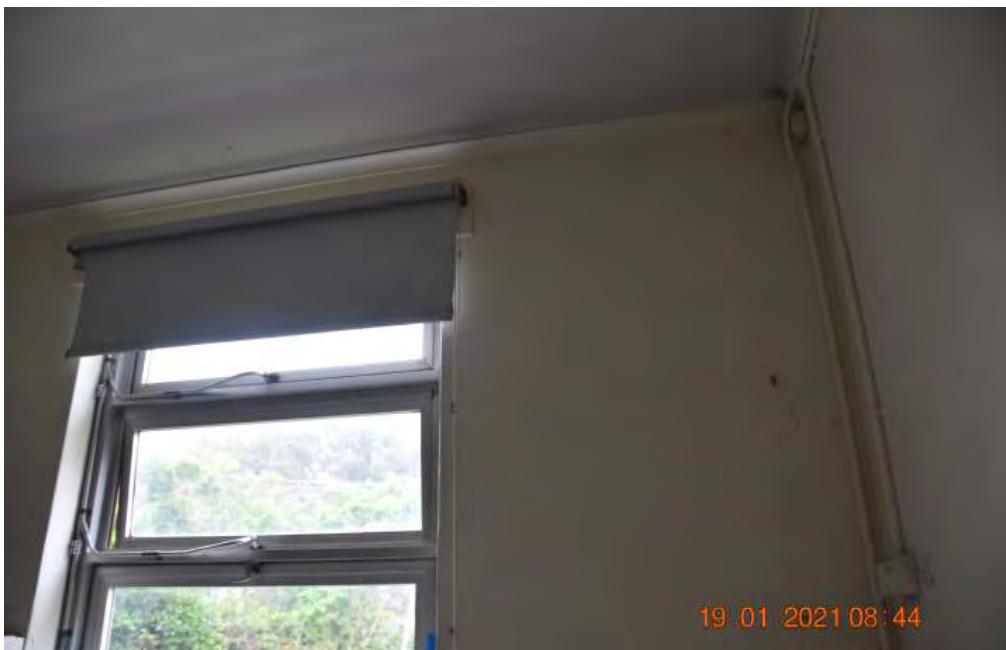
Figure: 0094

Separation cracking between the door frame and the east wall in the auditorium kitchenette.

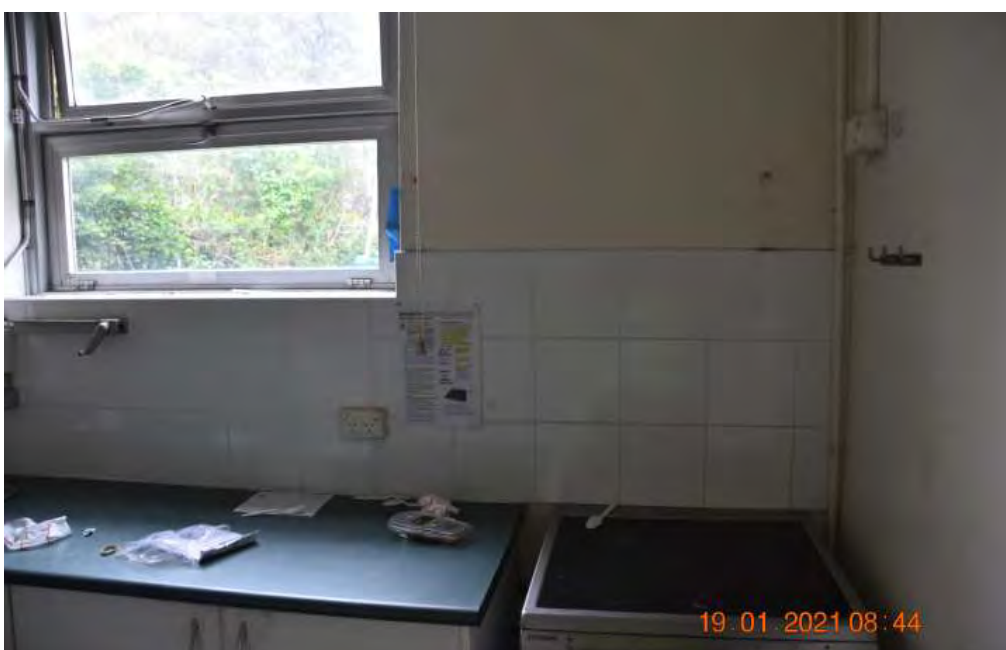
Figure: 0095

North wall in the auditorium kitchenette.

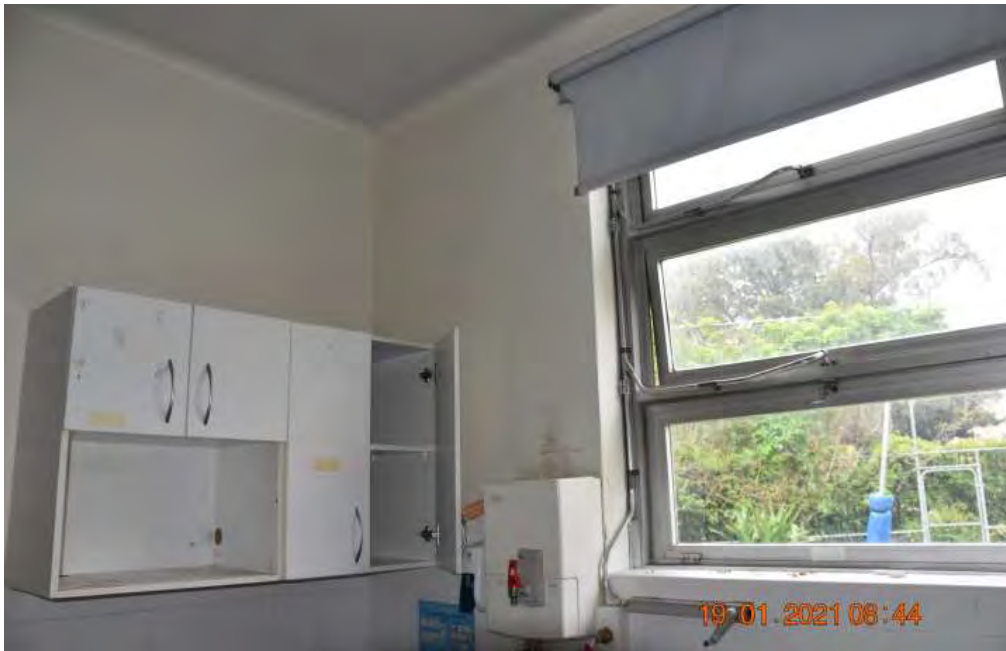
Figure: 0096

North wall in the auditorium kitchenette.

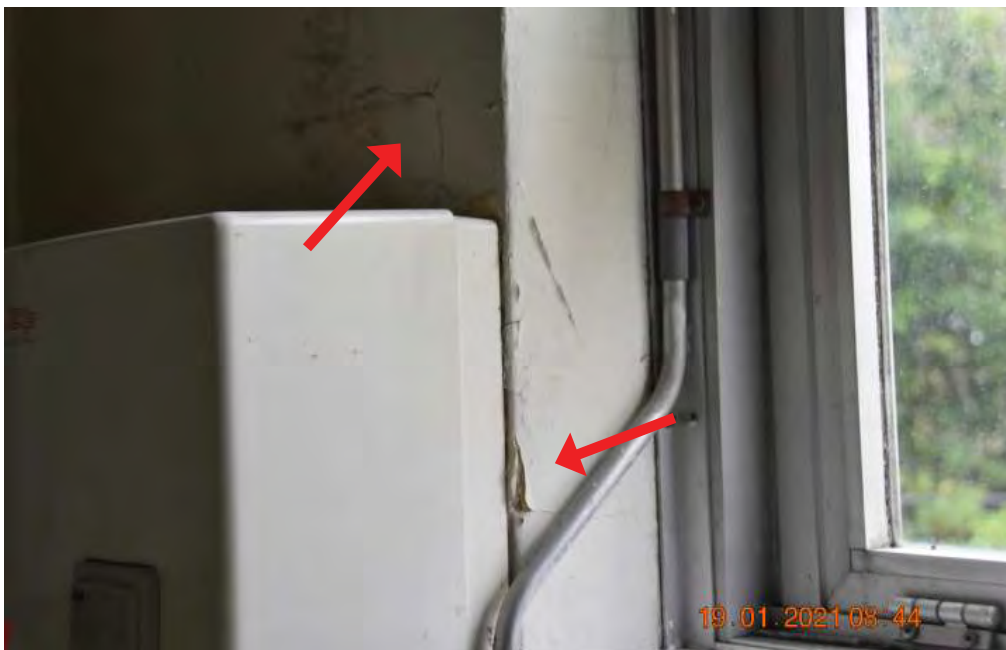
Figure: 0097

North wall in the auditorium kitchenette.

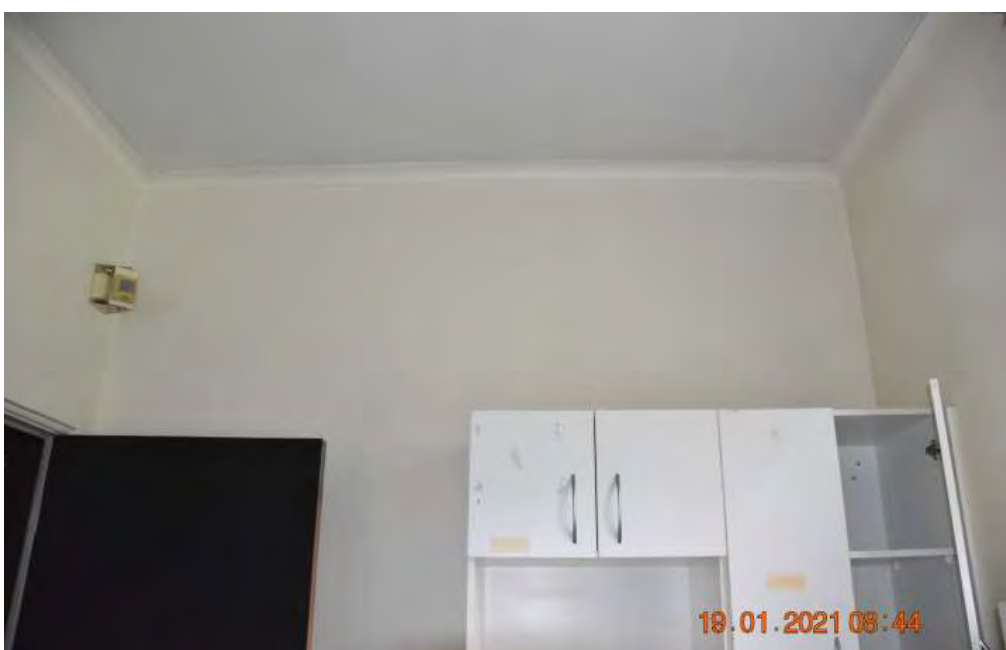
Figure: 0098

Chipping and cracking in the north wall in the auditorium kitchenette.

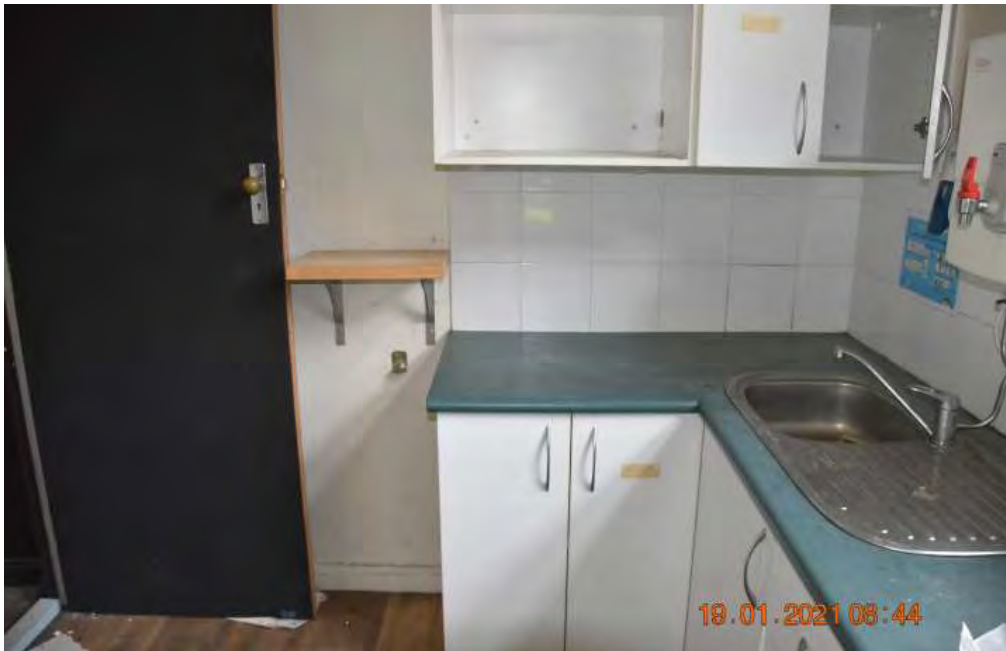
Figure: 0099

West wall in the auditorium kitchenette.

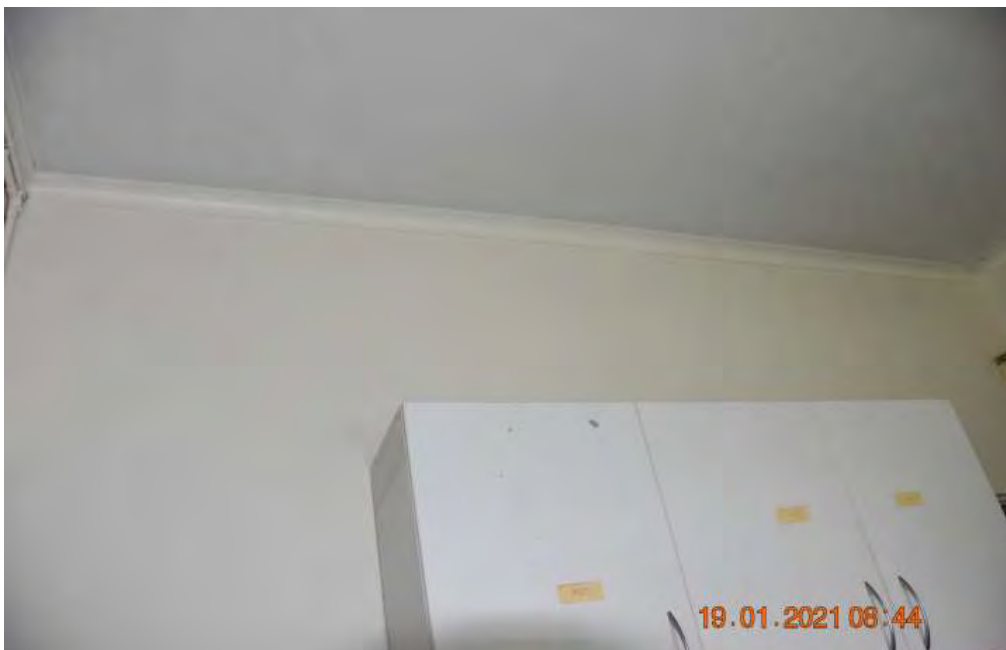
Figure: 0100

West wall in the auditorium kitchenette.

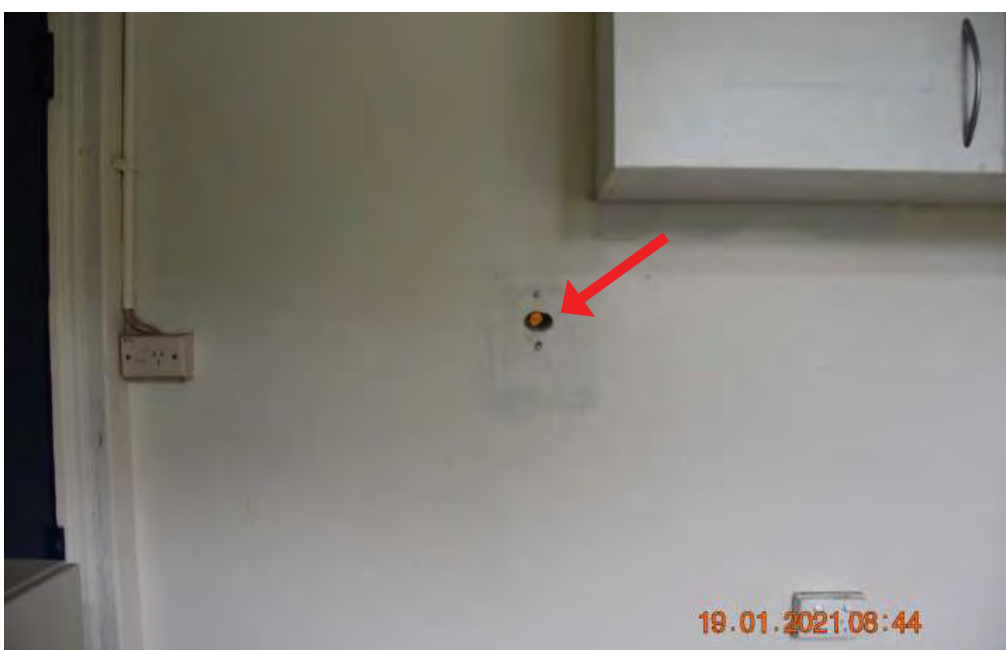
Figure: 0101

South wall in the auditorium kitchenette.

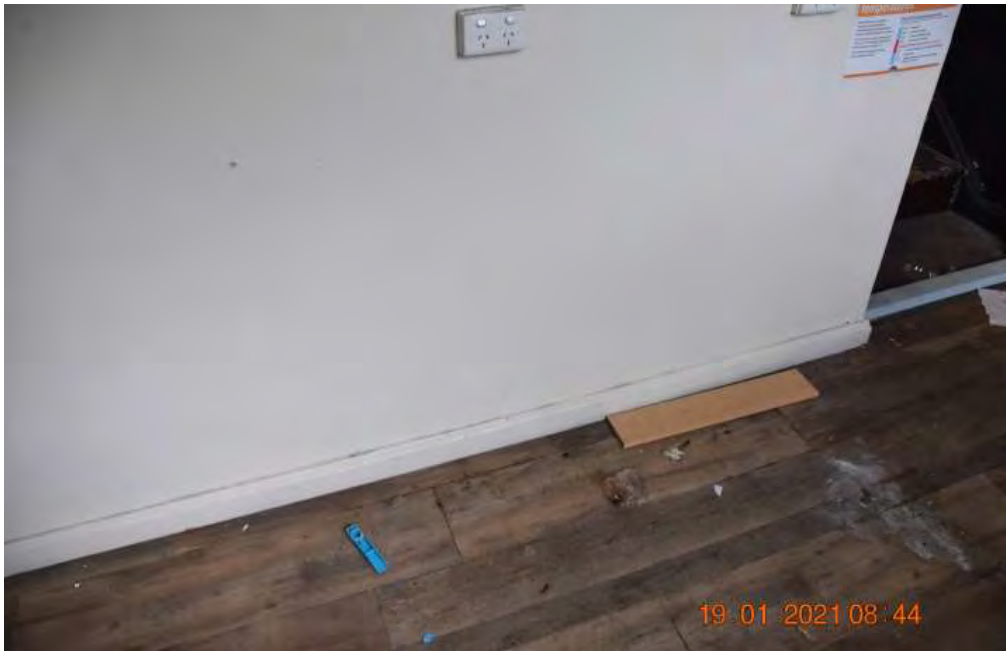
Figure: 0102

South wall in the auditorium kitchenette. Showing a hole.

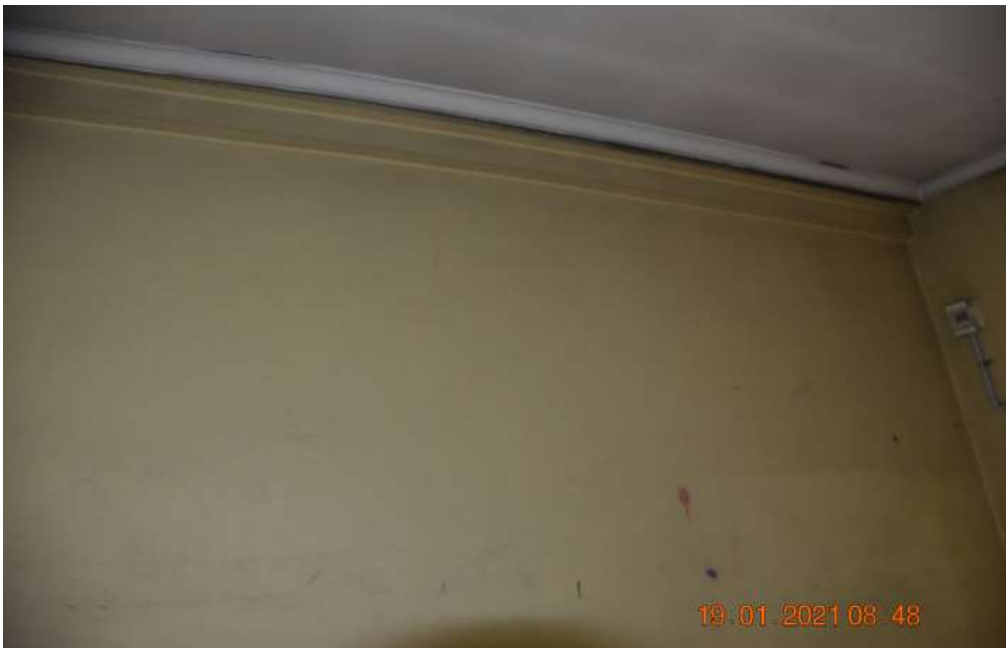
Figure: 0106

Water damage in the west wall in the auditorium kitchenette.

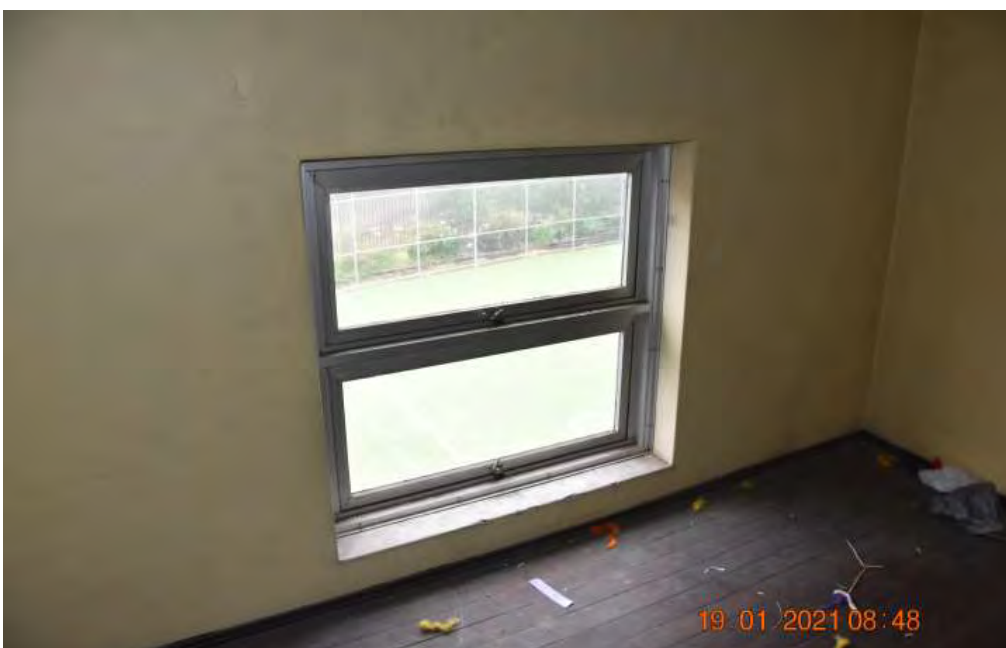
Figure: 0107

North wall in the drama room.

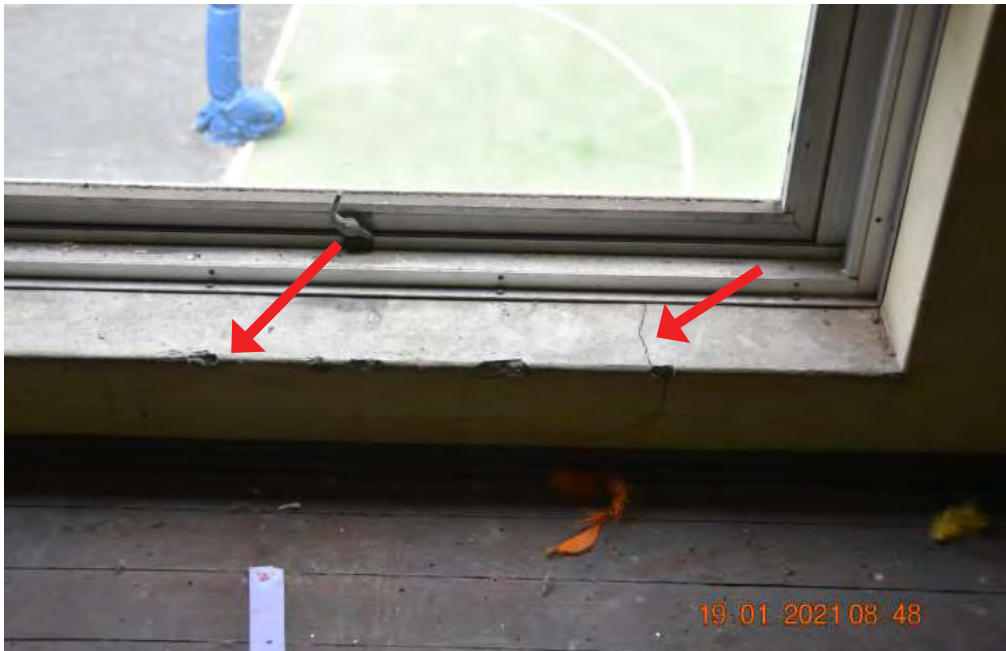
Figure: 0108

North wall in the drama room.
