## PRE CONSTRUCTION CONDITION SURVEY

Fort Street Public School, Millers Point NSW

Upper Fort Street Public School  
MILLERS POINT NSW 2000

19 January 2021

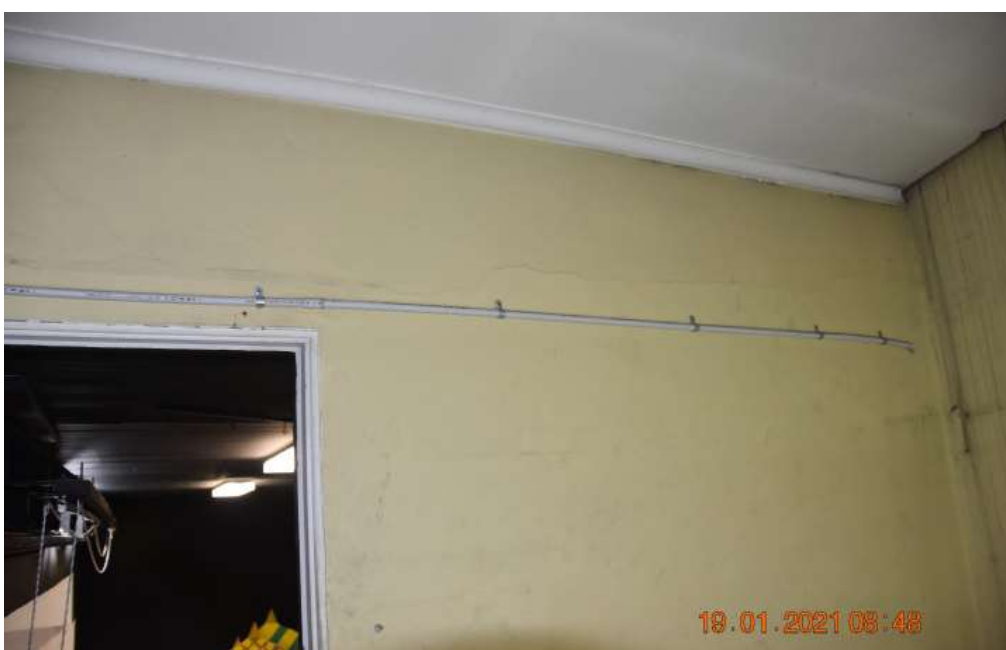
Figure: 0110

East wall in the drama room.

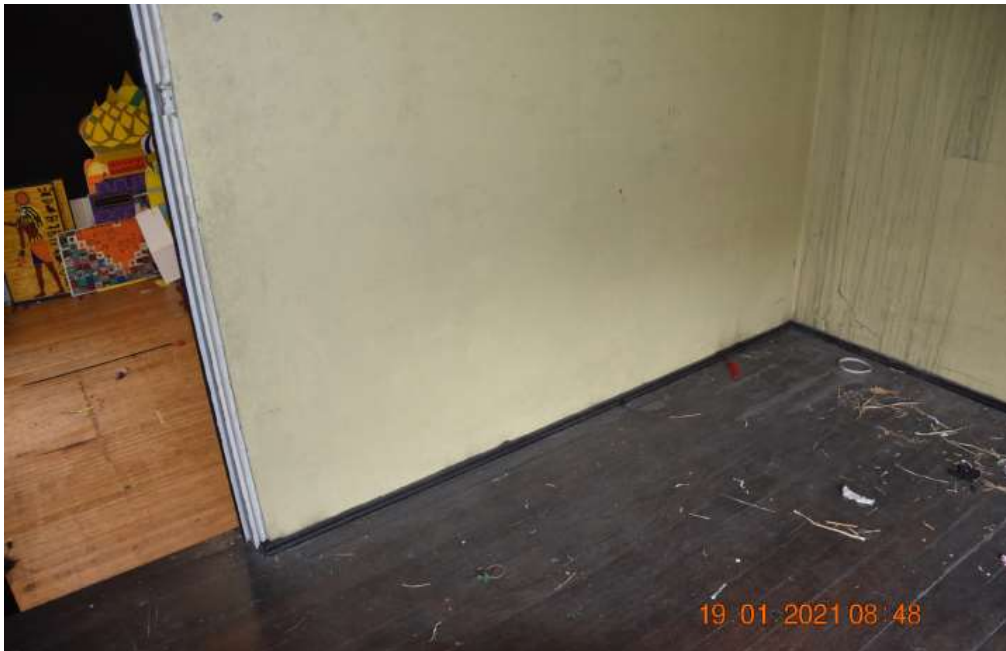
Figure: 0111

South wall in the drama room.

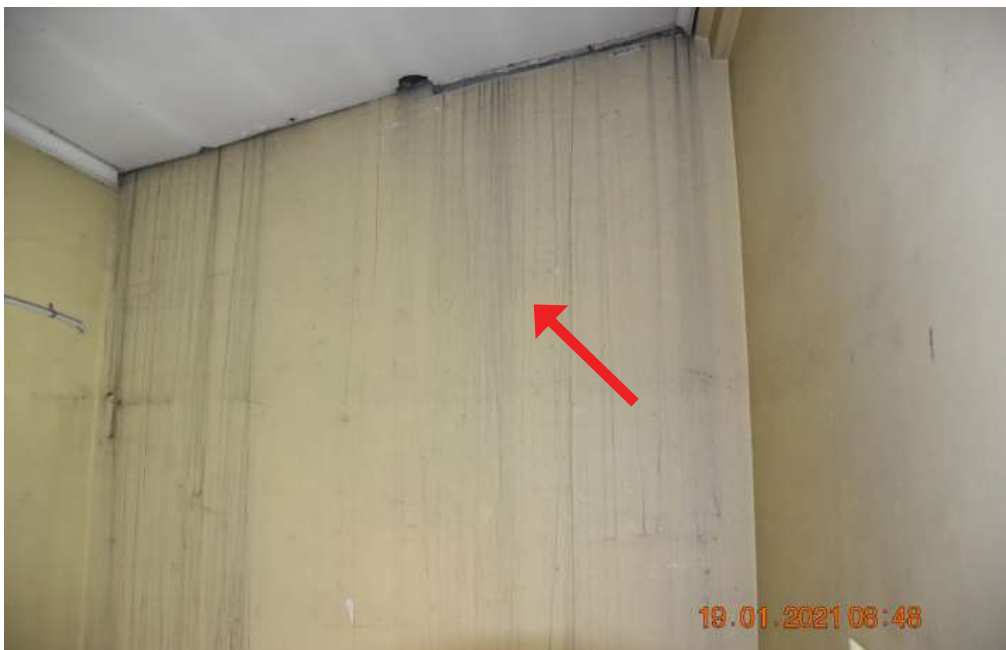
Figure: 0112

South wall in the drama room.

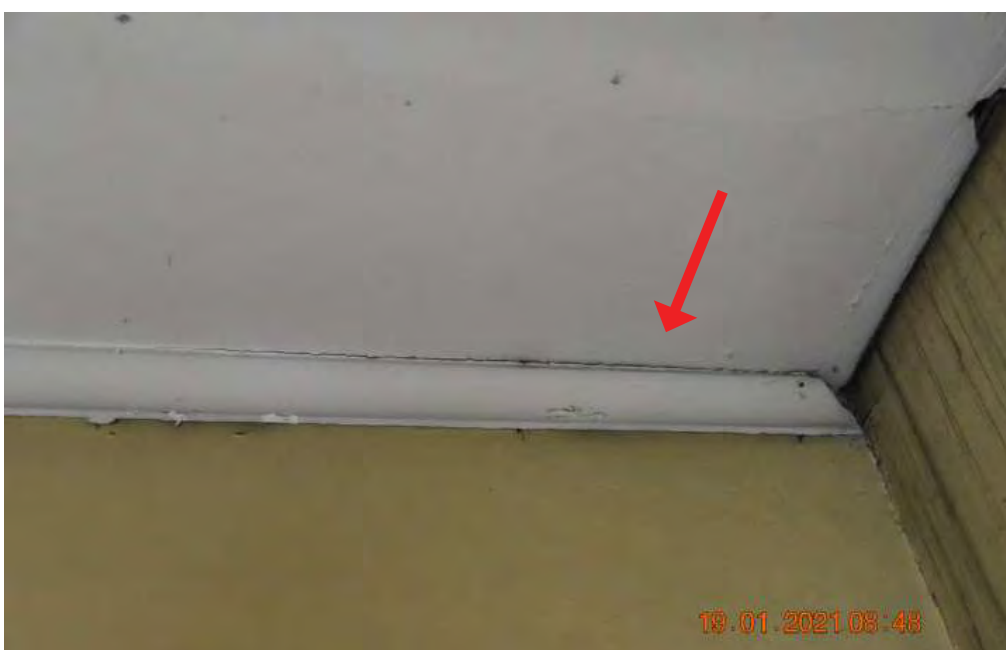
Figure: 0113

West wall in the drama room. Showing staining.

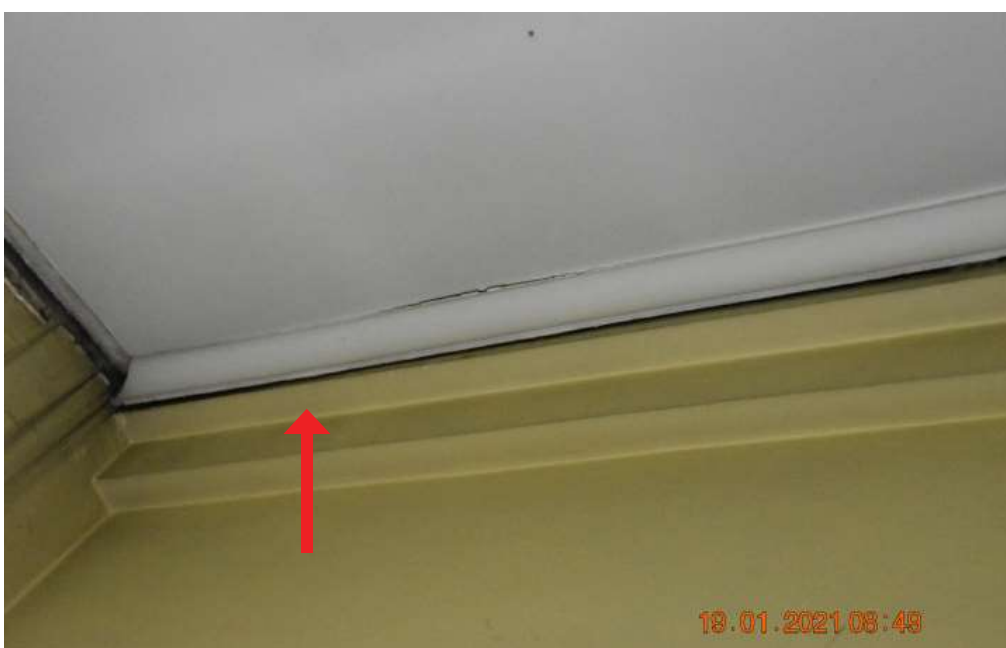
Figure: 0116

Separation between the ceiling cornice and the north wall in the drama room.

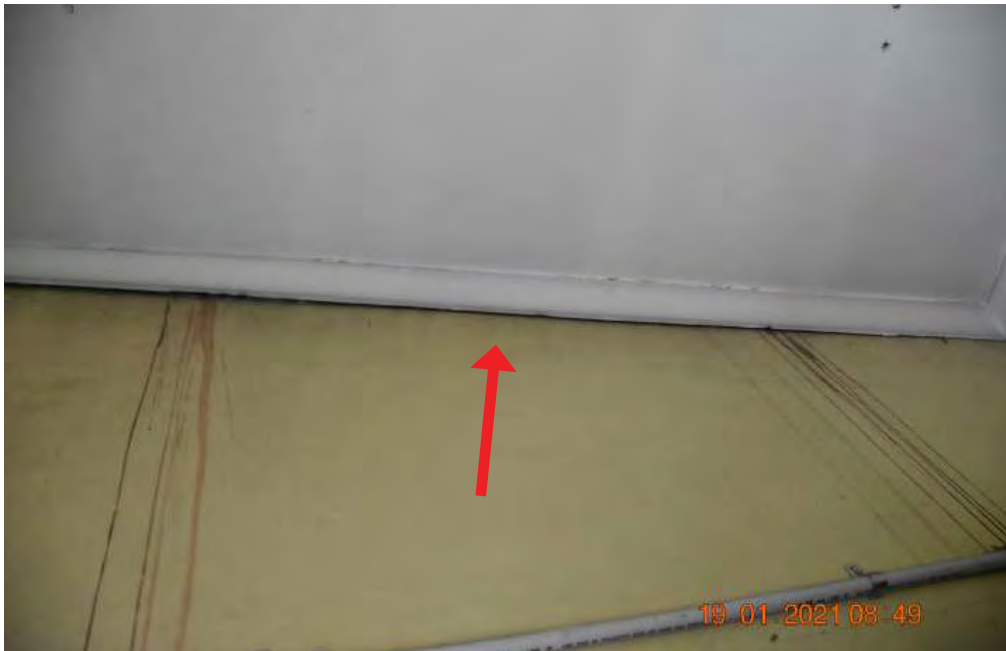
Figure: 0117

Separation between the ceiling cornice and the north wall in the drama room. Also showing separation between the ceiling cornice and the ceiling.

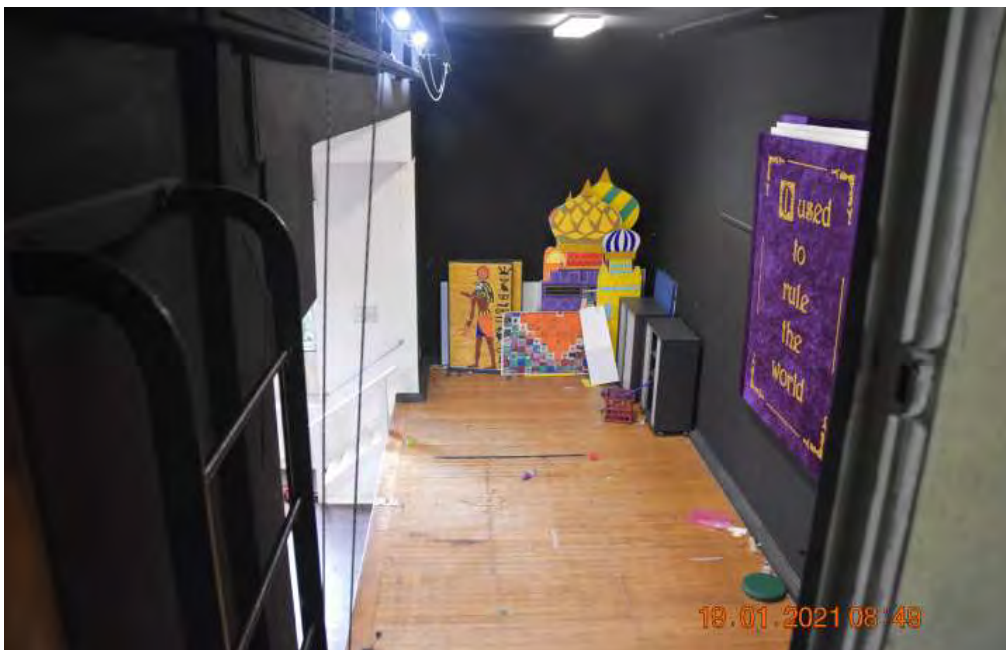
Figure: 0118

Separation between the ceiling cornice and the east wall in the drama room.

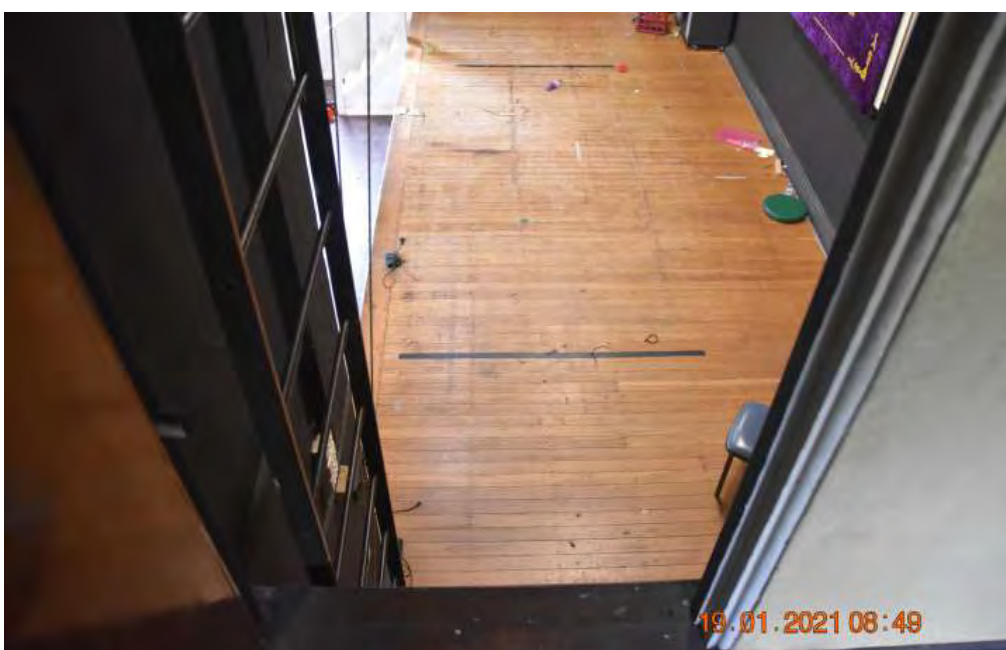
Figure: 0119

General view of the stage area in the auditorium, looking from the drama room.

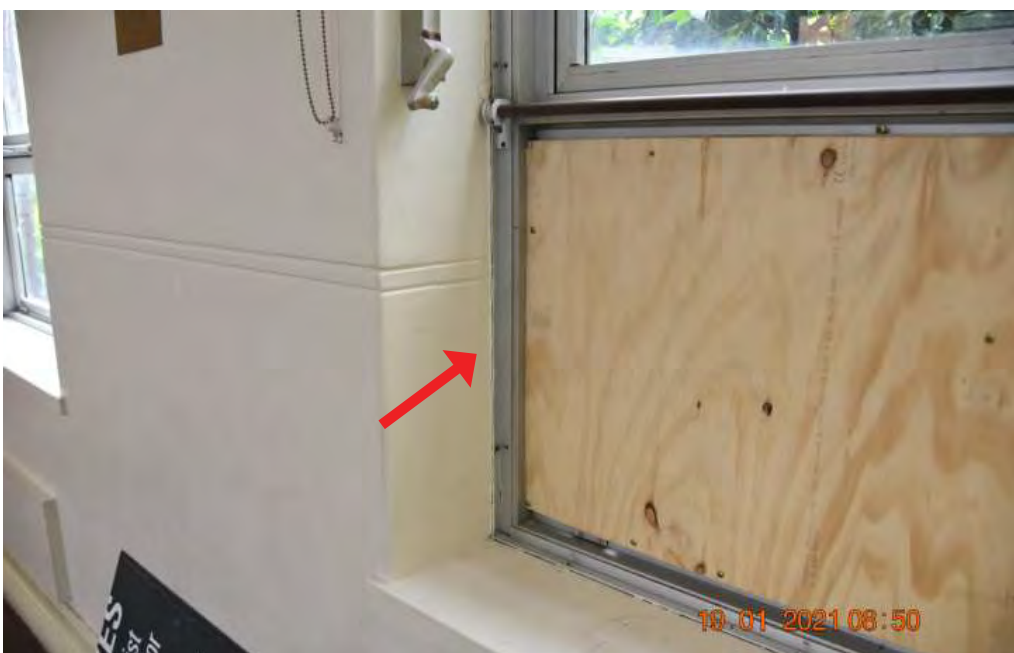
Figure: 0122

South wall in the auditorium.

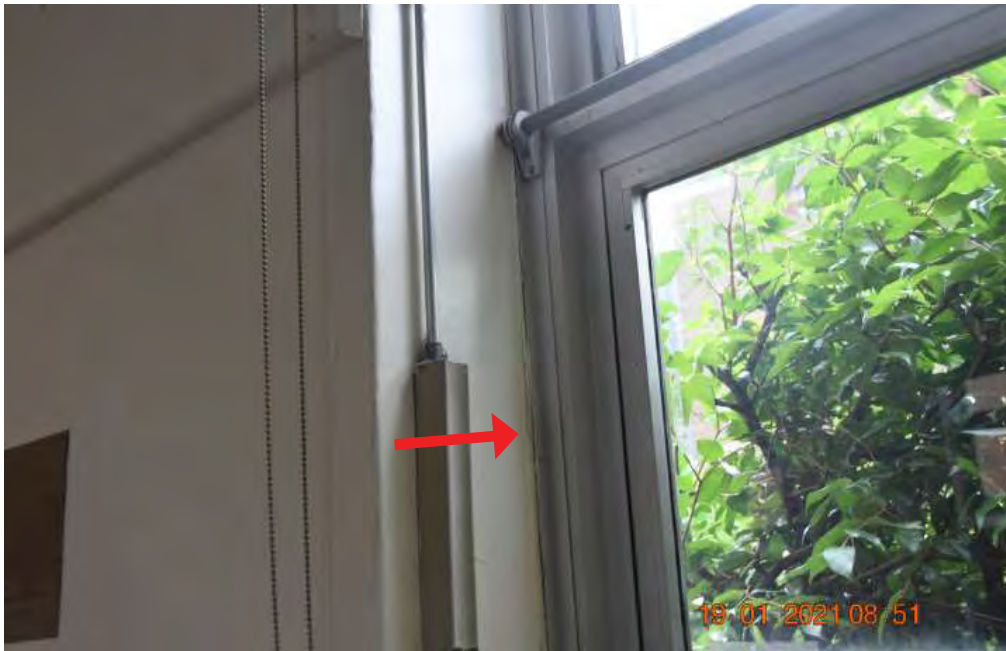
Figure: 0123

Separation between the window frame and the south wall in the auditorium.

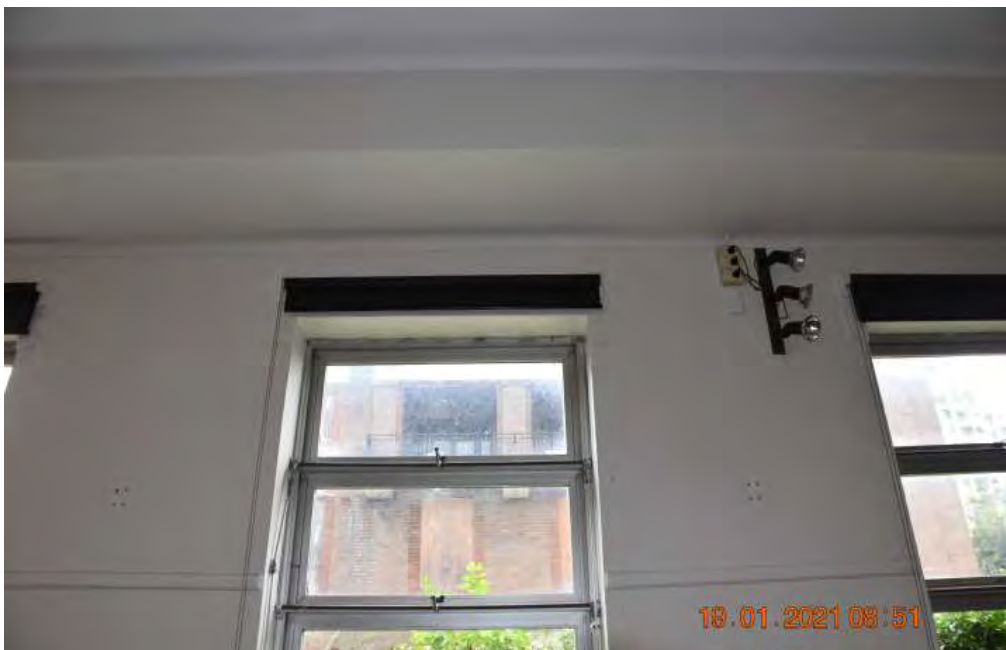
Figure: 0124

Separation between the window frame and the south wall in the auditorium.

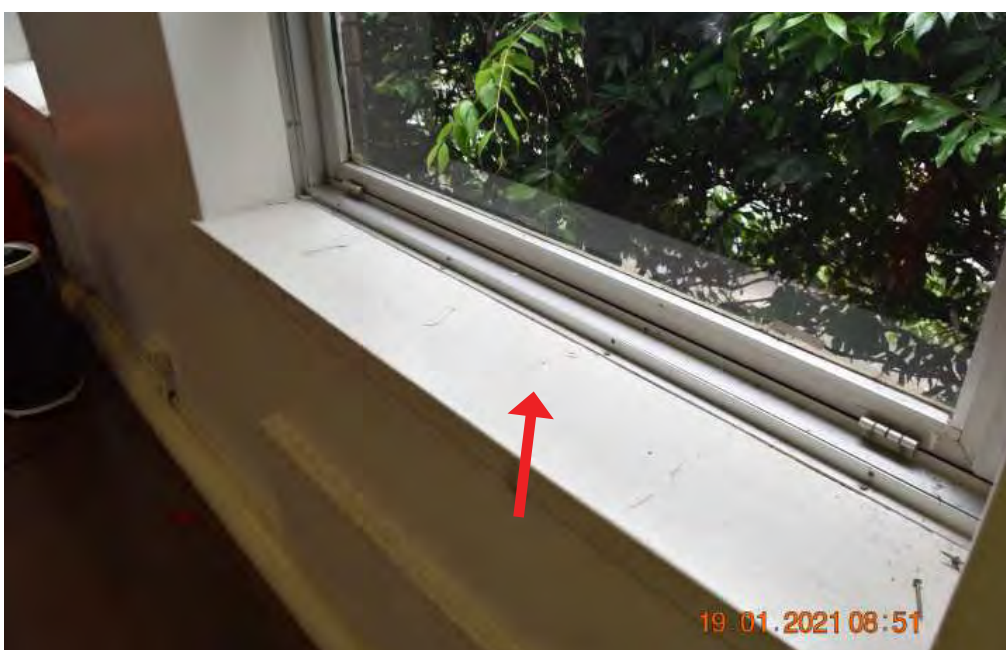
Figure: 0137

Cracking in the window sill in the south wall in the auditorium.

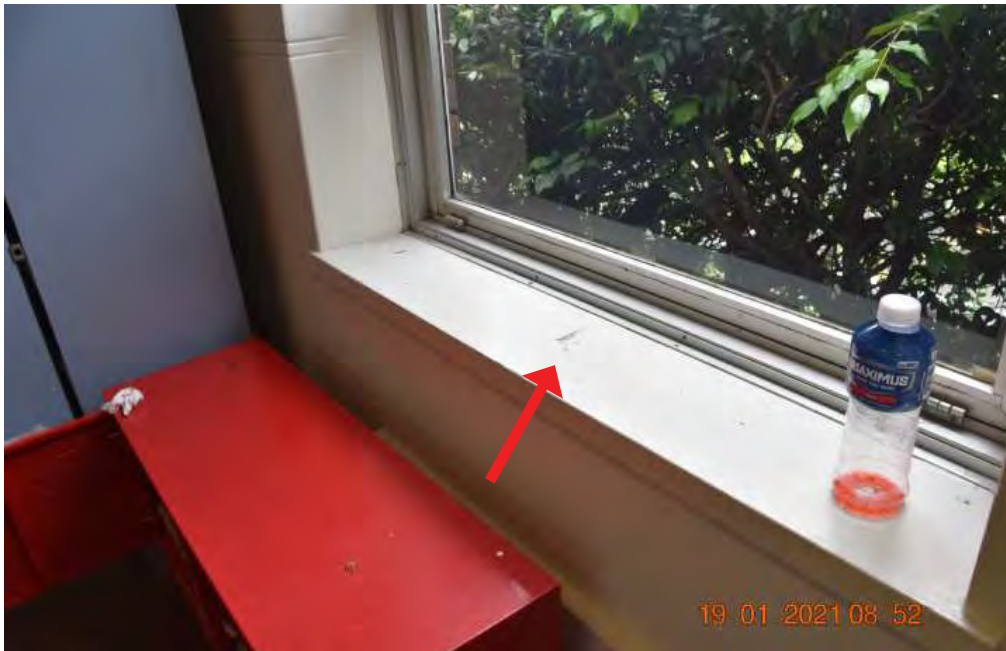
Figure: 0138

Cracking in the window sill in the south wall in the auditorium.

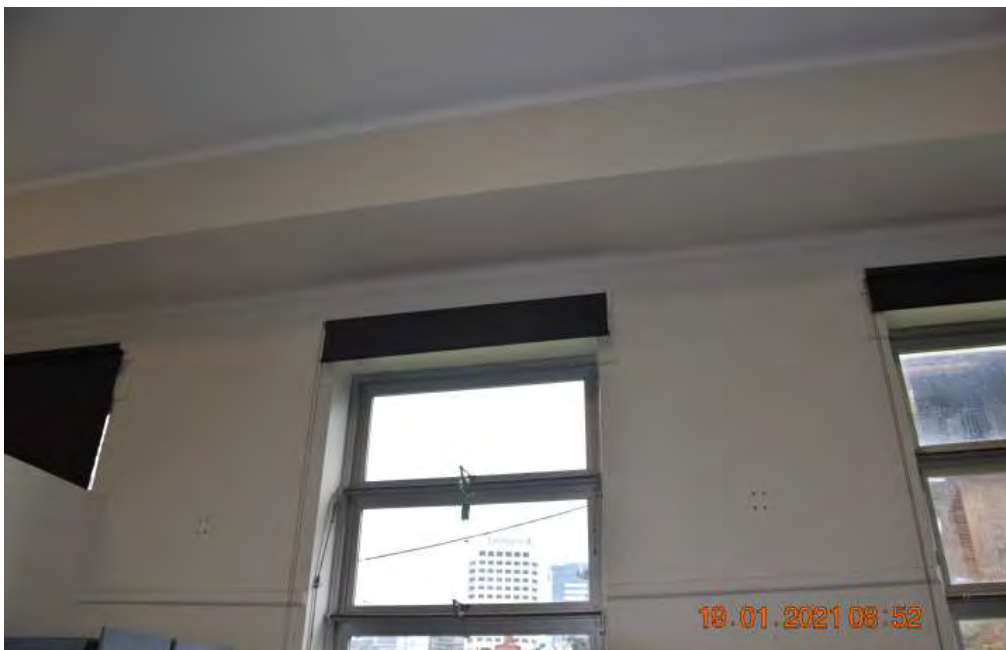
Figure: 0139

Cracking in the window sill in the south wall in the auditorium.

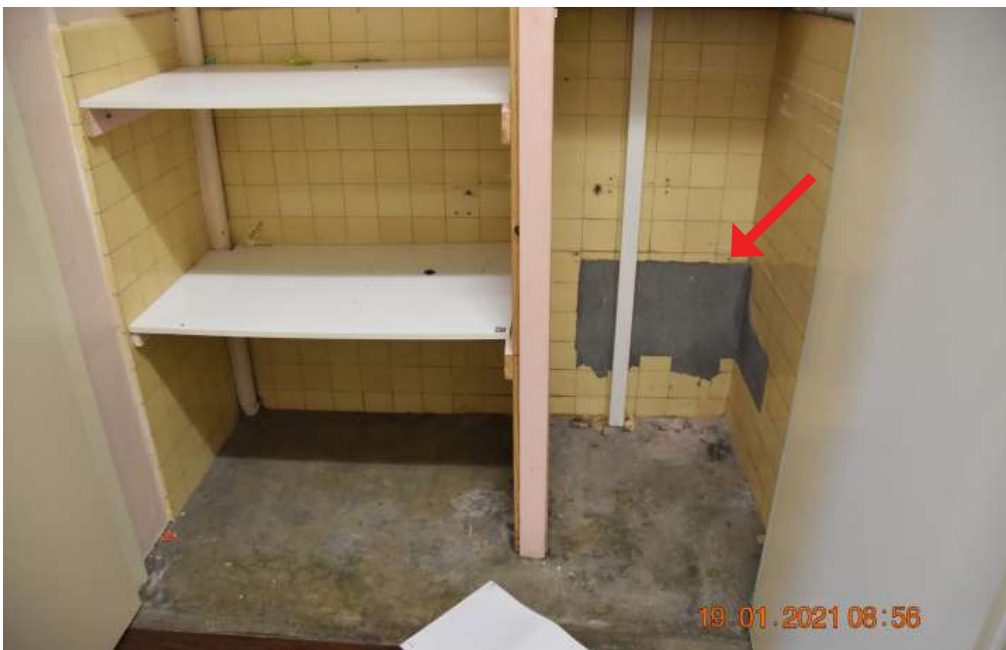
Figure: 0164

General view in the electrical distribution board cupboard.  
Showing missing tile.

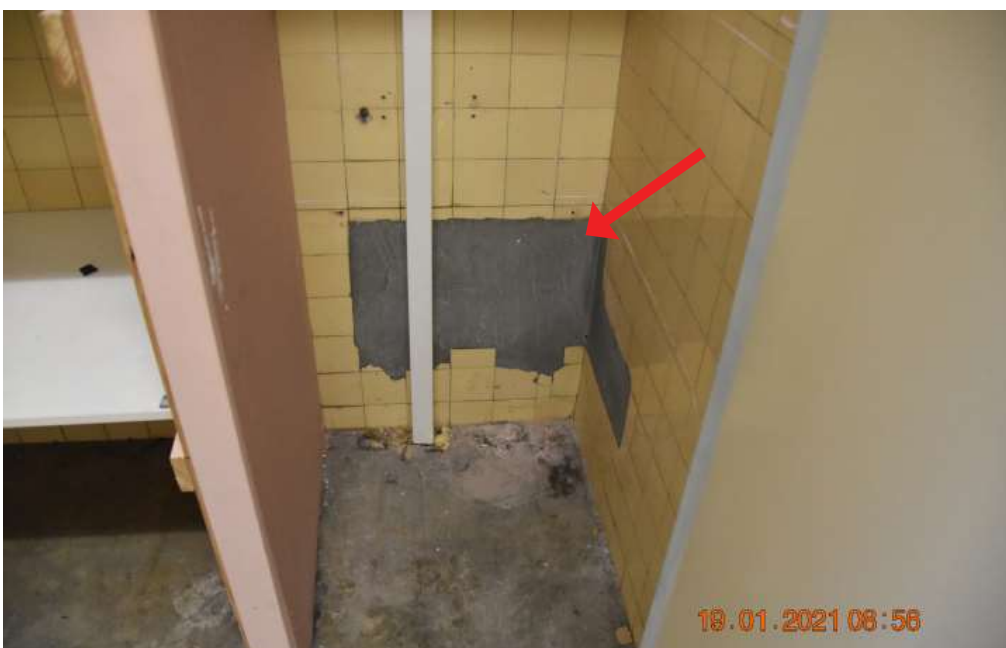
Figure: 0165

General view in the electrical distribution board cupboard.  
Showing missing tile.

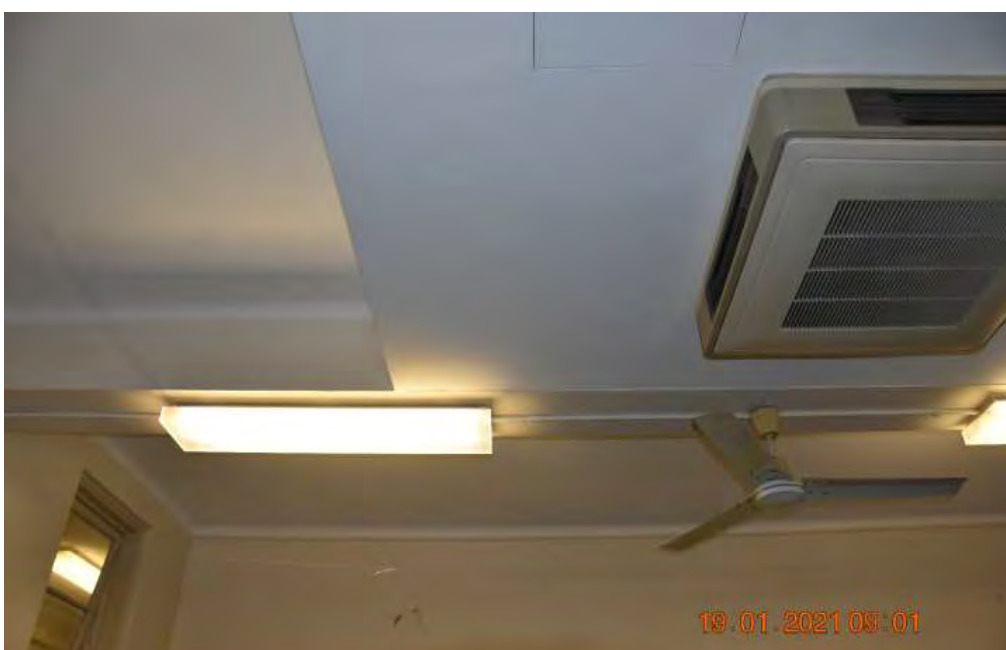
Figure: 0176

South wall in room 3. Showing peeling paint and damage.

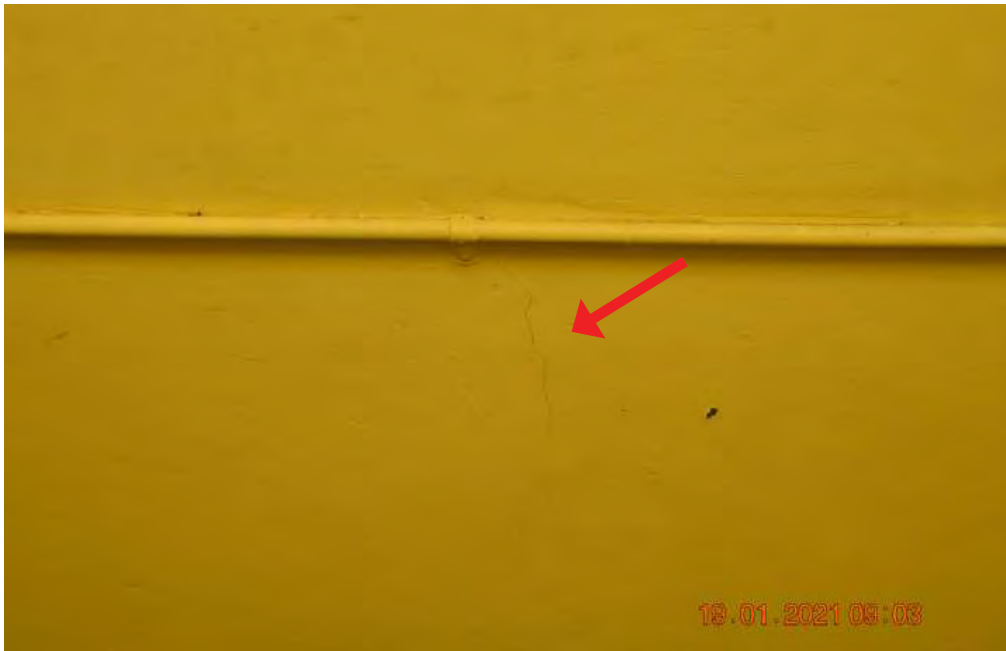
Figure: 0204

Fine cracking in the west wall in the art room.

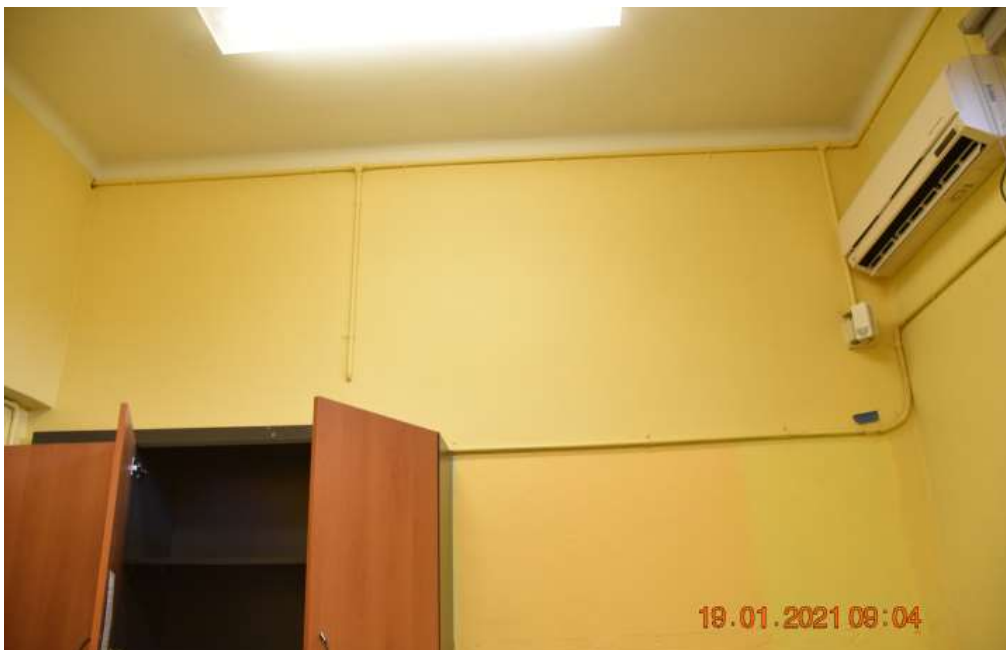
Figure: 0205

Fine cracking in the west wall in the art room.

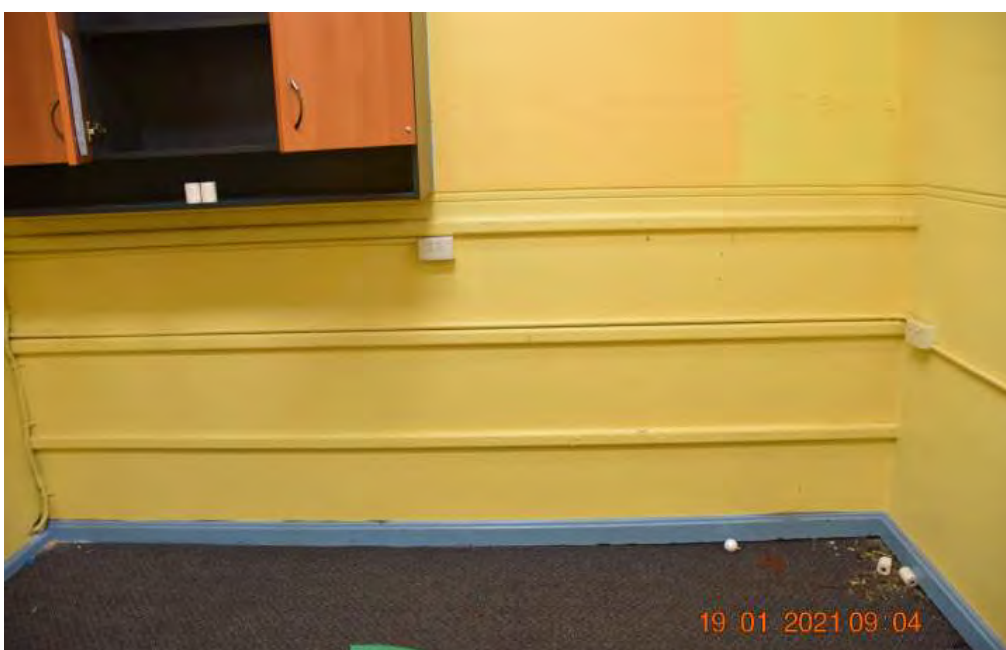
Figure: 0206

South wall in the art room.

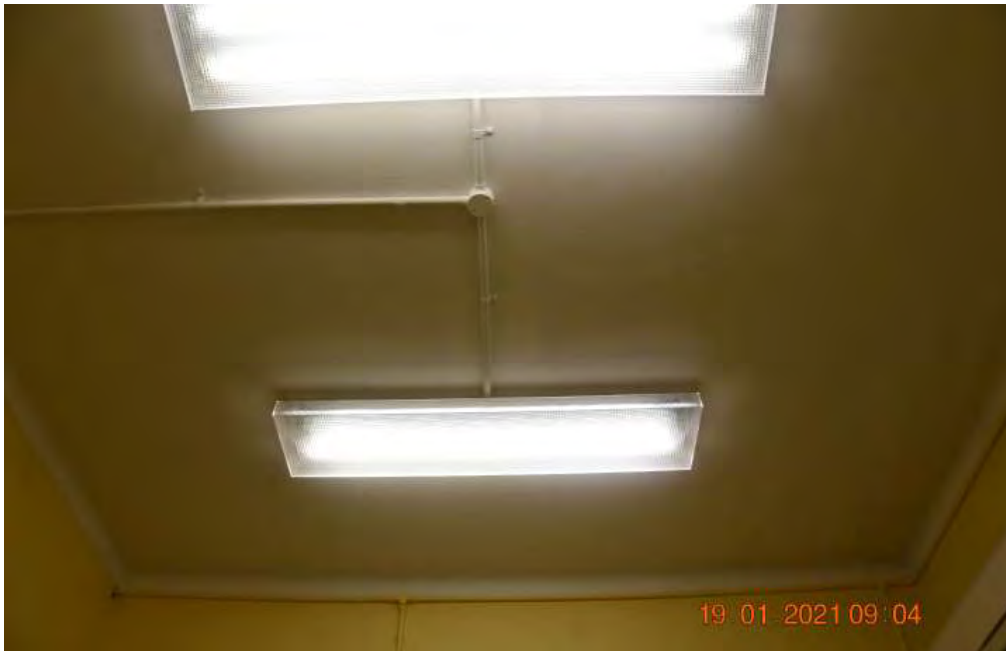
Figure: 0207

South wall in the art room.

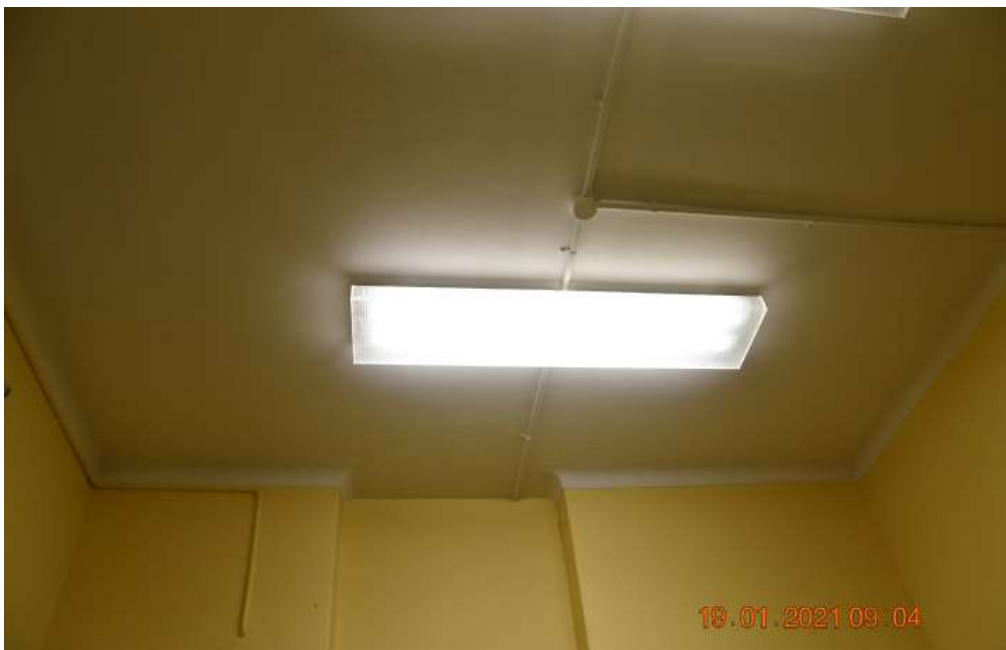
Figure: 0208

Ceiling in the art room.

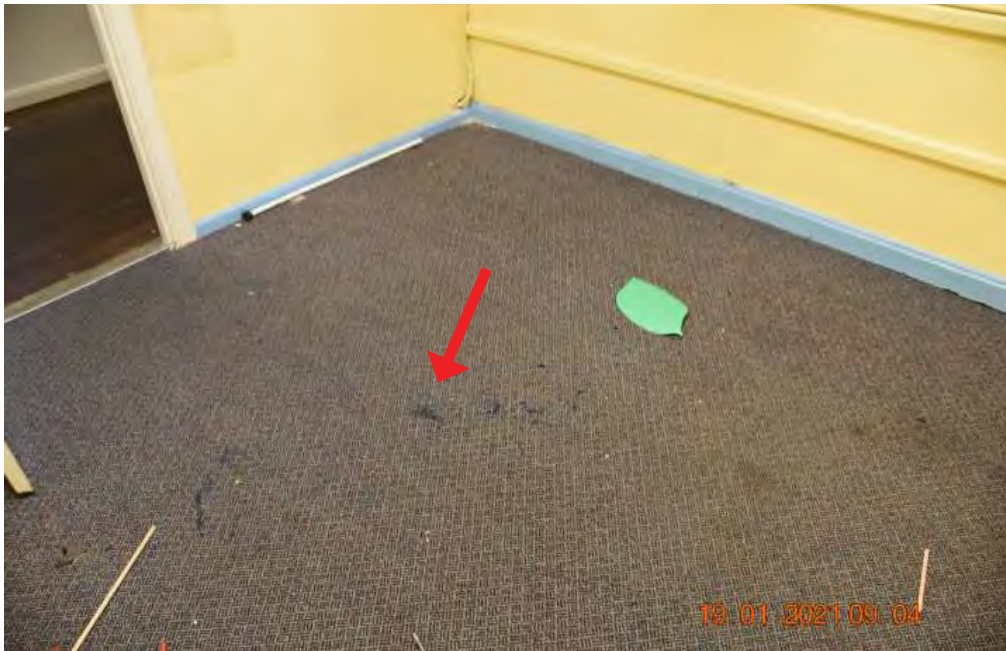
Figure: 0210

Flooring in the art room. Showing staining.

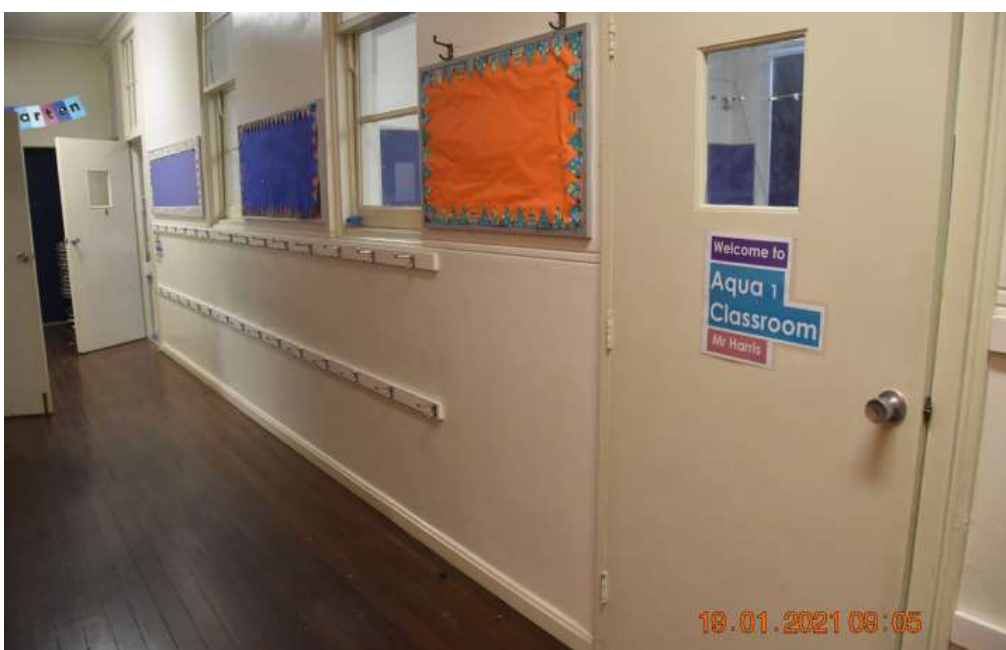
Figure: 0212

East wall in the ground floor corridor, outside aqua 1 classroom.

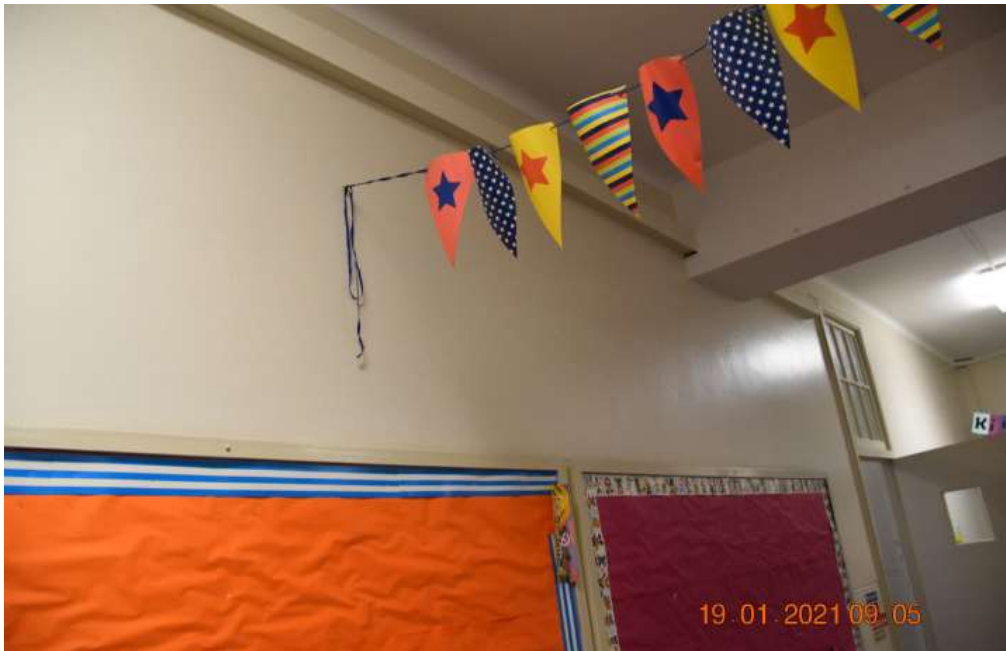
Figure: 0213

East wall in the ground floor corridor, outside aqua 1 classroom.

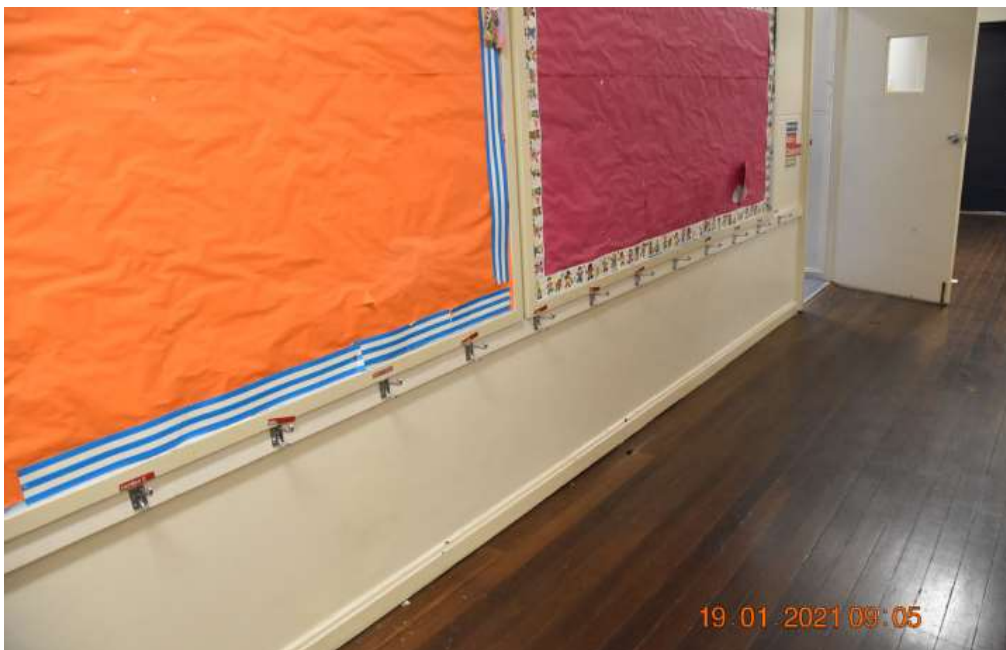
Figure: 0214

West wall in the ground floor corridor, outside aqua 1 classroom.

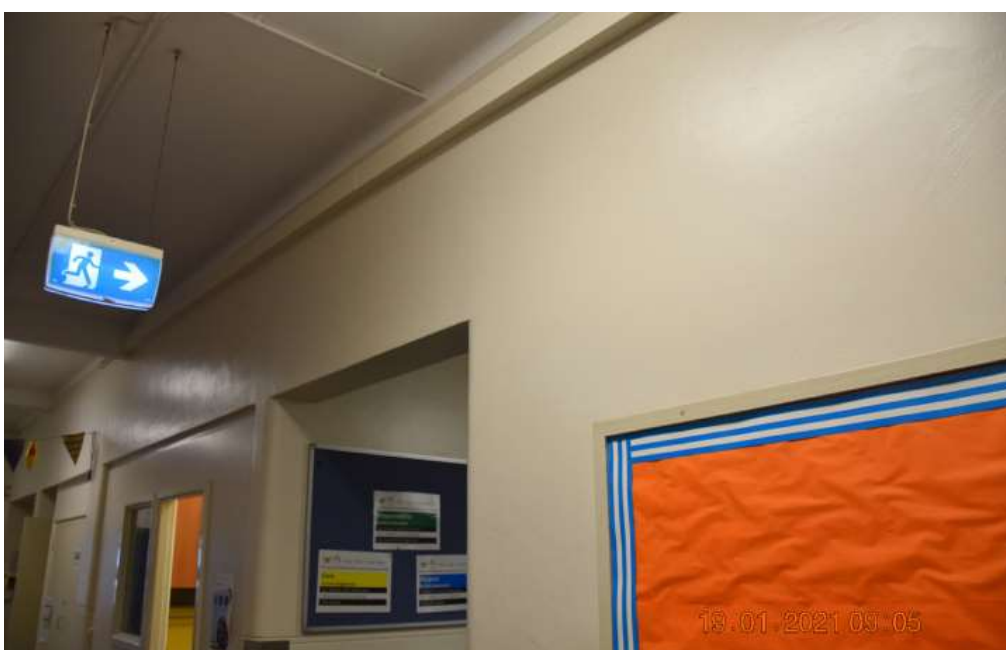
Figure: 0215

West wall in the ground floor corridor, outside aqua 1 classroom.

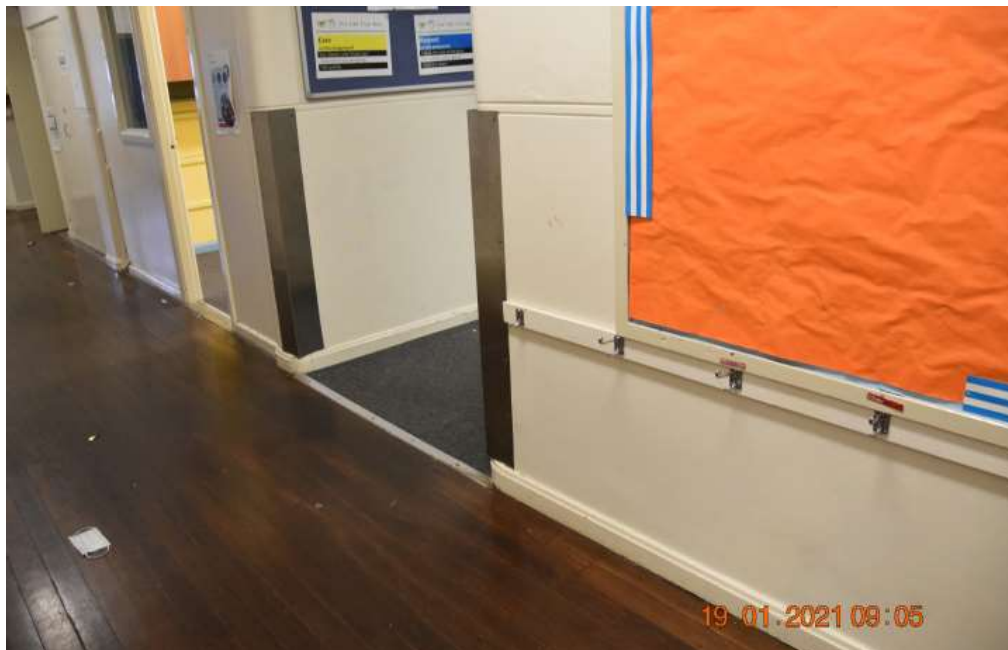
Figure: 0216

West wall in the ground floor corridor, outside aqua 1 classroom.

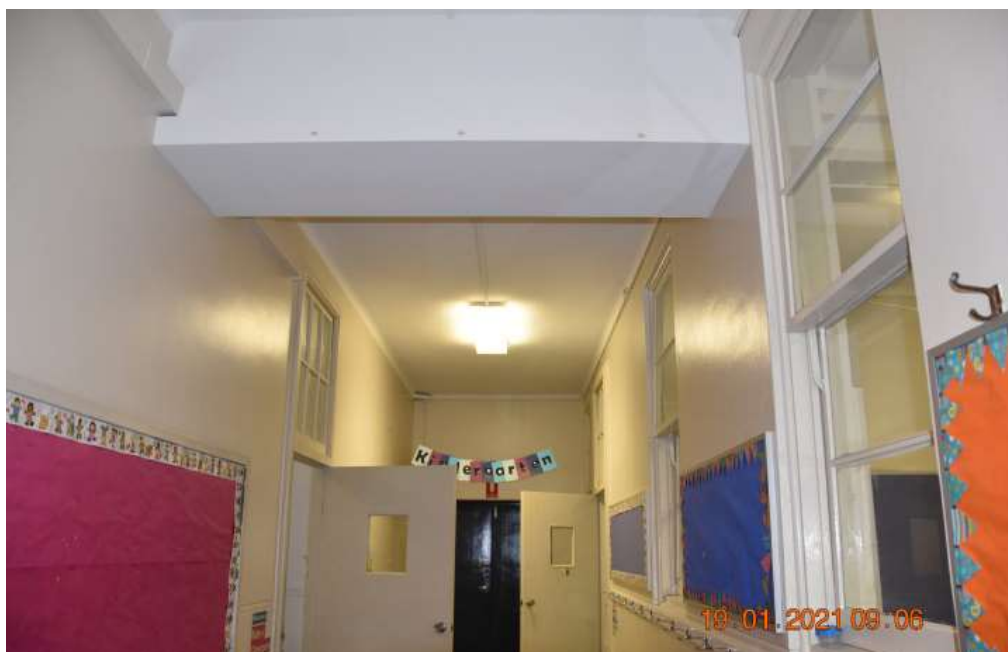
Figure: 0217

West wall in the ground floor corridor, outside aqua 1 classroom.

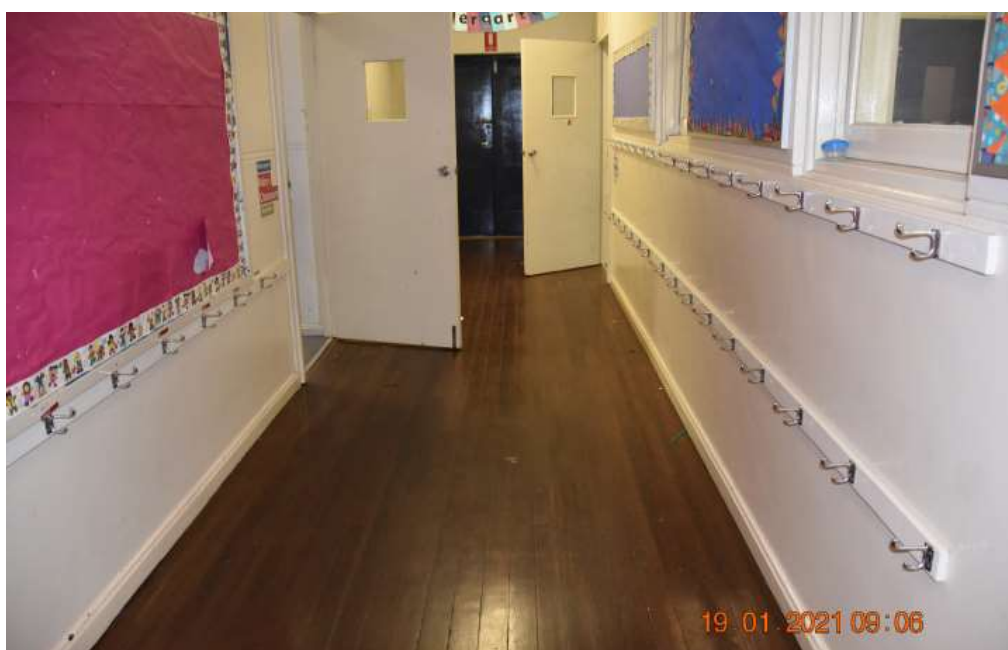
Figure: 0218

General view in the ground floor corridor, outside aqua 1 classroom.

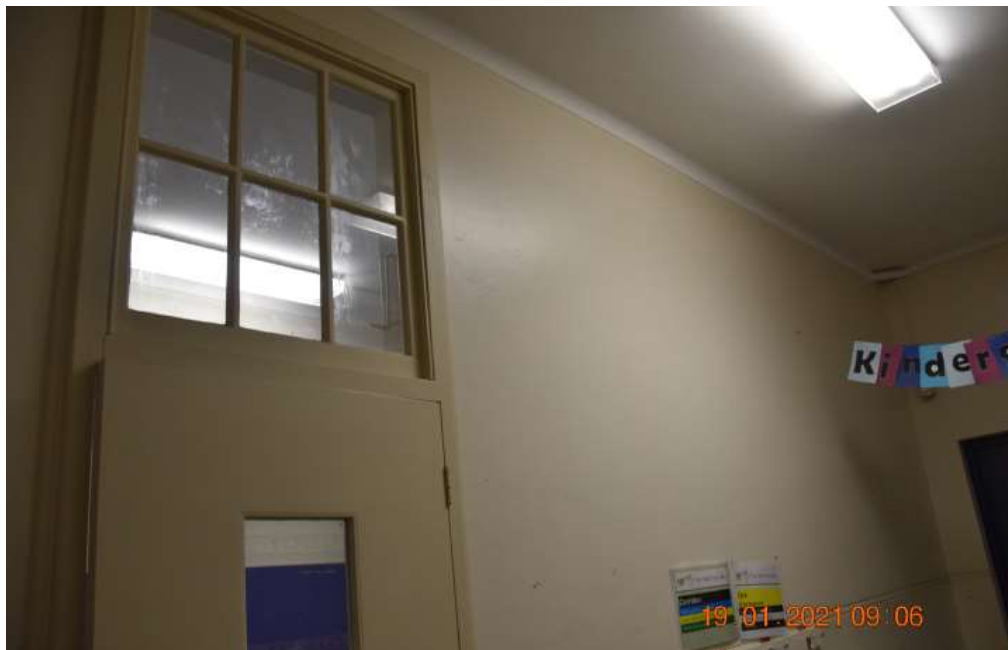
Figure: 0219

General view in the ground floor corridor, outside aqua 1 classroom.

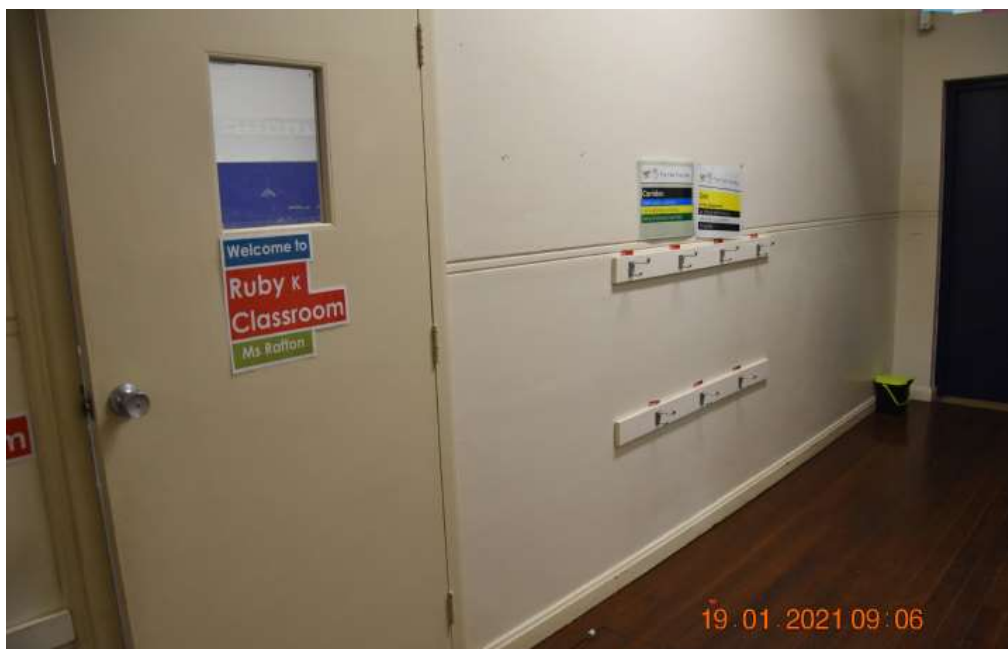
Figure: 0220

West wall in the ground floor corridor, outside ruby k classroom.

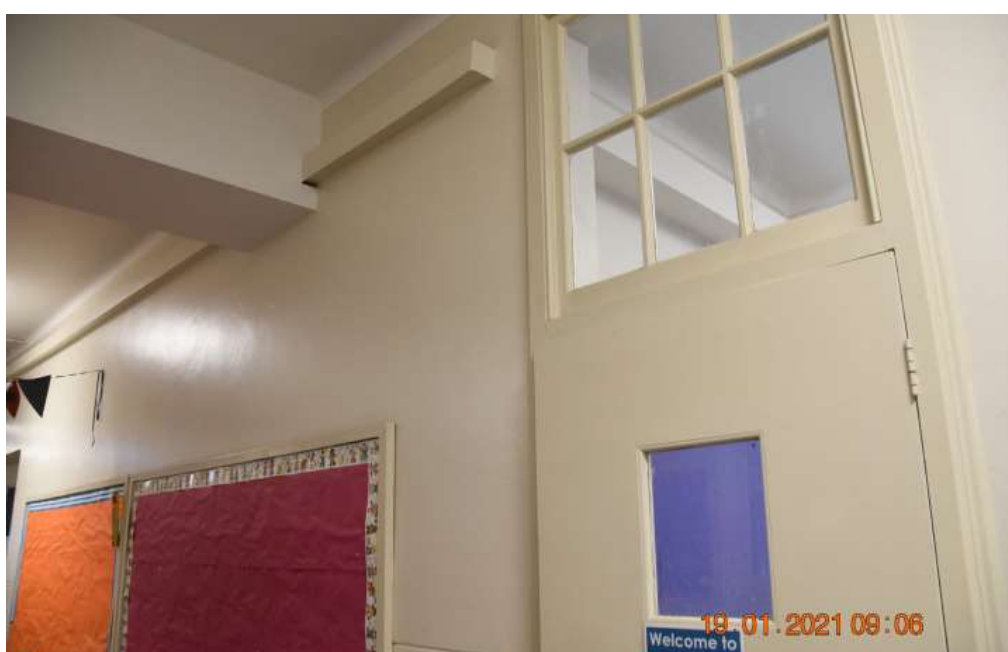
Figure: 0221

West wall in the ground floor corridor, outside ruby k classroom.

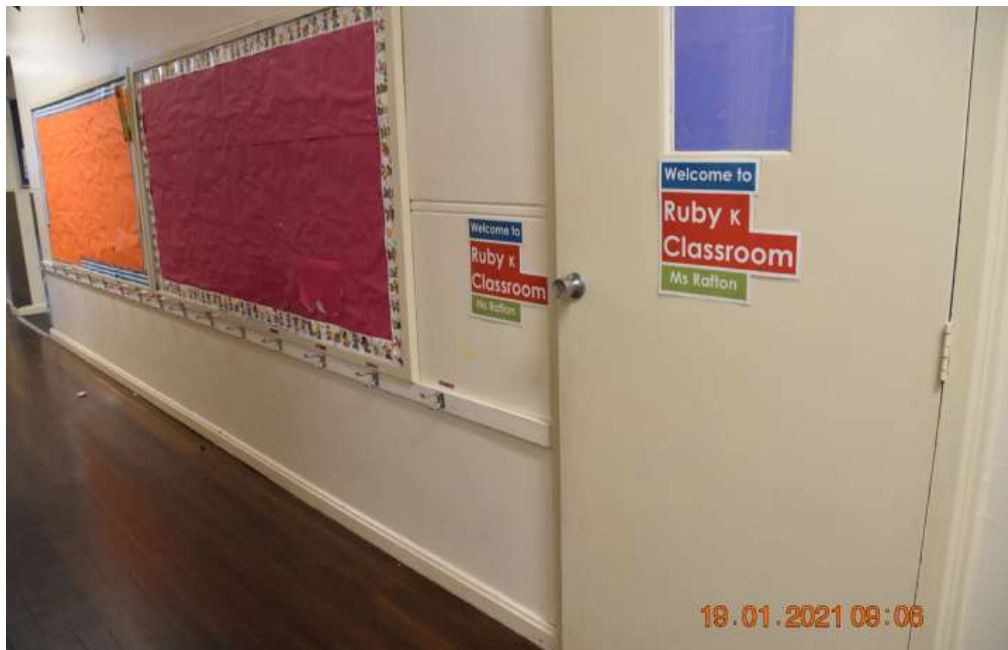
Figure: 0222

West wall in the ground floor corridor, outside ruby k classroom.
