## PRE CONSTRUCTION CONDITION SURVEY

Fort Street Public School, Millers Point NSW

Upper Fort Street Public School  
MILLERS POINT NSW 2000

19 January 2021

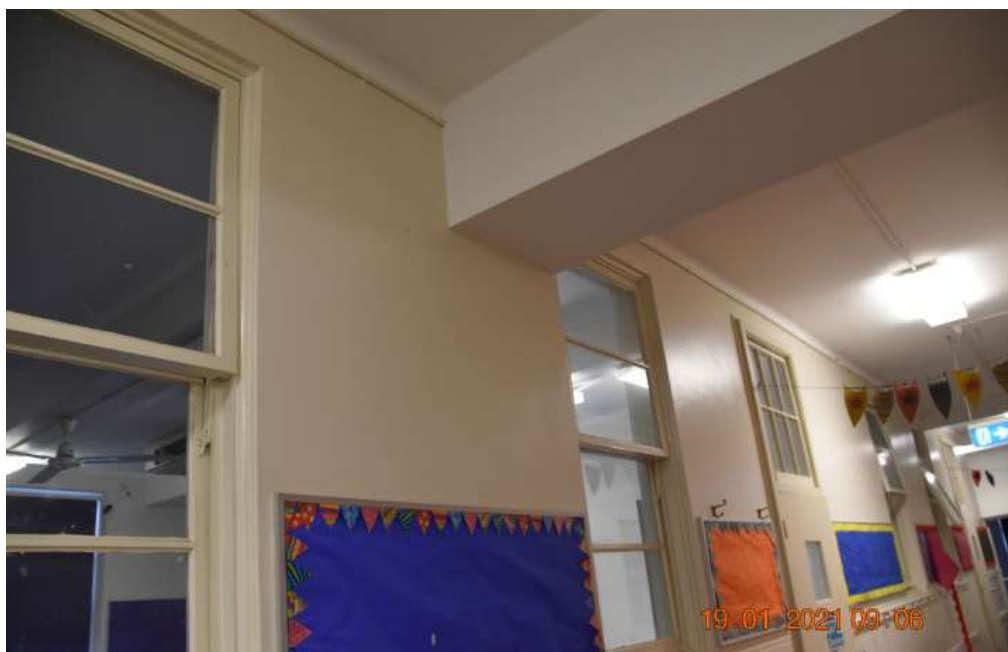
Figure: 0223

West wall in the ground floor corridor, outside ruby k classroom.

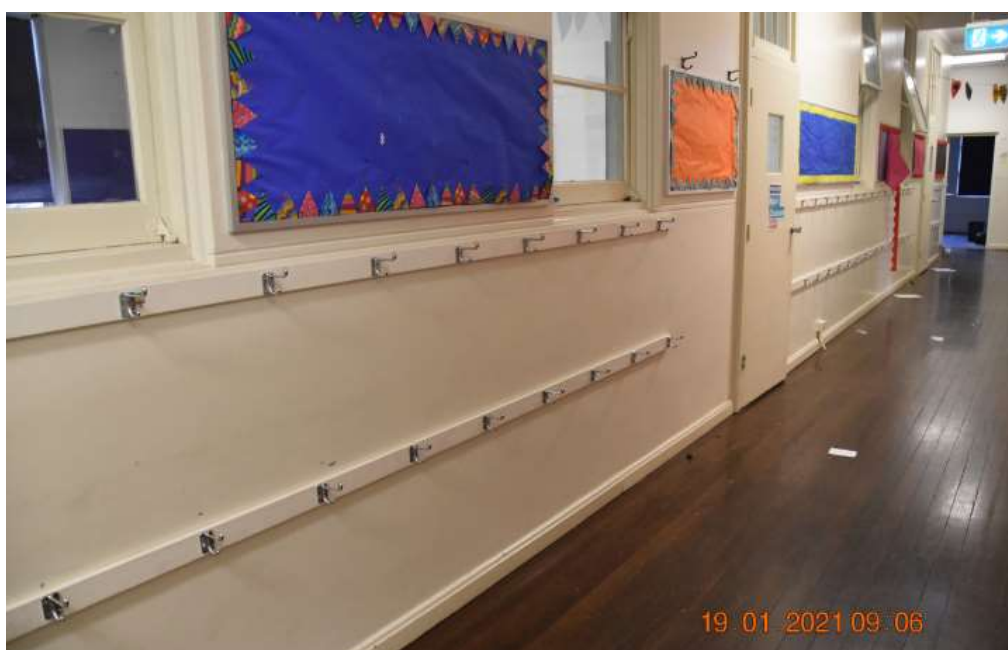
Figure: 0224

East wall in the ground floor corridor, outside ruby k classroom.

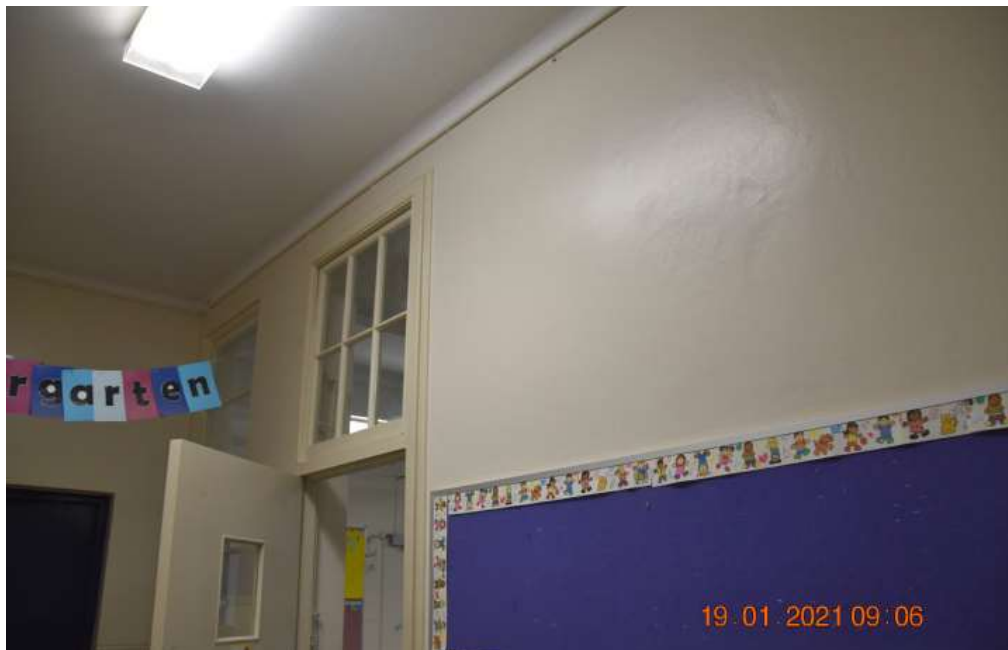
Figure: 0225

East wall in the ground floor corridor, outside ruby k classroom.

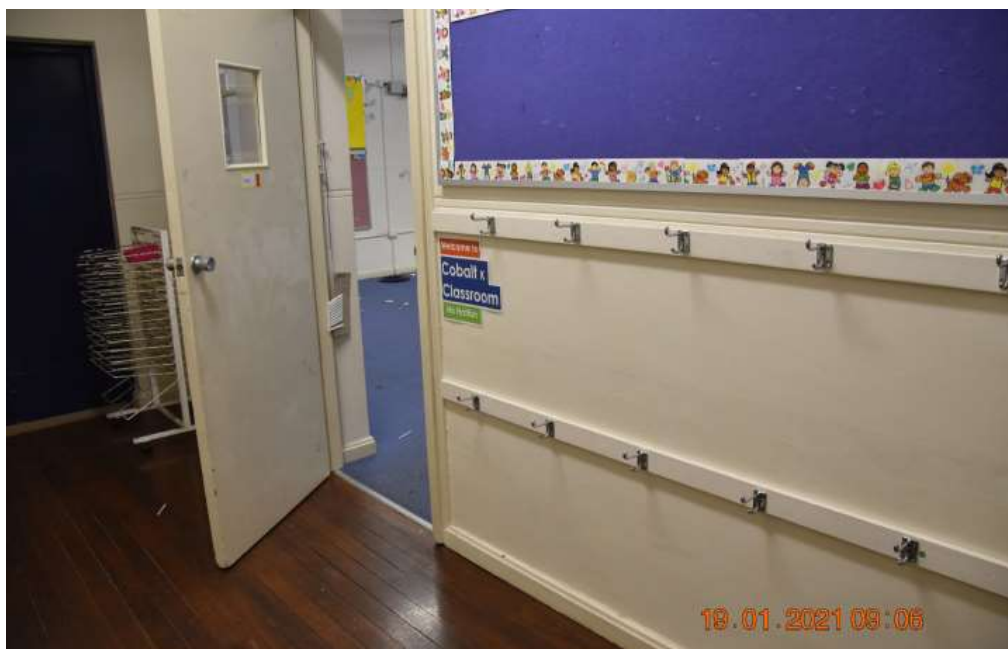
Figure: 0226

East wall in the ground floor corridor, outside ruby k classroom.

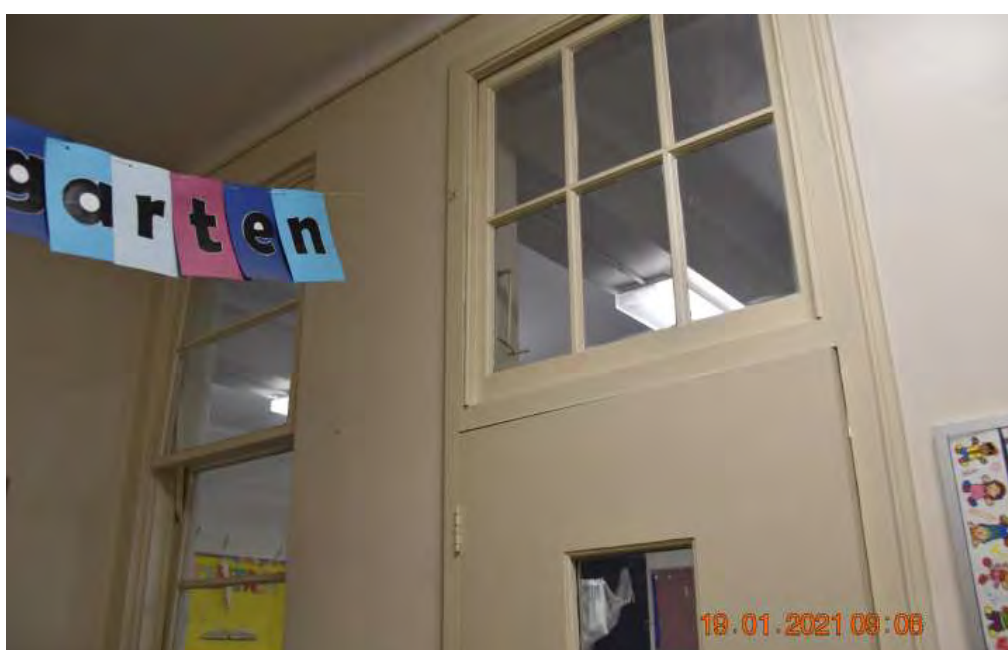
Figure: 0227

East wall in the ground floor corridor, outside ruby k classroom.

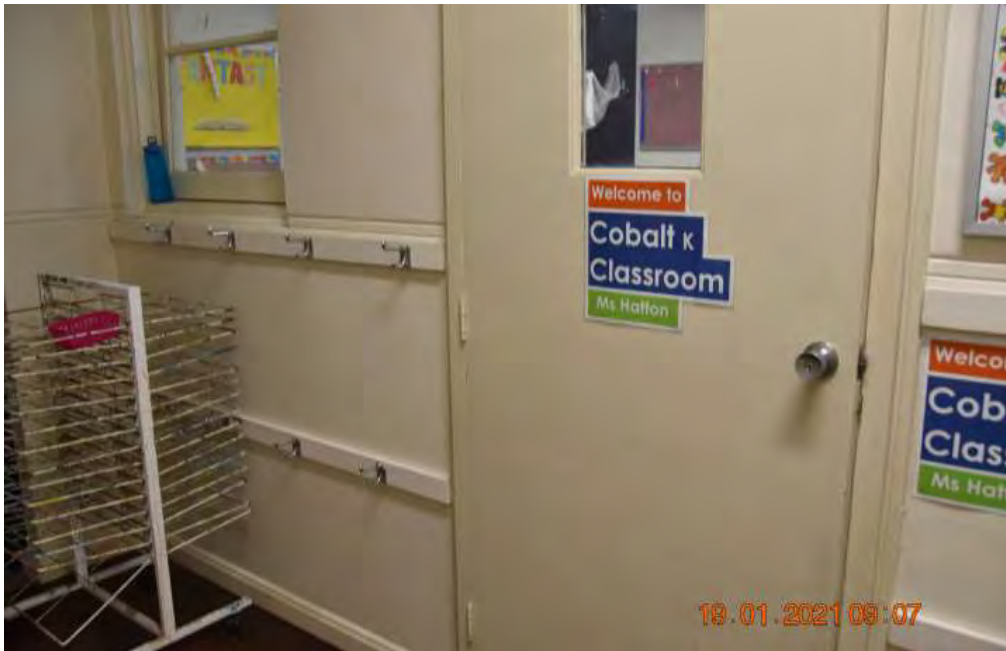
Figure: 0228

East wall in the ground floor corridor, outside cobalt k classroom.

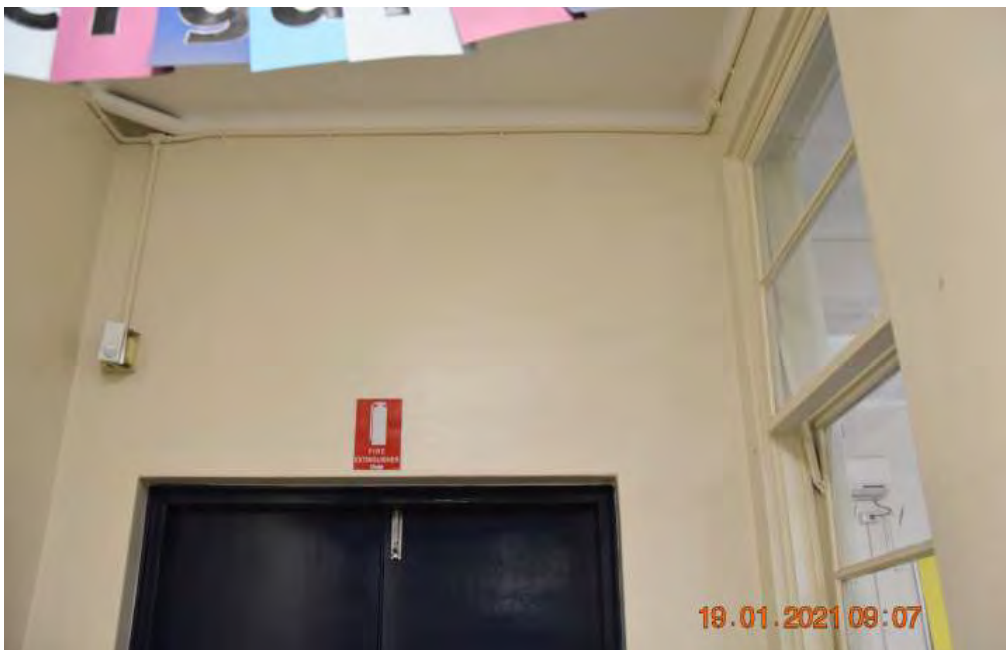
Figure: 0229

East wall in the ground floor corridor, outside cobalt k classroom.

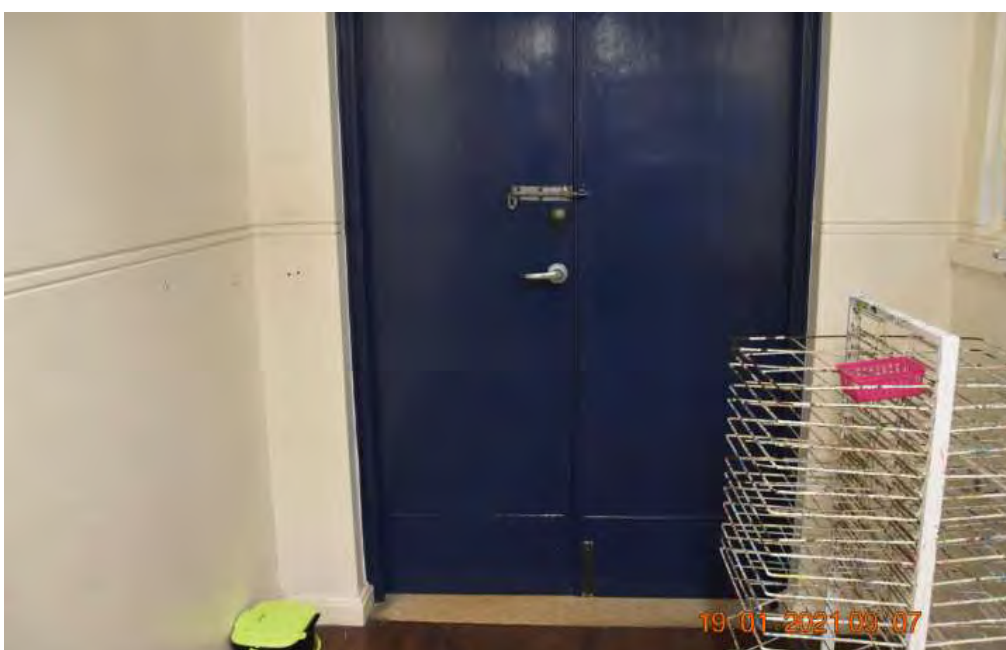
Figure: 0230

North wall in the ground floor corridor, outside cobalt k classroom.

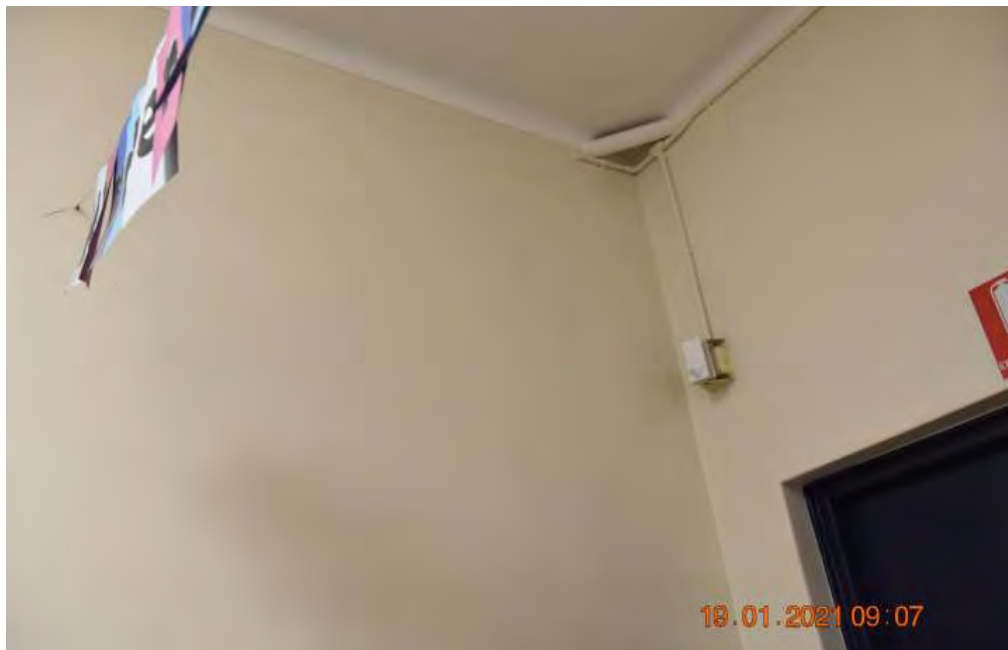
Figure: 0231

North wall in the ground floor corridor, outside cobalt k classroom.

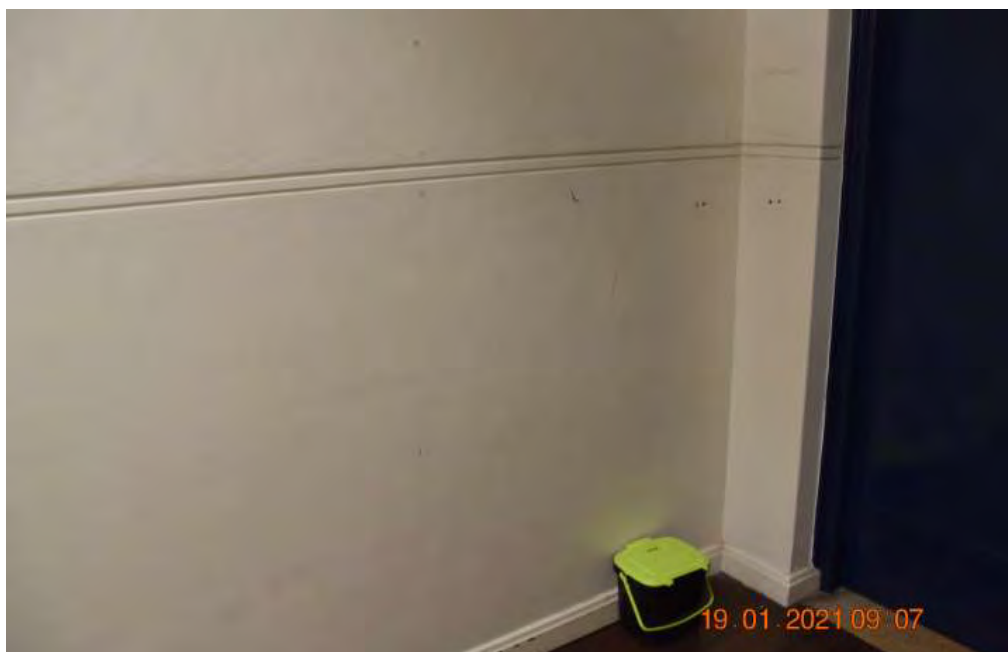
Figure: 0232

West wall in the ground floor corridor, outside cobalt k classroom.

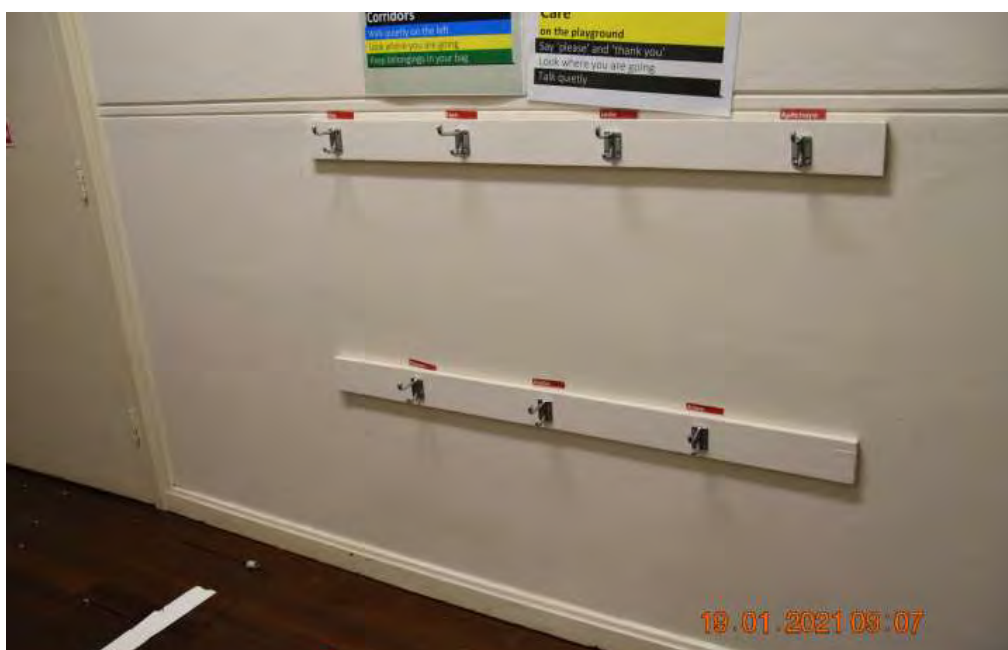
Figure: 0233

West wall in the ground floor corridor, outside cobalt k classroom.

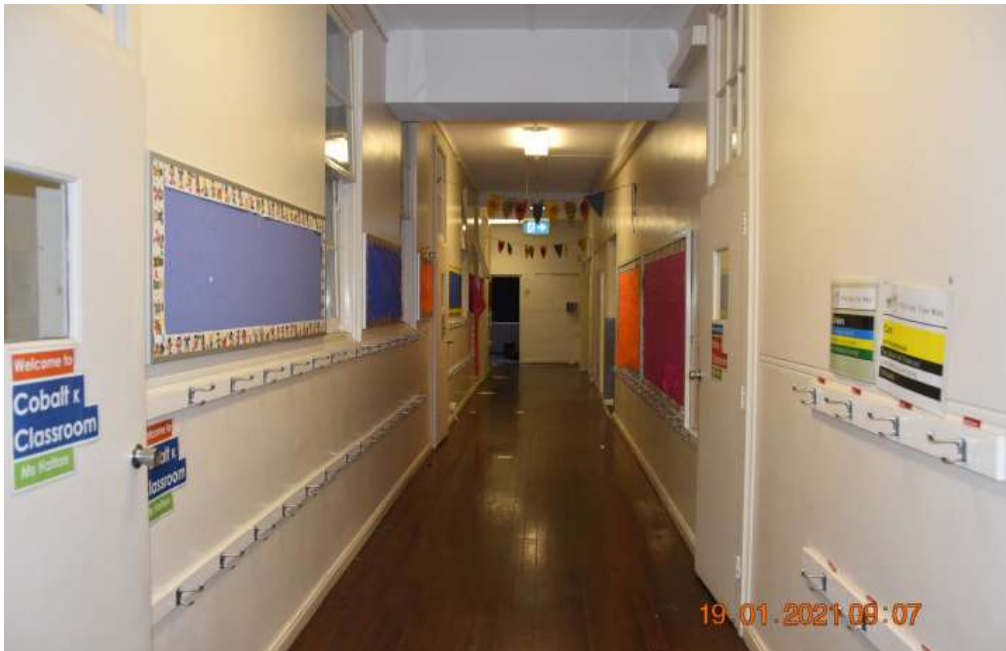
Figure: 0234

West wall in the ground floor corridor, outside cobalt k classroom.

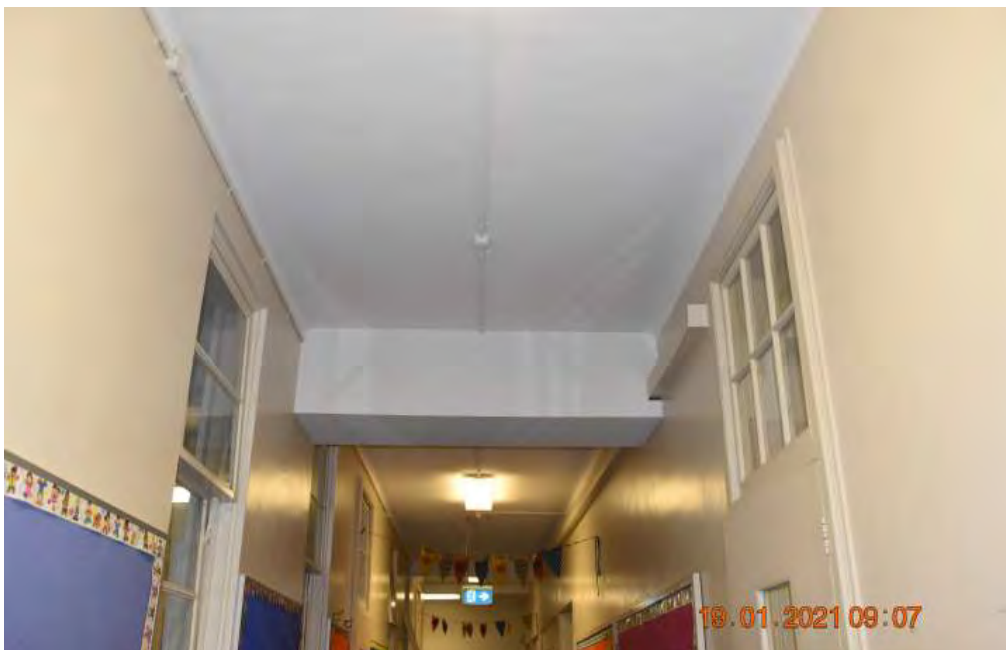
Figure: 0235

General view in the ground floor corridor, outside cobalt k classroom.

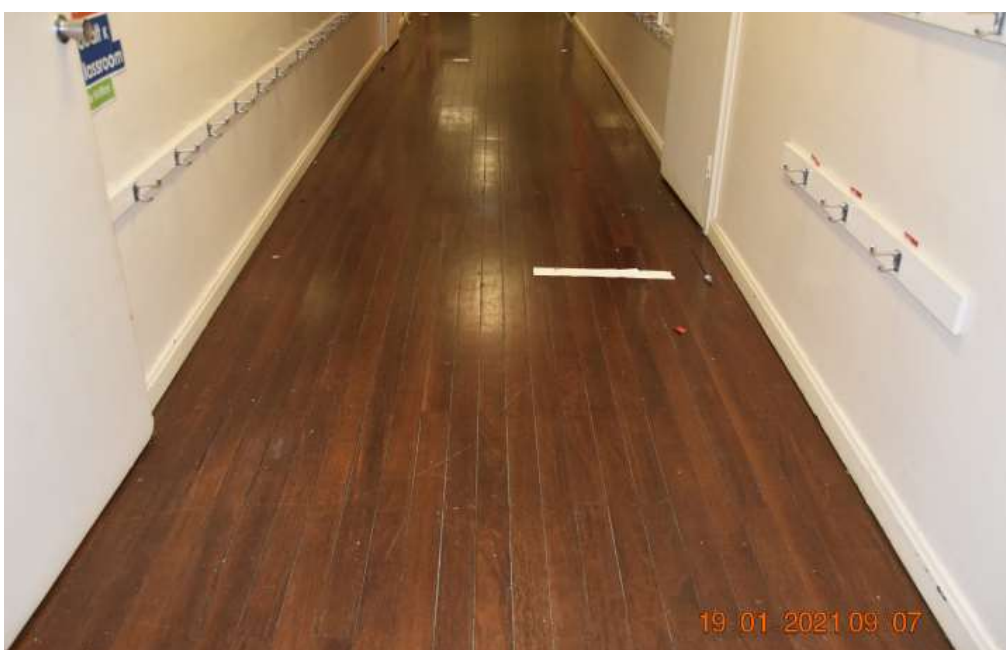
Figure: 0236

Ceiling in the ground floor corridor, outside cobalt k classroom.

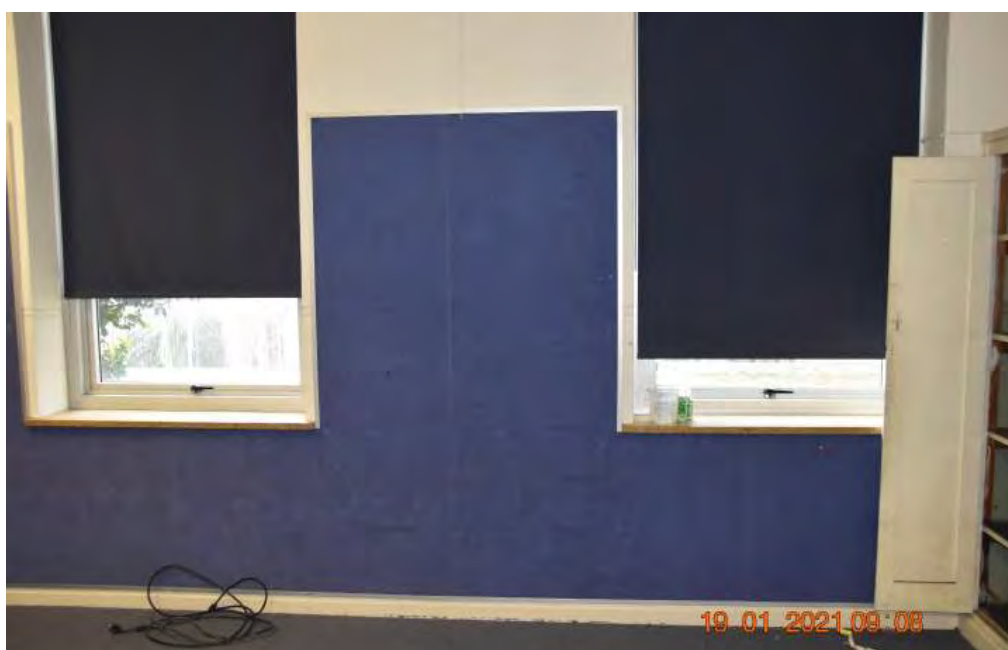
Figure: 0239

East wall in the aqua 1 classroom.

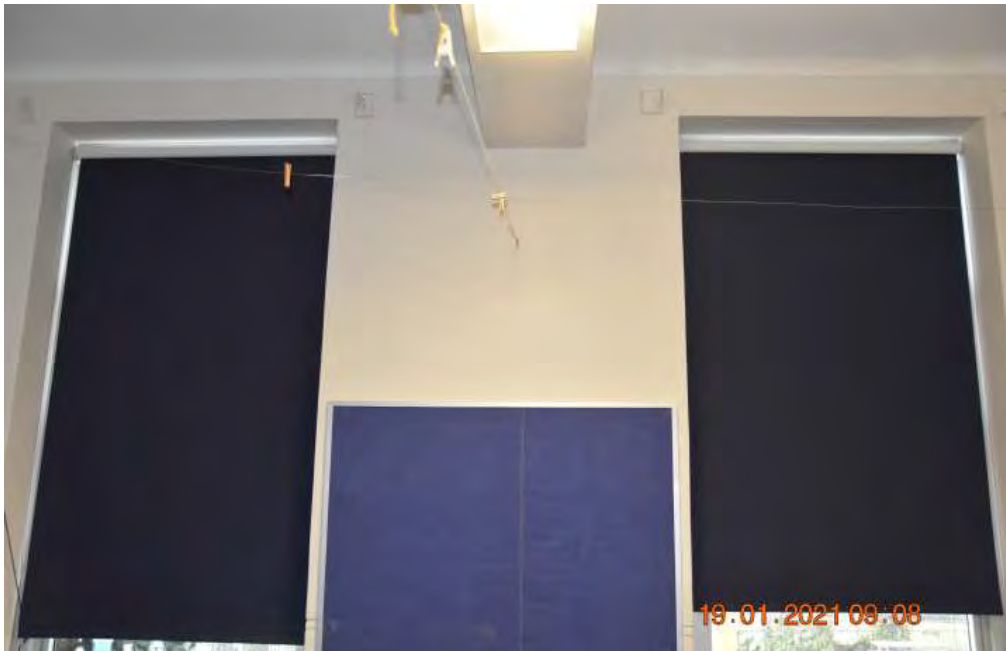
Figure: 0240

East wall in the aqua 1 classroom.

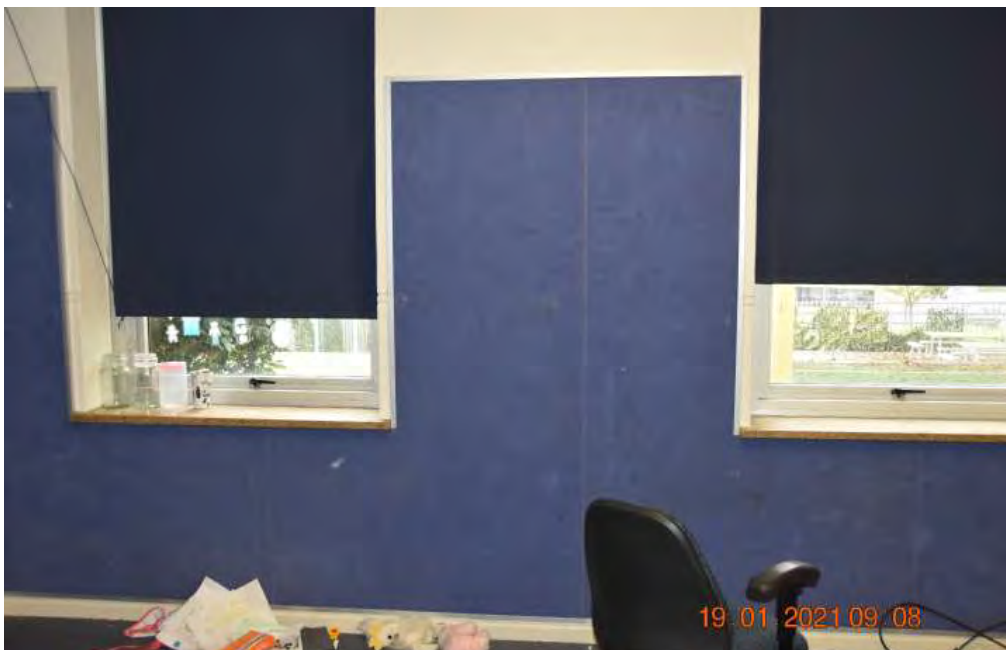
Figure: 0241

East wall in the aqua 1 classroom.

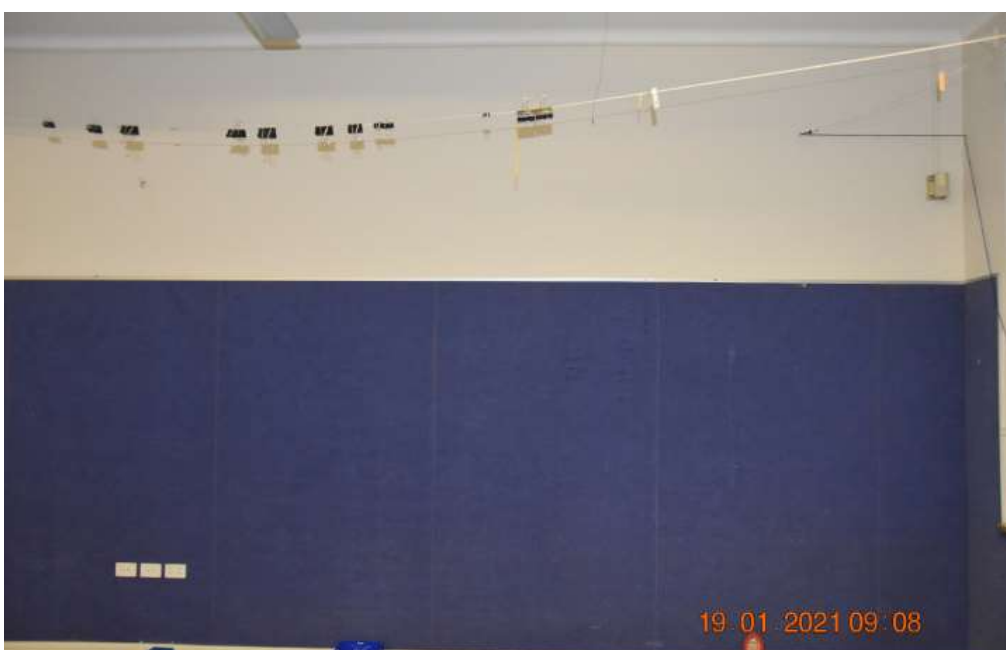
Figure: 0242

East wall in the aqua 1 classroom.

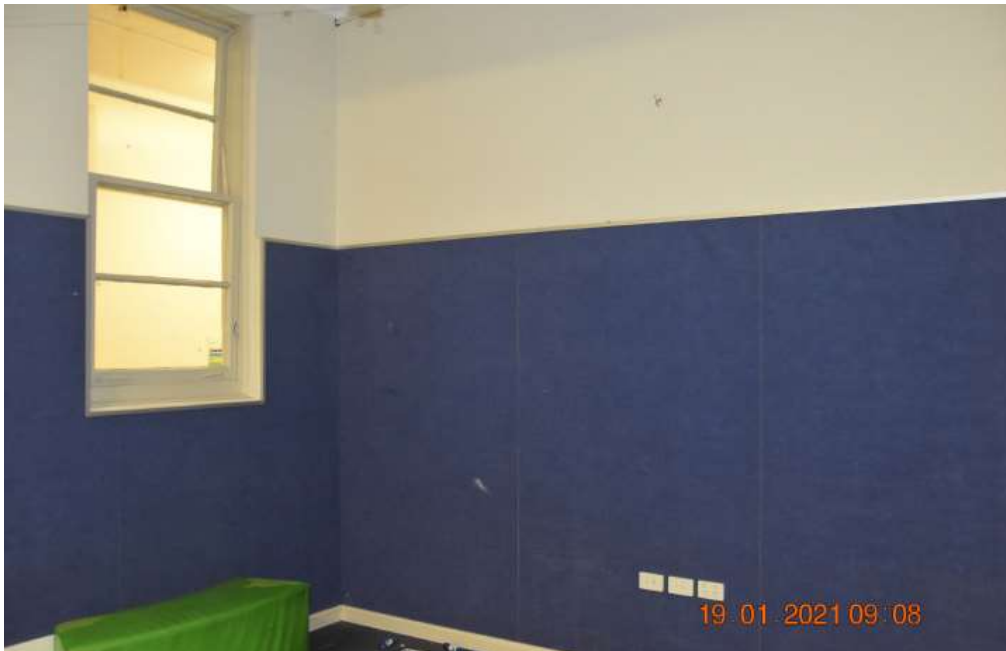
Figure: 0243

North wall in the aqua 1 classroom.

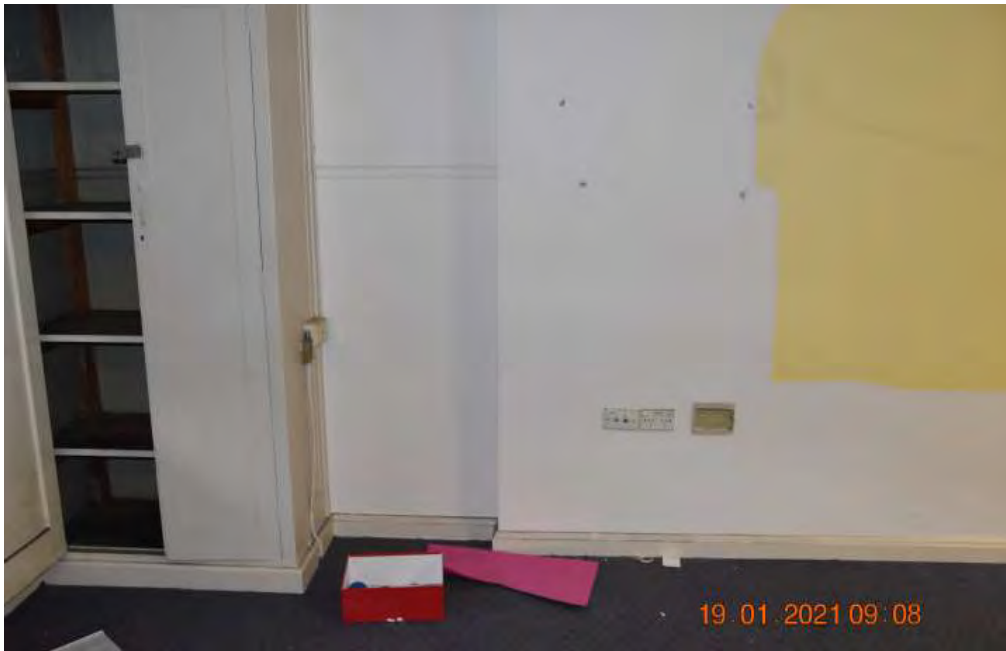
Figure: 0249

South wall in the aqua 1 classroom. Showing peeling paint and damage.

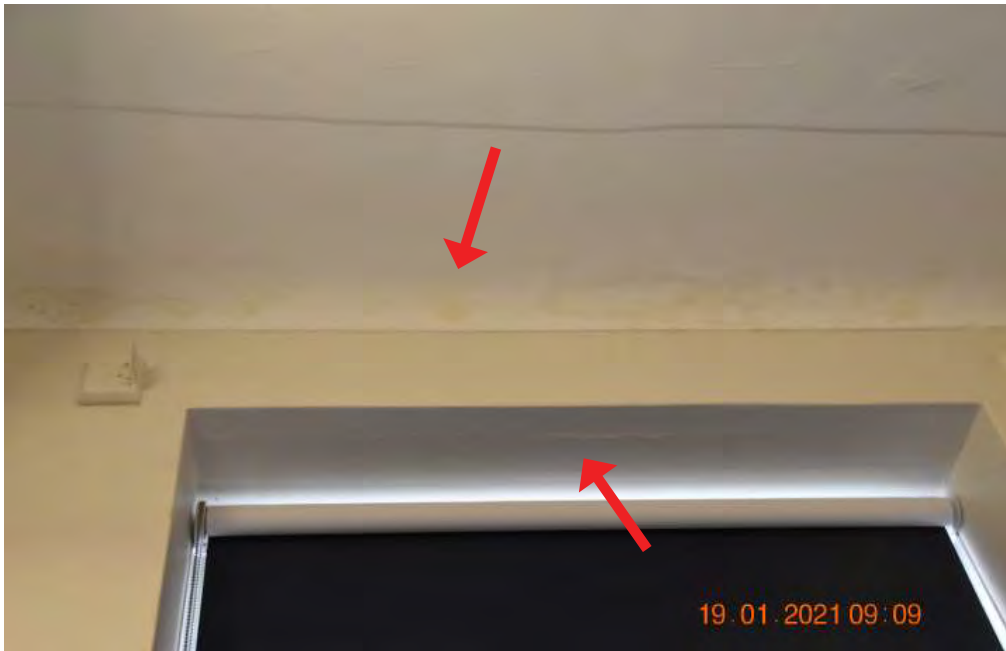
Figure: 0256

Water damage in the east wall in the aqua 1 classroom. Also showing cracking.

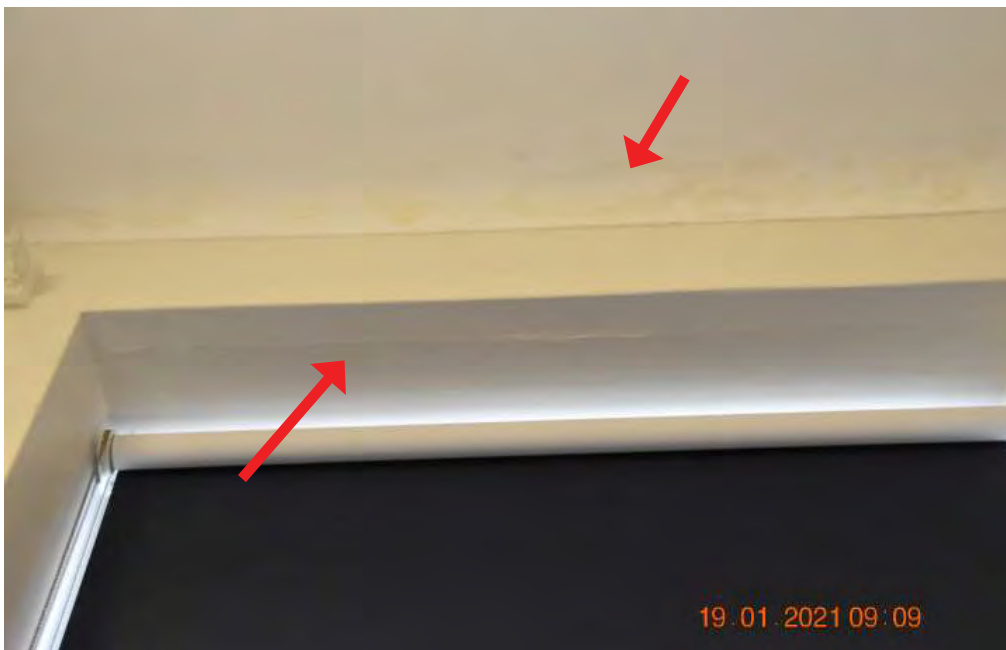
Figure: 0257

Cracking above the window in the south wall in the aqua 1 classroom. Also showing water damage.

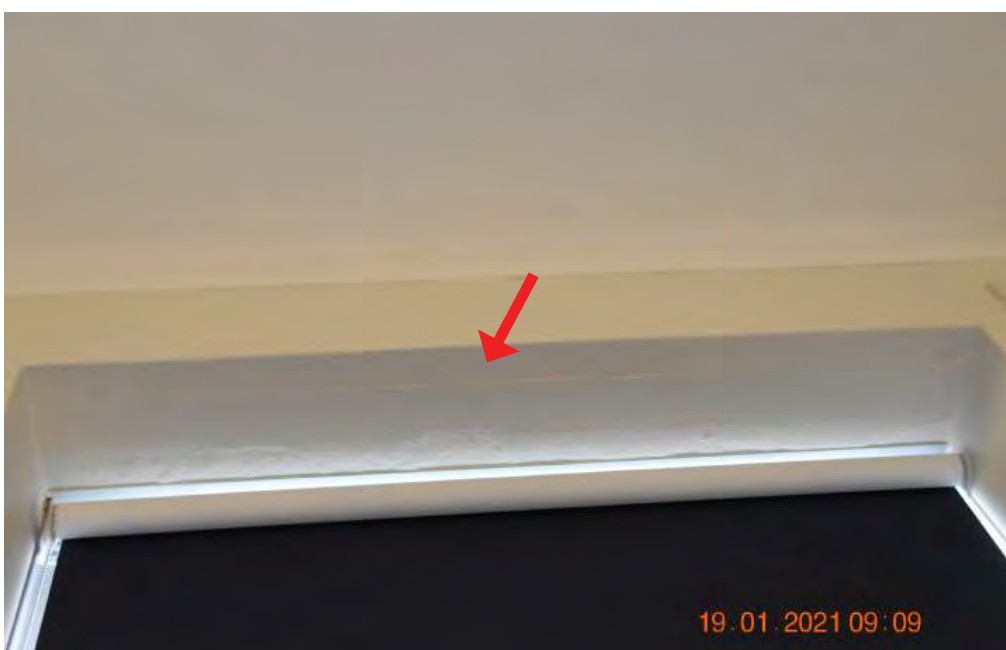
Figure: 0258

Cracking above the window in the south wall in the aqua 1 classroom.

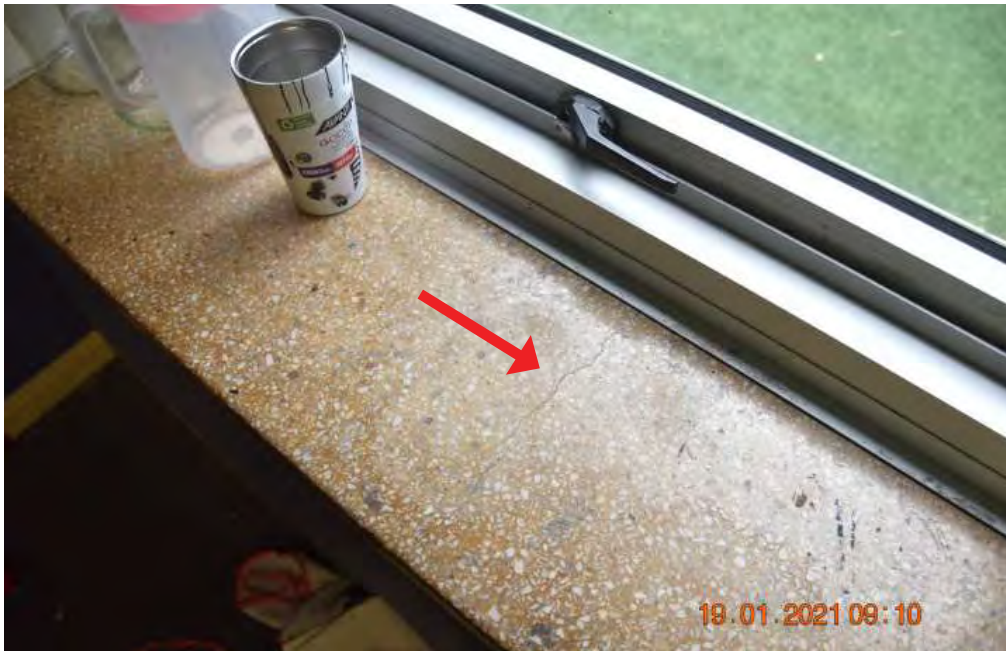
Figure: 0259

Fine cracking in the window sill in the south wall in the aqua 1 classroom.

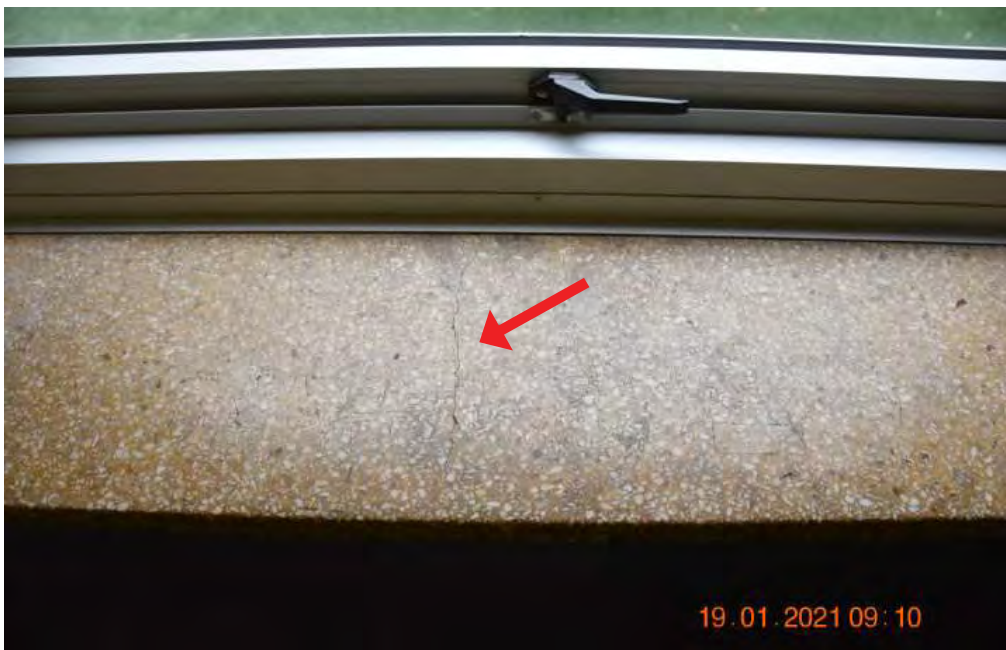
Figure: 0260

Fine cracking in the window sill in the south wall in the aqua 1 classroom.

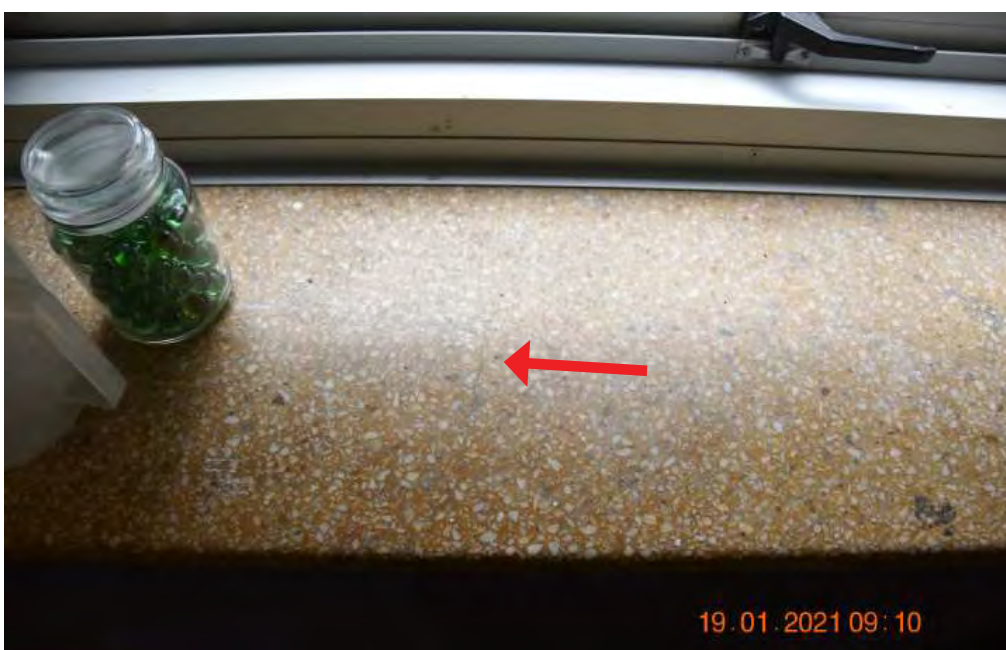
Figure: 0261

Fine cracking in the window sill in the south wall in the aqua 1 classroom.

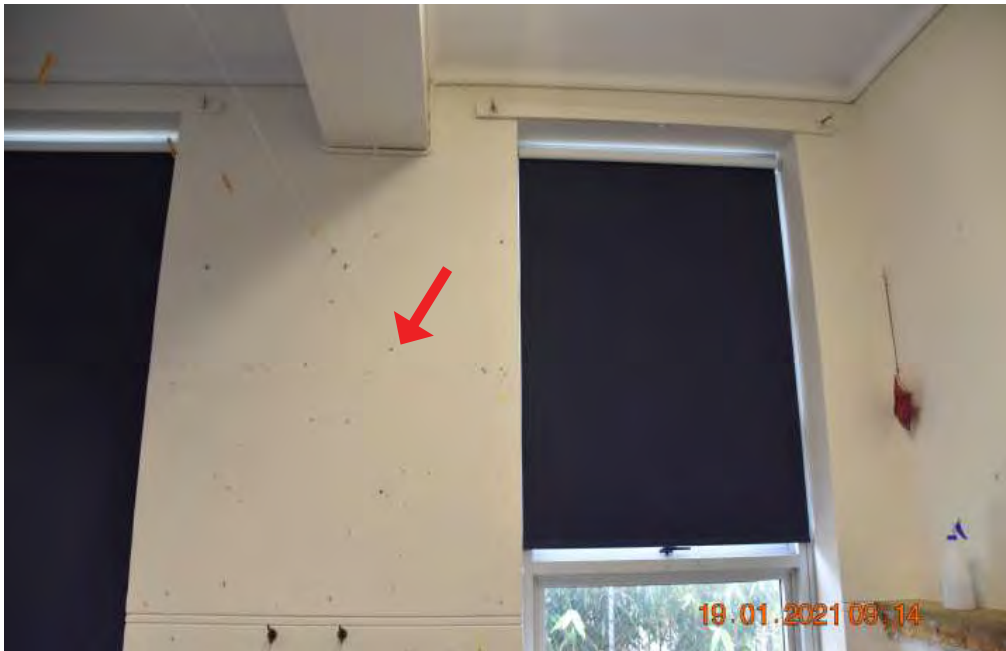
Figure: 0282

East wall in the entrance to ruby k classroom. Showing nailing marks and hole.

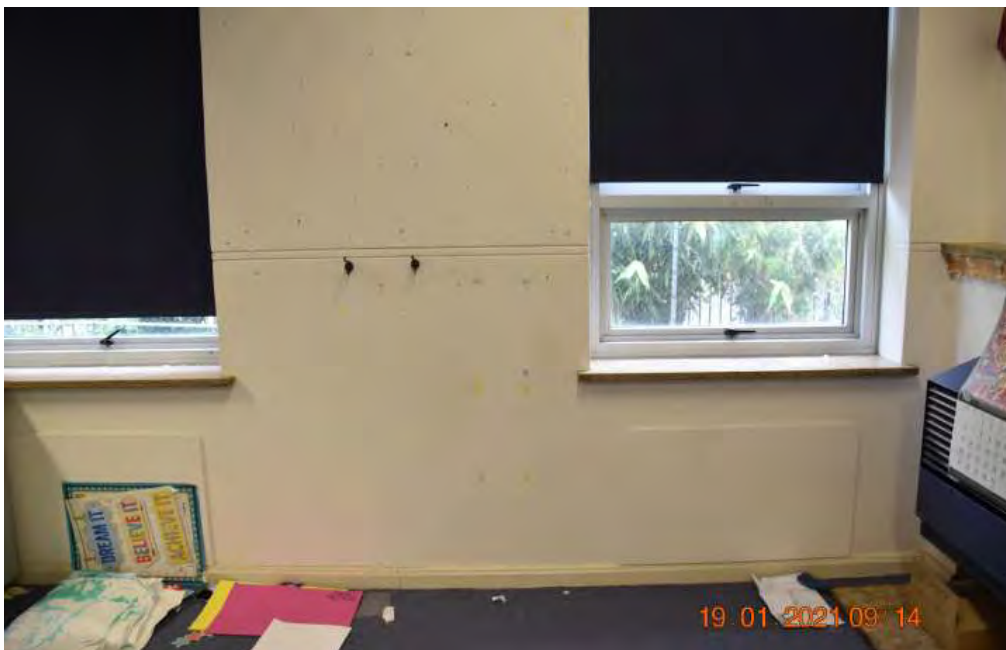
Figure: 0283

North wall in the entrance to ruby k classroom. Showing nailing marks.

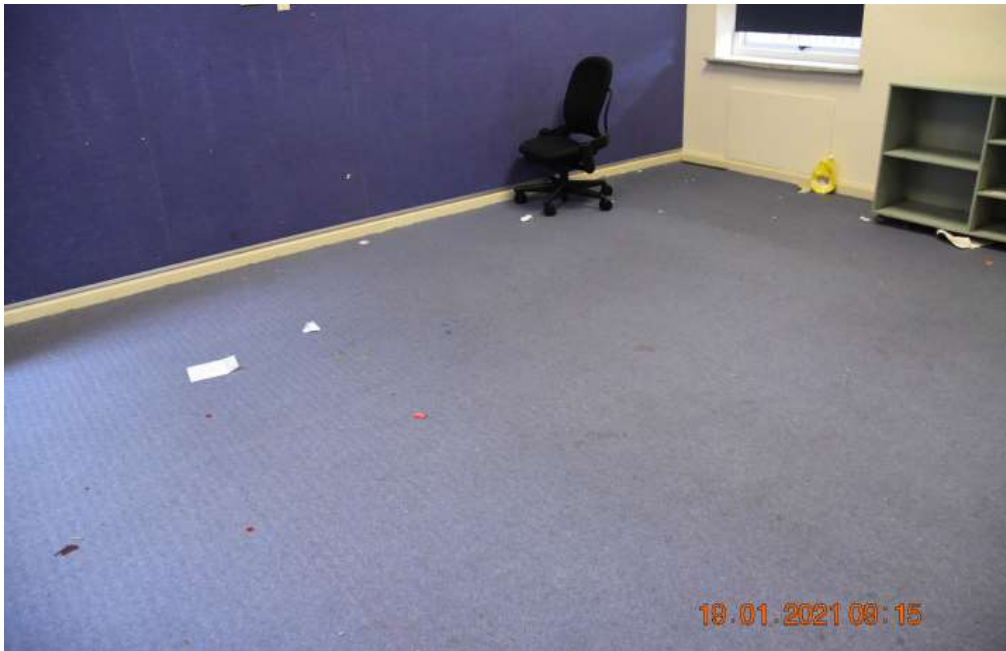
Figure: 0291

Flooring in the entrance to ruby k classroom. Showing staining.

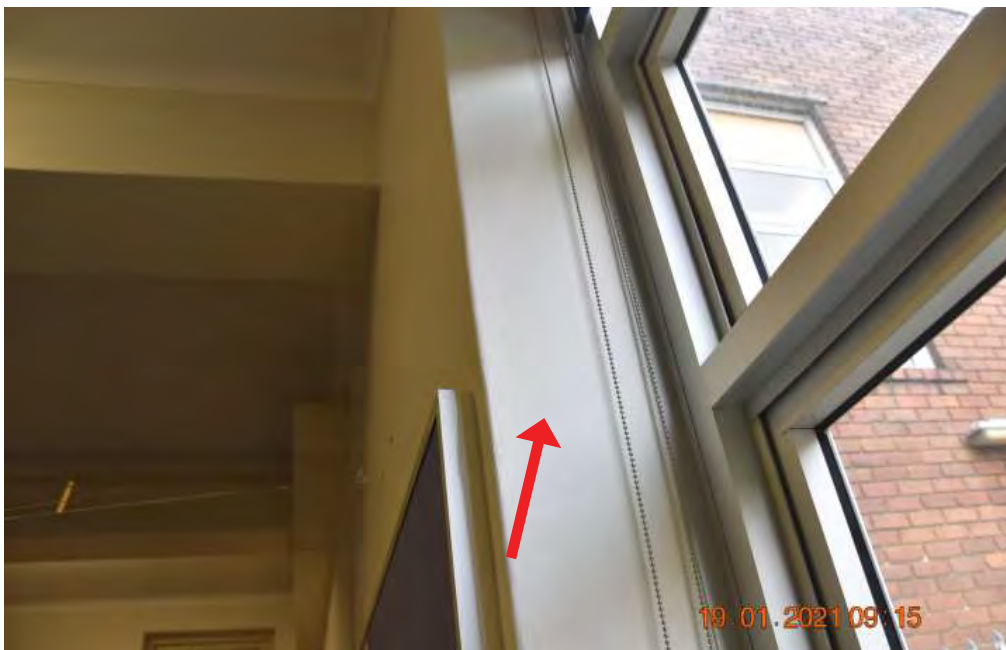
Figure: 0295

Fine cracking in the window sill in the southwest corner in the entrance to ruby k classroom.

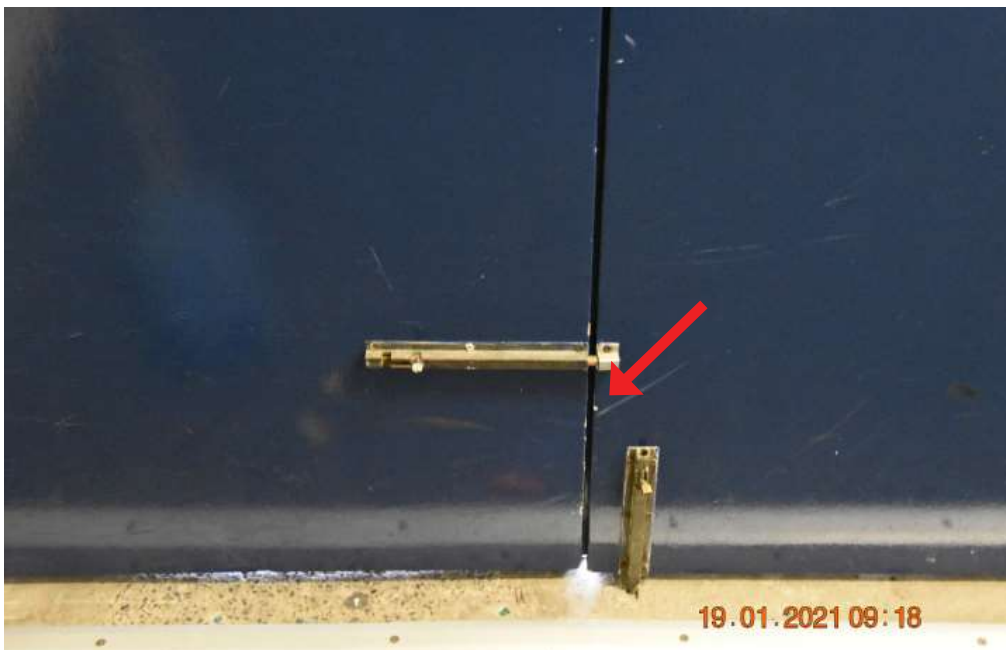
Figure: 0304

Damage in the door  
in the west wall in the  
west entrance.

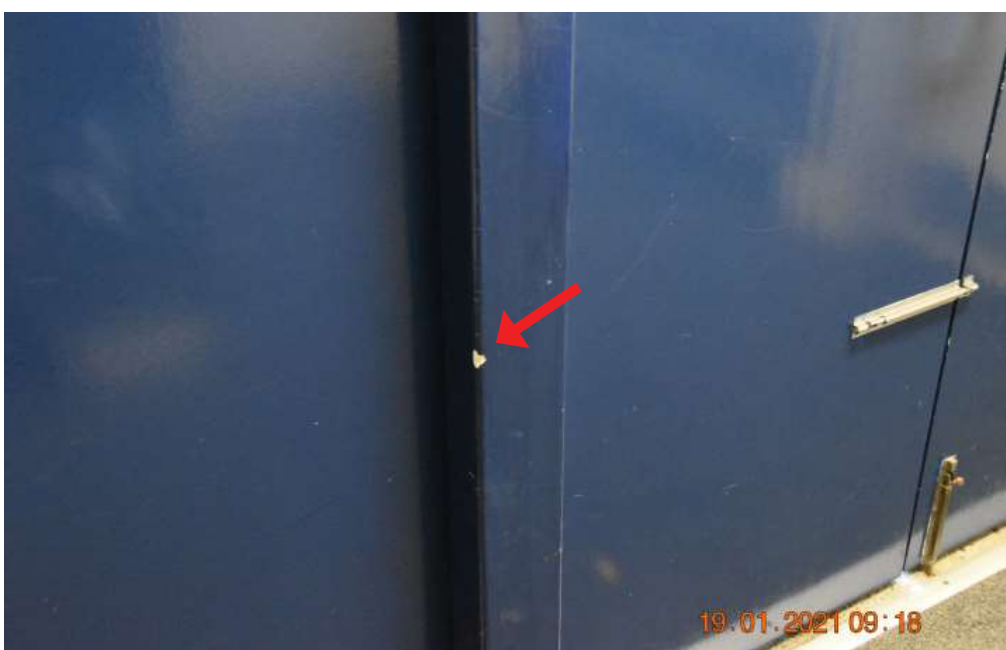
Figure: 0305

Chipping in the door  
in the west wall in the  
west entrance.

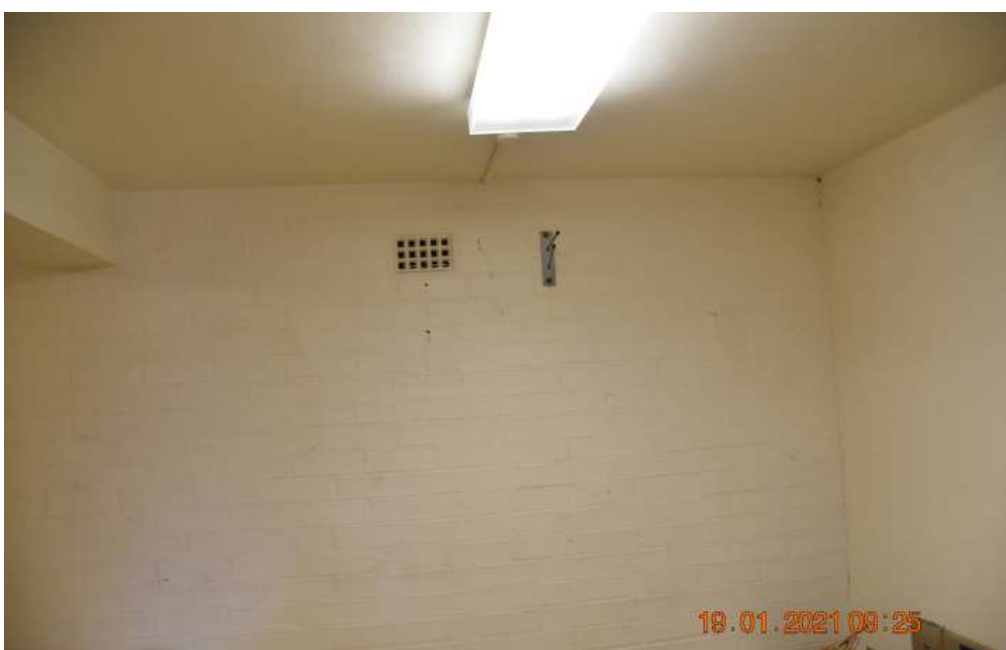
Figure: 0326

East wall in the  
storeroom.

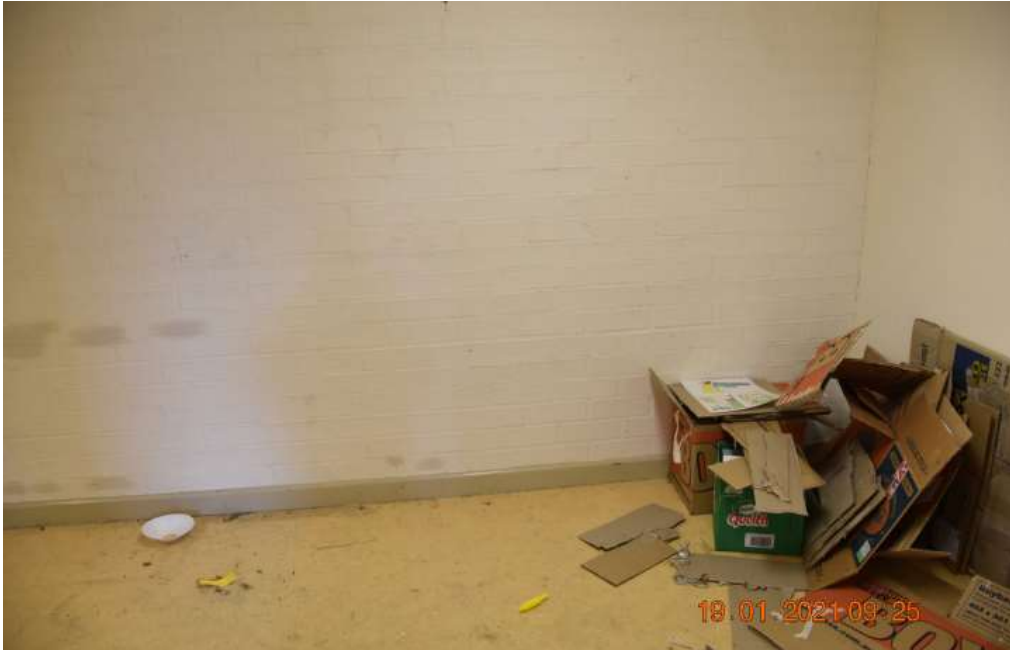
Figure: 0328

North wall in the storeroom.
