## PRE CONSTRUCTION CONDITION SURVEY

Fort Street Public School, Millers Point NSW

Upper Fort Street Public School  
MILLERS POINT NSW 2000

19 January 2021

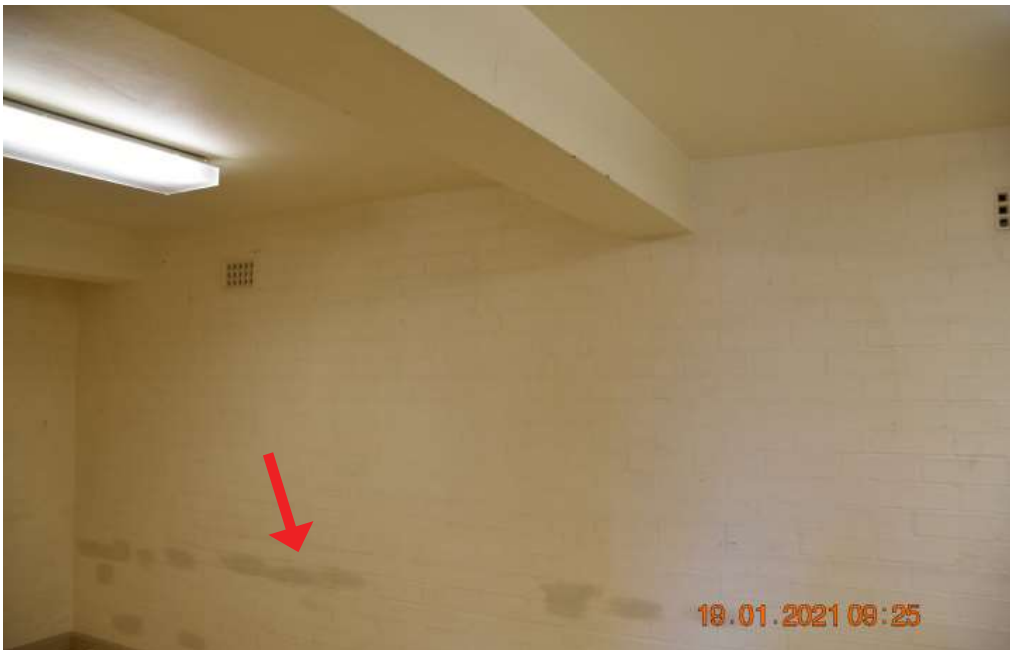
Figure: 0329

North wall in the storeroom. Showing patching.

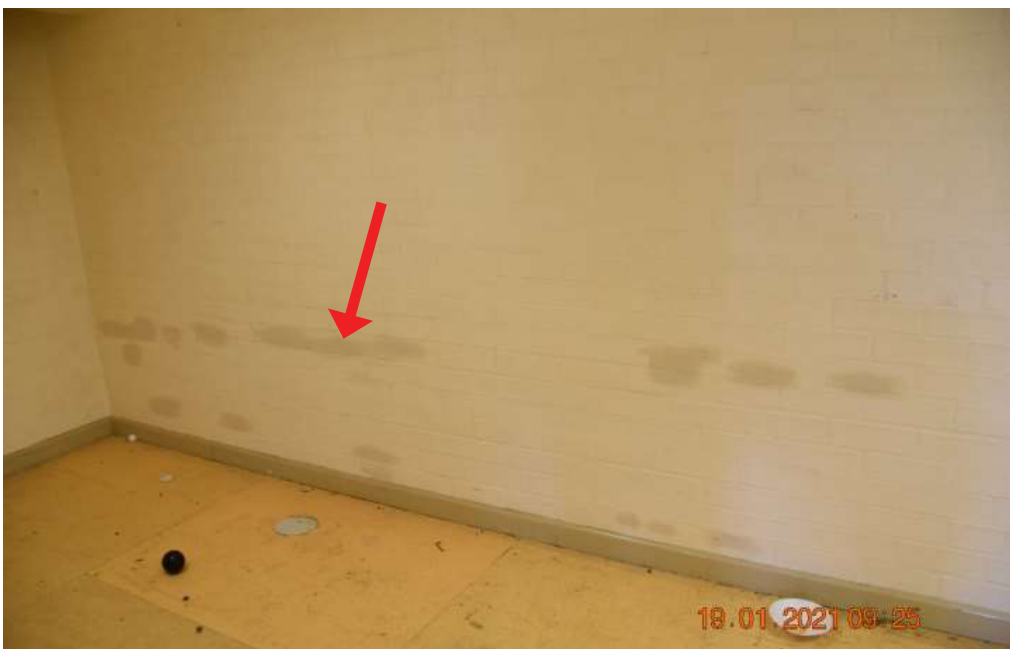
Figure: 0330

North wall in the storeroom. Showing patching.

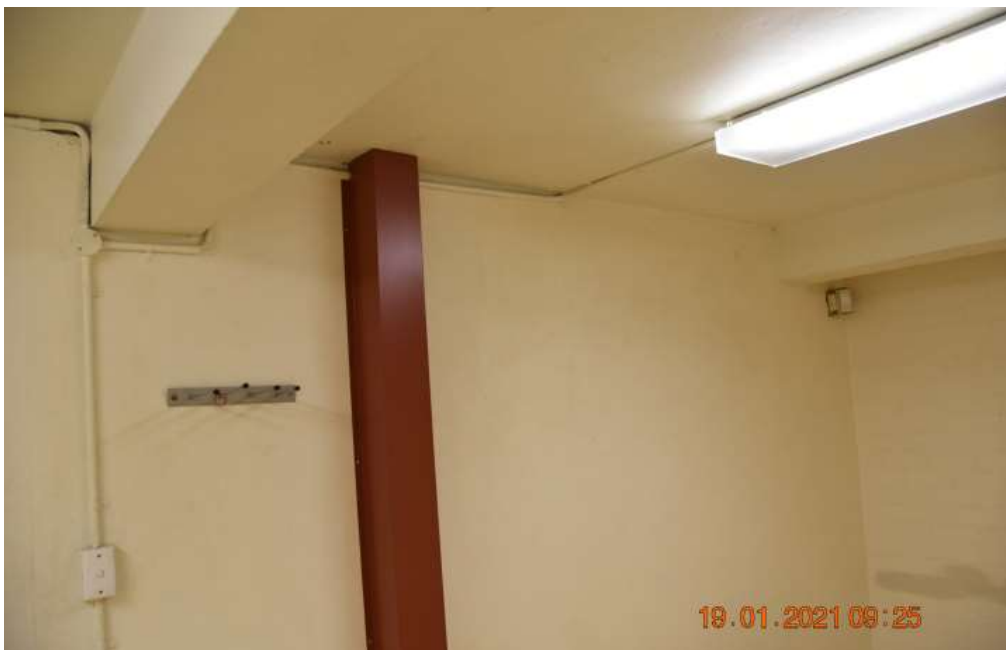
Figure: 0331

West wall in the storeroom. Showing patching.

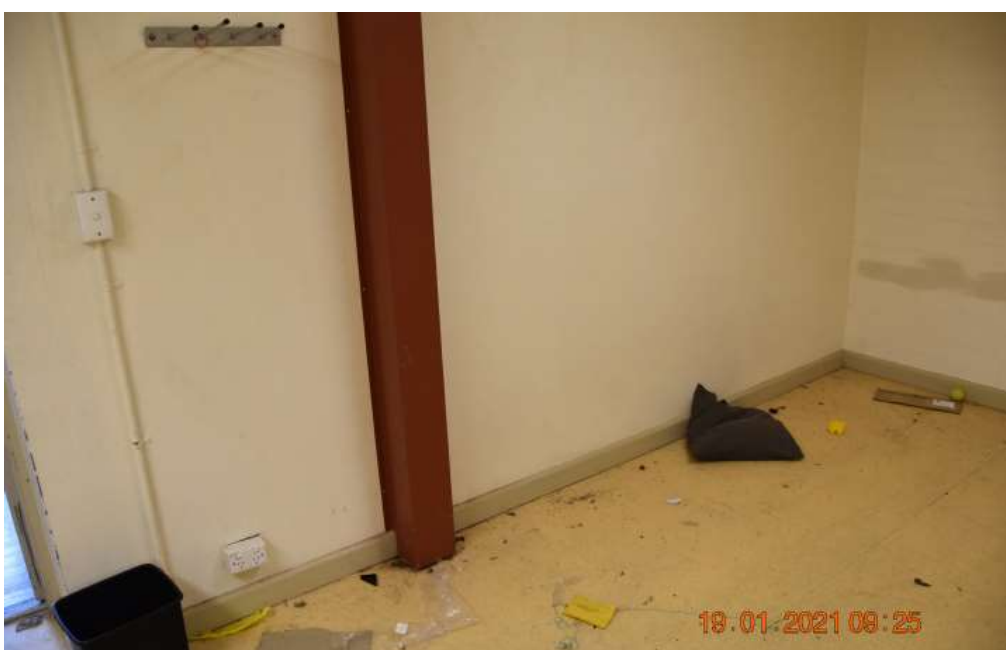
Figure: 0332

South wall in the storeroom.

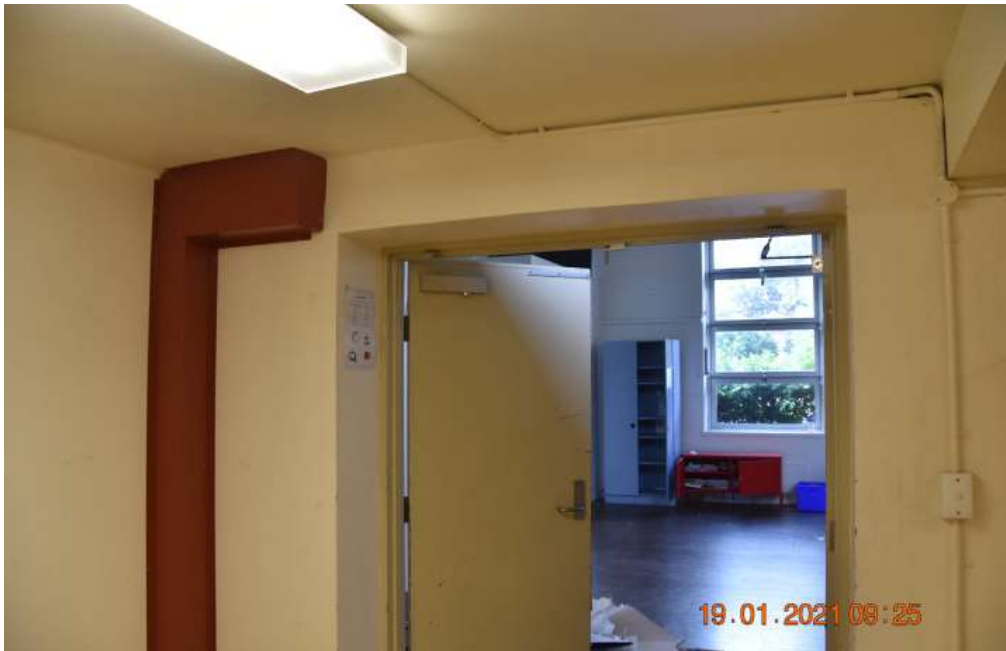
Figure: 0333

South wall in the storeroom.

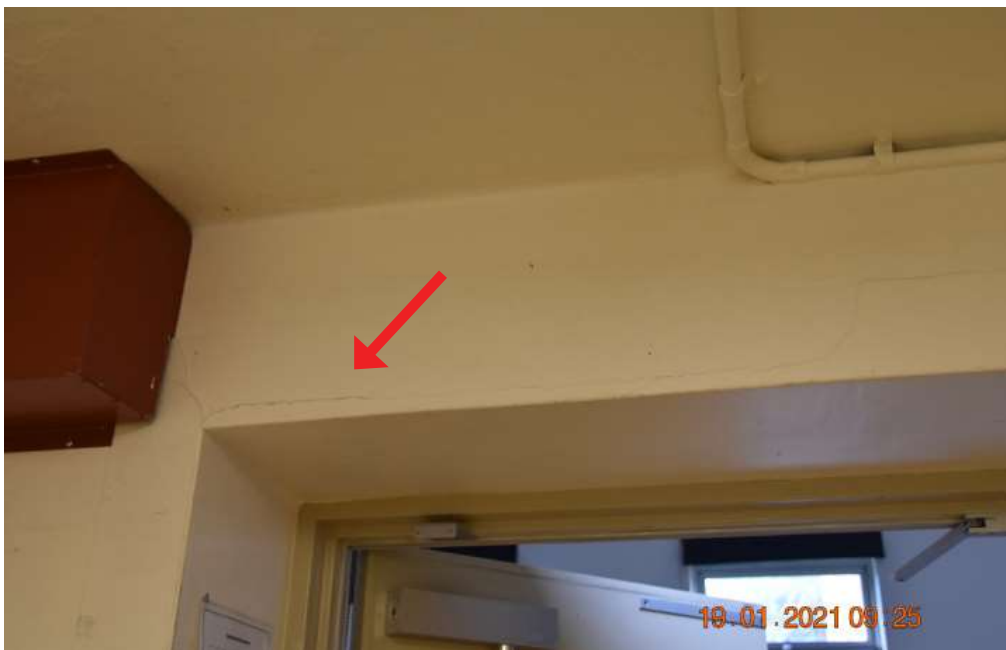
Figure: 0334

South wall in the storeroom.

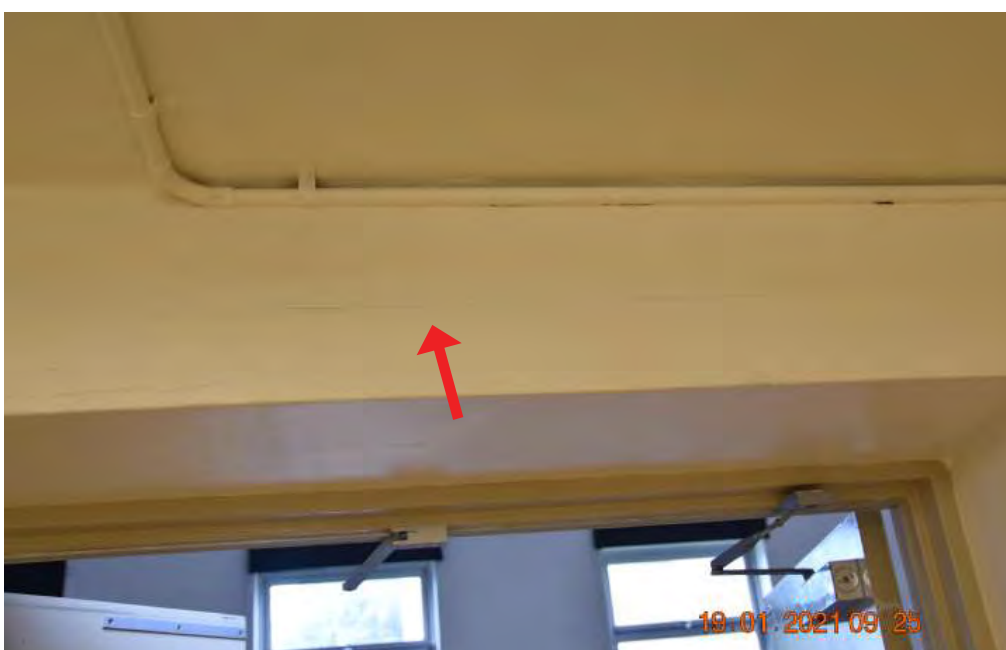
Figure: 0335

Fine cracking above the door in the south wall in the storeroom.

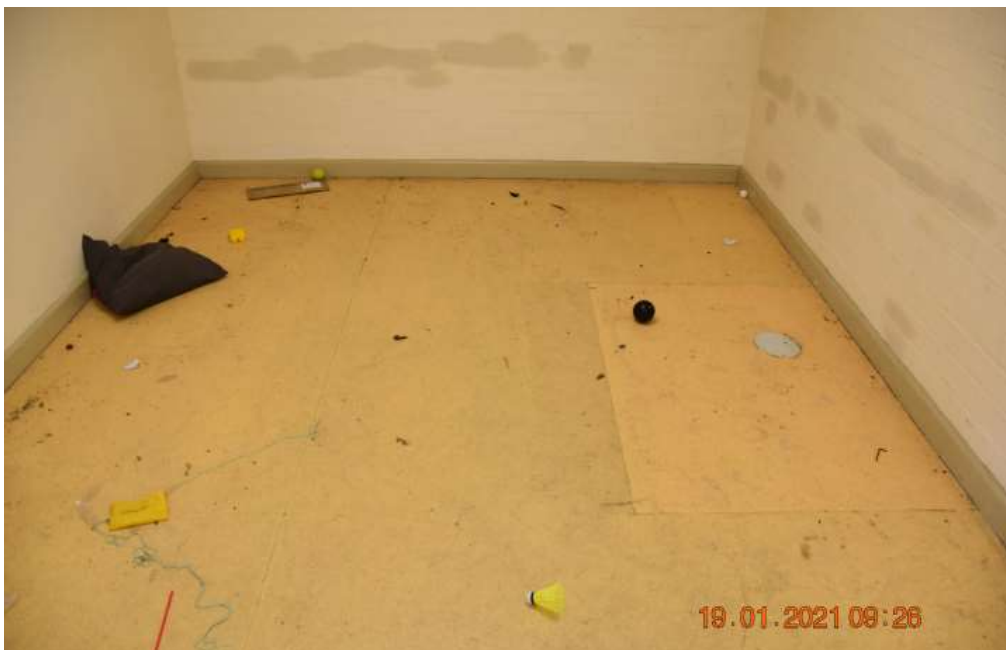
Figure: 0337

Flooring in the storeroom.

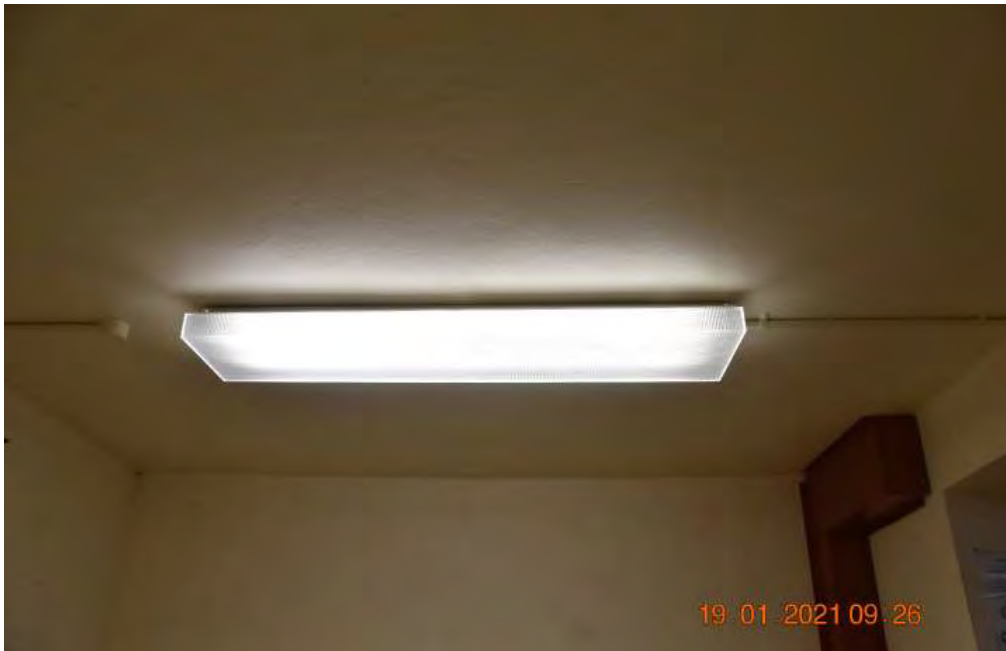
Figure: 0339

Ceiling in the storeroom.

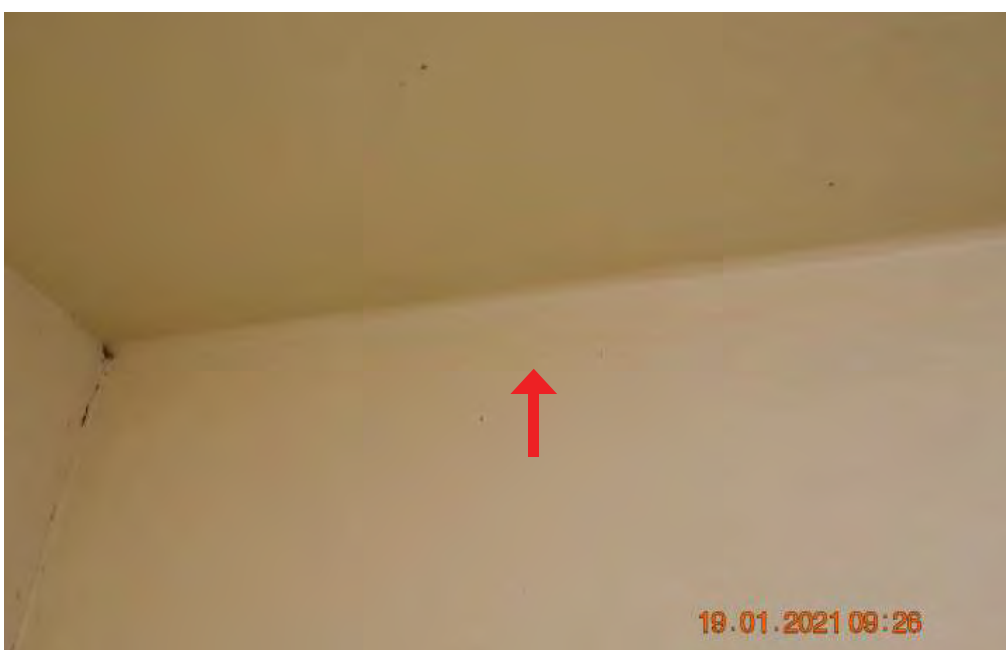
Figure: 0341

Patching in the ceiling in the storeroom, east side.

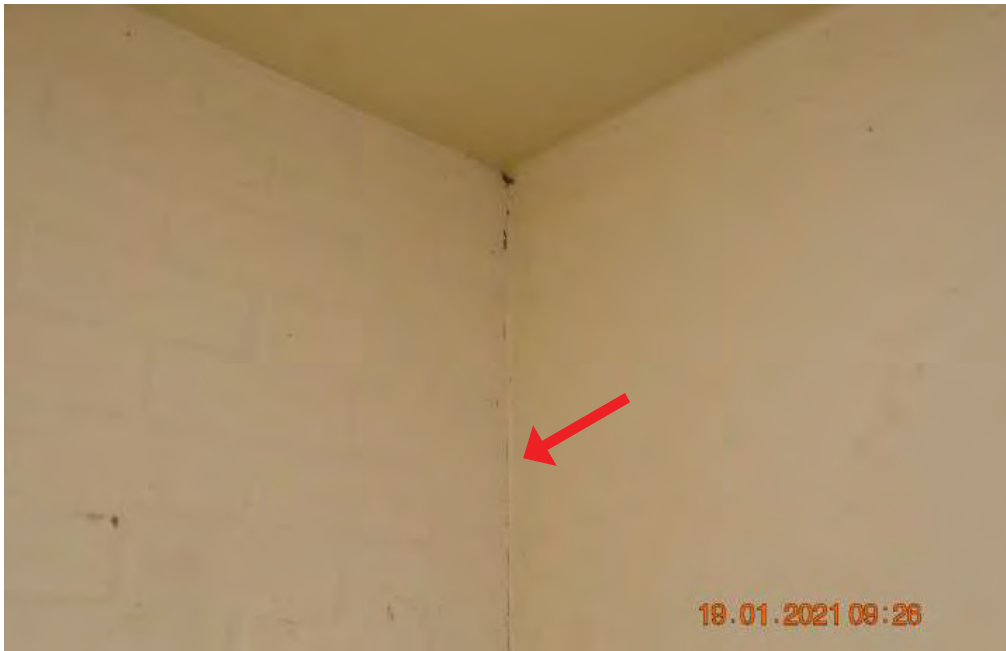
Figure: 0342

Fine cracking in the east wall in the storeroom, north side.

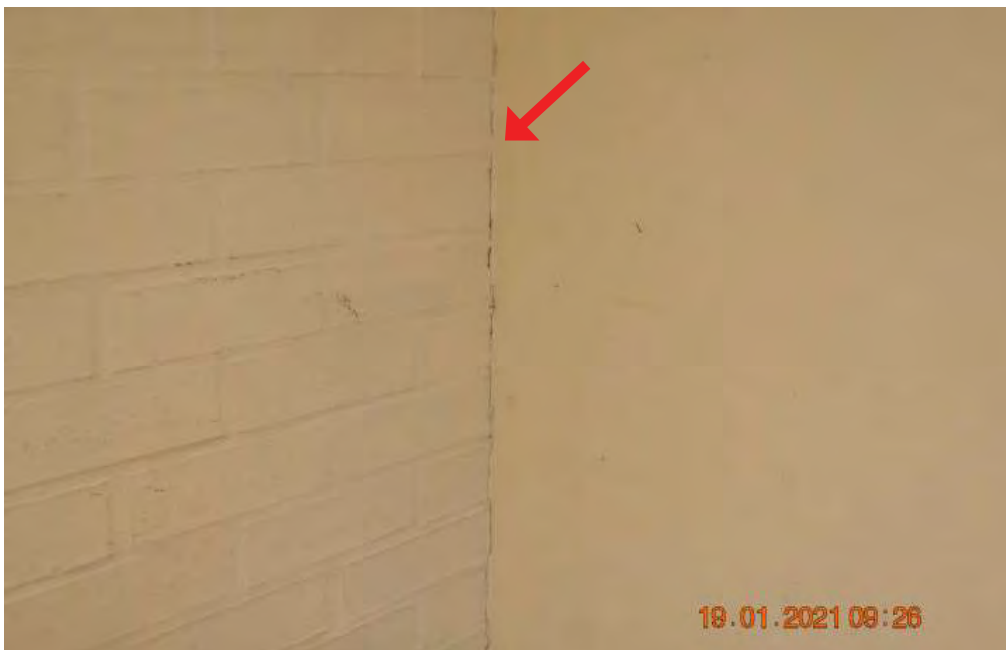
Figure: 0343

Separation in the northeast corner in the storeroom.

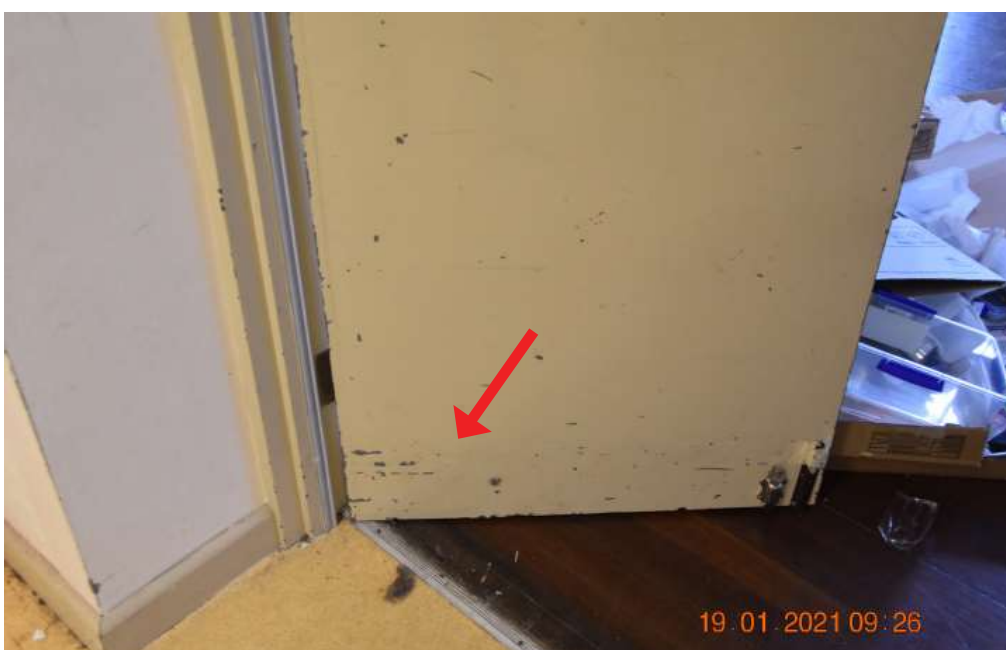
Figure: 0344

Separation in the northeast corner in the storeroom.

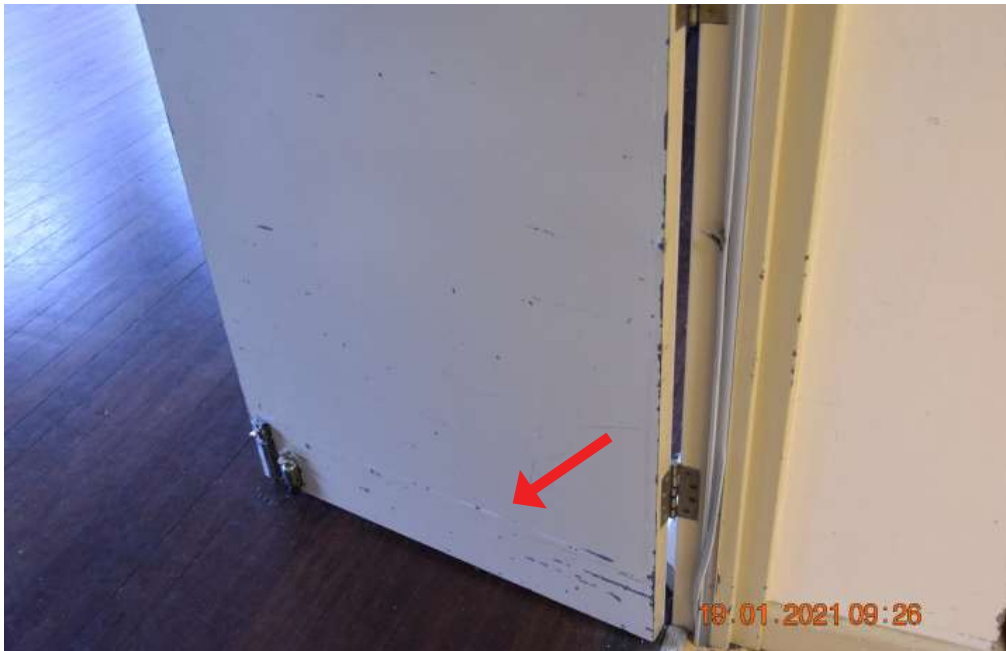
Figure: 0345

Scratching in the door in the storeroom.

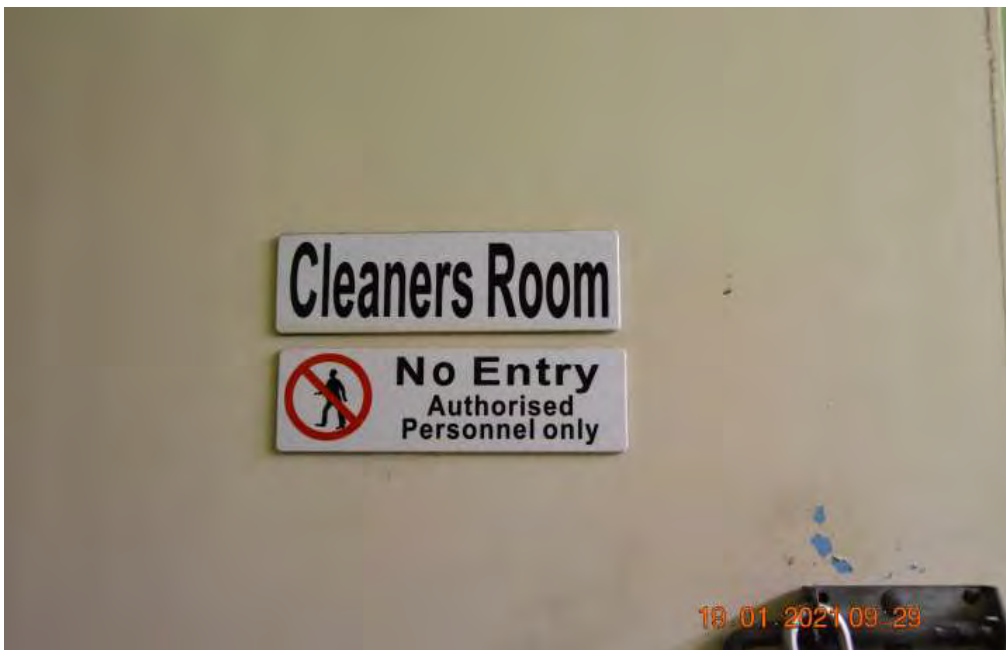
Figure: 0346

Scratching in the door in the storeroom.

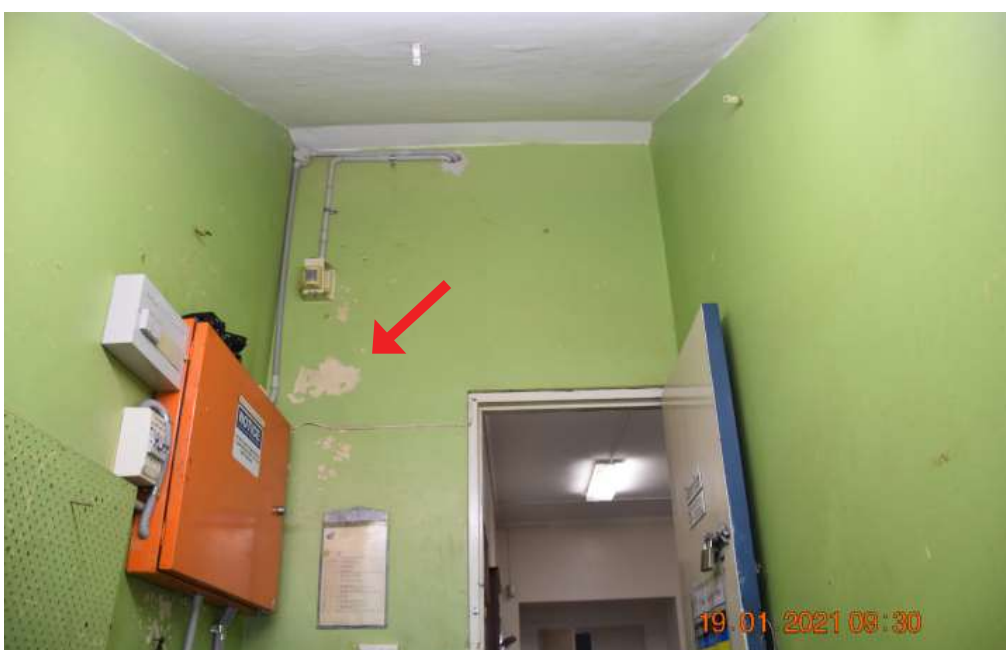
Figure: 0347

General view of the entrance to the cleaners room.

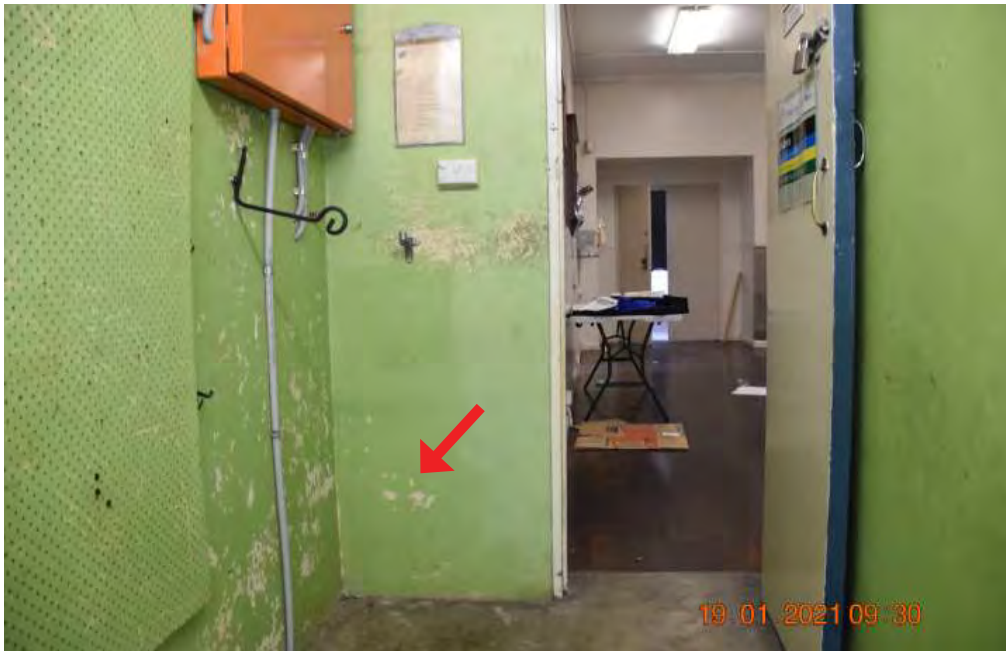
Figure: 0348

West wall in the cleaners room. Showing peeling paint.

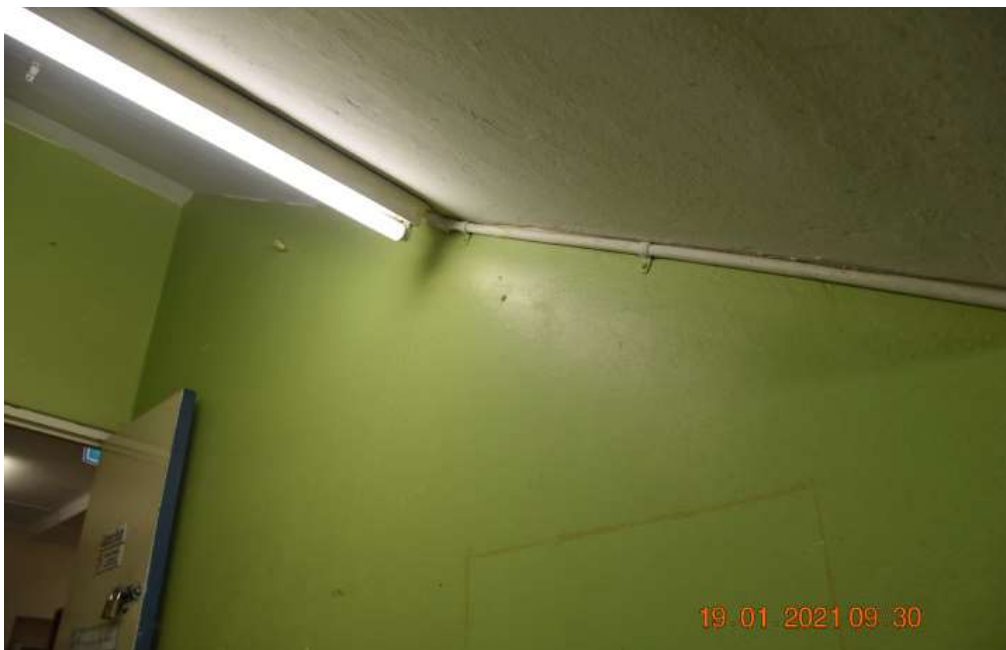
Figure: 0349

West wall in the cleaners room. Showing peeling paint.

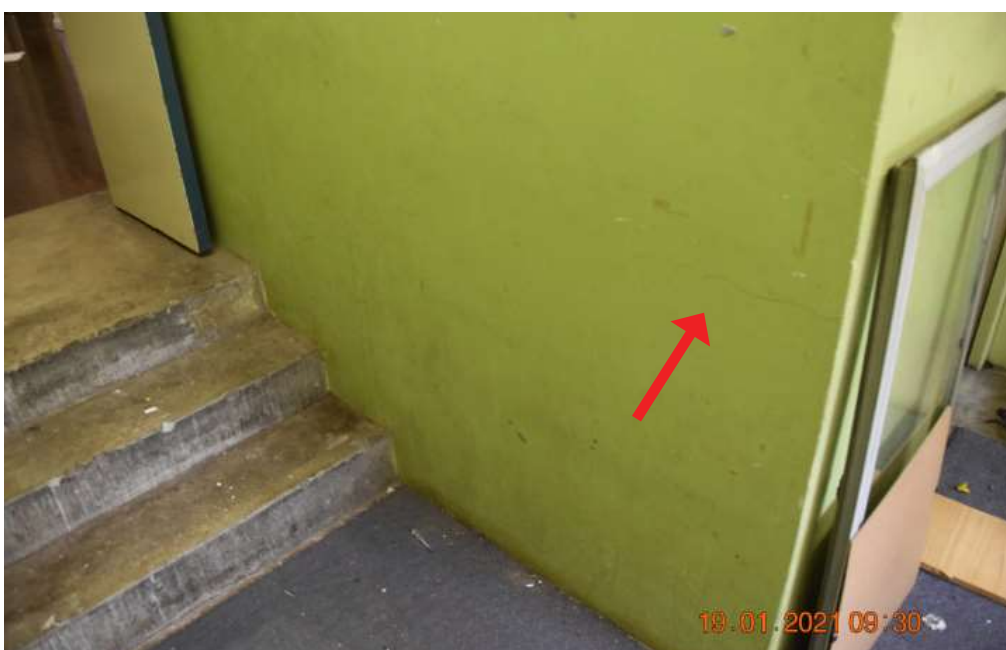
Figure: 0350

North wall in the cleaners room.

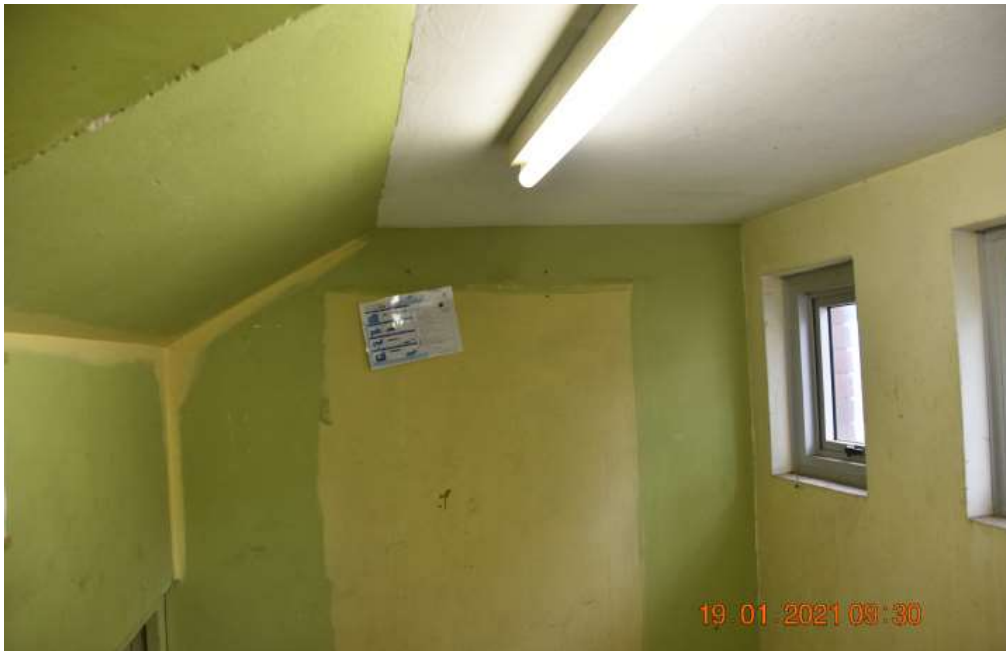
Figure: 0351

North wall in the cleaners room. Showing cracking.

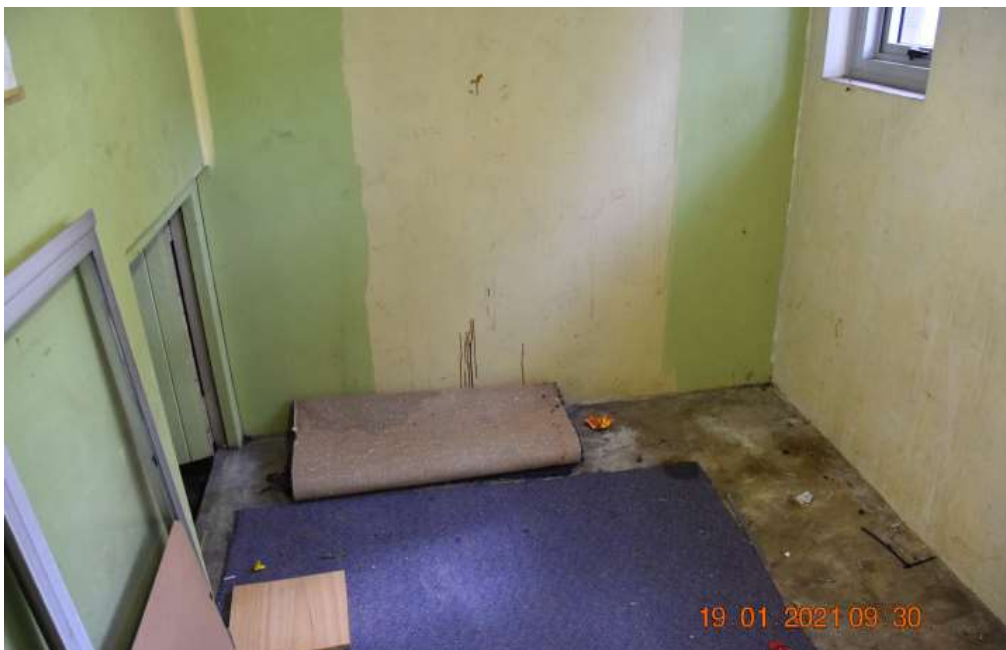
Figure: 0352

North wall in the  
cleaners room.

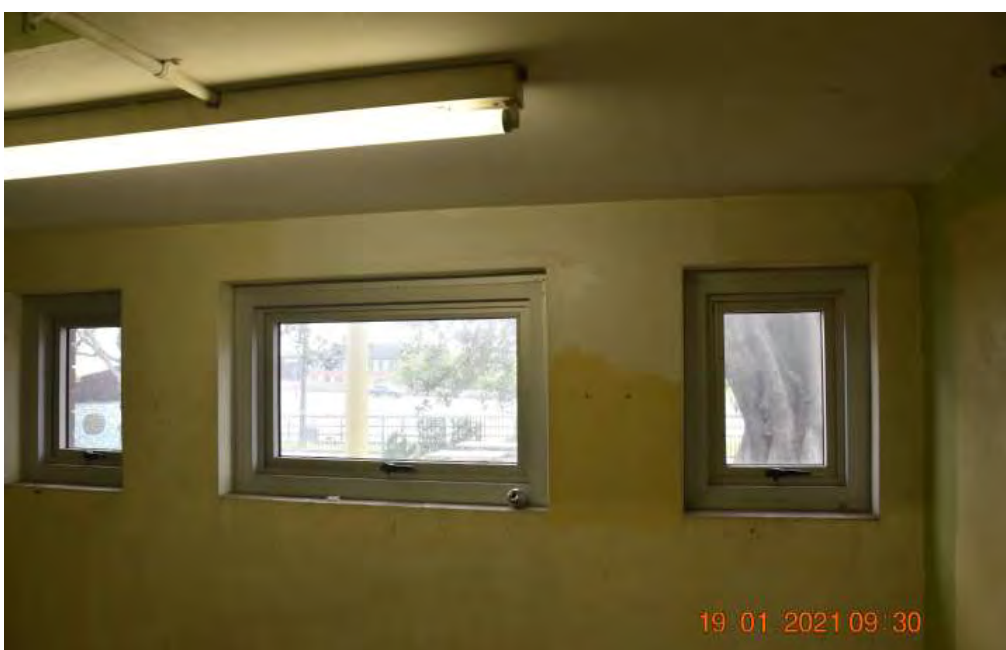
Figure: 0353

North wall in the  
cleaners room.

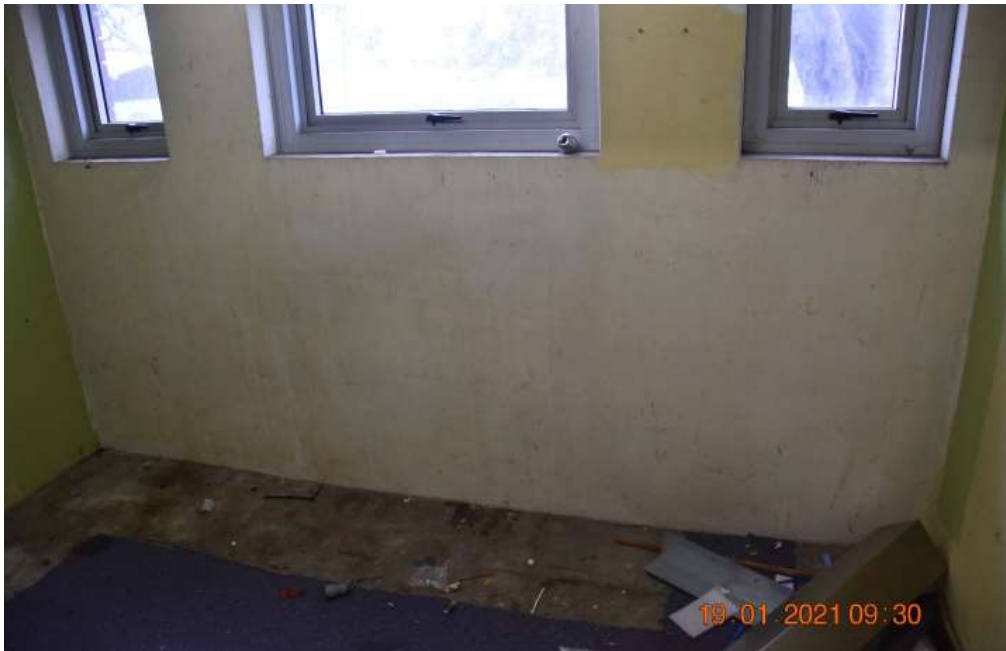
Figure: 0354

East wall in the  
cleaners room.

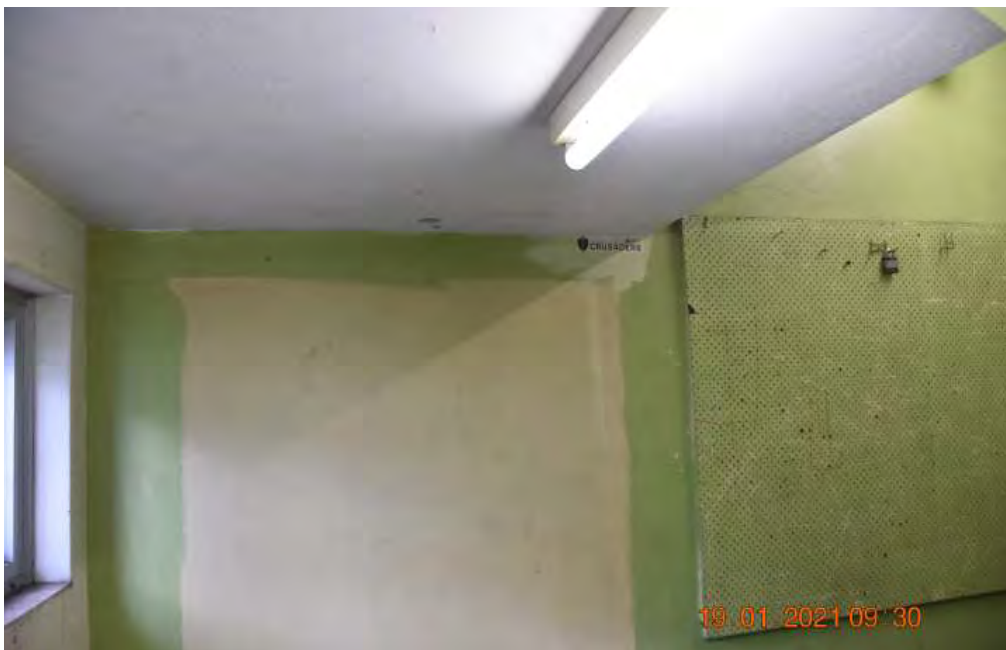
Figure: 0355

East wall in the  
cleaners room.

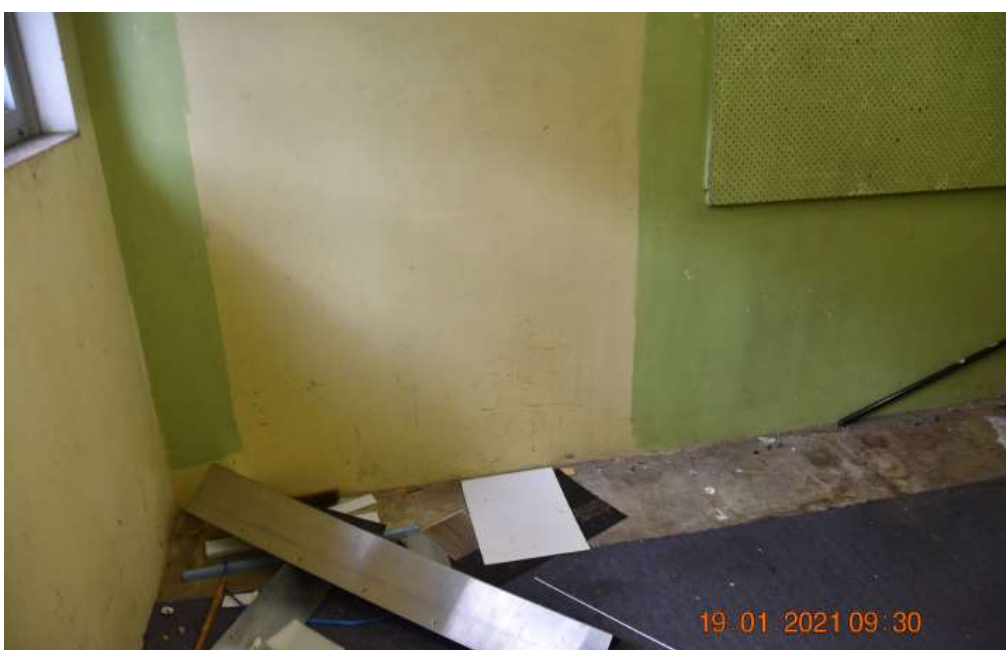
Figure: 0356

South wall in the  
cleaners room.

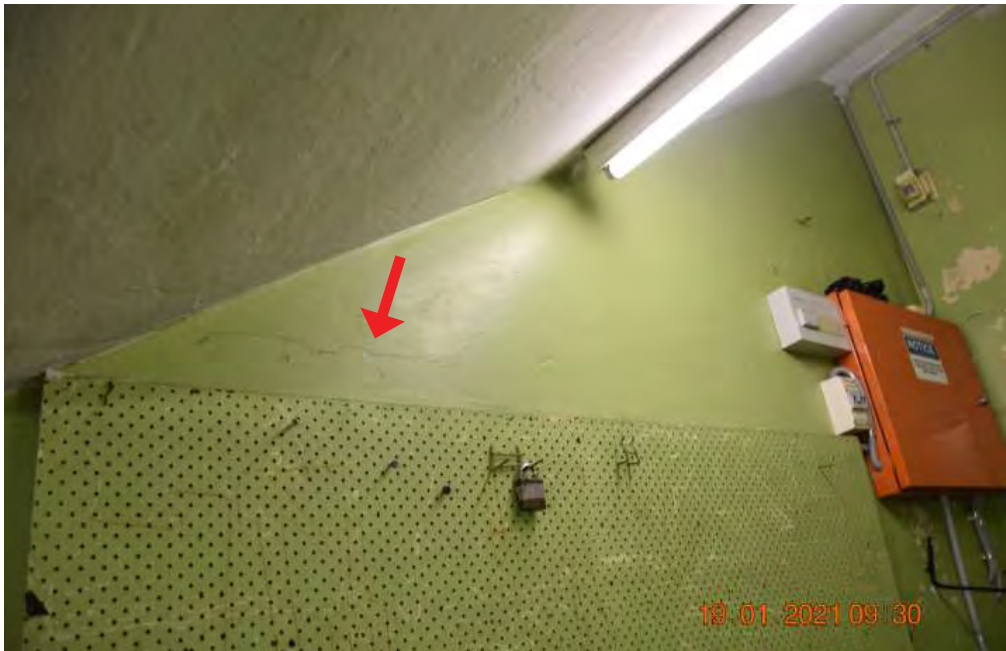
Figure: 0357

South wall in the  
cleaners room.

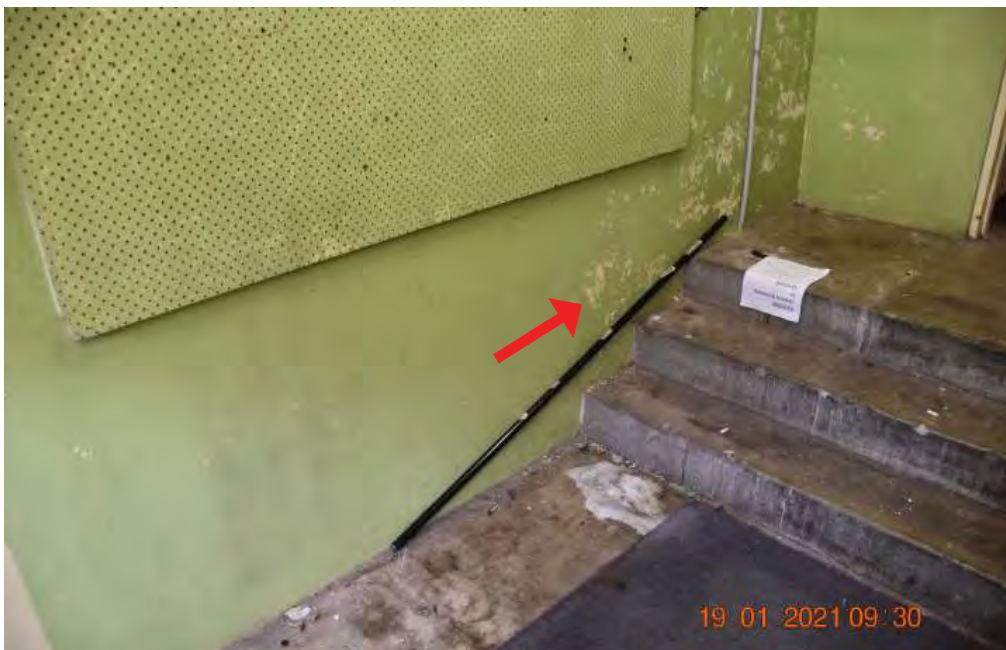
Figure: 0358

South wall in the cleaners room. Showing fine cracking.

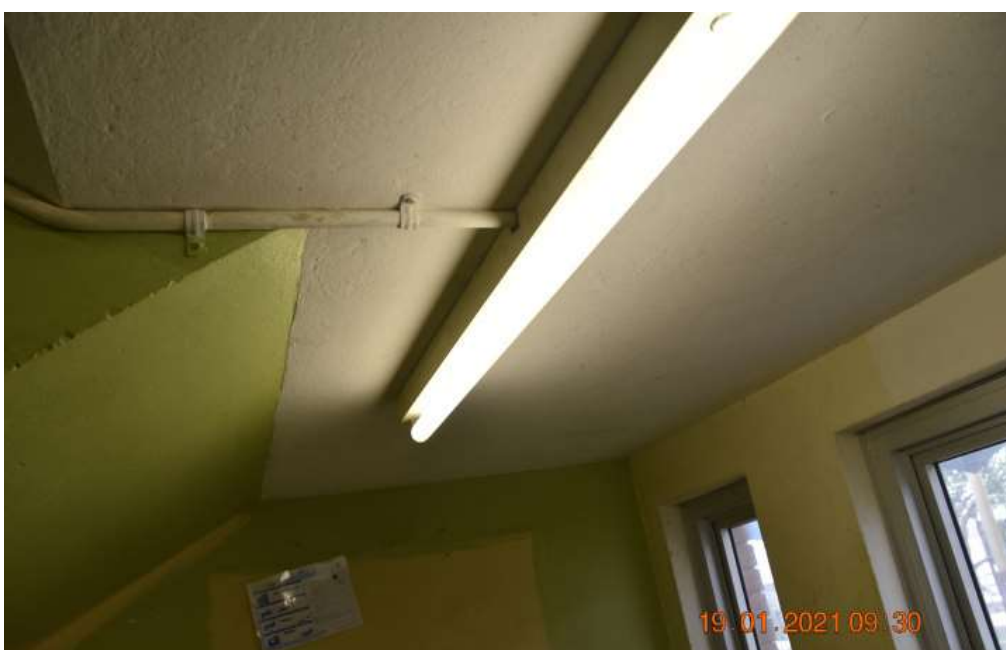
Figure: 0359

South wall in the cleaners room. Showing peeling paint.

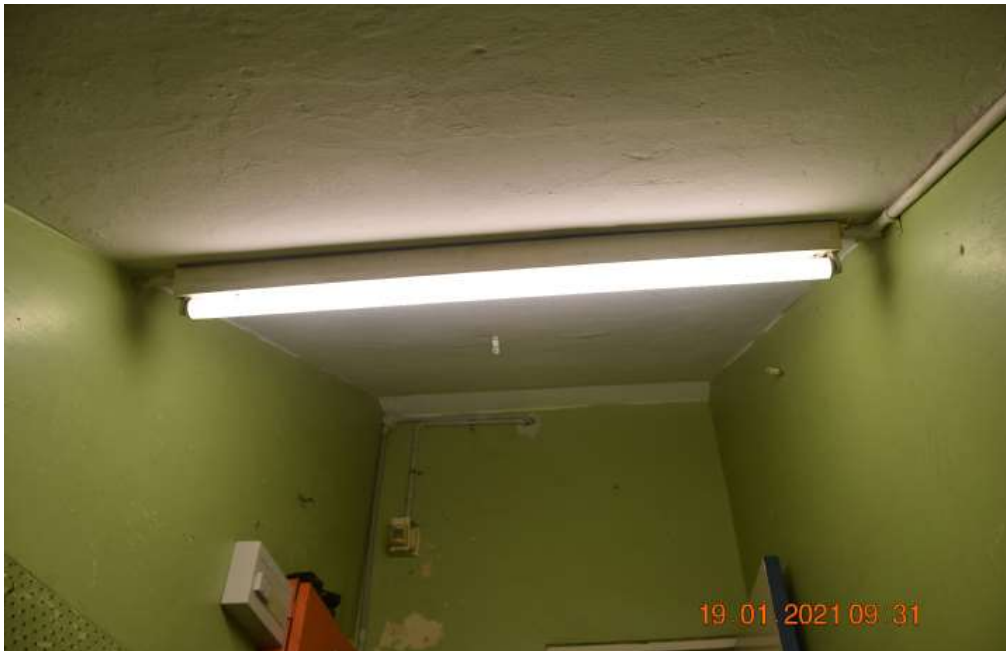
Figure: 0360

Ceiling in the cleaners room.

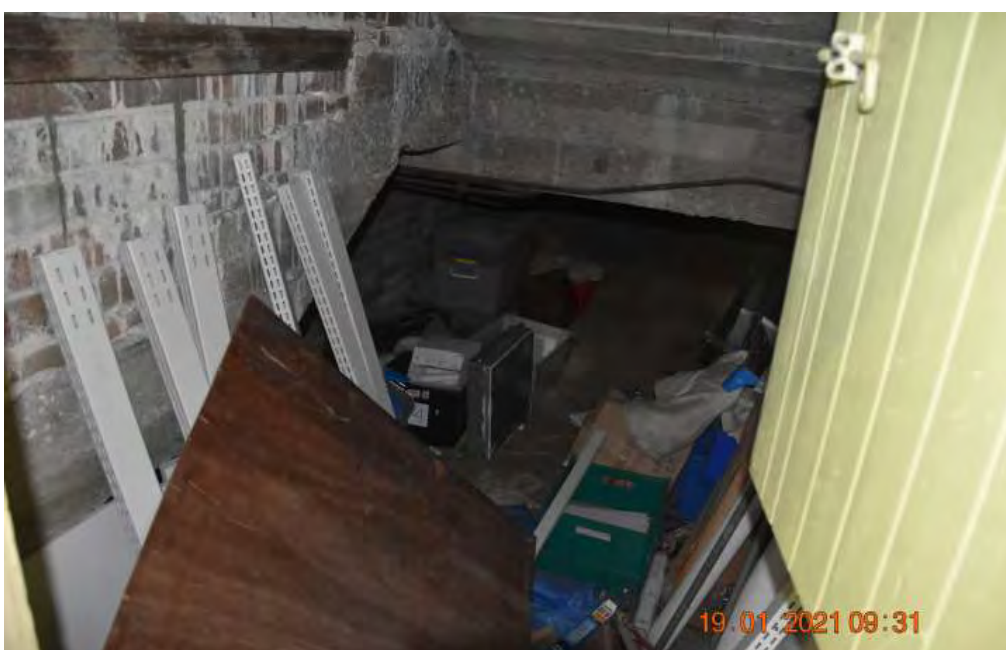
Figure: 0362

General view in the sub floor area in the cleaners room.

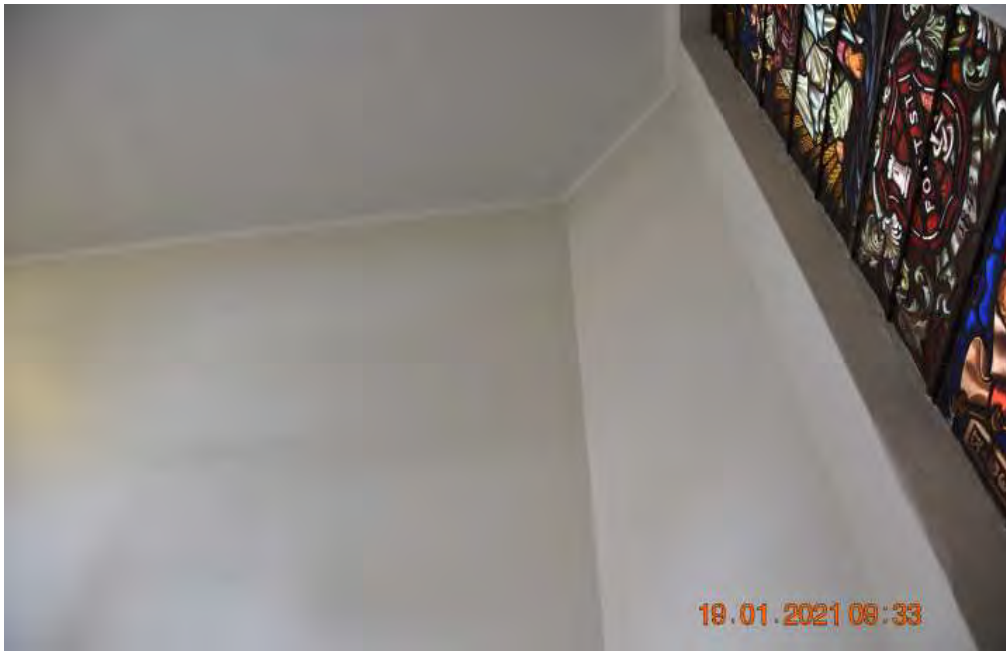
Figure: 0369

Chipping in the east wall in the landing area in the stairway.

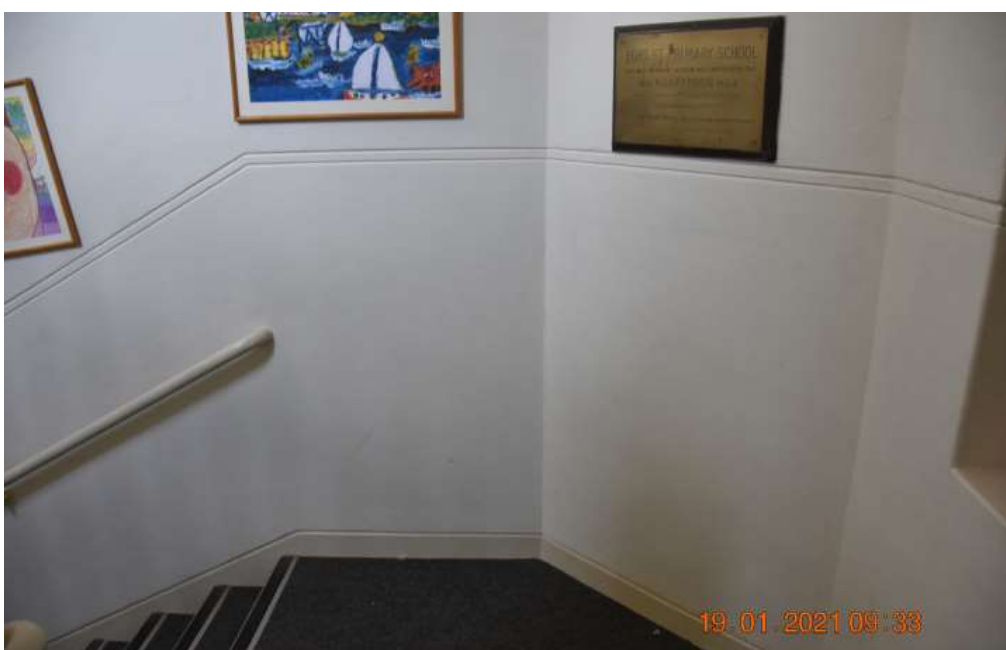
Figure: 0371

North wall in the stairway. Showing peeling paint.

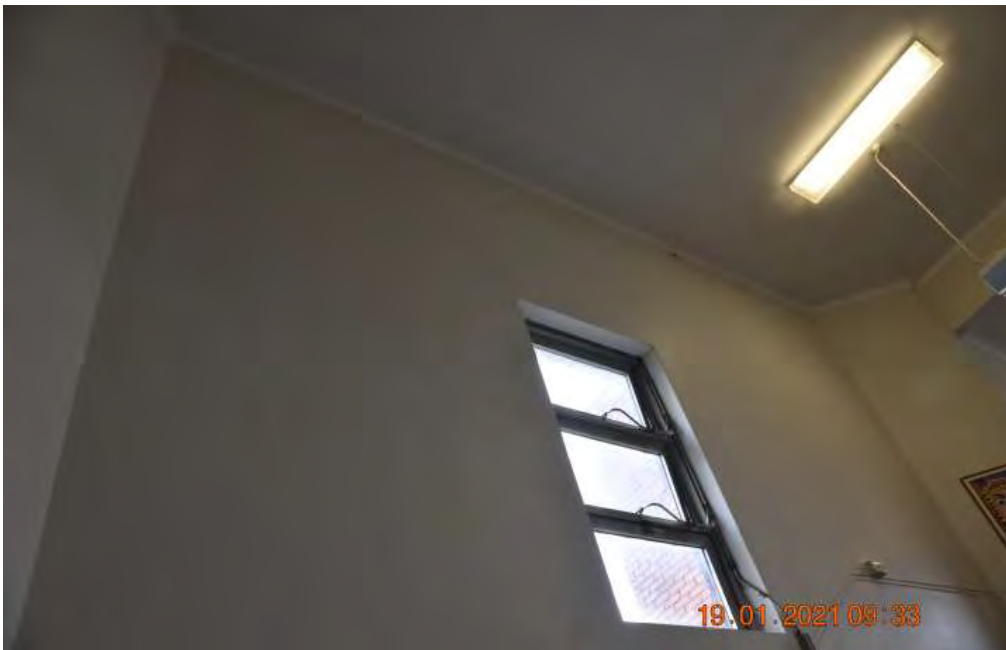
Figure: 0373

Fine cracking in the east wall in the stairway.

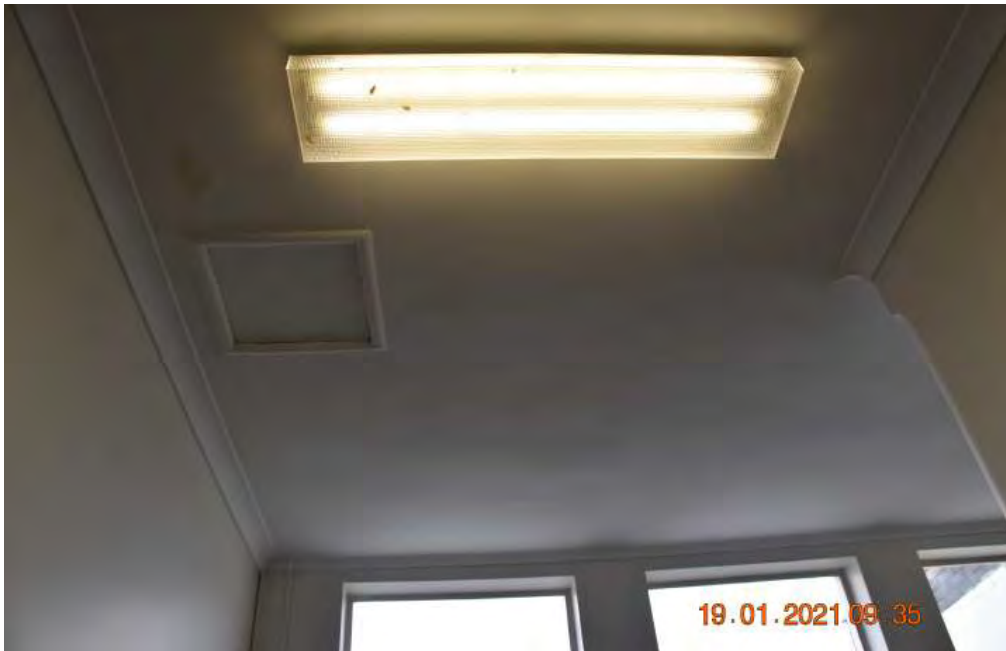
Figure: 0393

Cracking in the ceiling in the ground floor corridor, outside the kitchen.
