## PRE CONSTRUCTION CONDITION SURVEY

Fort Street Public School, Millers Point NSW

Upper Fort Street Public School  
MILLERS POINT NSW 2000

19 January 2021

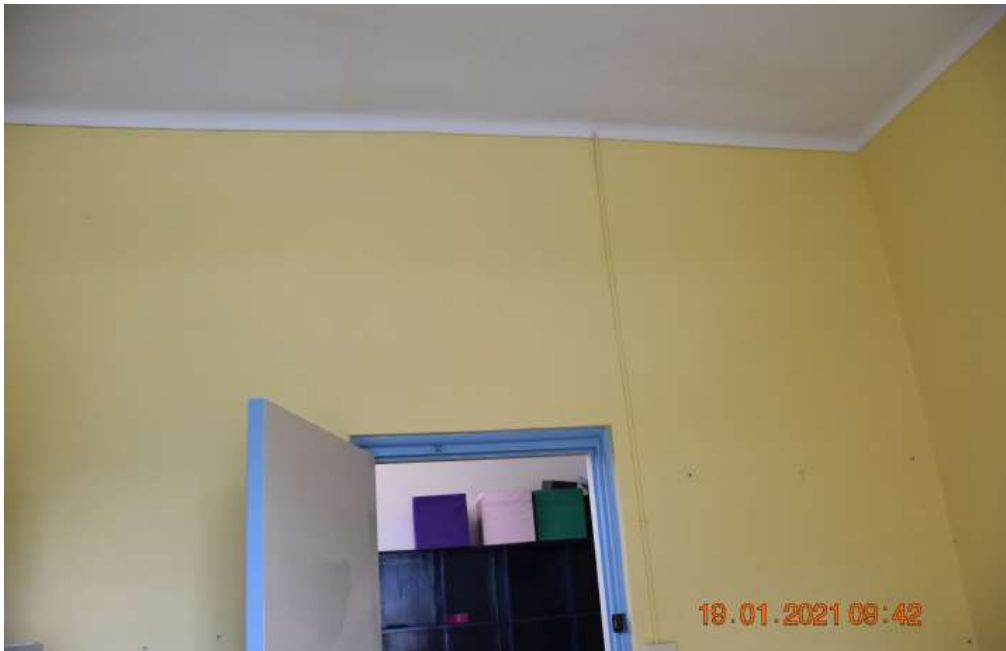
Figure: 0402

East wall in the kitchen. Showing peeling paint.

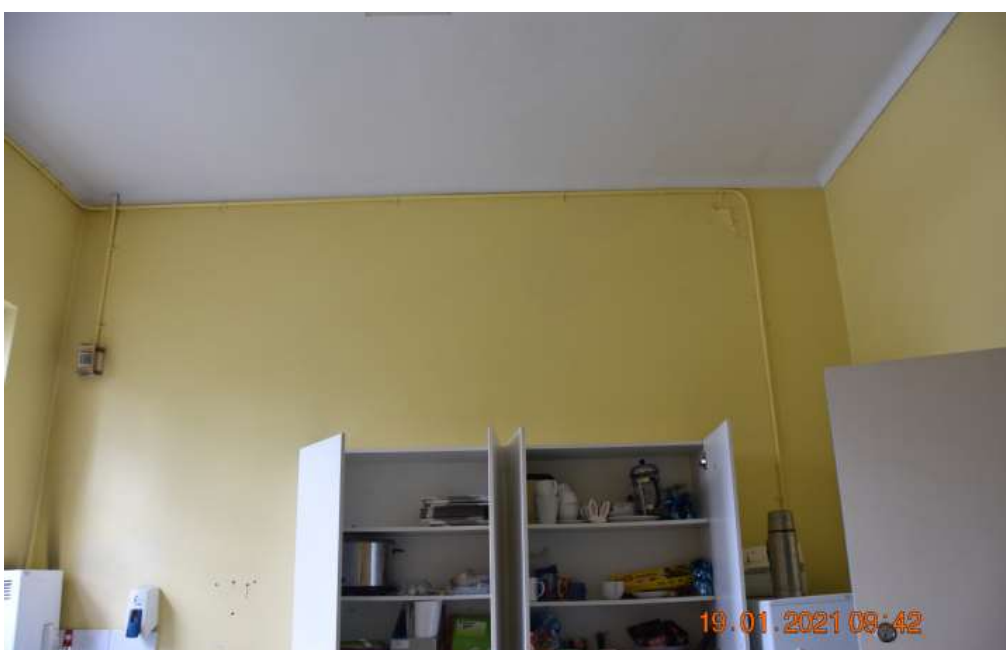
Figure: 0404

North wall in the kitchen.

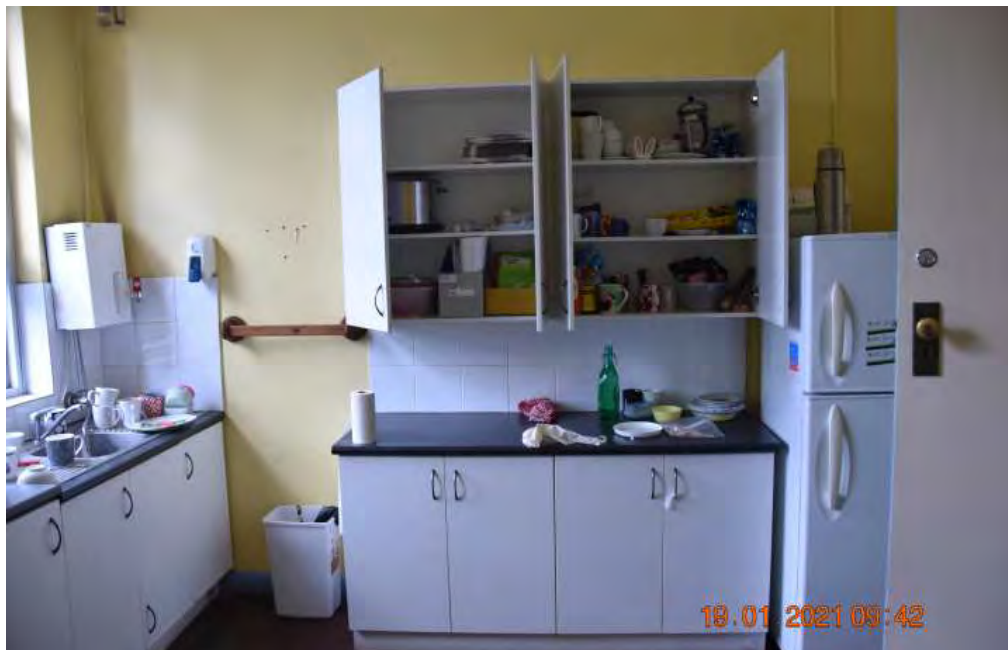
Figure: 0405

West wall in the kitchen.

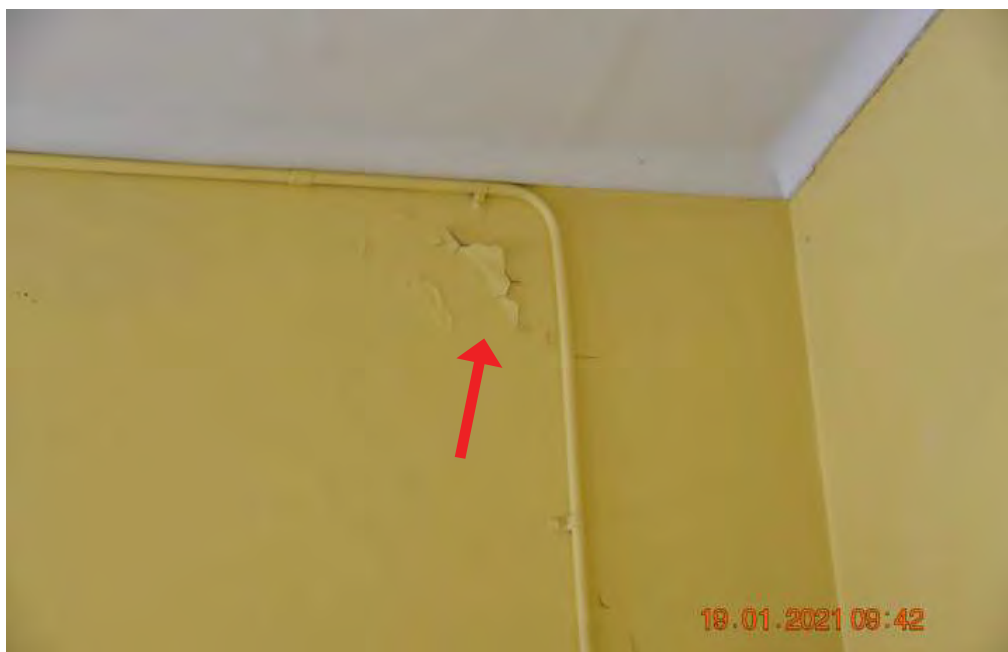
Figure: 0406

West wall in the kitchen.

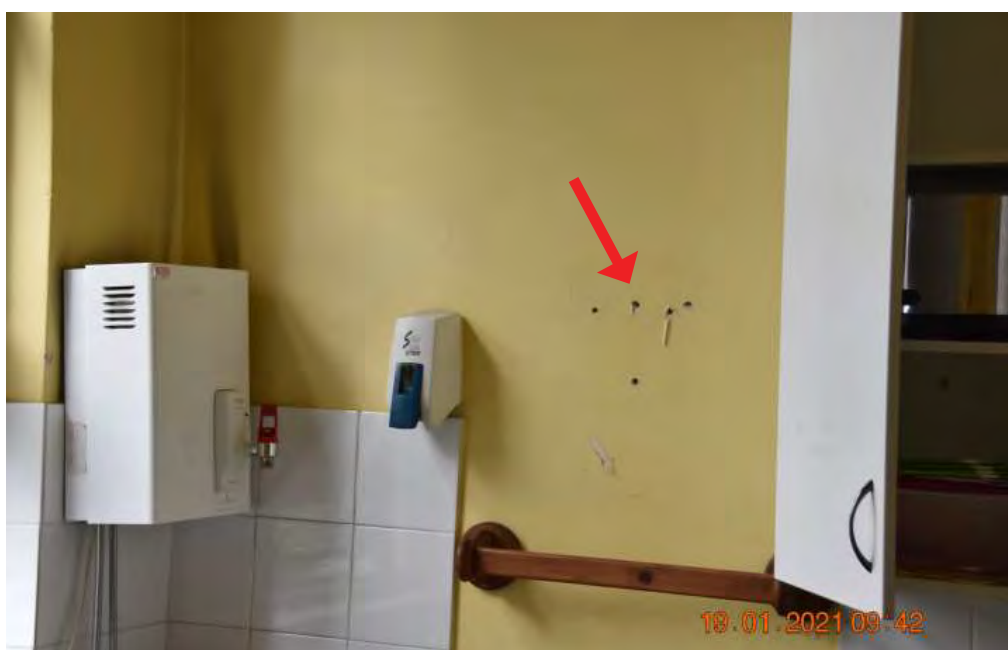
Figure: 0407

Peeling paint in the west wall in the kitchen.

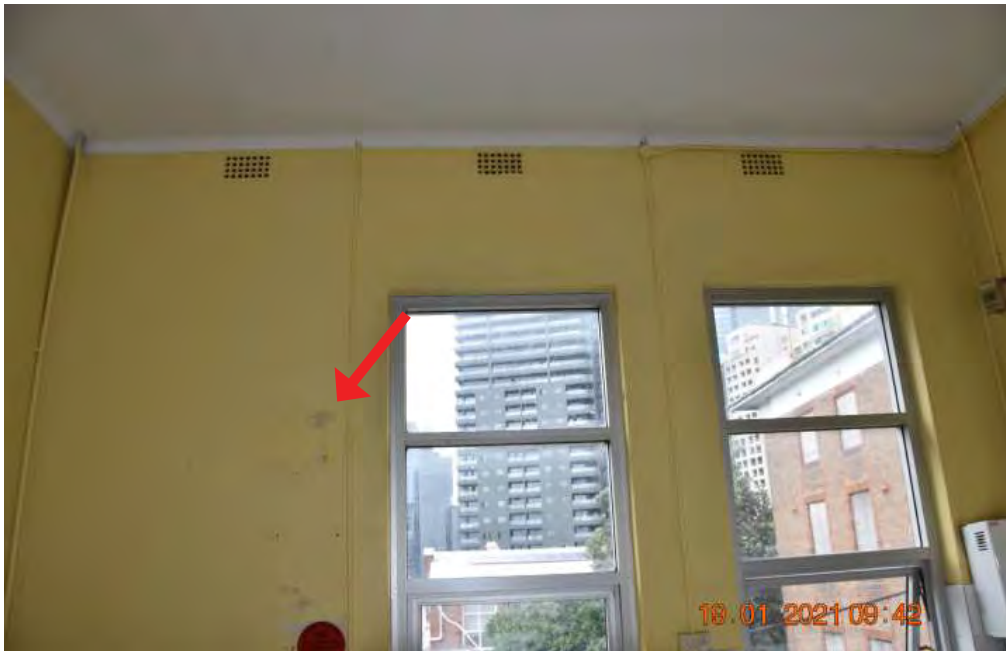
Figure: 0408

Nail holes in the west wall in the kitchen.

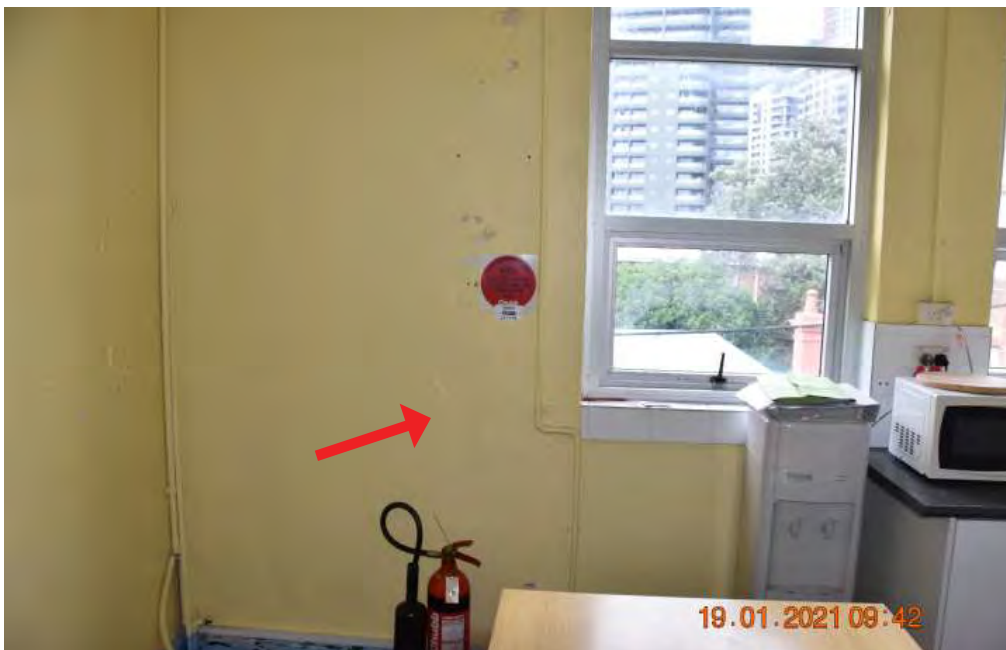
Figure: 0409

South wall in the kitchen. Showing peeling paint.

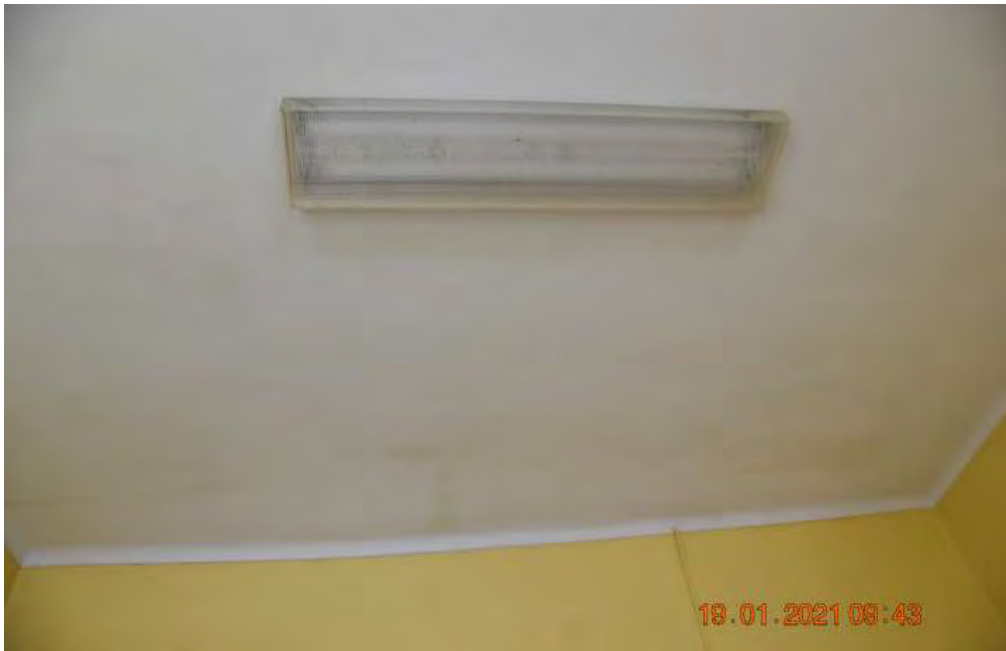
Figure: 0411

Ceiling in the kitchen.

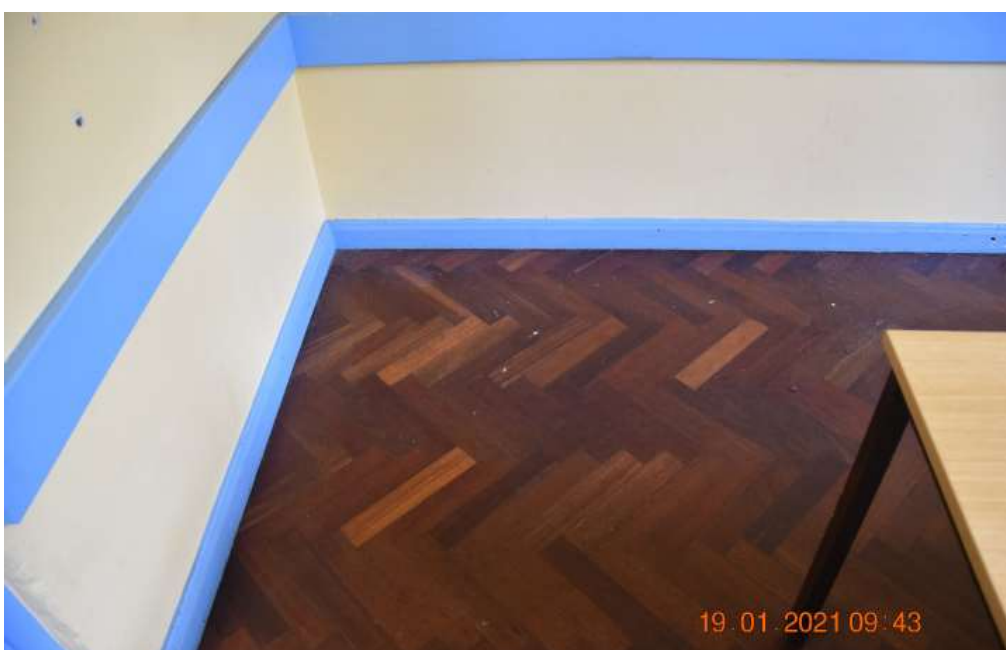
Figure: 0413

Timber floor in the kitchen.

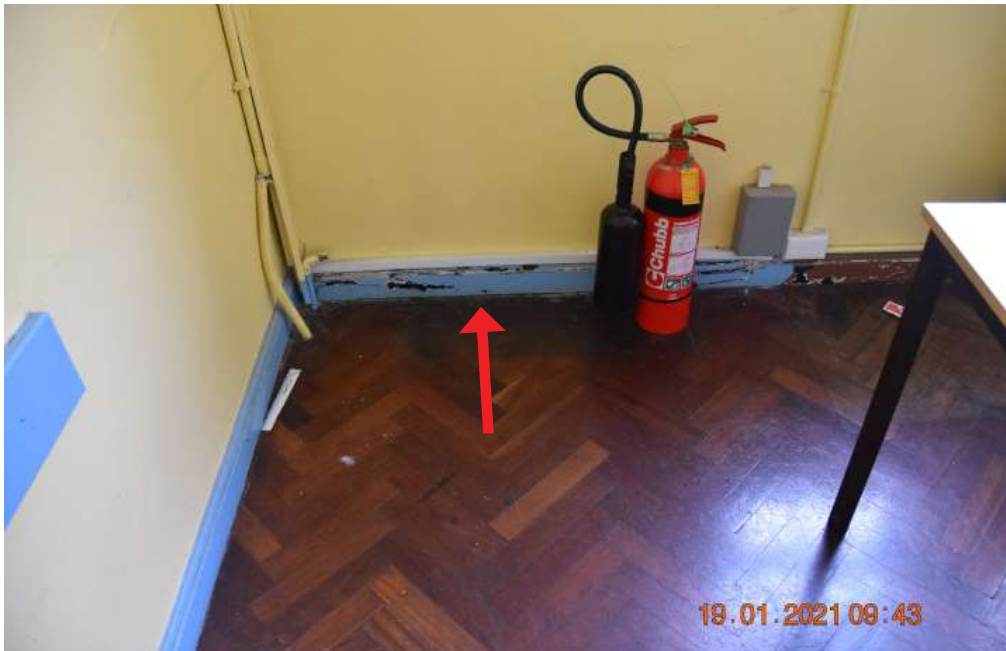
Figure: 0414

Timber floor in the kitchen.

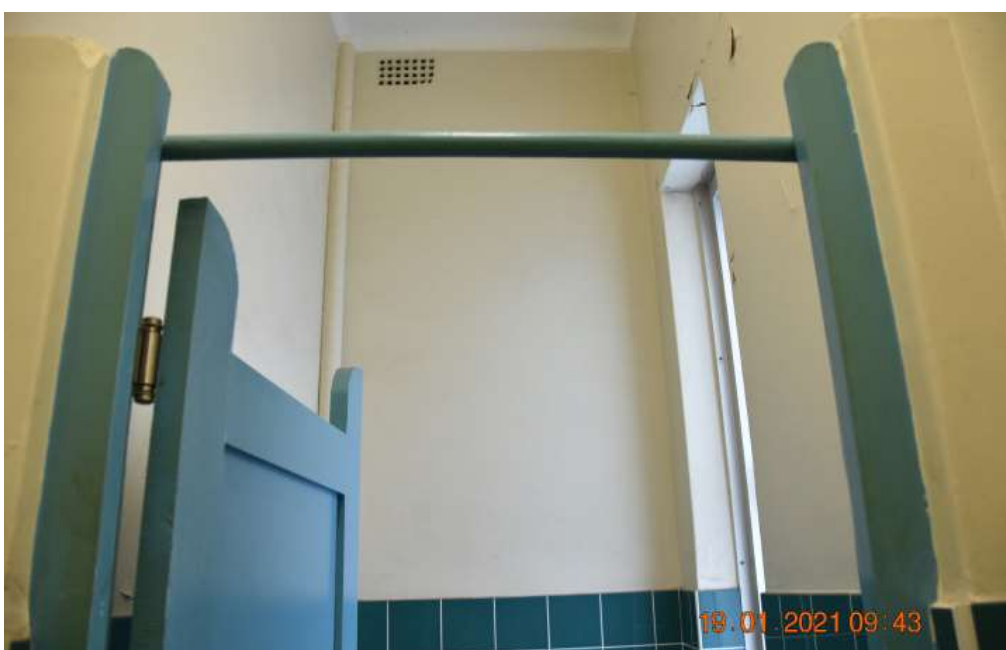
Figure: 0416

General view of the entrance to the south toilet.

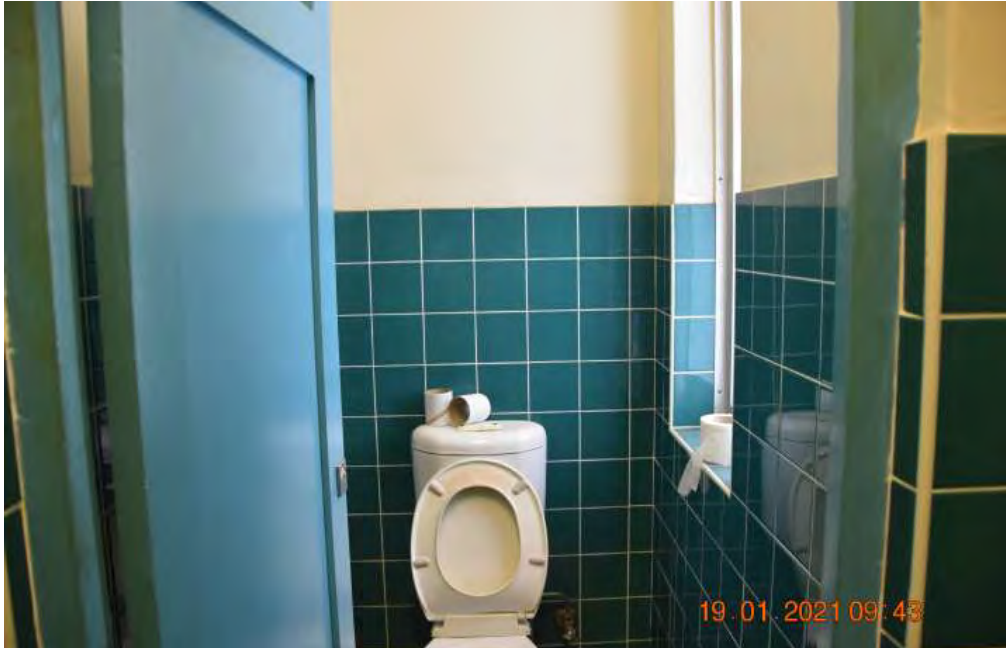
Figure: 0417

General view in the south toilet.

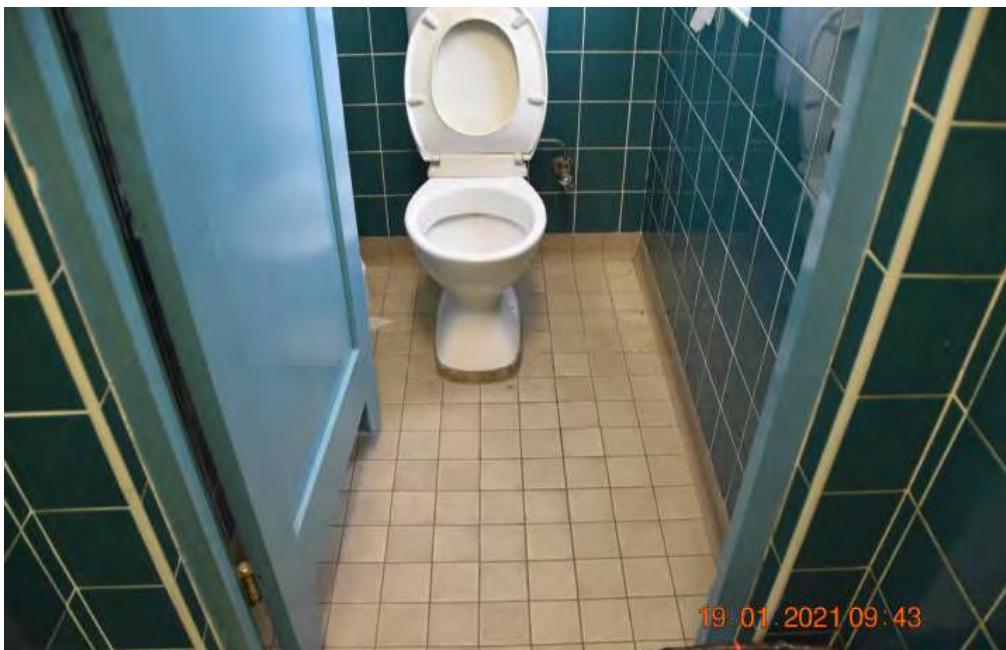
Figure: 0418

General view in the south toilet.

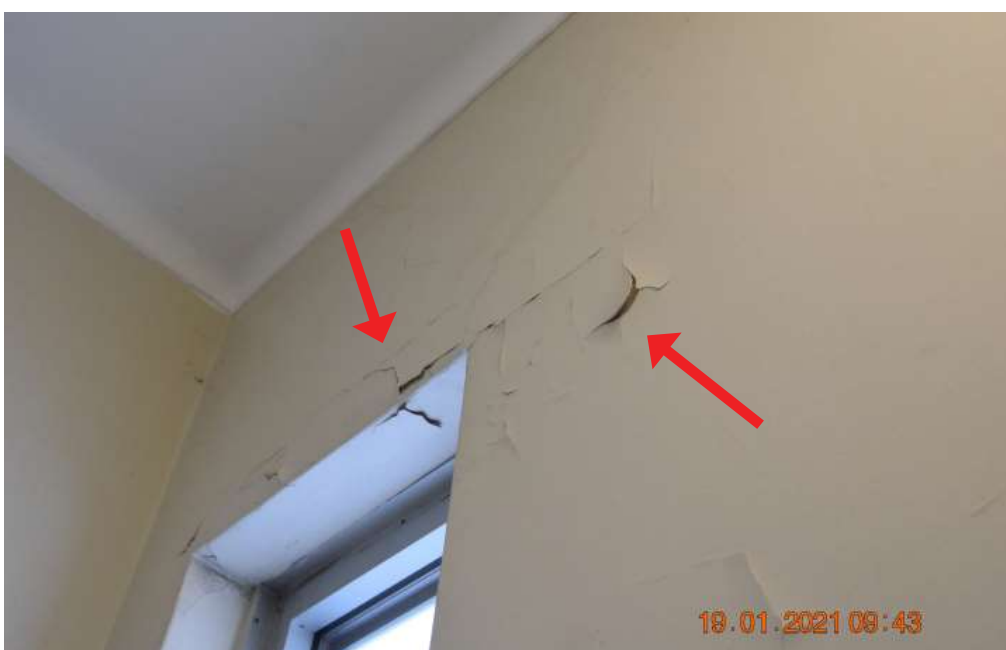
Figure: 0419

General view in the south toilet.

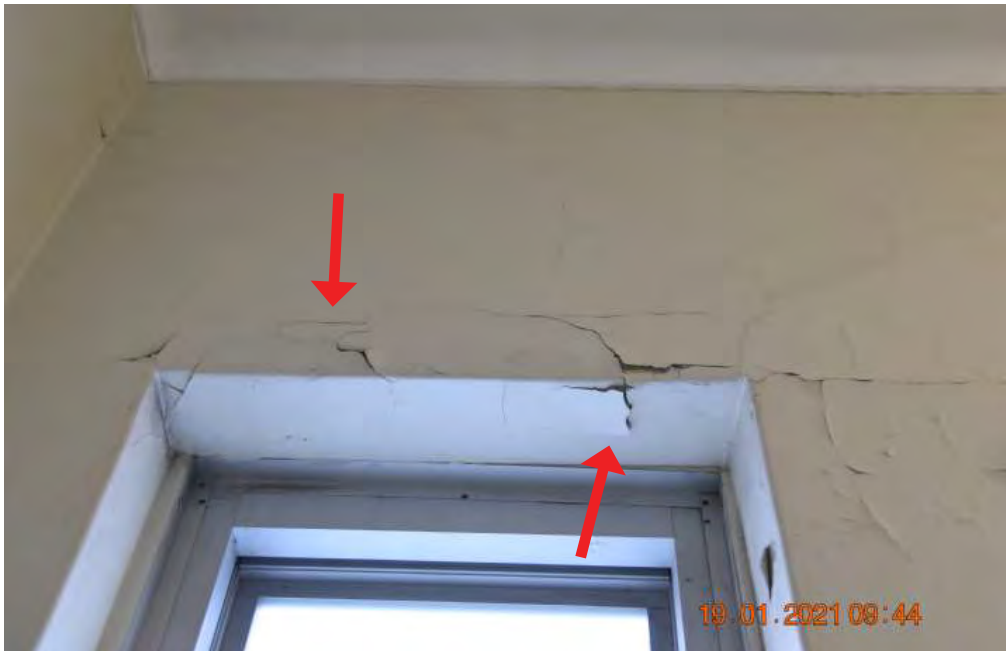
Figure: 0420

Peeling paint and cracking in the west wall in the south toilet.

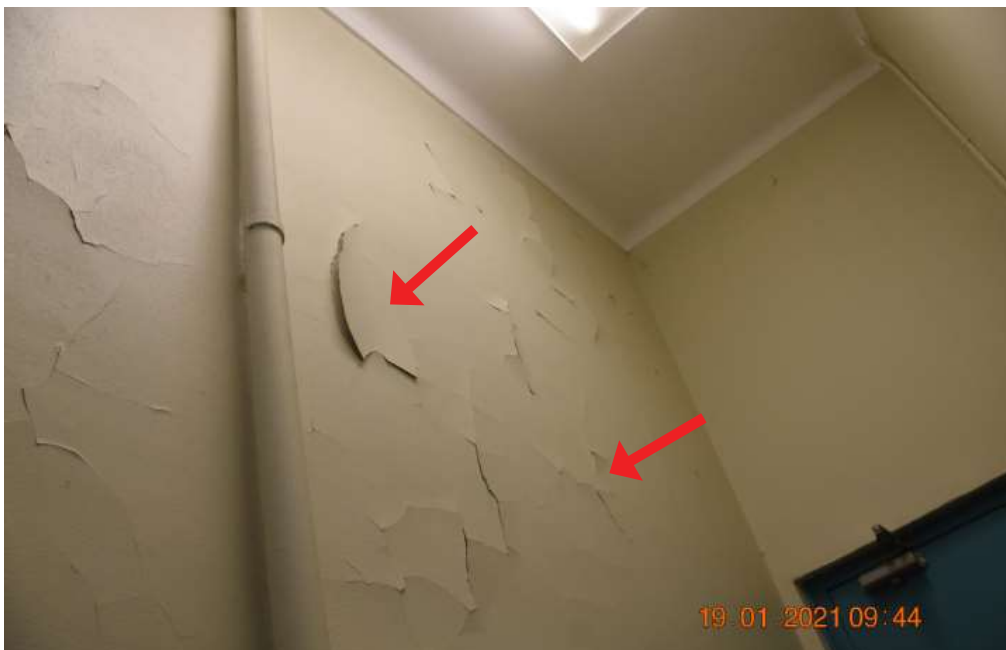
Figure: 0421

Peeling paint and cracking in the west wall in the south toilet.

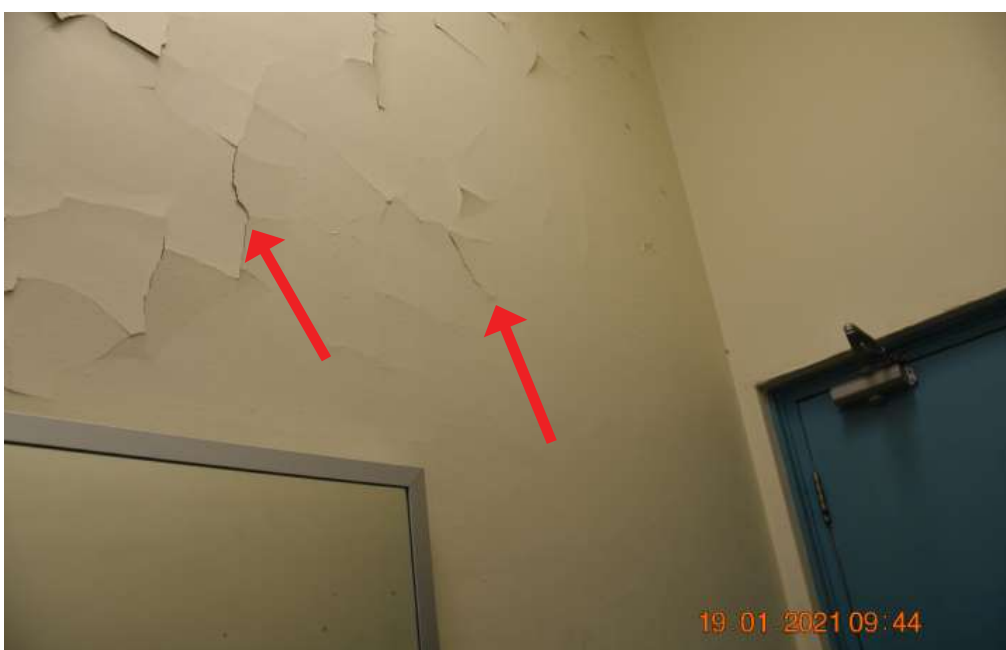
Figure: 0422

Peeling paint and crazing in the west wall in the south toilet.

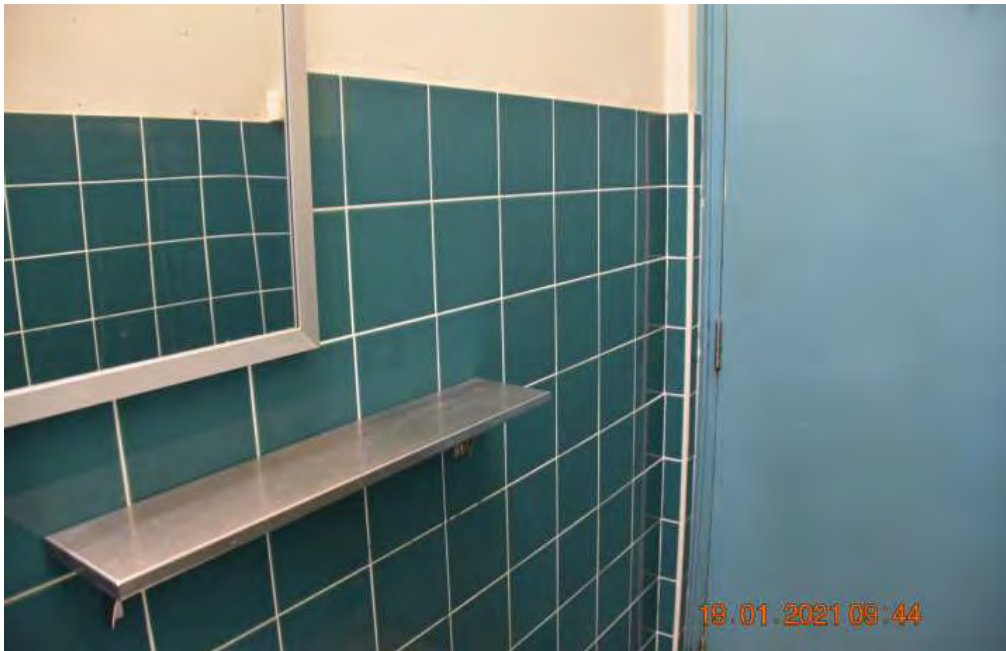
Figure: 0423

Peeling paint and crazing in the west wall in the south toilet.

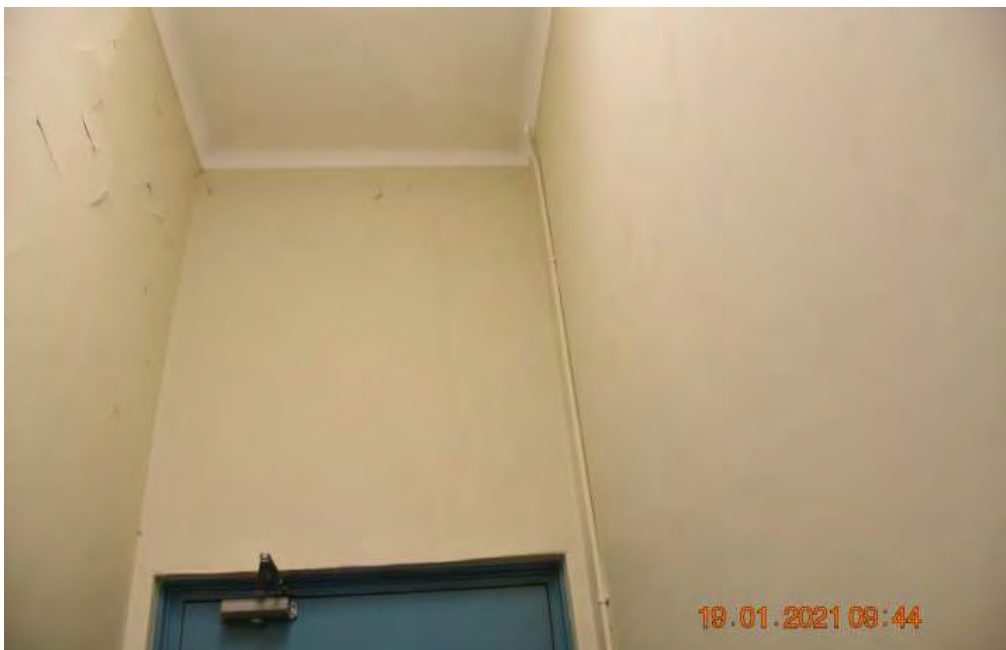
Figure: 0424

West wall in the south toilet.

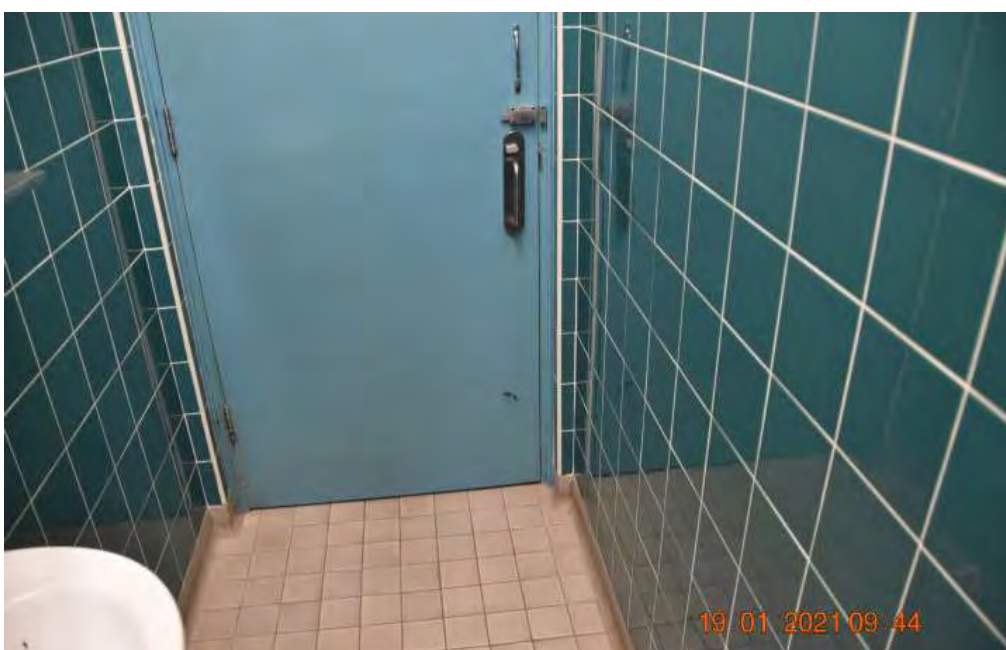
Figure: 0425

General view in the south toilet.

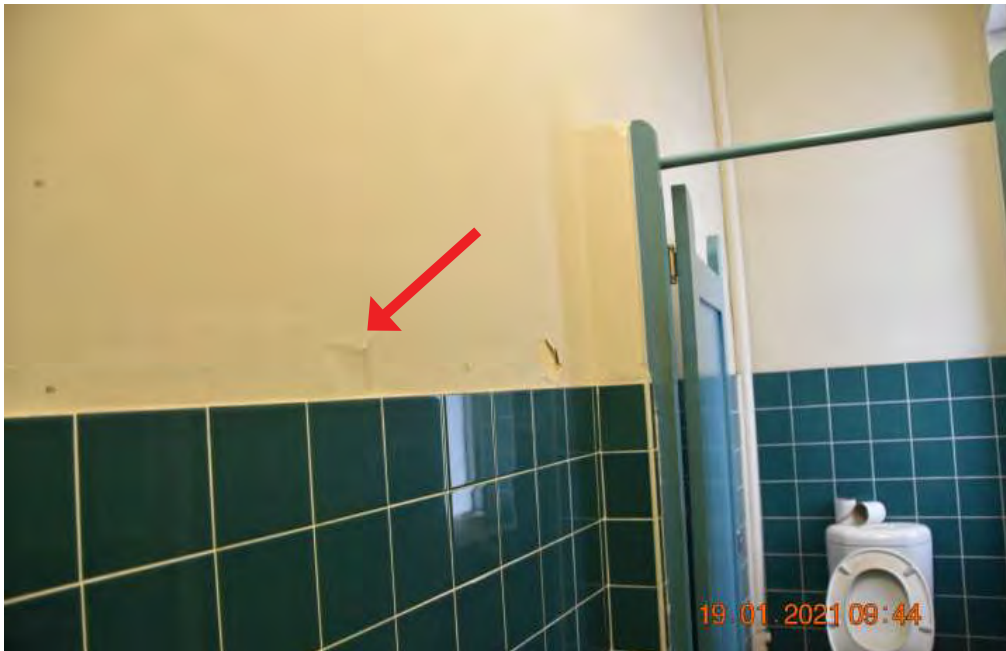
Figure: 0426

General view in the south toilet.

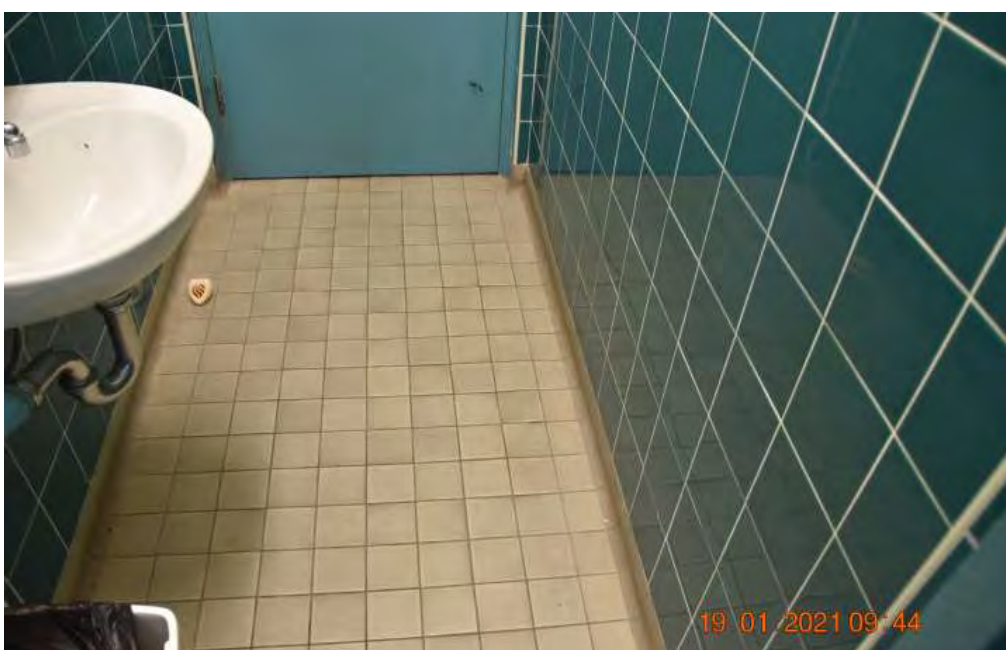
Figure: 0428

Tile floor in the south toilet.

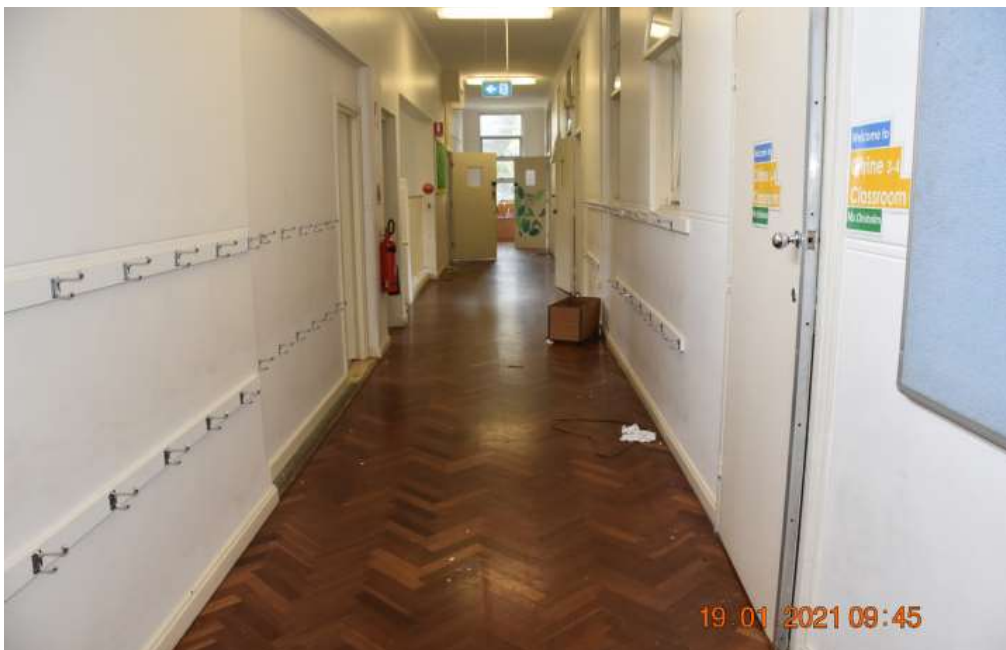
Figure: 0430

General view in the level 1 corridor.

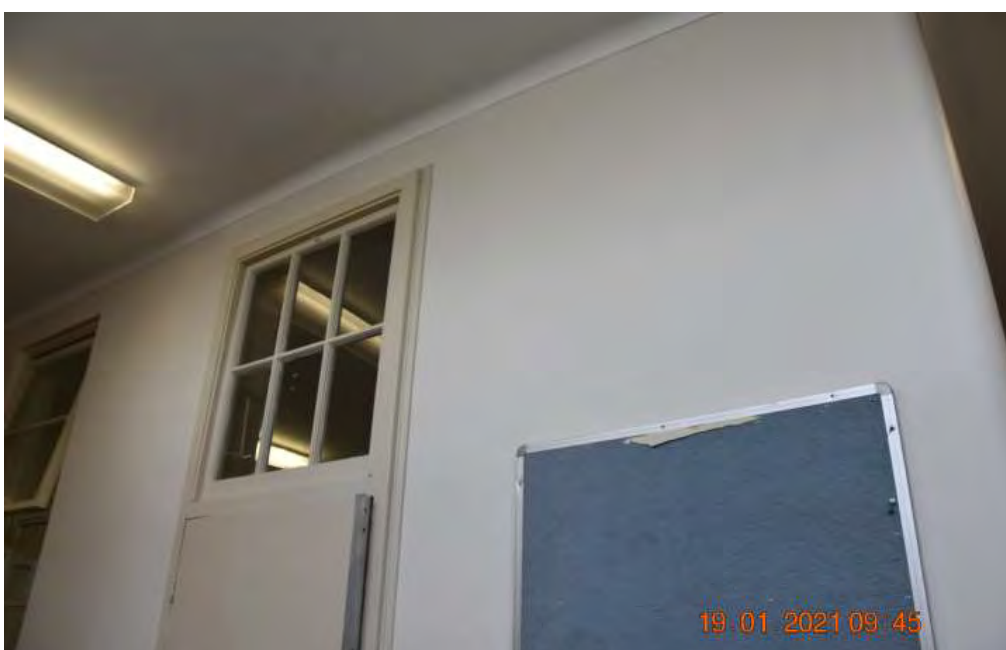
Figure: 0431

General view in the level 1 corridor.

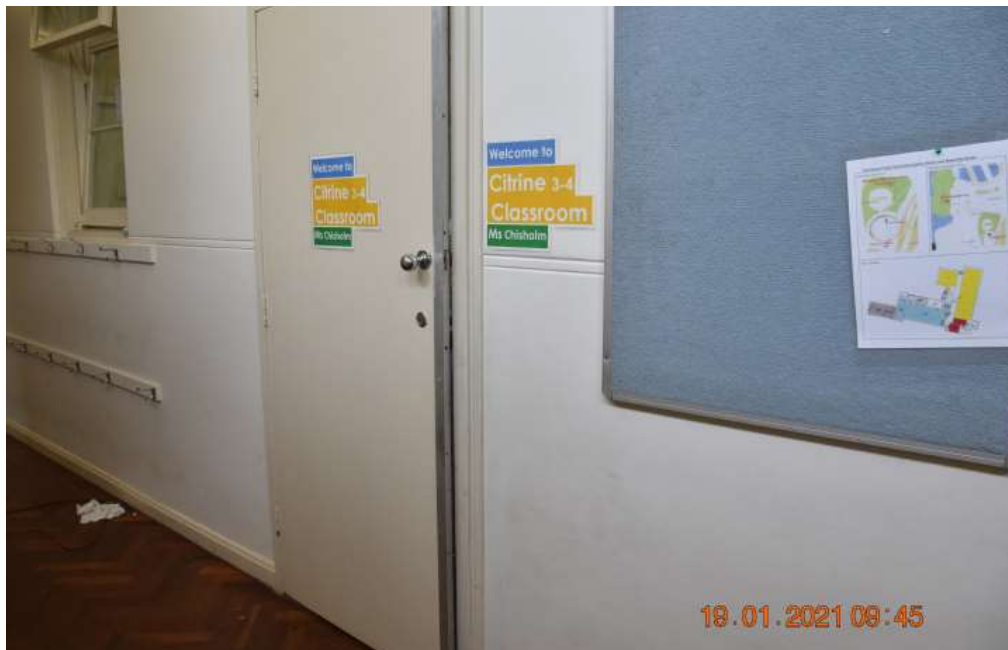
Figure: 0432

East wall in the level 1 corridor, outside the citrine classroom.

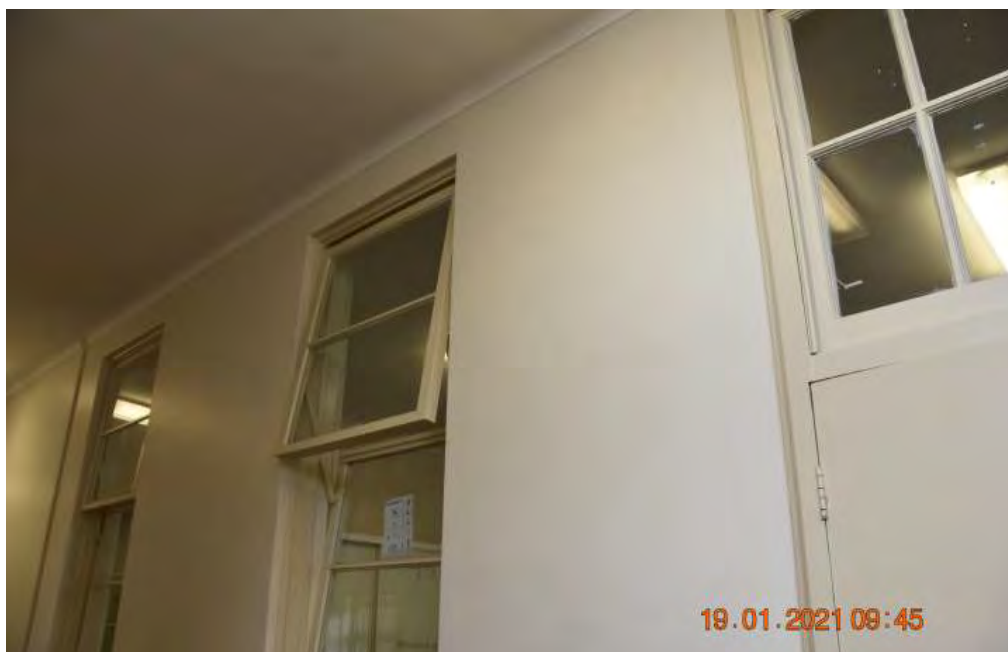
Figure: 0433

East wall in the level 1 corridor, outside the citrine classroom.

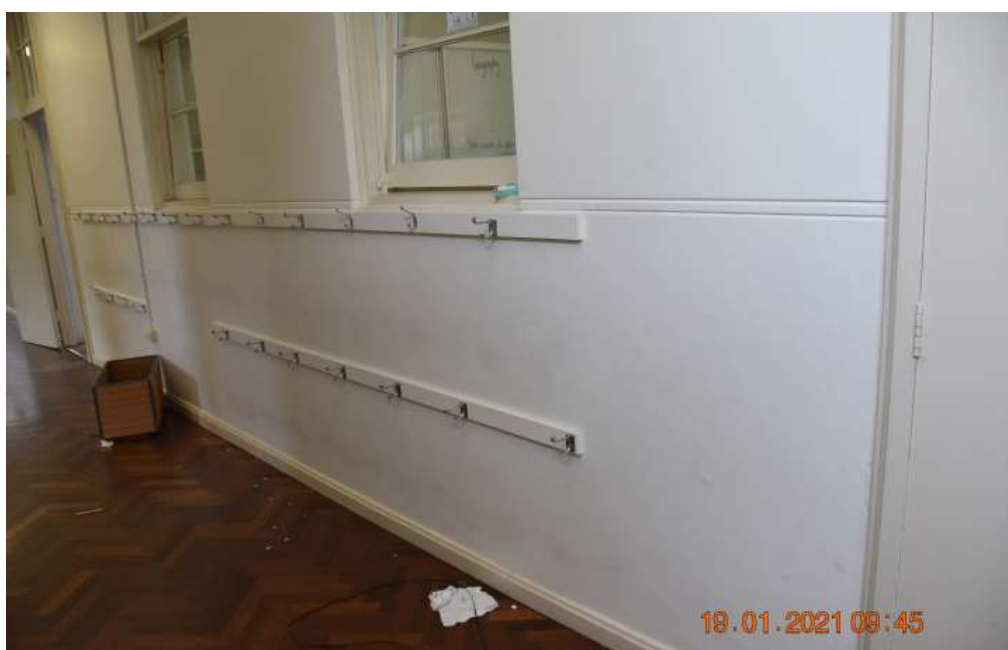
Figure: 0434

East wall in the level 1 corridor, outside the citrine classroom.

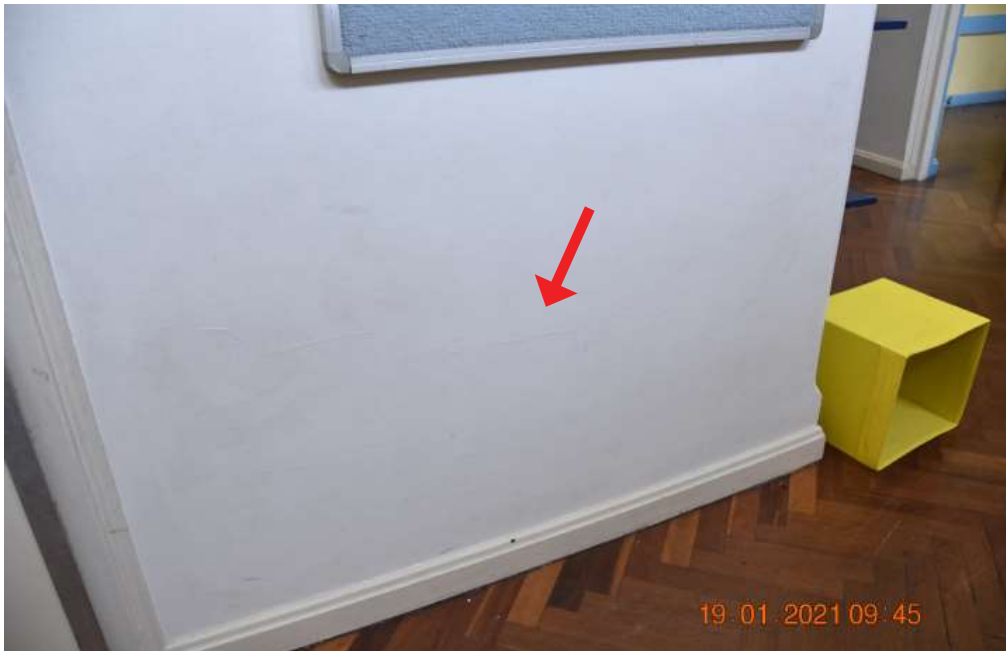
Figure: 0435

East wall in the level 1 corridor, outside the citrine classroom.

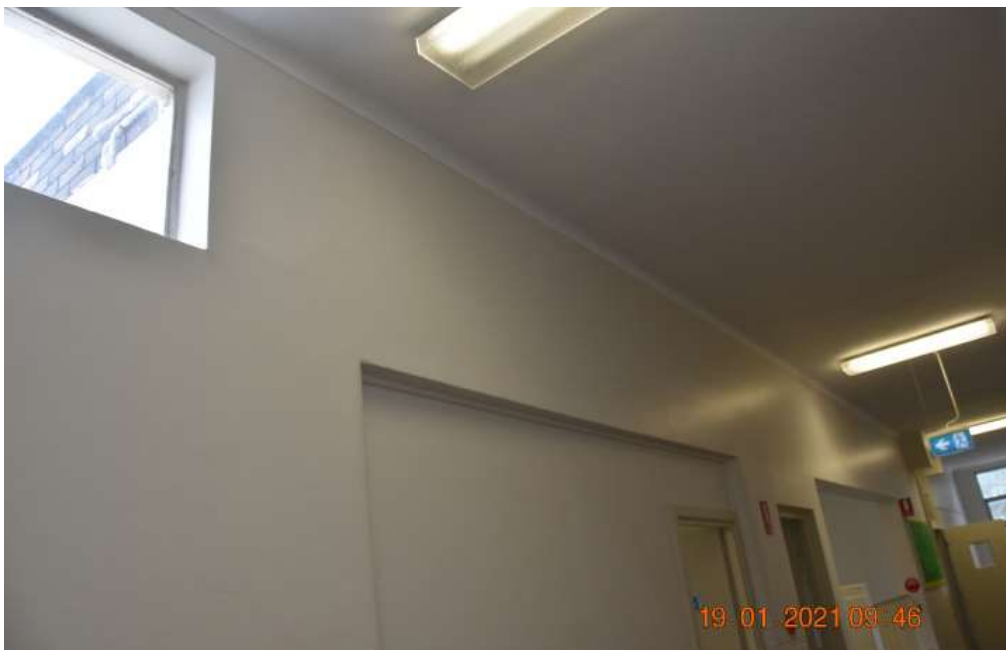
Figure: 0436

Fine cracking in the east wall in the level 1 corridor, outside the citrine classroom.

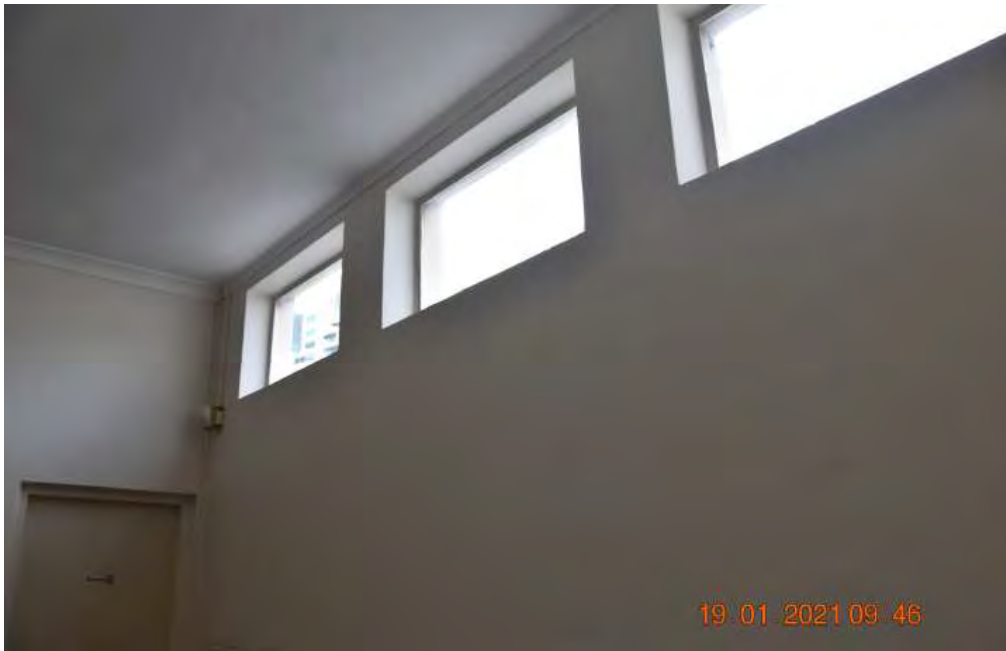
Figure: 0438

West wall in the level 1 corridor, outside the citrine classroom.

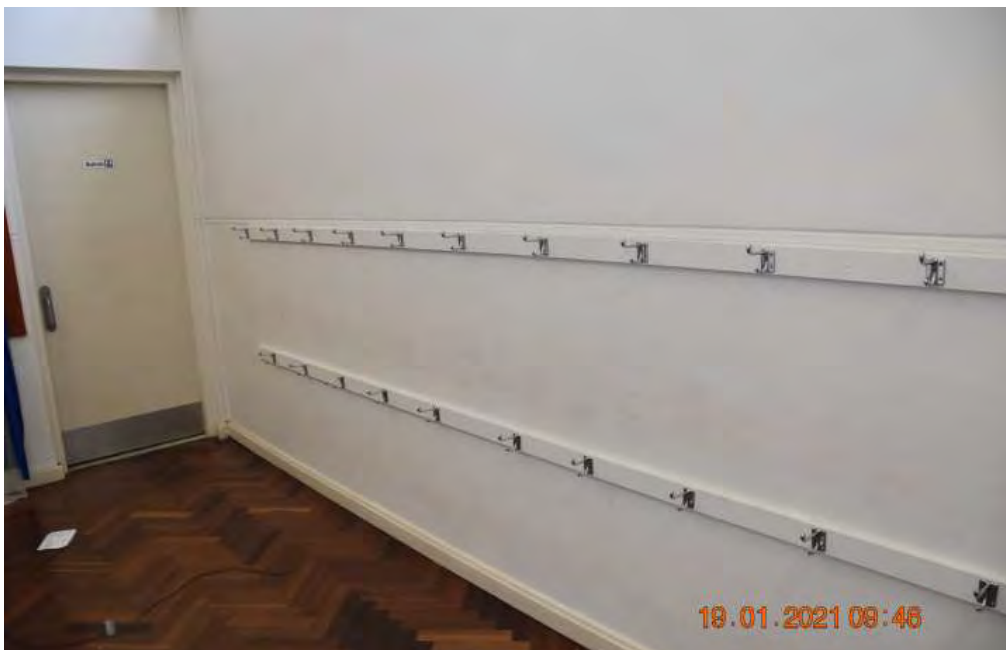
Figure: 0439

West wall in the level 1 corridor, outside the citrine classroom.

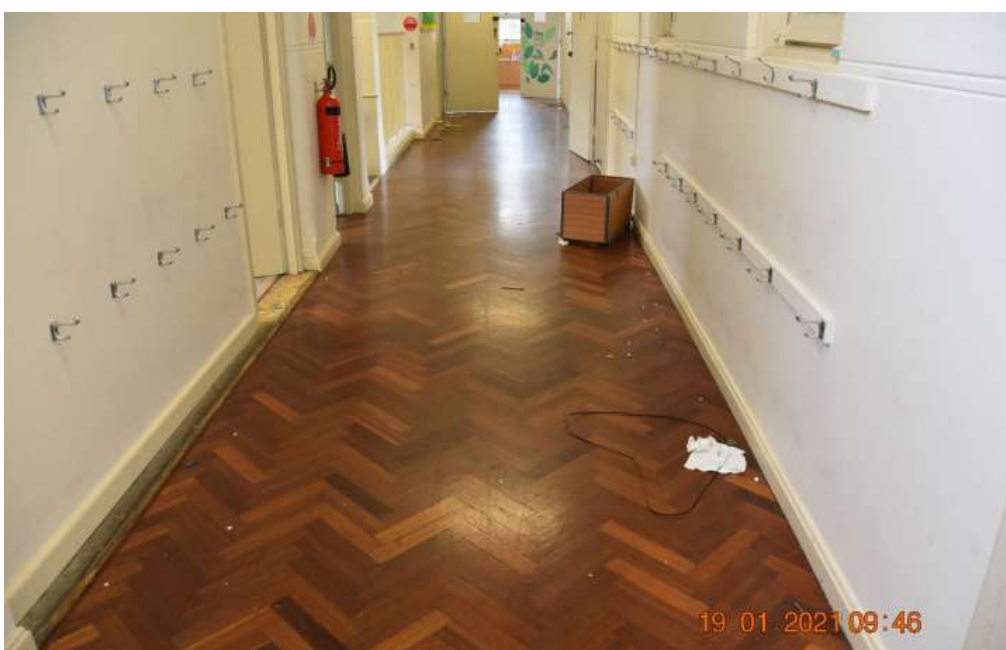
Figure: 0440

West wall in the level 1 corridor, outside the citrine classroom.

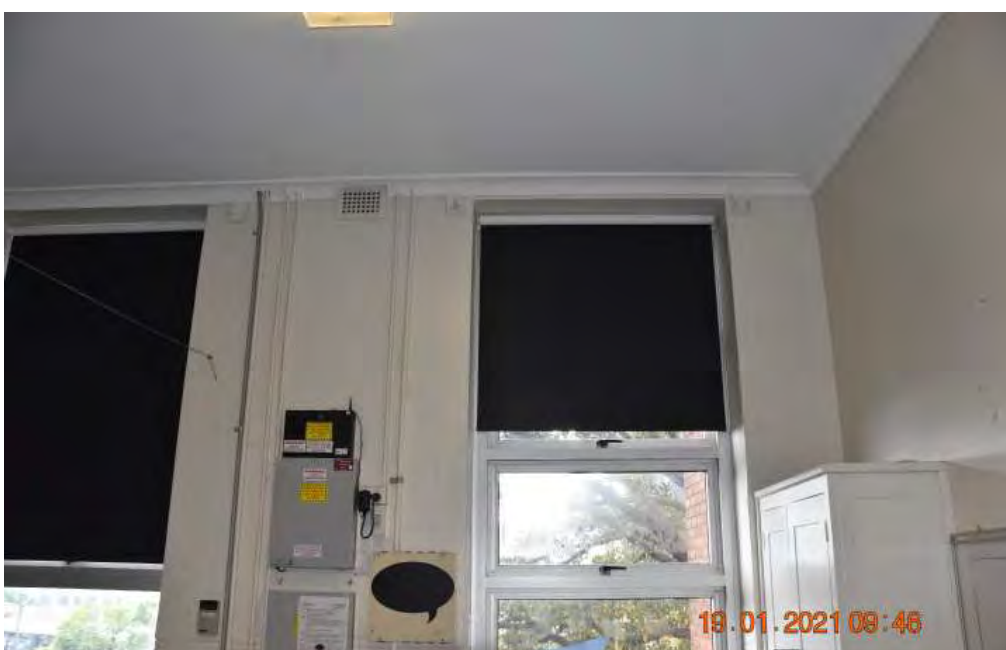
Figure: 0443

General view of the entrance to the citrine classroom.

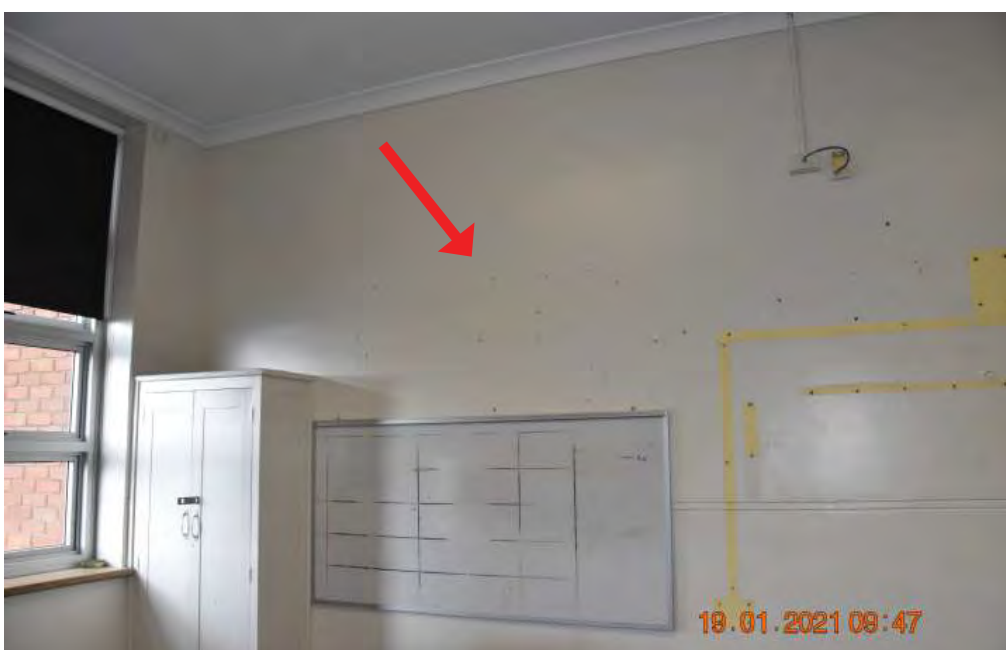
Figure: 0455

South wall in the citrine classroom. Showing nail markings.
