## PRE CONSTRUCTION CONDITION SURVEY

Fort Street Public School, Millers Point NSW

Upper Fort Street Public School  
MILLERS POINT NSW 2000

19 January 2021

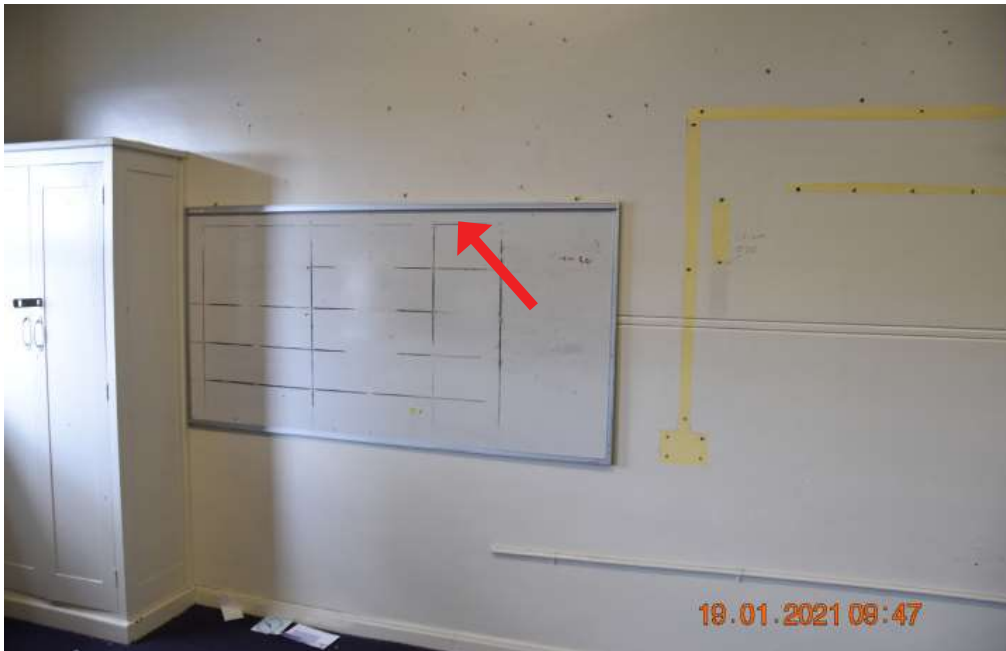
Figure: 0456

South wall in the citrine classroom. Showing nail markings.

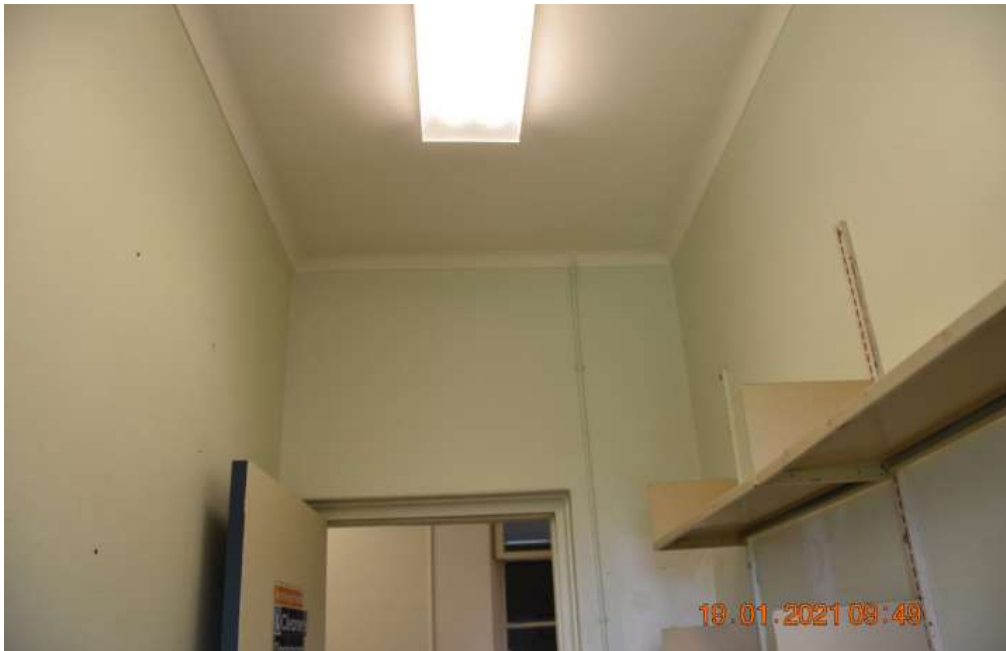
Figure: 0474

General view in the cleaners room. Showing patching and missing skirting.

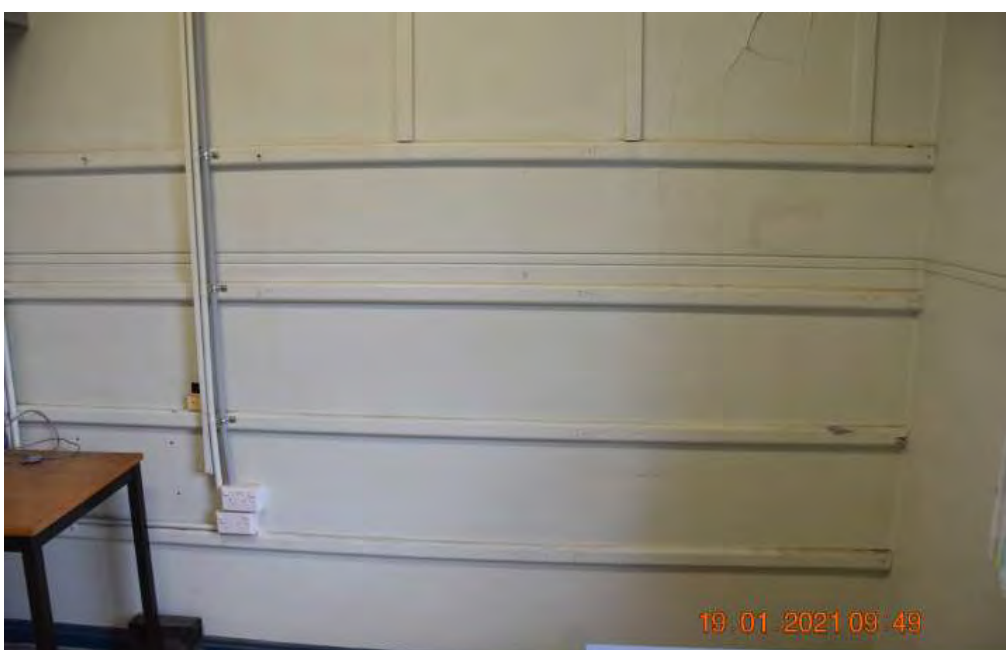
Figure: 0482

South wall in the maths resources room. Showing peeling paint.

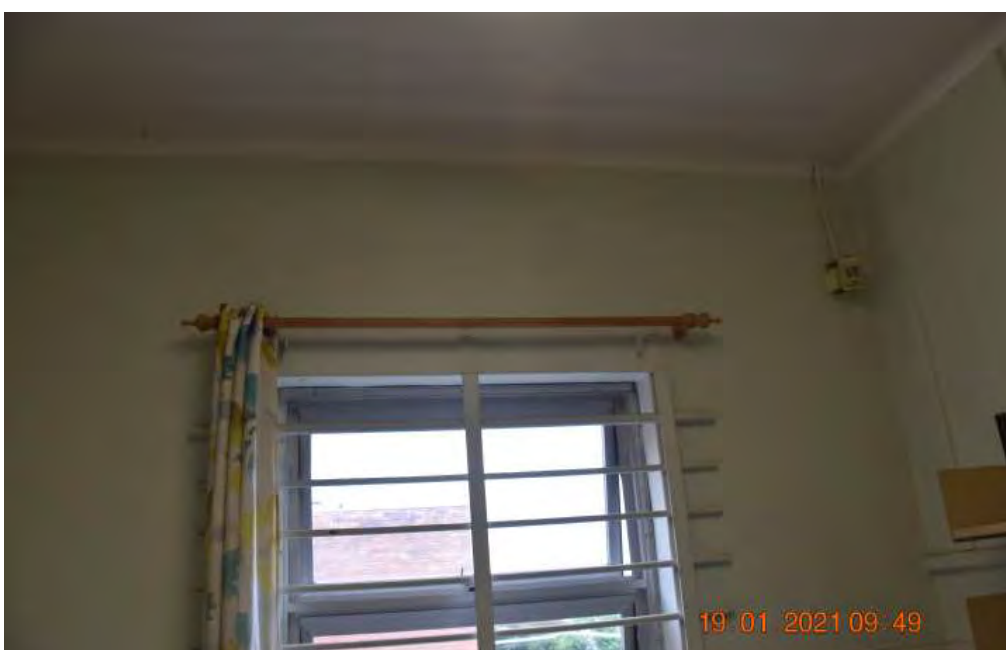
Figure: 0485

North wall in the maths resources room.

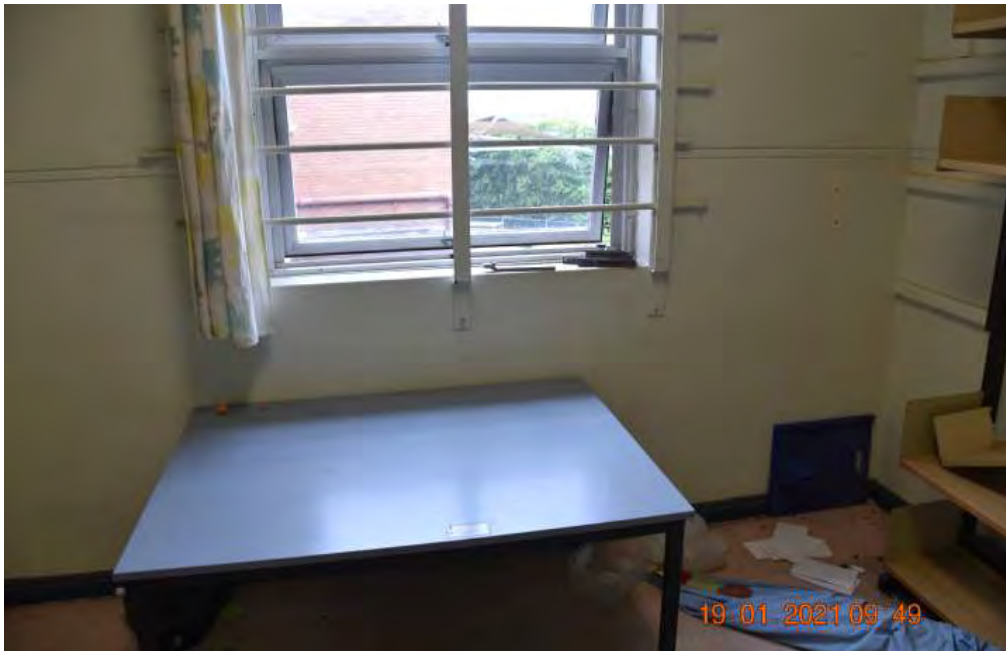
Figure: 0486

West wall in the maths resources room.

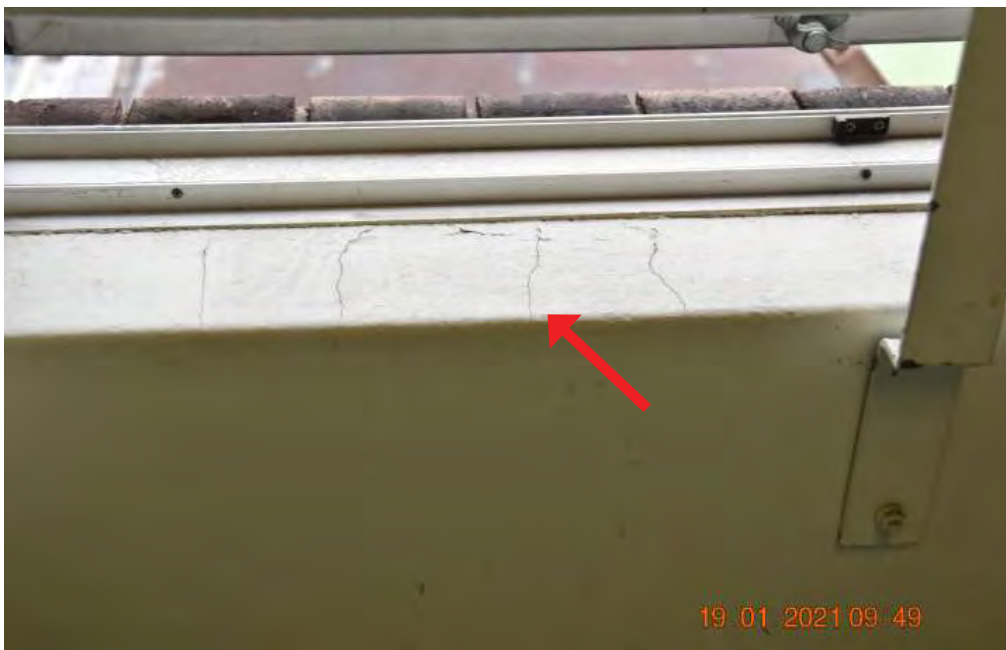
Figure: 0487

West wall in the maths resources room.

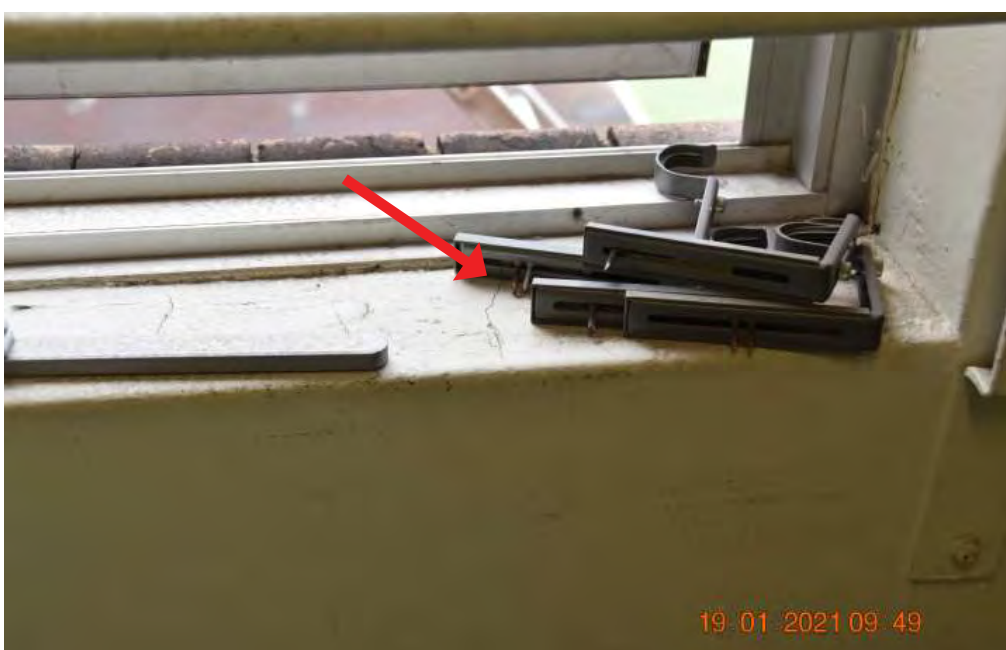
Figure: 0488

Cracking in the window sill in the west wall in the maths resources room.

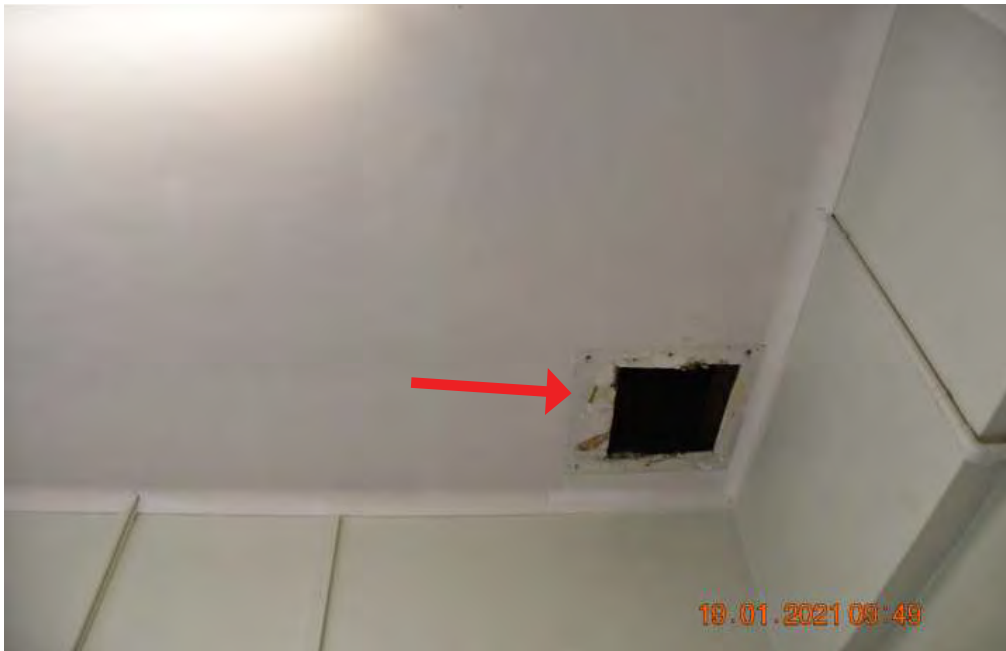
Figure: 0489

Cracking in the window sill in the west wall in the maths resources room.

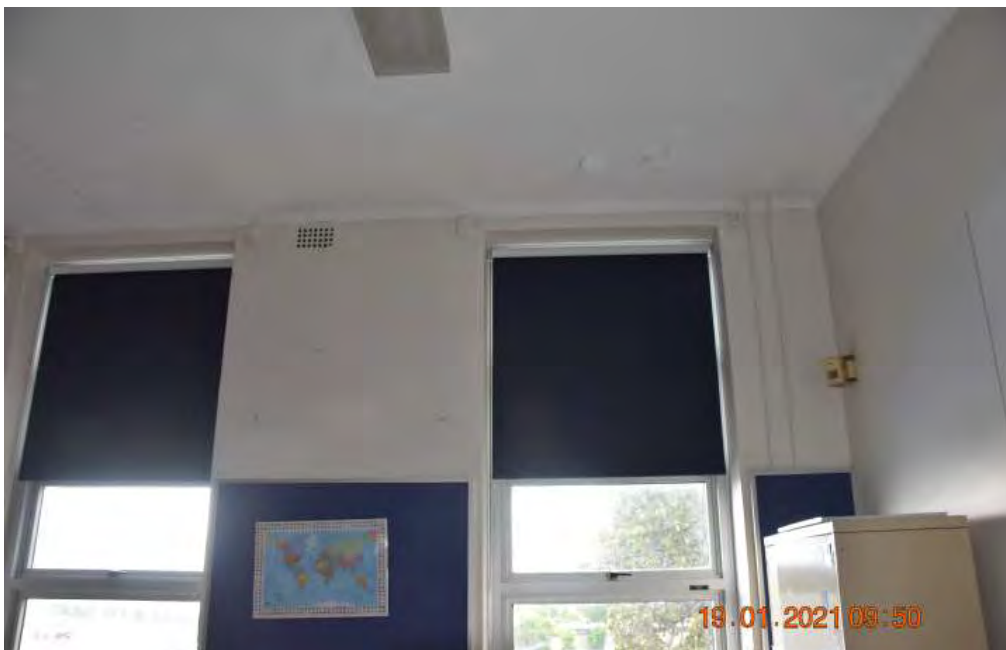
Figure: 0493

General view of the entrance to room 2.

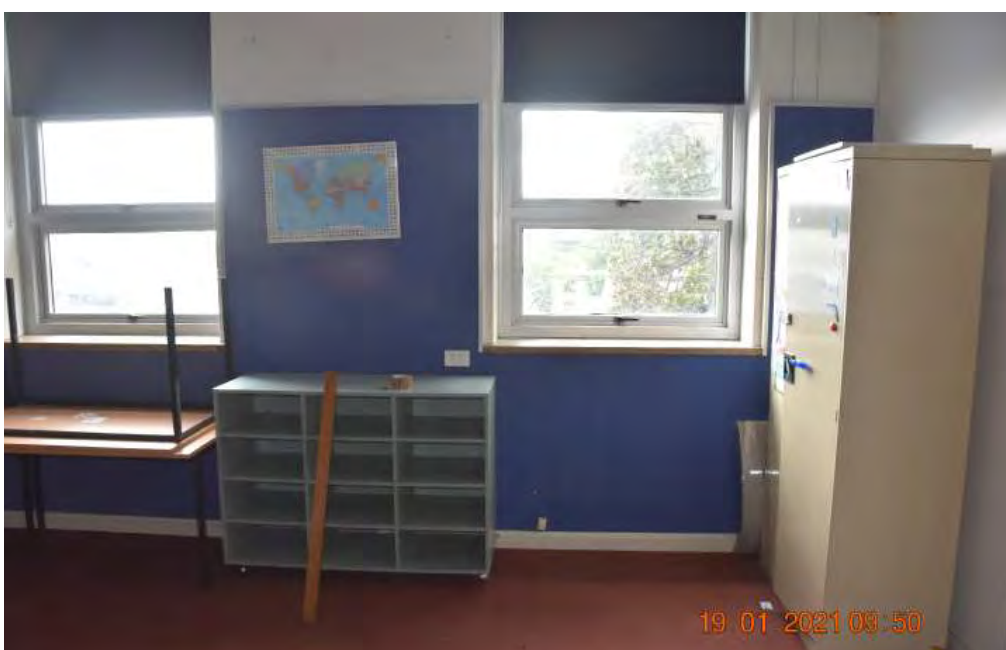
Figure: 0494

East wall in room 2.

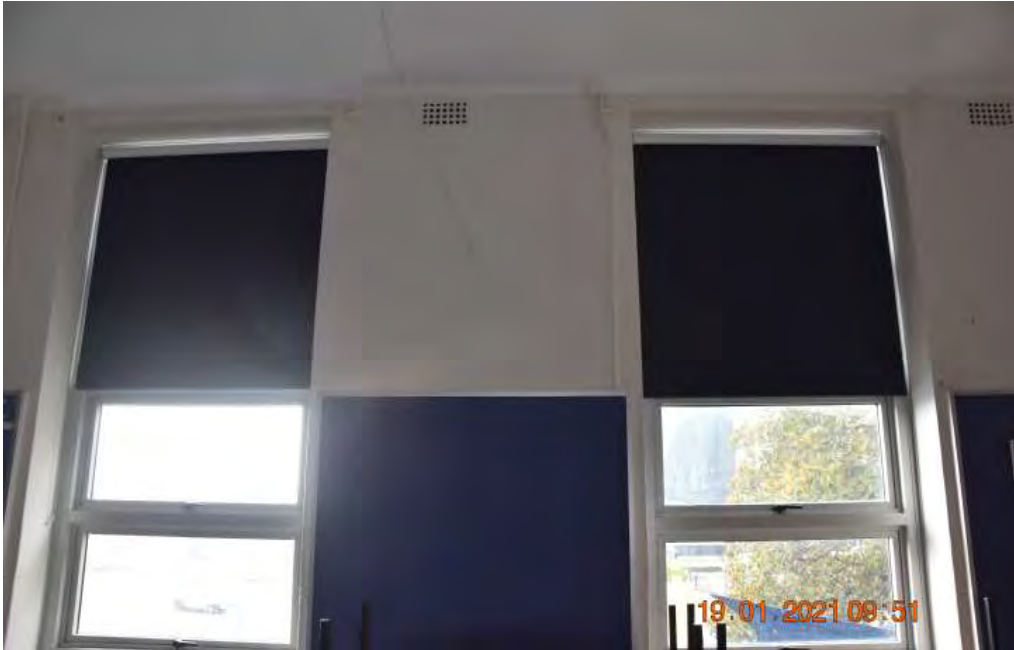
Figure: 0495

East wall in room 2.

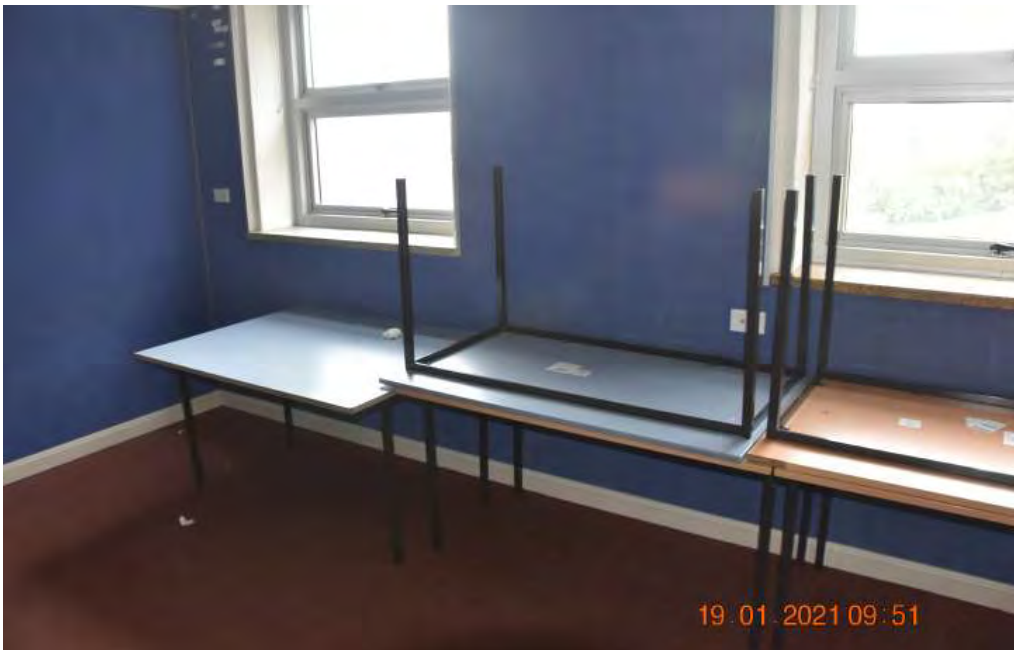
Figure: 0496

East wall in room 2.

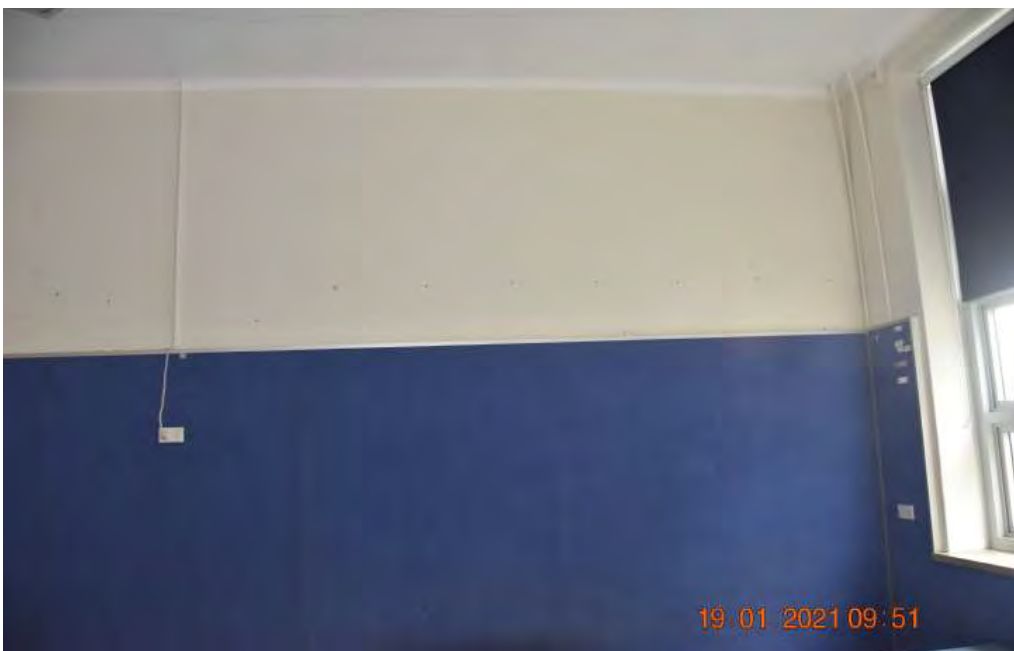
Figure: 0497

East wall in room 2.

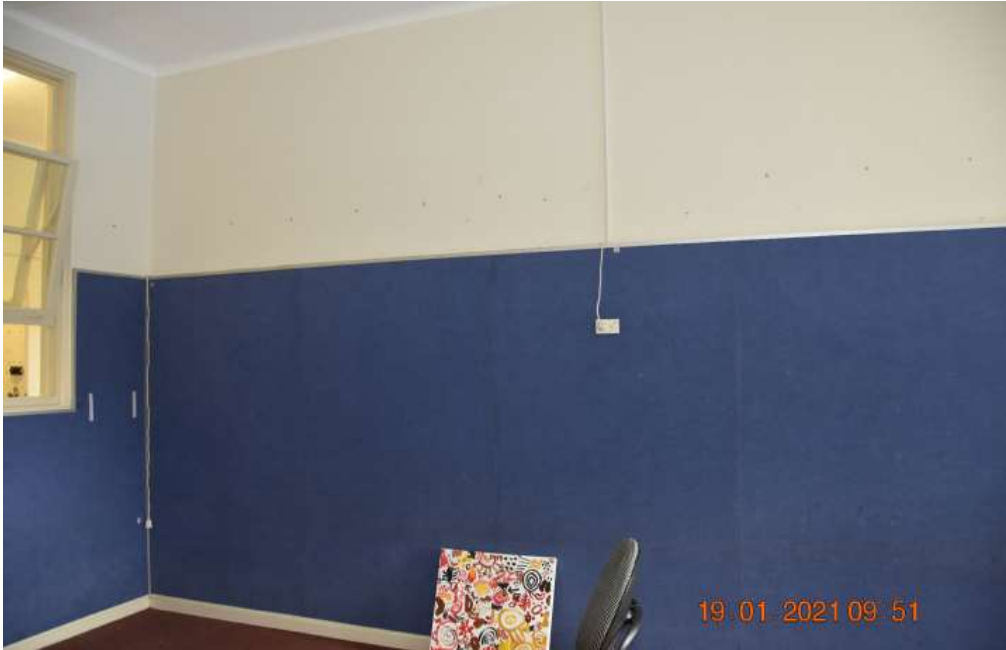
Figure: 0498

North wall in room 2.

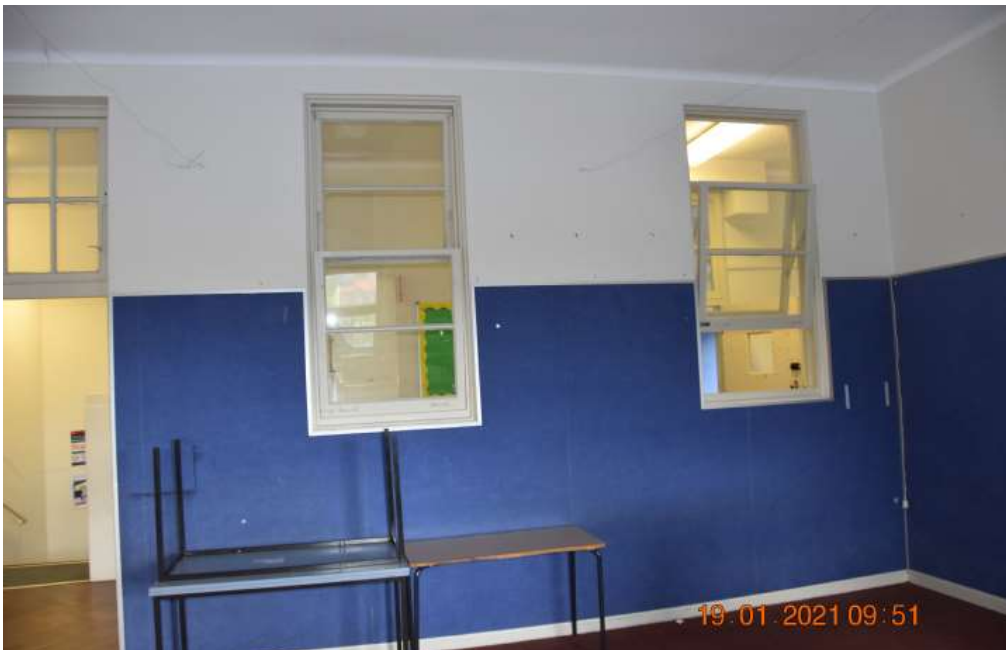
Figure: 0499

North wall in room 2.

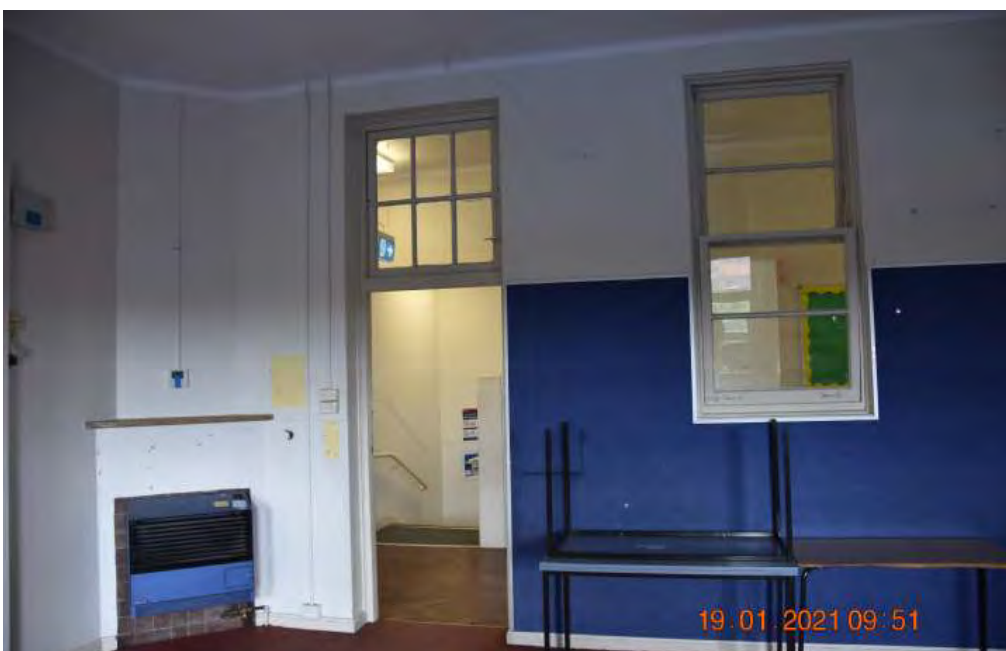
Figure: 0500

West wall in room 2.

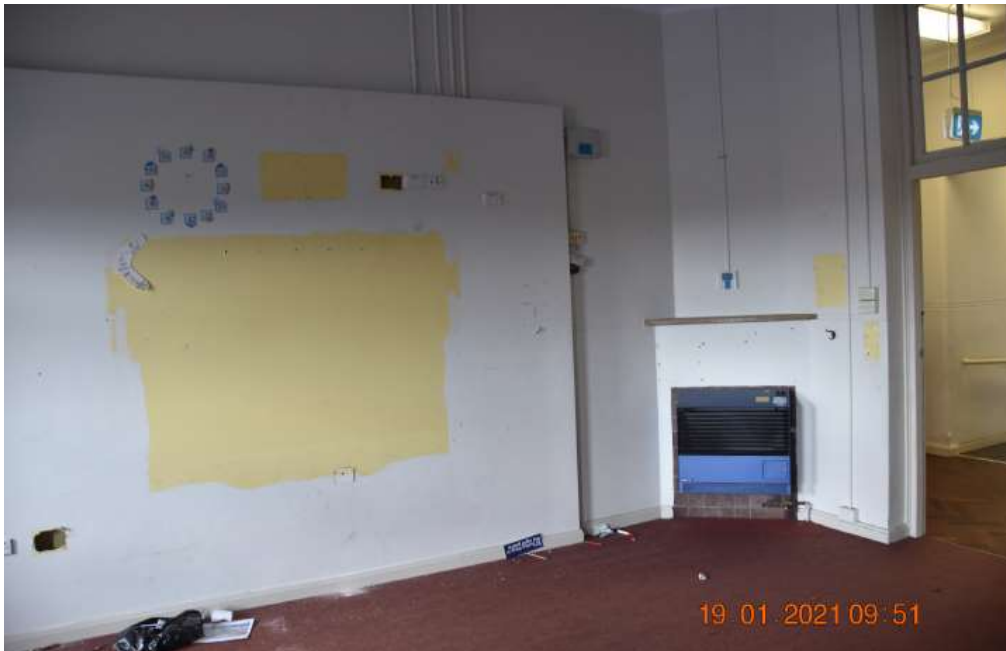
Figure: 0501

West wall in room 2.

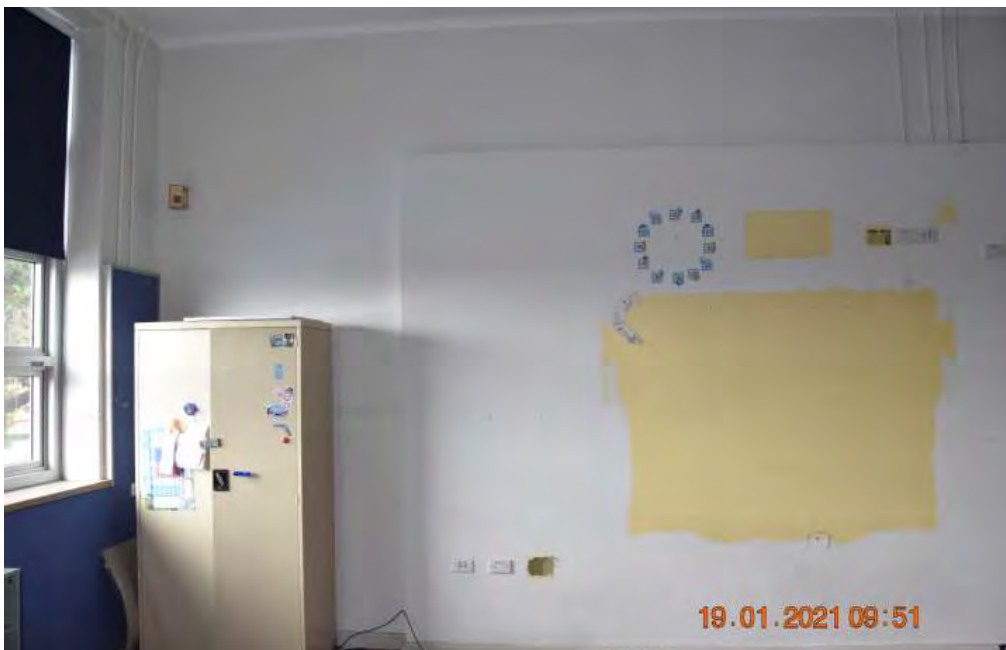
Figure: 0502

South wall in room 2.

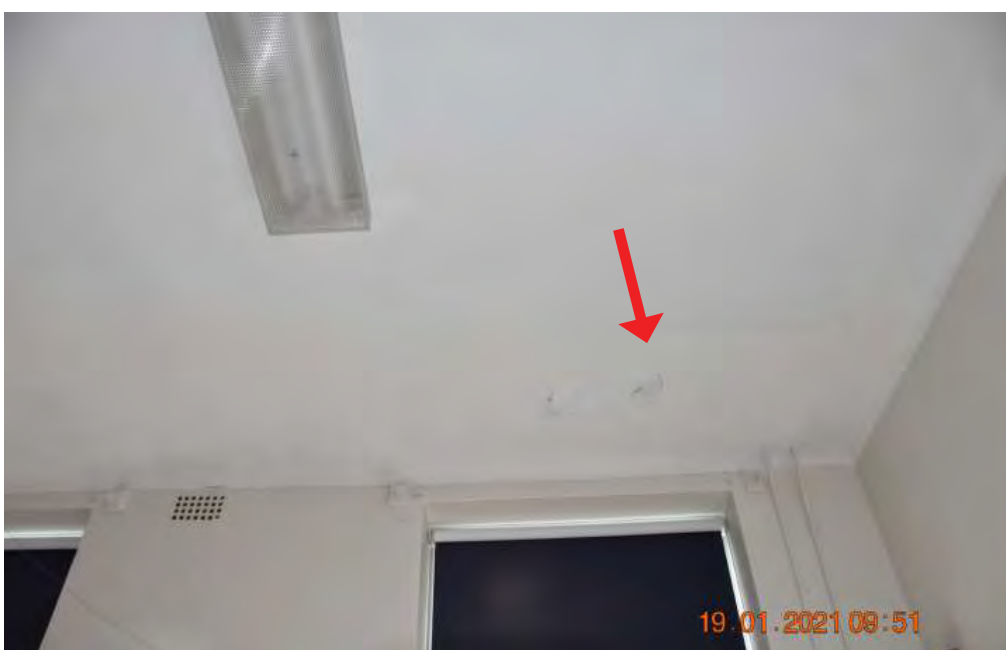
Figure: 0503

South wall in room 2.

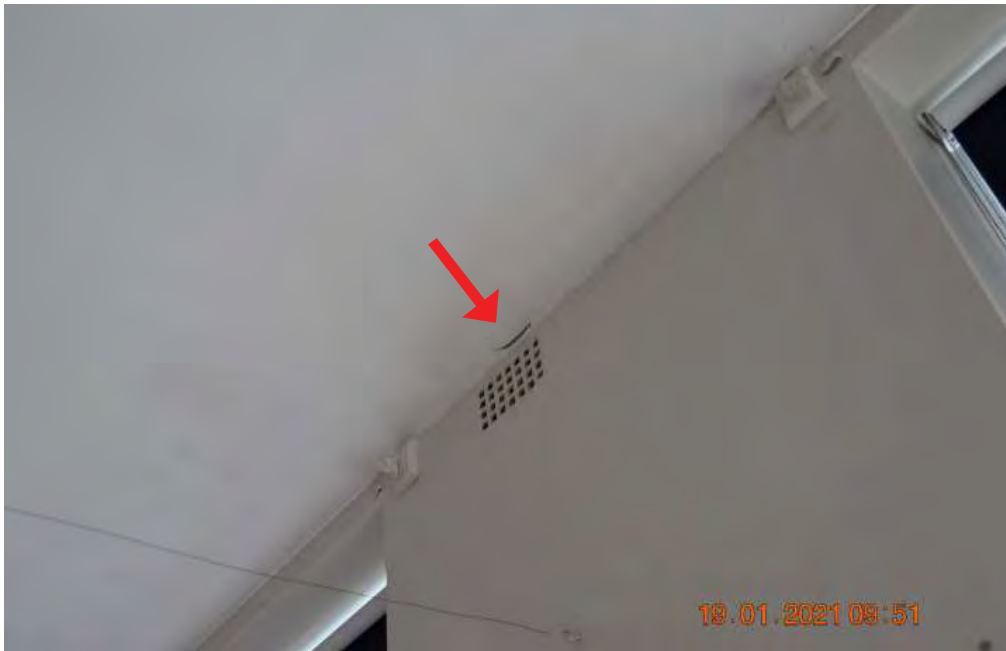
Figure: 0504

Ceiling in room 2.  
Showing peeling paint.

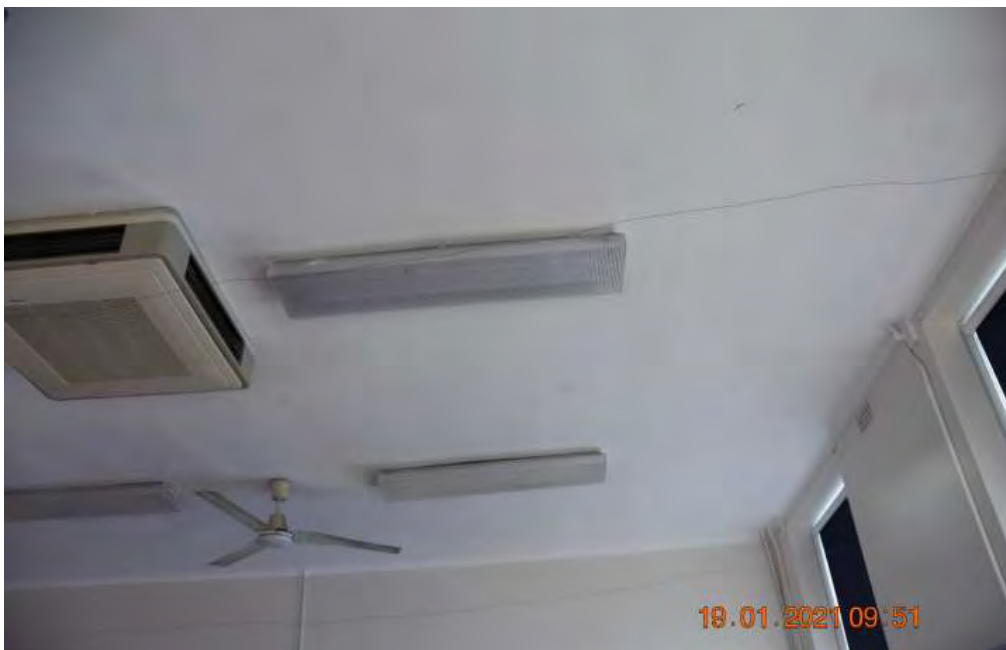
Figure: 0505

Ceiling in room 2.  
Showing peeling paint.

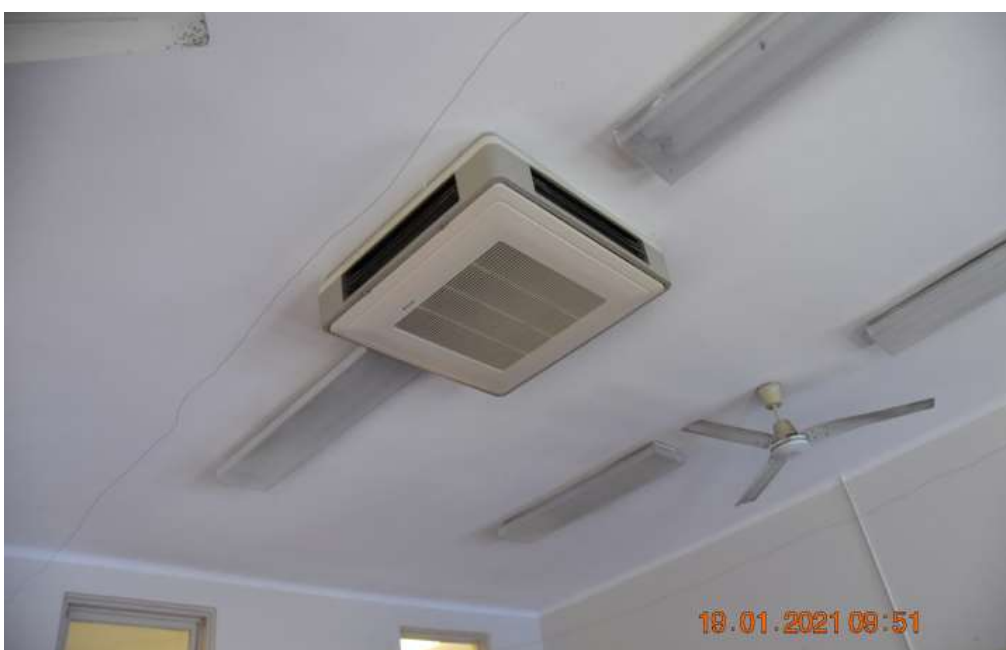
Figure: 0506

Ceiling in room 2.

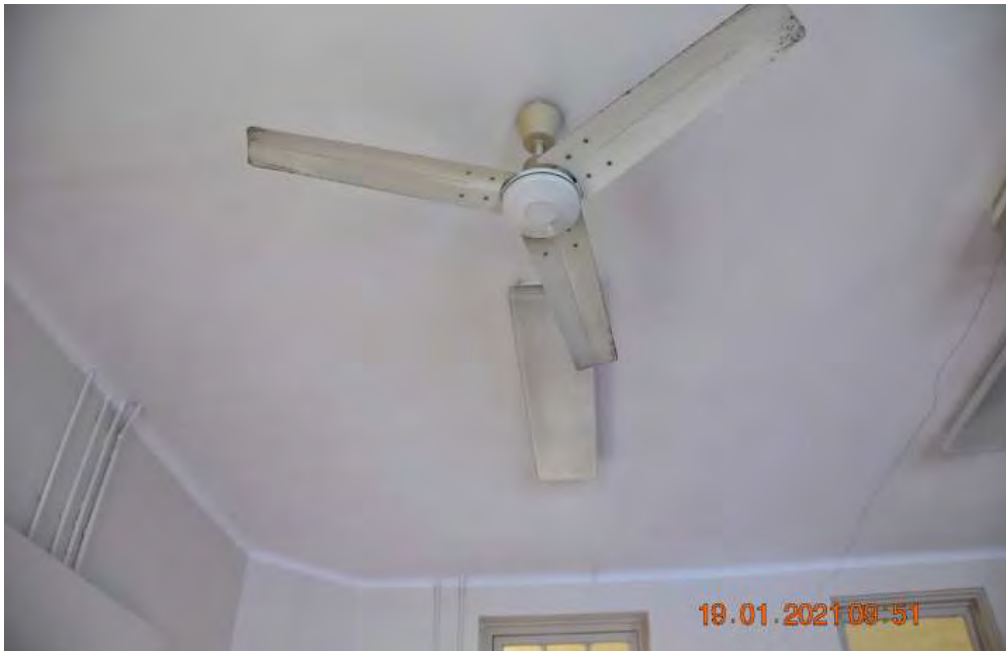
Figure: 0507

Ceiling in room 2.

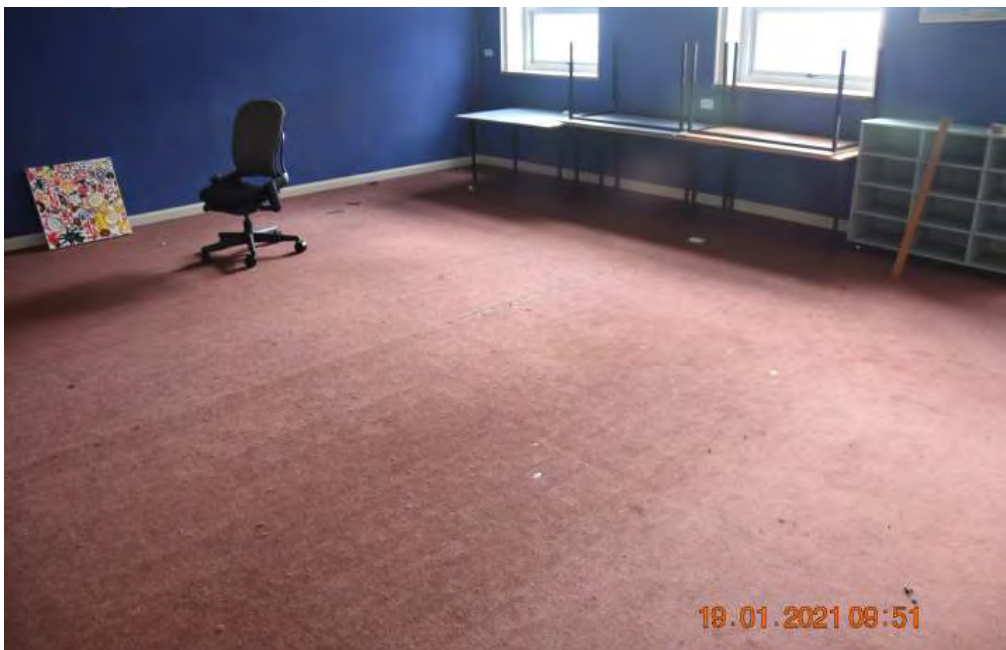
Figure: 0508

Ceiling in room 2.

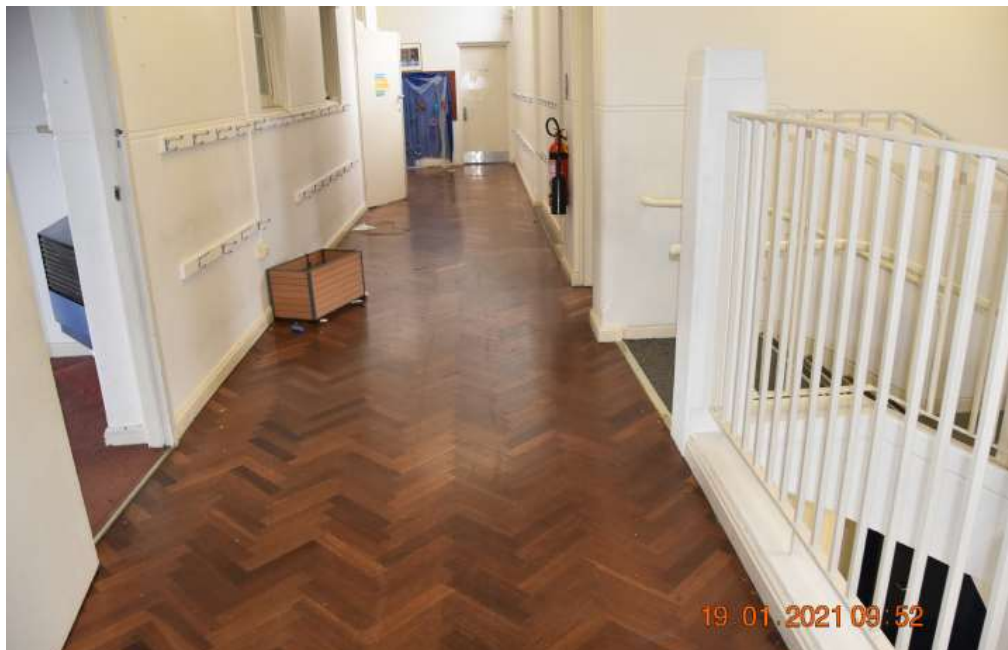
Figure: 0510

General view in the level 1 corridor, looking from the stairway.

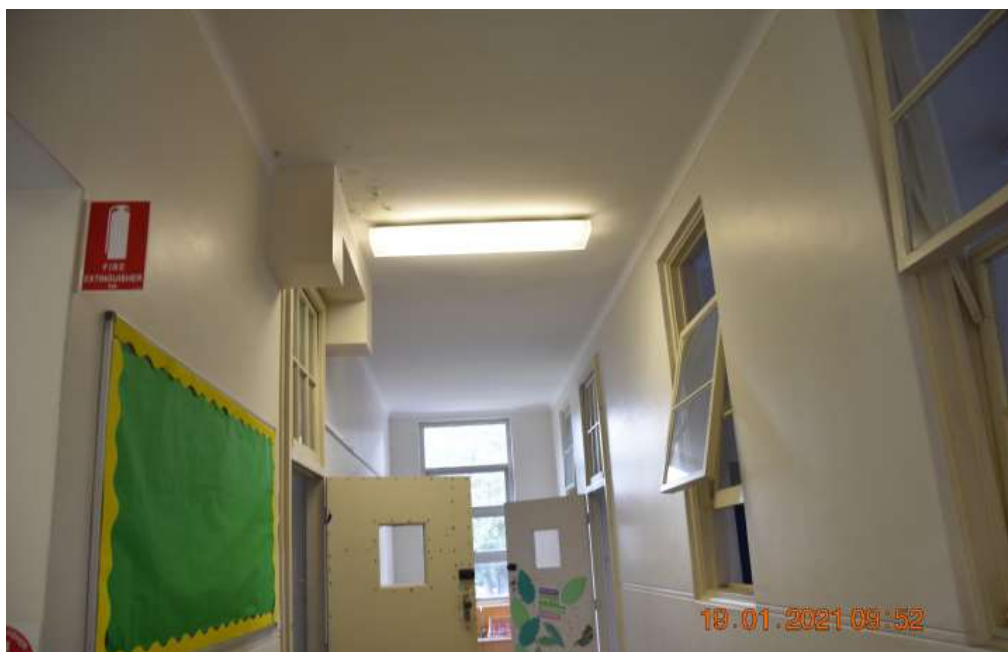
Figure: 0511

General view in the level 1 corridor, looking from the stairway.

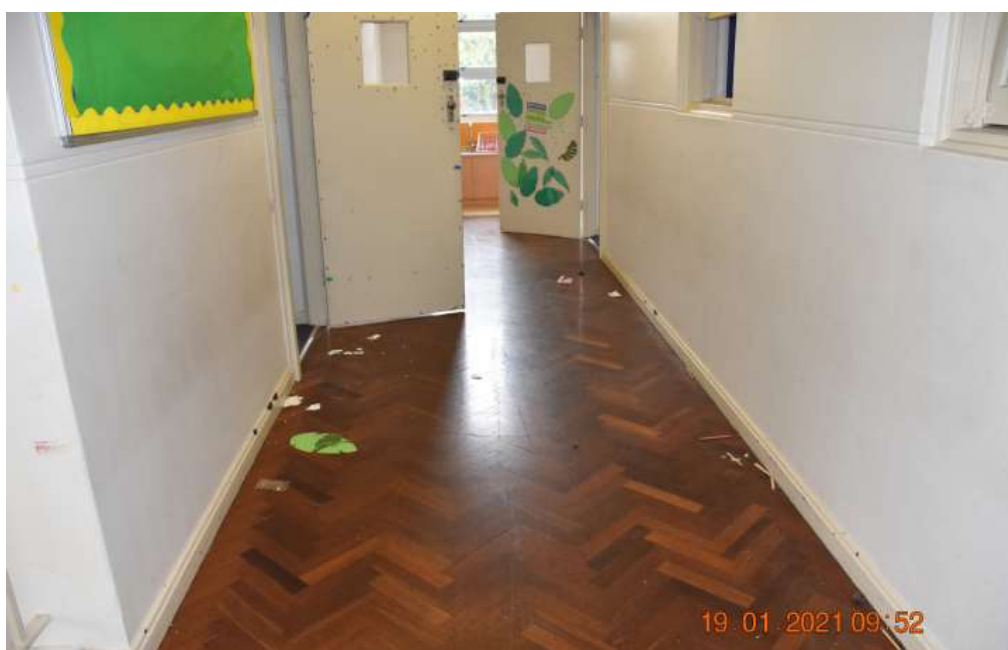
Figure: 0512

West wall in the level 1 corridor, looking from the stairway.

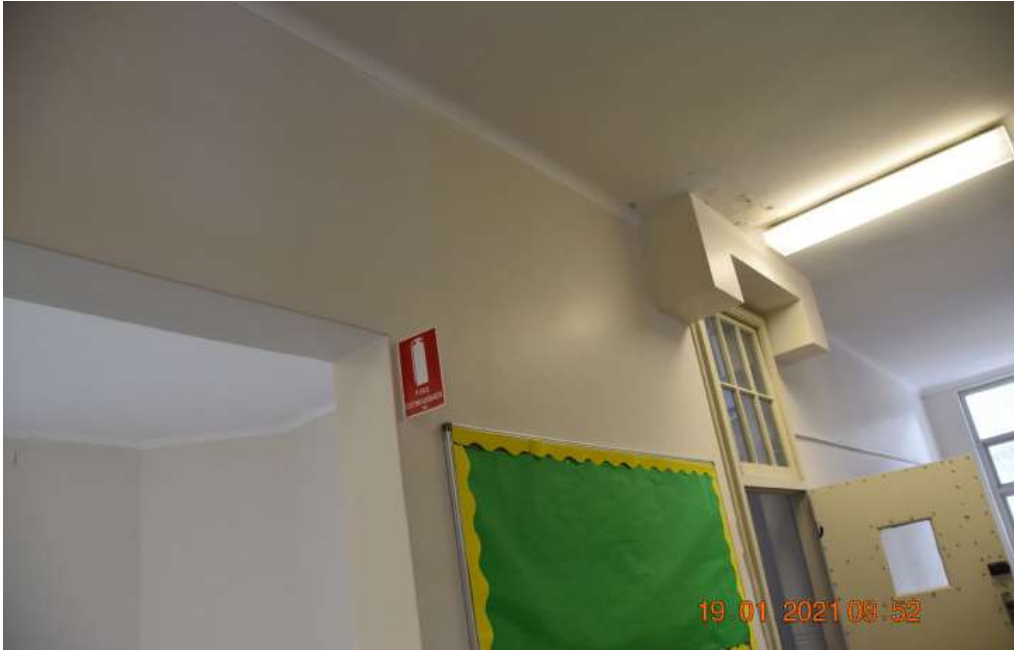
Figure: 0513

West wall in the level 1 corridor, looking from the stairway.

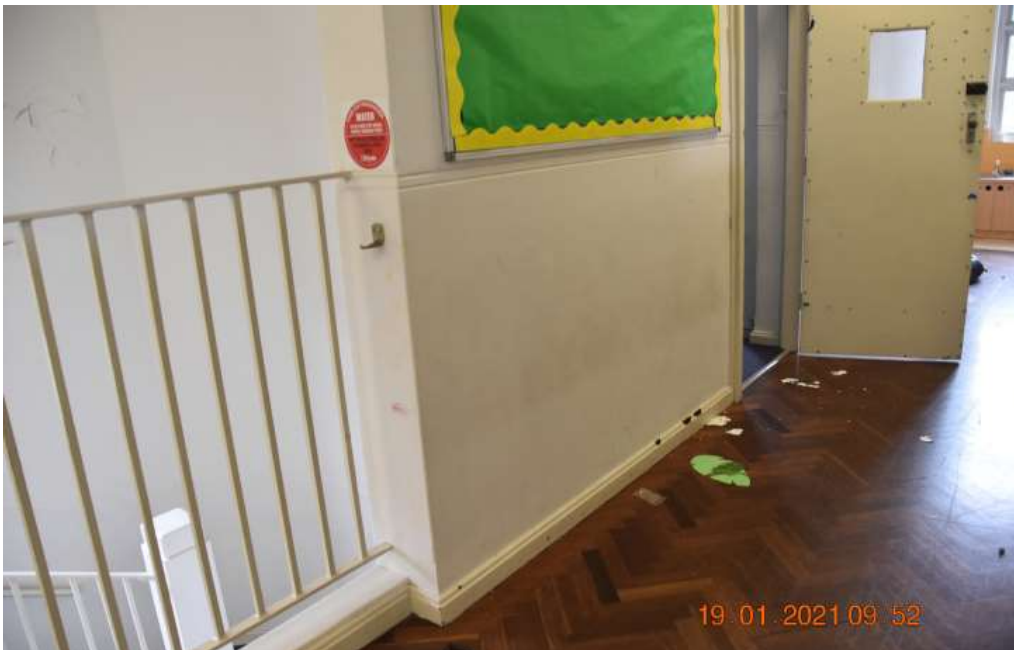
Figure: 0514

West wall in the level 1 corridor, looking from the stairway.

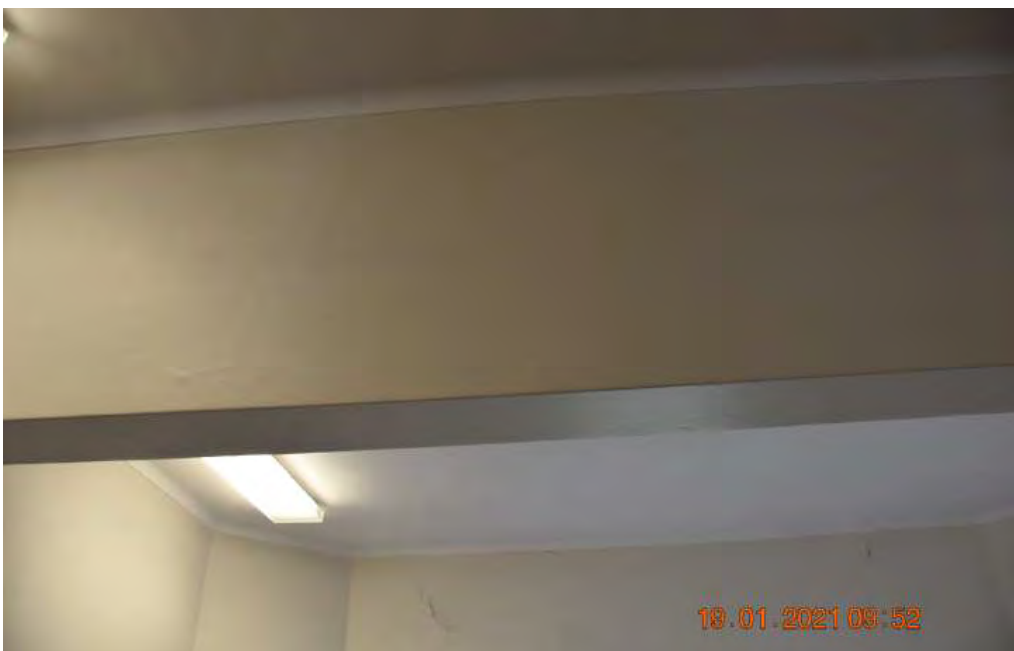
Figure: 0515

West wall in the level 1 corridor, looking from the stairway.

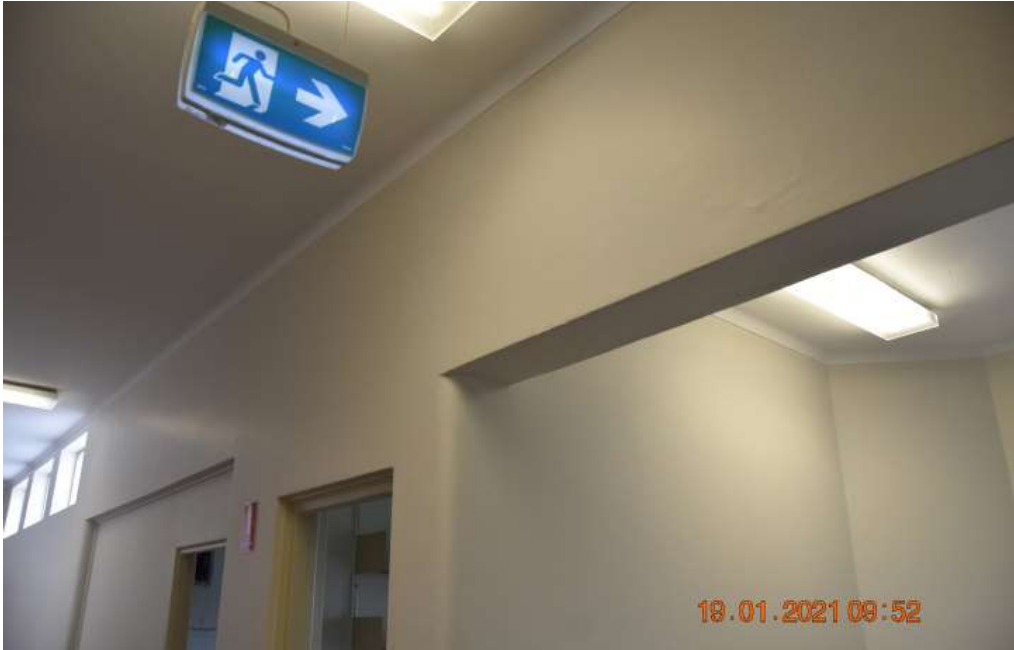
Figure: 0516

East wall in the level 1 corridor, looking from the stairway.

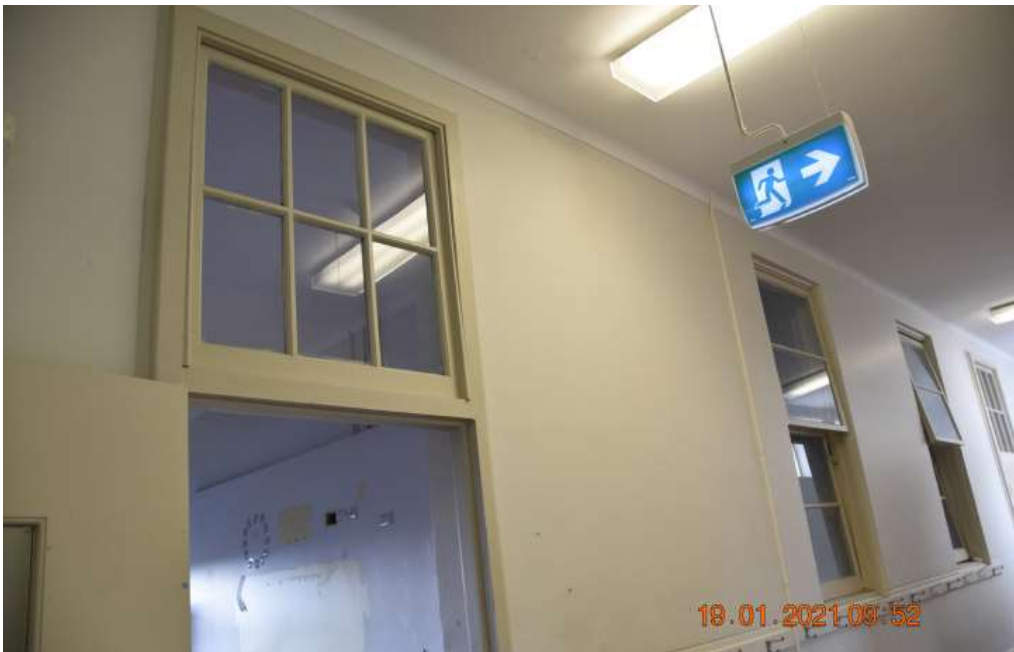
Figure: 0517

East wall in the level 1 corridor, looking from the stairway.

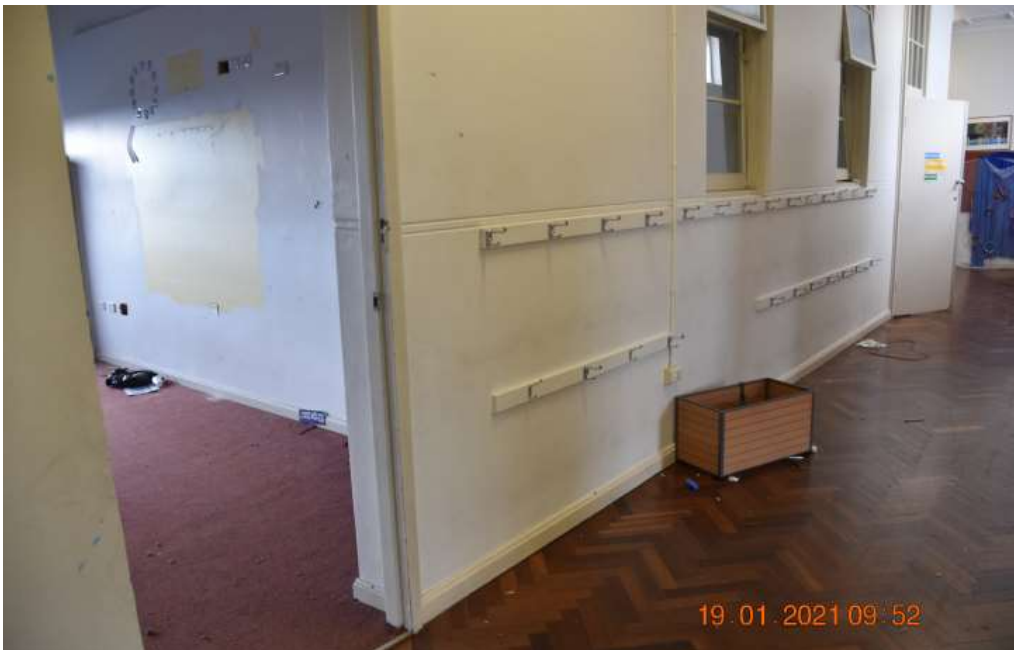
Figure: 0518

East wall in the level 1 corridor, looking from the stairway.

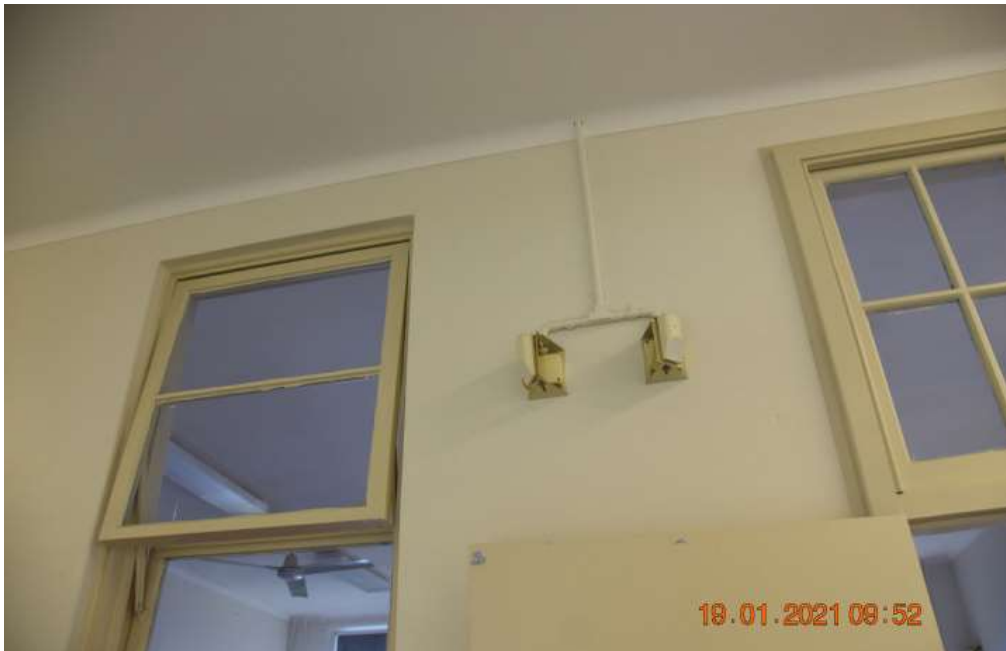
Figure: 0519

East wall in the level 1 corridor, looking from the stairway.
