## PRE CONSTRUCTION CONDITION SURVEY

Fort Street Public School, Millers Point NSW

Upper Fort Street Public School  
MILLERS POINT NSW 2000

19 January 2021

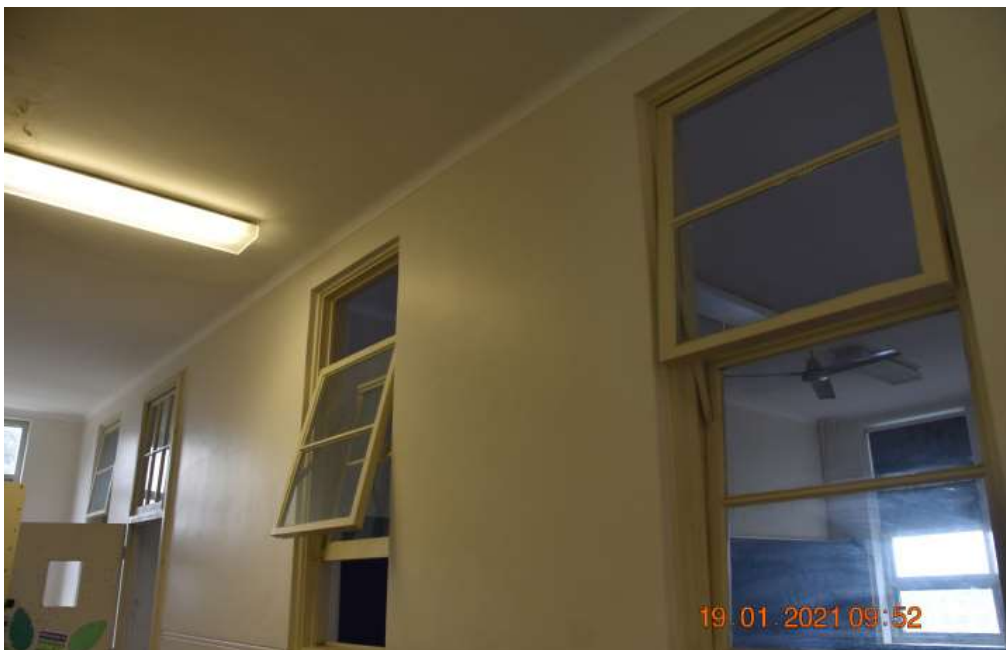
Figure: 0520

West wall in the level 1 corridor, looking from the emerald classroom.

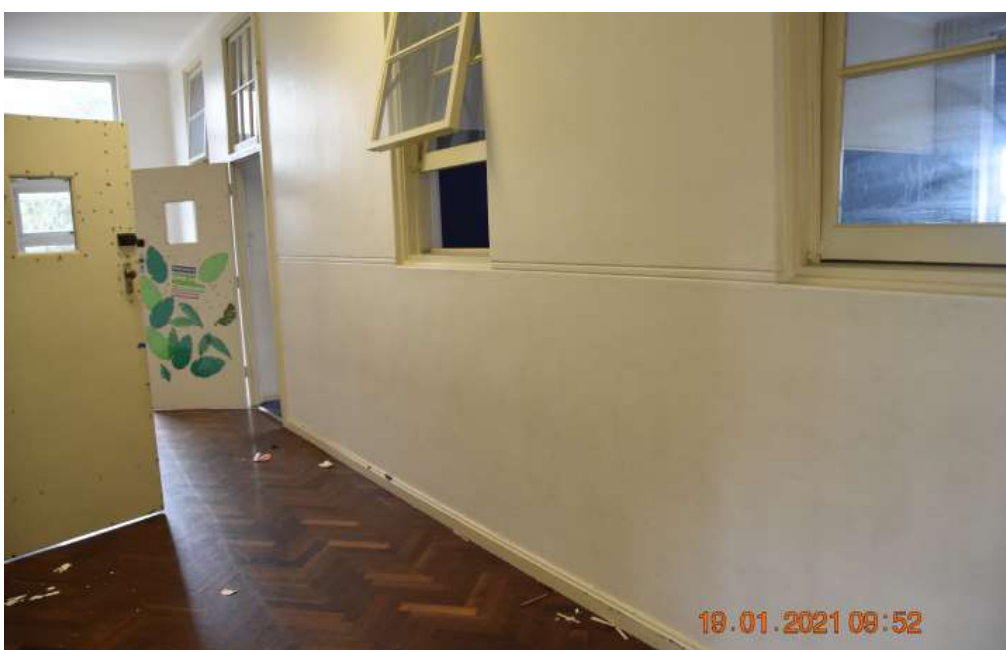
Figure: 0521

West wall in the level 1 corridor, looking from the emerald classroom.

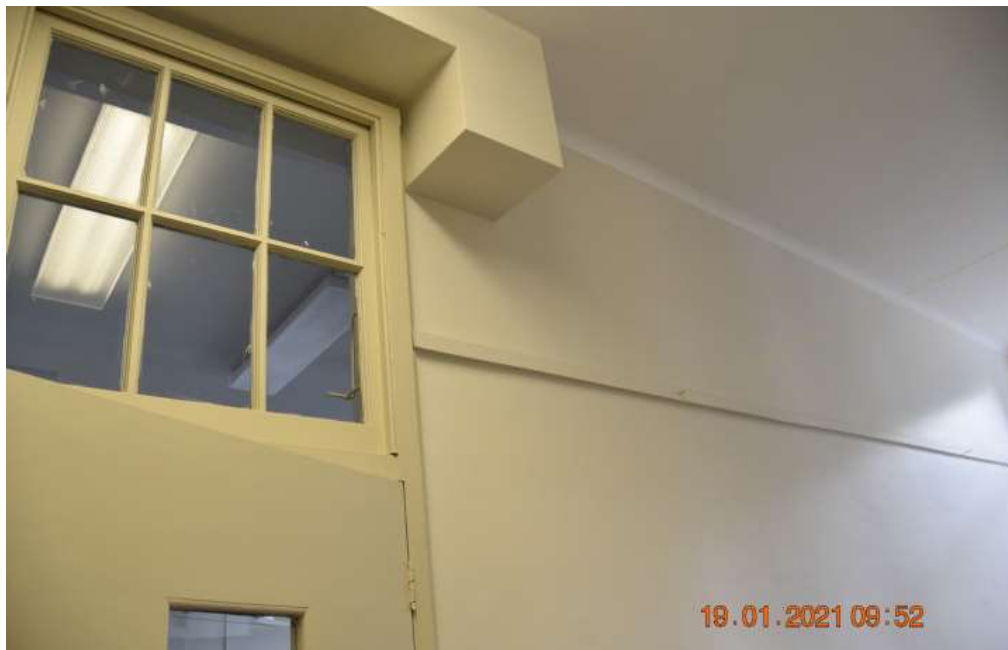
Figure: 0522

West wall in the level 1 corridor, looking from the emerald classroom.

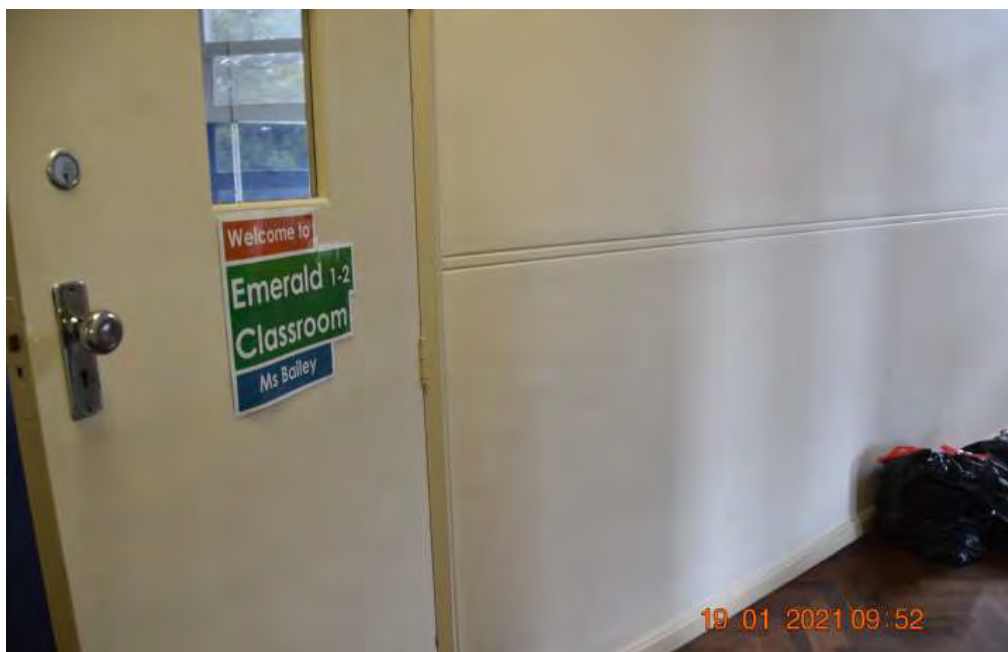
Figure: 0523

West wall in the level 1 corridor, looking from the emerald classroom.

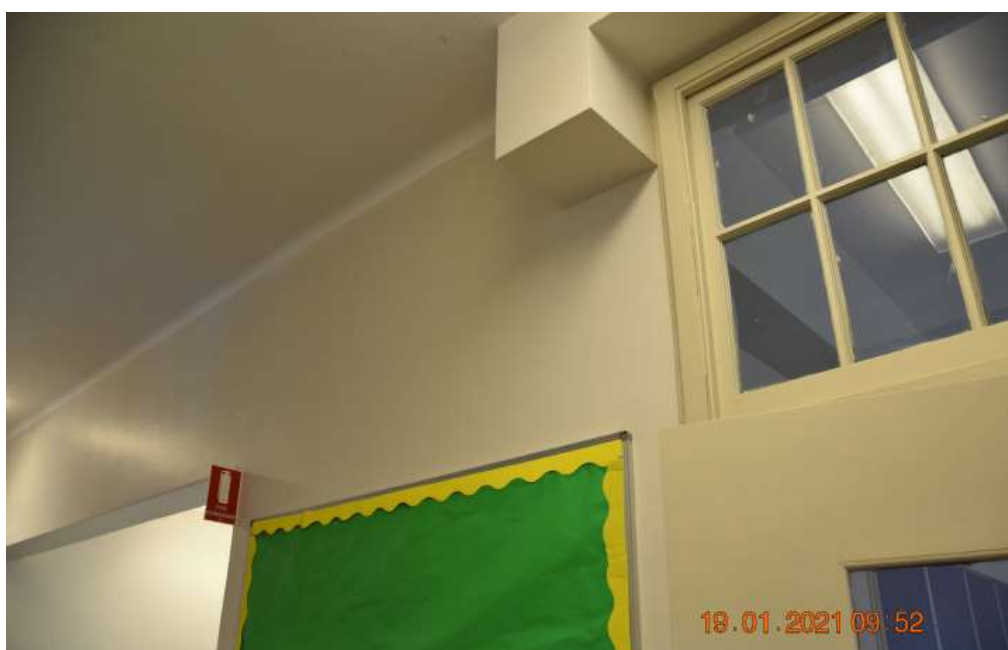
Figure: 0524

West wall in the level 1 corridor, looking from the emerald classroom.

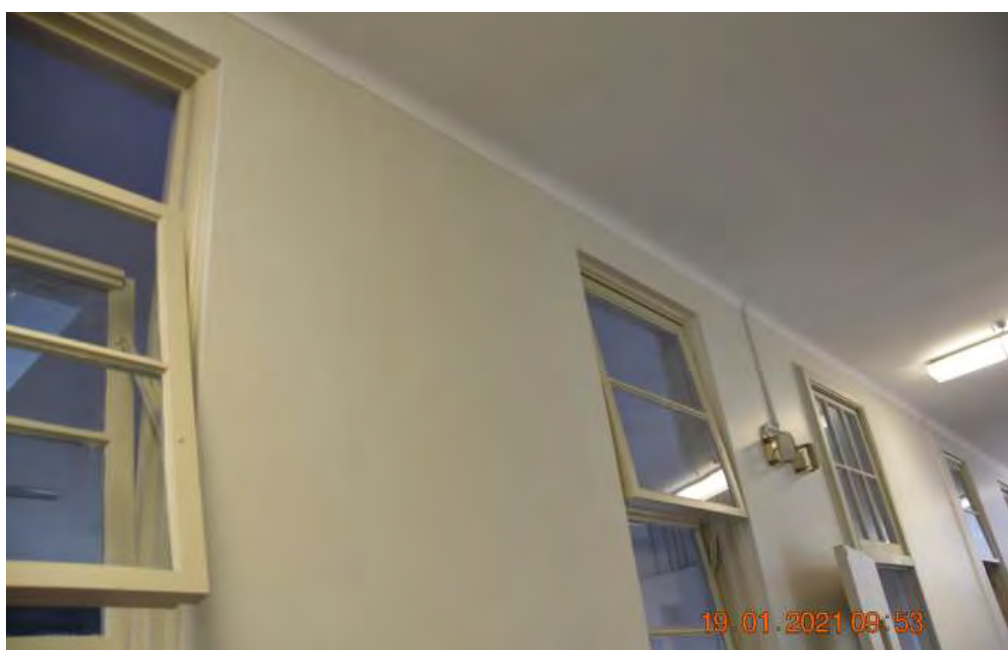
Figure: 0527

Water damage in the level 1 corridor, looking from the emerald classroom.

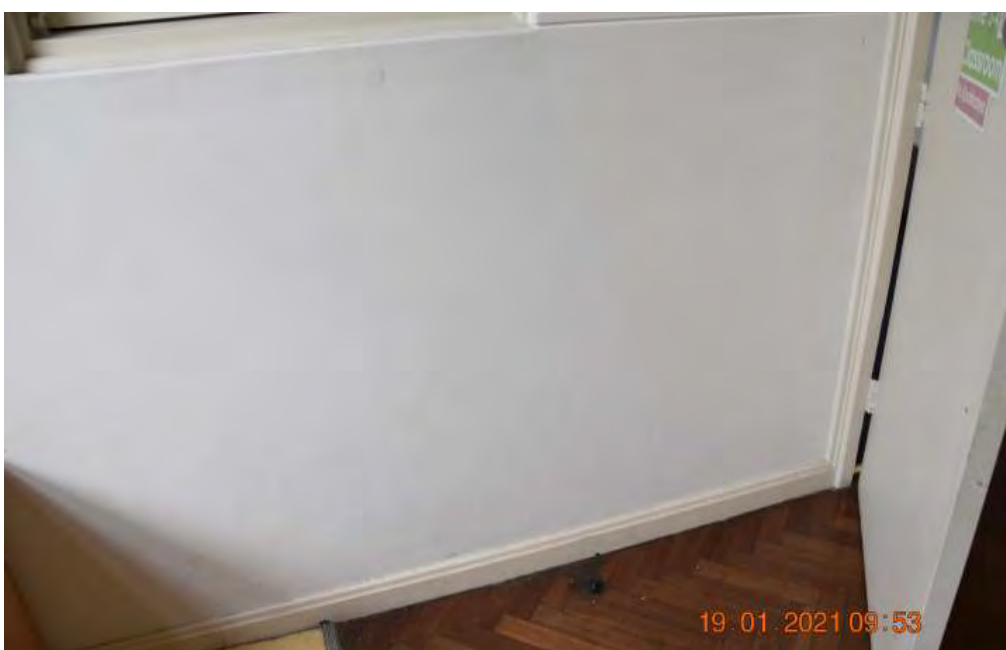
Figure: 0536

East wall in the level 1 corridor, north side. Showing cracking.

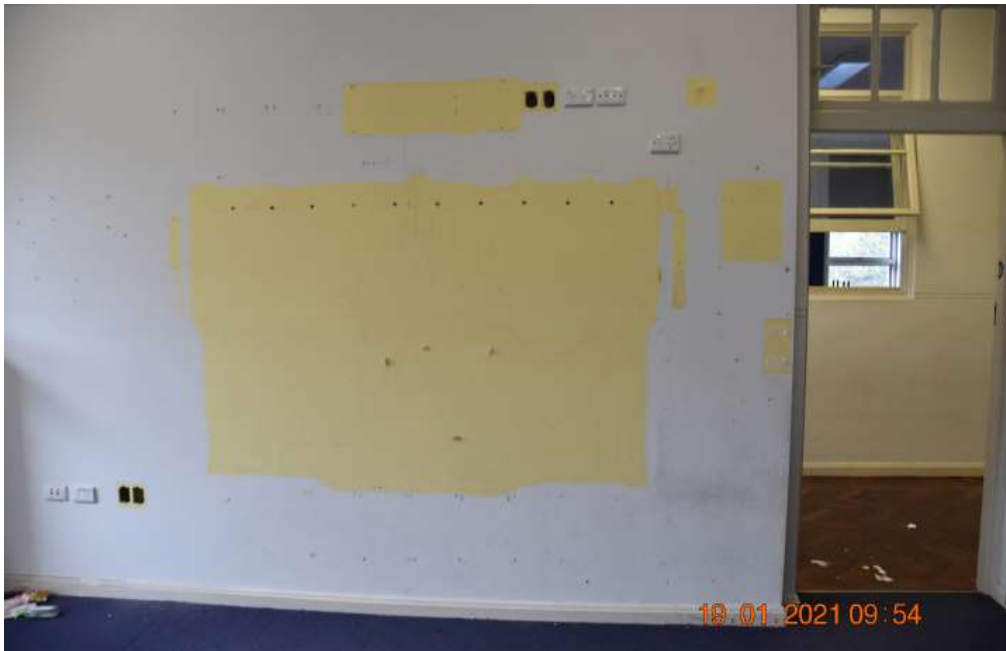
Figure: 0543

East wall in the emerald classroom. Showing nail markings.

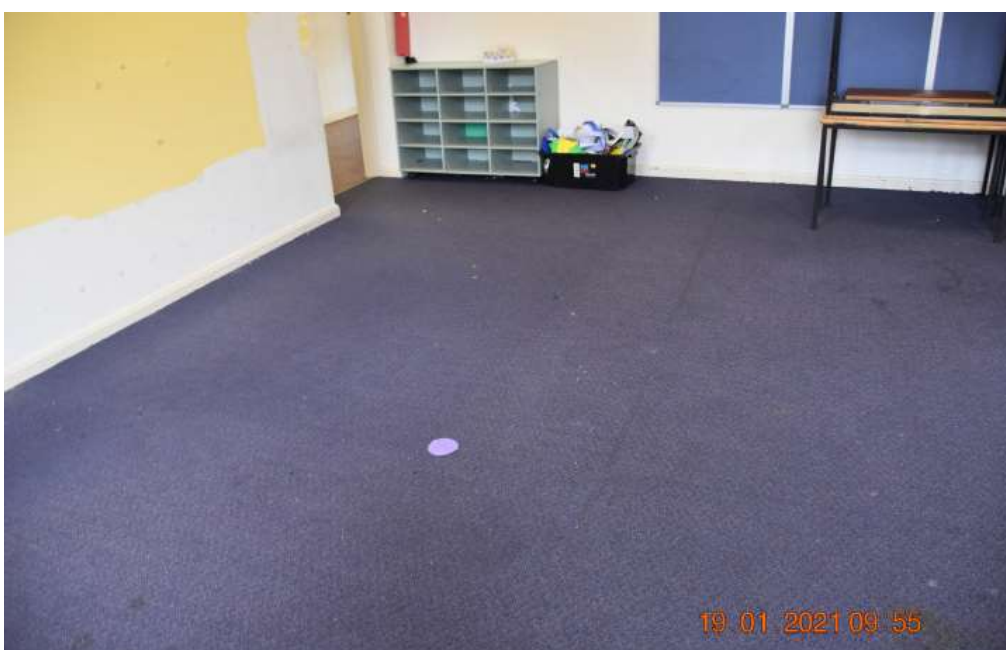
Figure: 0557

Staining in the ceiling cornice in the northeast corner in the emerald classroom.

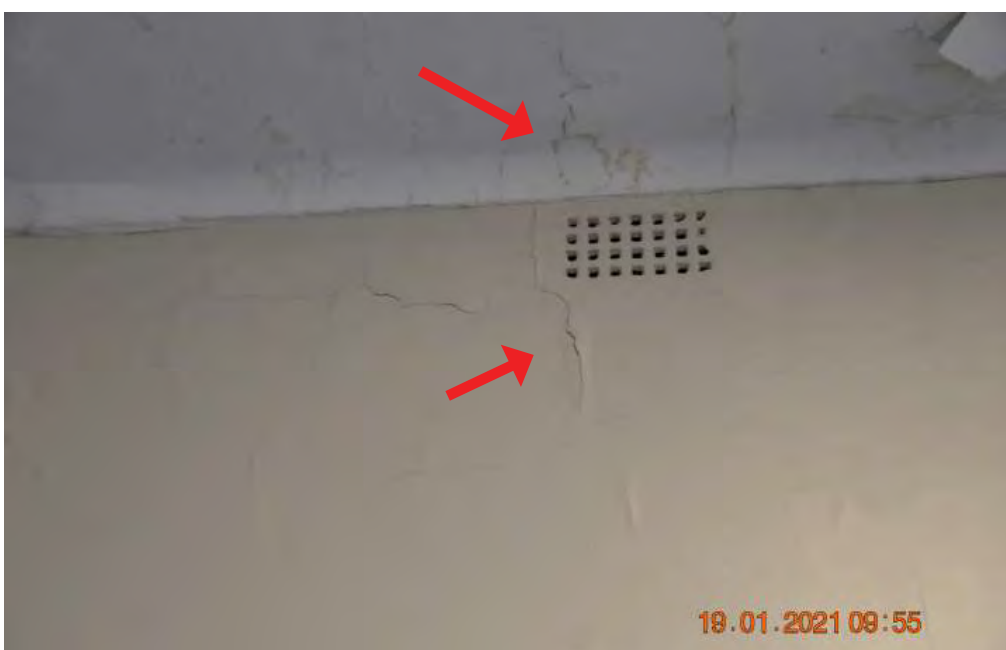
Figure: 0563

Water damage in the emerald classroom, west side.

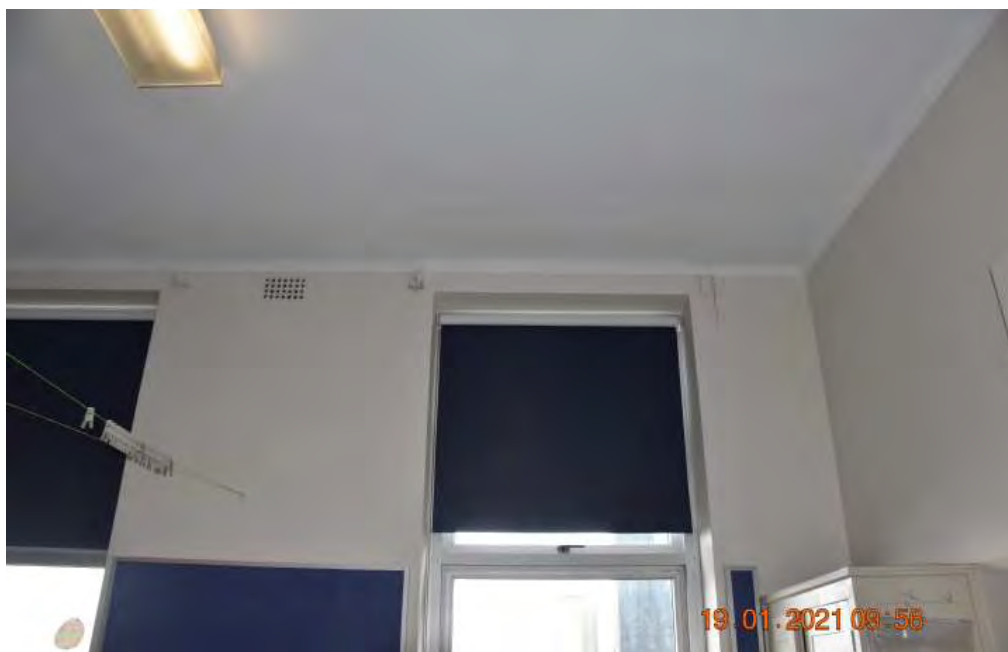
Figure: 0566

East wall in the lime classroom.

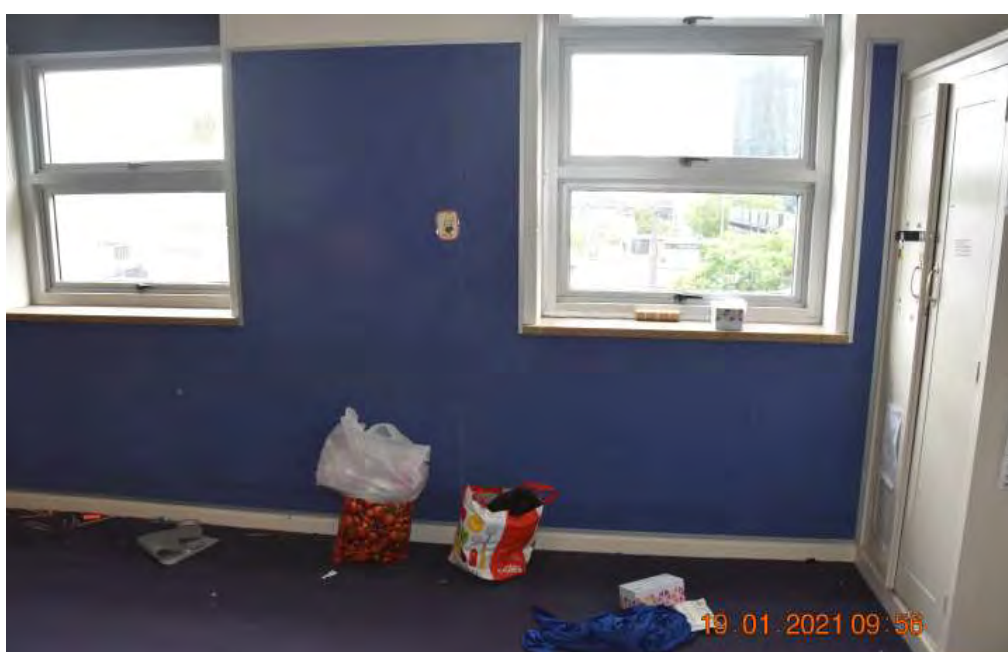
Figure: 0567

East wall in the lime classroom.

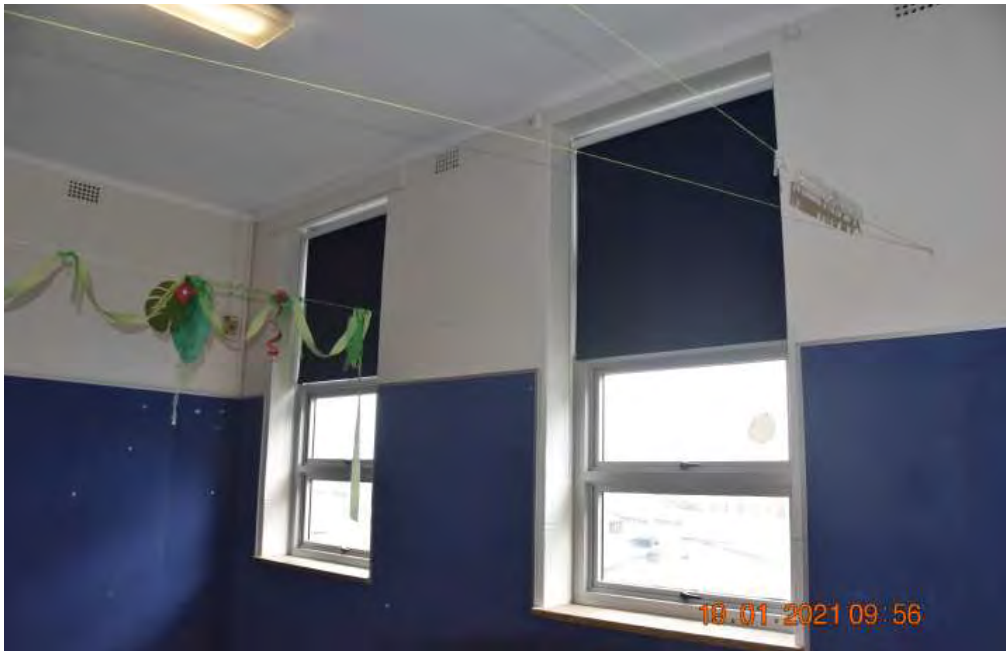
Figure: 0568

East wall in the lime classroom.

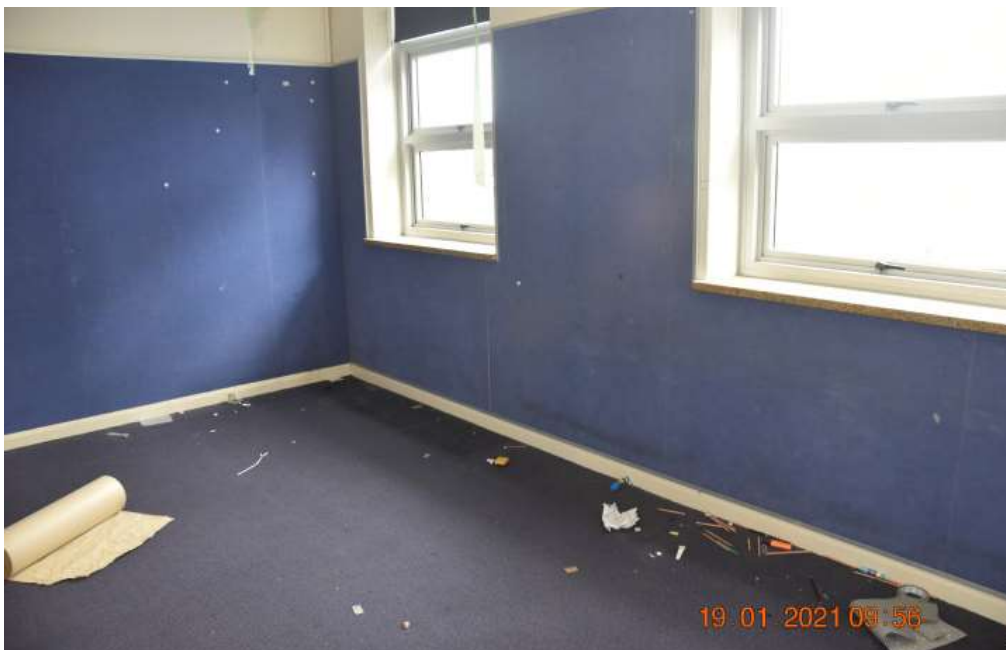
Figure: 0569

East wall in the lime classroom.

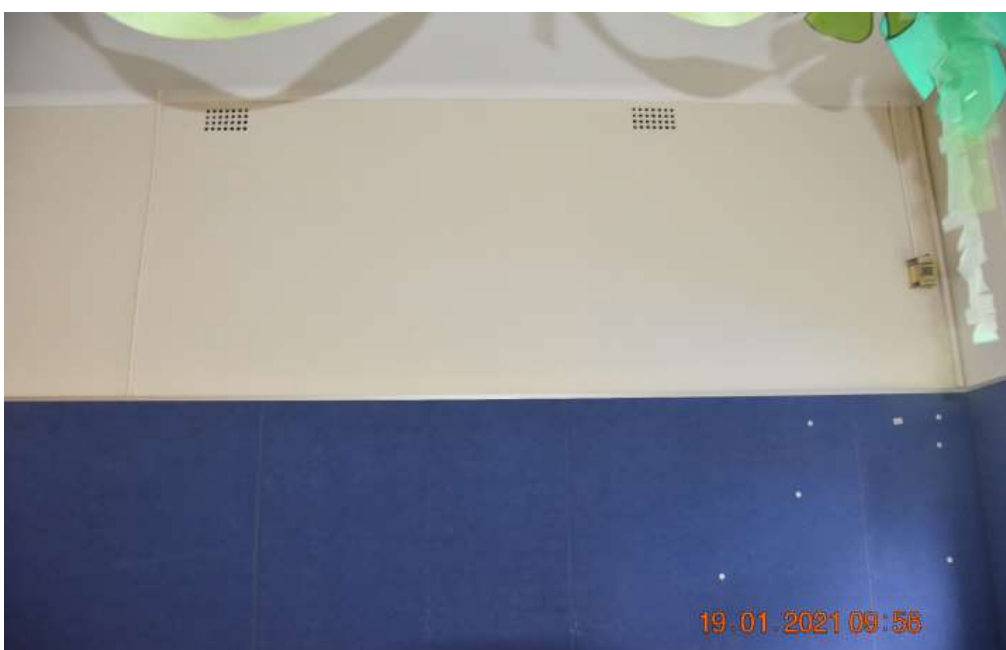
Figure: 0570

North wall in the lime classroom.

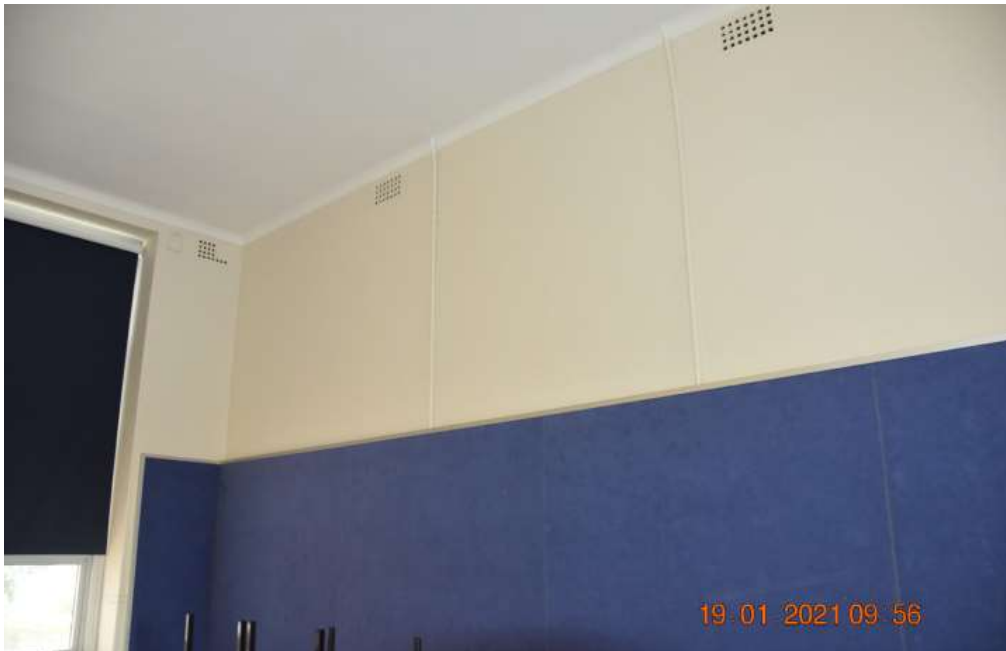
Figure: 0571

North wall in the lime classroom.

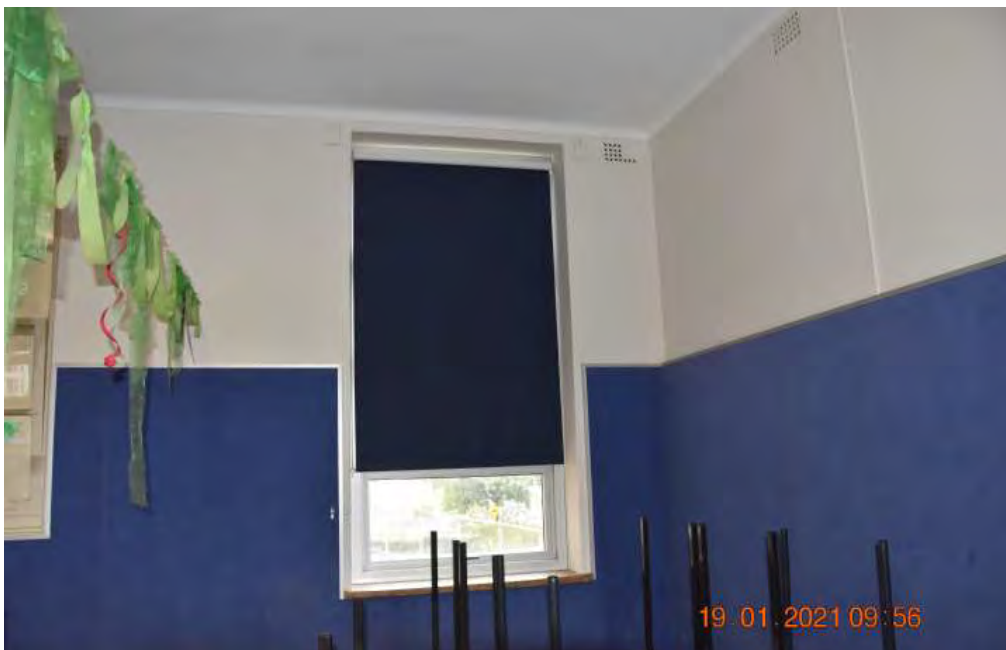
Figure: 0572

West wall in the lime classroom.

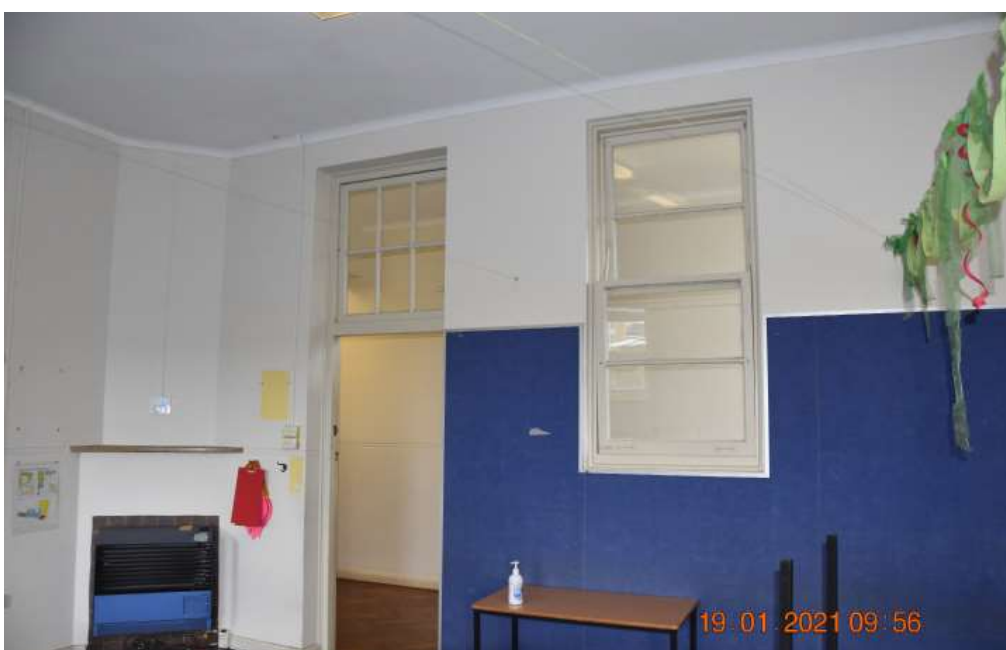
Figure: 0573

West wall in the lime classroom.

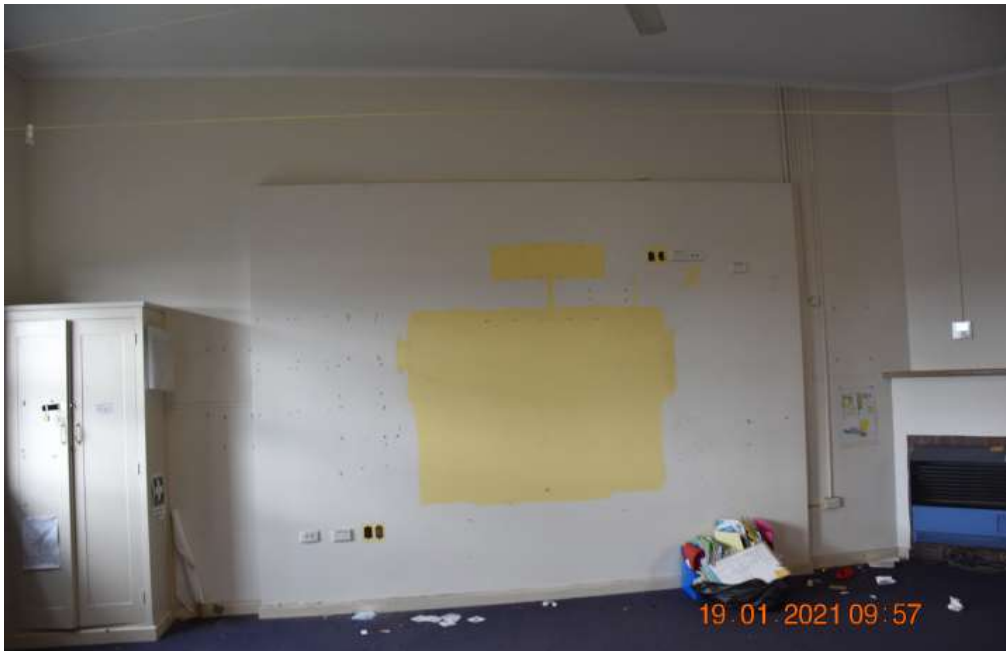
Figure: 0574

South wall in the lime classroom.

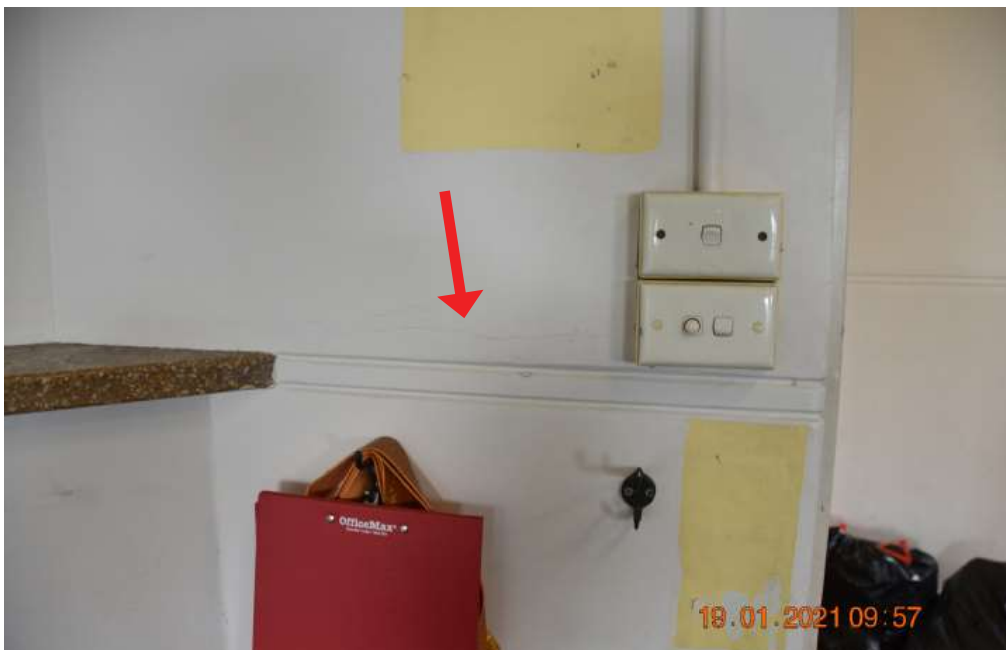
Figure: 0575

Fine cracking in the west wall in the lime classroom.

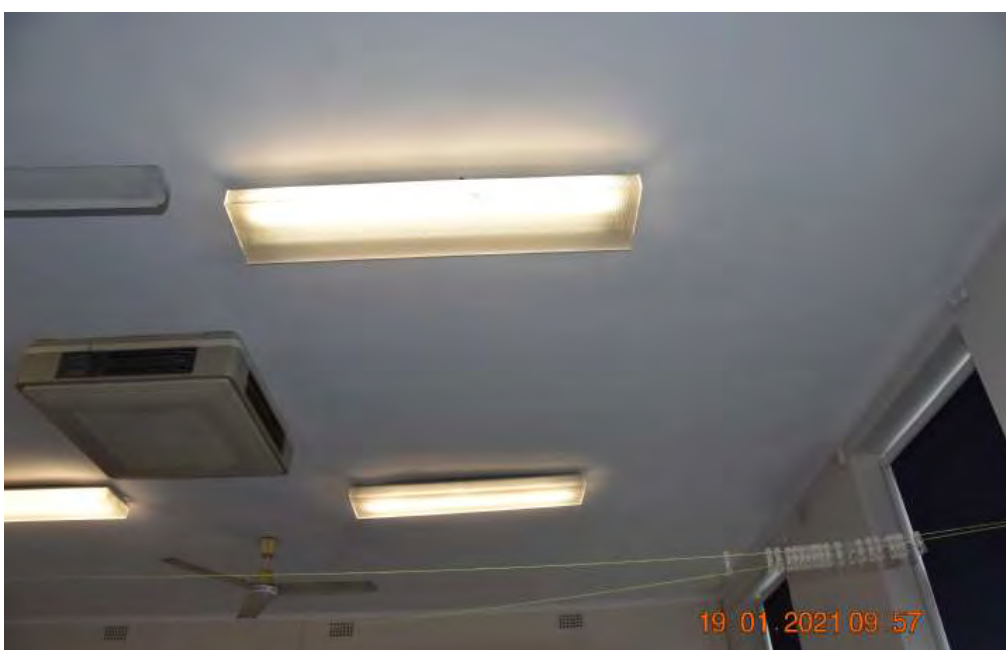
Figure: 0576

Ceiling in the lime classroom.

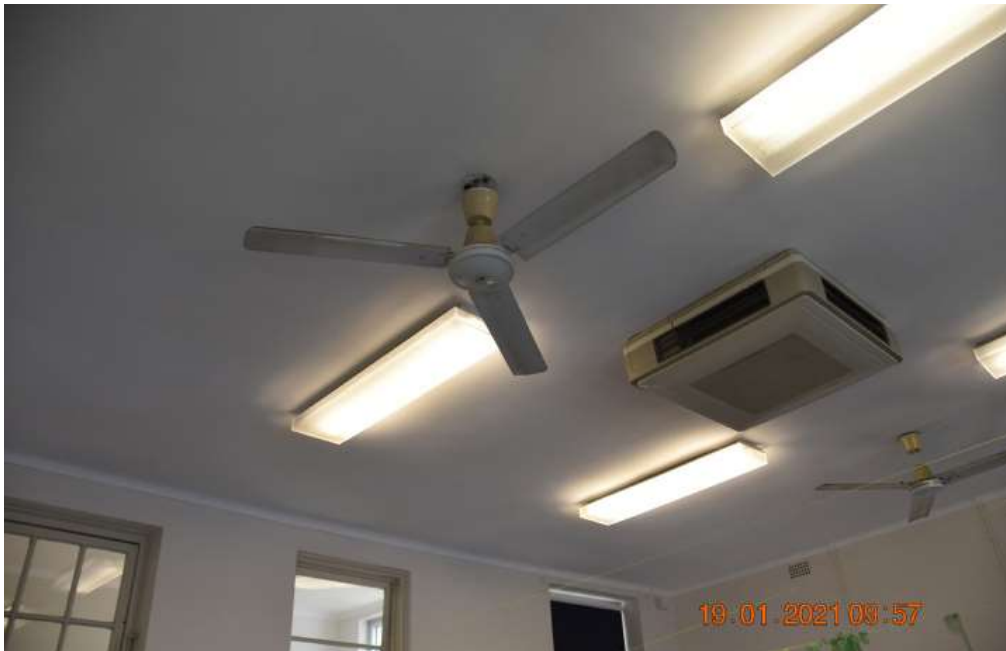
Figure: 0577

Ceiling in the lime classroom.

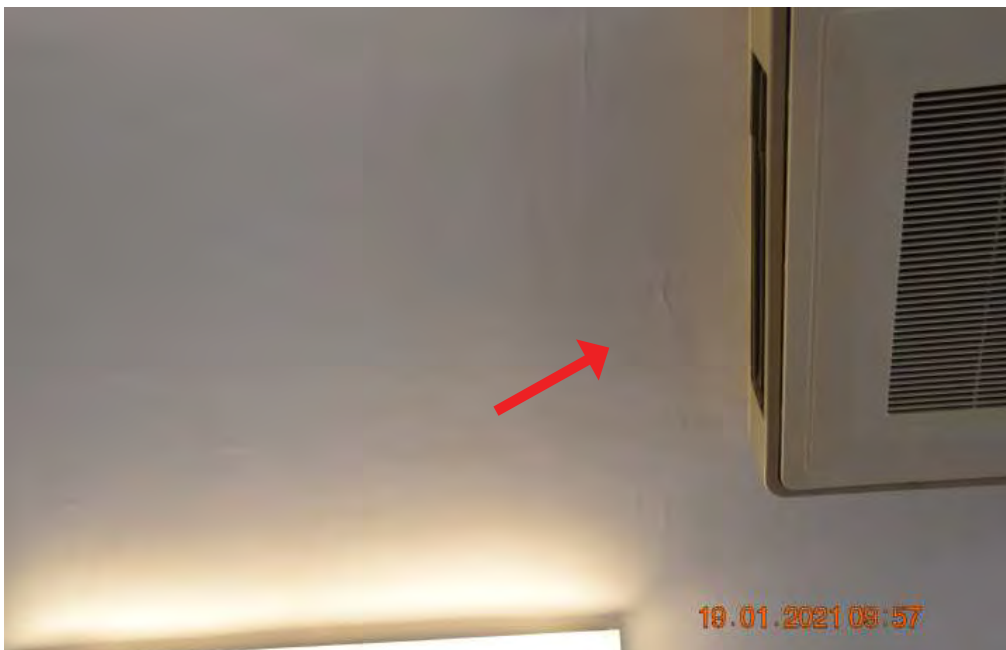
Figure: 0578

Crazing in the ceiling in the lime classroom.

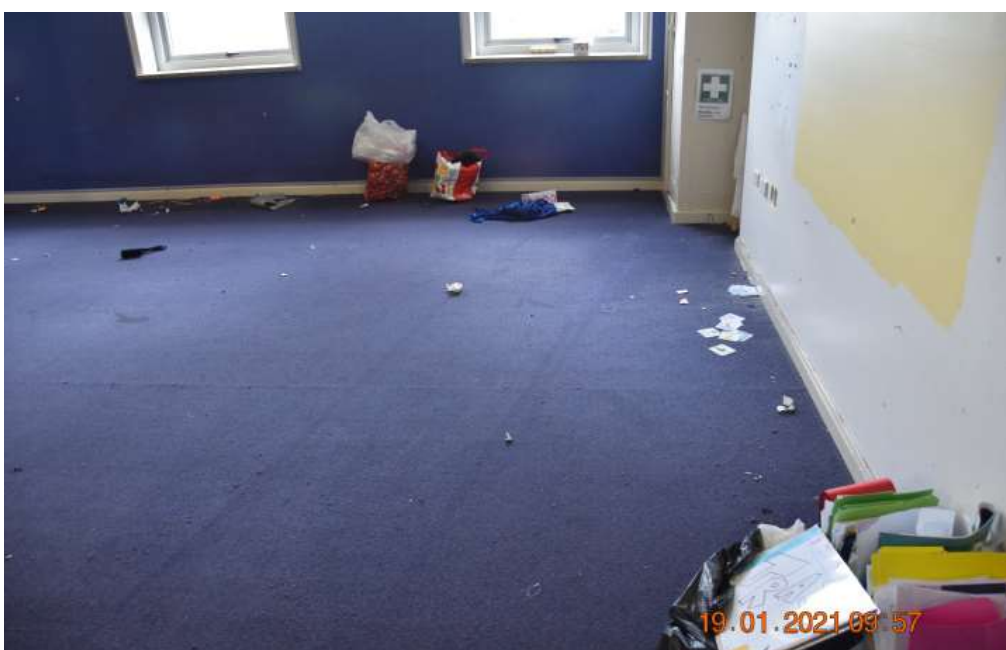
Figure: 0579

Flooring in the lime classroom.

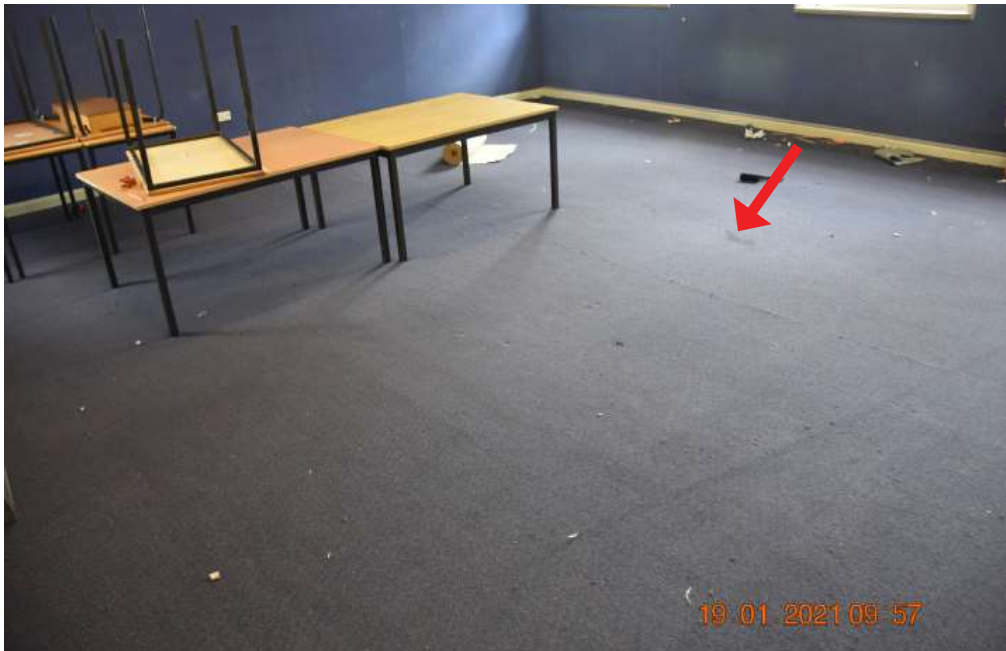
Figure: 0580

Flooring in the lime classroom. Showing staining.

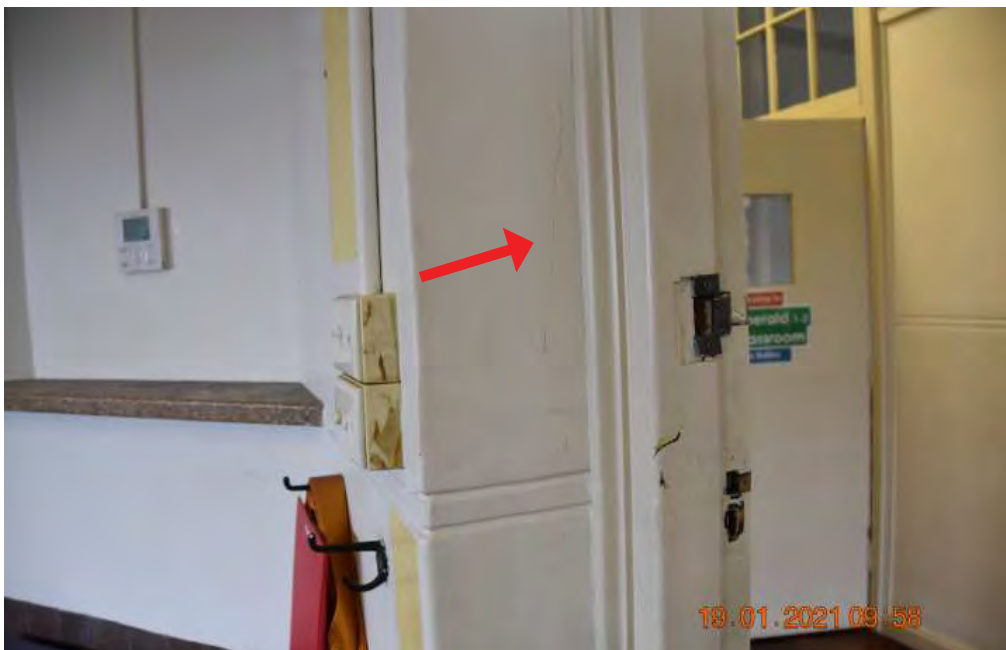
Figure: 0581

Fine cracking in the west wall in the lime classroom, adjacent to the door.

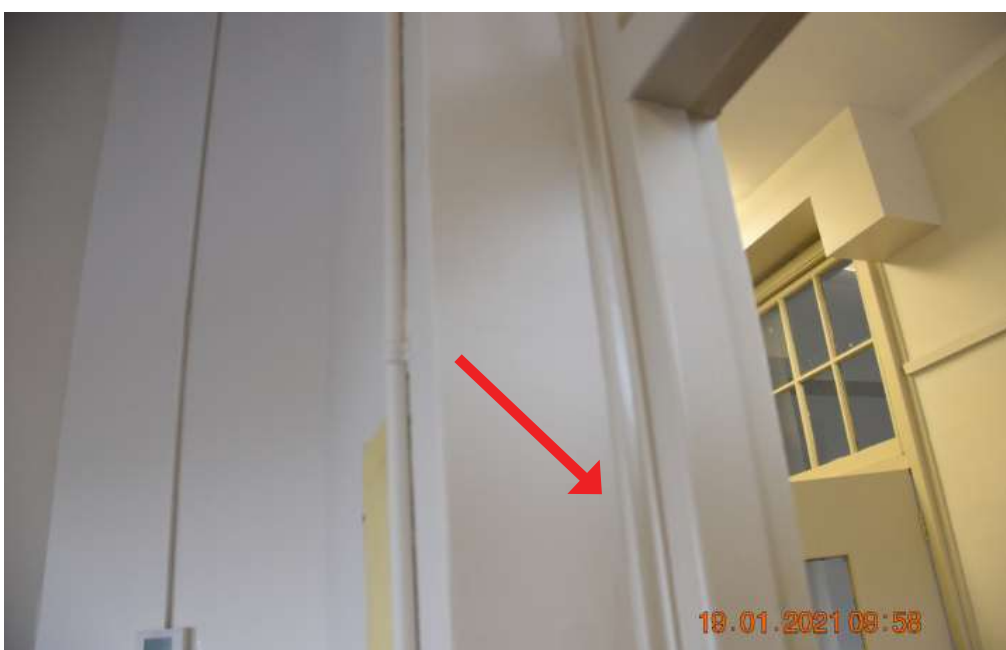
Figure: 0582

Fine cracking in the west wall in the lime classroom, adjacent to the door.

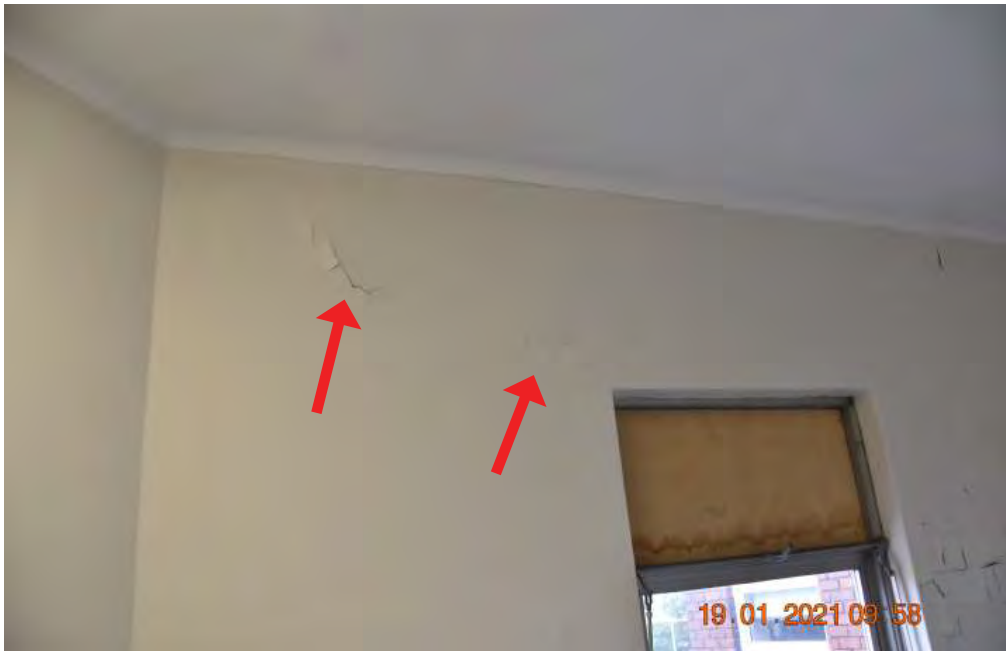
Figure: 0586

Peeling paint and crazing in the west wall in the stairway.

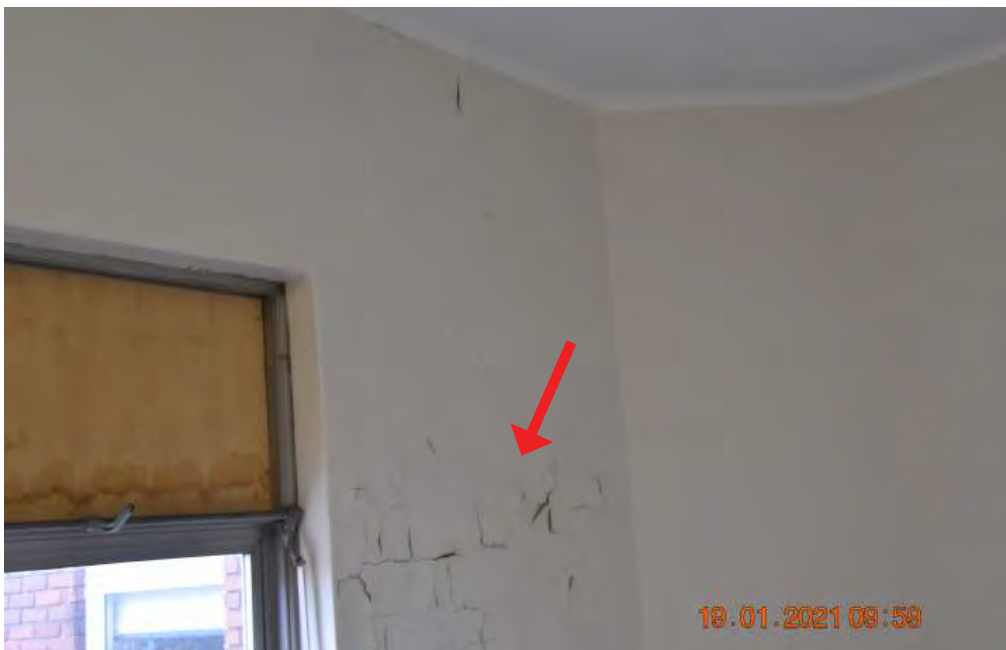
Figure: 0587

Peeling paint and crazing in the west wall in the stairway.

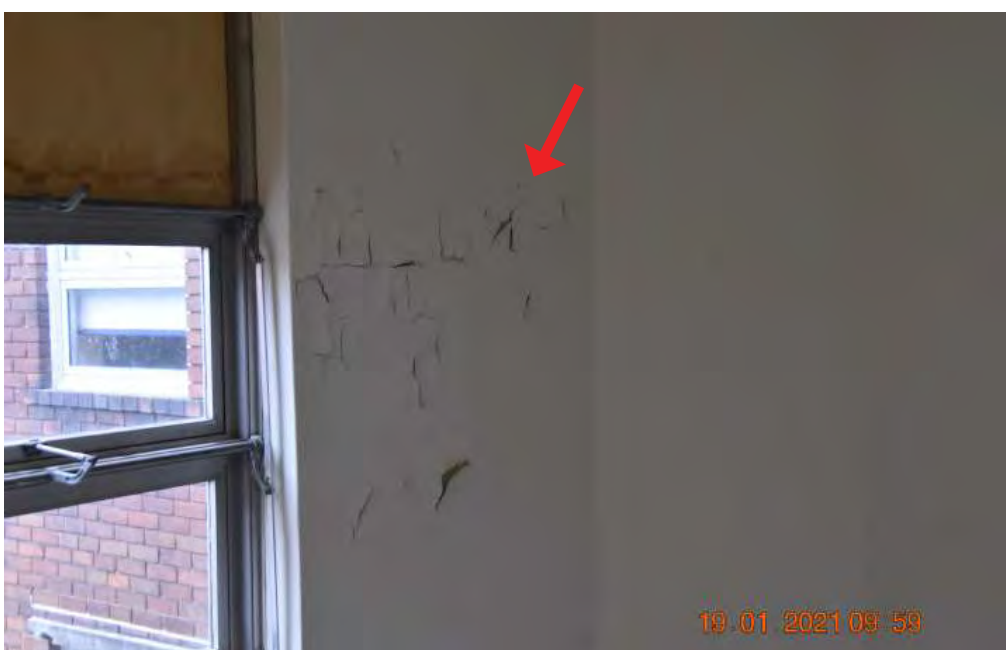
Figure: 0588

Peeling paint and crazing in the west wall in the stairway.

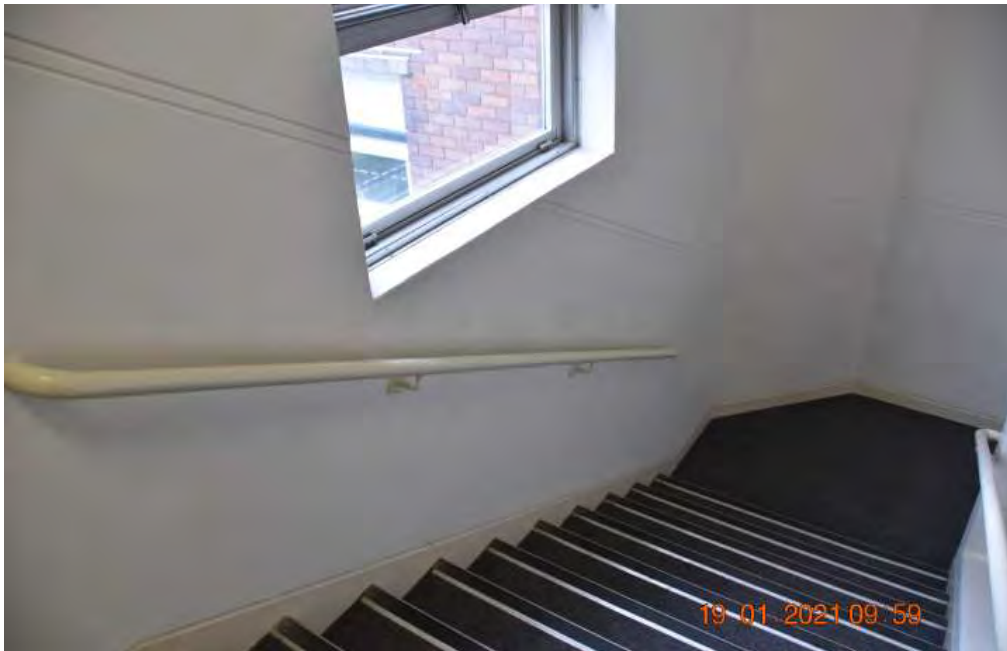
Figure: 0589

West wall in the stairway.

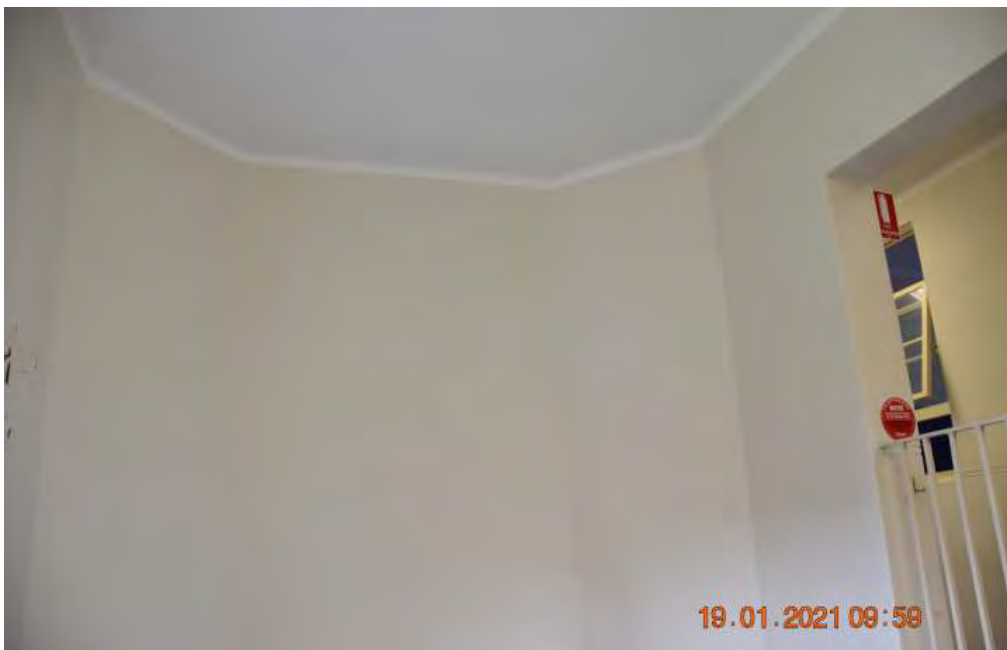
Figure: 0590

North wall in the stairway.

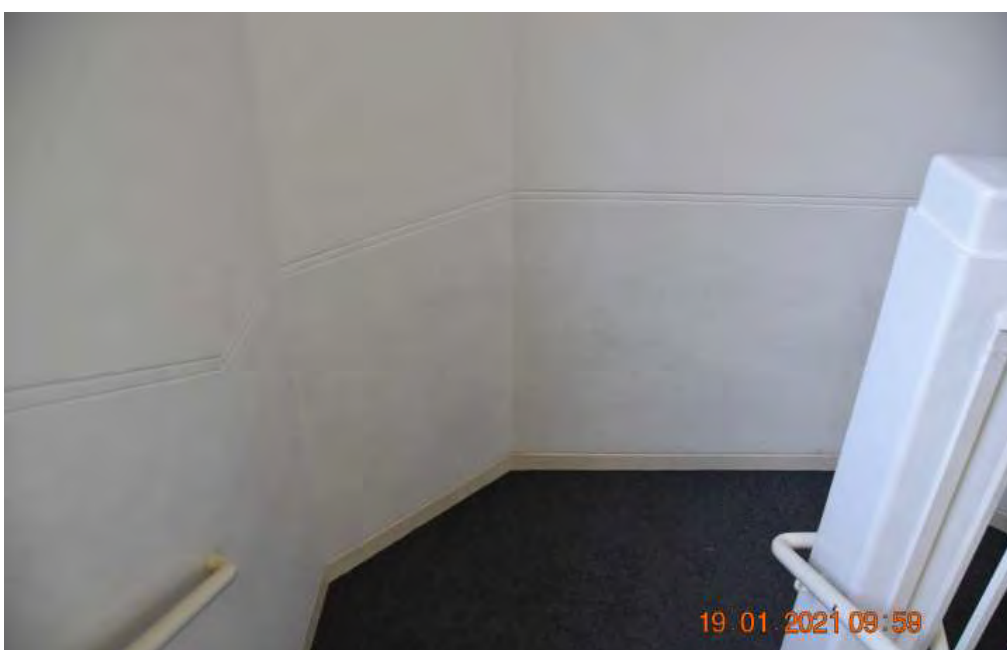
Figure: 0591

North wall in the stairway.

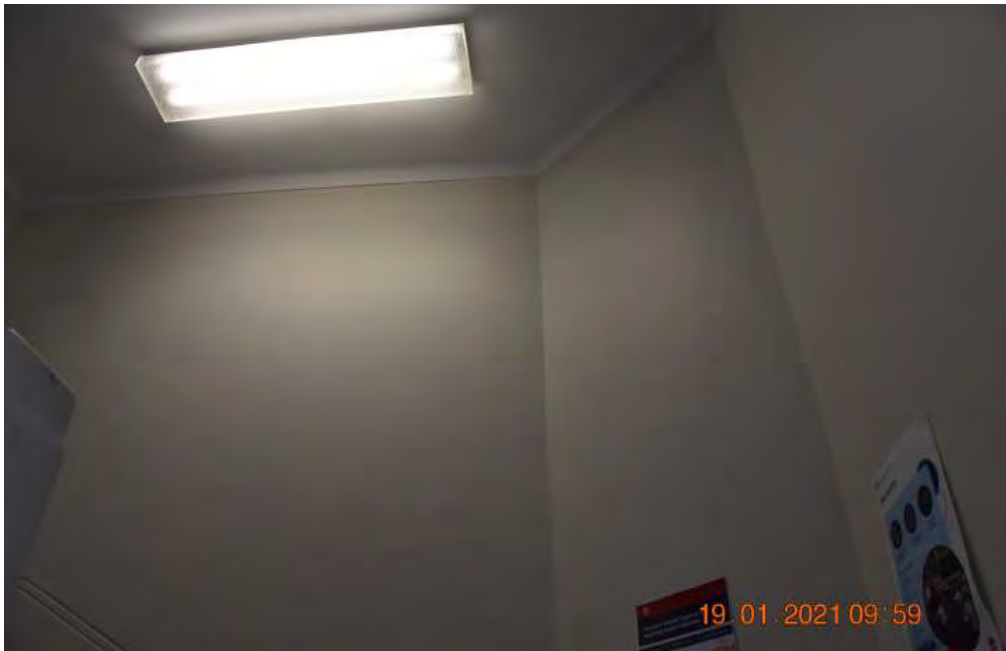
Figure: 0592

South wall in the stairway.
