## PRE CONSTRUCTION CONDITION SURVEY

Fort Street Public School, Millers Point NSW

Upper Fort Street Public School  
MILLERS POINT NSW 2000

19 January 2021

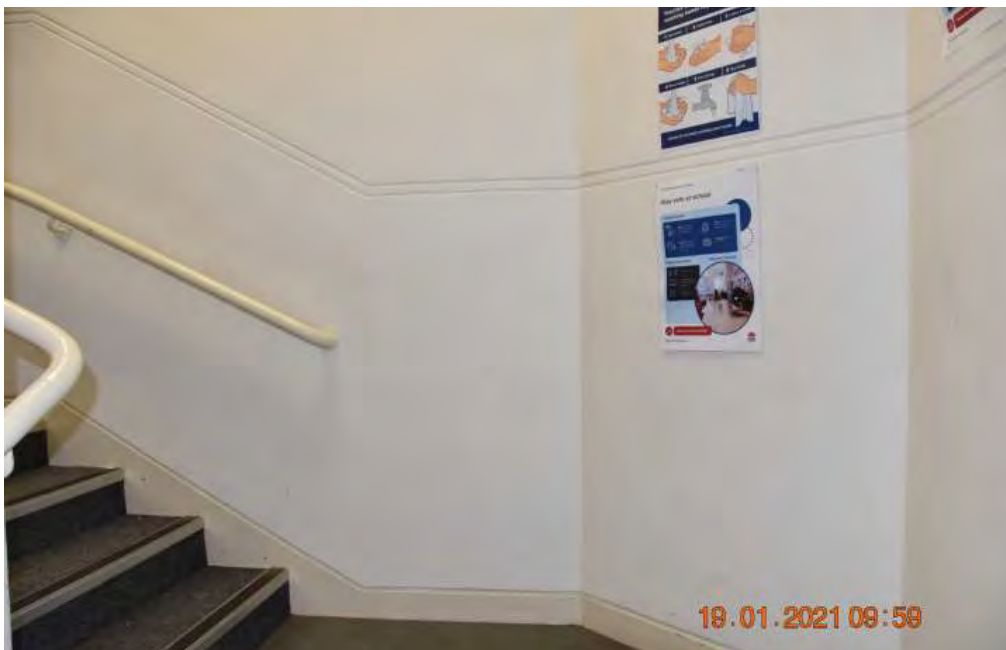
Figure: 0593

South wall in the stairway.

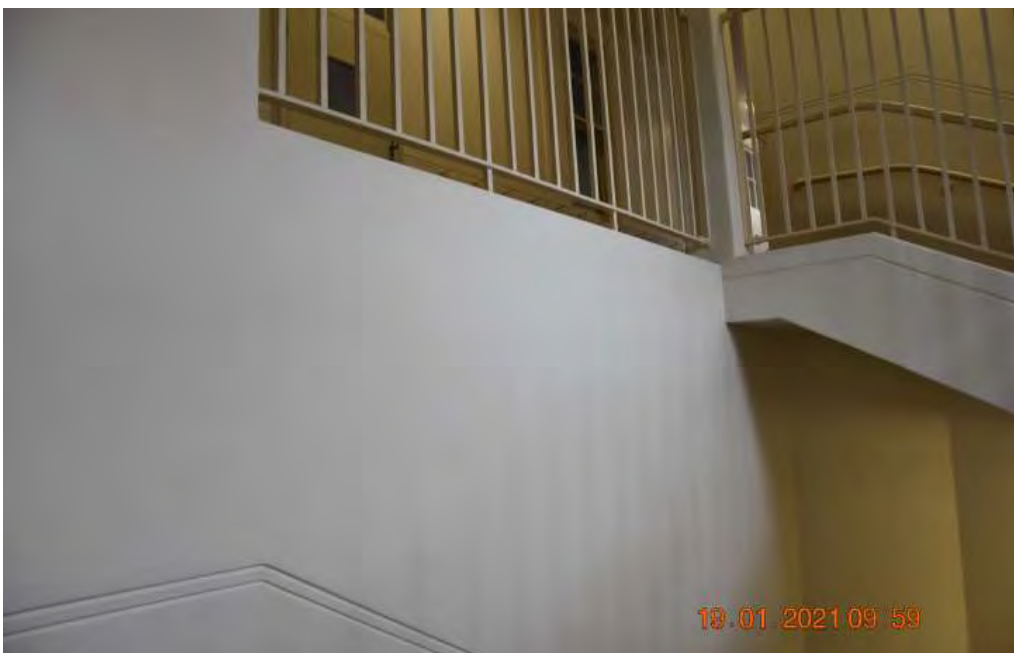
Figure: 0597

East wall in the stairway.

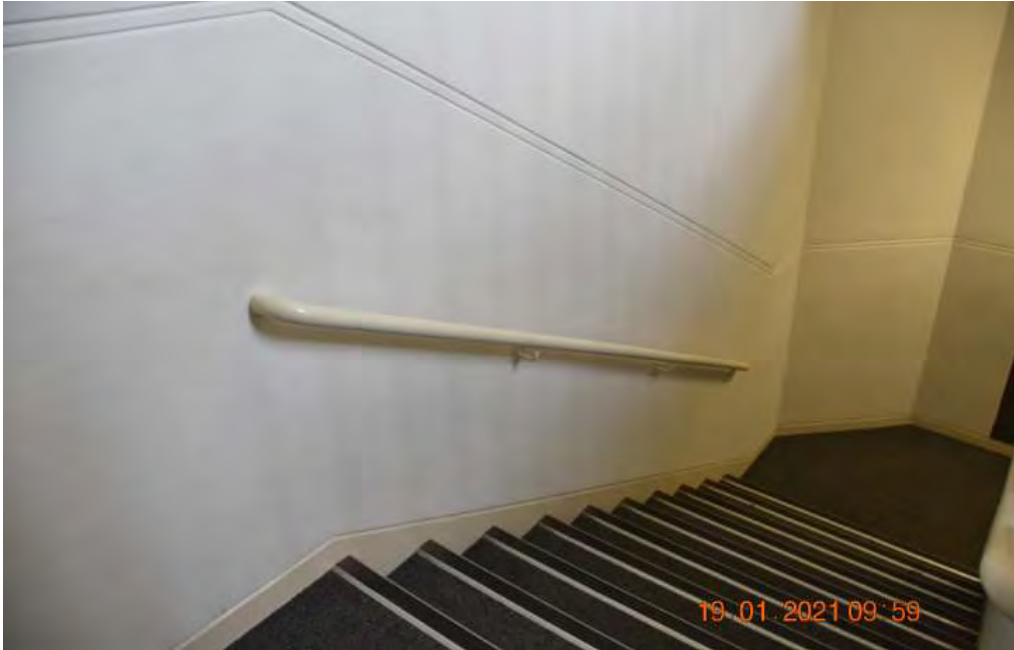
Figure: 0598

East wall in the stairway.

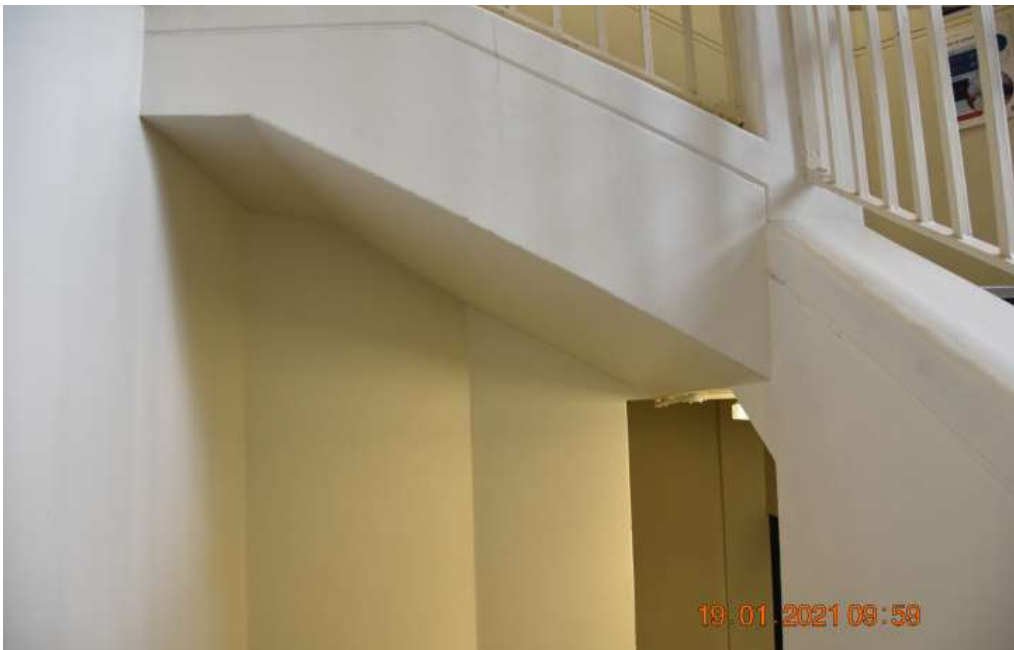
Figure: 0599

South wall in the stairway.

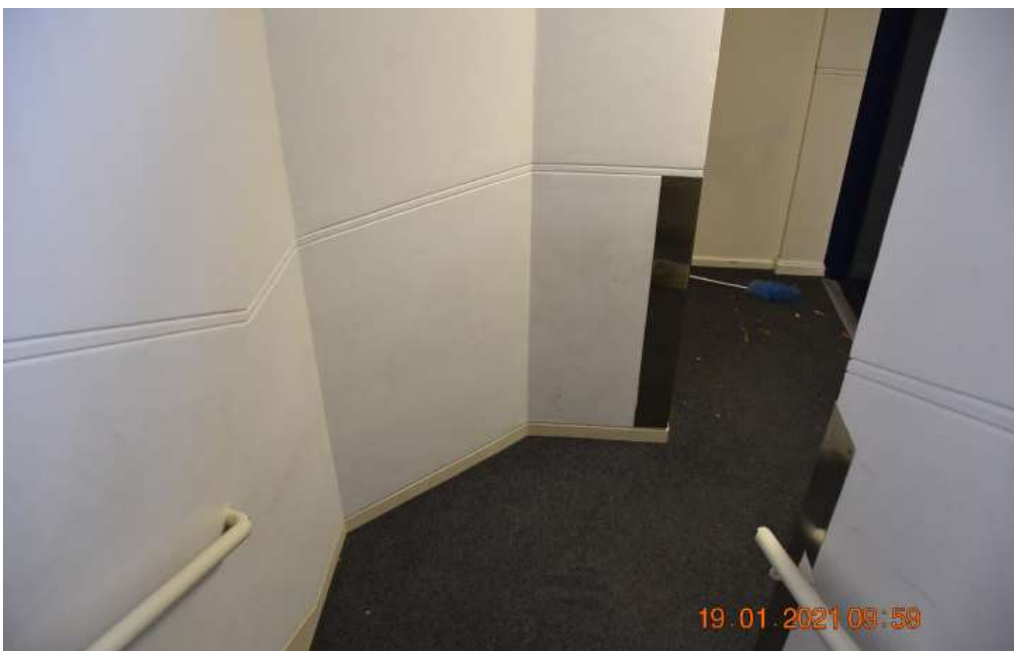
Figure: 0600

South wall in the stairway.

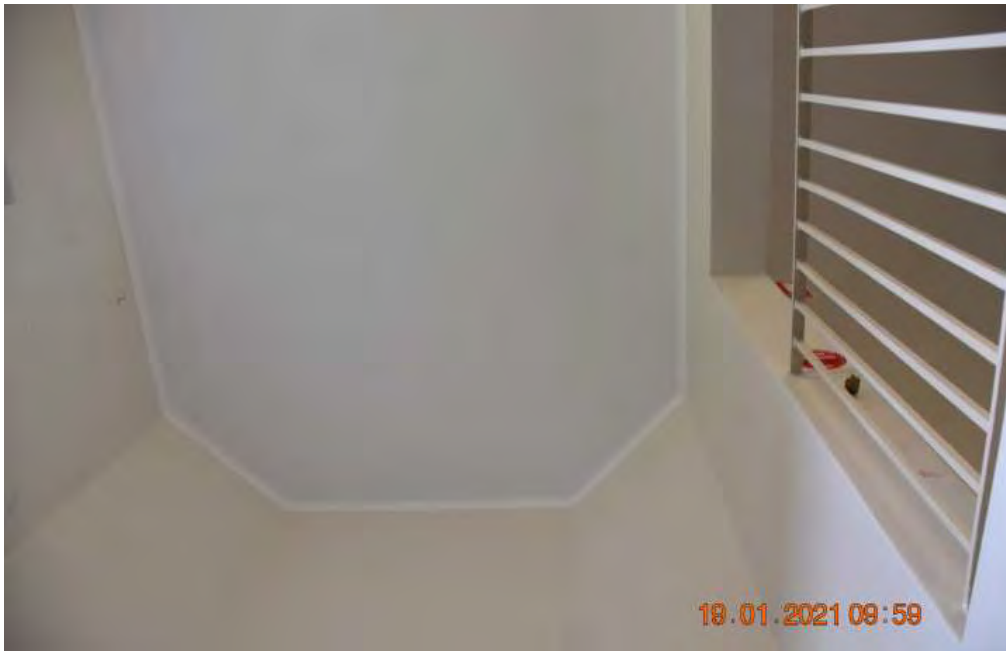
Figure: 0601

Ceiling in the stairway.

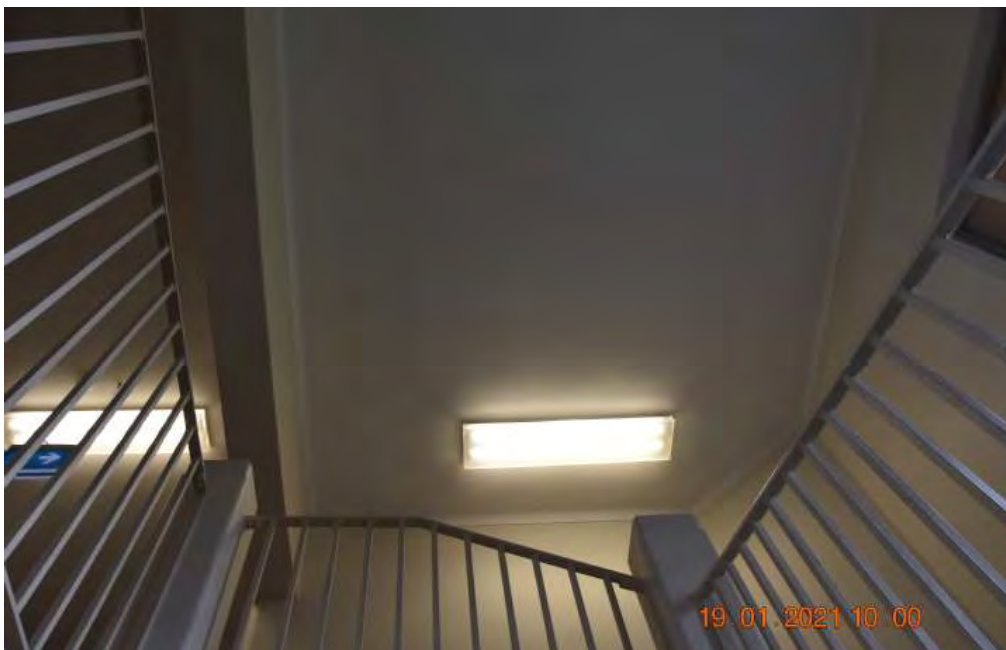
Figure: 0602

Ceiling in the stairway.

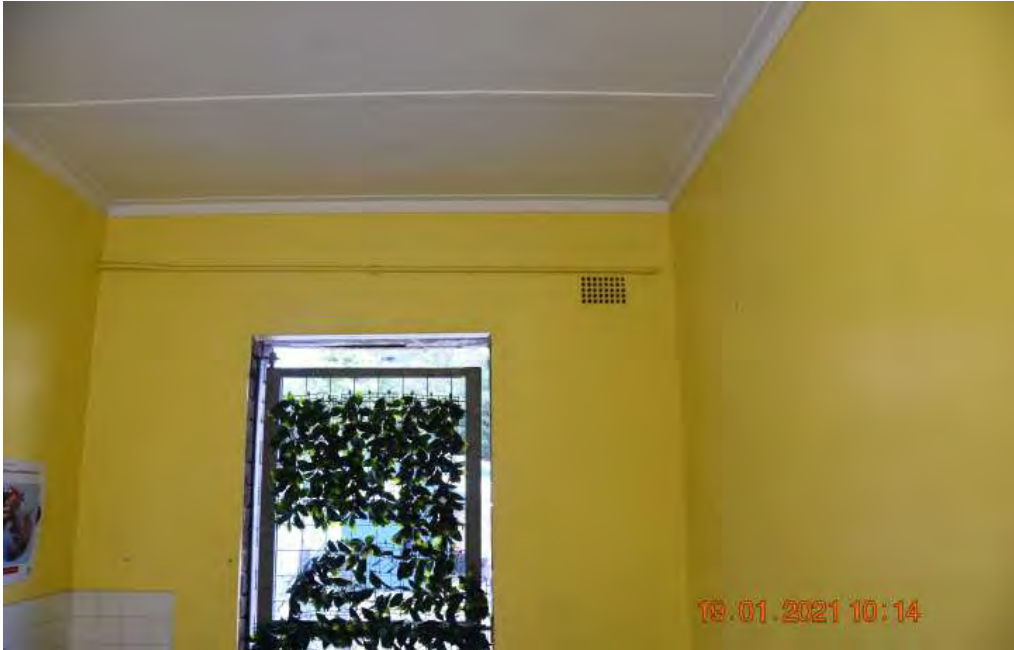
Figure: 0604

South wall in room 15.

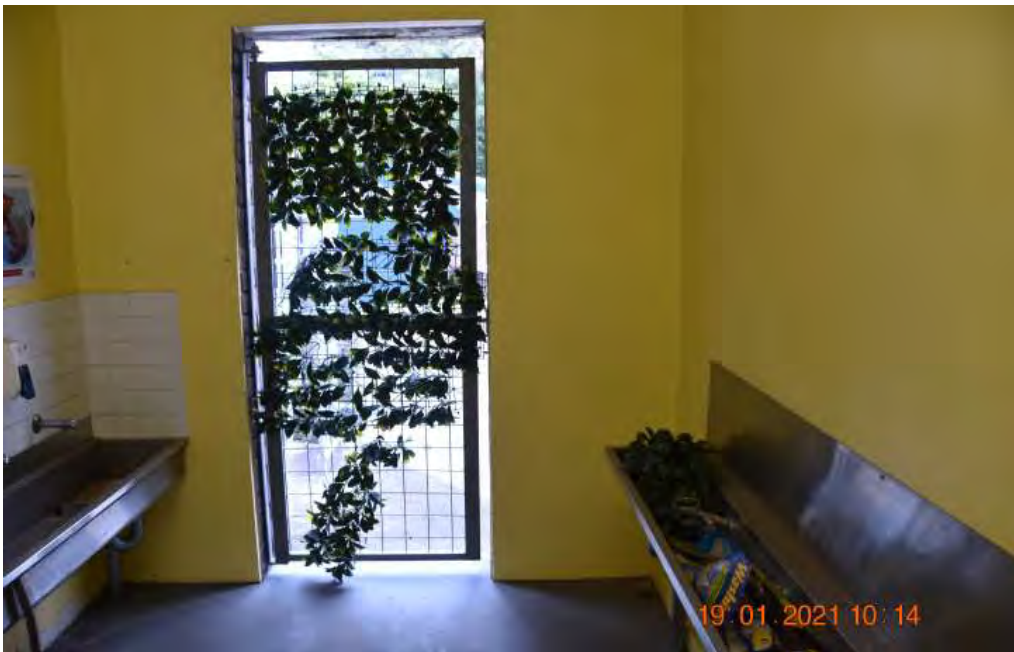
Figure: 0605

South wall in room 15.

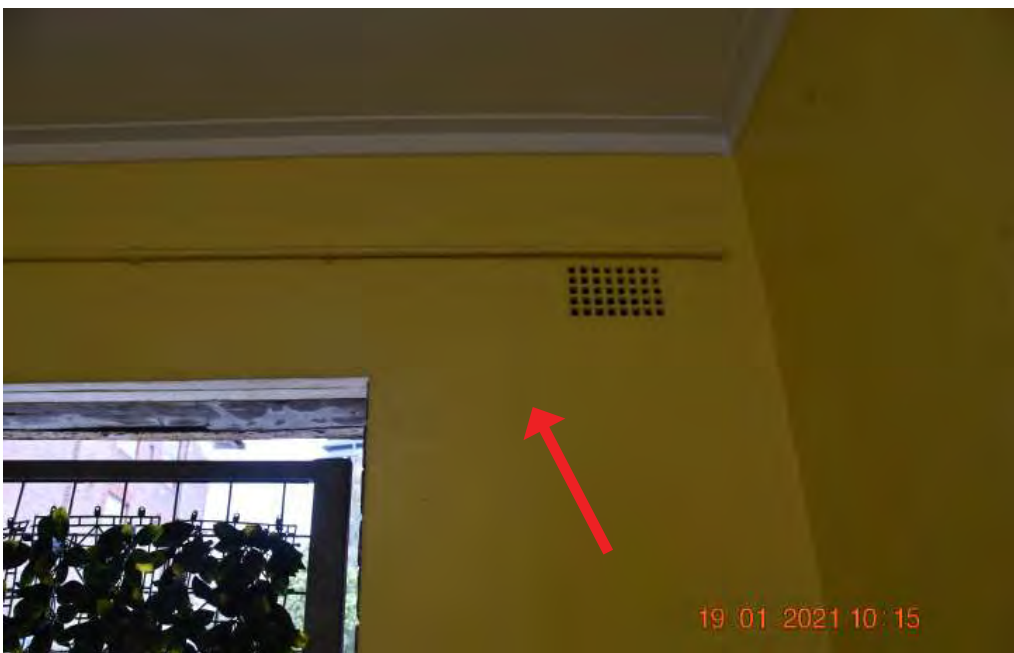
Figure: 0606

Fine cracking in the south wall in room 15.

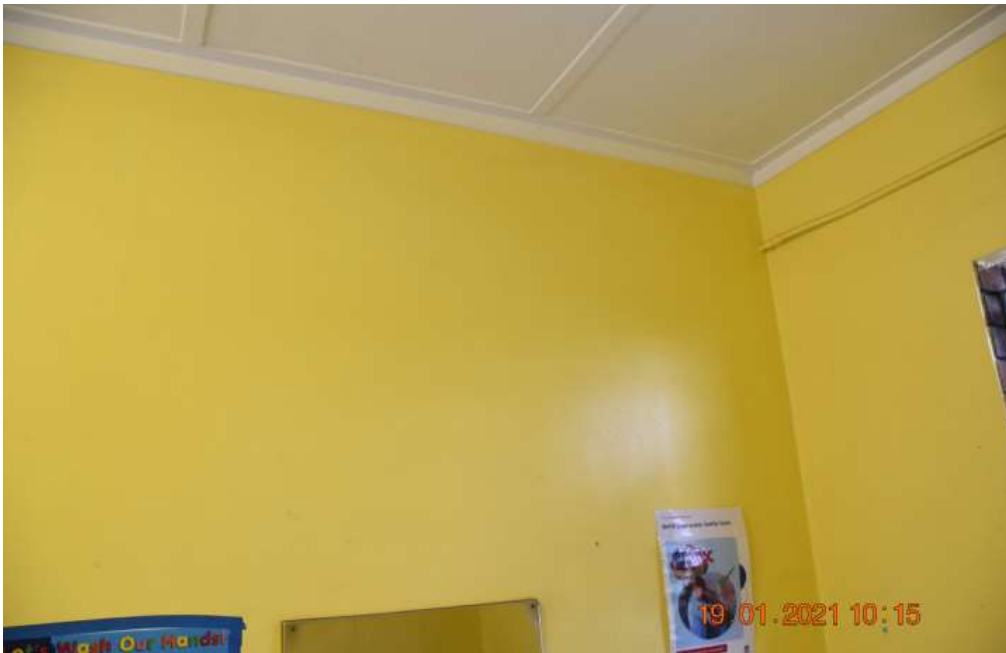
Figure: 0608

East wall in room 15. Showing peeling paint.

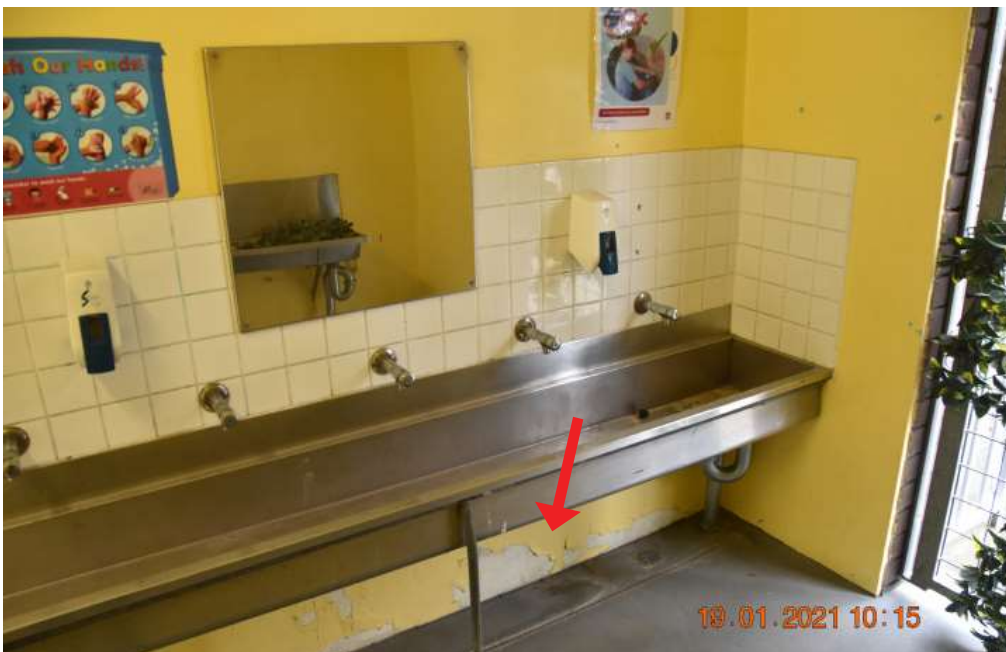
Figure: 0609

East wall in room 15. Showing peeling paint.

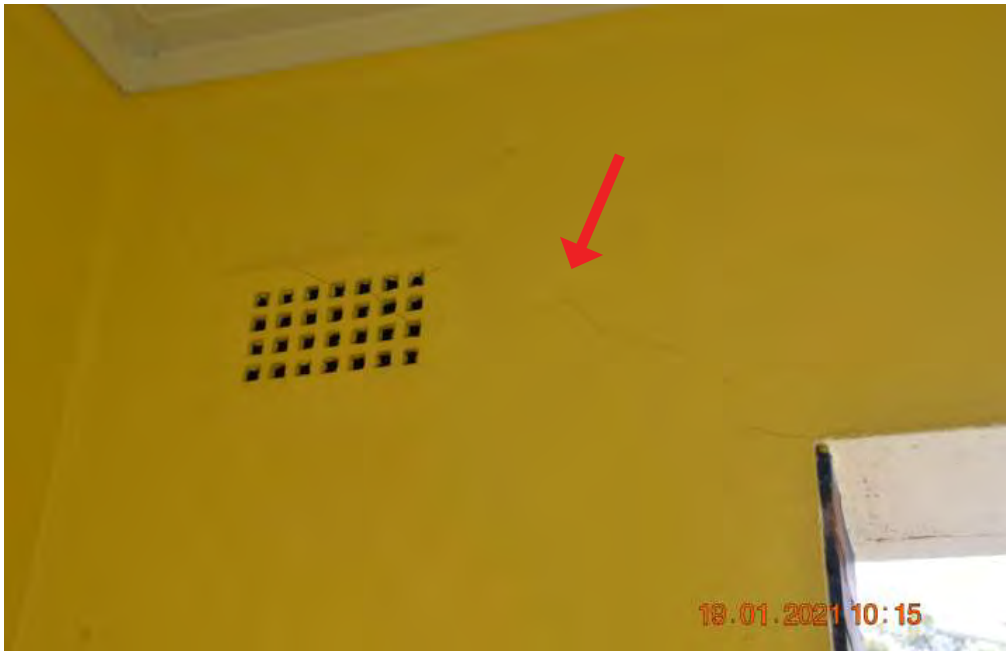
Figure: 0613

Fine cracking in the north wall in room 15.

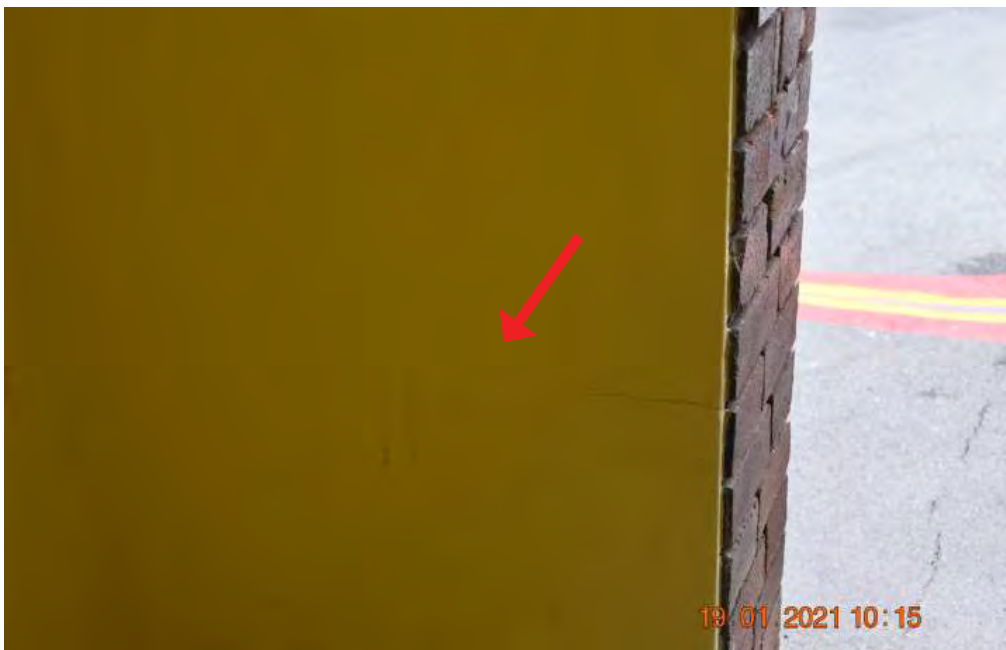
Figure: 0614

Fine cracking in the north wall in room 15.

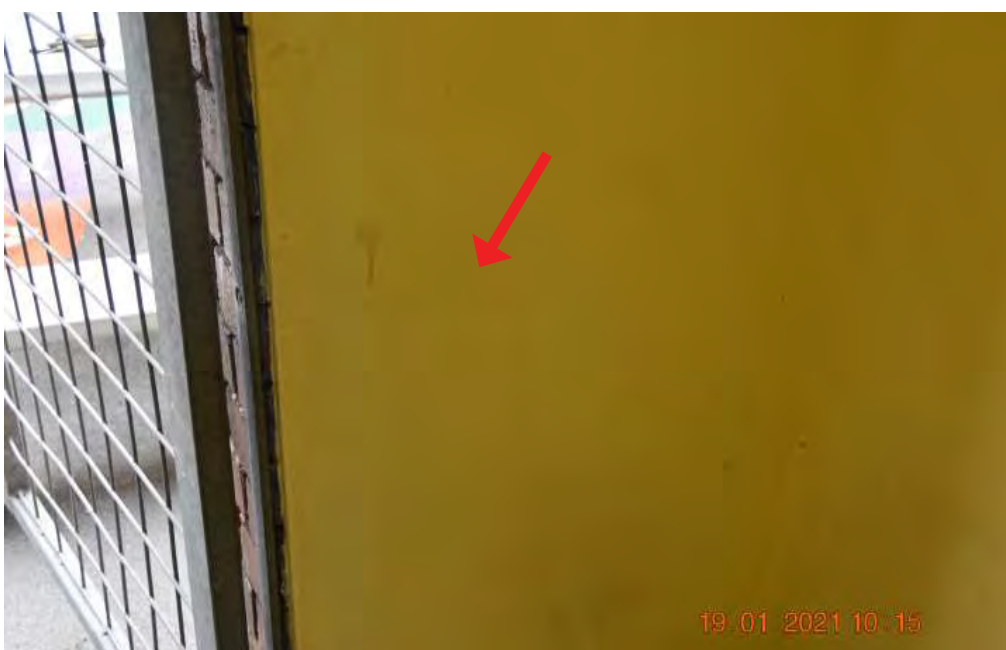
Figure: 0615

Fine cracking in the north wall in room 15.

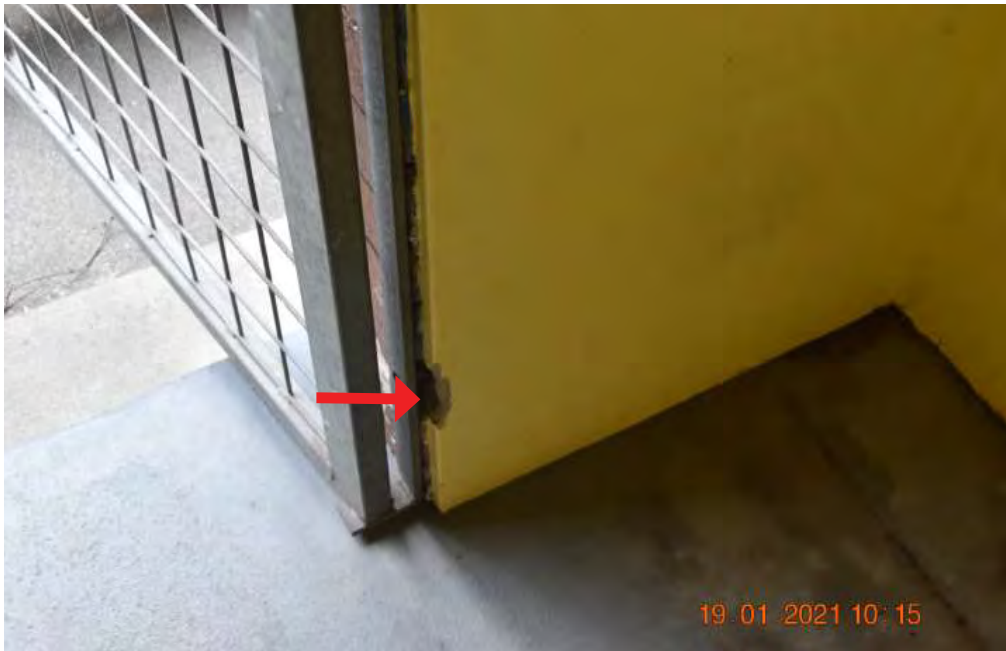
Figure: 0616

Chipping in the north wall in room 15, adjacent to the door.

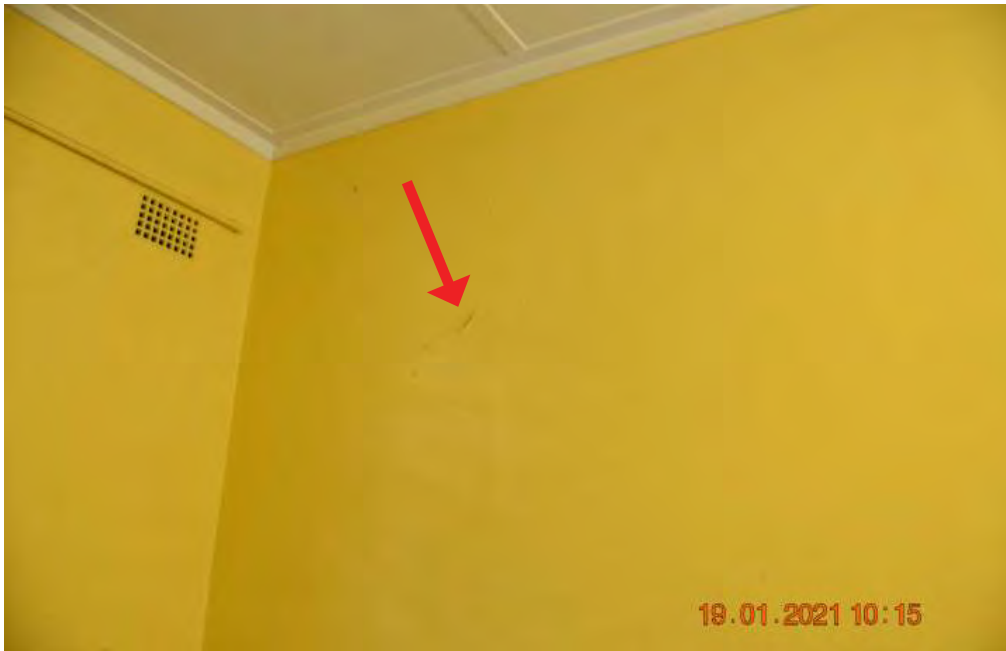
Figure: 0619

East wall in room 15. Showing peeling paint and crazing.

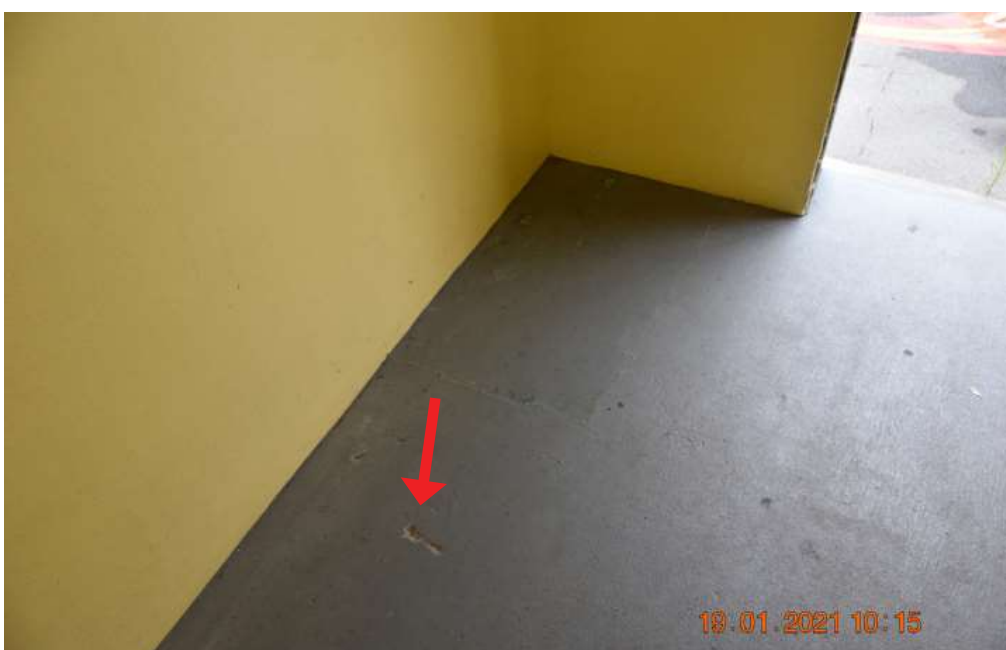
Figure: 0621

Floor slab in room 15. Showing scoring.

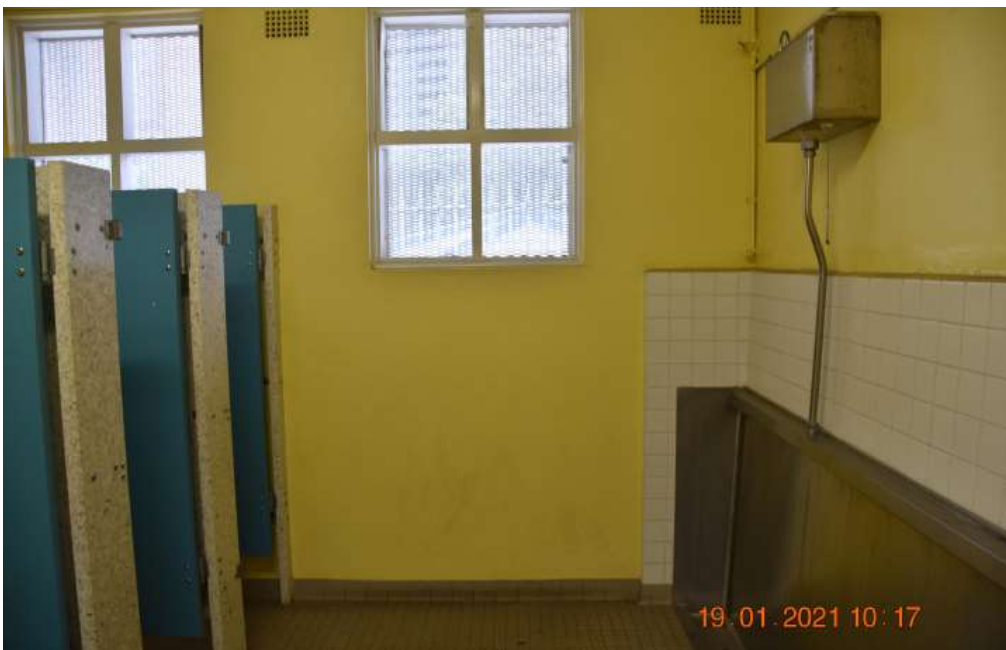
Figure: 0627

Fine cracking in the south wall in room 14.

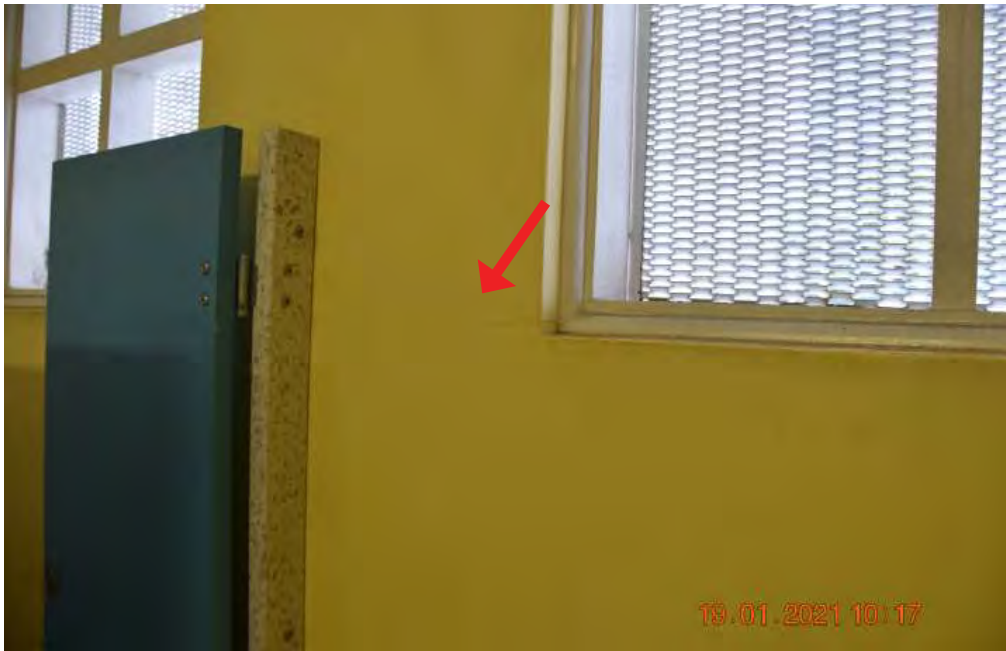
Figure: 0628

Fine cracking in the south wall in room 14.

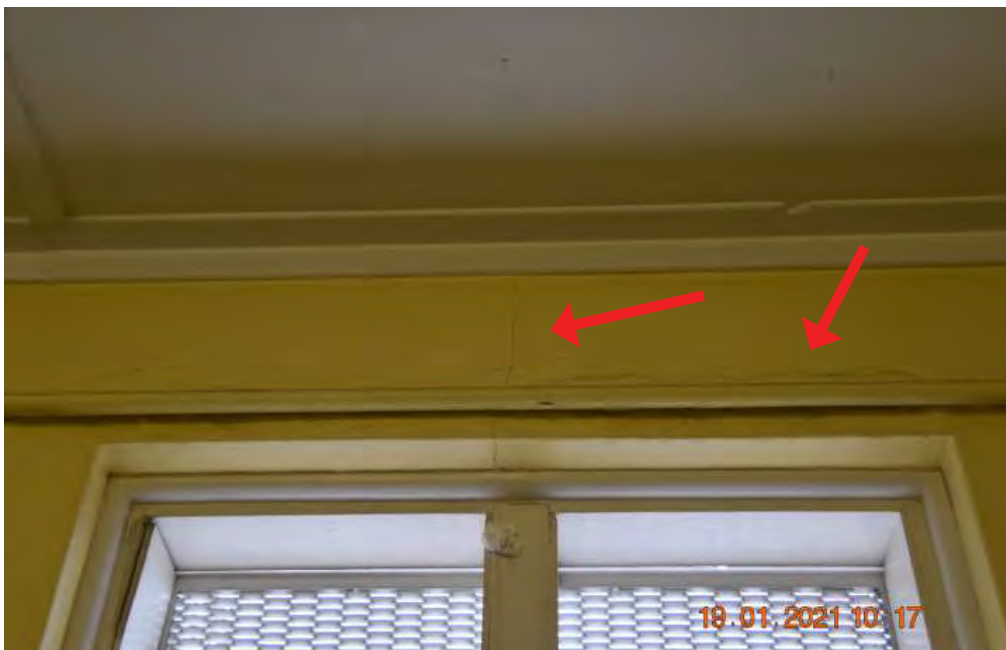
Figure: 0629

Fine cracking in the south wall in room 14.

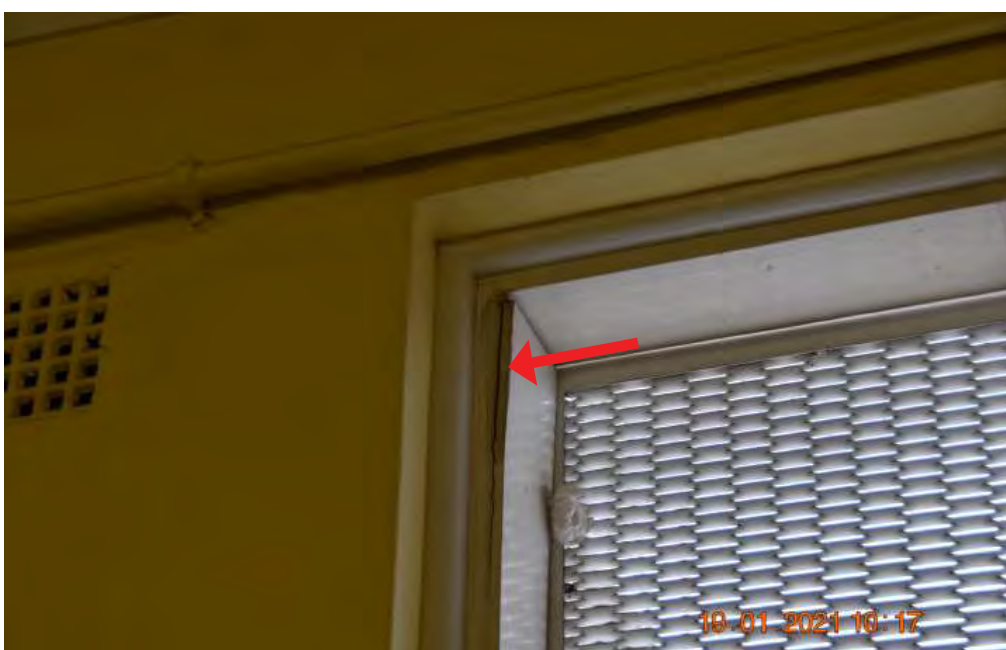
Figure: 0630

Separation in the window frame in the south wall in room 14.

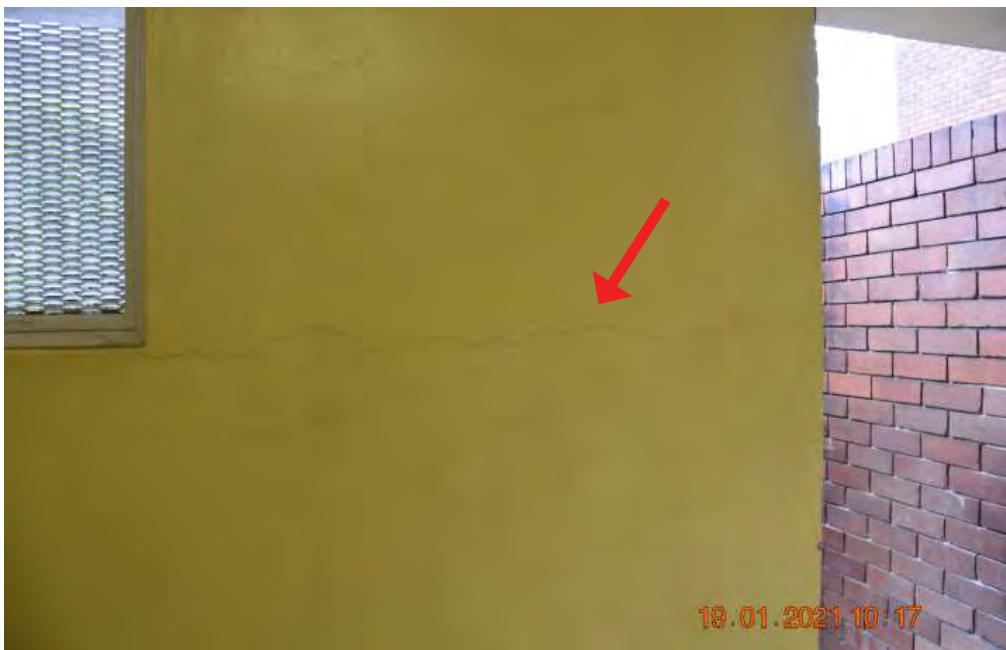
Figure: 0641

Fine cracking in the north wall in room 14.

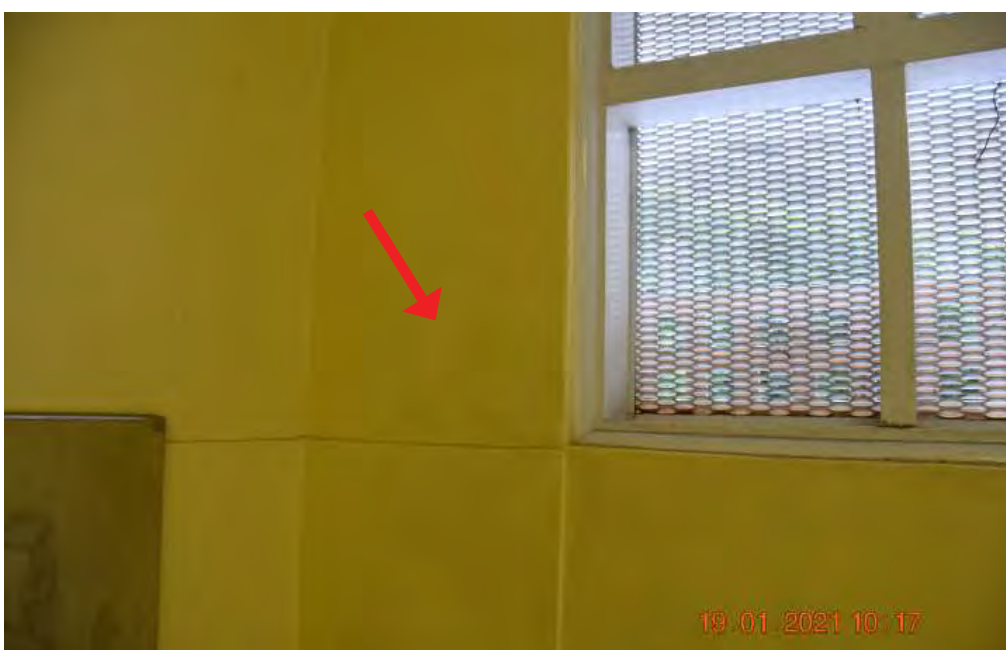
Figure: 0642

Fine cracking in the north wall in room 14.

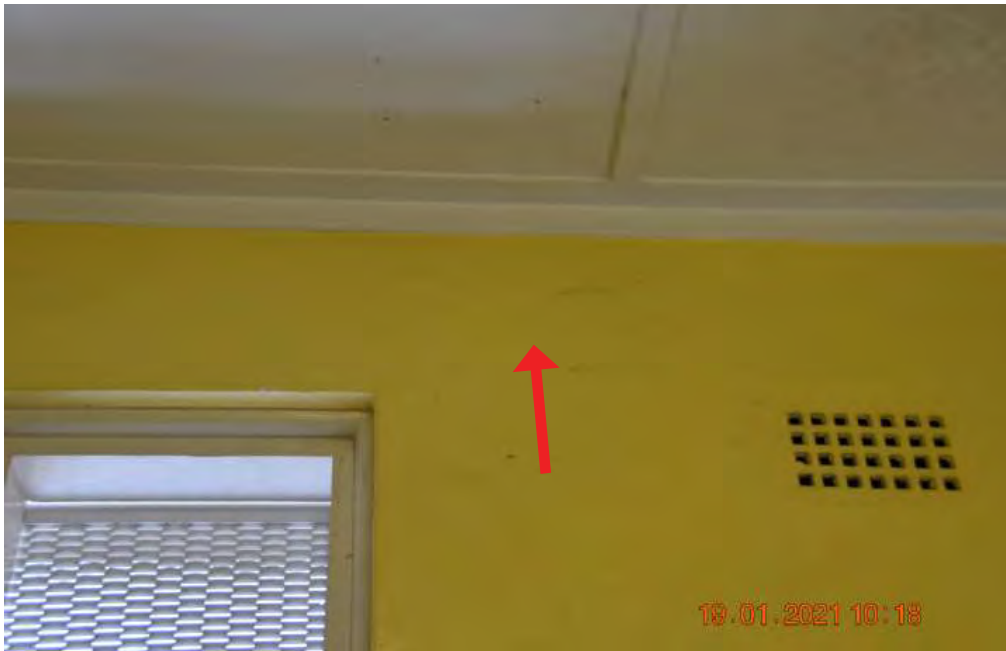
Figure: 0643

Fine cracking in the north wall in room 14.

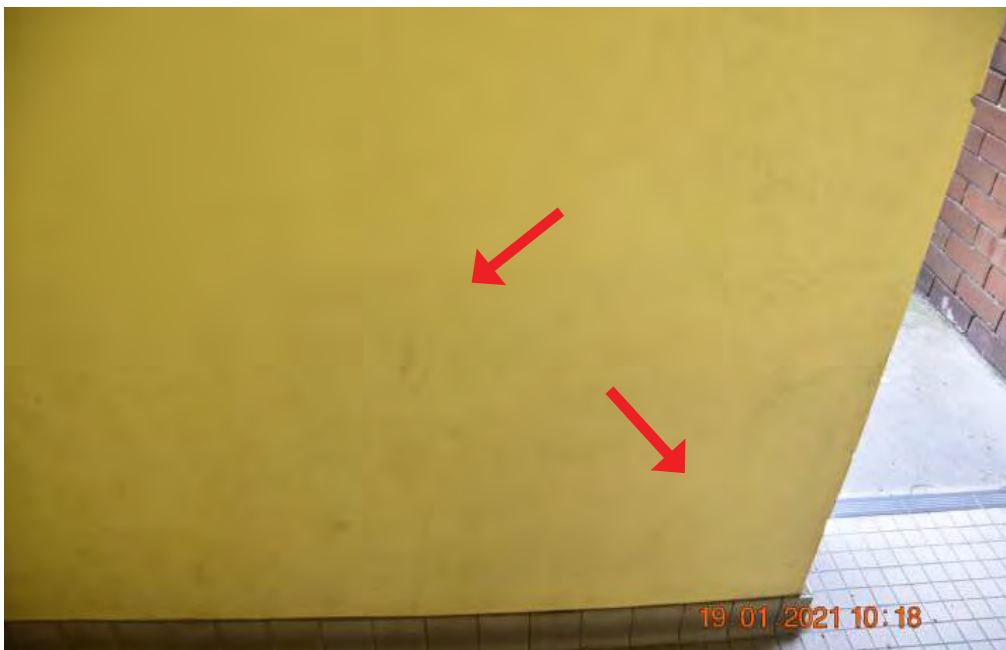
Figure: 0644

Crazeing in the north wall in room 14.

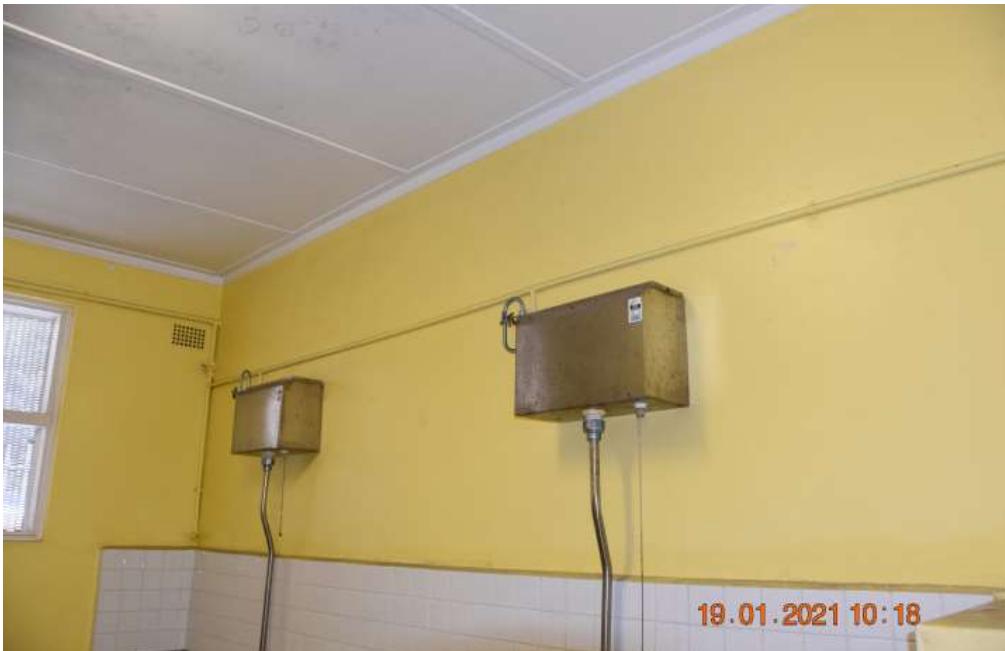
Figure: 0646

West wall in room 14.

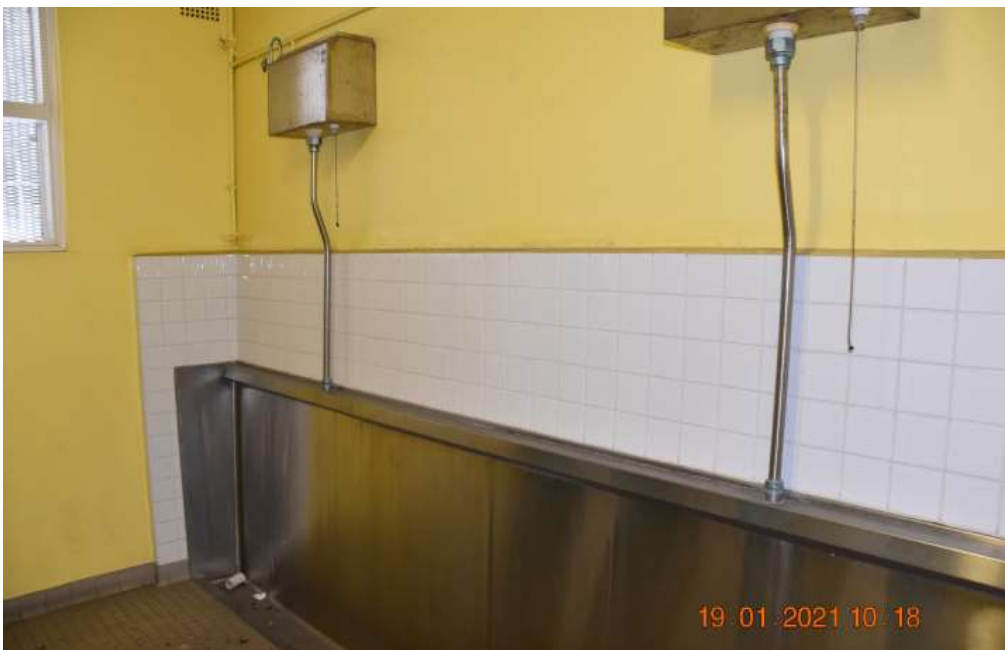
Figure: 0647

West wall in room 14.

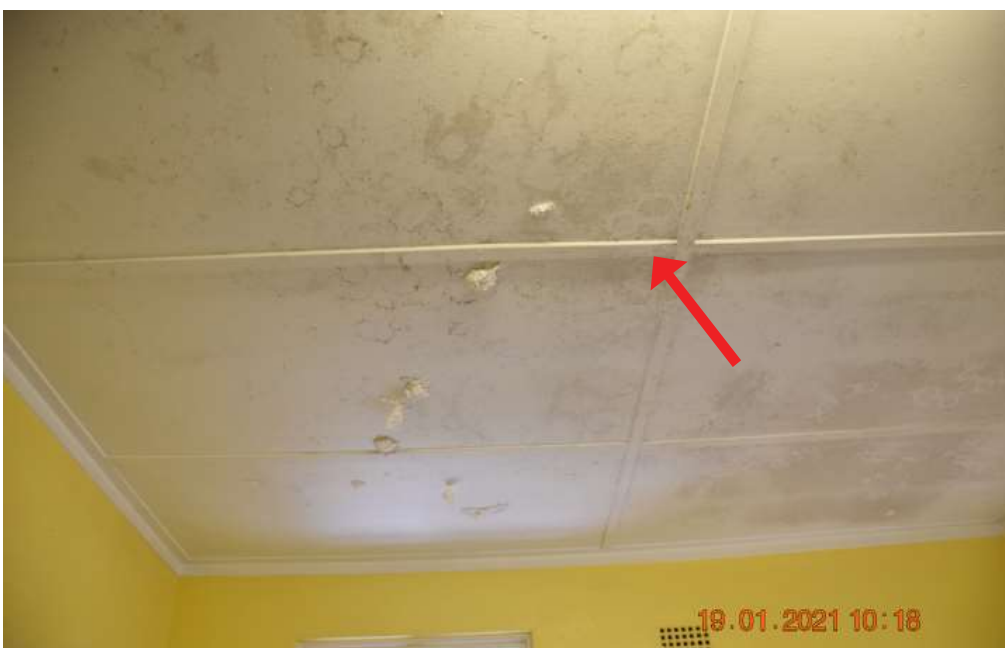
Figure: 0648

Ceiling in room 14.  
Showing staining.

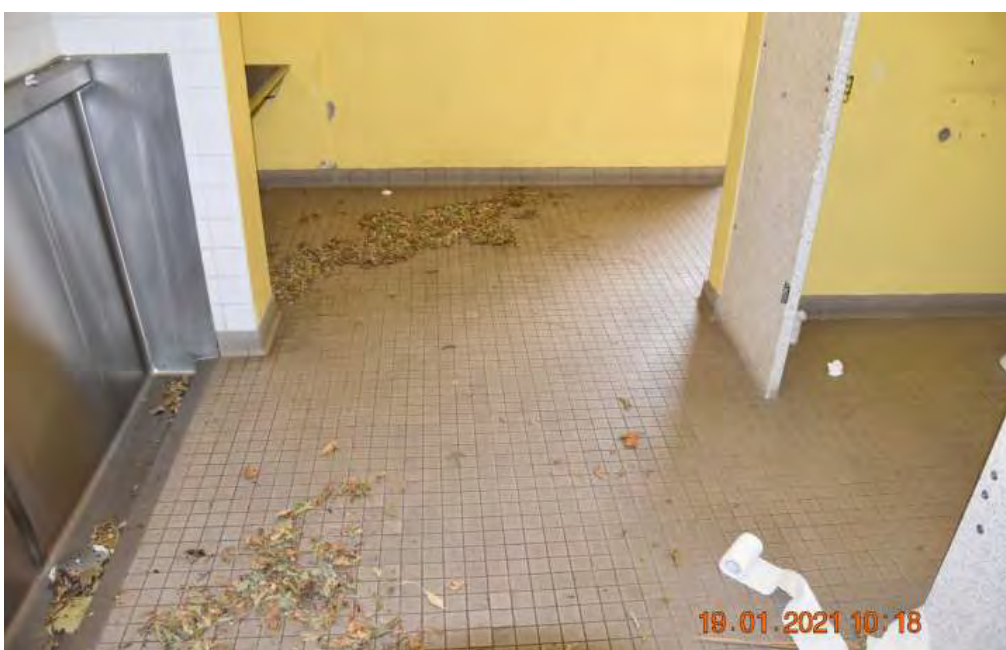
Figure: 0650

Tile floor in room 14.

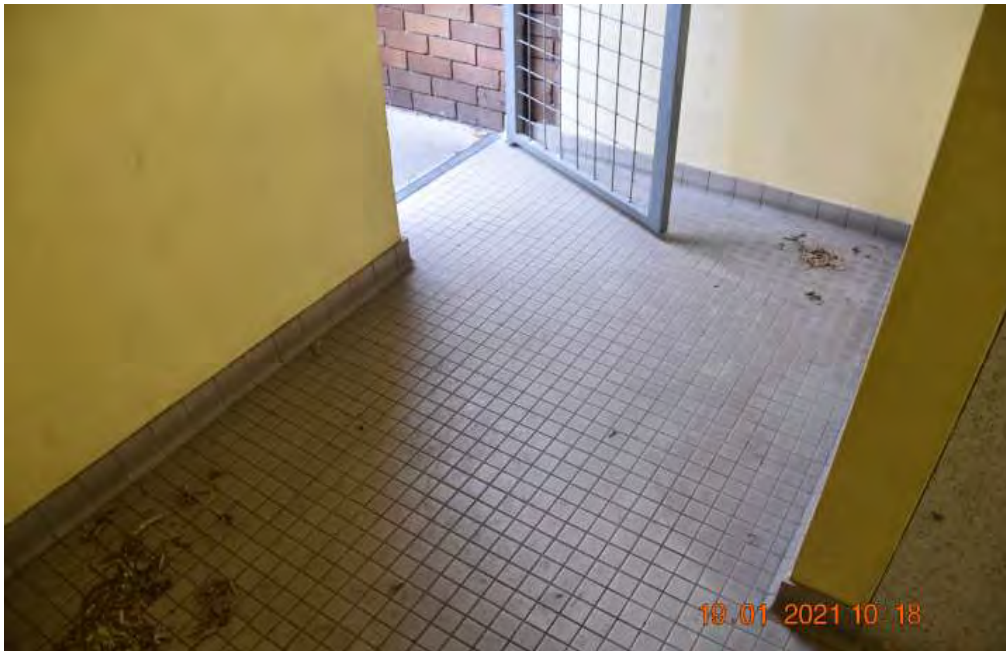
Figure: 0651

Tile floor in room 14.

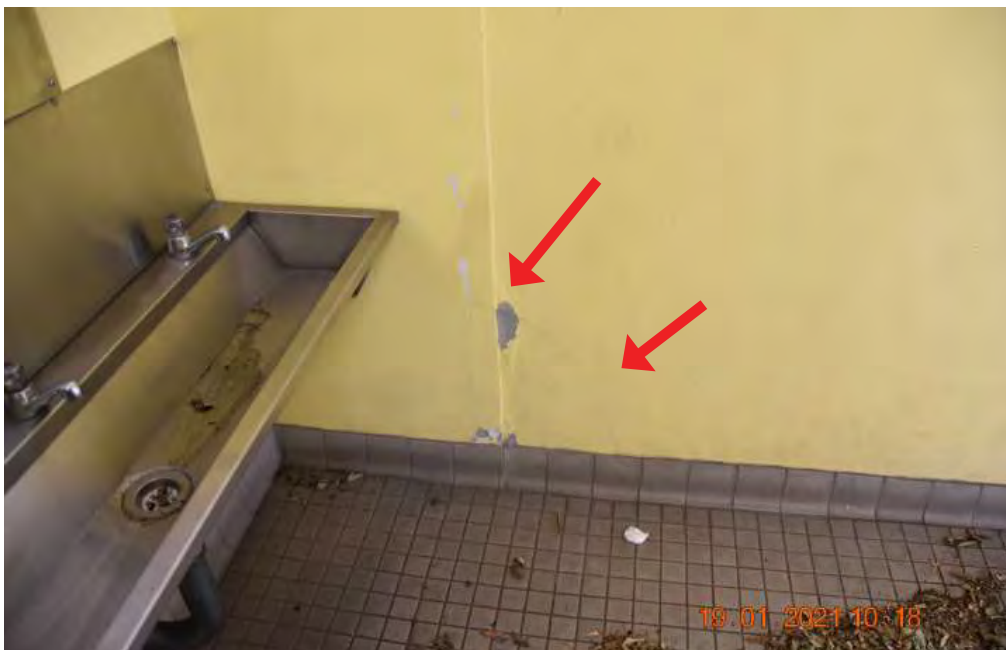
Figure: 0652

Tile floor in room 14.

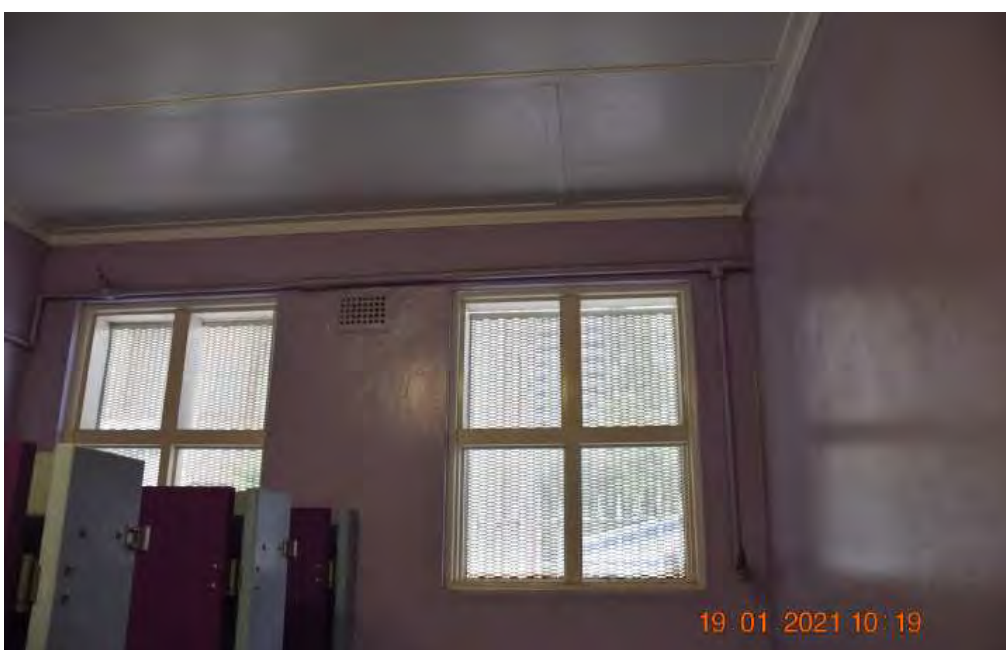
Figure: 0653

Peeling paint and crazing in the north wall in room 14.

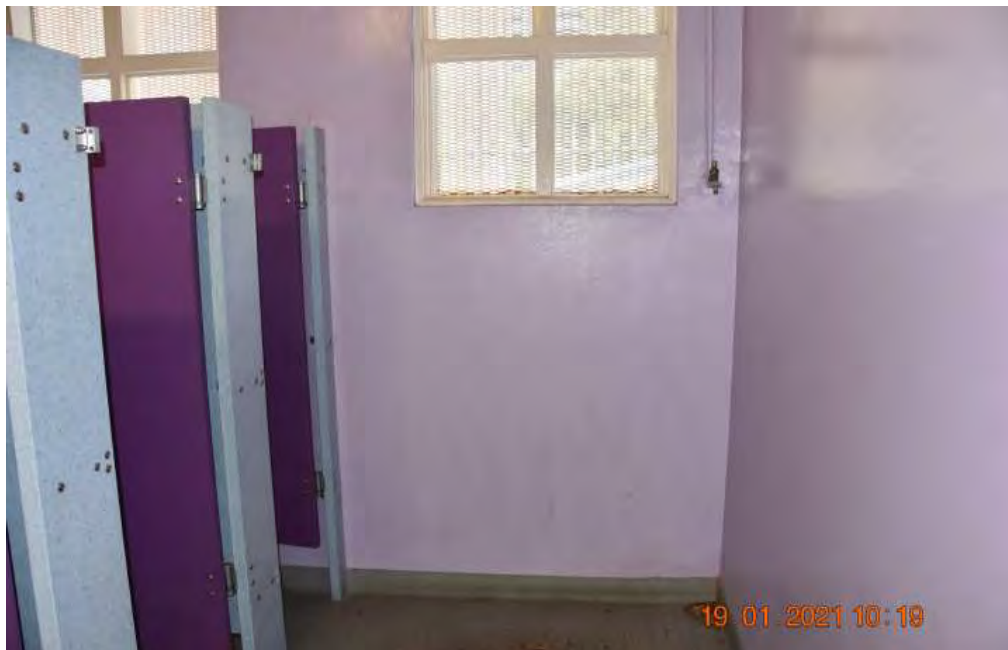
Figure: 0654

South wall in room 13.
