## PRE CONSTRUCTION CONDITION SURVEY

Fort Street Public School, Millers Point NSW

Upper Fort Street Public School  
MILLERS POINT NSW 2000

19 January 2021

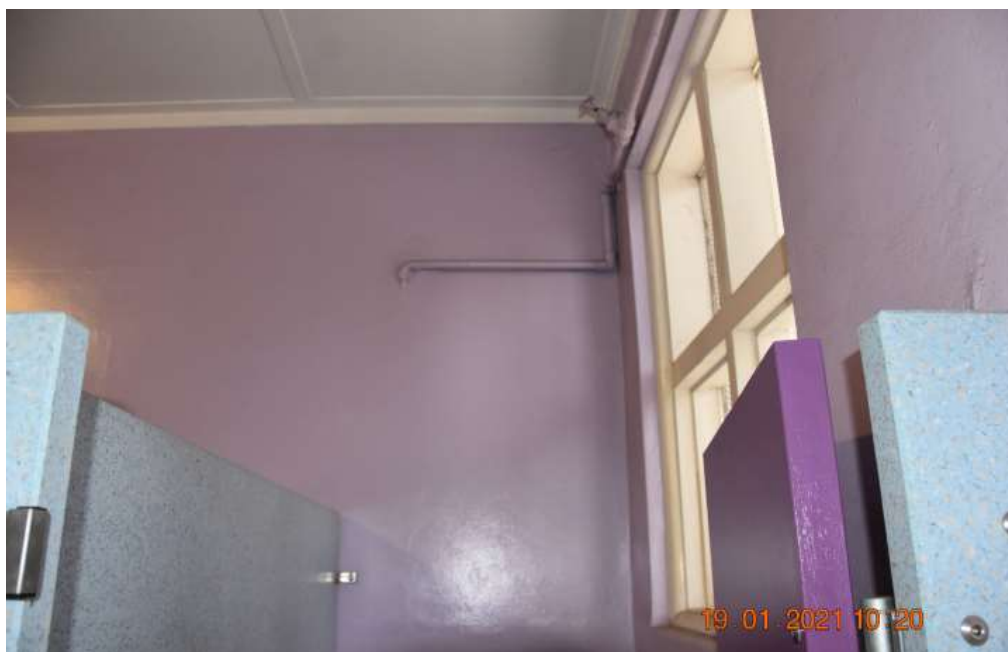
Figure: 0655

South wall in room 13.

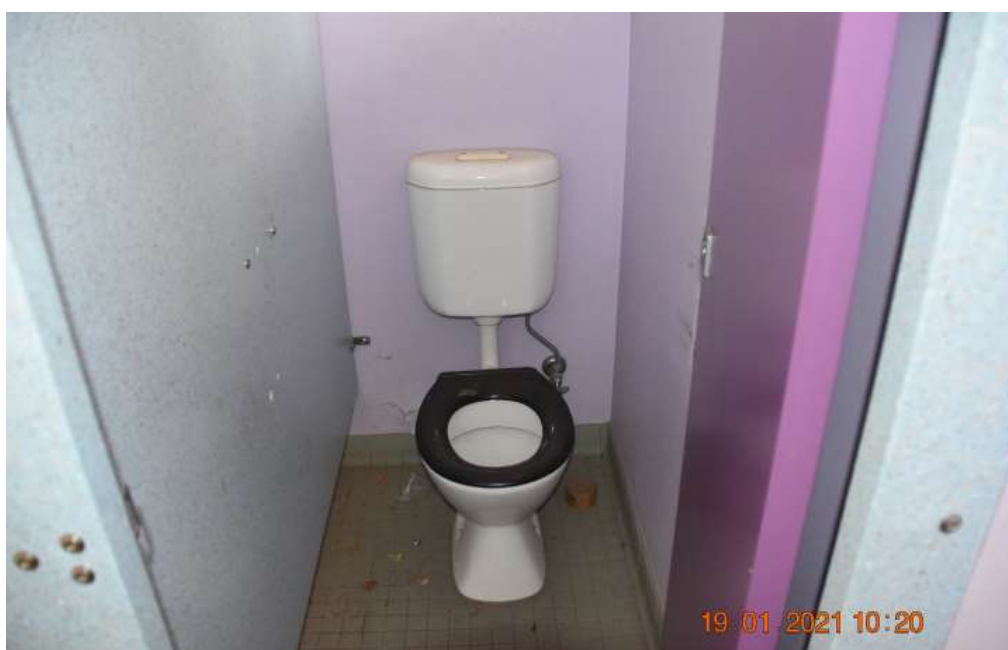
Figure: 0656

General view in the toilet in room 13.

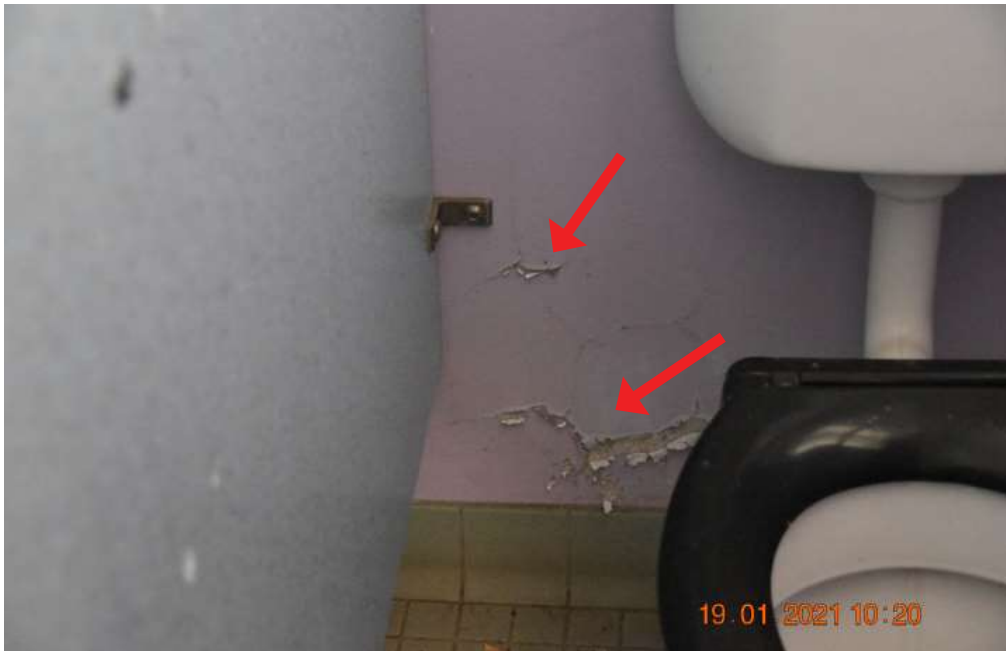
Figure: 0657

General view in the toilet in room 13.

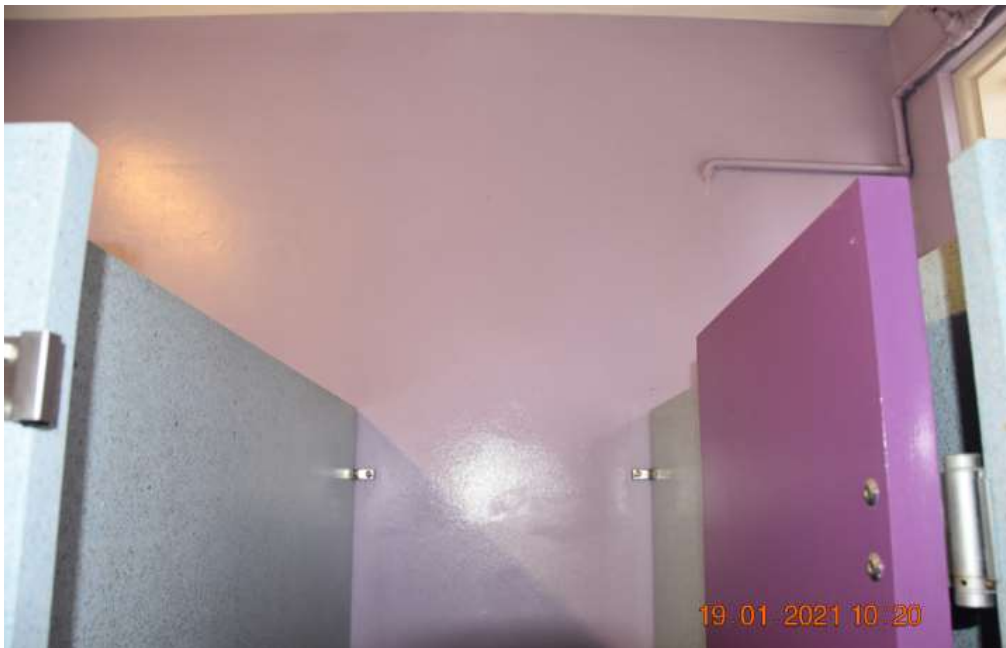
Figure: 0658

Peeling paint in the east wall in the toilet in room 13.

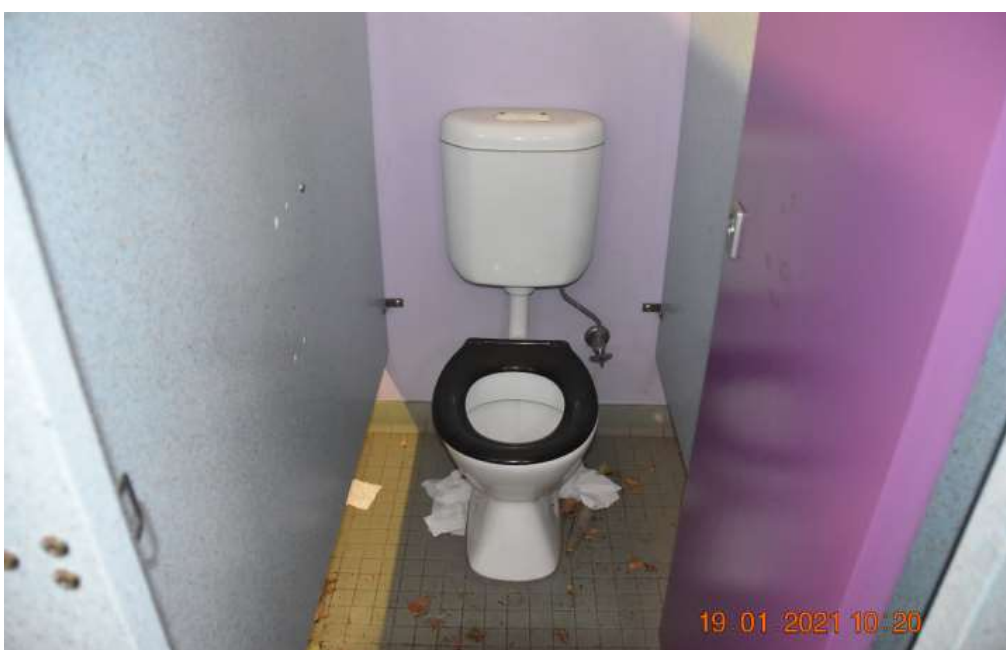
Figure: 0659

General view in the toilet in room 13.

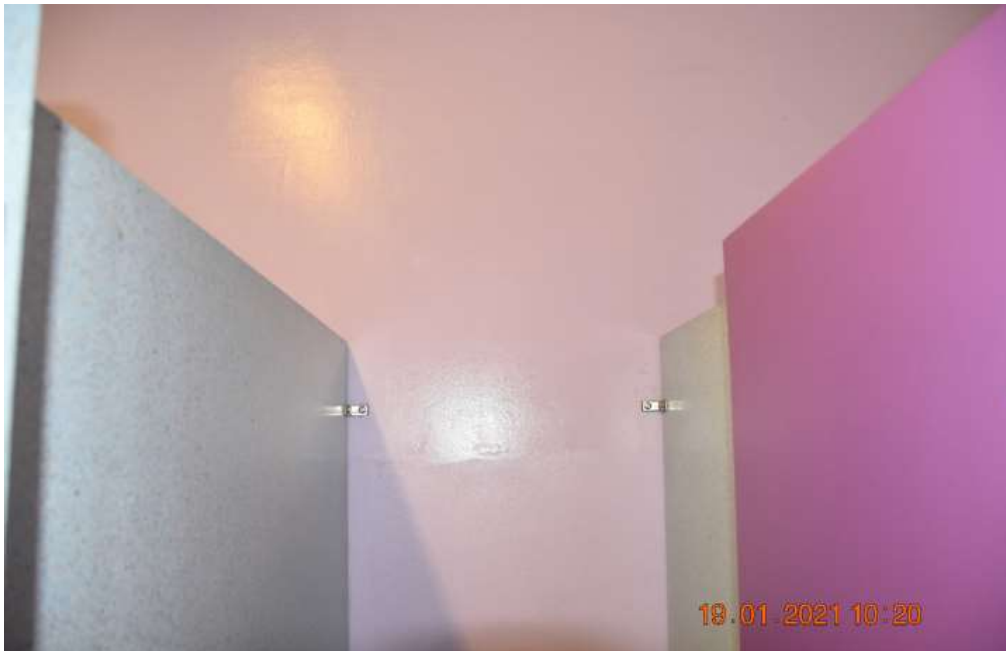
Figure: 0660

General view in the toilet in room 13.

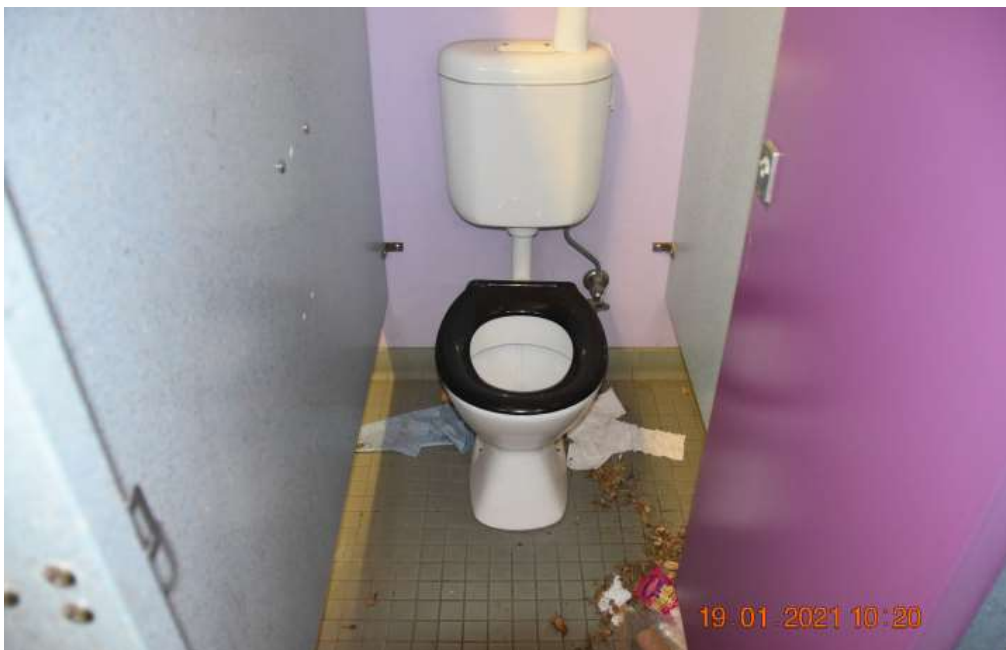
Figure: 0661

General view in the toilet in room 13.

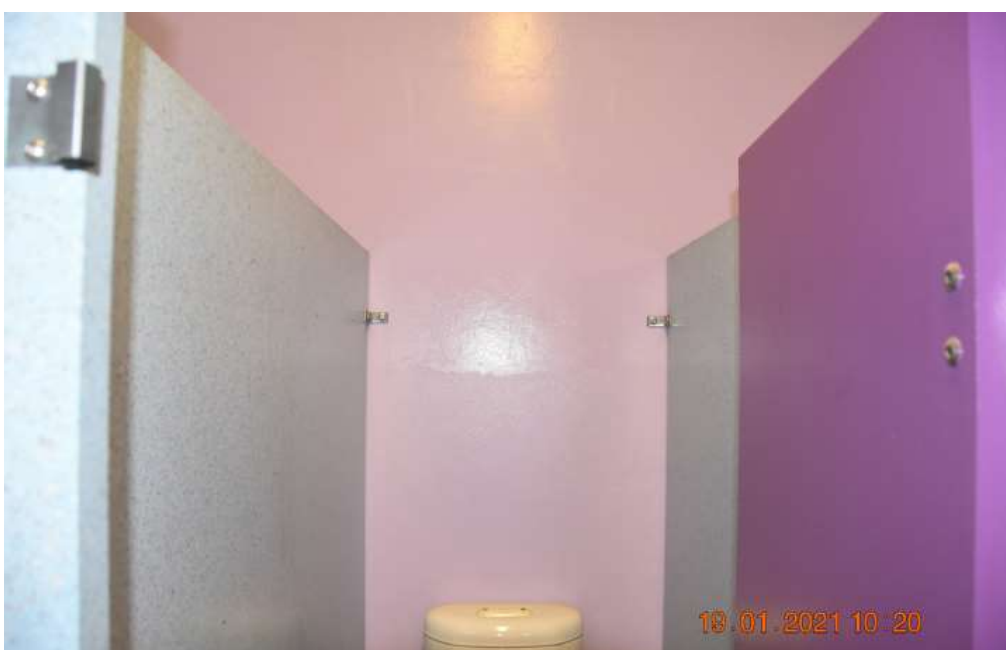
Figure: 0662

General view in the toilet in room 13.

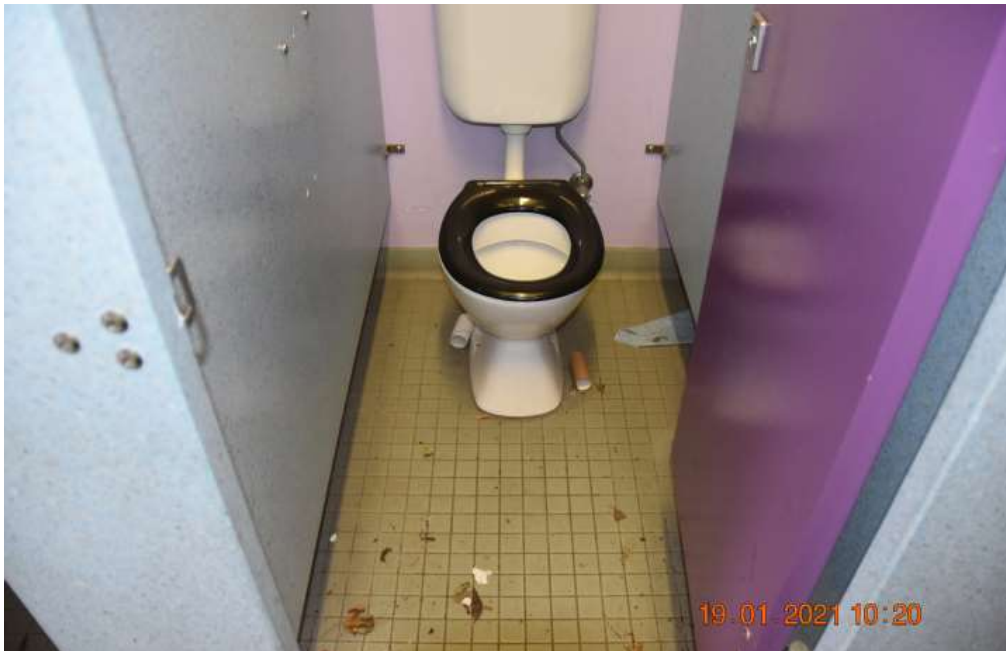
Figure: 0663

General view in the toilet in room 13.

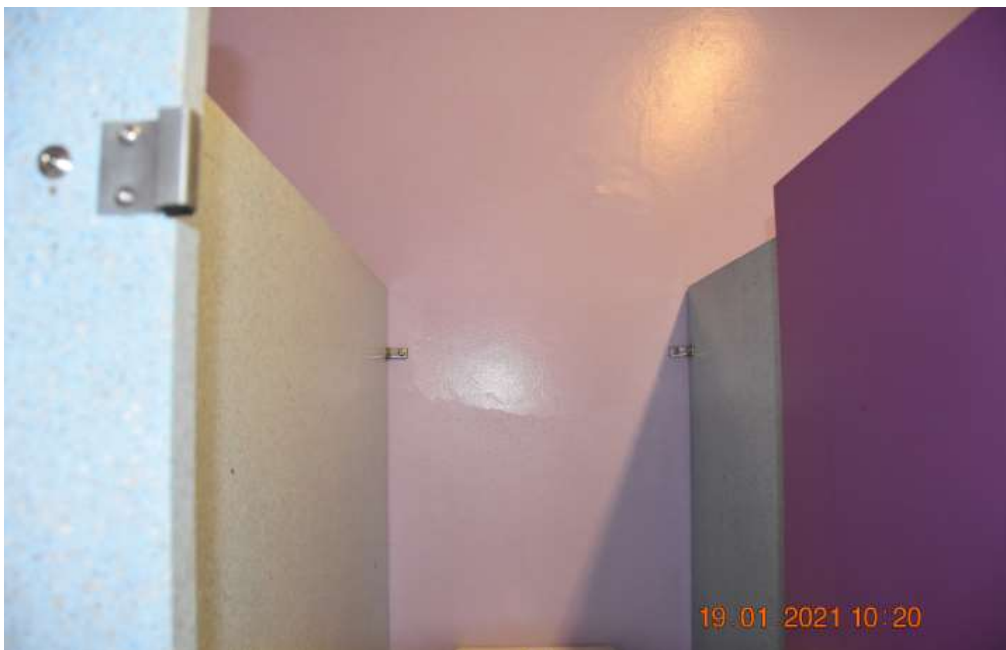
Figure: 0664

General view in the toilet in room 13.

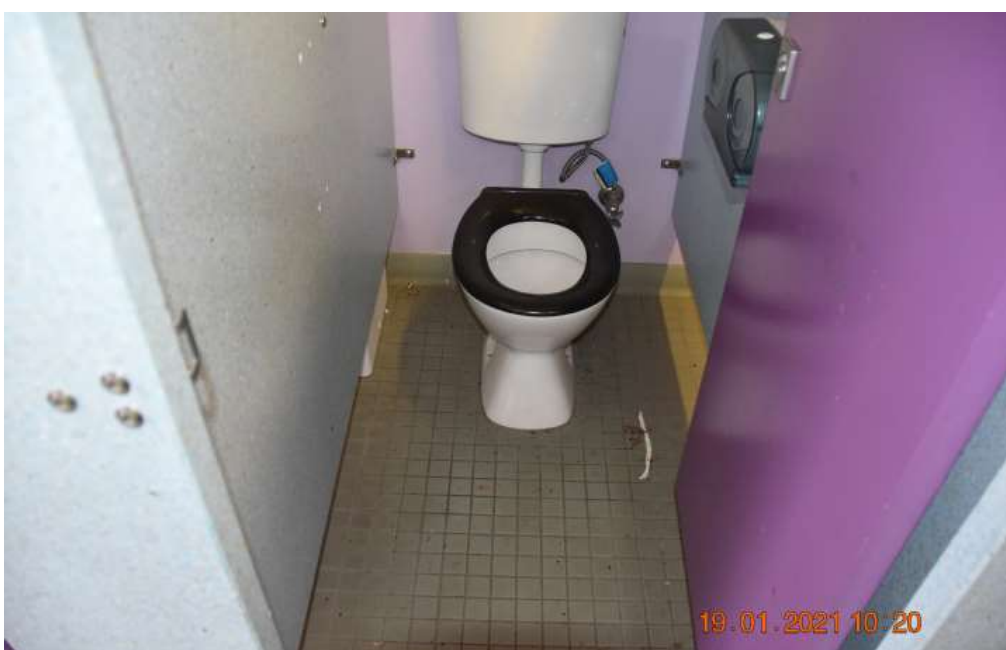
Figure: 0665

General view in the toilet in room 13.

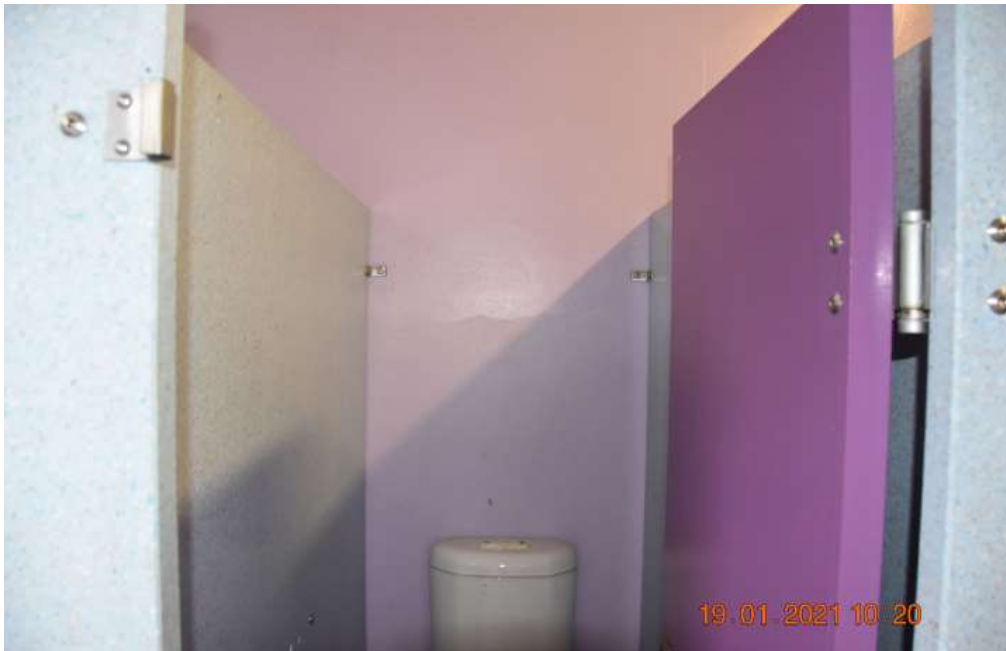
Figure: 0666

General view in the toilet in room 13.

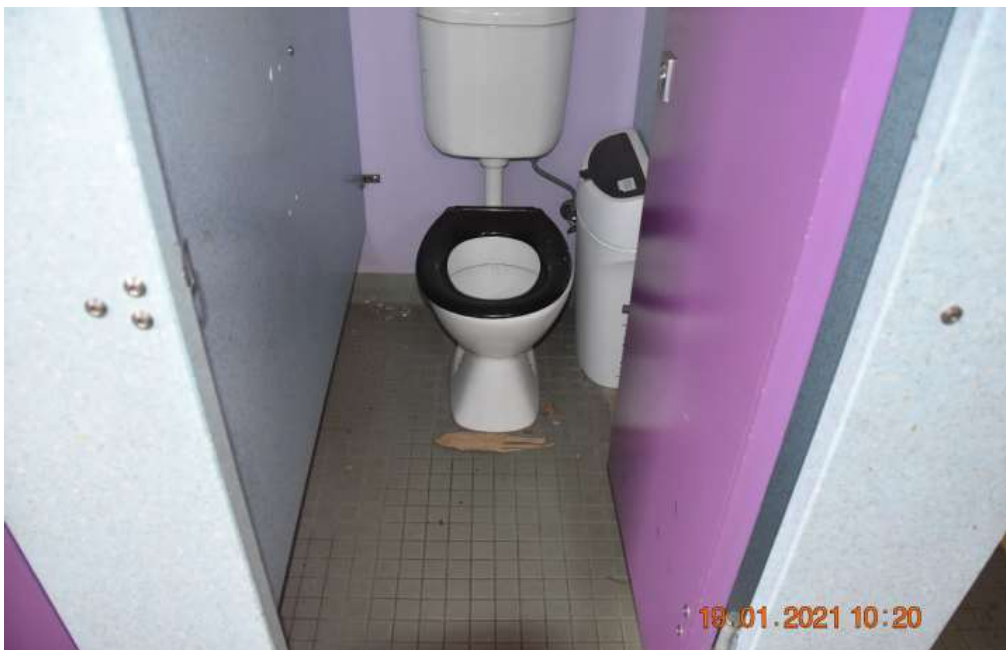
Figure: 0667

General view in the toilet in room 13.

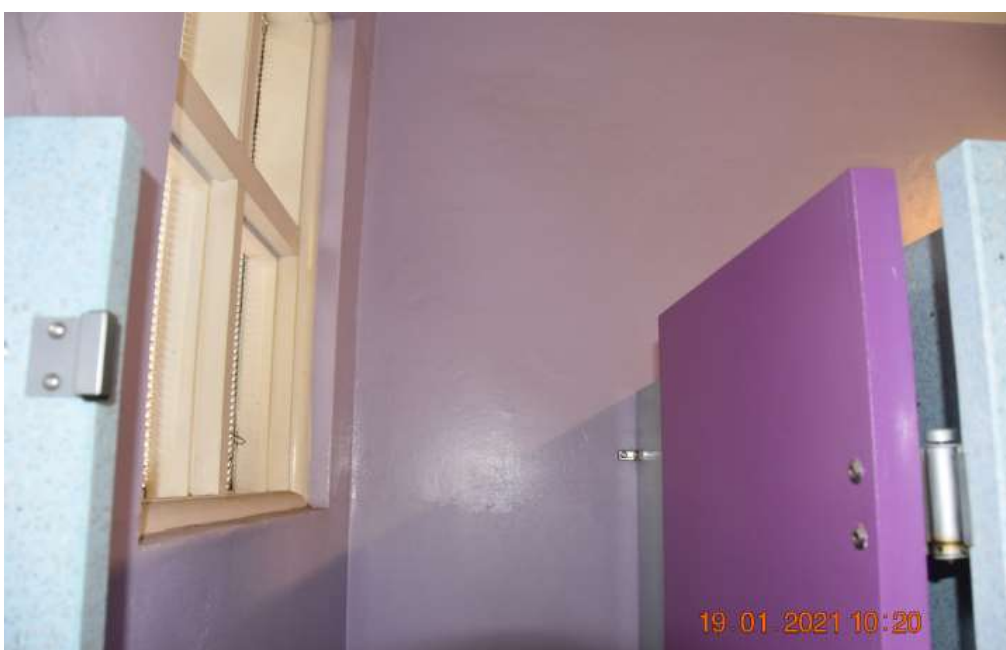
Figure: 0668

General view in the toilet in room 13.

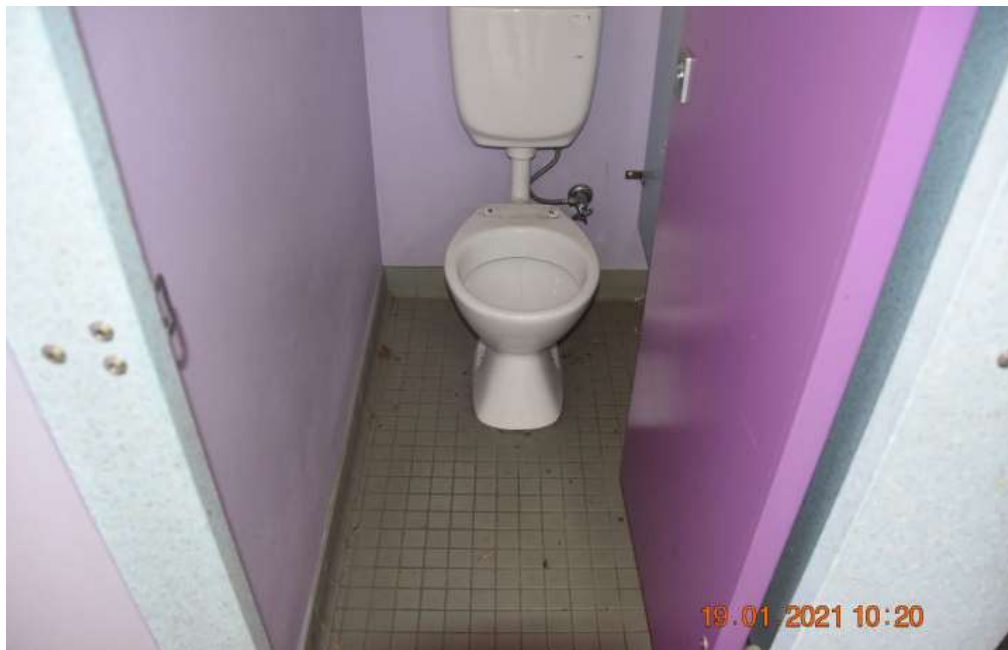
Figure: 0669

General view in the toilet in room 13.

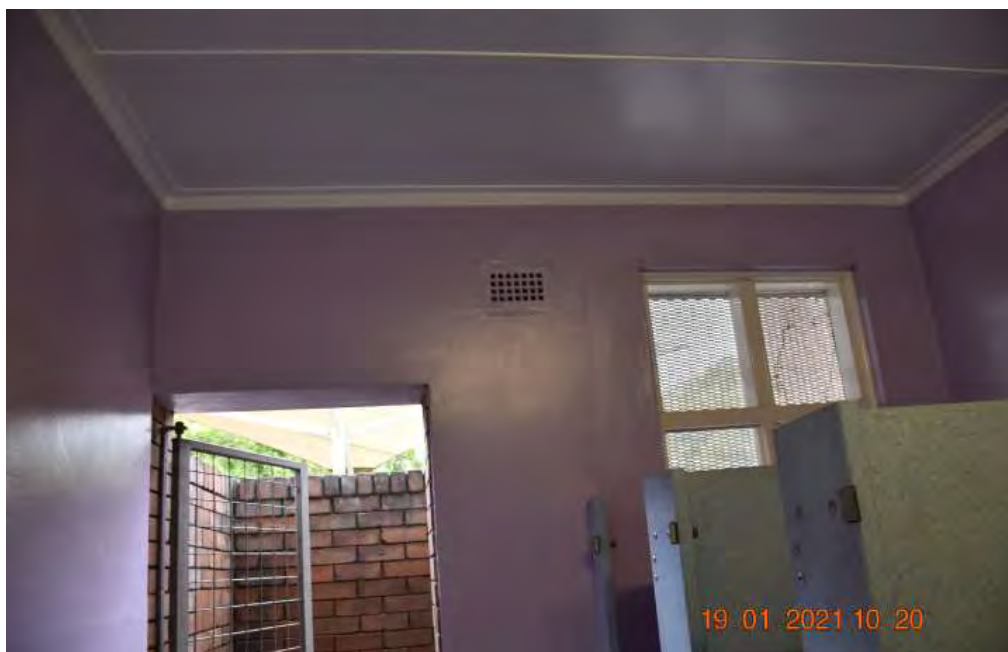
Figure: 0670

General view in the toilet in room 13.

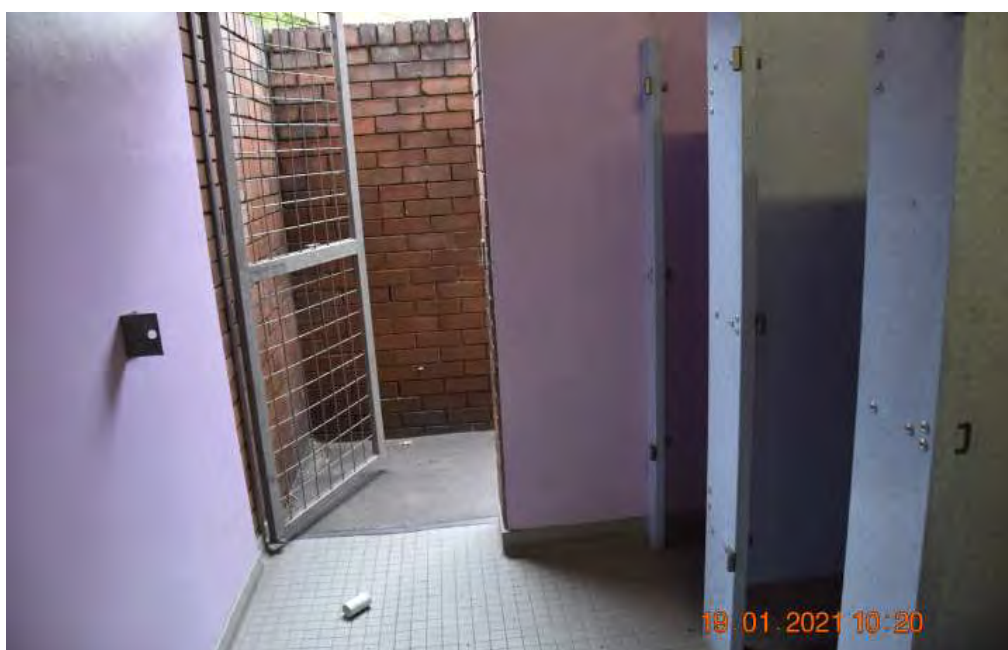
Figure: 0671

North wall in room 13.

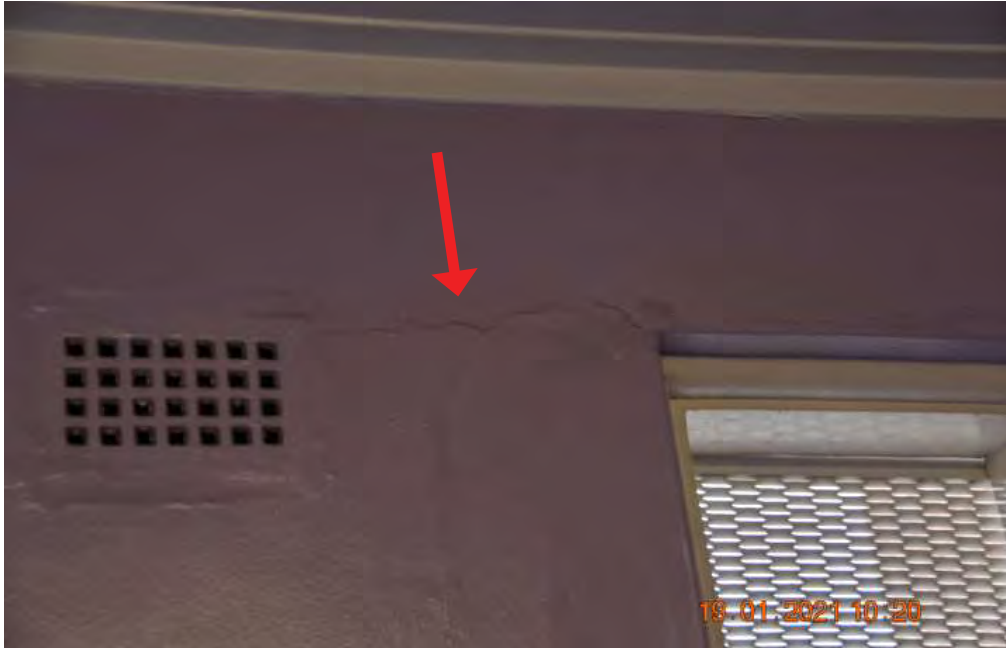
Figure: 0672

North wall in room 13.

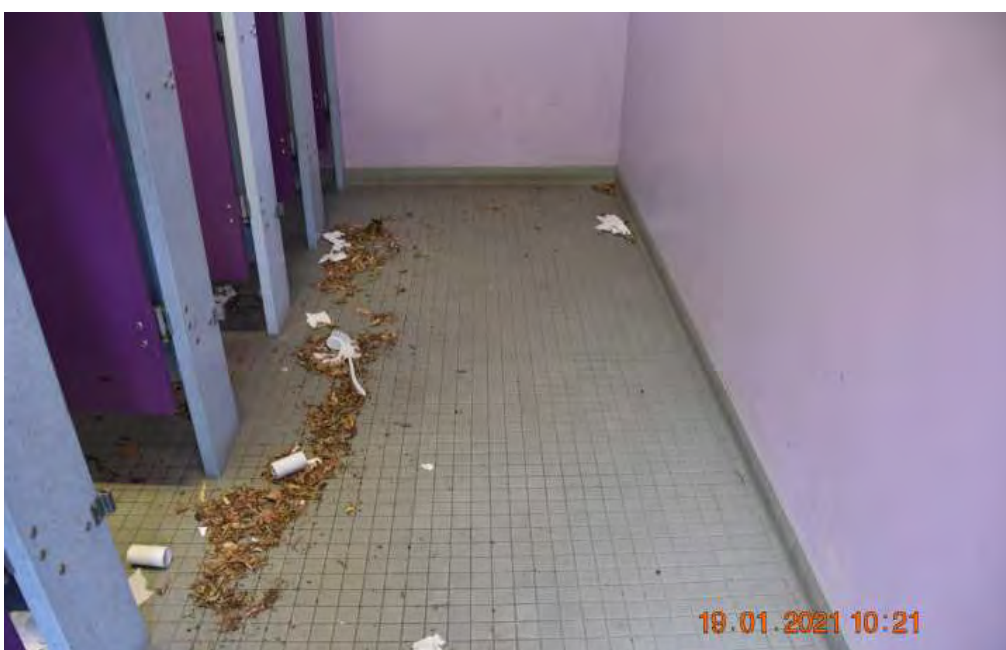
Figure: 0674

Tile floor in room 13.

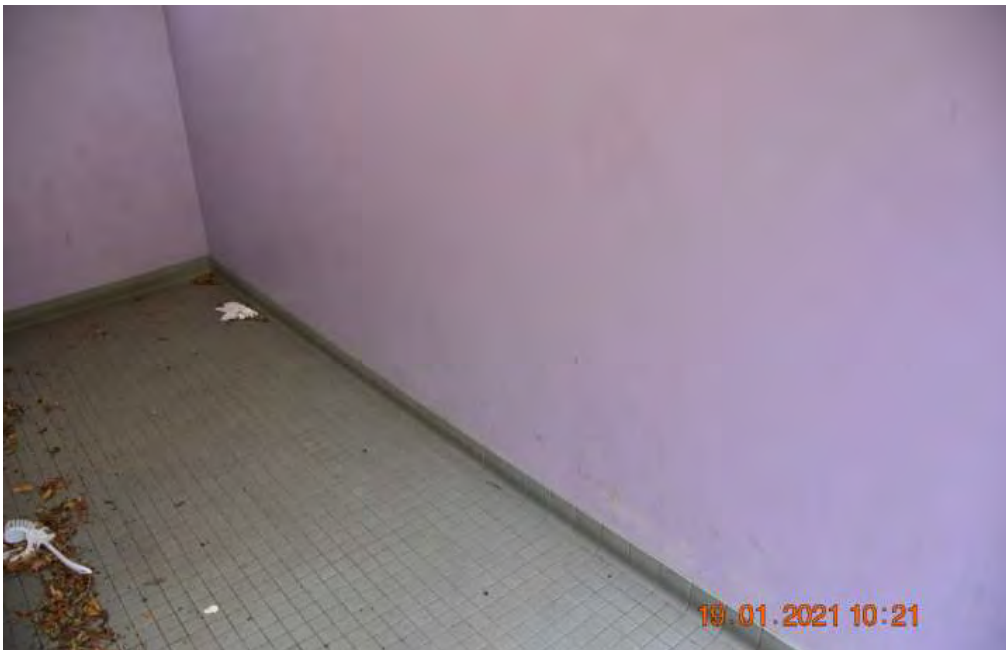
Figure: 0676

West wall in room  
13.

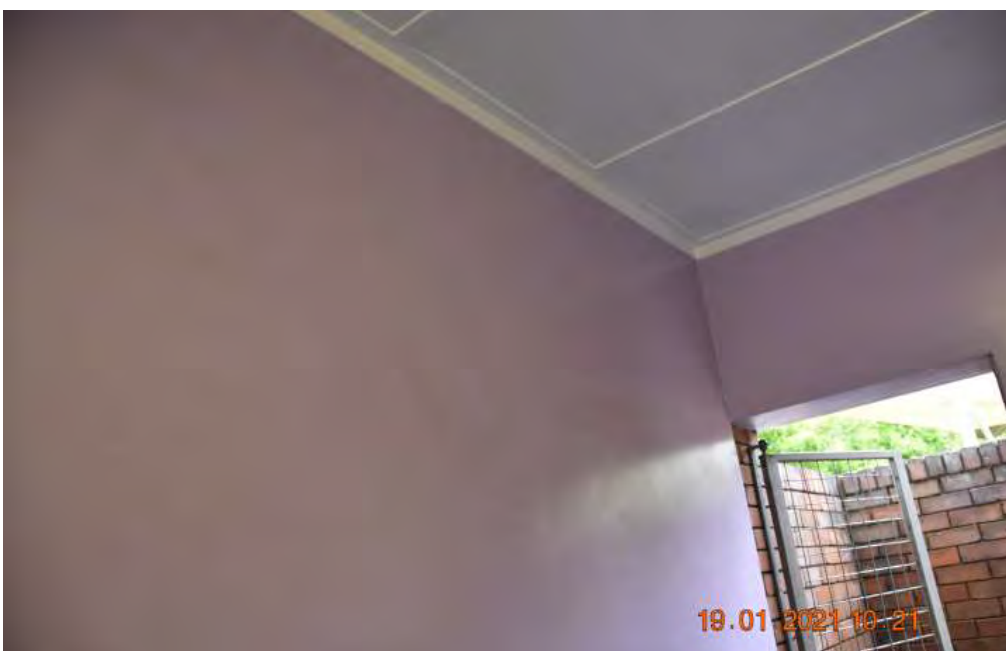
Figure: 0677

West wall in room  
13.

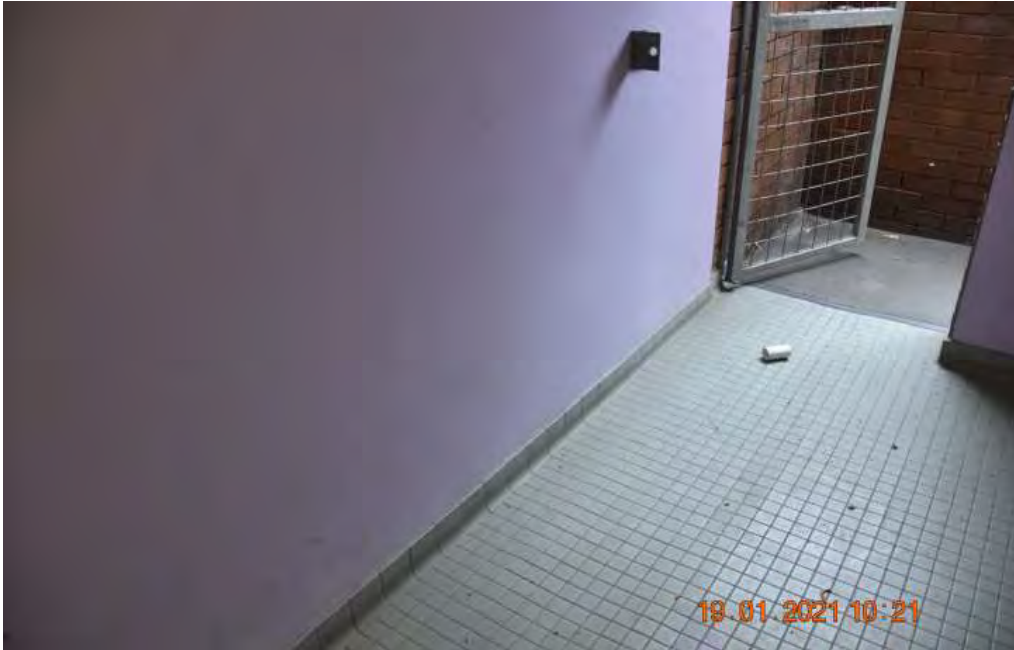
Figure: 0678

West wall in room  
13.

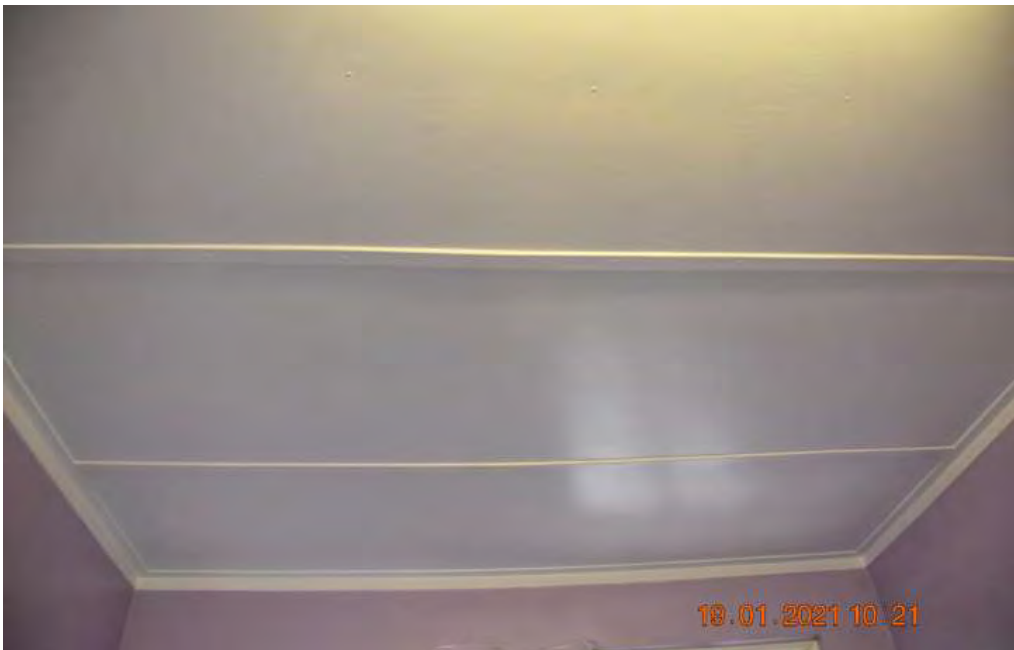
Figure: 0679

West wall in room 13.

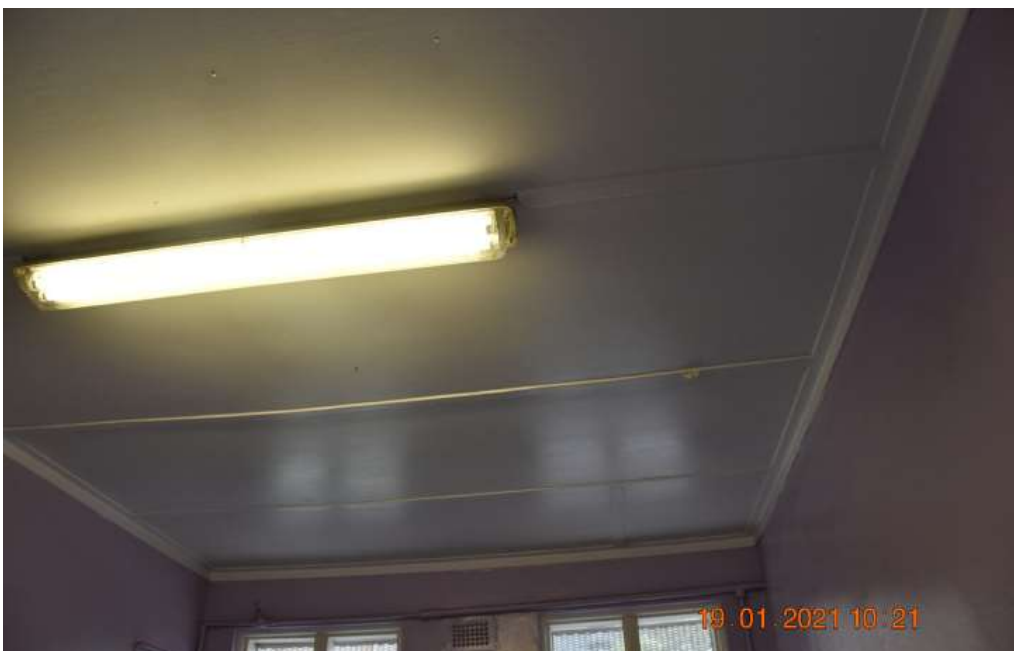
Figure: 0680

Ceiling in room 13.

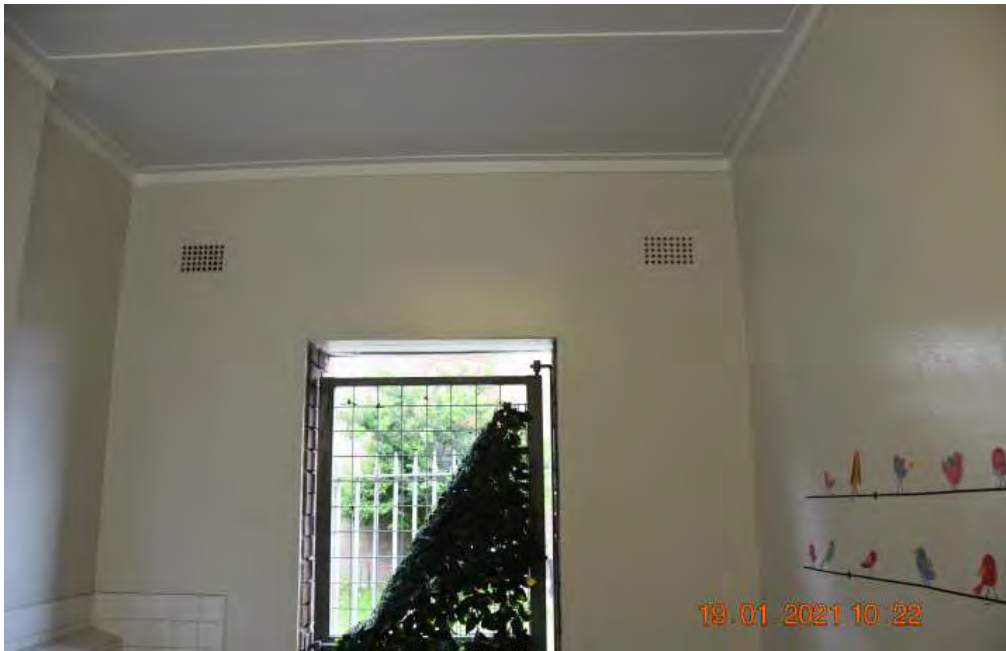
Figure: 0681

Ceiling in room 13.

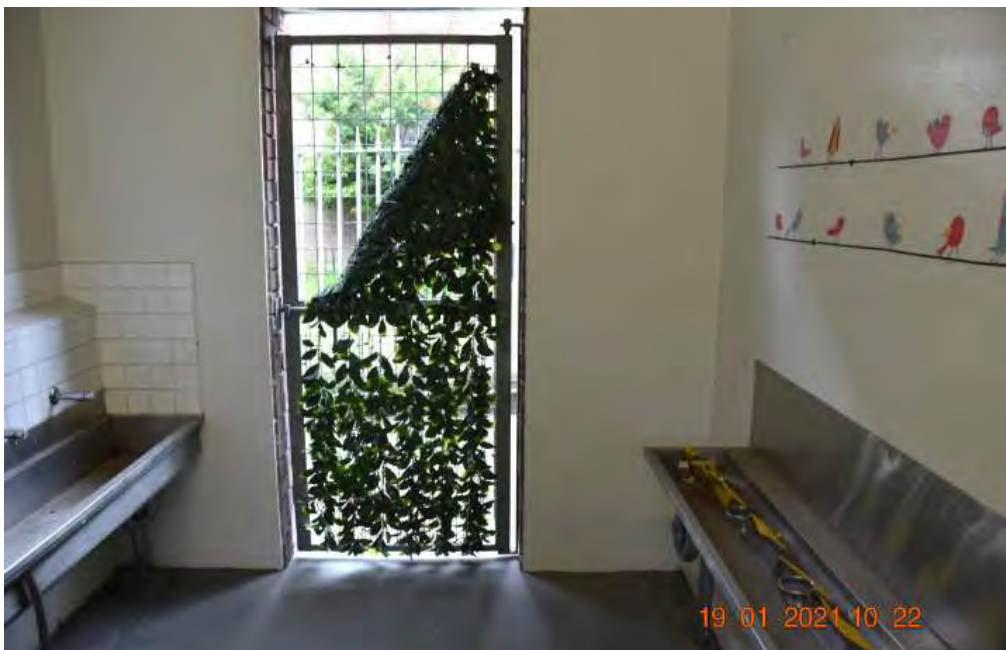
Figure: 0682

South wall in room 12.

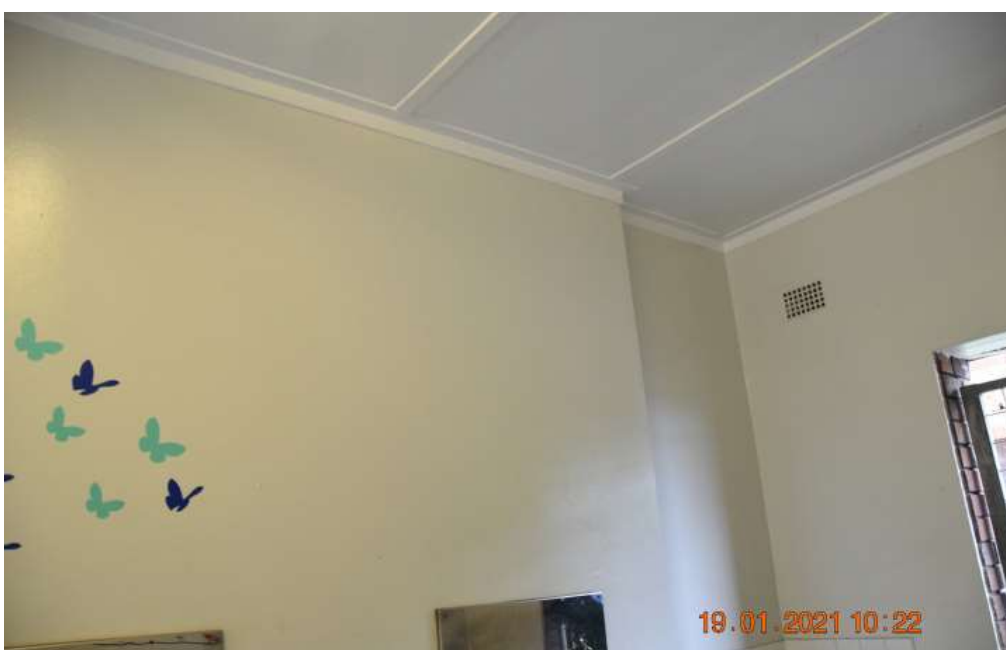
Figure: 0683

South wall in room 12.

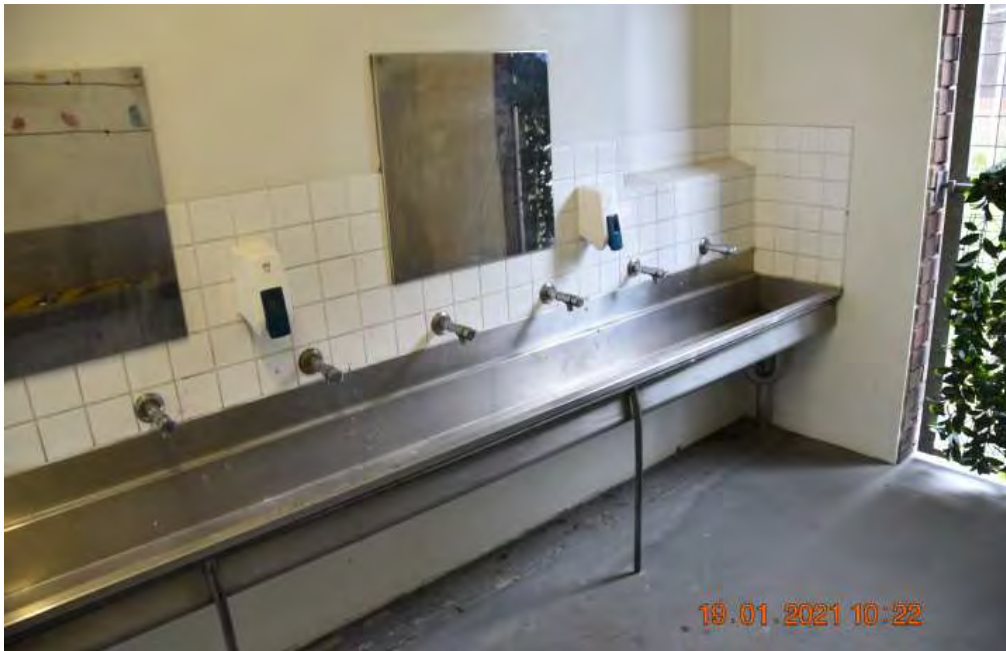
Figure: 0684

East wall in room 12.

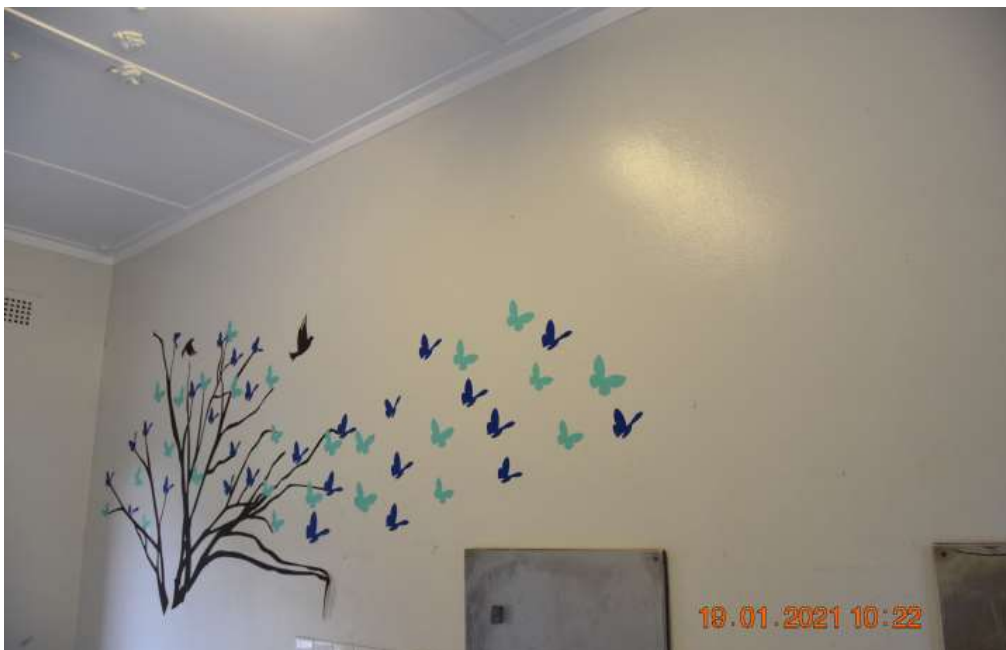
Figure: 0685

East wall in room 12.

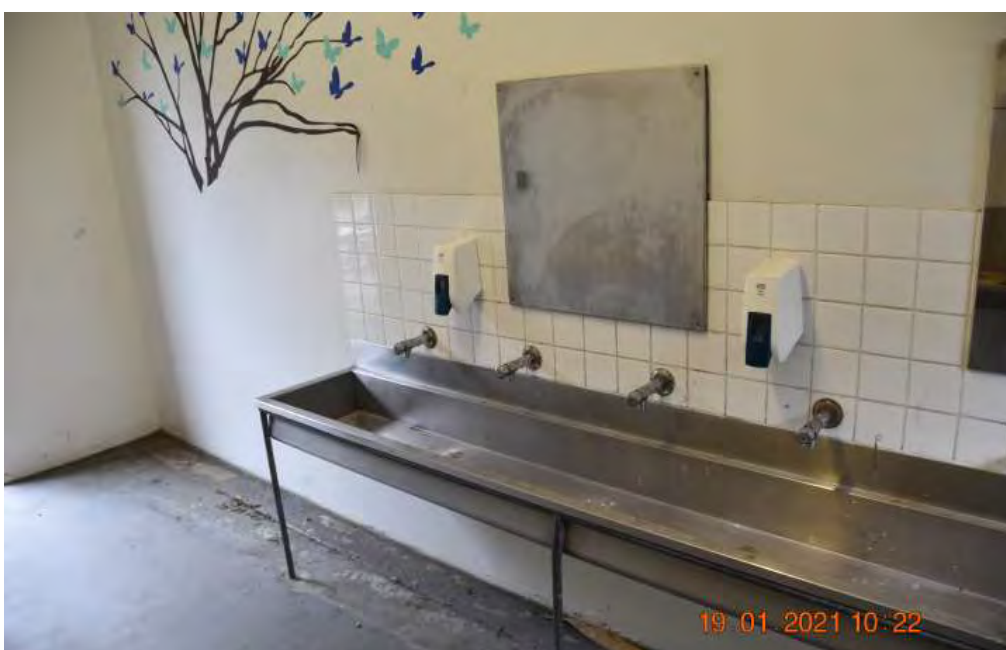
Figure: 0686

East wall in room 12.

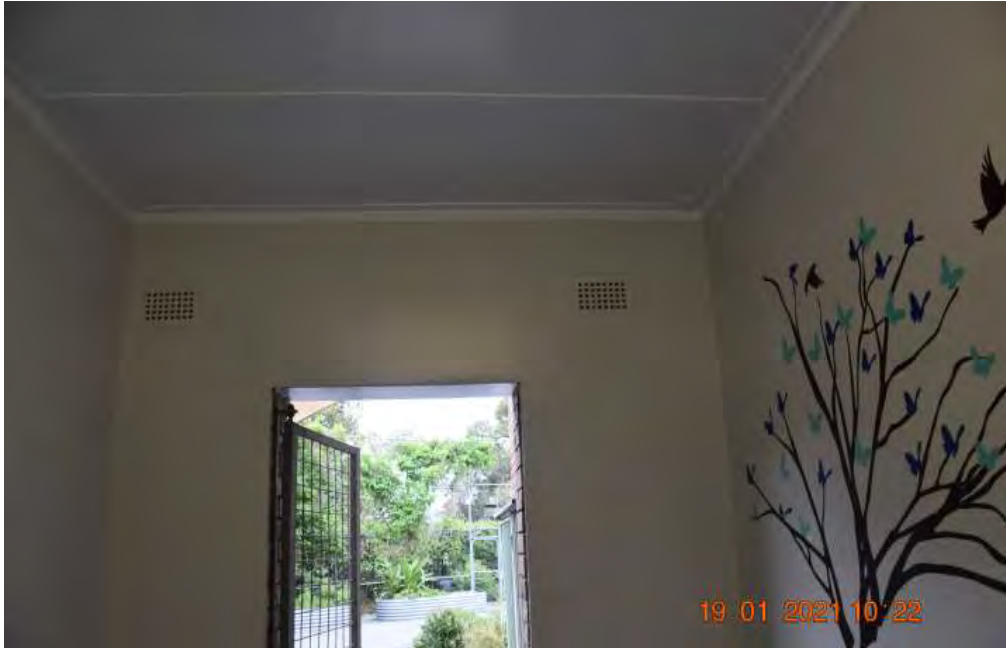
Figure: 0687

East wall in room 12.

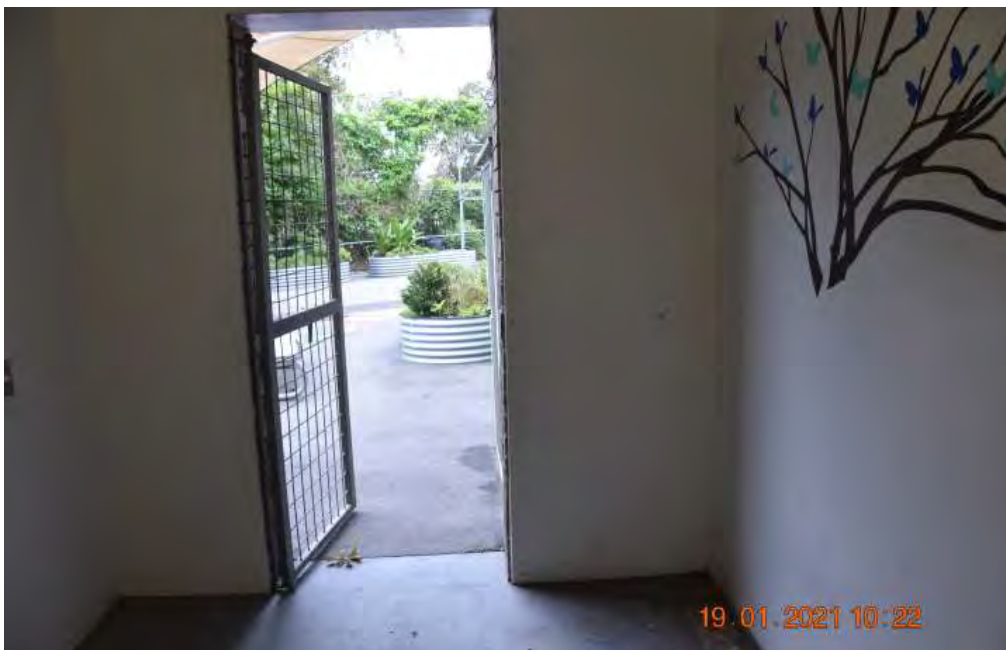
Figure: 0688

North wall in room  
12.

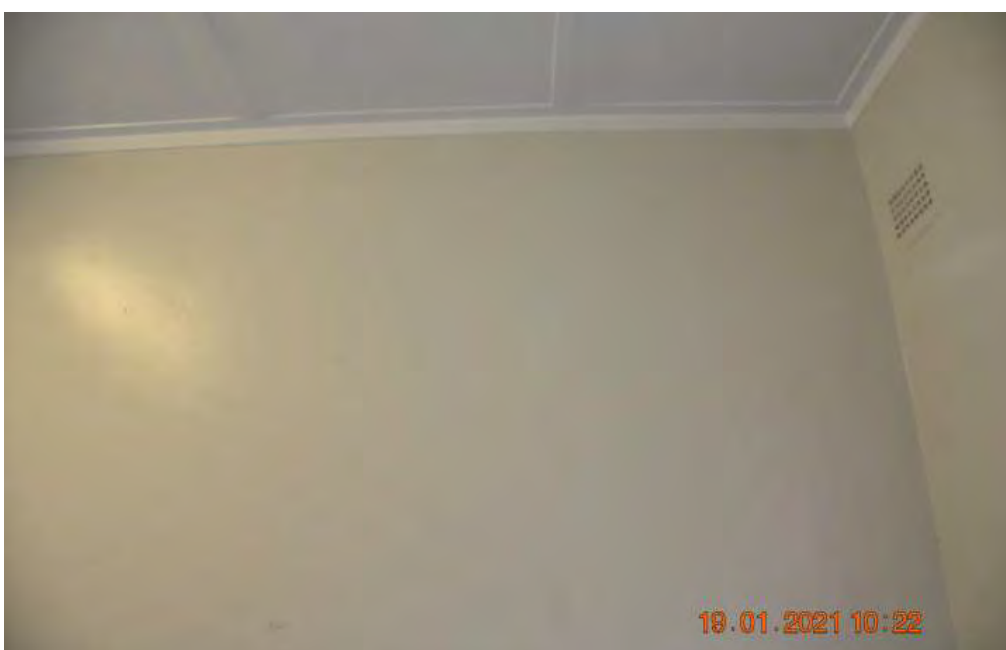
Figure: 0689

North wall in room  
12.

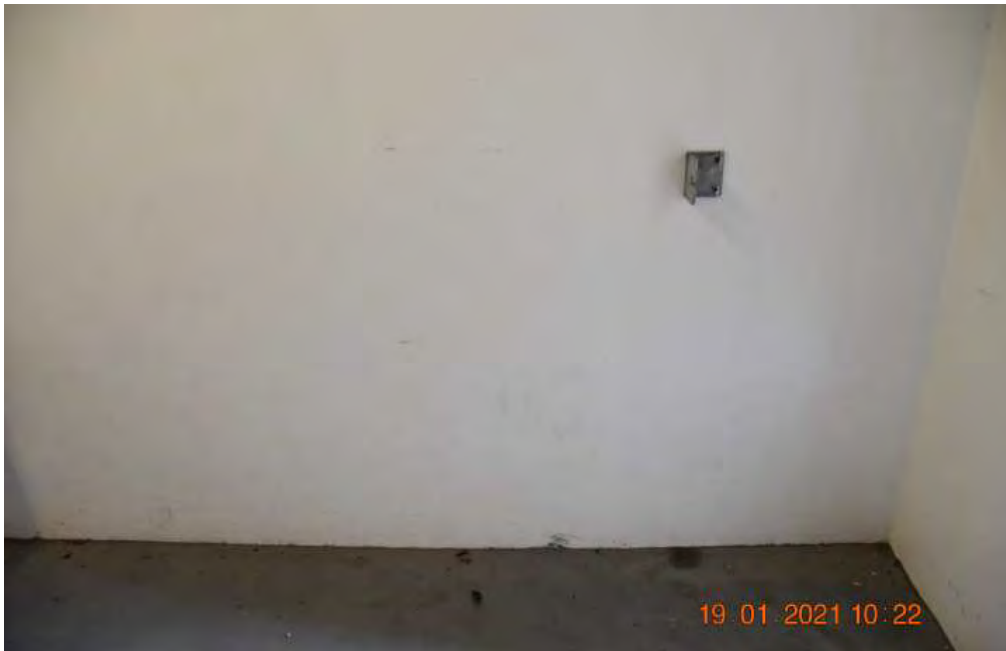
Figure: 0690

West wall in room  
12.

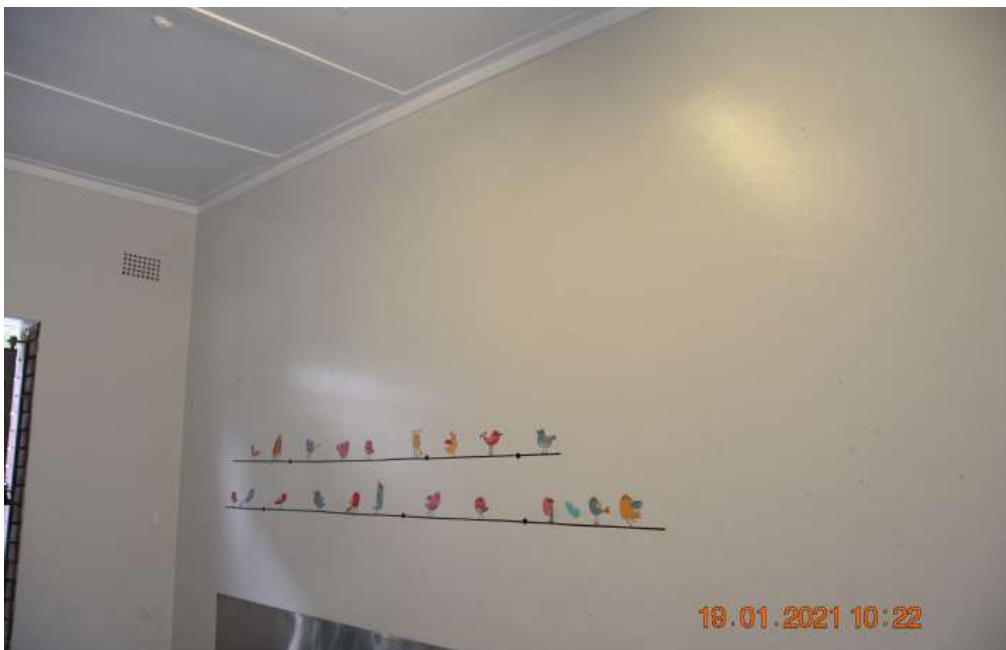
Figure: 0691

West wall in room  
12.
