## PRE CONSTRUCTION CONDITION SURVEY

Fort Street Public School, Millers Point NSW

Upper Fort Street Public School  
MILLERS POINT NSW 2000

19 January 2021

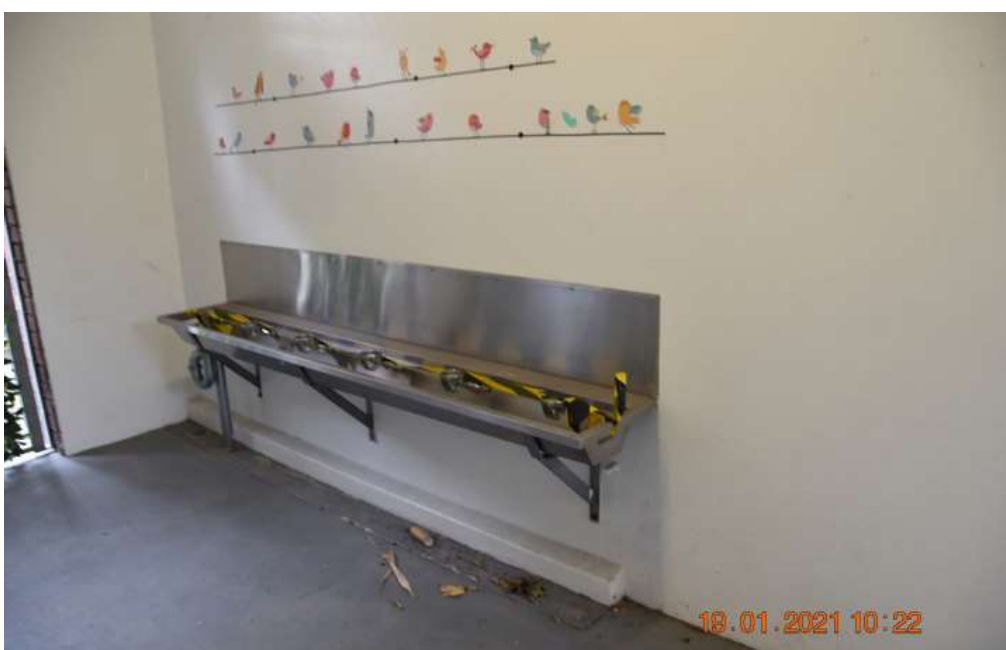
Figure: 0692

West wall in room  
12.

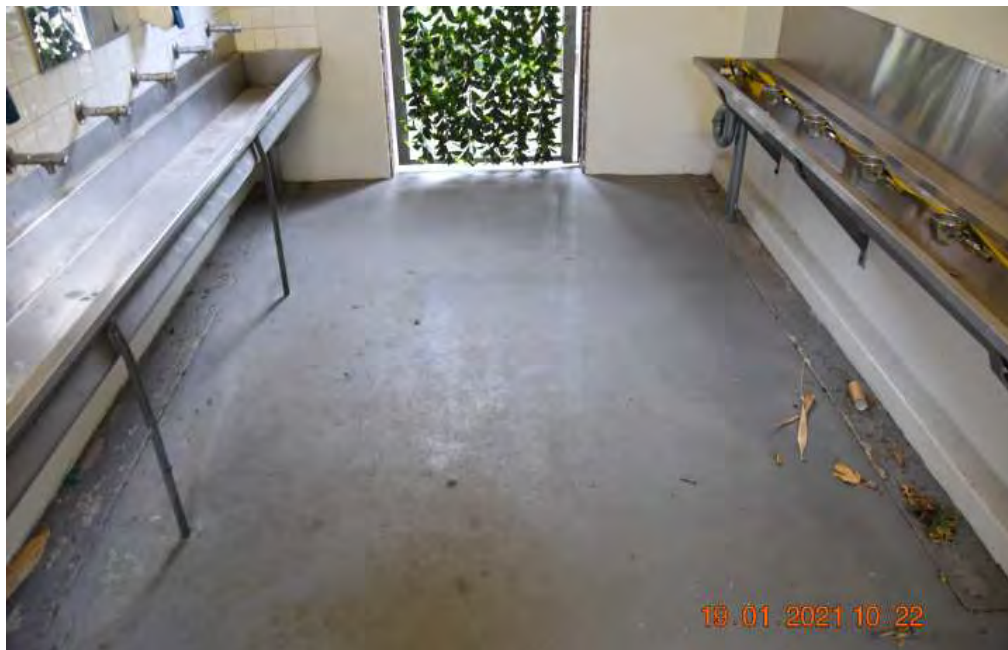
Figure: 0693

West wall in room  
12.

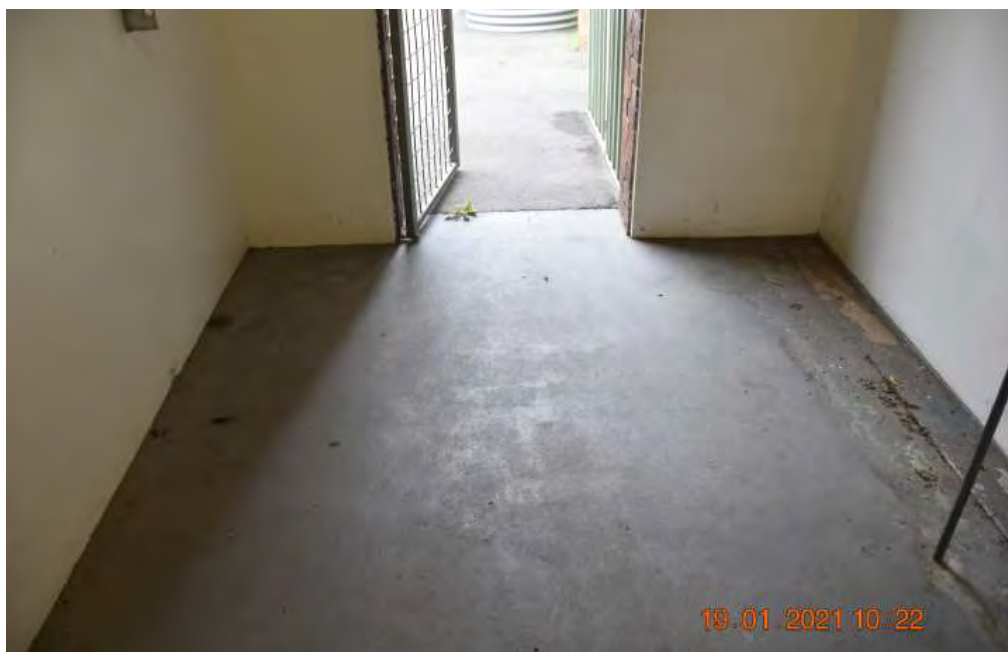
Figure: 0694

Floor slab in room 12.

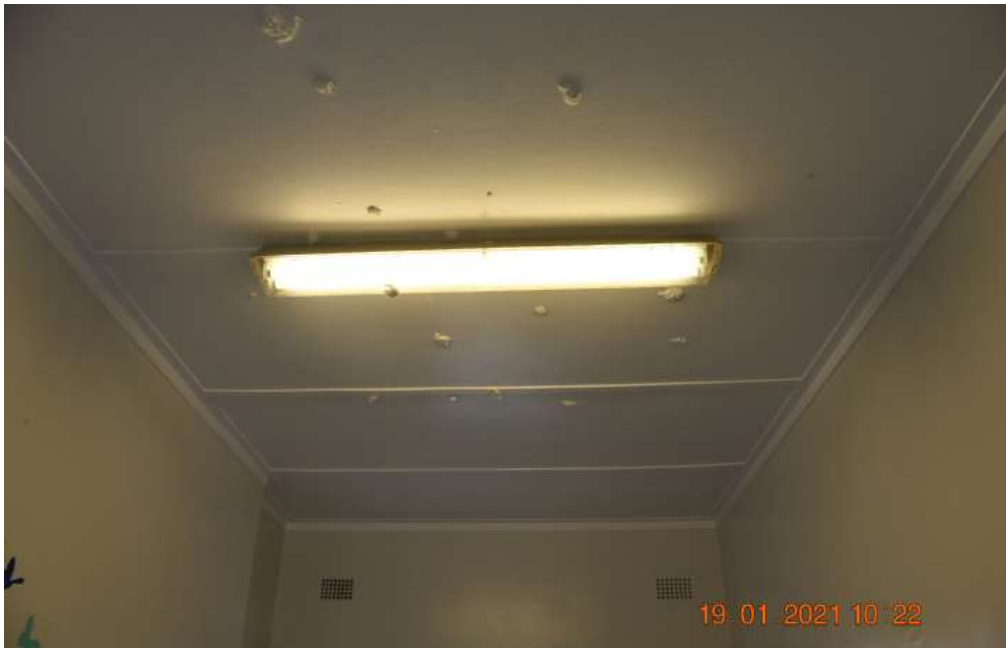
Figure: 0696

Ceiling in room 12.

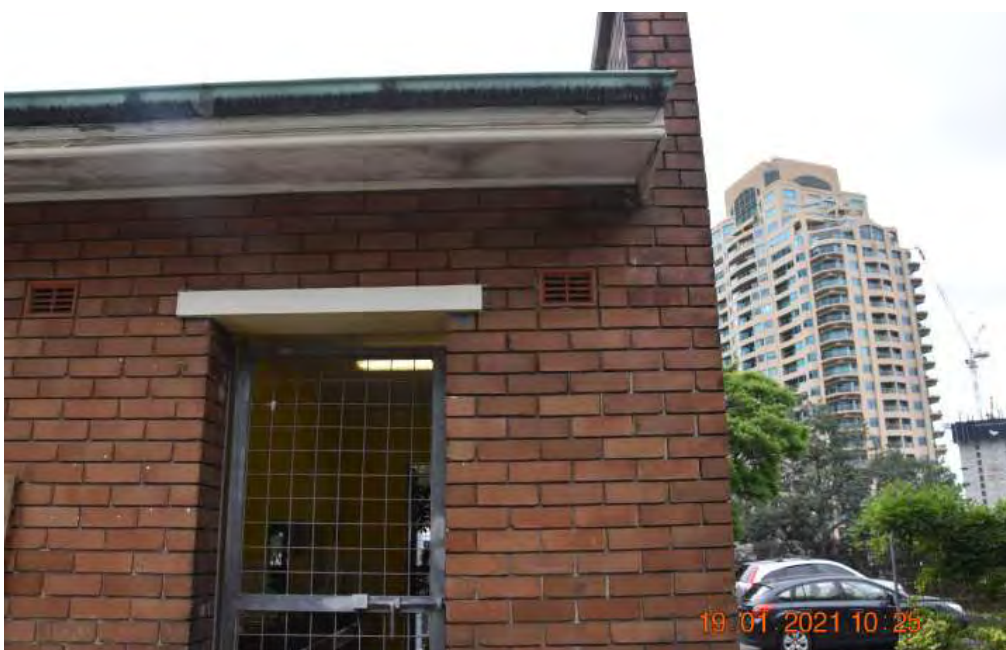
Figure: 0698

North wall of building A, outside the girls and boys toilet.

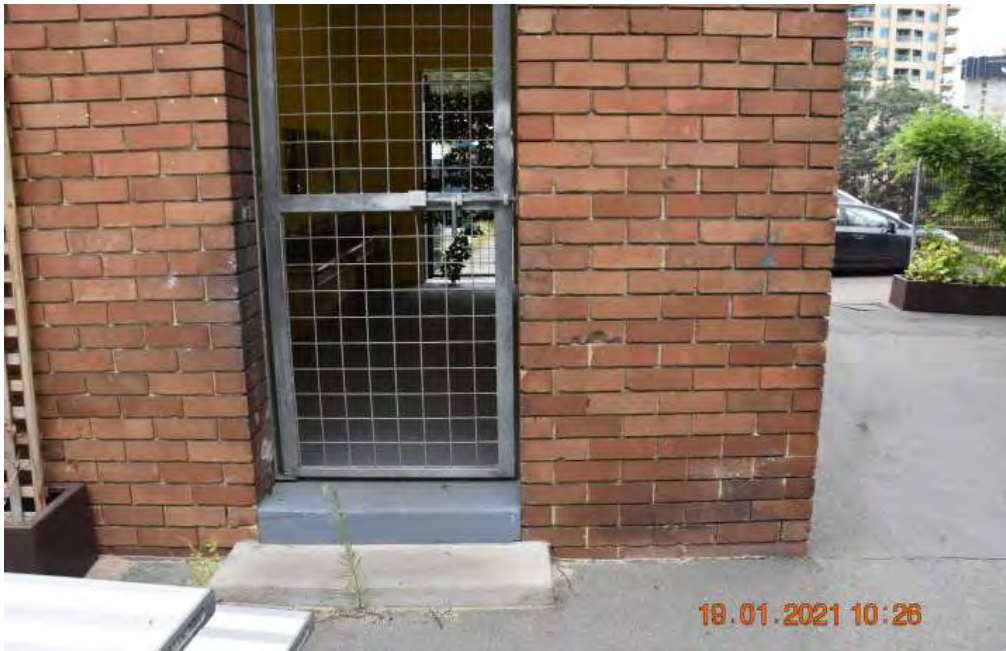
Figure: 0699

North wall of building A, outside room 15.

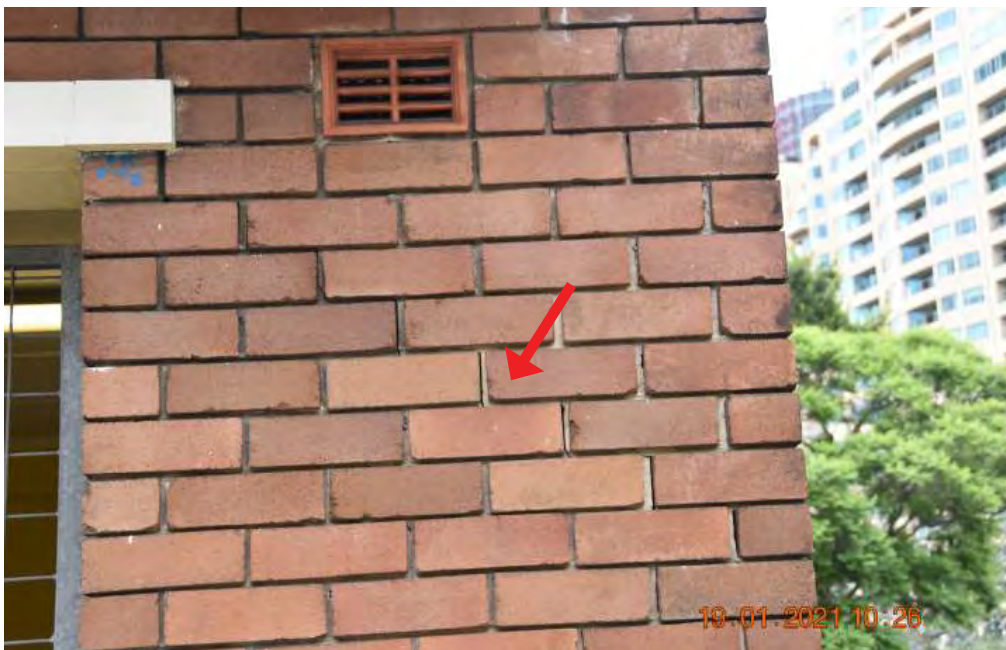
Figure: 0700

North wall of building A, outside room 15.

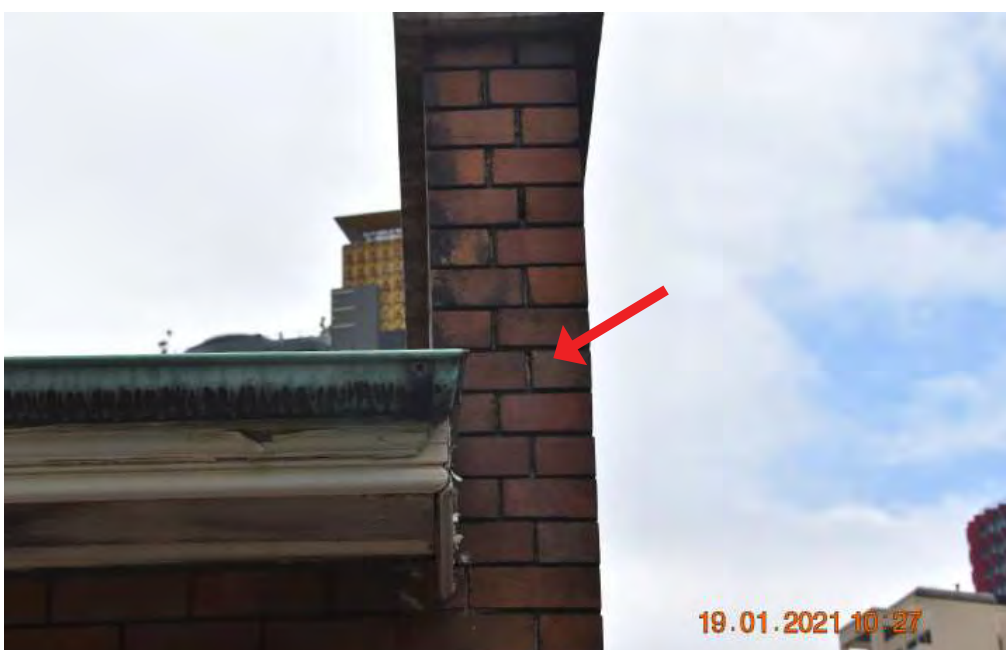
Figure: 0701

Slight stepped cracking in the mortar joint in the north wall of building A, outside room 15.

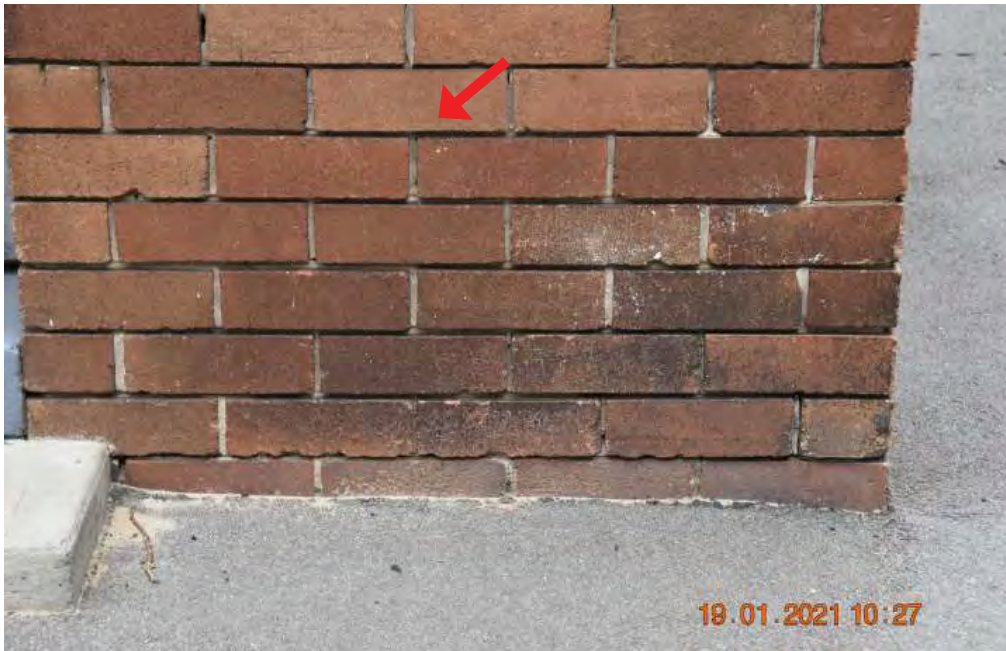
Figure: 0702

Erosion in the mortar joints in the north wall of building A, outside room 15.

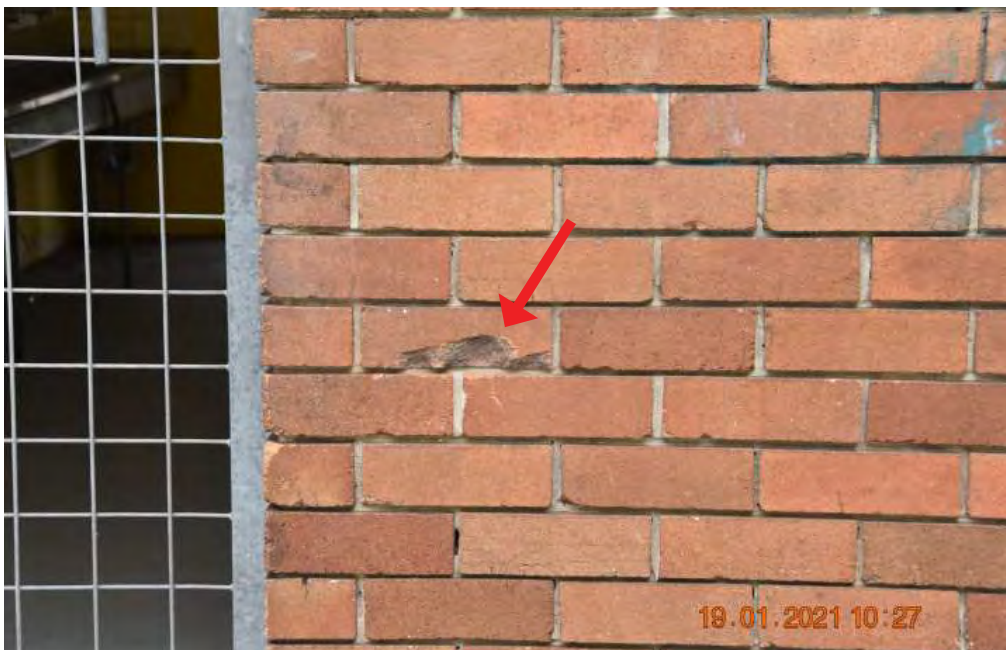
Figure: 0703

Erosion in the mortar joints in the north wall of building A, outside room 15.

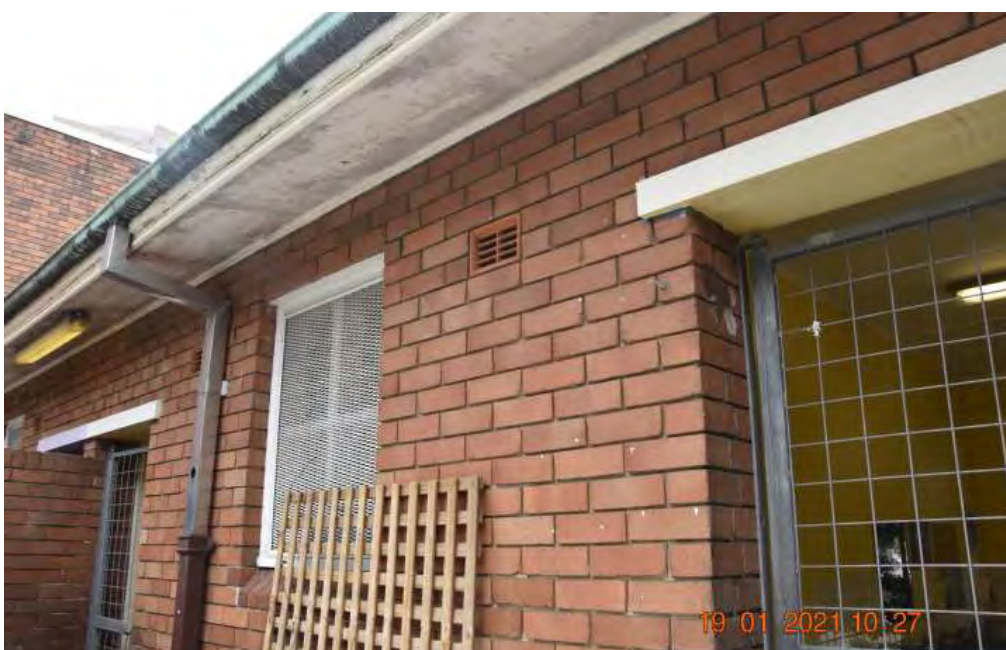
Figure: 0704

Chipping in the brick in the north wall of building A, outside room 15.

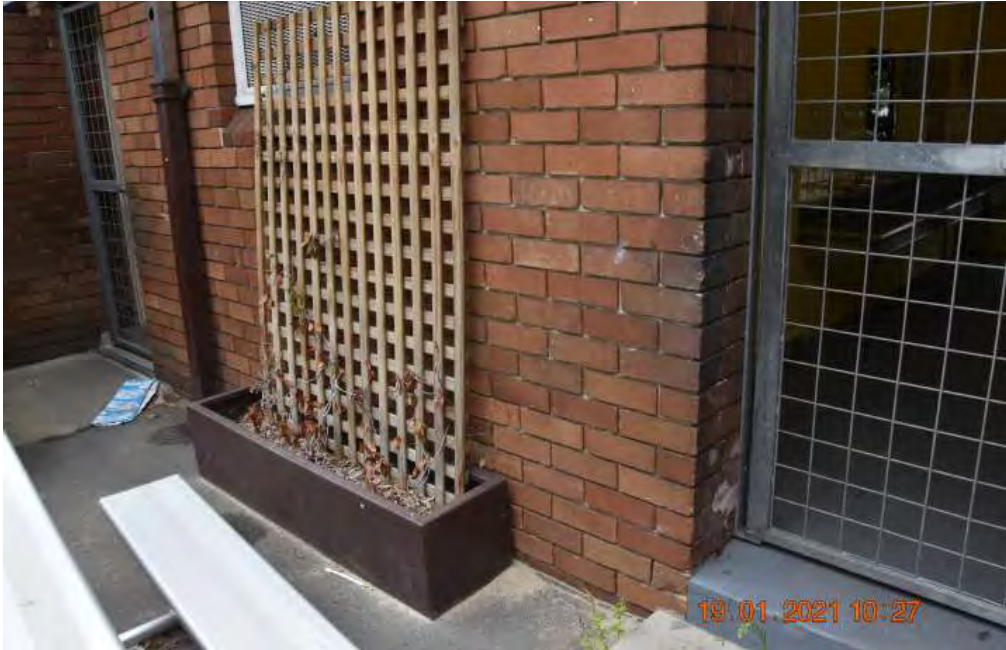
Figure: 0705

North wall of building A, outside room 15.

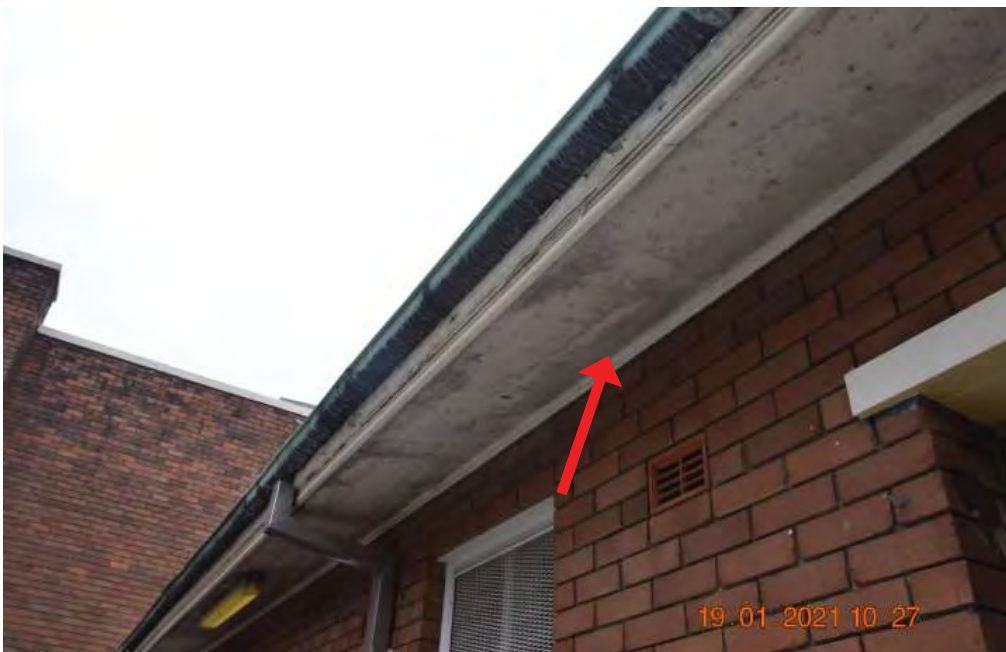
Figure: 0706

North wall of building A, outside room 15.

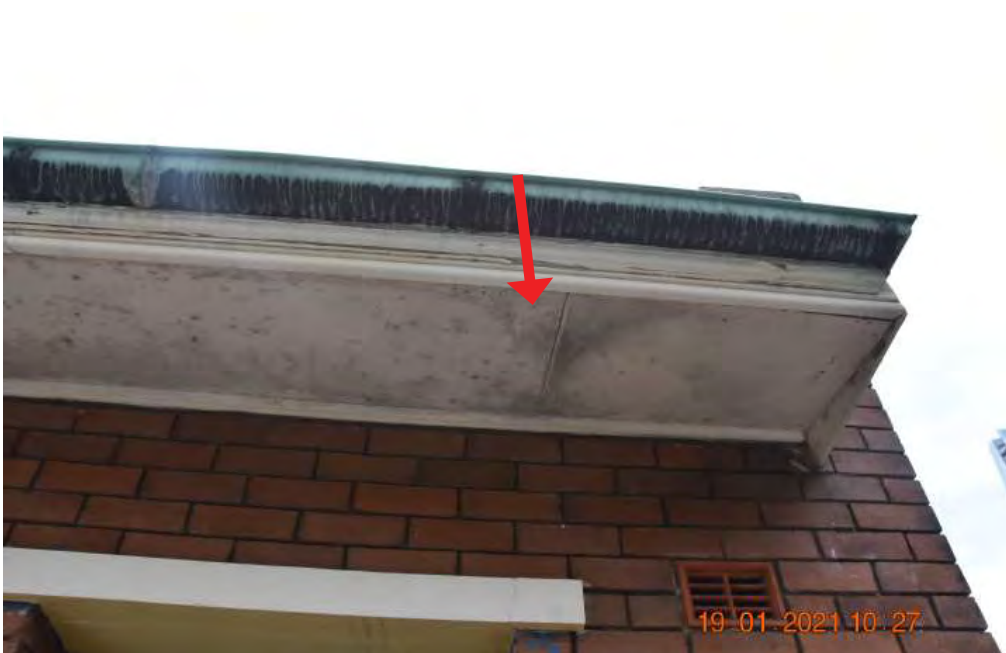
Figure: 0707

Mold on the soffit on the north side of building A, outside room 15.

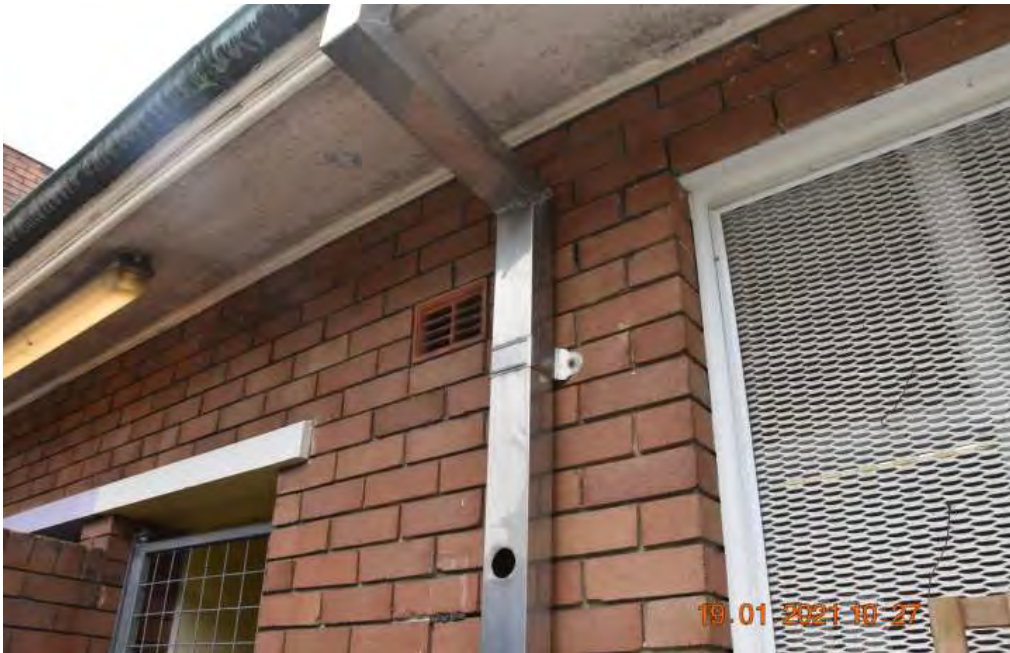
Figure: 0709

North wall of building A, outside room 14.

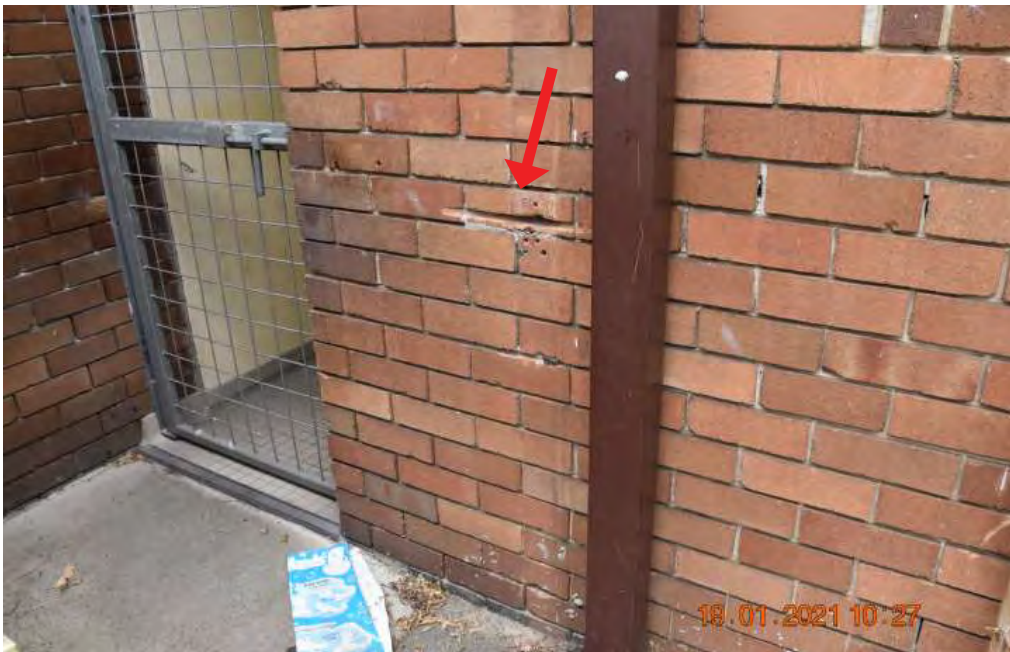
Figure: 0710

North wall of building A, outside room 14. Showing chipping and nail markings.

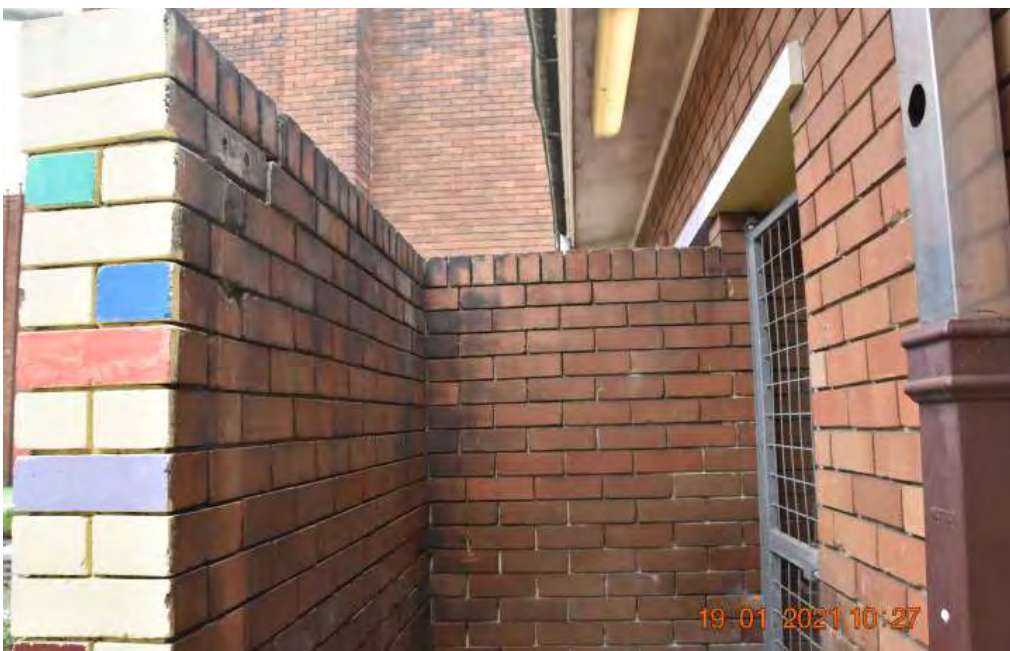
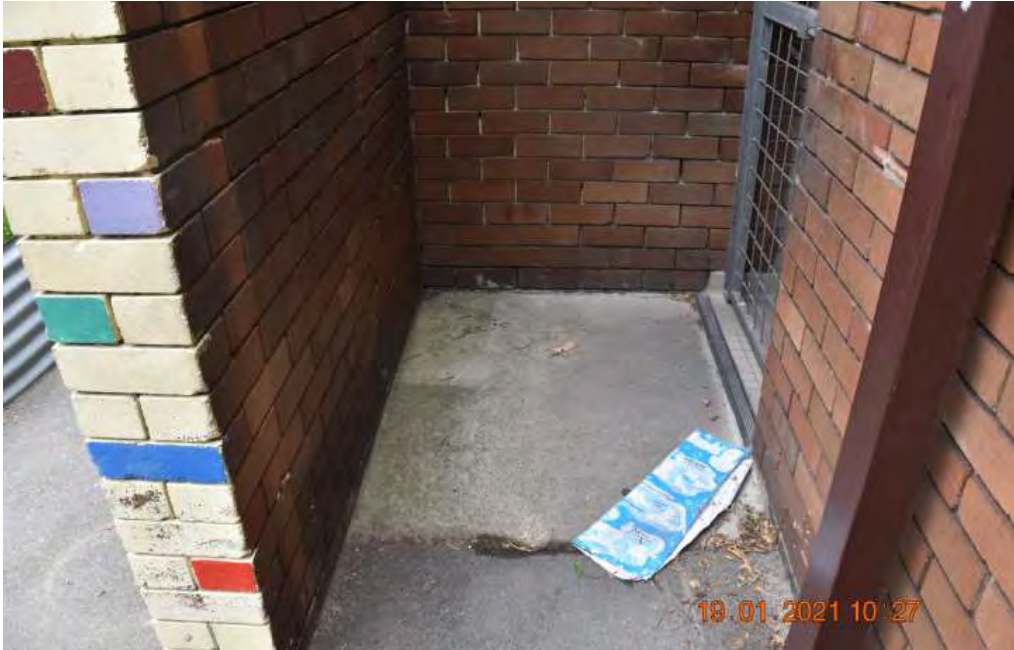
Figure: 0711

General view of the wall on the north side of room 14.

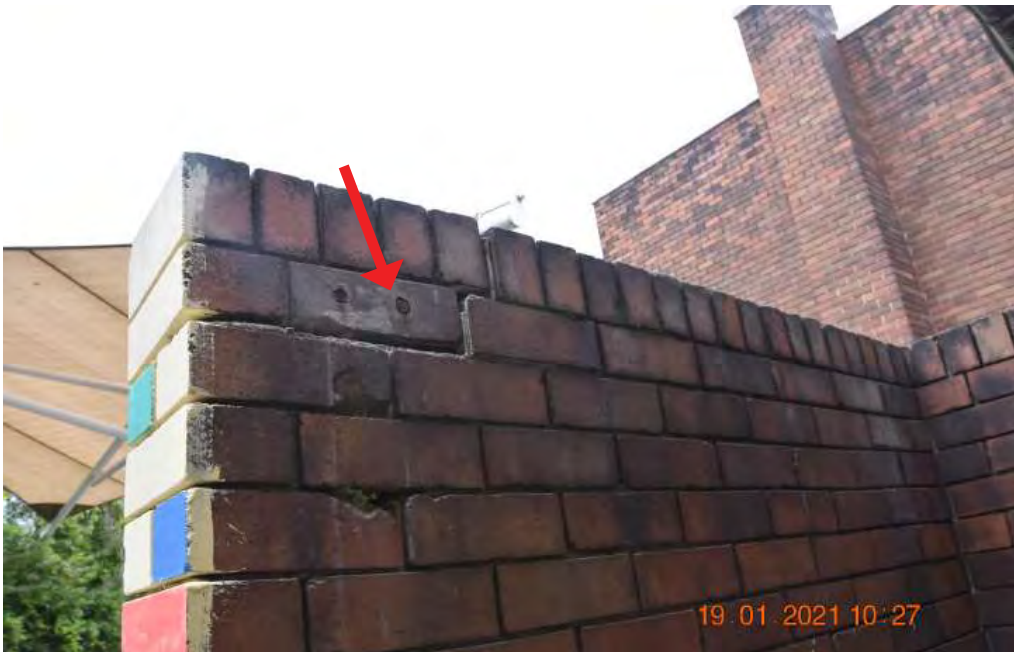
Figure: 0712

General view of the wall on the north side of room 14.

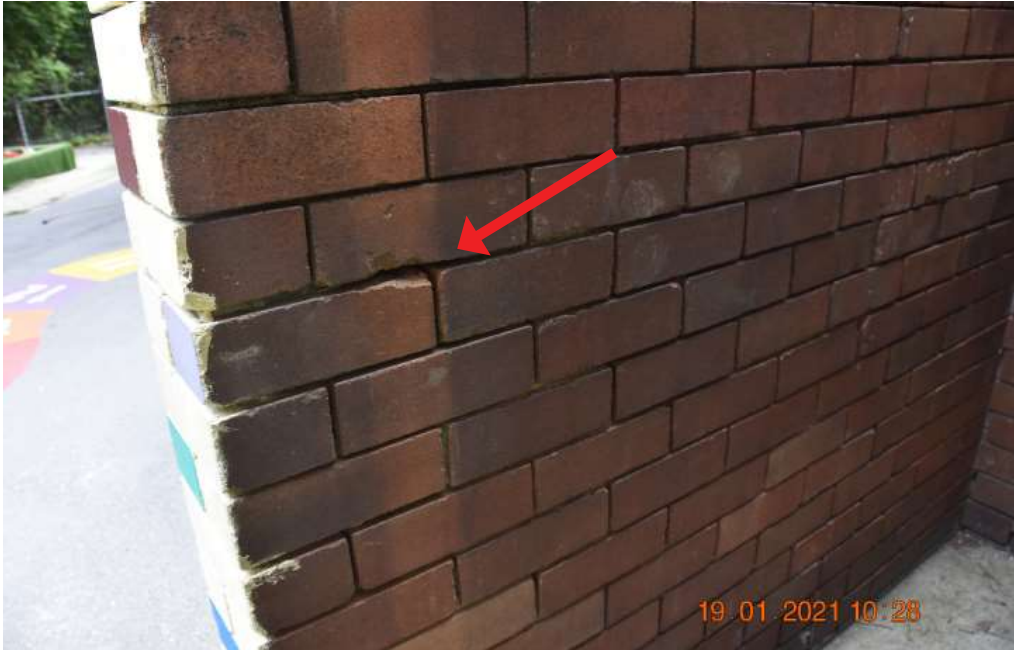
Figure: 0714

Erosion in the mortar joints in the wall on the north side of room 14.

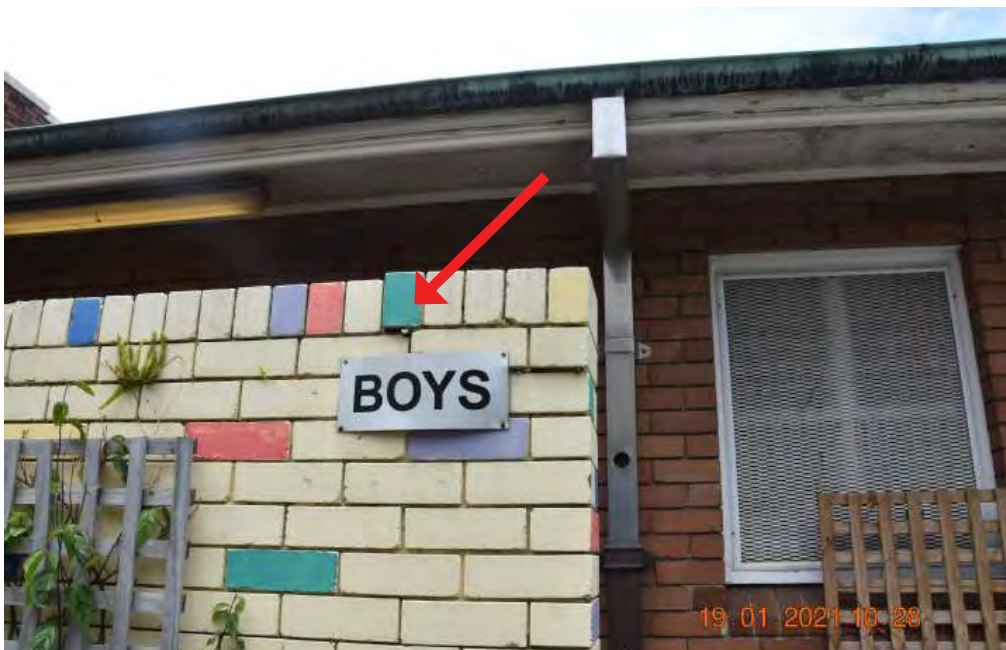
Figure: 0721

General view of the wall on the north side of building A, outside the toilets.

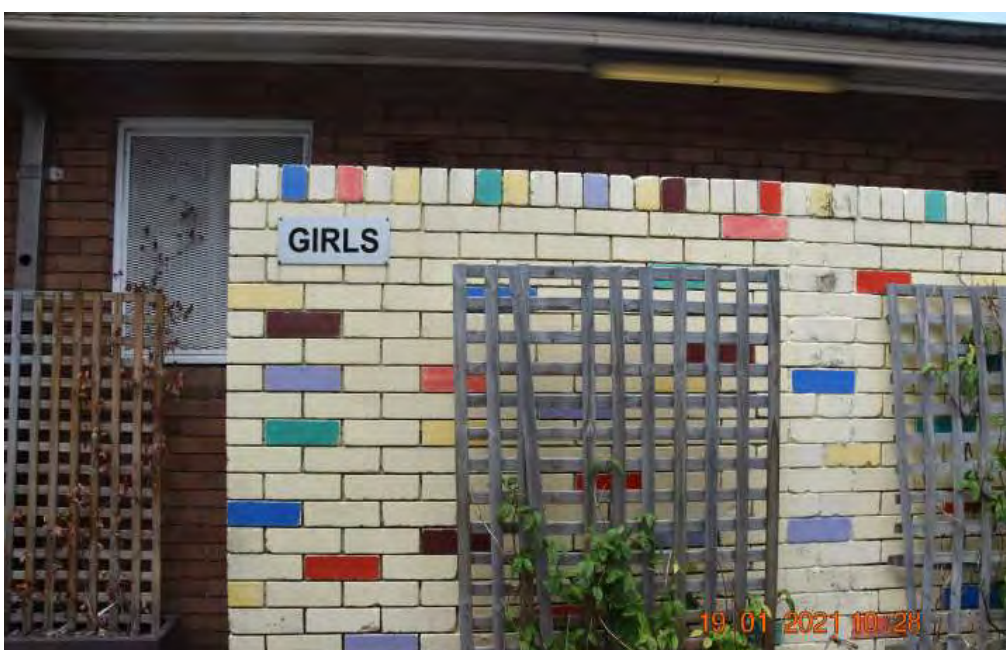
Figure: 0722

General view of the wall on the north side of building A, outside the toilets. Showing wide cracking and movement.

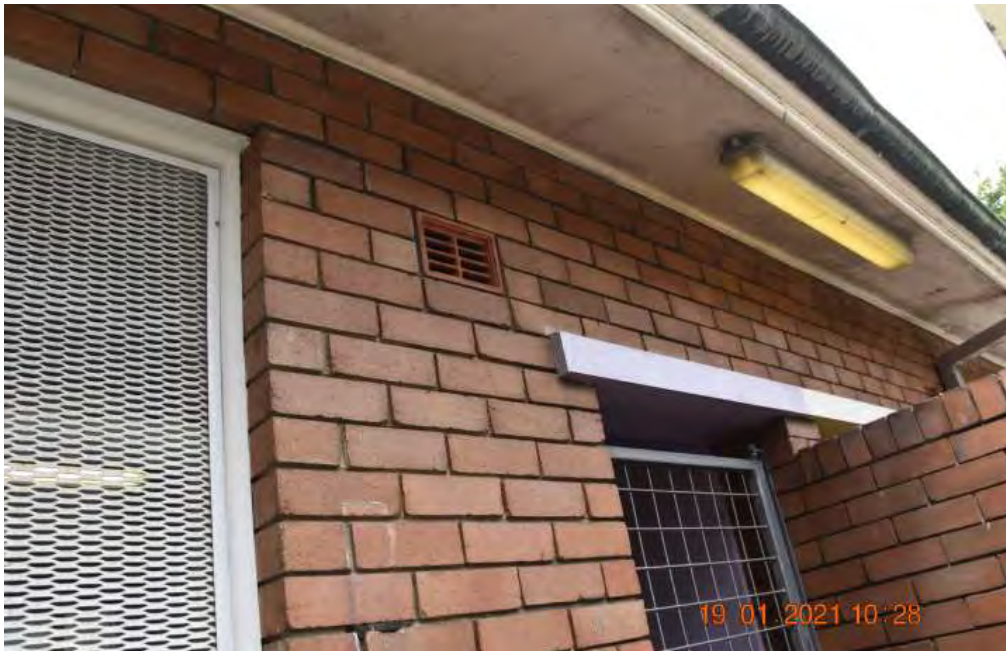
Figure: 0723

General view of the wall on the north side of building A, outside the toilets.

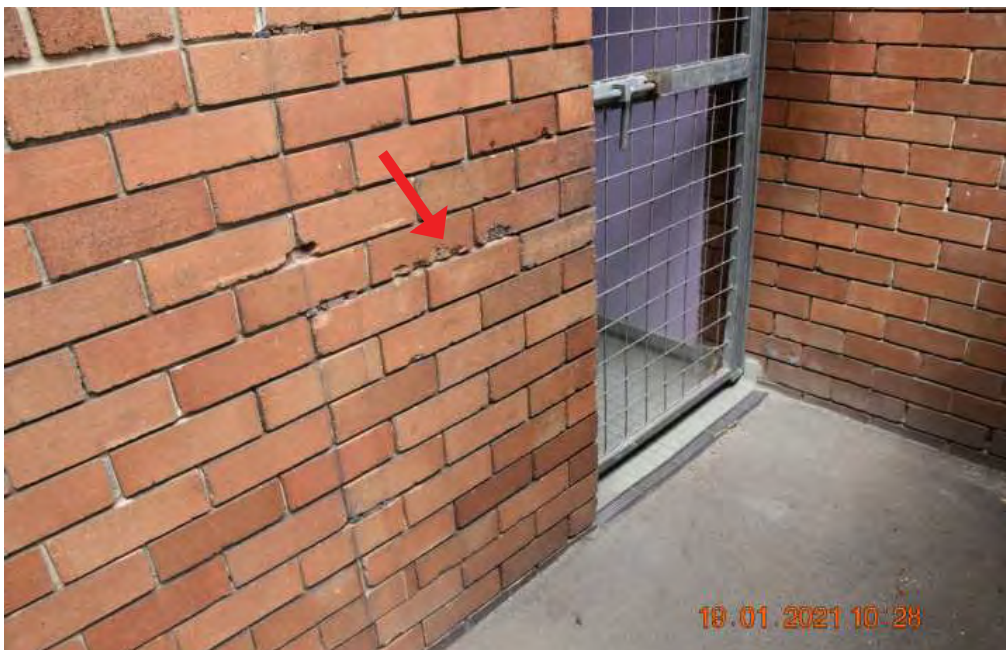
Figure: 0724

North wall of building A, outside room 13.

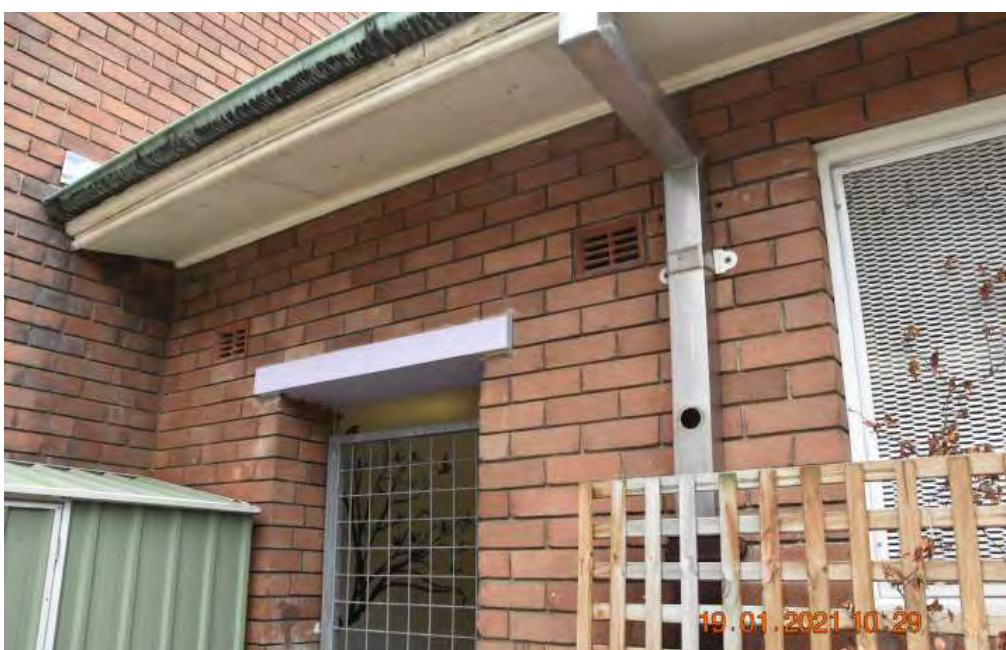
Figure: 0725

North wall of building A, outside room 13.  
Showing chipping.

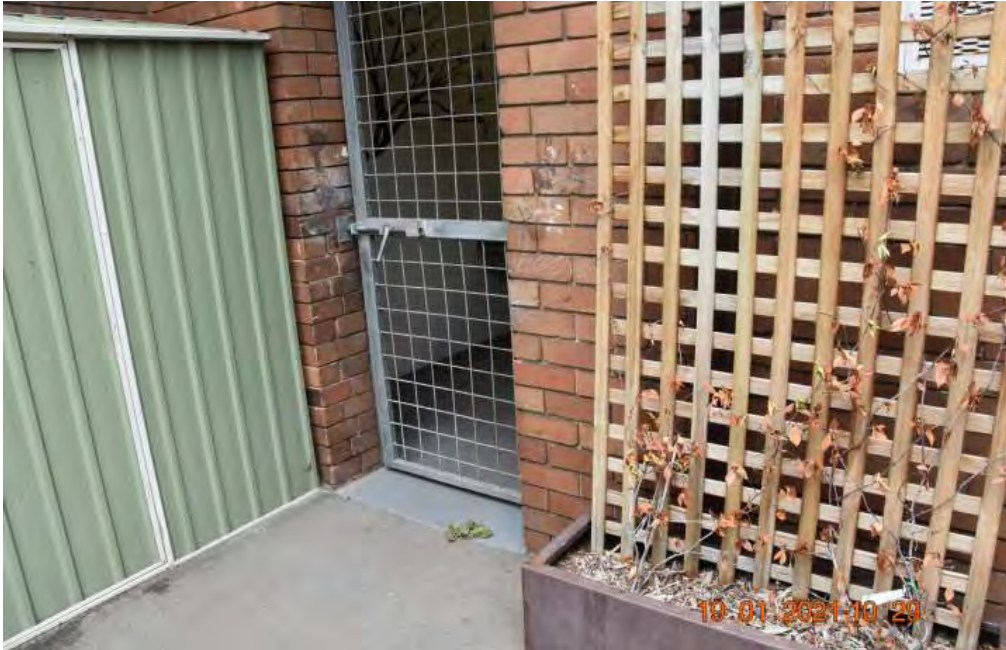
Figure: 0726

North wall of building A, outside room 12.

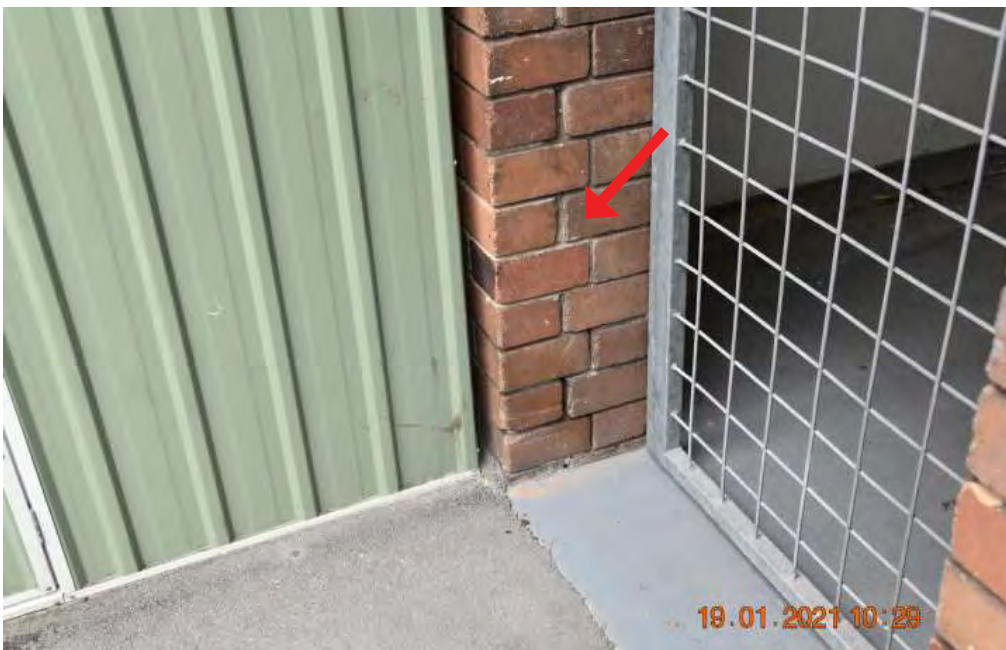
Figure: 0727

North wall of building A, outside room 12.

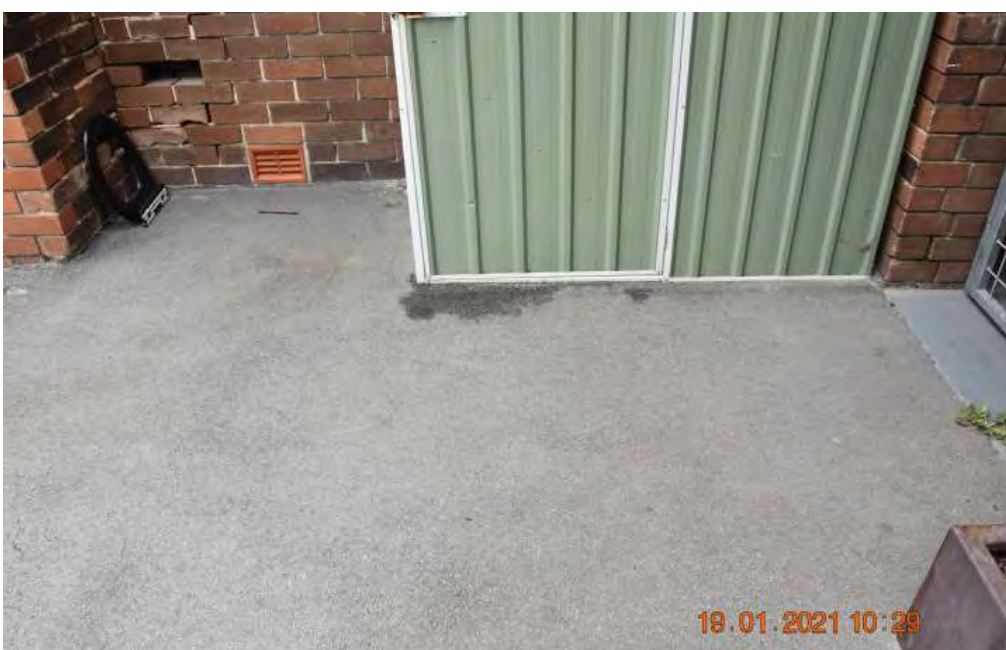
Figure: 0728

Erosion in the mortar joints in the north wall of building A, outside room 12.

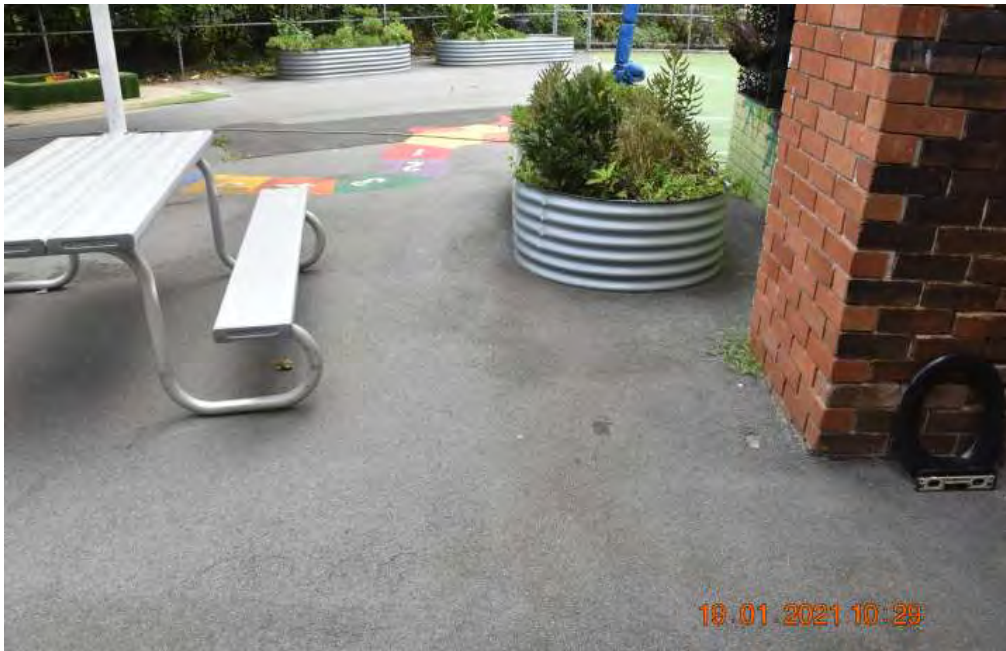
Figure: 0729

General view of the paving on the north side of building A, looking from room 12.

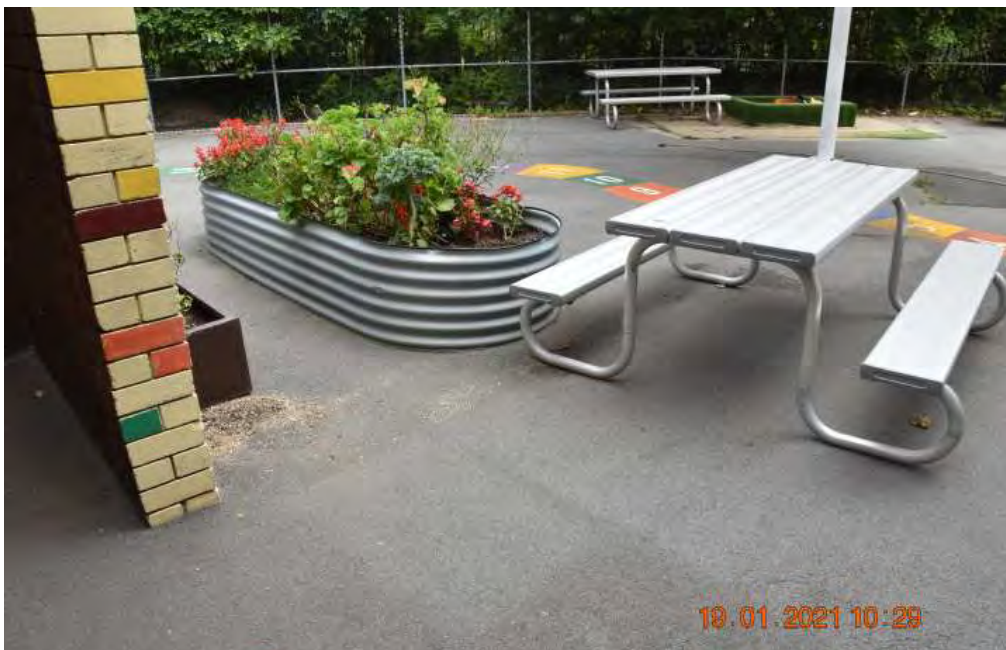
Figure: 0730

General view of the paving on the north side of building A, looking from room 12.

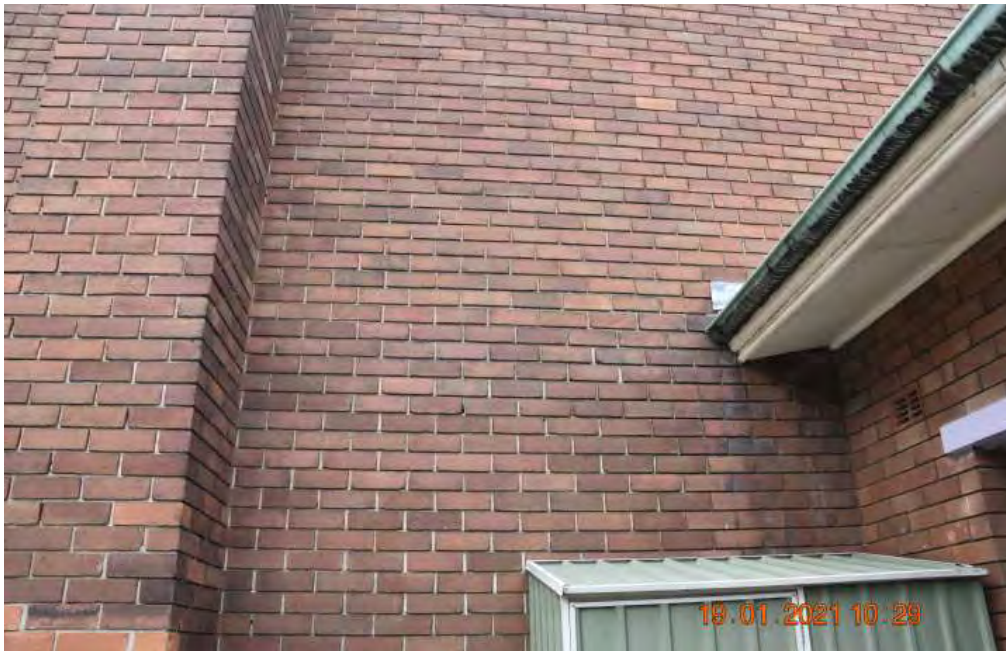
Figure: 0732

West wall of building A, looking from room 12.

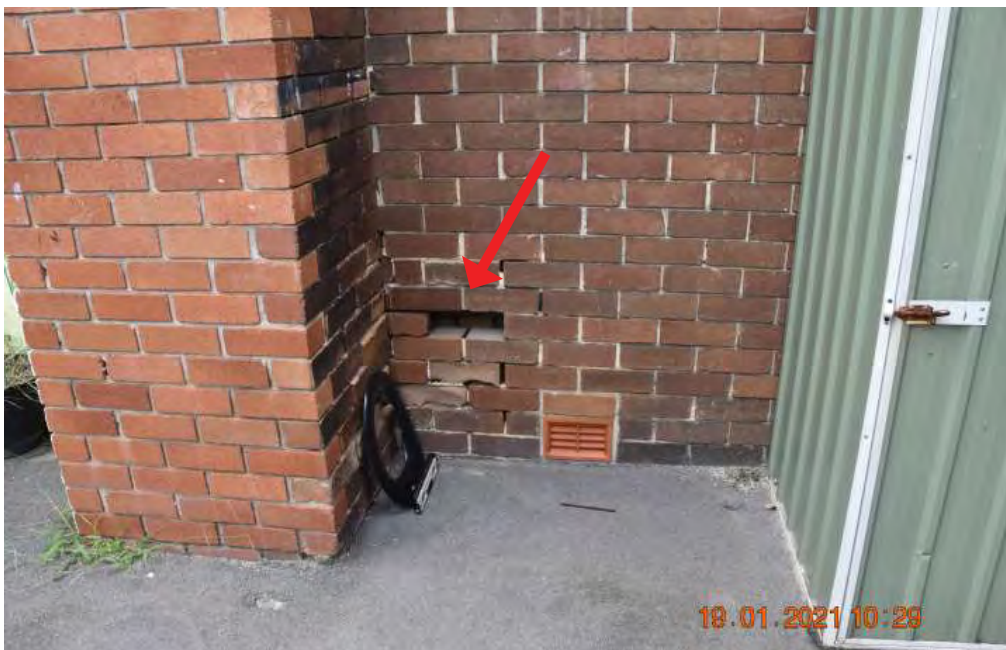
Figure: 0733

West wall of building A, looking from room 12.

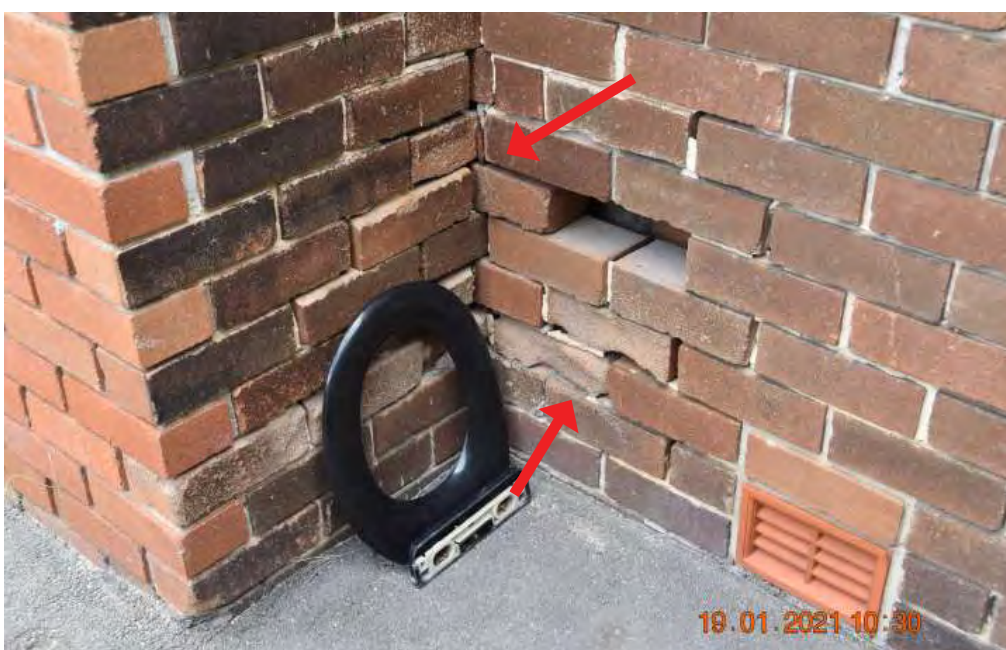
Figure: 0734

West wall of building A, looking from room 12. Showing missing brick.

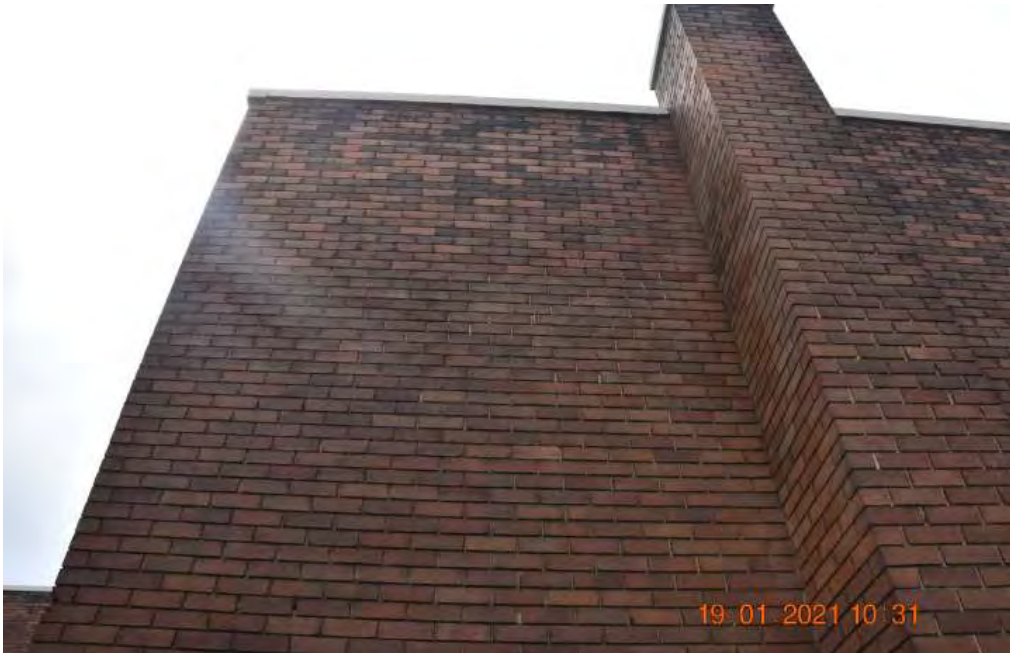
Figure: 0736

West wall of building  
A.
