## PRE CONSTRUCTION CONDITION SURVEY

Fort Street Public School, Millers Point NSW

Upper Fort Street Public School  
MILLERS POINT NSW 2000

19 January 2021

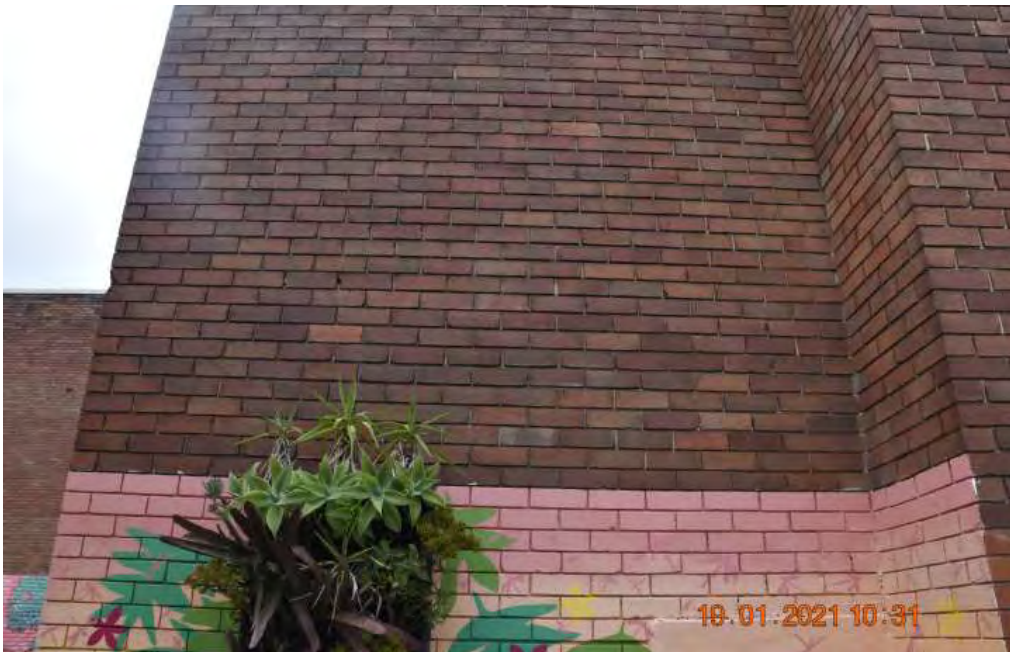
Figure: 0737

West wall of building  
A.

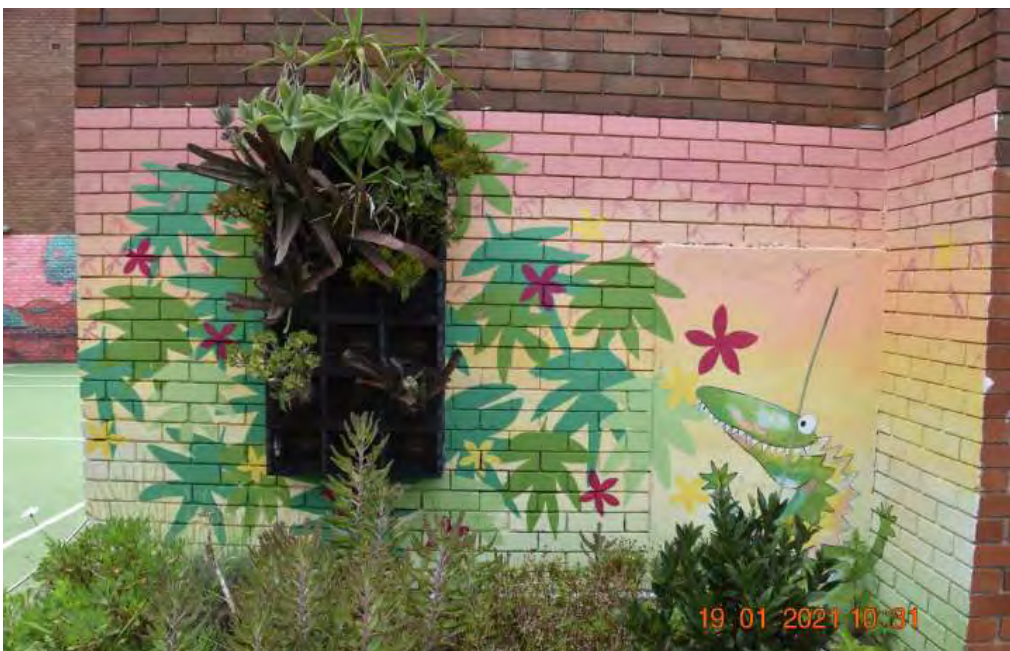
Figure: 0738

West wall of building  
A.

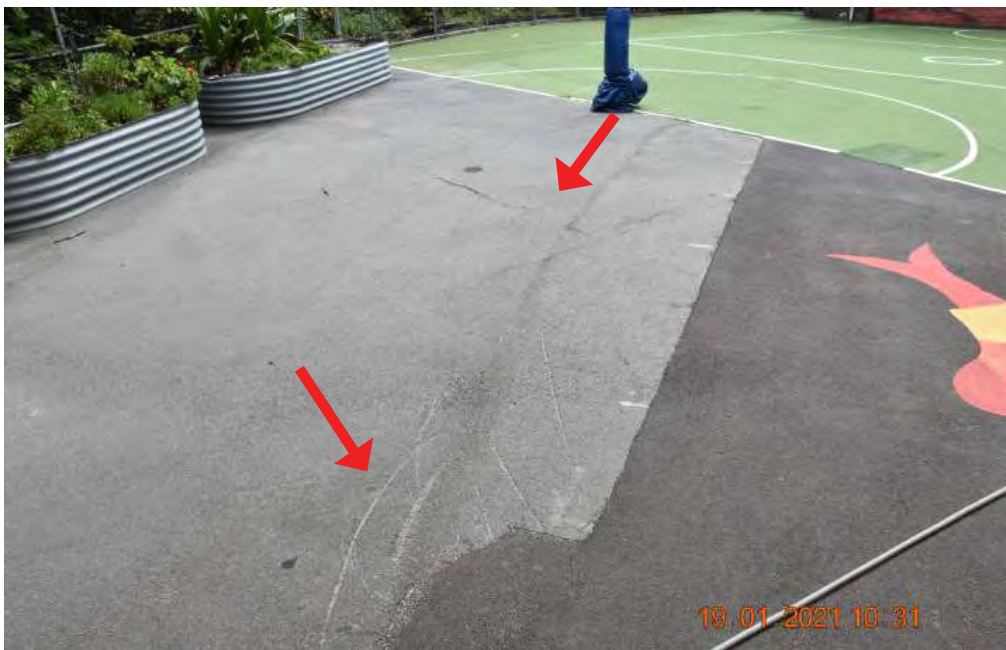
Figure: 0739

General view of the paving on the north side of building A.

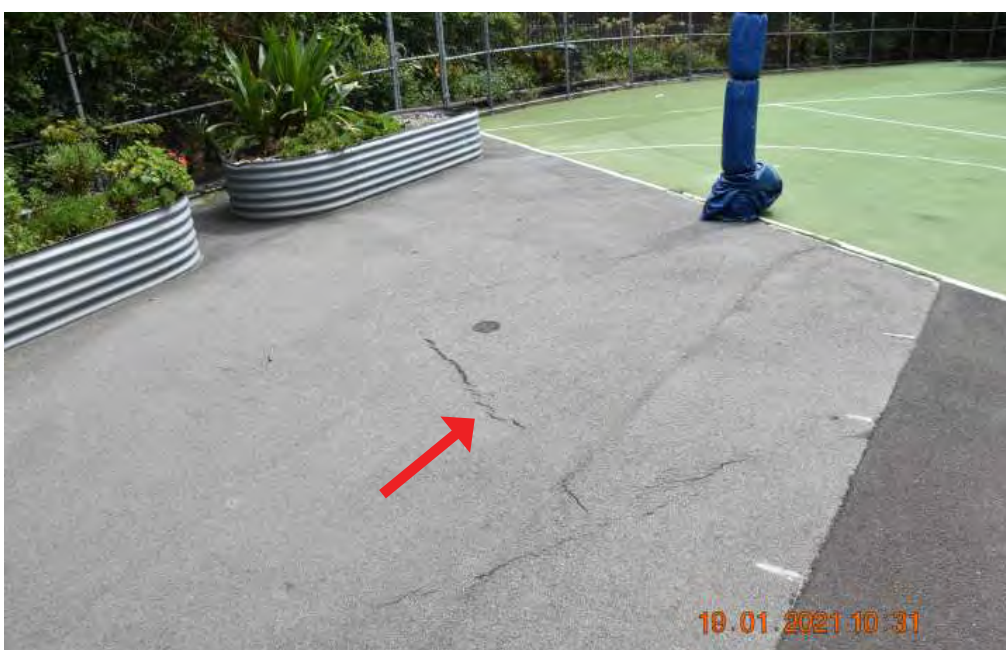
Figure: 0740

General view of the paving on the north side of building A. Showing scoring and cracking.

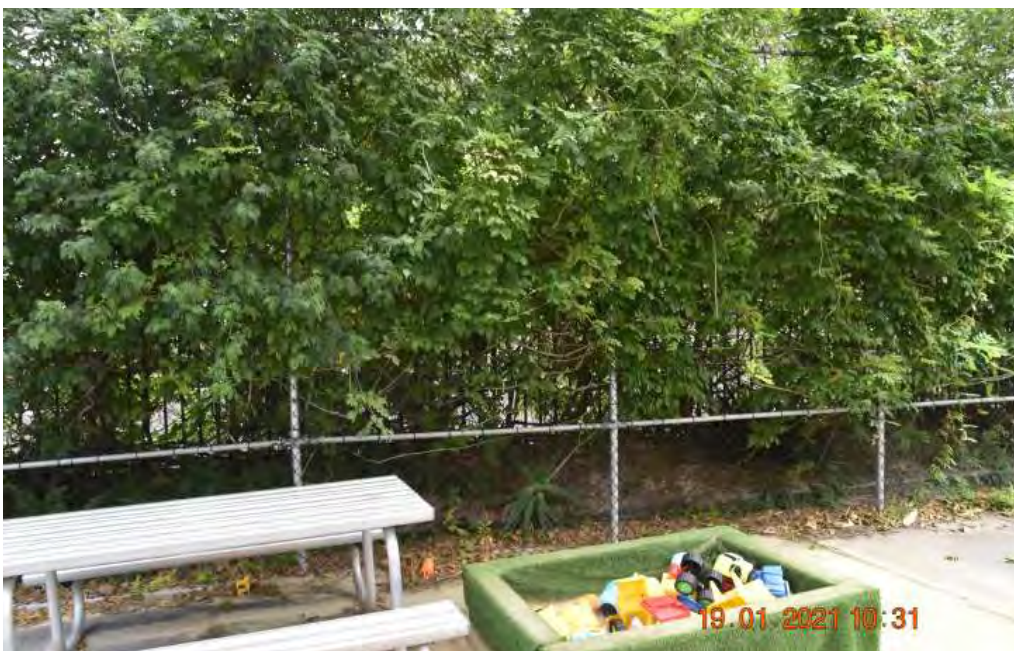
Figure: 0743

General view of the fence on the north side of building A.

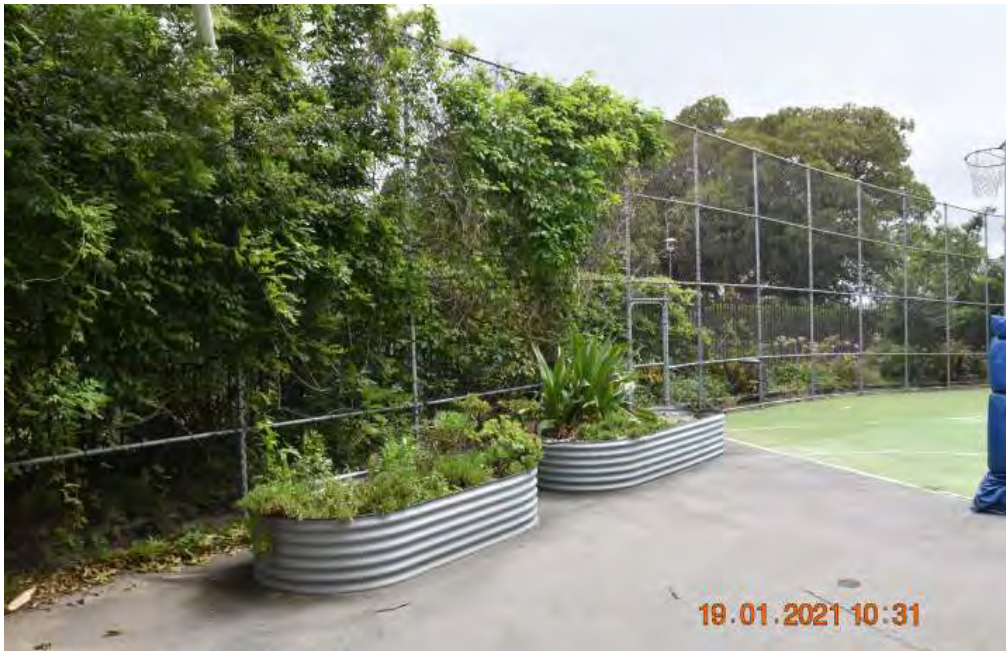
Figure: 0744

General view of the fence on the north side of building A.

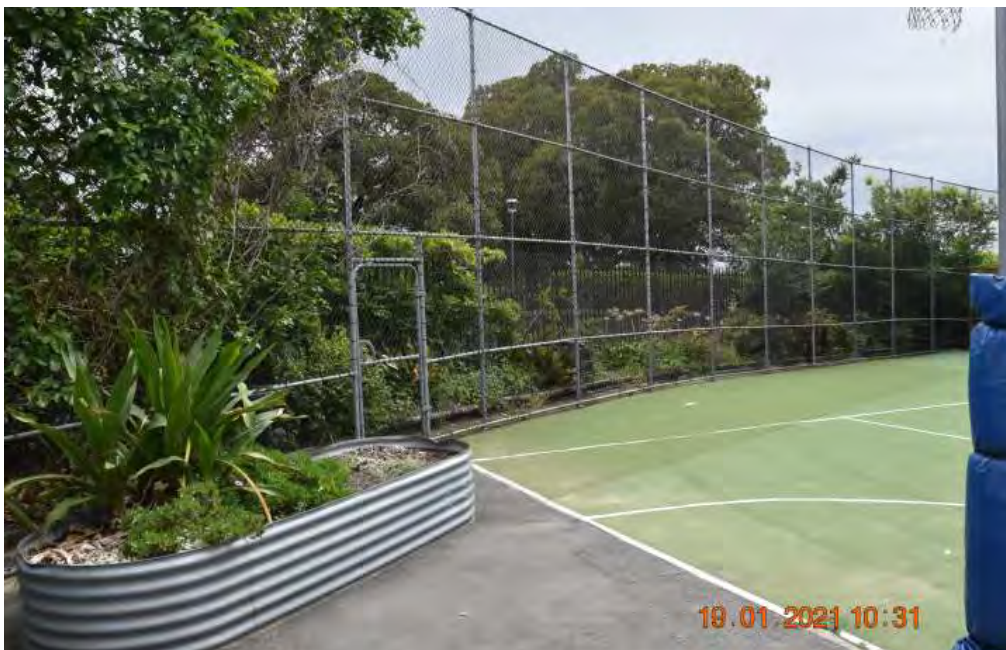
Figure: 0745

General view of the fence on the north side of building A.

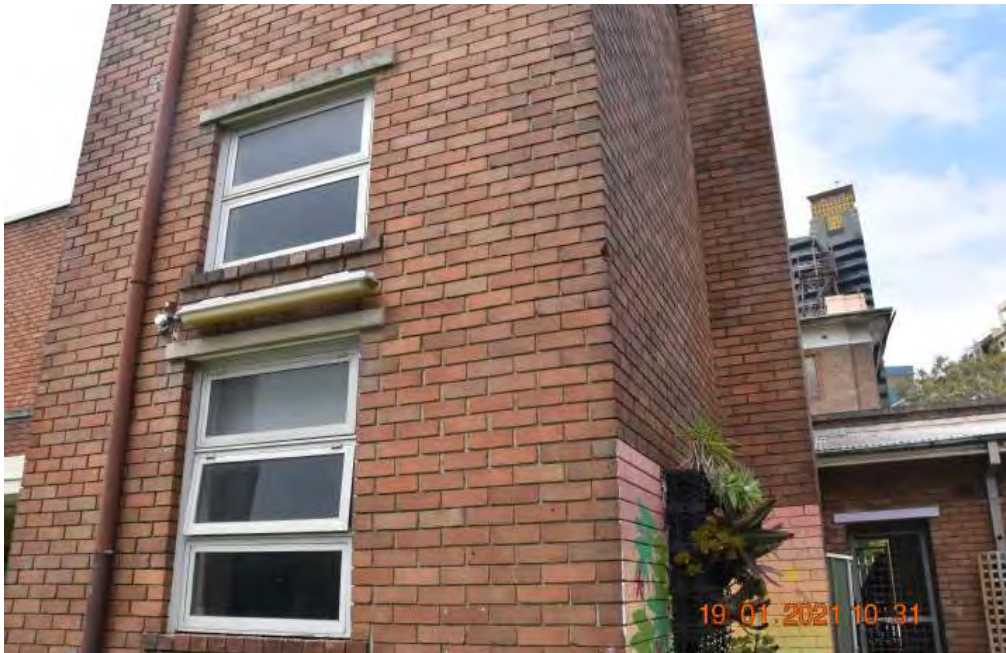
Figure: 0747

North wall of building A.

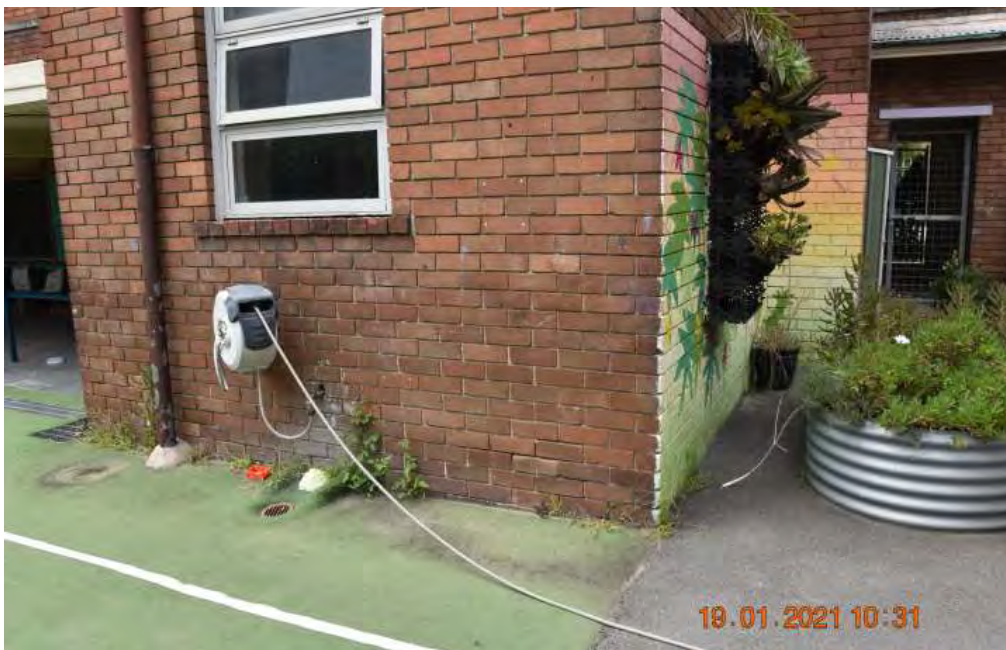
Figure: 0748

North wall of building A.

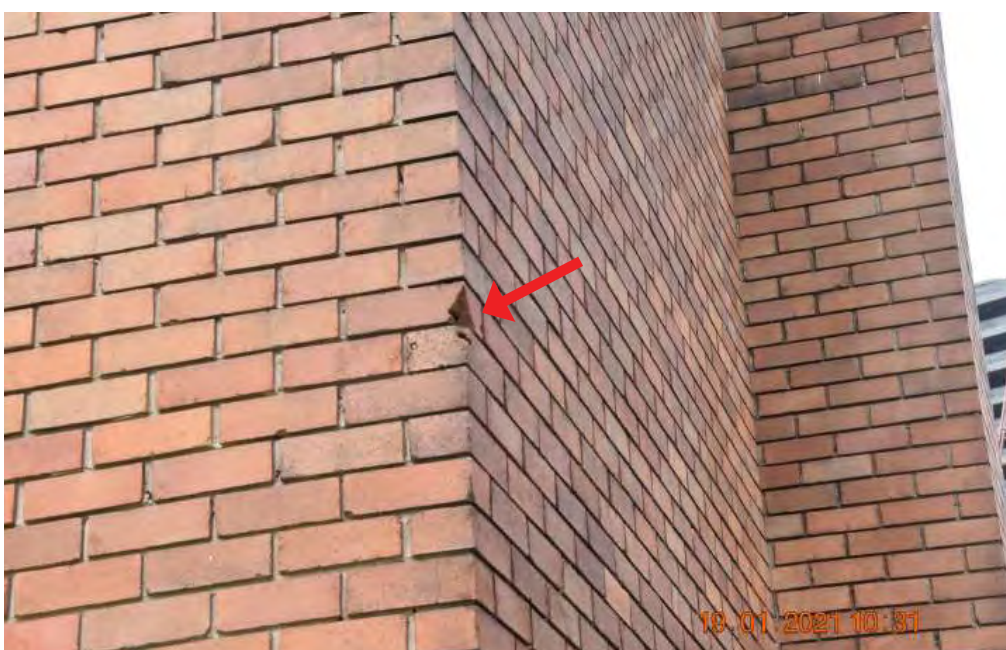
Figure: 0749

North wall of building A.

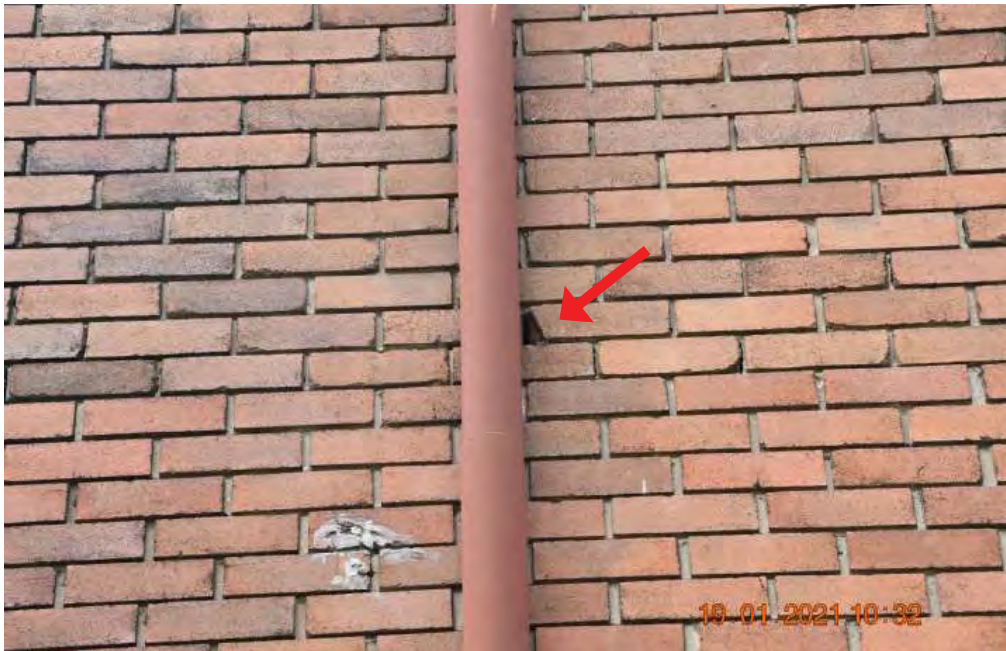
Figure: 0750

Chipping in the north wall of building A, outside the auditorium kitchenette.

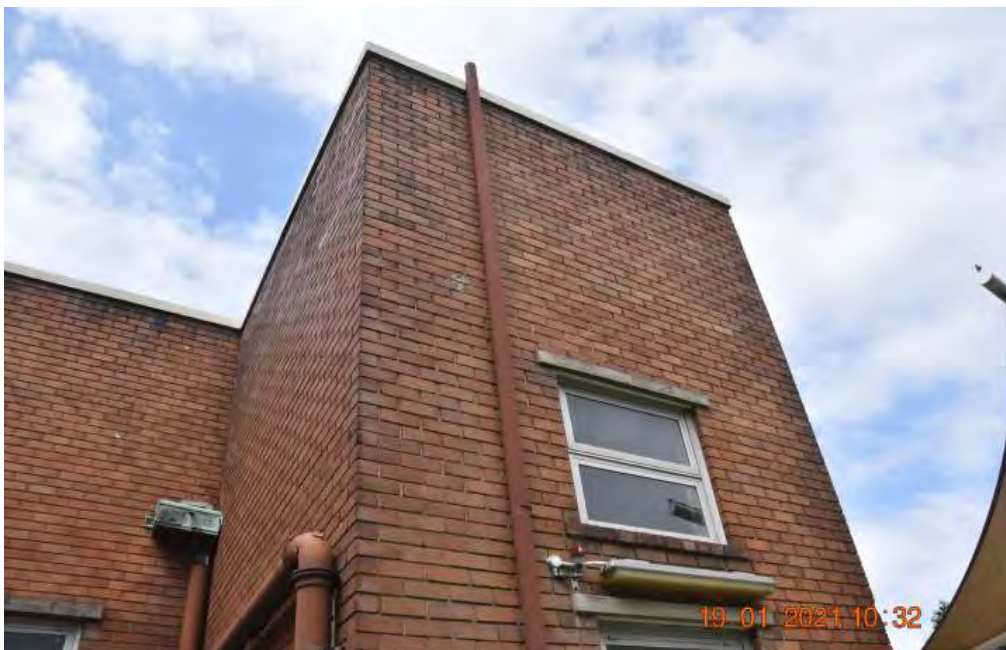
Figure: 0751

Chipping in the north wall of building A, outside the drama room.

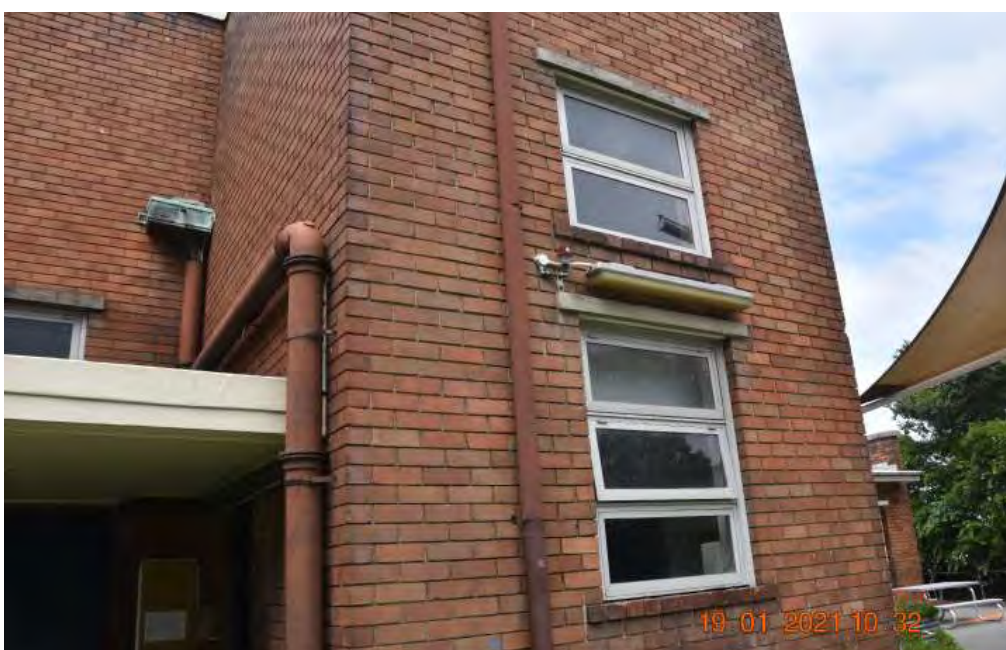
Figure: 0752

North wall of building A.

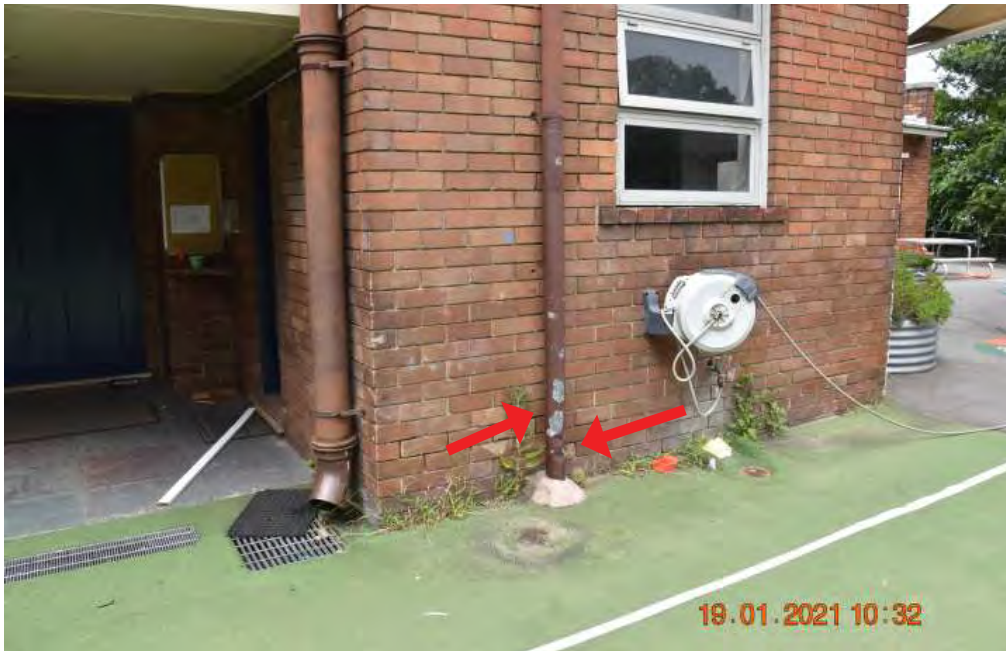
Figure: 0753

North wall of building A.

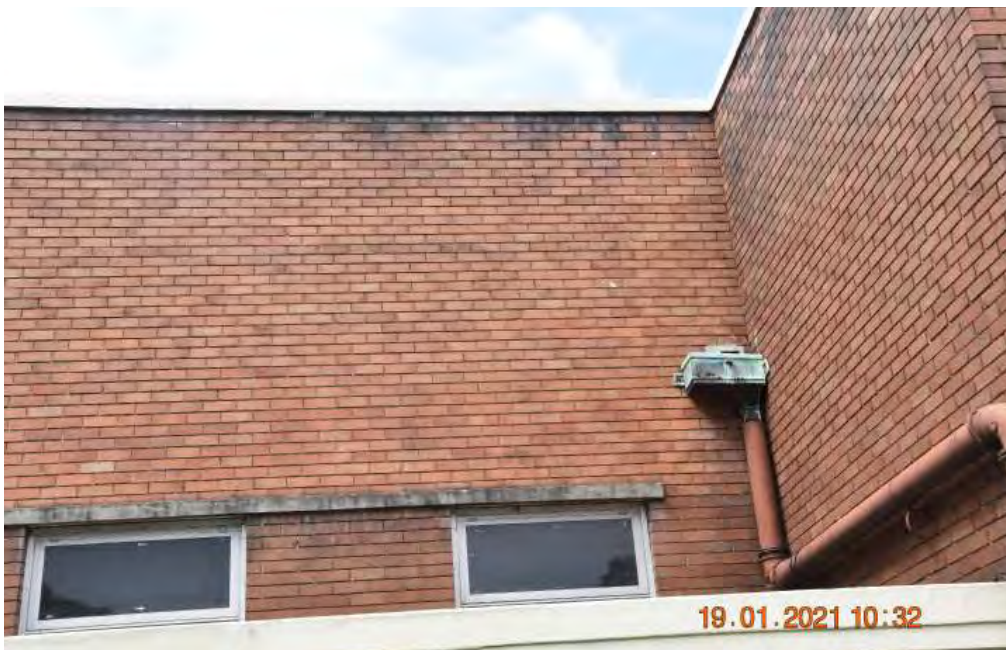
Figure: 0754

North wall of building A. Showing peeling paint and dent in the down pipe.

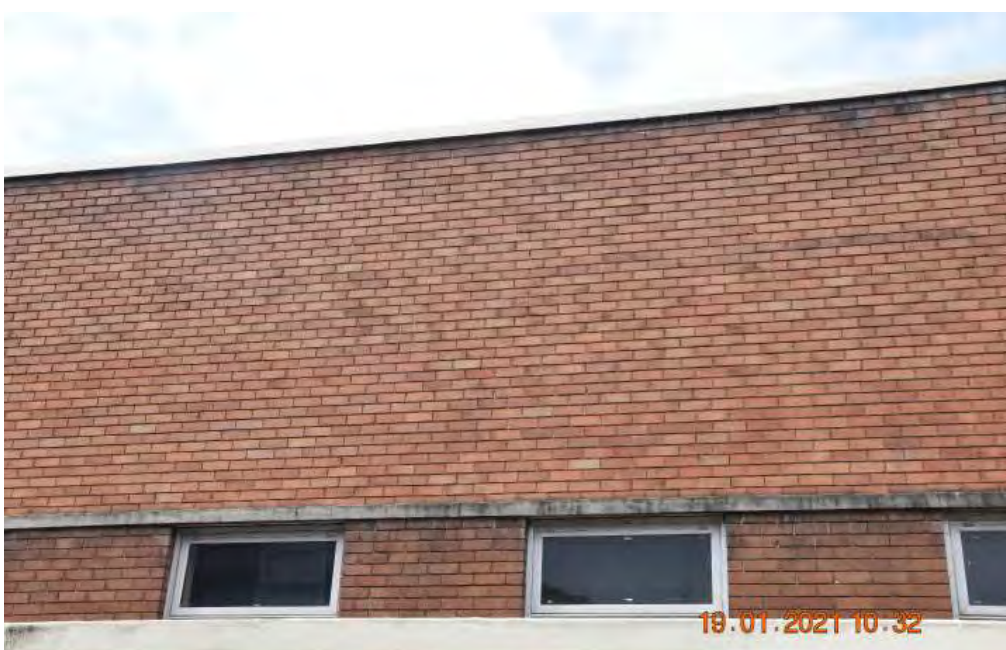
Figure: 0755

North wall of building A.

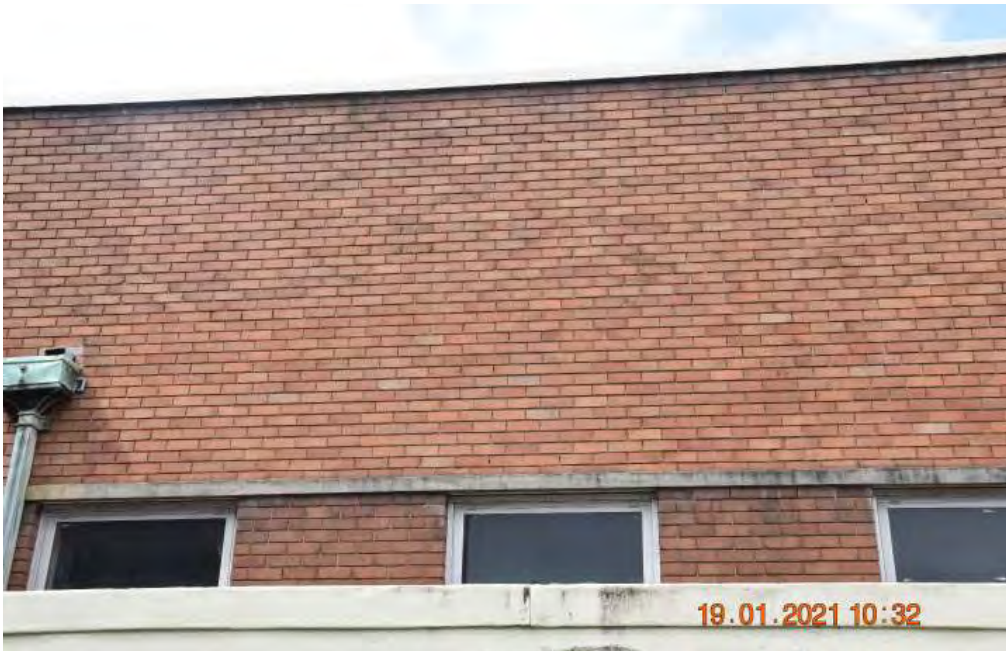
Figure: 0757

North wall of building A.

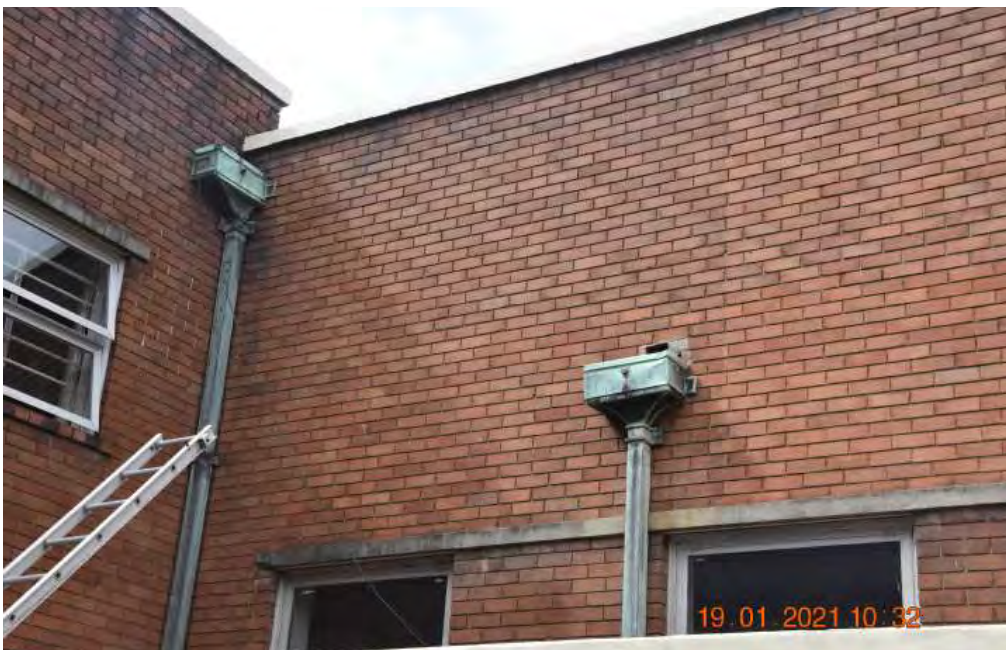
Figure: 0758

North wall of building A.

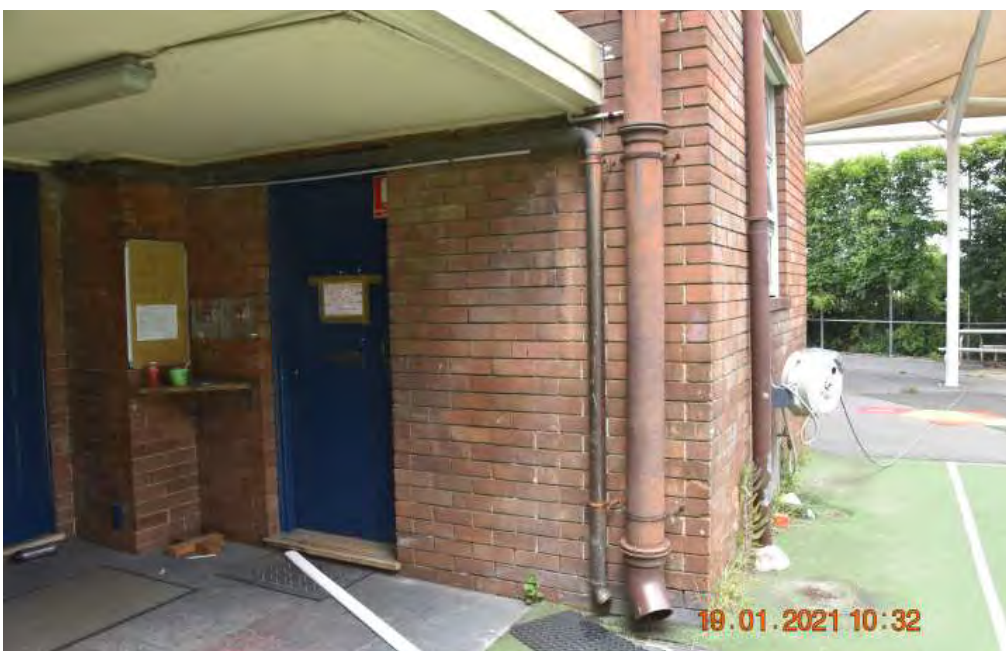
Figure: 0759

East wall of building A, outside the auditorium.

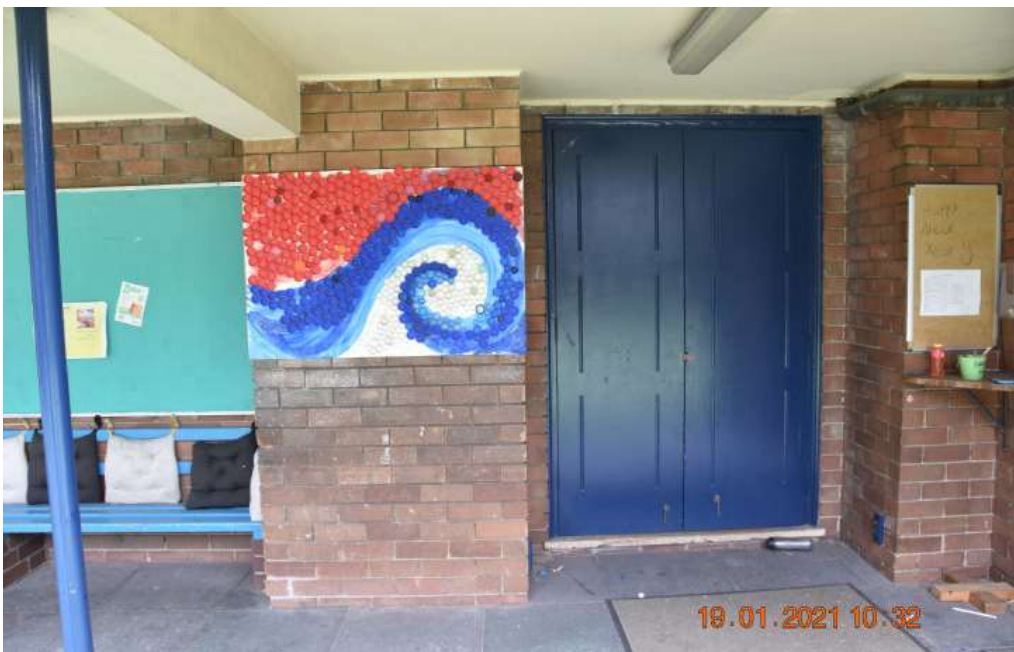
Figure: 0760

North wall of building A, outside the auditorium.

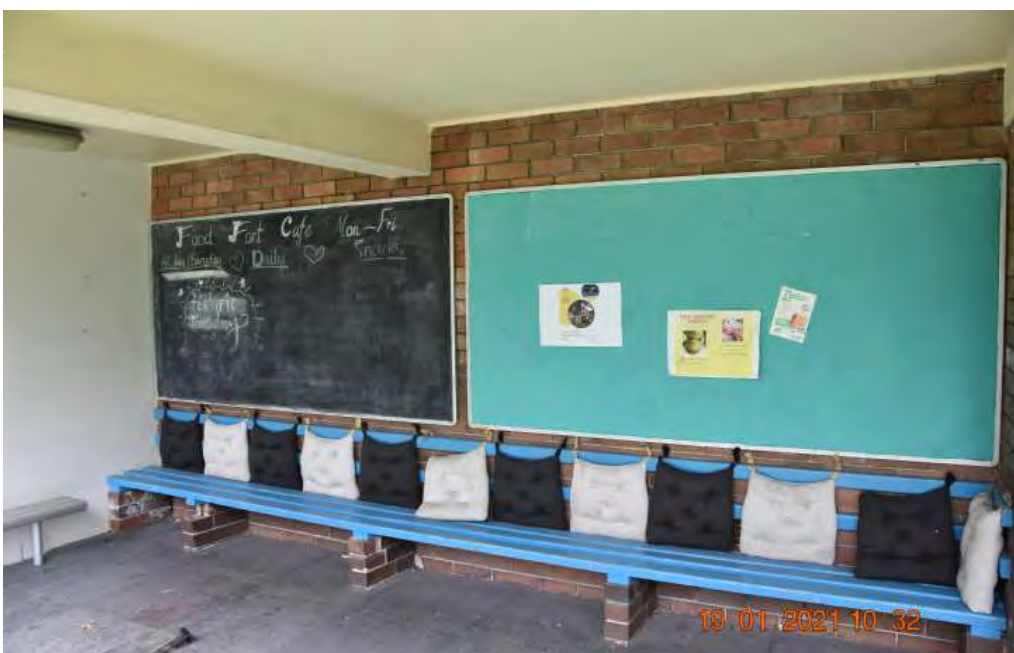
Figure: 0761

North wall of building A, outside the auditorium.

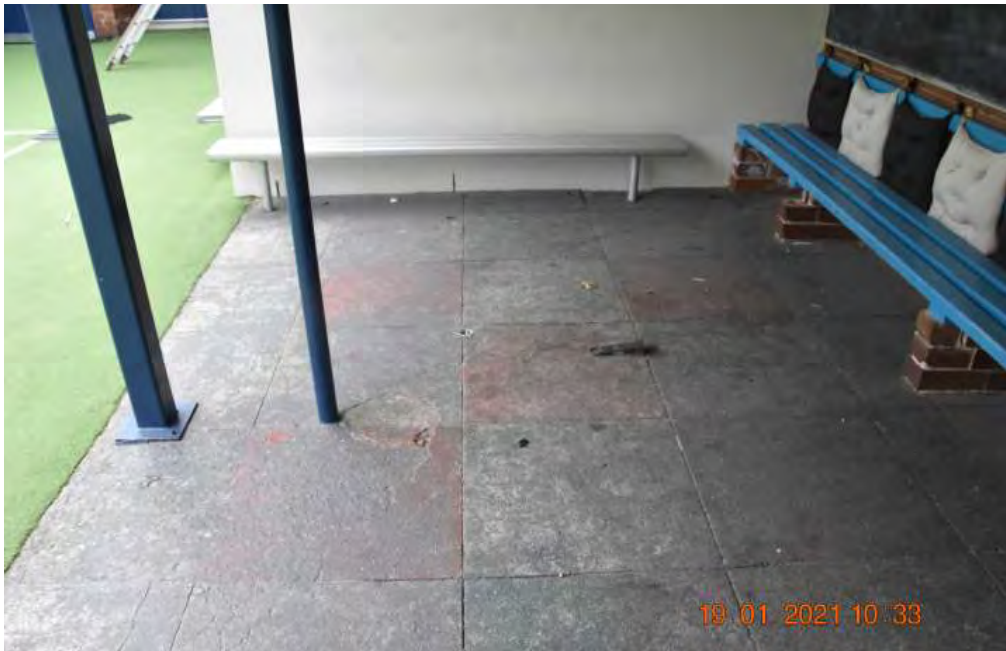
Figure: 0762

North wall of building A, outside the auditorium.

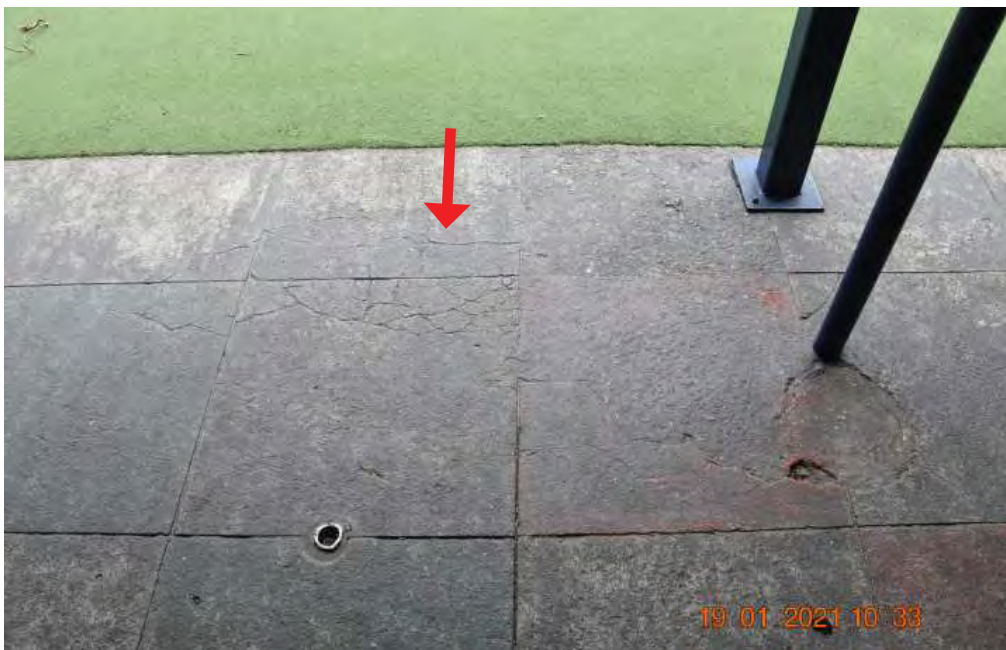
Figure: 0763

Paving on the north side of building A.

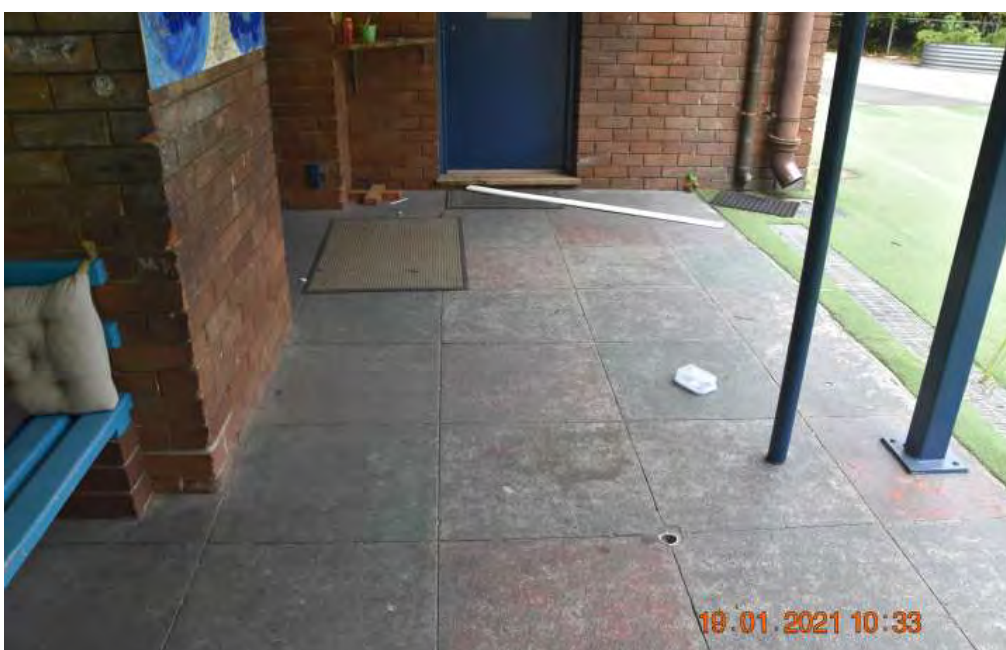
Figure: 0764

Cracking in the paving on the north side of the auditorium.

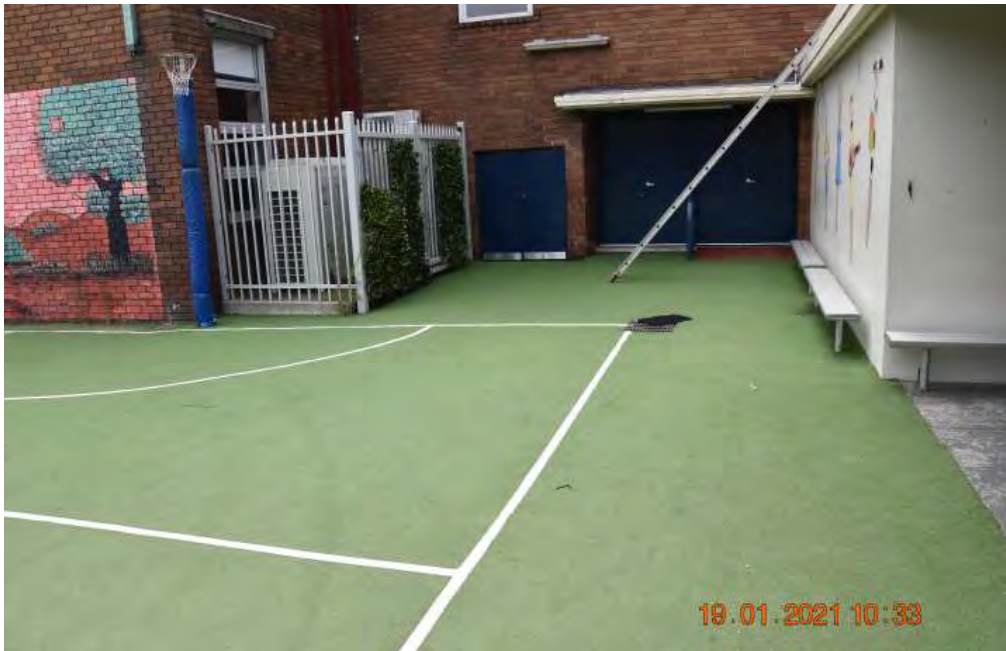
Figure: 0765

Paving on the north side of building A.

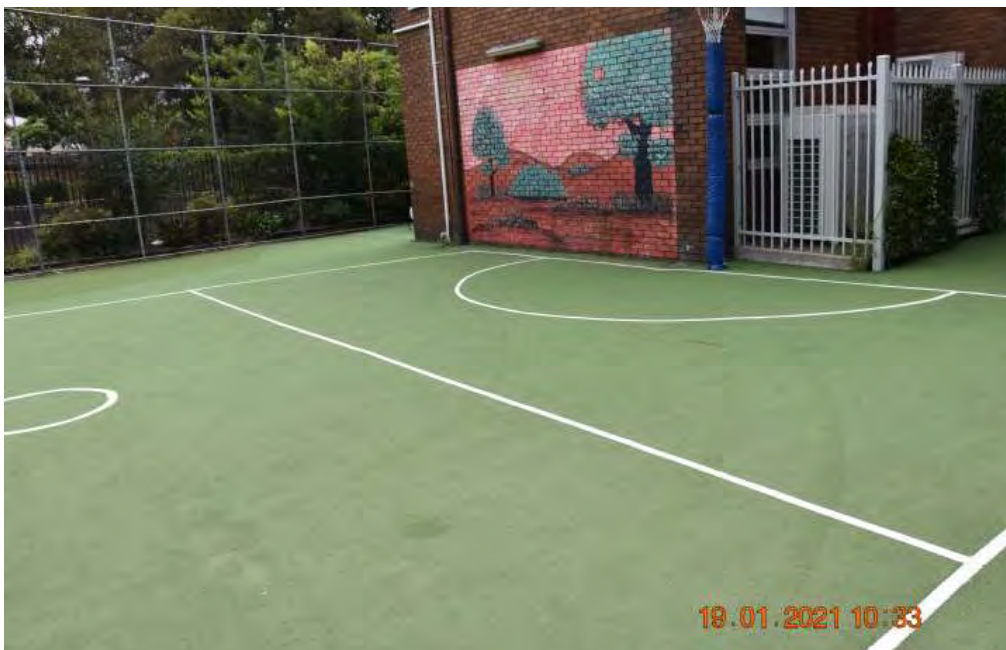
Figure: 0766

General view in the playground on the north side of building A.

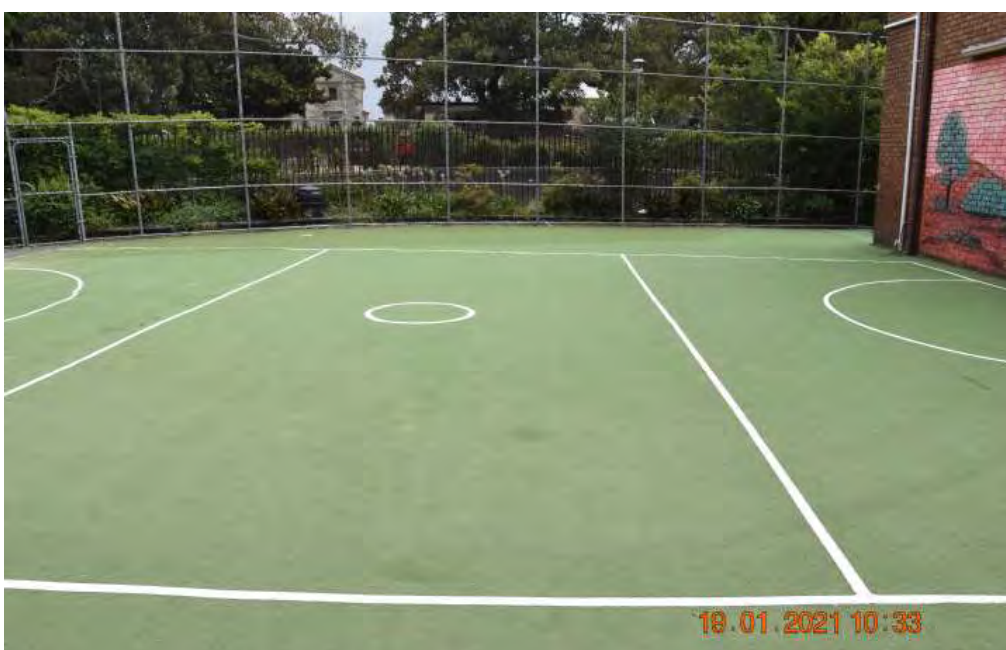
Figure: 0767

General view in the playground on the north side of building A.

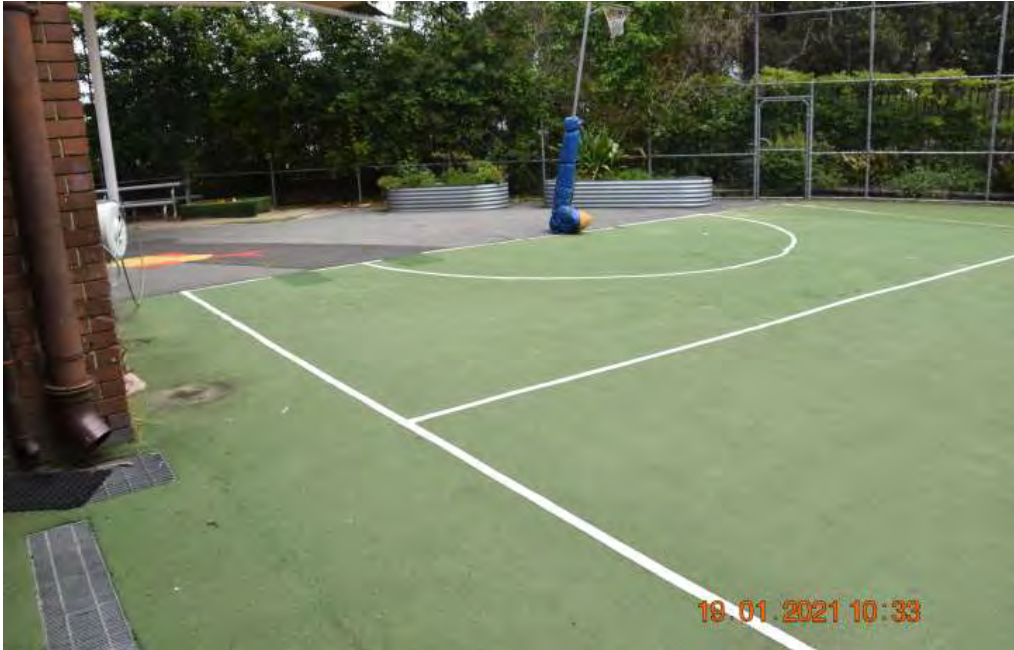
Figure: 0768

General view in the playground on the north side of building A.

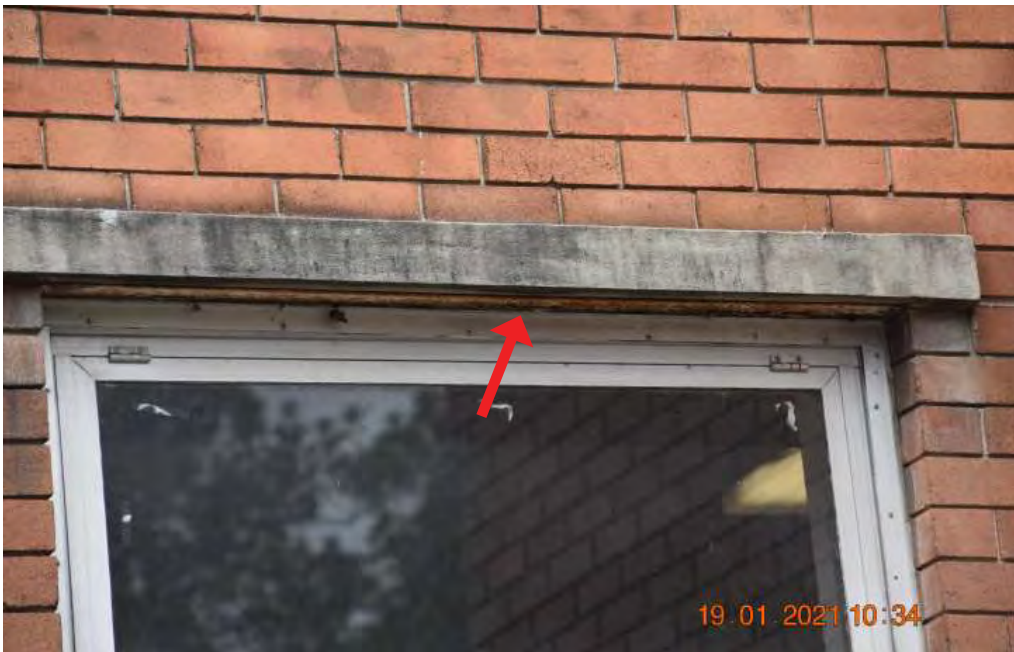
Figure: 0769

General view in the playground on the north side of building A.

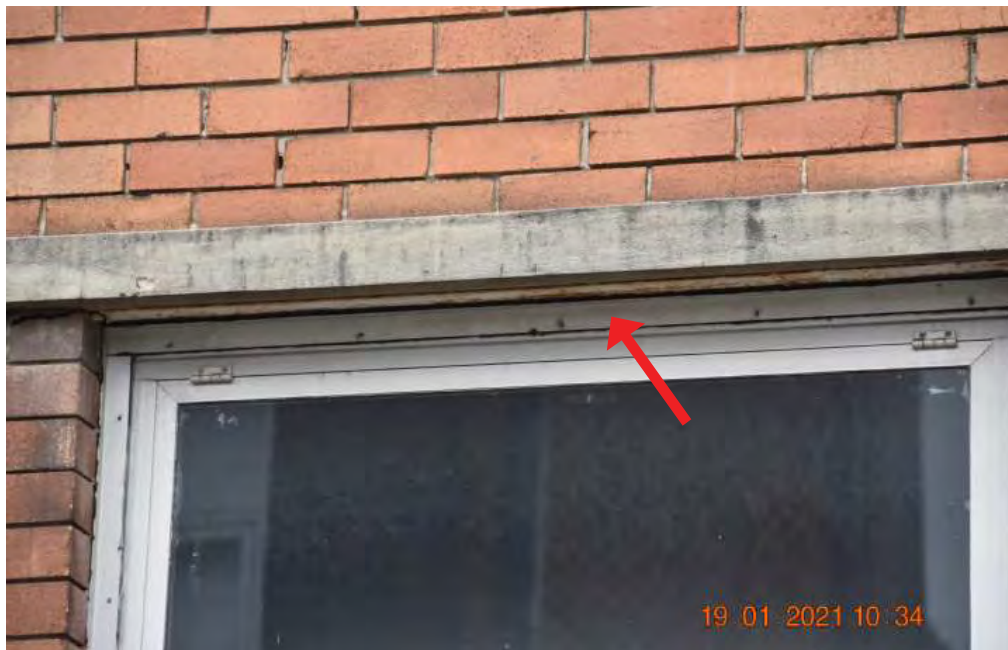
Figure: 0771

Rusting above the window in the north wall of building A.

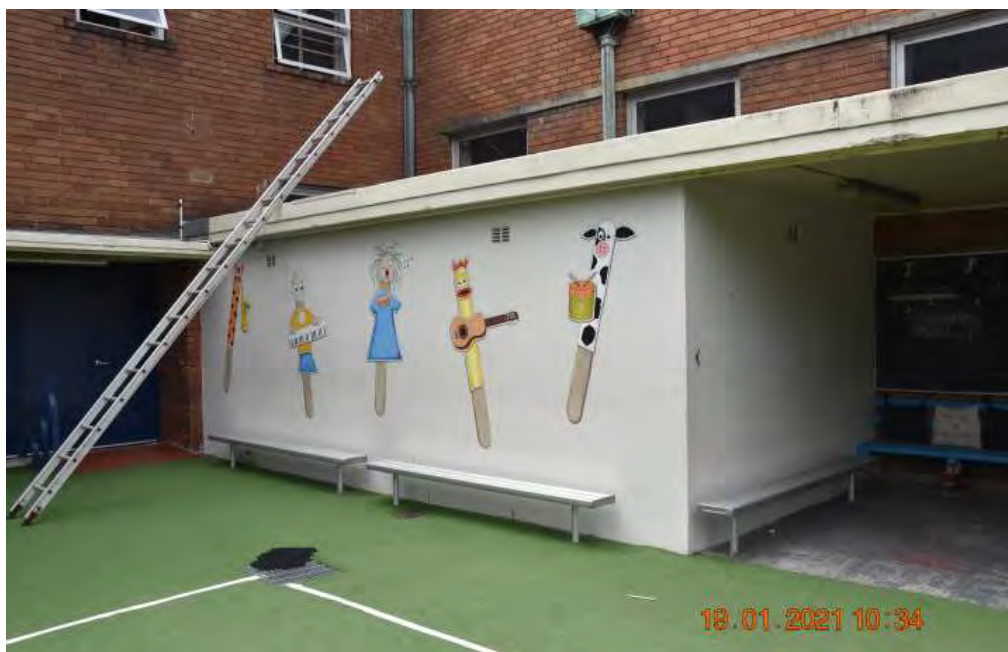
Figure: 0772

Rusting above the window in the north wall of building A.

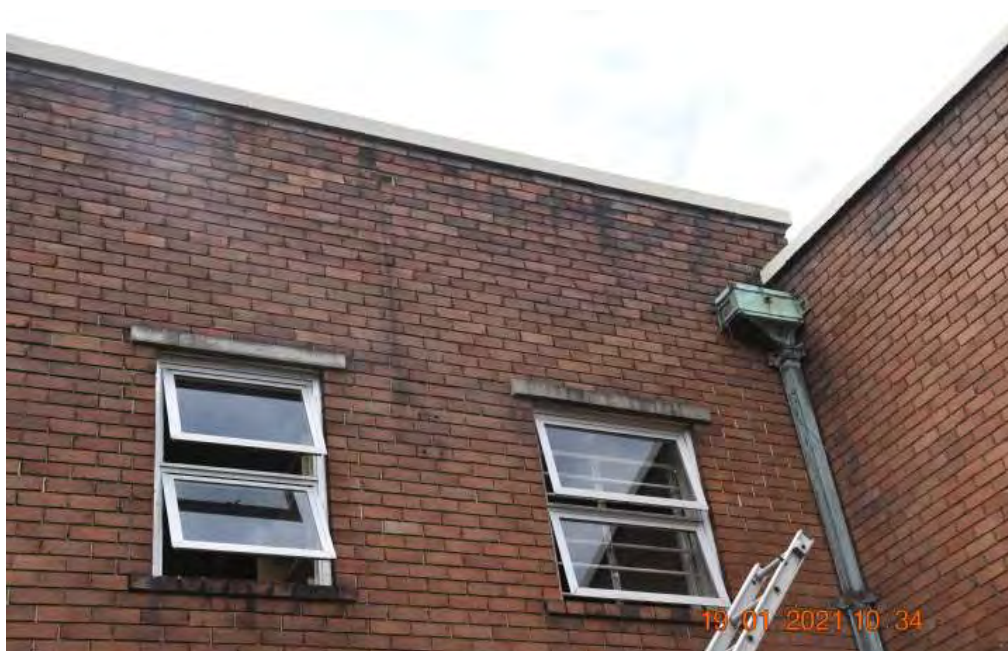
Figure: 0773

North wall of building A.

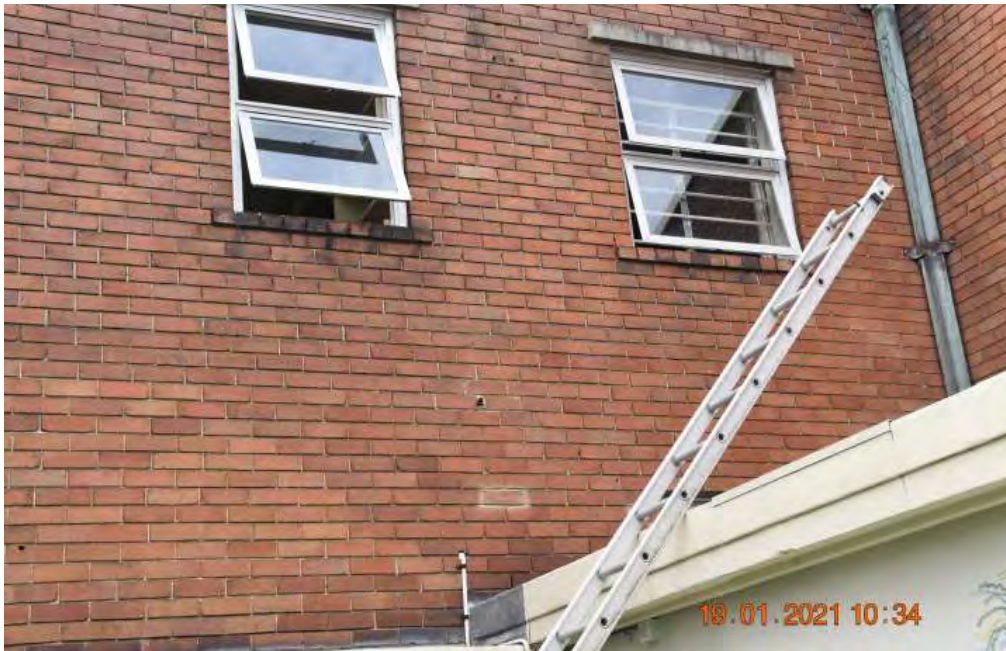
Figure: 0774

West wall of building A, looking from the playground.

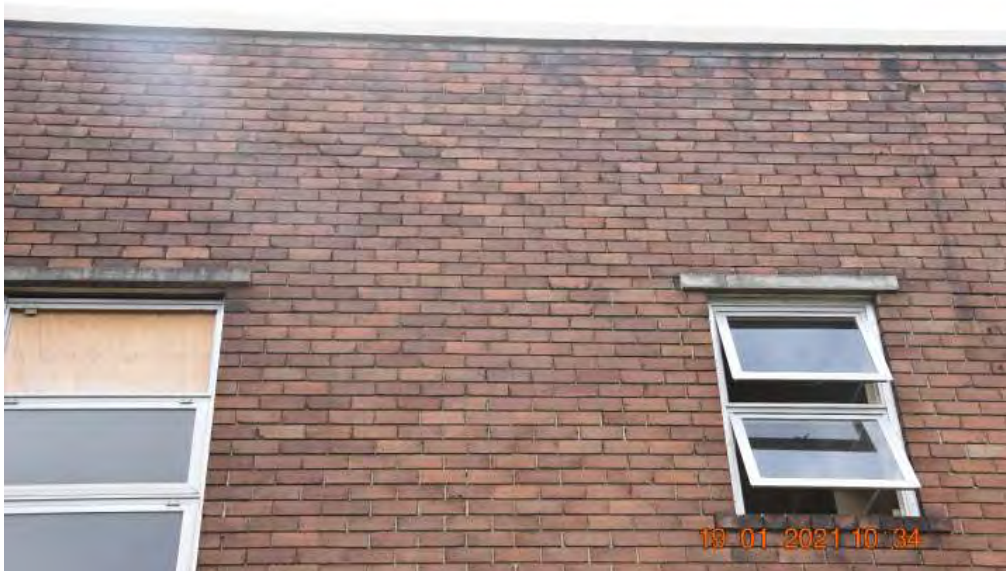
Figure: 0775

West wall of building A, looking from the playground.
