## PRE CONSTRUCTION CONDITION SURVEY

Fort Street Public School, Millers Point NSW

Upper Fort Street Public School  
MILLERS POINT NSW 2000

19 January 2021

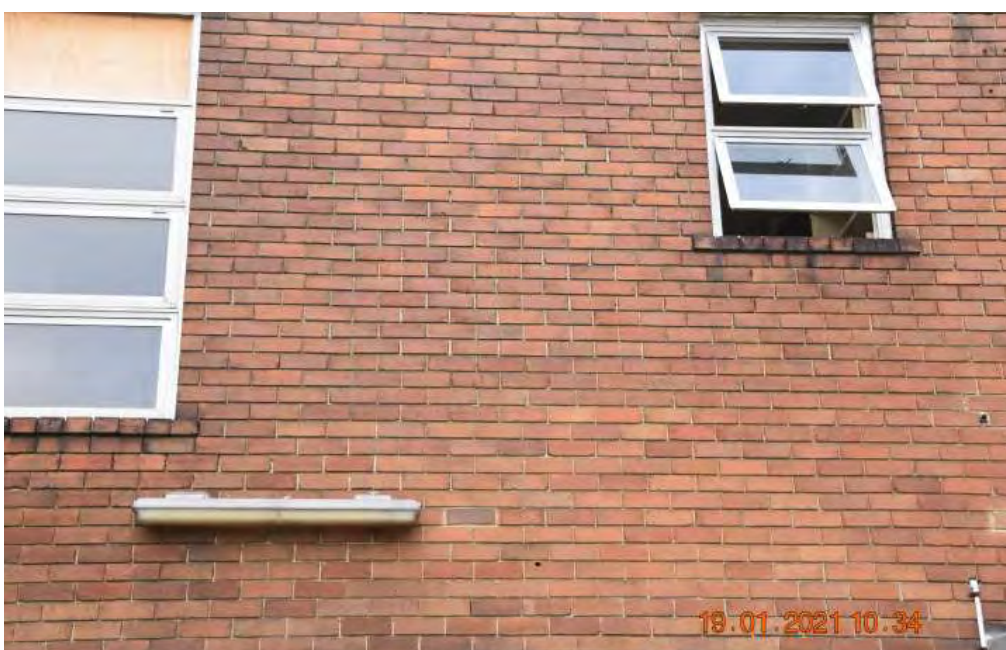
Figure: 0776

West wall of building A, looking from the playground.

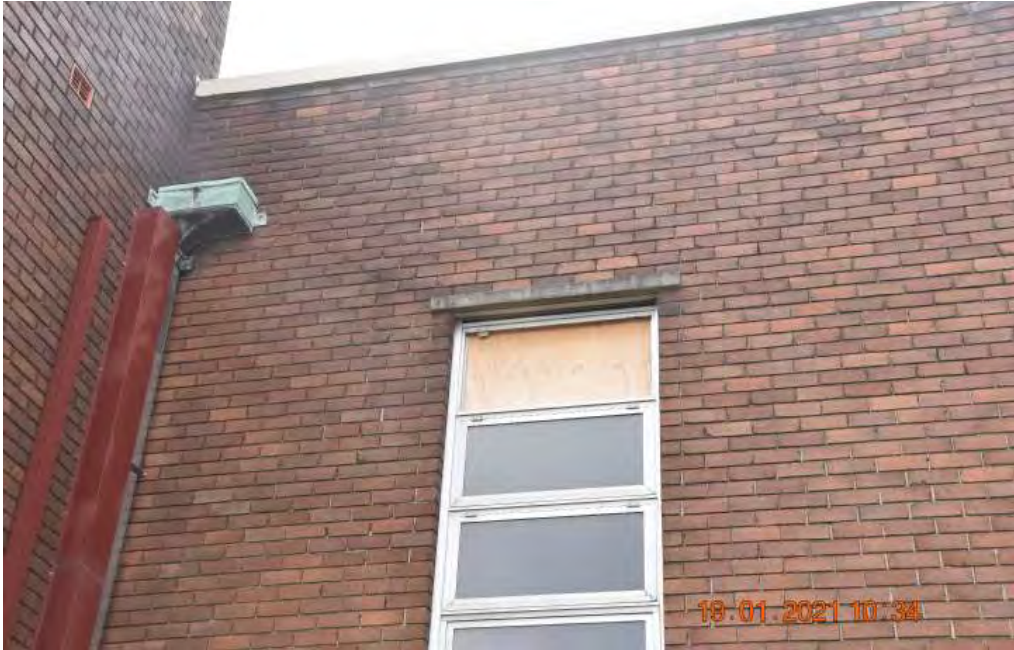
Figure: 0777

West wall of building A, looking from the playground.

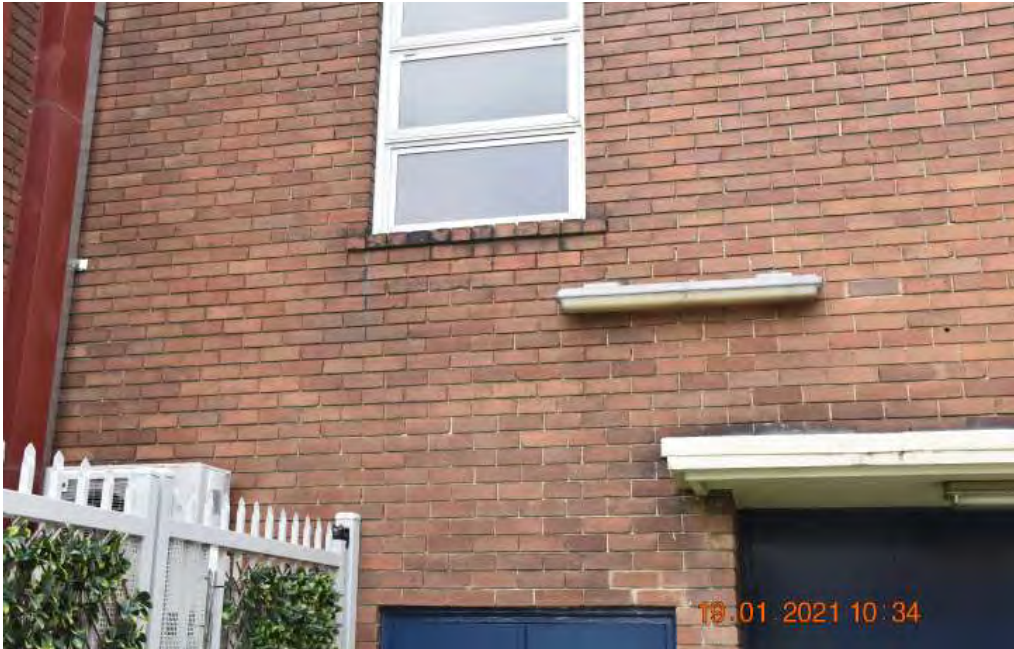
Figure: 0778

West wall of building A, looking from the playground.

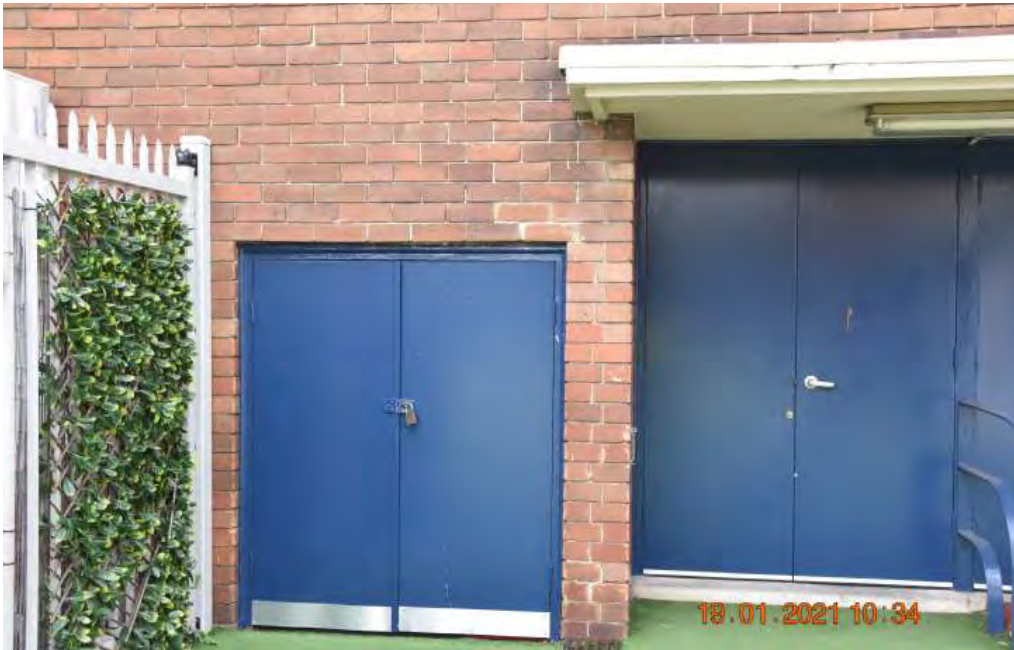
Figure: 0779

West wall of building A, looking from the playground.

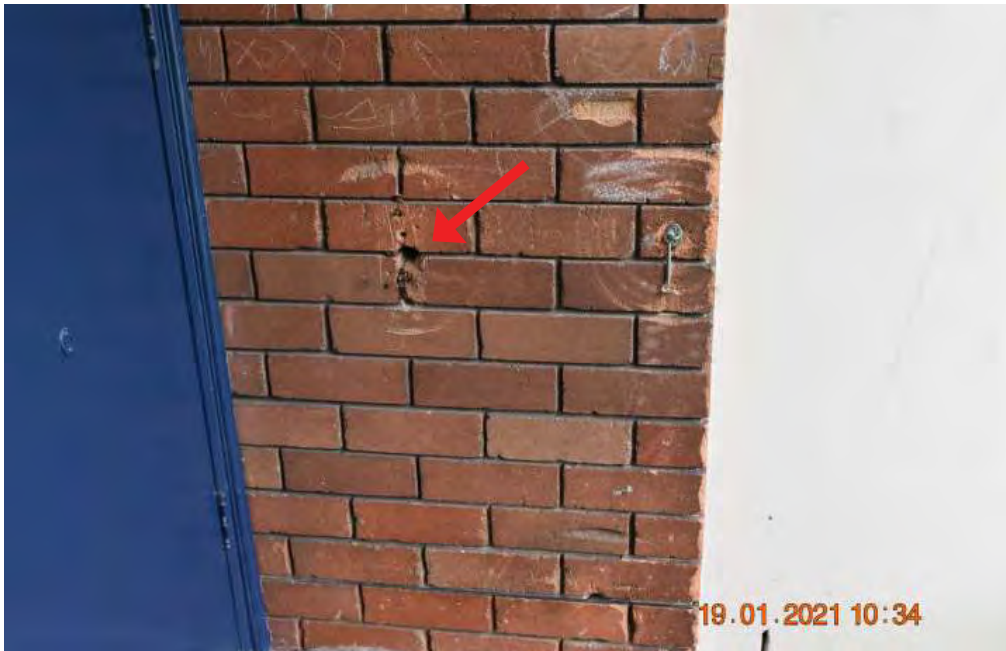
Figure: 0780

West wall of building A, looking from the playground.

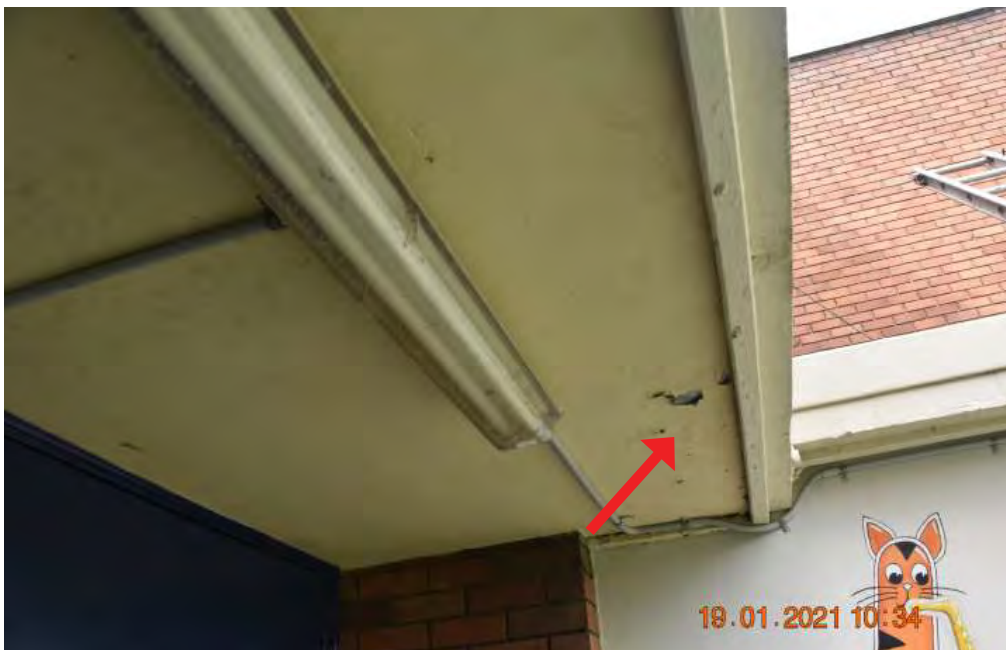
Figure: 0781

Nail marking in the north wall of building A.

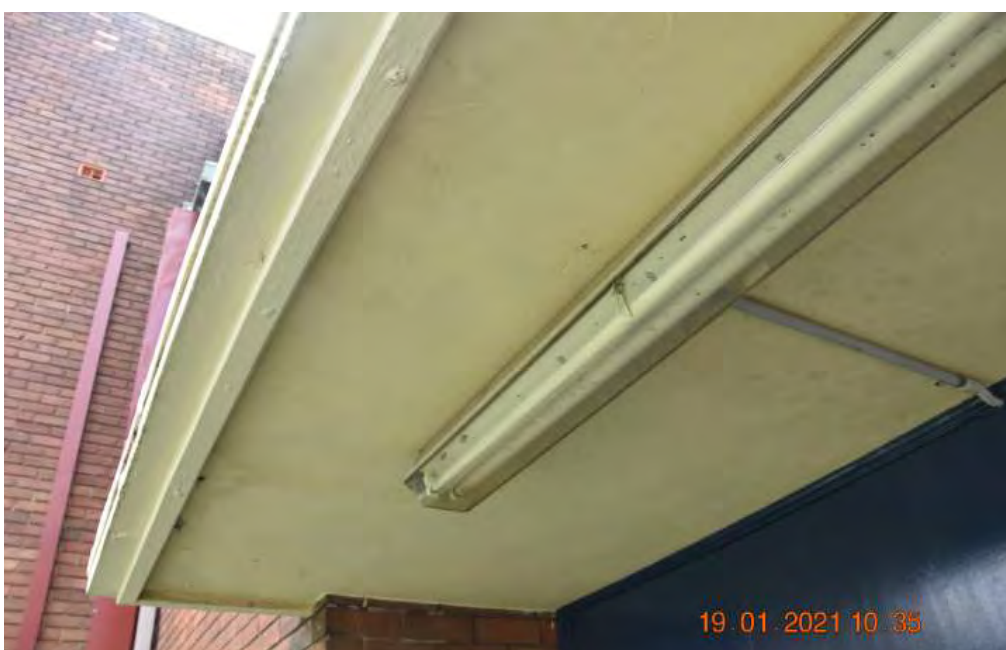
Figure: 0782

General view of the soffit at the entrance on the west side of building A. Showing peeling paint.

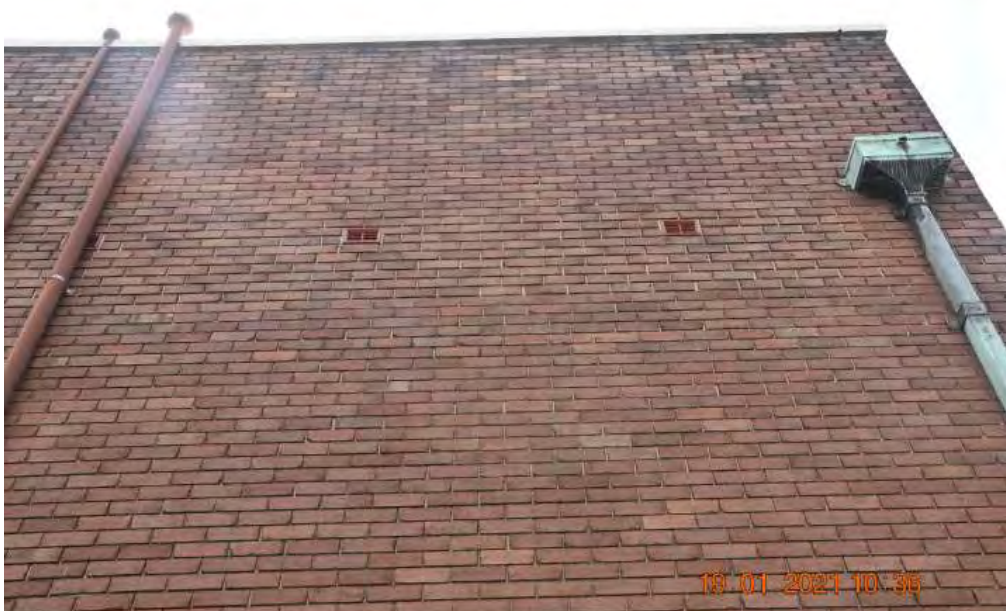
Figure: 0794

Nail markings in the west wall of building A, looking from the playground.

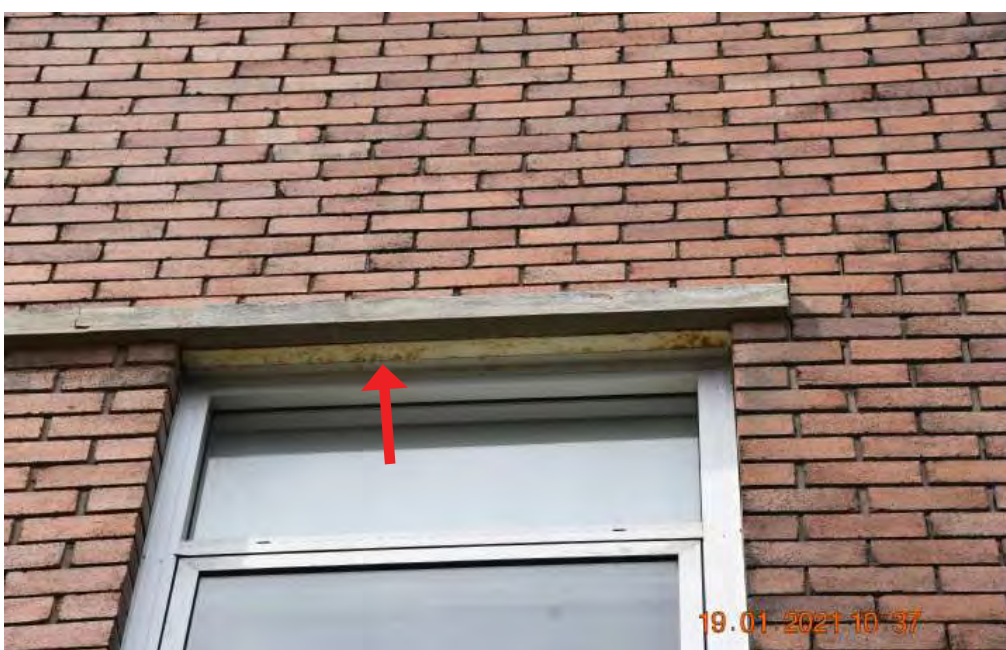
Figure: 0809

Rusting and cracking above the window in the north wall of building A.

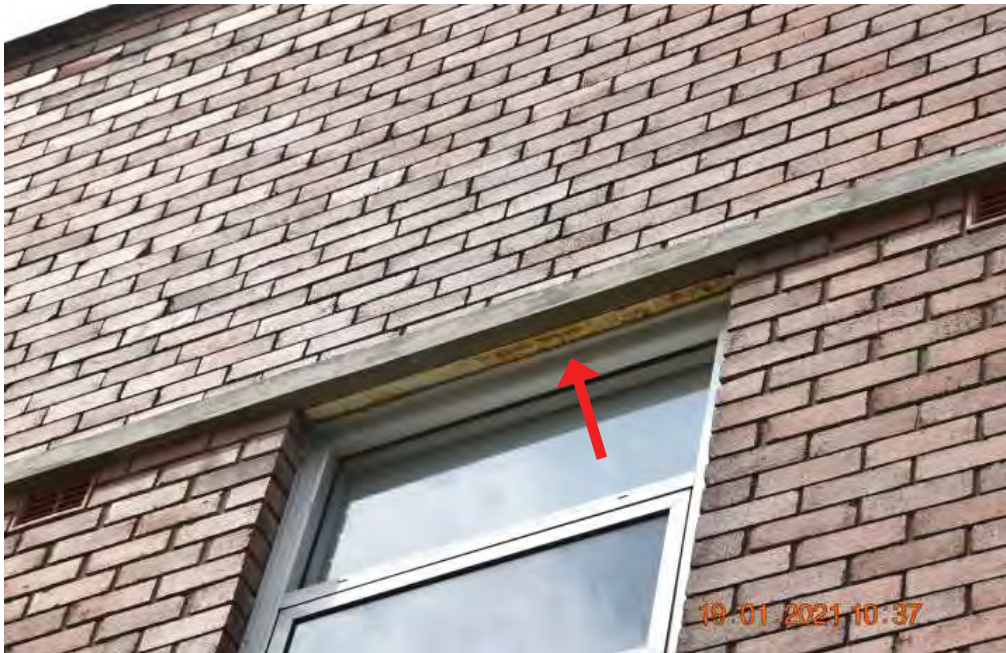
Figure: 0810

Rusting above the window in the north wall of building A.

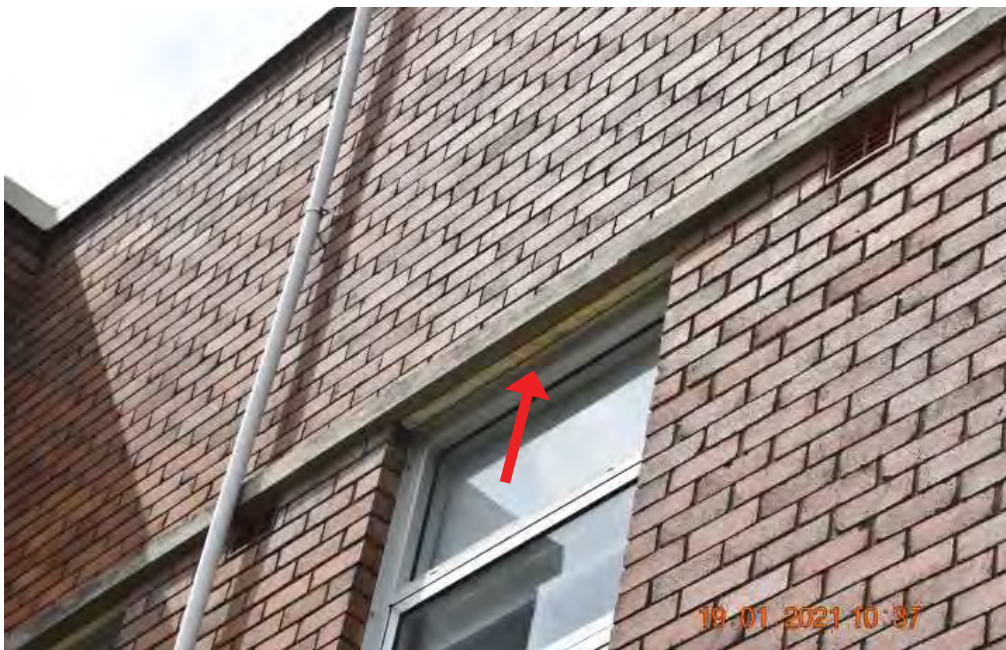
Figure: 0811

Rusting above the window in the north wall of building A.

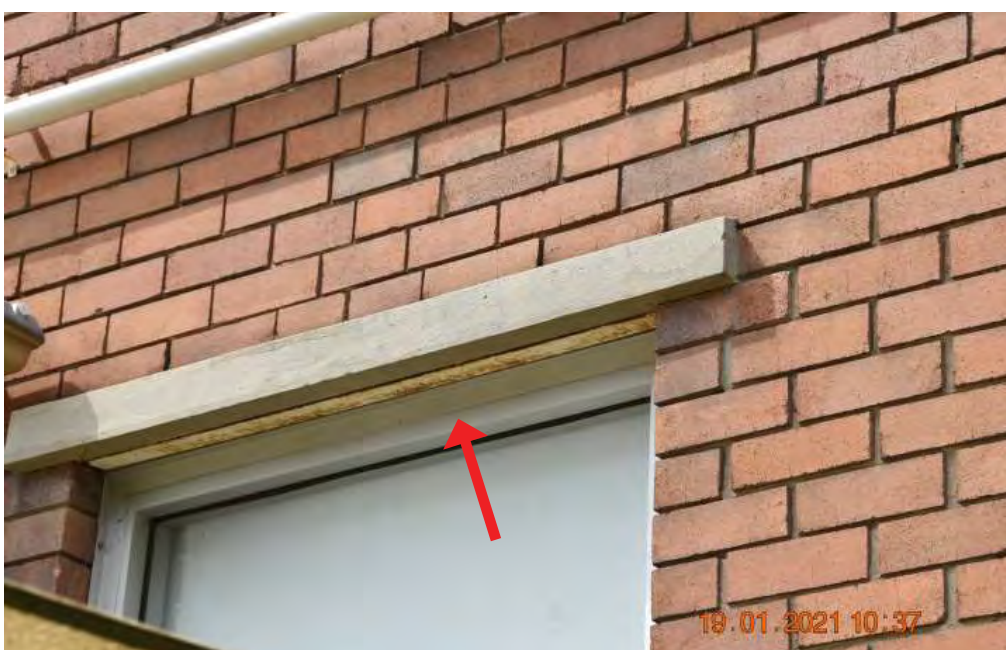
Figure: 0812

Rusting above the window in the north wall of building A.

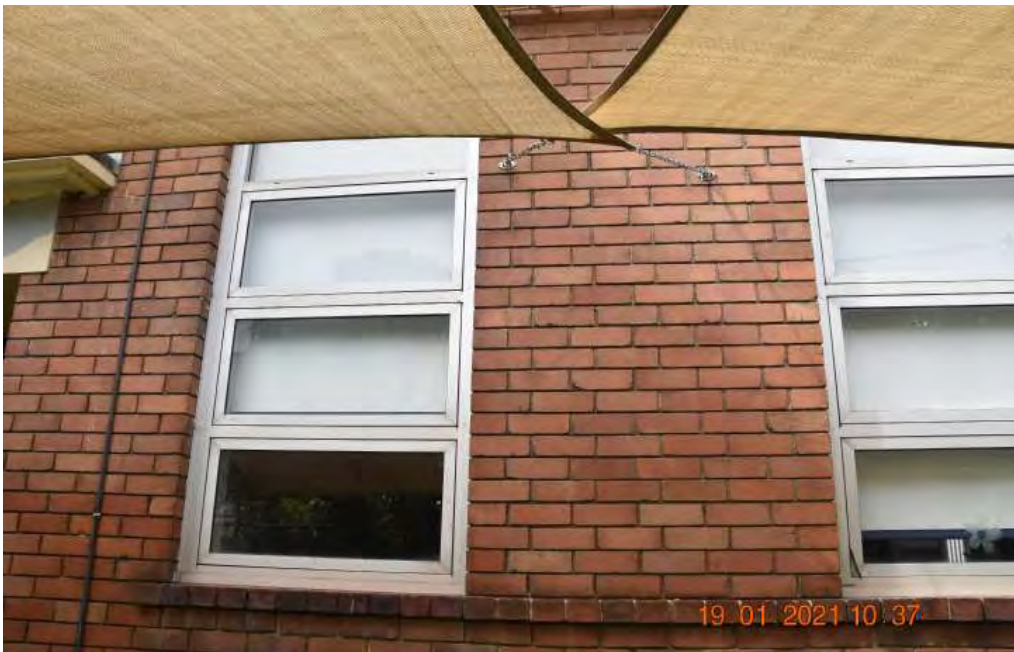
Figure: 0814

North wall of building A. Showing erosion in the mortar joints.

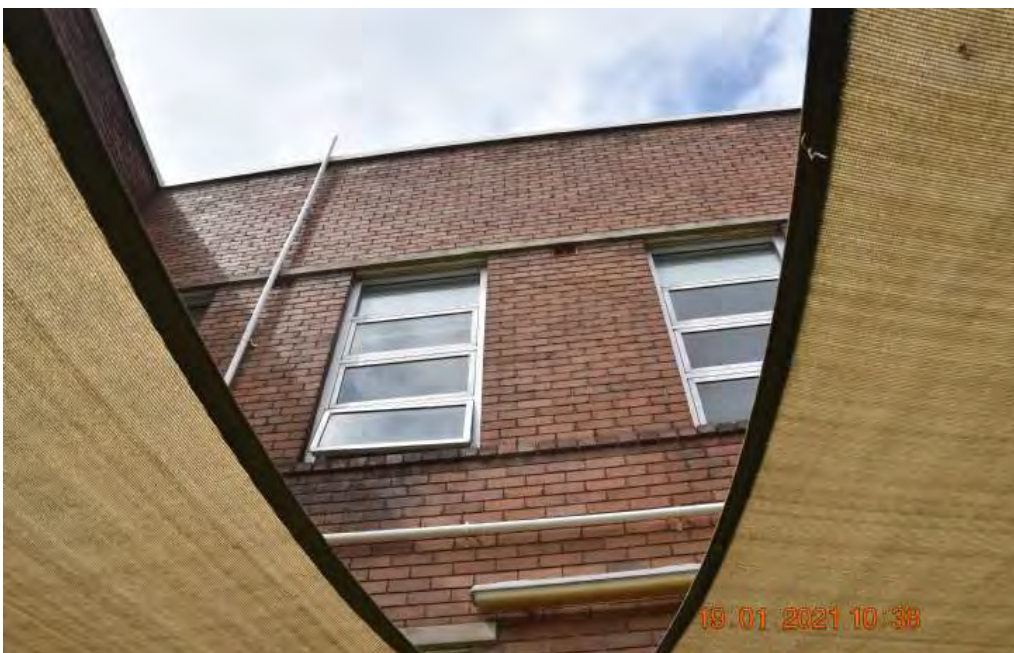
Figure: 0815

North wall of building A.

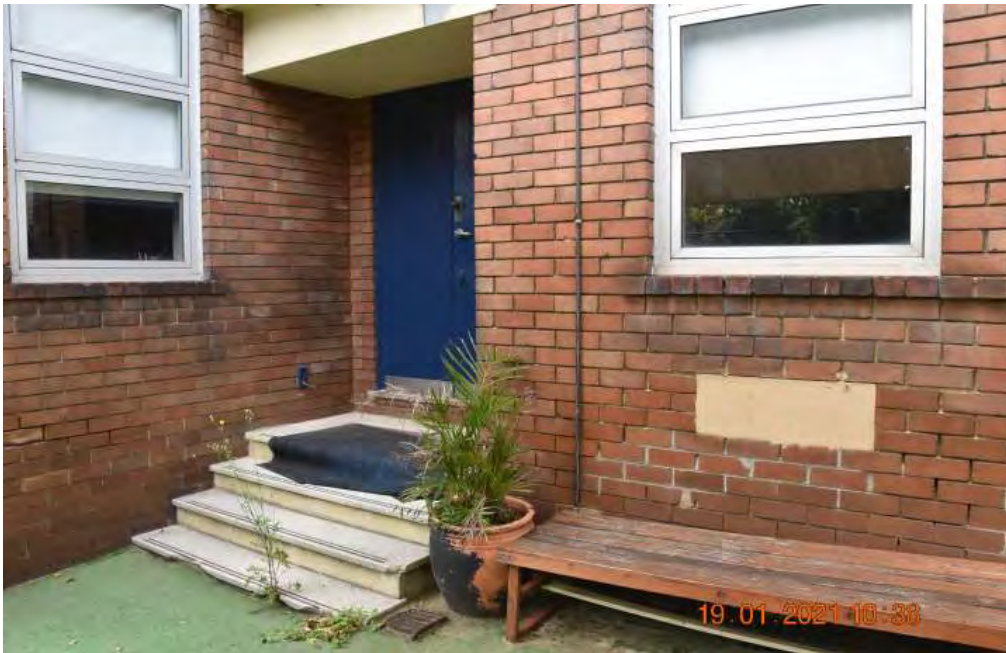
Figure: 0816

North wall of building A.

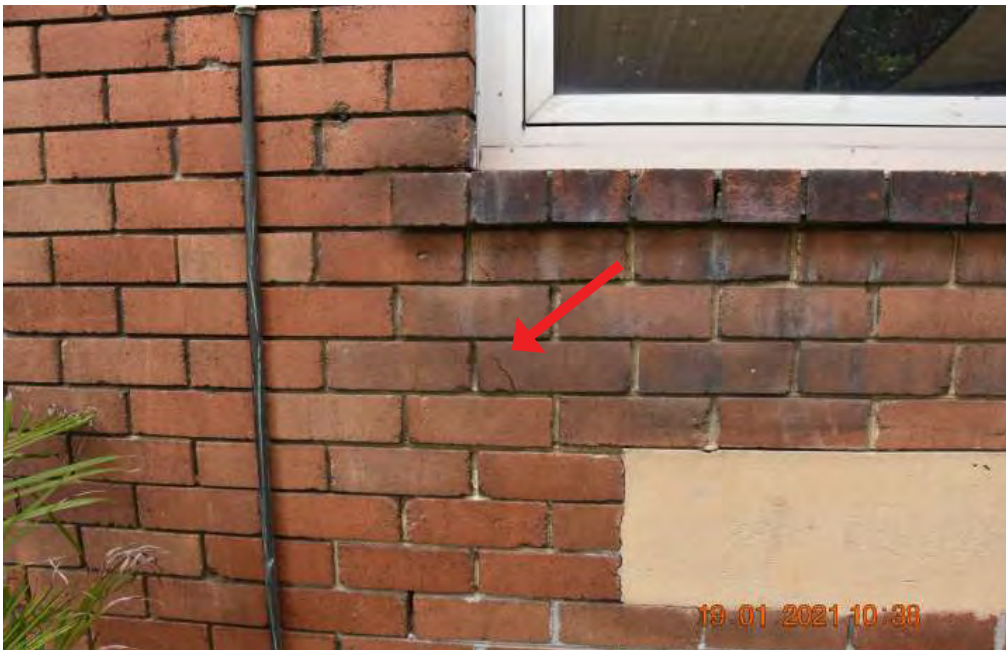
Figure: 0817

North wall of building A.

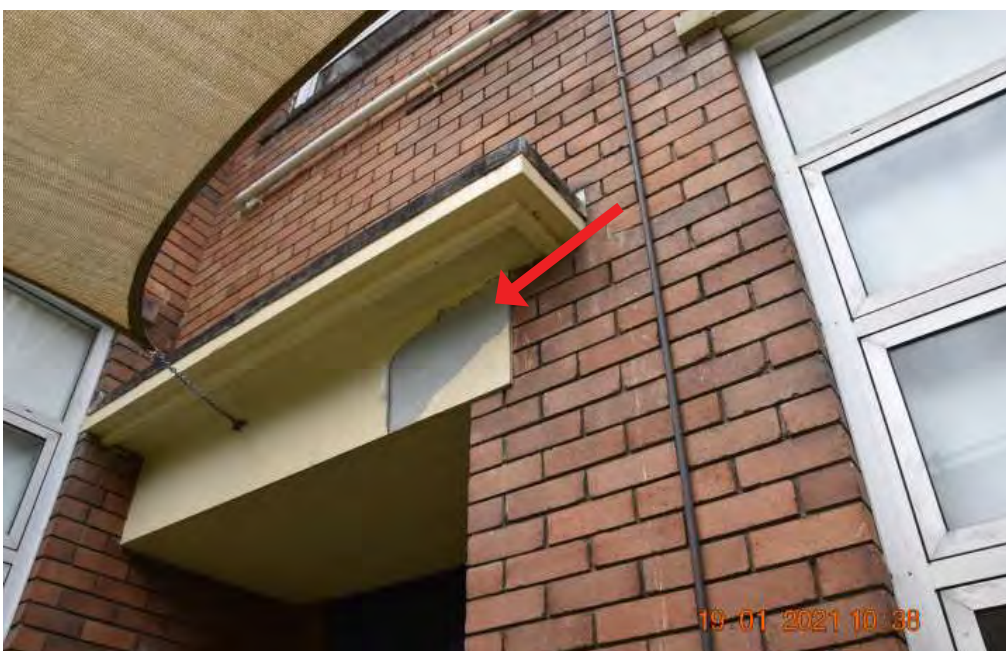
Figure: 0818

Cracking in the brick in the north wall of building A, outside room 23.

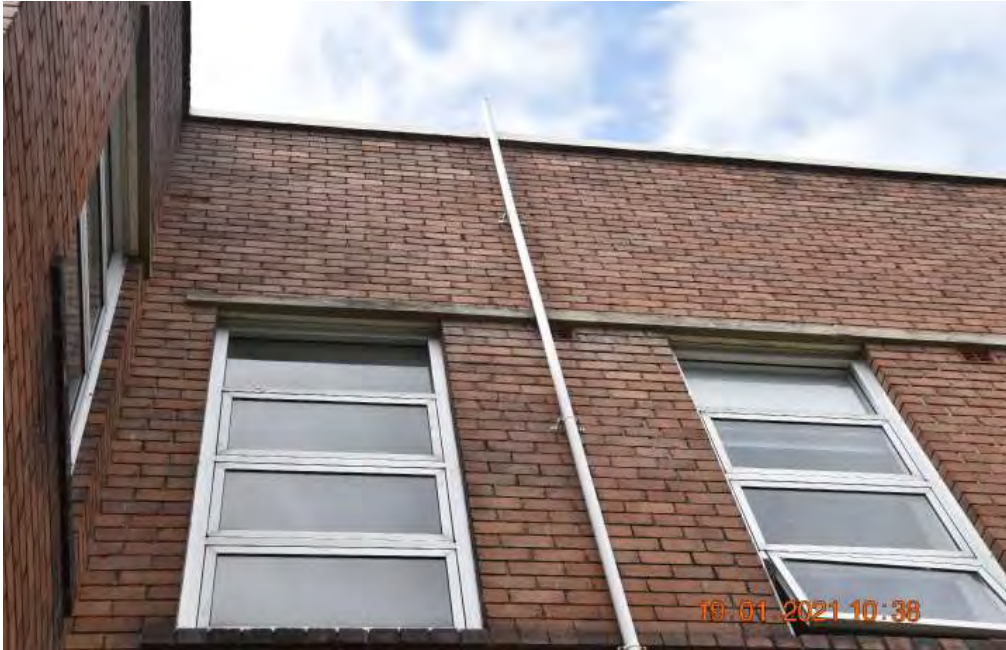
Figure: 0819

Peeling paint in the north wall of building A, outside the entrance.

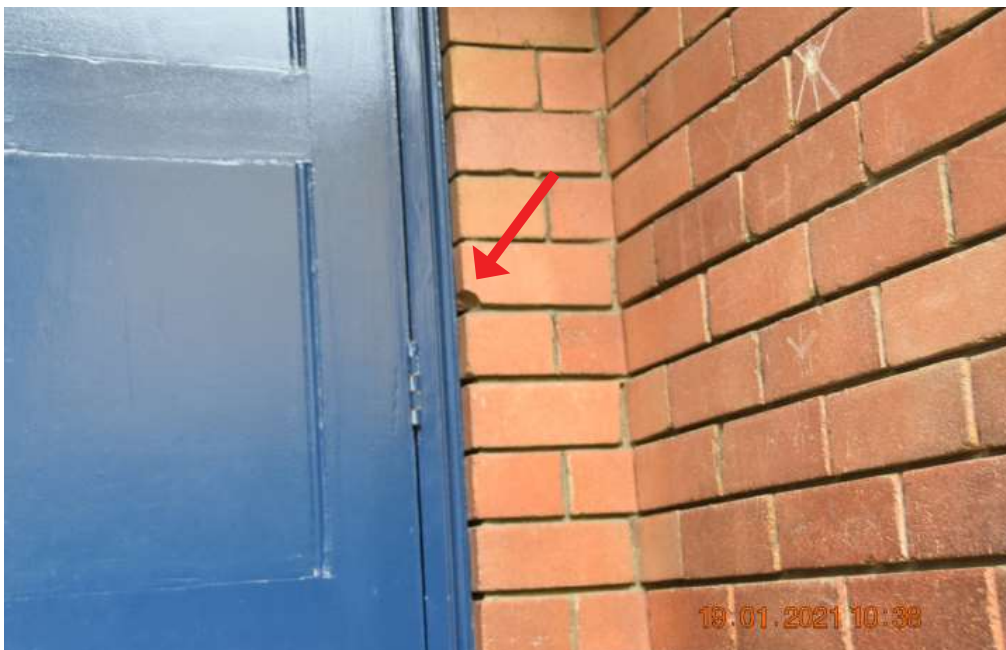
Figure: 0823

Chipping in the steps at the north entrance.

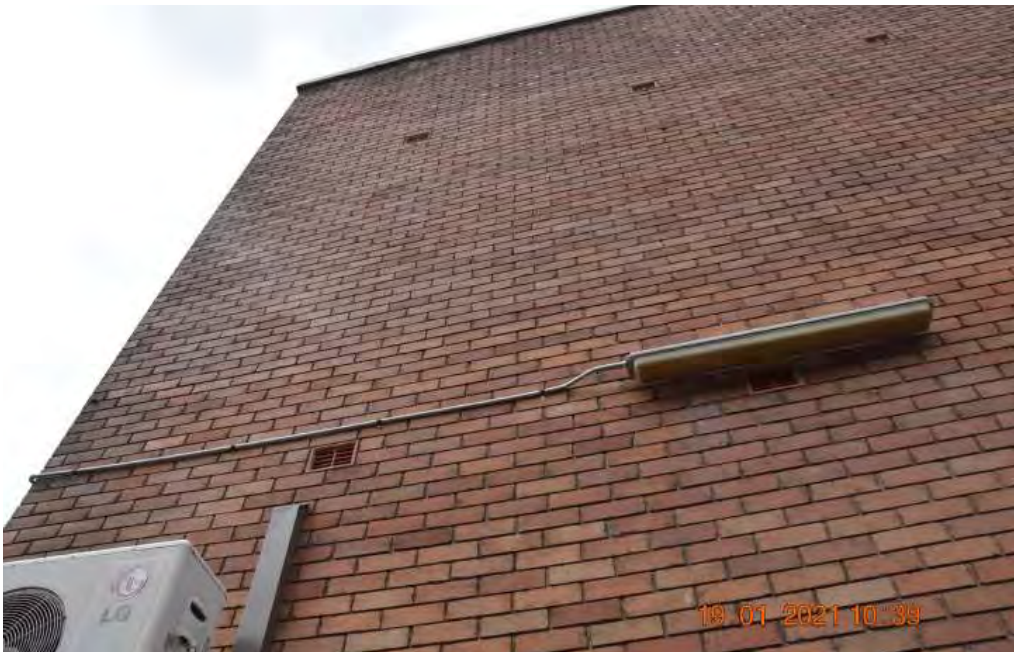
Figure: 0835

North wall of building A, east side. Showing erosion in the mortar joints.

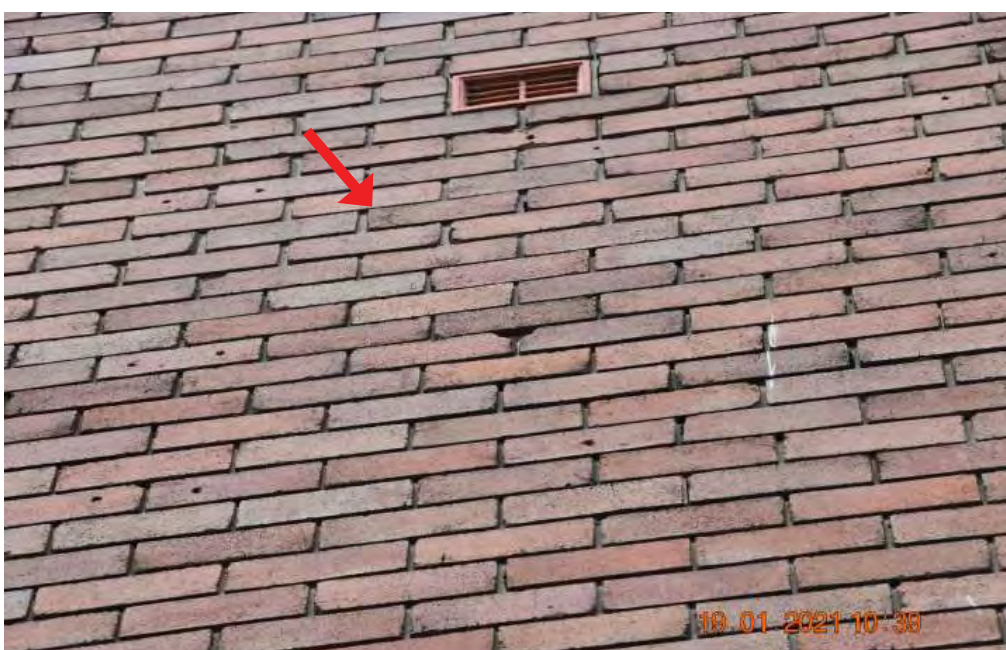
Figure: 0839

North wall of building A, east side. Showing corrosion.

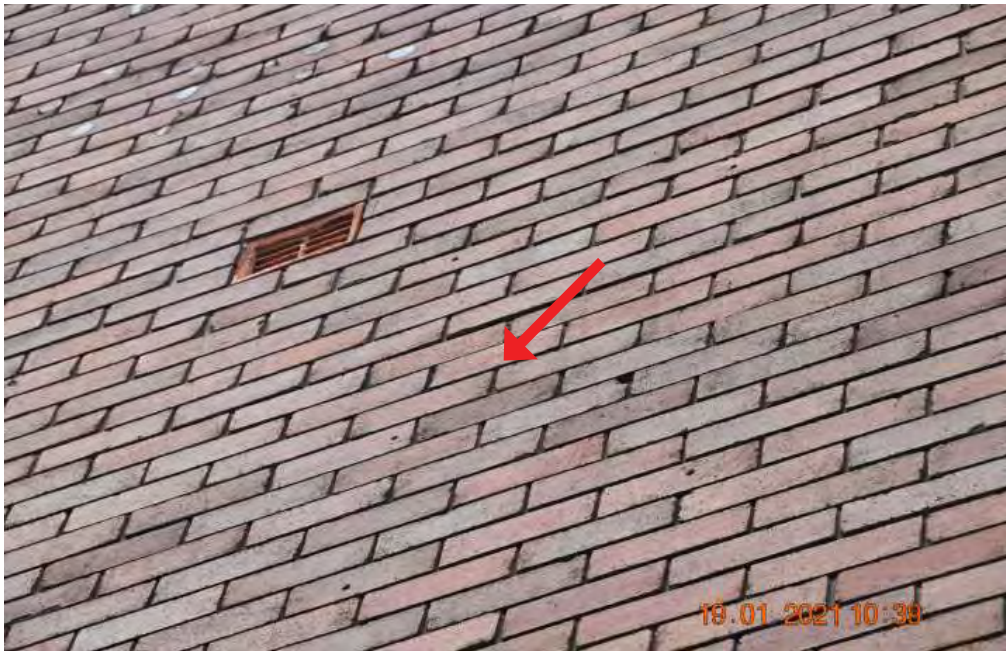
Figure: 0840

North wall of building A, east side. Showing corrosion.

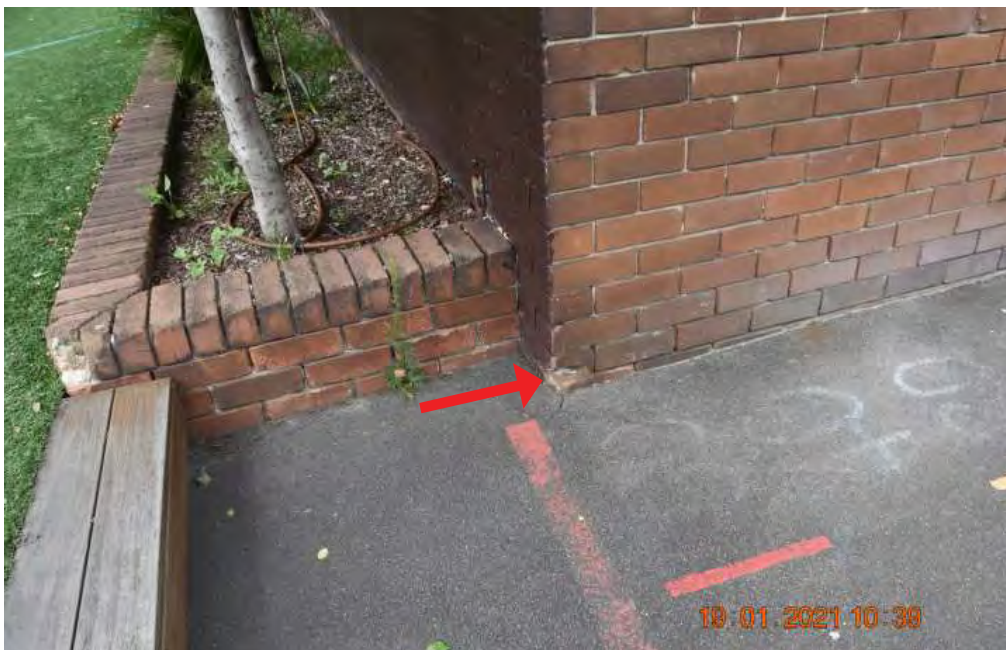
Figure: 0841

North wall of building A, east side. Showing corrosion.

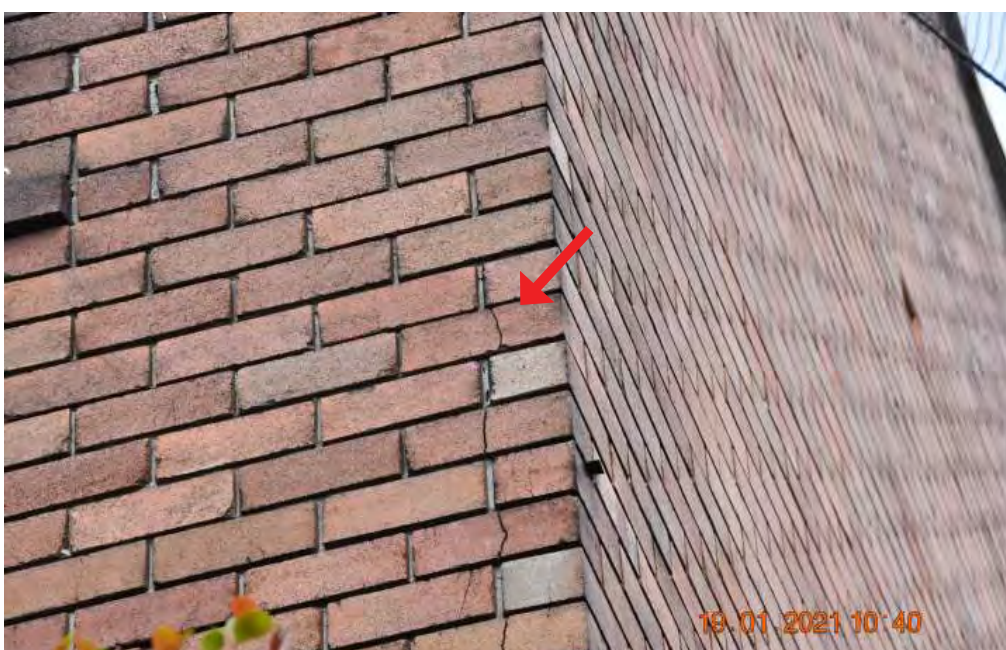
Figure: 0842

Chipping in the brick at the northeast corner of building A.

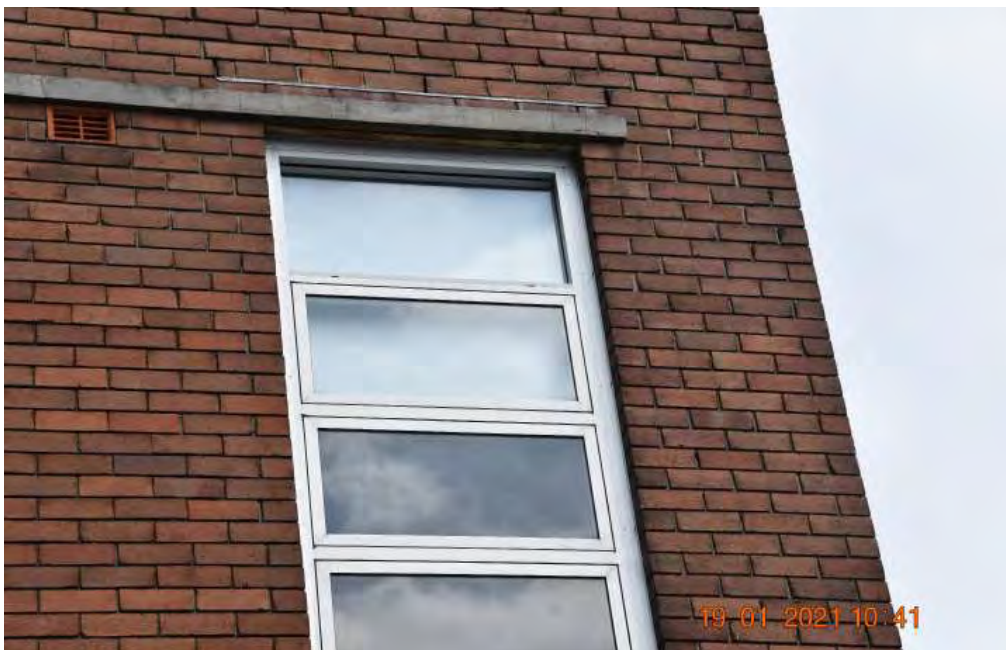
Figure: 0859

East wall of building A, north side.  
Showing slight stepped cracking in the mortar joints.

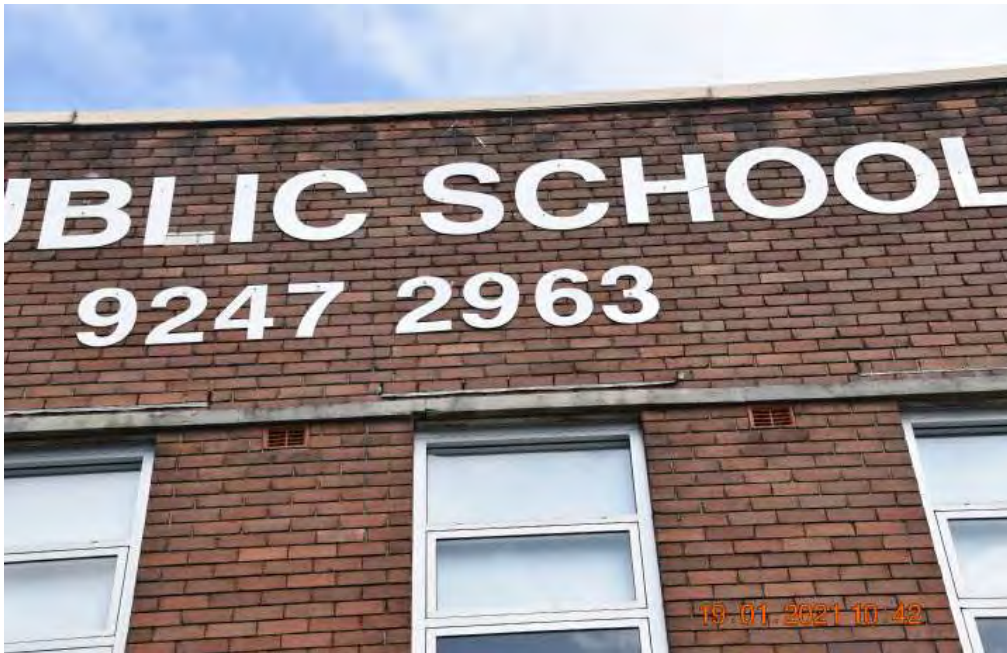
Figure: 0861

East wall of building A, north side.  
Showing chipping above the window.

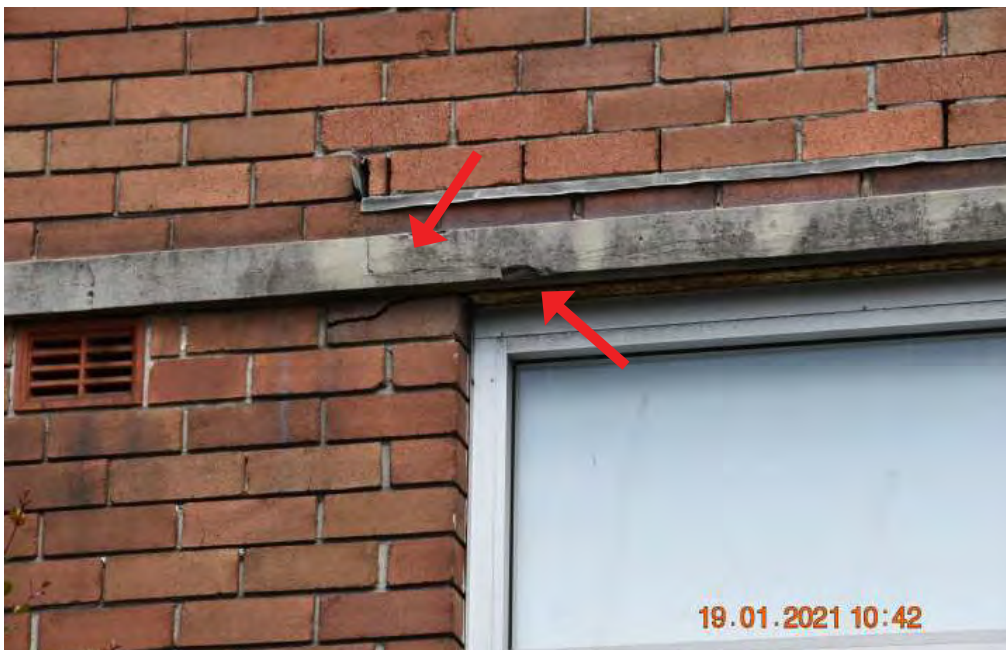
Figure: 0865

Cracking above the second window from the north in the brick in the east wall of building A.

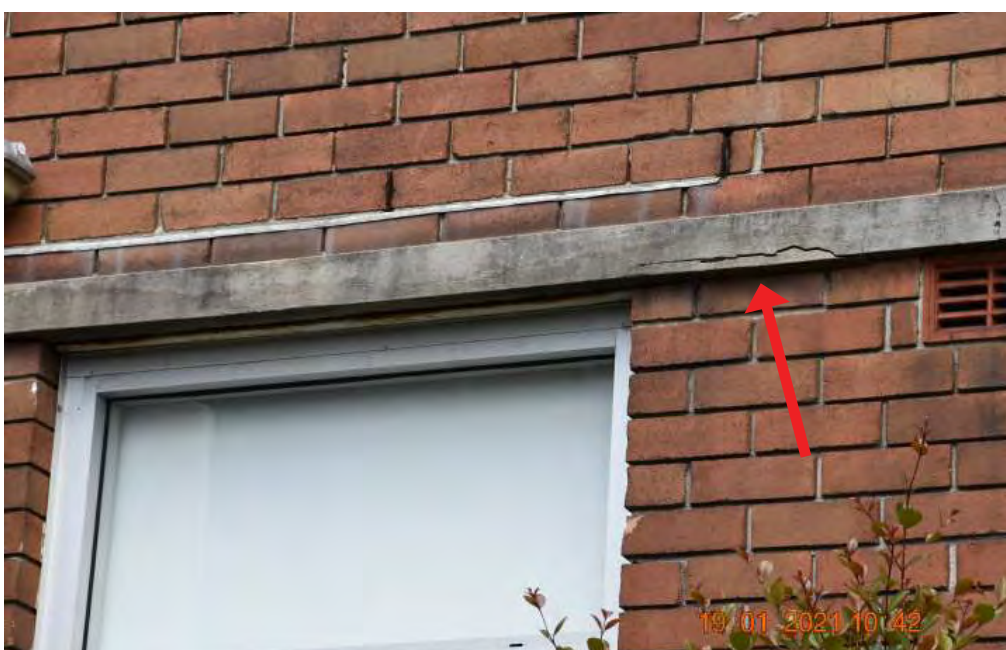
Figure: 0866

Cracking above the third window from the north in the brick in the east wall of building A.

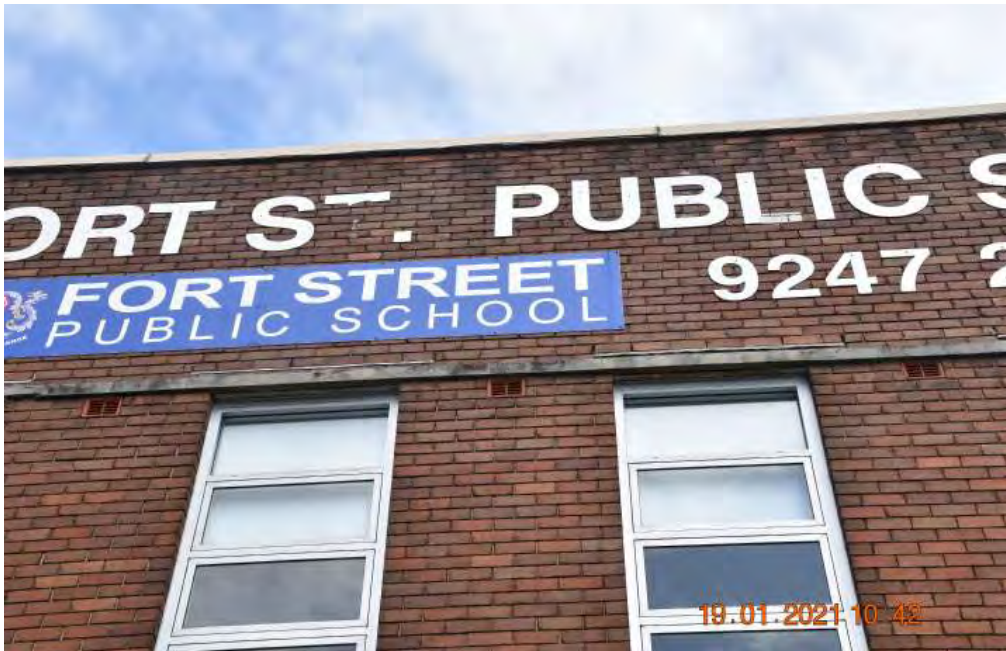
Figure: 0867

Cracking above the fourth window from the north in the brick in the east wall of building A.

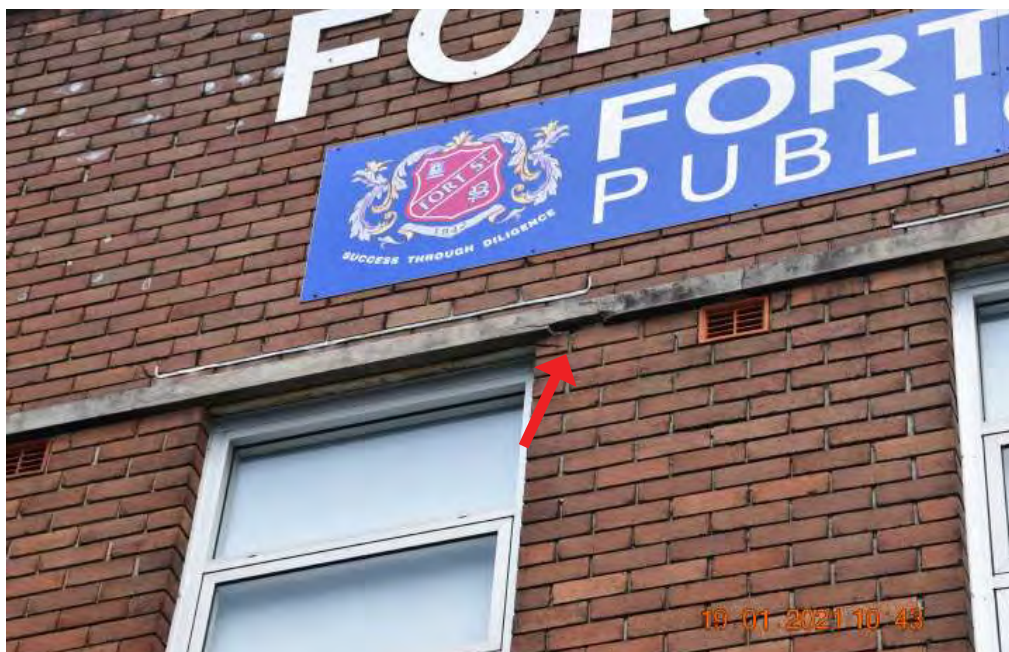
Figure: 0877

Cracking and chipping above the third window from the north in the east wall of building A.

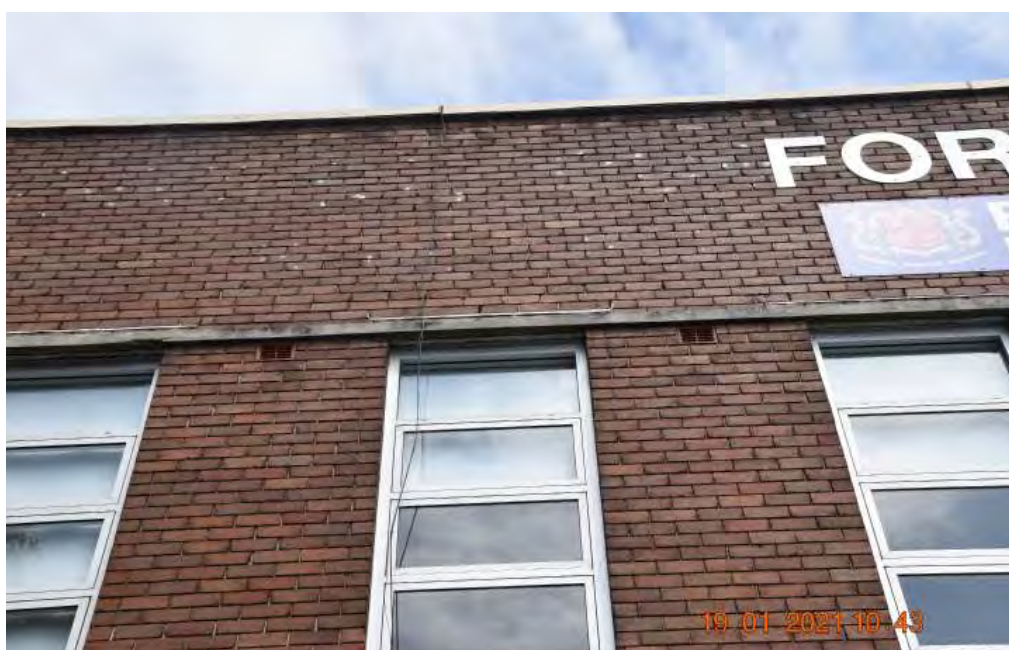
Figure: 0878

Cracking and chipping above the fifth window from the north in the east wall of building A.

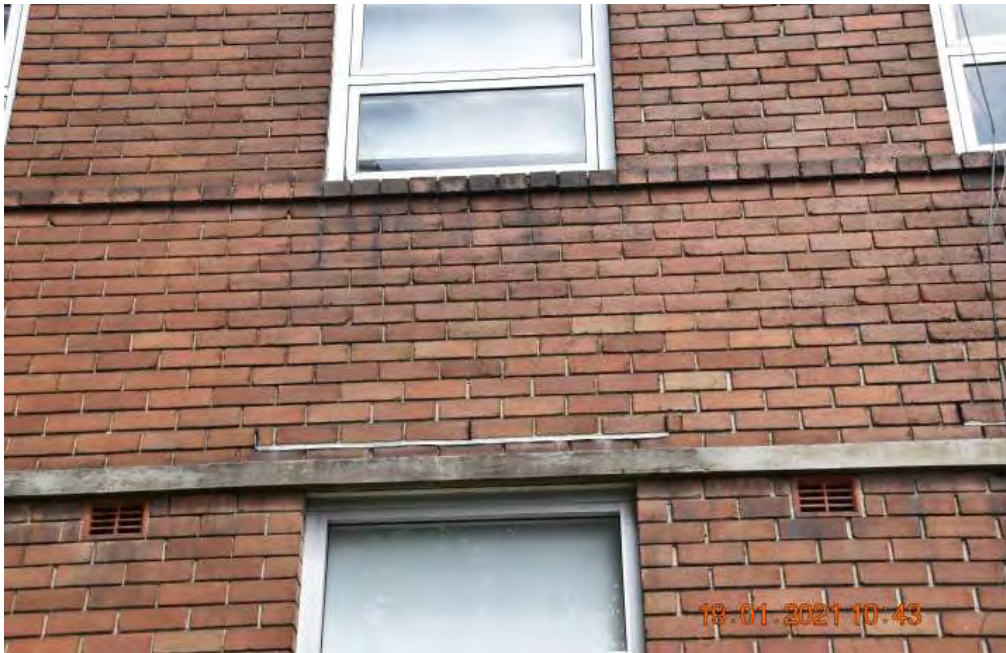
Figure: 0882

East wall of building A, looking from the sixth window from the north. Showing damage above the window.

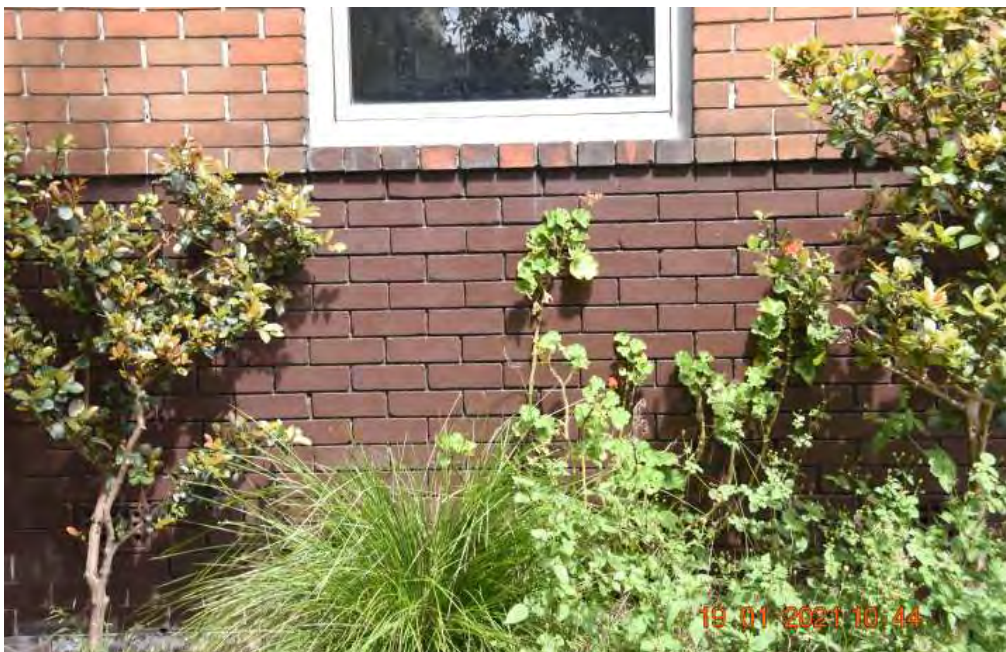
Figure: 0886

East wall of building A, looking from the eighth window from the north. Showing chipping above the window.

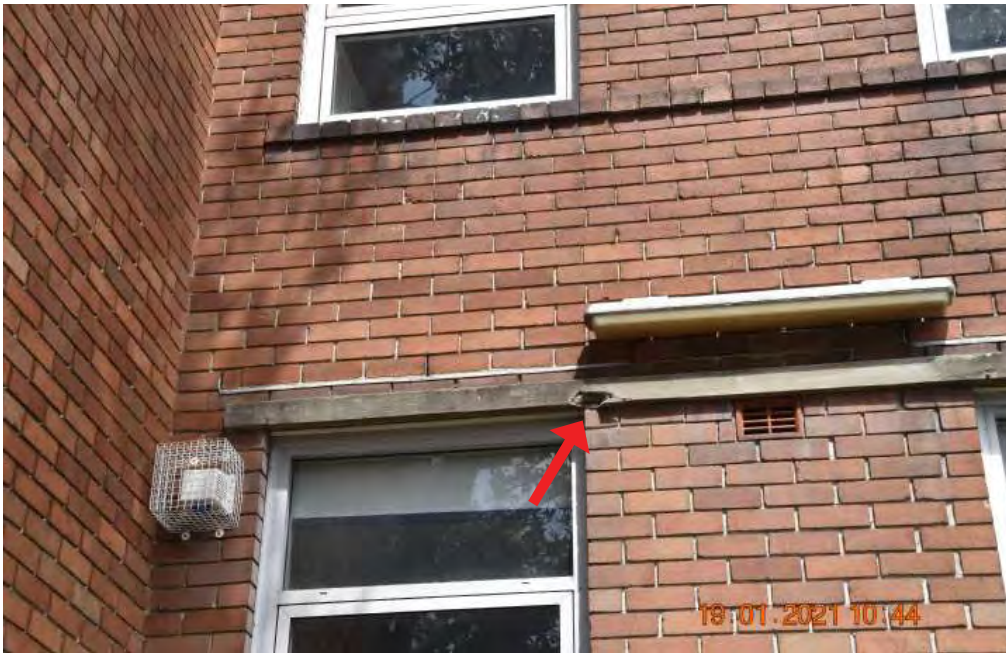
Figure: 0889

East wall of building A, looking from the ninth window from the north. Showing chipping above the window.
