## PRE CONSTRUCTION CONDITION SURVEY

Fort Street Public School, Millers Point NSW

Upper Fort Street Public School  
MILLERS POINT NSW 2000

19 January 2021

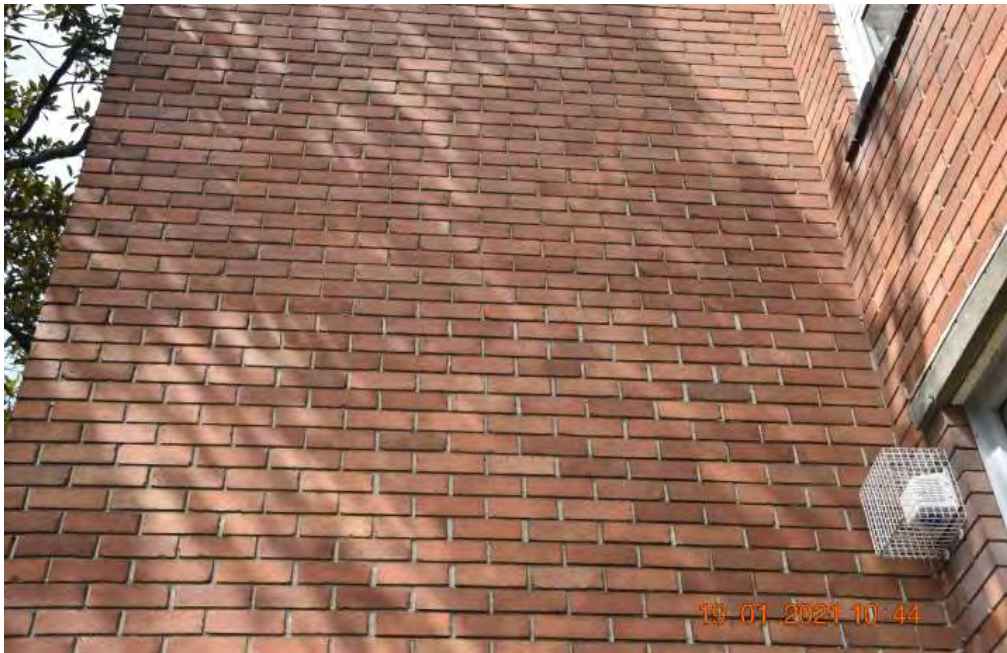
Figure: 0898

North wall of building A.

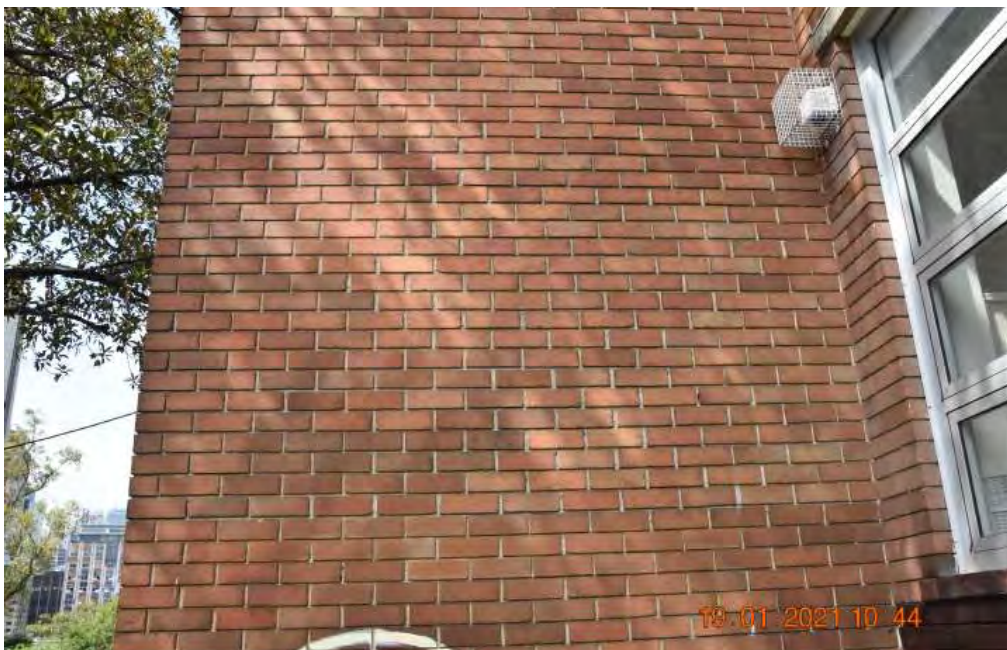
Figure: 0899

North wall of building A.

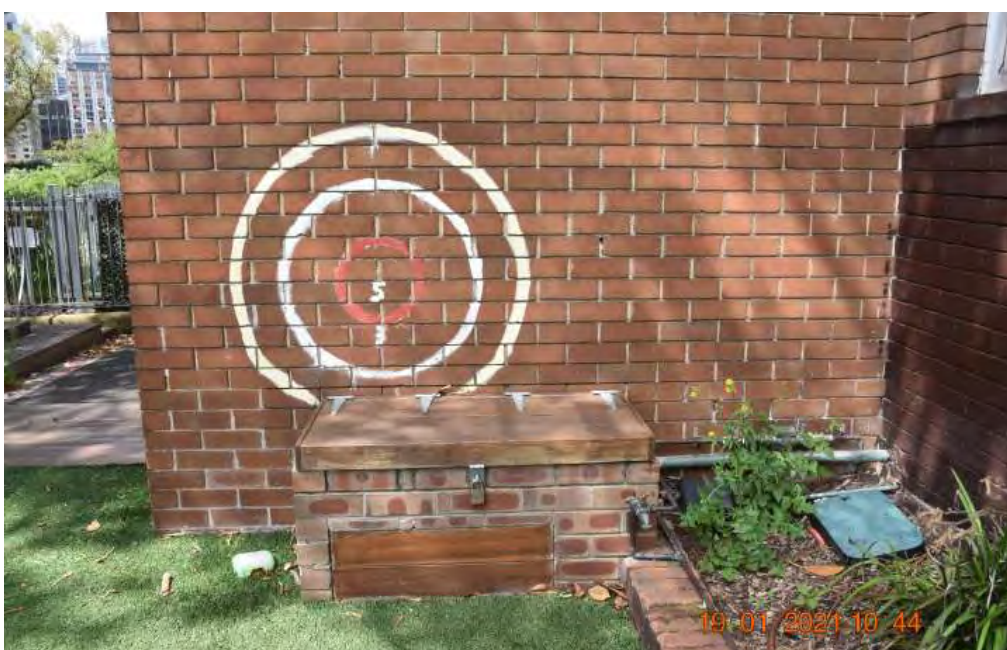
Figure: 0900

North wall of building A.

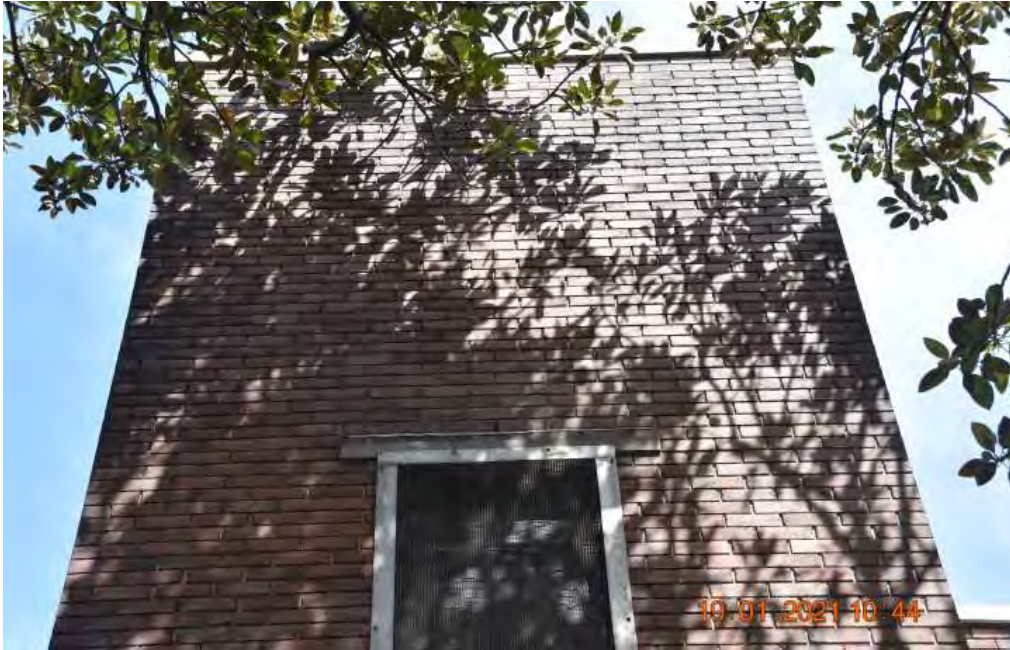
Figure: 0901

East wall of building  
A.

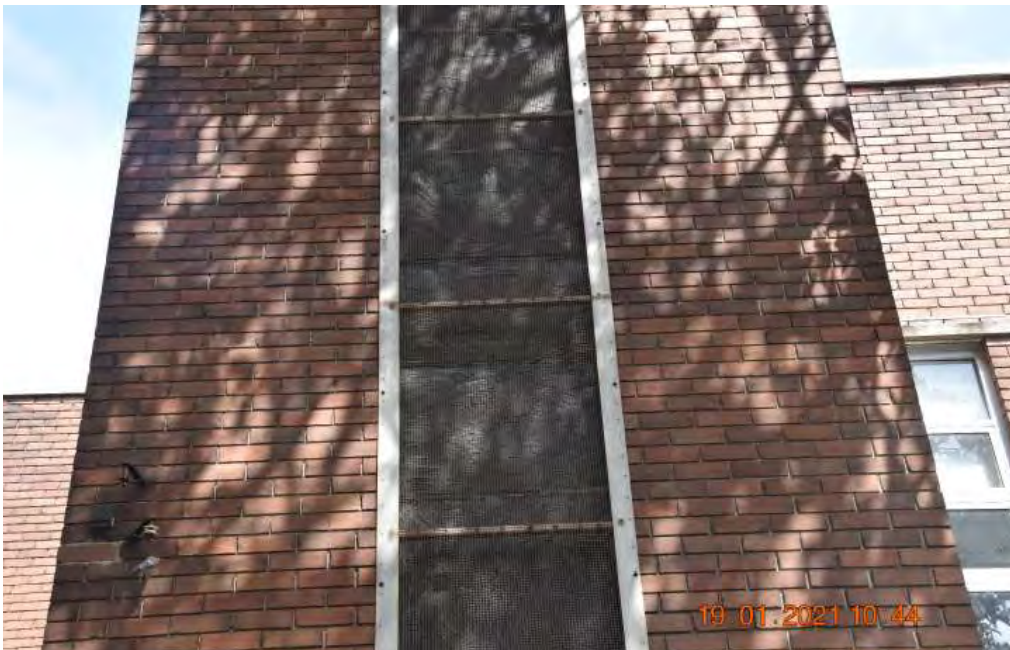
Figure: 0902

East wall of building  
A.

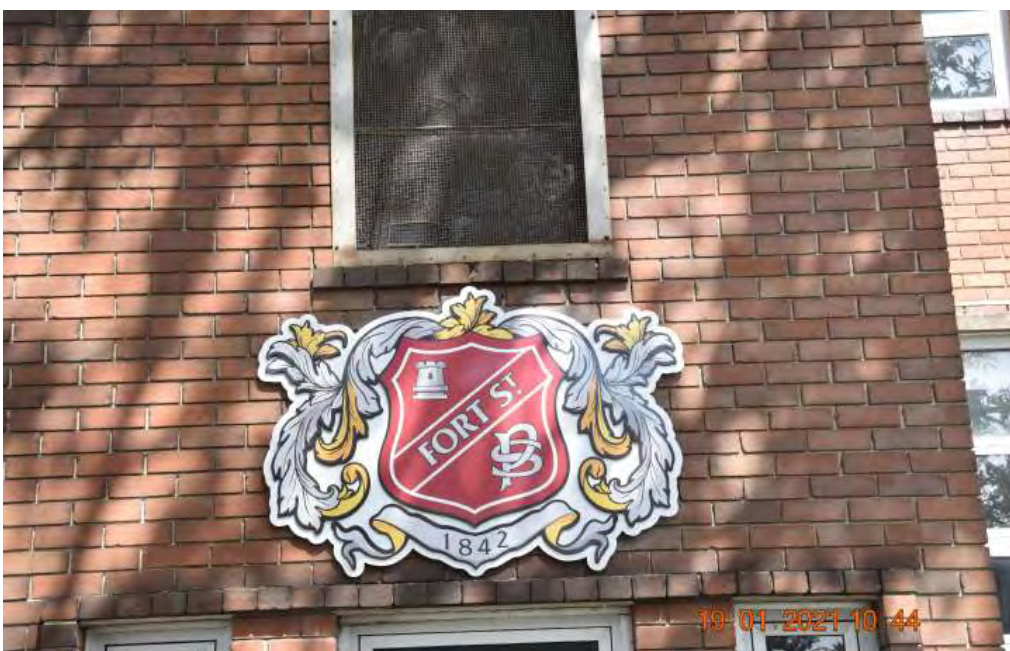
Figure: 0903

East wall of building  
A.

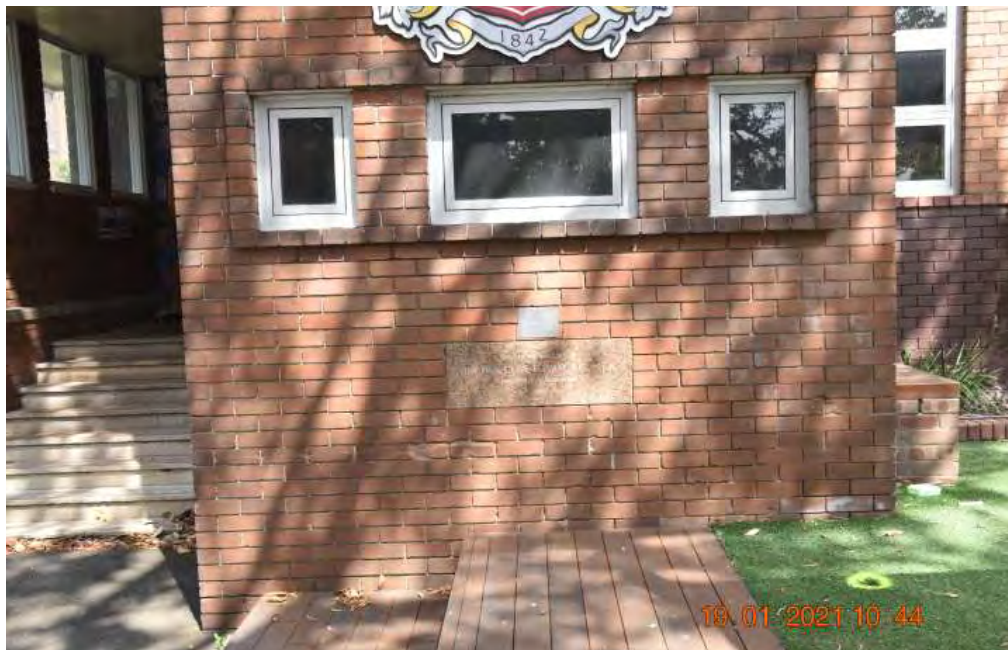
Figure: 0904

East wall of building A.

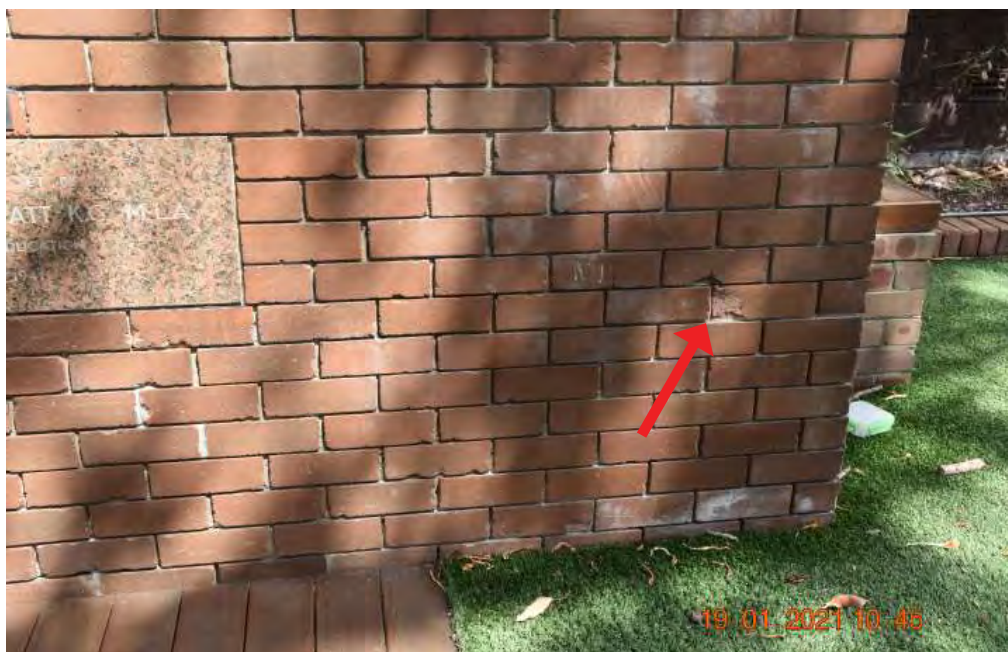
Figure: 0905

Chipping in the brick in the east wall of building A.

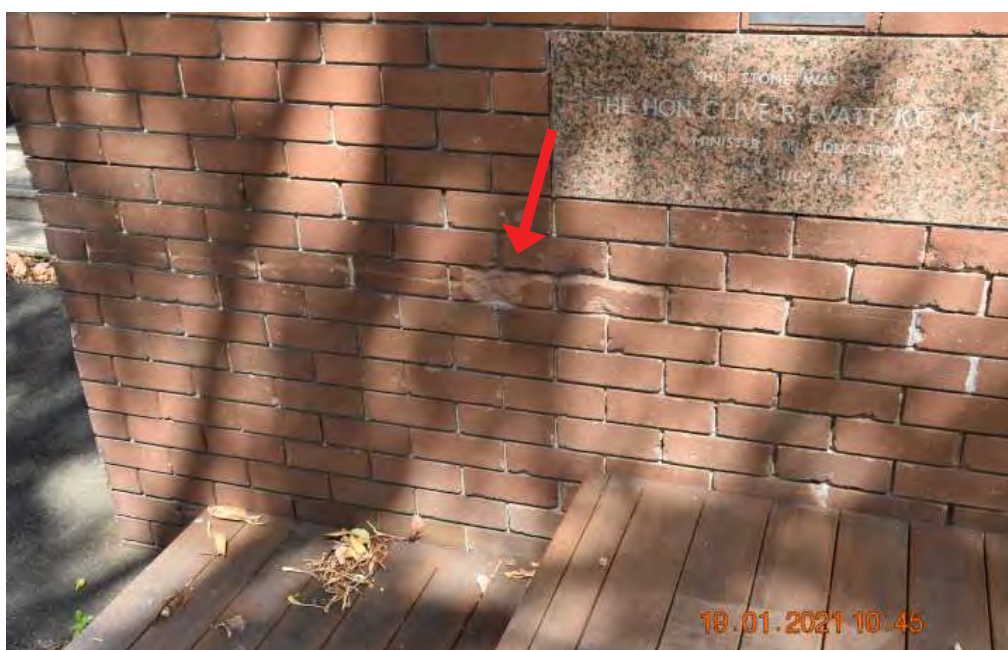
Figure: 0906

Chipping in the brick in the east wall of building A.

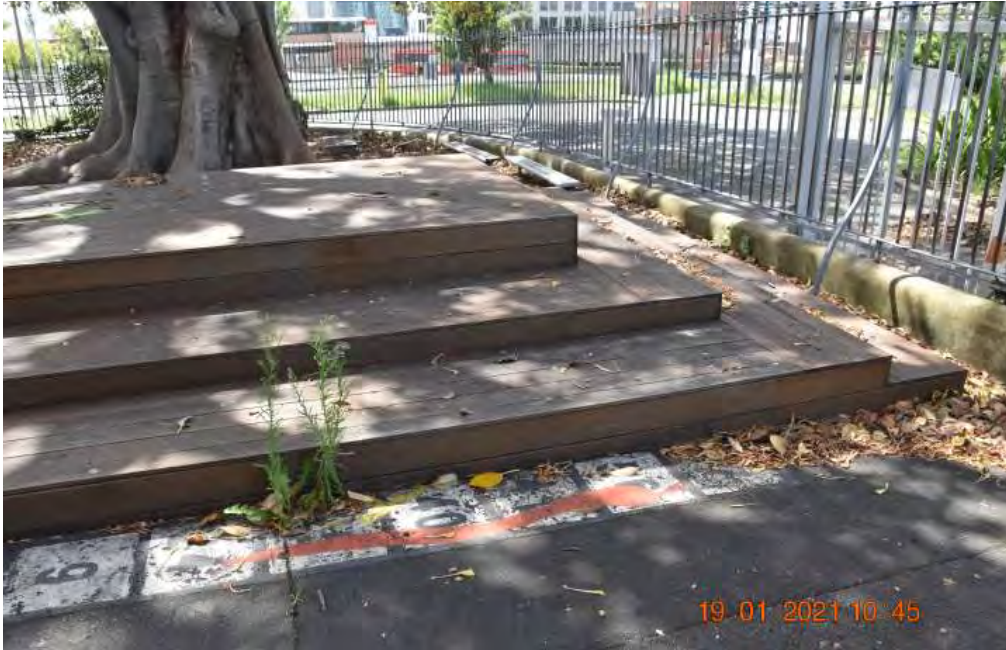
Figure: 0907

General view of the timber decking at the southeast corner of building A.

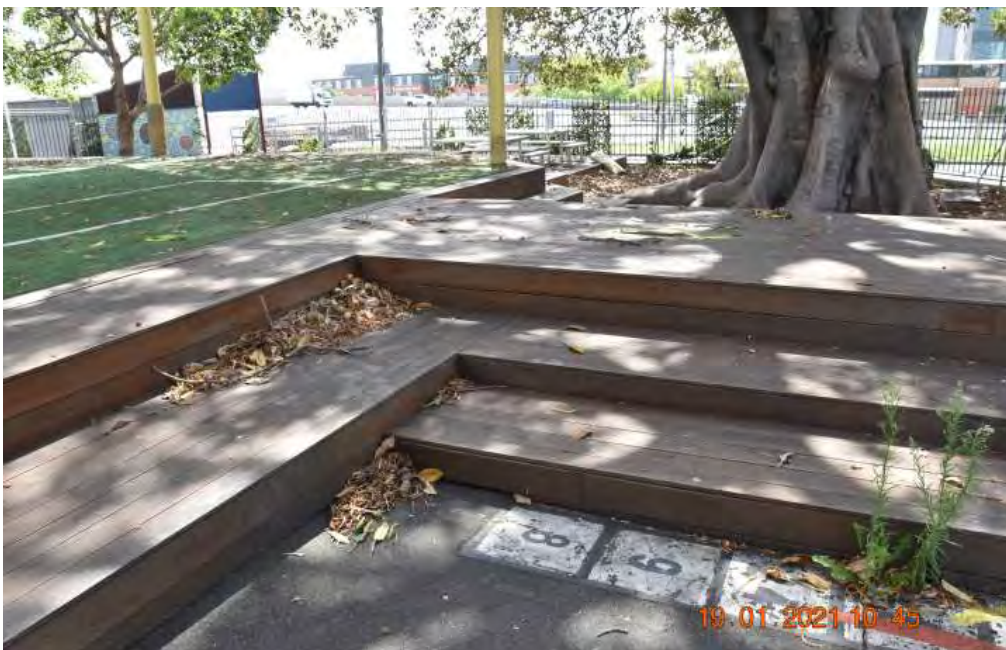
Figure: 0908

General view of the timber decking at the southeast corner of building A.

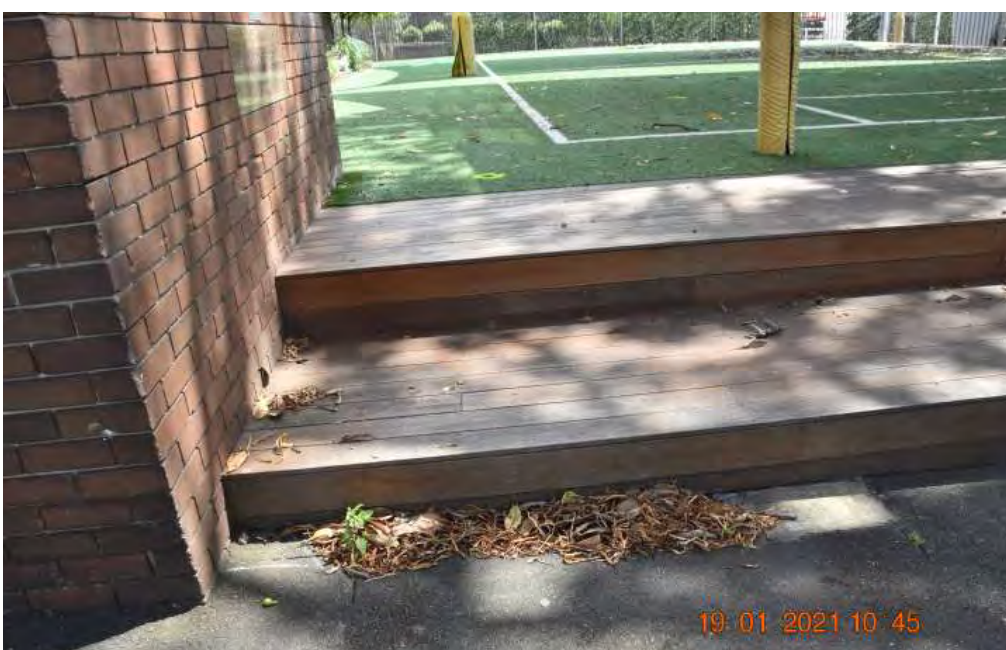
Figure: 0909

General view of the timber decking at the southeast corner of building A.

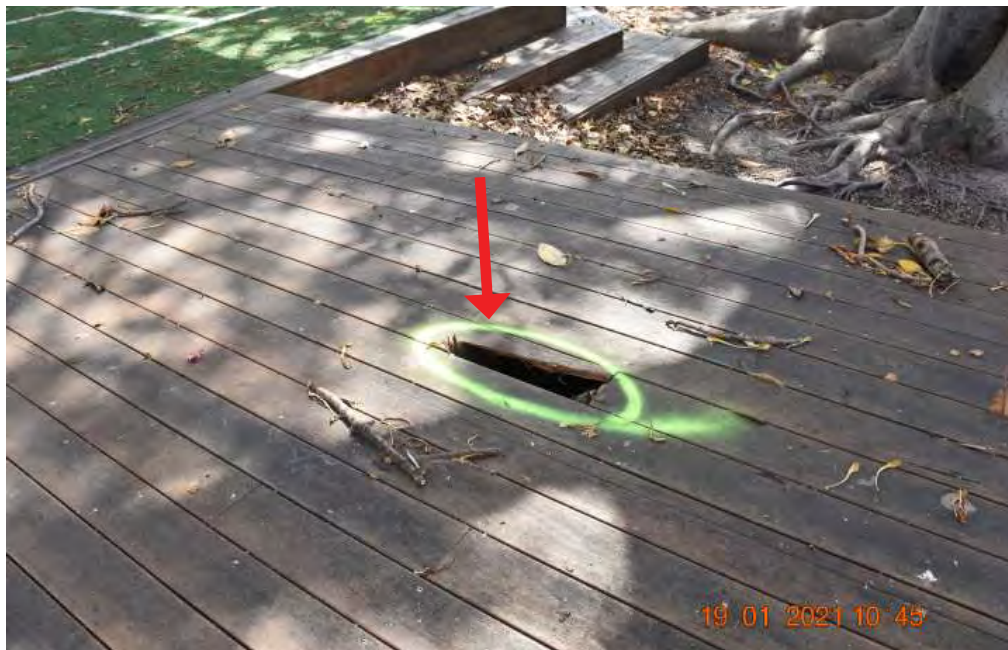
Figure: 0910

Damage in the timber decking at the southeast corner of building A.

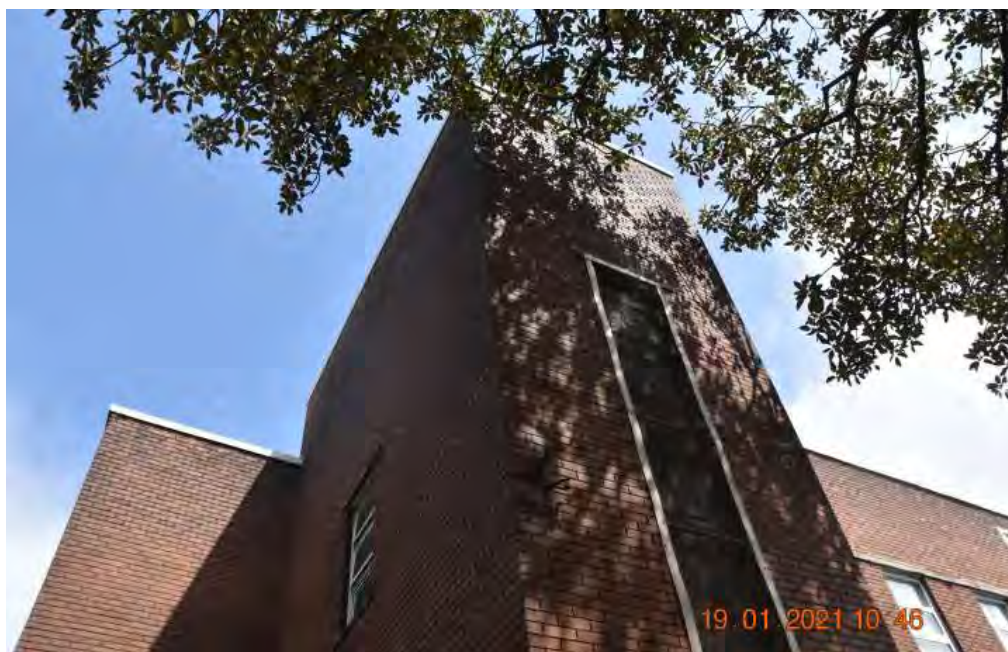
Figure: 0911

East wall of building A, outside the main entrance.

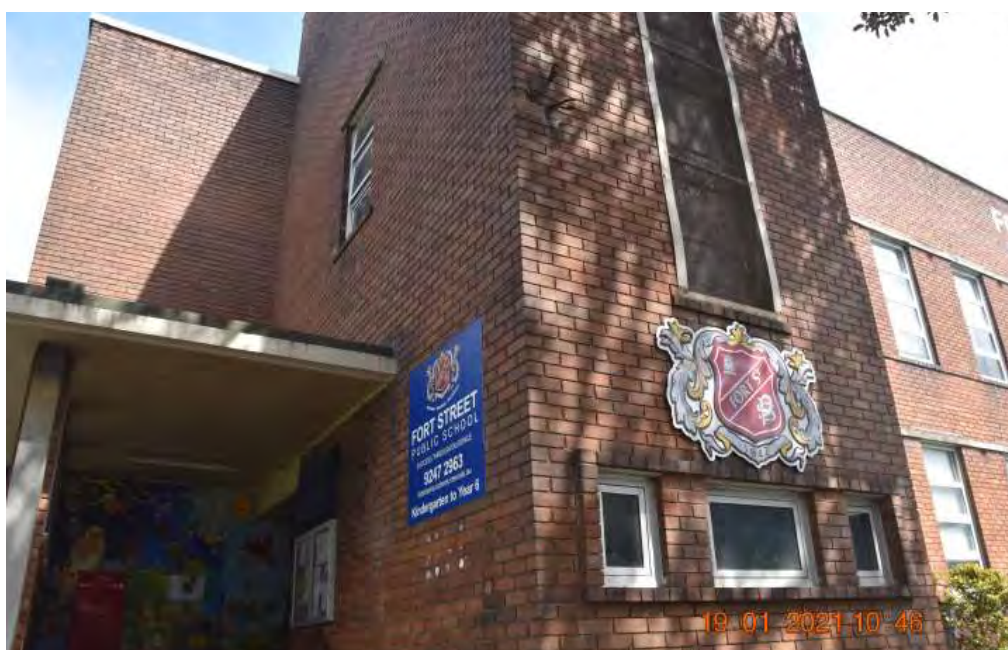
Figure: 0912

East wall of building A, outside the main entrance.

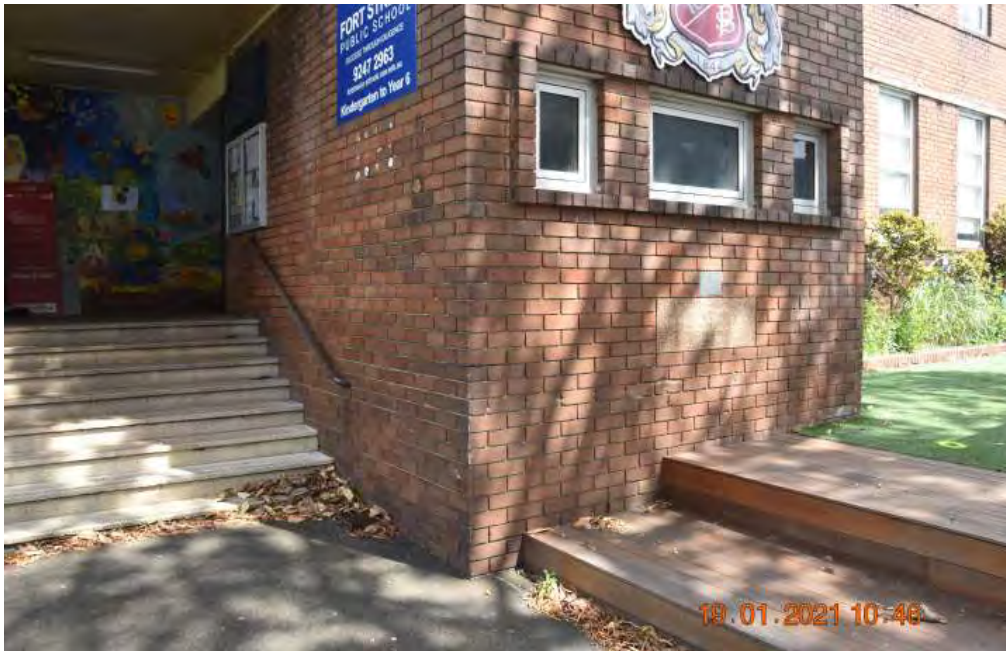
Figure: 0913

East wall of building A, outside the main entrance.

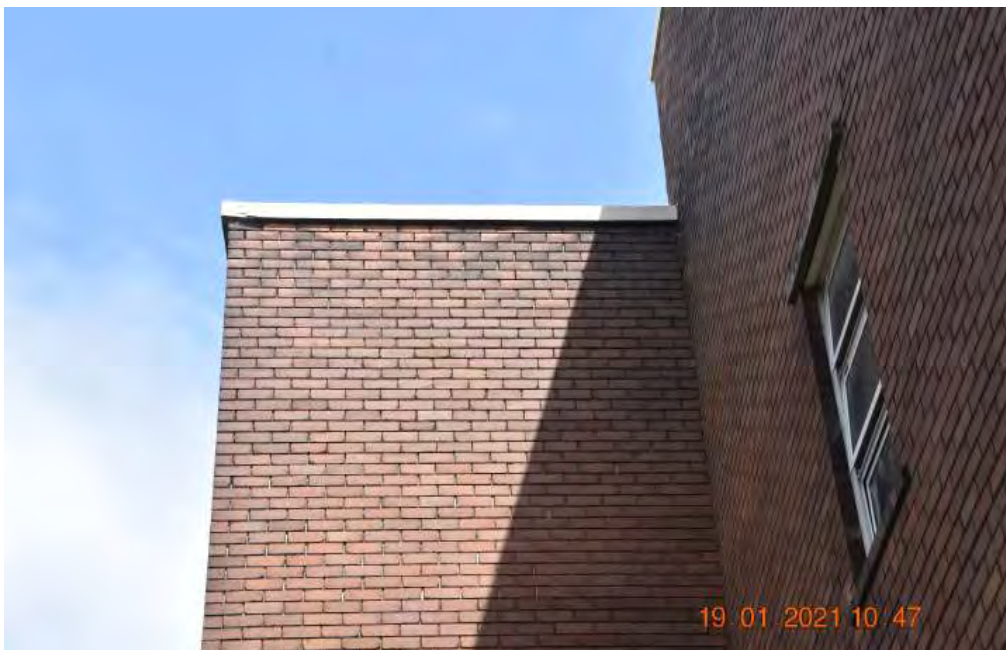
Figure: 0914

East wall of building A, south side.

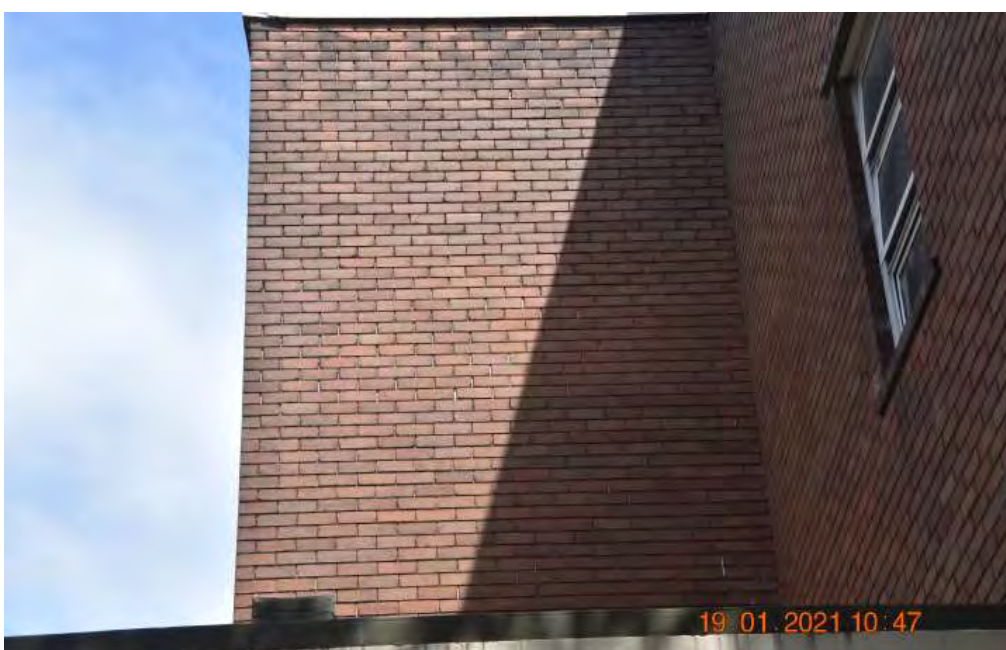
Figure: 0915

East wall of building A, south side.

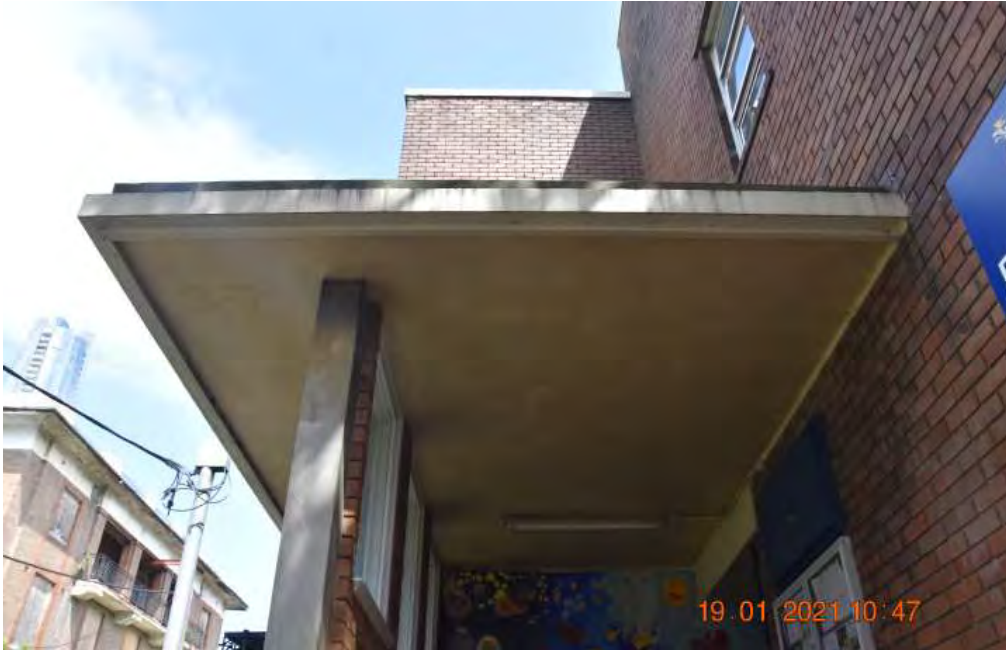
Figure: 0917

Ceiling on the east side of building A, outside the main entrance.

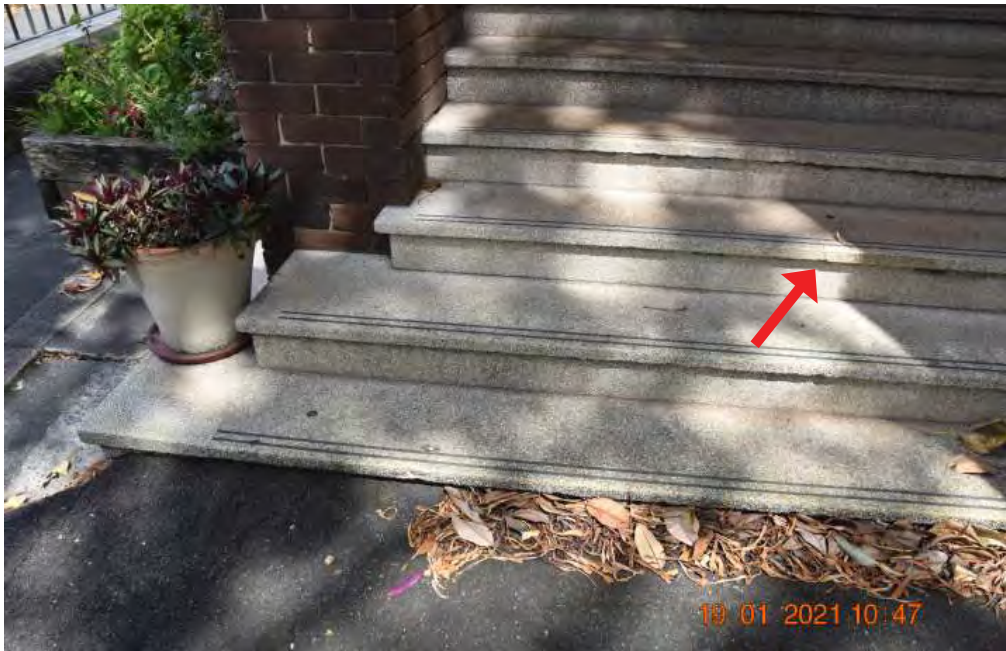
Figure: 0919

General view of the steps on the east side of building A, outside the main entrance. Showing chipping.

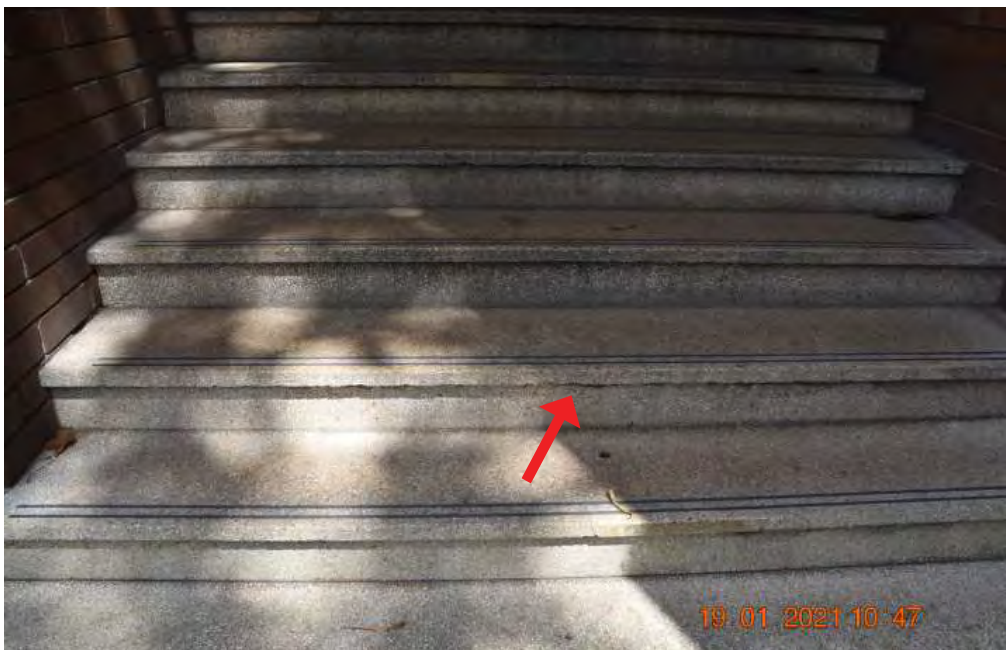
Figure: 0920

General view of the steps on the east side of building A, outside the main entrance. Showing chipping.

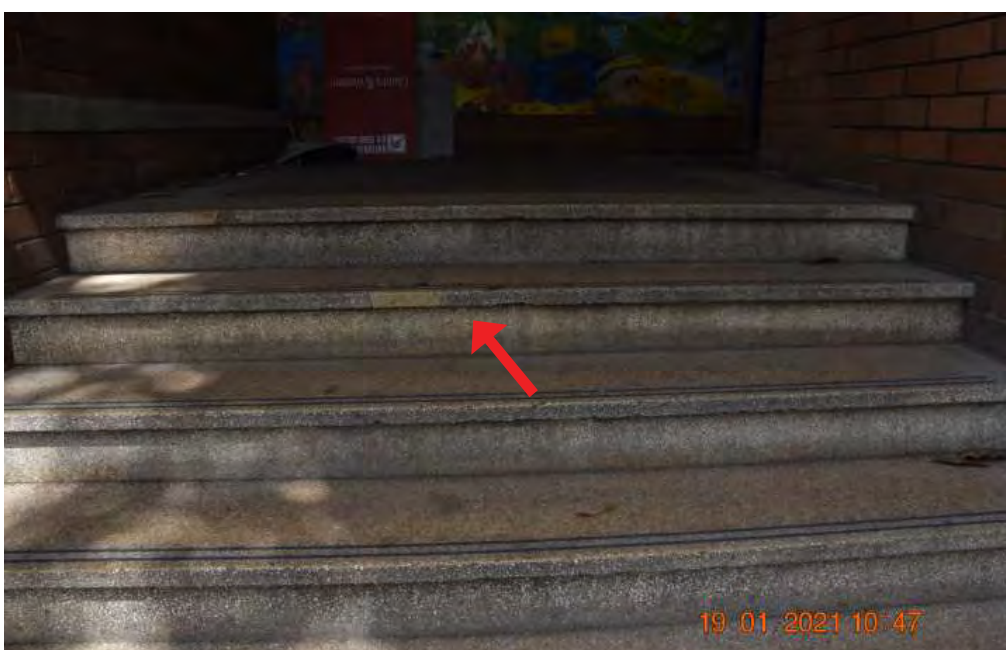
Figure: 0921

General view of the steps on the east side of building A, outside the main entrance. Showing chipping.

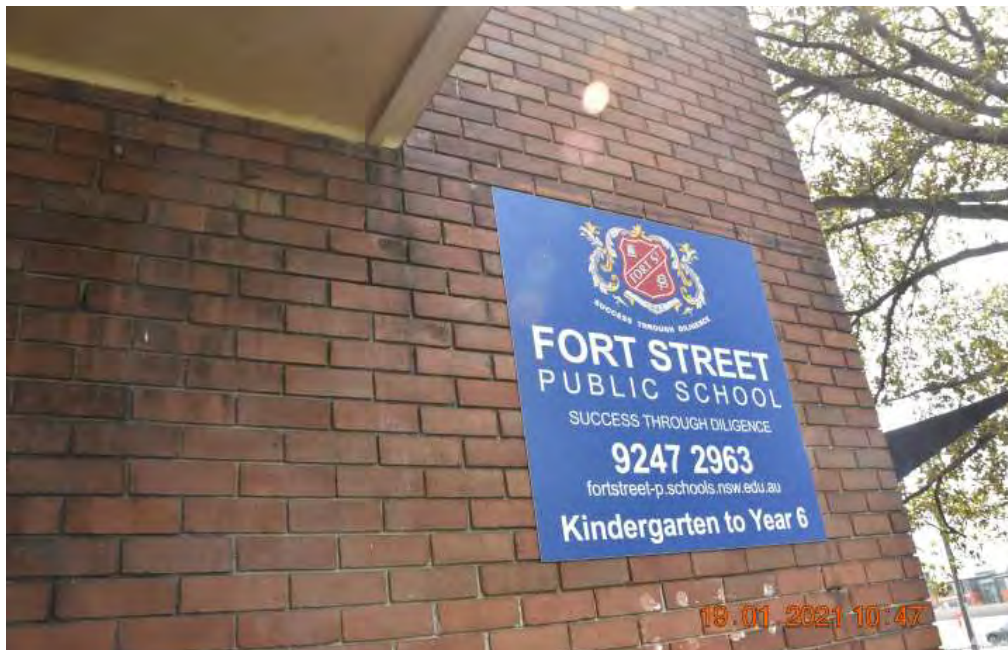
Figure: 0922

South wall of building A, outside the main entrance.

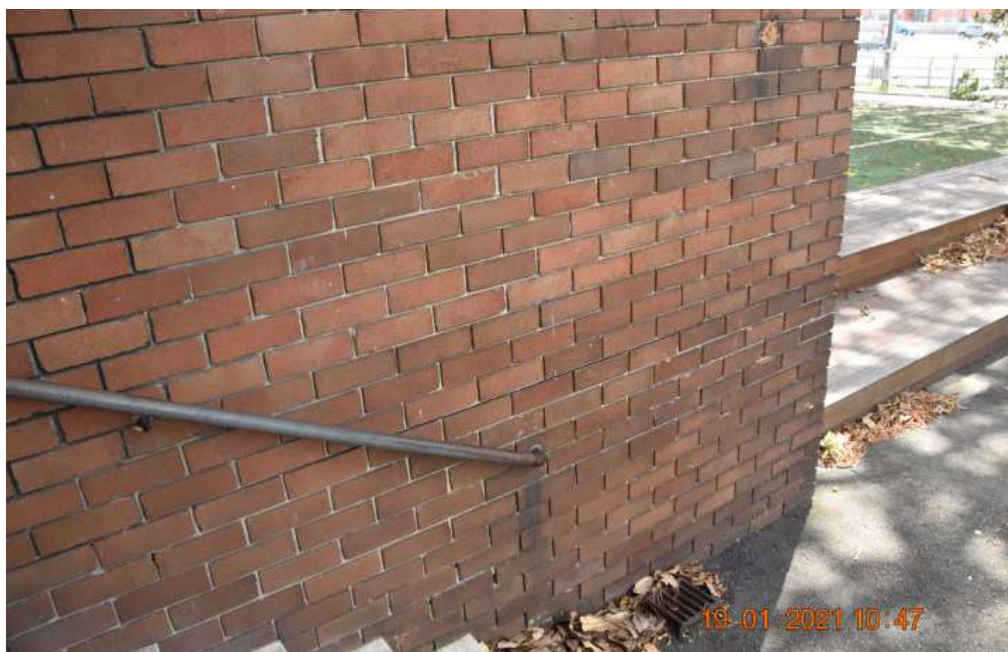
Figure: 0923

South wall of building A, outside the main entrance.

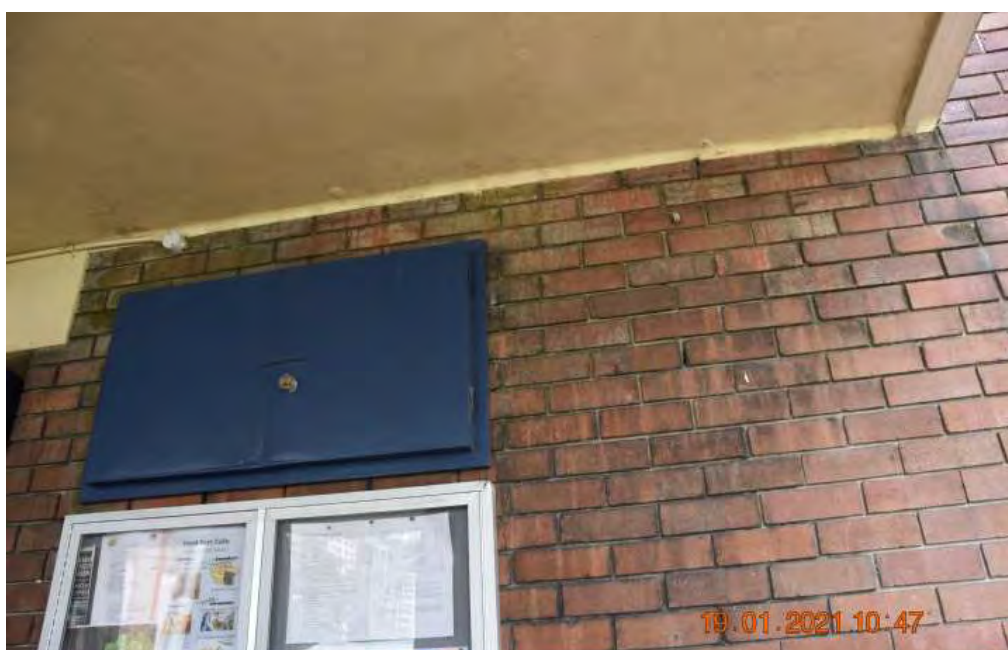
Figure: 0924

South wall of building A, outside the main entrance.

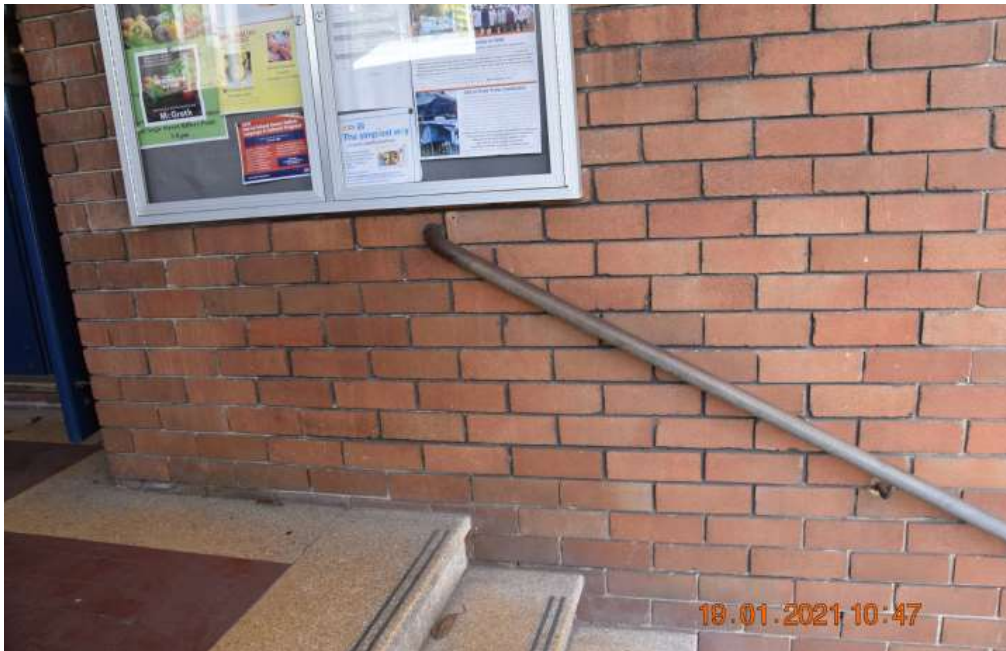
Figure: 0925

South wall of building A, outside the main entrance.

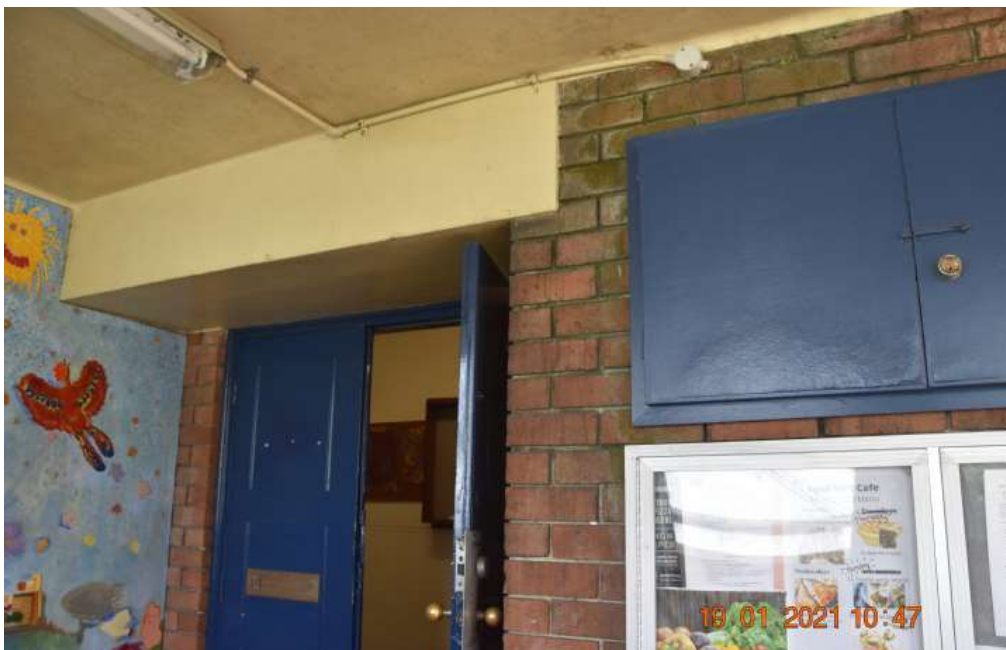
Figure: 0926

South wall of building A, outside the main entrance.

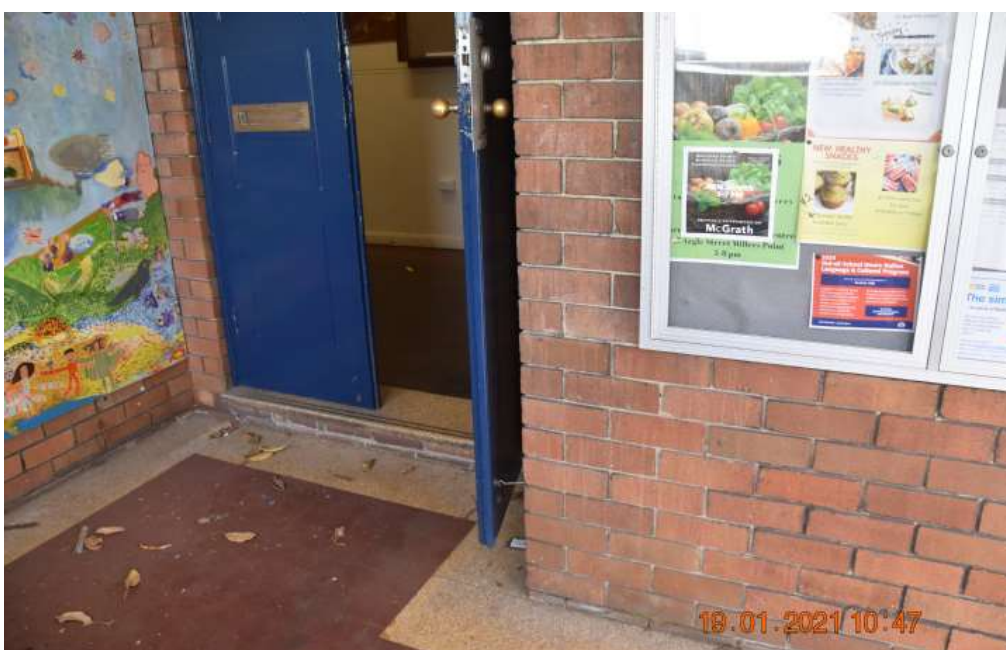
Figure: 0927

South wall of building A, outside the main entrance.

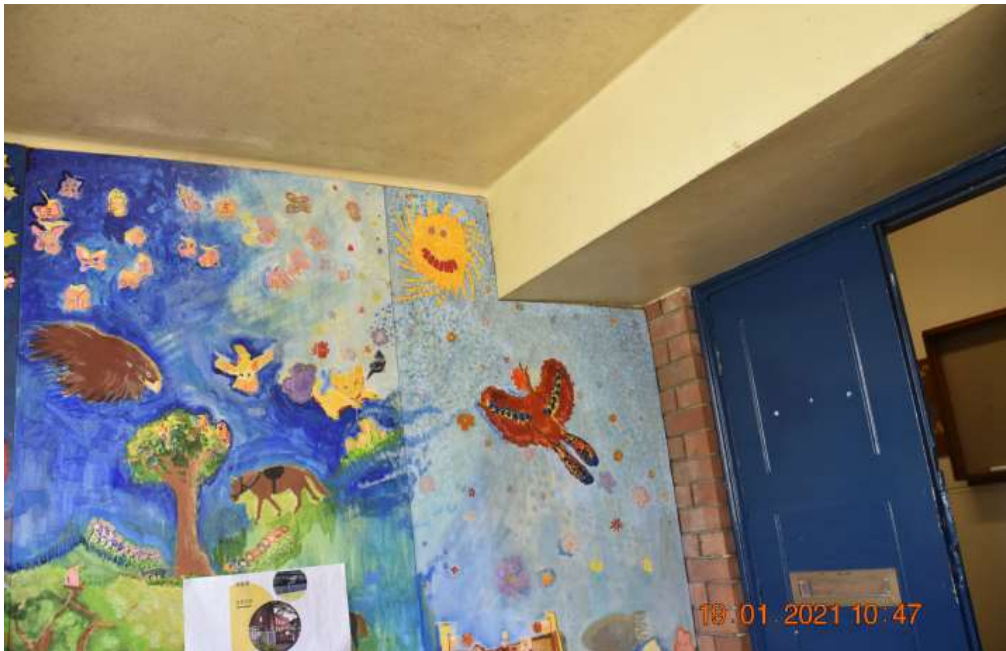
Figure: 0928

West wall of building A, outside the main entrance.

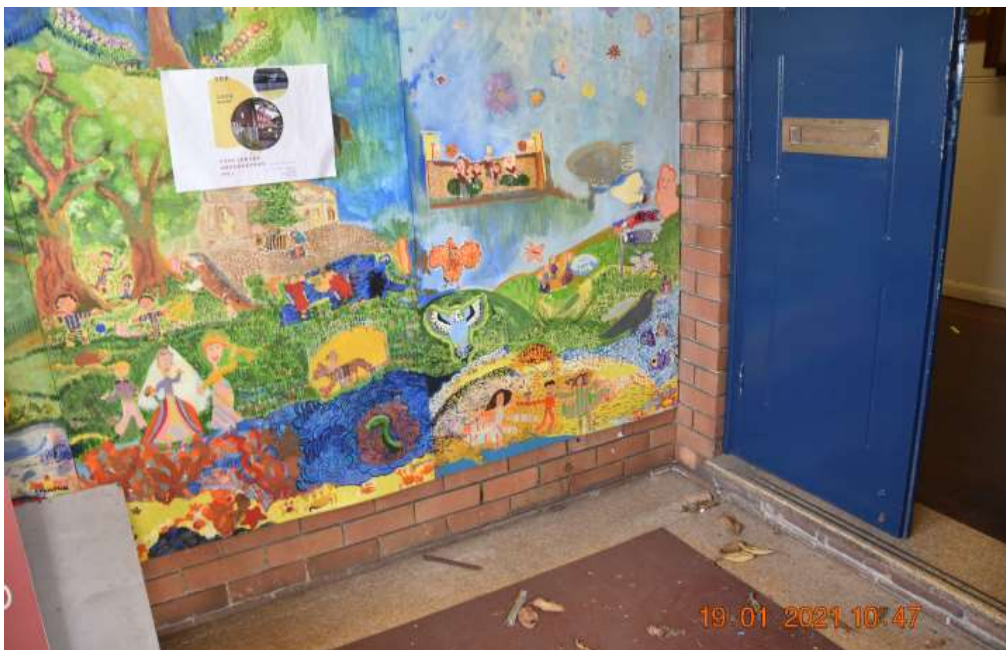
Figure: 0929

West wall of building A, outside the main entrance.

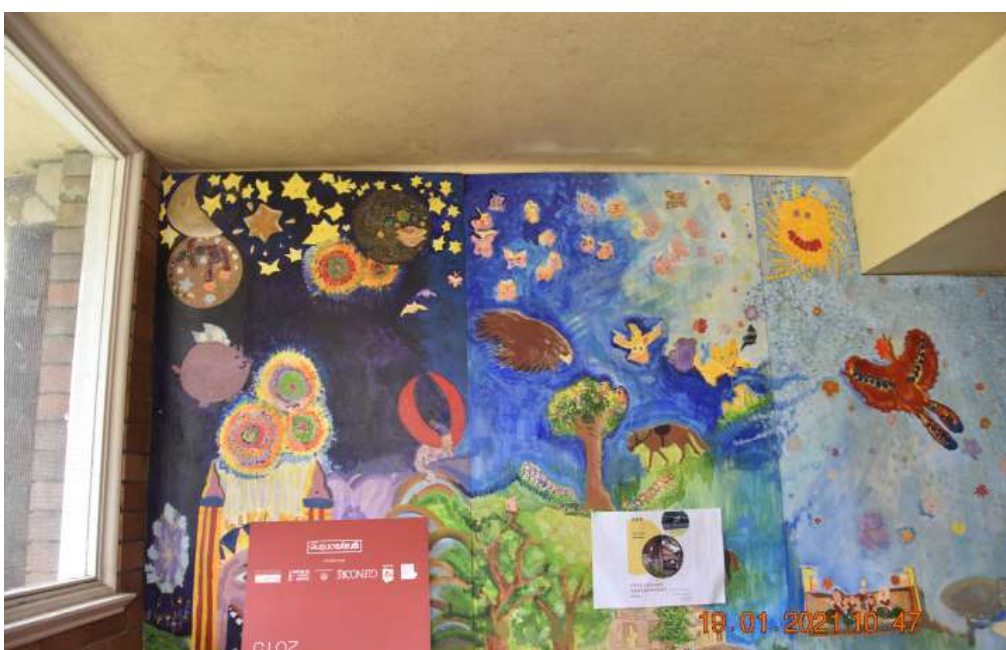
Figure: 0930

West wall of building A, outside the main entrance.

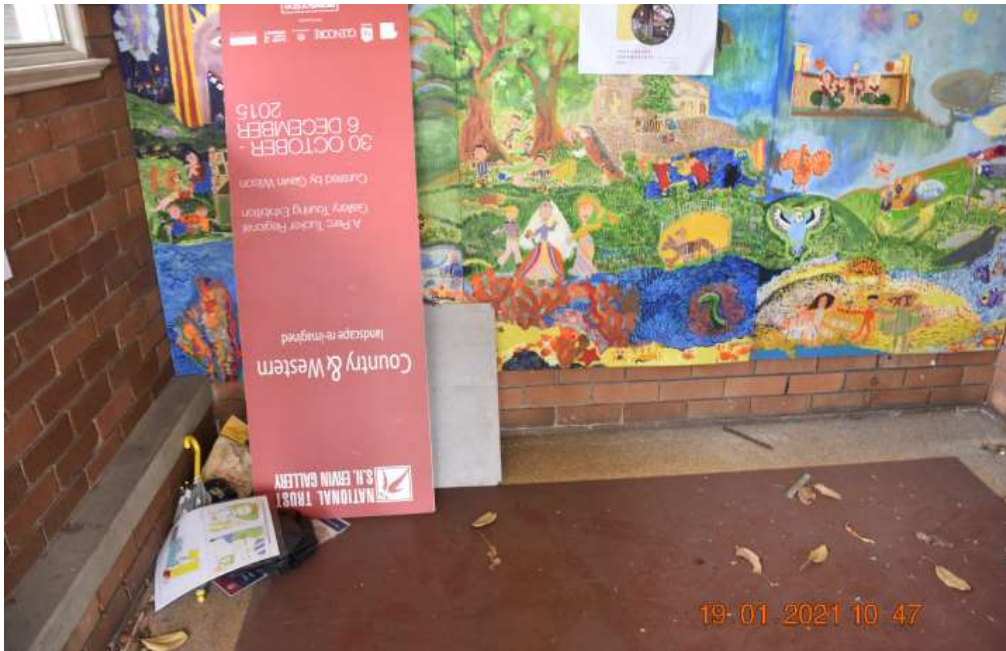
Figure: 0931

West wall of building A, outside the main entrance.

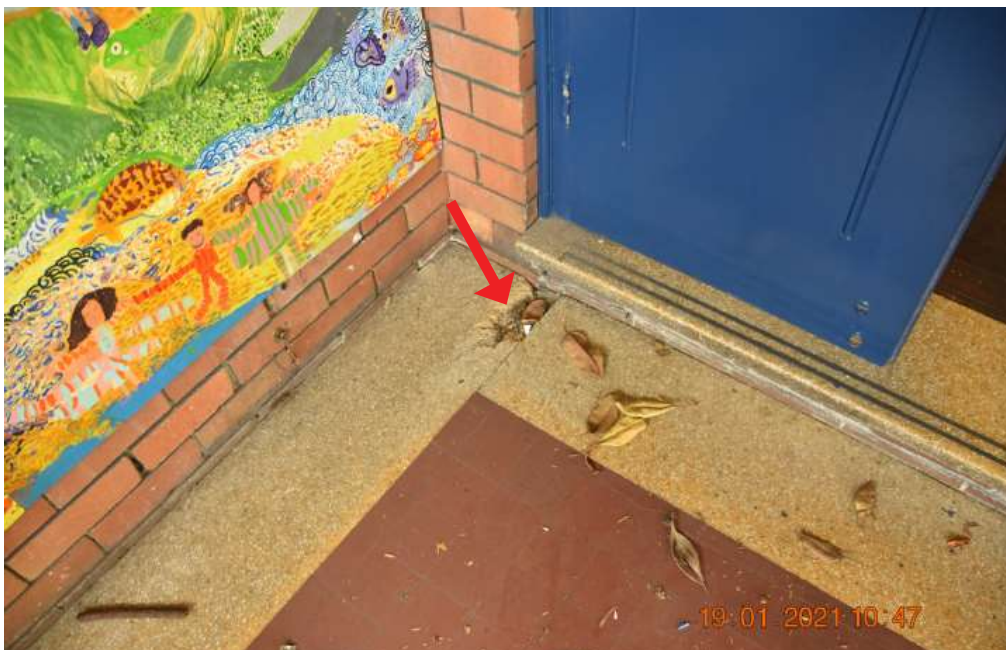
Figure: 0932

Chipping in the paving at the main entrance.

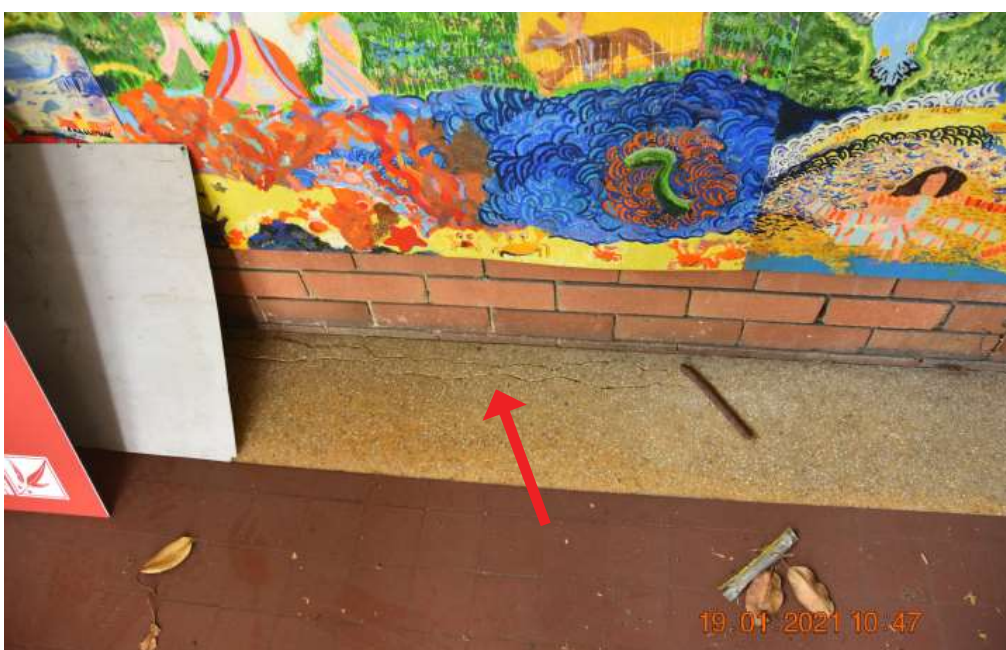
Figure: 0933

Slight cracking in the paving at the entrance.
