## PRE CONSTRUCTION CONDITION SURVEY

Fort Street Public School, Millers Point NSW

Upper Fort Street Public School  
MILLERS POINT NSW 2000

19 January 2021

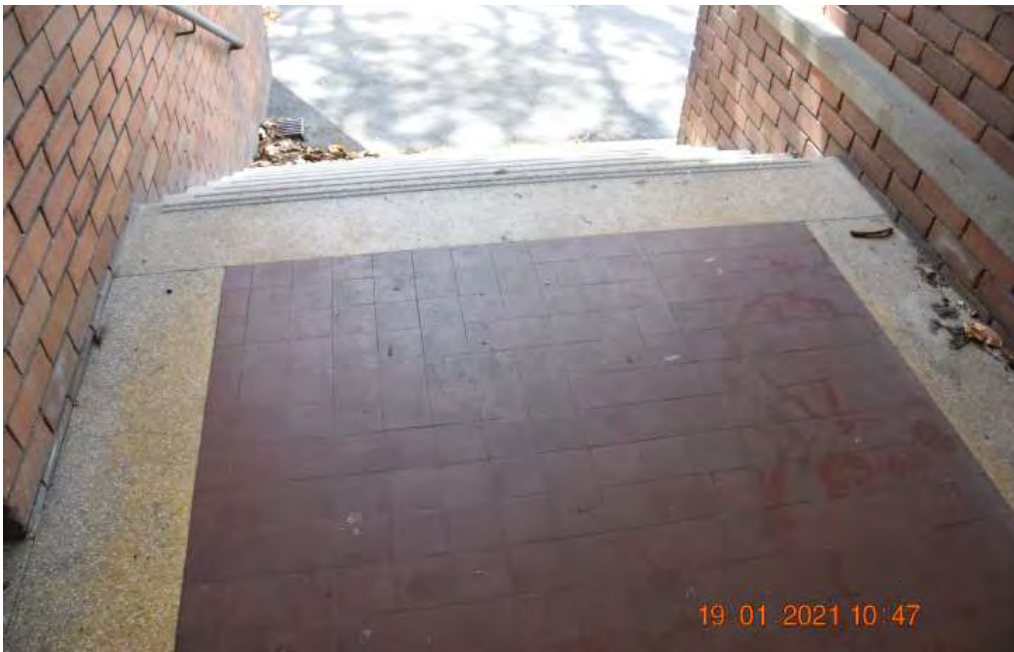
Figure: 0935

Tile paving at the main entrance.

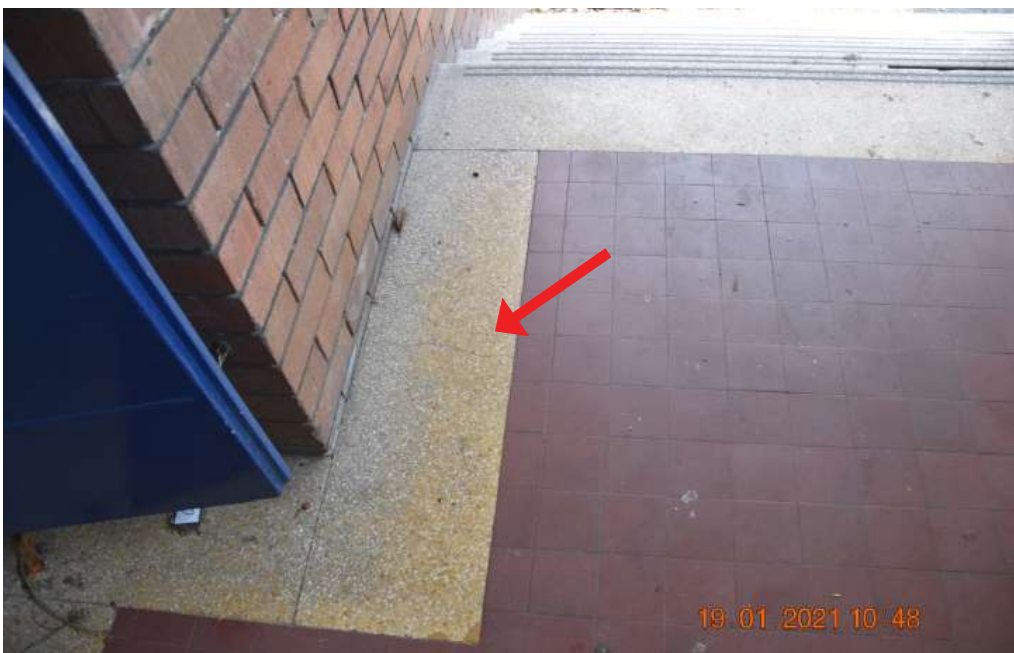
Figure: 0936

Tile paving at the main entrance.  
Showing cracking.

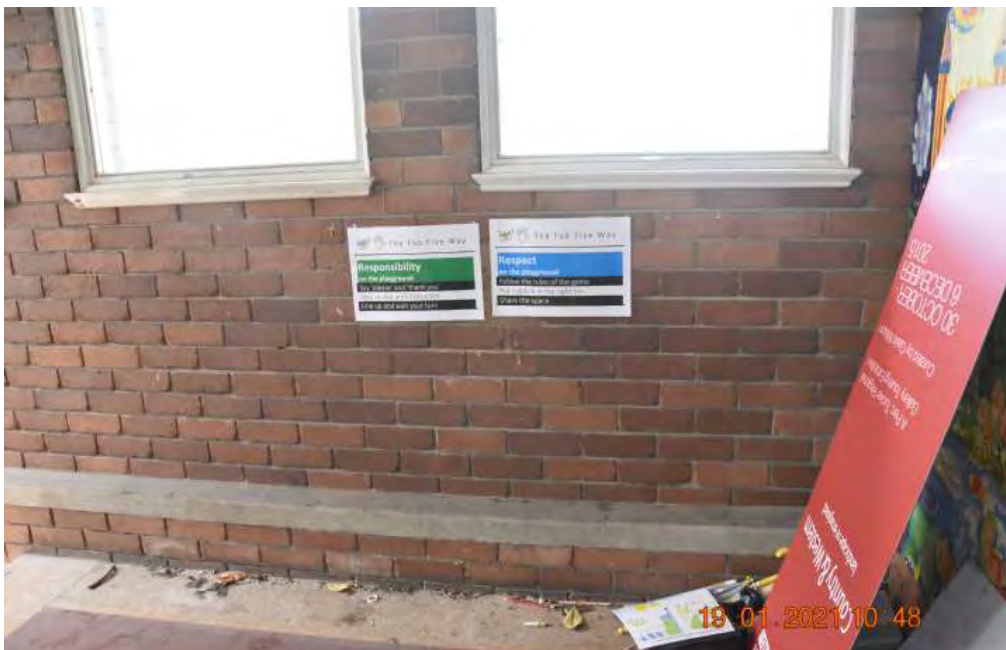
Figure: 0938

South wall at the main entrance.

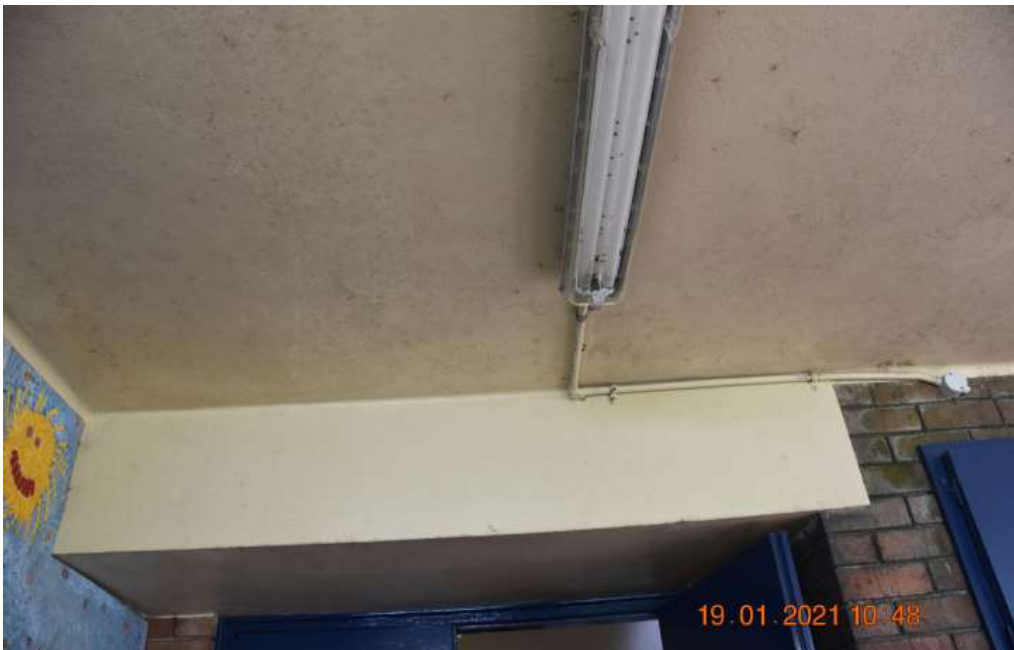
Figure: 0940

Ceiling at the main entrance.

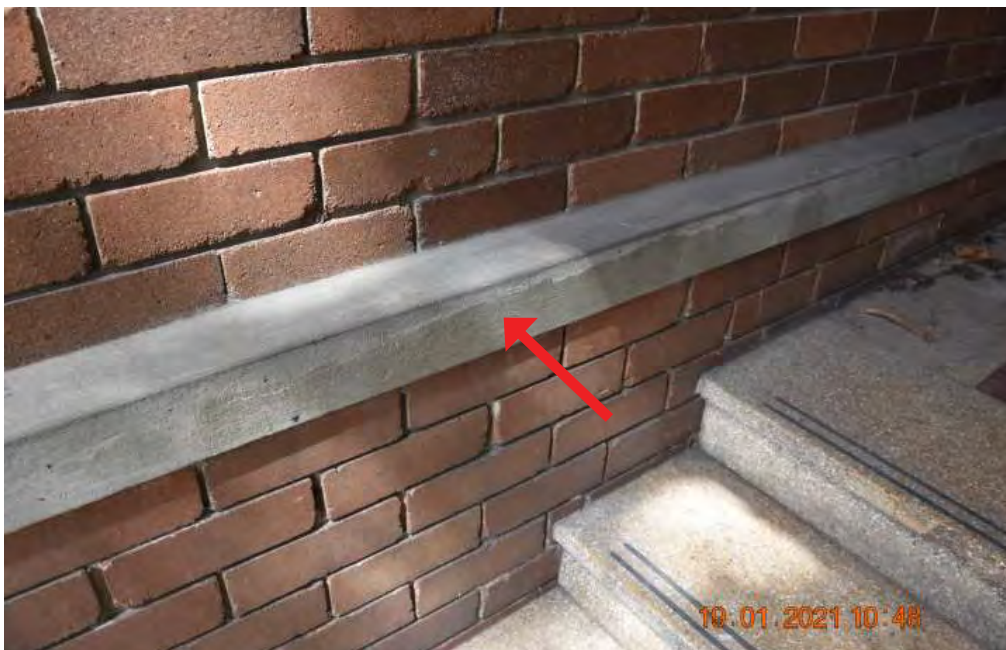
Figure: 0943

Cracking in the south wall at the entrance.

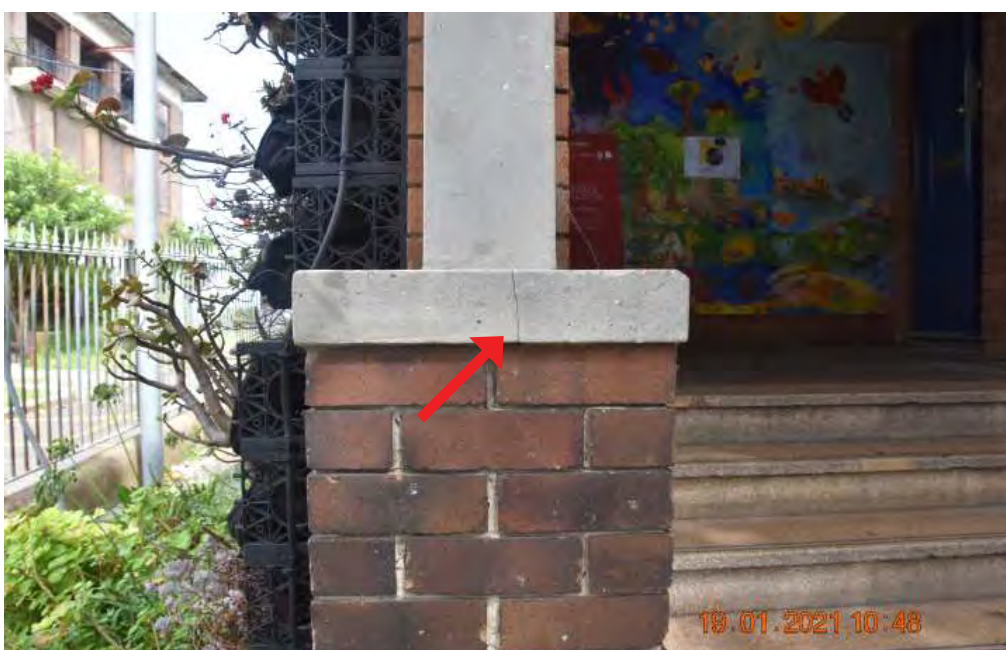
Figure: 0944

Cracking in the south wall at the entrance.

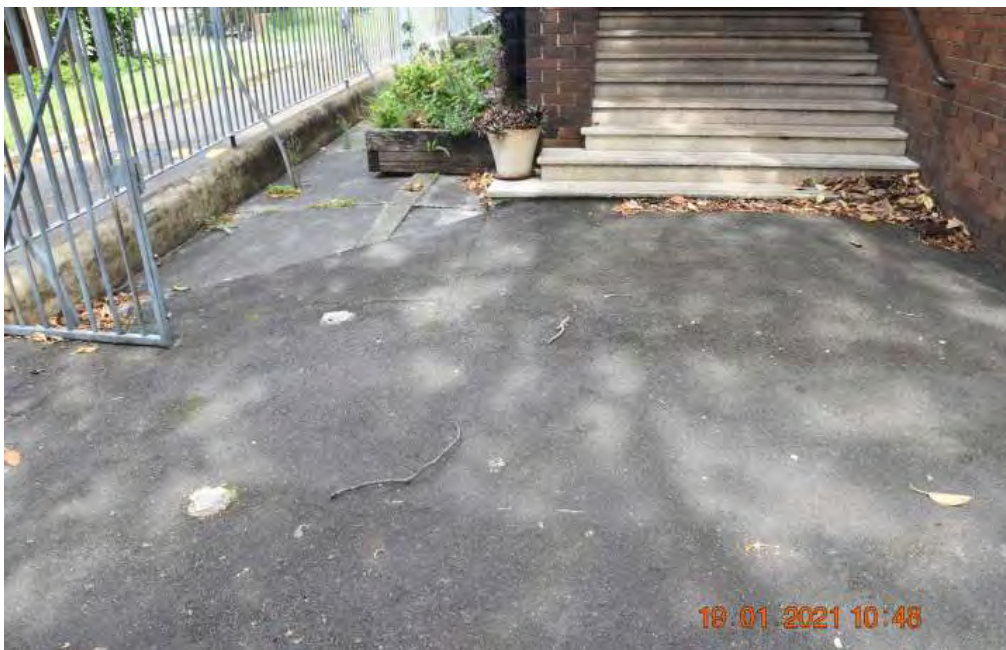
Figure: 0946

Paving at the southeast corner of building A.

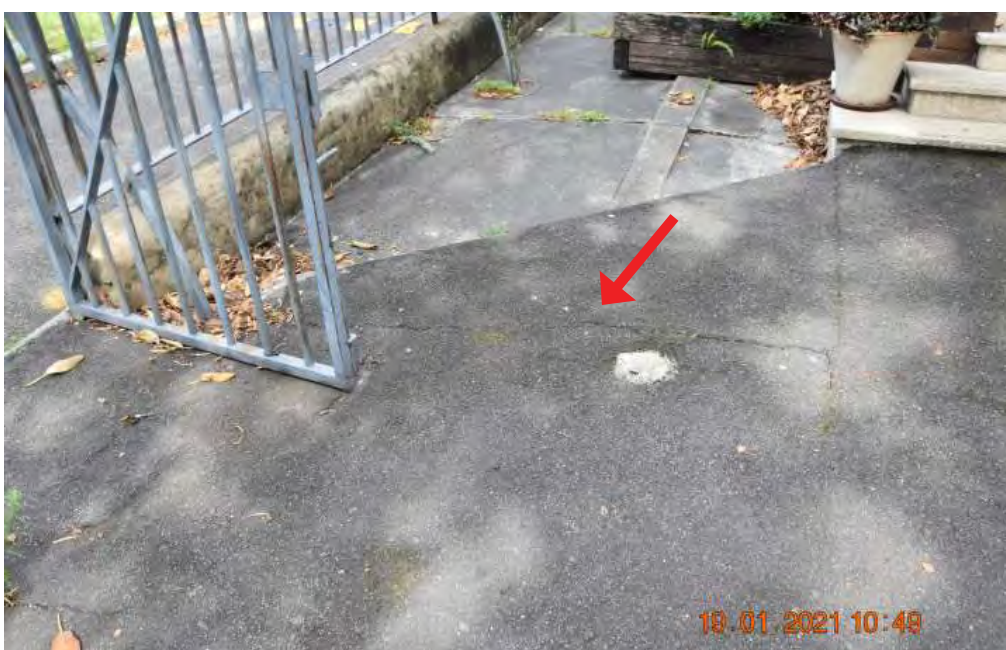
Figure: 0947

Paving at the southeast corner of building A.

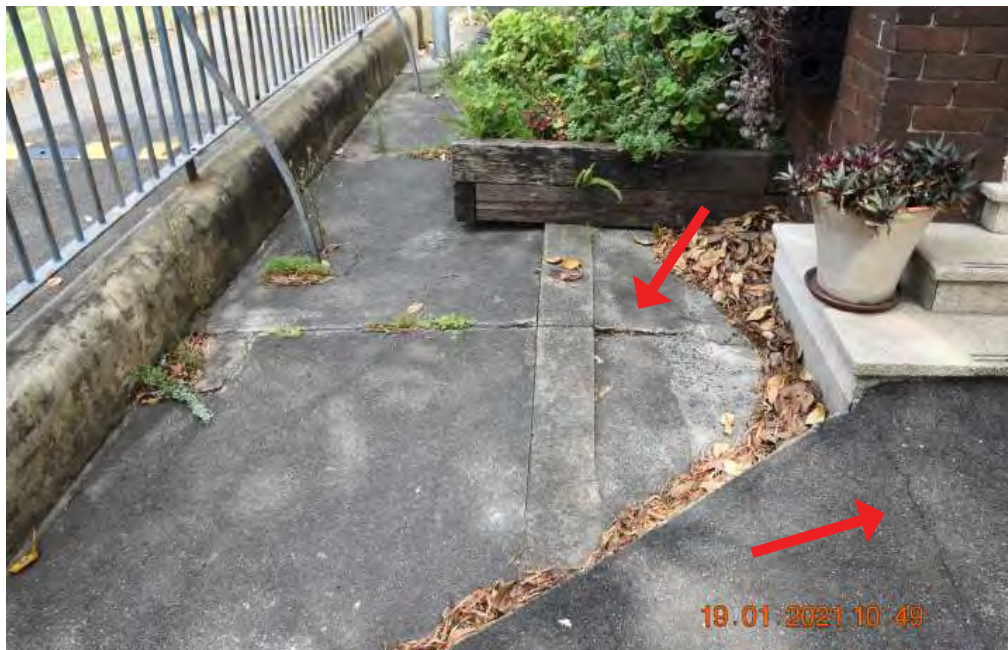
Figure: 0948

Cracking in the paving at the southeast corner of building A.

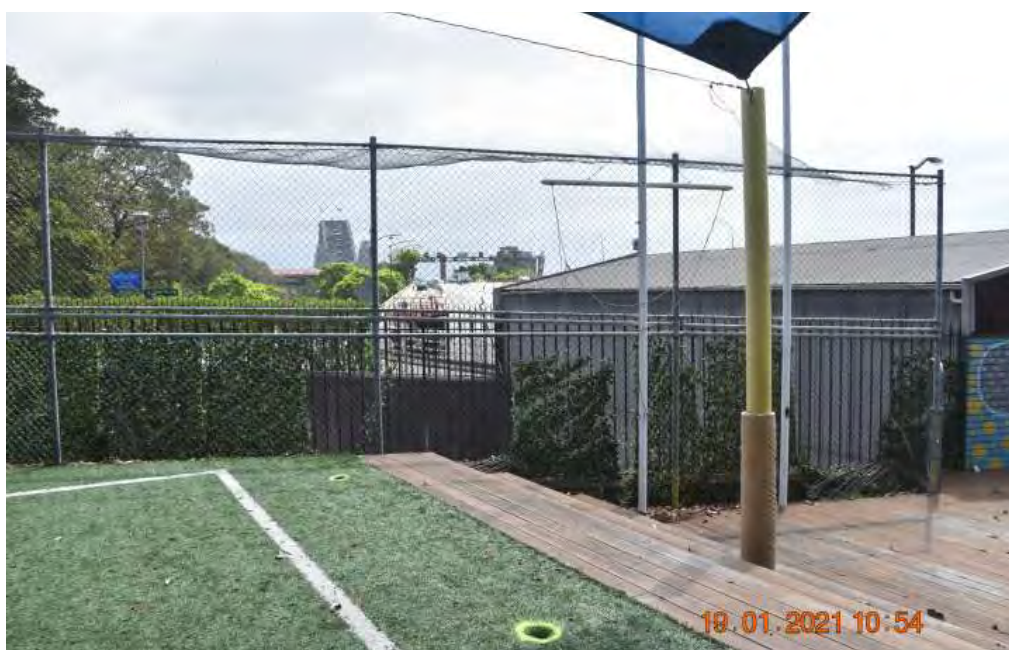
Figure: 0977

General view of the fence on the north side of the playground.

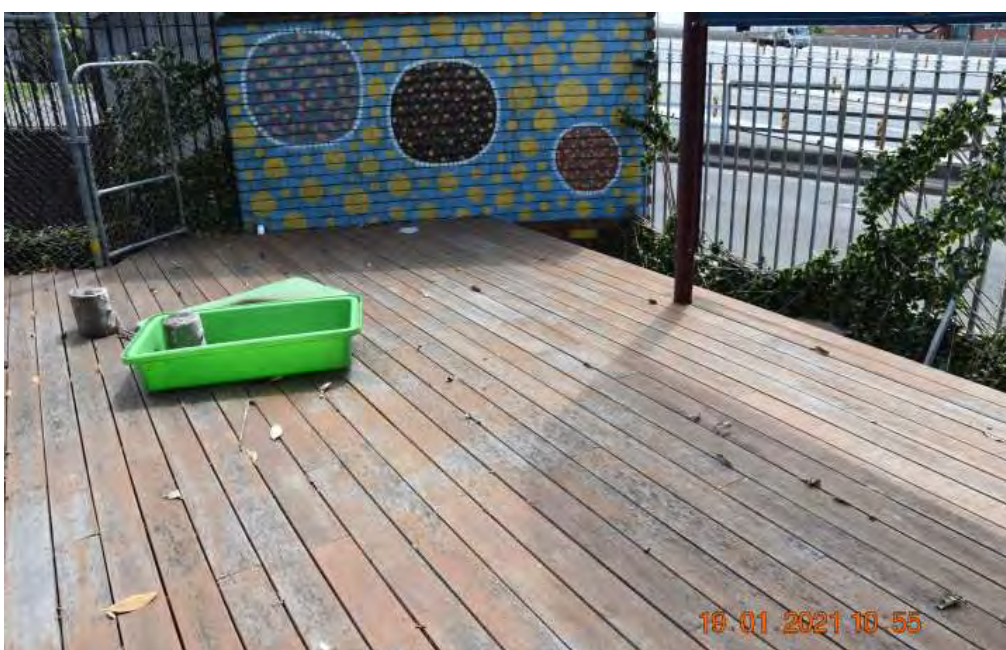
Figure: 0980

General view of the timber deck on the east side of the property. Showing damage.

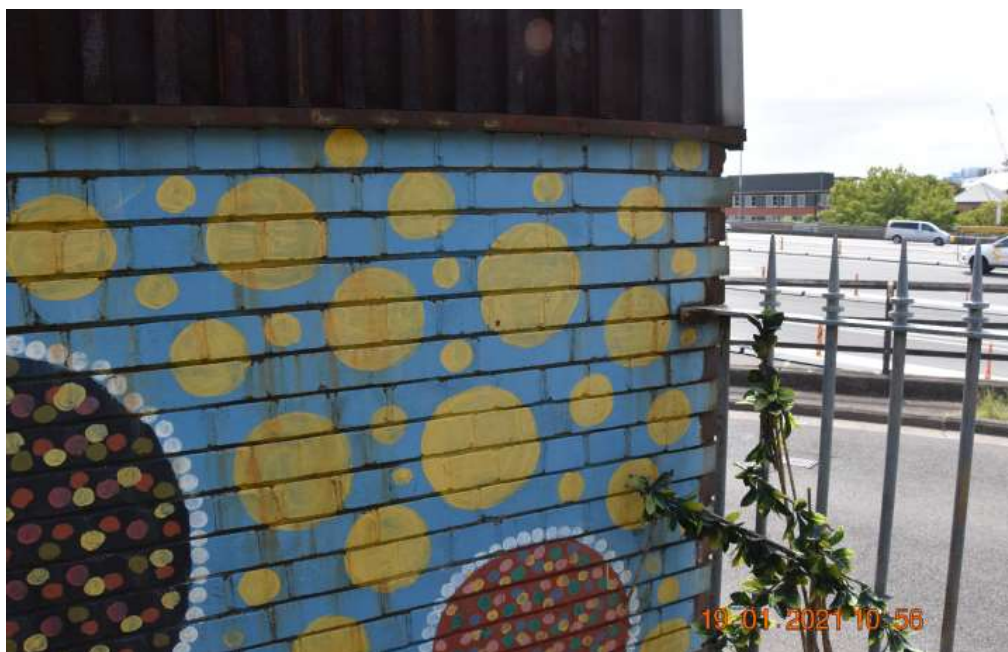
Figure: 0994

Rusting in the south wall of the ventilation shed.

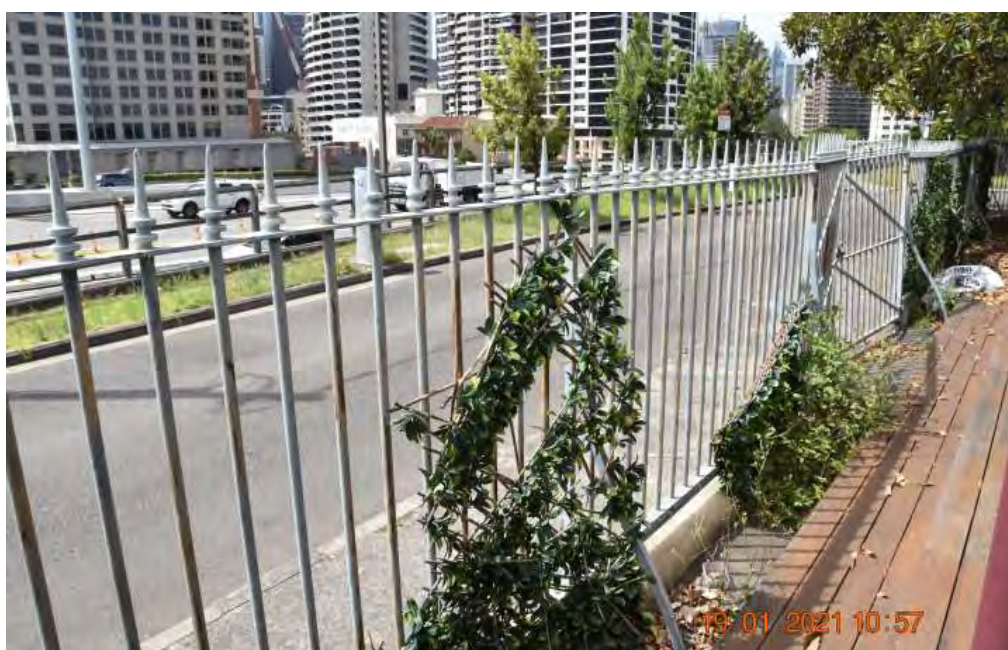
Figure: 0998

Missing top in the fence on the east side of the property.

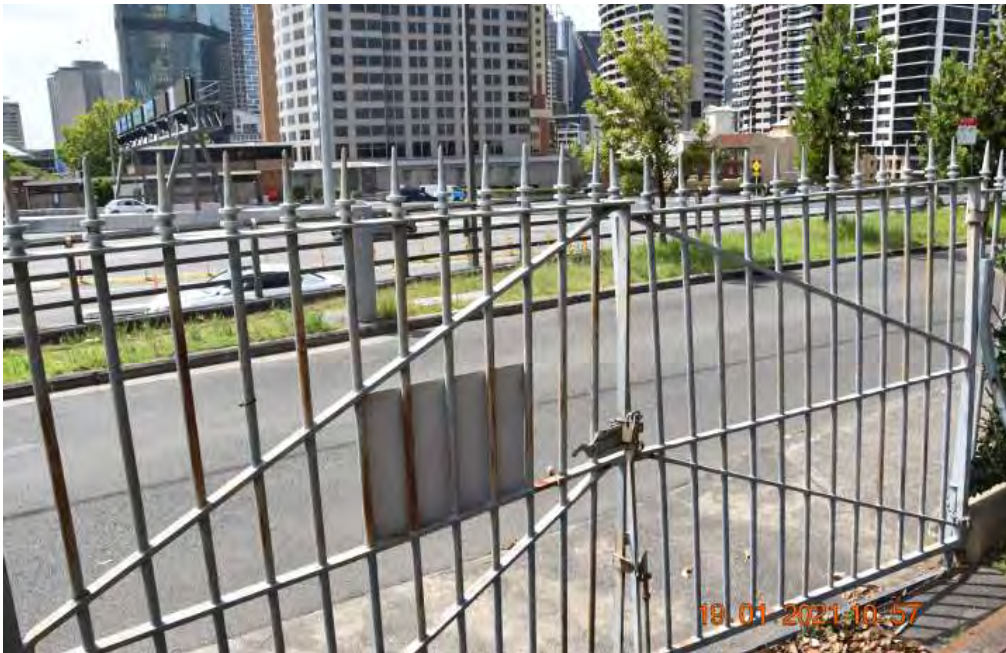
Figure: 1002

General view of the gate on the east side of the property. Showing rusting.

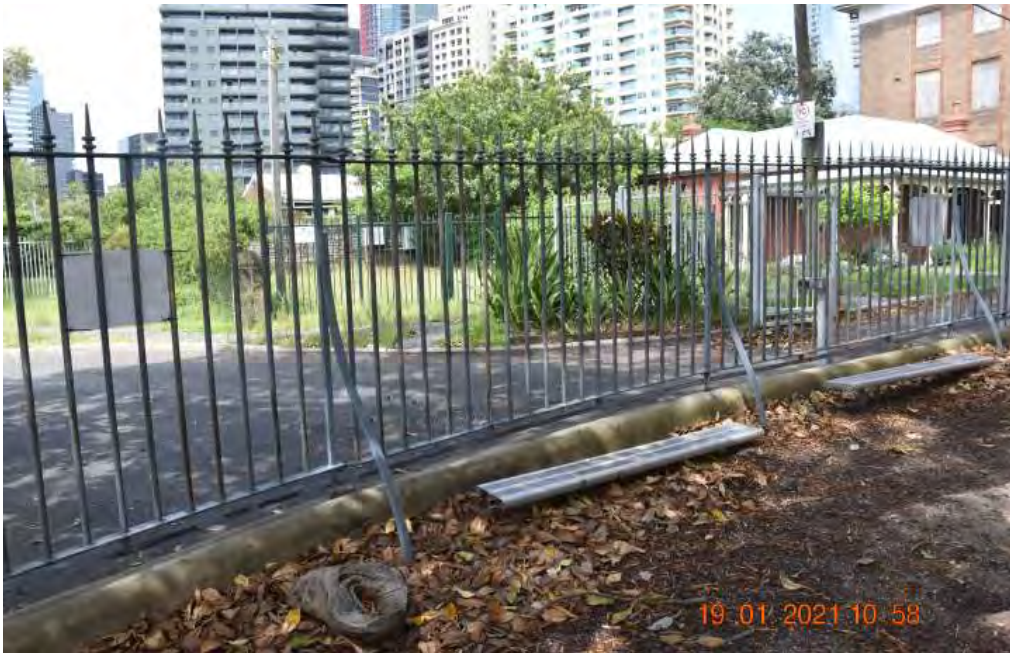
Figure: 1021

Fence on the south side of building A, east side.

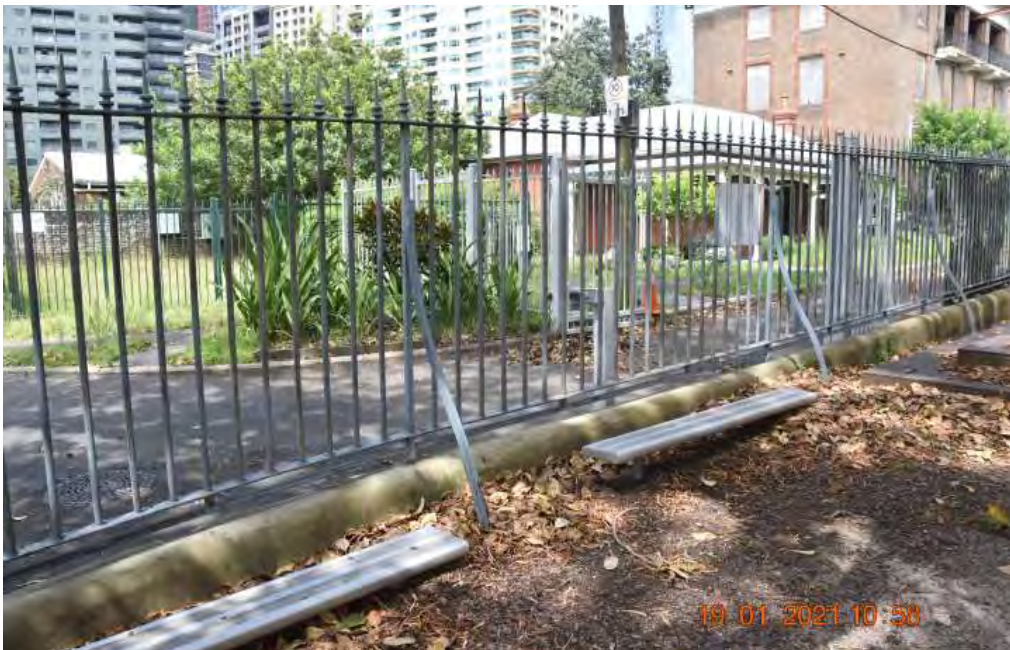
Figure: 1022

Fence on the south side of building A, east side.

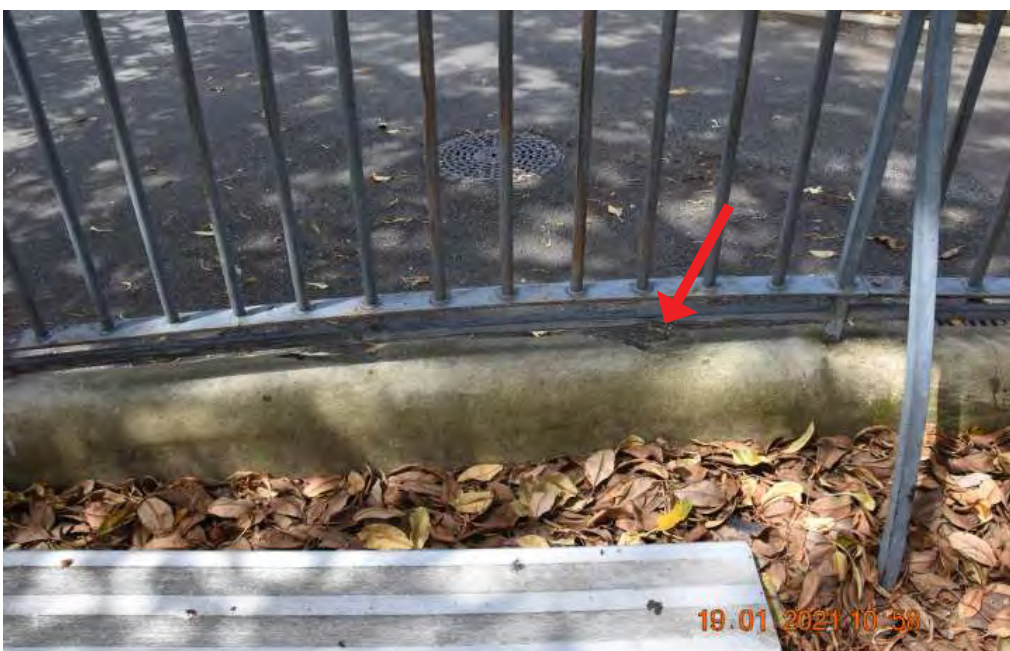
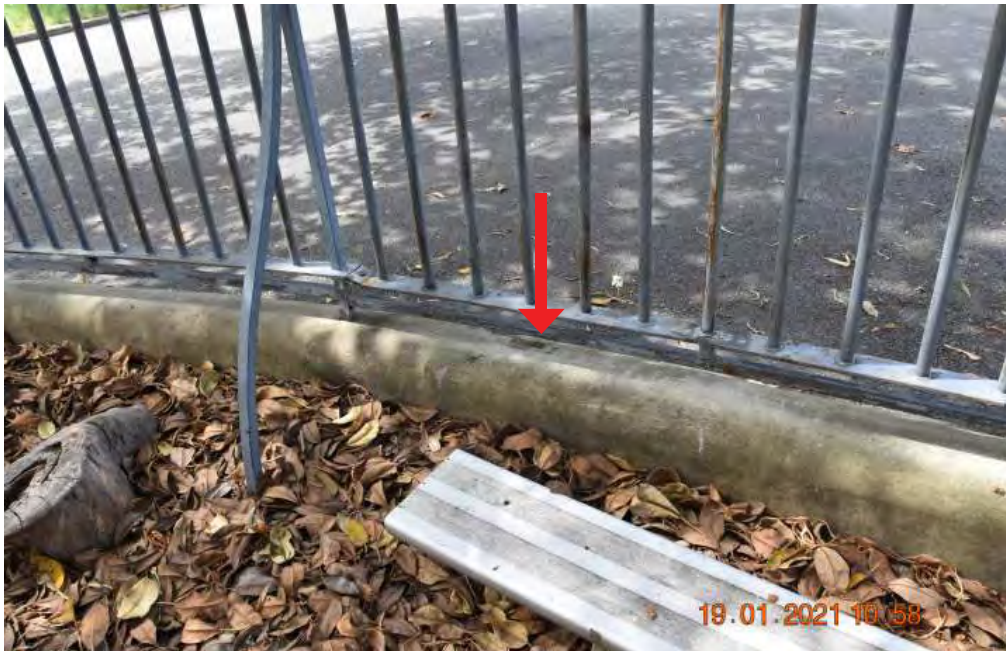
Figure: 1023

Chipping in the base of the fence on the south side of building A, east side.

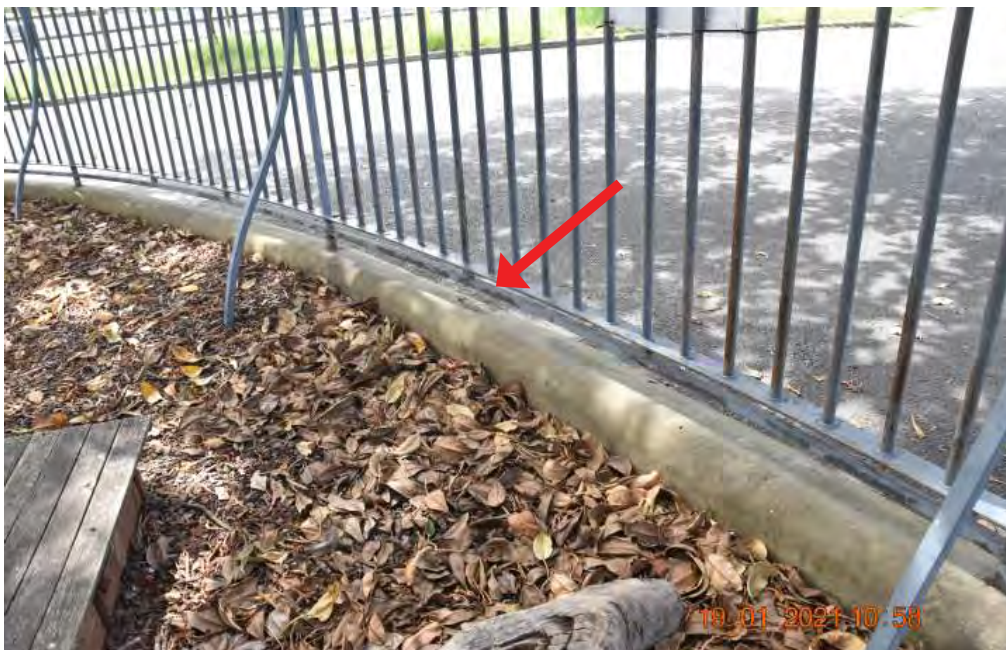
Figure: 1024

Chipping in the fence on the south side of building A, east side.

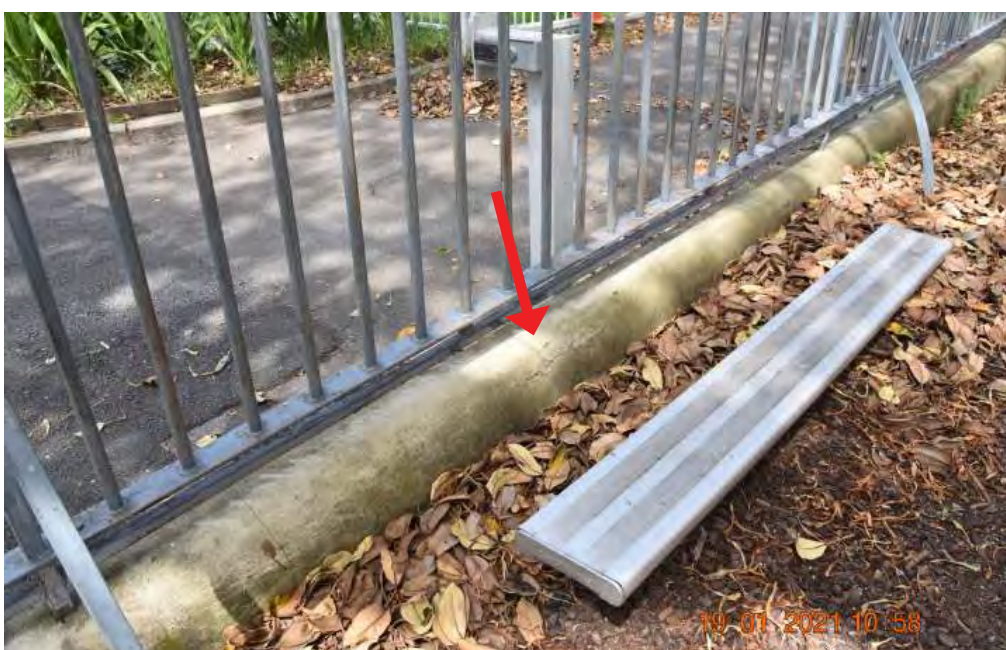
Figure: 1025

Chipping in the fence on the south side of building A, east side.

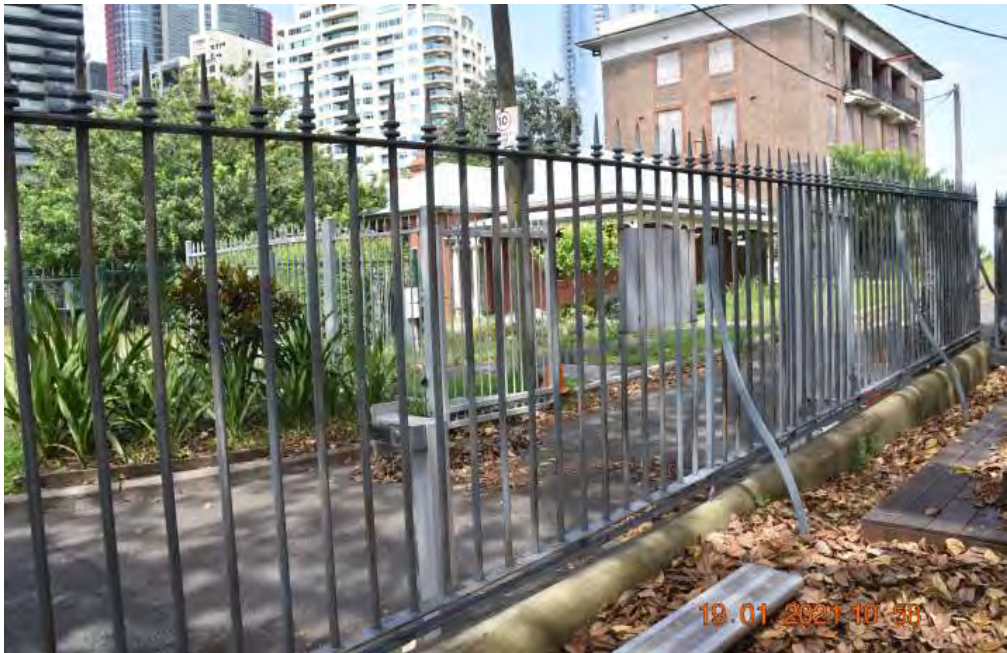
Figure: 1026

Cracking in the fence on the south side of building A, east side.

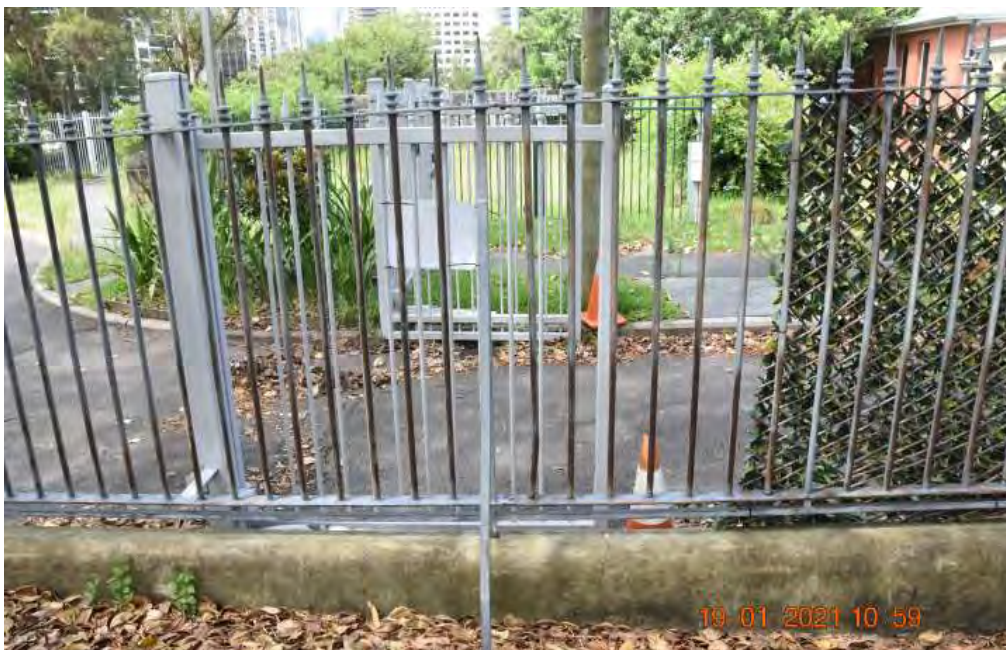
Figure: 1030

Cracking in the base of the fence on the south side of building A.

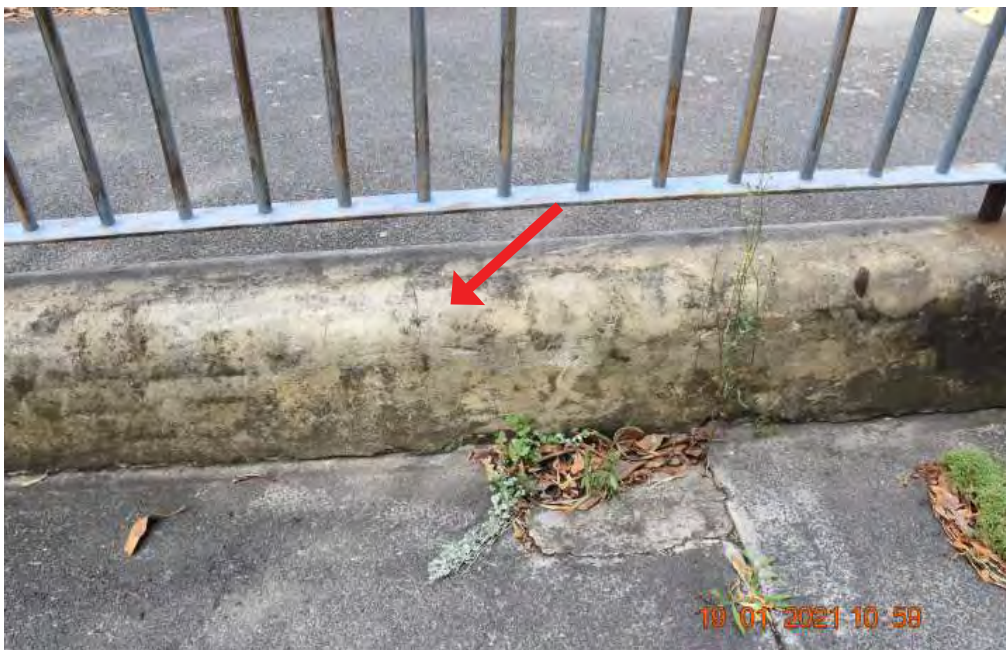
Figure: 1042

Cracking in the base of the fence on the south side of building A.

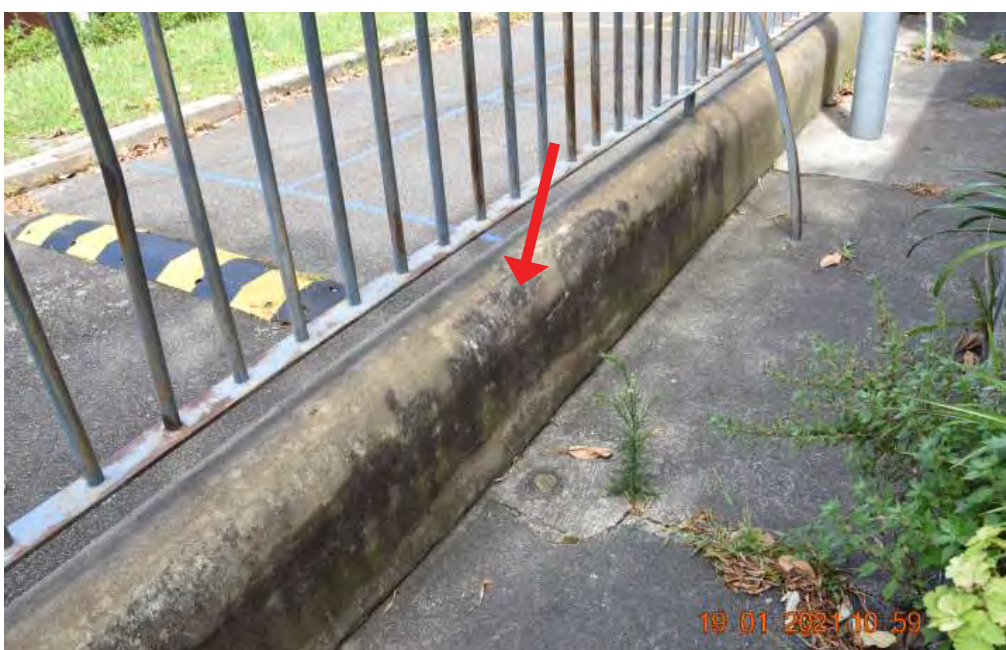
Figure: 1043

Cracking in the base of the fence on the south side of building A.

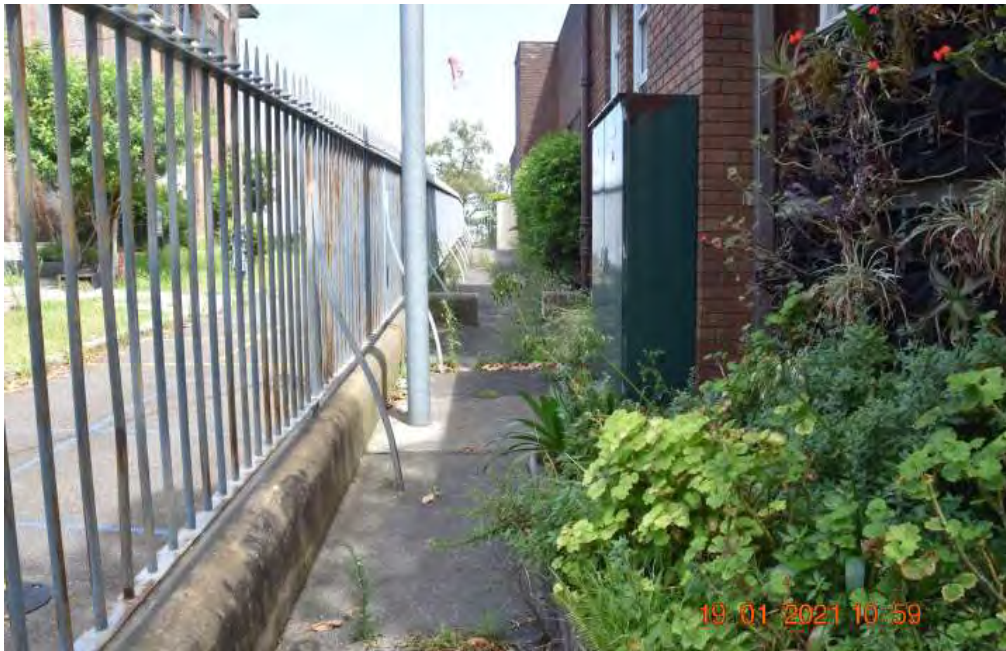
Figure: 1044

Cracking in the base of the fence on the south side of building A.

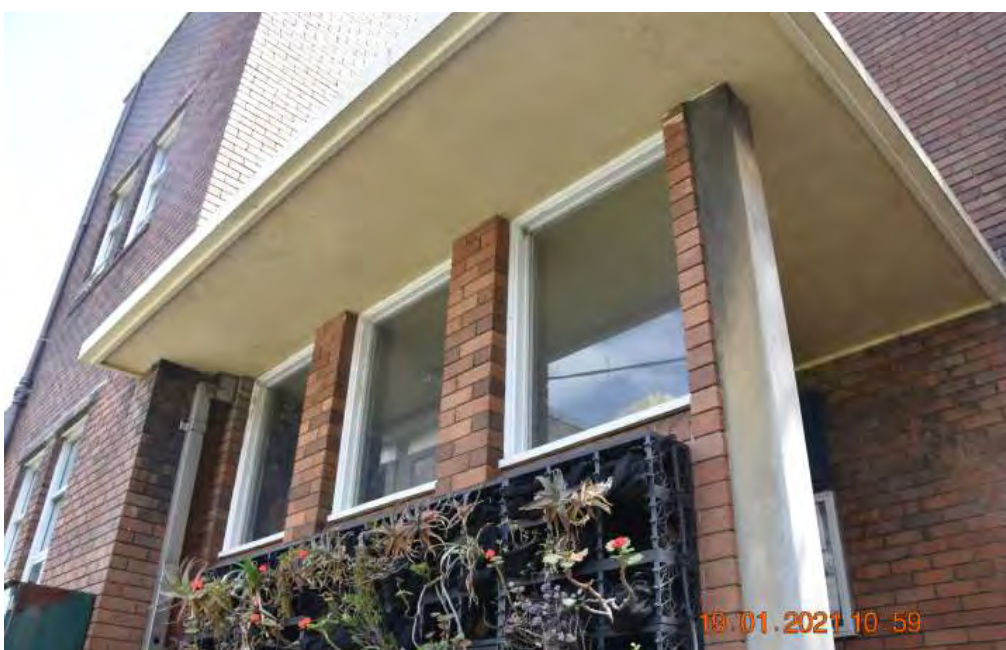
Figure: 1046

Subsidence in the paving on the south side of building A.

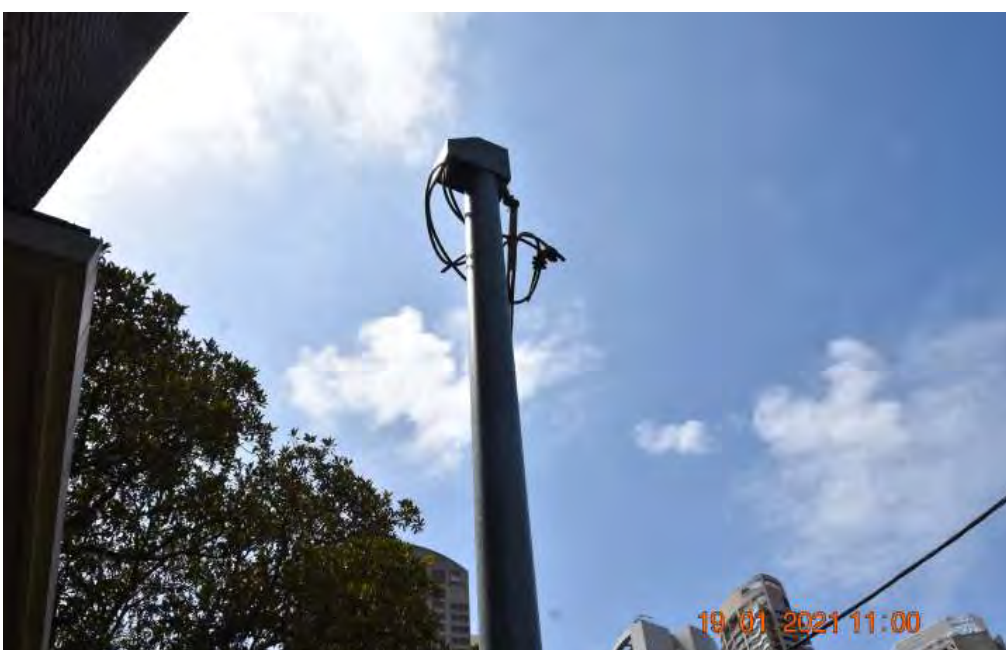
Figure: 1058

Fence on the south side of building A. Showing cracking in the base.

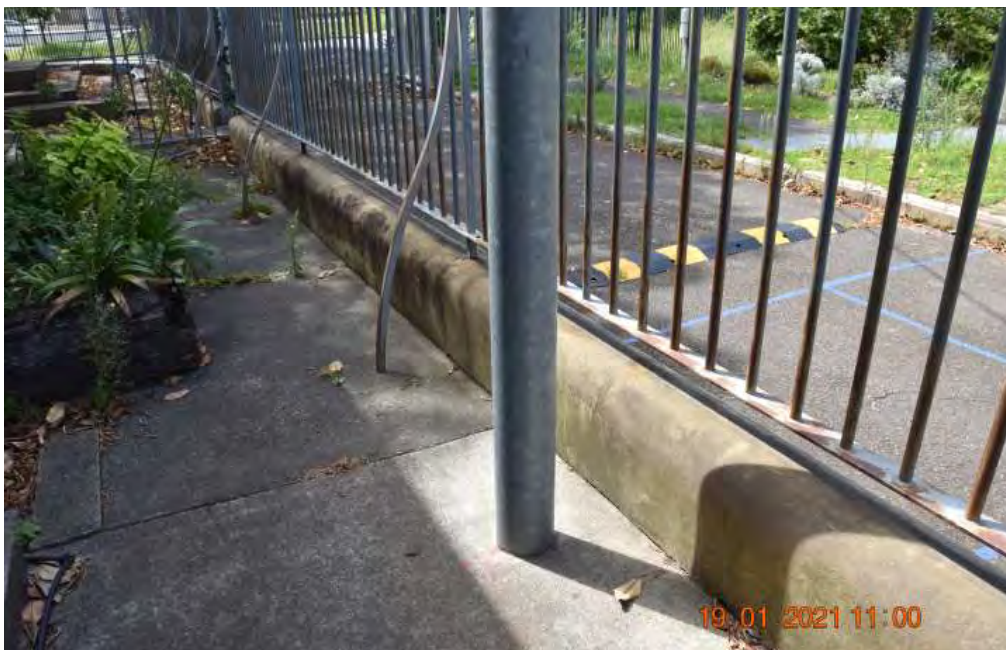
Figure: 1060

General view of the power pole on the south side of building A.

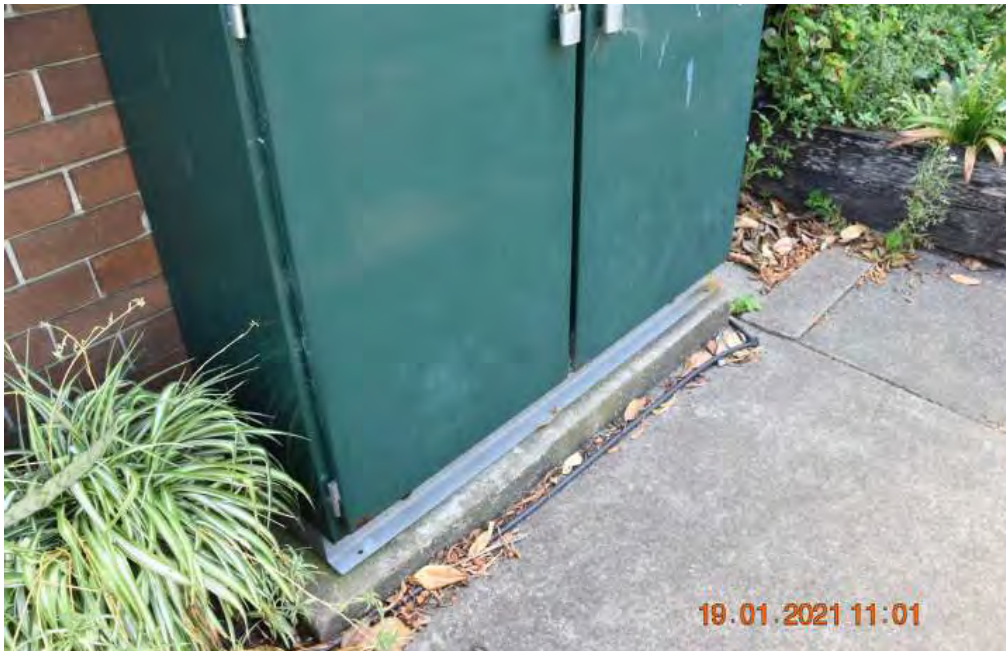
Figure: 1062

General view of the main switchboard on the south side of building A.

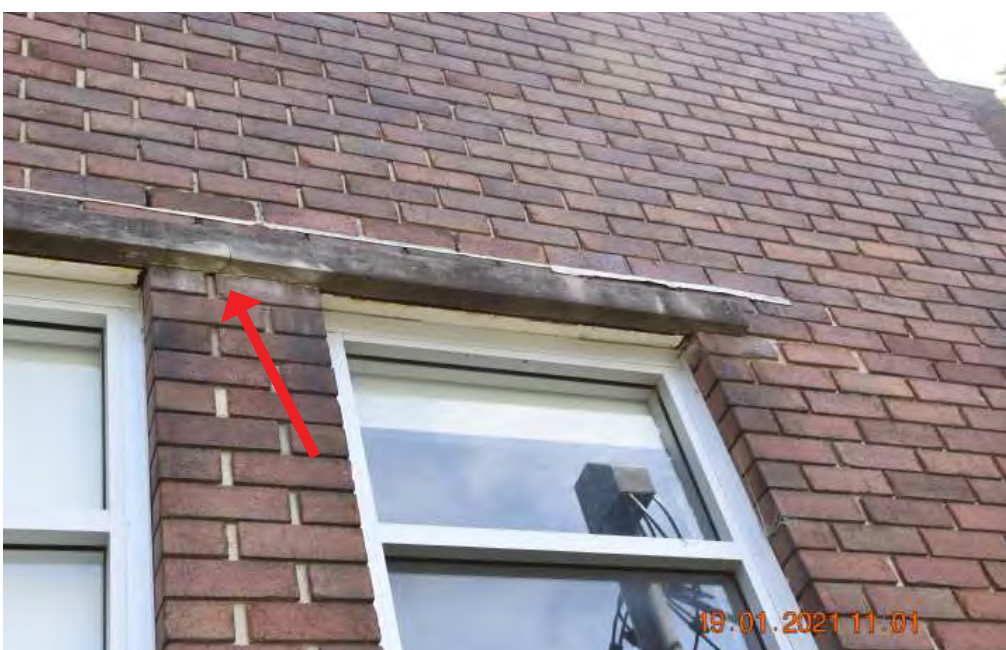
Figure: 1067

Damage above the window in the south wall of building A.

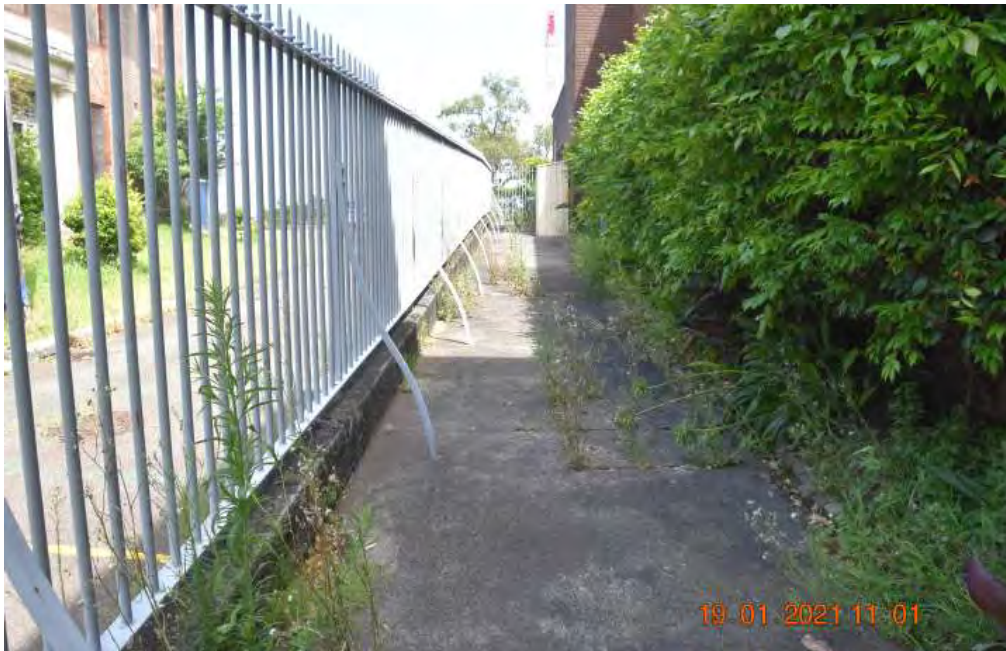
Figure: 1068

South wall of building A. Showing cracking above the window.

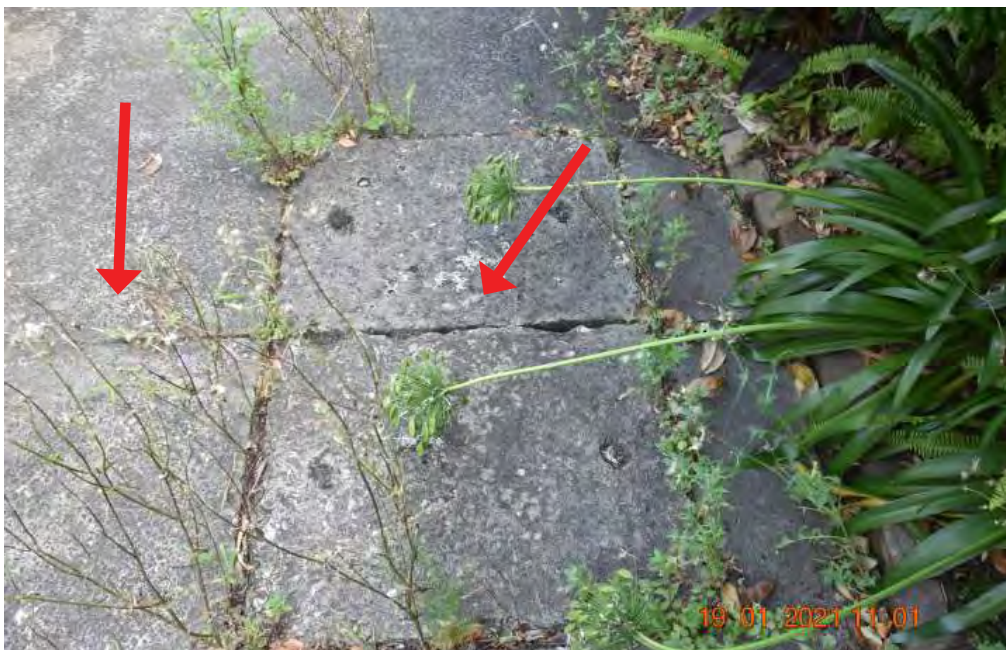
Figure: 1075

Cracking in the paving on the south side of building A.

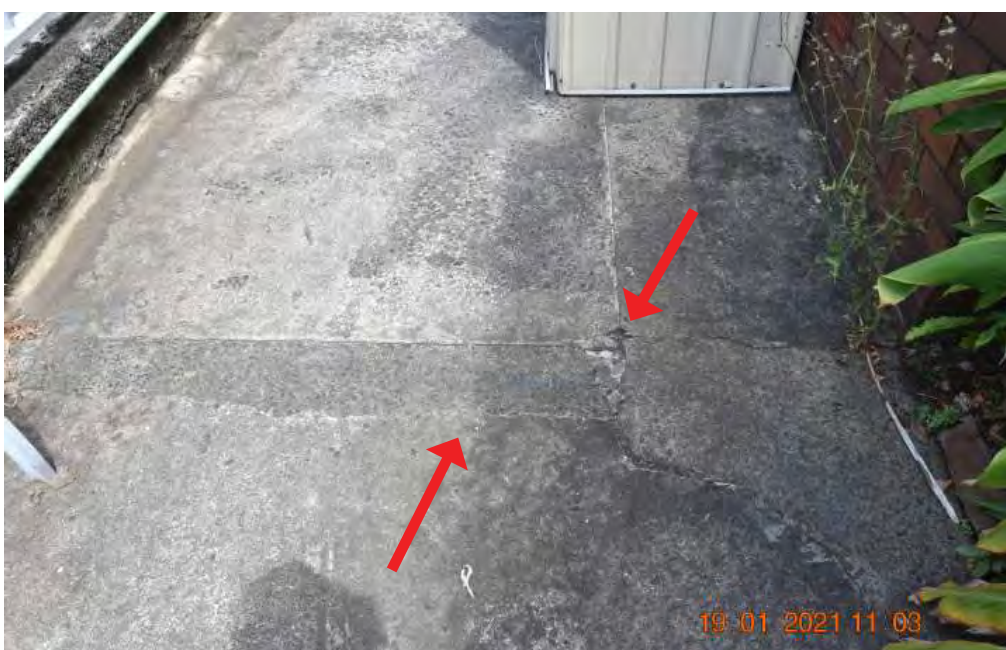
Figure: 1100

Paving on the south side of building A.

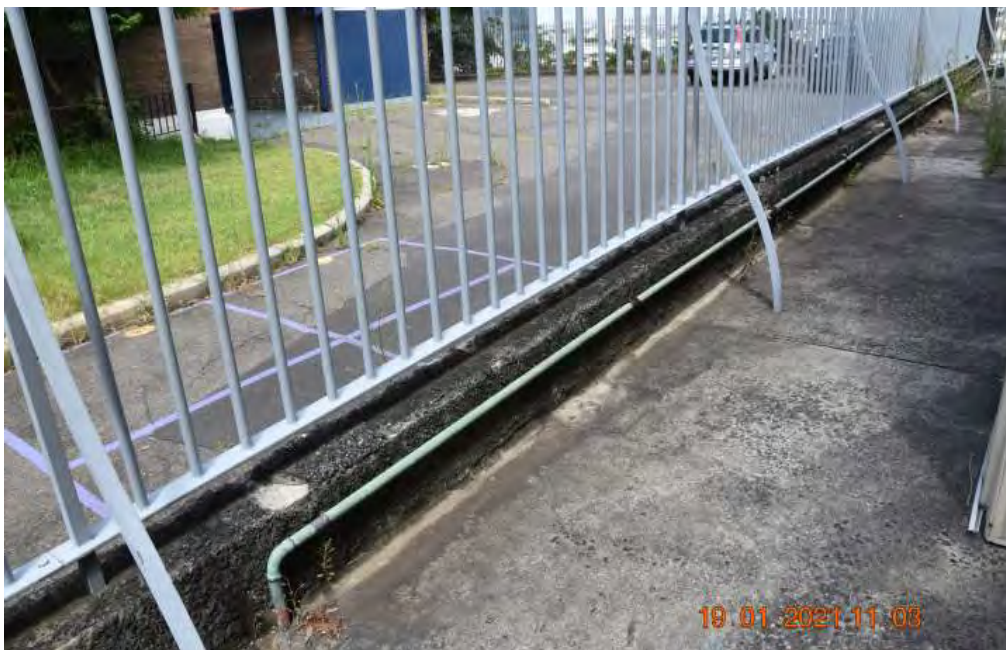
Figure: 1102

Fence on the south side of building A.
