## PRE CONSTRUCTION CONDITION SURVEY

Fort Street Public School, Millers Point NSW

Upper Fort Street Public School  
MILLERS POINT NSW 2000

19 January 2021

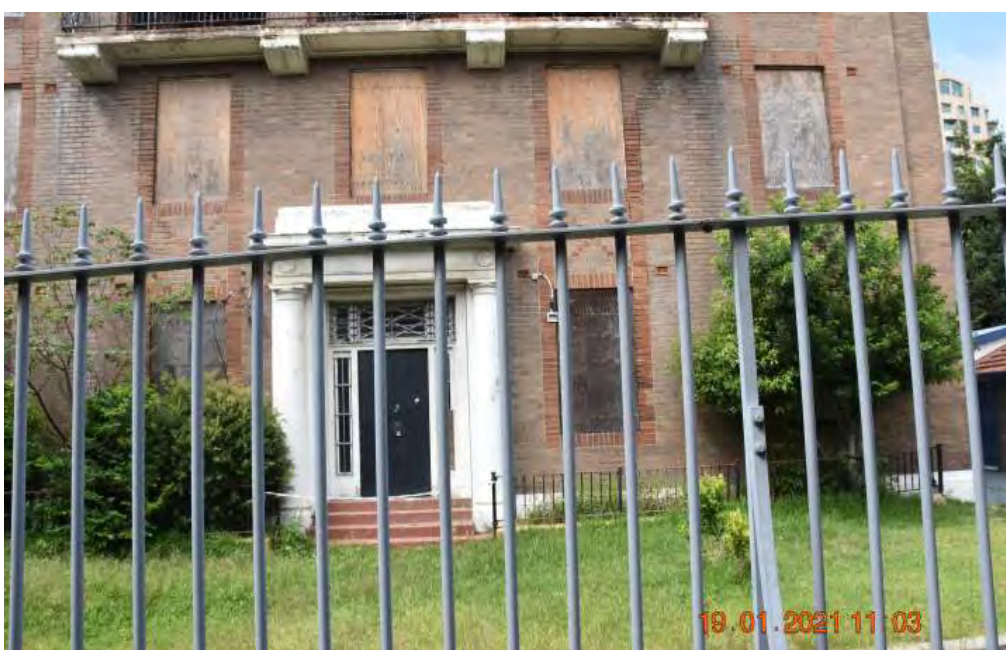
Figure: 1103

Fence on the south side of building A.

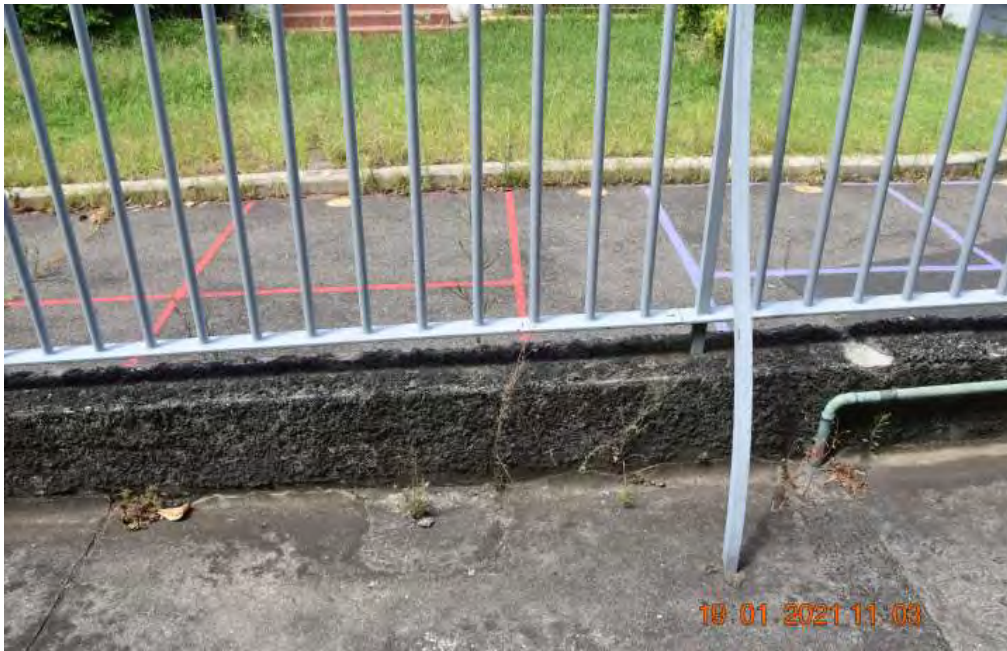
Figure: 1104

Fence on the south side of building A.

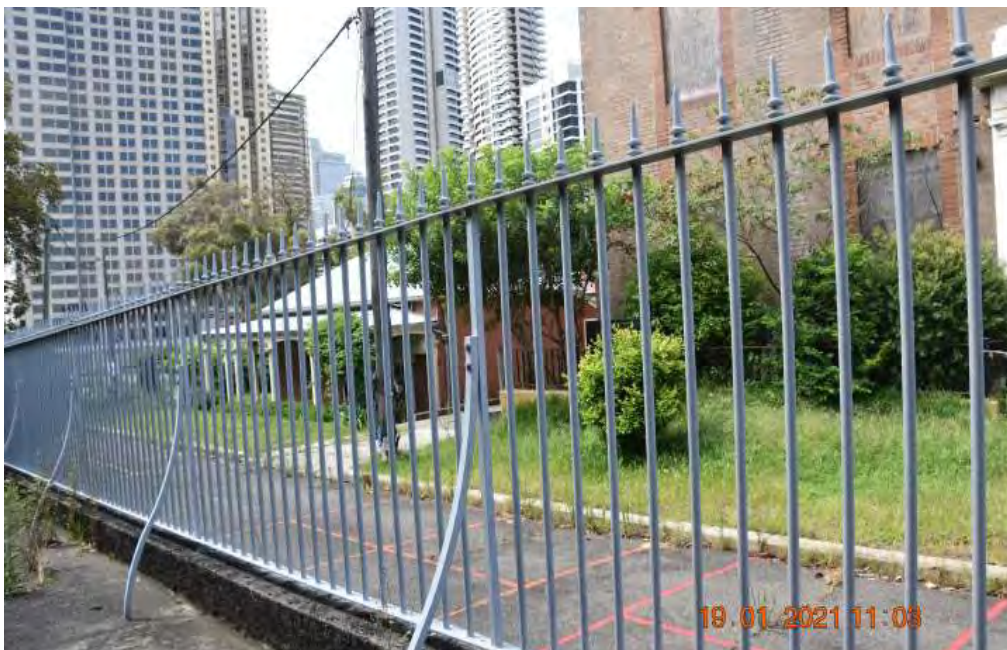
Figure: 1105

Fence on the south side of building A.

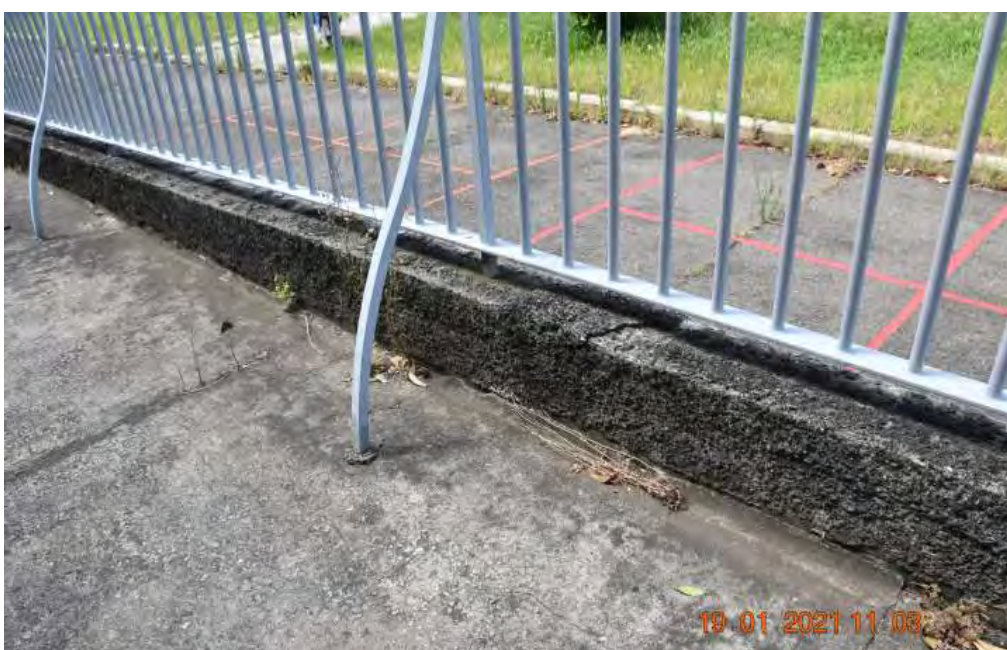
Figure: 1106

Fence on the south side of building A.

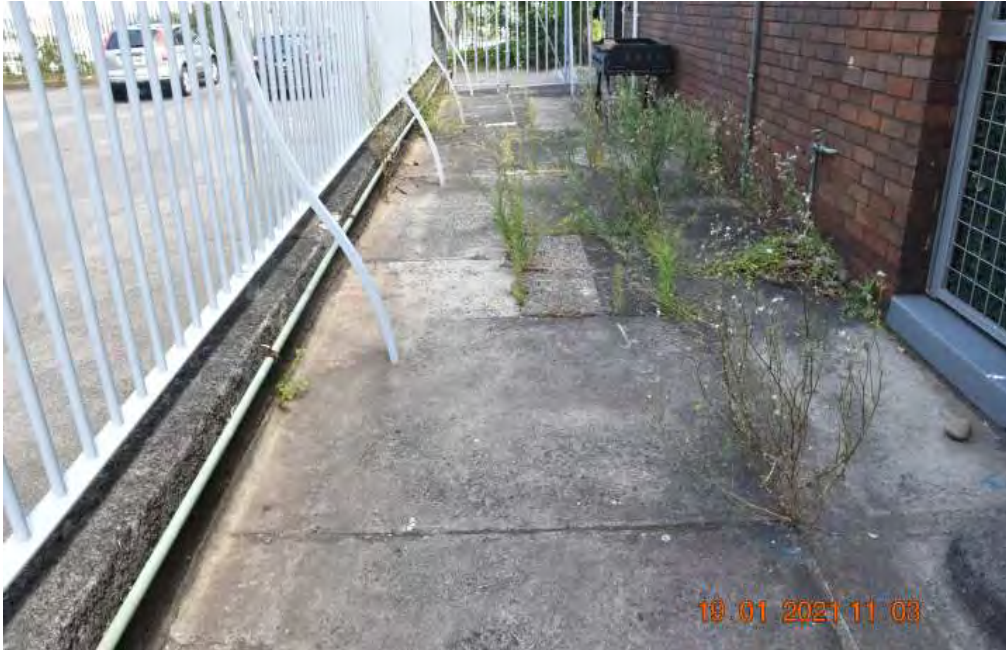
Figure: 1107

Fence on the south side of building A.

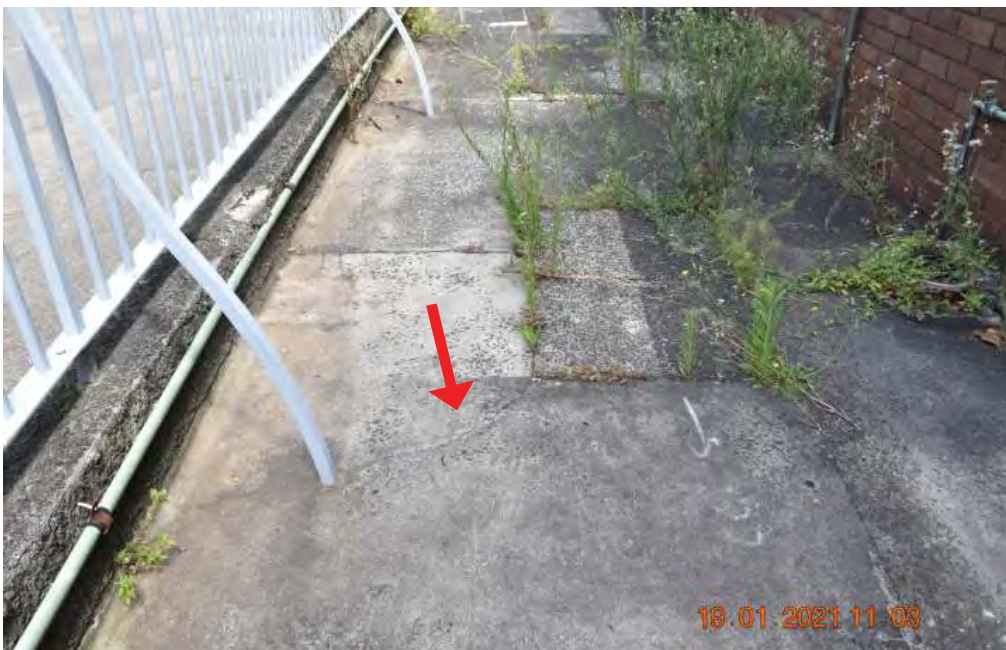
Figure: 1108

Paving on the south side of building A.

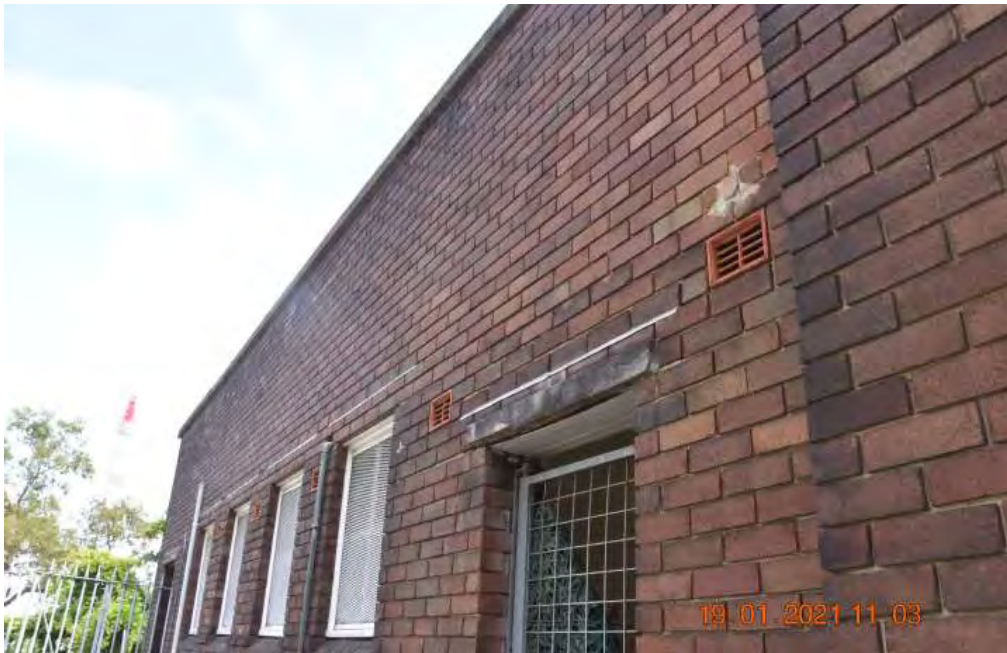
Figure: 1110

South wall of building A.

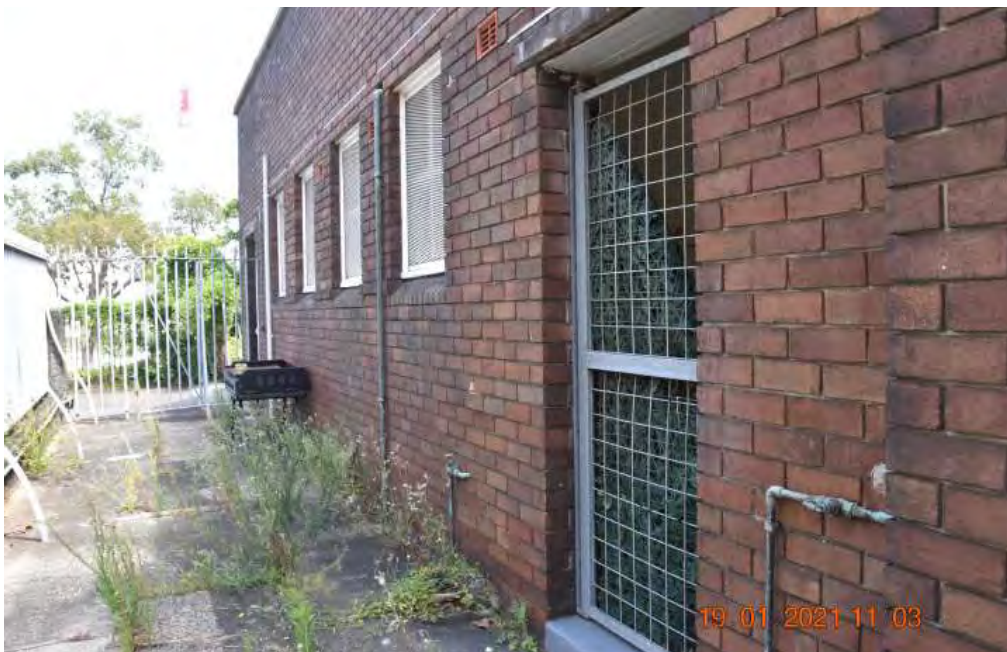
Figure: 1111

South wall of building A.

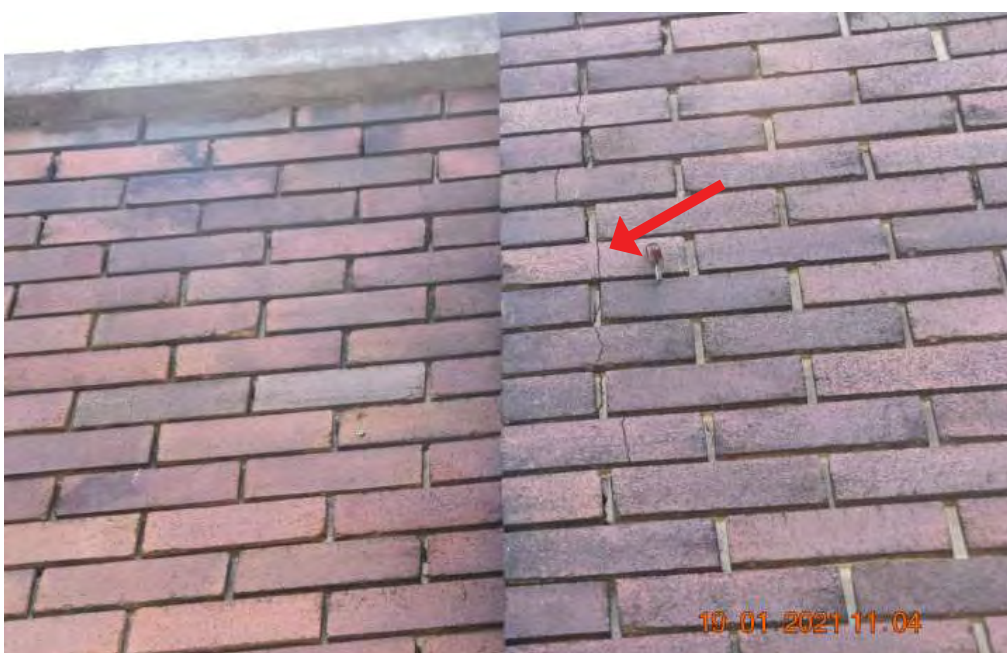
Figure: 1112

South wall of building A.

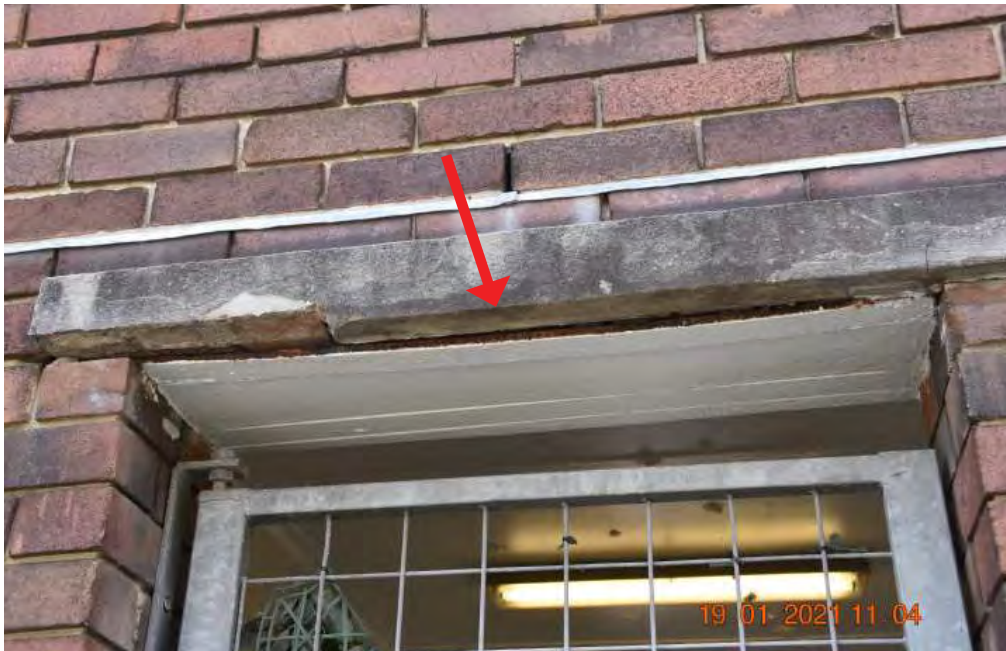
Figure: 1113

Slight cracking in the south wall of building A.

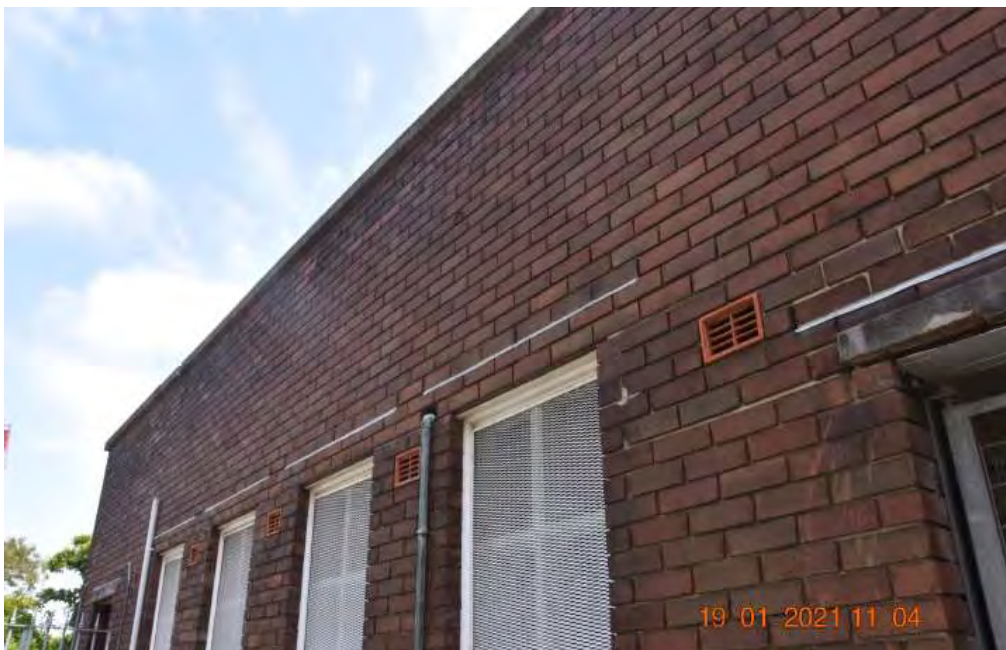
Figure: 1114

Bowing in the lintel in the south wall of building A, outside room 12.

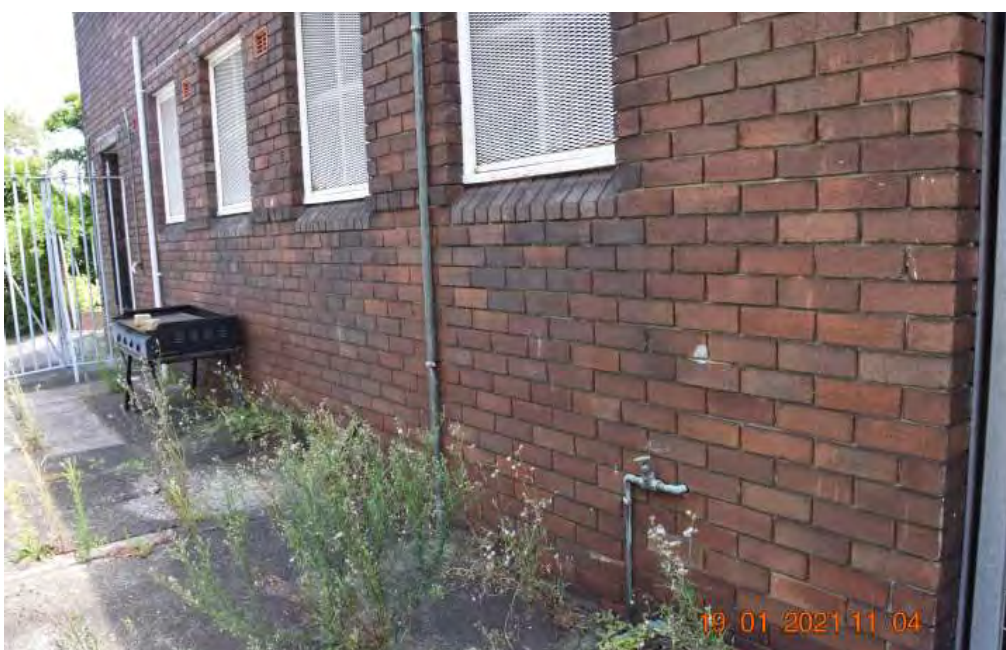
Figure: 1115

South wall of building A, looking from outside room 12.

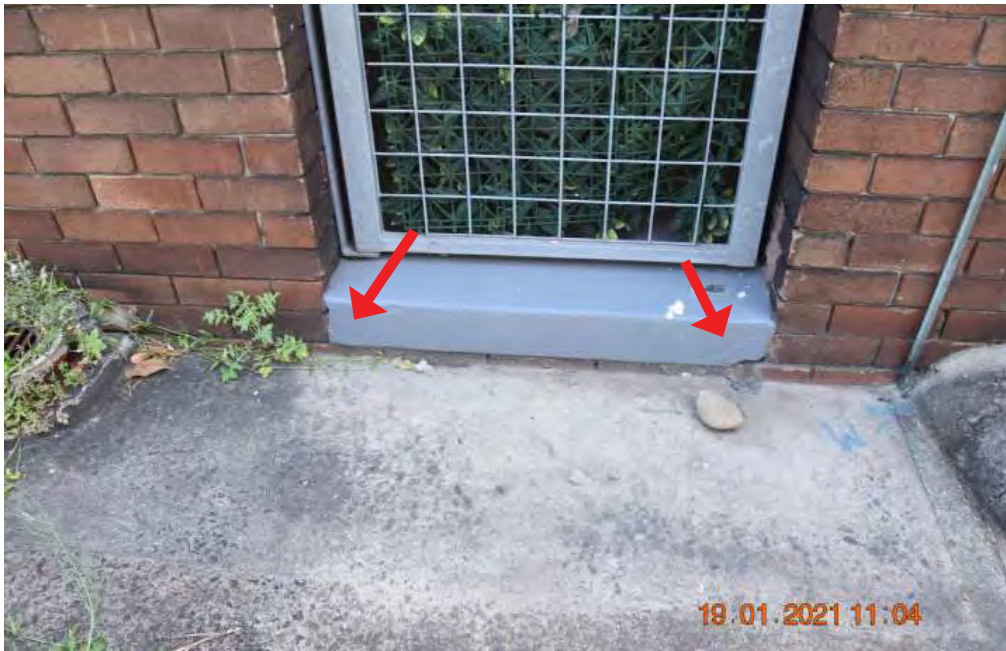
Figure: 1116

South wall of building A, looking from outside room 12.

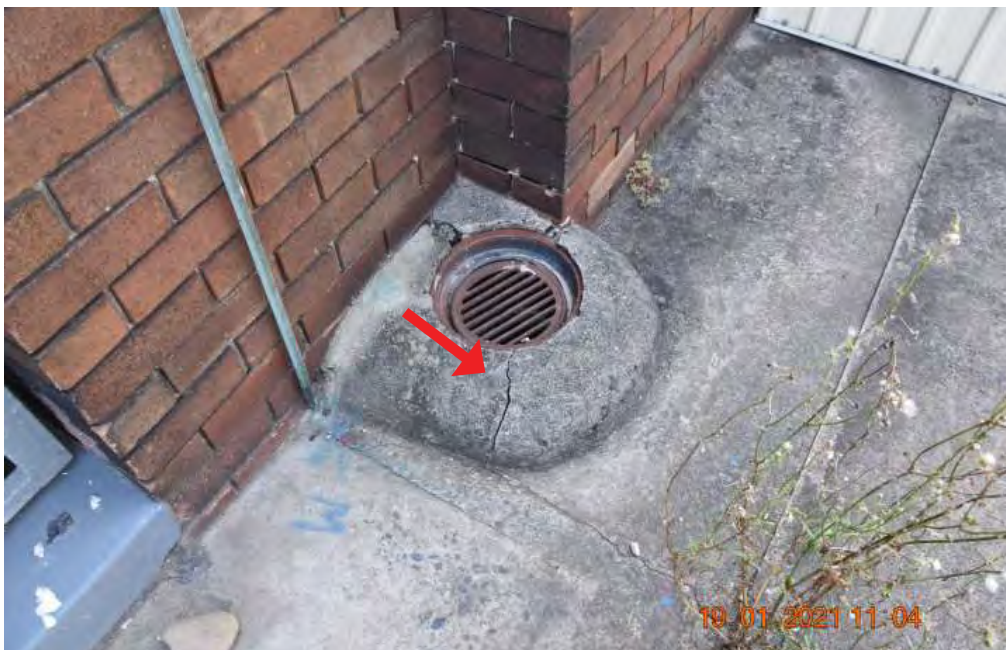
Figure: 1117

Cracking in the doorstep on the south side of building A, outside room 12.

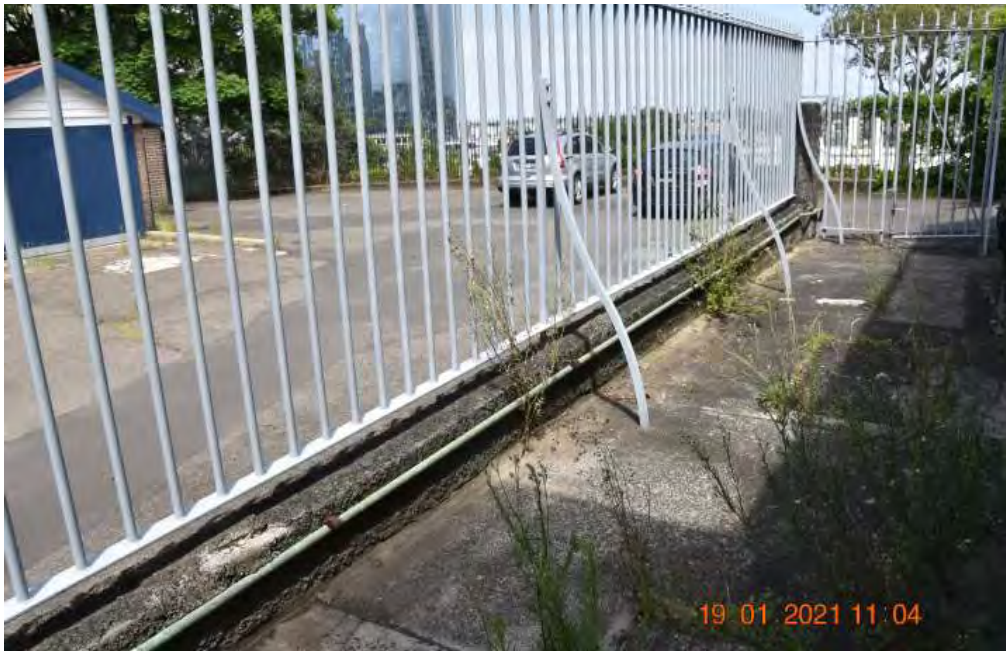
Figure: 1119

Fence on the south side of building A, looking from room 12.

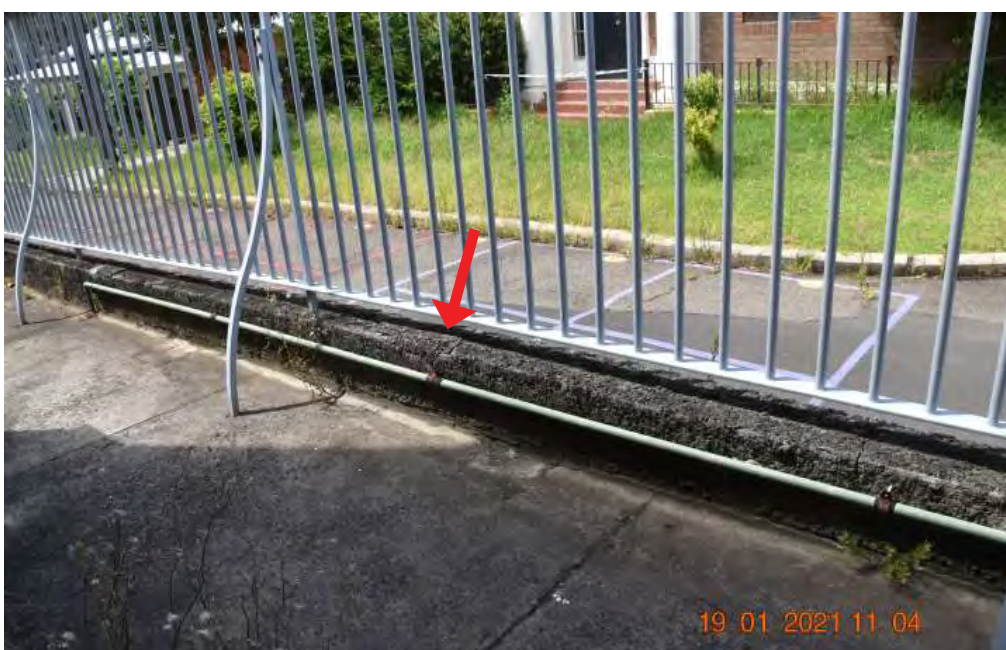
Figure: 1121

Fence on the south side of building A, looking from room 12.

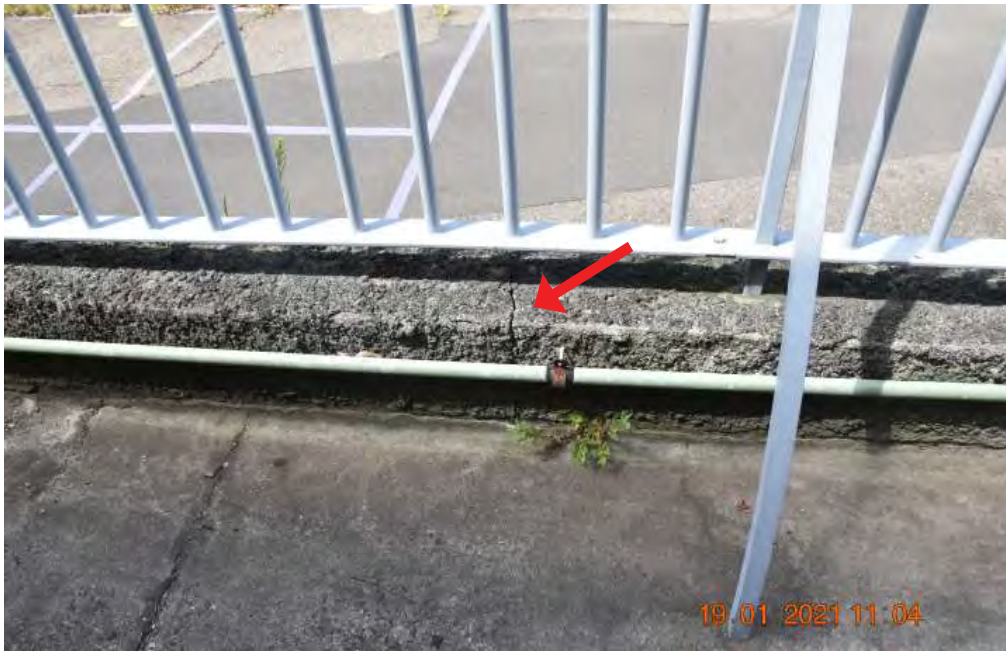
Figure: 1122

Fence on the south side of building A, looking from room 12. Showing cracking.

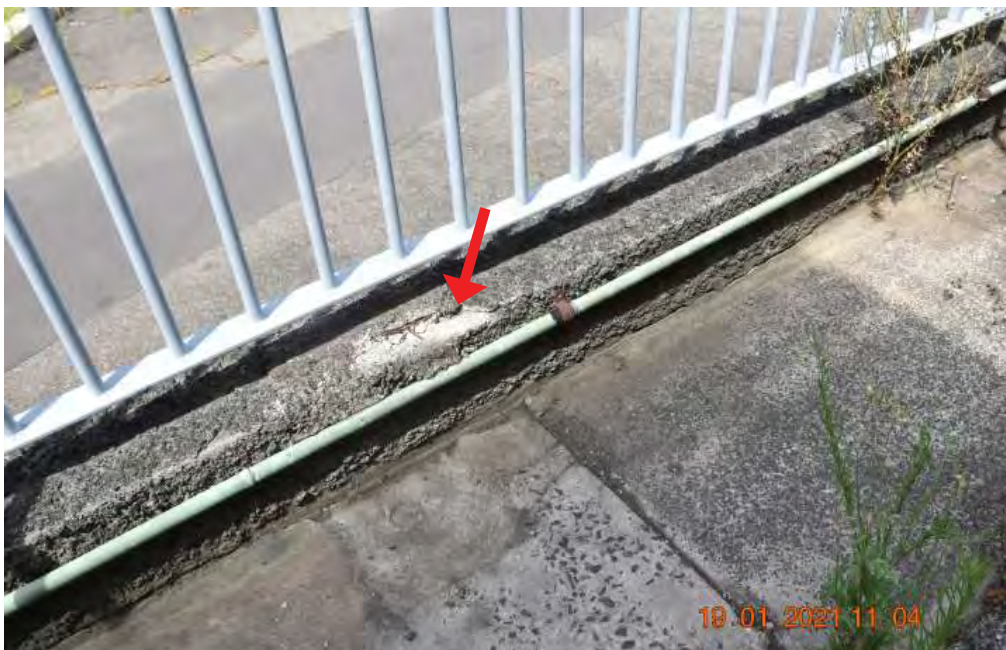
Figure: 1123

Cracking in the base of the fence on the south side of building A, outside room 12.

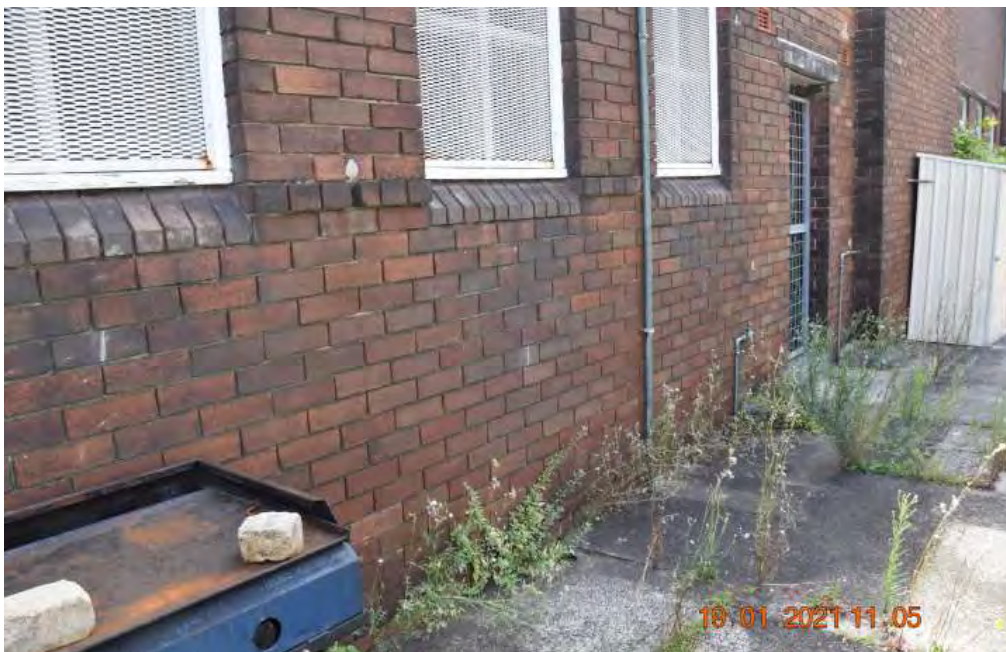
Figure: 1126

South wall of building A, looking from outside room 14.

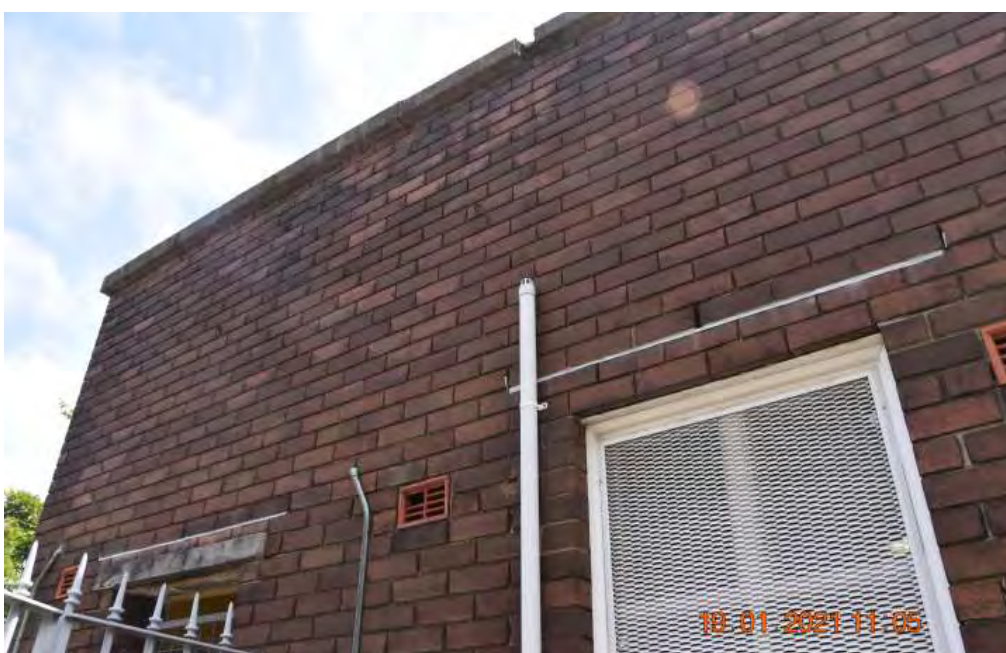
Figure: 1127

South wall of building A, looking from outside room 14.

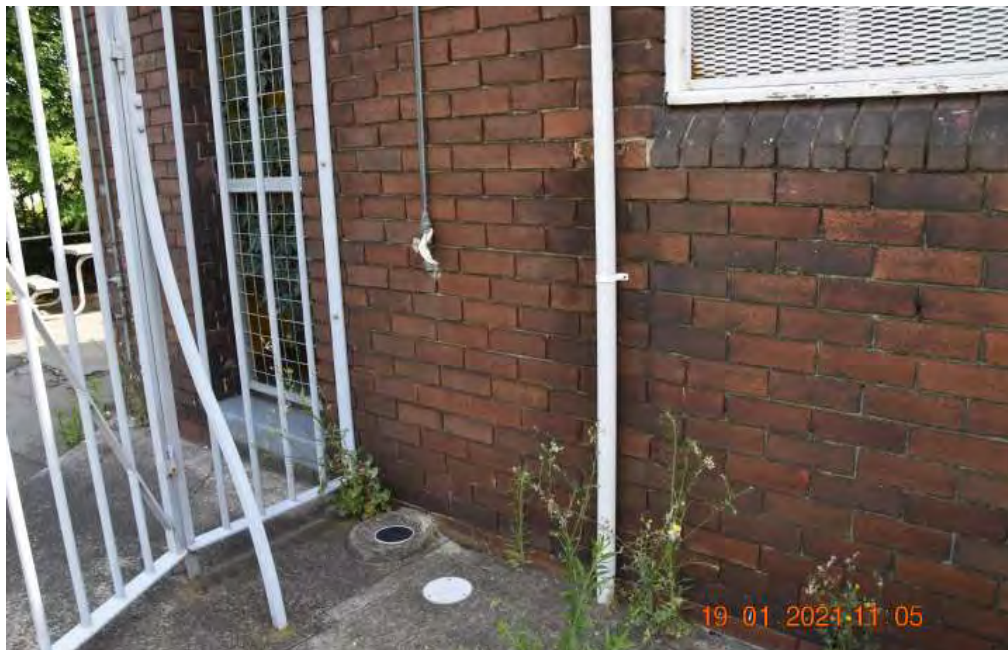
Figure: 1128

South wall of building A, looking from outside room 14.

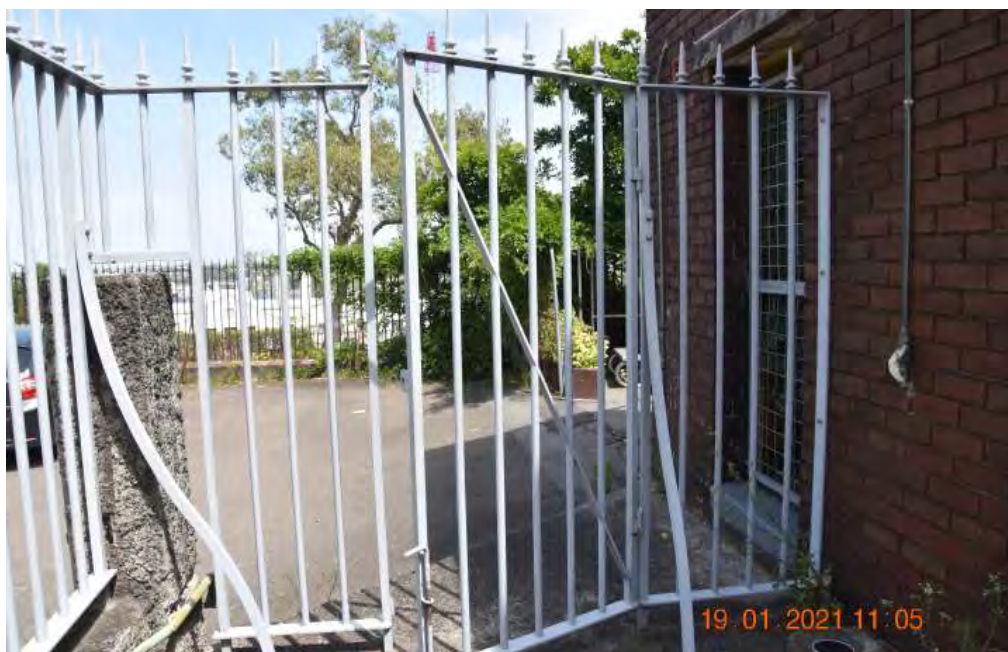
Figure: 1129

South wall of building A, looking from outside room 14.

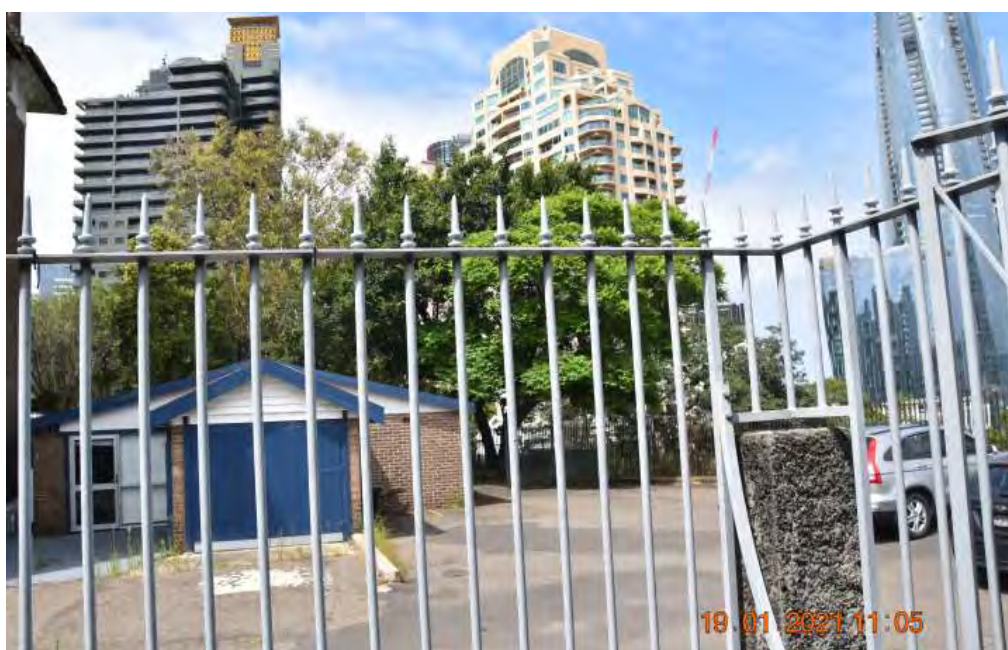
Figure: 1130

General view of the gate on the south side of building A, outside room 12.

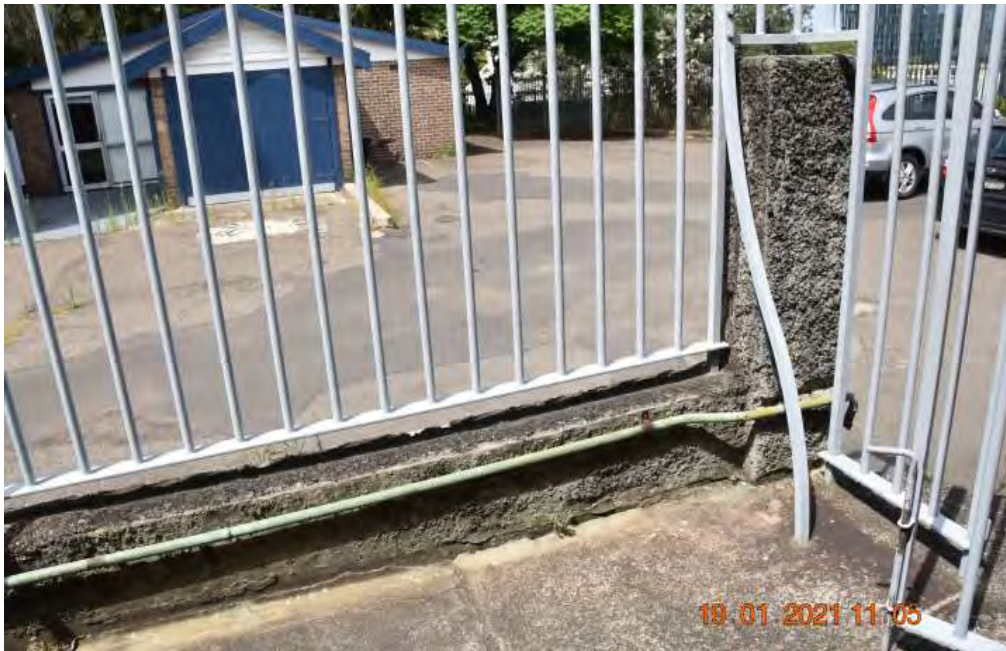
Figure: 1131

Fence on the south side of building A.

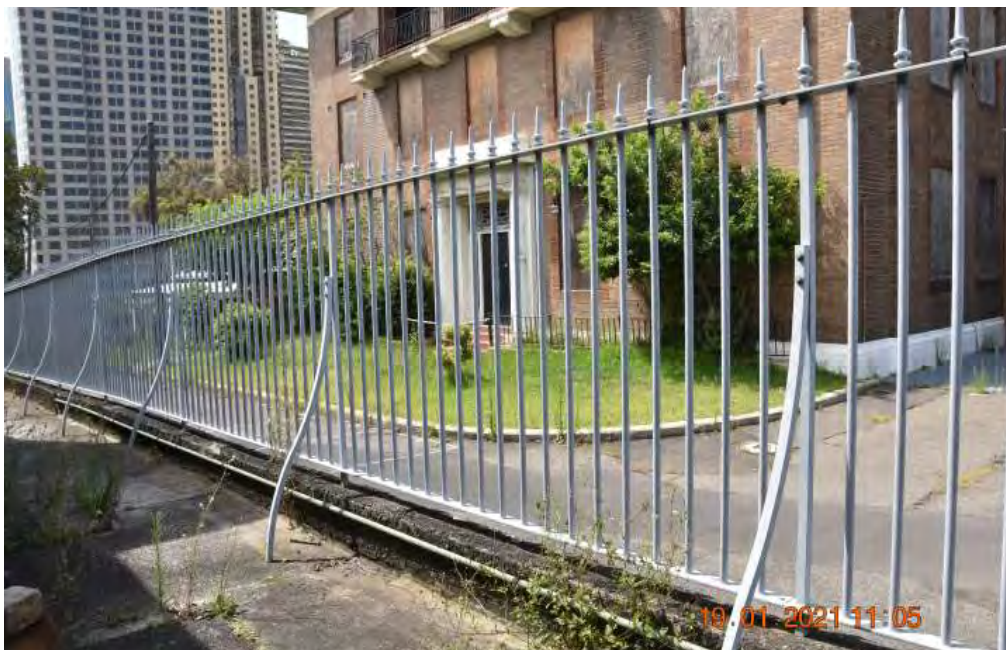
Figure: 1132

Fence on the south side of building A.

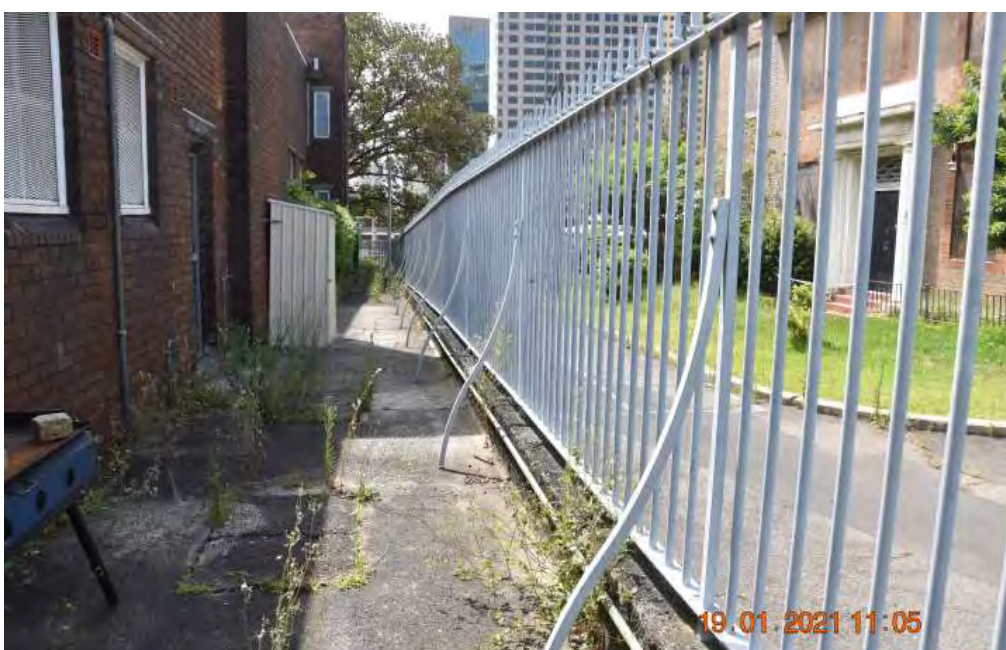
Figure: 1133

Fence on the south side of building A.

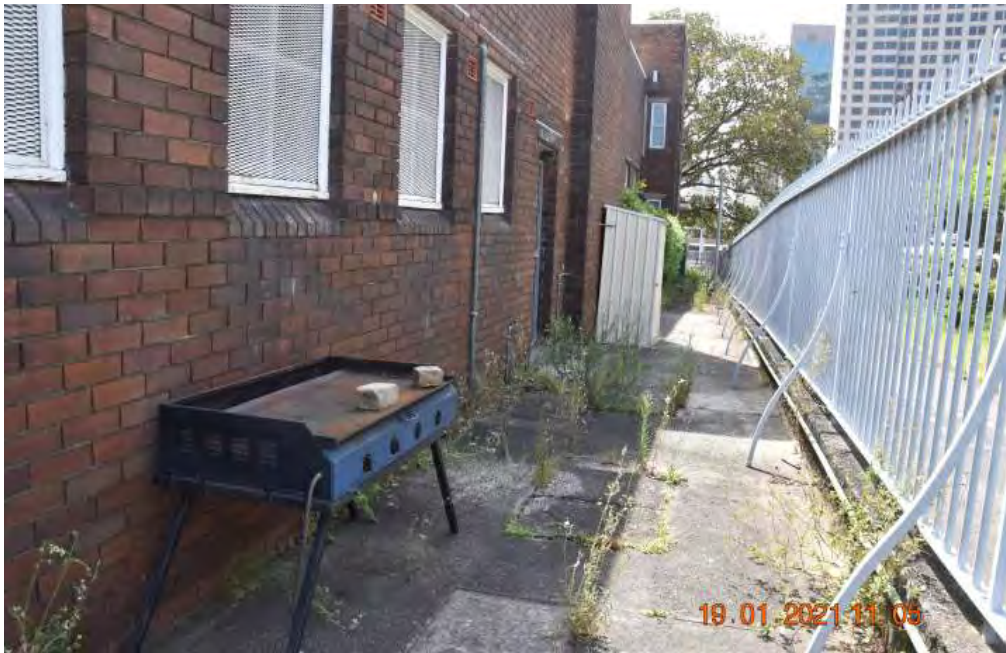
Figure: 1134

Alignment of the fence on the south side of building A, looking from the west.

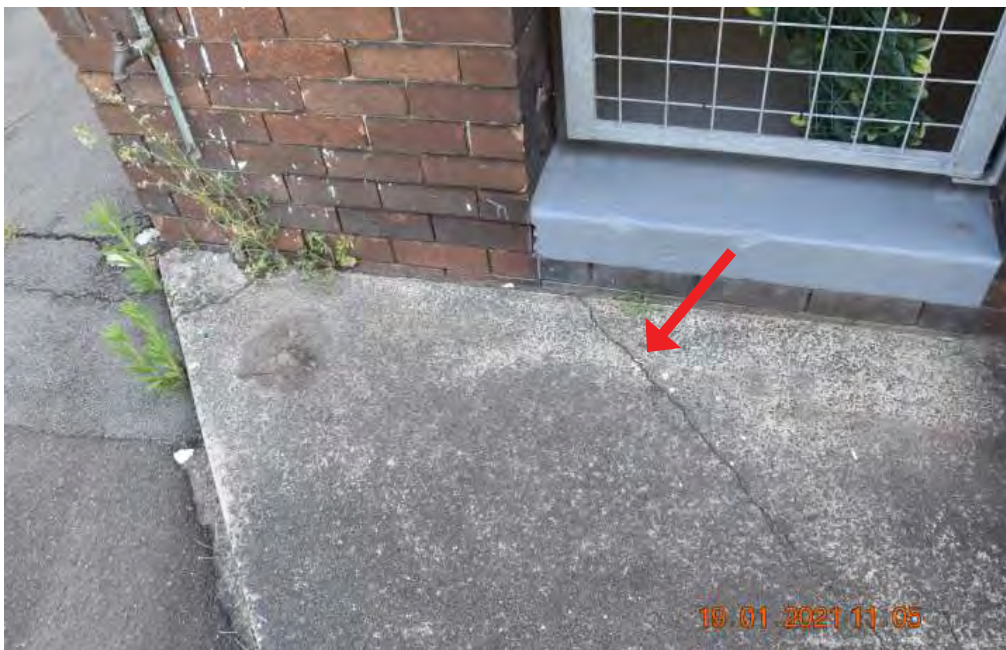
Figure: 1135

General view of the paving on the south side of building A.

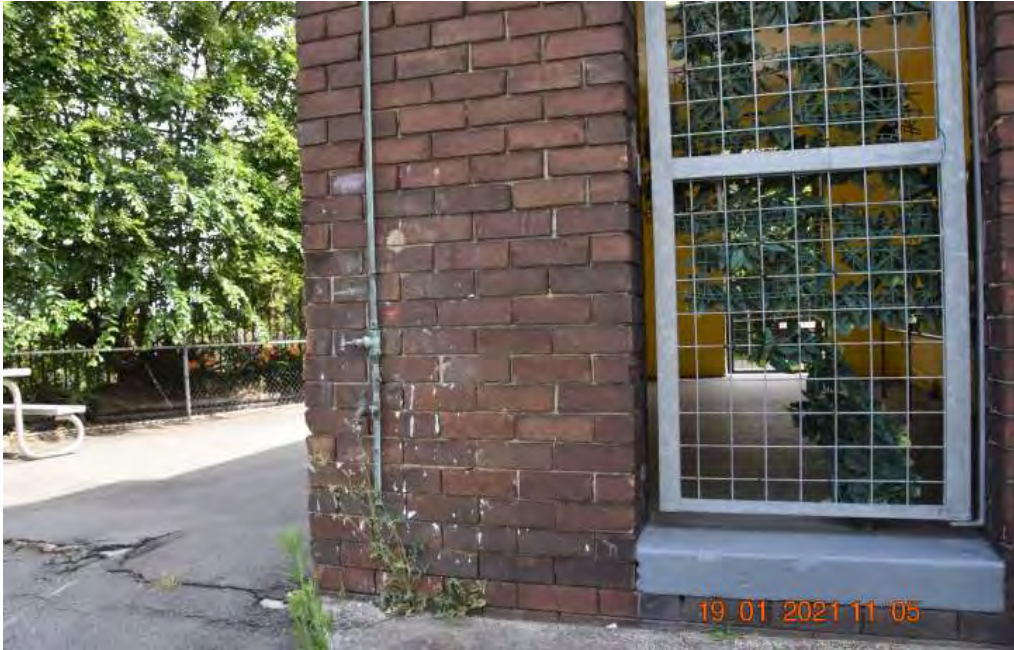
Figure: 1137

South wall of building A, outside room 12.

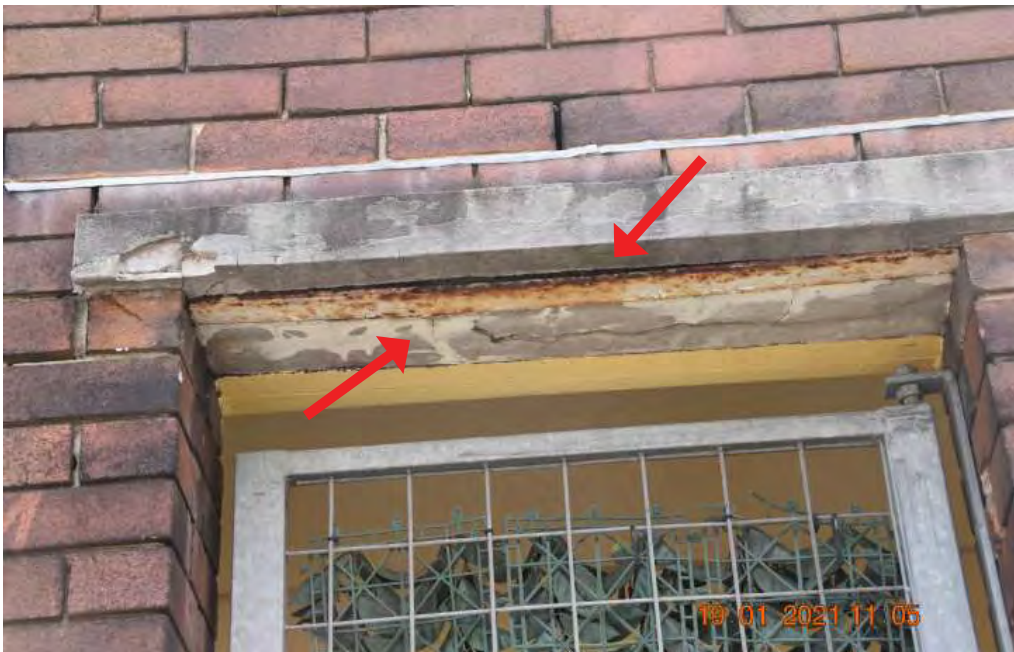
Figure: 1138

South wall of building A, outside room 12.

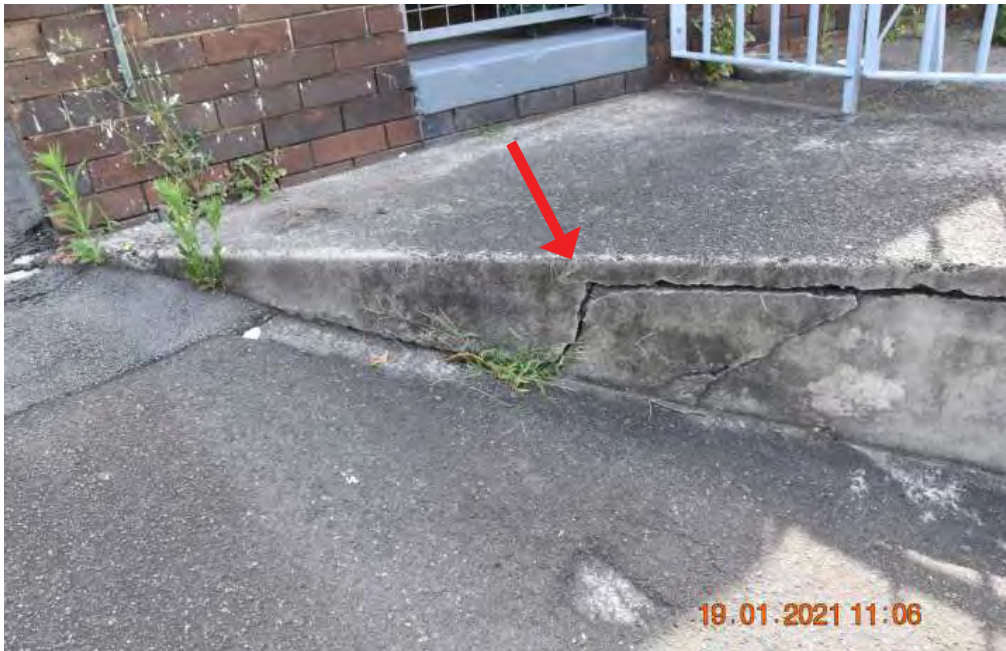
Figure: 1140

Wide separation in the paving on the south side of building A, outside room 12.

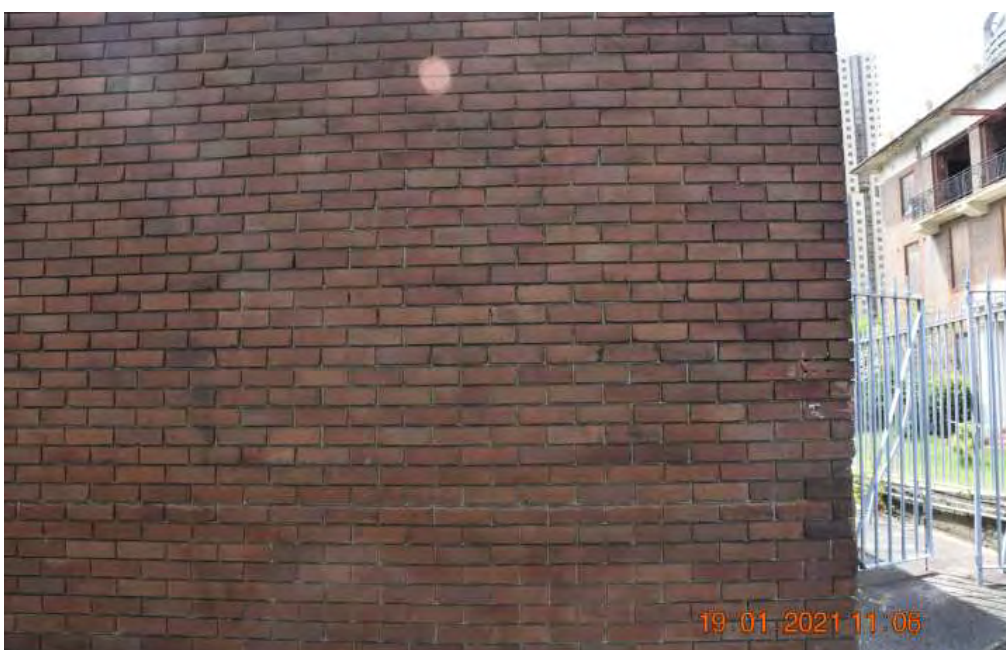
Figure: 1142

West wall of building A.

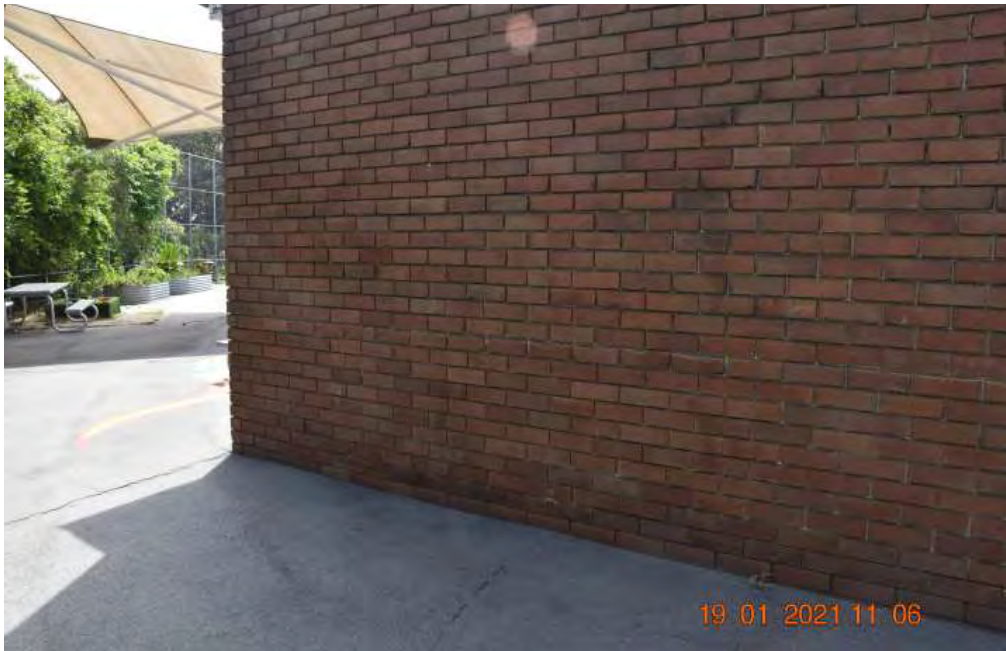
Figure: 1143

West wall of building A.

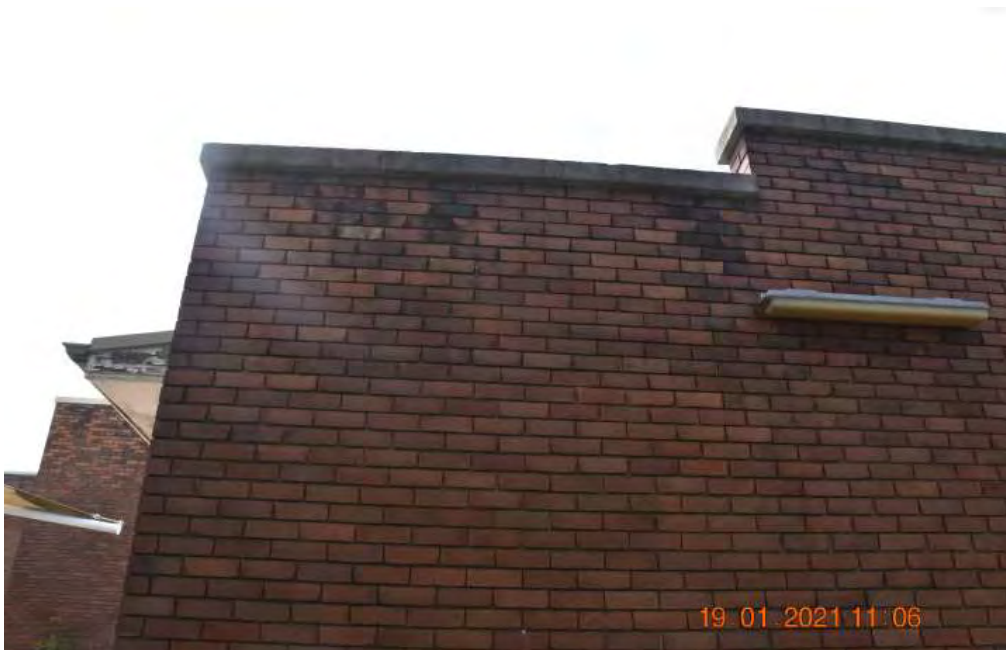
Figure: 1144

West wall of building A.
