## PRE CONSTRUCTION CONDITION SURVEY

Fort Street Public School, Millers Point NSW

Upper Fort Street Public School  
MILLERS POINT NSW 2000

19 January 2021

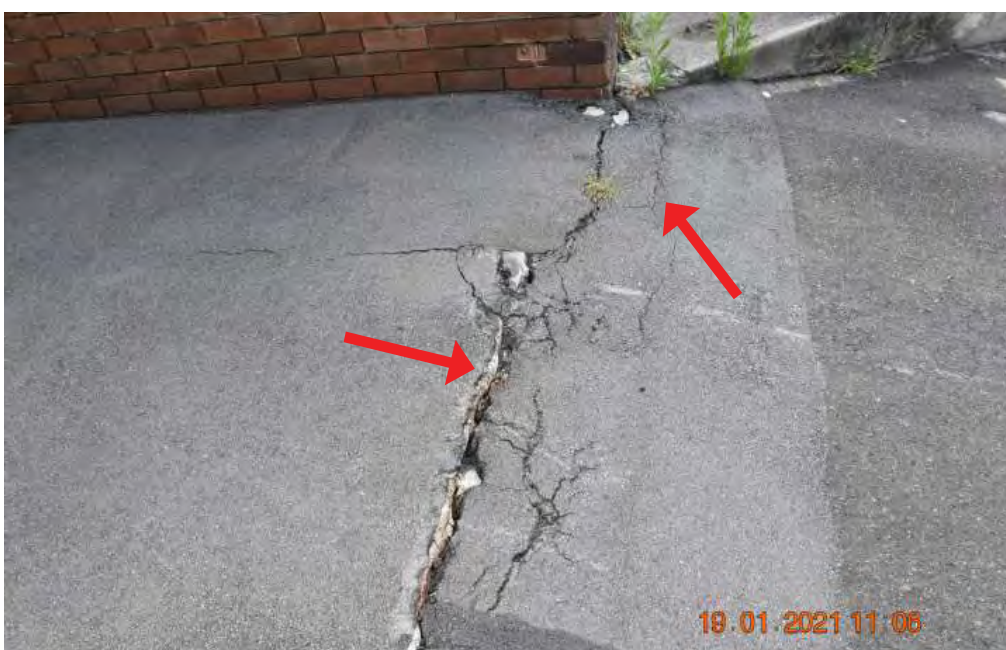
Figure: 1145

West wall of building A.

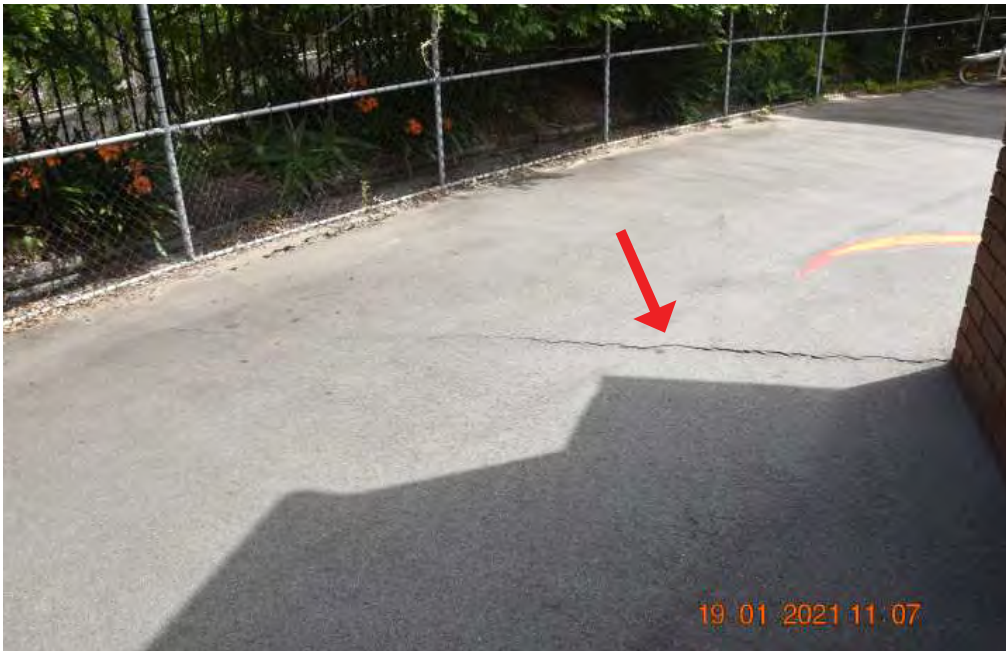
Figure: 1150

Cracking in the paving on the west side of building A.

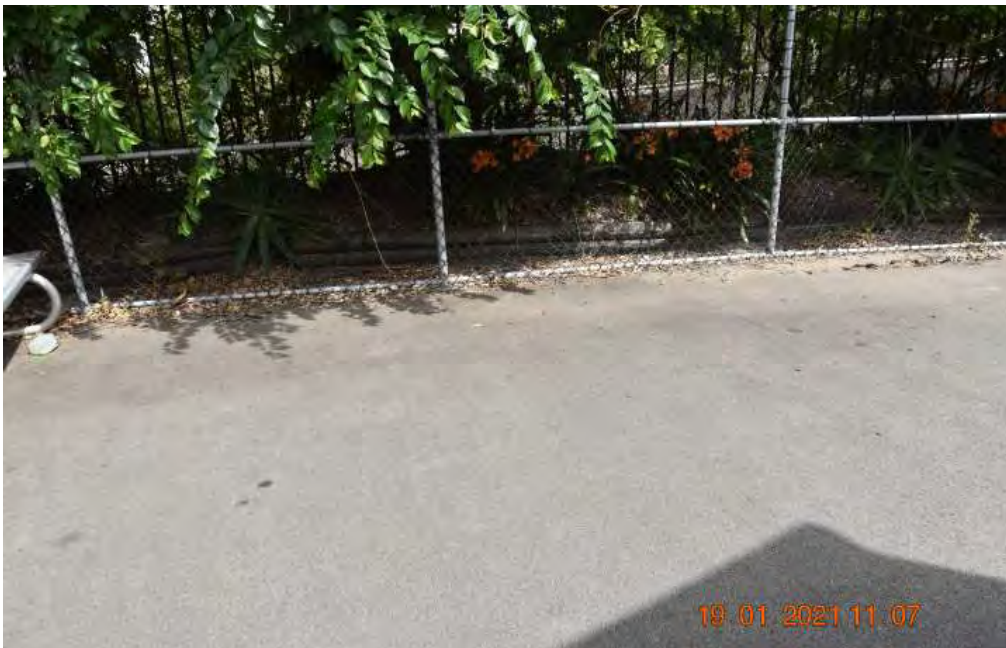
Figure: 1151

Paving on the west side of building A.

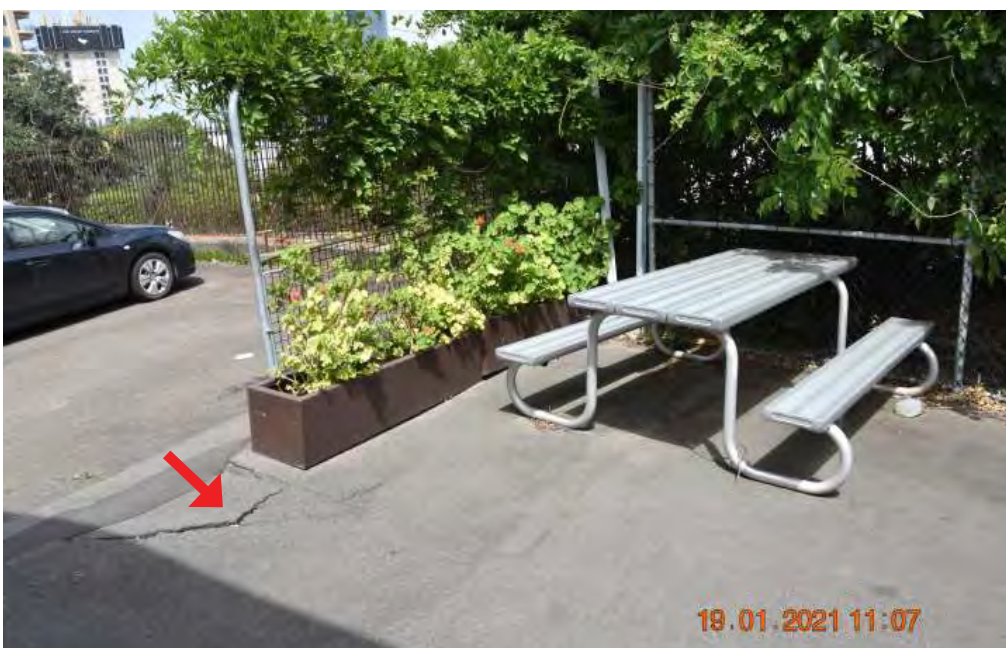
Figure: 1152

Paving on the west side of building A. Showing wide cracking.

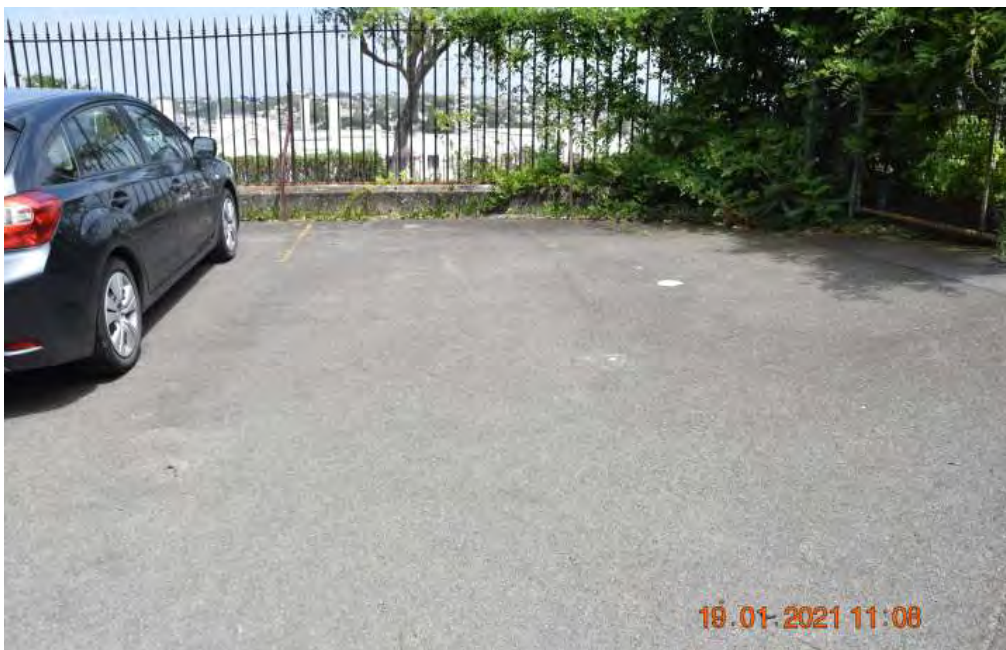
Figure: 1153

Cracking in the carpark at the southwest corner of building A.

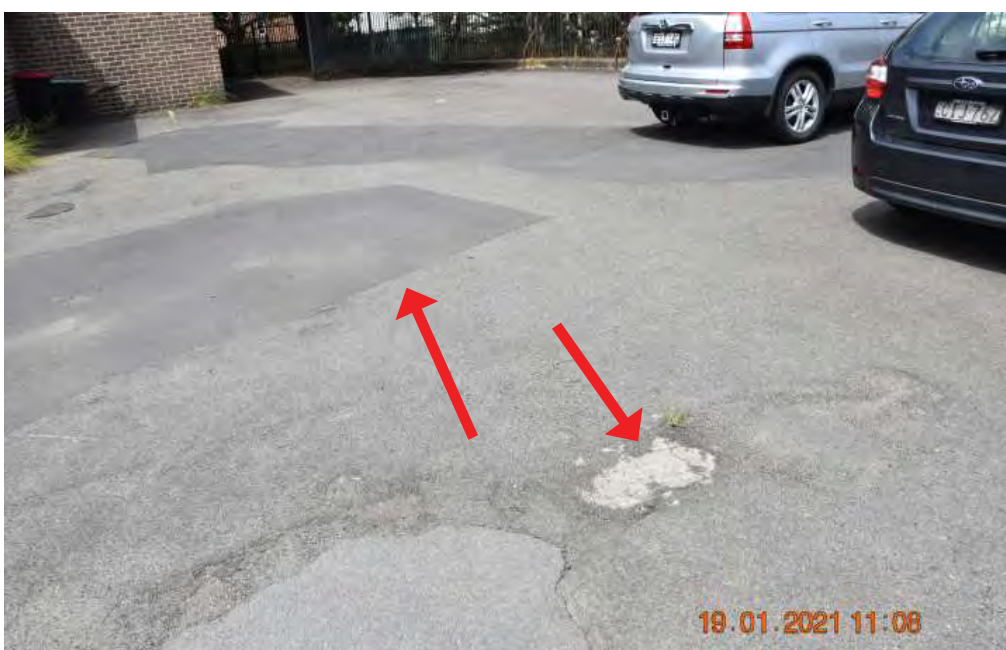
Figure: 1154

Carpark at the southwest corner of building A.

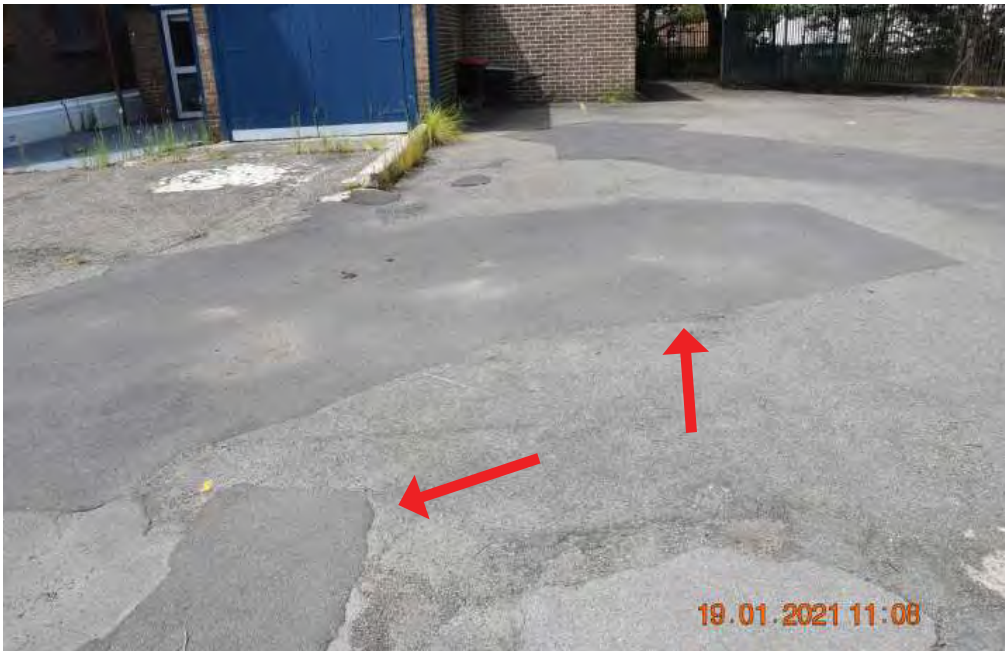
Figure: 1156

Patching in the carpark at the southwest corner of building A.

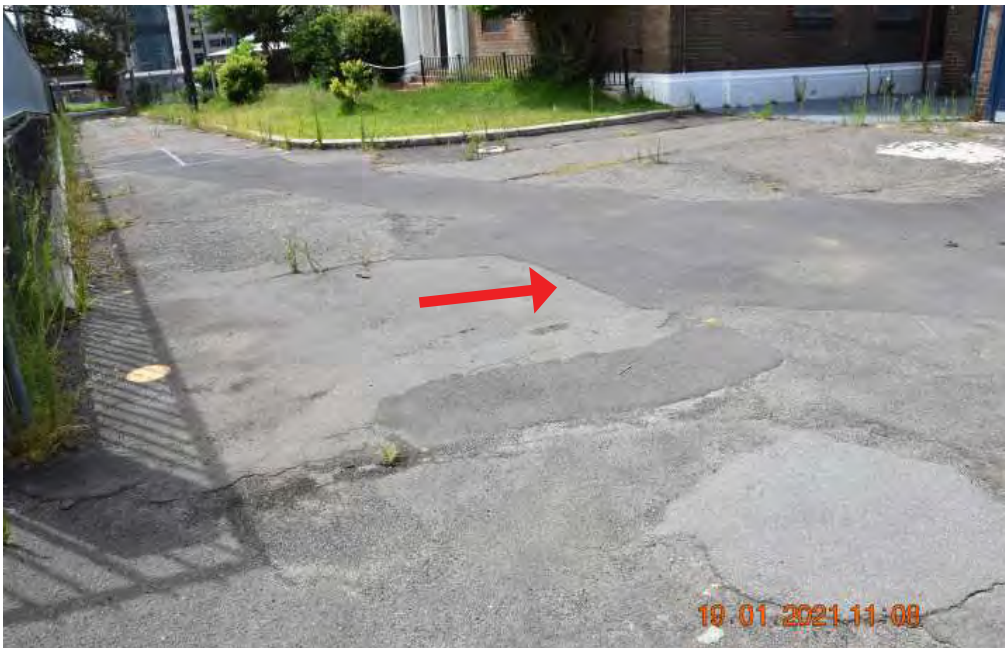
Figure: 1157

Patching in the carpark at the southwest corner of building A.

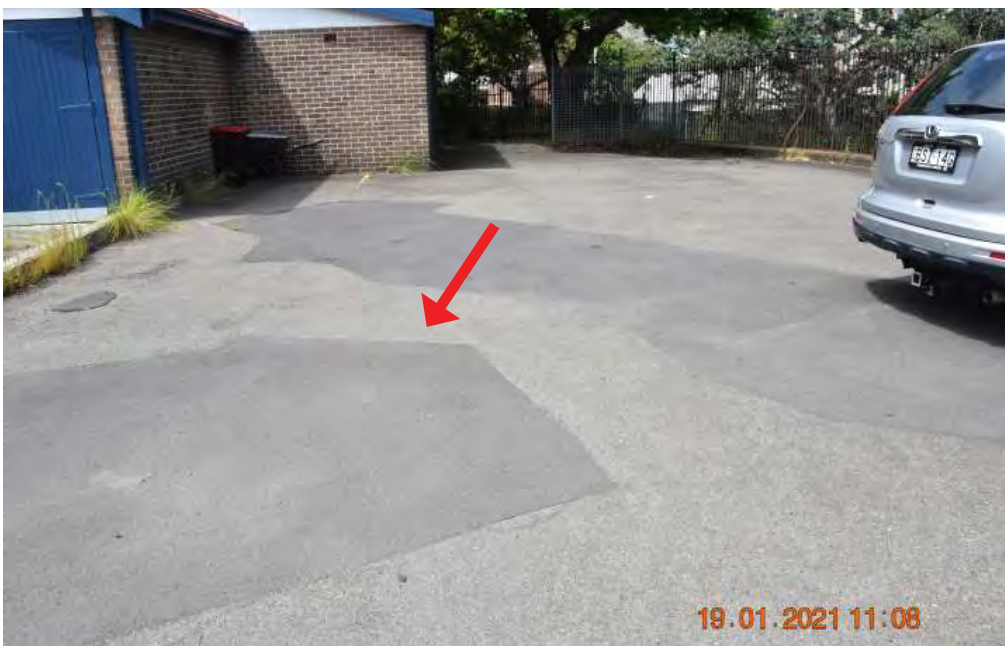
Figure: 1158

Carpark at the southwest corner of building A. Showing patching.

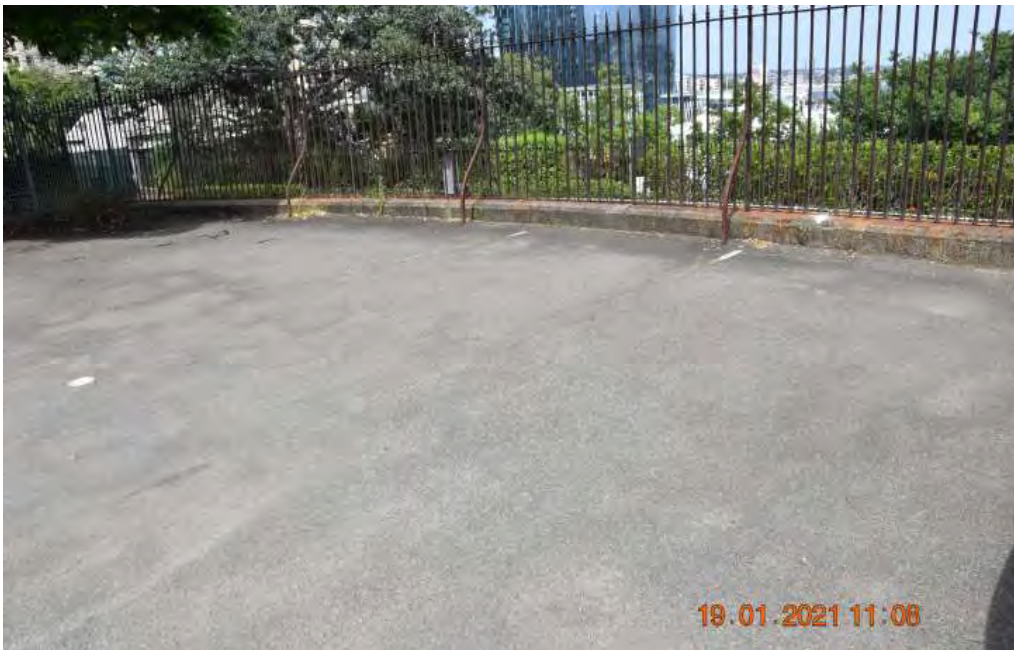
Figure: 1159

Carpark at the southwest corner of building A. Showing patching and scoring.

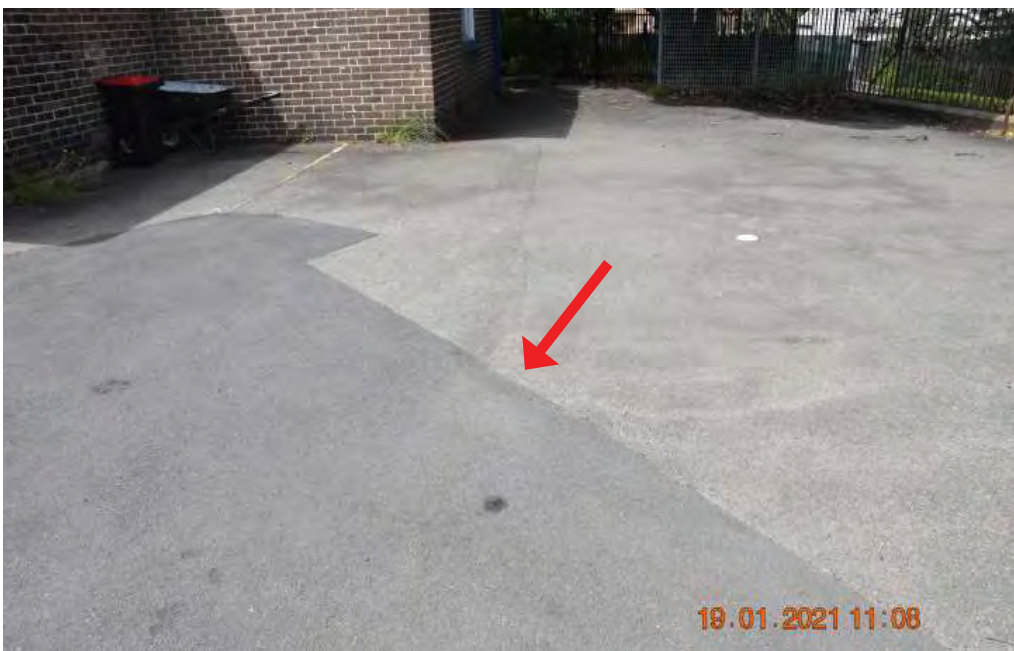
Figure: 1160

Carpark at the southwest corner of building A.

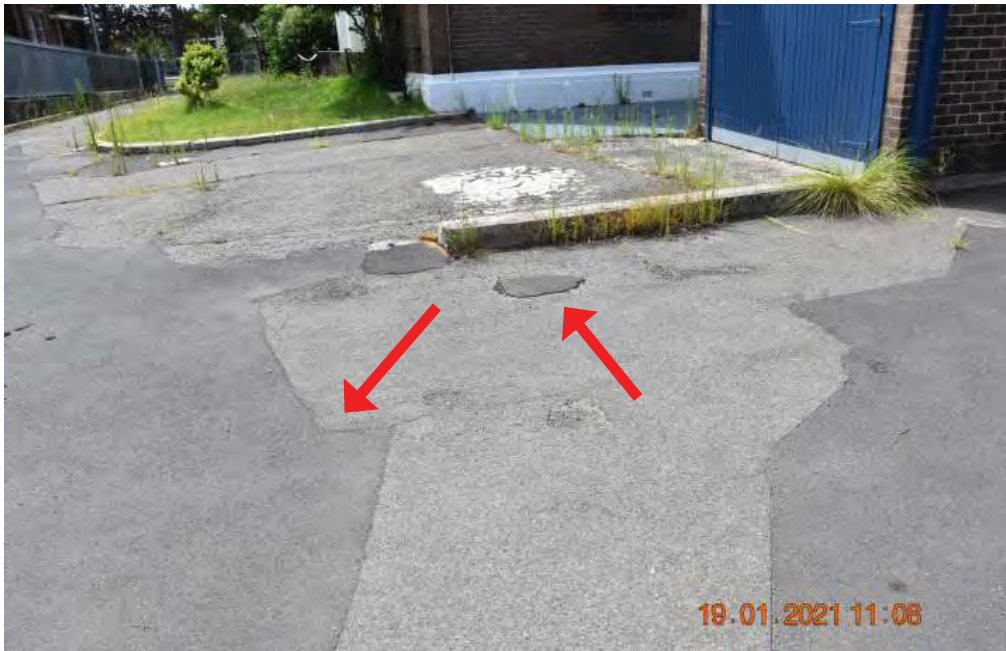
Figure: 1161

Carpark at the southwest corner of building A. Showing patching.

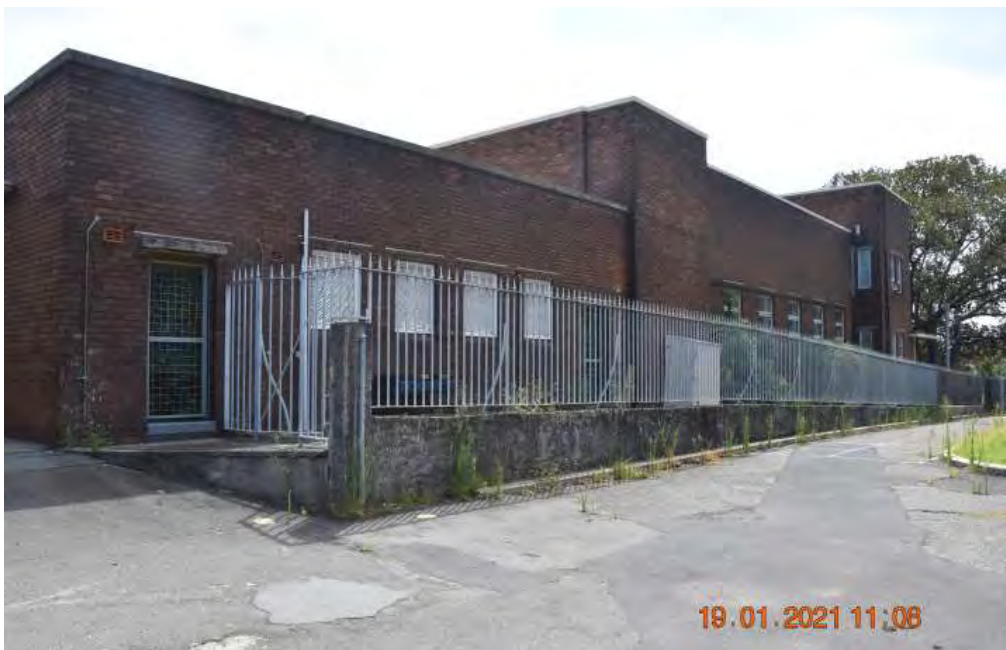
Figure: 1162

Patching in the carpark at the southwest corner of building A.

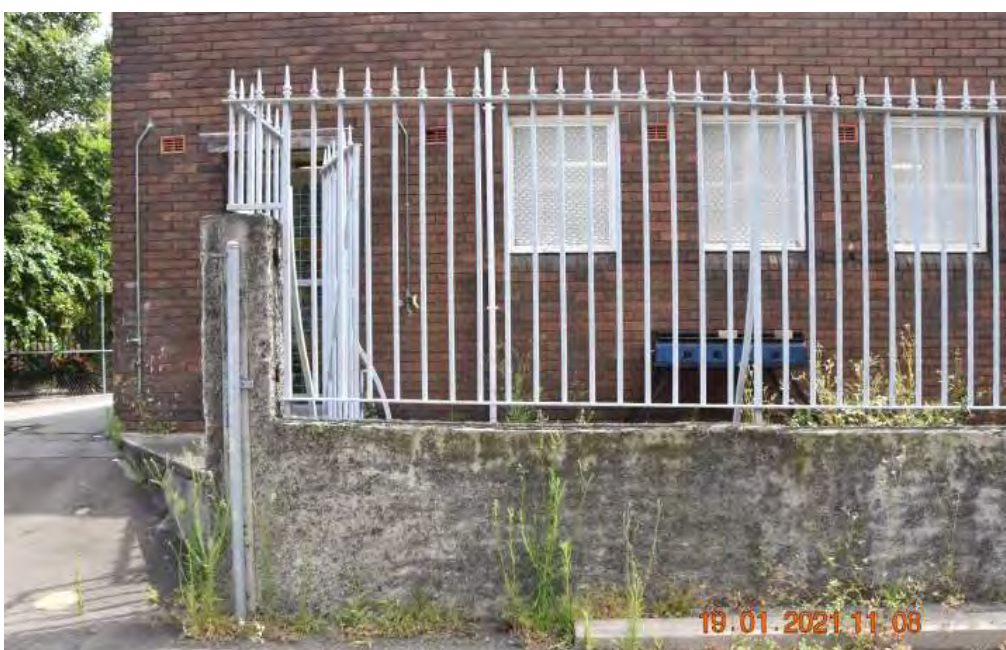
Figure: 1163

South wall of building A.

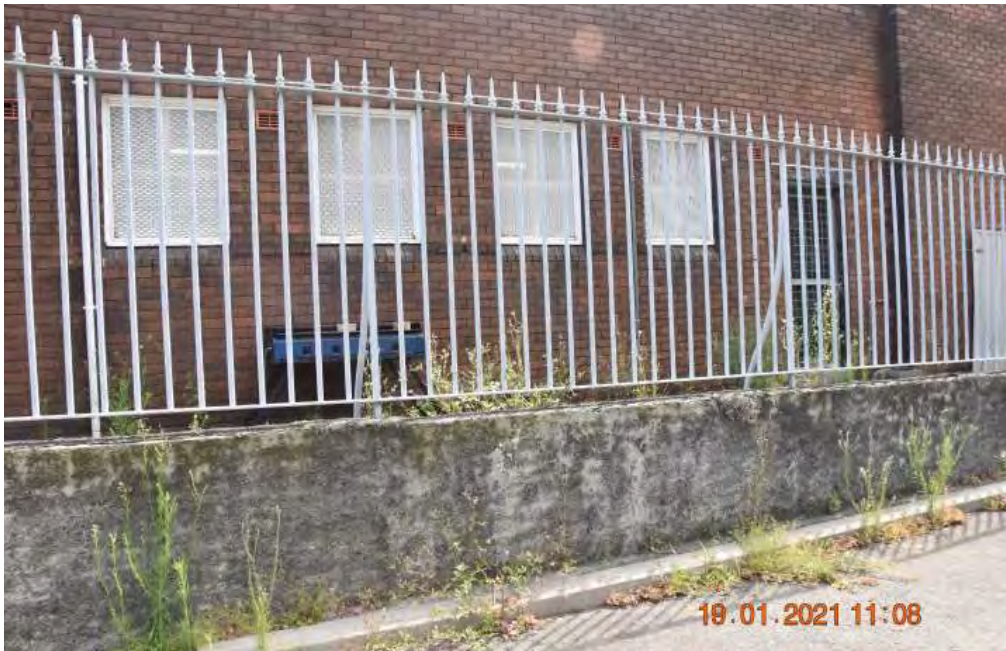
Figure: 1164

Fence on the south side of the building.

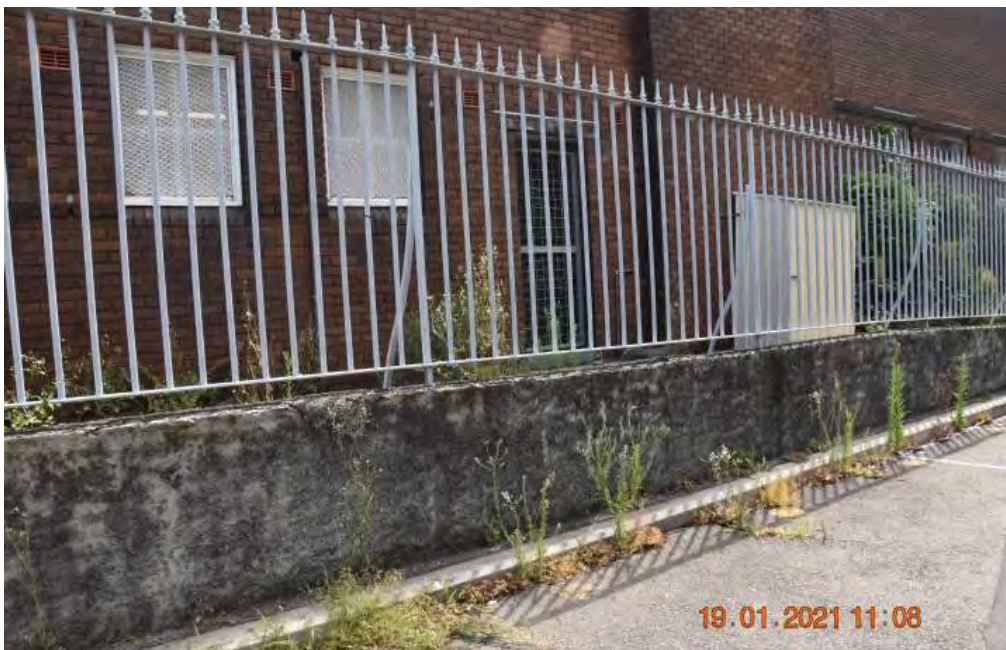
Figure: 1165

Fence on the south side of the building.

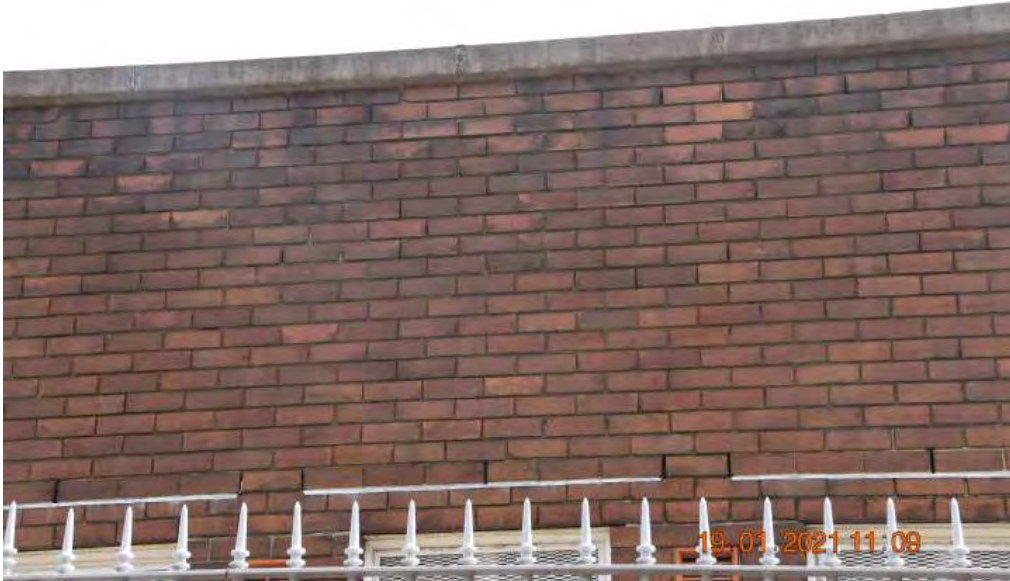
Figure: 1168

South wall of building  
A.

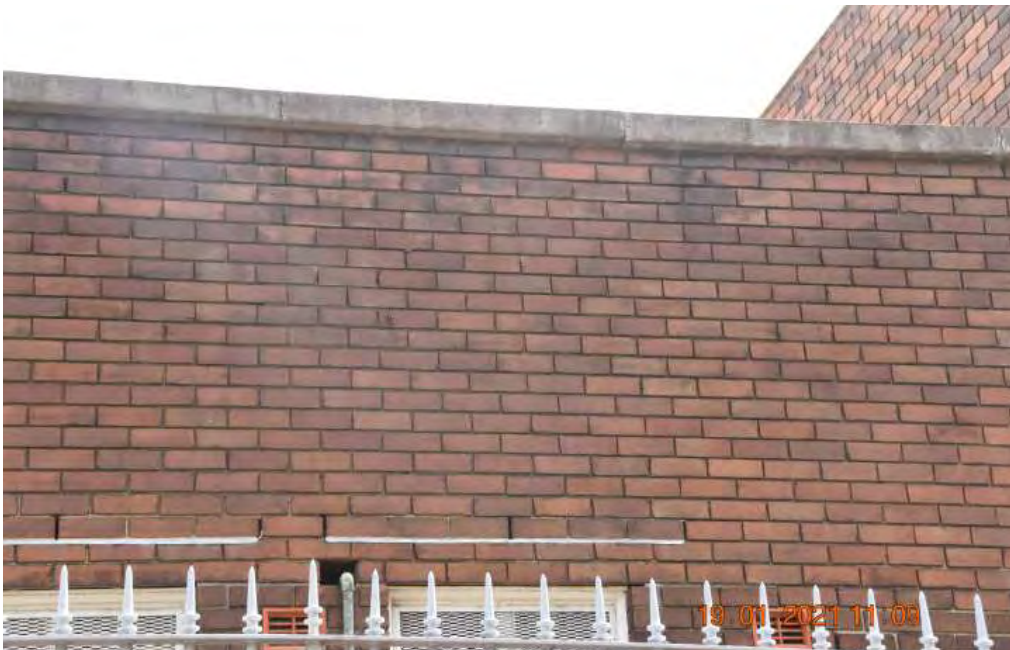
Figure: 1169

South wall of building  
A.

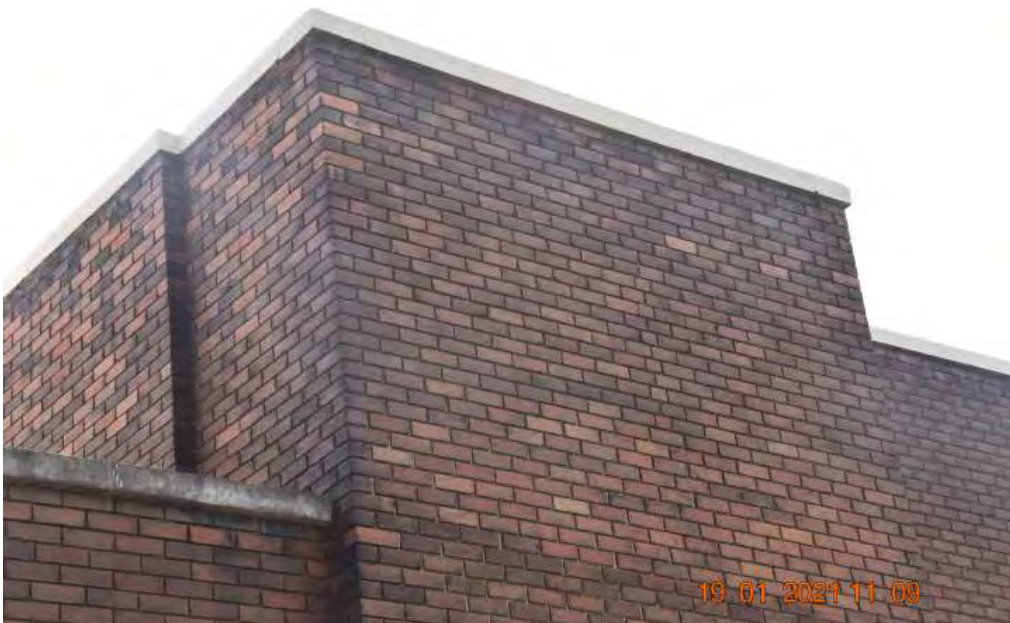
Figure: 1170

South wall of building  
A.

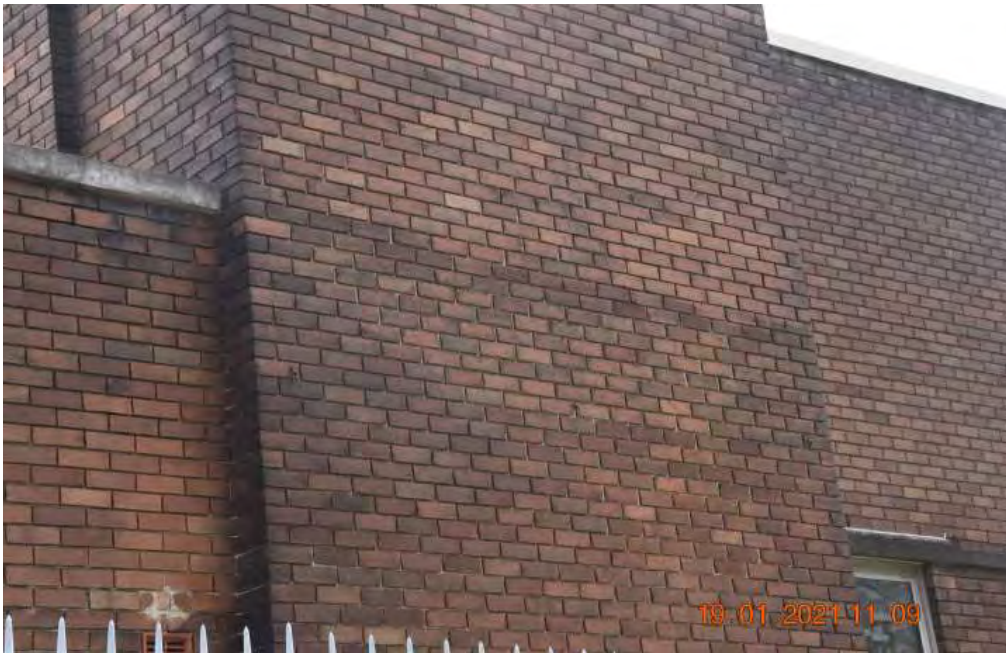
Figure: 1171

South wall of building A.

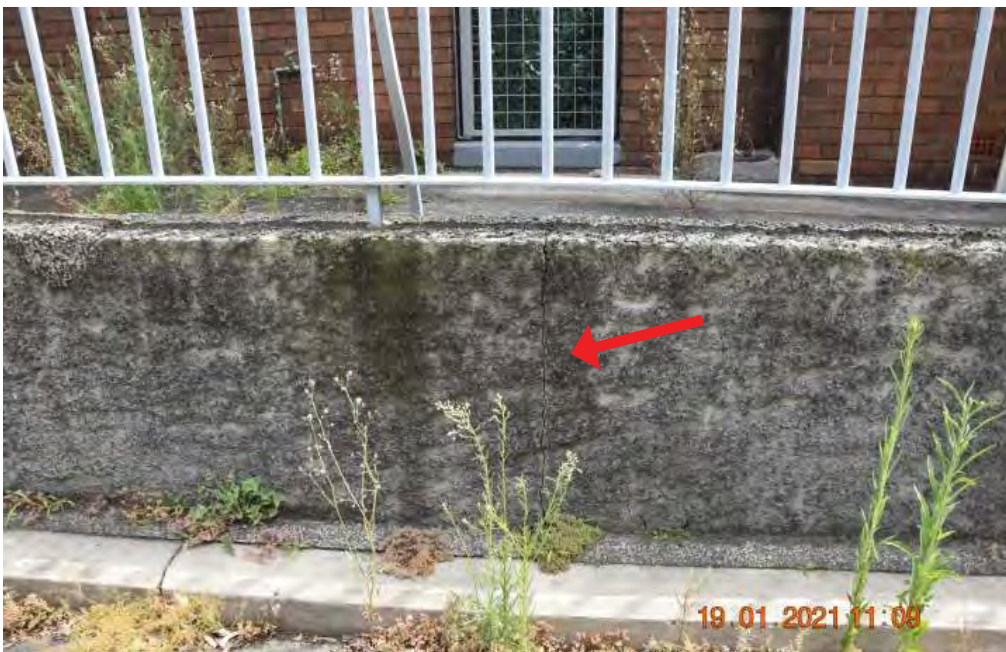
Figure: 1172

Separation in the base of the fence on the south side of building A.

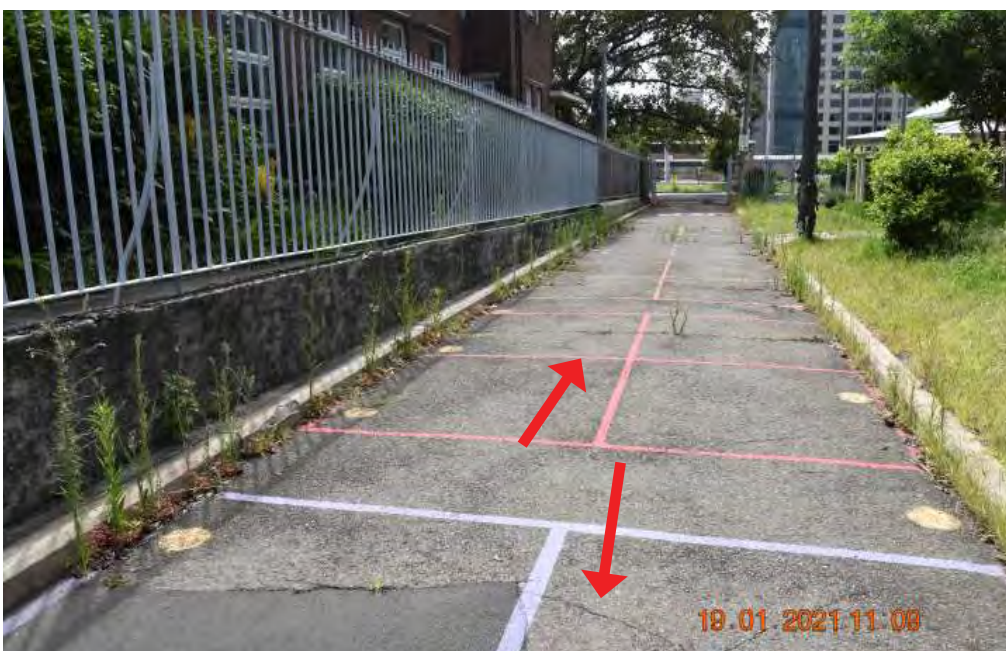
Figure: 1173

General view of the driveway on the south side of building A. Showing cracking.

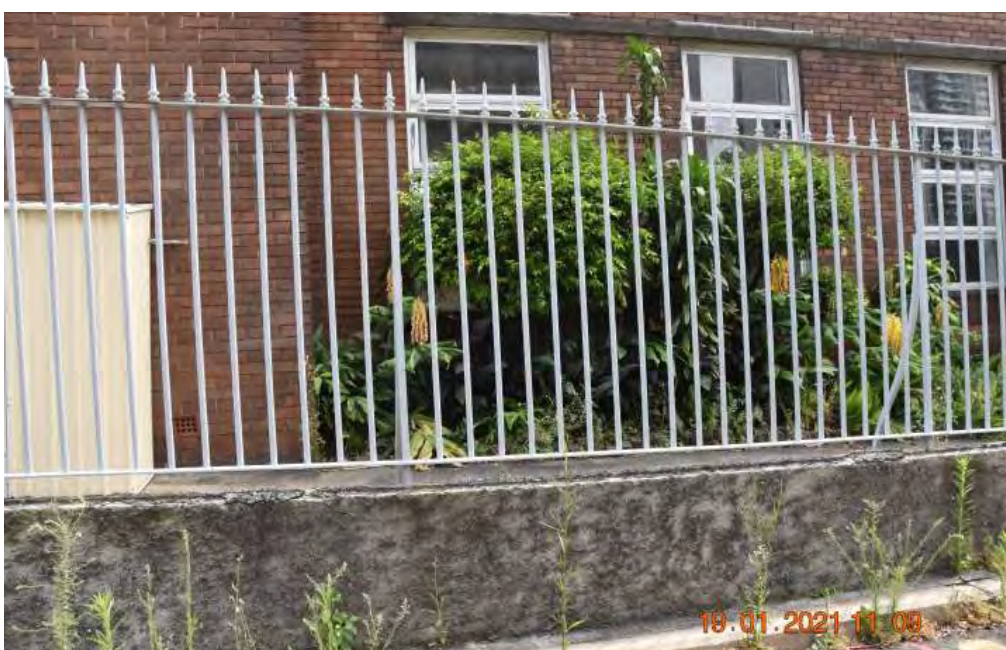
Figure: 1175

Fence on the south side of building A.

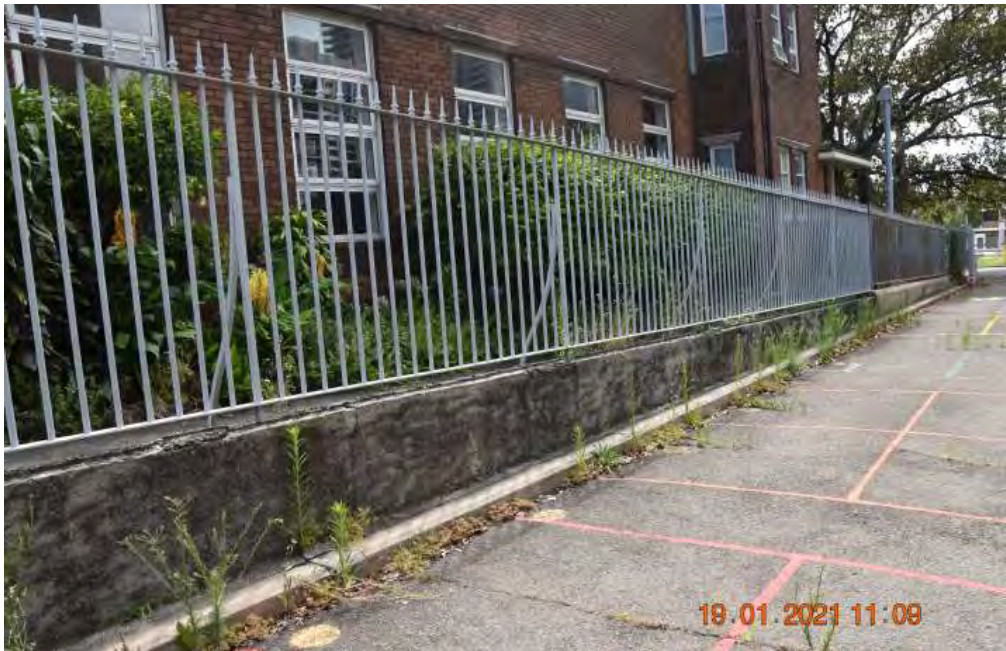
Figure: 1176

Fence on the south side of building A.

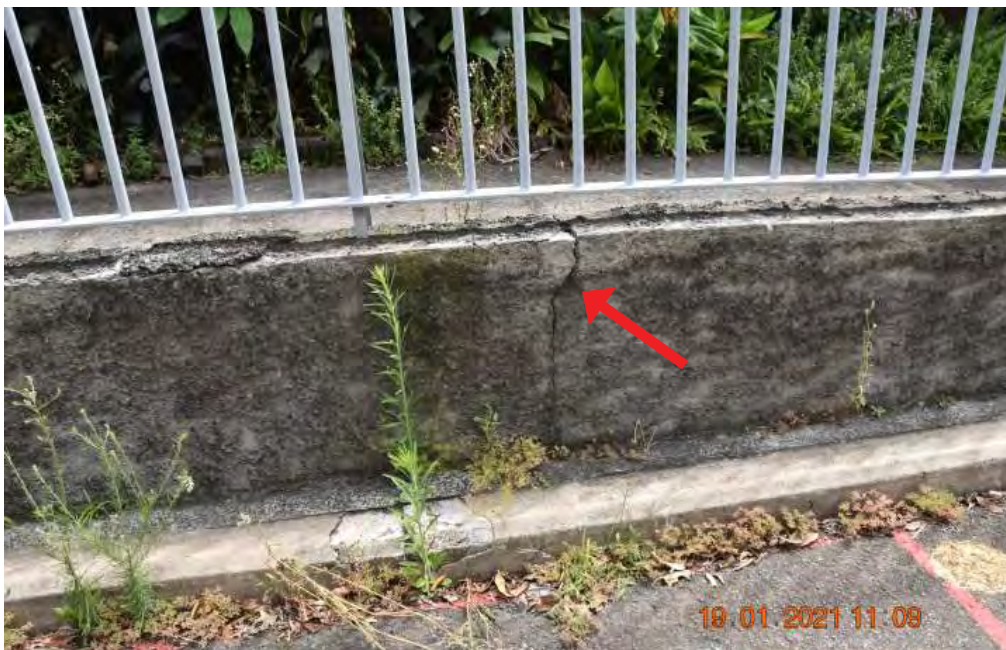
Figure: 1177

Fence on the south side of building A.

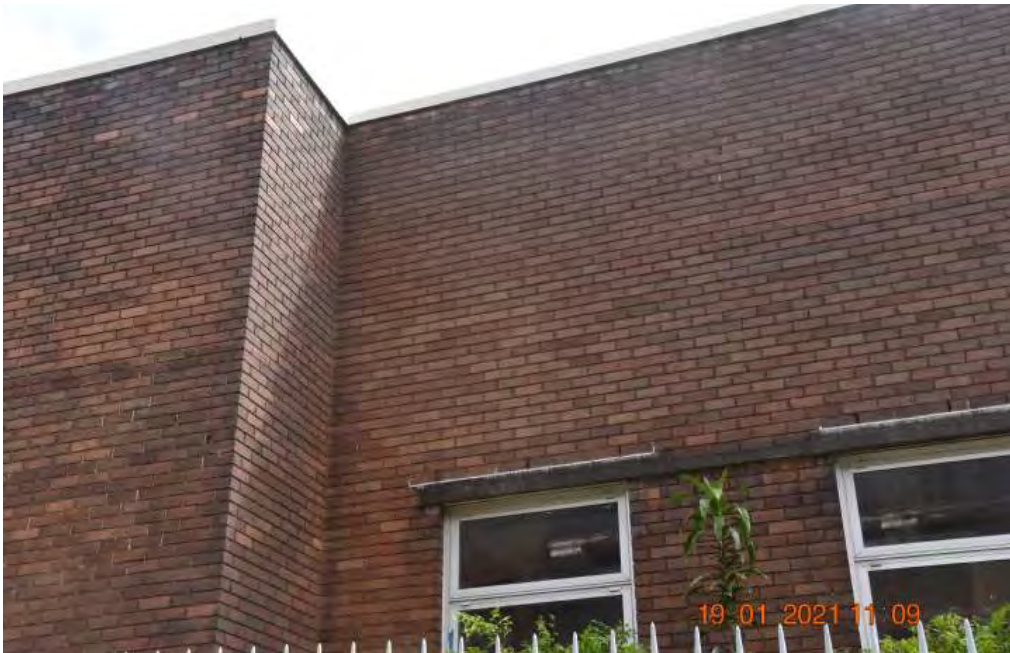
Figure: 1180

South wall of building  
A.

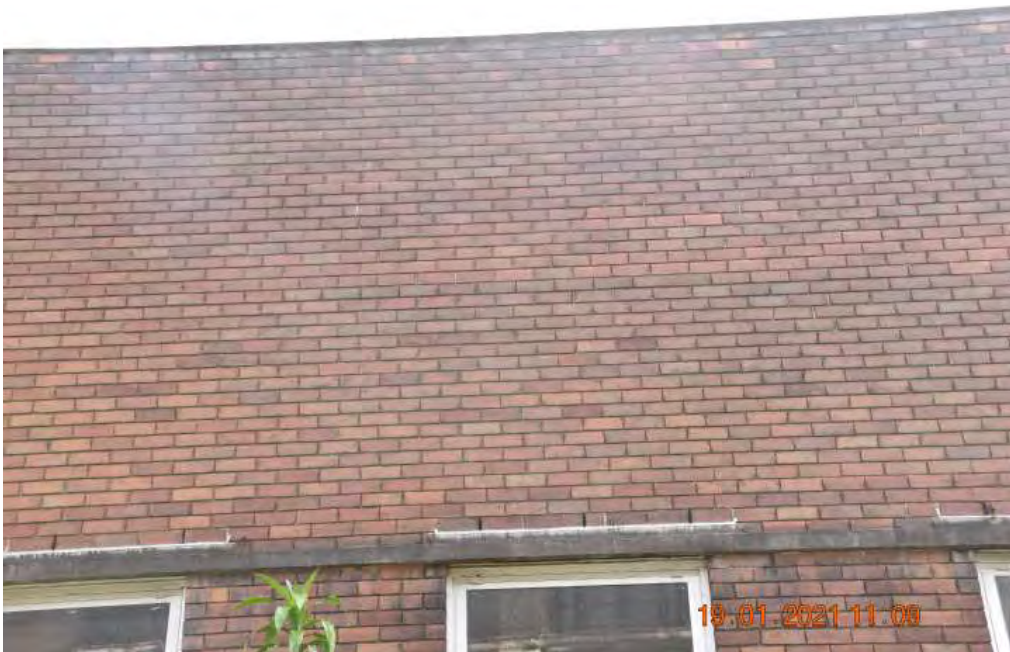
Figure: 1181

South wall of building  
A.

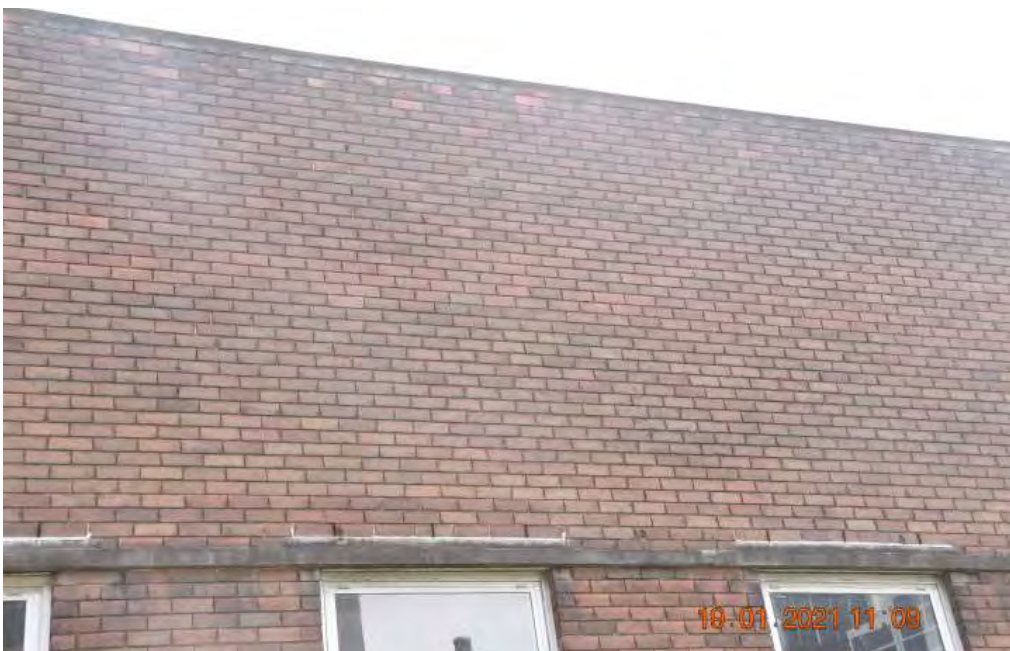
Figure: 1182

South wall of building  
A.

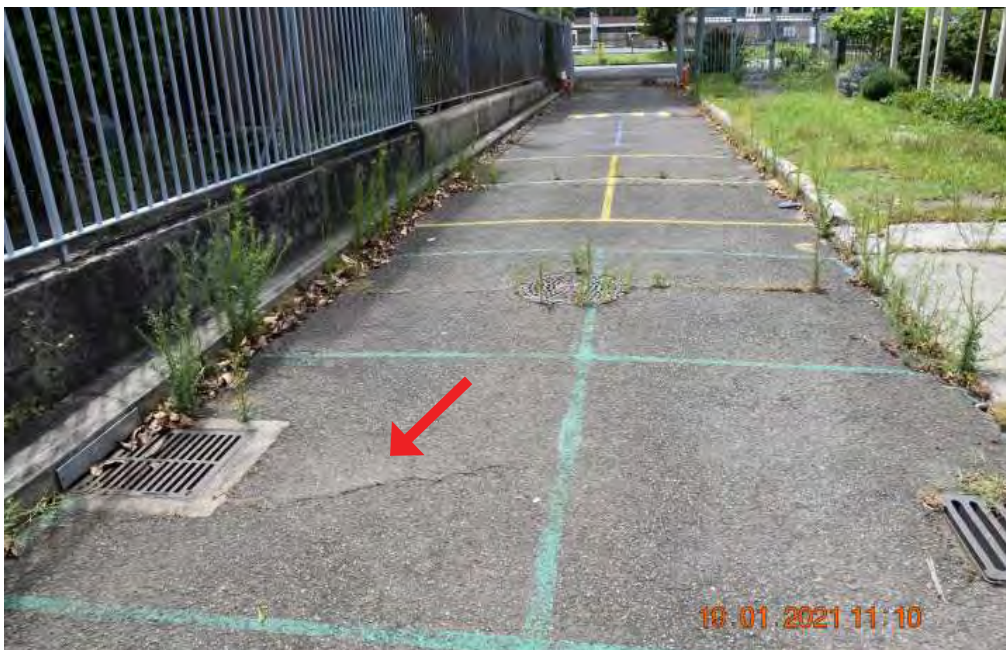
Figure: 1183

Cracking in the driveway on the south side of building A.

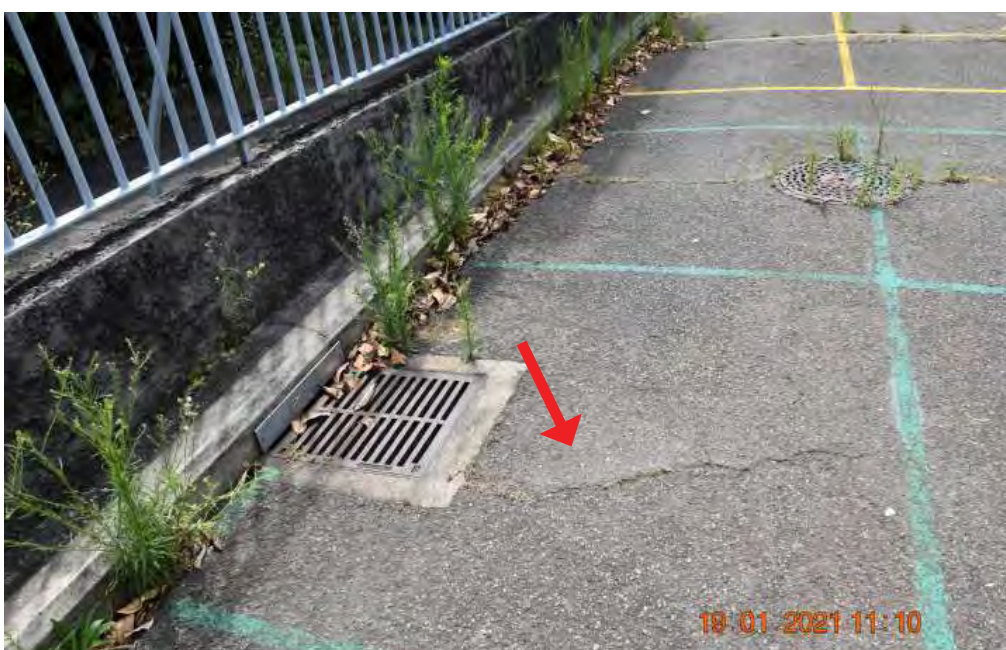
Figure: 1184

General view of the driveway on the south side of building A. Showing cracking.

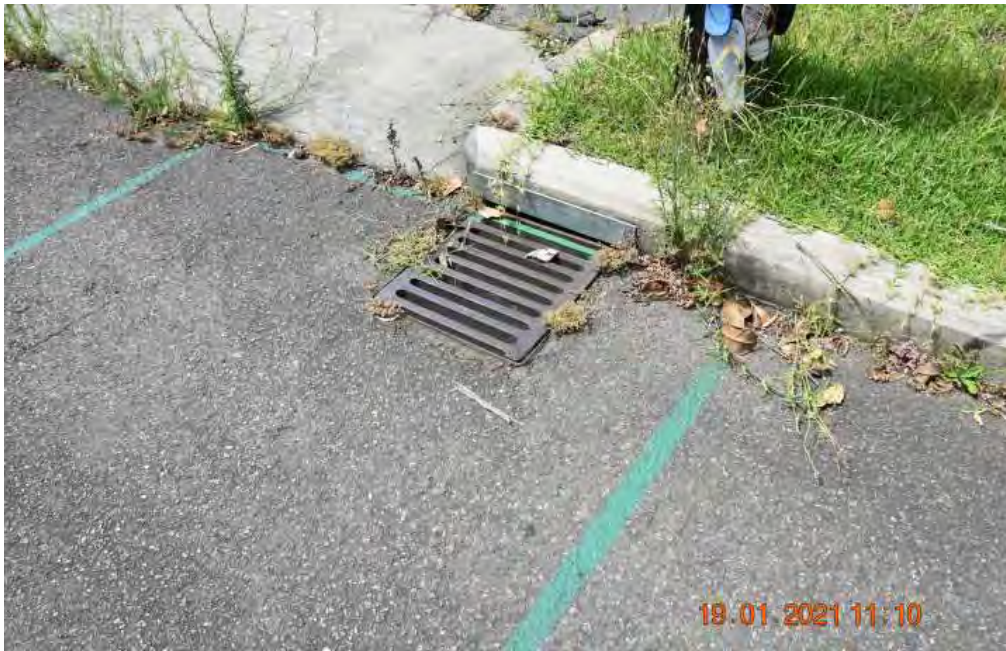
Figure: 1185

General view of the storm drain in the driveway on the south side of building A. Showing cracking.

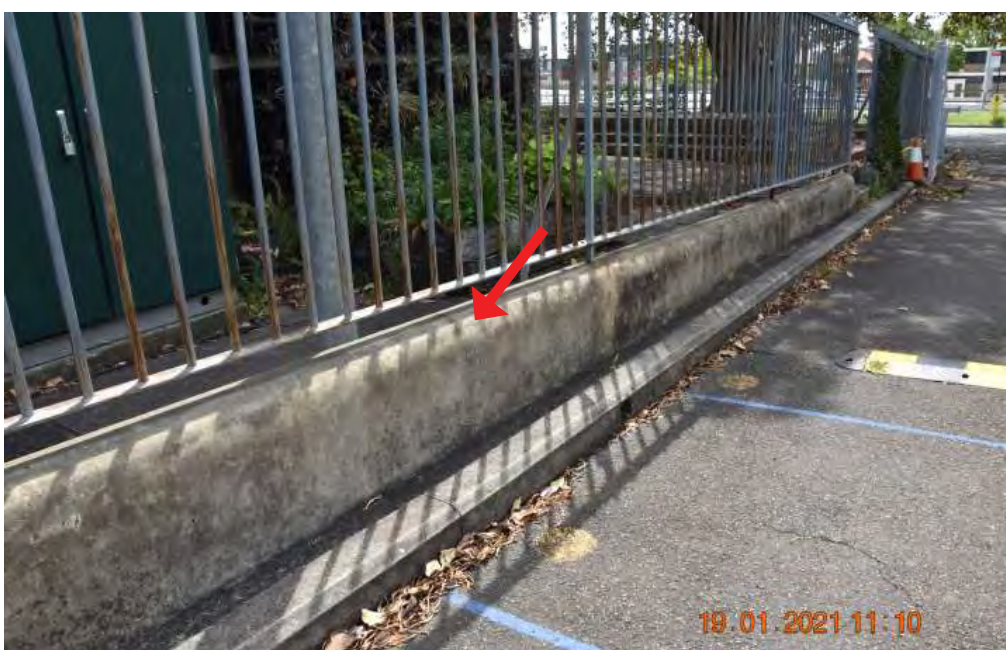
Figure: 1196

Cracking in the base of the fence on the south side of building A.

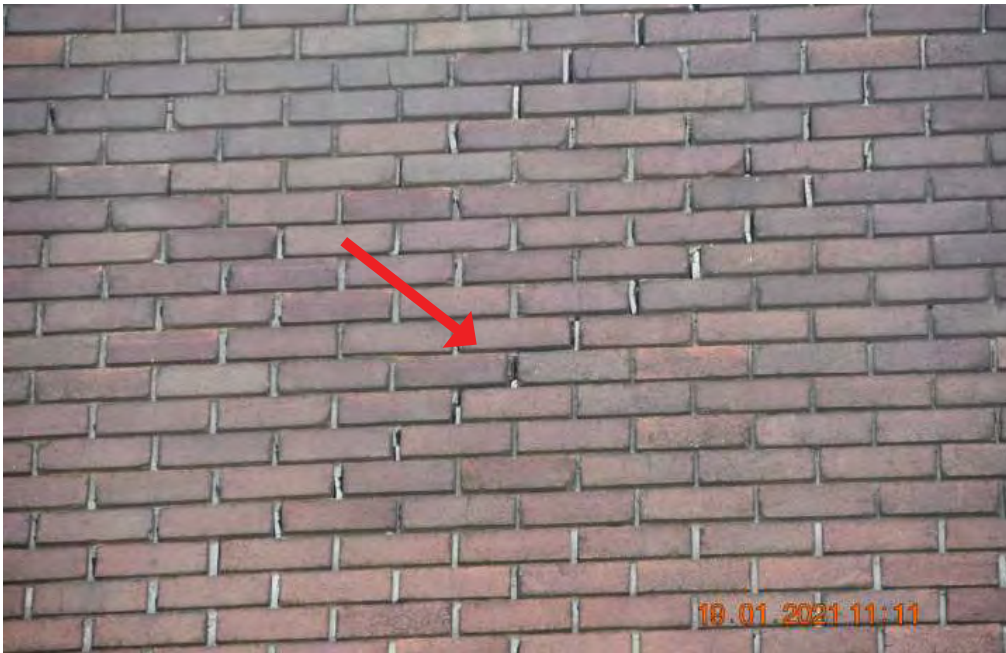
Figure: 1201

Stepped cracking in the south wall of building A.

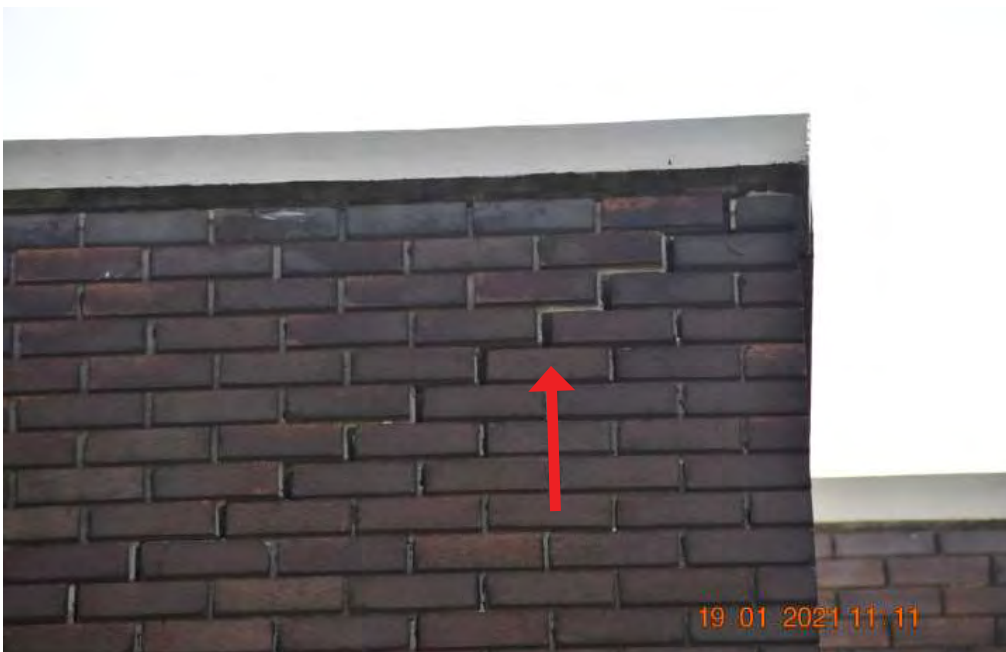
Figure: 1202

Stepped cracking in the south wall of building A.
