## PRE CONSTRUCTION CONDITION SURVEY

Fort Street Public School, Millers Point NSW

Upper Fort Street Public School  
MILLERS POINT NSW 2000

19 January 2021

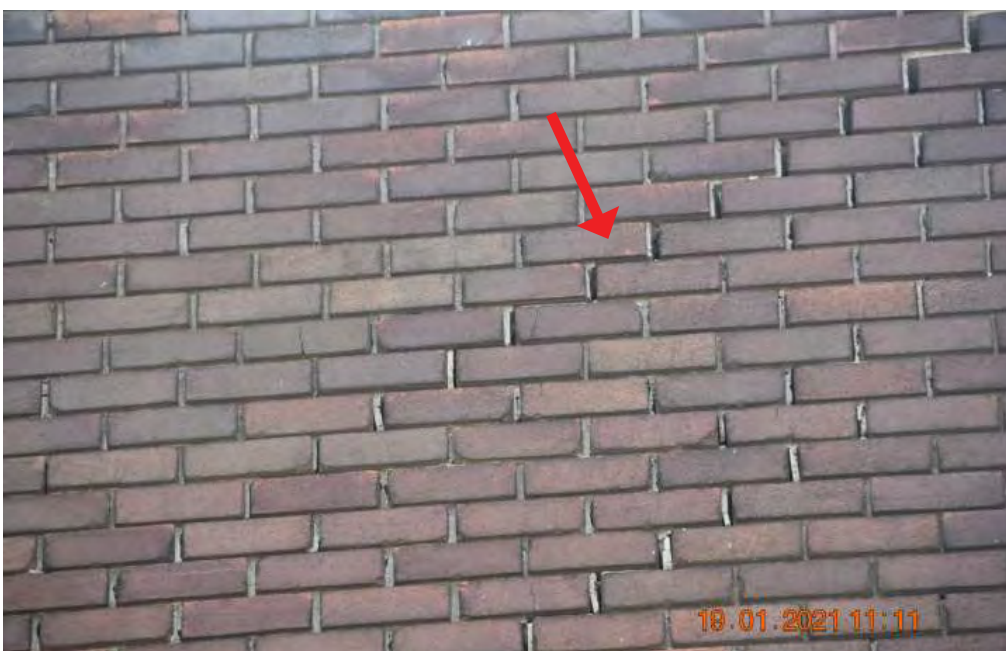
Figure: 1203

Stepped cracking in the south wall of building A.

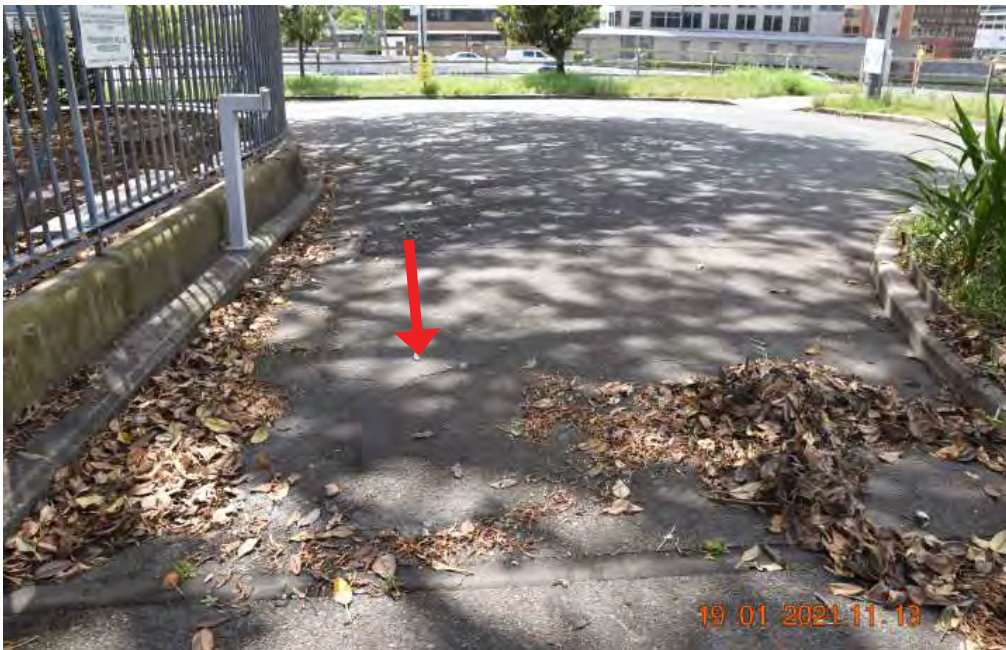
Figure: 1220

Cracking in the driveway on the south side of building A.

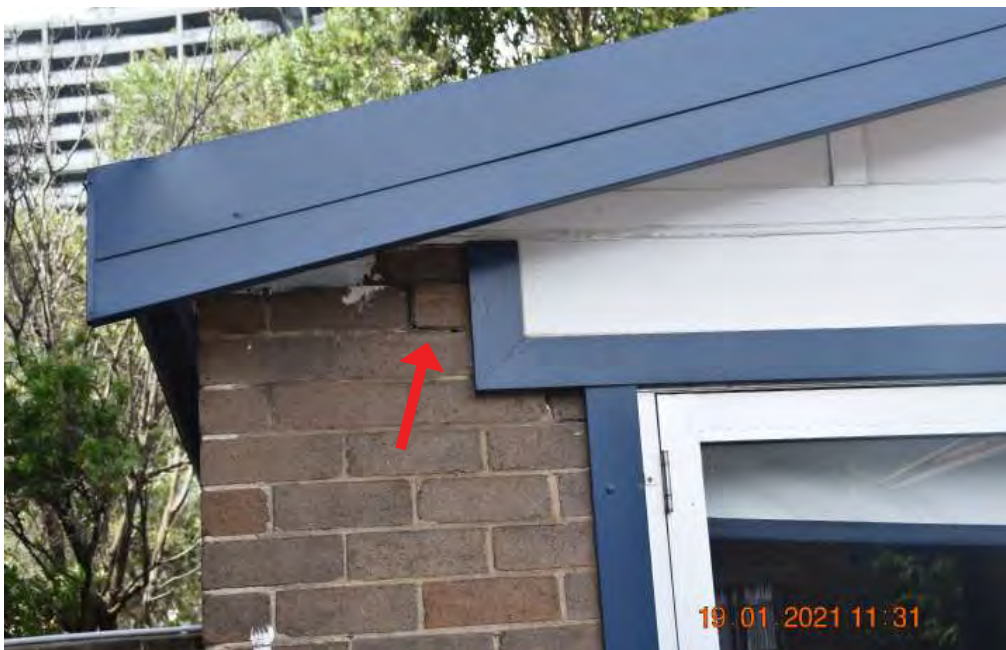
Figure: 1225

Slight stepped cracking in the north wall of building F.

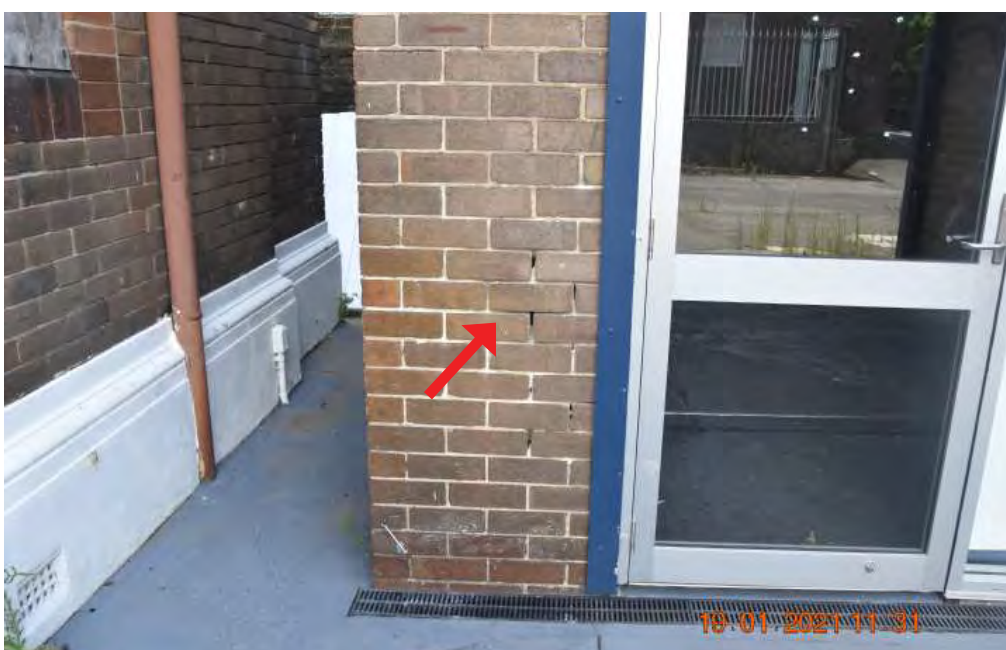
Figure: 1226

Erosion in the mortar joints in the north wall of building F.

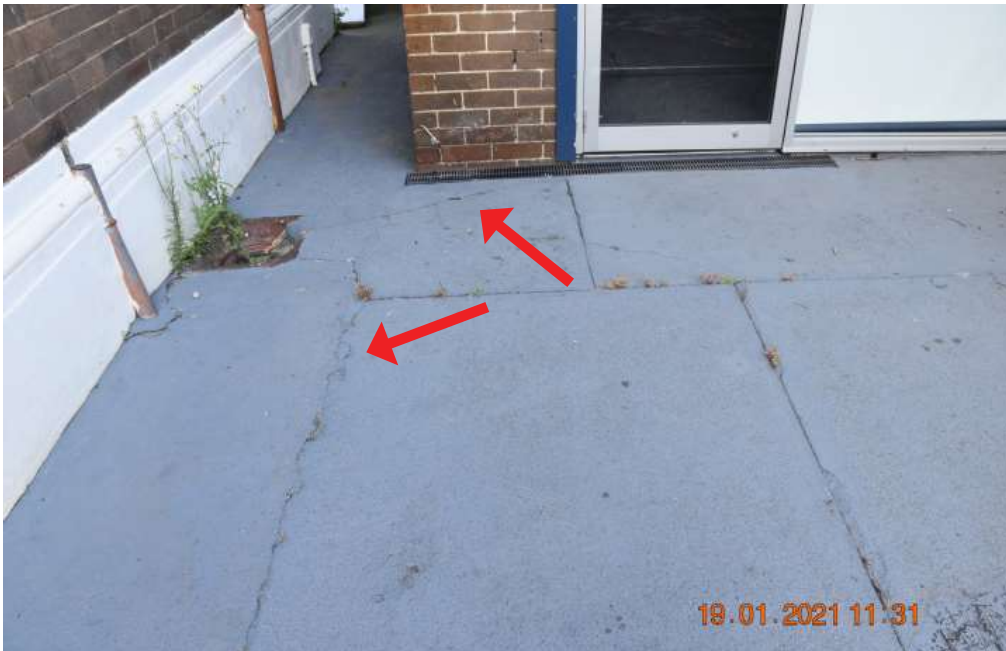
Figure: 1228

Cracking in the paving on the west side of building B.

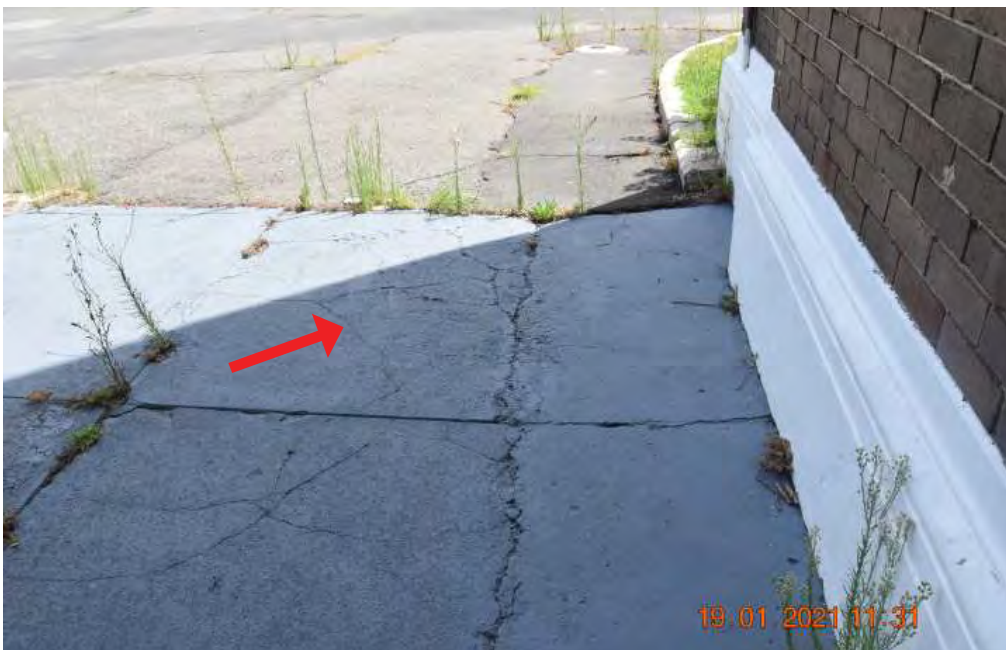
Figure: 1229

Cracking in the paving on the west side of building B.

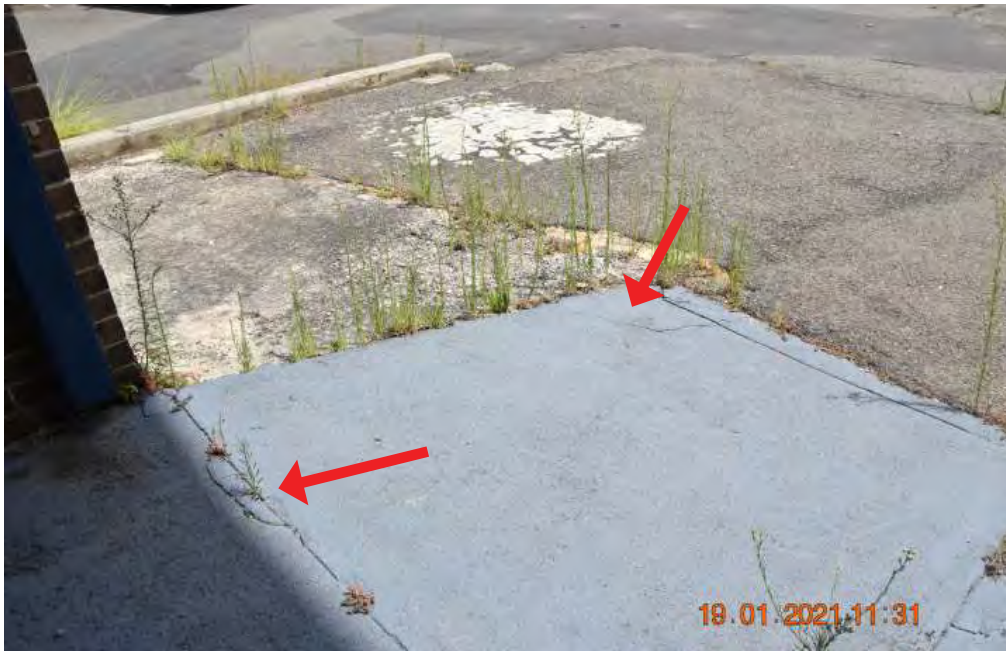
Figure: 1230

Cracking in the paving on the west side of building B.

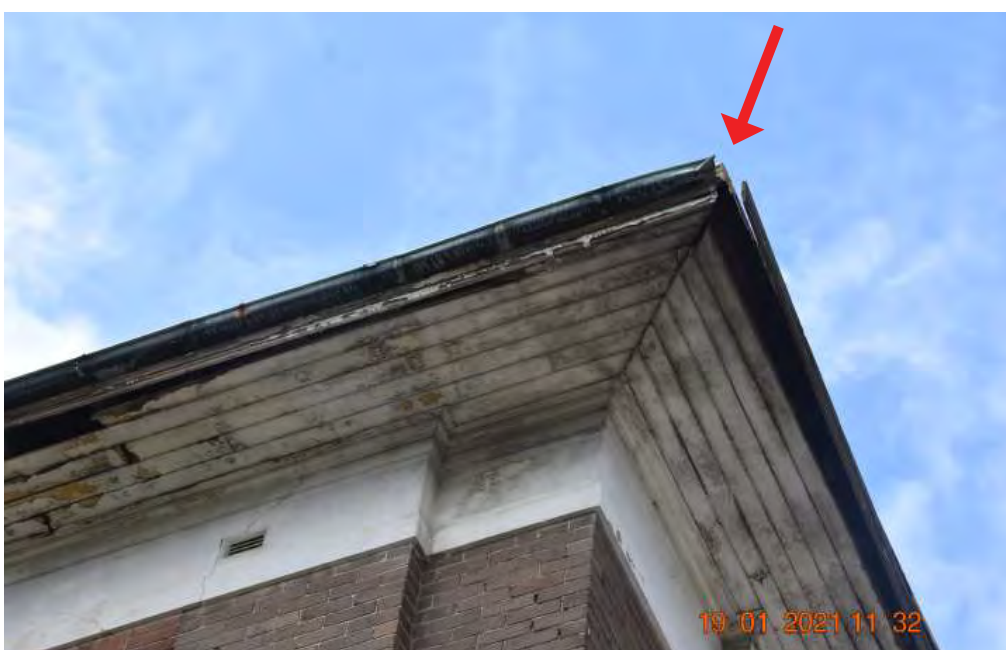
Figure: 1236

Damage in the soffit on the north side of building B.

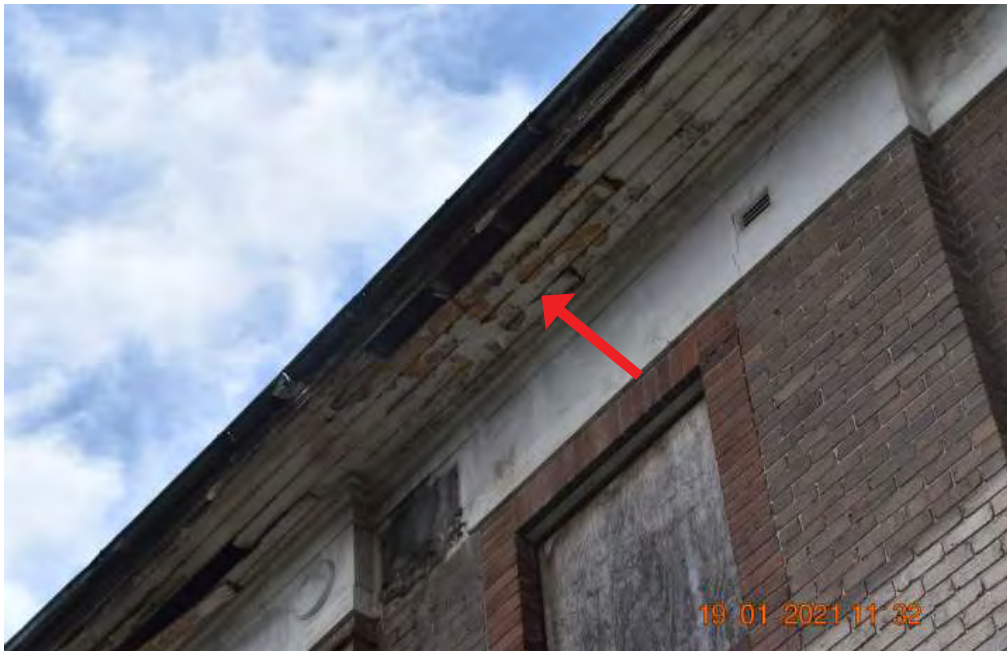
Figure: 1237

Damage in the soffit on the north side of building B.

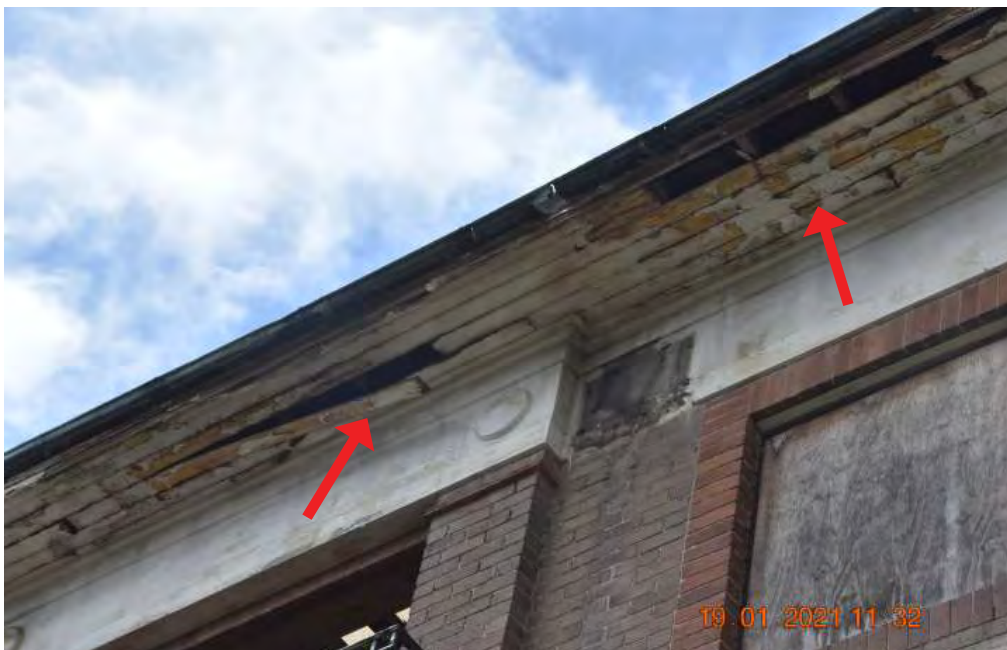
Figure: 1238

Damage in the soffit on the north side of building B.

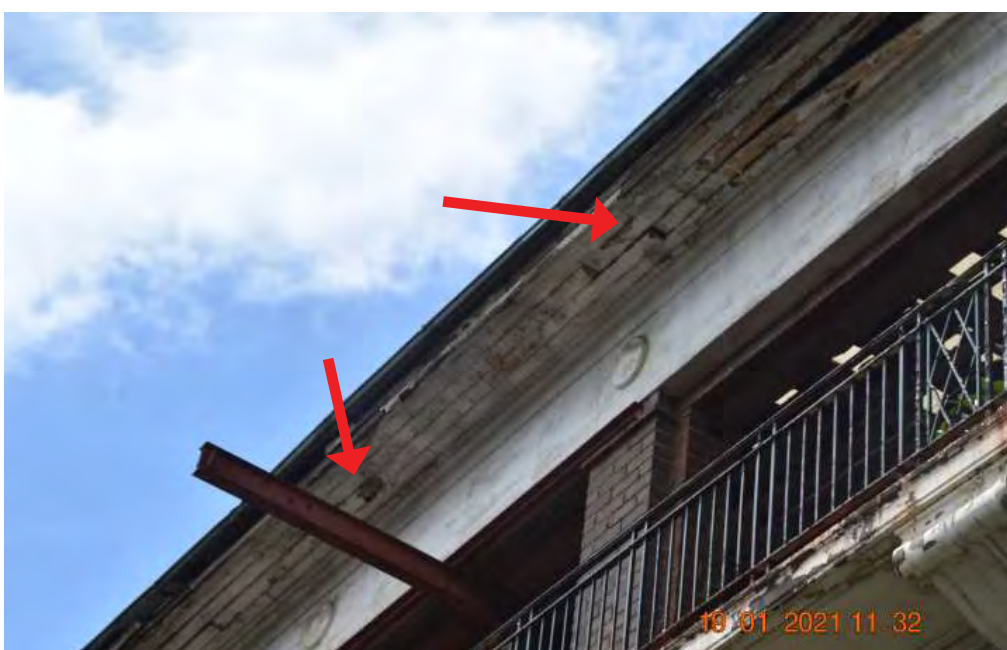
Figure: 1239

North wall of building B, west side. Showing cracking.

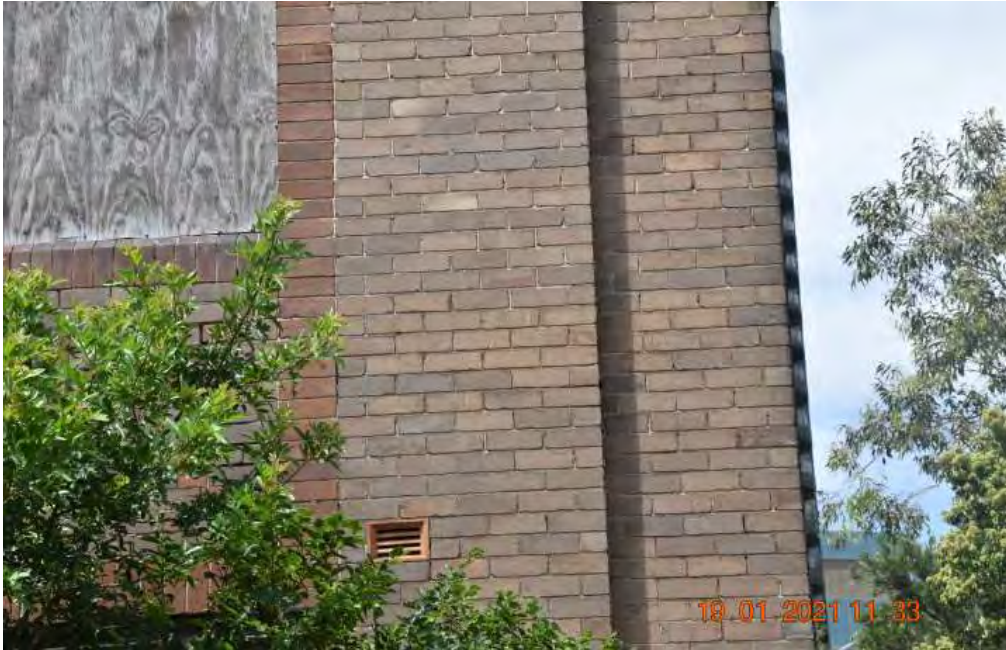
Figure: 1243

North wall of building B, west side. Showing erosion in the mortar joints.

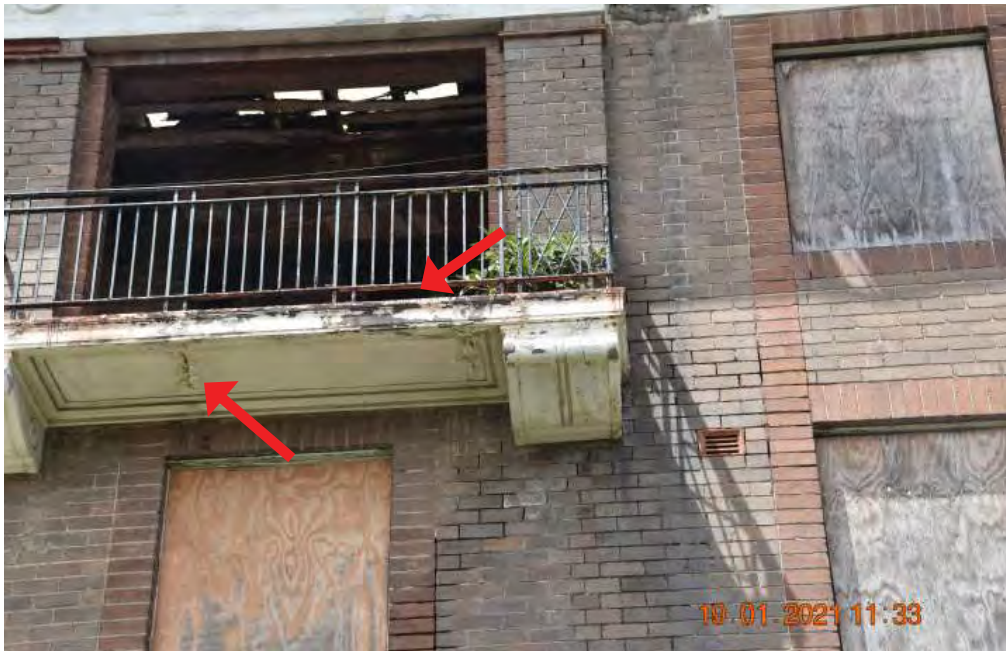
Figure: 1245

North wall of building B. Showing corrosion in the balcony.

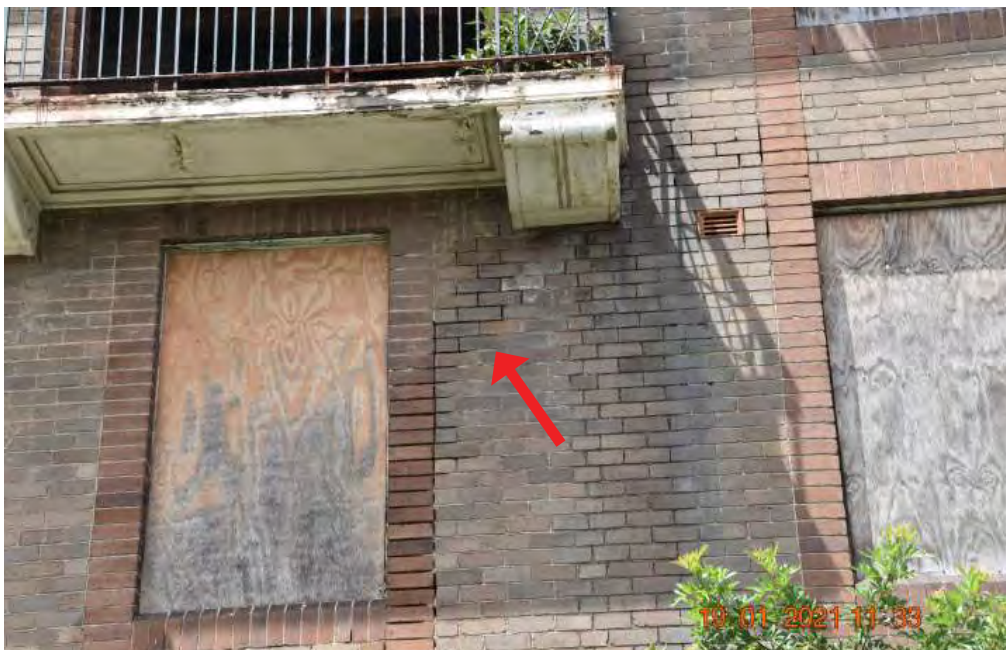
Figure: 1246

North wall of building B. Showing erosion in the mortar joints.

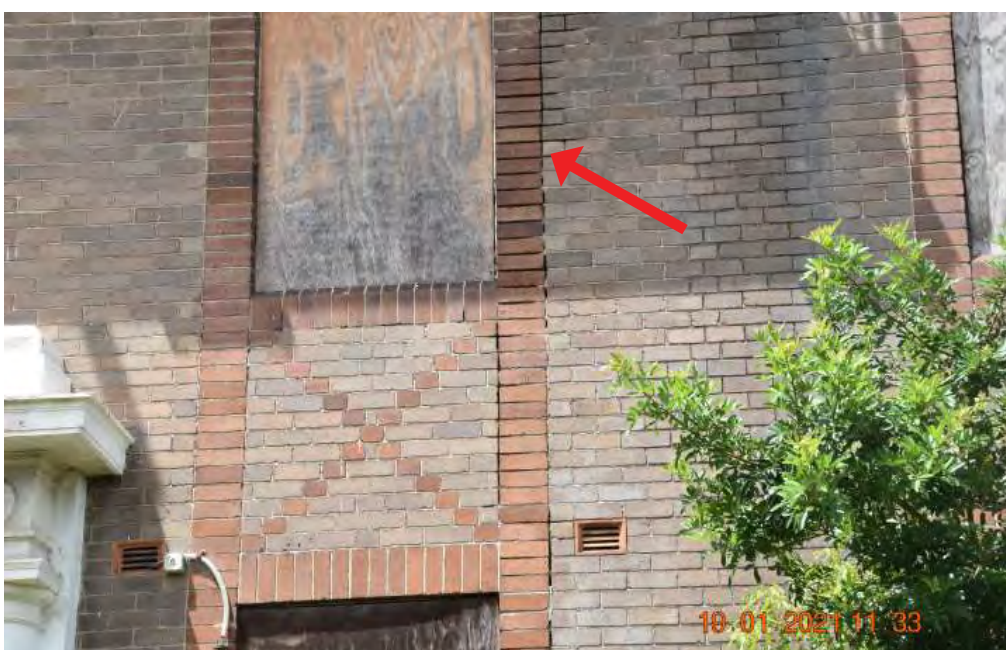
Figure: 1247

North wall of building B. Showing erosion in the mortar joints.

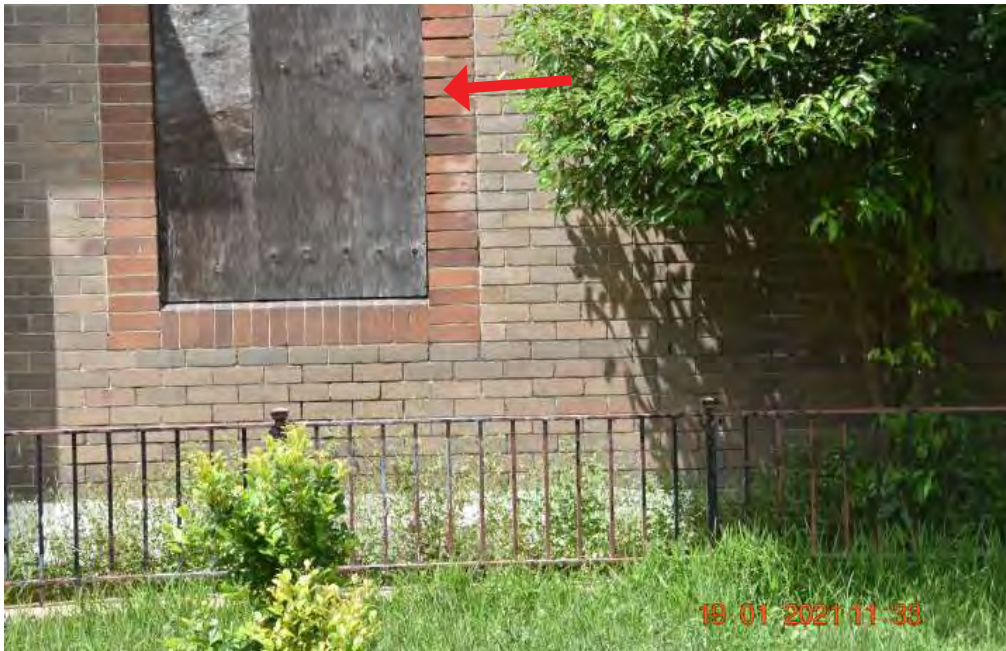
Figure: 1248

North wall of building B. Showing erosion in the mortar joints.

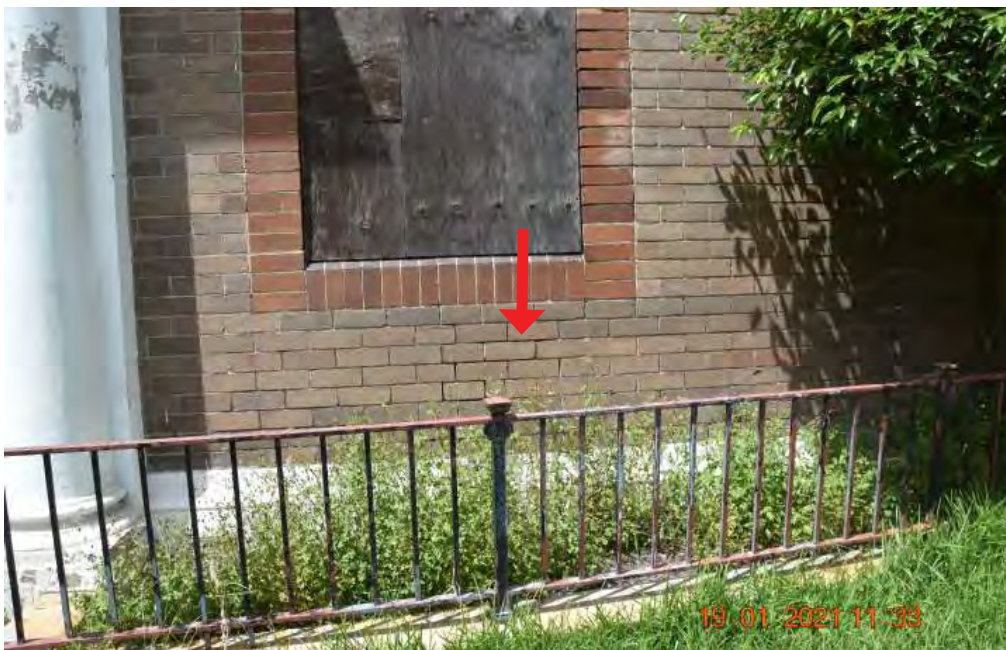
Figure: 1249

North wall of building B. Showing erosion in the mortar joints.

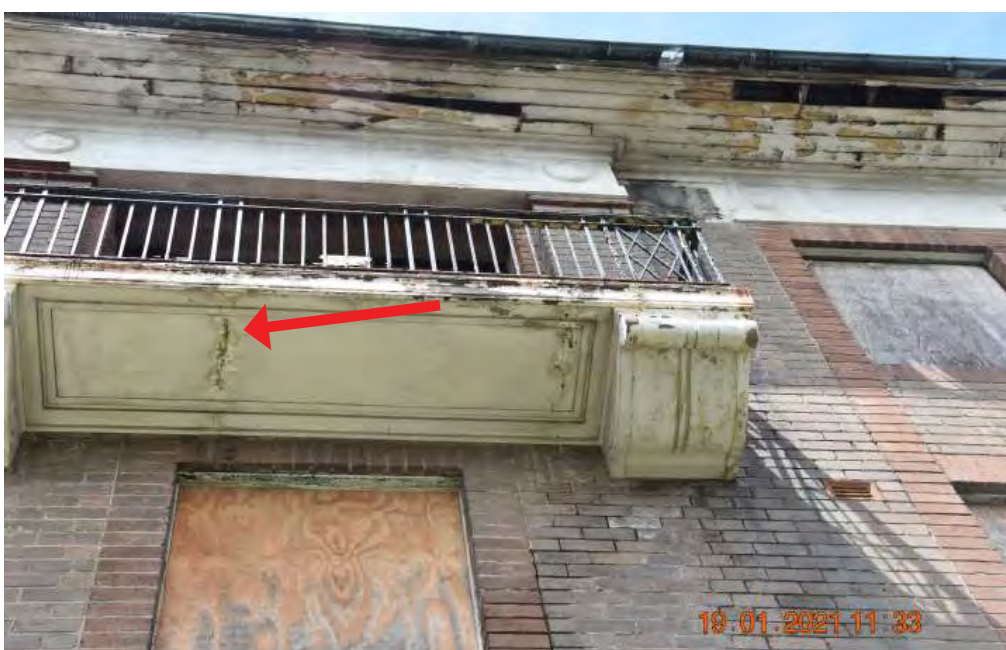
Figure: 1250

Cracking on the underside of the balcony, on the north side of building B.

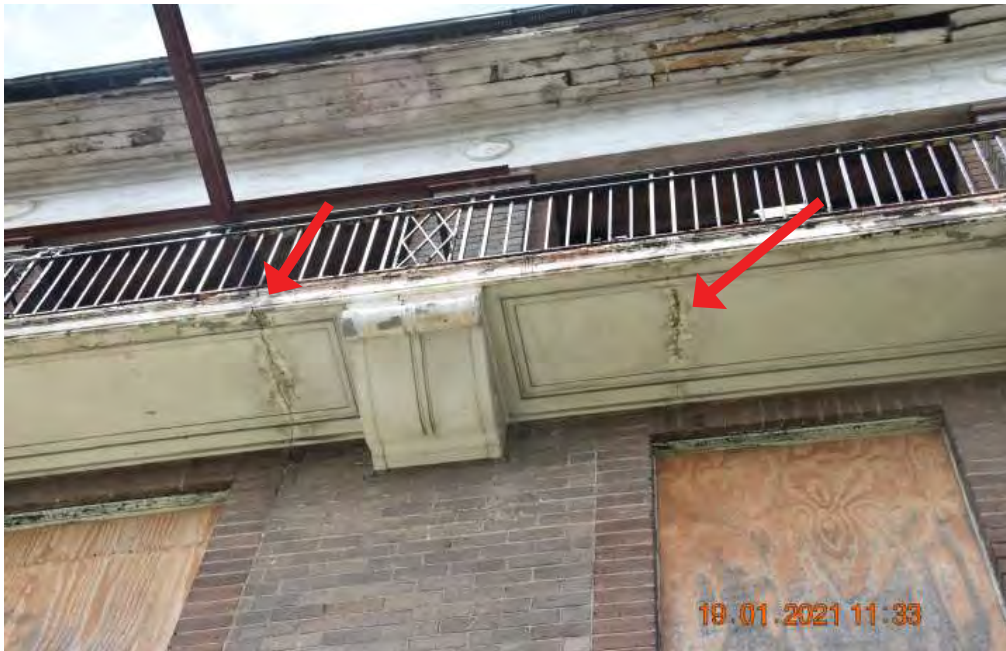
Figure: 1251

Cracking on the underside of the balcony, on the north side of building B.

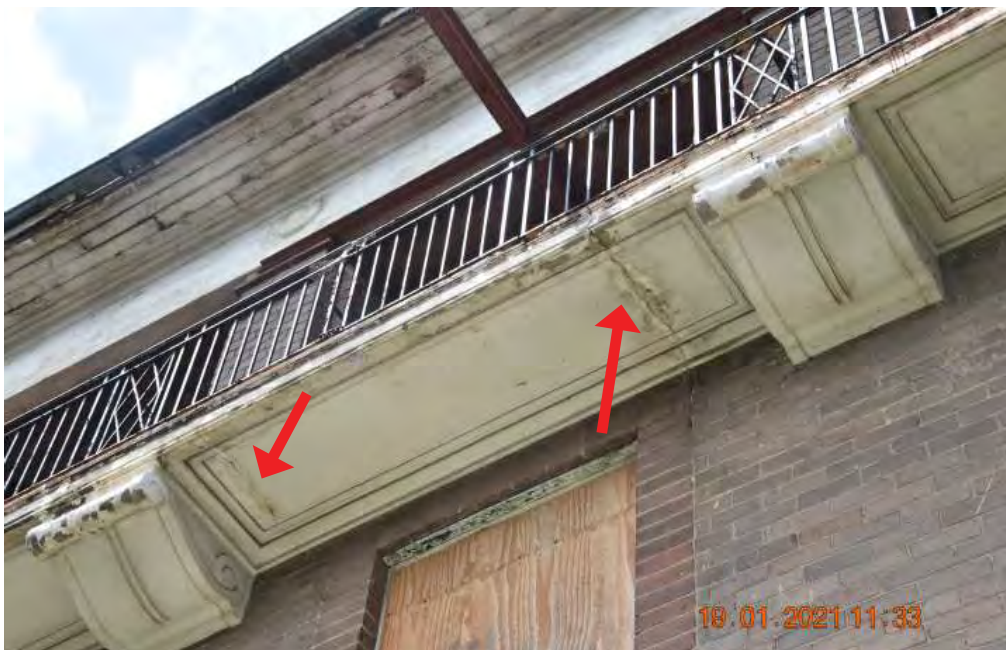
Figure: 1252

Cracking on the underside of the balcony, on the north side of building B.

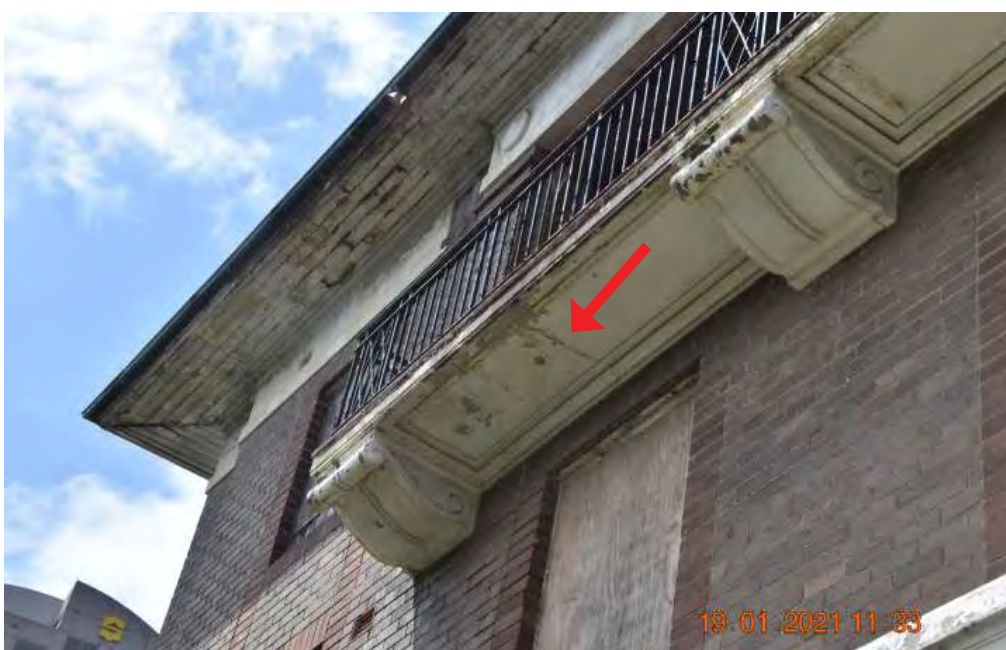
Figure: 1253

Cracking on the underside of the balcony, on the north side of building B.

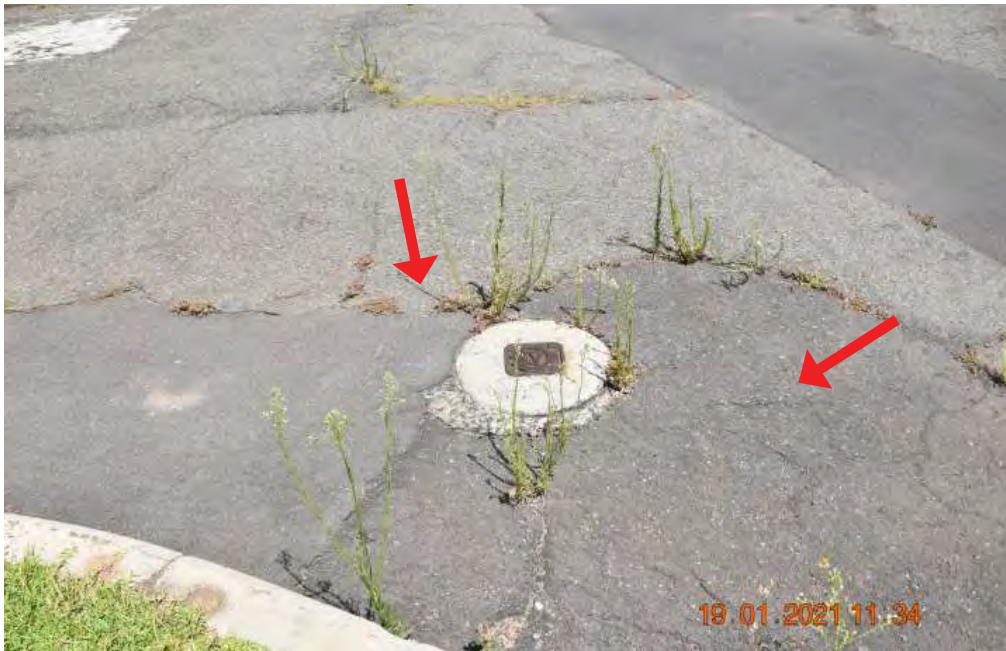
Figure: 1254

General view of the pit lid in the paving at the northwest corner of building B. Showing cracking.

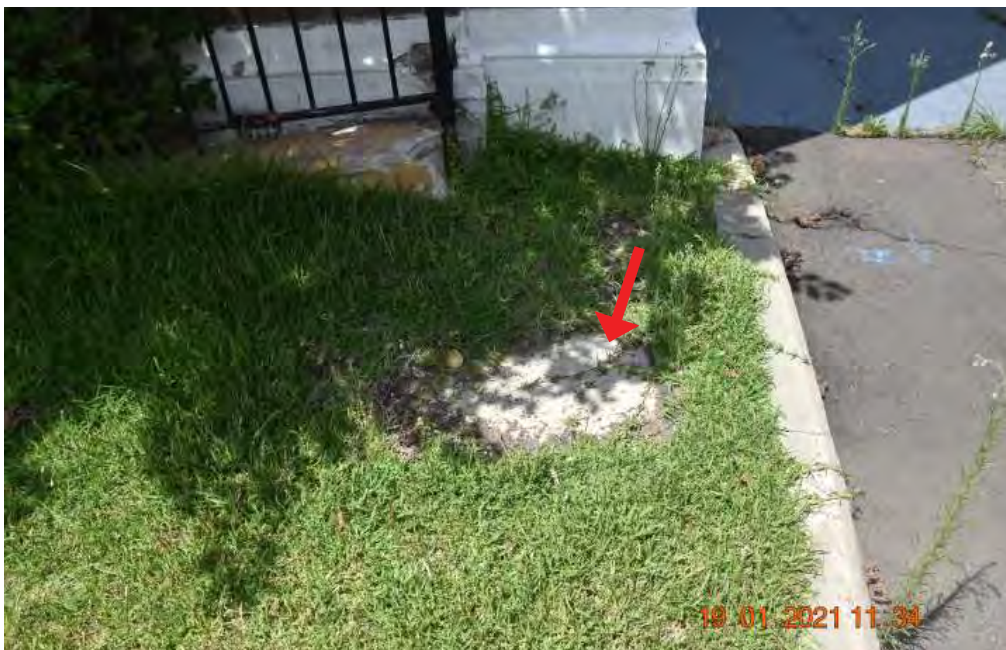
Figure: 1255

General view of the pit lid in the grass area at the northwest corner of building B. Showing cracking.

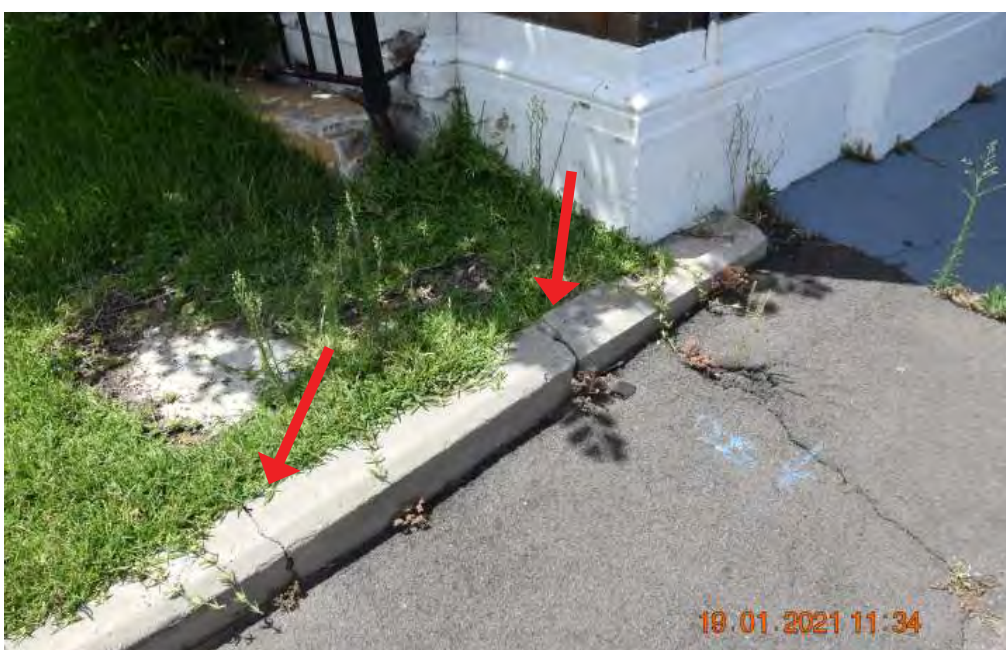
Figure: 1256

Cracking in the kerb at the northwest corner of building B.

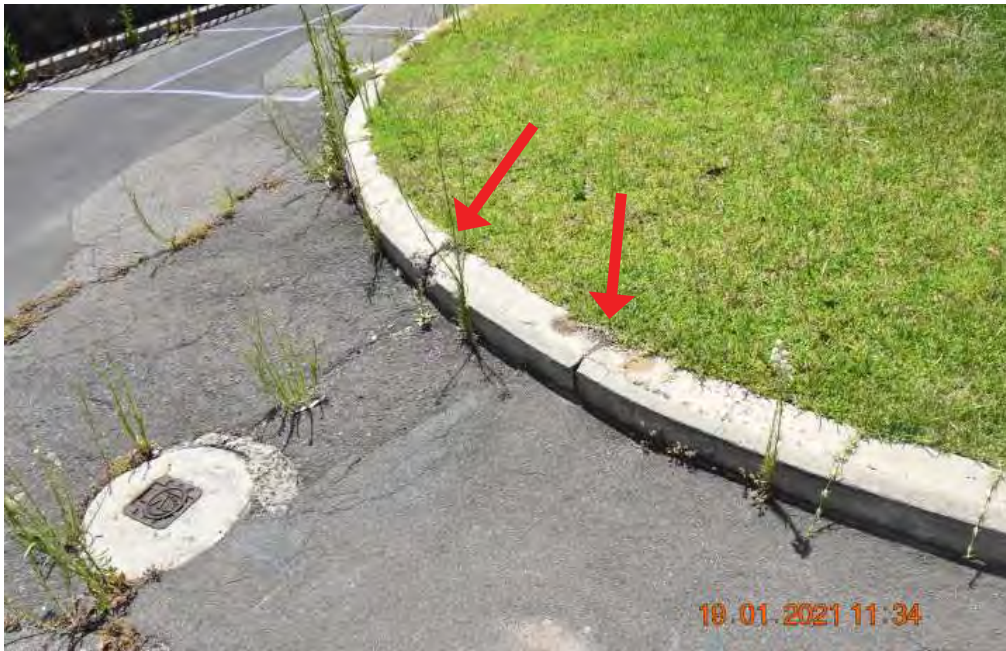
Figure: 1257

Cracking and chipping in the kerb at the northwest corner of building B.

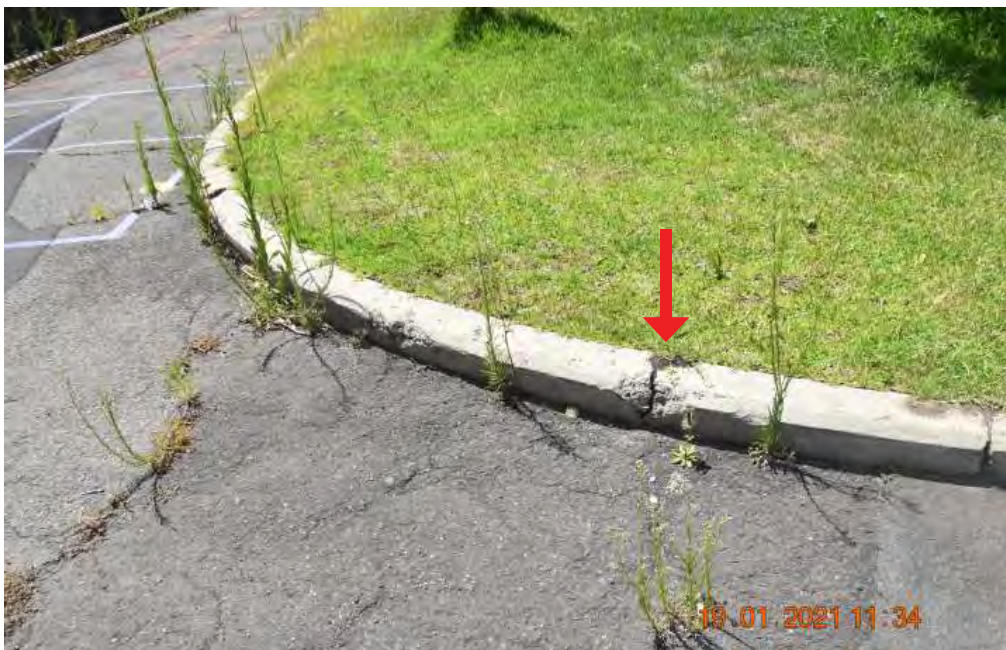
Figure: 1258

Chipping in the kerb at the northwest corner of building B.

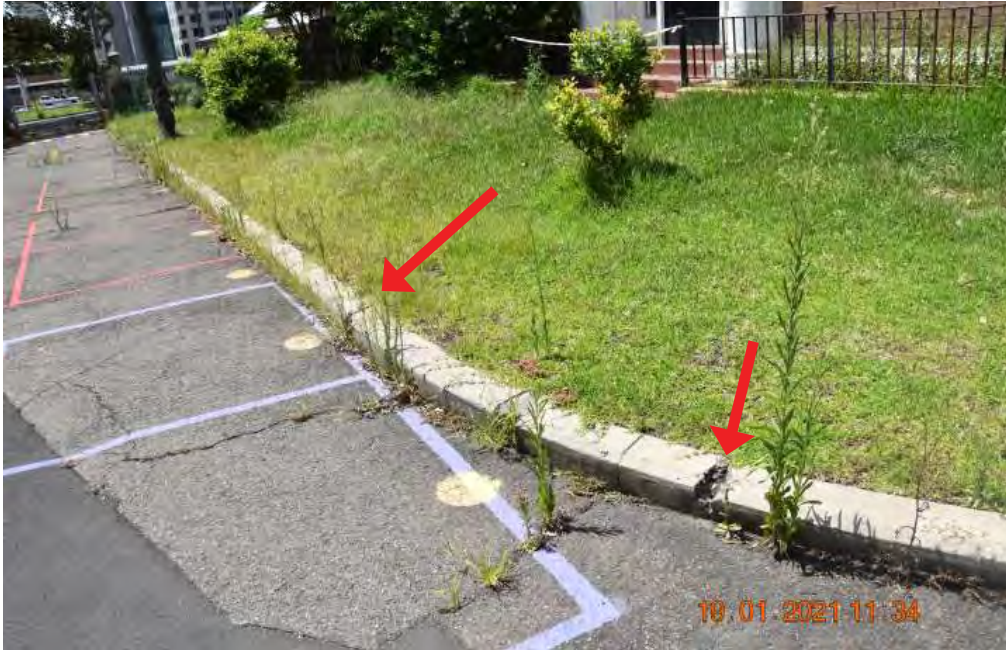
Figure: 1260

Chipping in the kerb on the north side of building B.

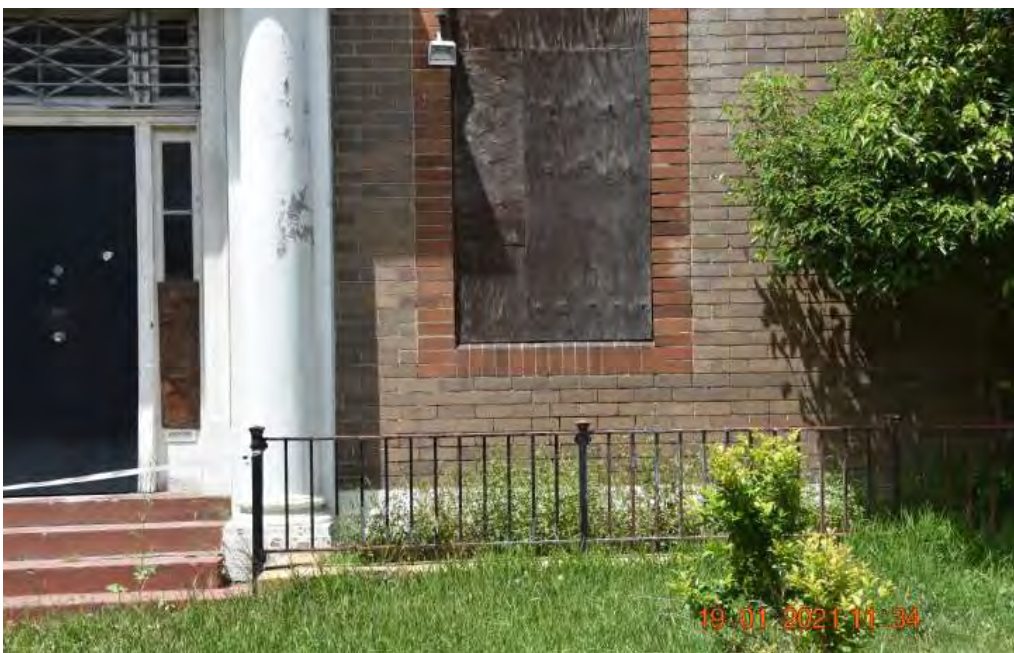
Figure: 1265

North wall of building B.

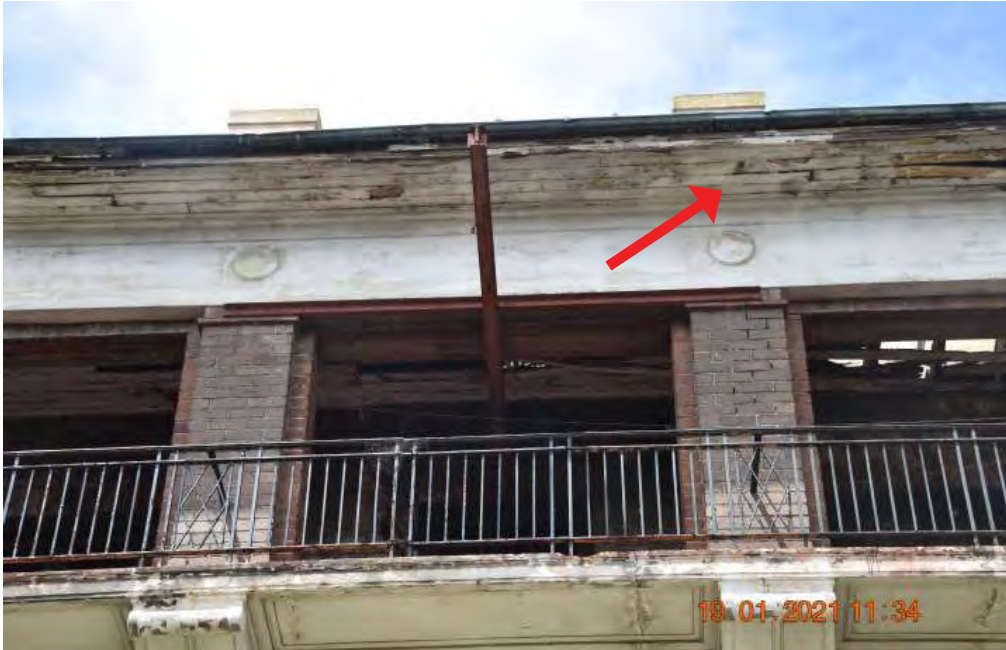
Figure: 1267

North wall of building B. Showing cracking in the underside of the balcony.

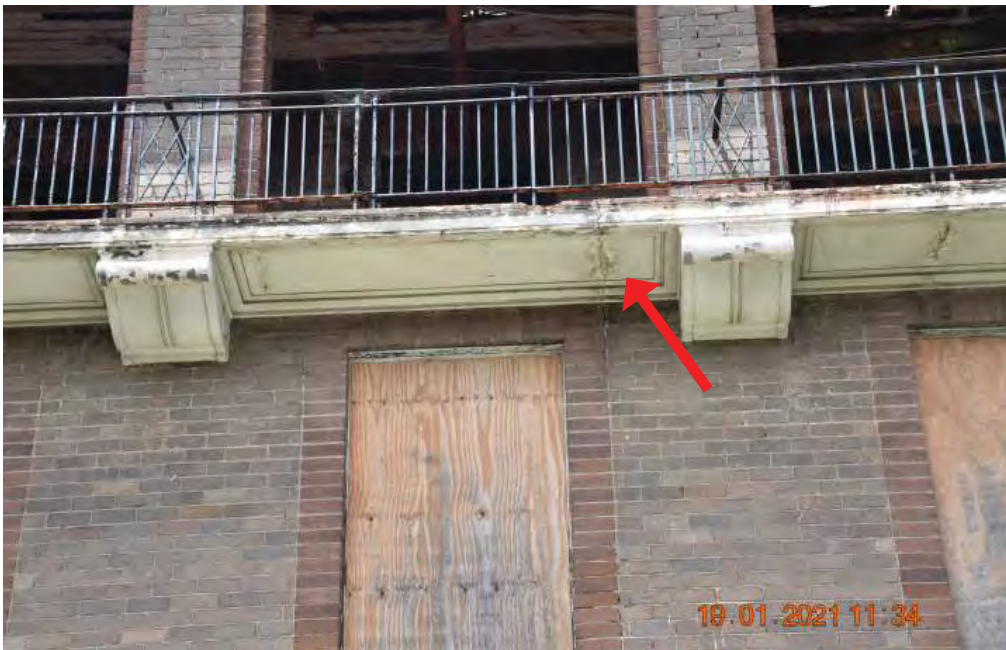
Figure: 1268

North wall of building B, outside the main entrance. Showing peeling paint.

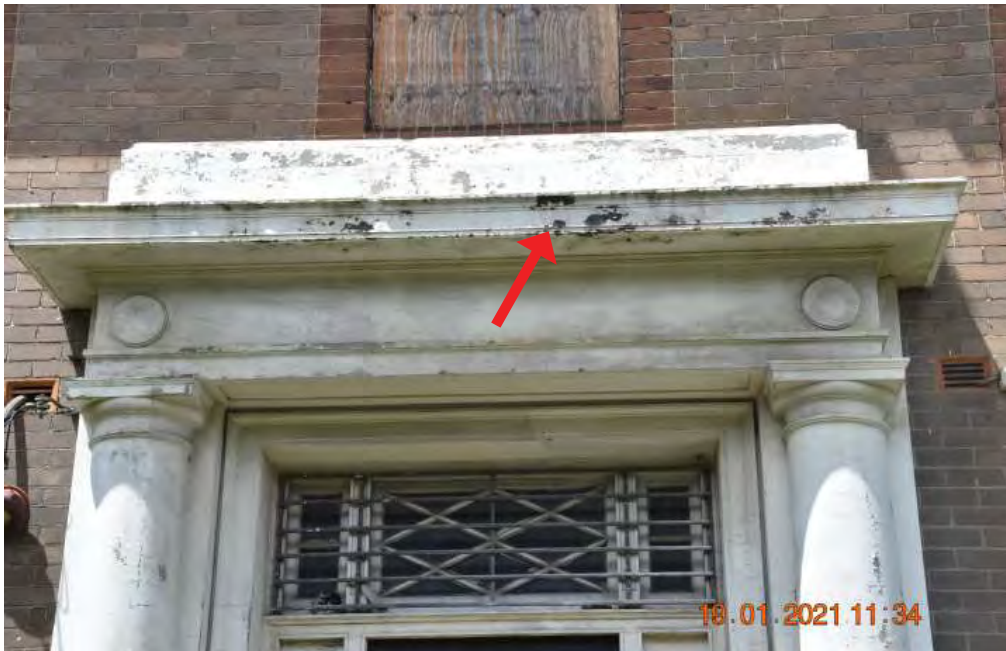
Figure: 1269

North wall of building B, outside the main entrance. Showing peeling paint.

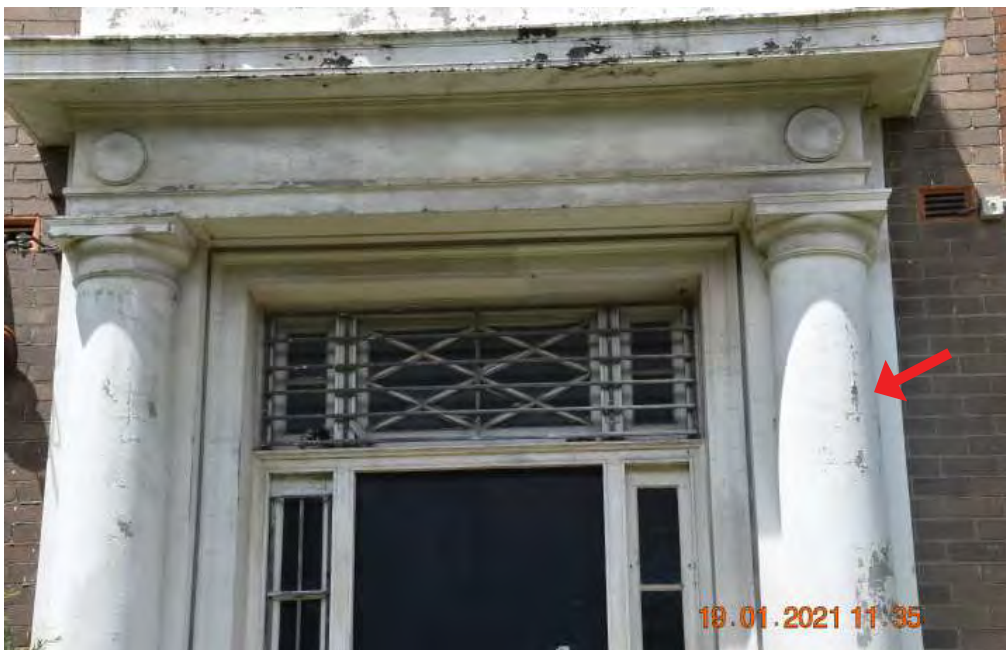
Figure: 1270

North wall of building B, outside the main entrance. Showing peeling paint.

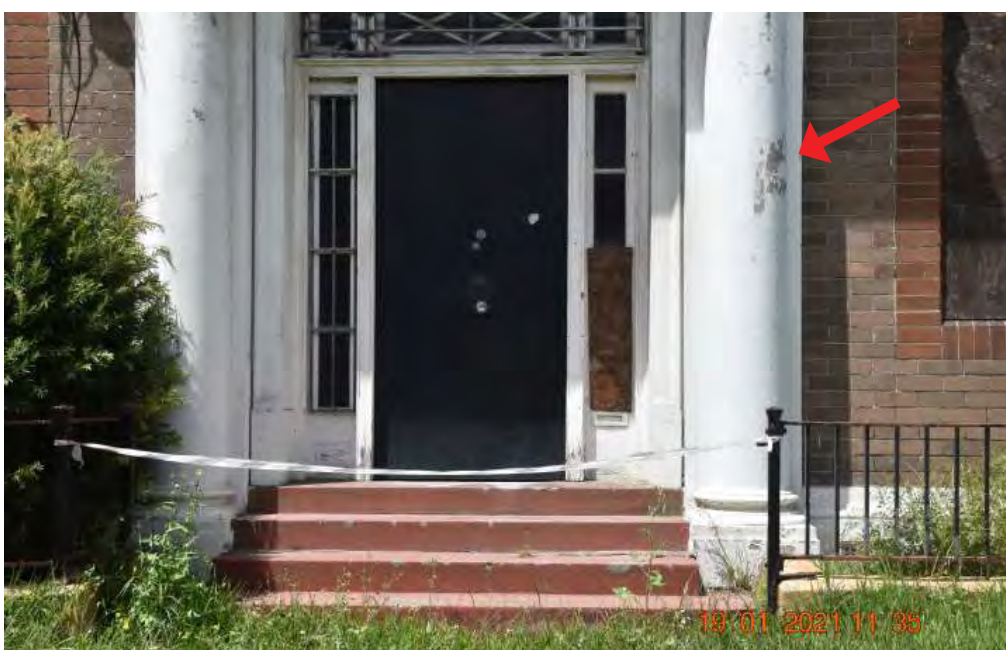
Figure: 1271

North wall of building B, outside the main entrance. Showing peeling paint.

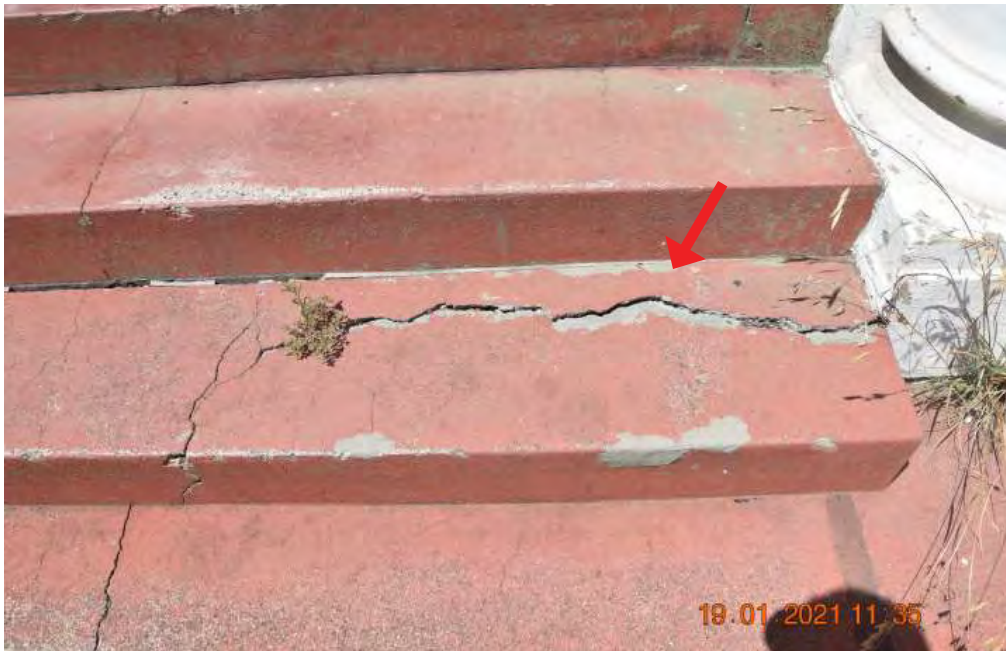
Figure: 1272

Wide cracking in the steps on the north side of building B, outside the entrance.
