## PRE CONSTRUCTION CONDITION SURVEY

Fort Street Public School, Millers Point NSW

Upper Fort Street Public School  
MILLERS POINT NSW 2000

19 January 2021

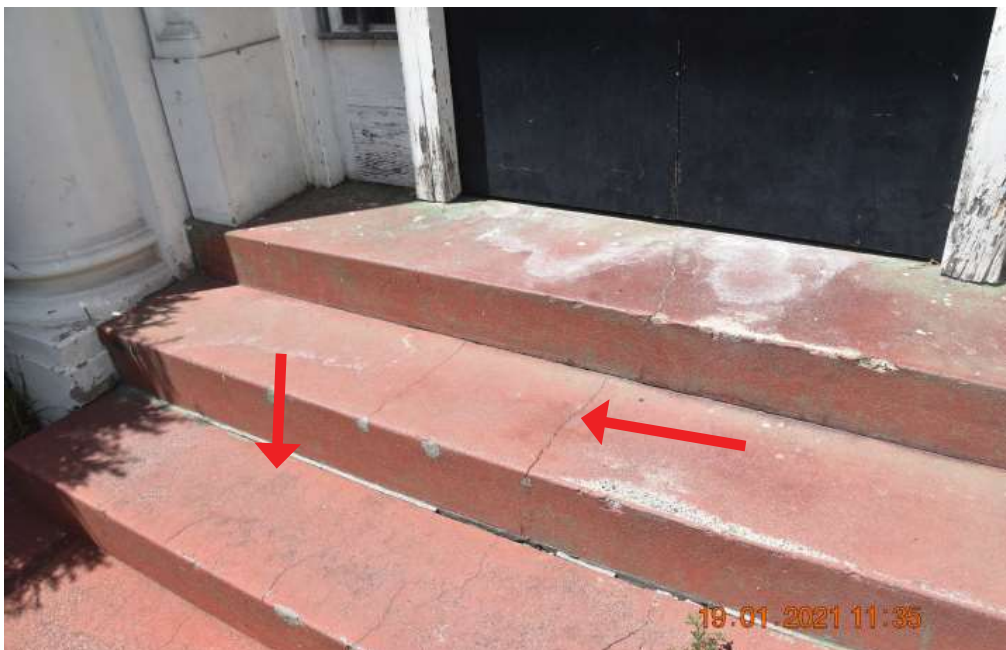
Figure: 1273

Crazing and cracking in the steps on the north side of building B, outside the entrance.

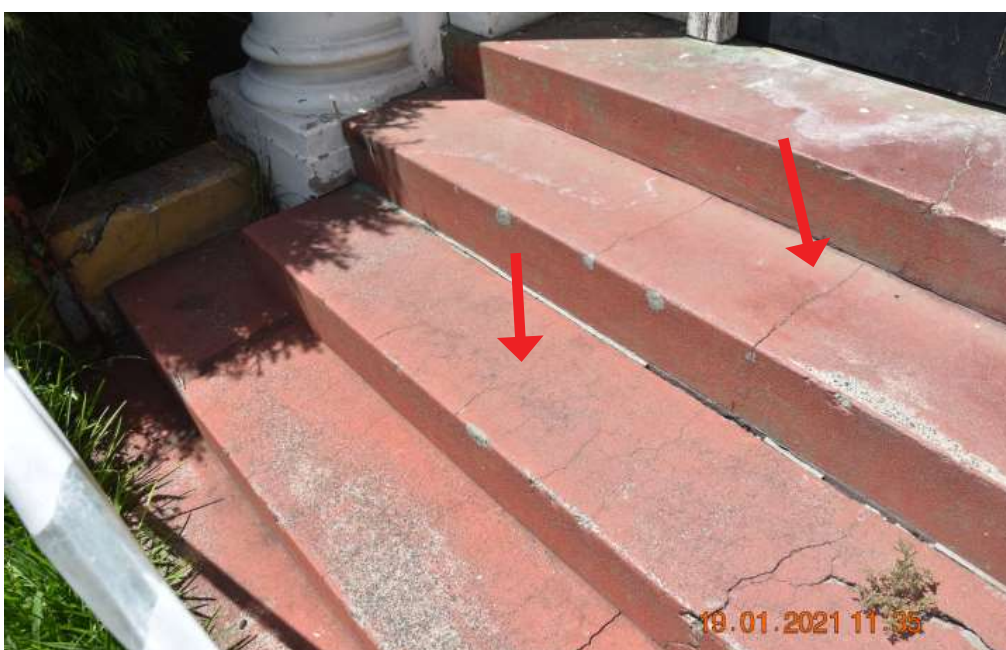
Figure: 1274

Crazing and cracking in the steps on the north side of building B, outside the entrance.

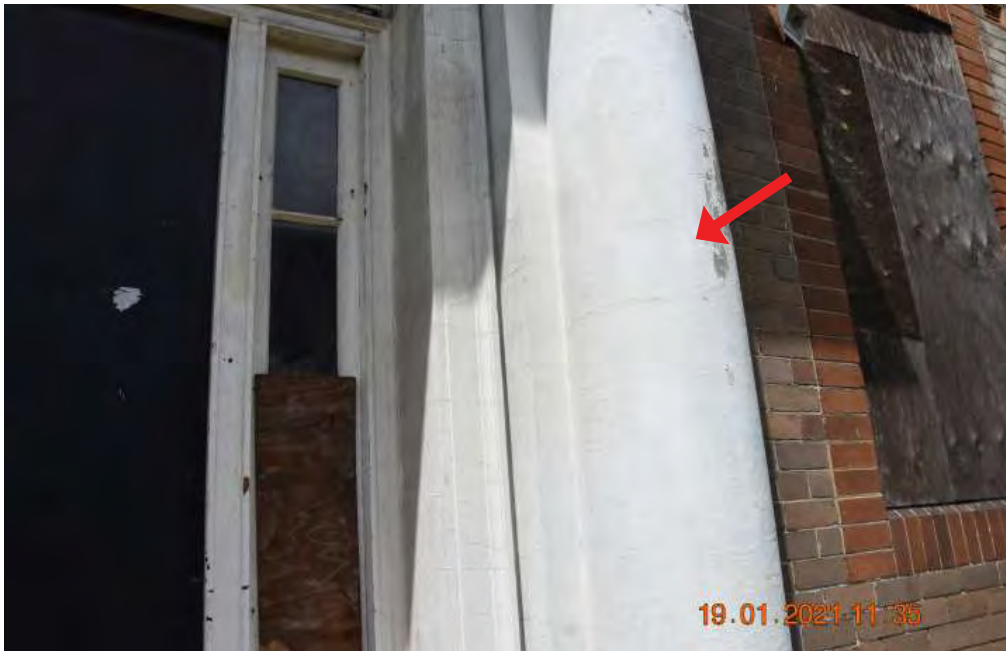
Figure: 1275

Crazing in the north wall of building B, outside the entrance.

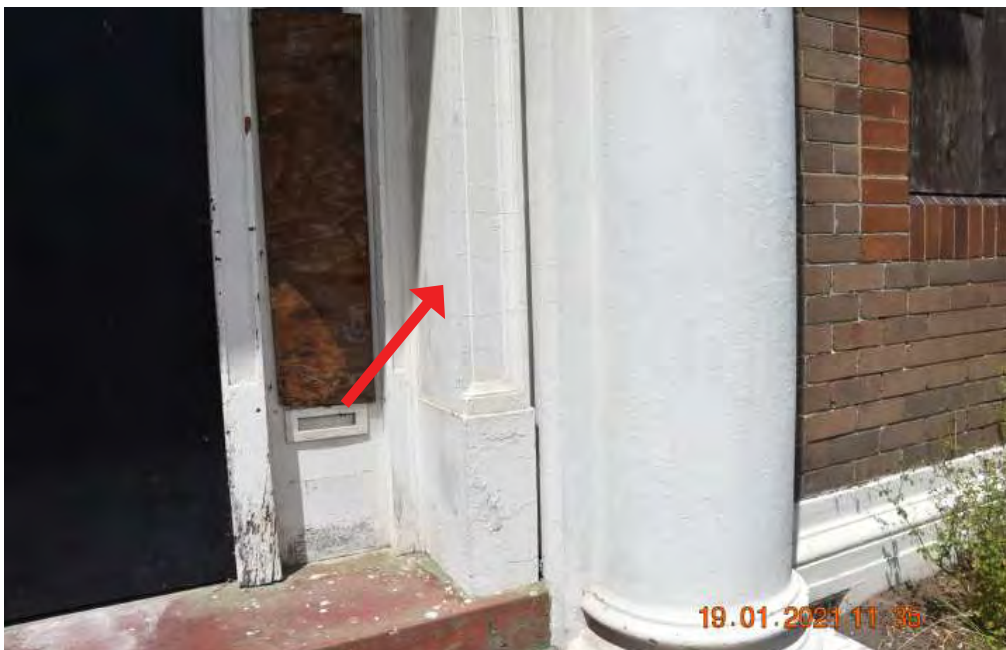
Figure: 1276

Crazing in the north wall of building B, outside the entrance.

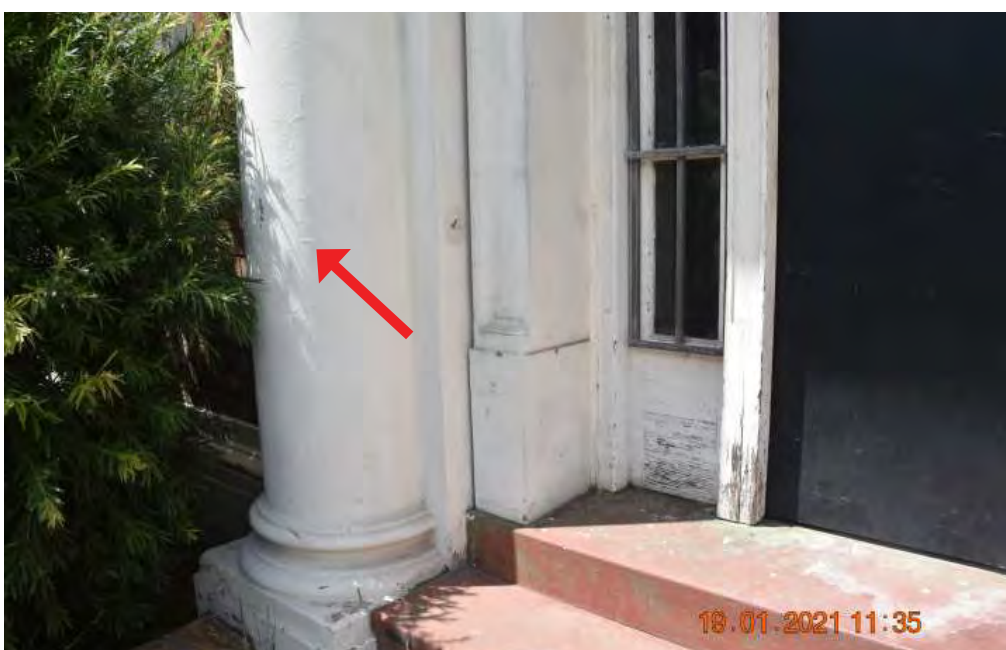
Figure: 1277

Crazing in the north wall of building B, outside the entrance.

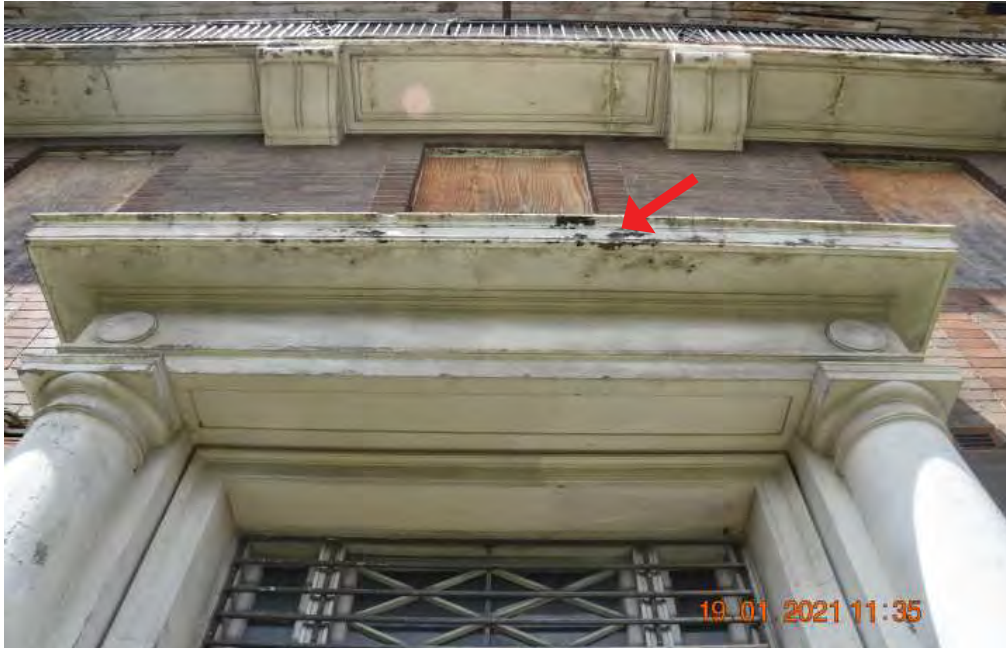
Figure: 1278

Chipping in the awning on the south side of building B, outside the entrance.

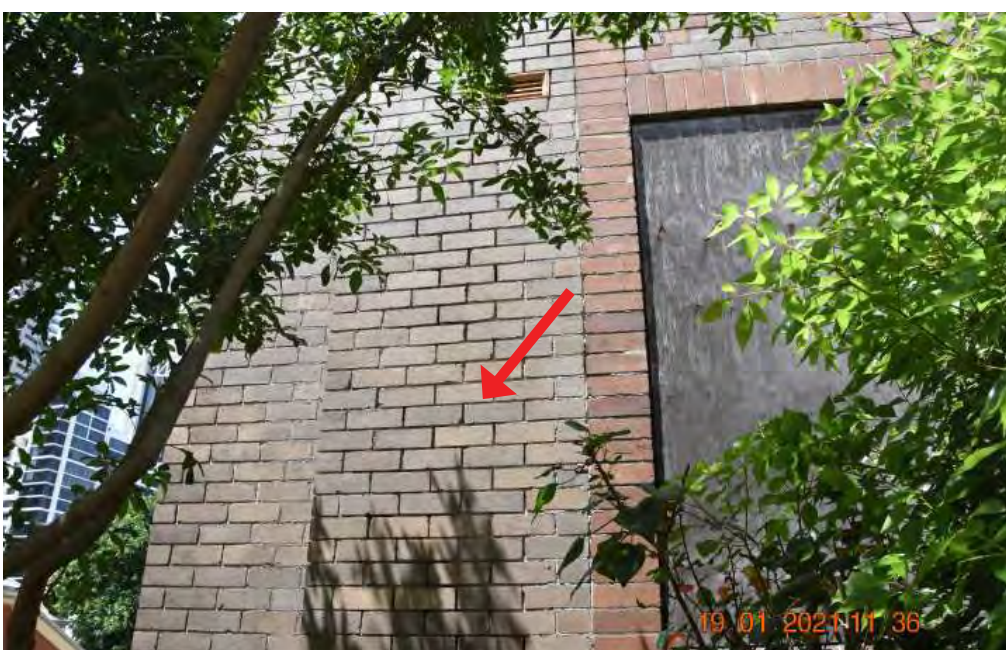
Figure: 1289

North wall of building B. Showing erosion in the mortar joints.

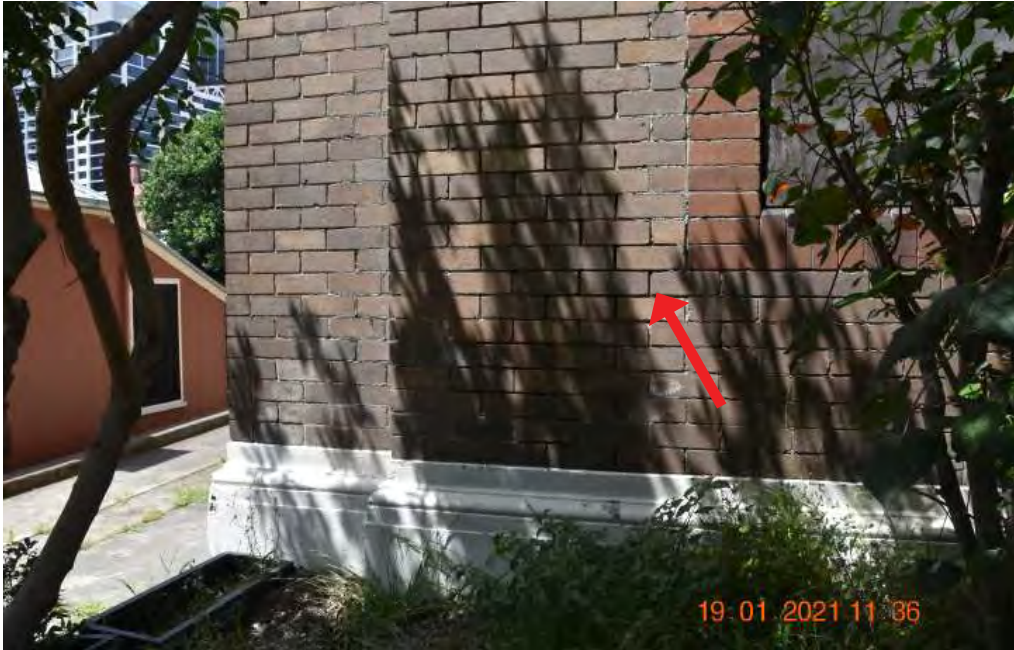
Figure: 1290

North wall of building B. Showing erosion in the mortar joints.

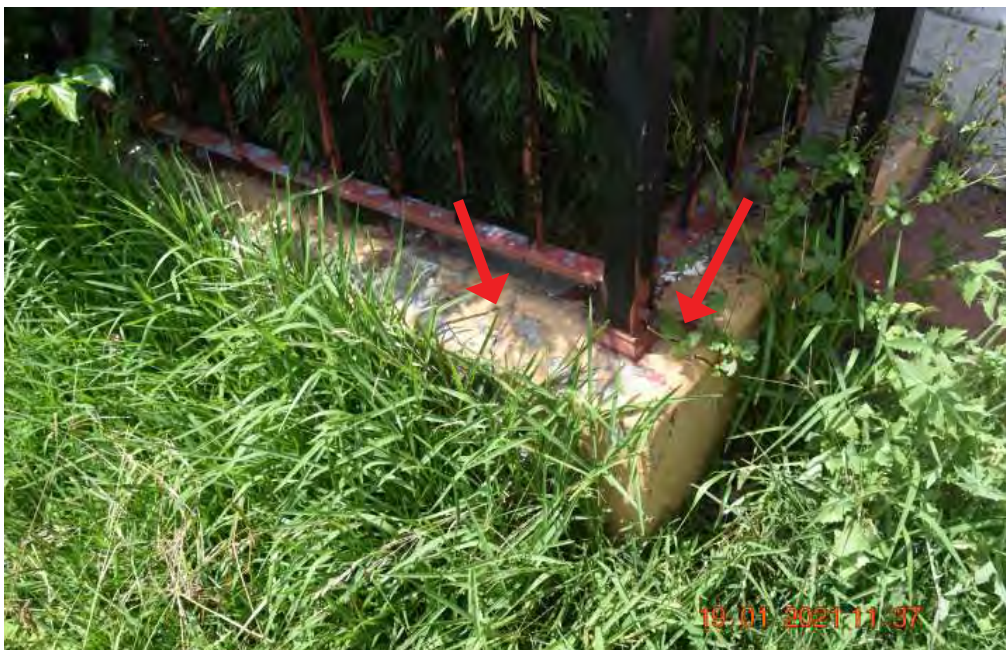
Figure: 1297

General view of the garden bed on the north side of building B. Showing cracking.

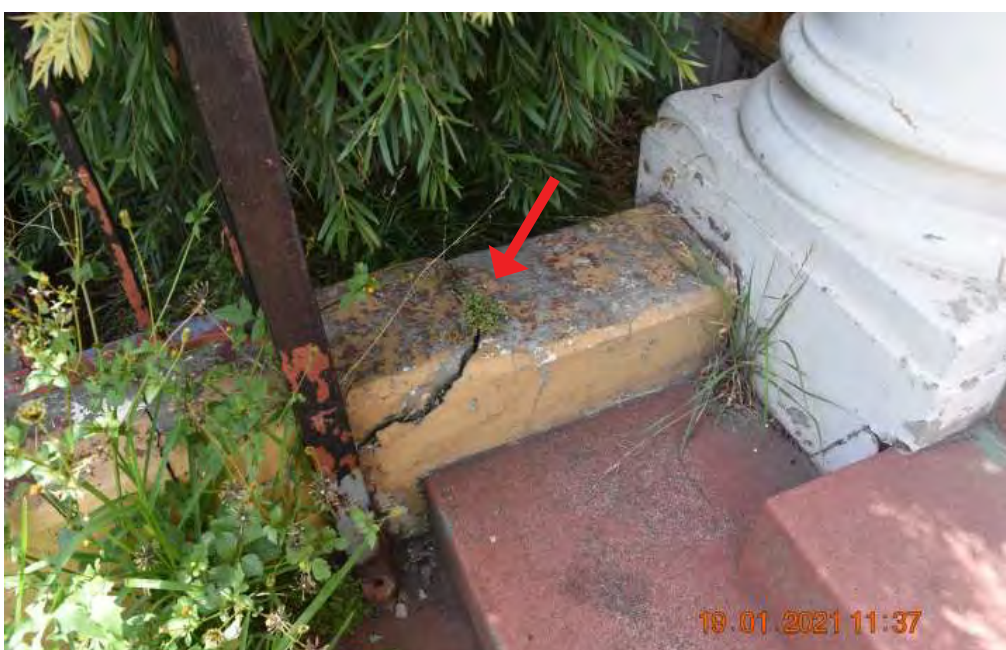
Figure: 1298

Wide cracking in the garden bed on the north side of building B, outside the entrance.

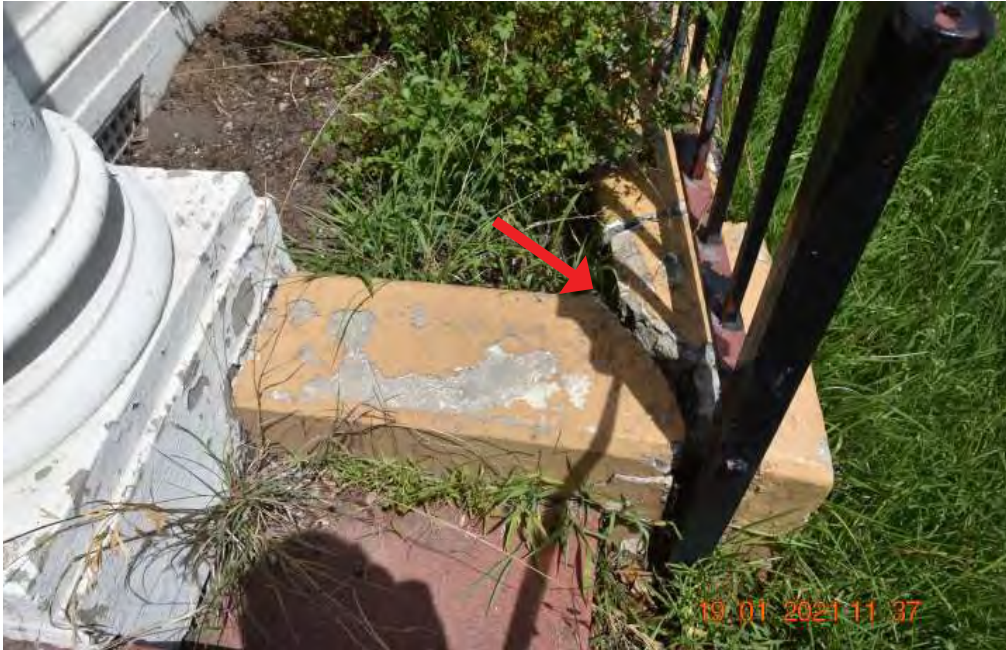
Figure: 1299

Wide cracking in the garden bed on the north side of building B, outside the entrance.

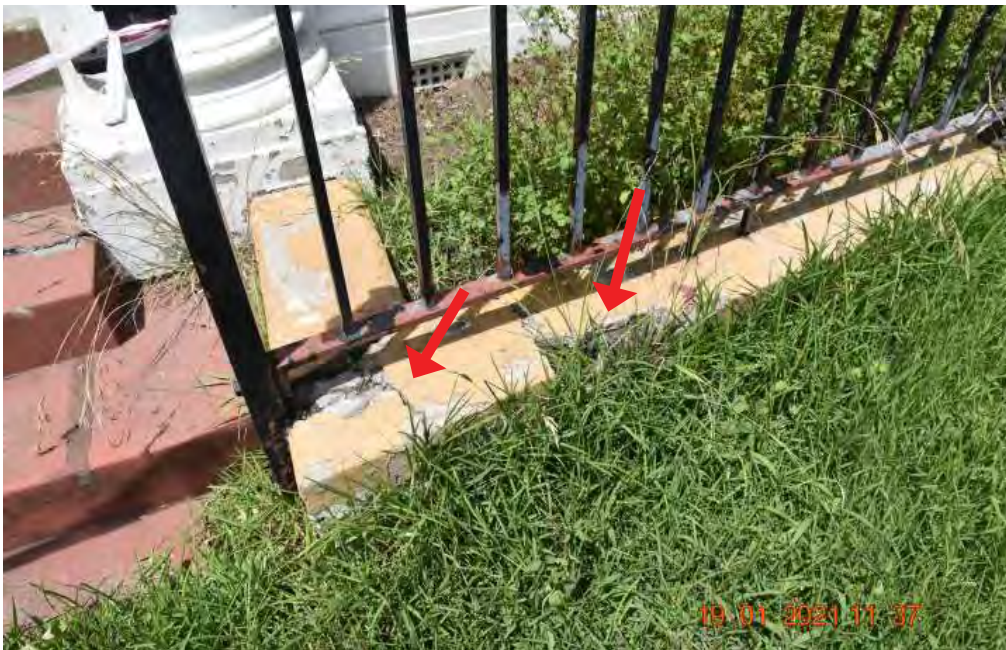
Figure: 1300

Wide cracking in the garden bed on the north side of building B, outside the entrance.

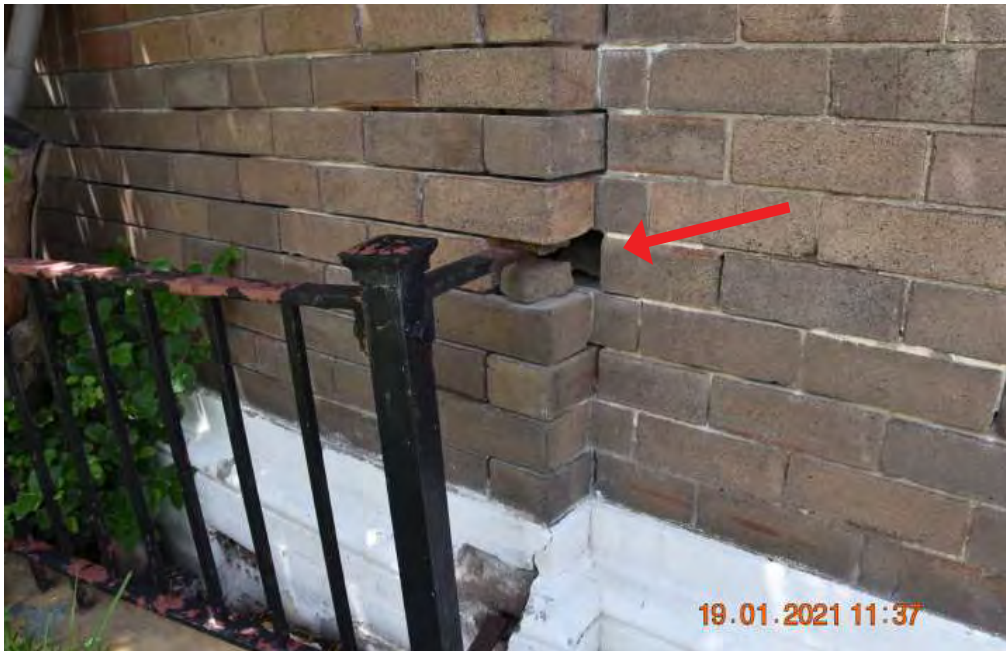
Figure: 1305

Missing brick in the north wall of building B. Also showing erosion in the mortar joints.

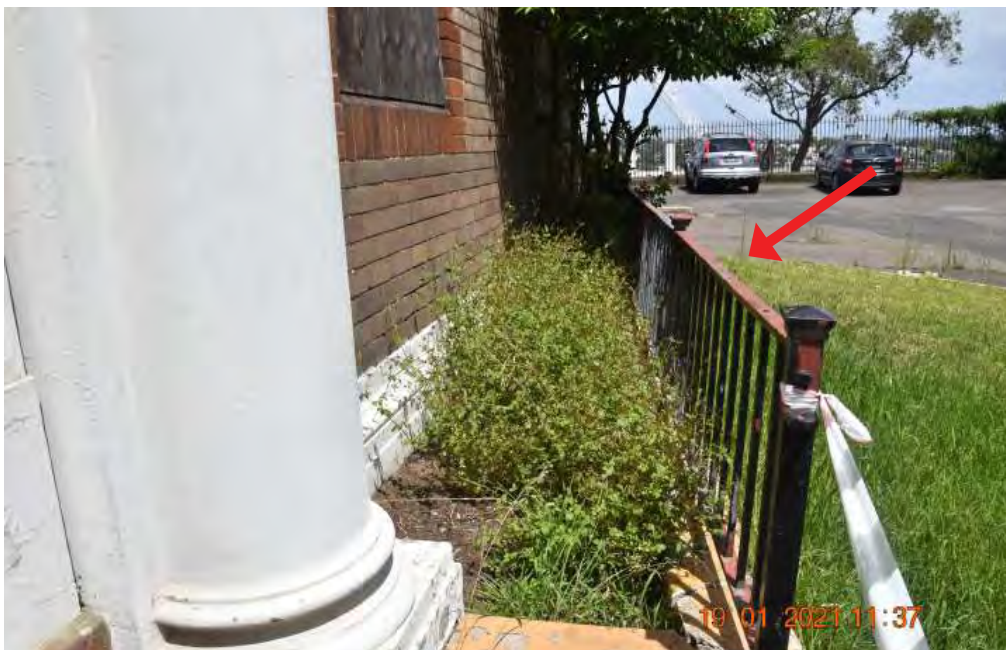
Figure: 1306

Leaning in the garden bed fence on the north side of building B.

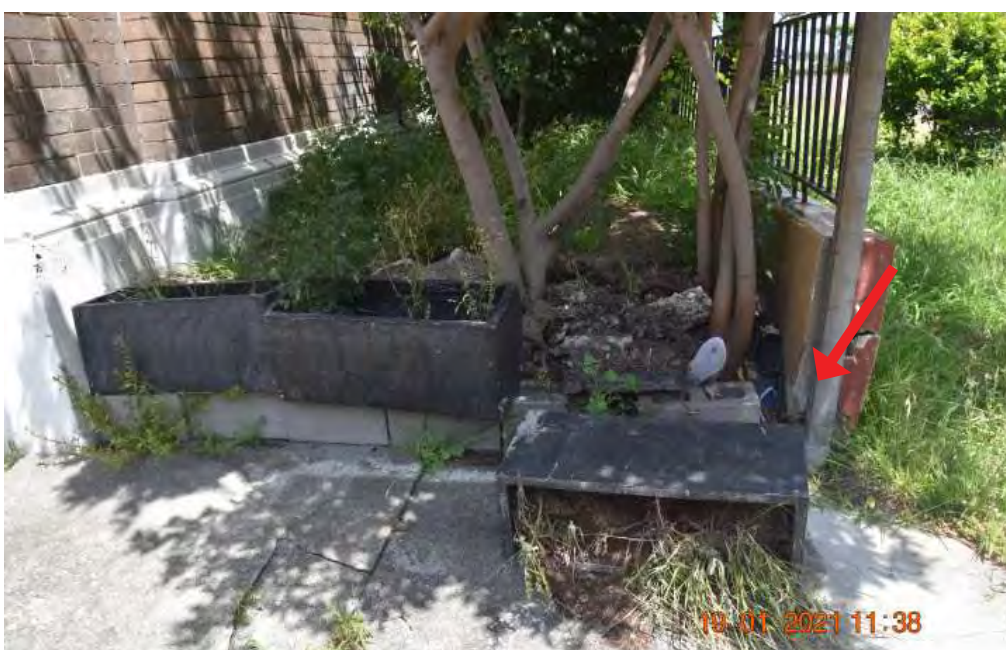
Figure: 1307

Damage in the garden bed fence at the northeast corner of building B.

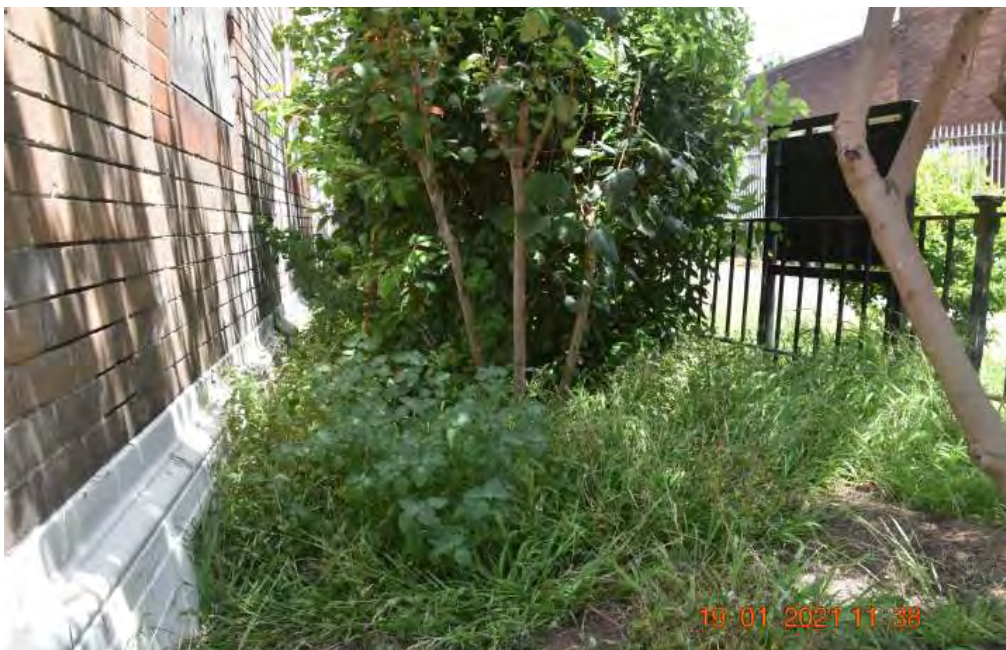
Figure: 1308

Damage in the garden bed fence at the northeast corner of building B.

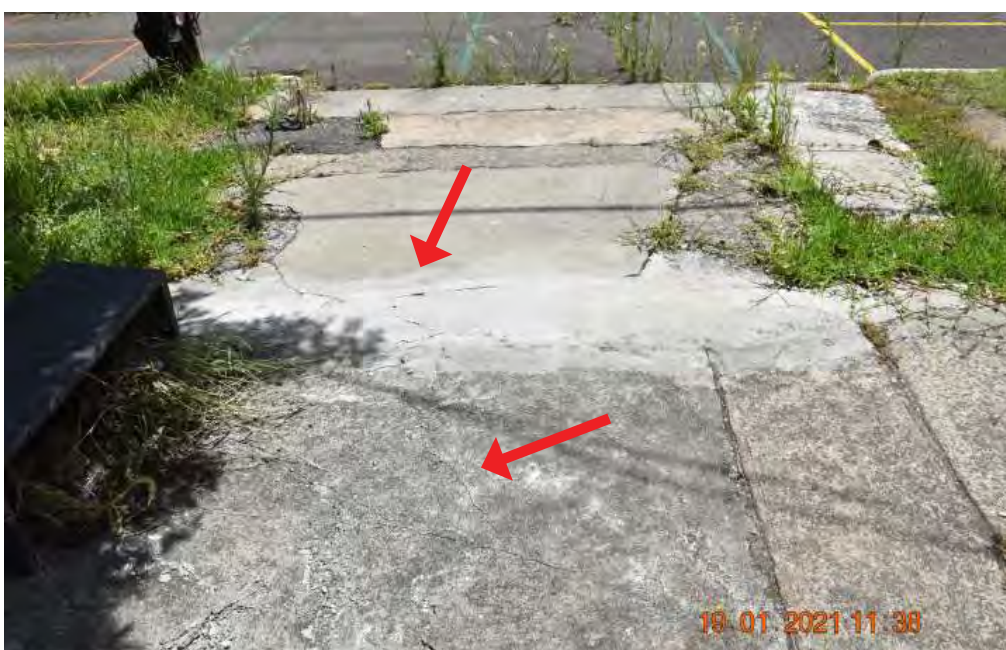
Figure: 1309

General view of the garden bed fence on the north side of building B.

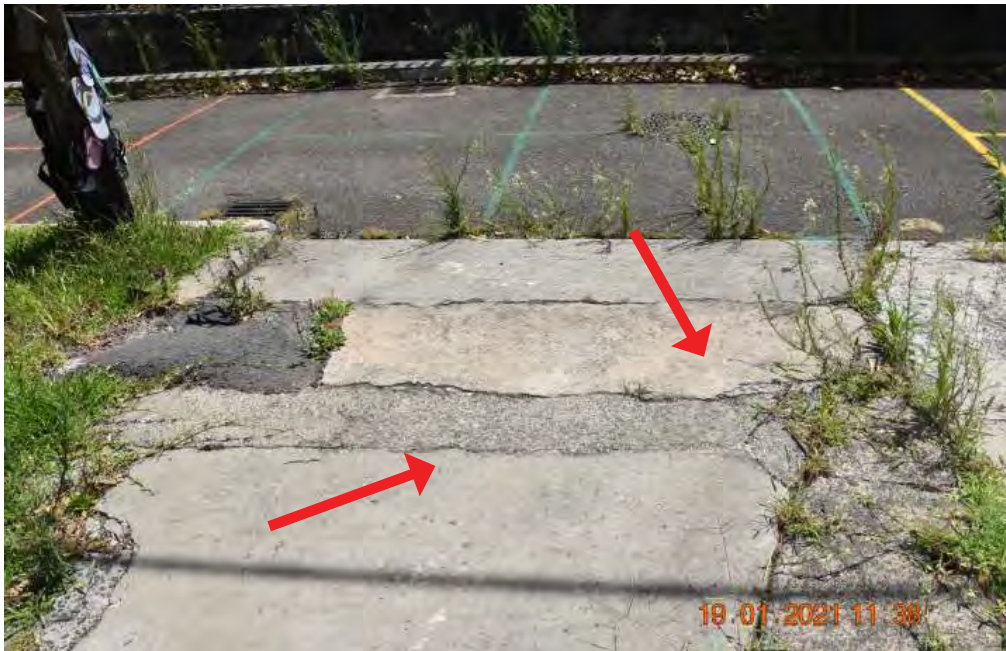
Figure: 1310

Cracking in the paving at the northeast corner of building B.

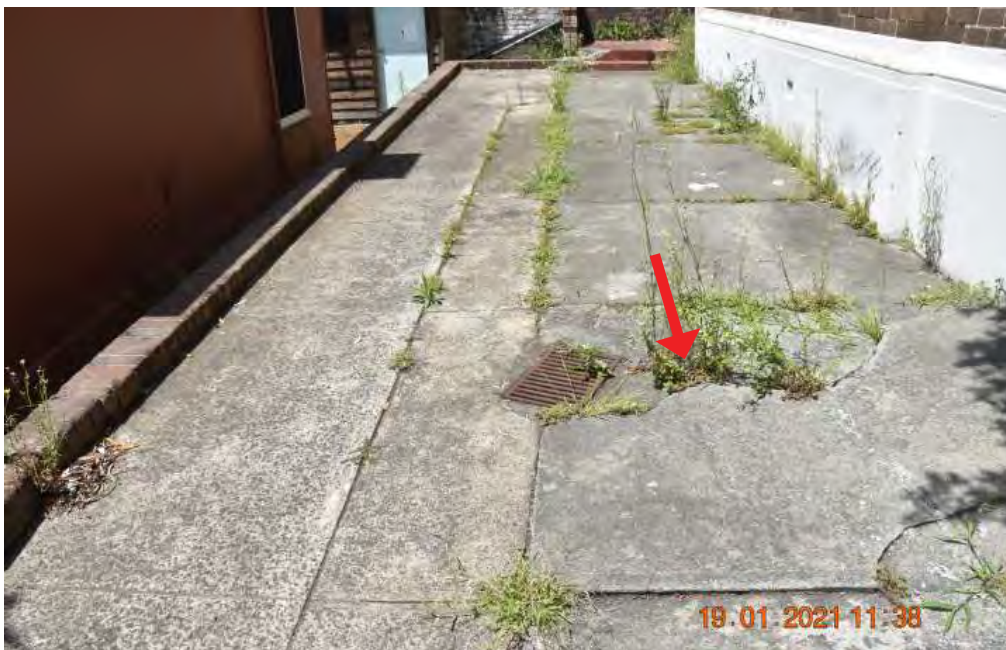
Figure: 1311

Cracking in the paving at the northeast corner of building B.

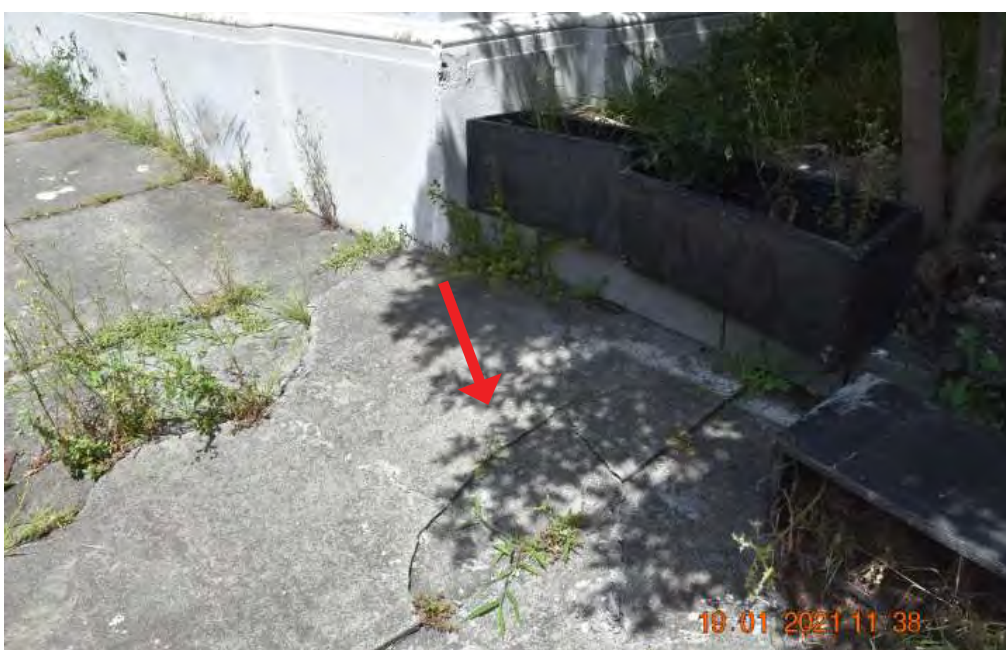
Figure: 1312

Cracking in the paving at the northeast corner of building B.

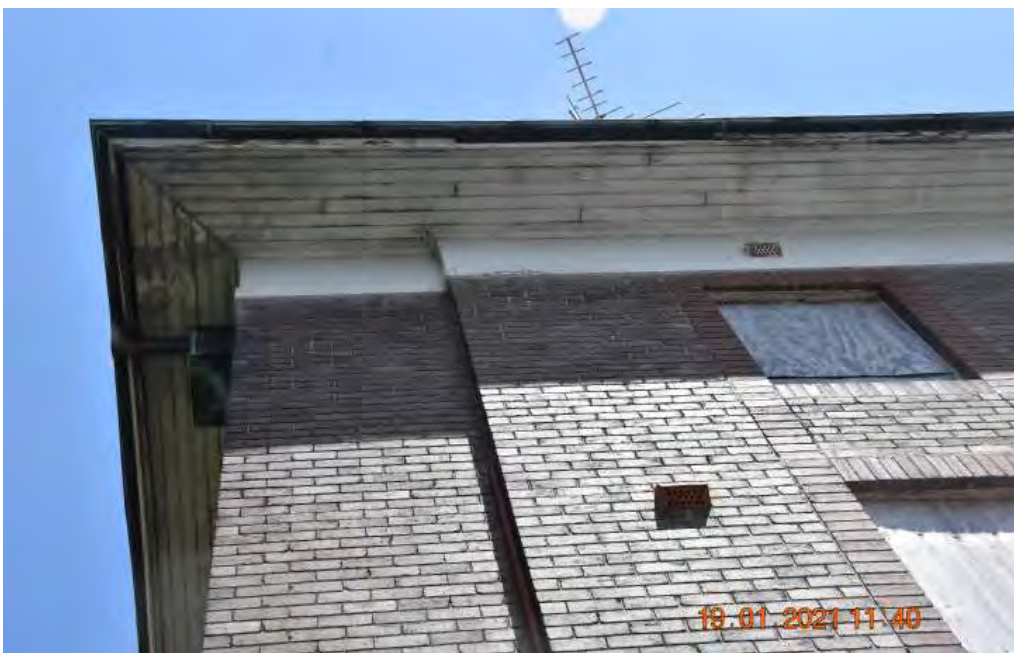
Figure: 1330

East wall of building B. Showing crazing.

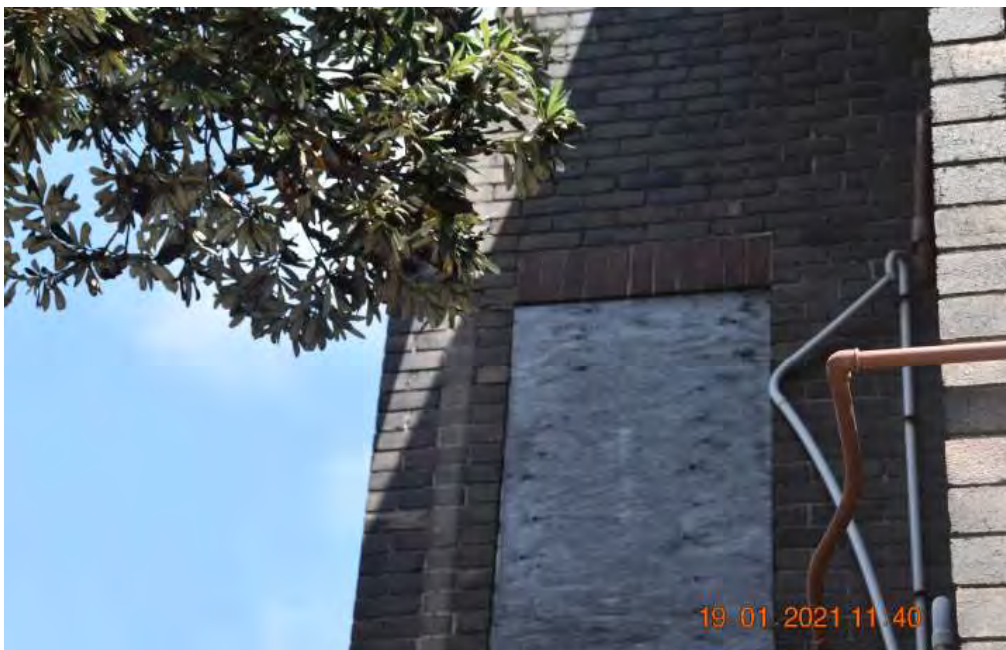
Figure: 1335

East wall of building B, south side. Showing rusting and peeling paint.

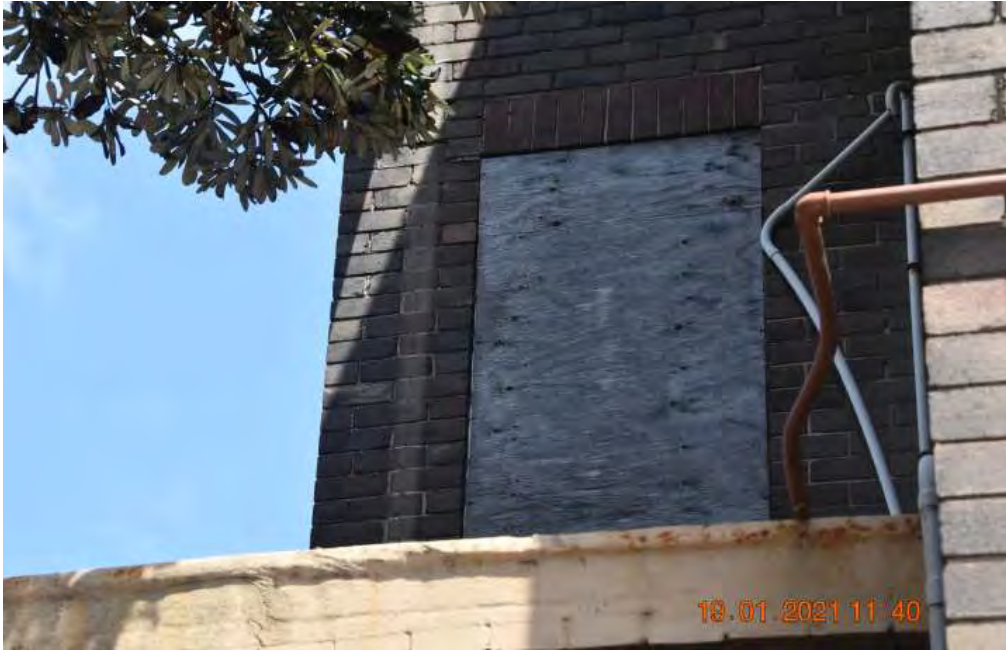
Figure: 1337

Stepped cracking and movement in the east wall of building B, south side.

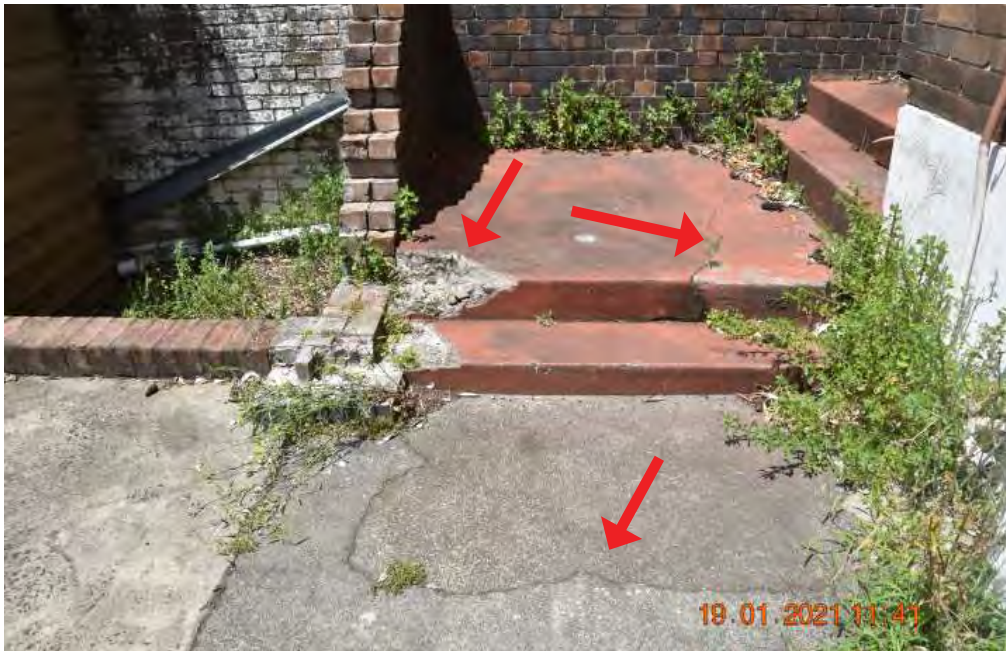
Figure: 1343

Cracking in the paving at the southeast corner of building B.

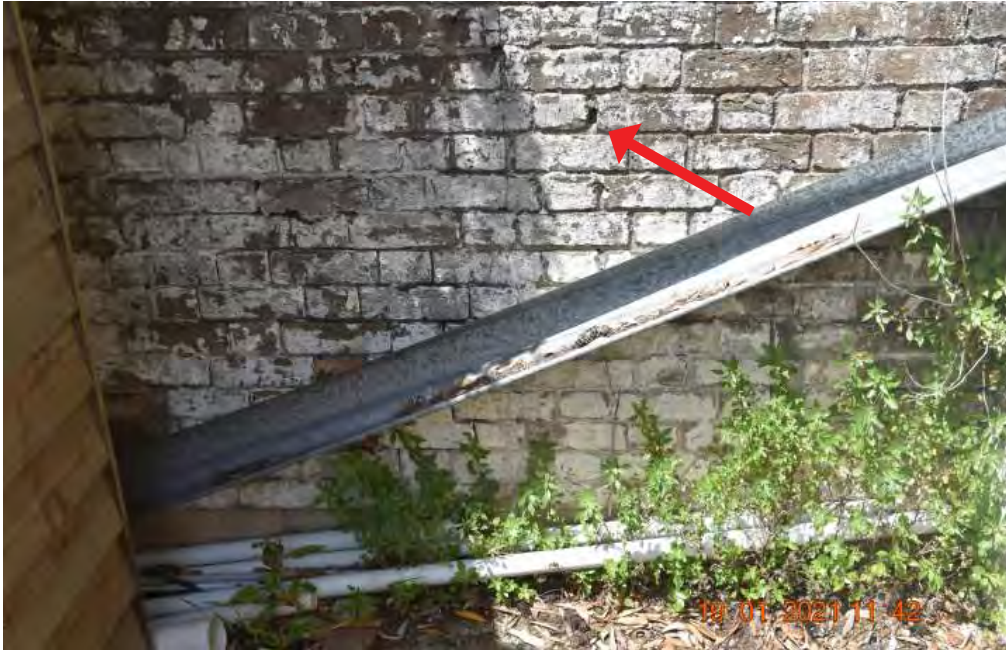
Figure: 1346

General view of the heritage wall, looking from the southeast corner of building B. Showing erosion in the mortar joints.

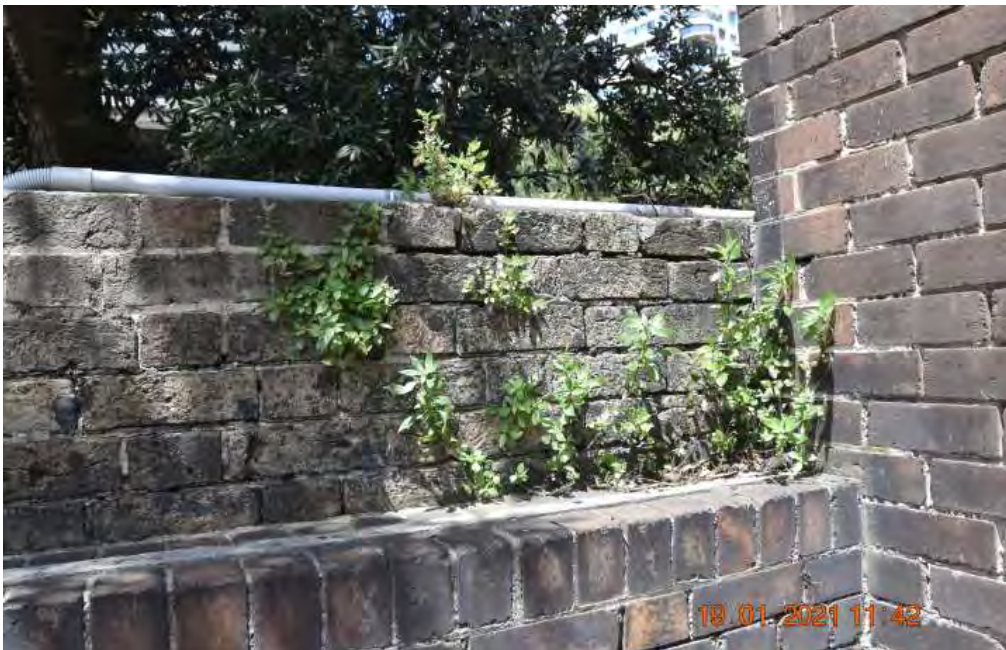
Figure: 1347

General view of the heritage wall, looking from the southeast corner of building B. Showing erosion in the mortar joints.

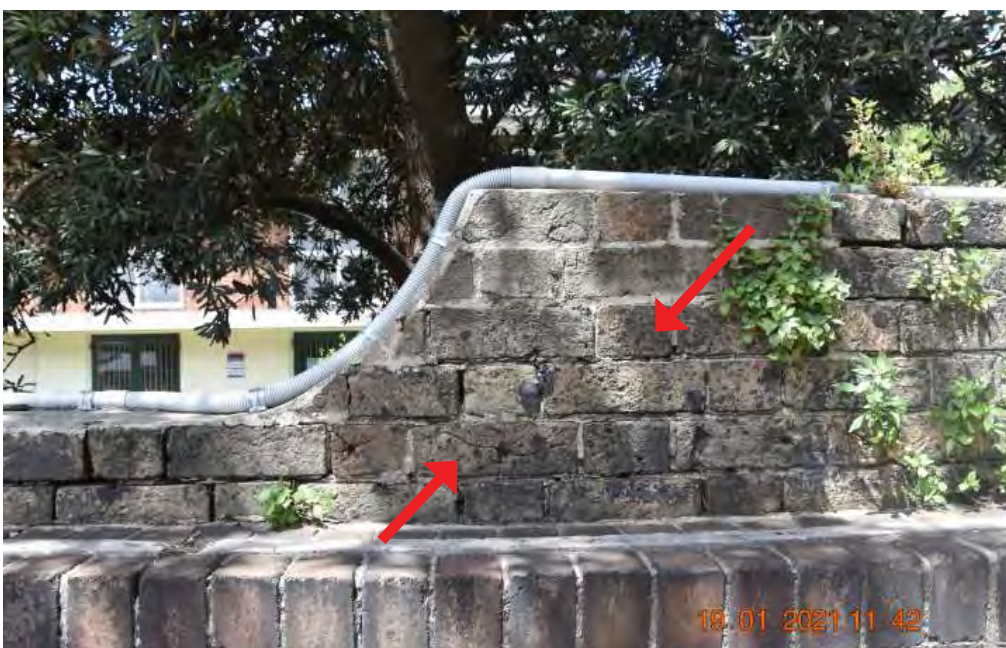
Figure: 1348

General view of the heritage wall, looking from the southeast corner of building B. Showing erosion in the mortar joints.

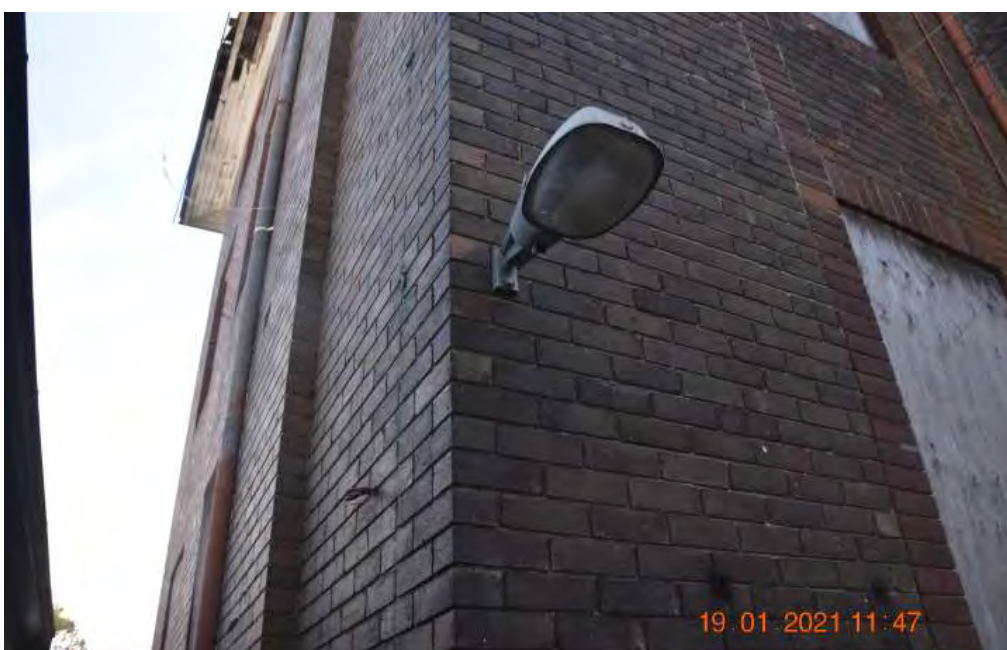
Figure: 1357

General view of the southwest corner of building B.

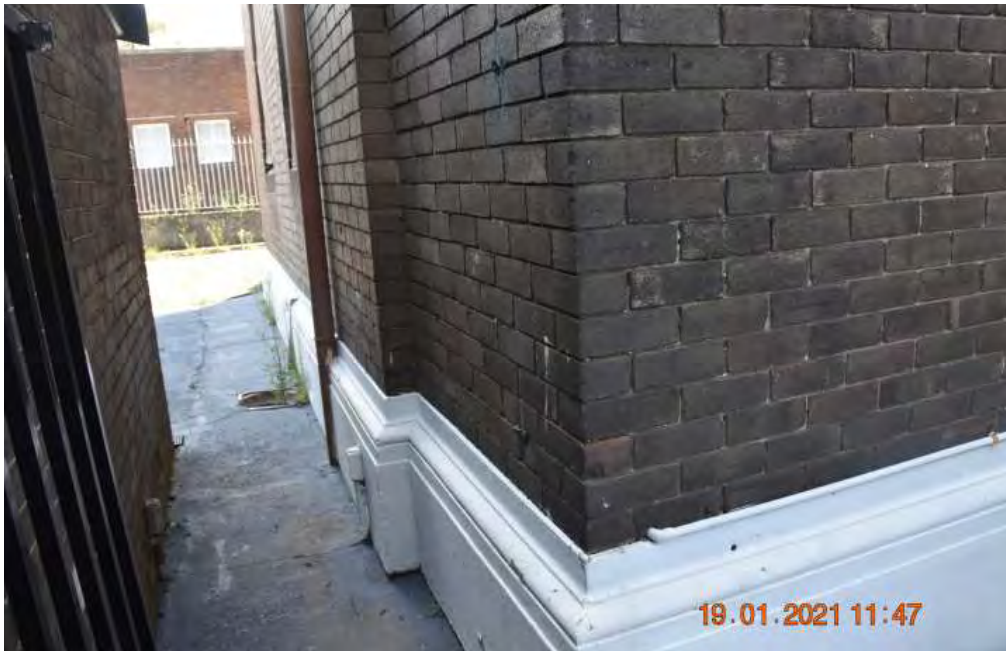
Figure: 1358

General view of the southwest corner of building B.

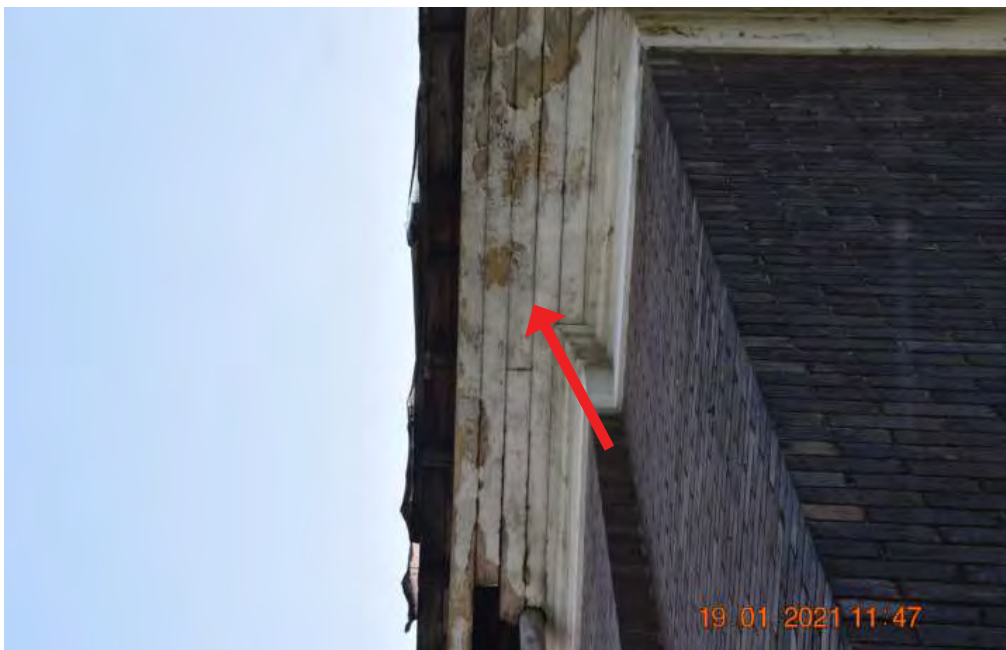
Figure: 1359

General view of the southwest corner of building B.

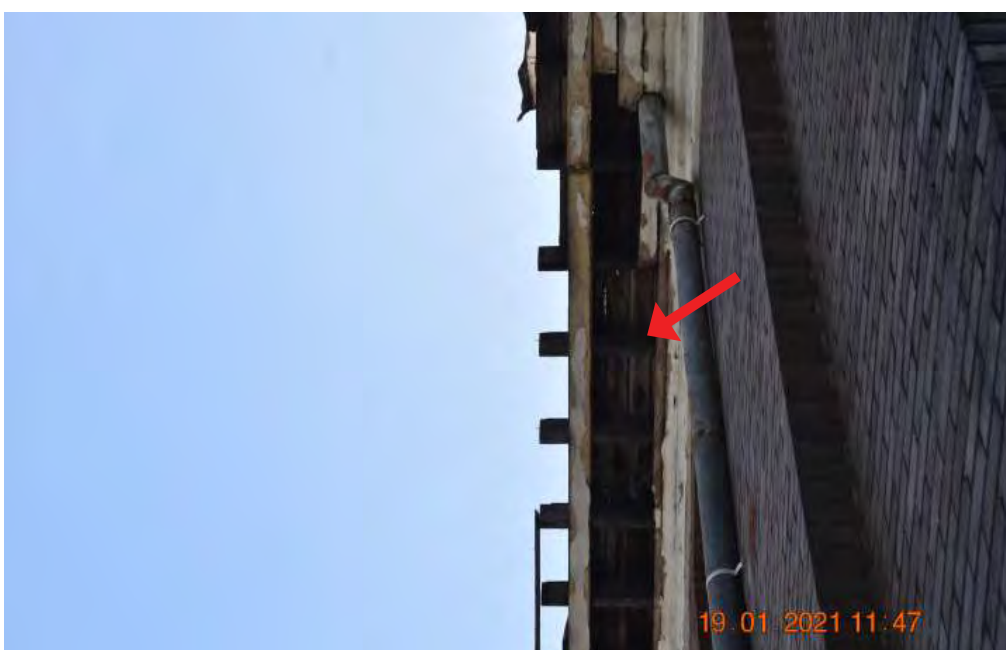
Figure: 1360

Damage in the soffit on the west side of building B.

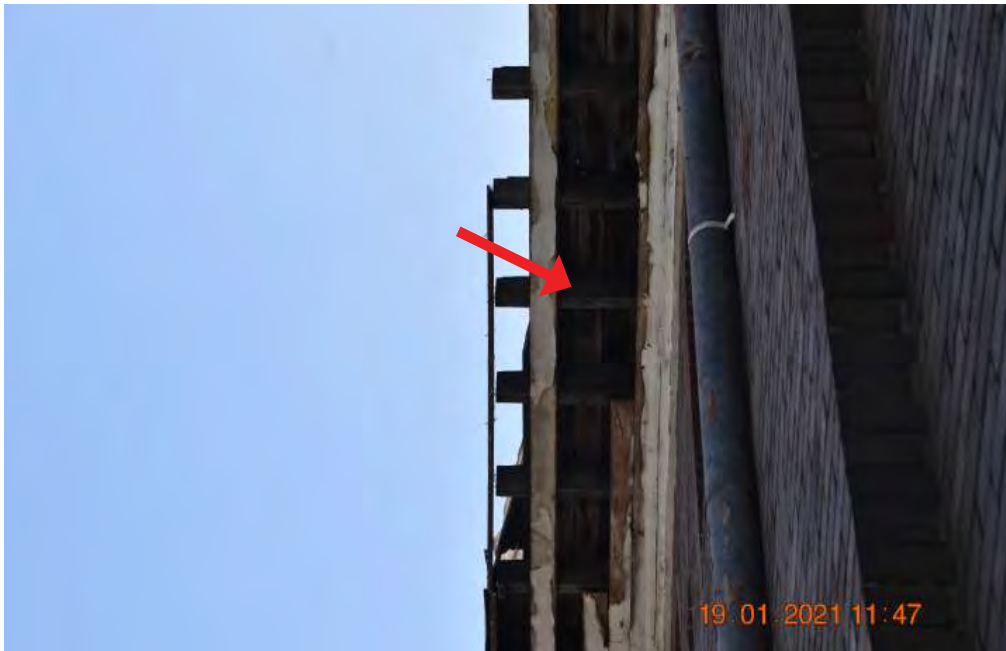
Figure: 1361

Damage in the soffit on the west side of building B.

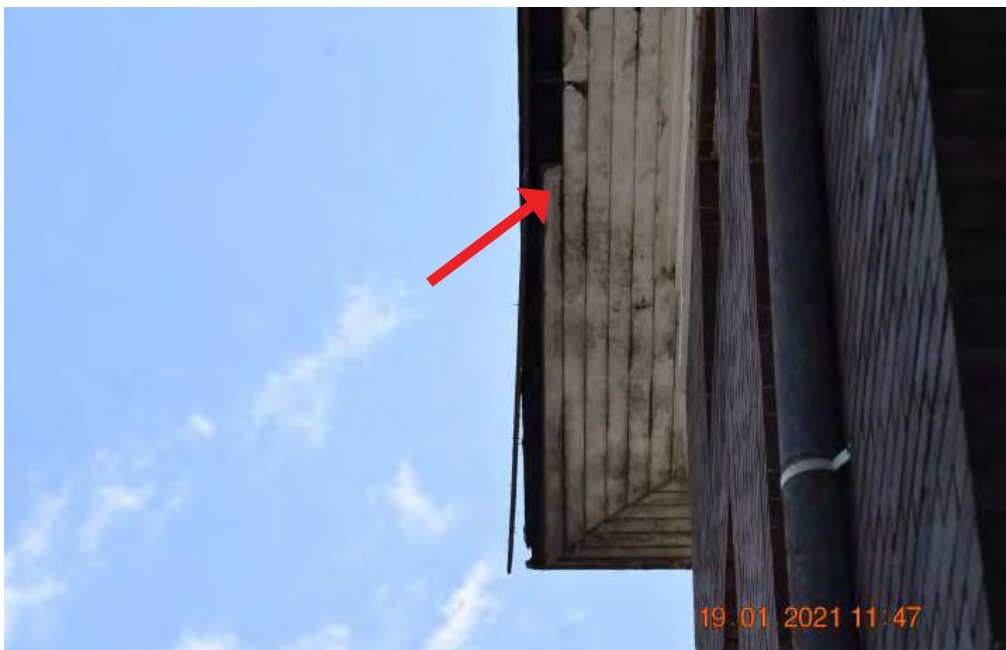
Figure: 1362

Damage in the soffit on the west side of building B.

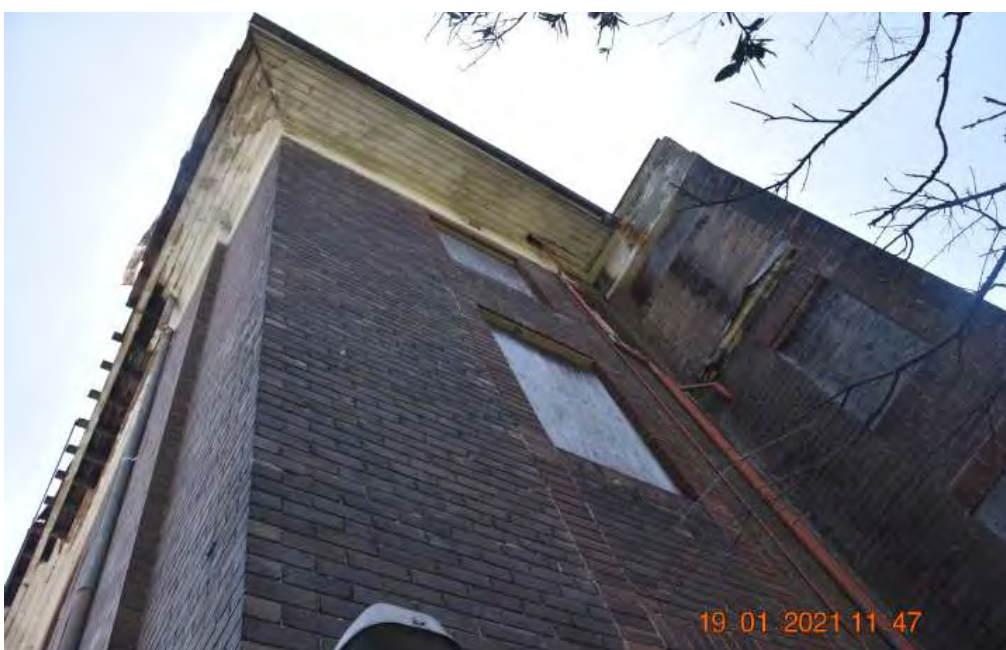
Figure: 1363

Damage in the soffit on the west side of building B.
