## PRE CONSTRUCTION CONDITION SURVEY

Fort Street Public School, Millers Point NSW

Upper Fort Street Public School  
MILLERS POINT NSW 2000

19 January 2021

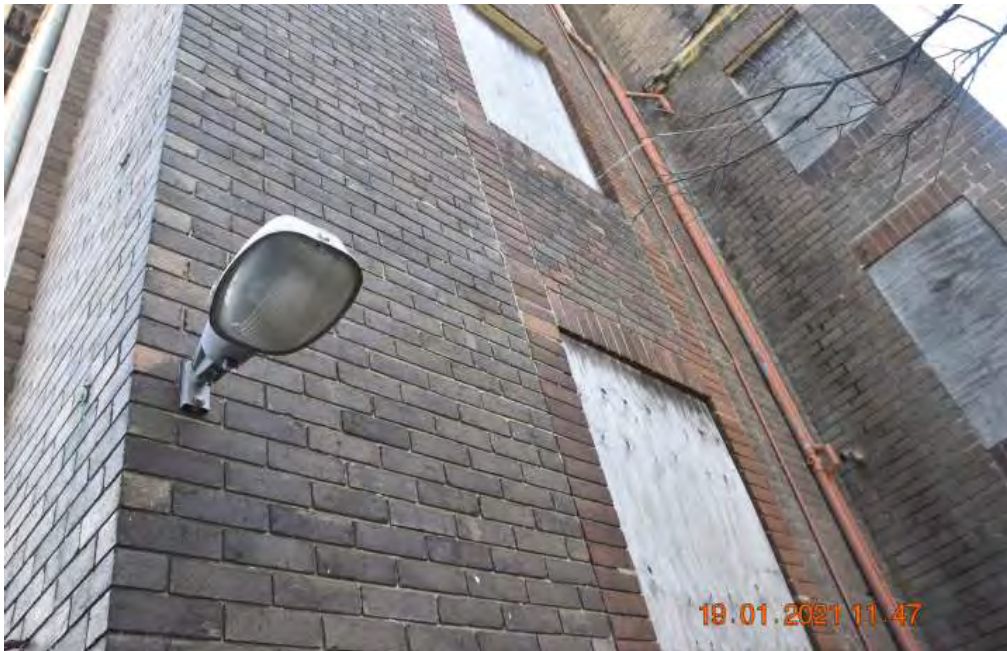
Figure: 1364

South wall of building B, west side.

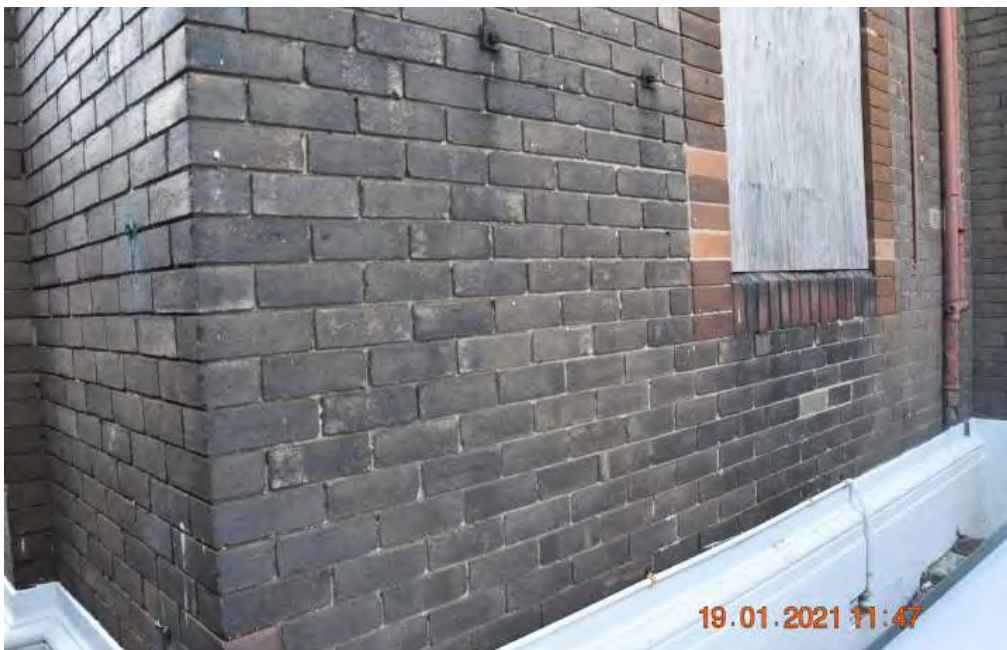
Figure: 1365

South wall of building B, west side.

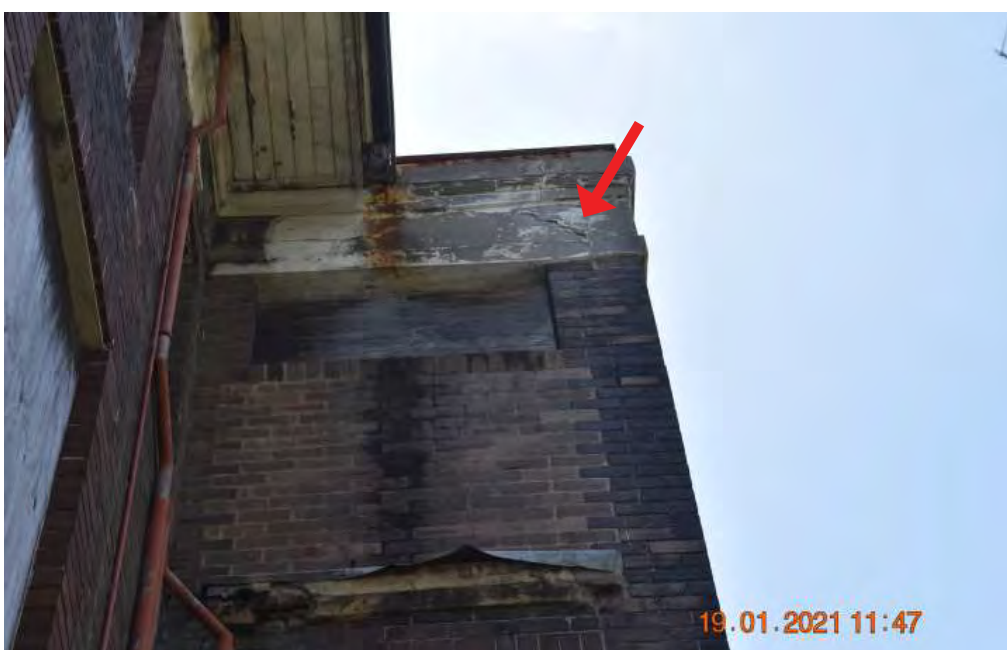
Figure: 1366

South wall of building B, west side.

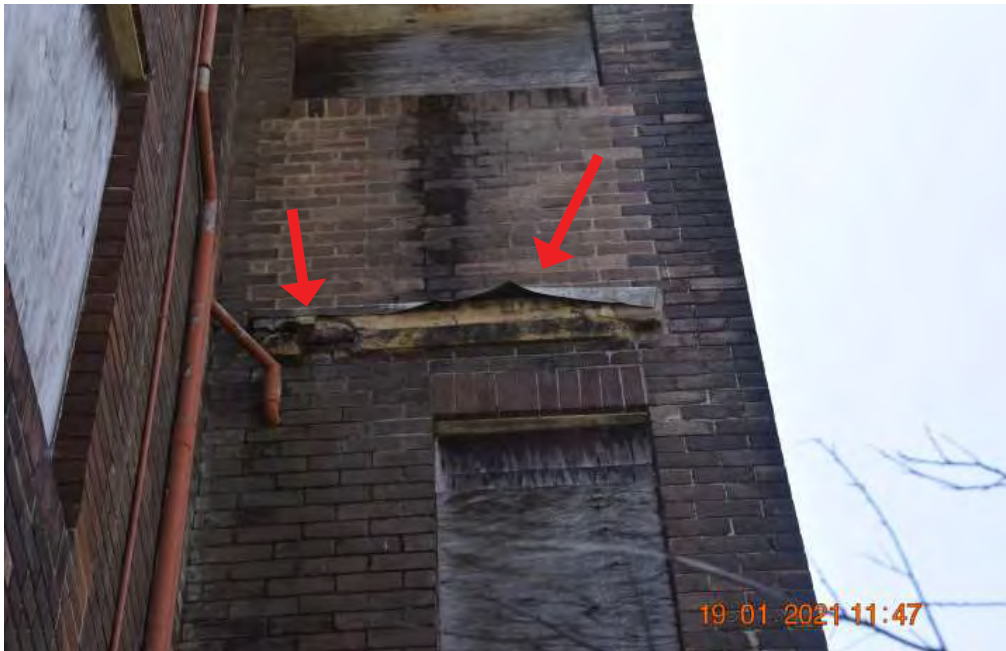
Figure: 1367

West wall of building B, south side.  
Showing cracking above the window.

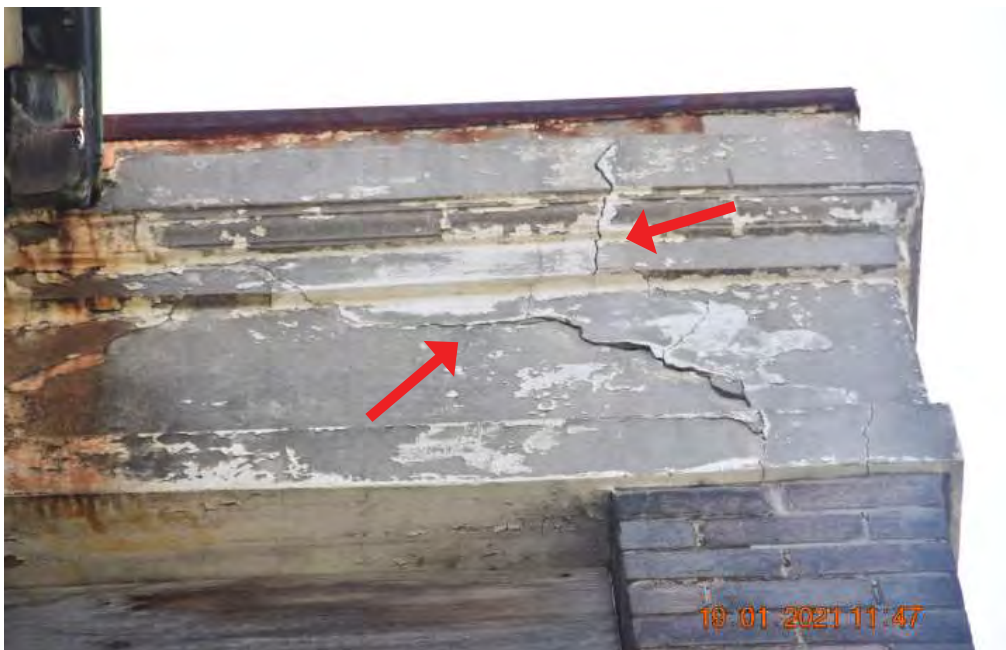
Figure: 1368

West wall of building B, south side.  
Showing damage above the window.

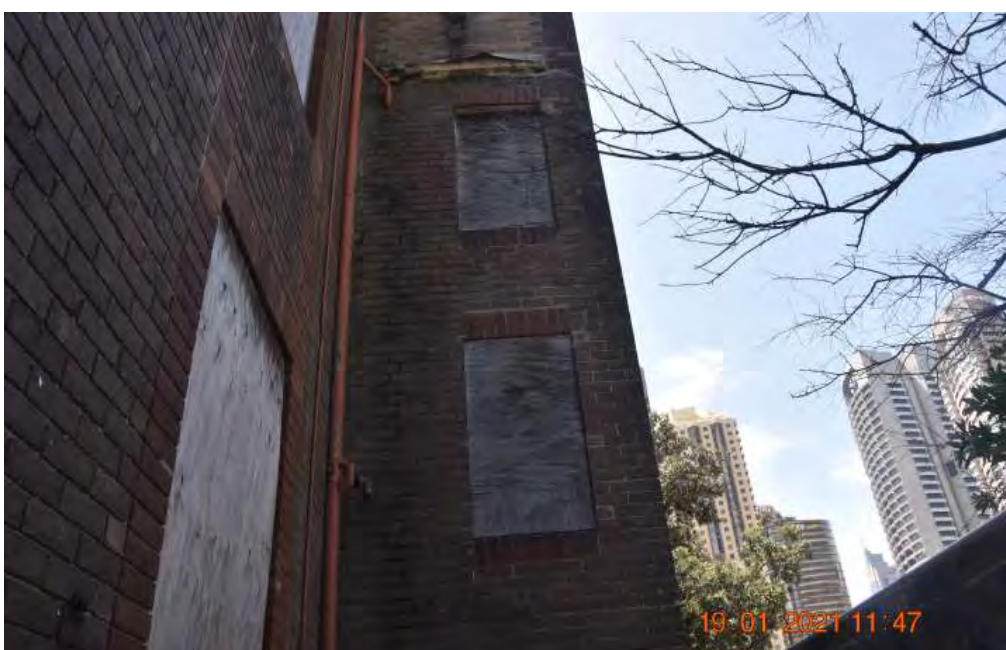
Figure: 1369

Slight cracking  
above the window in  
the west wall of the  
building, south side.

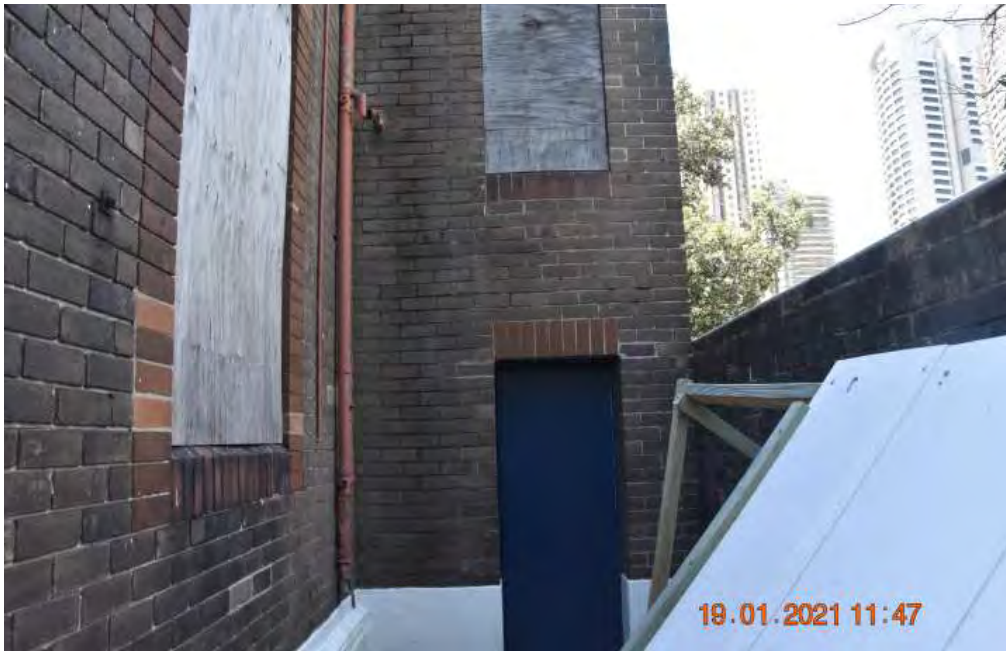
Figure: 1370

West wall of building B, south side.

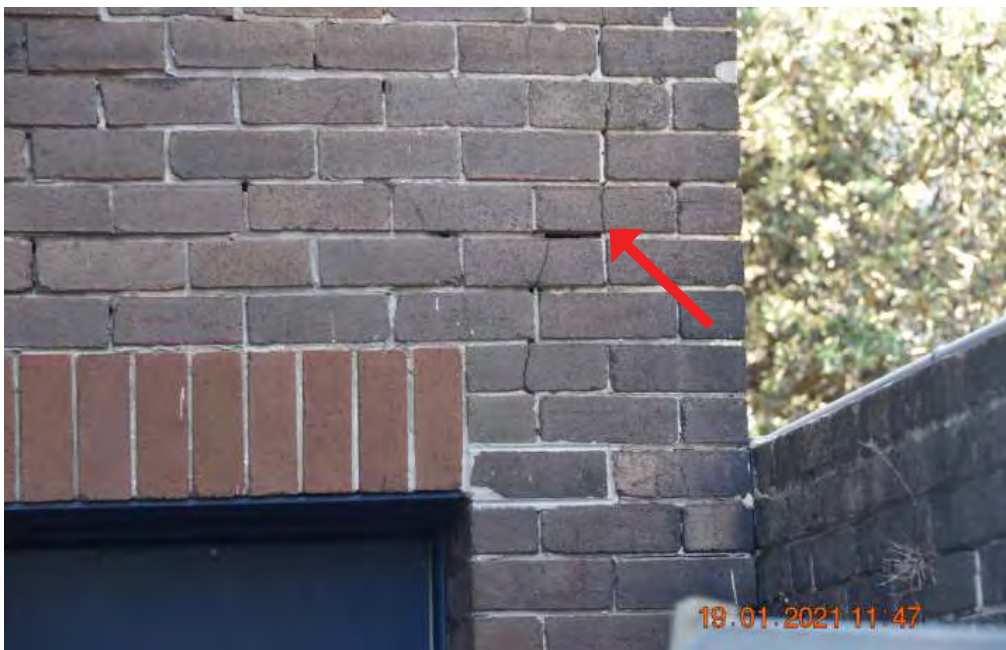
Figure: 1371

West wall of building B, south side.

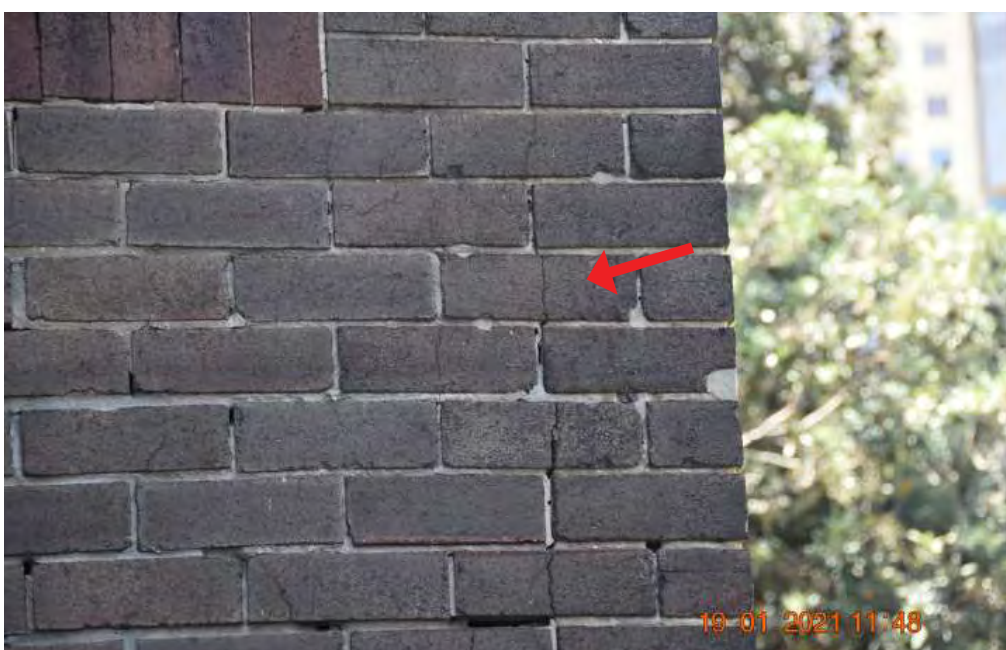
Figure: 1372

Cracking in the west wall of building B, south side.

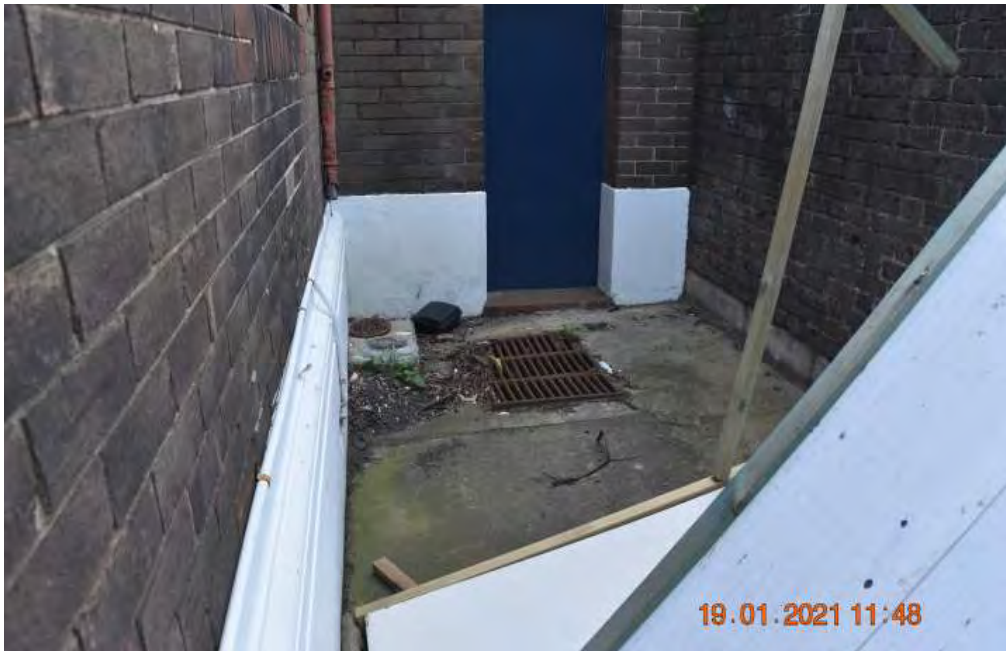
Figure: 1373

Cracking in the west wall of building B, south side.

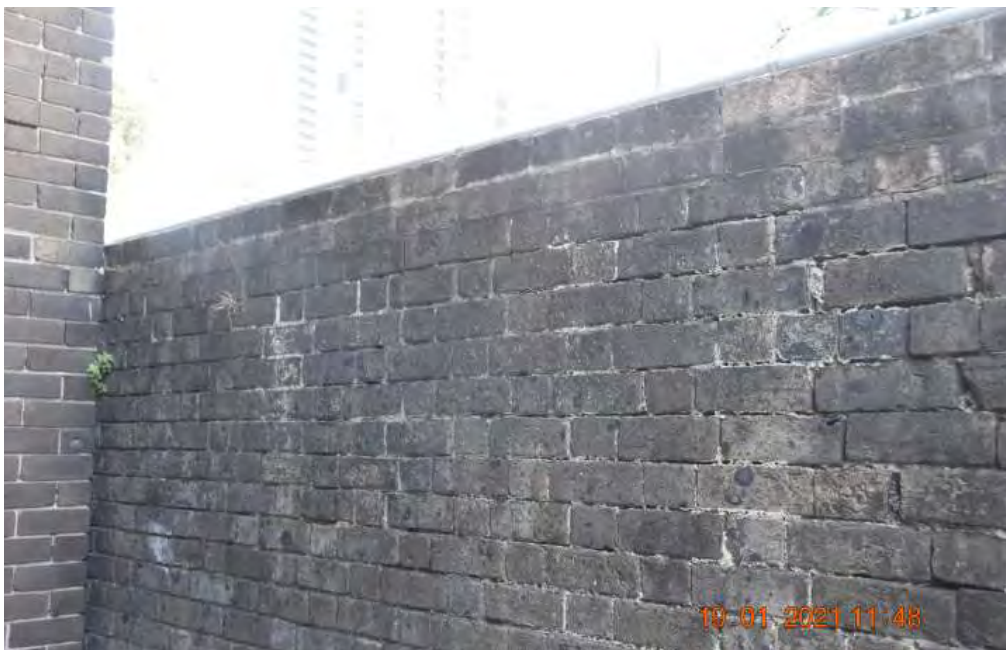
Figure: 1374

General view of the pathway at the southwest corner of building B.

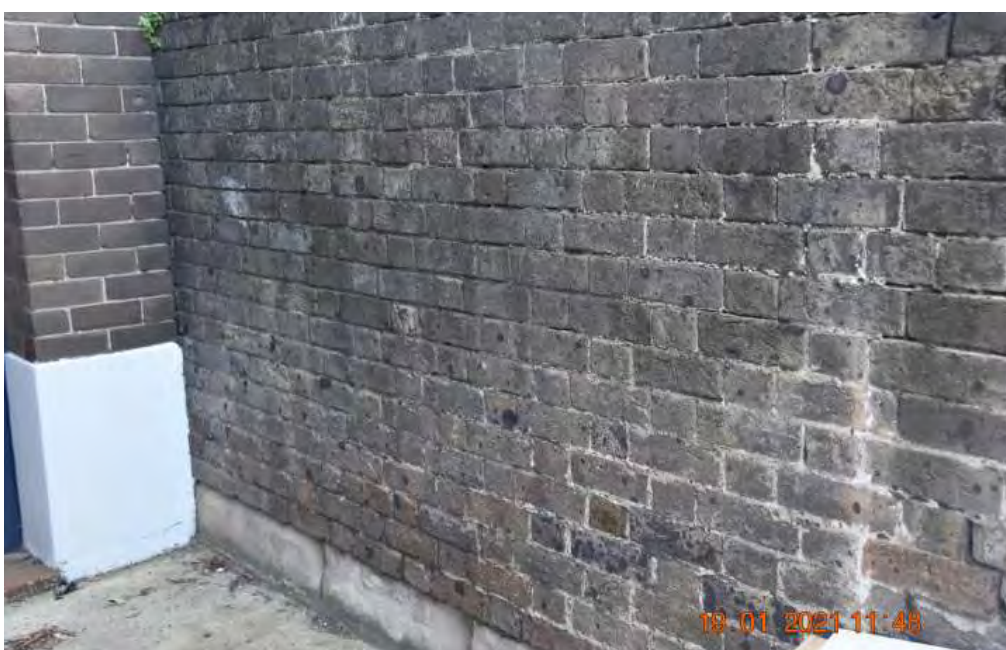
Figure: 1375

General view of the heritage wall, looking from the southwest corner of building B.

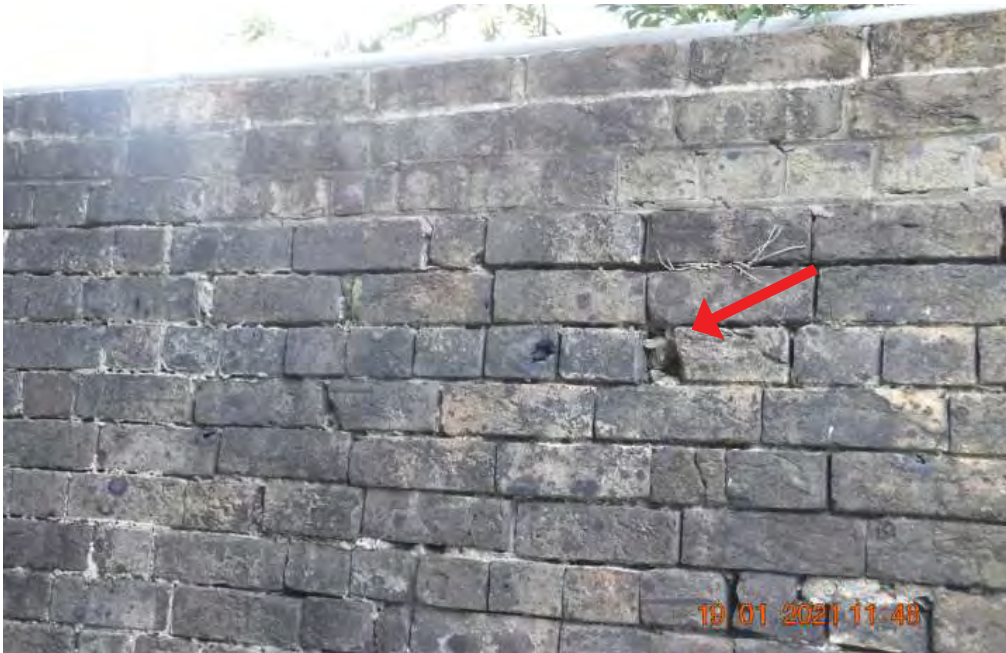
Figure: 1377

General view of the heritage wall, looking from the southwest corner of building B. Showing erosion in the mortar joints.

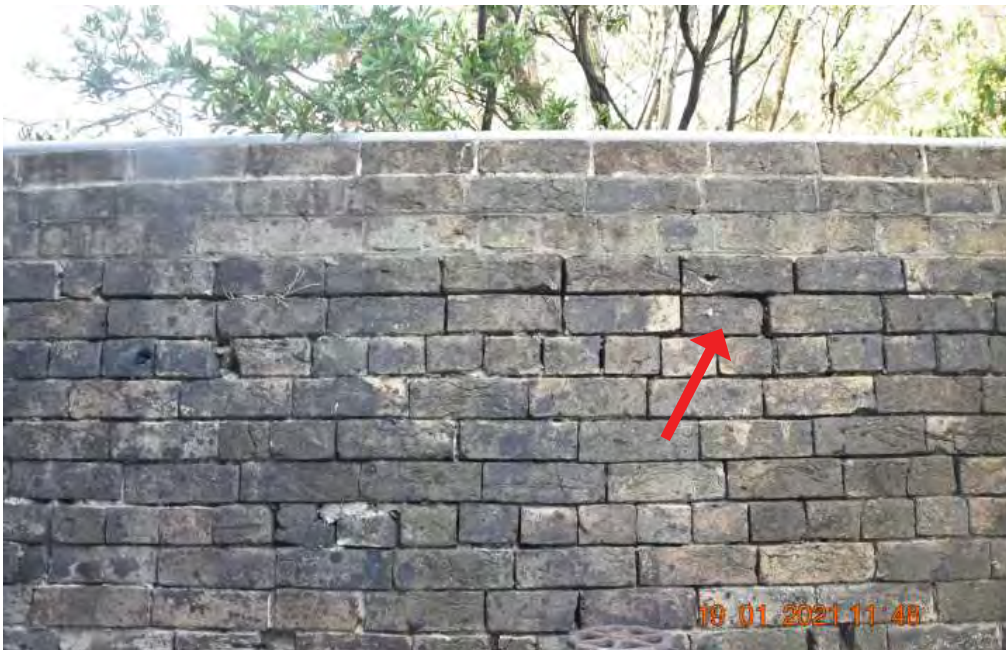
Figure: 1378

General view of the heritage wall, looking from the southwest corner of building B. Showing erosion in the mortar joints.

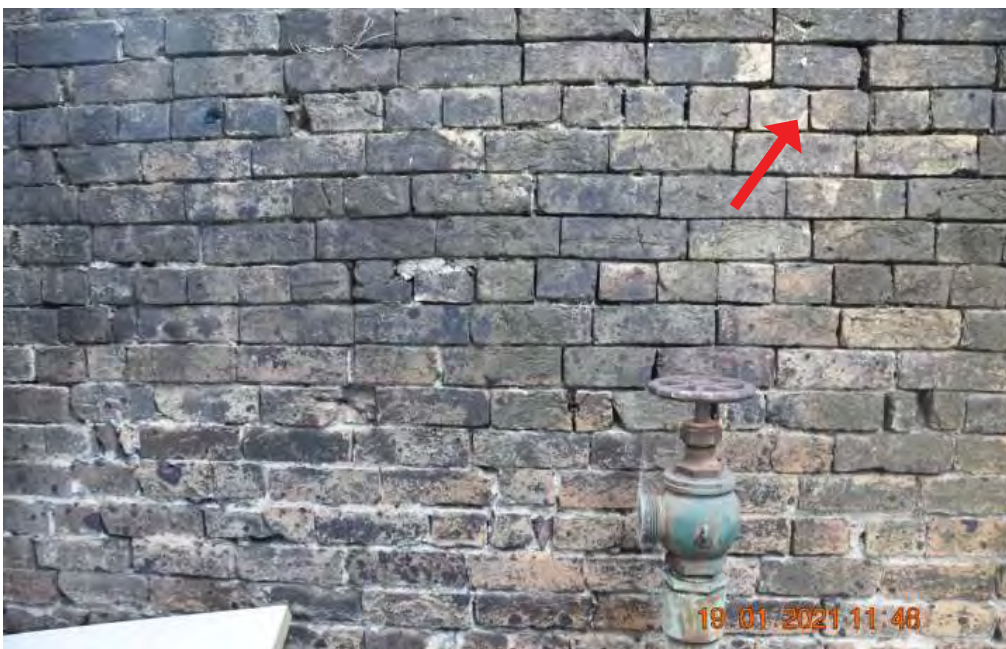
Figure: 1379

General view of the heritage wall, looking from the southwest corner of building B. Showing erosion in the mortar joints.

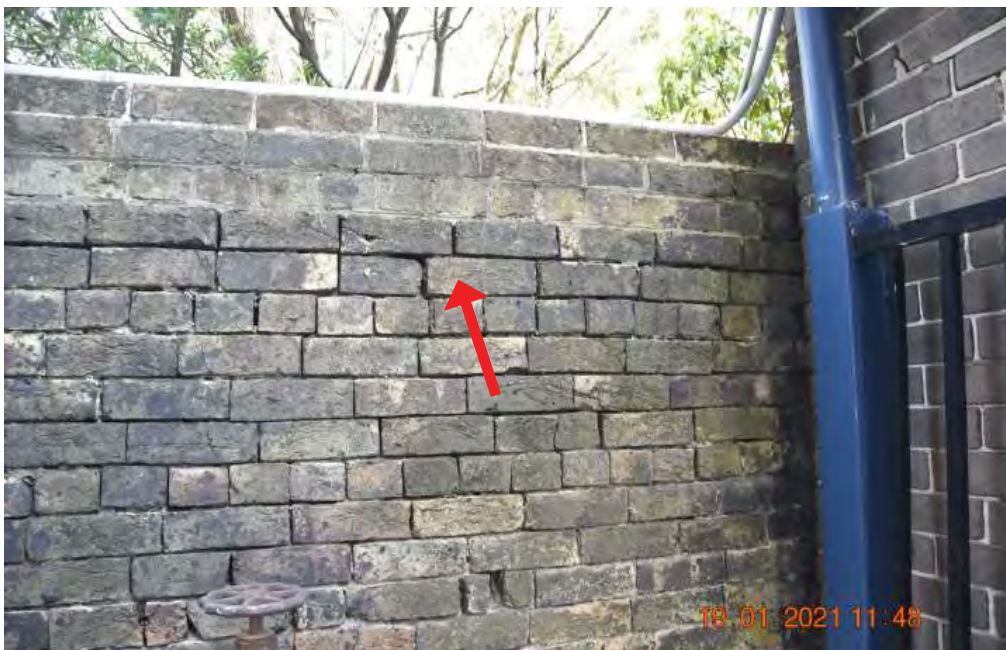
Figure: 1380

General view of the heritage wall, looking from the southwest corner of building B. Showing erosion in the mortar joints.

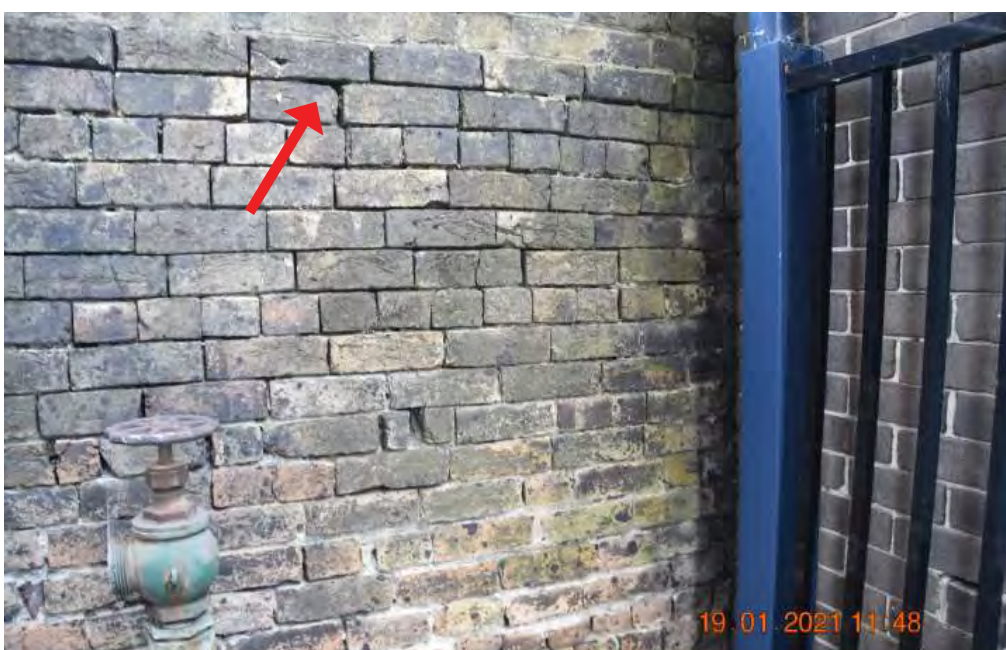
Figure: 1381

General view of the heritage wall, looking from the southwest corner of building B. Showing erosion in the mortar joints.

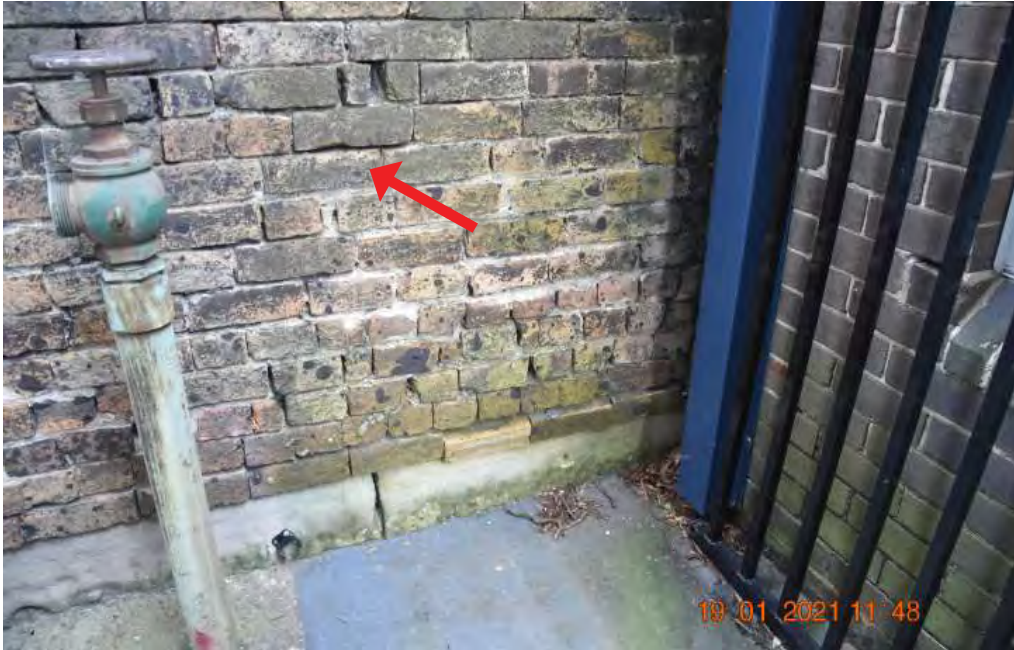
Figure: 1382

General view of the heritage wall, looking from the southwest corner of building B. Showing erosion in the mortar joints.

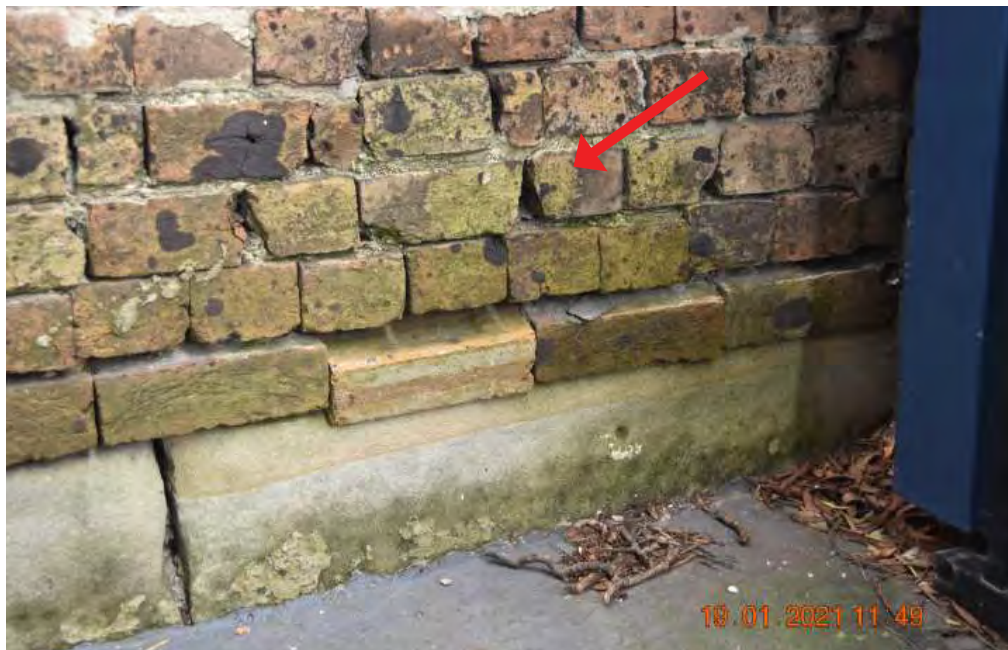
Figure: 1388

Movement in the heritage wall at the southwest corner of building B.

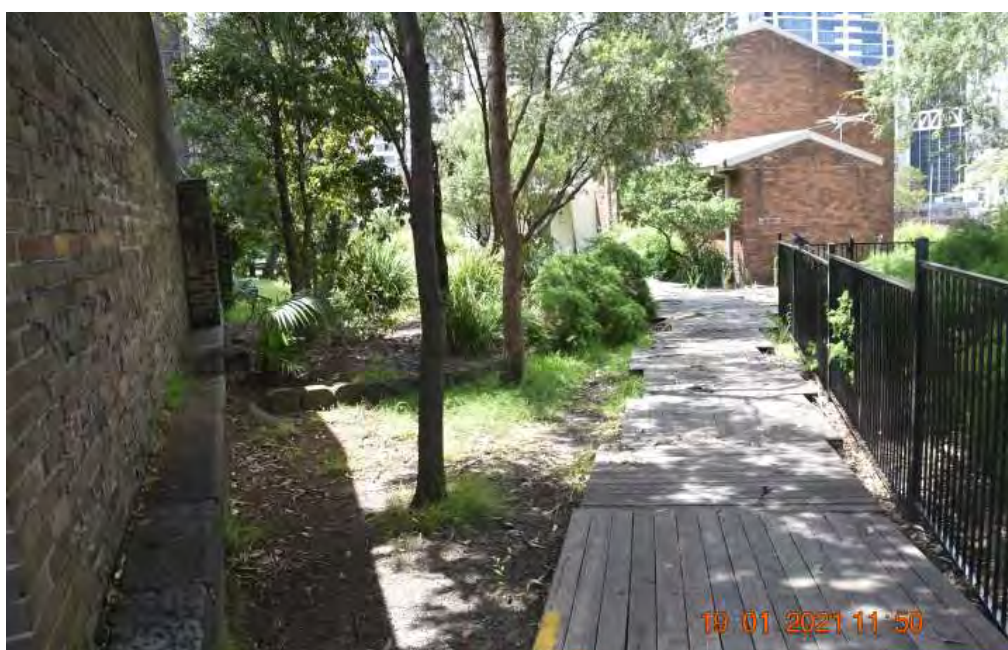
Figure: 1390

Cracking in the paving on the west side of building B.

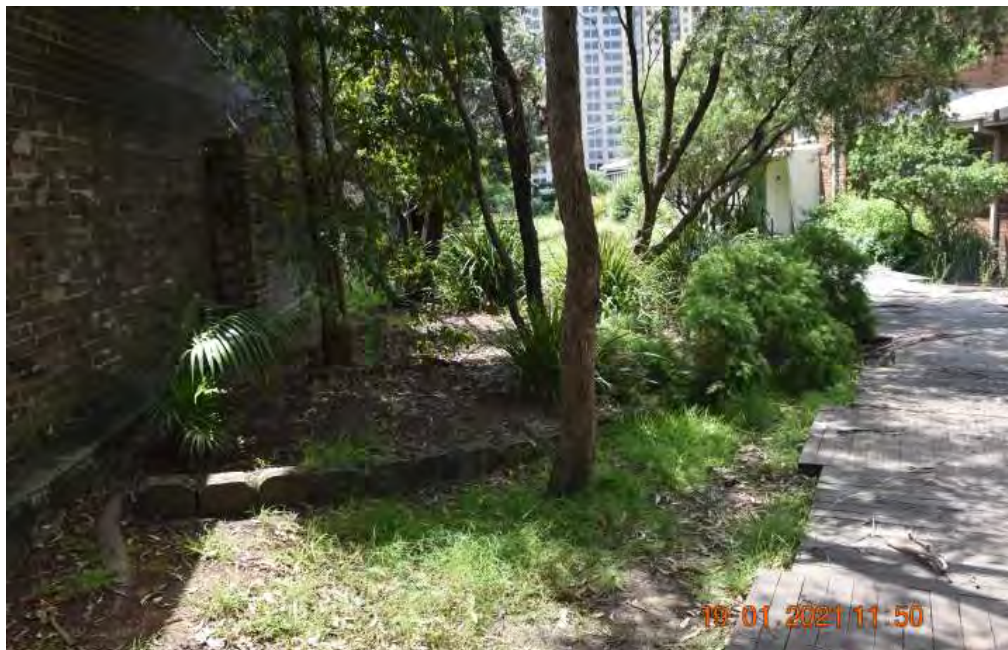
Figure: 1391

General view of the pathway and grass area on the south side of building F.

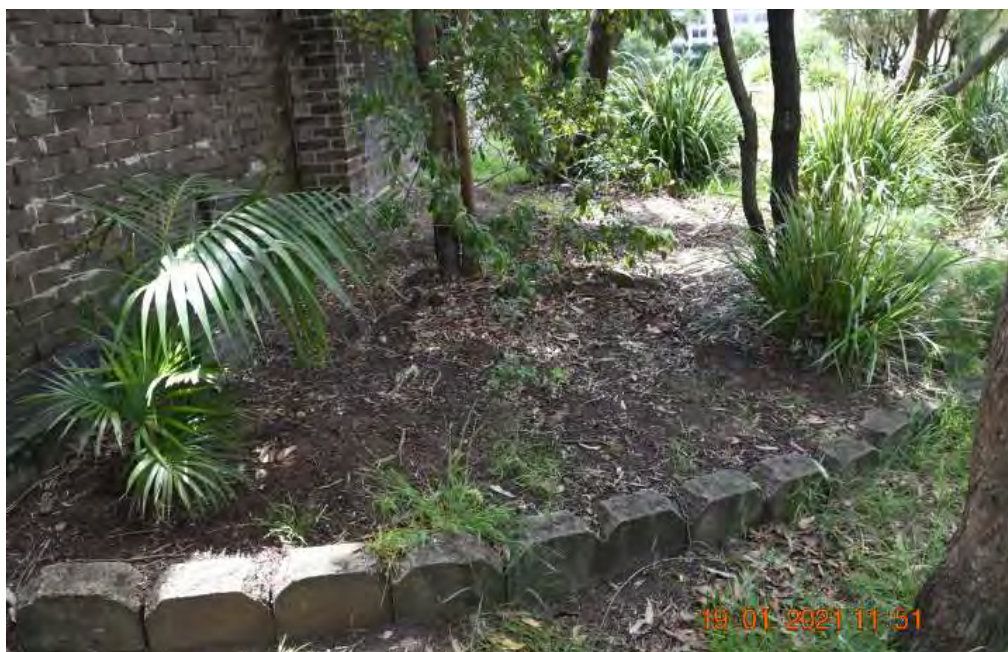
Figure: 1392

General view of the pathway and grass area on the south side of building F.

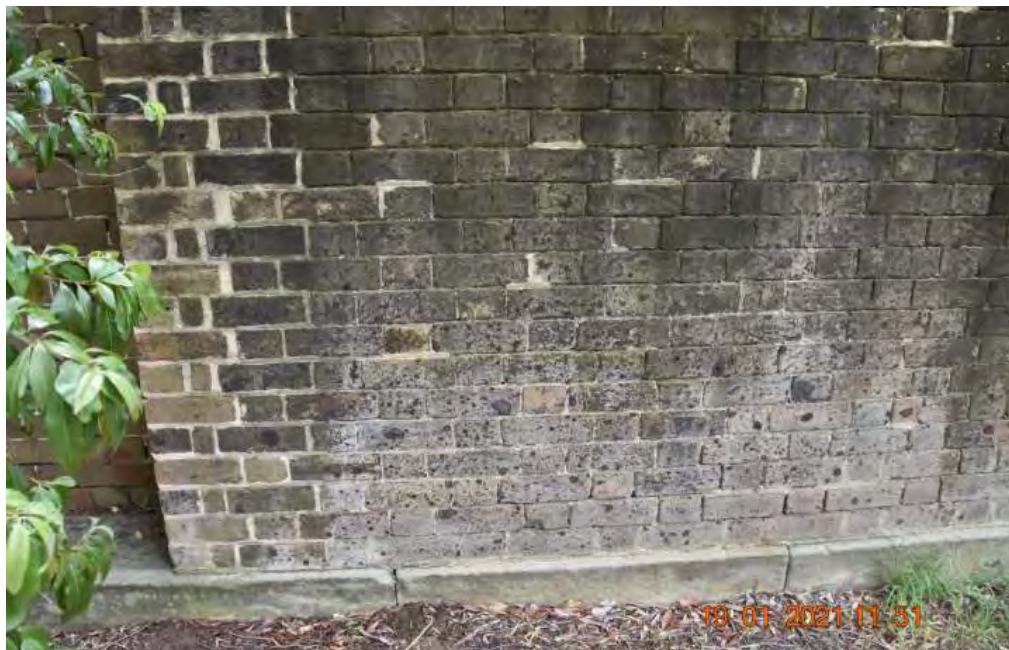
Figure: 1394

General view of the heritage wall on the south side of building B.

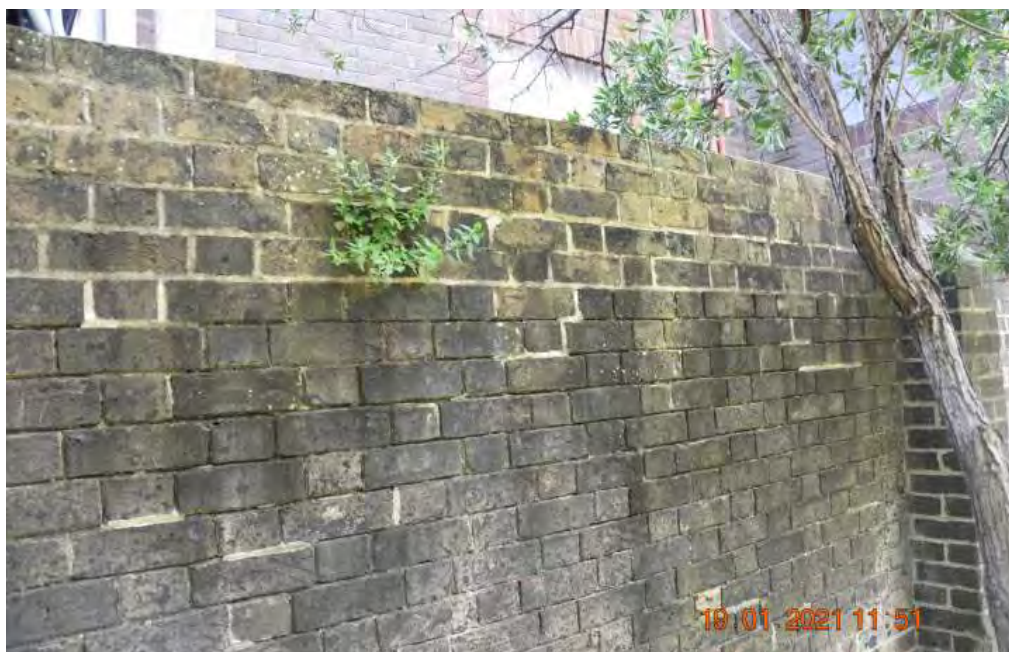
Figure: 1395

General view of the heritage wall on the south side of building B.

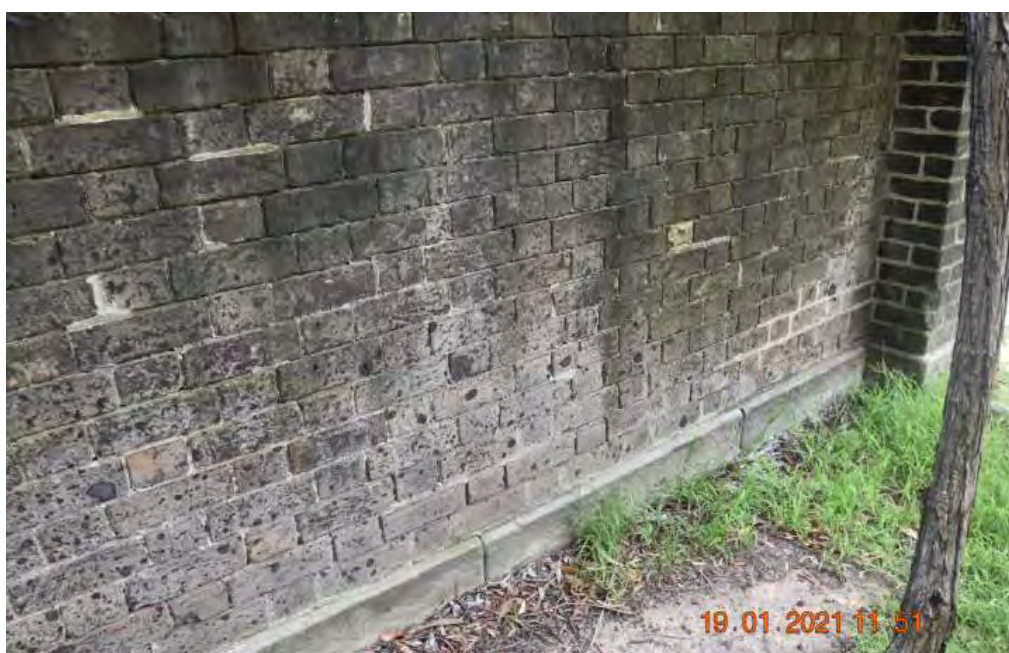
Figure: 1396

General view of the heritage wall on the south side of building B.

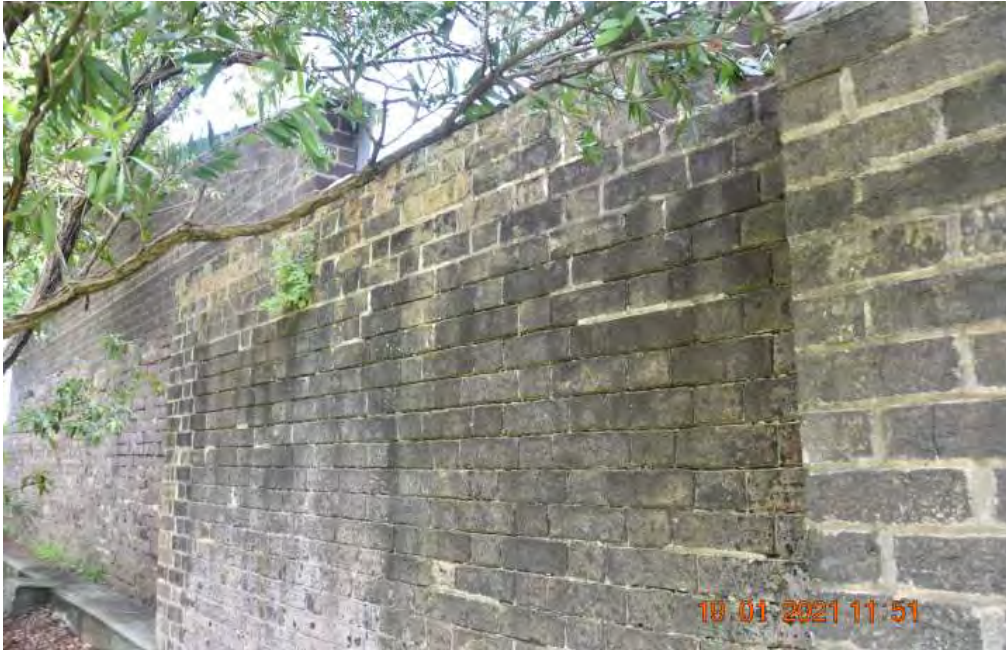
Figure: 1397

General view of the heritage wall on the south side of building B.

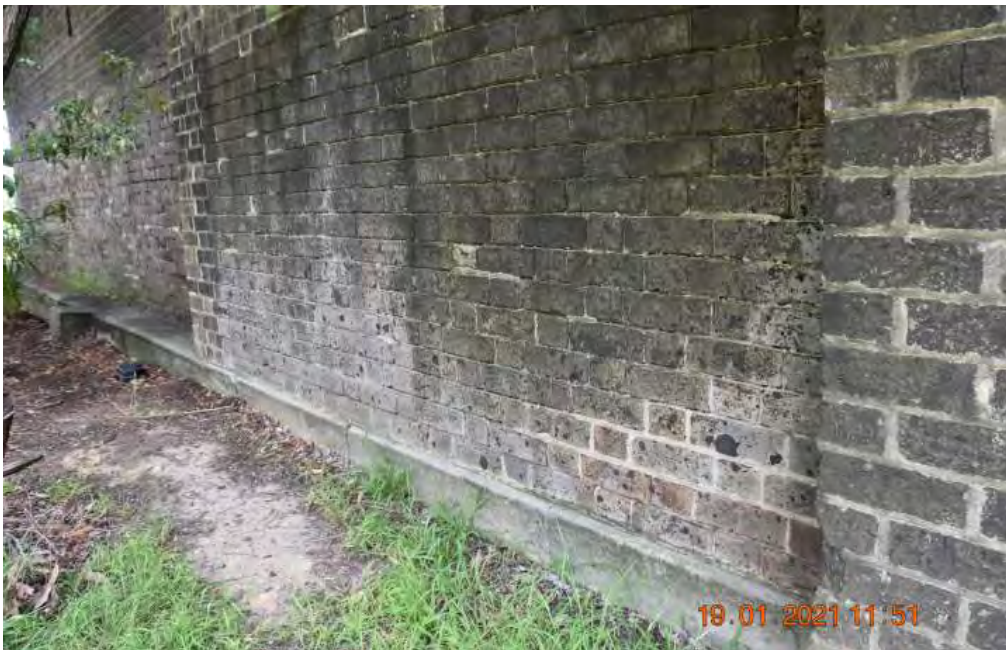
Figure: 1398

General view of the heritage wall on the south side of building B.

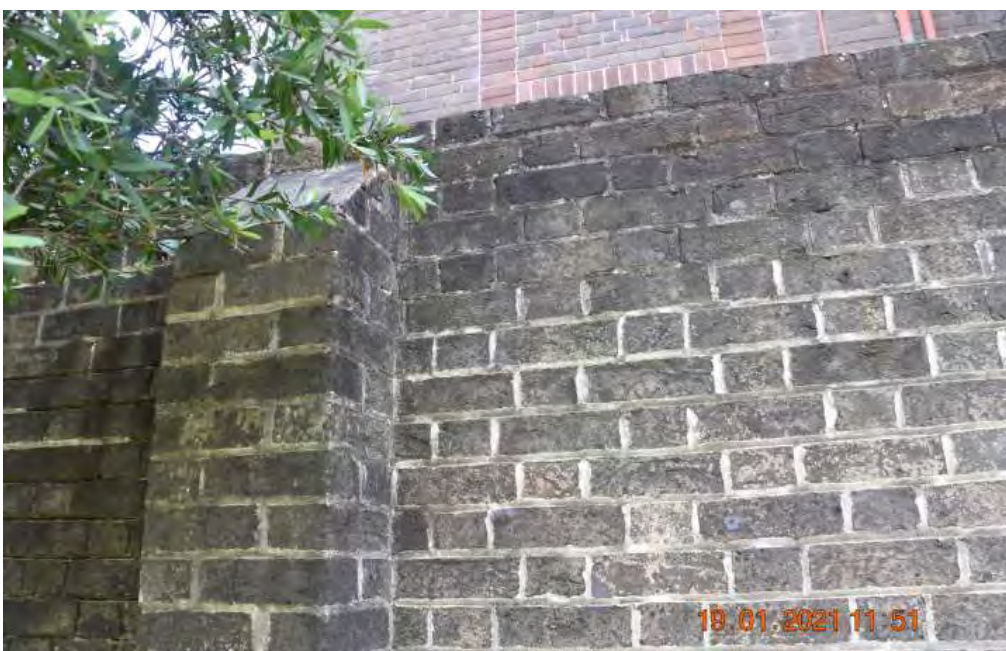
Figure: 1399

General view of the heritage wall on the south side of building B.

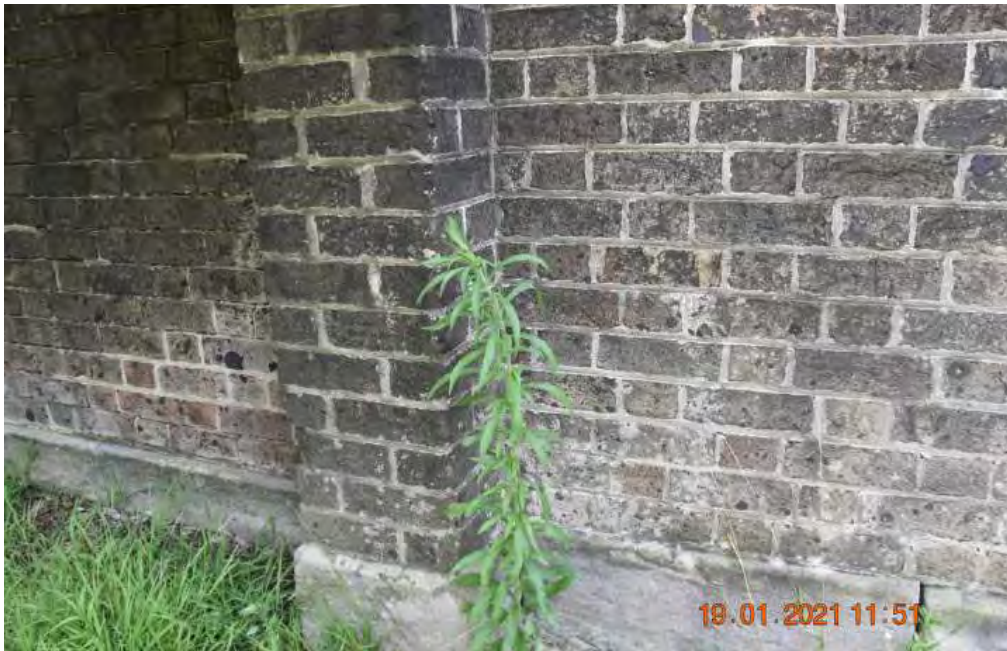
Figure: 1400

General view of the heritage wall on the south side of building B.

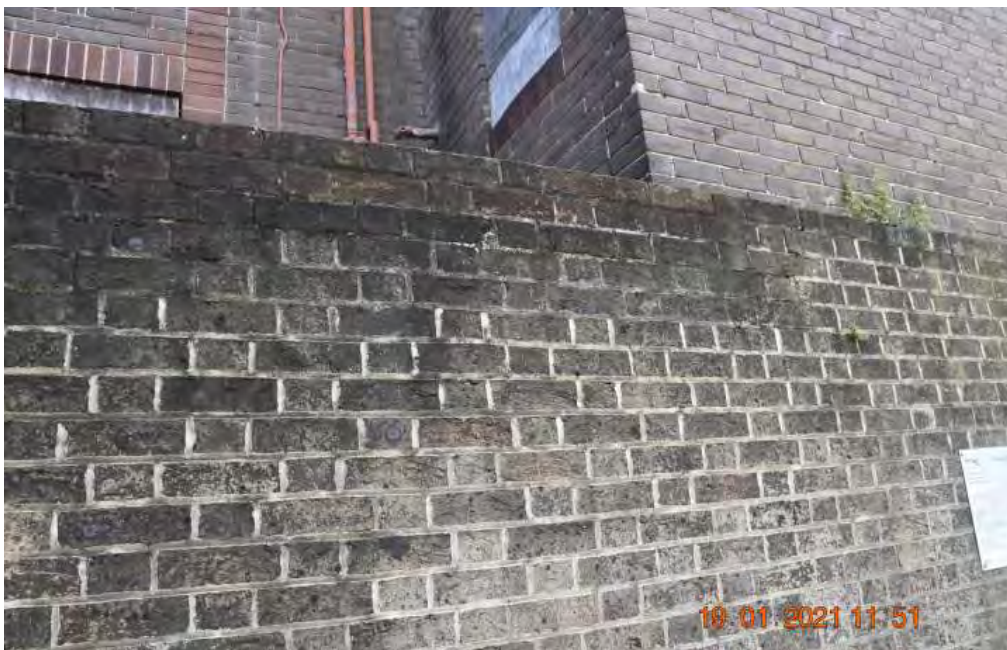
Figure: 1401

General view of the heritage wall on the south side of building B.

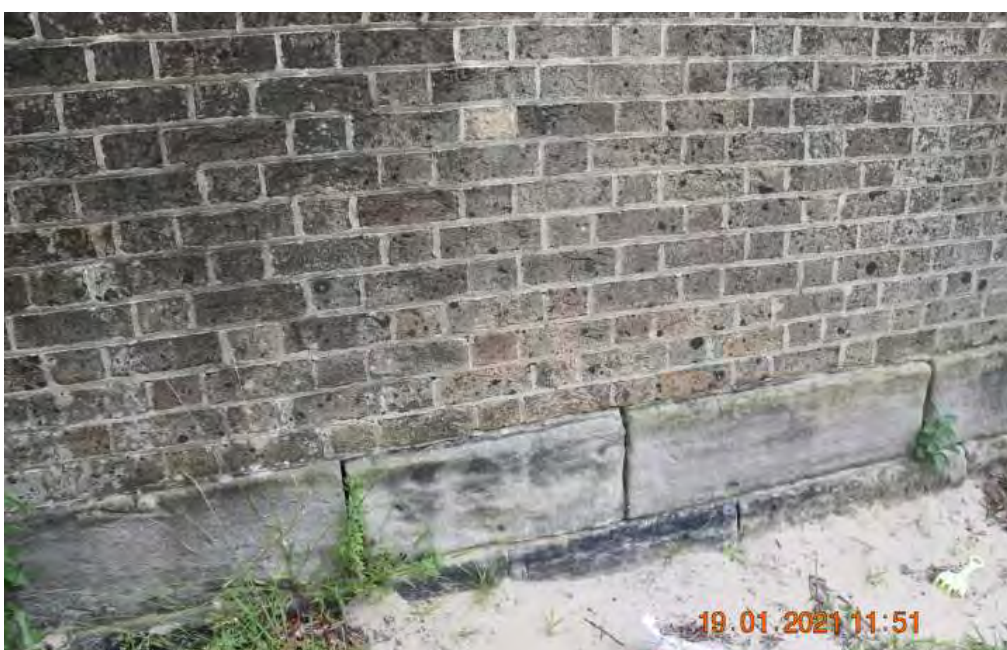
Figure: 1402

General view of the heritage wall on the south side of building B.

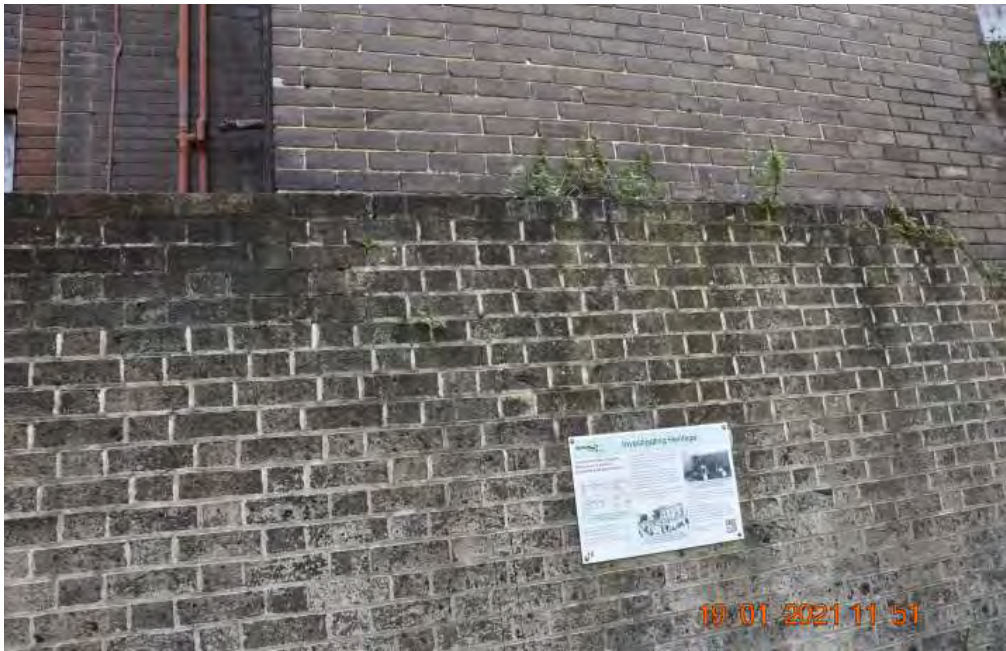
Figure: 1403

General view of the heritage wall on the south side of building B.

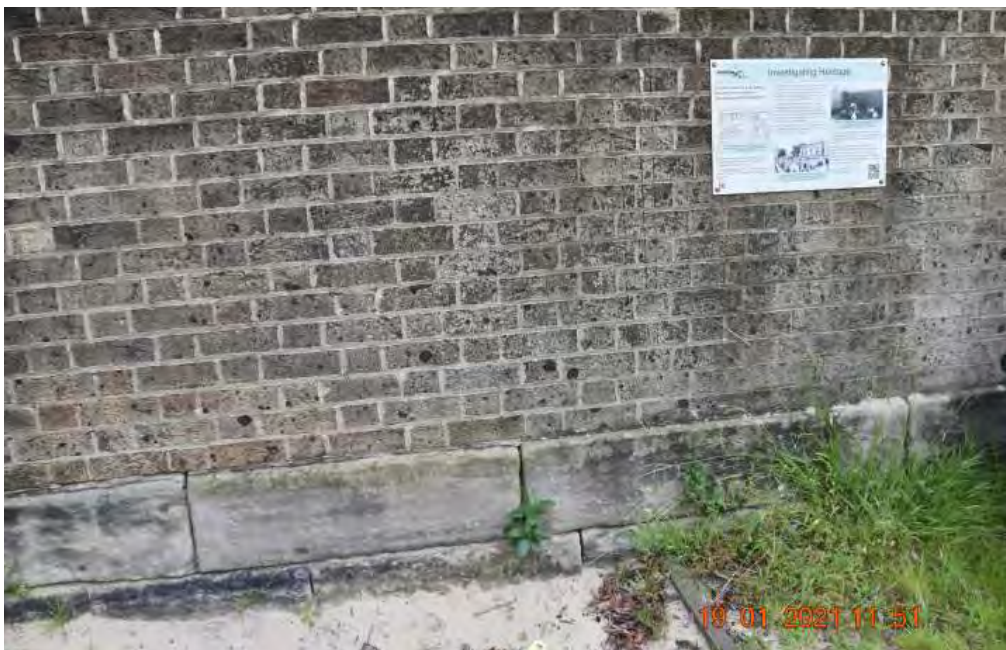
Figure: 1404

General view of the heritage wall on the south side of building B.

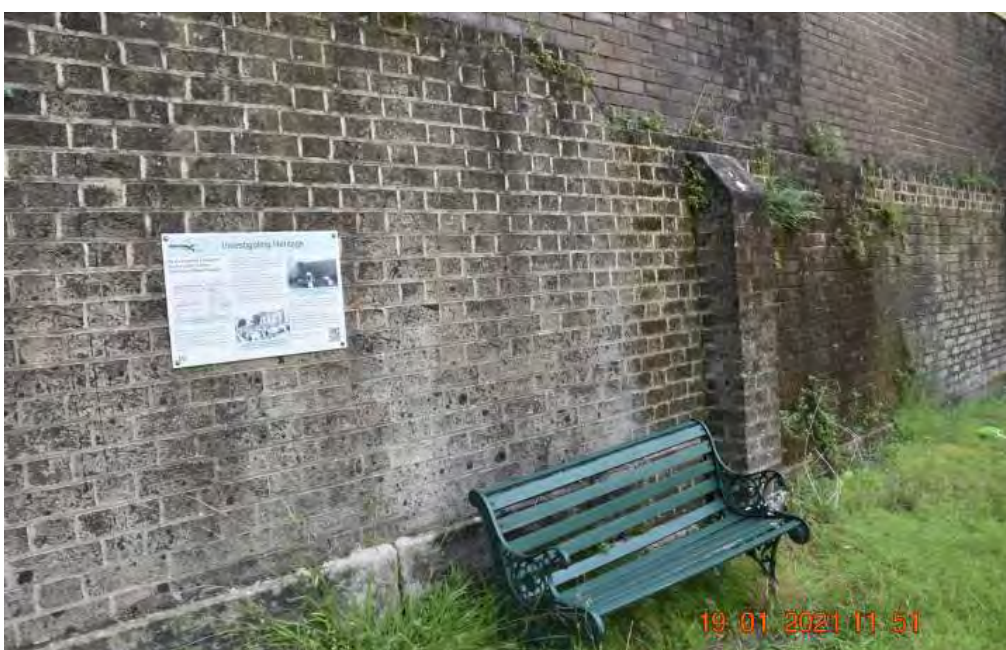
Figure: 1405

General view of the heritage wall on the south side of building B.
